Executive Summary

ADA Self-Evaluation Report

Plan Purpose

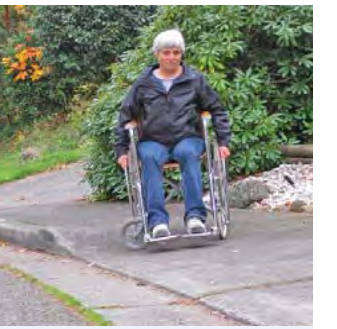
Steep driveway cross slope.

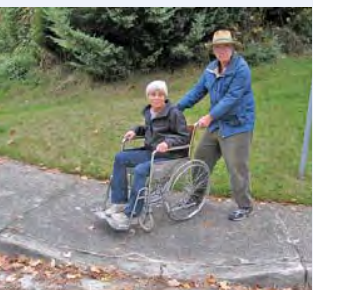
No ramp landing panel.
