**Toward Universal Access: Americans with Disabilities Act  
Sidewalk and Curb Ramp Self-Evaluation Report  
for the City of Bellevue**

*September 2009*

# ADA Self-Evaluation Report

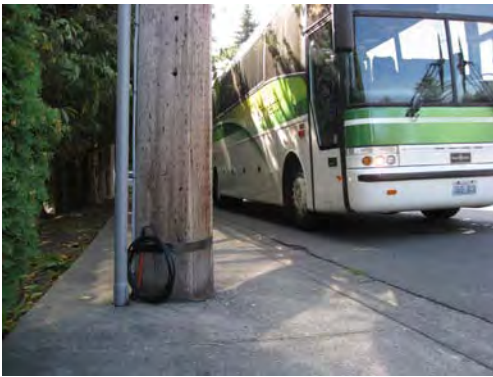
*Fixed obstructions.*

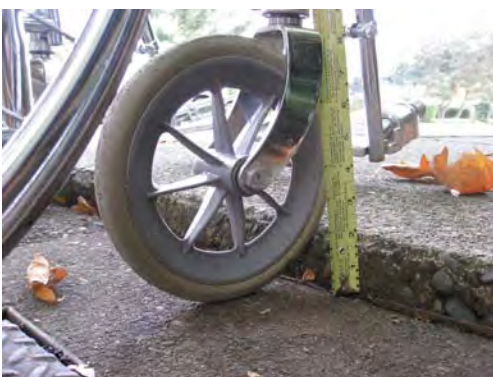
*Change in level.*

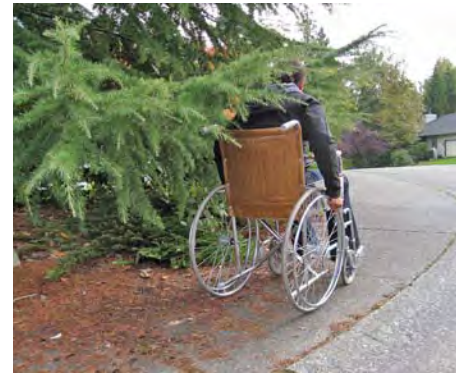
*Vegetation and grade barriers.*

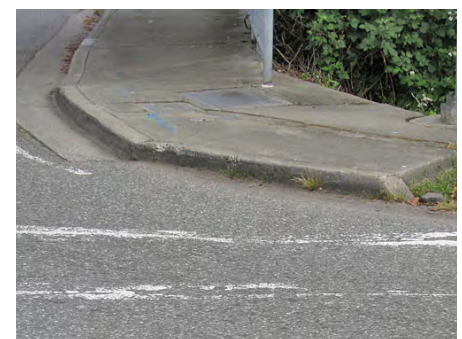
*Missing ramp.*

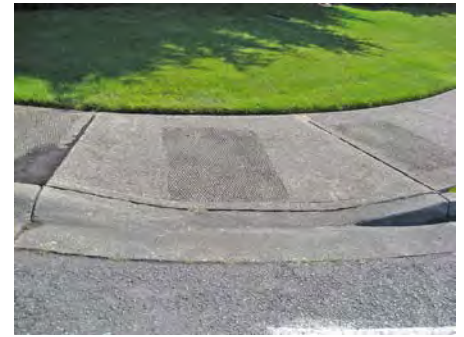
*Missing detectable warning surface.*

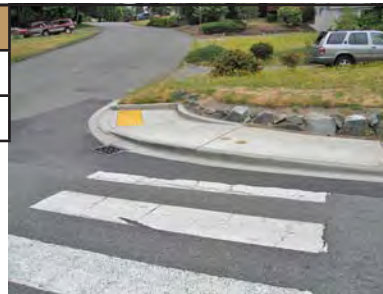
*Ramp not aligned with crosswalk at Main Street & 164th Avenue NE.*

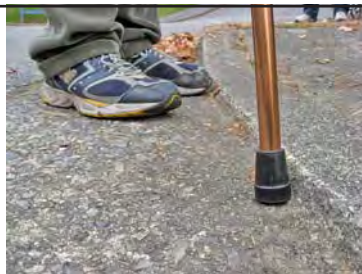
- (iv) **Smooth Gutter/Ramp Transition.** Vertical changes that exceed 1/4 inch in elevation at the bottom of a ramp can cause front casters to swivel and impede the momentum needed to propel the chair up-slope at a curb ramp threshold. ADAAG 4.7.2 specifies that transitions from ramps to gutter and streets should be flush and free of level changes.

Gutter/ramp transition not smooth at SE 26th Street & 130th Avenue SE.

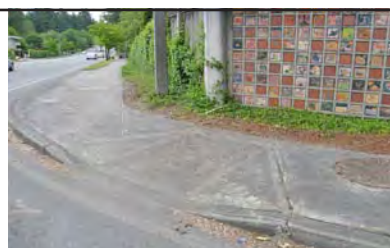
Ramp landing panel missing at 126th Avenue NE & NE 9th Street.

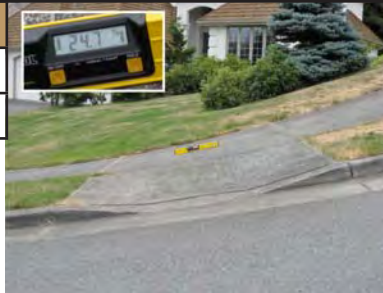
*Steep ramp landing panel slope at SE 56th Street & 175th Place SE.*

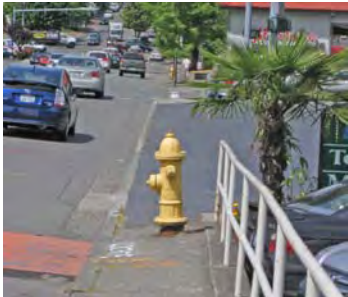
Hydrant on 3 foot sidewalk at Main Street & 107th Avenue NE renders sidewalk unusable to people with disabilities.

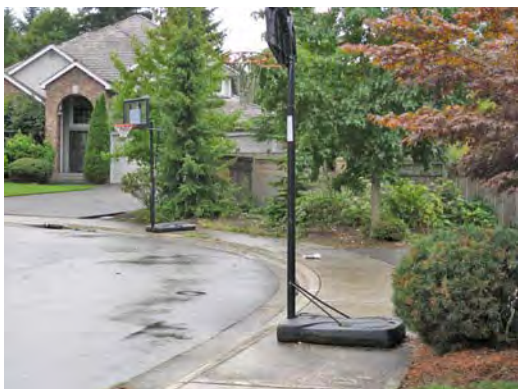
*Two basketball hoops obstructing sidewalk at 159th Avenue NE and NE 24th Street.*

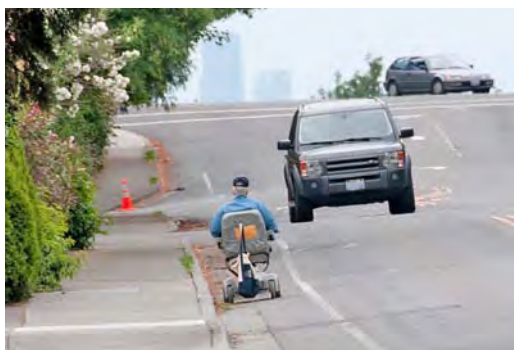
*Wheelchair user is forced to use the gutter along SE 8th Street instead of the adjacent sidewalk because of a poorly placed garage sale sign at the curb ramp located at 143rd Avenue SE and SE 8th Street. In Bellevue, portable signs, including sandwich boards, are generally prohibited from the right-of-way. No signs shall be placed "so as to be hazardous to a...pedestrian's ingress and egress from...any way open to the public" (22B.20.140).*

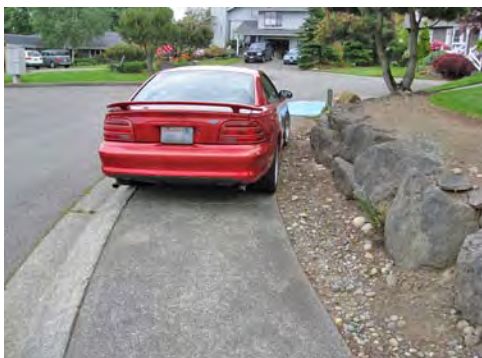
Parked vehicle obstructing sidewalk with rolled curb on SE 52nd Place.

Unlike the GMS-2 with manual entry, the ULIP methodology was not set up to allow field staff to record what specific object caused the obstruction. However, trash cans and parked cars seemed to be the most common movable obstructions. Field staff observed a higher incidence of obstructing parked cars in neighborhoods with rolled curbs as opposed to vertical curbs. Because motorists can easily drive over them, rolled curbs tend to encourage obstructive parking.

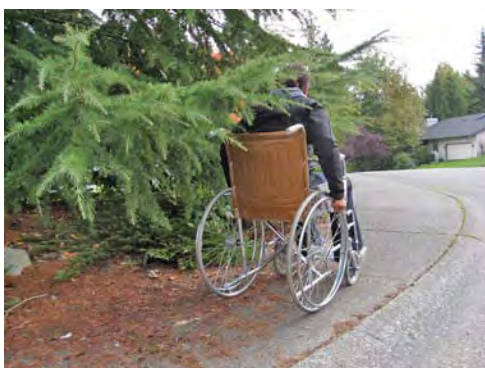
*Wheelchair user struggles to traverse a sidewalk that has both vegetation and debris at 165th Place SE & SE 39th Place.*

In addition to narrowing the pedestrian path of travel, unchecked plants drop debris. While there is no standard threshold for debris, ADAAG 4.5.1 requires that pedestrian surfaces be “stable, firm, and slip-resistant.” Downed branches, fallen conifer needles, leaves, and scattered gravel create uneven and slippery surfaces. The image at right shows debris fallen from trees on adjacent properties and the uneven conditions they create on sidewalks.
