# ADA Self-Evaluation Report

## Executive Summary

### Plan Purpose

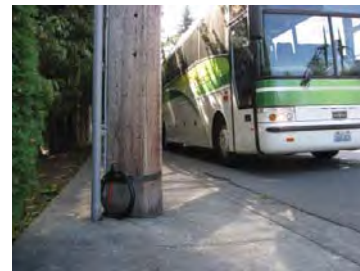
Fixed obstructions.

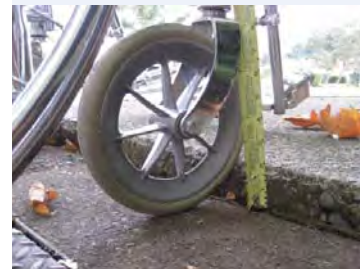
Change in level.

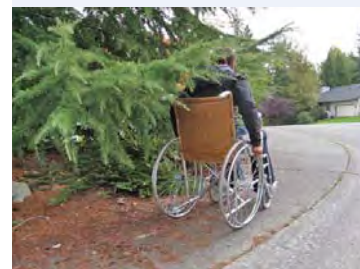
Vegetation and grade barriers.

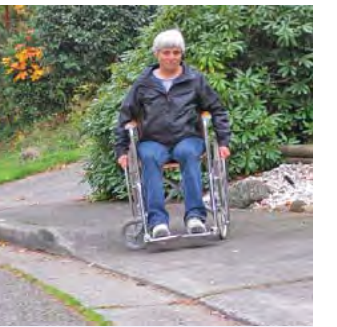
Steep driveway cross slope.

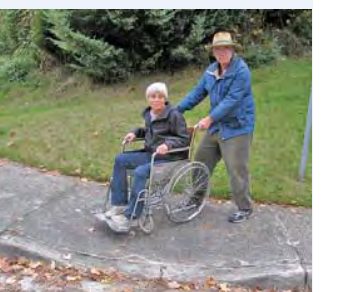
No ramp landing panel.
