City of Bellevue 2015 Electric System Reliability Review

August 19, 2016

2015 Bellevue Reliability Overview

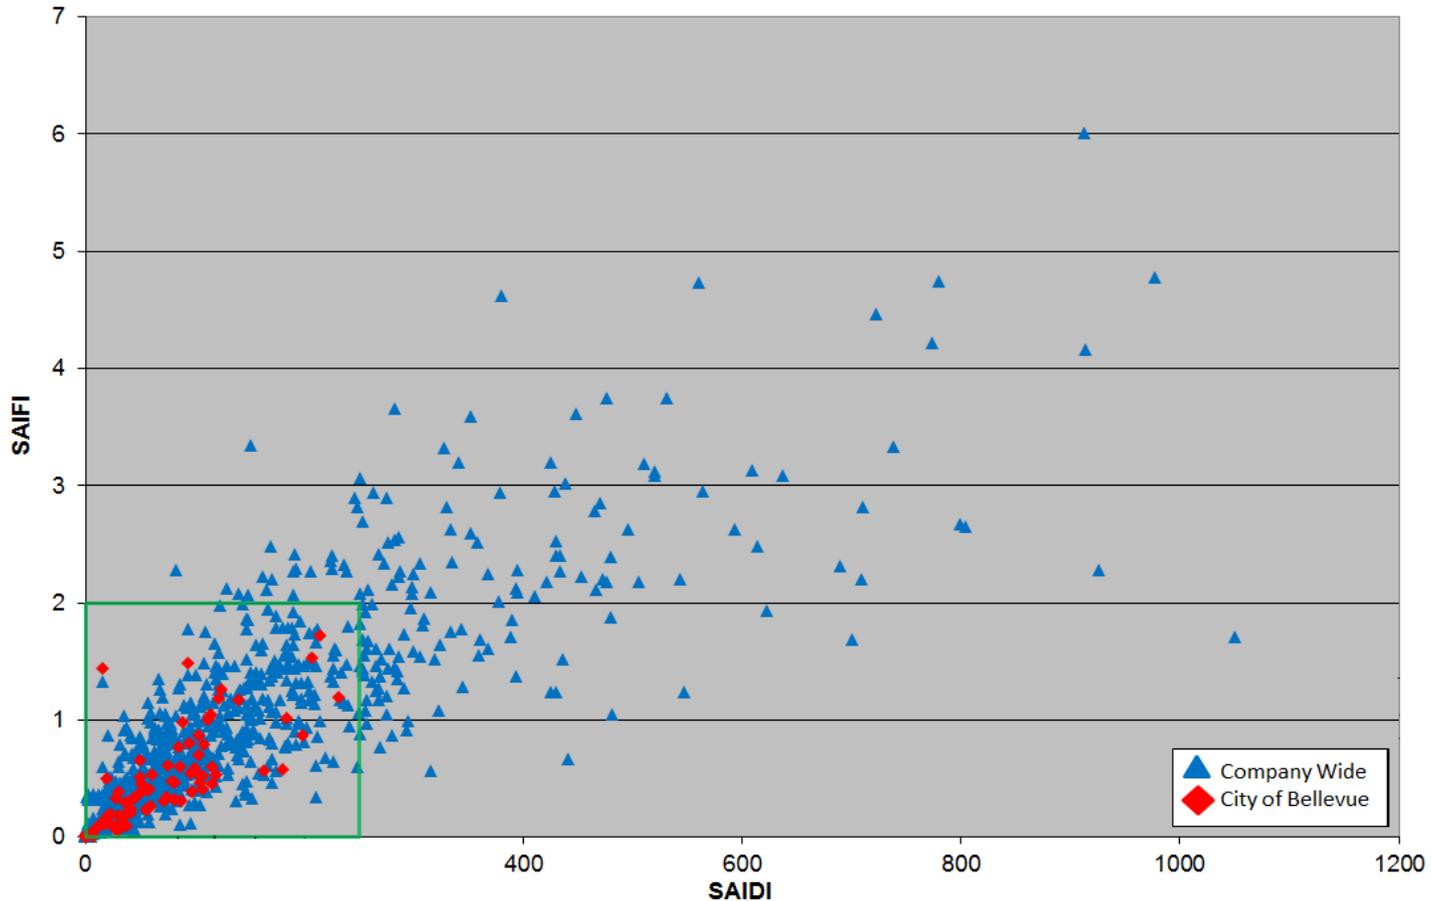
Three Year Average SAIDI/SAIFI (IEEE) Scatterplot
(2013-2015 unplanned non-storm including substation and transmission line)

Distribution circuits serving Bellevue relative to all PSE circuits

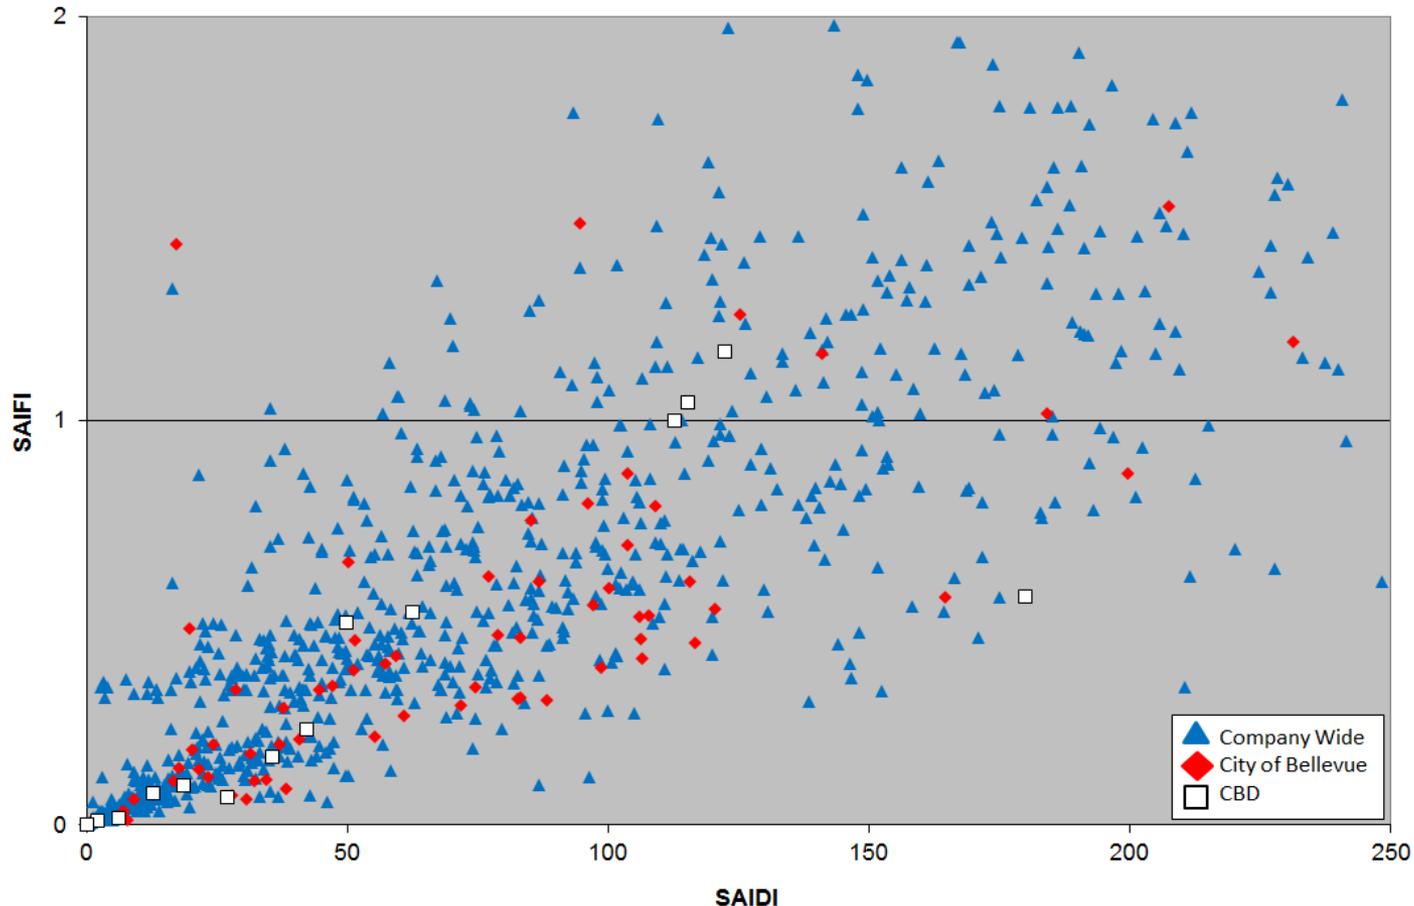
Three Year Average SAIDI/SAIFI (IEEE) Scatterplot
(2013-2015 unplanned non-storm including substation and transmission line)

Enlargement focusing on distribution of circuits serving Bellevue
