City of Bellevue

Preliminary Engineering Design Report for Reservoir Structural/Seismic Evaluation

March, 1999

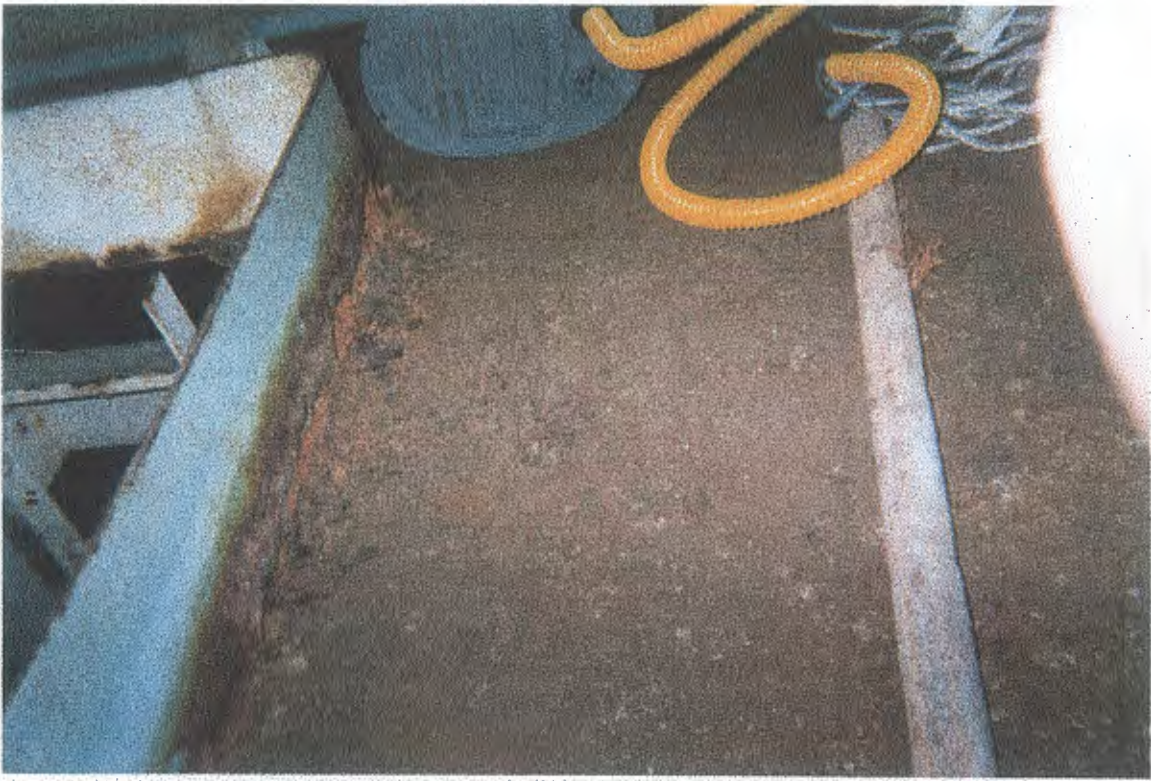
Lake Hills North - Corrosion Adjacent to Access Hatch

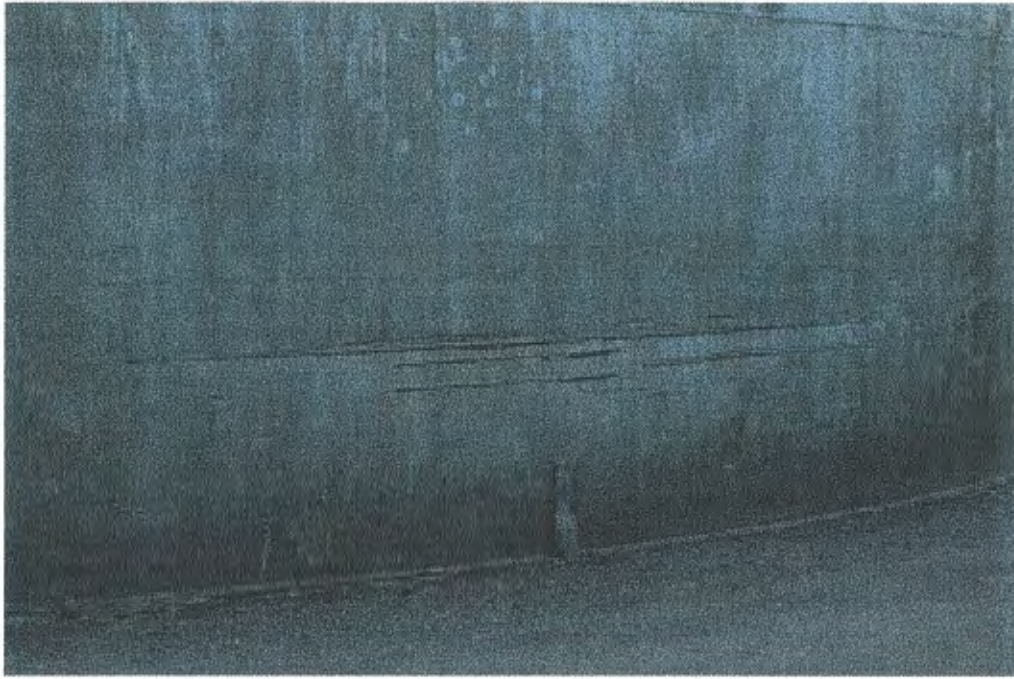
COMMENT 2 The gouges in the tank picture look significant, but were not addressed in the text of the report. Are they significant? Were they measured? Should bollards be installed to prevent future damage?

RESPONSE: These gouges are significant and should be repaired. Bollards should be installed to prevent future damage. This was clarified in the "General Reservoir Condition" subsection of Section 8 and noted in Section 11.

Lake Hills South - Gouged Shell Plate

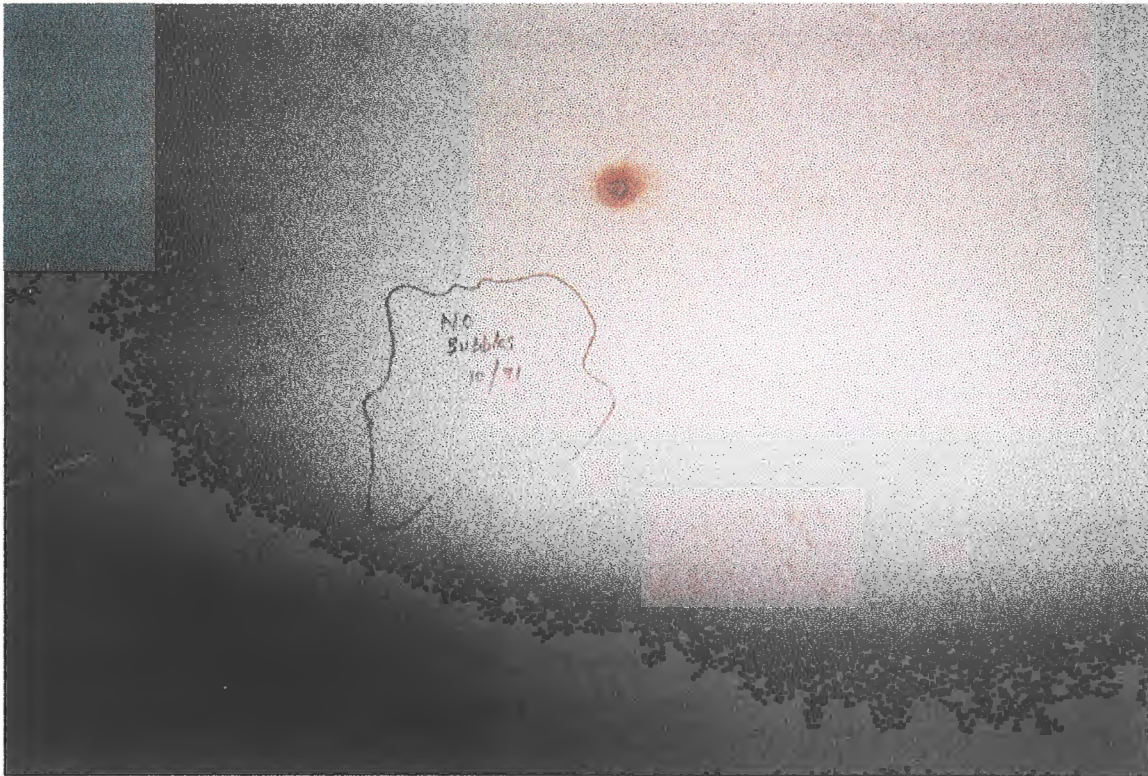
Lake Hills South - Pitting in Floor Plate

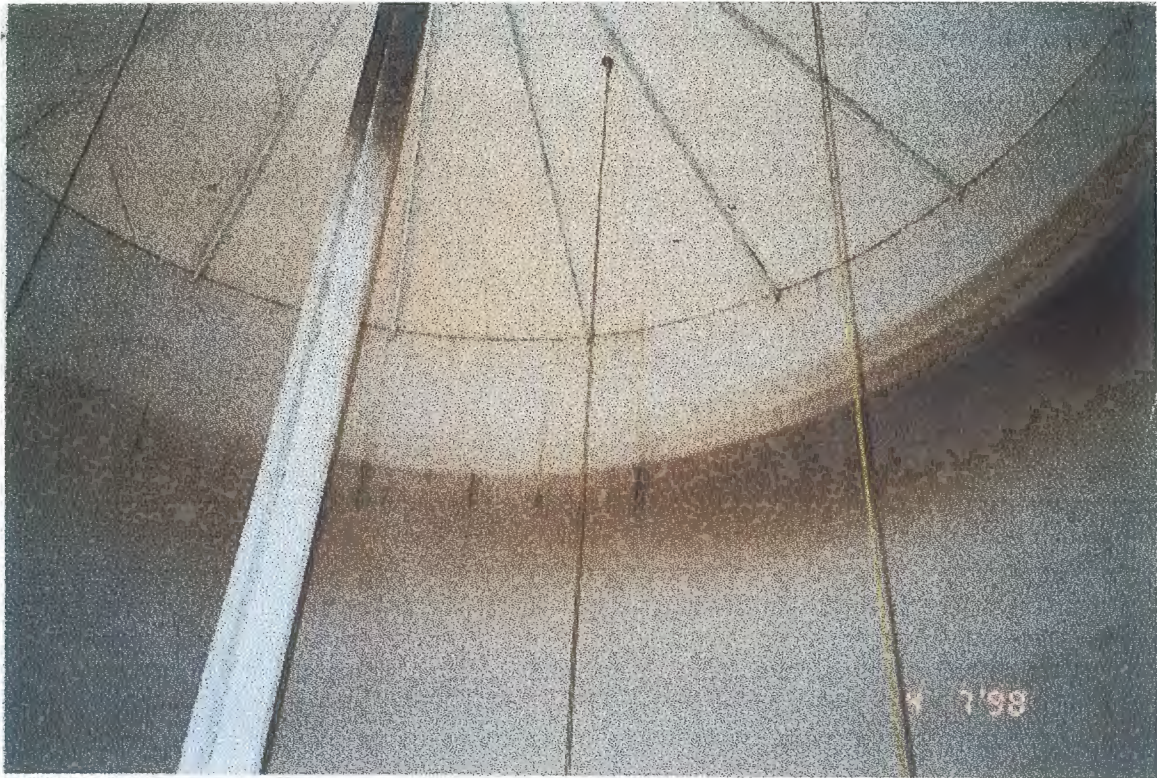
Horizon View No. 1 - Corroded Shell Plate

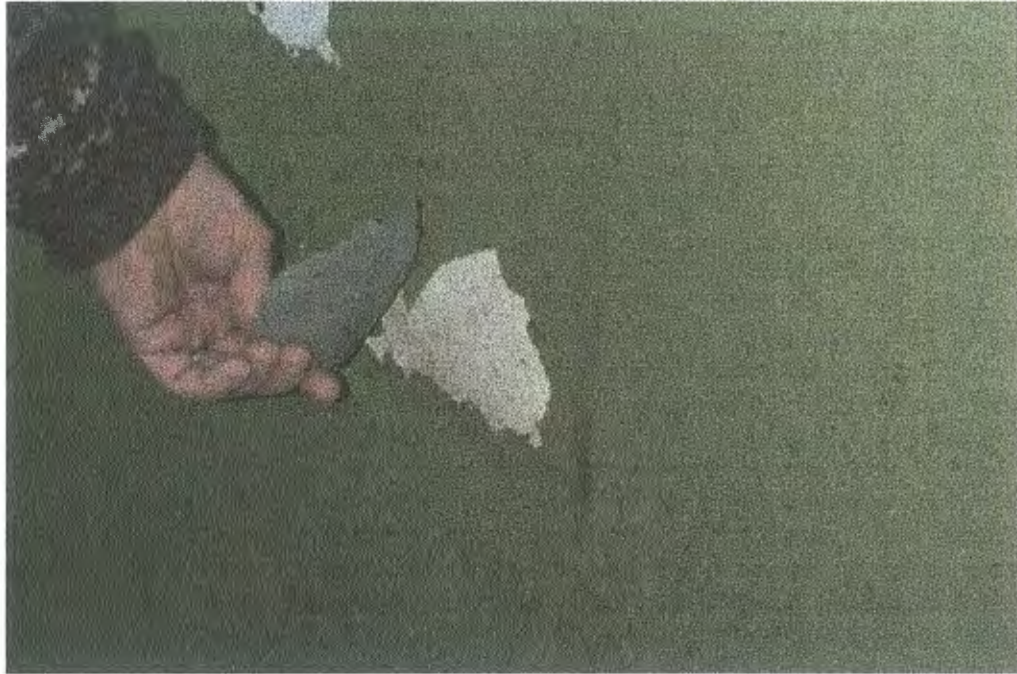
RESPONSE: There were a couple of minor instances where the exterior coating was delaminated and some locations on the west side of the reservoir where the coating system was damaged. This damage appeared to be from vandalism and not from coating failure. The damage was added to the "Interior and Exterior Coatings" subsection of Section 8.

Parksite - Delaminated Exterior Coating

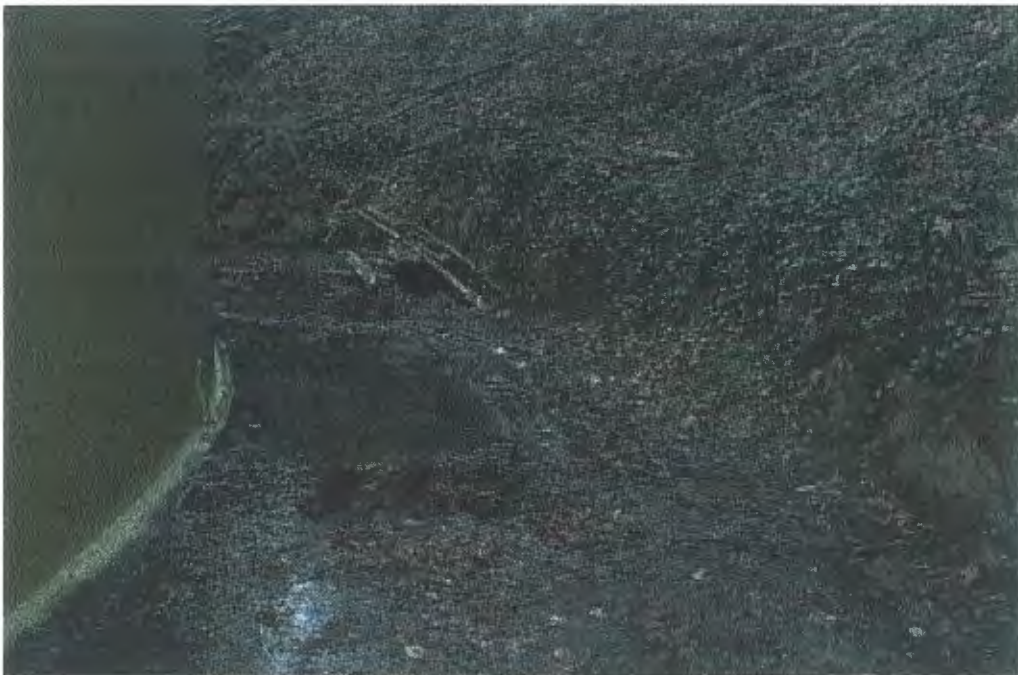
COMMENT 1 The photos show ponding around the reservoir. Note that drainage improvements should be performed to remove this condition.

Parksite - Site Drainage Problem

RESPONSE: Required drainage improvements are noted in the General Reservoir Conditions in Section 8 and Section 11 of the report.

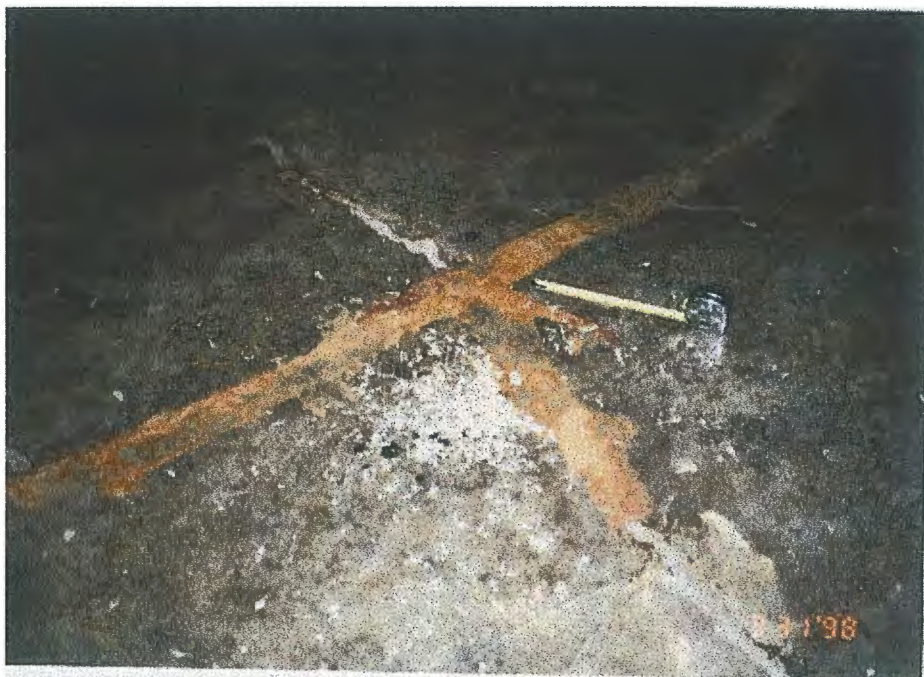
Somerset No. 1 - Cracks in Floor Slab

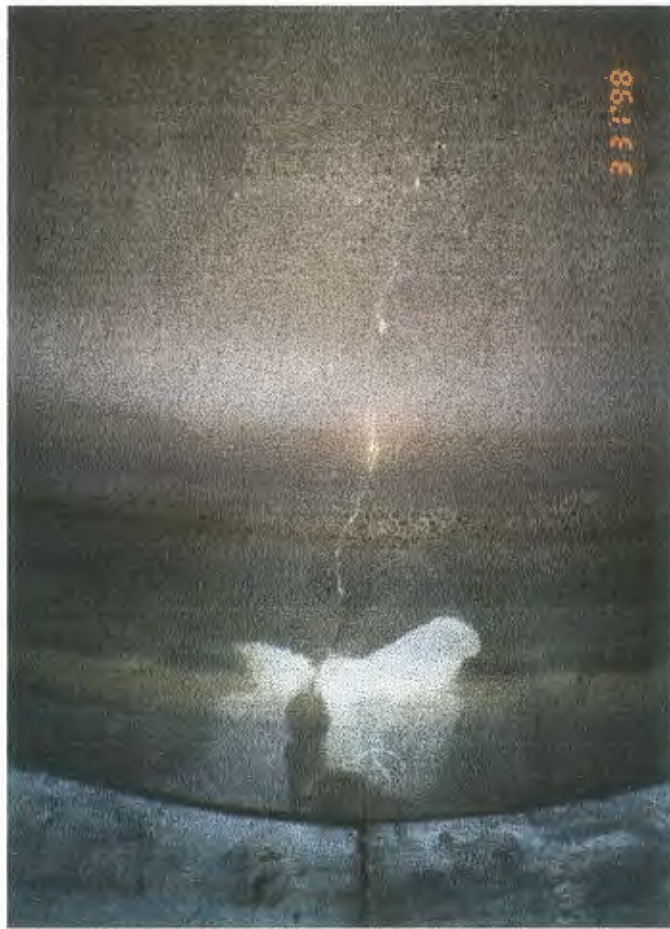
Somerset No. 1 - Vertical Wall Crack

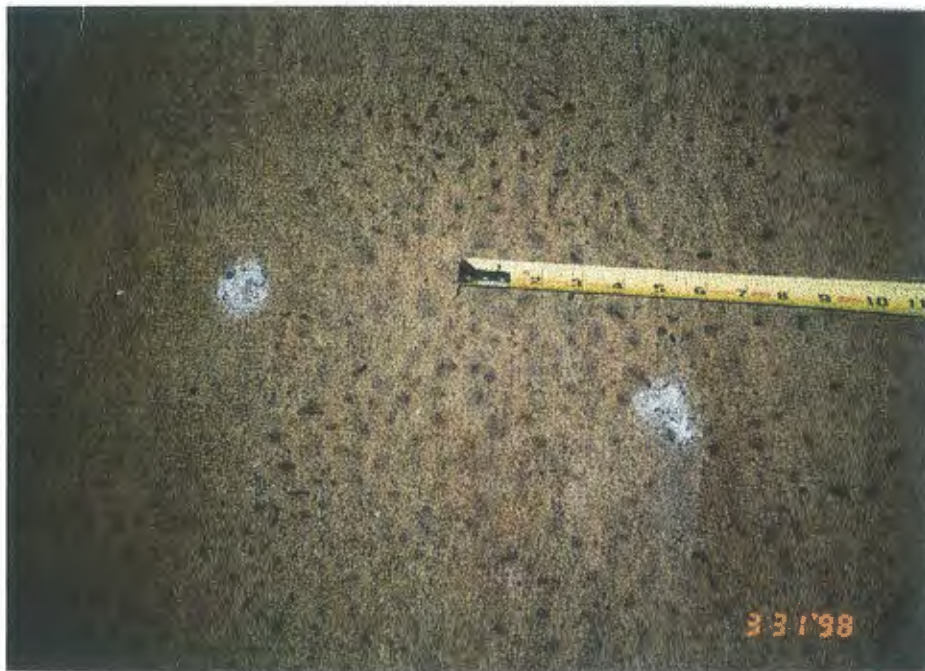
COMMENT 2 The concrete in the precast panels was noted to be in poor condition "the fine aggregate can be hand rubbed away". If this is considered typical wear for a 35-year old reservoir, what is the life expectancy for a concrete reservoir?

Somerset No. 1 - Deteriorated Wall

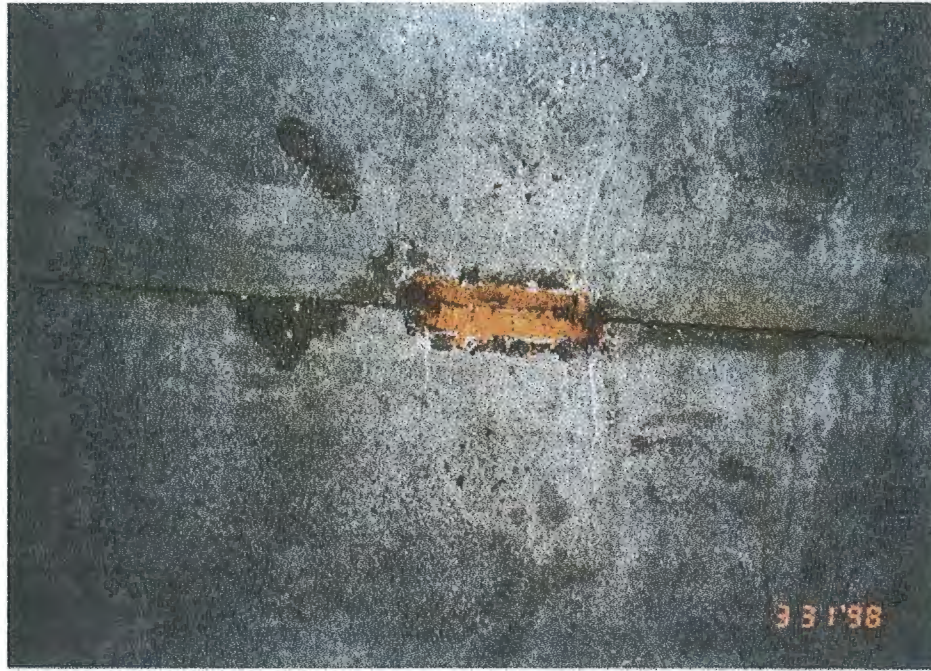
Somerset No. 1 - Spalled Concrete at Diaphragm Connection

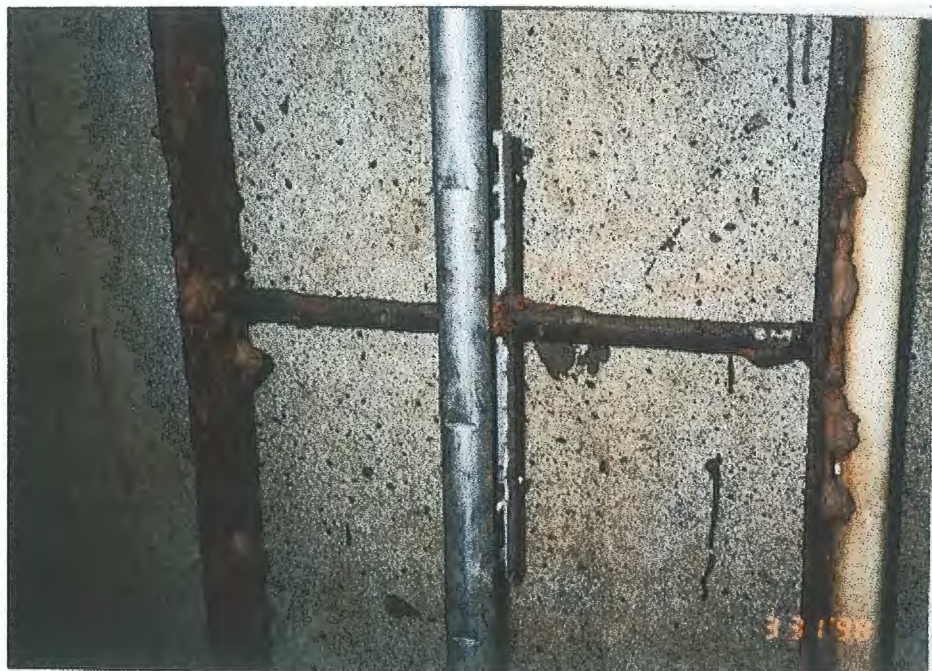
Somerset No. 1 - Corroded Access Ladder

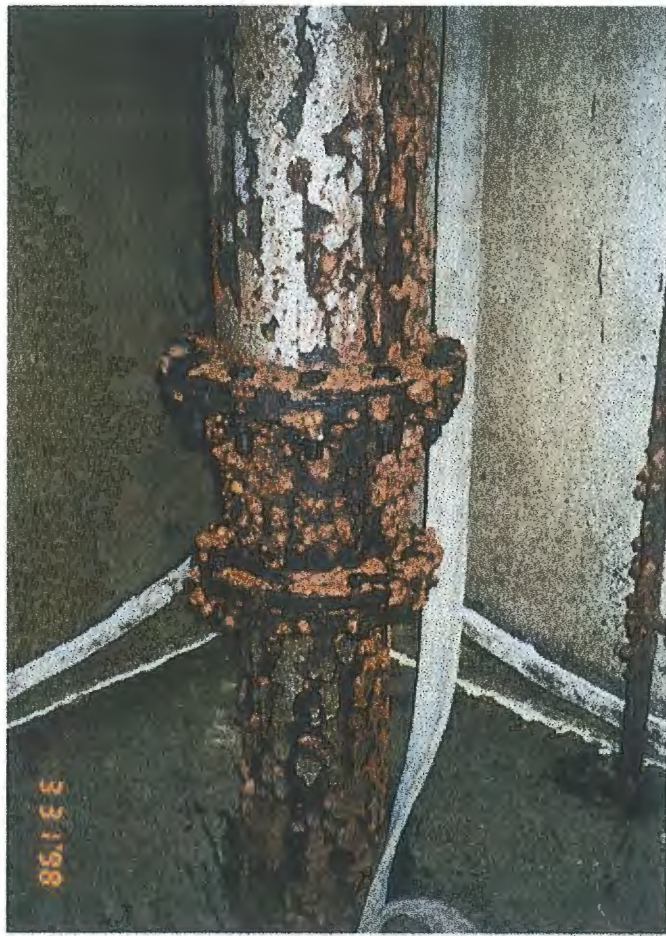
Somerset No. 1 - Corroded Overflow
