January 27, 2022

Subject: Landslide Damage Assessment
SURDI RESIDENCE
5008 139th Place SE
Bellevue, Washington 98006

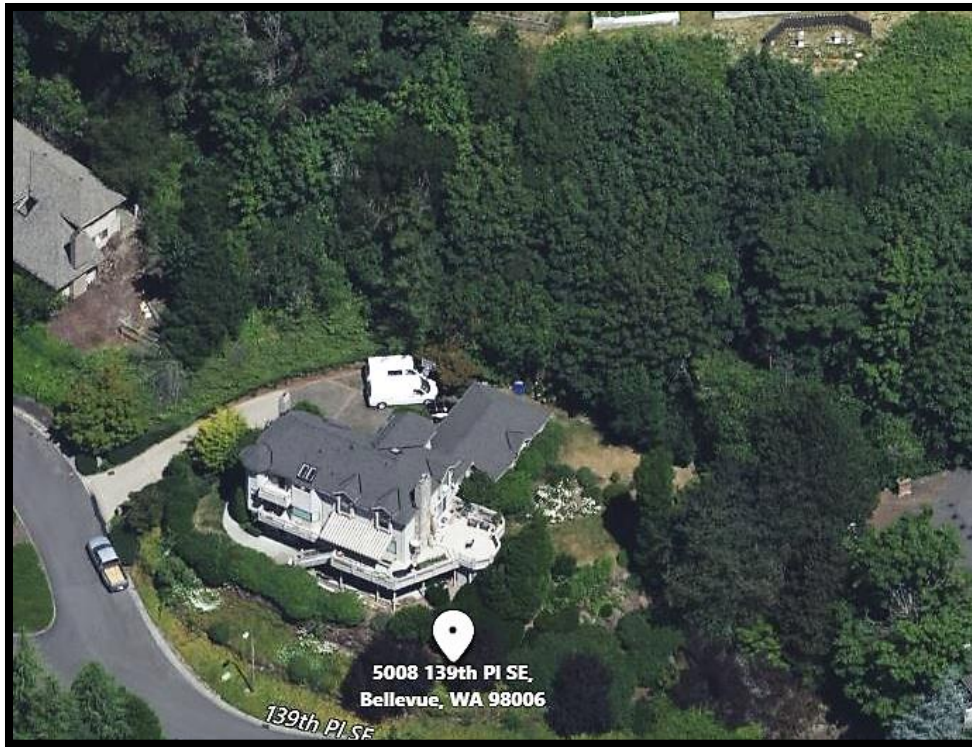
The Surdi Residence is a wood-framed, two-story home with a daylight basement and a concrete foundation located on the north side of 139th Place SE in the Somerset neighborhood of Bellevue, Washington (Photograph Nos. 1 & 3). According to the King County Assessor, the building was originally constructed in approximately 1984. The building is generally rectangular in shape with approximate overall dimensions of 30' by 45' with the long axis of the building oriented in the east-west direction. A 20' by 30' garage extends north from the eastern end of the home. A driveway extends around the west side of the property to the north entry/garage. A deck wraps around the east and south sides of the home. The home is on a site that slopes steeply down to the south (down towards 139th Place SE).

1. The Surdi property prior to the January 17, 2022 landslide looking north (bird's eye aerial image courtesy of Bing Maps).

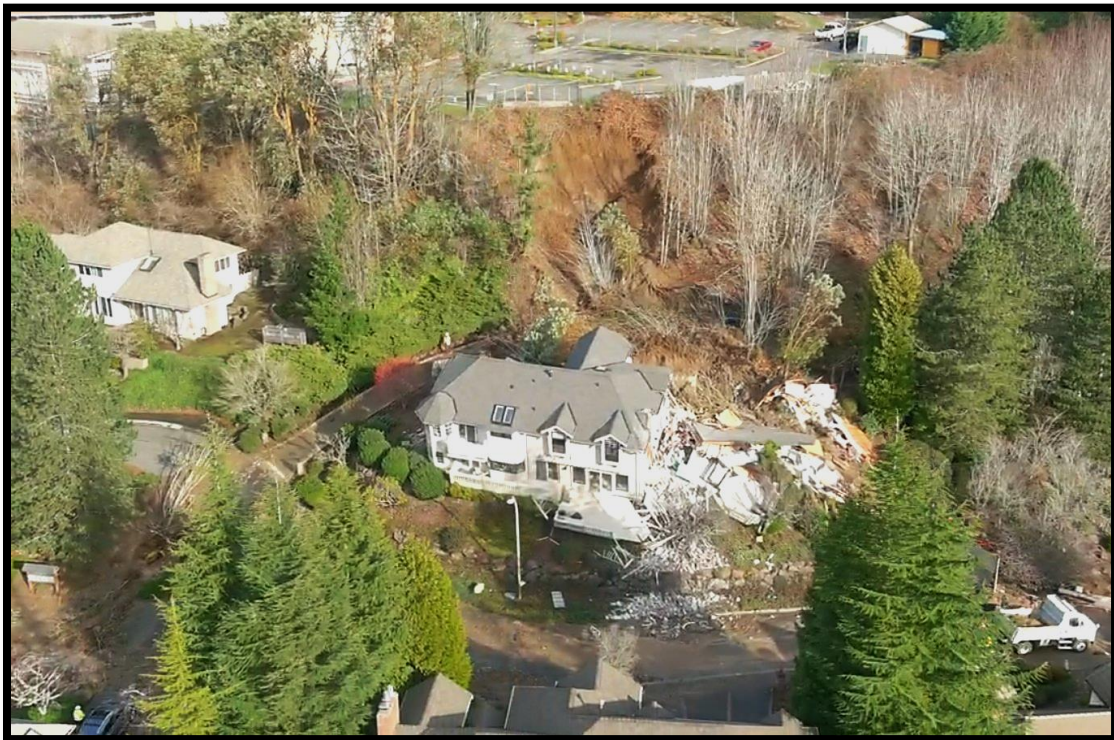
On January 17, 2022, a landslide occurred above and just north of the home, and the debris from the landslide impacted the residence and pushed it off its foundation and downhill (Photograph Nos. 2, 4 & 5).

1. The north side of the home was impacted by the landslide debris and the wood structure was pushed approximately 15' or more south off its concrete foundation. The south daylight basement wall appears to have collapsed, and the south side of the home and the deck are currently resting upon or adjacent to a rock wall downslope of where the home was originally situated. The entire home has tilted and is leaning down the hill such that the top of the home is more than 4' further downhill than the bottom (leaning approximately 15 degrees to the south). (Photograph Nos. 2, 4, 5, & 6)

2. The Surdi property after the January 17, 2022 landslide looking north (aerial image courtesy of KIRO 7).

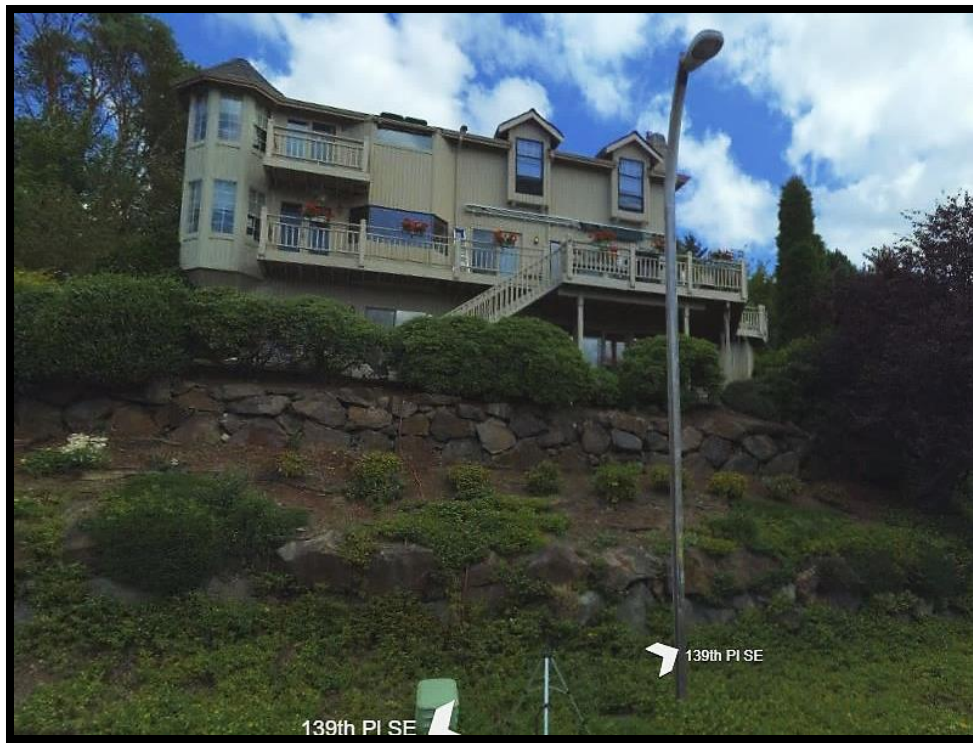
3. The south elevation of the Surdi residence prior to the January 17, 2022 landslide (street view image courtesy of Bing Maps).

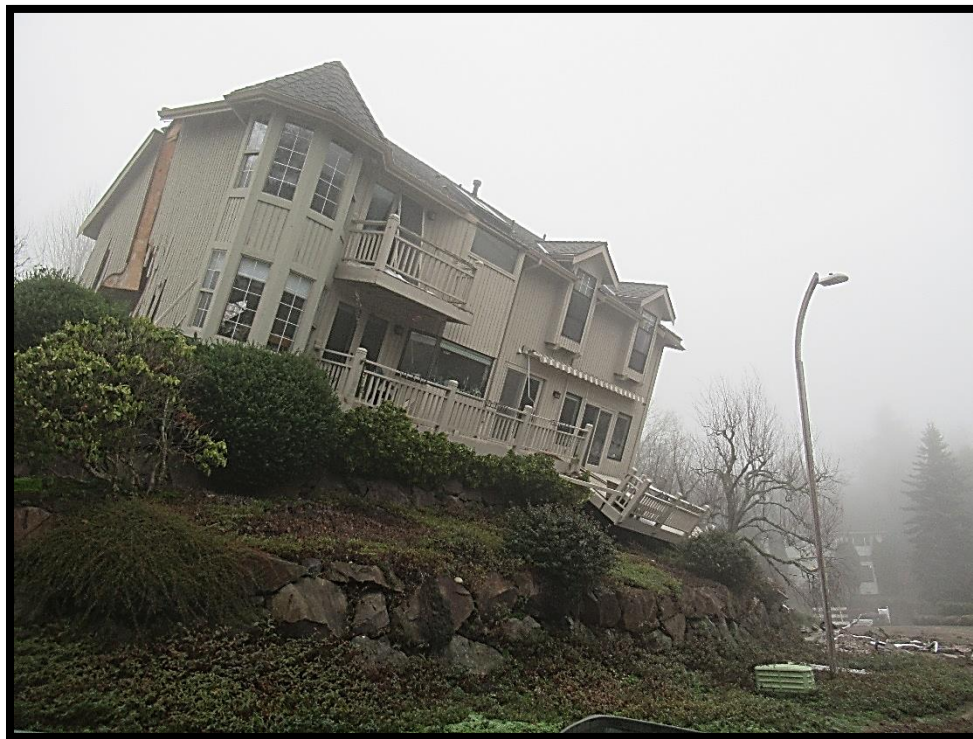
4. The home was impacted by the landslide and the structure was pushed approximately 15' or more south off its concrete foundation.

Due to the instability of the subject wood structure and the ongoing risk that the home poses to the adjacent street and structures, we recommend that the home be demolished as soon as possible. It is our opinion that the safety risks are too great to allow construction personnel to work in close proximity to the home, and therefore, we are unable to recommend the installation of bracing near/for the home prior to demolition. There does not appear to be any portions of the wood-framed sections of the home that are salvageable. After demolition and debris removal, the home's concrete foundation may be evaluated for reuse.

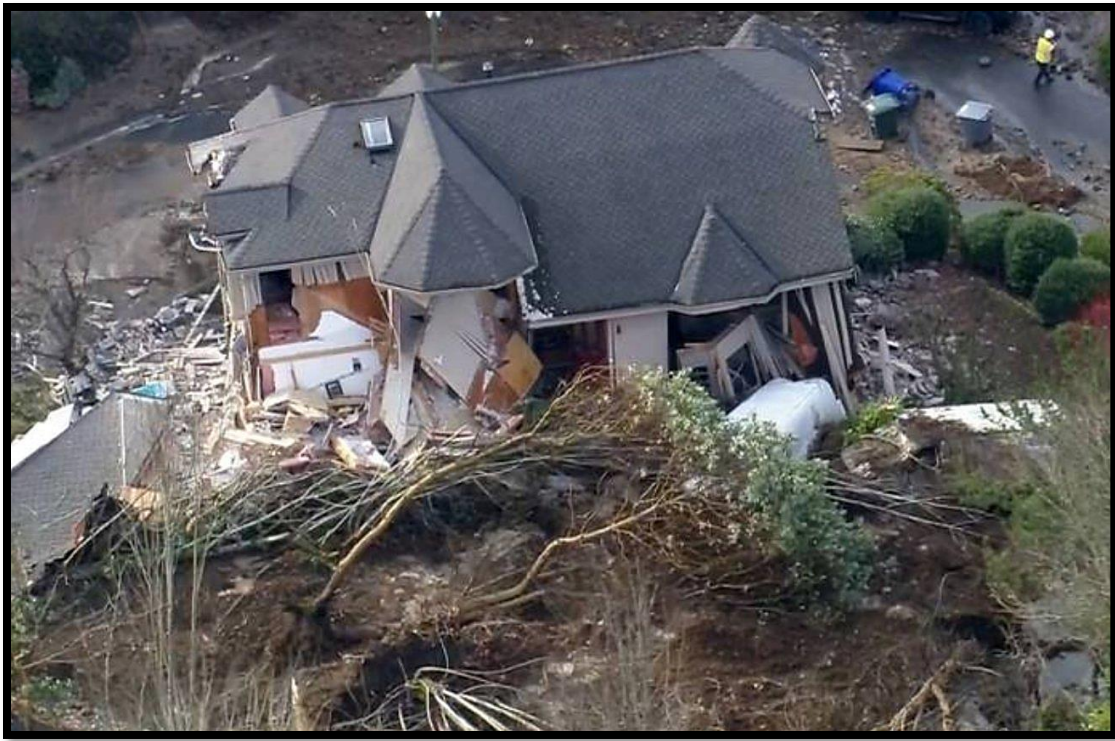
2. The north exterior wall of the home that previously supported the roof framing has broken into pieces (Photograph Nos. 5 & 7). The west wall is breaking apart where a chimney had been located adjacent to a two-story tall, vaulted section of the home (Photograph No. 8). Portions of the east wall are buckling along the floor line (Photograph No. 9). Only the south wall is relatively intact.

5. The north elevation of the Surdi Residence after the January 17, 2022 landslide (aerial image courtesy of KIRO 7).

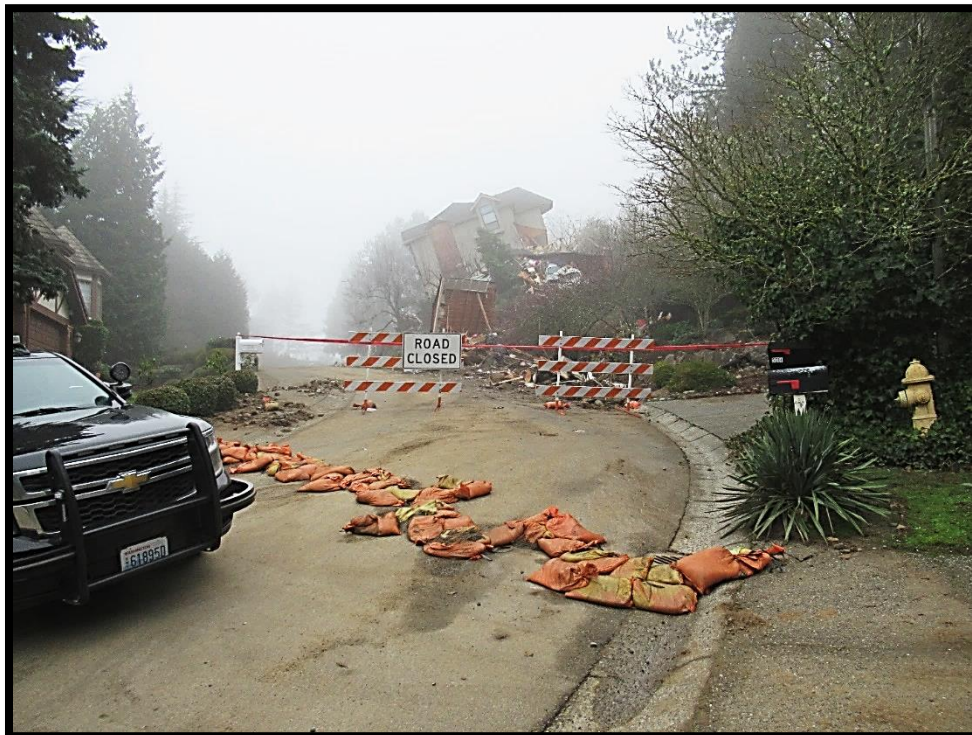
The subject wood structure is unstable and presents a safety hazard for people as well as the nearby street and structures. The wood structure has come off its foundation and is currently leaning downslope. Another period of heavy rains, or a natural event, such as a windstorm or an earthquake, could cause the home to further displace and break apart.

6. The east side of the Surdi residence as observed on January 24, 2022. The entire home has tilted and is leaning down the hill such that the top of the home is more than 4' further downhill than the bottom (leaning approximately 15 degrees to the south).

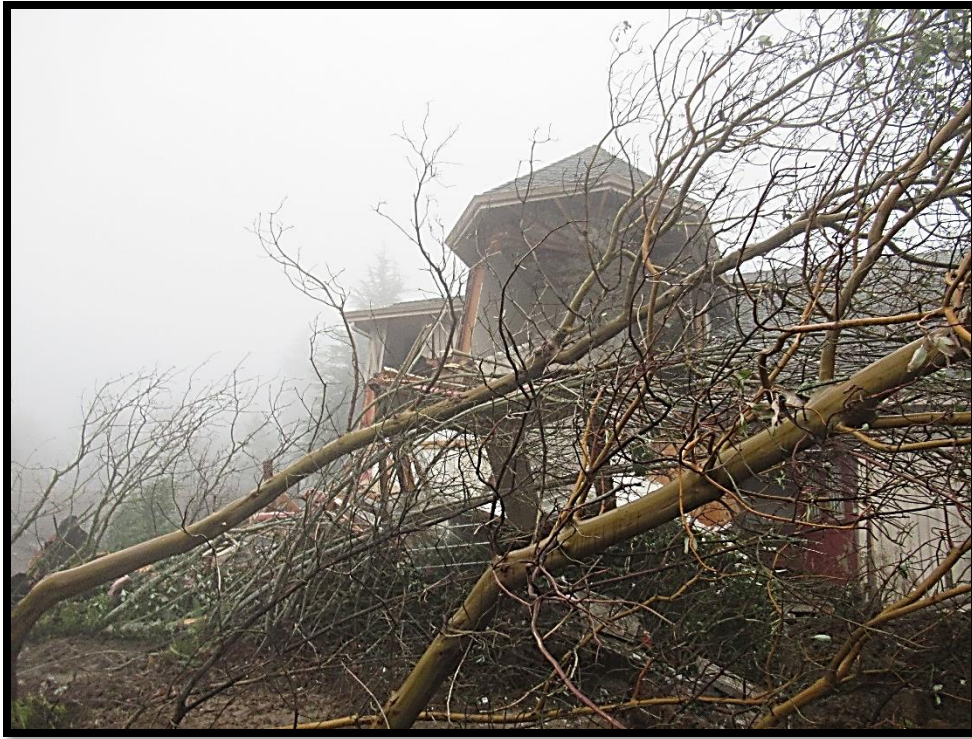
7. The north exterior wall of the home, which previously supported the roof framing, has collapsed.

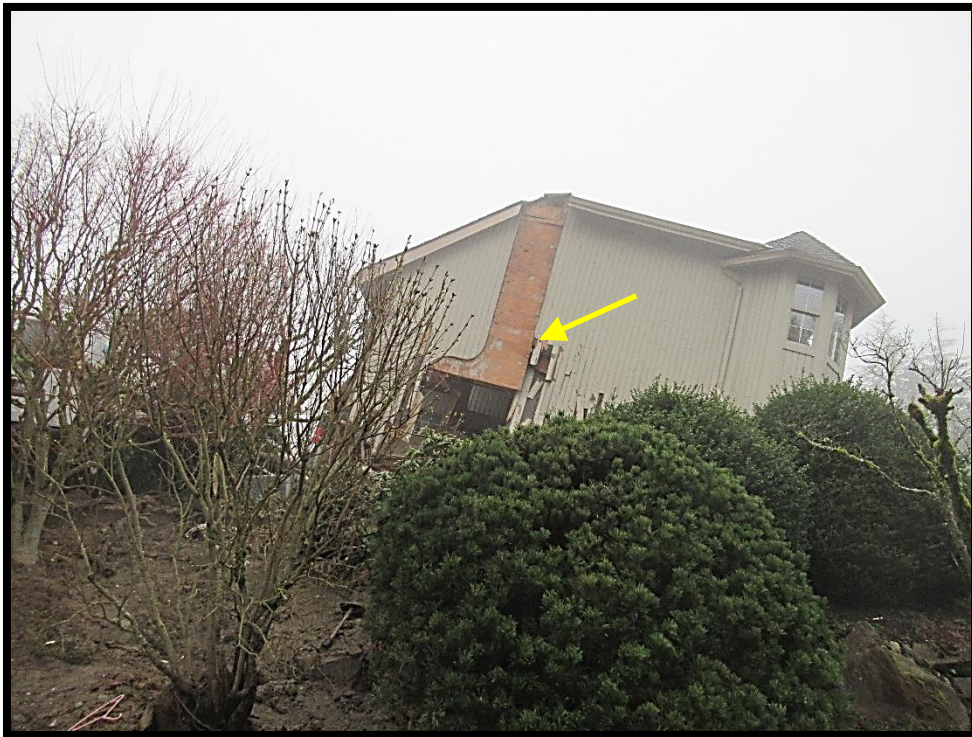
8. The west wall is breaking apart where a chimney had been located adjacent to a two-story tall, vaulted section of the home.

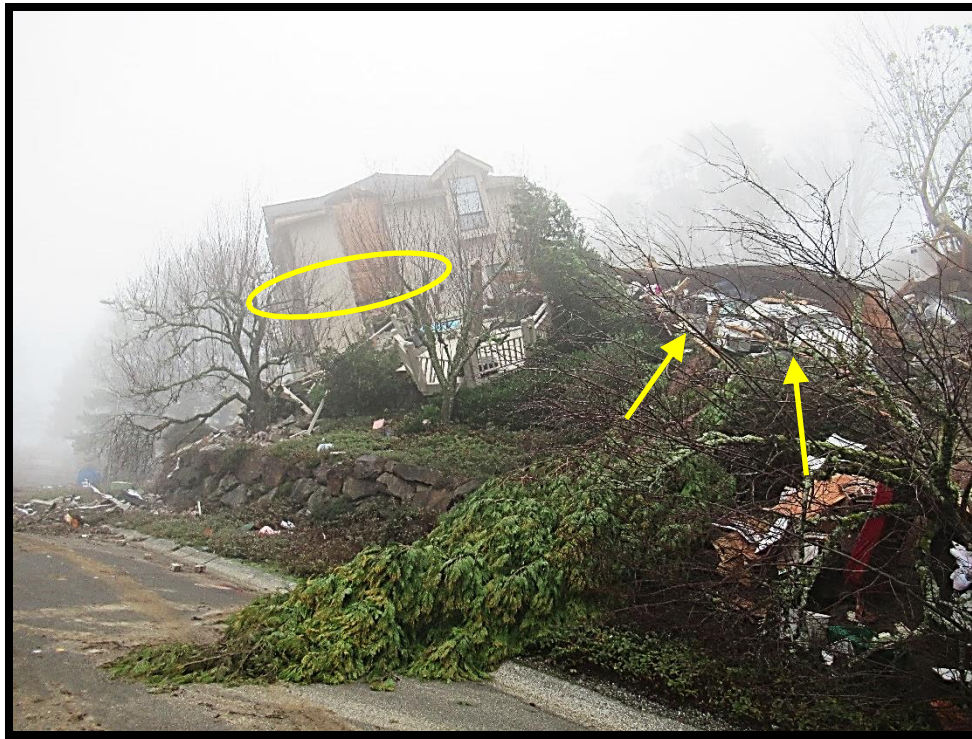
3. The south and east decks have been pulled down the hill along with the home. Most of the east side deck has broken to pieces and the debris is resting on trees in places (Photographs Nos. 9 & 10).

5. Landslide debris (loose and wet soil/mud/rock and vegetation) has filled portions of the basement as observed from the north side of the home. Two cars and two vans have been pushed into the north walls of the home and are located either up against the home or in the basement of the home (Photograph Nos. 12 & 13). Two additional cars are facing downhill in the middle of the debris at the east end of the home (Photograph No. 9).

9. Portions of the east wall are buckling along the floor line (oval). Two cars are facing downhill to the east of the home (arrows). A portion of the deck has also collapsed and is resting upon a tree.

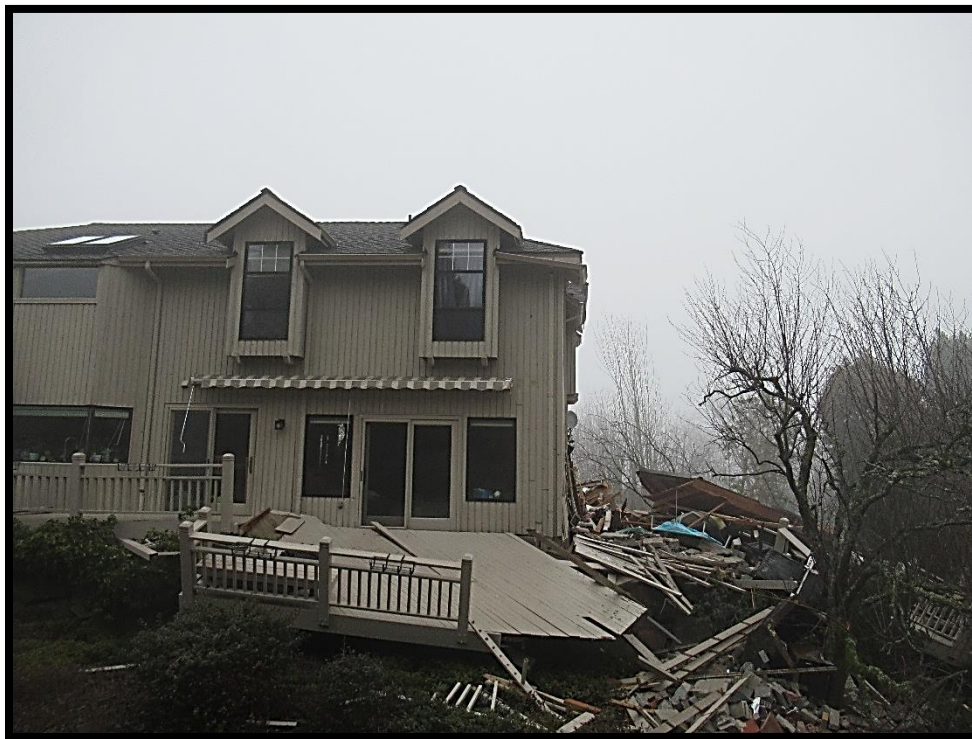
10. Portions of the east side deck have collapsed and are leaning downslope and, in places, are resting upon trees.

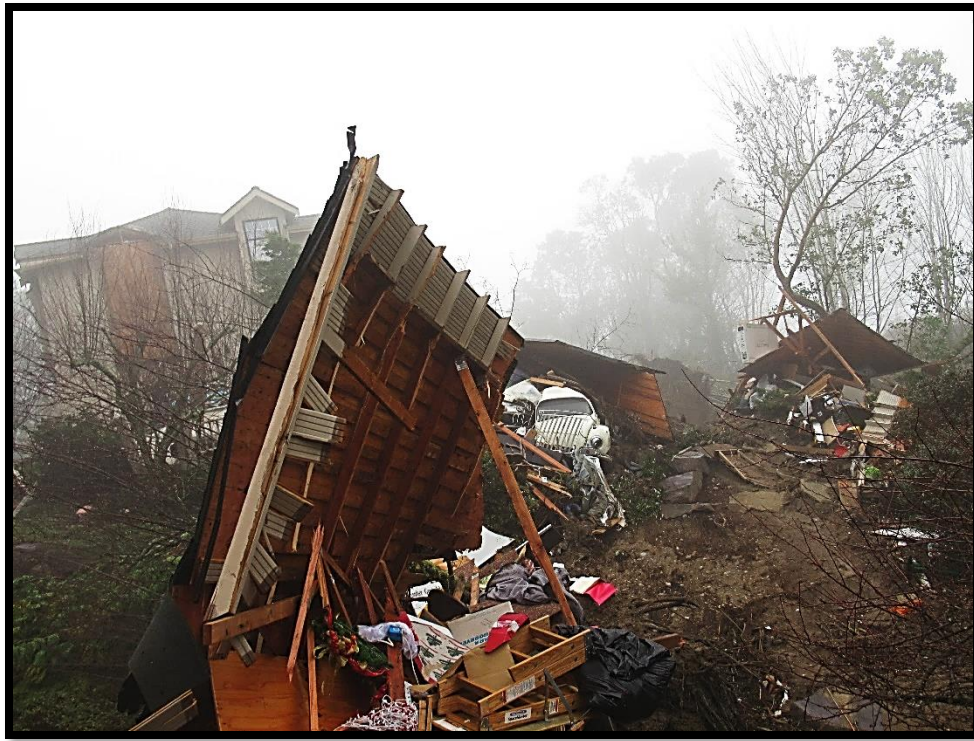
4. The garage was impacted by the landslide and separated from the home. Debris from the garage (framing, contents, vehicles) extends down towards the road to the south and east (Photograph No. 11).

11. The garage was impacted by the landslide and separated from the home. Debris from the garage extends down towards the road to the south and east.

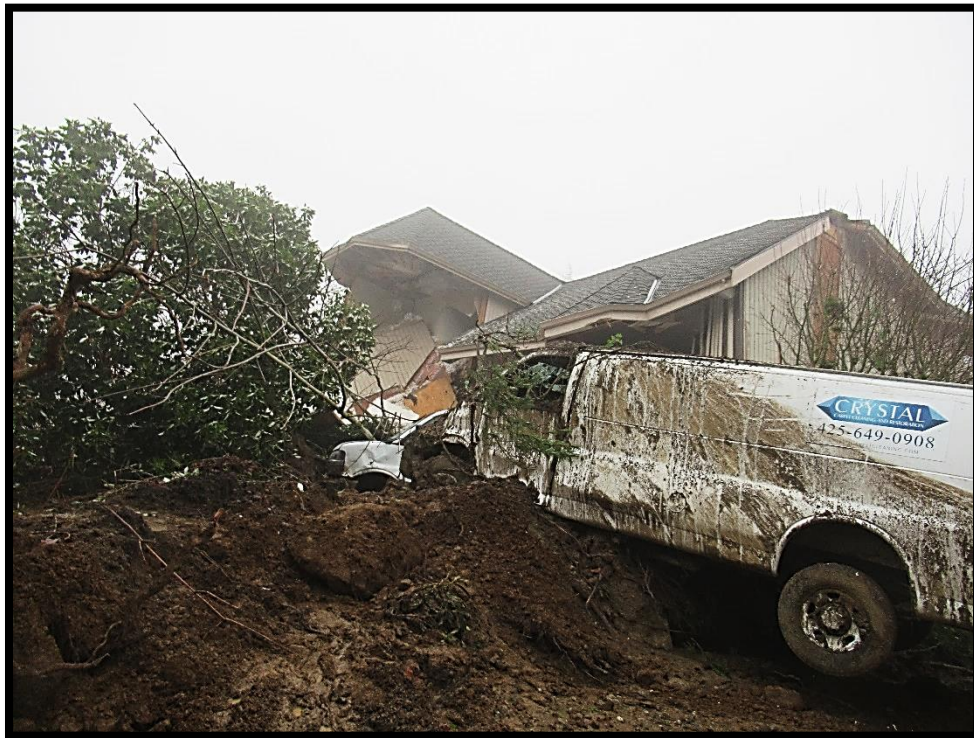
12. Two vans have been pushed into the north side of the home.

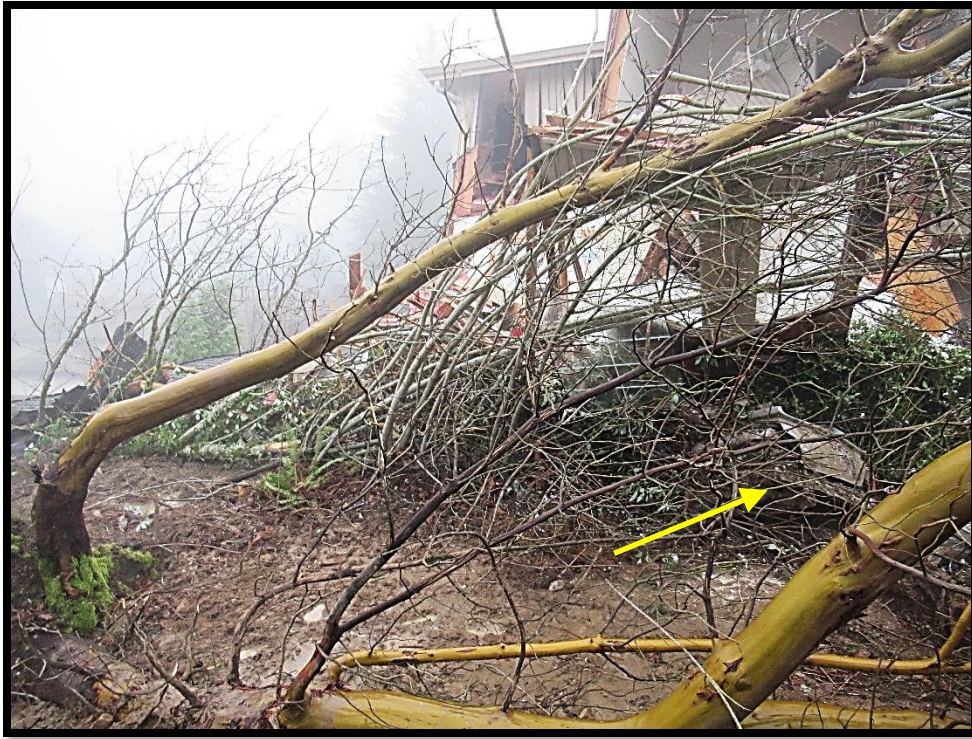
13. One of the vehicles is now in the basement.

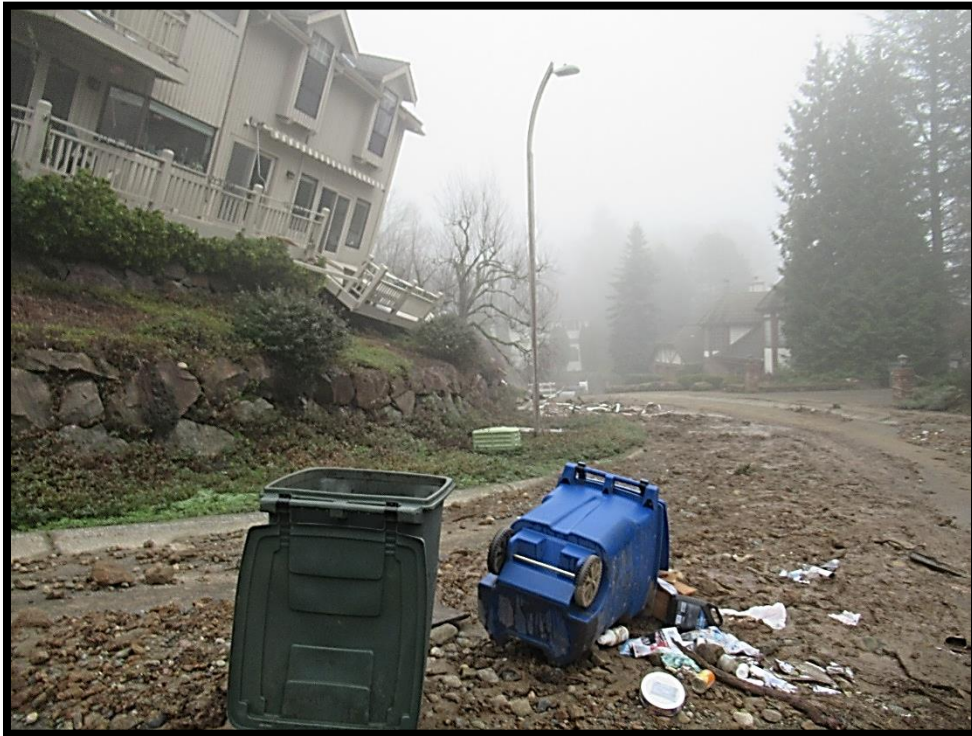
6. Landslide debris, wood framing, and personal contents extend around the home and down into the street below the home (Photograph No. 14). Currently, there is no vehicular access permitted up 139th Place SE.

14. Landslide debris extends down into the street below.

Due to the risk of collapse of the home into the street, the street should remain closed until the subject wood structure has been demolished. Access to the homes across the street (directly to the south of the home) as well as the homes in the western portion of the cul-de-sac should not be permitted until demolition is complete.
