Lakemont Boulevard at Coal Creek Project

July 26, 2023

Project Purpose

Emergency project to address safety hazards, road and embankment instability, and flood conveyance.

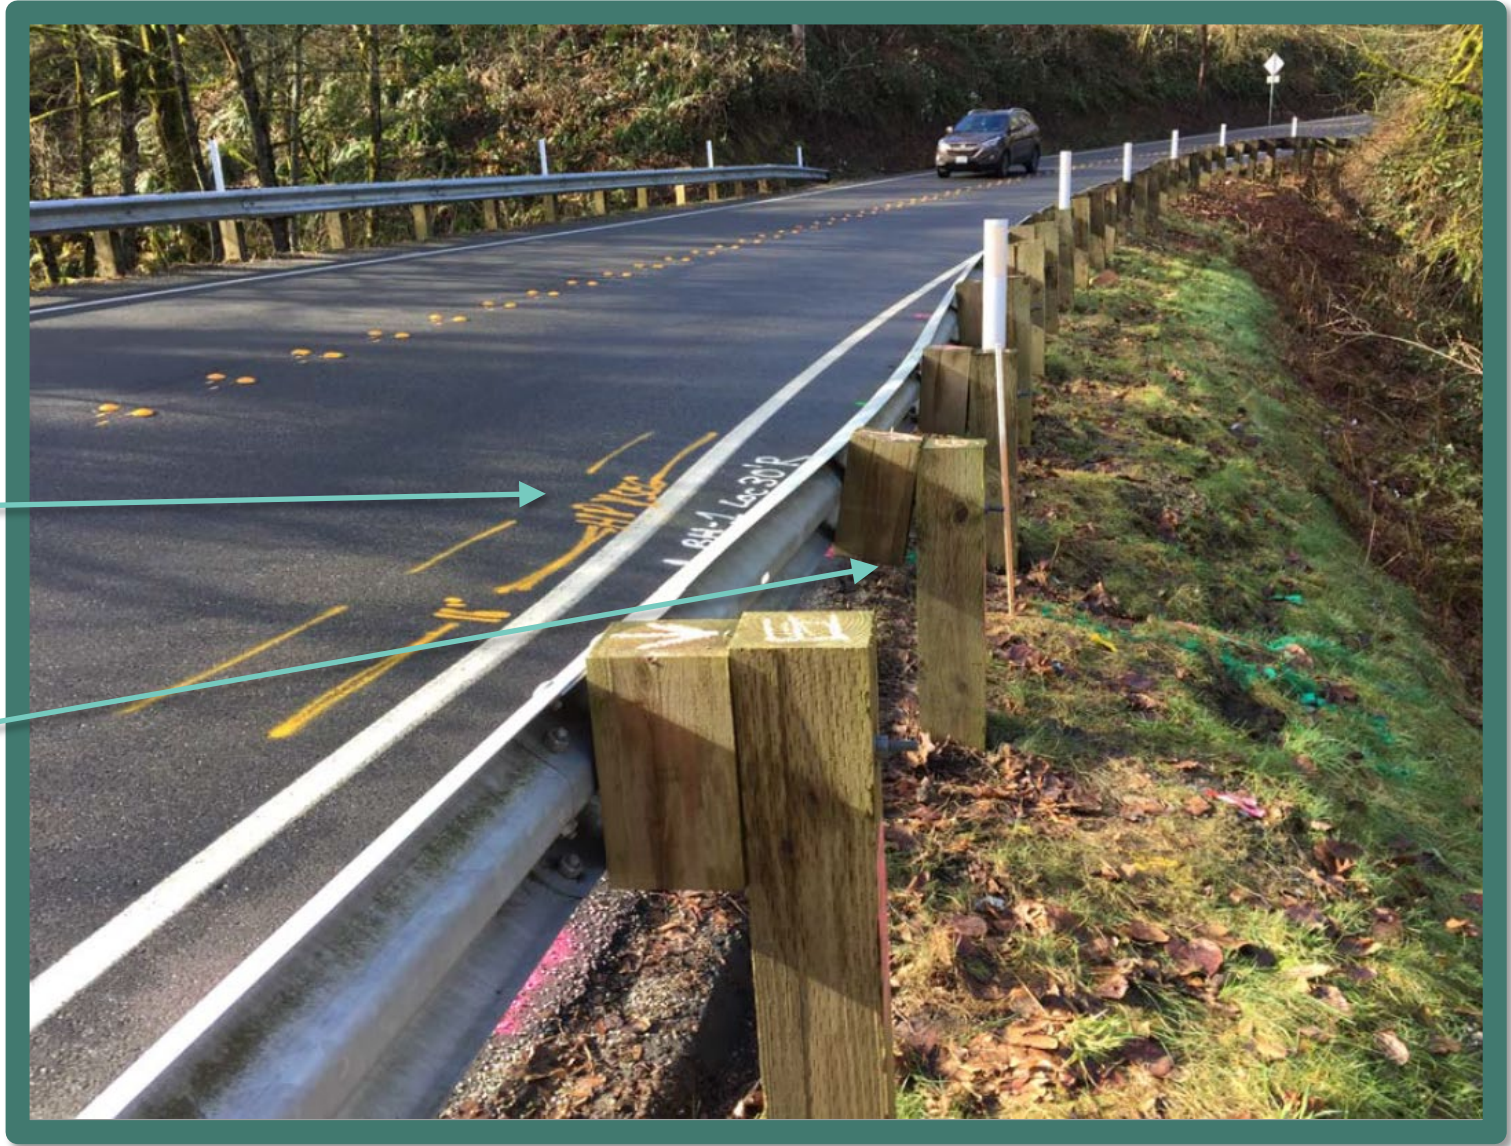
February 2017 Settlement

- Pavement deformation
- Separation of blocks from posts

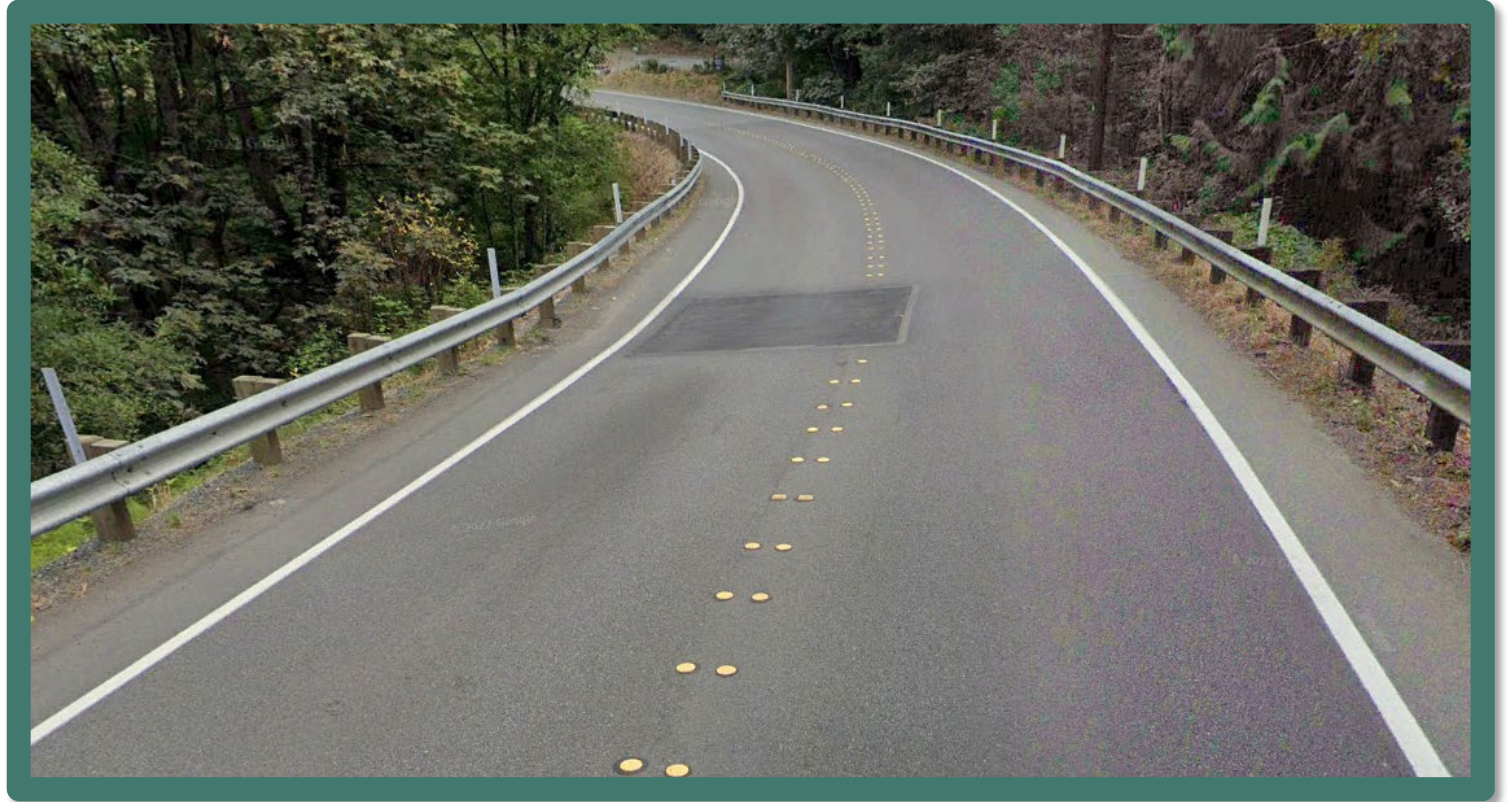
Reoccurrence of Settlement in 2022

- Pavement deformation occurred at the same location
- Over the culvert crossing

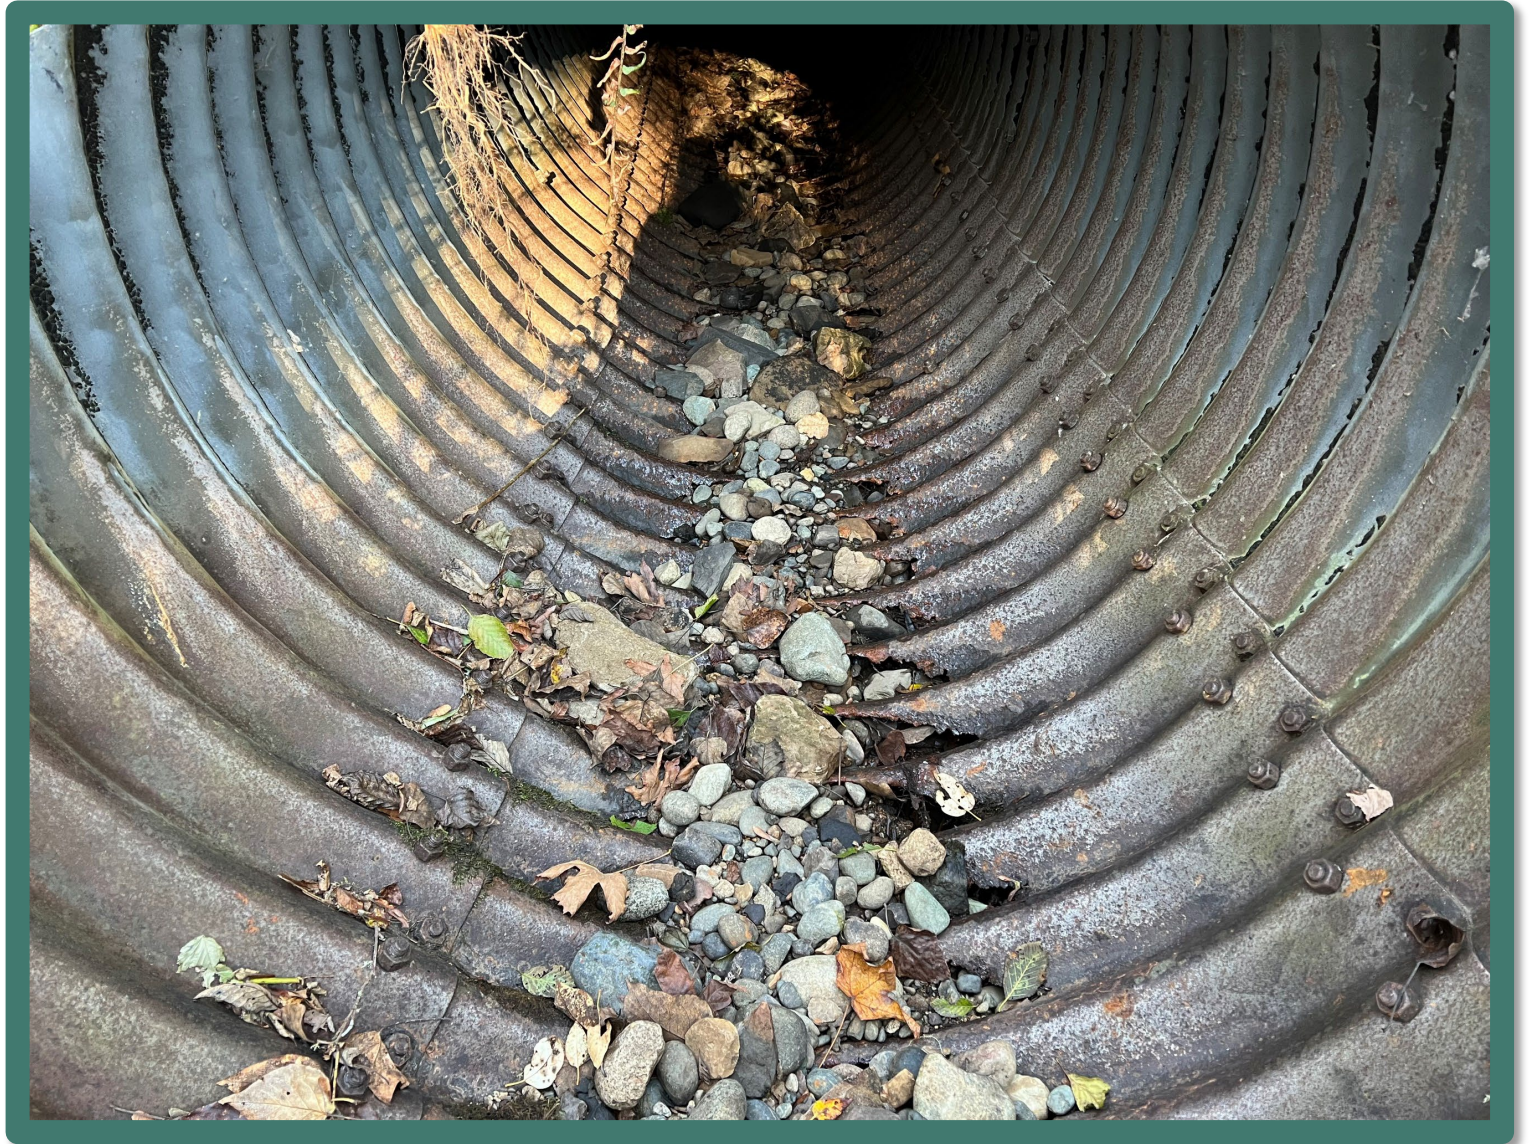
2022 Condition Assessment

- Eroded corrugation
- Culvert is no longer structurally sound or watertight
- Streamflow leaking into culvert foundation material

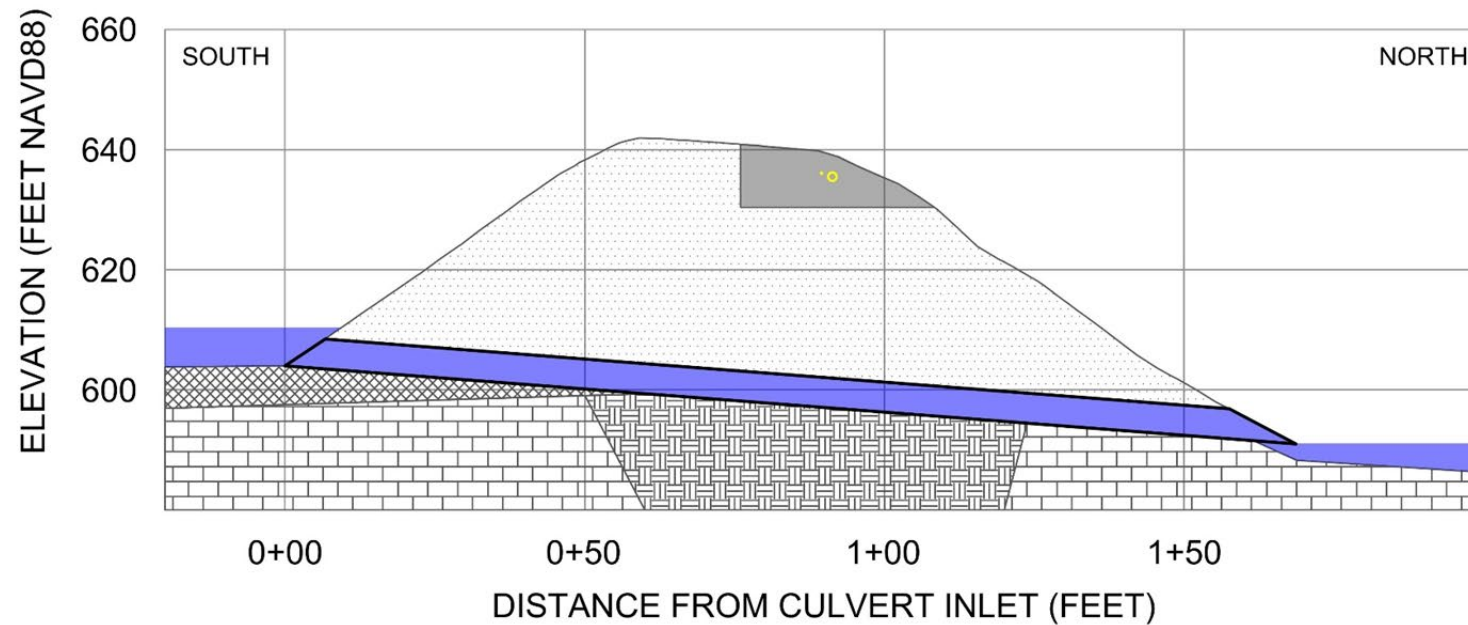
- Bottom of culvert eroded

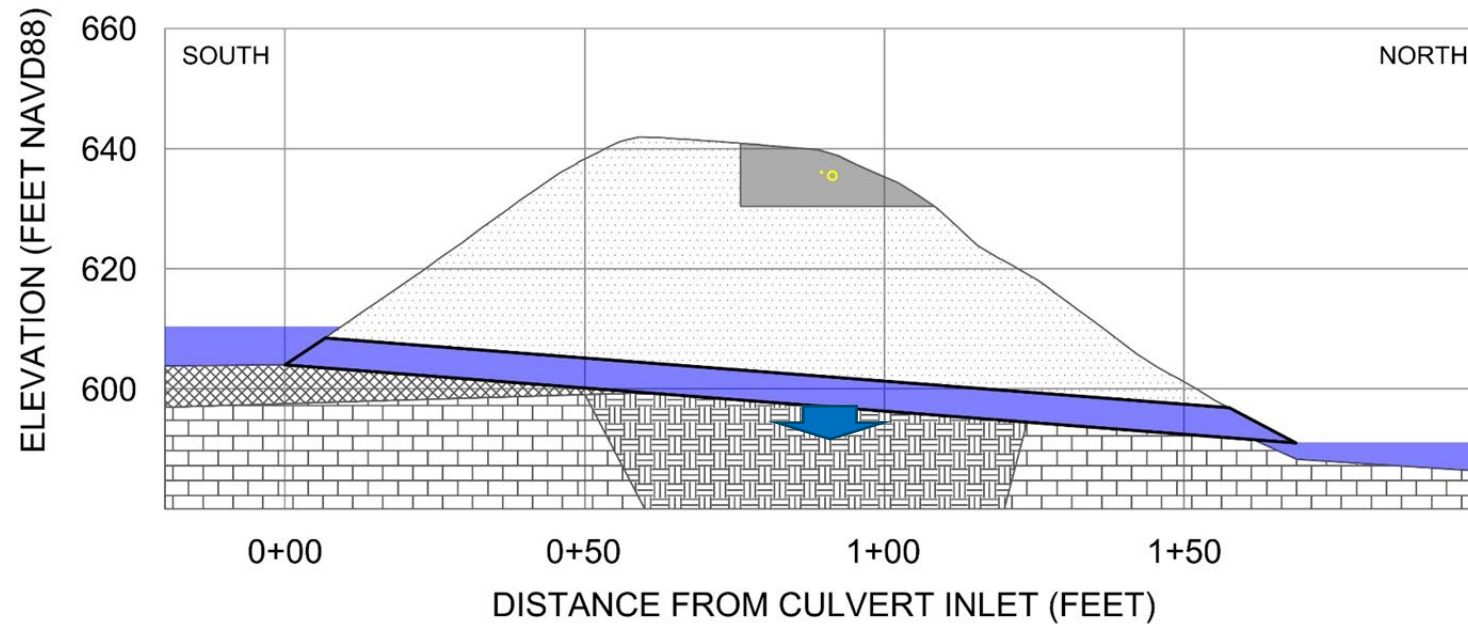
- Bottom of culvert eroded
- Water leaked from culvert bottom into mine entrance

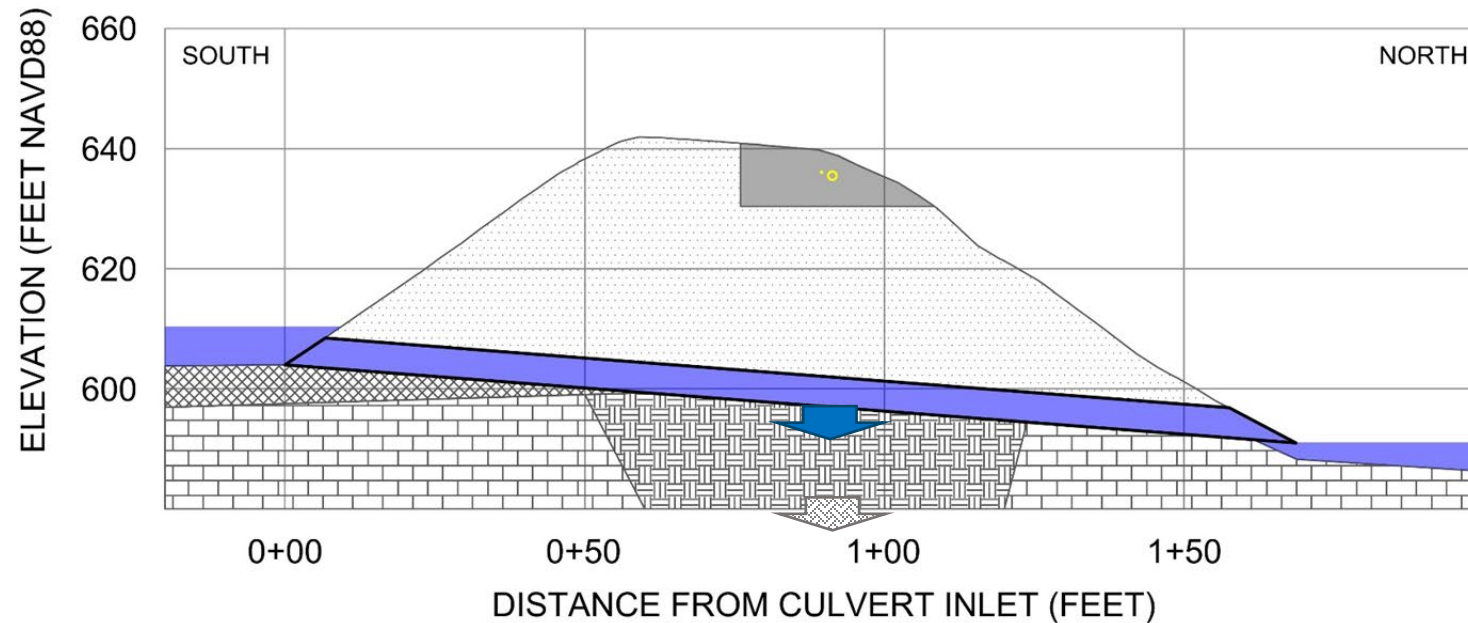
- Bottom of culvert eroded
- Water leaked from culvert bottom into mine entrance
- Vertical erosion occurred in fill placed to seal mine opening

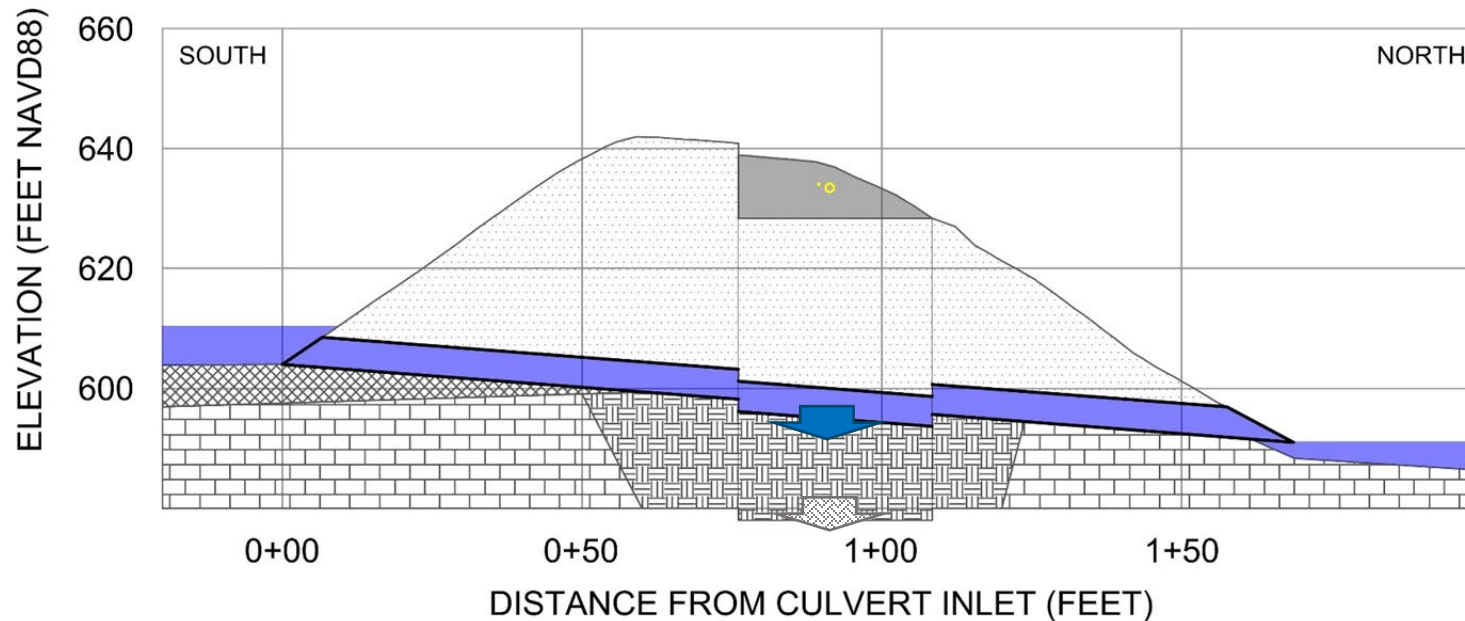
- Bottom of culvert eroded
- Water leaked from culvert bottom into mine entrance
- Vertical erosion occurred in fill placed to seal mine opening
- Erosion resulted in culvert sag and road subsidence
- Sagging culvert creates voids in embankment and weakened zone in embankment fill

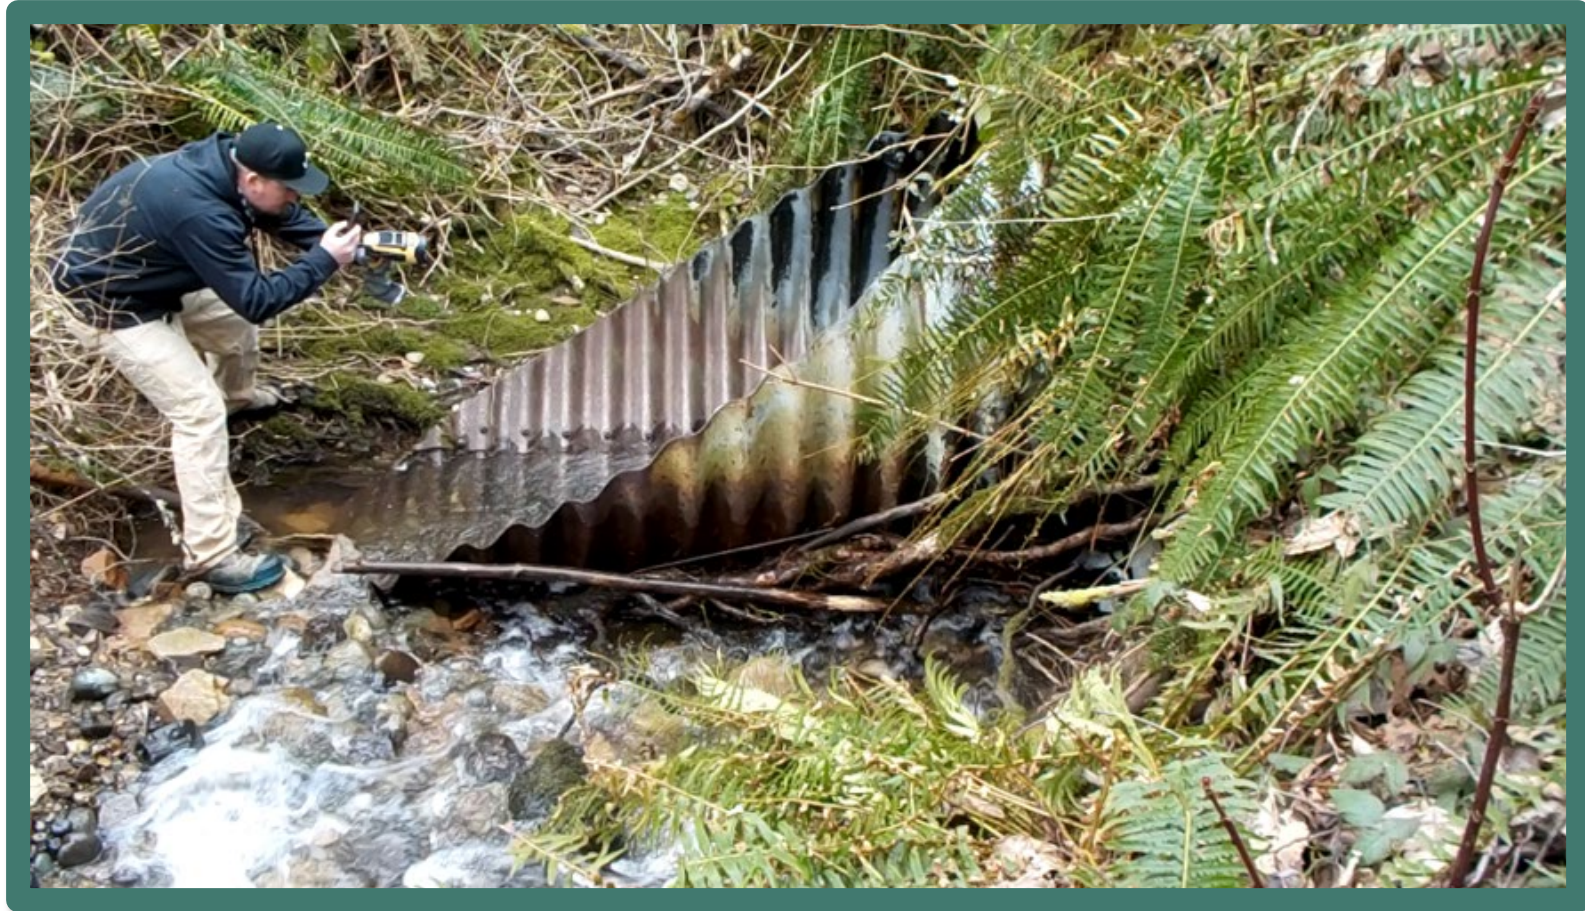
- Streamflow at culvert inlet
 - Flow beneath invert
- ➡ Mine cap entrance fill eroding

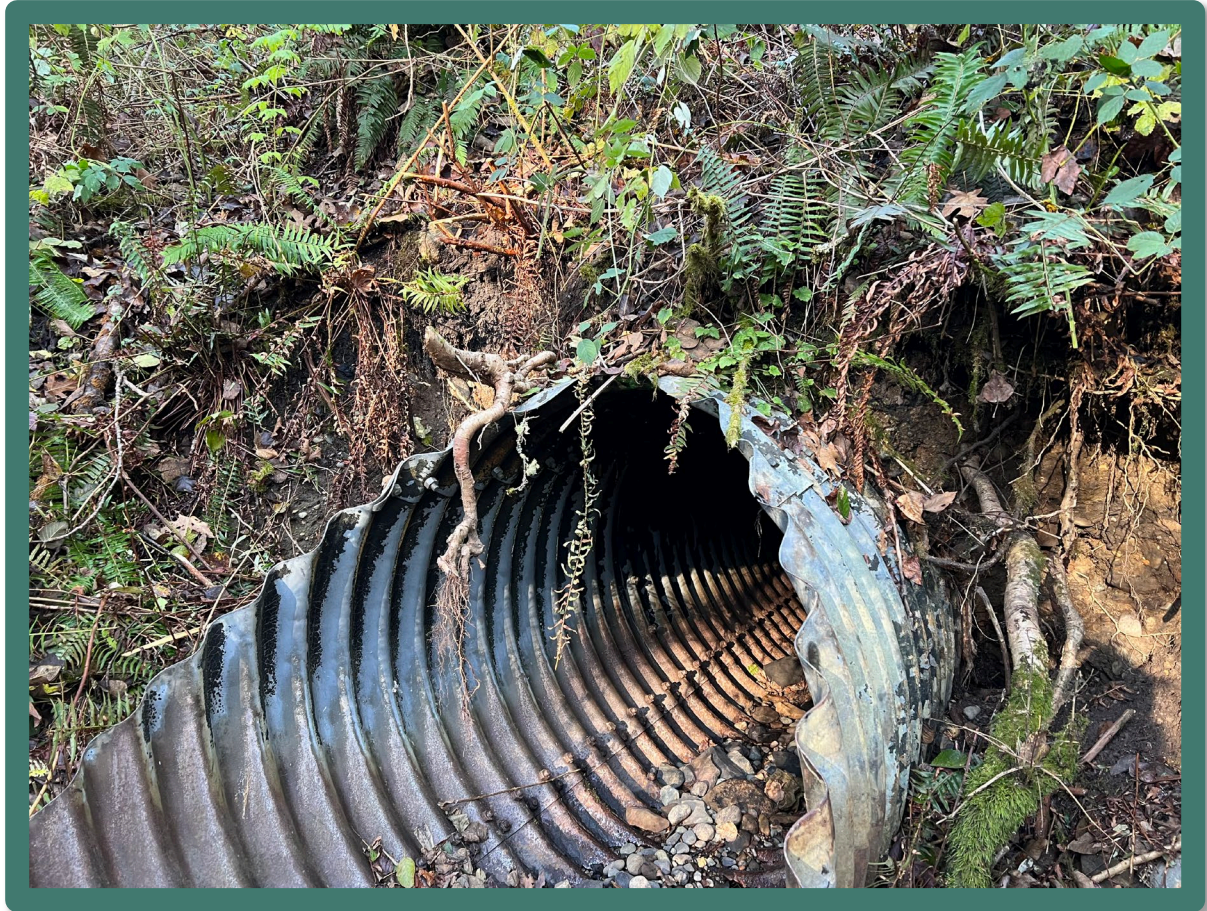
Scour holes and voids

- ➡ Flow into embankment
- ➡ Weakened material below road
- ➡ Risk of piping around culvert

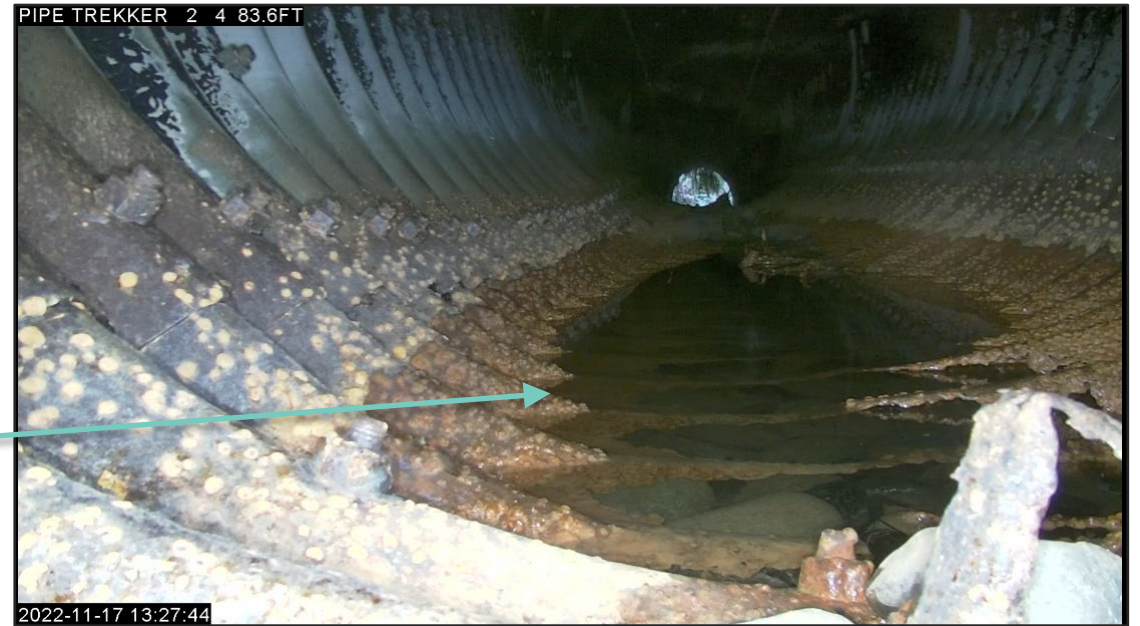
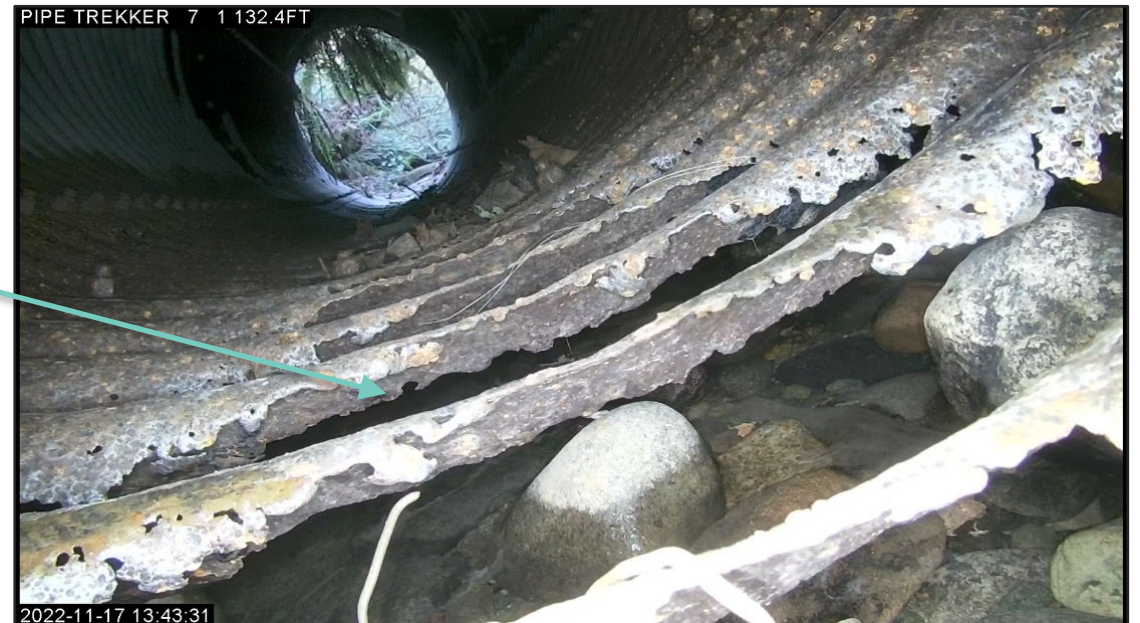
- Sag in middle of culvert
- Abraded corrugation and subgrade near outlet
