# Landslide/Sediment

# Vasa Creek Landslide Inventory and Slope Stability Reconnaissance

VASA CREEK FISH HABITAT EVALUATION AND LANDSLIDE HAZARD ASSESSMENT PROJECT

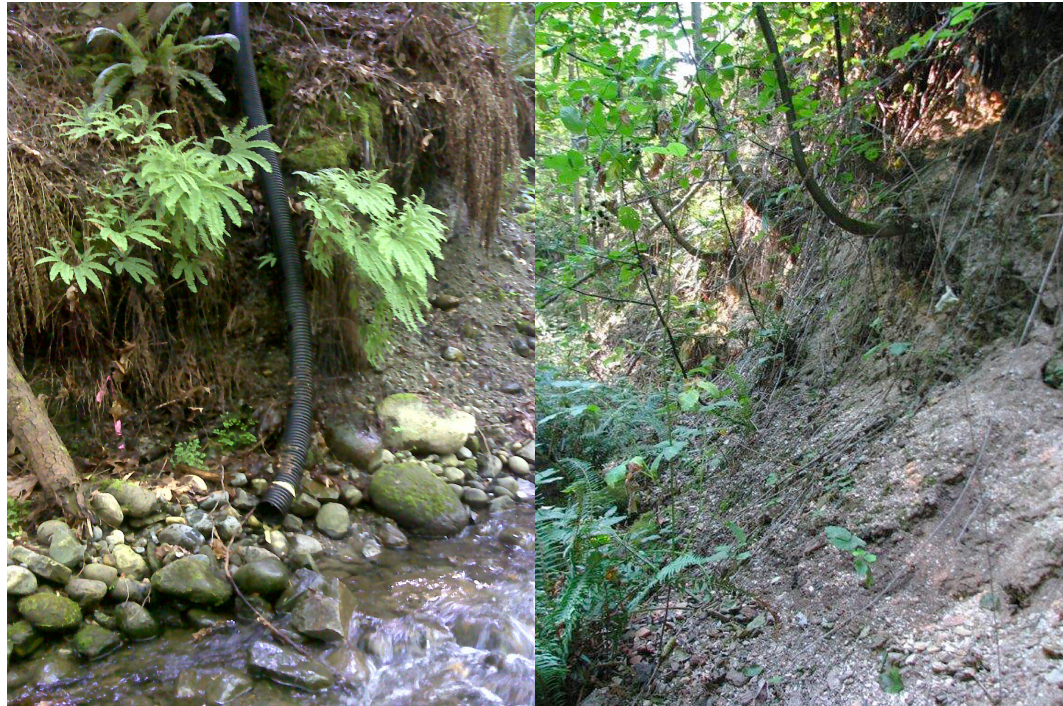
*Property owners should make sure the outfalls are intact.*

*Gooseneck trees indicate areas of increased risk for landslides.*

- Divert water outfalls away from steep slopes.
- Inspect and maintain drainage pipes.
- Dispose of leaves and debris in yard waste service, not into the ravine. Yard waste piles absorb water and can kill plants whose roots stabilize the soil, increasing the potential for slides. Yard waste piles also create habitat for rats and snakes.
- Hire a geotechnical specialist to evaluate potential hazards and provide recommendations to reduce risk. Homeowners with fractures in their foundation, settling of the building or yard, or gooseneck tree trunks, should consider hiring specialists to help reduce risk of landslides.

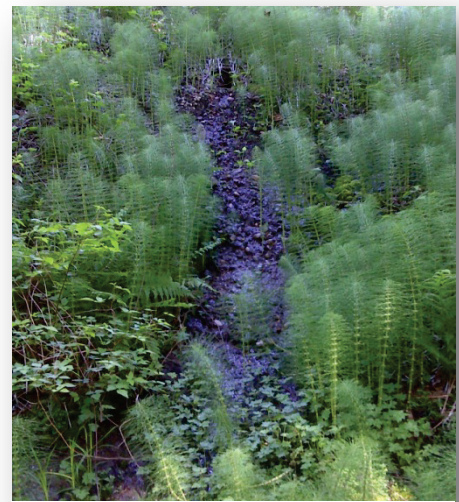
**Figure 2. Seep Observed Upslope of Access Road**

There was potential instability observed on the south-facing slope at Site PI-02, as shown in Figure A-2 (Attachment A). Site PI-02 was identified as having several indicators of potential instability including steep slopes (> 60%), wet soil vegetation indicators and the highly abundant presence of seeps and subsurface drainage as shown in the example photograph in Figure 2. The flow from seeps and subsurface flows at this location is intercepted and stored by the existing access road and an abandoned road grade shown in Figure A-2. There is an existing 18-inch culvert on the access road and a 24-inch culvert on the abandoned road but no cross drain structures were observed to drain any of the seeps.

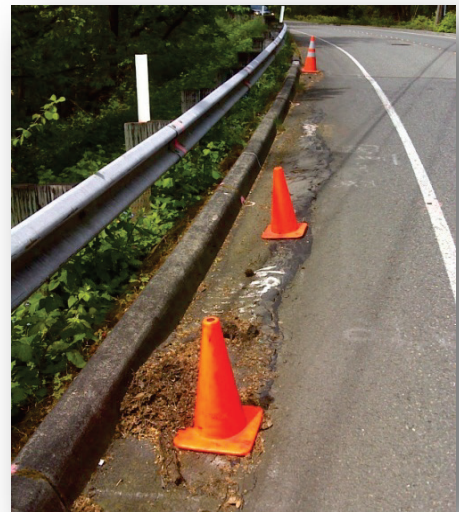
**Figure 3. Cracked Road Fill Slope along SE 35th Place (PP-11)**

Insufficient road drainage may increase soil saturation and lead to an increased landslide risk on potentially unstable slopes. Also observed was a surface rupture in the road fill and asphalt on SE 35th Place, as shown in the photograph in Figure 3. Surface ruptures in glacial materials are a good indicator of potential instability and may indicate the potential for deep-seated landslides. Further geotechnical analyses would be required to determine the landslide hazard at this location, as discussed further in Section 4.

- Conduct a detailed geotechnical evaluation of landslide hazard in Reach 1 of Vasa Creek, particularly in the two areas described in Section 3.1 and shown in Figure A-2.

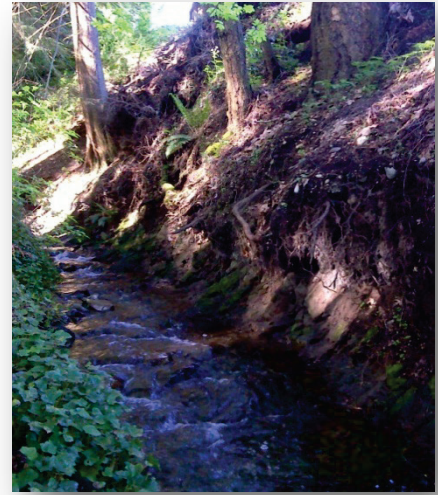
**Figure 4. Bank Erosion Undercutting Slope at PI-03**

There was one area identified as having potential instability (PI-03) in Reach 3. Table 3 contains summary of the data collected for PI-03. The primary cause for potential instability at PI-03 is bank erosion undermining a small forested streambank. This location has the potential for continued undercutting to cause bank collapse and maintenance issues particularly because this site is located just upstream of the intake structure that diverts water through the Eastgate Elementary property. The overall sediment volume for PI-03 would be relatively modest however, since the relief of the slope is small (approximately 20 feet). The photograph in Figure 4 shows the bank erosion at PI-03.

There were no areas of substantial in-stream erosion observed in Reach 3 other than the bank erosion associated with the potential instability at PI-03 described above.

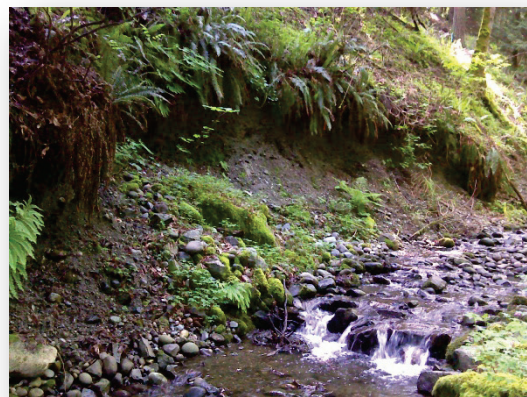
**Figure 5. Bank Erosion Causing Potential Instability at PI-04**

There was one area in Reach 4 identified as having indicators of potential instability (PI-04).

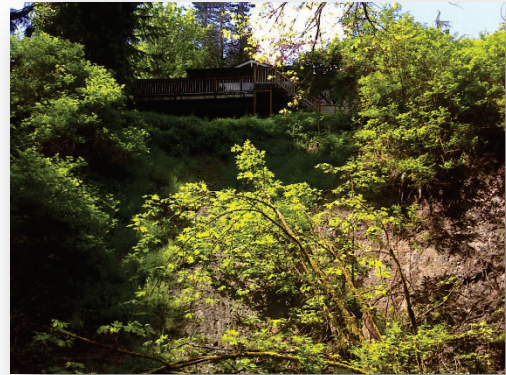
**Figure 6. Close Proximity of Residential Property to the Scarp of LS-09**

The pedestrian trail system continues to follow the creek upstream along Reach 5 until a foot bridge crossing near LS-09 where the trail climbs out of the gorge for the remainder of the reach. In addition, there have been a number of restoration efforts. In general, the landslide risk in Reach 5 is similar to Reach 4 although there are less steep slopes (> 60%) and somewhat less relief (Figure A-6). There was one landslide (LS-09) observed in Reach 5. The landslide was a shallow rapid debris slides on the east-facing slope with a deposit volume of 28 m<sup>3</sup> (37 CY). Table 2 contains a summary of the data collected for LS-09. As shown in the photograph in Figure 6, the scarp of LS-09 was close to the deck of the property to the west of the landslide. Other properties in Reach 5 that are in close proximity to the gorge boundary may be subject to property damage from future landslides. Further geotechnical analyses would be required to determine which properties are at risk and the level of hazard.

- Conduct a risk assessment and detailed geotechnical evaluation for residential properties in close proximity to the gorge boundary, particularly in Vasa Reach 1 and East Vasa Tributary to Vasa Creek, and evaluate potential hazards downstream of Vasa Reach 1.

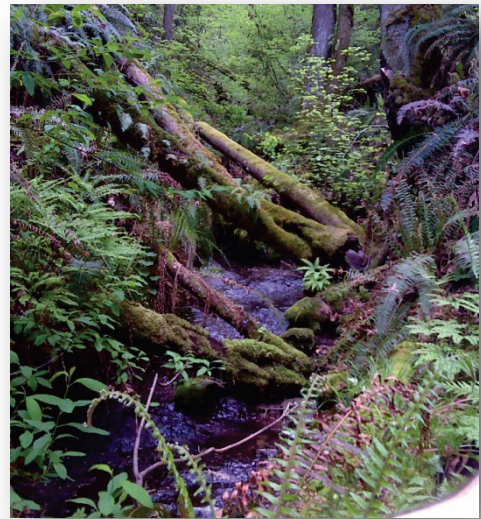
**Figure 7. Typical Channel Conditions in East Tributary to Vasa Creek**

The characteristics of the East Tributary to Vasa Creek are notably different than those of Vasa Creek. The average channel gradient (12%) is much steeper and the channel bed is scoured to bedrock in most places except where in-channel LWD are retaining wedges of sediment. The channel gradient of frequent bedrock chutes exceeds 20 percent. The channel is highly confined in a narrow gorge bottom and has a high density of LWD (Table 1). The photograph in Figure 7 shows typical channel conditions in East Tributary to Vasa Creek. Of the reaches surveyed, the East Tributary of Vasa Creek has the greatest potential to produce a landslide that could develop into a debris flow that could travel for considerable distance down the channel. A debris flow from East Vasa Creek would likely cause considerable damage to the SE Newport Way crossing and have potential downstream impacts as well.

The East Tributary to Vasa Creek survey reach should all be considered potentially unstable although the risk increases on the steeper slopes (> 60%). As in Reach 5, the East Tributary to Vasa Creek has residential properties that are in close proximity to the gorge boundary that may be subject to property damage from future landslides. Further geotechnical analyses would be required to determine which properties are at risk and the level of hazard.

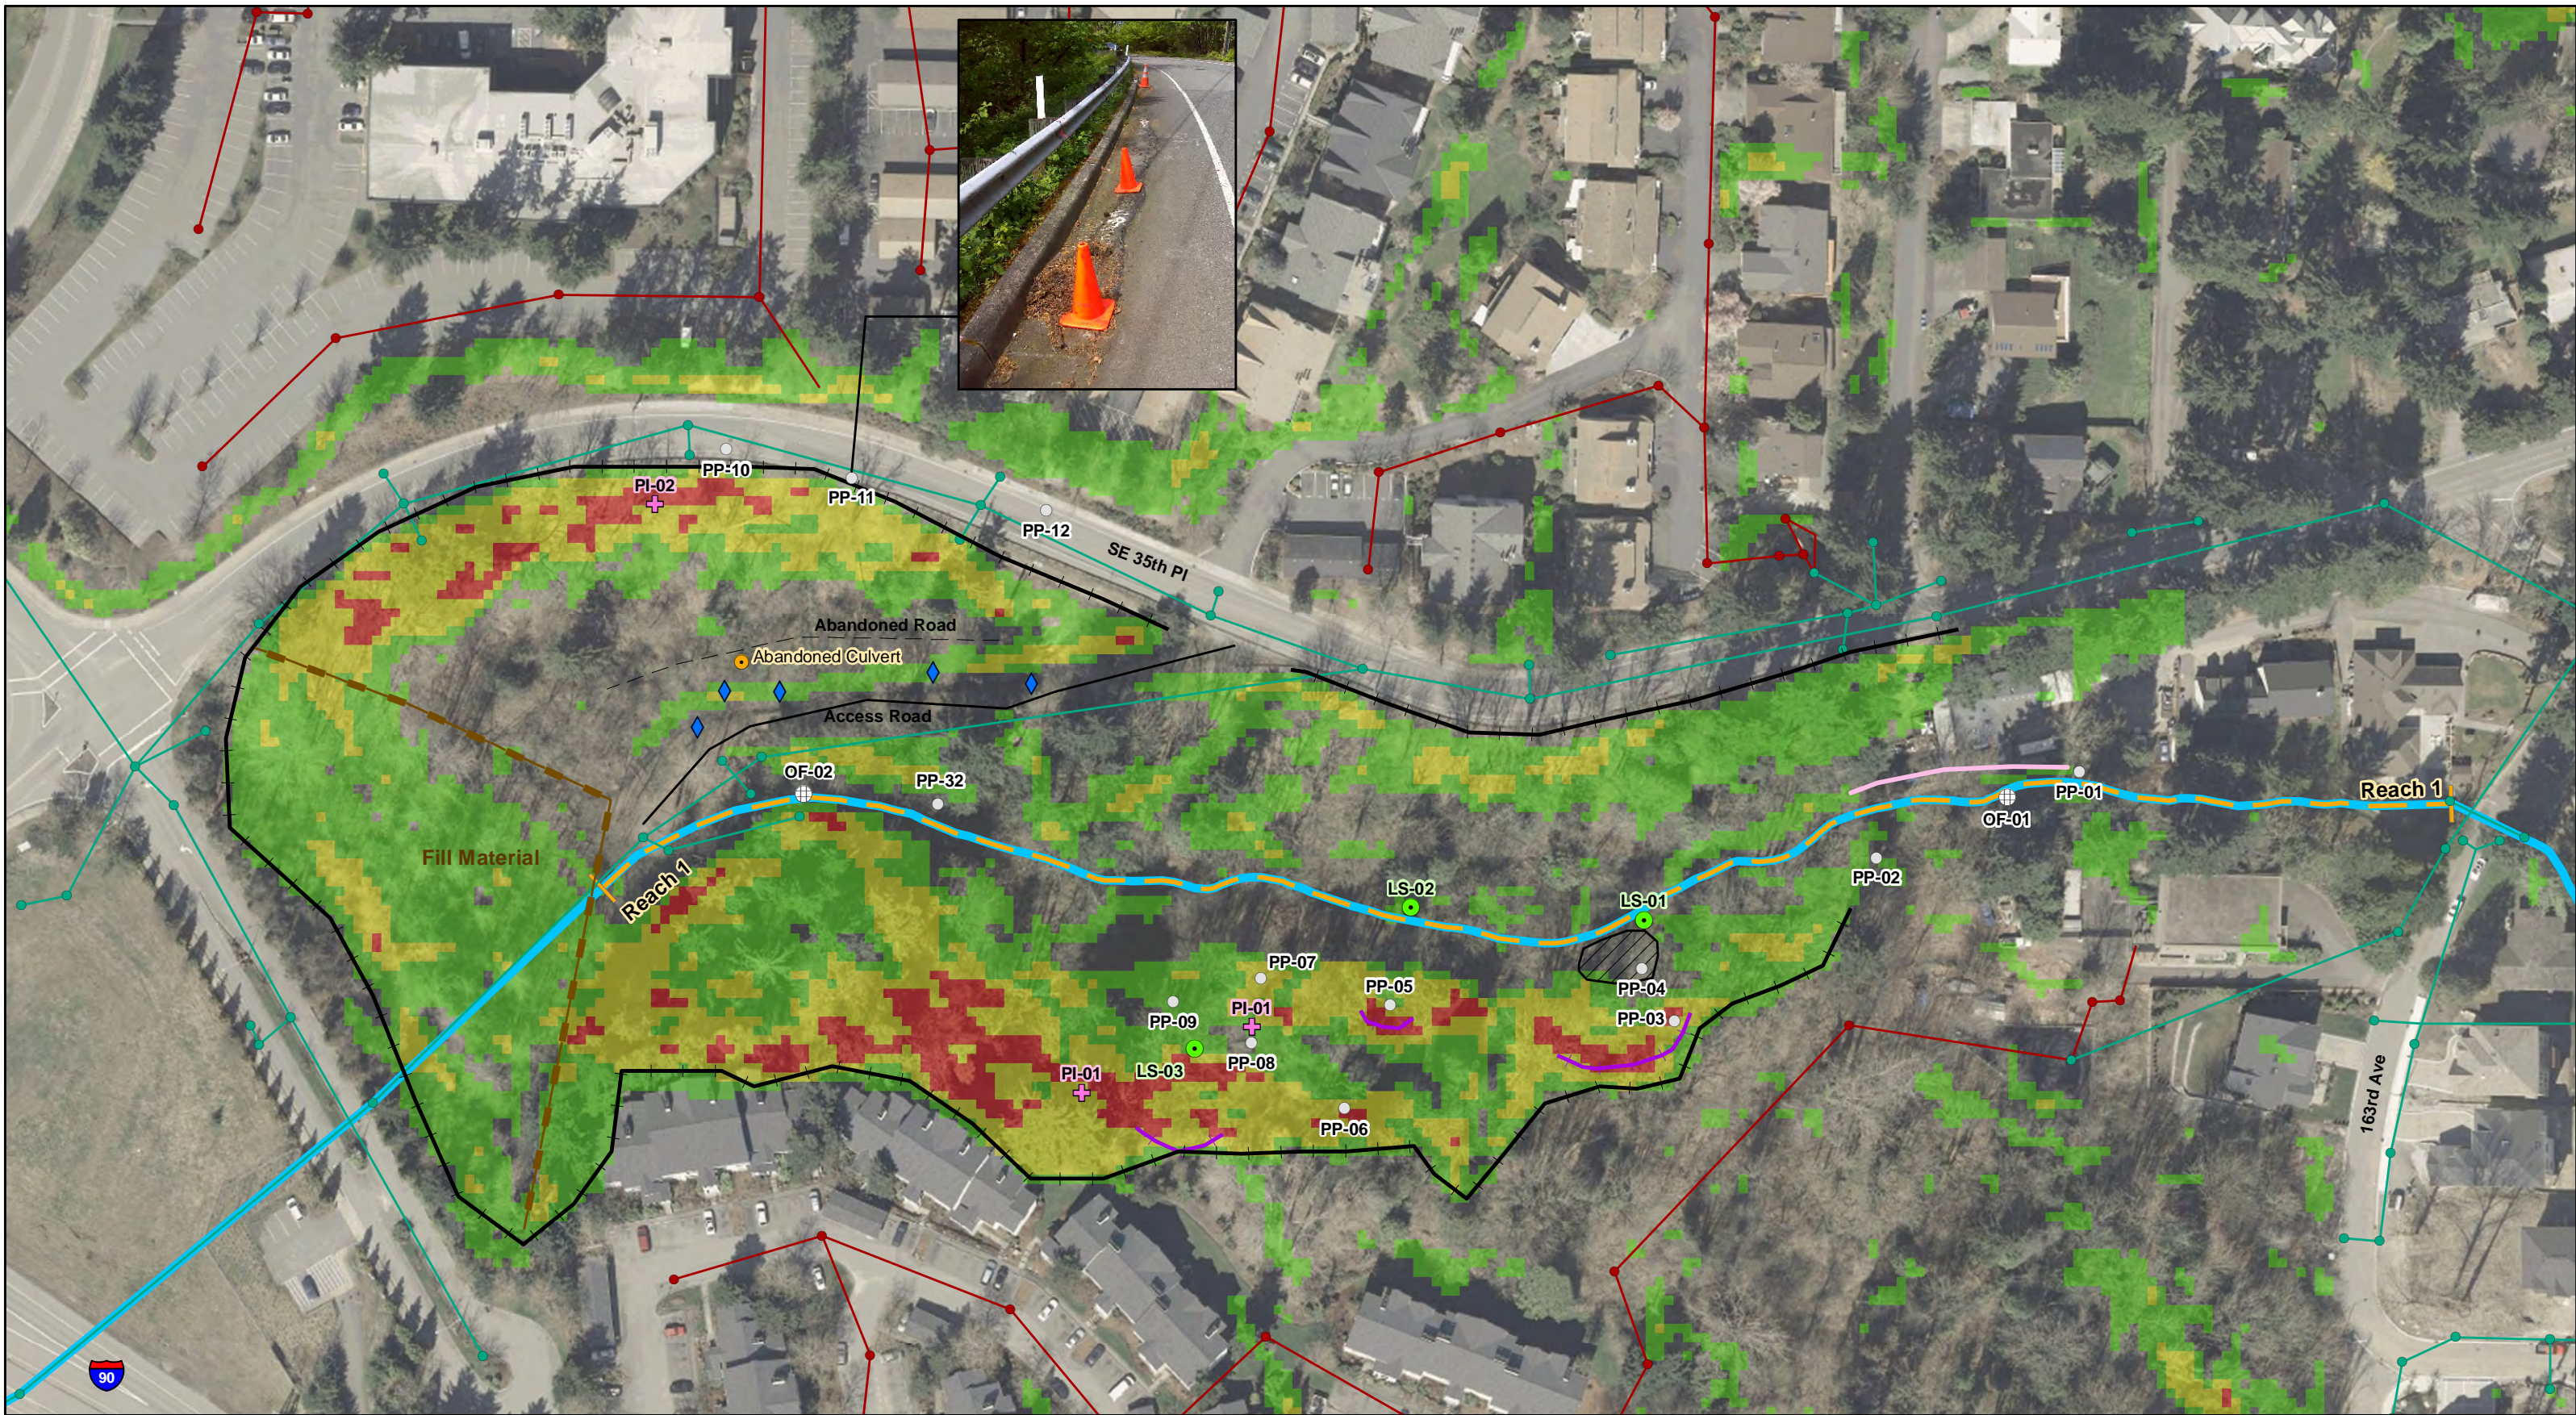
There were three observed landslides (Sites LS-01, LS-02, and LS-03) in Reach 1. As shown in Figure A-2, all three of the existing landslides were located on the north-facing slope opposite of SE 35th Place. Two of the observed landslides (LS-01 and LS-03) were shallow, rapid debris

There were no existing landslides observed on the south-facing slopes of Reach 1. East of the access road on the south-facing slopes, the landslide potential is low. Hillslope gradients are relatively low and there were no observed signs of potential instability.

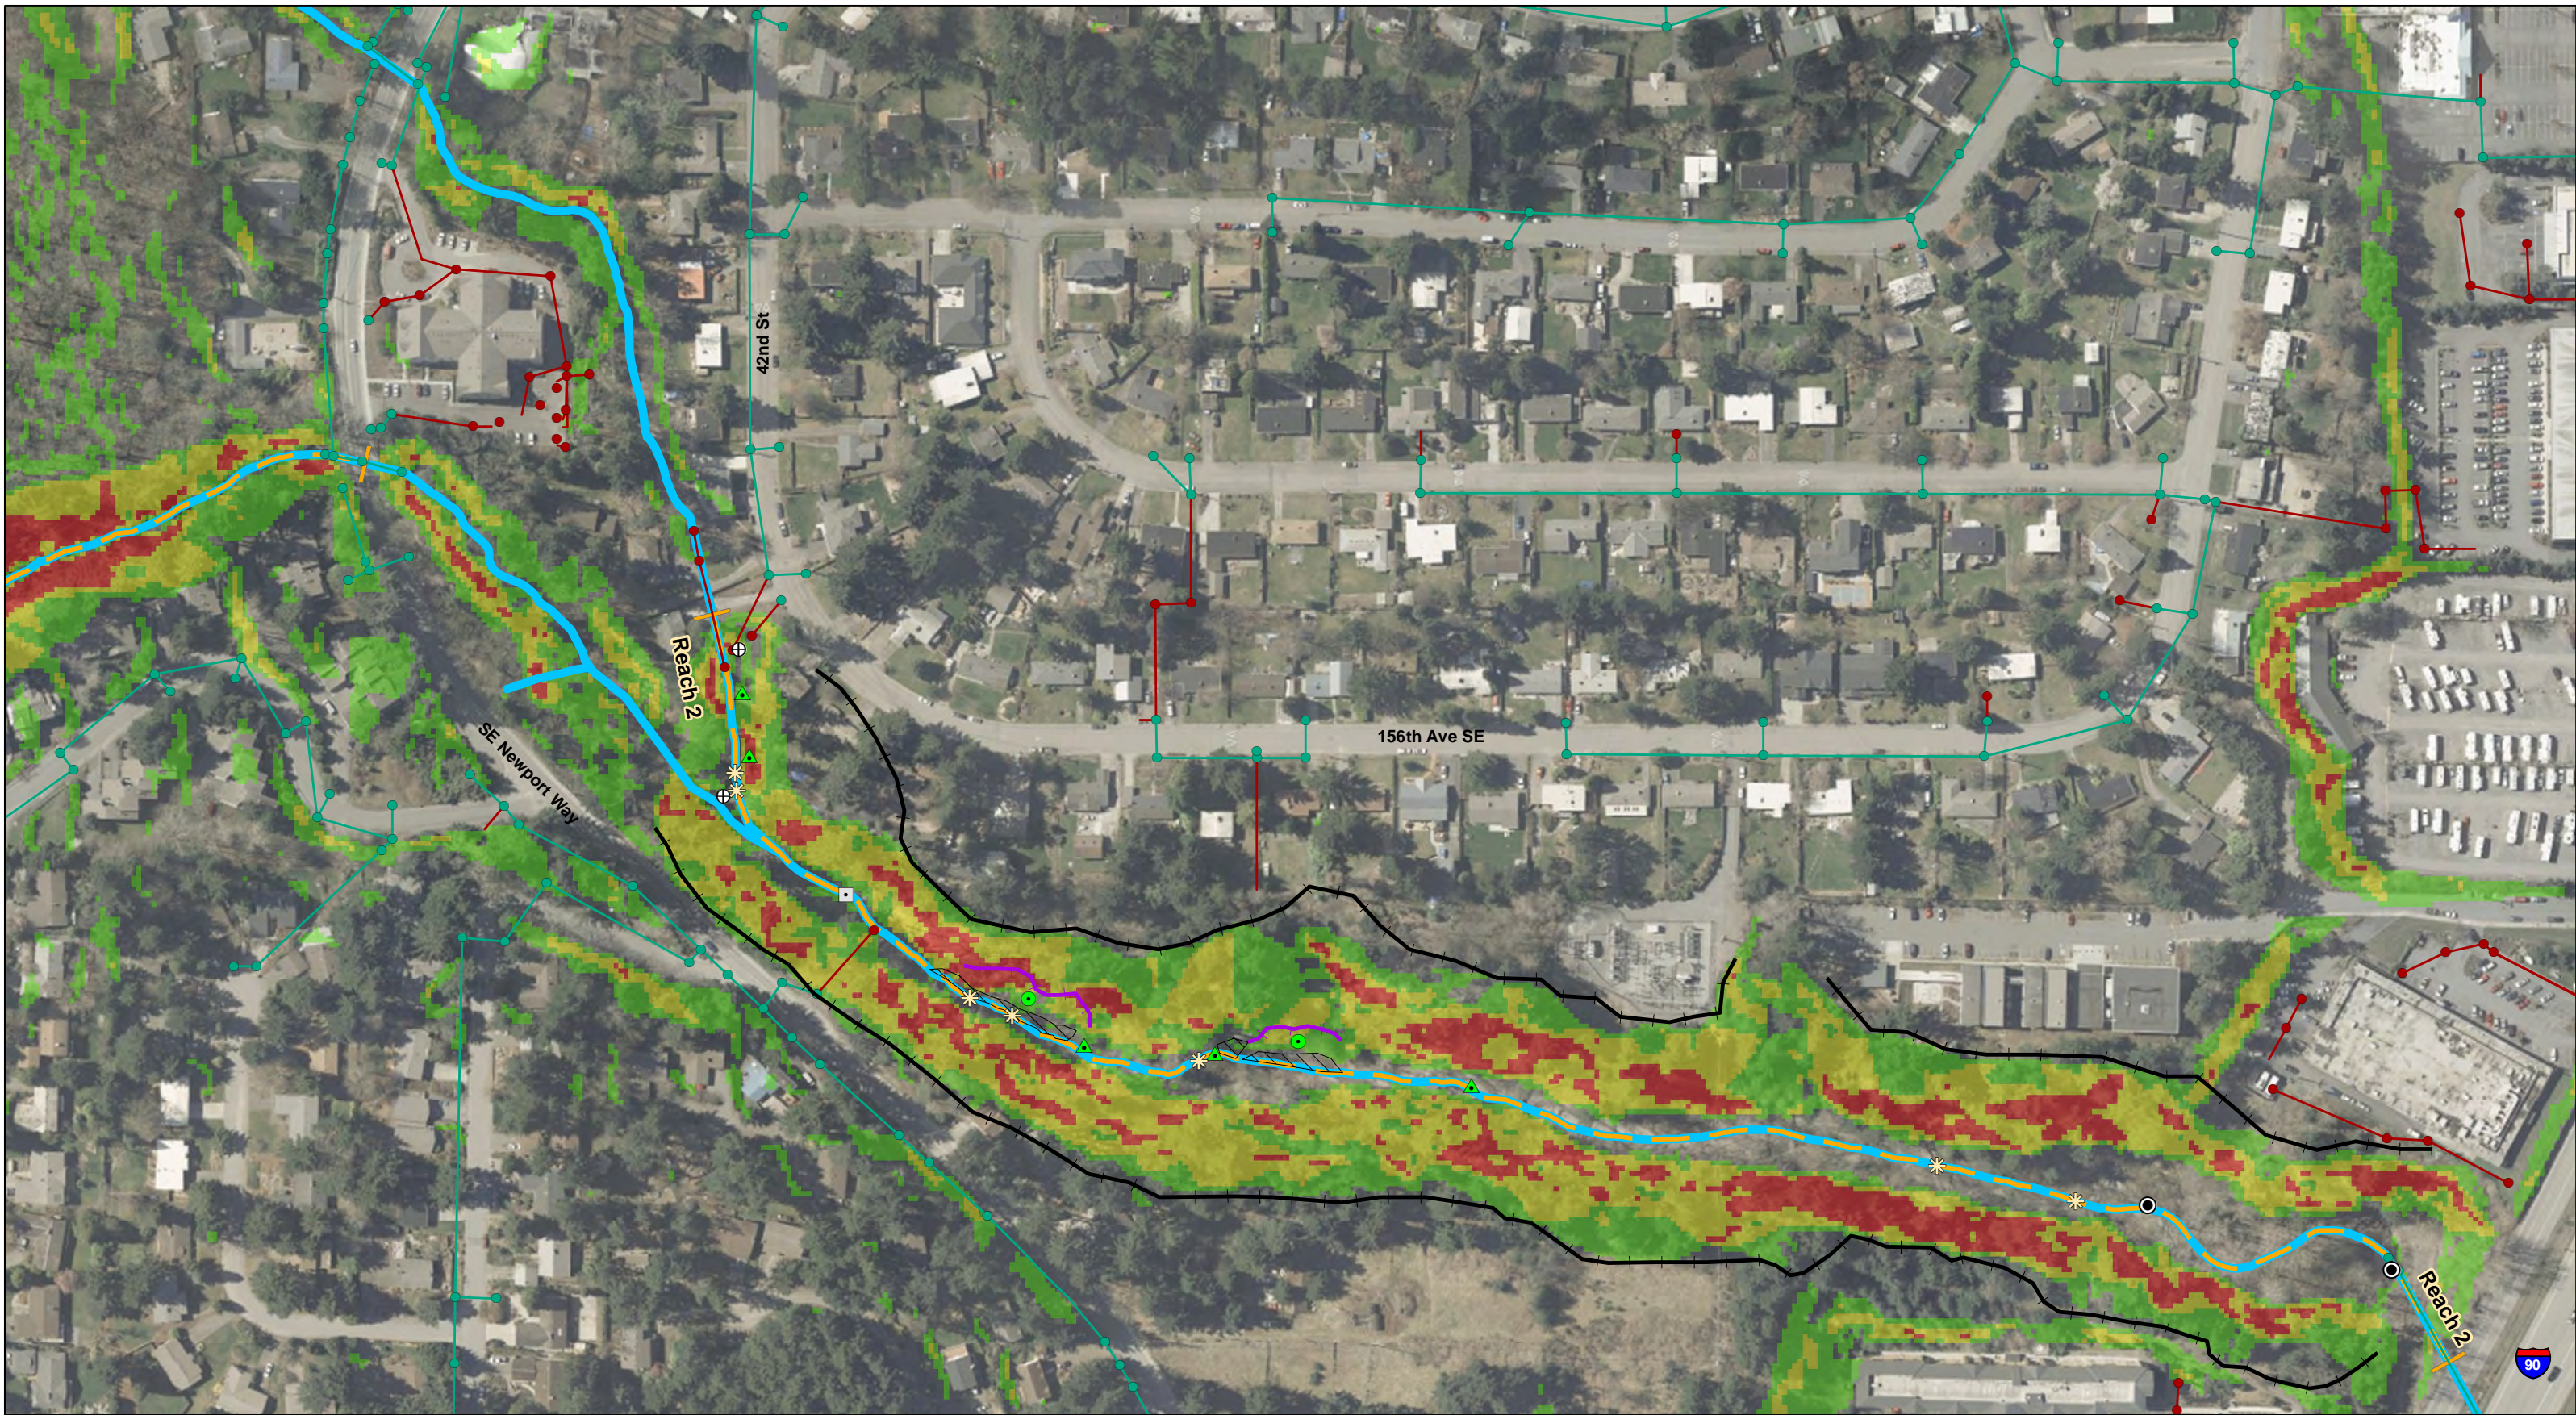
**Figure A-3.**  
**Vasa Creek Landslide Assessment**  
**Reach 2 Field Data**

The results of the slope stability assessment of Vasa Creek Reach 2 are included in Britton (2013). The field data from Britton (2013) are shown in Figure A-3 (Attachment A) for completeness, and also to correct an error by showing the correct slope gradients calculated from the LiDAR DEM. The corrected slopes are also shown in the landslide hazard map (Figure A-8).

The lower segment of this reach of Vasa Creek serves as a large sediment storage area. The I-90 crossing has caused aggradation in the lower segment of Reach 2 resulting in deep deposits of alluvial gravels. Britton (2013) observed that flows are subsurface in this area during the summer low flow period, while flows upstream and downstream are perennial. This observation in combination with the abundant subsurface flow observed downstream of the I-90 crossing in Reach 1 may indicate that a considerable portion of Vasa Creek flows are subsurface through the I-90 crossing rather than in storm drain infrastructure. More detailed hydrologic analyses would need to be conducted to determine flow distributions.

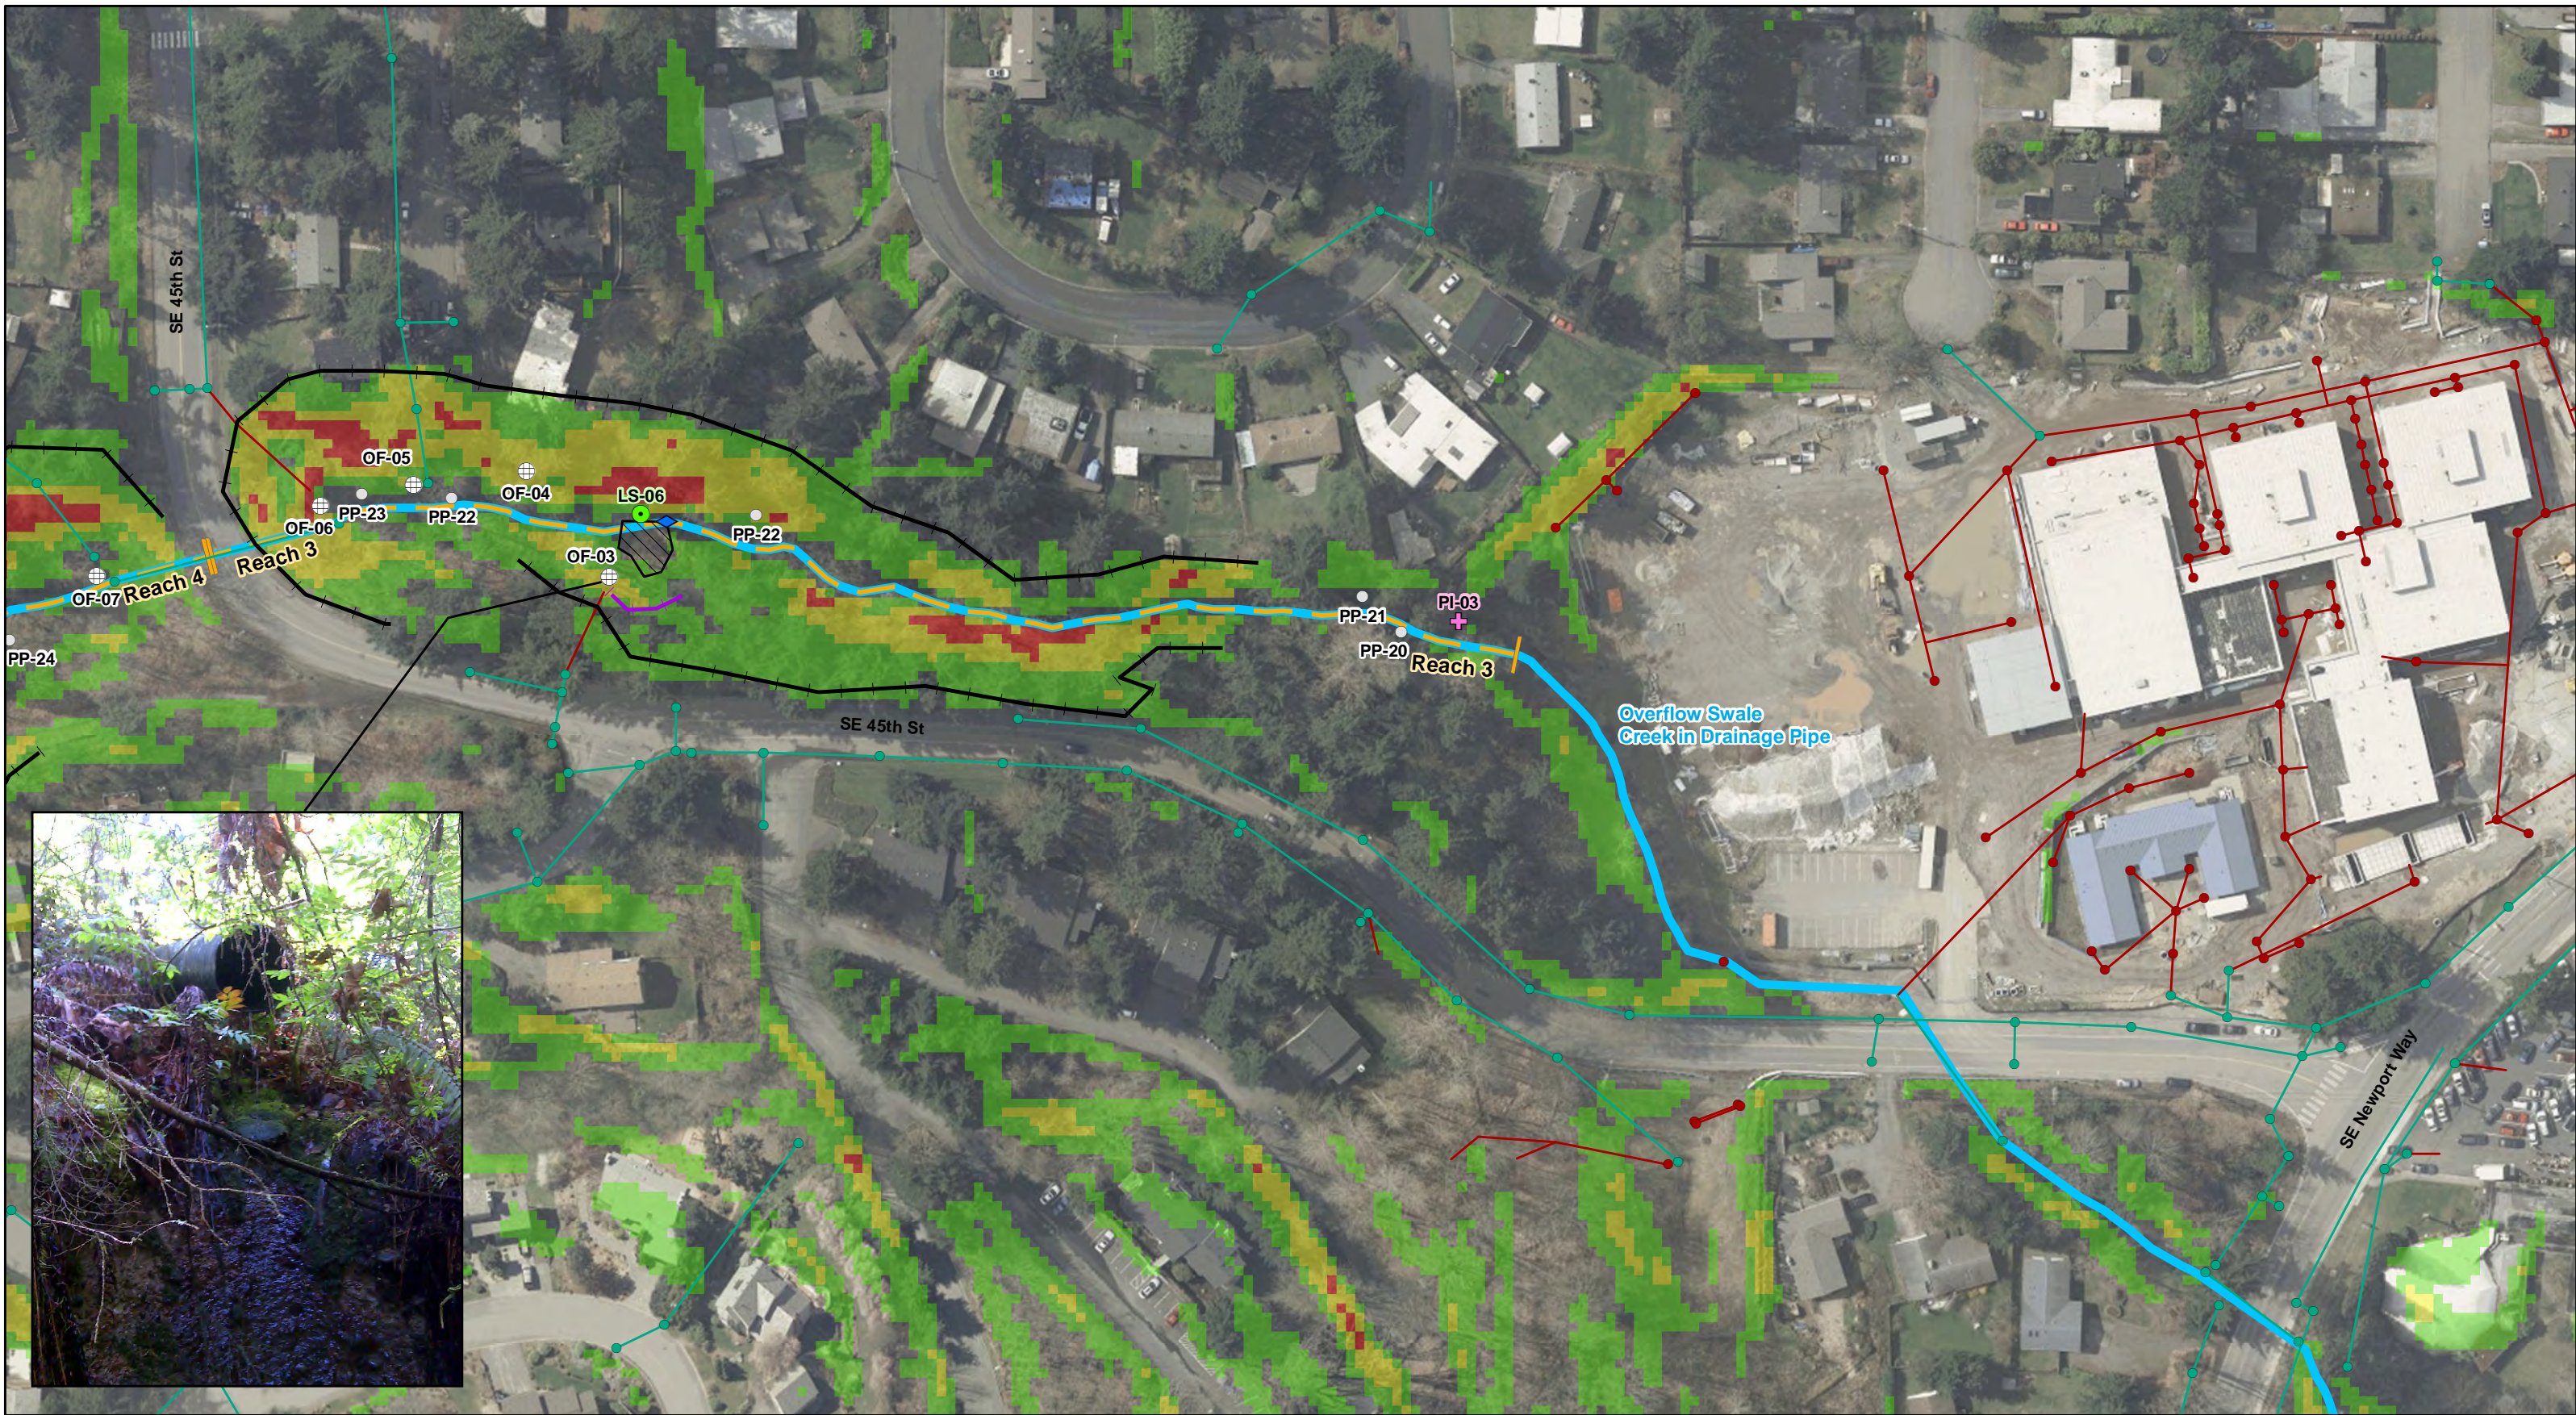
**Figure A-4.**  
**Vasa Creek Landslide Assessment**  
**Reach 3 Field Data**

The overall landslide risk in Reach 3 is relatively low. There was one small slump landslide observed (LS-06) on the west-facing slope. The LS-06 landslide had an estimated deposition volume of 248 m<sup>3</sup> (324 CY). The addition of flow to this location delivered from the storm drain shown on Figure A-4 may have contributed to the slope failure. The LS-06 deposit has

apparently forced the flow of Vasa Creek into the opposite bank causing additional bank erosion. Table 2 contains a summary of the data collected for LS-06.

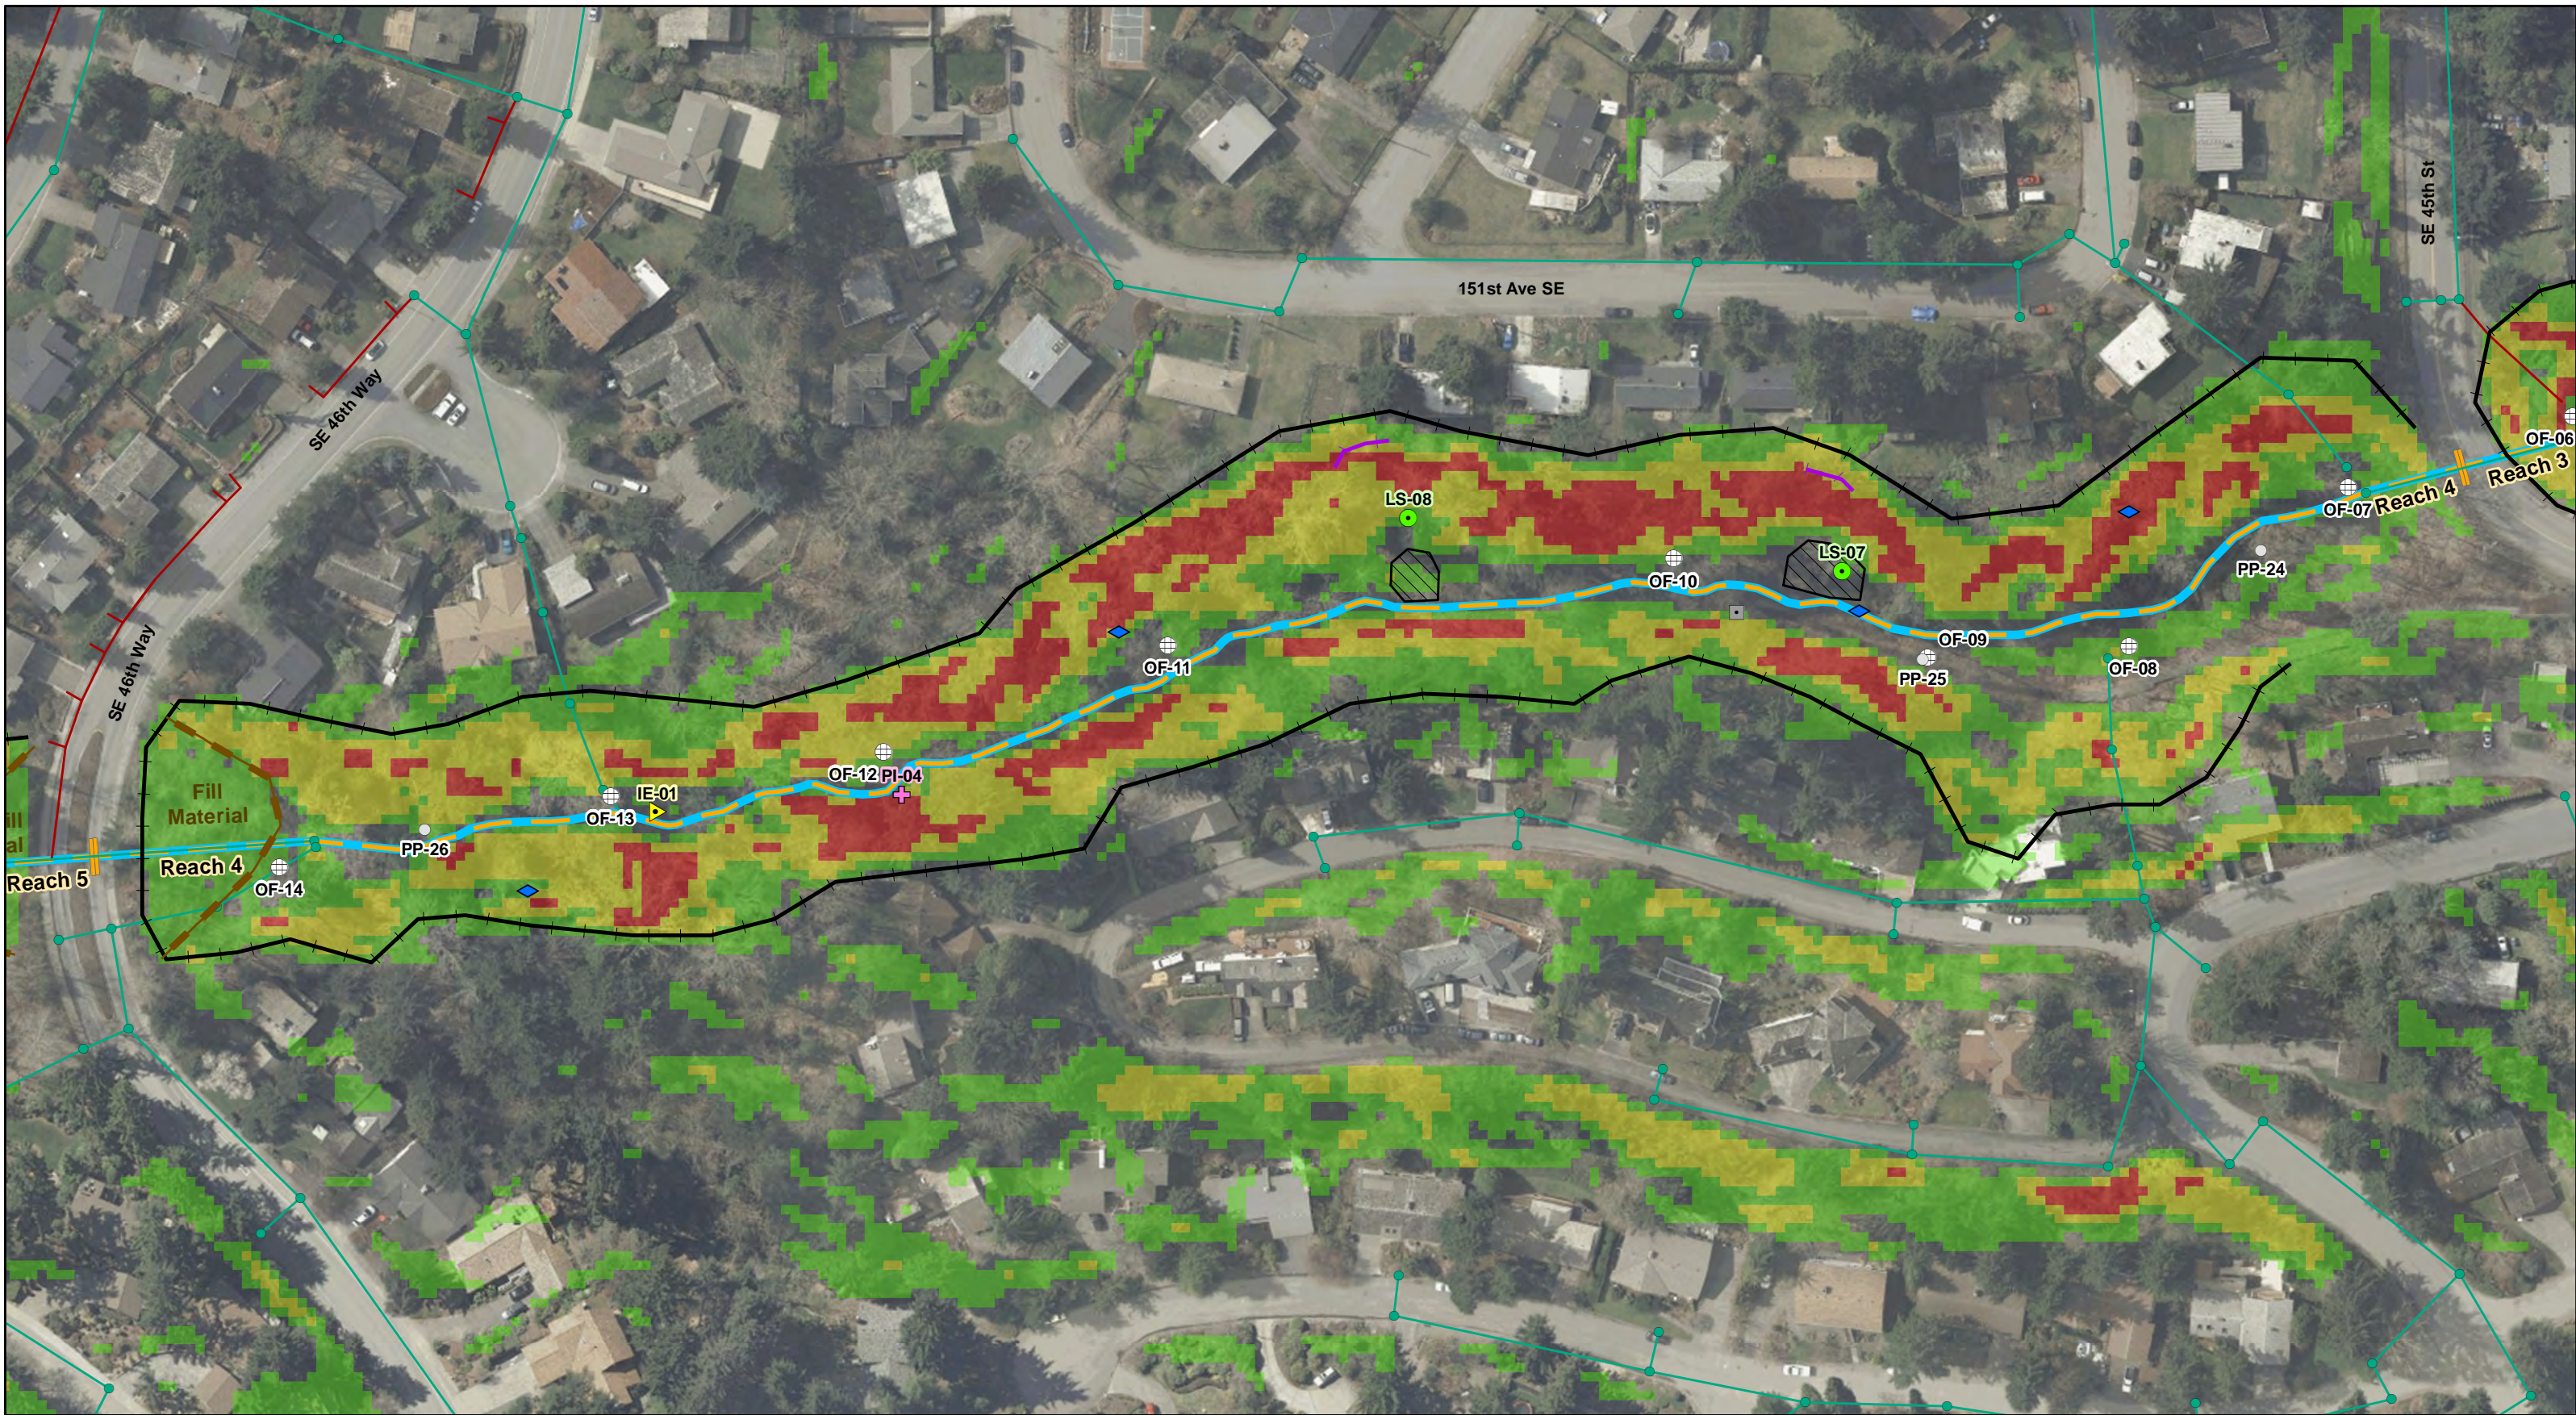
**Figure A-5.**  
**Vasa Creek Landslide Assessment**  
**Reach 4 Field Data**

A pedestrian trail system follows the creek along Reach 4. In addition, there have been a number of restoration efforts (e.g. installed grade control structures, LWD bank protection and sediment retention) made in the channel in this reach to improve channel conditions. The landslide risk in Reach 4 increases slightly from Reach 3 due to generally steeper slopes and somewhat greater relief (Attachment A, Figure A-5 and Table 1).

There were two observed landslides (LS-07 and LS-08) in Reach 4. The observed landslides were shallow rapid debris slides on east-facing slopes with deposition volumes ranging from 96 m<sup>3</sup> to 150 m<sup>3</sup> (126 CY to 196 CY). Table 2 contains summary information of the observed landslides and Figure A-5 shows their location.

There was one area of active in-stream erosion (bank erosion) of 26 meters (85 feet) in length observed in Reach 4 (IE-01). Table 4 contains a summary of the data collected at IE-01. The in-stream erosion at this site is differentiated from the bank erosion at PI-03 and PI-04 in that the erosion at IE-01 was not believed to be associated with future potential hillslope instability.
