# Landslide/Sediment

# Vasa Creek Landslide Inventory and Slope Stability Reconnaissance

VASA CREEK FISH HABITAT EVALUATION AND LANDSLIDE HAZARD ASSESSMENT PROJECT

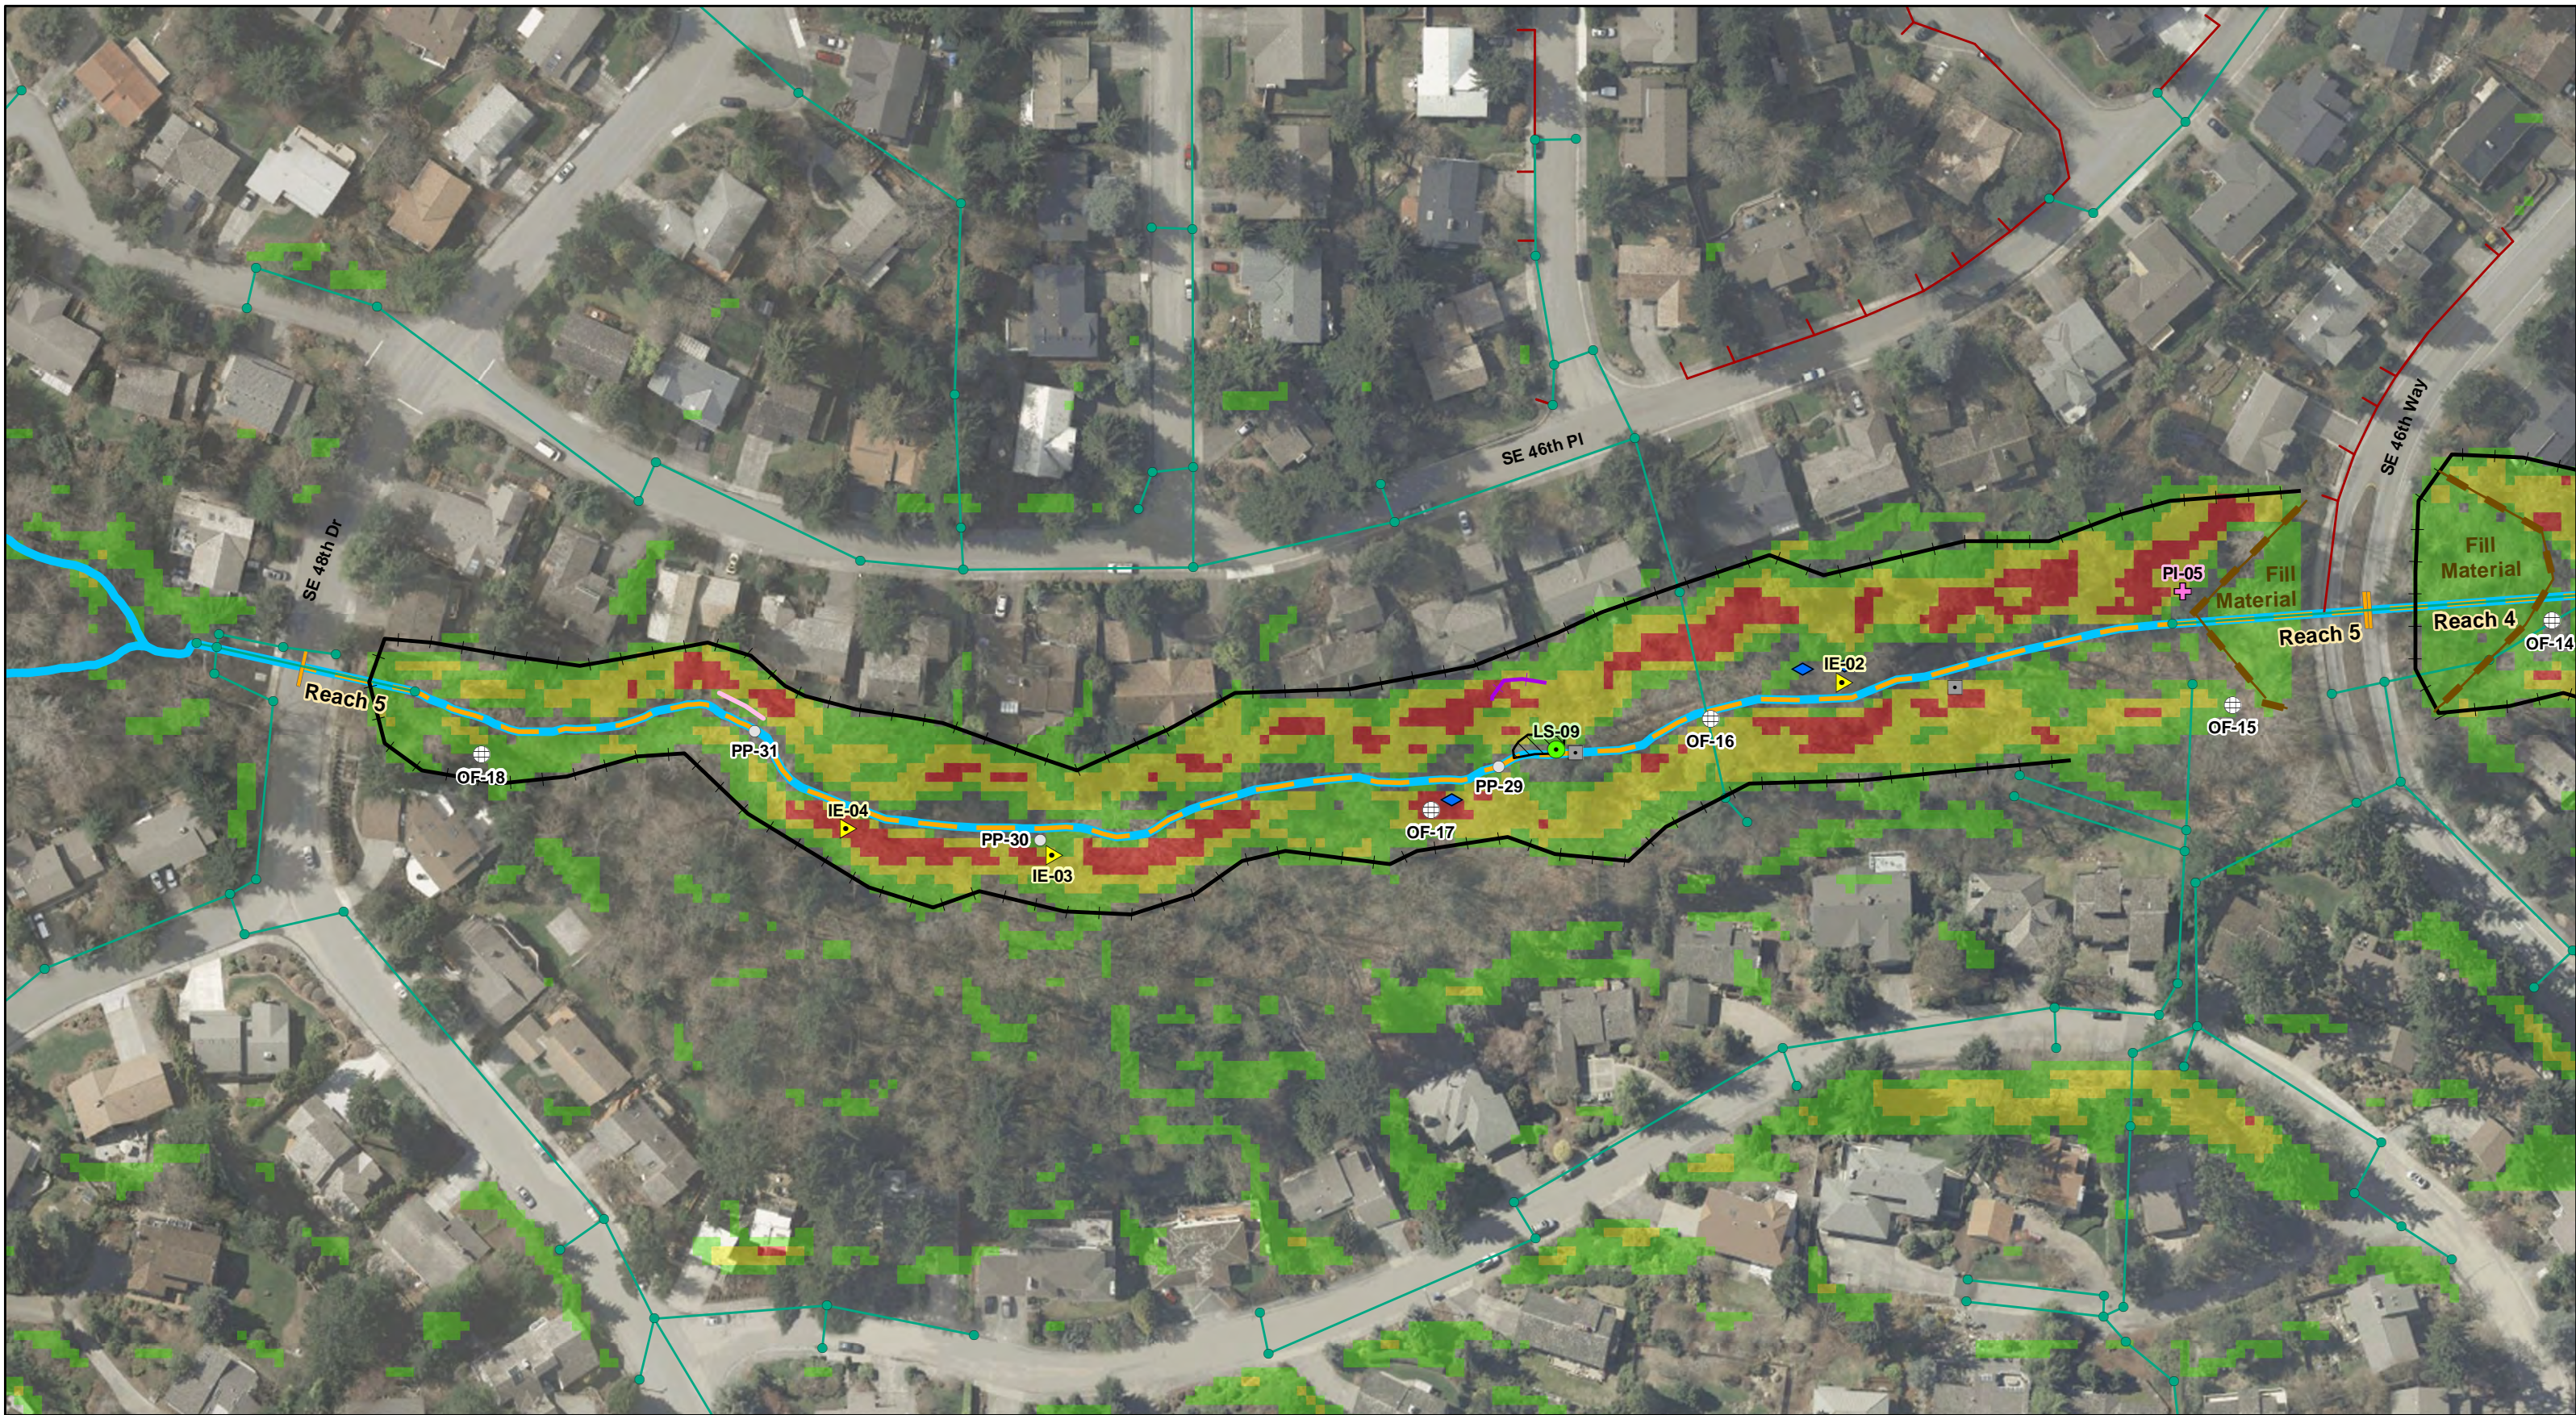
**Figure A-6.**  
**Vasa Creek Landslide Assessment**  
**Reach 5 Field Data**

There was one site identified as potentially unstable (PI-05). Table 3 contains a summary of the data collected for PI-05. In addition there is the potential for future instability at LS-09. There is a block of oversteepened and saturated material still in place on the hillslope to the north of LS-09 that is potentially unstable. The deposit volume of this landslide would be relatively small but would likely cause severe damage to the footbridge at this location.

There were three areas of in-stream erosion (bank erosion) observed in Reach 5 (IE-02, IE-03, and IE-04). The bank erosion at these sites ranged from 13 meters to 20 meters (43 feet to 66 feet) in length. Table 4 contains a summary of the data collected at IE-02, IE-03, and IE-04.

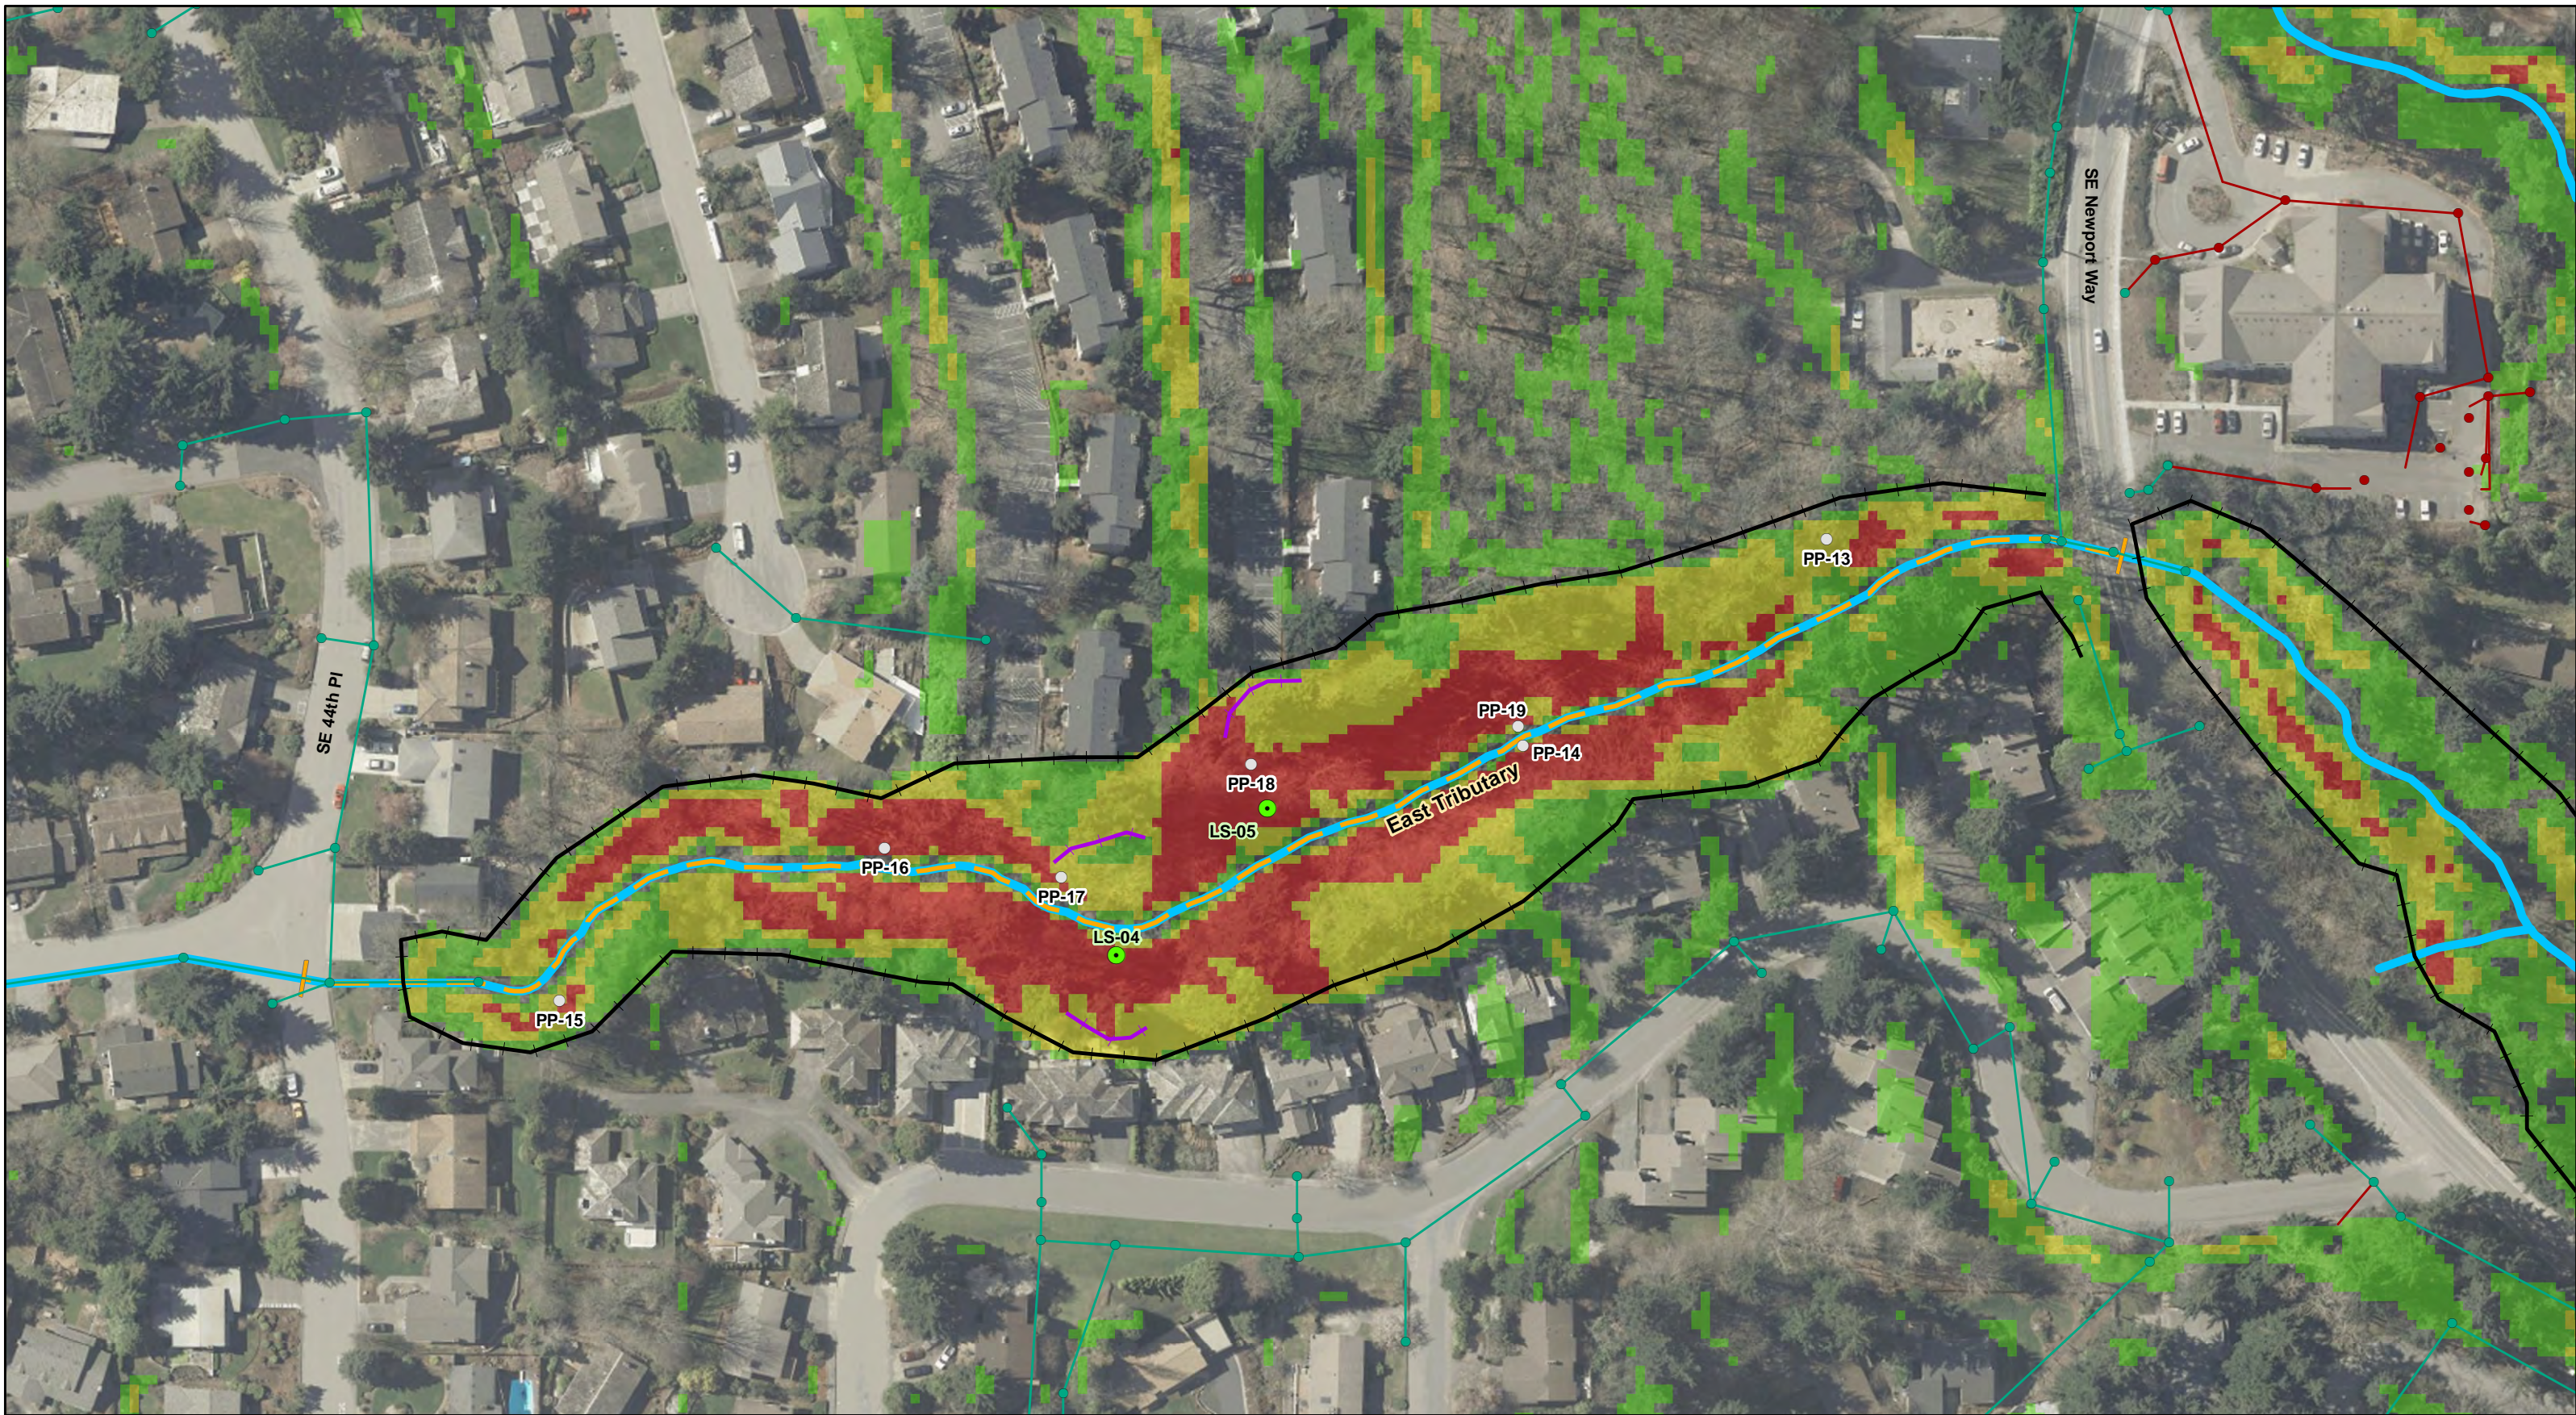
**Figure A-7.**  
**Vasa Creek Landslide Assessment**  
**East Tributary to Vasa Creek Field Data**

There were two observed landslides (LS-04 and LS-05) in Reach 5 (Attachment A, Figure A-7). Table 2 contains a summary of the data collected for LS-04 and LS-05. These landslides were shallow rapid debris slides. Deposit volumes were not measured because the landslide material had been transported downstream, likely shortly after or during the event.

The East Tributary to Vasa Creek survey reach should all be considered potentially unstable although the risk increases on the steeper slopes (> 60%). As in Reach 5, the East Tributary to Vasa Creek has residential properties that are in close proximity to the gorge boundary that may be subject to property damage from future landslides. Further geotechnical analyses would be required to determine which properties are at risk and the level of hazard.

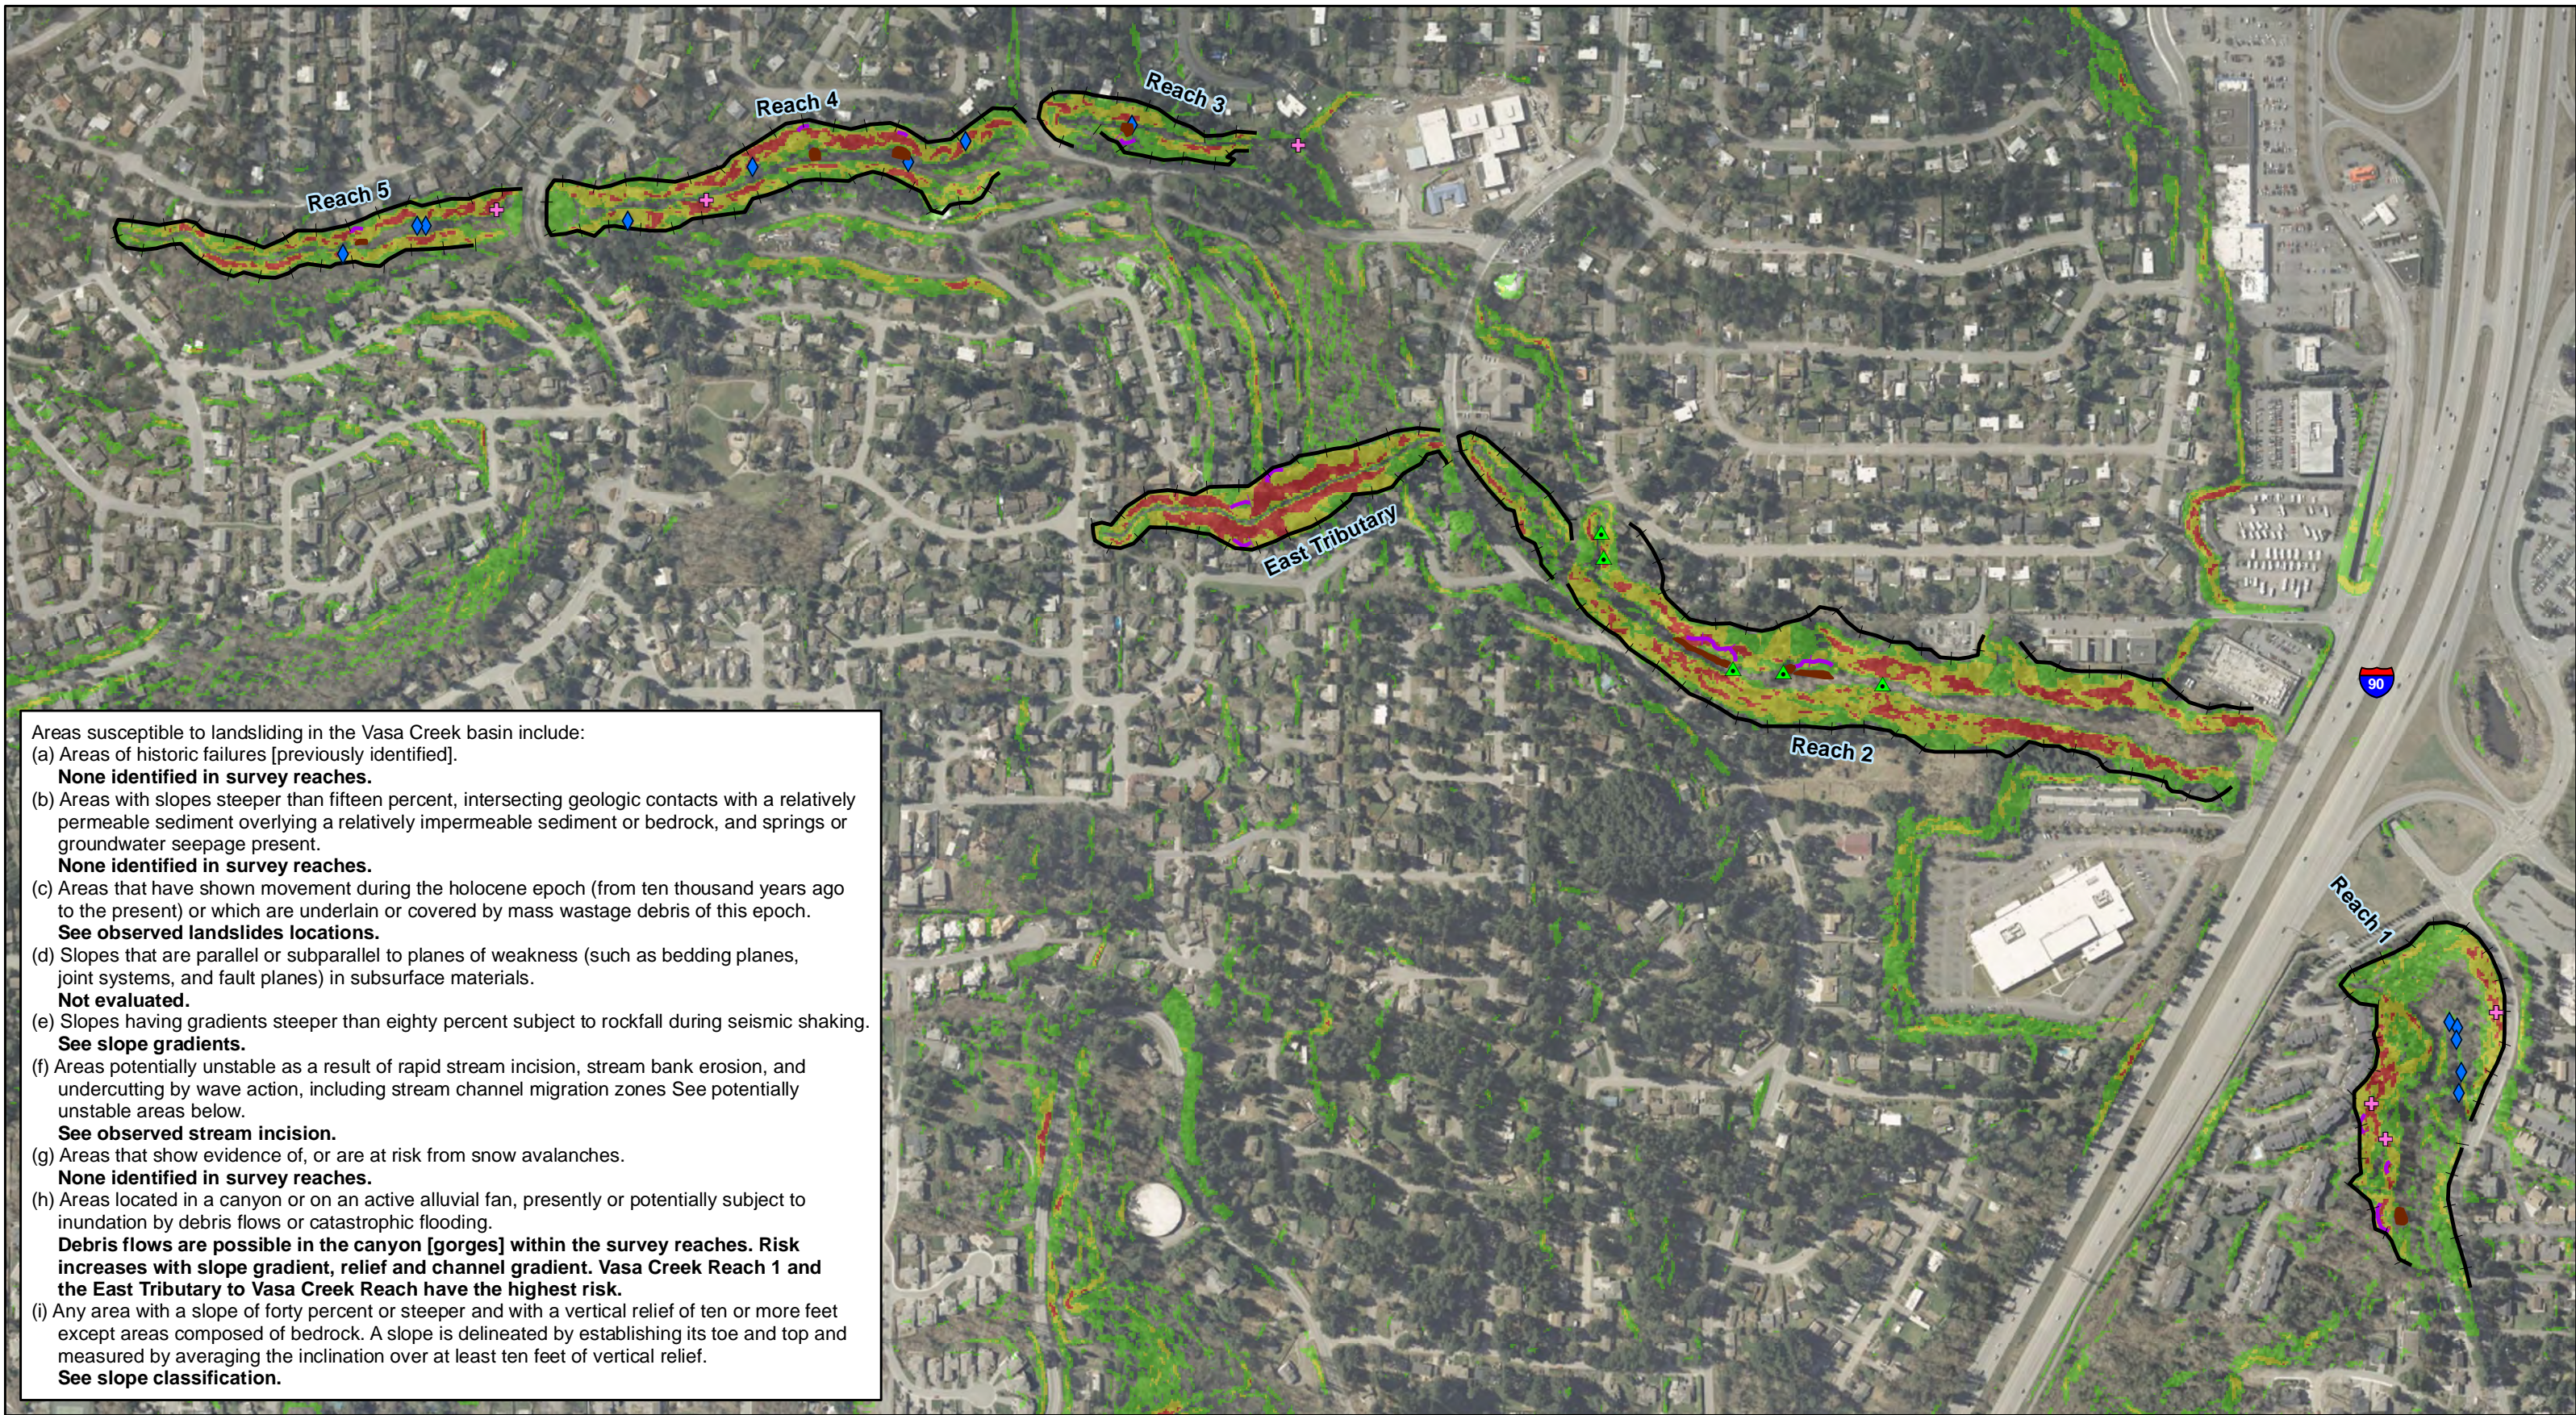
**Figure A-8**  
**Vasa Creek and East Tributary to Vasa Creek**  
**Landslide Hazard Map**

(a) Areas of historic failures [previously identified].  
**None identified in survey reaches.**

(c) Areas that have shown movement during the holocene epoch (from ten thousand years ago to the present) or which are underlain or covered by mass wastage debris of this epoch.  
**See observed landslides locations.**

(f) Areas potentially unstable as a result of rapid stream incision, stream bank erosion, and undercutting by wave action, including stream channel migration zones See potentially unstable areas below.  
**See observed stream incision.**
