MEYDENBAUER RESIDENCE

707 94TH AVE SE
BELLEVUE, WA 98004

PROJECT DESCRIPTION:
REMODEL TO AN EXISTING SINGLE-FAMILY RESIDENCE, NEW ACCESSORY STRUCTURES, AND ASSOCIATED SITE WORK AND DRIVEWAY UPGRADES.

As requested, PanGEO has completed a geotechnical engineering evaluation for the utilities that have been installed in the mapped Geologic Hazard Areas (i.e. Steep Slope and High Erosion Areas) in the western portion of the property. The purpose of our study is to evaluate the potential impacts of the installed utilities on the slope stability and the residence located to the east of the slope. Our service scope included reviewing readily-available geologic and geotechnical data, conducting a site reconnaissance, drilling one test boring, and developing the conclusions and recommendations presented in this report.

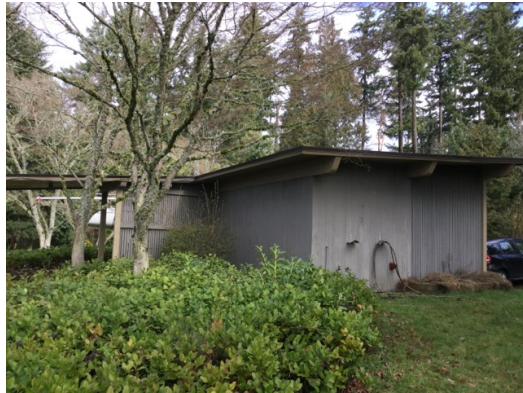
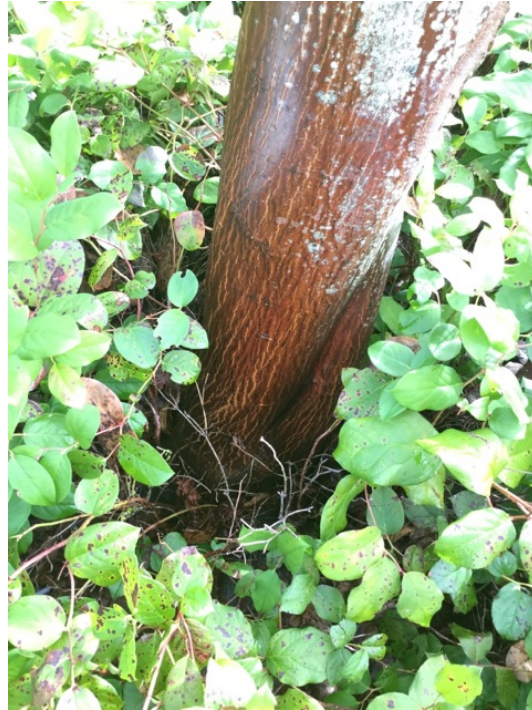
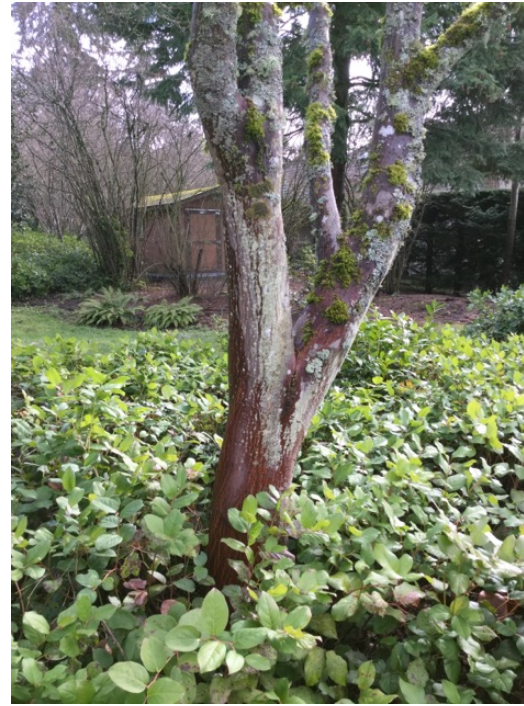
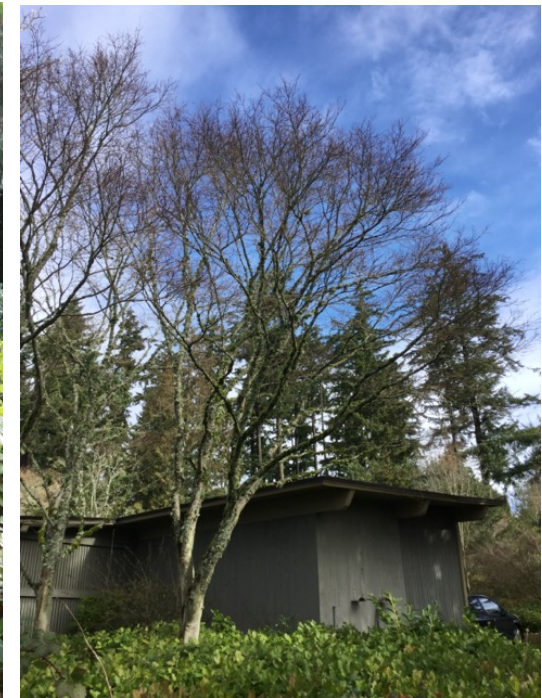
Tree	Species	DBH (in)	Drip Avg (ft)	CRZ (ft)	Vigor	Structure	Risk	Pres. Value	Recommendations
1	Japanese maple <i>Acer palmatum</i>	9.7, (9.7)	9.6	9.7	Fair to Good	Fair to Good	Low	Medium	
Notes / Defects	Red form of Japanese maple. At 4.5 feet above grade, trunk diameters are 7.5 and 7.1-inches . Crown has an asymmetrical form, with the majority of the crown located to the south of this tree.								Dripline (ft) N 4.5 S 14 E 13 W 7

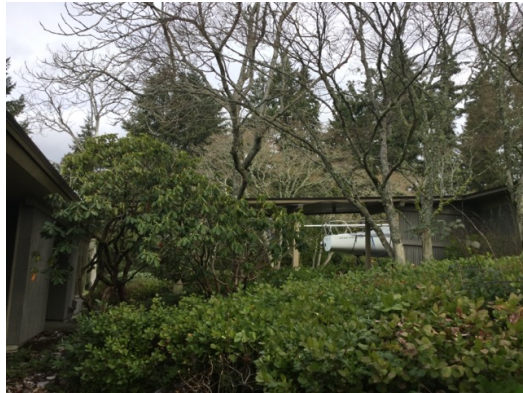
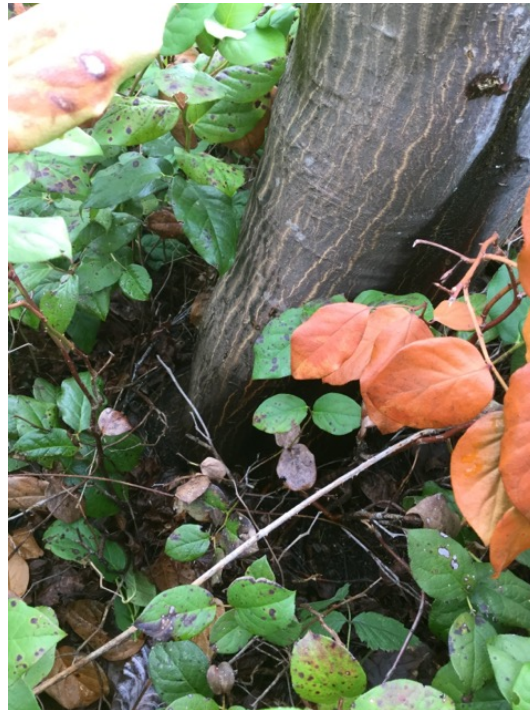
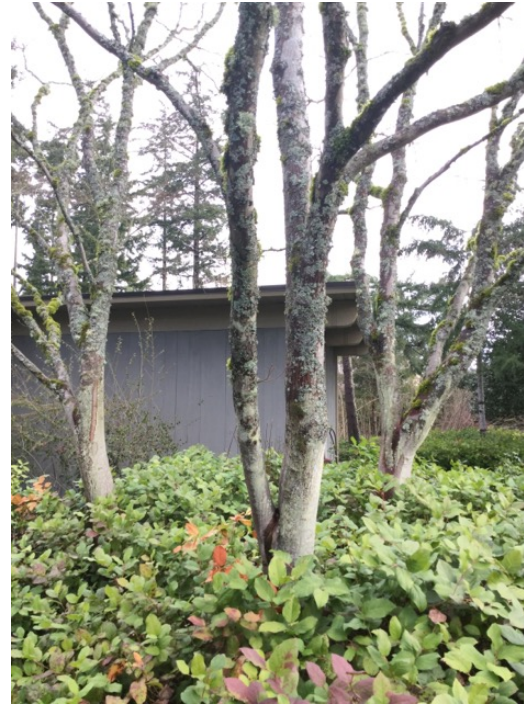
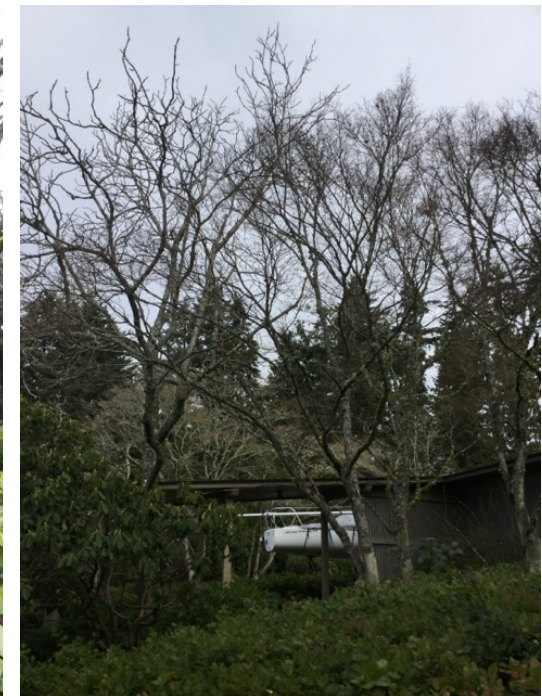
Tree	Species	DBH (in)	Drip Avg (ft)	CRZ (ft)	Vigor	Structure	Risk	Pres. Value	Recommendations
2	Japanese maple <i>Acer palmatum</i>	6.9, 4.1 (8.03)	8.7	8.0	Fair to Good	Fair to Good	Low	Medium	
Notes / Defects	Red form of Japanese maple. Crown has an asymmetrical form, with the majority of the crown located to southeast of the trees center.								Dripline (ft) N 4.5 S 12.5 E 4 W 14

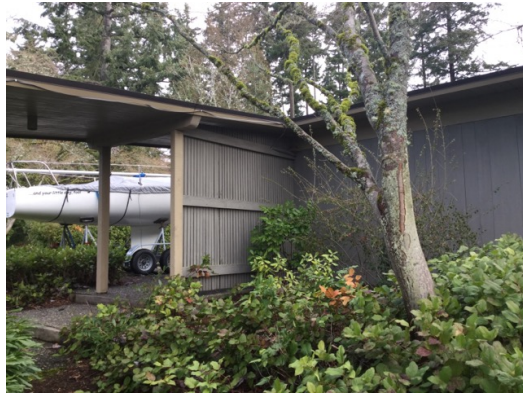
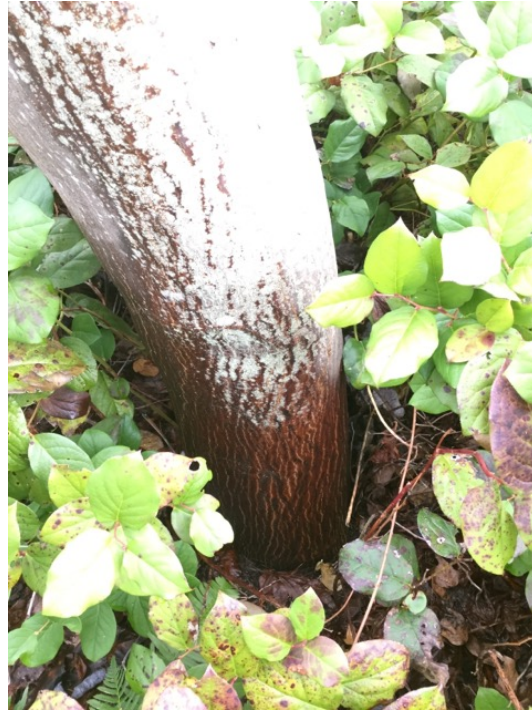
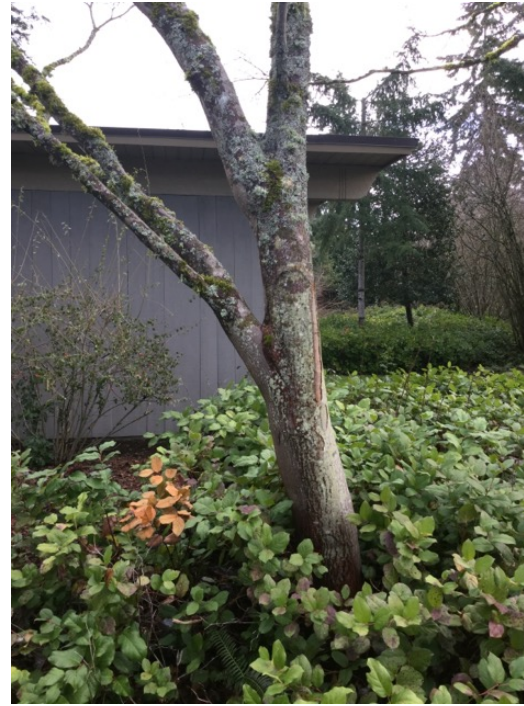
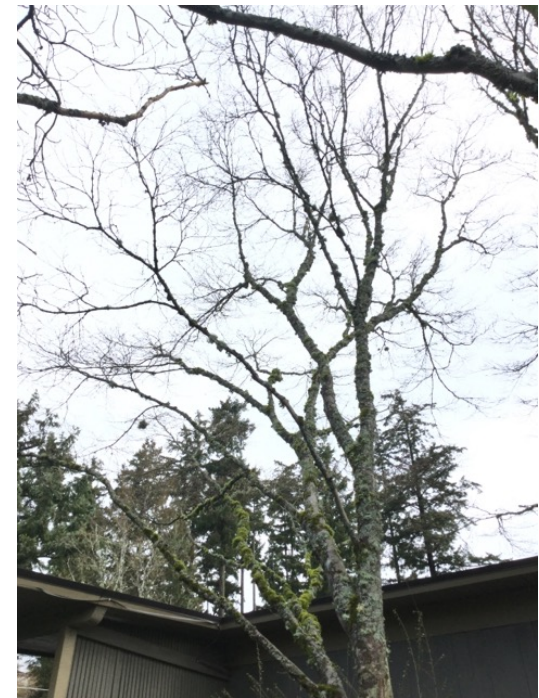
Tree	Species	DBH (in)	Drip Avg (ft)	CRZ (ft)	Vigor	Structure	Risk	Pres. Value	Recommendations
3	Japanese maple <i>Acer palmatum</i>	8.6, (8.6)	10.1	8.6	Fair to Good	Fair to Good	Low	Medium	
Notes / Defects	Red form of Japanese maple. Crown has an asymmetrical form, with the majority of the crown located to the northeast of the crowns center.								Dripline (ft) N 13 S 4.5 E 15.5 W 8

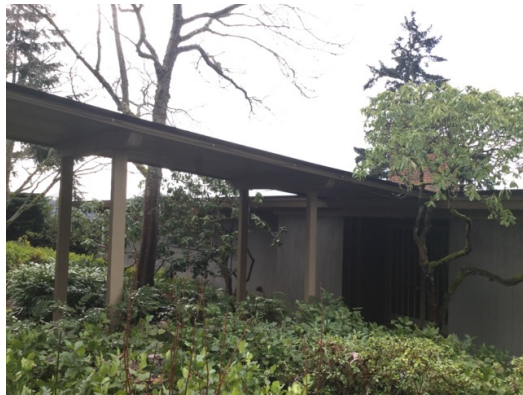
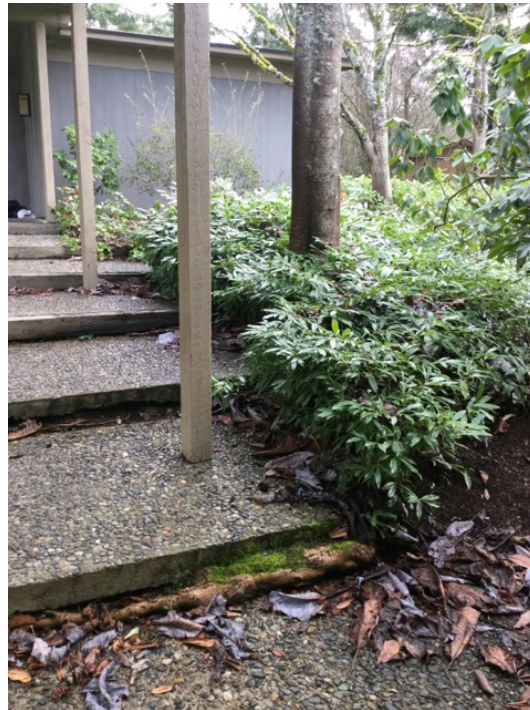
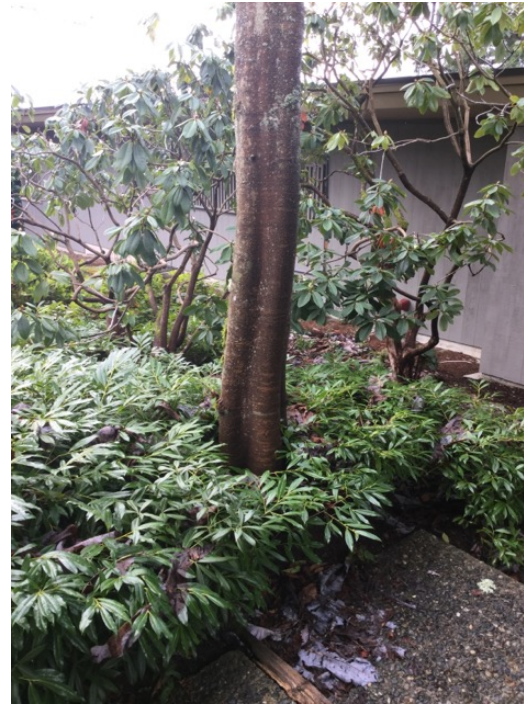
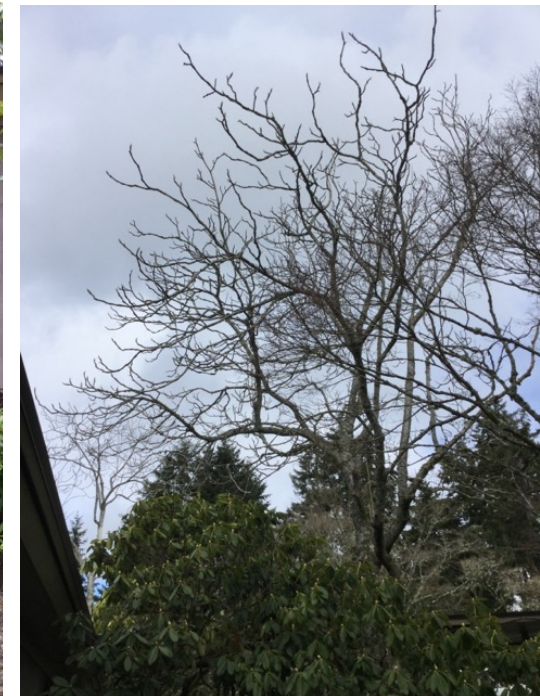
Tree	Species	DBH (in)	Drip Avg (ft)	CRZ (ft)	Vigor	Structure	Risk	Pres. Value	Recommendations
4	Magnolia <i>Magnolia species</i>	12.9, (12.9)	15.4	12.9	Fair to Good	Fair to Good	Low	Medium	
Notes / Defects	A surface root is growing around and over the concrete stairway, at 7-feet distance from the tree base. The surface root growing over the the pathway is 4-inches diameter. This root will need to cut or retained and protected during demolition. If retained the new stairway path will need to bridge over this root.								Dripline (ft) N 15 S 20 E 12 W 15

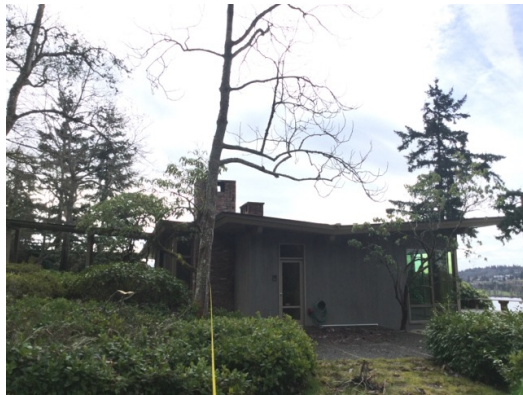
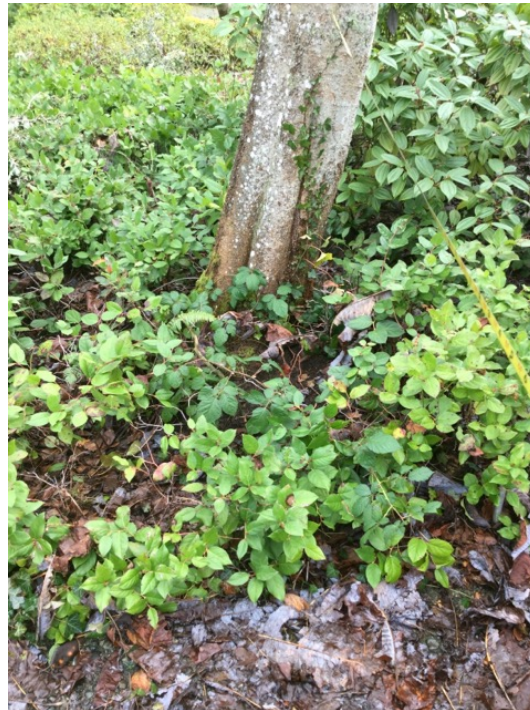
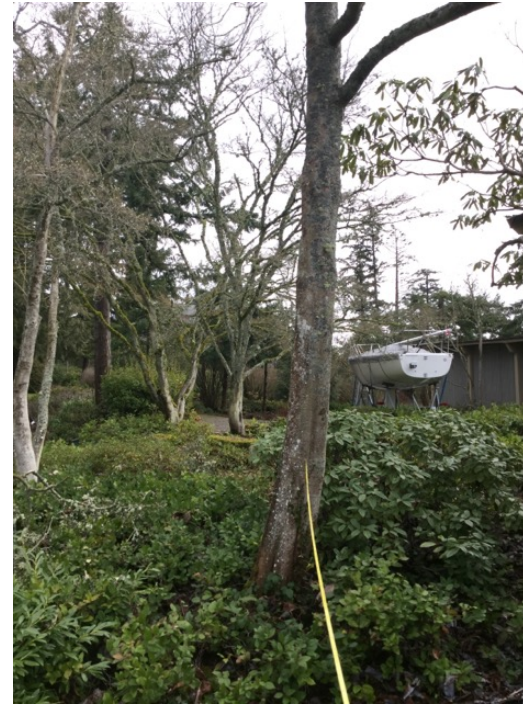
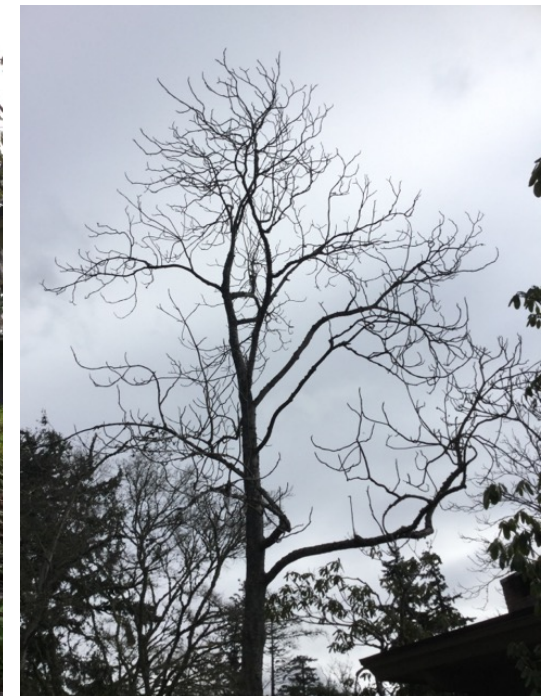
Tree	Species	DBH (in)	Drip Avg (ft)	CRZ (ft)	Vigor	Structure	Risk	Pres. Value	Recommendations
5	Magnolia <i>Magnolia species</i>	13.7, (13.7)	14.1	13.7	Fair to Good	Fair to Good	Low	Medium	
Notes / Defects	A concrete patio surface is within 3-feet, current residential building within 9-feet. If retained caution will need to be exercised in demolishing the building. Careful staging of the demolition work will also be required to avoid damaging the soils in this trees Critical Root Zone. Tree protection and possibly pruning and branch tieback may be required.								Dripline (ft) N 15 S 13.5 E 12 W 16

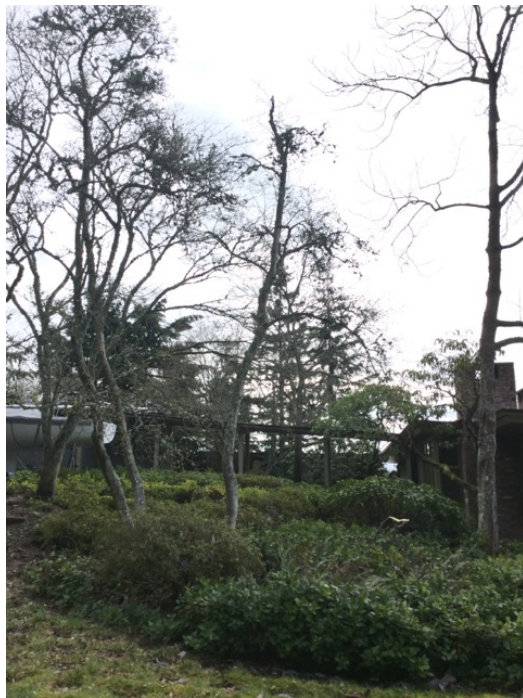
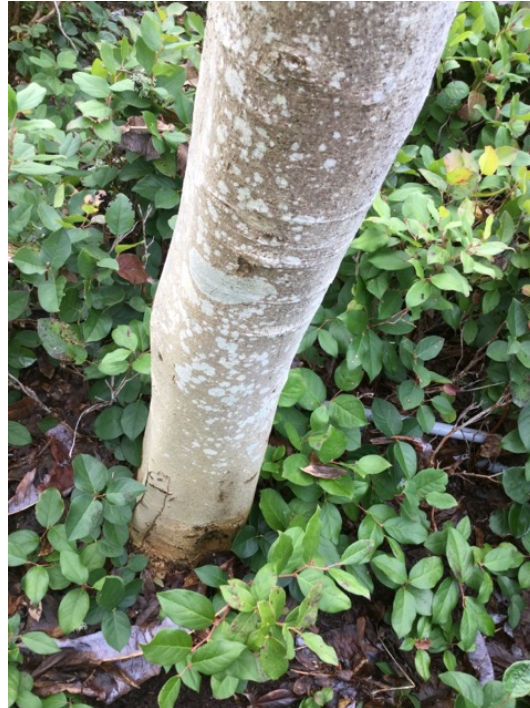
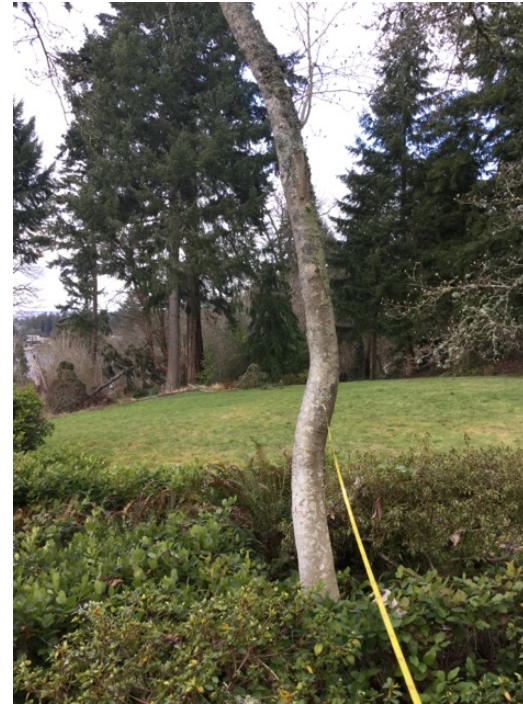
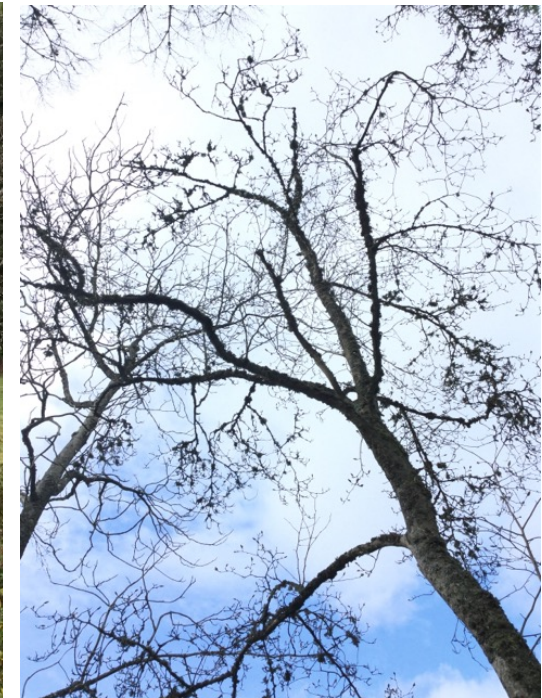
Tree	Species	DBH (in)	Drip Avg (ft)	CRZ (ft)	Vigor	Structure	Risk	Pres. Value	Recommendations
6	Magnolia <i>Magnolia species</i>	7.5, (7.5)	7.4	7.5	Fair	Fair	Low	Medium	
Notes / Defects	The crown of this tree has recently failed. I noticed scarring on the trunk possibly the result of a canker disease.								Dripline (ft) N 7 S 10 E 5 W 8

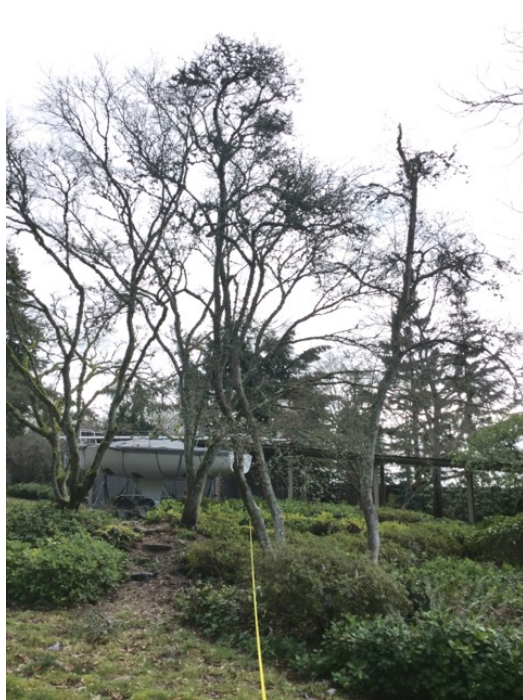
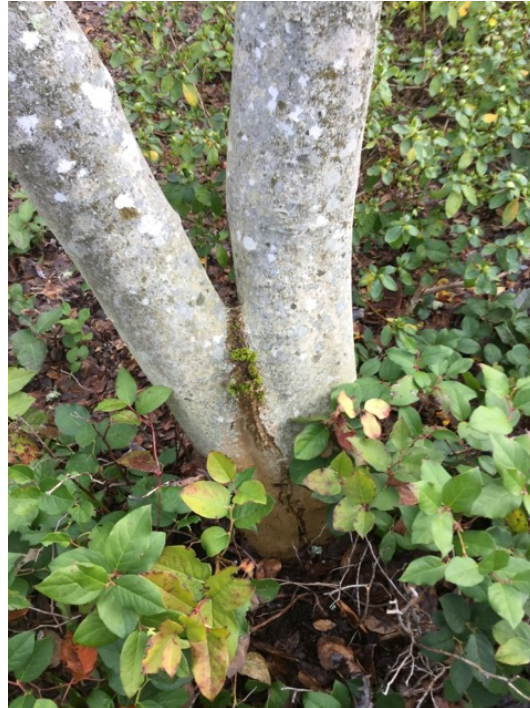
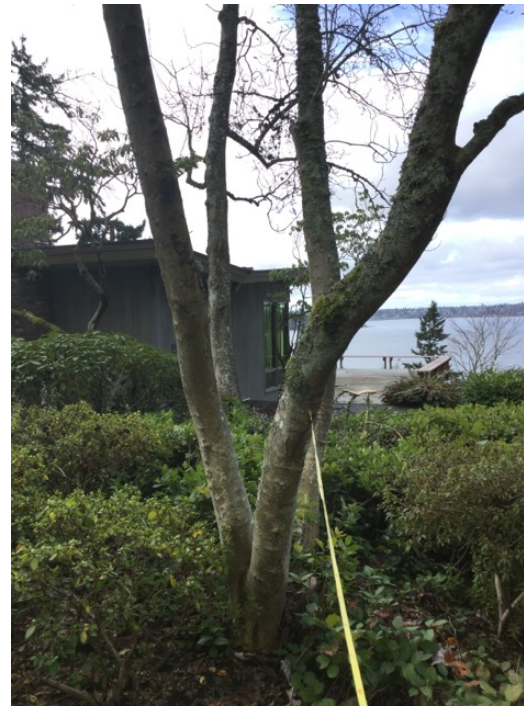
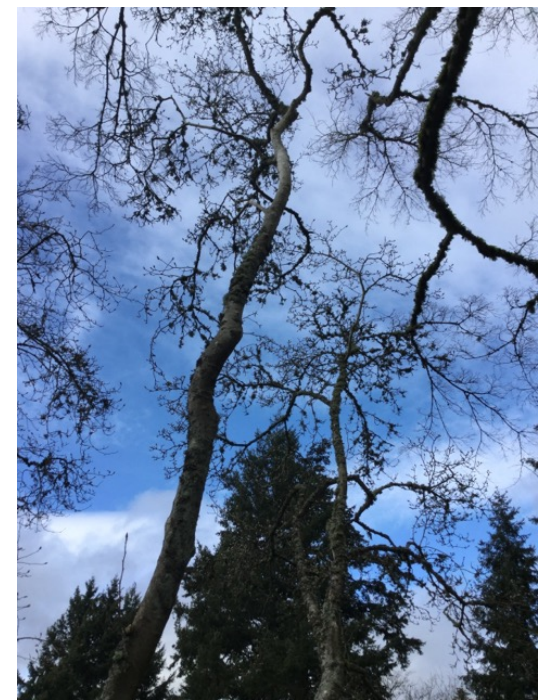
Tree	Species	DBH (in)	Drip Avg (ft)	CRZ (ft)	Vigor	Structure	Risk	Pres. Value	Recommendations
7	Magnolia <i>Magnolia species</i>	6.2, 6.7 (9.13)	8.9	9.1	Fair	Fair	Low	Medium	
Notes / Defects	I noticed scaring on the trunk, possibly the result of a canker disease.								Dripline (ft) N 13 S 6 E 7.5 W 9

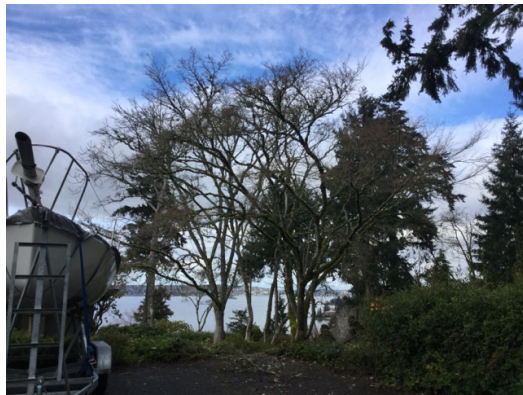
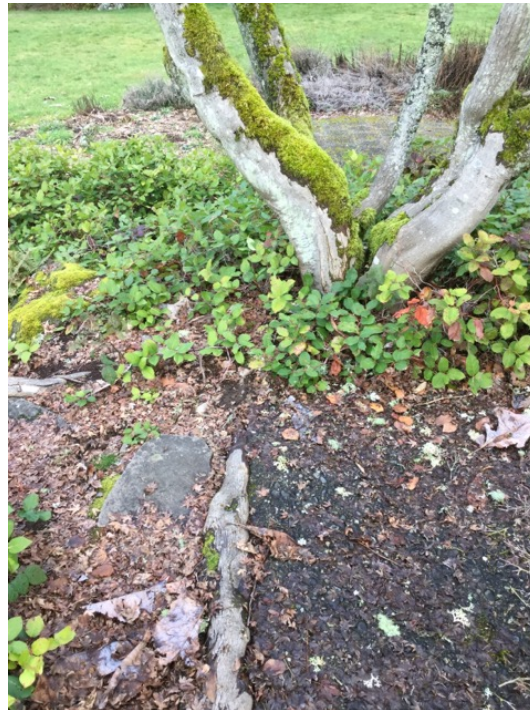
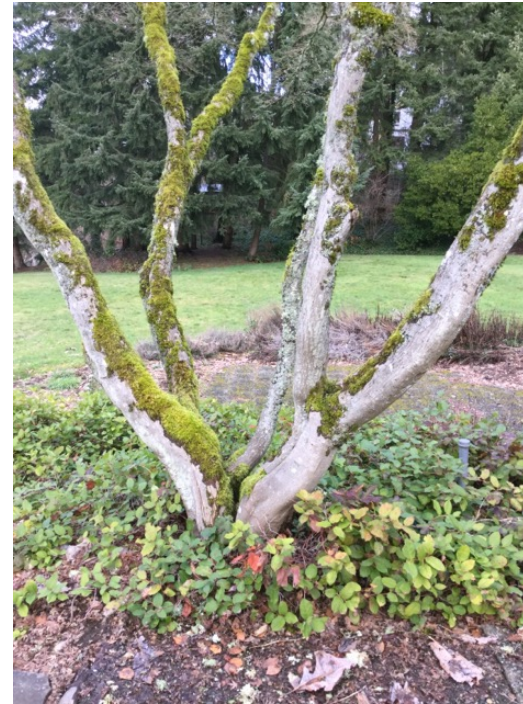
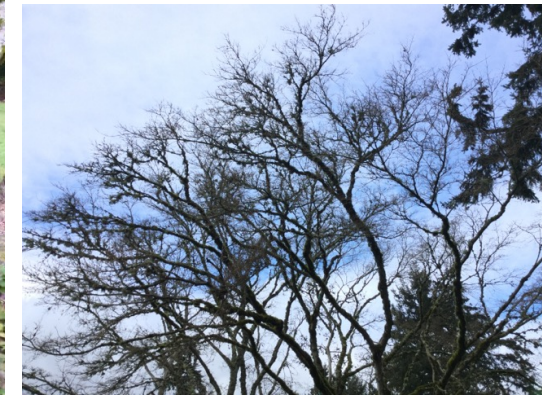
Tree	Species	DBH (in)	Drip Avg (ft)	CRZ (ft)	Vigor	Structure	Risk	Pres. Value	Recommendations
8	Japanese maple <i>Acer palmatum</i>	7.8, 5.5, 7.7,		14.6	Fair	Fair	Medium	Medium	
Notes / Defects	As per tree #9; Significant surface roots, 3 to 5.5-inches in diameter, 4 to 6-feet from the base of this tree. Bifurcation of codominant trunks at 2-feet height are stable, although it contains included bark. If retained, this structure should be monitored in future for signs of failure.								Dripline (ft) N S E W

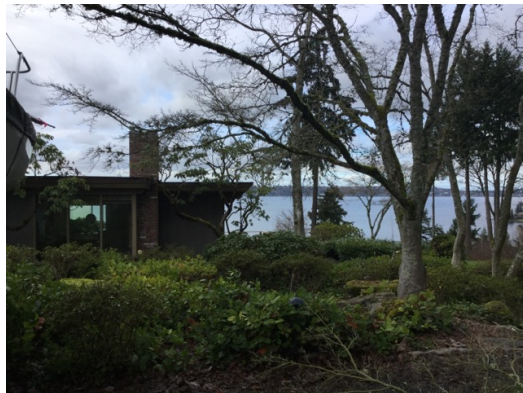
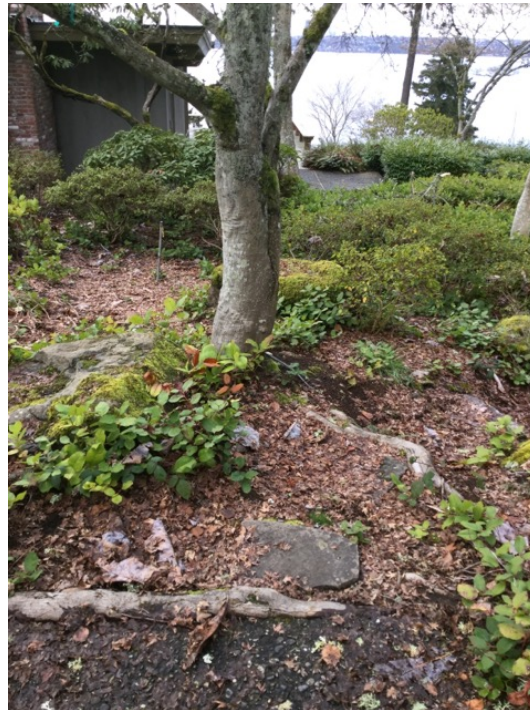
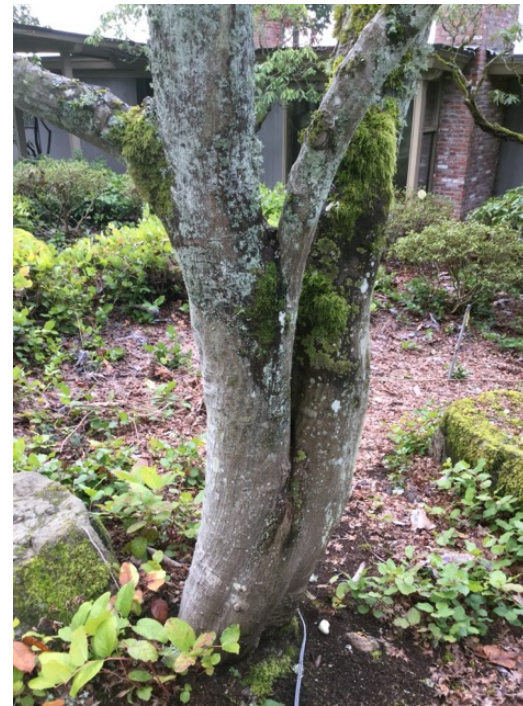
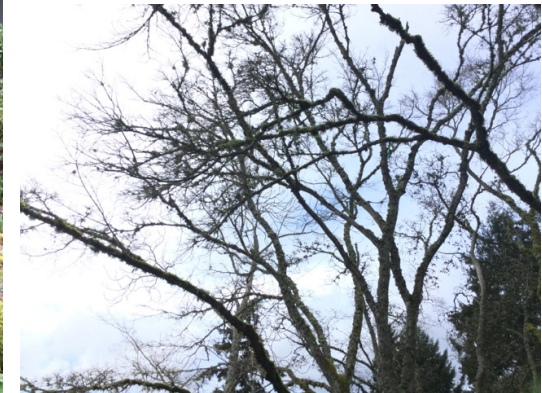
Tree	Species	DBH (in)	Drip Avg (ft)	CRZ (ft)	Vigor	Structure	Risk	Pres. Value	Recommendations
9	Japanese maple <i>Acer palmatum</i>	9.8, 9.4 (13.58)	18.4	13.6	Fair	Fair	Medium	Medium	
Notes / Defects	Significant surface roots, 3 to 5.5-inches in diameter, 4 to 6-feet from the base of this tree. Bifurcation at the trunk base has led to the development of a slightly weaker structure due to codominant structure, and the wide spread of the crown to the east.								Dripline (ft) N 22 S 18 E 21 W 12.8

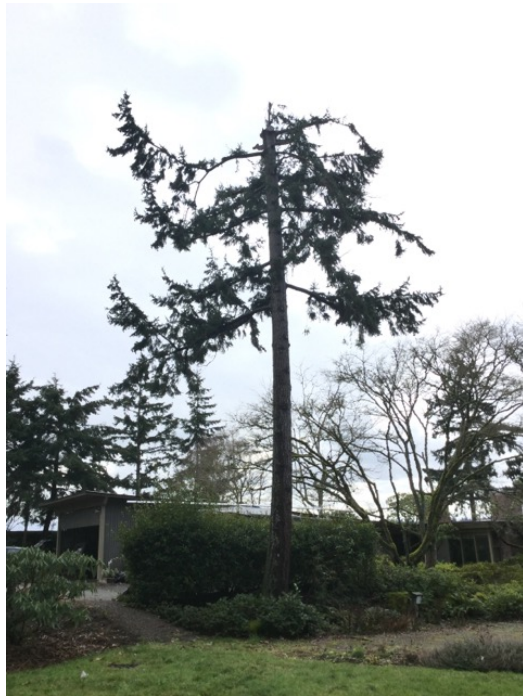
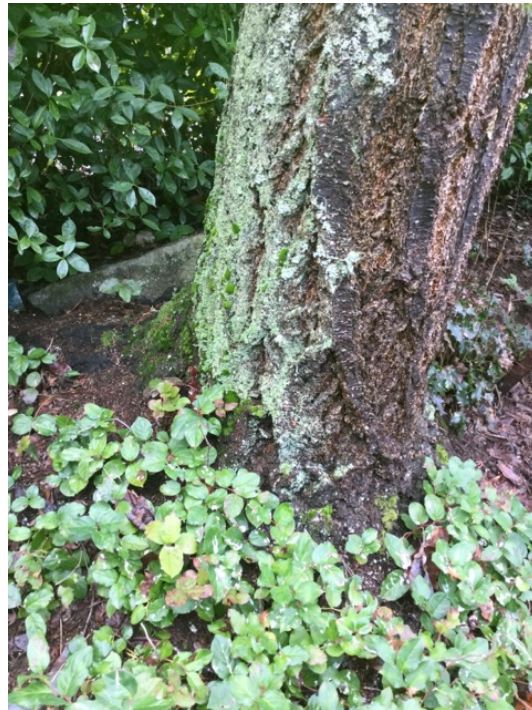
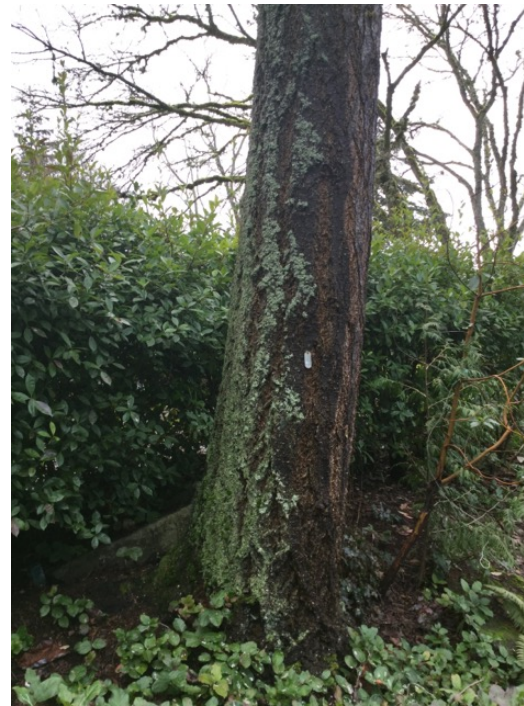
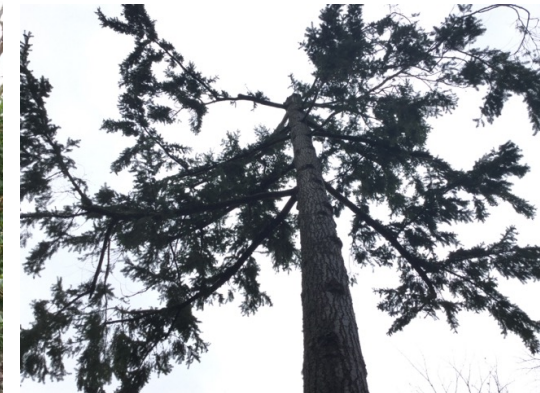
Tree	Species	DBH (in)	Drip Avg (ft)	CRZ (ft)	Vigor	Structure	Risk	Pres. Value	Recommendations
10	Douglas fir <i>Pseudotsuga menziesii</i>	24.5, (24.5)	14.1	24.5	Fair	Poor to Fair	Low	Low	
Notes / Defects	This tree has been topped, crown reduction has shortened the remaining branches.								Dripline (ft) N 12 S 17 E 14 W 13.5

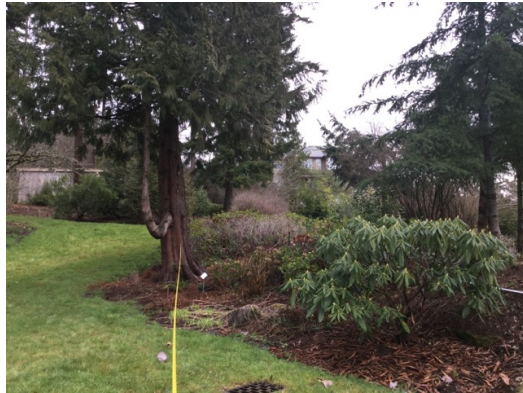
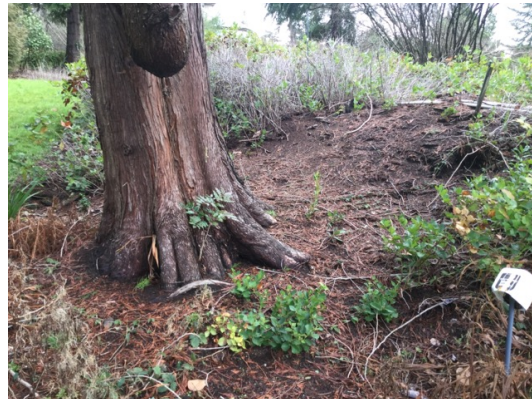
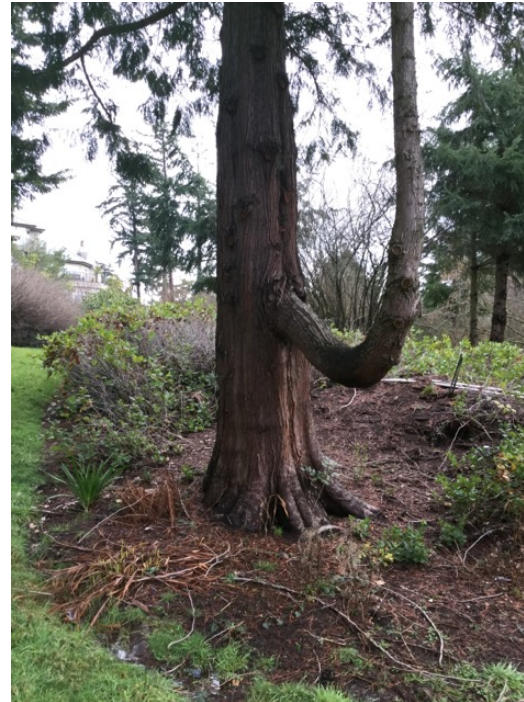
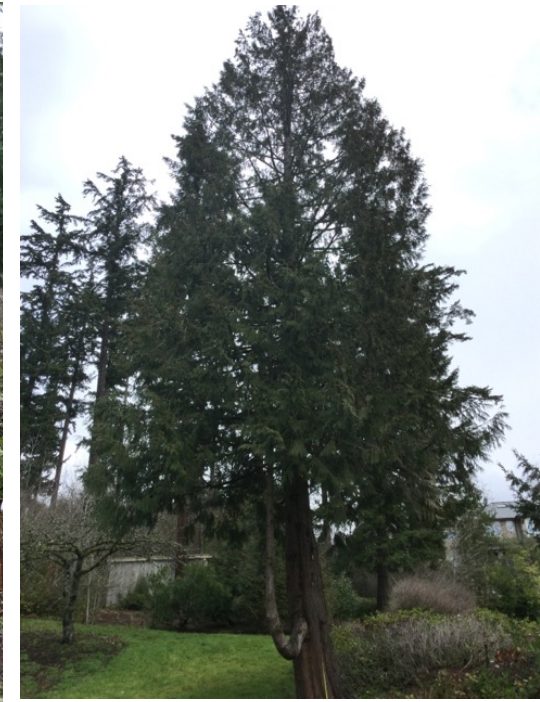
Tree	Species	DBH (in)	Drip Avg (ft)	CRZ (ft)	Vigor	Structure	Risk	Pres. Value	Recommendations
11	Western red cedar <i>Thuja plicata</i>	33.5, (33.5)	14.1	33.5	Fair	Fair	Medium	Medium	
Notes / Defects	This tree has small diameter codominant leaders. It also has a large and prominent swept lower branch on the west side of the tree. (See photographs.)								Dripline (ft) N 14 S 14 E 13.5 W 15

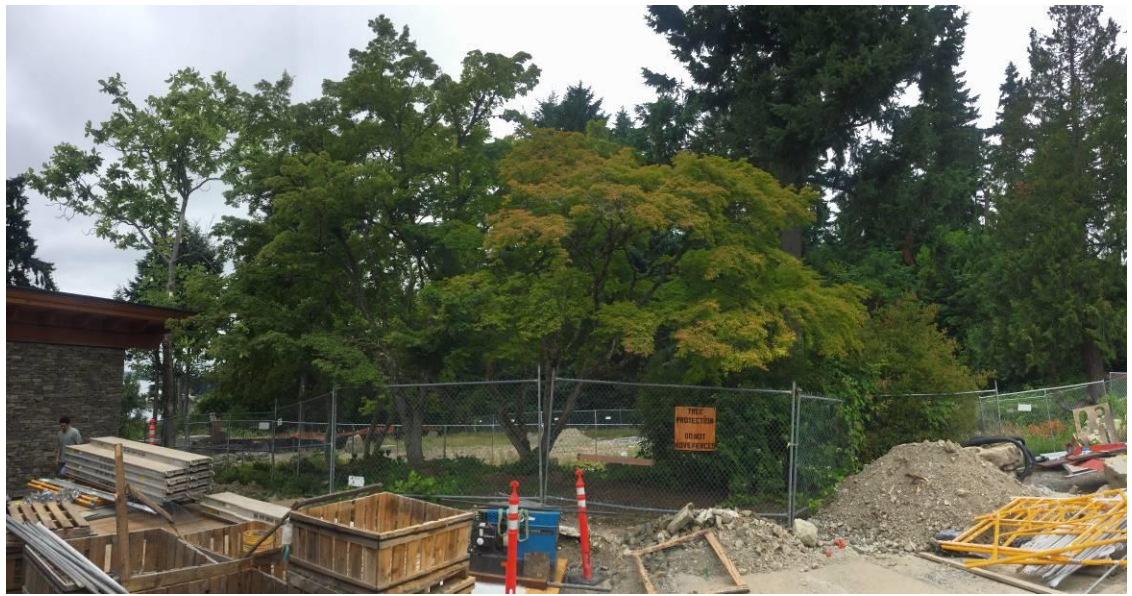
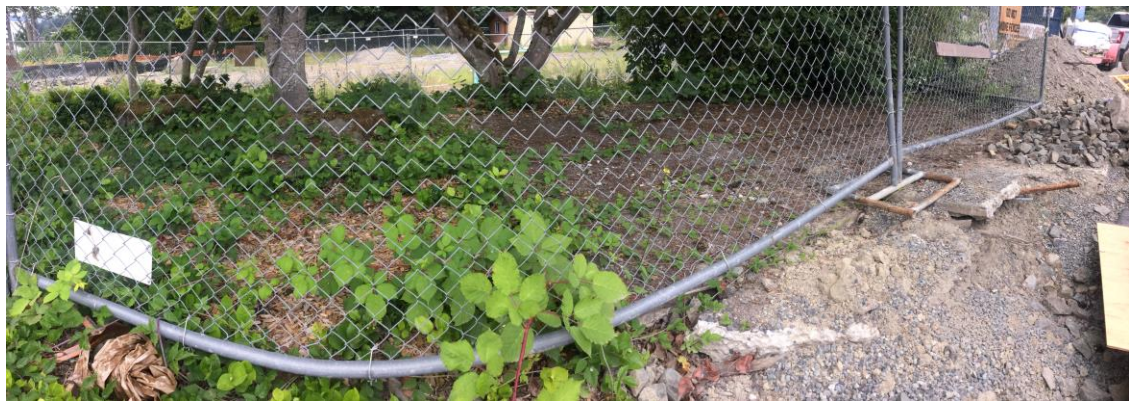
Photo 1: Concrete surfacing that is removed from within the Critical Root Zone of Tree No.8 and 9 must be immediately replaced with woodchip mulch, applied to a depth of 4 inches, and the Critical Root Zone watered as per the schedule for the tree protection area.

this site. Watering is critical to maintain the condition of both trees following concrete removal.

2. Immediately following removal of the concrete parking surface, apply a mulch layer of woodchips, and water as per the watering schedule used on the other retained trees on

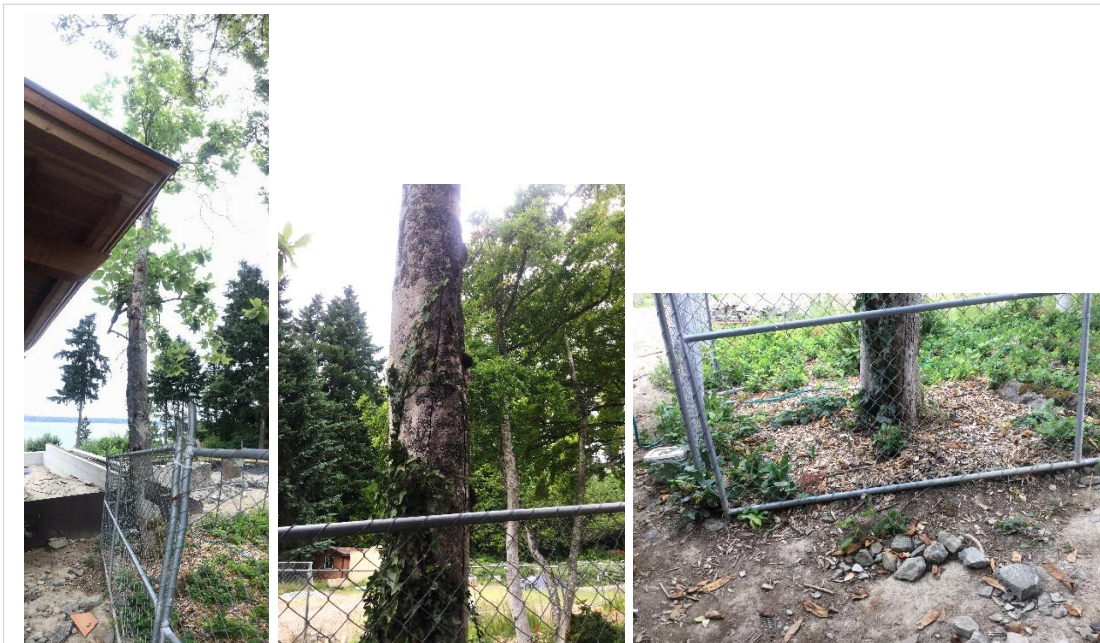
Photo 2: Tree No.5 has been heavily impacted by construction activity within its Critical Root Zone. However, no root cutting has been observed or reported. Based on the trees condition, I have determined that most of the root system is within the fenced, mulched and irrigated area. I have recommended that woodchip mulch be applied to a depth of 4 inches outside of the fence, and that the mulch within the tree protection area be replenished. This tree, and Tree No.4 will receive the sugar water feeding. A dead vertical seam of trunk tissue indicates that this trees roots have been impacted by soil damage (compaction.)

4. I recommend that all exposed soil surfaces, including those outside of the tree protection fence area be mulched with woodchips to a minimum depth of 4 inches. I also recommend that tree protection areas that are currently mulched with woodchips have a new layer of mulch applied. The woodchip mulch depth should be maintained at 4 inches indefinitely.
5. Continue to irrigate the retained trees as per the current schedule. Watering is critical to maintaining the condition of all the retained trees on this site.

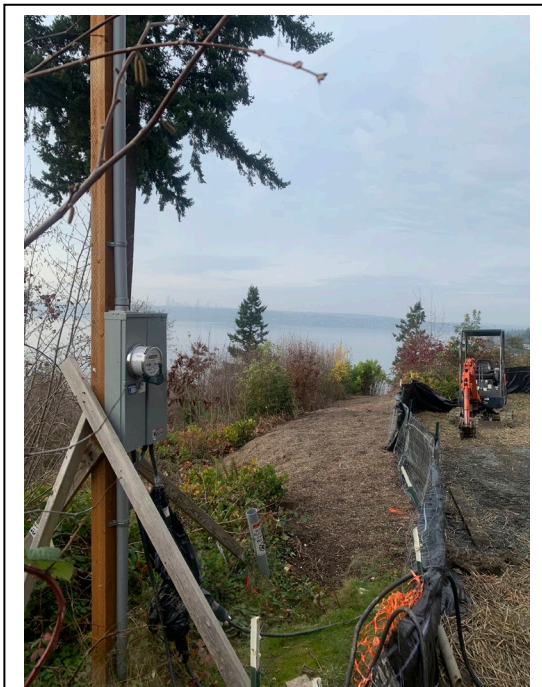
Image 1. This view to the west shows the extent of the disturbed area, now covered with a thick layer of woodchip mulch.

the trenching and utilities installation had long been completed. What remains is a well mulched non-vegetated corridor.

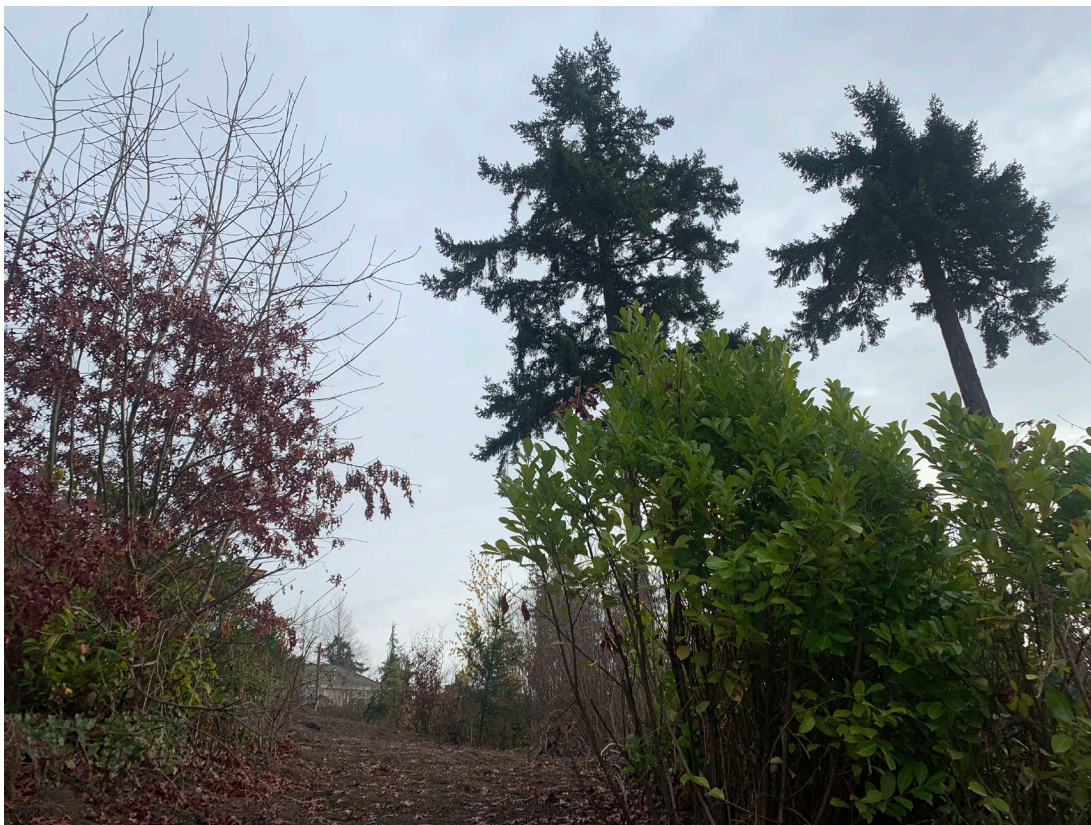
Image 2. Facing east. The two (2) Douglas fir tree (*P. menziesii*), Trees #23 and #24 can be seen in the background. Non-native species like red oak (*Q. rubra*) and cherry laurels (*P. laurocerasus*) can be seen framing the disturbed corridor.

Two (2) large Douglas fir trees (*P. menziesii*), Trees #23 and #24, located near and to the south of the disturbed trenching area, received an ISA Level 1 Limited visual Tree Risk Assessment. These trees are included in the original Meydenbaure Residence Tree and Plant Protection Plan dated 05-11-17. I can confirm that these two (2) trees have not been removed. The trenching area has negligibly encroached within the Critical Root Zone (CRZ) of Tree#24. The two (2) trees are in good condition, exhibiting fair to good vigor, fair to good structure and present a low risk of failure. At this time, the trees may be safely retained.
