West Tributary Habitat Assessment

Final Report

September 2016

Tetra Tech, Inc.

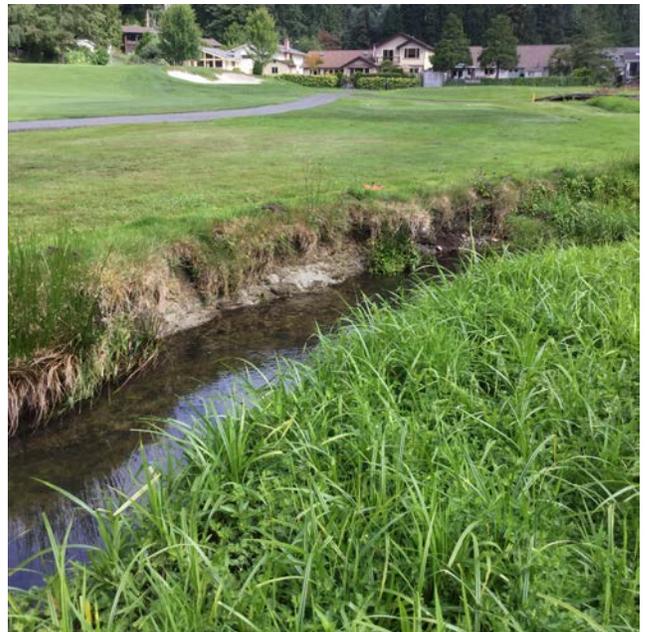
Areas of erosion were most pronounced within the Glendale Country Club Golf Course (Reach 80_01), where the combination of a high groundwater table and stream forces on banks with limited vegetation have likely both contributed to bank slumps. No other substantial areas of erosion were observed. Armoring was abundant, particularly on private property in residential areas (Reaches 80_02 and 80_03).

Reach 80_01 Golf Course Bank Erosion

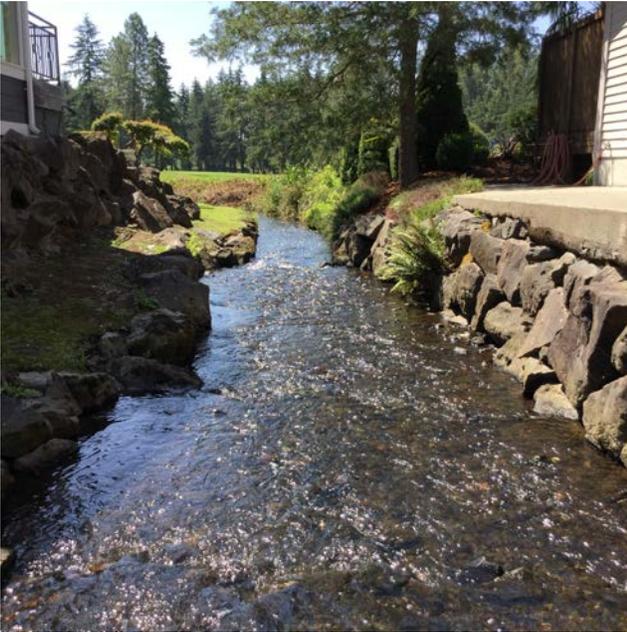
The vast majority of this reach is armored on both banks. We estimated that 90% of the reach is armored and did not identify individual armoring segments after the first properties. Armoring includes riprap, gabions, concrete blocks and a variety of debris. As a result of the extensive armoring, signs of erosion were not observed. This reach includes two culvert crossings (NE 1st Street and NE 3rd Street), one pedestrian bridge, and at least two fence crossings with low clearance. Of immediate flood concern is the sediment deposition in the NE 1st Street culvert. This culvert provides only 1.6 feet of clearance and appears to be accumulating debris. The adjacent landowner indicated that logs had been jammed in this culvert in the past (now removed) and they have notified the City of their concerns.

Reach 80_02-1 Riffle and Armoring in Residential Area

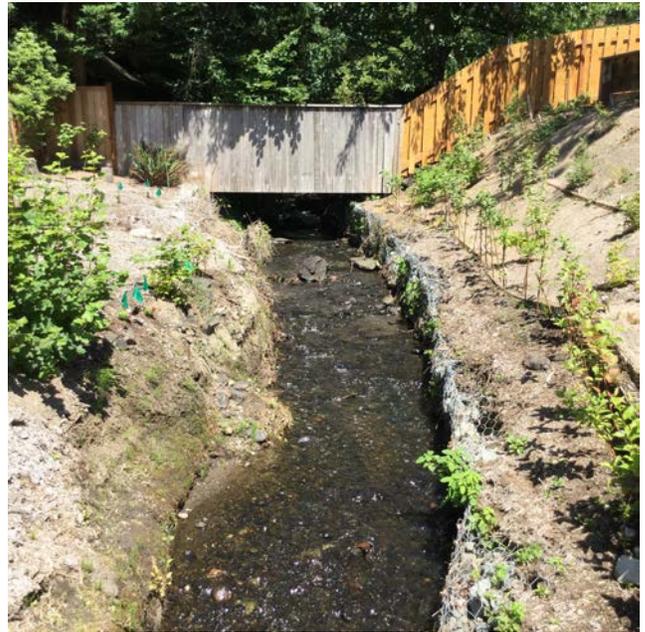
Reach 80_02 Armoring and Fence in Residential Area

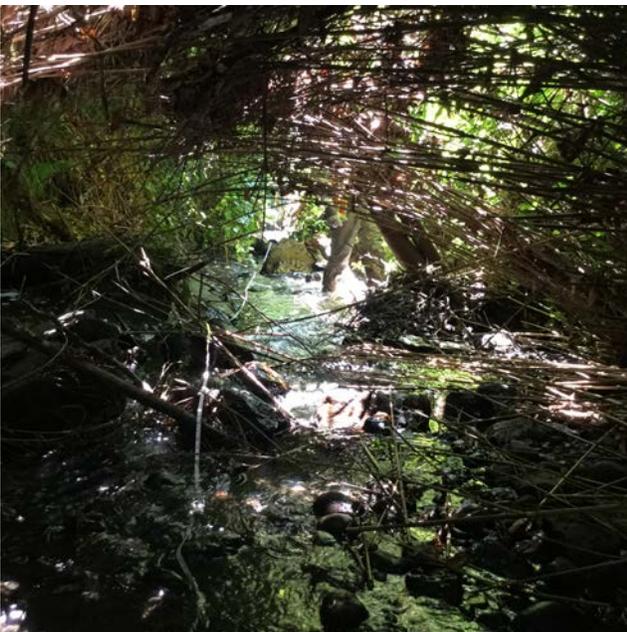
Reach 80_02-2 Overgrown Bamboo Over Riffle

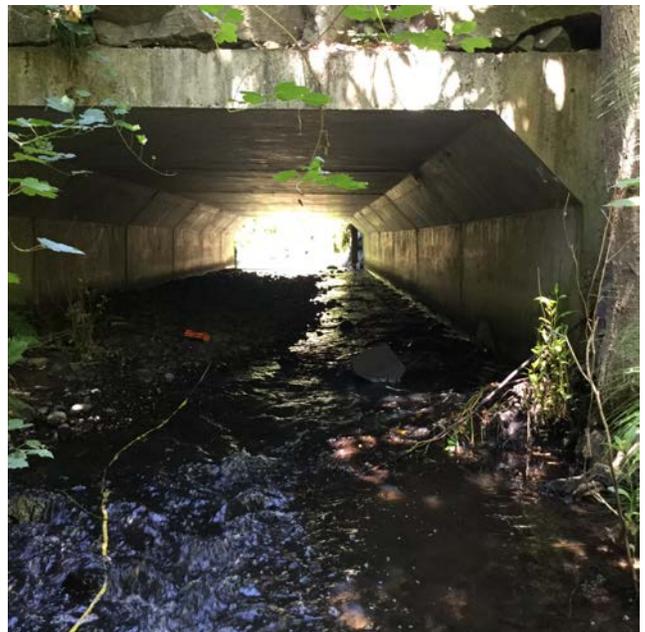
Four drops greater than 12 inches were observed over weirs (2 upstream of 3rd Street and 2 downstream of 3rd Street) in the upstream 130 feet (40 m) of this reach. The culvert at NE 1st Street is likely to cause a velocity barrier to fish at higher flows due to its limited capacity. The culvert at NE 3rd Street does not appear to be a fish passage barrier as there is no drop at the outlet, the culvert is countersunk and the width is at least 75% of the average channel width. Gradient was estimated at 2% (as compared to 2.2% in City GIS).

Reach 80_02 Culvert at NE 3rd Street

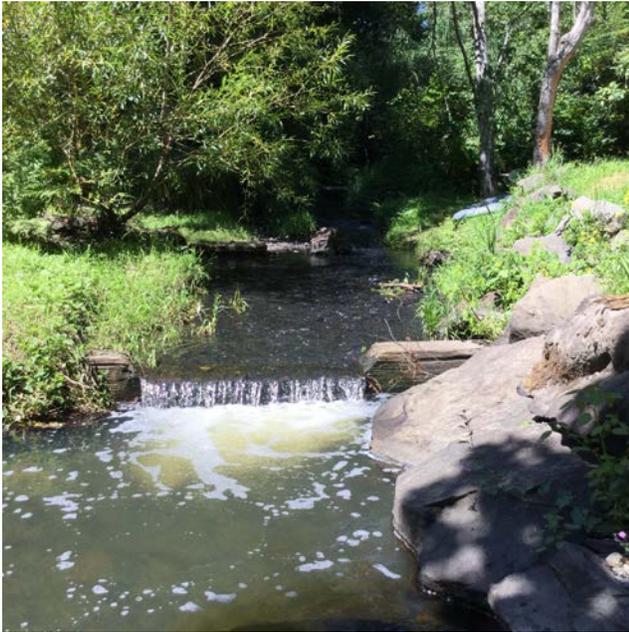
Reach 80_03 Drop Structure in Residential Area

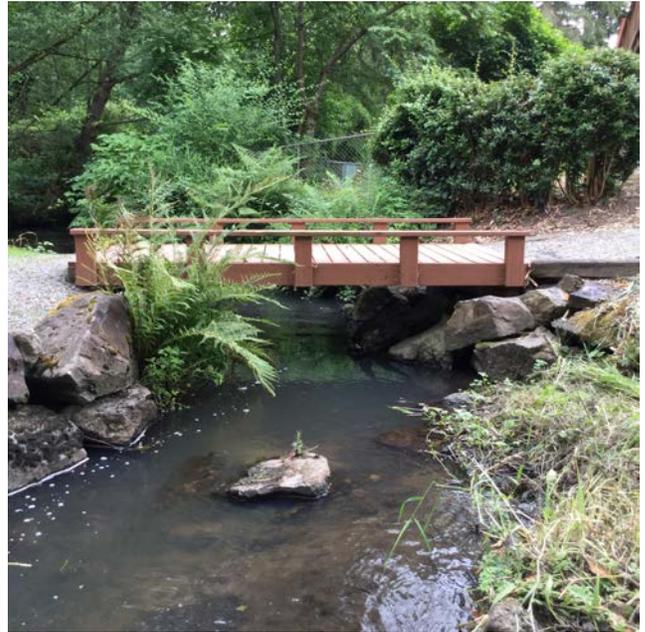
The vast majority of this reach is armored on both banks. We estimated that 80% of the reach is armored and did not identify individual armoring segments. Armoring includes riprap, gabions, concrete blocks and a variety of debris. As a result of the extensive armoring, signs of erosion were not observed. This reach includes two culvert crossings (NE 8th Street and a roadway to a gate structure) and at least six pedestrian bridges. Both banks are armored between NE 8th Street and the roadway with gate structure.

Reach 80_03-2 Low Bridge and Armoring

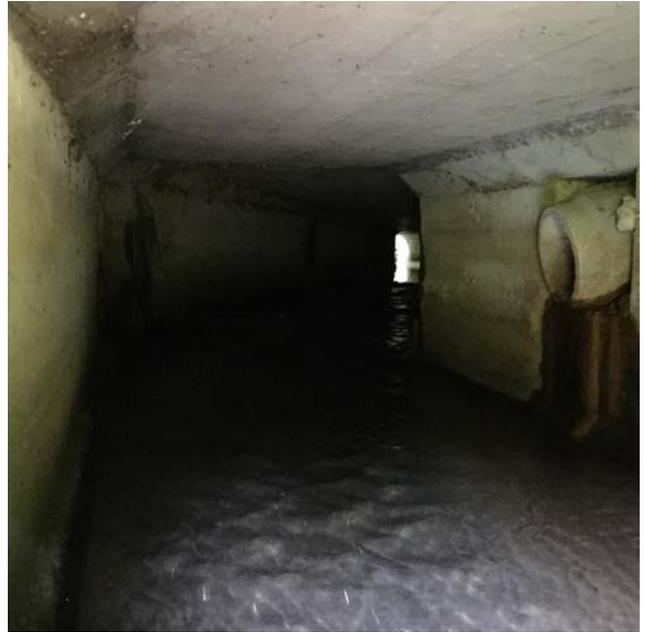
No drops were observed in this reach, however, water depths were consistently less than 12 inches and often less than 6 inches. The culvert at NE 8th Street is likely to cause a velocity barrier to fish at higher flows due to its length and turns (~100 feet), although it has no drop at its outlet, is countersunk, and is at least 75% of the channel width. The two culverts at the road crossing to the gates would be fish passage barriers when the gates are closed for stormwater detention. Gradient was estimated at 1% in the lower half and 2% in the upper half (as compared to average of 1.2% in City GIS).

The culvert at NE 8th Street is likely a partial fish passage barrier due to its length and velocities at high flows. This would be an expensive culvert to replace and would not provide access to spawning habitat in the West Tributary (although spawning habitat may be available in Goff Creek), but would provide access to rearing habitat in Reach 80_04. Low pedestrian bridges will likely be damaged during floods; the City could consider a tax incentive for landowners to raise or eliminate pedestrian bridges.

Reach 80_03 Culvert at NE 8th Street

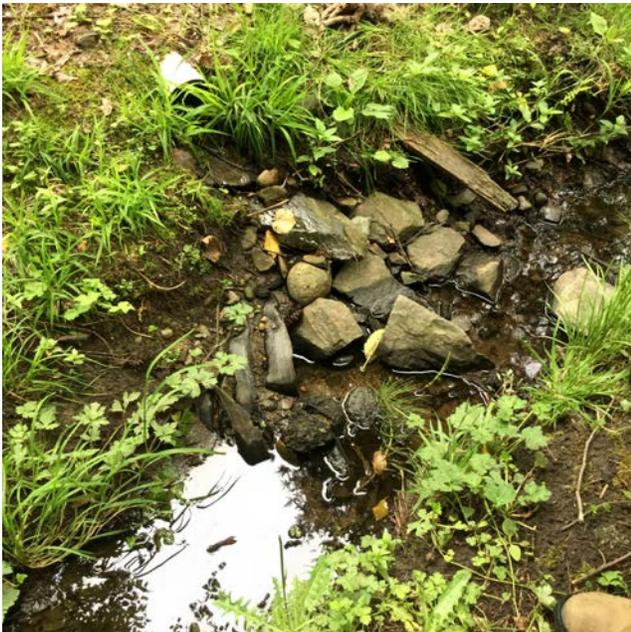
Flood risk locations were observed at two sites; the NE 1st Street culvert on the West Tributary and the 126th Avenue NE culvert on the unnamed tributary that has partially collapsed. Both of these culverts are owned by the City of Bellevue. The box culvert at NE 1st Street is as wide as the channel width, but of very low clearance (<2 feet) due to extensive sediment deposition in the culvert. Small debris piles have also accumulated in the culvert. The property owners at this location indicated that large wood has blocked the culvert in the past and that they have reported this condition to the City previously.

Reach 80_03_01-2 Collapsed Culvert at 126th Ave NE

The culvert under 126th Avenue NE may be buried or collapsed. This should be investigated to determine if it should be replaced as it could cause a flood risk concern.

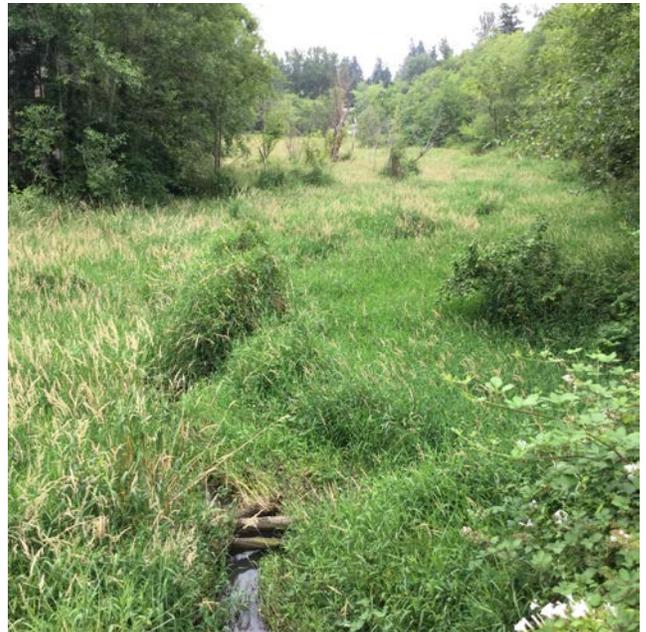
Reach 80_04-2 Reed Canary grass Obscures Stream
