NE 8th St, Bellevue, King County, Washington

STEP Pedestrian Road Safety Assessment

Report

March 25-26, 2021

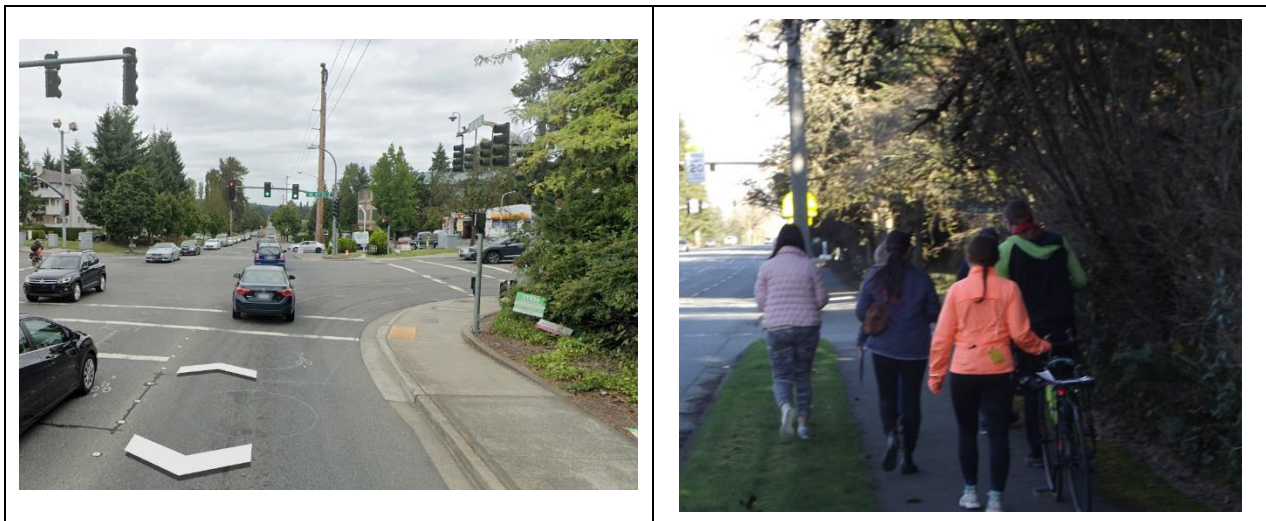
Left – Picture of NE 8th St at 140th Ave, looking north, showing the presence of vegetation on the southeast corner than may reduce the visibility of pedestrians for turning vehicles, and also the lack of a stop bar for the right and thru lanes. Credit: Google.

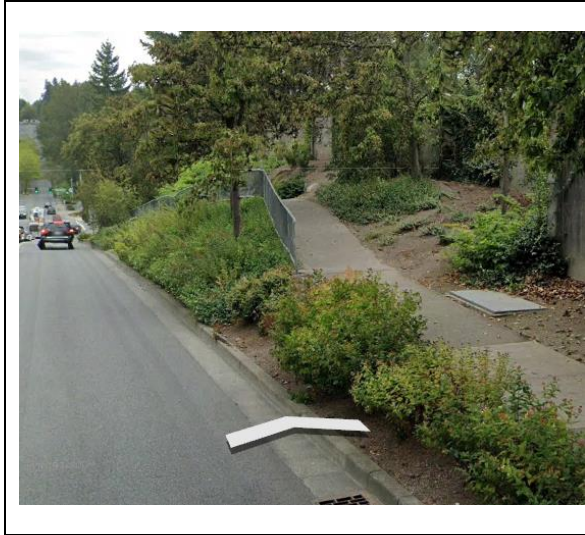
Left – Picture of NE 8th St, looking east near 146th Ave NE, the sidewalk sloping up and downhill and the associated ADA issue identified by the City. Credit: Google.

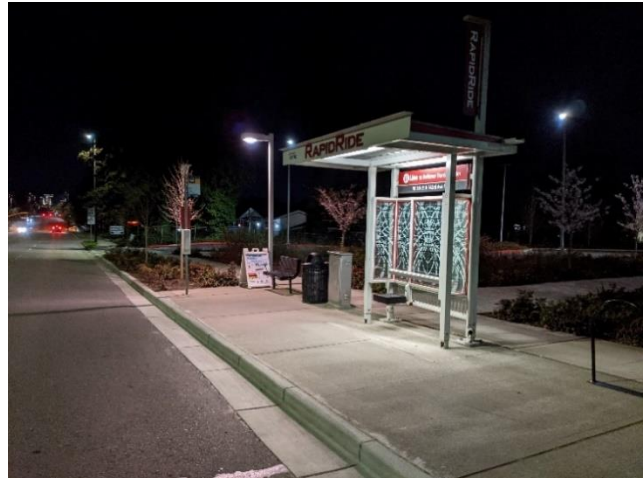
Right – Picture of NE 8th St at 143rd Ave NE, looking west, showing the Metro transit stop near Stevenson Elementary under low light conditions. Credit: Metro.

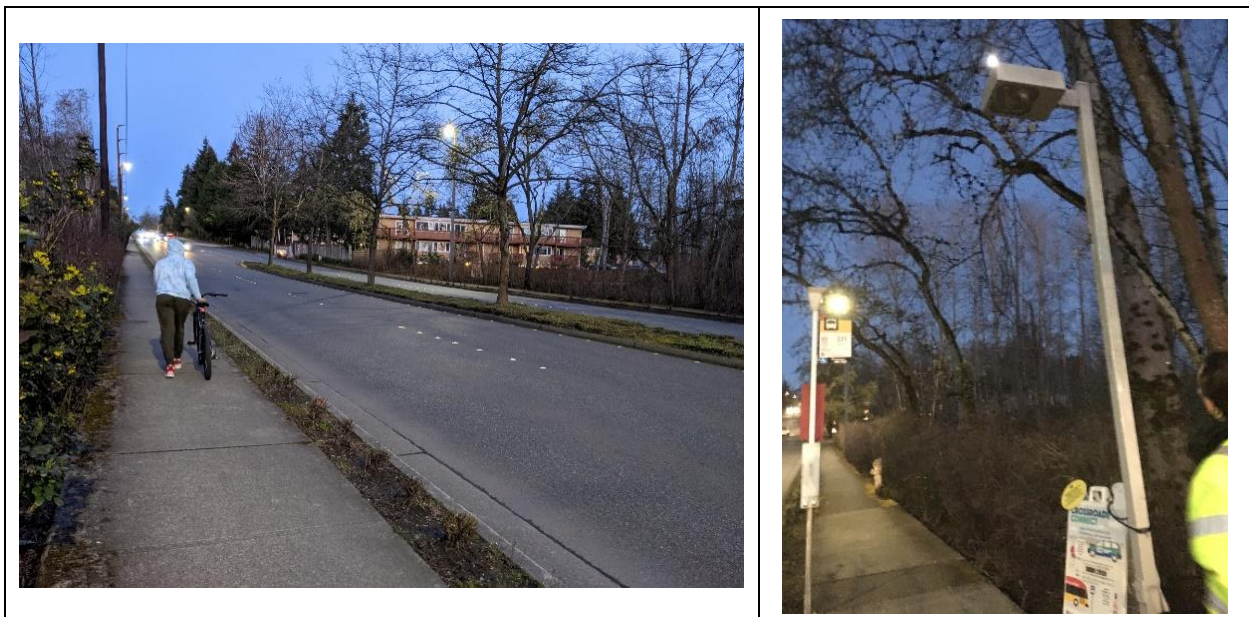
Left – Picture of NE 8th St, on north side of roadway looking east near 148th Ave NE, showing the four-lane median divided cross section under dusk conditions and a potential location for an investigation of a midblock crossing. Credit: Metro

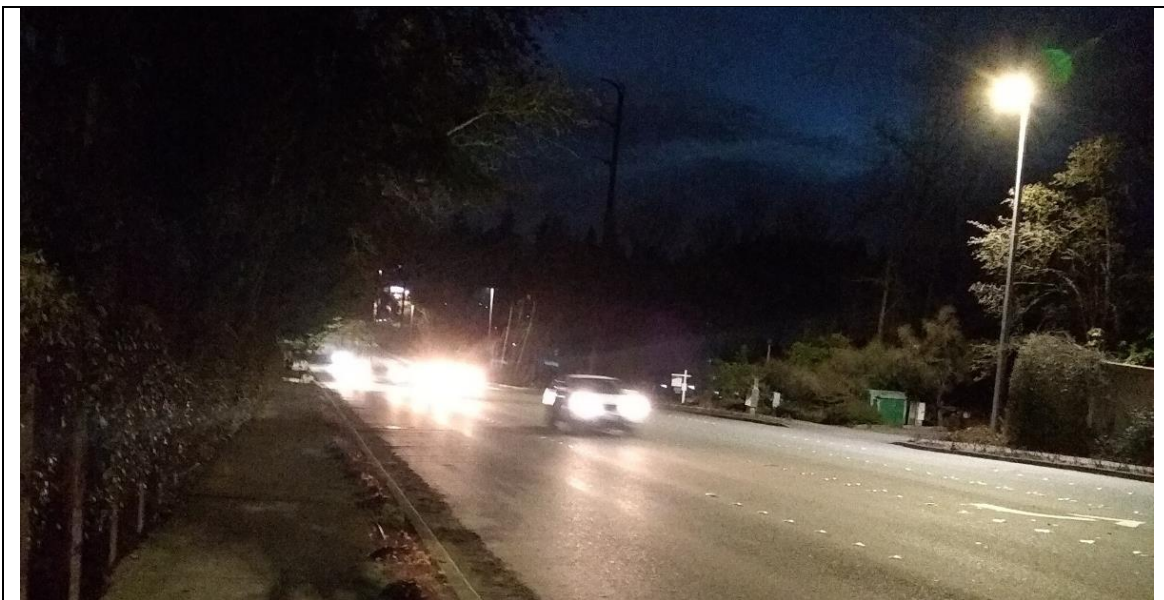
Above – Picture of NE 8th St, near 151st PI NE, showing the roadway’s grade and lighting levels during nighttime conditions. Walk audit participants reported this area as dark and described it as a personal safety risk. Credit: Complete Streets Bellevue.

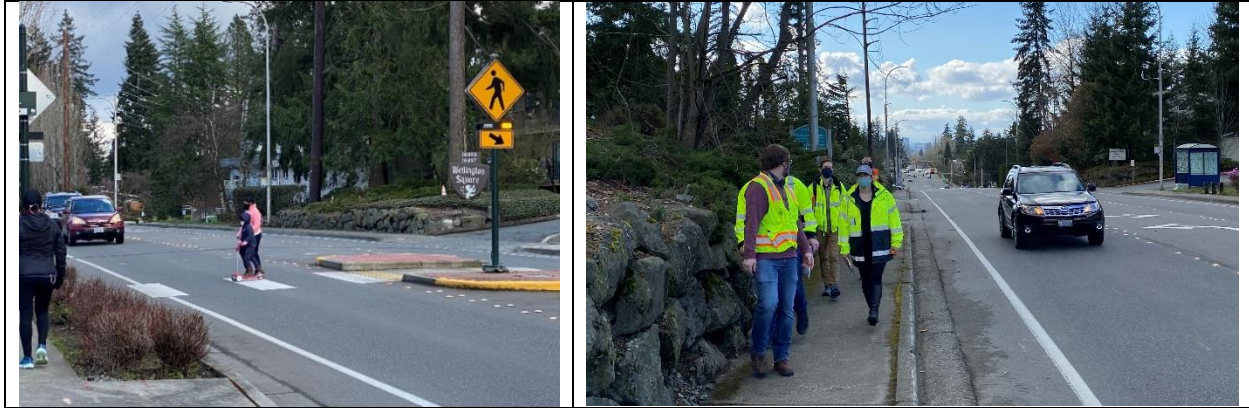
Left – Picture of NE 8th at Crossroads Park, showing a family crossing after having activated the RRFB. Credit: City of Bellevue.

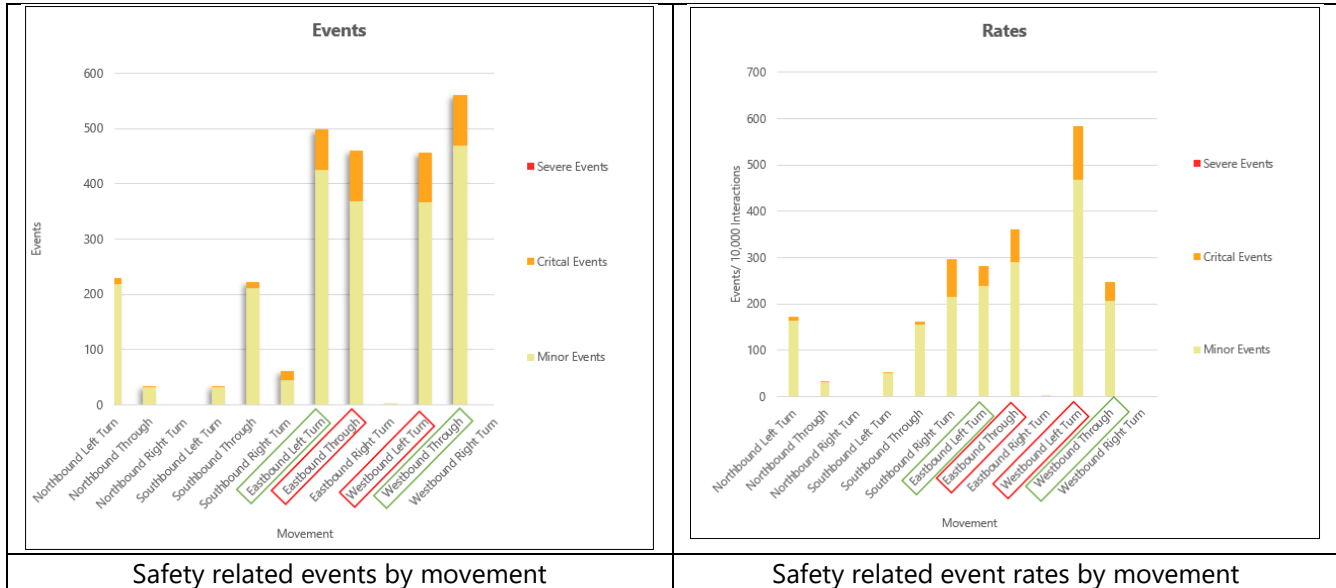
The number and rates of events per movement are presented in the charts below. A superficial look at the data indicates that the movements with the highest number of events and highest rates appear to form left turning and through scenario pairs – Westbound Left Turn with Eastbound Through and Eastbound Left Turn with Westbound Through.

A further look at the platform did indicate that those two scenarios were in fact among the top 3 conflict scenarios. The most critical conflict scenarios at this location were:

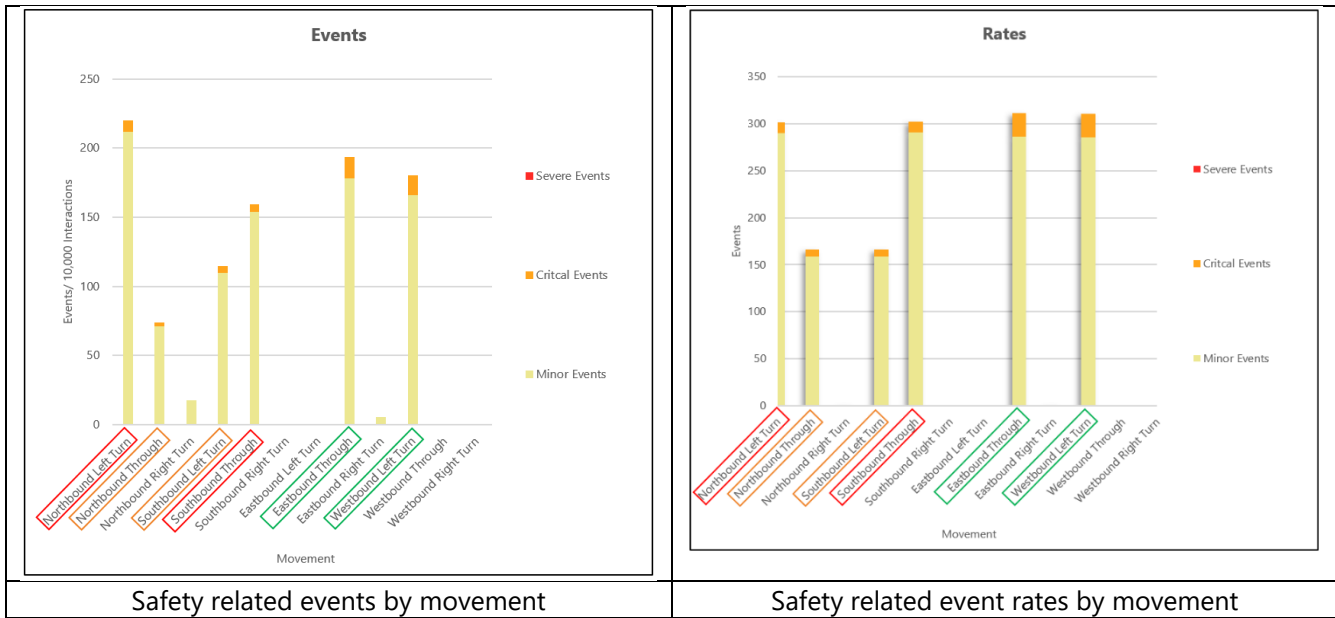
Th number and rates of events per movement are presented in the charts below. A superficial look at the data indicates that the movements with the highest number of events and highest rates appear to form left turning and through scenario pairs – Northbound Left Turn with Southbound Through, Southbound Left Turn with Northbound Through, and Westbound Left Turn with Eastbound Through.

A further look at the platform did indicate that those two scenarios were in fact among the top 3 conflict scenarios. The most critical conflict scenarios at this location were:

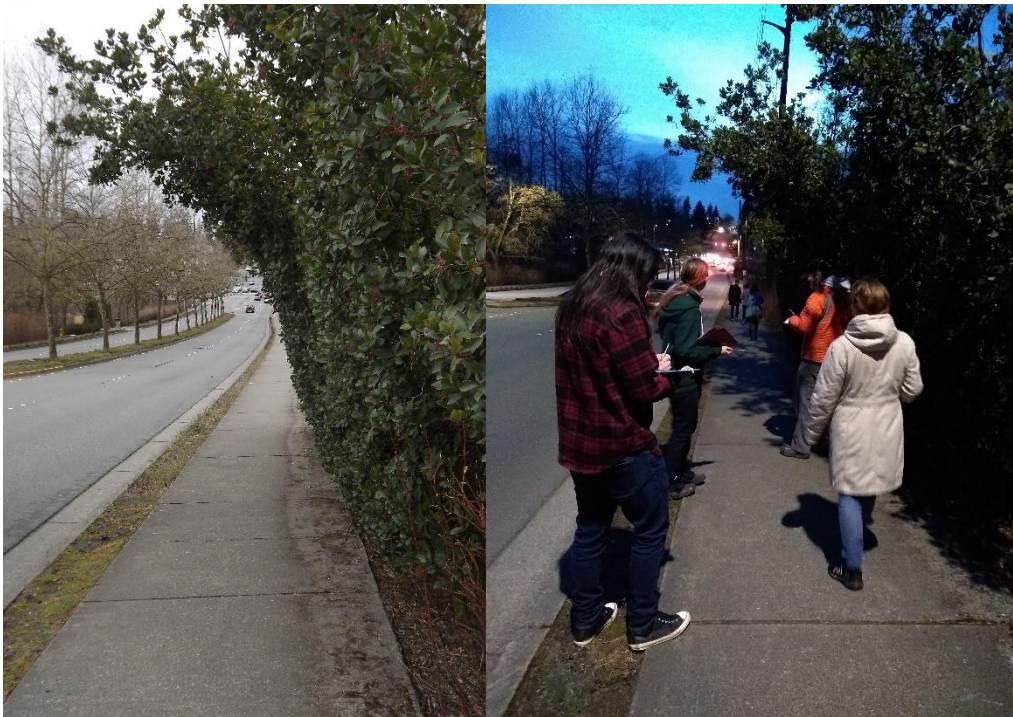
Far Left: Overgrown vegetation overhangs the sidewalk by approximately 2 feet and is at face-level for most adults. Low-vision pedestrians might run into these obstructions without seeing them.

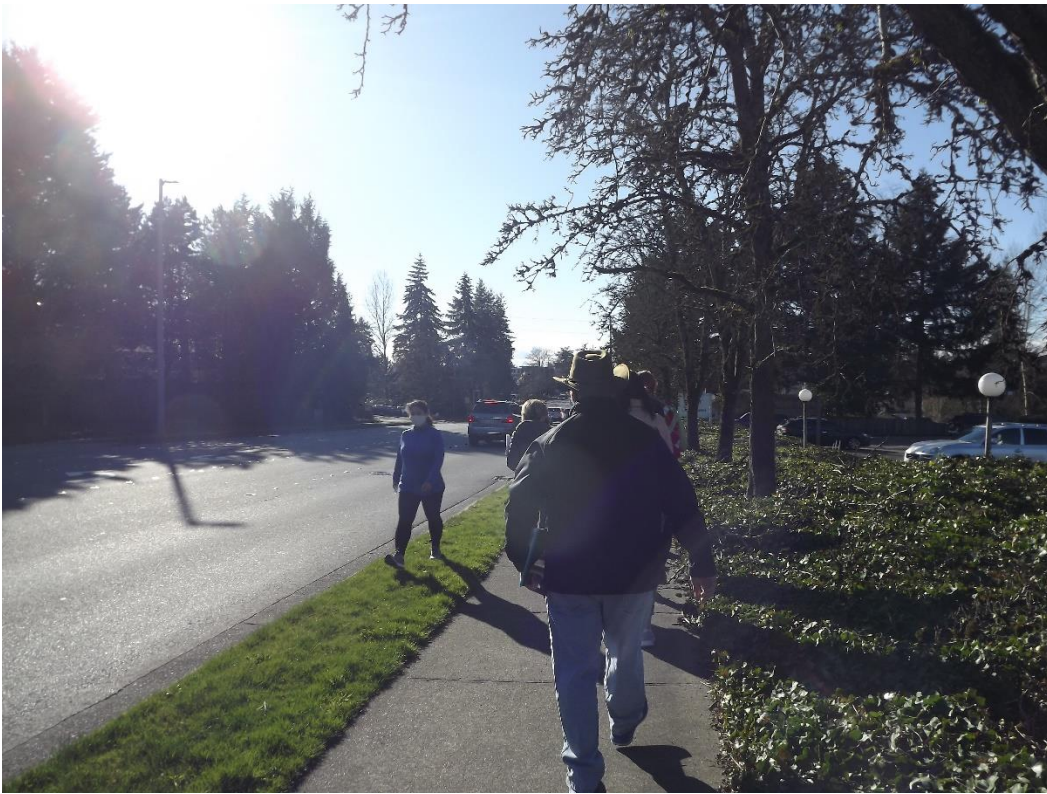
Left: A pedestrian enters the grass to pass our group as we walk westwards towards 140th Ave NE. Wider sidewalks would provide safe distances for pedestrians to pass each other, especially because of COVID-19 concerns.

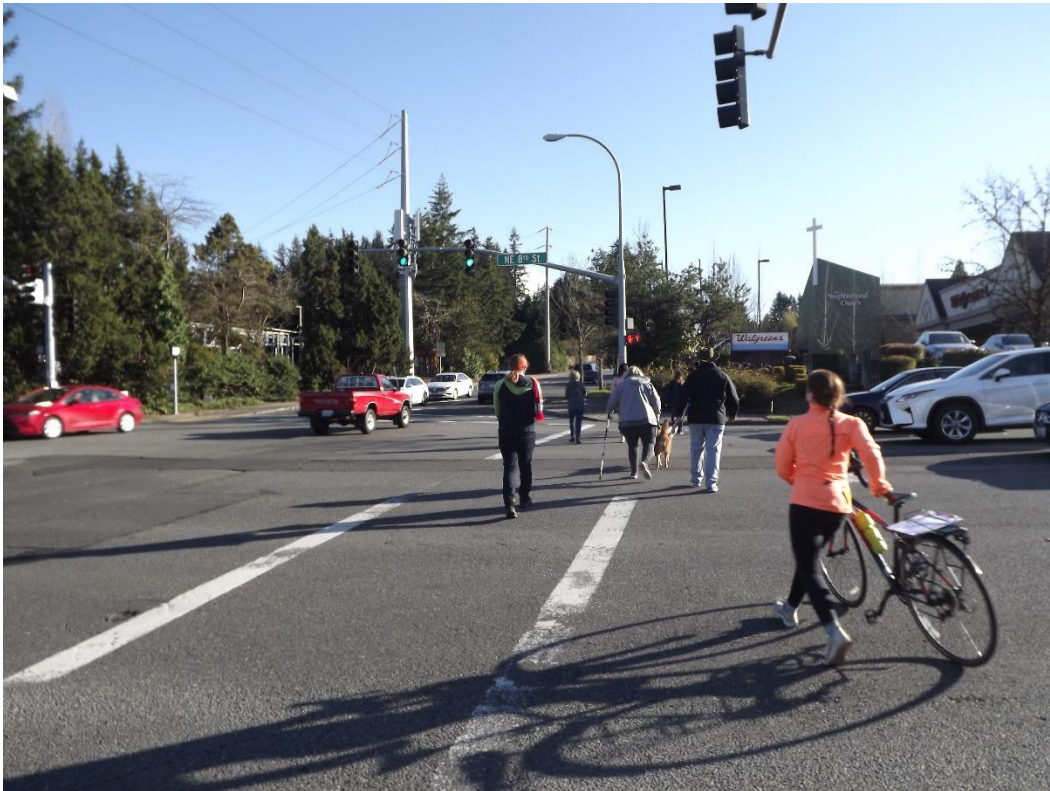
Left: Most of our group was still tens of feet removed from the other side of the crosswalk when the timer reached zero. Because this intersection is used by families, seniors, and people of different mobility levels, these crosswalk times should be lengthened to safely accommodate more people.

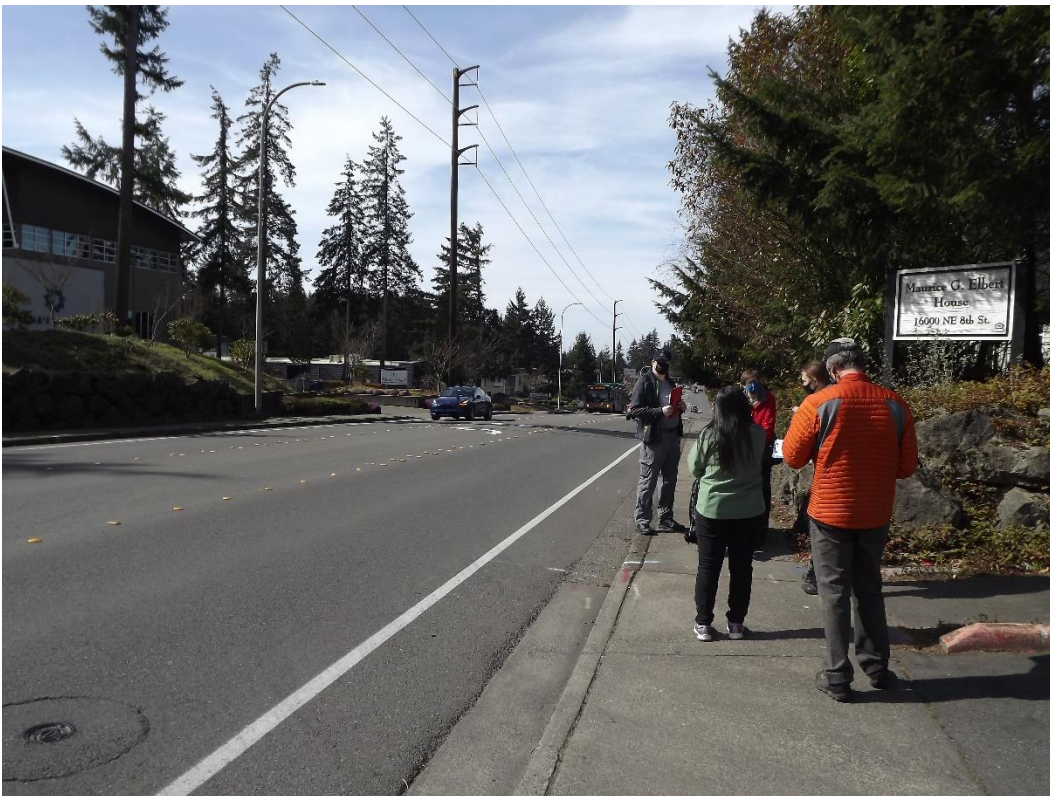
Left: Our group stops at the site of a pedestrian fatality in November 2020 and reflects on the road design elements that contributed to this collision. The nearest marked & signalized crosswalks were several hundred feet away – an added distance that can be inaccessible for mobility-challenged residents.

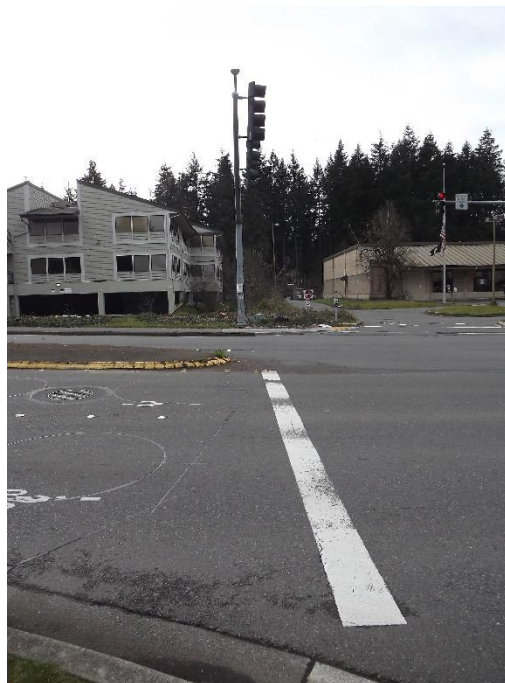
Left: The eastern side of the intersection of NE 8th & 158th Pl NE is currently lacking a crosswalk. If people approaching from the east need to cross and then double back slightly to reach their destination, this adds time & distance to their trip.

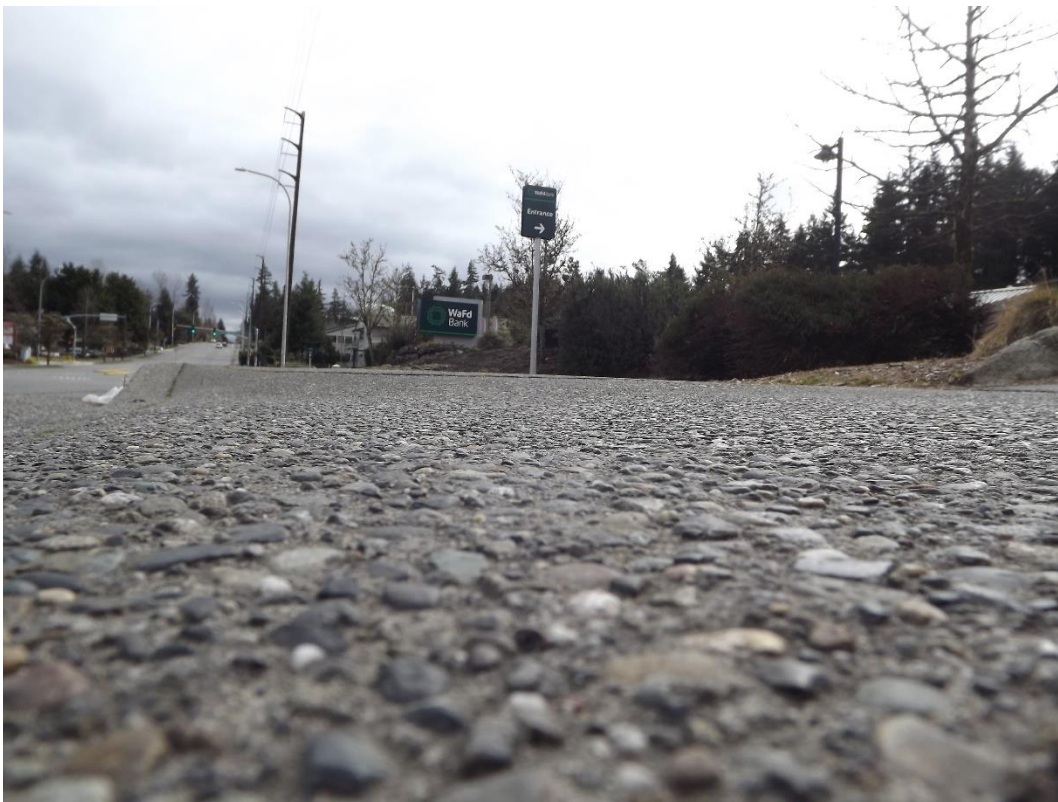
Left: Nearly every driveway along this section of the corridor has a corresponding bump in the sidewalk that was most pronounced closest to the roadway but decreased as one moved away. This added bump has the consequence of making half of the sidewalk less accessible for people who are biking or rolling.

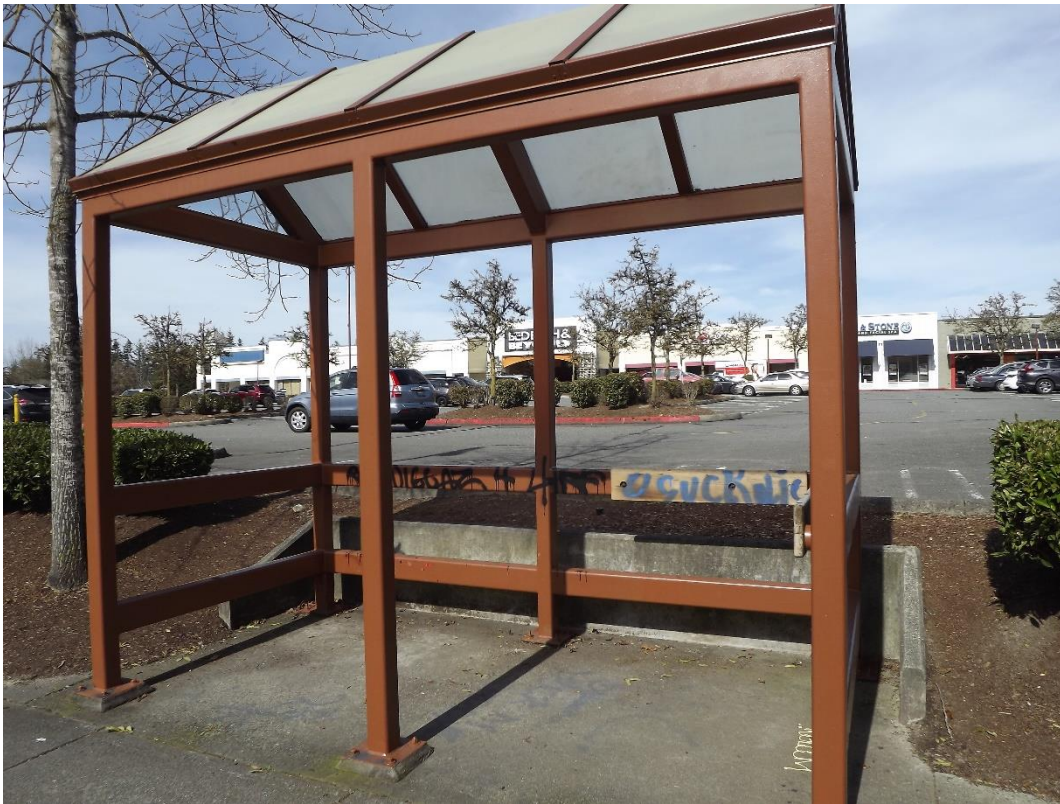
Left: This bus shelter at the NW corner of NE 8th St & 158th Pl NE had no walls to protect patrons from the wind, is heavily graffitied, and does not include a bench. Although likely not under Bellevue's jurisdiction, improving this bus shelter would greatly better the transit experience for riders who regularly use this stop.

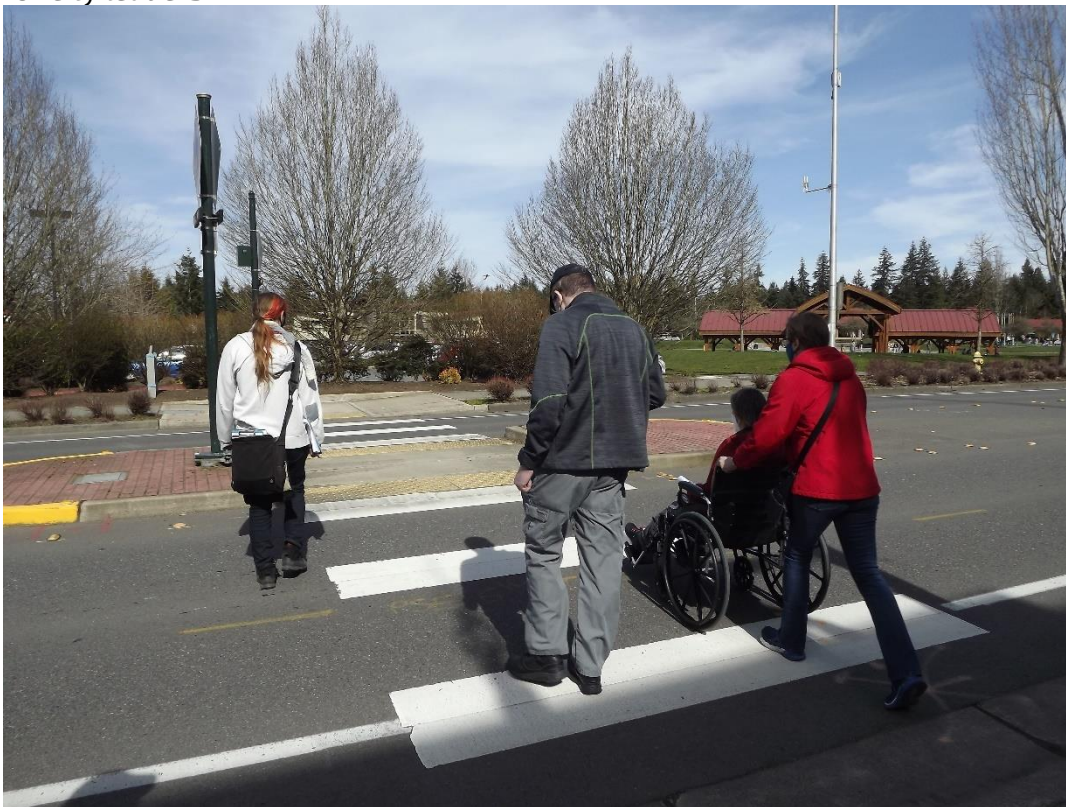
Left: Our group crosses a marked & signalized crosswalk in front of Crossroads Park. For the number of businesses & residences on this corridor, more crosswalks like these should be added to improve pedestrian safety.
