# Coal Creek Watershed Assessment Report

prepared in support of the City of Bellevue Watershed Management Plan

Final  
April 23, 2021

**Bellevue Utilities Department**

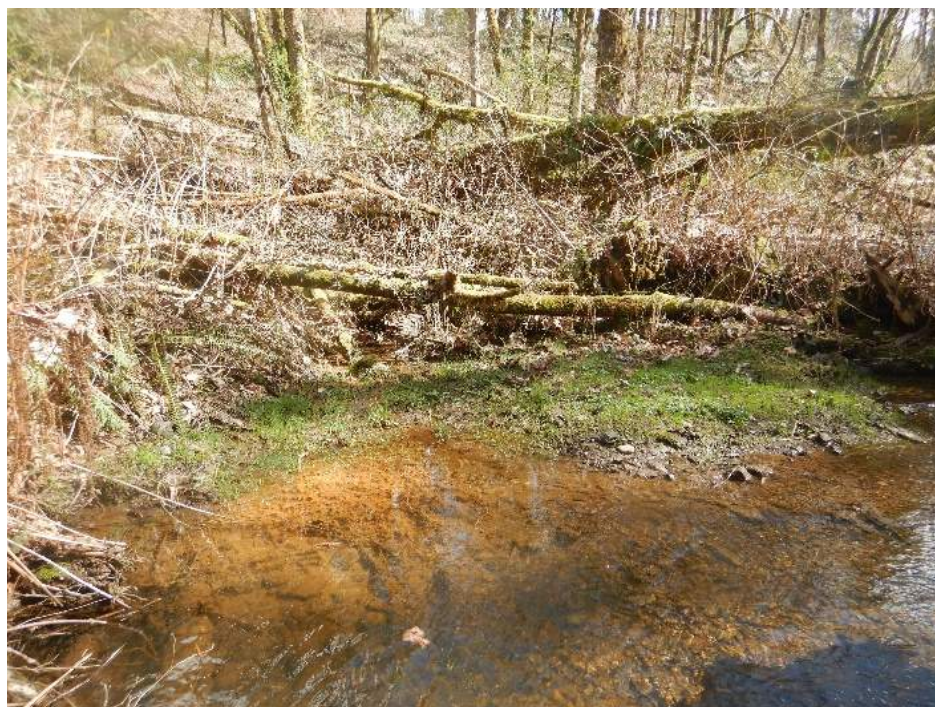
Figure 16. Ferric hydroxide (or iron oxide) deposits observed in Reach 10 of the Coal Creek mainstem..

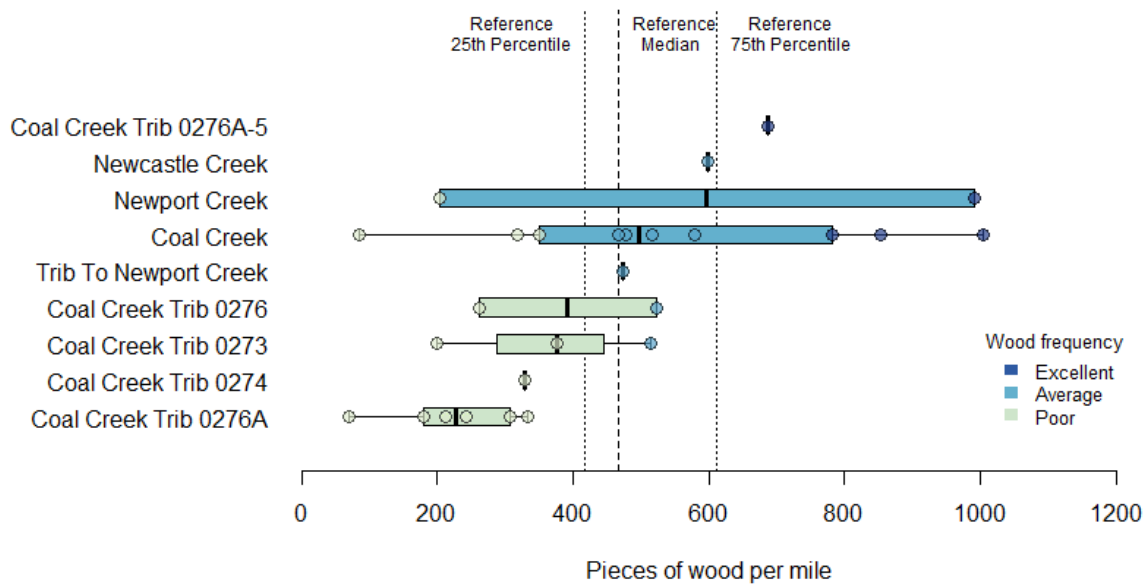
Figure 20. Boxplot of the Large Woody Material Frequency for Streams of the Coal Creek Watershed.

\*Points represent the LWM values for individual reaches. Points are colored by LWM frequency and boxes are colored by median LWM frequency, grouped as poor, average, and excellent based on reference conditions.

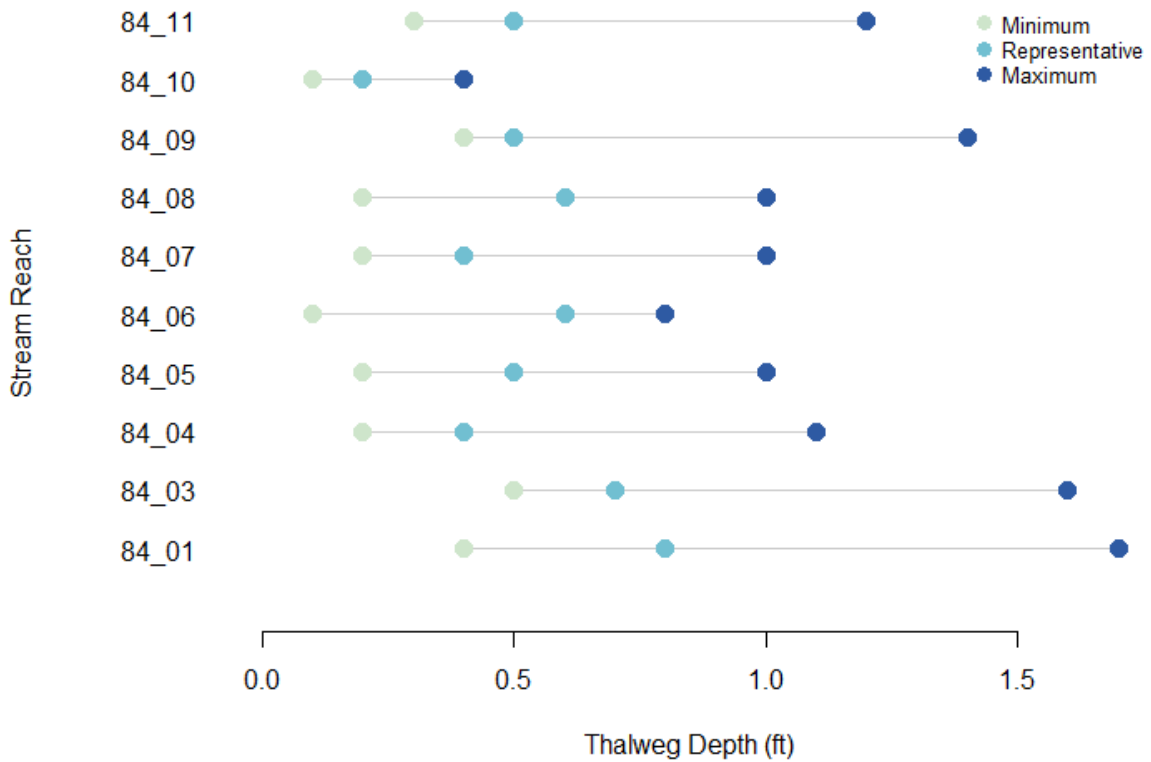
**Figure 4. Dumbbell plot of wetted stream depths. Points represent the median value for the minimum, representative, and maximum depth in each reach of the Coal Creek mainstem**

The median representative wetted channel depth of 0.6 ft is fairly consistent across all reaches with a few notable exceptions: Reaches 1 and 3 tend to be slightly deeper and Reach 10 is much shallower (Figure 4). Median minimum depths range from 0.1 ft (Reaches 6 and 10) to 0.5 ft (Reach 3), indicating that summer low-flow conditions may create barriers to migratory fish. Trout and Coho Salmon generally require a minimum depth of 0.4 and 0.6 ft, respectively (Thompson 1972).

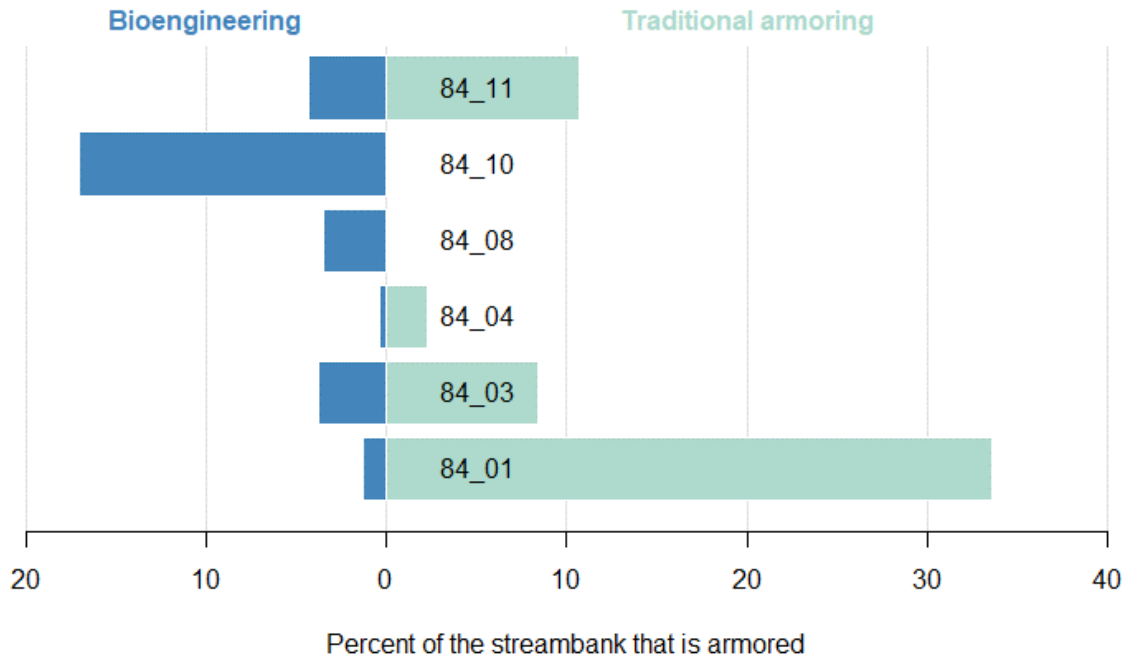
**Figure 11. Diverging bar chart showing the proportion of the stream bank that is armored using traditional materials (right) and bioengineering (left)**

Bank armoring along the mainstem reaches of Coal Creek is relatively low, in large part due to the park space that helps to buffer the creek from local impacts of development through much of the stream corridor. Overall, 10% of the Coal Creek mainstem banks are armored (8% traditional armoring and 2% bioengineering; Figure 11). Reaches 5, 6, 7, and 9 are completely free of armoring and all armoring in Reaches 8 and 10 is bioengineering. Bank armoring is greatest along Reach 1, which flows through the Newport Shores community, as well as in the upstream most reaches, 10 and 11, where there are several trail crossings and remnants from historic coal mining, such as old flumes.
