Key Findings from 108th Ave and Main St

City of Bellevue, Washington

Case Study

October, 2019

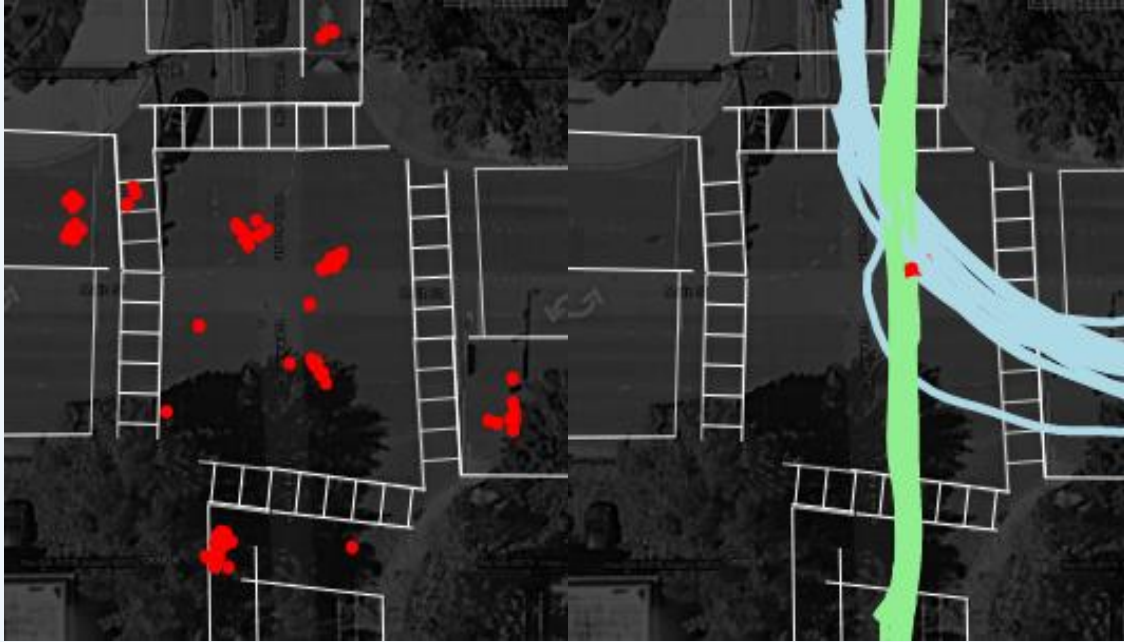
Figure 1. Left: Near miss locations identified during study. Right: High risk near miss scenario with 108th SB left vehicles and 108th NB thru vehicles.

The most significant finding of the study was a pattern of near miss events on 108th southbound left turning vehicles with 108th northbound through vehicles. 17 near miss events with Post Encroachment Time (PET) less than 2.5 seconds were detected during the study period. 1 near miss almost resulted in a crash. 2.2% of left turning vehicles on 108th SB were part of a near miss during the study period. Figures 1 to 4 show examples.

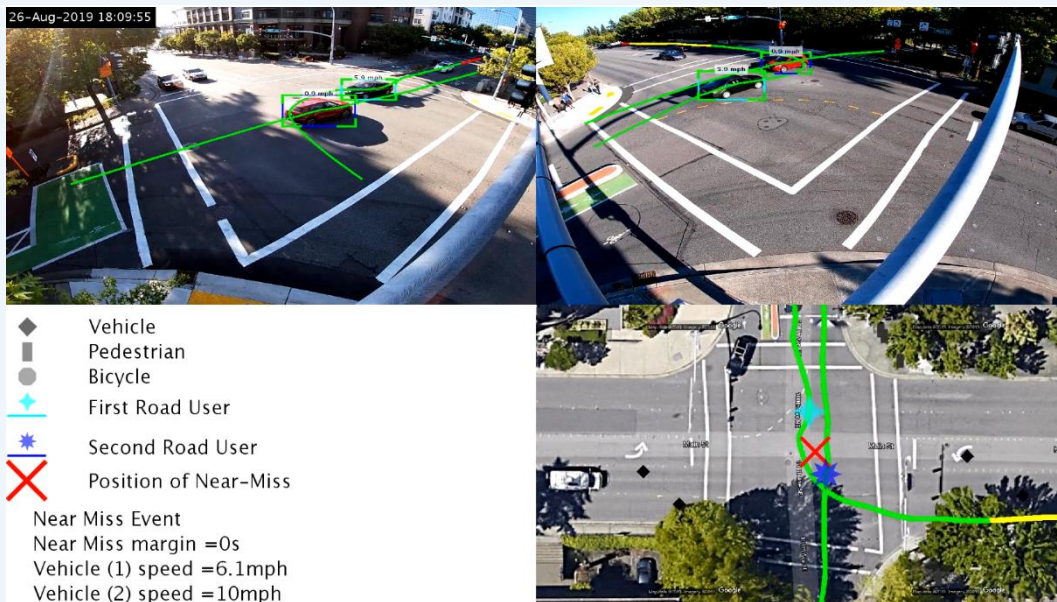
Figure 2. High risk near miss event on 108th SB left with 108th NB through. Vehicles almost collide, abruptly stop, and maneuver around each other to complete their motions. The top left and right views are the videos used for the study overlaid with the vehicle path information and vehicle speeds. The bottom left pane shows the conflict type, the post encroachment time (near miss margin), and the average vehicle speeds of each road user. The bottom right pane is a google maps overlay showing the paths each road user took, and the location of the near miss.

The City of Bellevue recently installed protected/permissive signal heads on the left turns on 108th and Main to reduce conflicts between through motions and left turning motions. Bellevue is also investigating what can be done to decrease speeding on Main street in light of the study findings. Street Simplified is working with the City of Bellevue on a before/after study to validate the impact of these improvements.

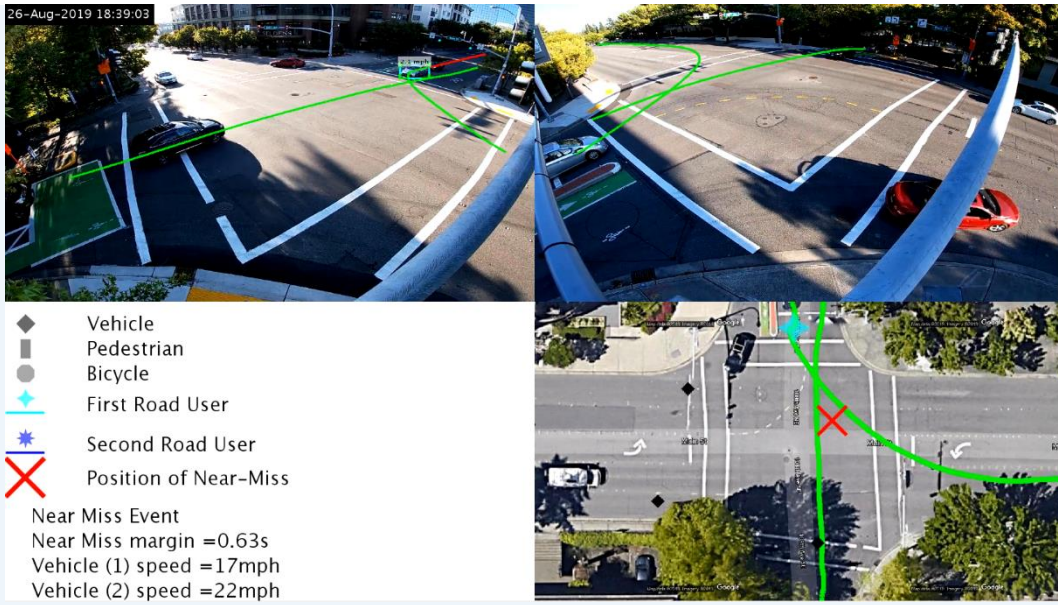
Figure 3. Shadows as a contributing factor to the conflicts shown above. Heavy shadowing of northbound vehicles could inhibit visibility to southbound left turning vehicles. Left turning vehicles are observed either failing to see oncoming vehicles or misjudging distance and speed. Once the through motion vehicle exits the shaded area the left turning vehicle has less than 3 seconds to react. The top right view is similar to the view that 108th southbound drivers have of the scene.

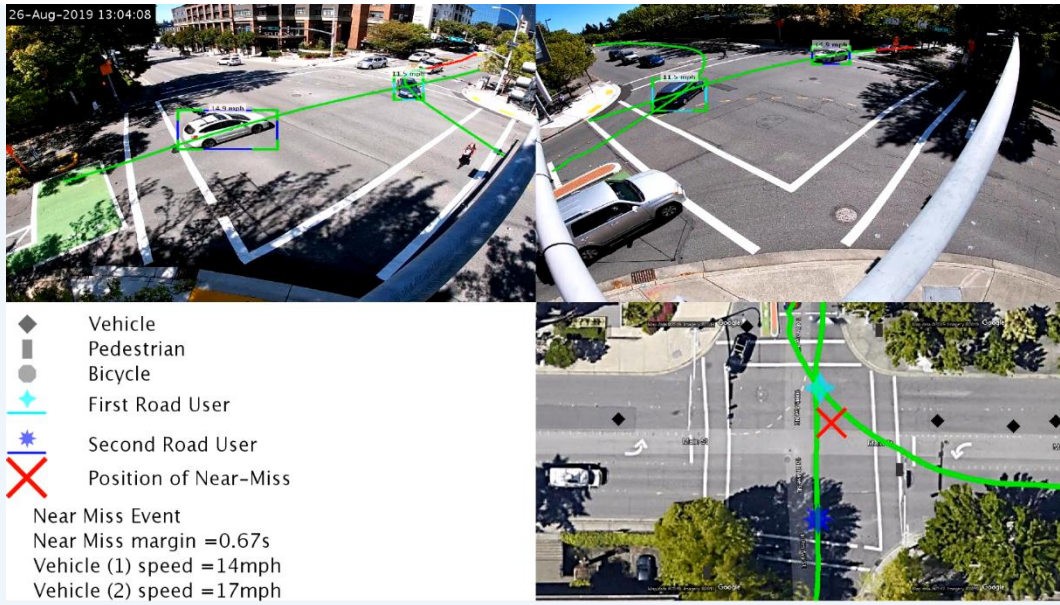
Two of the near miss events detected above involved pedestrians crossing the east crosswalk on 108th. This scenario put left turning vehicles in a dilemma where they had to decide between blocking the intersection and potentially being struck by oncoming vehicles or cutting off pedestrians in the crosswalk. This is illustrated in Figure 5 and 6.

Figure 5. Three conflict participant near miss involving 108th southbound left vehicle, 108th northbound through vehicle, and southbound pedestrian in the East crosswalk. The left turning vehicle took a sharp left near a pedestrian to avoid being hit by a fast approaching through vehicle. The post-encroachment time between the two vehicles was only 0.67 seconds which is not enough time for either road user to stop.

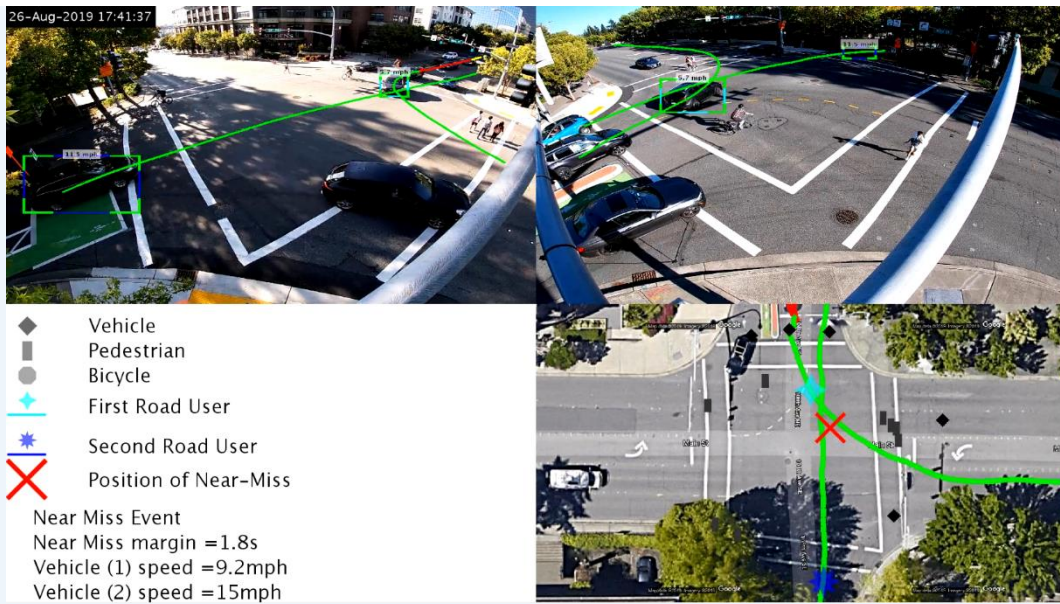
Figure 6. A second three conflict participant near miss involving 108th southbound left vehicle, northbound 108th through vehicle, and southbound pedestrian in the east crosswalk. In this case, the through moving vehicle on northbound 108th was occluded by a right turning vehicle of the same color. The left turning vehicle committed to the motion, blocking the through motion lane, but slowed down to avoid hitting three pedestrians crossing the street. The through moving vehicle quickly accelerated, then slowed to allow the left turning vehicle to clear the intersection.

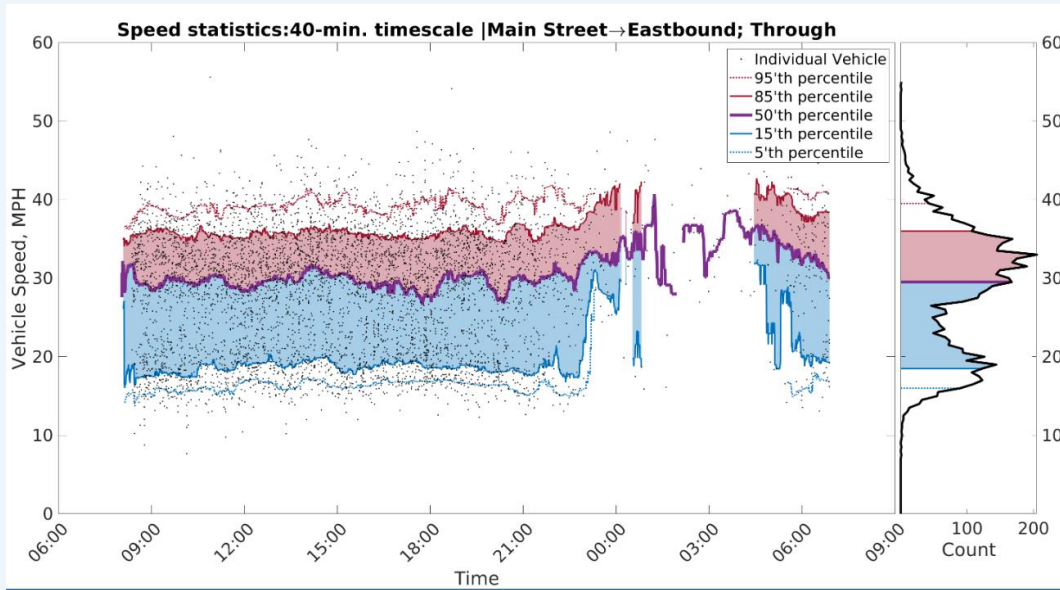
In addition to the highest risk near misses mentioned above, high speed vehicles were identified on both west bound and east bound Main St with ~80% of the speeding events occurring on Main St eastbound. Street Simplified uses 10mph above the speed limit as the threshold for classifying a speeding event. The speed limits on Main St EB and WB were 30 MPH, thus any event 40 MPH or more on these through movements will be flagged as a speeding event.

Figure 7. Vehicle speeds on Main St eastbound through. Each black dot represents the speed of a single vehicle half way through its motion. The section of data without blue and red borders is at night, where not enough vehicles made through motions to estimate the 15th and 85th percentiles. The curve on the right is a histogram of vehicle speed over the study period. One will notice that the 95th percentile is at 40 MPH meaning that 5% of all through motion vehicles on this approach were traveling 40 MPH or more.

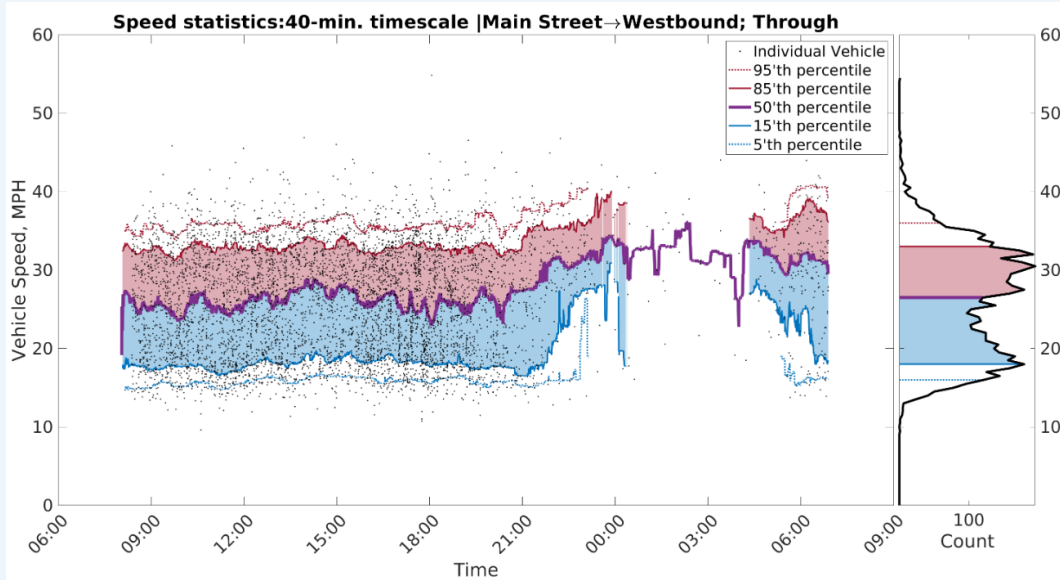
Figure 8. Vehicle speeds on Main St westbound. In comparison to eastbound motions, far fewer vehicles reach 40 MPH or more, even though the traffic volume eastbound and westbound is nearly the same over the study period.

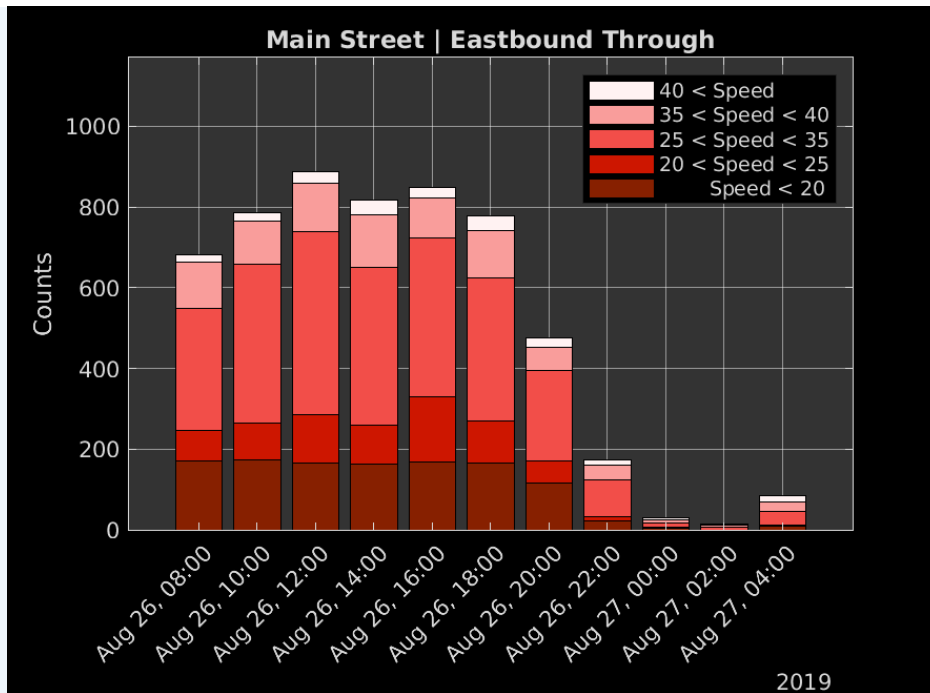
Figure 9. Histogram showing counts of vehicles traveling different speeds over the course of the study day for Main St eastbound through.

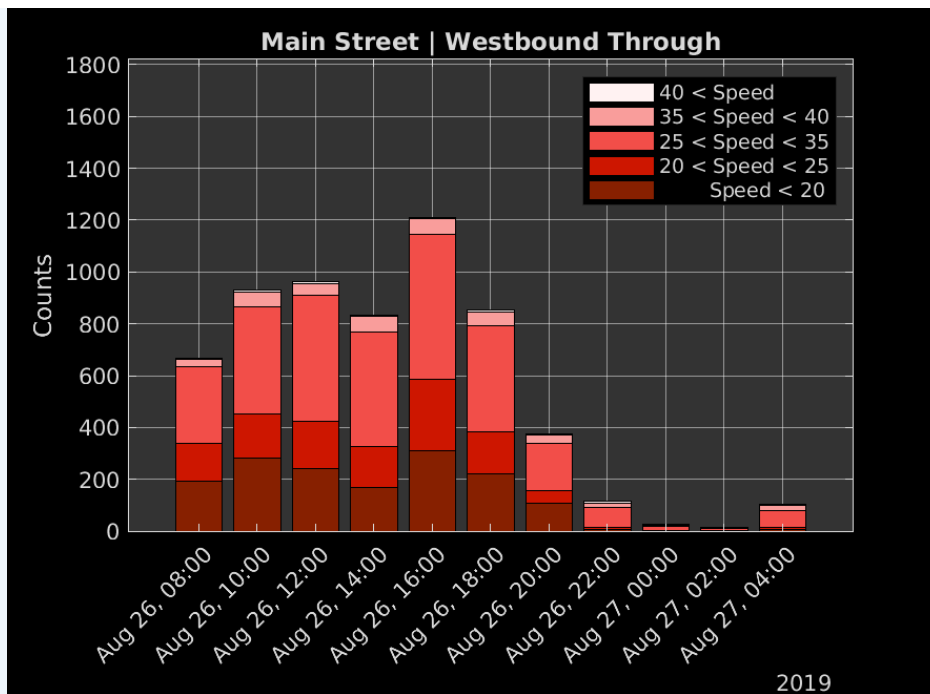
Figure 10. Speeds histograms for Main St. westbound through.

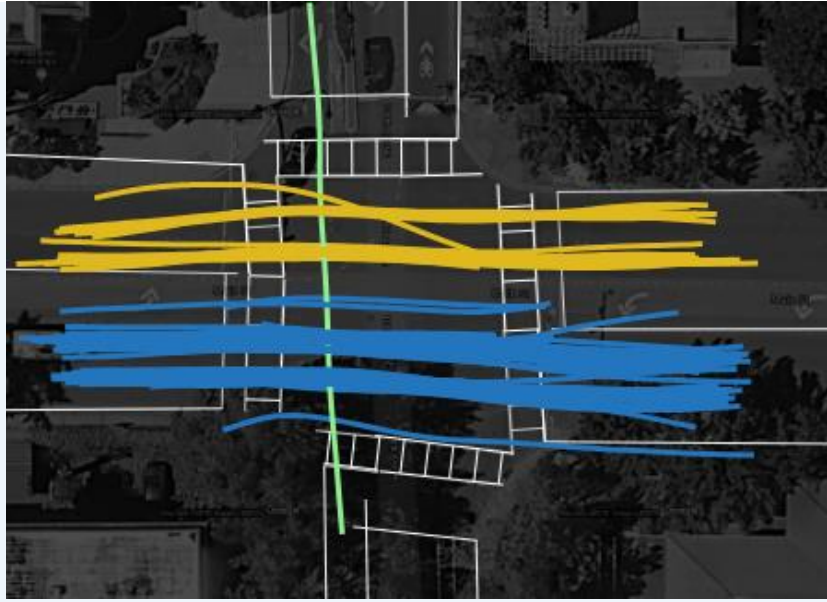
Figure 11. Vehicle paths of vehicles traveling 10 MPH or more above speed limit on 108th and Main.

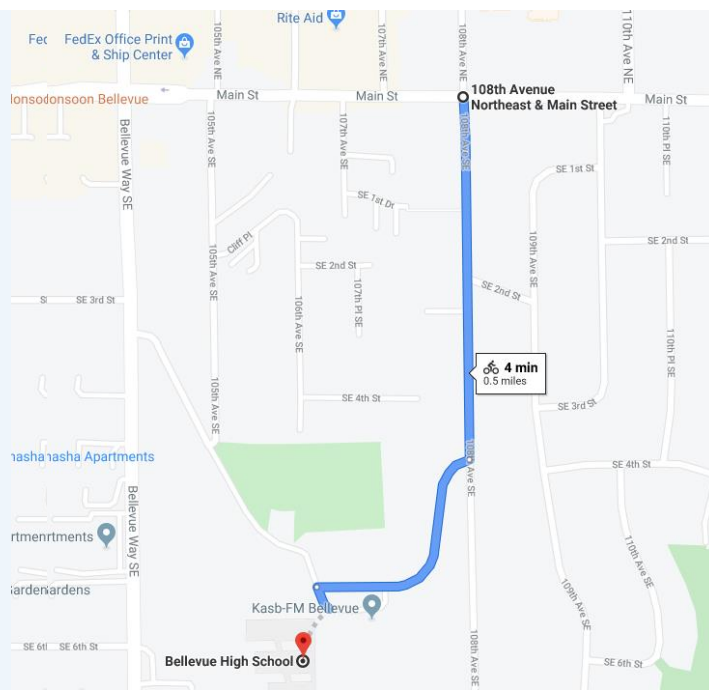
Figure 12. 108th and Main is within a half mile of Bellevue high school and 108th is designed as a bike arterial between the school and the city center. Consistent speeding on Main poses an increased risk for pedestrian and bike traffic coming from the school.
