**BOUNDARY/TOPOGRAPHIC SURVEY**  
**KNAPP PROPERTY**  
**MURRAY FRANKLYN HOMES, LLC**  
14410 BEL-RED ROAD  
BELLEVUE, WA 98007

# **CRITICAL AREA REPORT**

**Knapp Property  
Bellevue, Washington**

Title: Critical Area Report  
Knapp Property,  
Bellevue, Washington

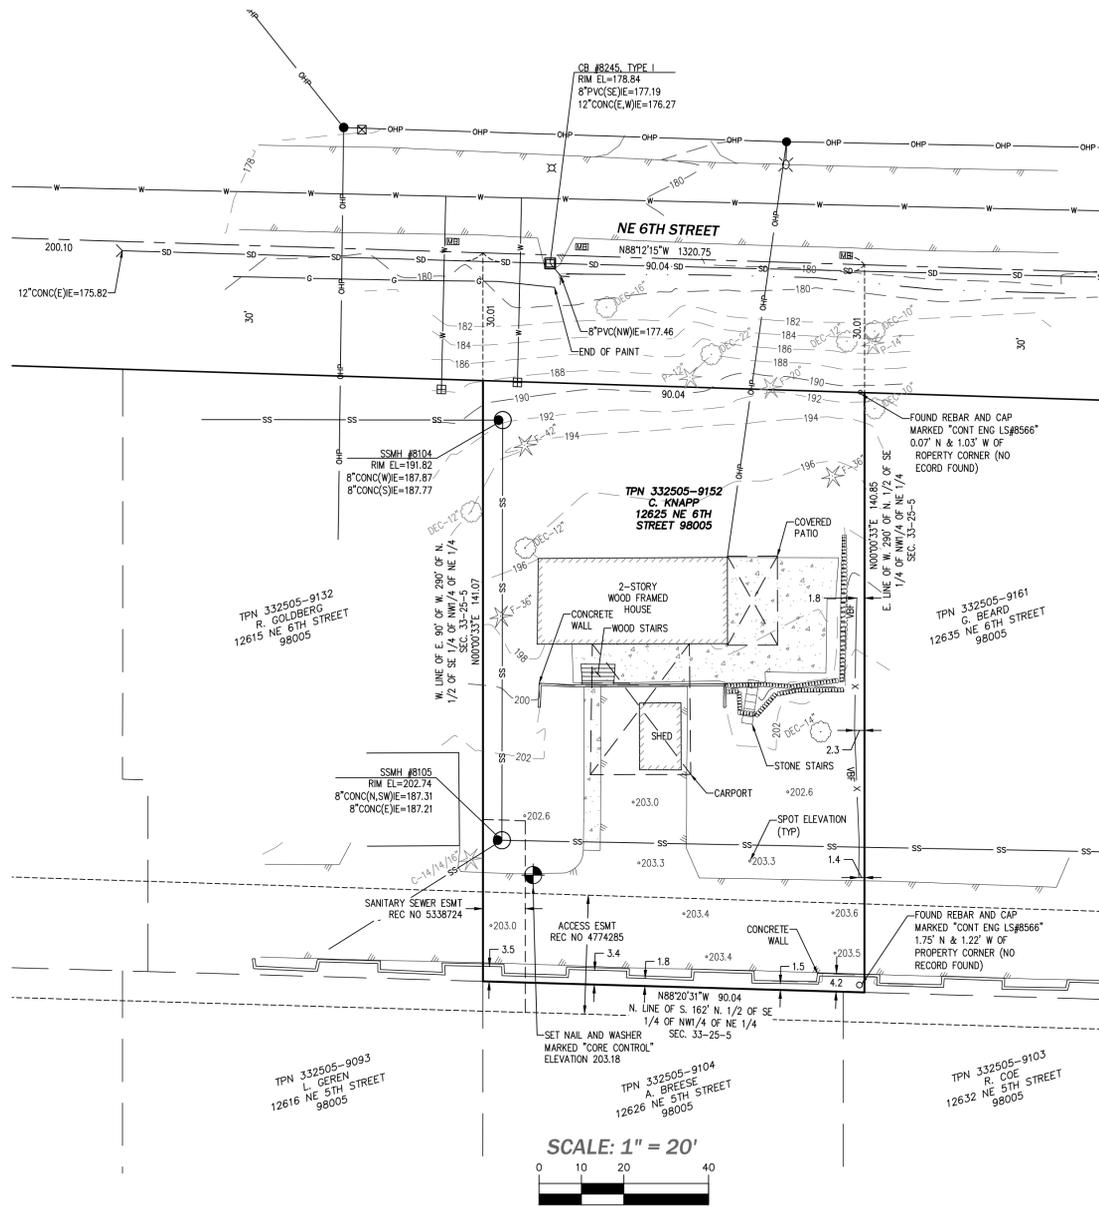
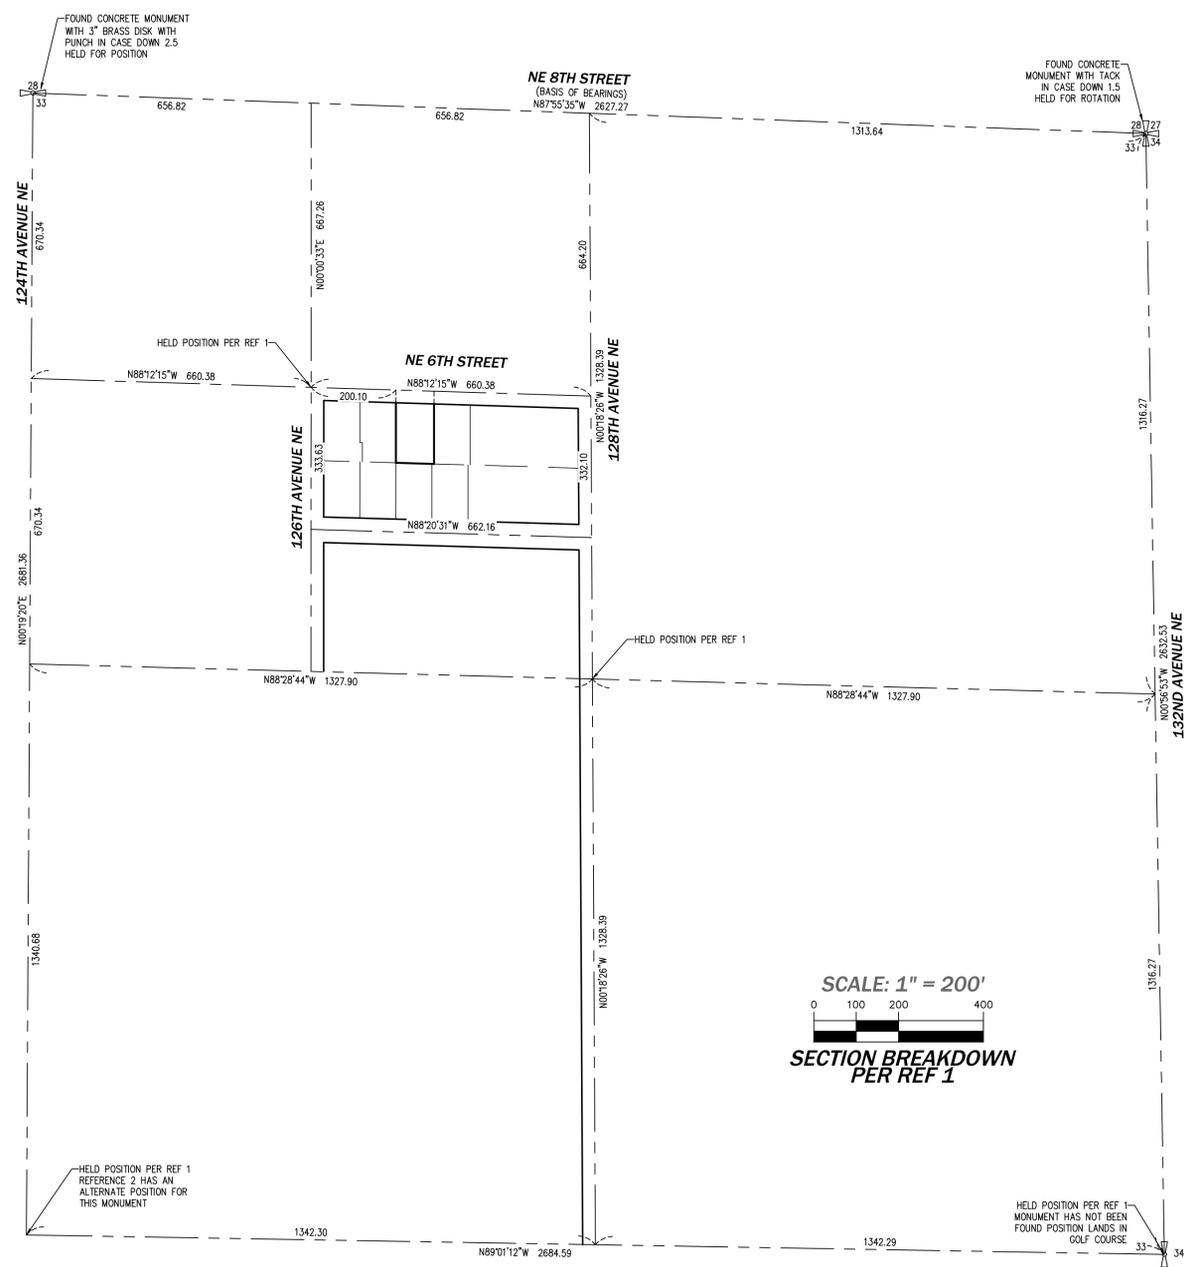
- THIS SURVEY REPRESENTS VISIBLE PHYSICAL IMPROVEMENT CONDITIONS EXISTING ON FEBRUARY 19, 2021. ALL SURVEY CONTROL INDICATED AS "FOUND" WAS RECOVERED FOR THIS PROJECT IN FEBRUARY, 2021.

- BOUNDARY INFORMATION SHOWN HEREON IS DERIVED FROM OBSERVATION OF CONTROLLING MONUMENTATION AND INTERPRETATION OF RECORD DESCRIPTIONS AND OTHER EVIDENCE. TOPOGRAPHIC INFORMATION SHOWN HEREON IS RELATED TO THE BOUNDARY BY DIRECT FIELD OBSERVATION FROM CONTROLLING MONUMENTATION.

- THIS IS A FIELD TRAVERSE SURVEY. A THREE SECOND COMBINED ELECTRONIC TOTAL STATION WAS USED TO MEASURE THE ANGULAR AND DISTANCE RELATIONSHIPS BETWEEN THE CONTROLLING MONUMENTATION AS SHOWN. CLOSURE RATIOS OF THE TRAVERSE MET OR EXCEEDED THOSE SPECIFIED IN IAC 332-30-090. ALL MEASURING INSTRUMENTS AND EQUIPMENT ARE MAINTAINED IN ADJUSTMENT ACCORDING TO MANUFACTURER'S SPECIFICATIONS.

Based on our review of the survey completed by CORE Design, dated February 26, 2021, the slope north of the subject property descends from the property to NE 6th Street with an overall relief of approximately 14 feet. The slope is between 40 and 50 percent, therefore, meets the City of Bellevue's definition of a steep slope and would be classified as a geologic hazard/critical area.

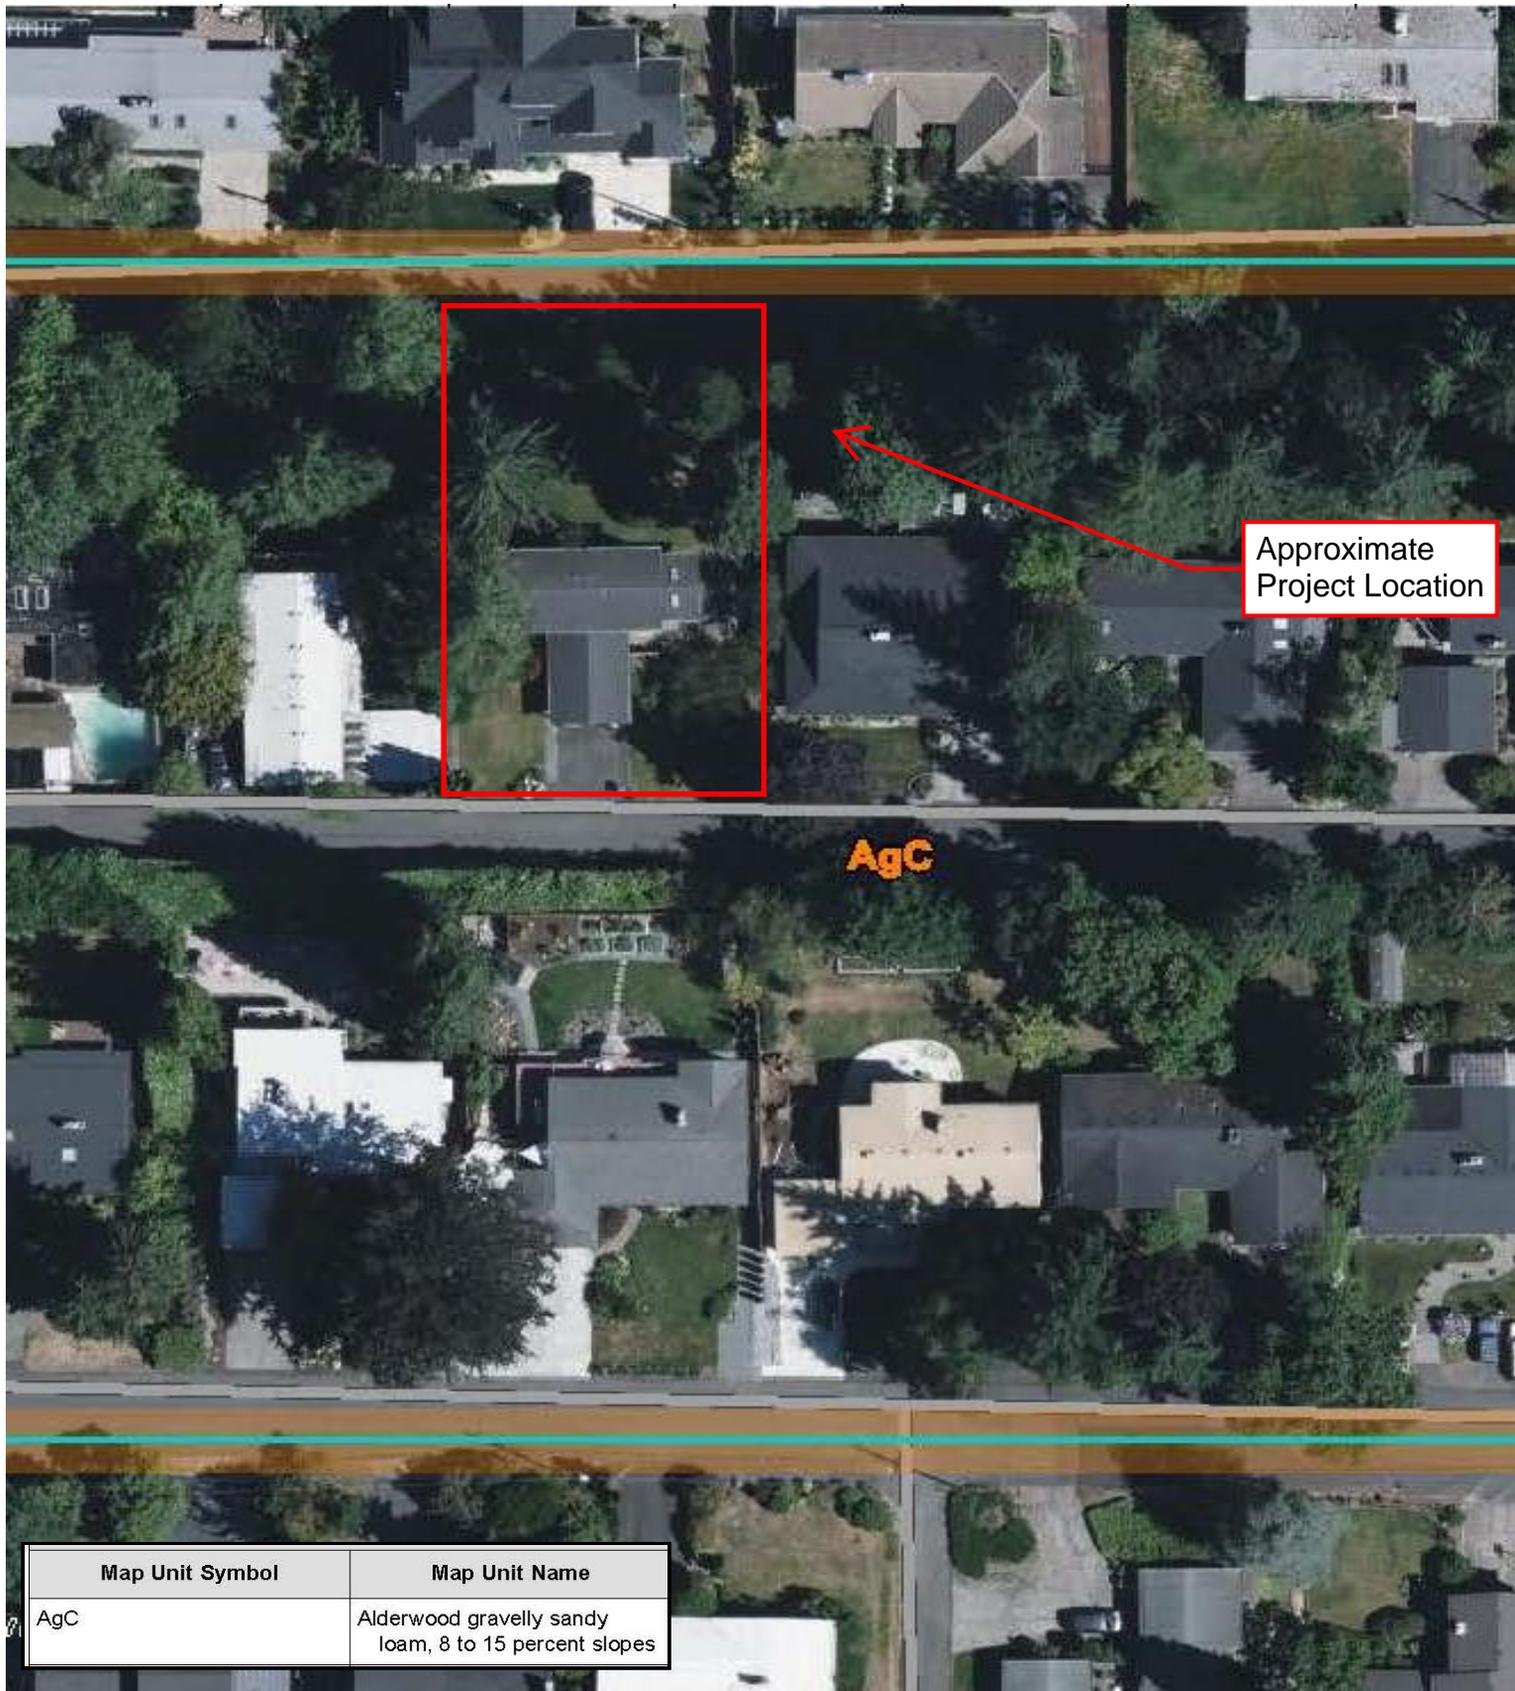
**FIGURE 1 - Vicinity Map  
Knapp Bellevue**

The Knapp Bellevue project site consists of an approximately 0.29-acre parcel located at 12625 NE 6th Street in the City of Bellevue, Washington (Figure 1). The property is identified as King County Tax Parcel No. 3325059152. This puts the project site in a portion of Section 33, Township 25 North, Range 5 East, W.M. Parcel maps retrieved on-line from King County (2021) iMap depict the property boundaries.

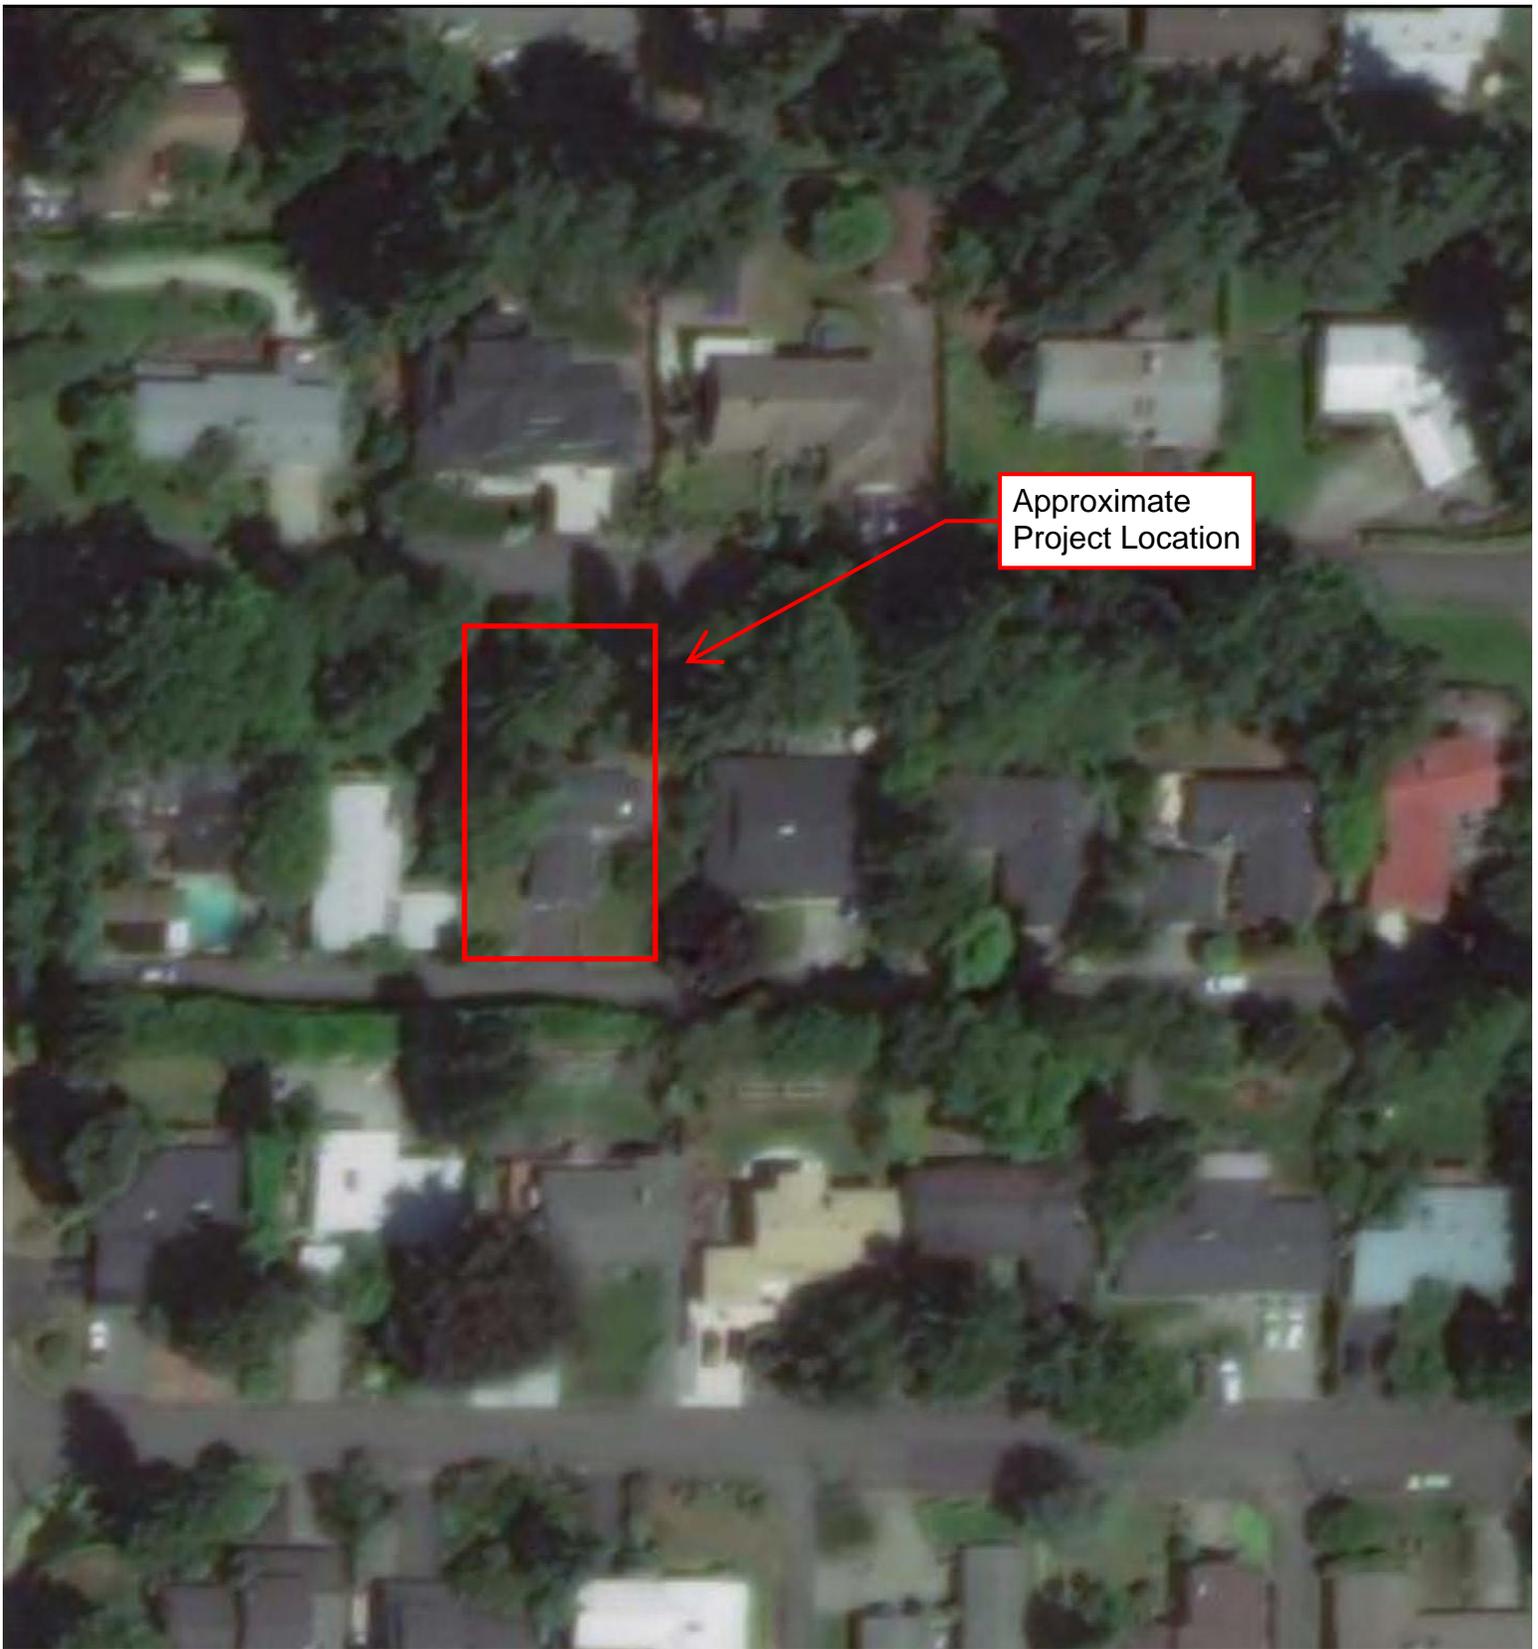
### FIGURE 3 - National Wetland Inventory map

The USFWS (2021) NWI (Figure 3) shows no wetlands or streams on or within the immediate vicinity of the project site. Wetlands shown on the NWI are general in terms of location and extent, as they are determined primarily from aerial photograph interpretation. Thus, the number and extent of existing wetlands located within the project area may differ from those marked on the NWI map.

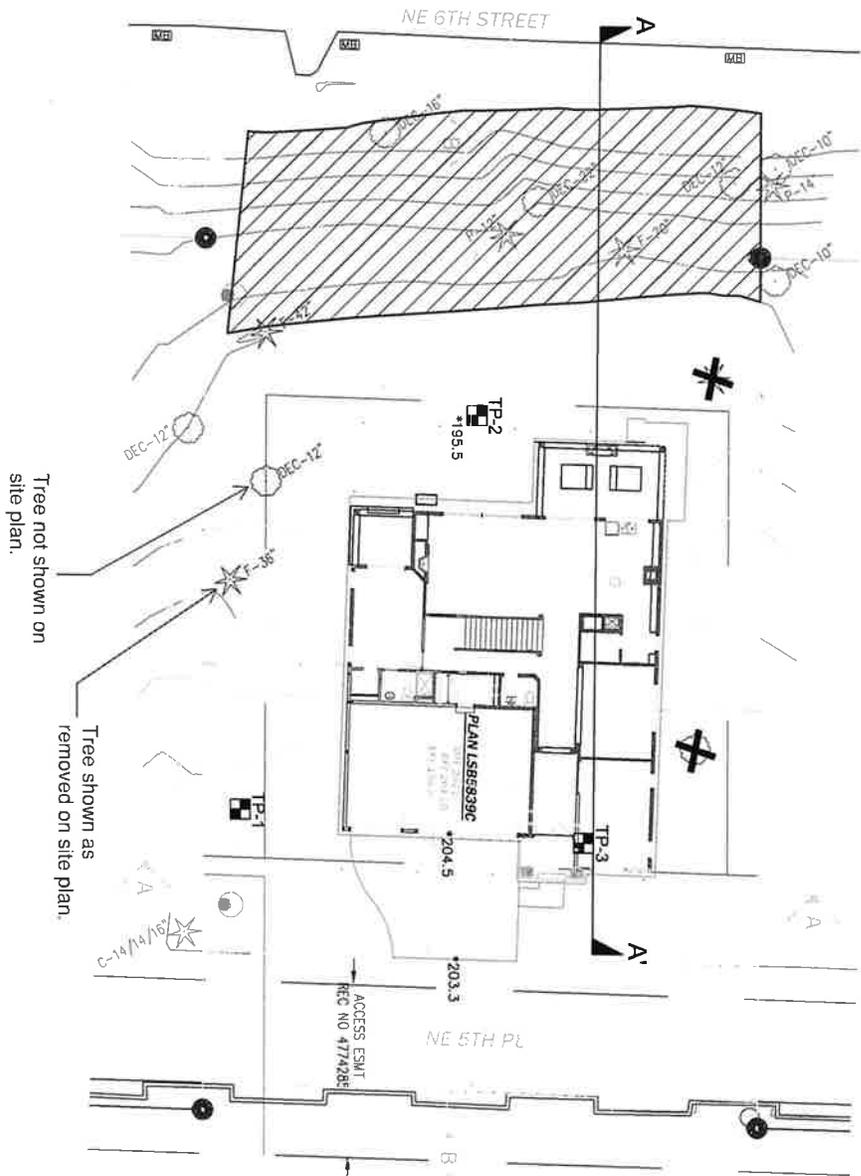
**NOTE:**  
 THIS SITE PLAN IS SCHEMATIC. ALL LOCATIONS AND DIMENSIONS ARE APPROXIMATE. IT IS INTENDED FOR REFERENCE ONLY AND SHOULD NOT BE USED FOR DESIGN OR CONSTRUCTION PURPOSES.

**REFERENCE:** SITE PLAN PROVIDED BY CLIENT.

Carolyn S. Becker, P.E.  
Project Engineer  
Enc. Figure 1 – Exploration Location Plan  
Appendix Slope Stability Analysis Graphical Output

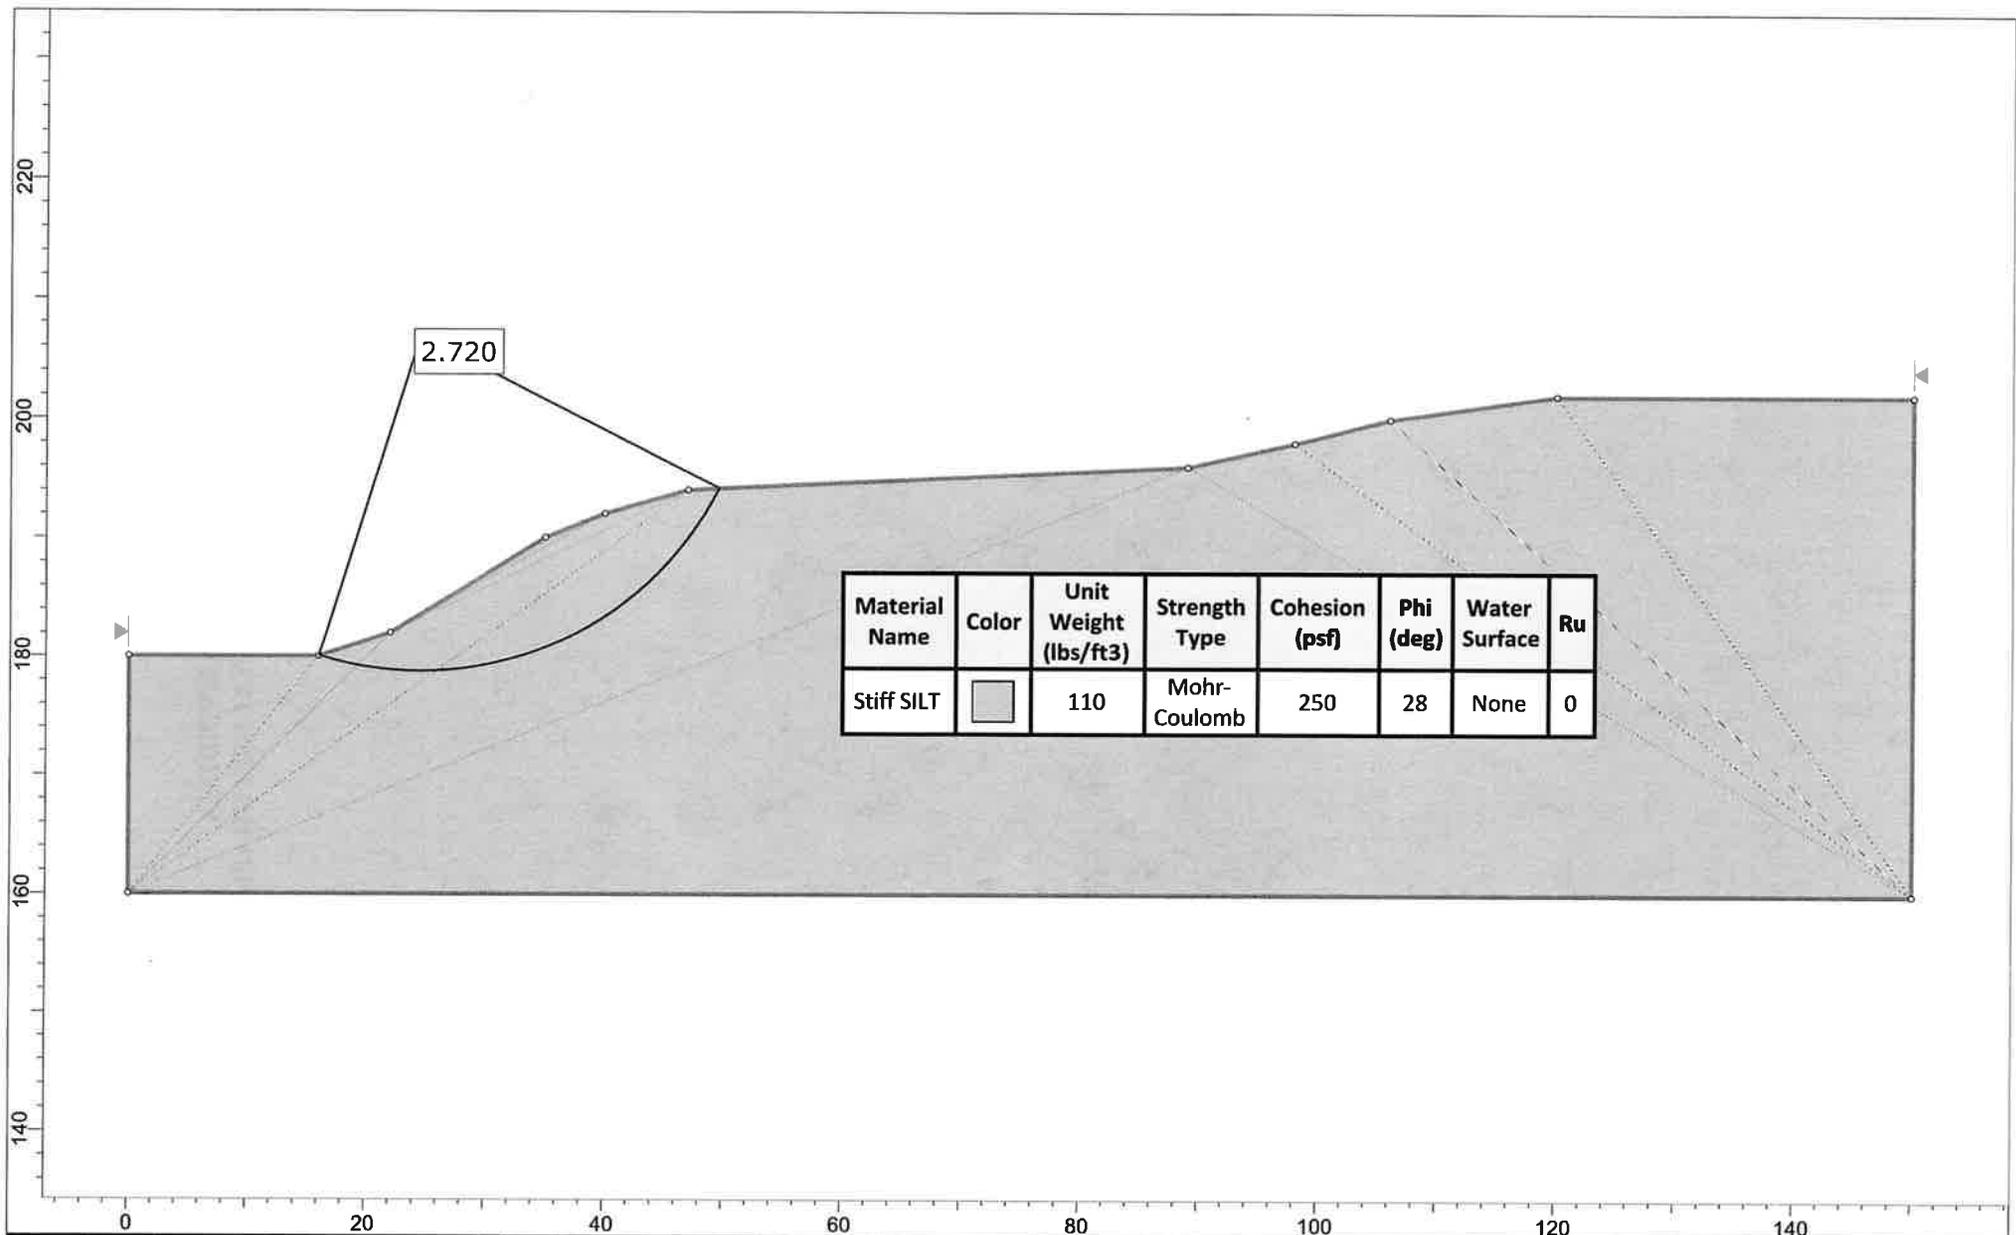
<i>Project</i> <b>Knapp Property</b>	
	<i>Group</i> Existing Conditions	<i>Scenario</i> Master Scenario
	<i>Drawn By</i> C. Decker	<i>Company</i> Terra Associates, Inc.
	<i>Date</i> April 26, 2021	<i>File Name</i> Cross Section A-A'.slmd

The results of our slope stability analysis, as shown by the lowest safety factors for each condition, are presented in the following table:

Cross Section	Minimum Safety Factors	
	Existing Conditions	Post Construction
A-A'	2.72 (Seismic 1.54)	2.72 (Seismic 1.54)

Results of the analysis show the proposed project has no impact on the existing steep slope in both the static and pseudostatic condition. Therefore, it is our opinion, that the project can be constructed as shown. Results of the Slide analysis are attached for review.

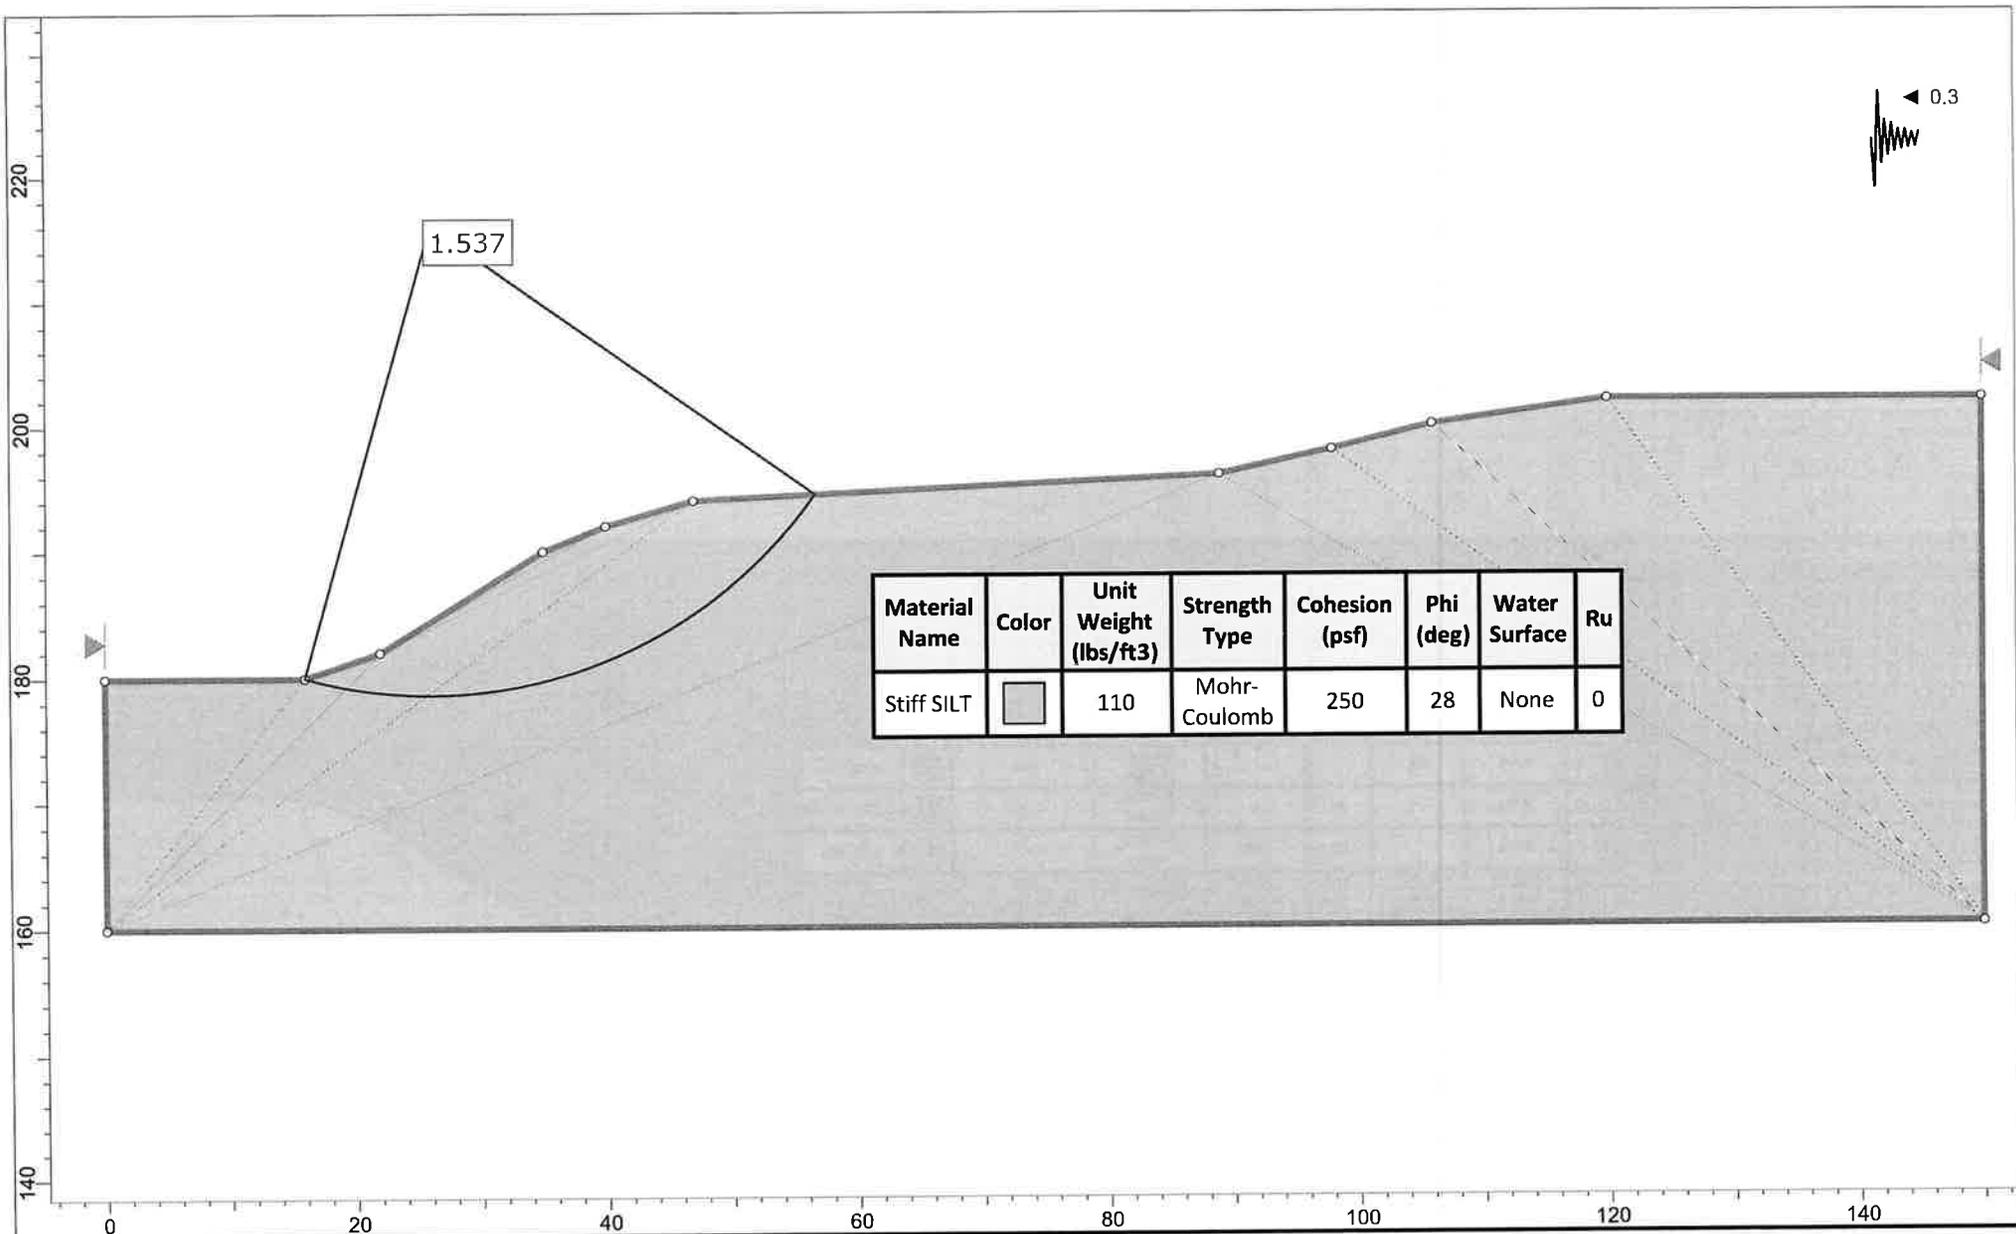
Our analysis considered both static and pseudostatic (seismic) conditions. A horizontal acceleration of 0.3g was used in the pseudostatic analysis to simulate slope performance under earthquake loading. This acceleration is equal to one-half of the peak horizontal ground acceleration with 2 percent in a 50-year probability of exceedance as defined by the 2018 International Building Code.

Project		Knapp Property	
	Group		Existing Conditions	Scenario
	Drawn By		C. Decker	Company
	Date		April 26, 2021	File Name
			Seismic	Terra Associates, Inc.
				Cross Section A-A'.slmd

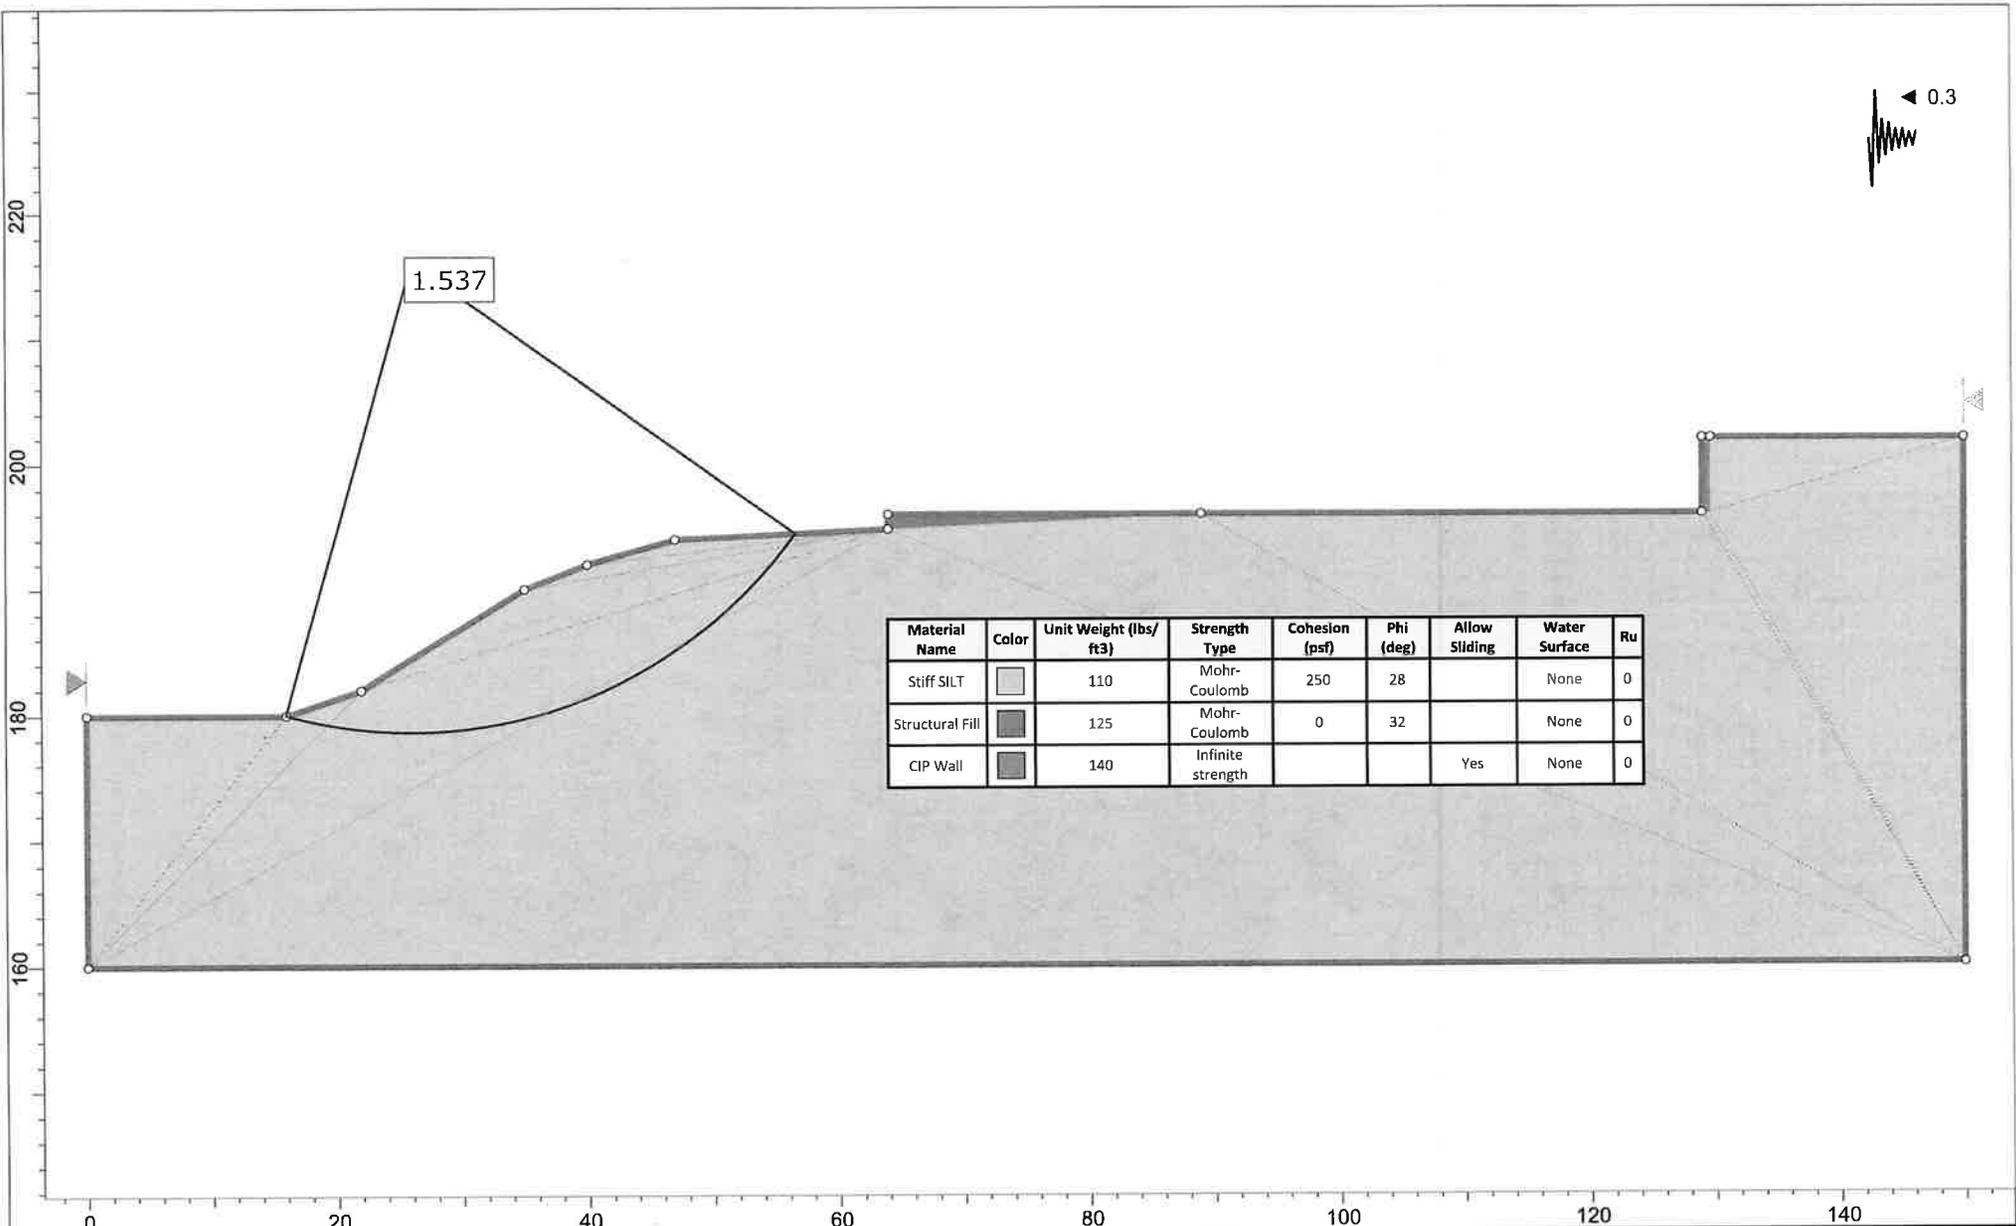
<i>Project</i>		Knapp Property	
<i>Group</i>	Post Construction	<i>Scenario</i>	Seismic
<i>Drawn By</i>	C. Decker	<i>Company</i>	Terra Associates, Inc.
<i>Date</i>	April 26, 2021	<i>File Name</i>	Cross Section A-A'.slmd
