City of Bellevue Watershed Management Plan

Coal Creek Watershed Assessment Report

EXECUTIVE SUMMARY

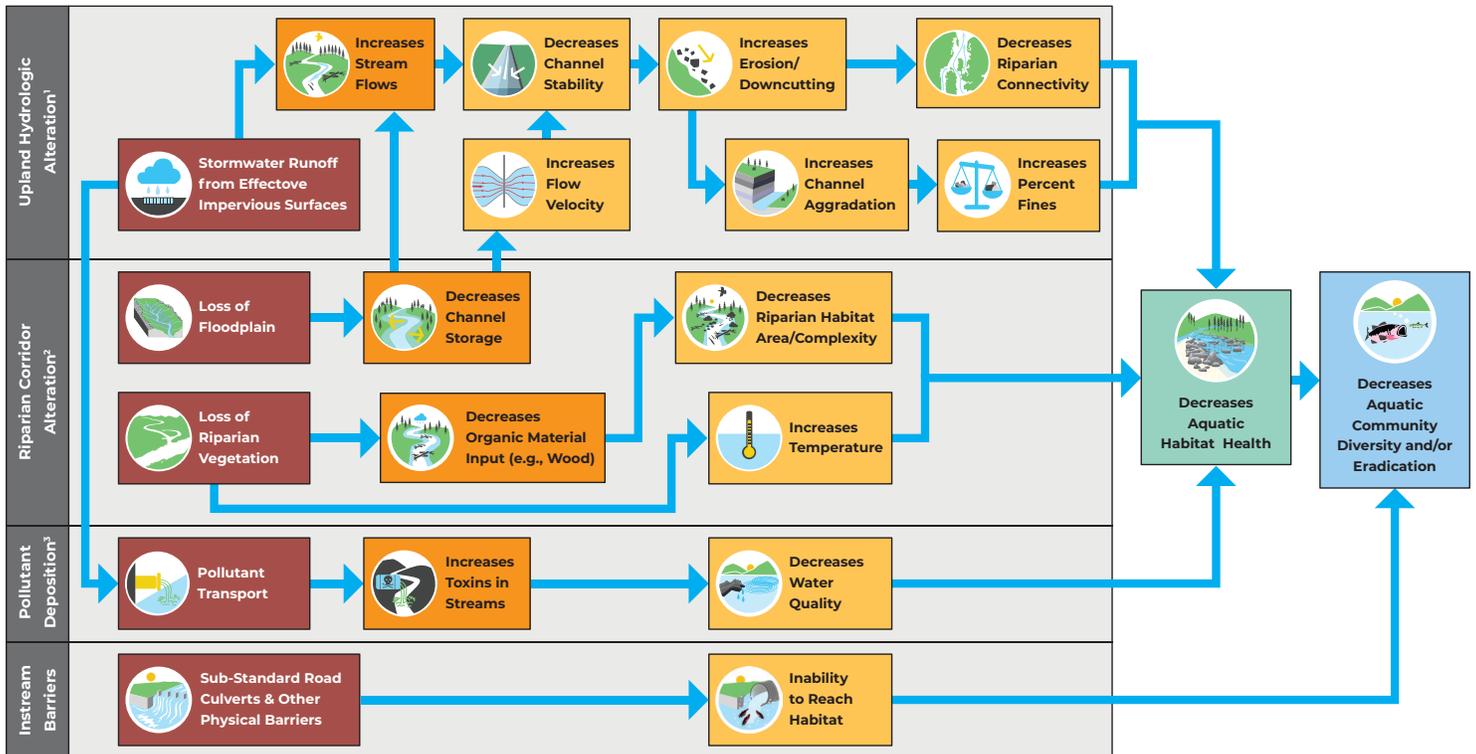
Figure 1. Conceptual Model of the Major Unmanaged Effects of Urbanization on Stream Health

1 = Conversion of upland forest/ other vegetated areas to: Impervious areas (roads, roofs, sidewalks, driveways, parking lots, sport courts) that drain to streams
 2 = Removal of vegetation, paving, and armoring of riparian corridor
 3 = Vehicle deposits on roads and other impervious surfaces (petroleum products, antifreeze, brake and tire residue, etc.)
 - Releases from septic tanks/drain fields regulated by King County Public Health
 - Releases categorized as "Illicit Discharges" (illegal dumping, misuse of herbicides/ pesticides/ other chemicals, accidental spills, etc.) regulated by COB Phase II NPDES program

The purpose of this report is to assess the conditions in the Coal Creek Watershed that are limiting the health of its streams. The evaluation of potential limiting factors from the Conceptual Model that describes the primary effects of urban runoff on streams (brown boxes in Figure 1, next page) and their consequences for stream health.

The following were identified as limiting factors for the Coal Creek Watershed per the Conceptual Model (Figure 1), in general order of importance:

Increased stormwater runoff flow rates and volumes during storm events from impervious surfaces in the watershed, in combination with historic channel alterations from logging and coal mining land uses, are contributing to negative effects on fish & wildlife habitat. As shown in Figure 1, these effects can include channel, bank, and slope instability. These effects are noticeable in the middle and upper reaches of Coal Creek. The majority of the development in the Coal Creek Watershed was built prior to the requirement for stream protection-based stormwater controls. Changes in rainfall patterns in the region may also be contributing to increased effects of stormwater runoff on stream health.

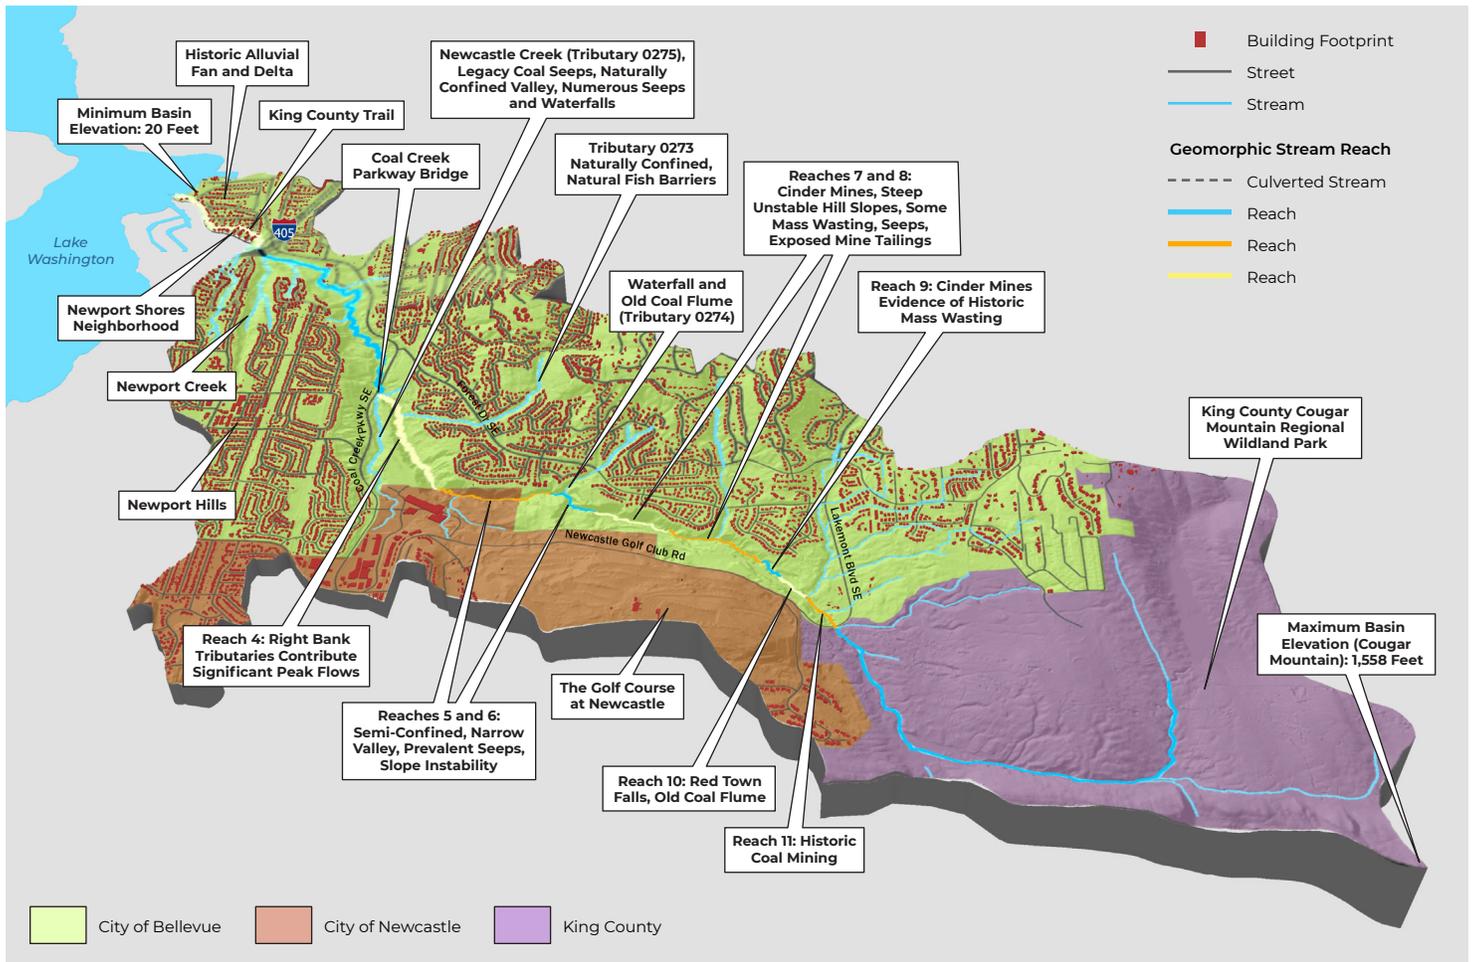
Figure 2. Features of the Coal Creek Watershed

The headwaters of Coal Creek originate in the steep terrain of Cougar Mountain at an elevation of about 1,400 feet. The creek flows for about seven miles through a series of steep, narrow ravines before entering Lake Washington. The Coal Creek Watershed encompasses a total area of approximately 4,550 acres, with 63 percent of this area located within the City of Bellevue and the remainder is within King County and the City of Newcastle.
