# Vegetation Inventory & Management Plan Report for the North Bellevue Segment

## PSE ENERGIZE EASTSIDE PROJECT CITY OF BELLEVUE

March 4, 2021

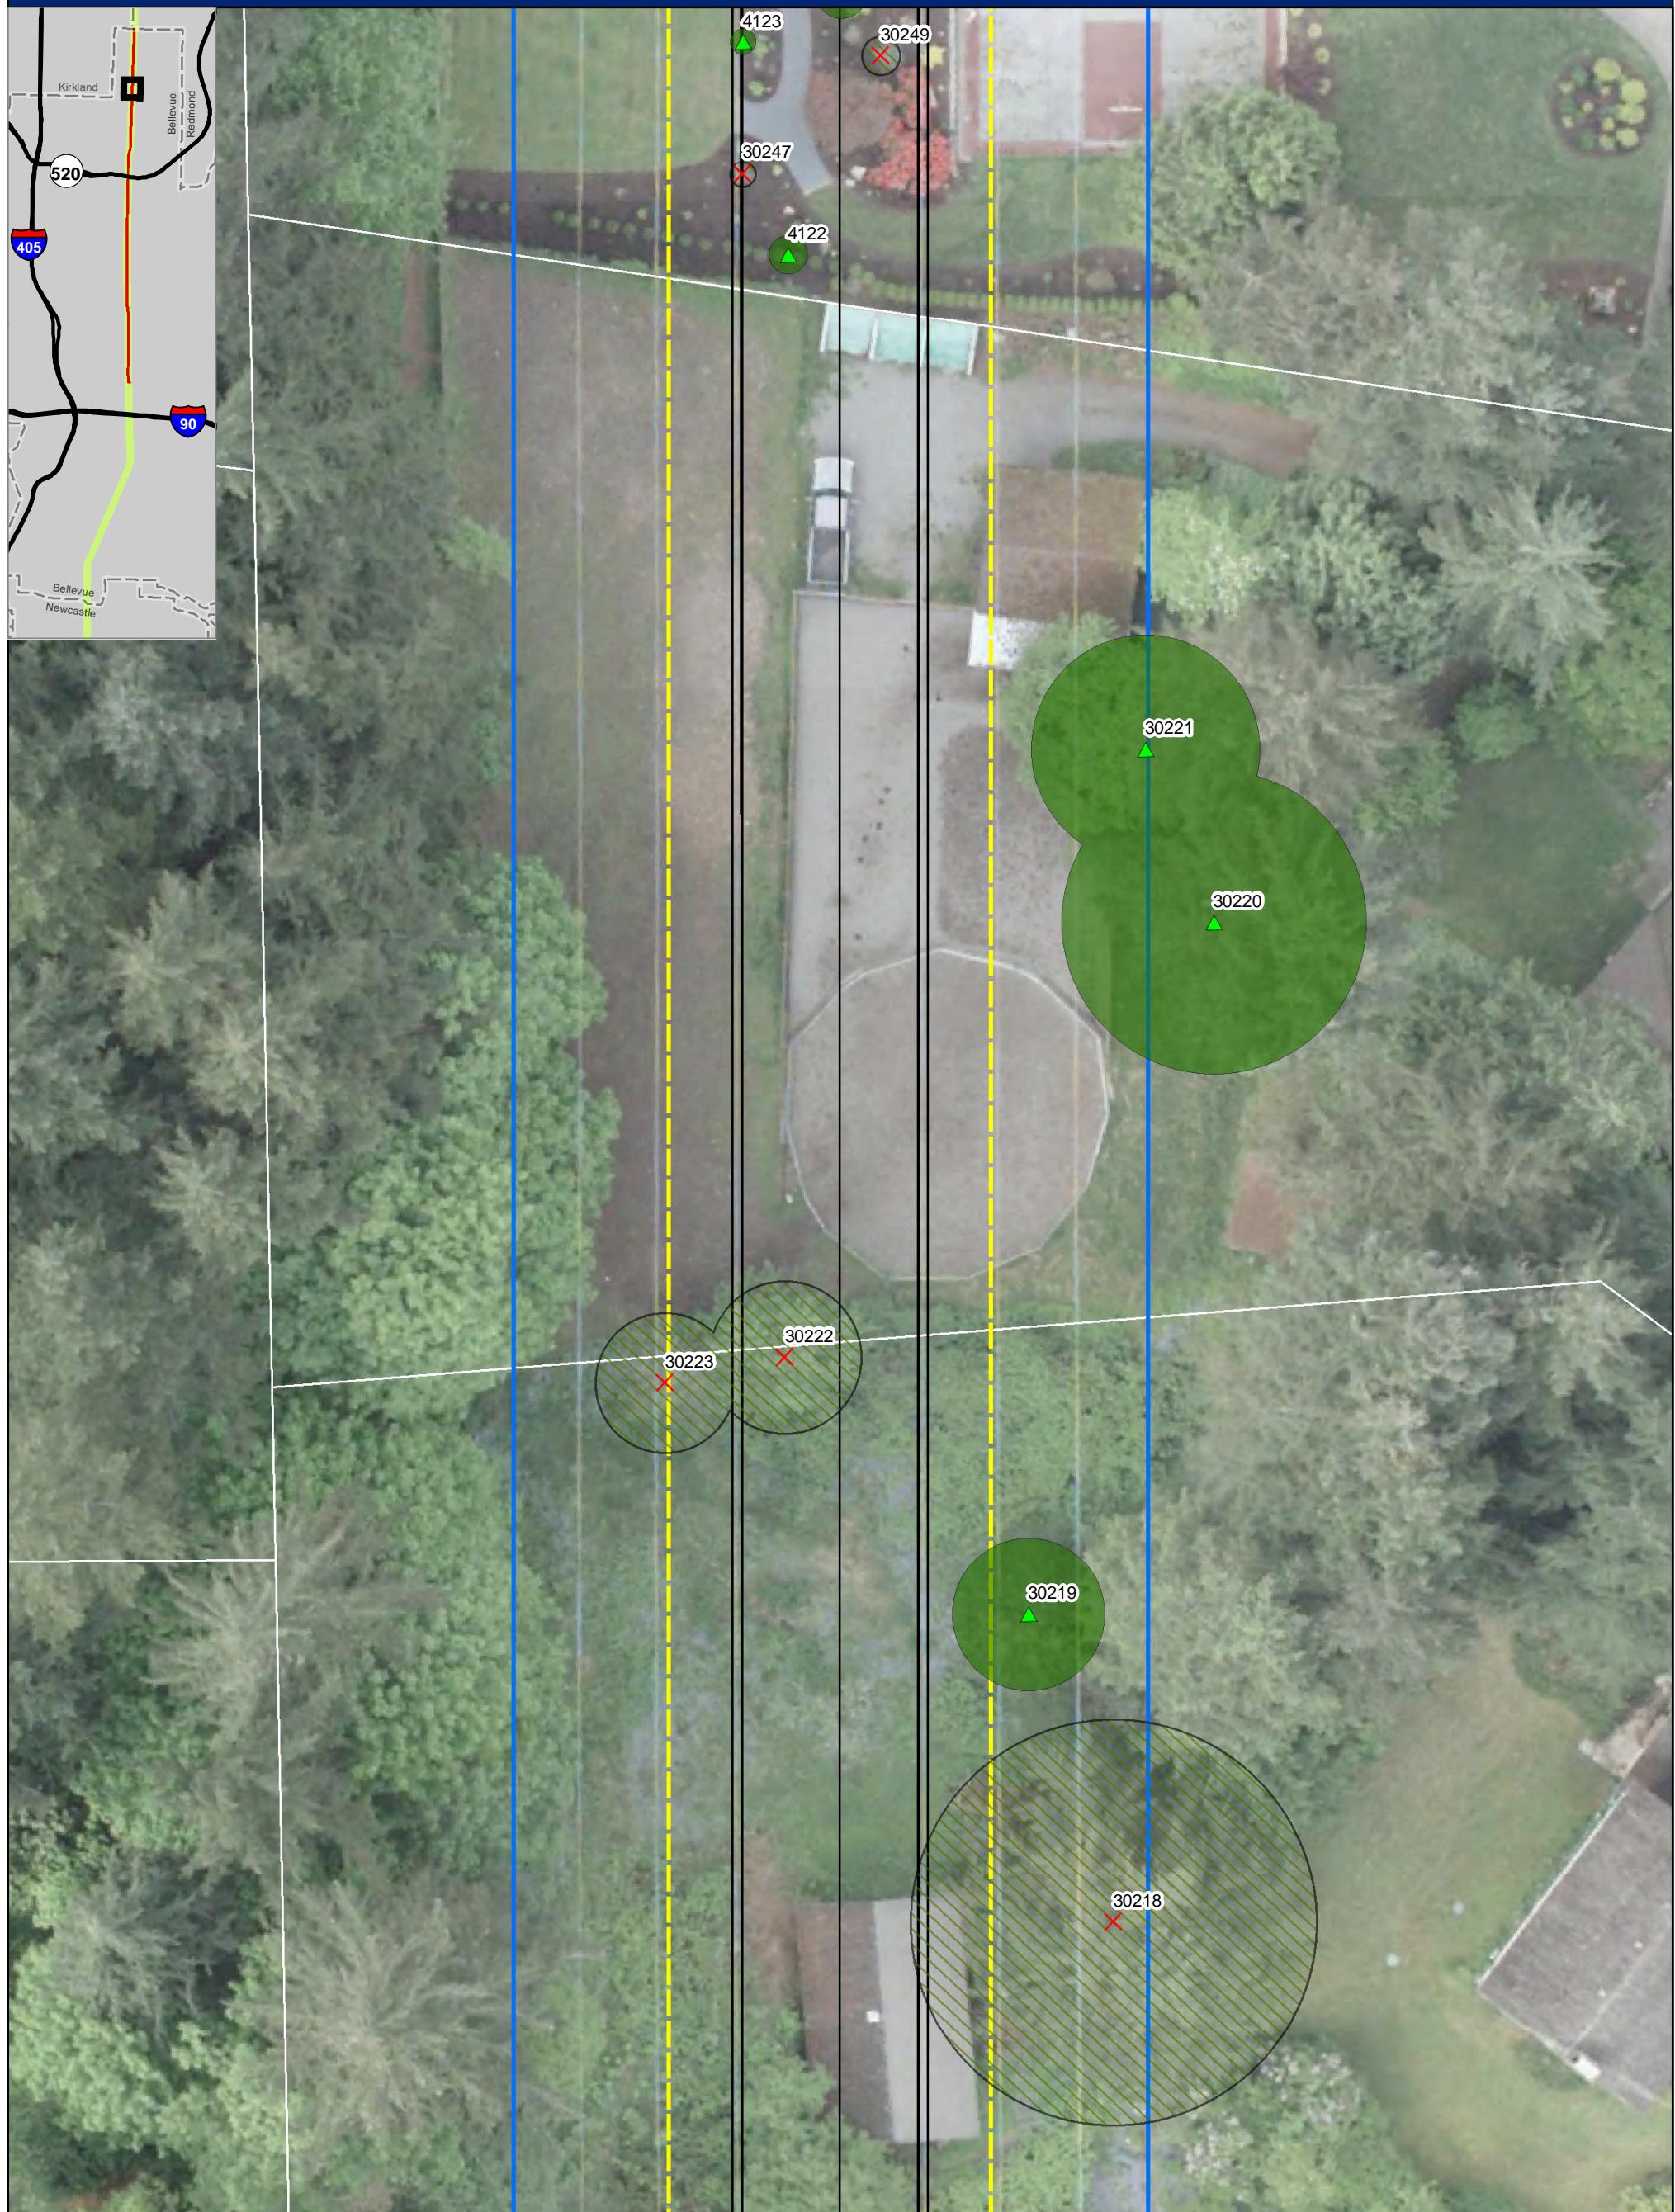
PSE EE230 - NORTH BELLEVUE OUTREACH MAP: TREE REMOVAL AND RETENTION

City Limit  
Parcel Boundary<sup>COB - white</sup>  
Existing Easement

Wire Zone  
Proposed Wires  
Existing Pole Locations  
Proposed Pole Locations

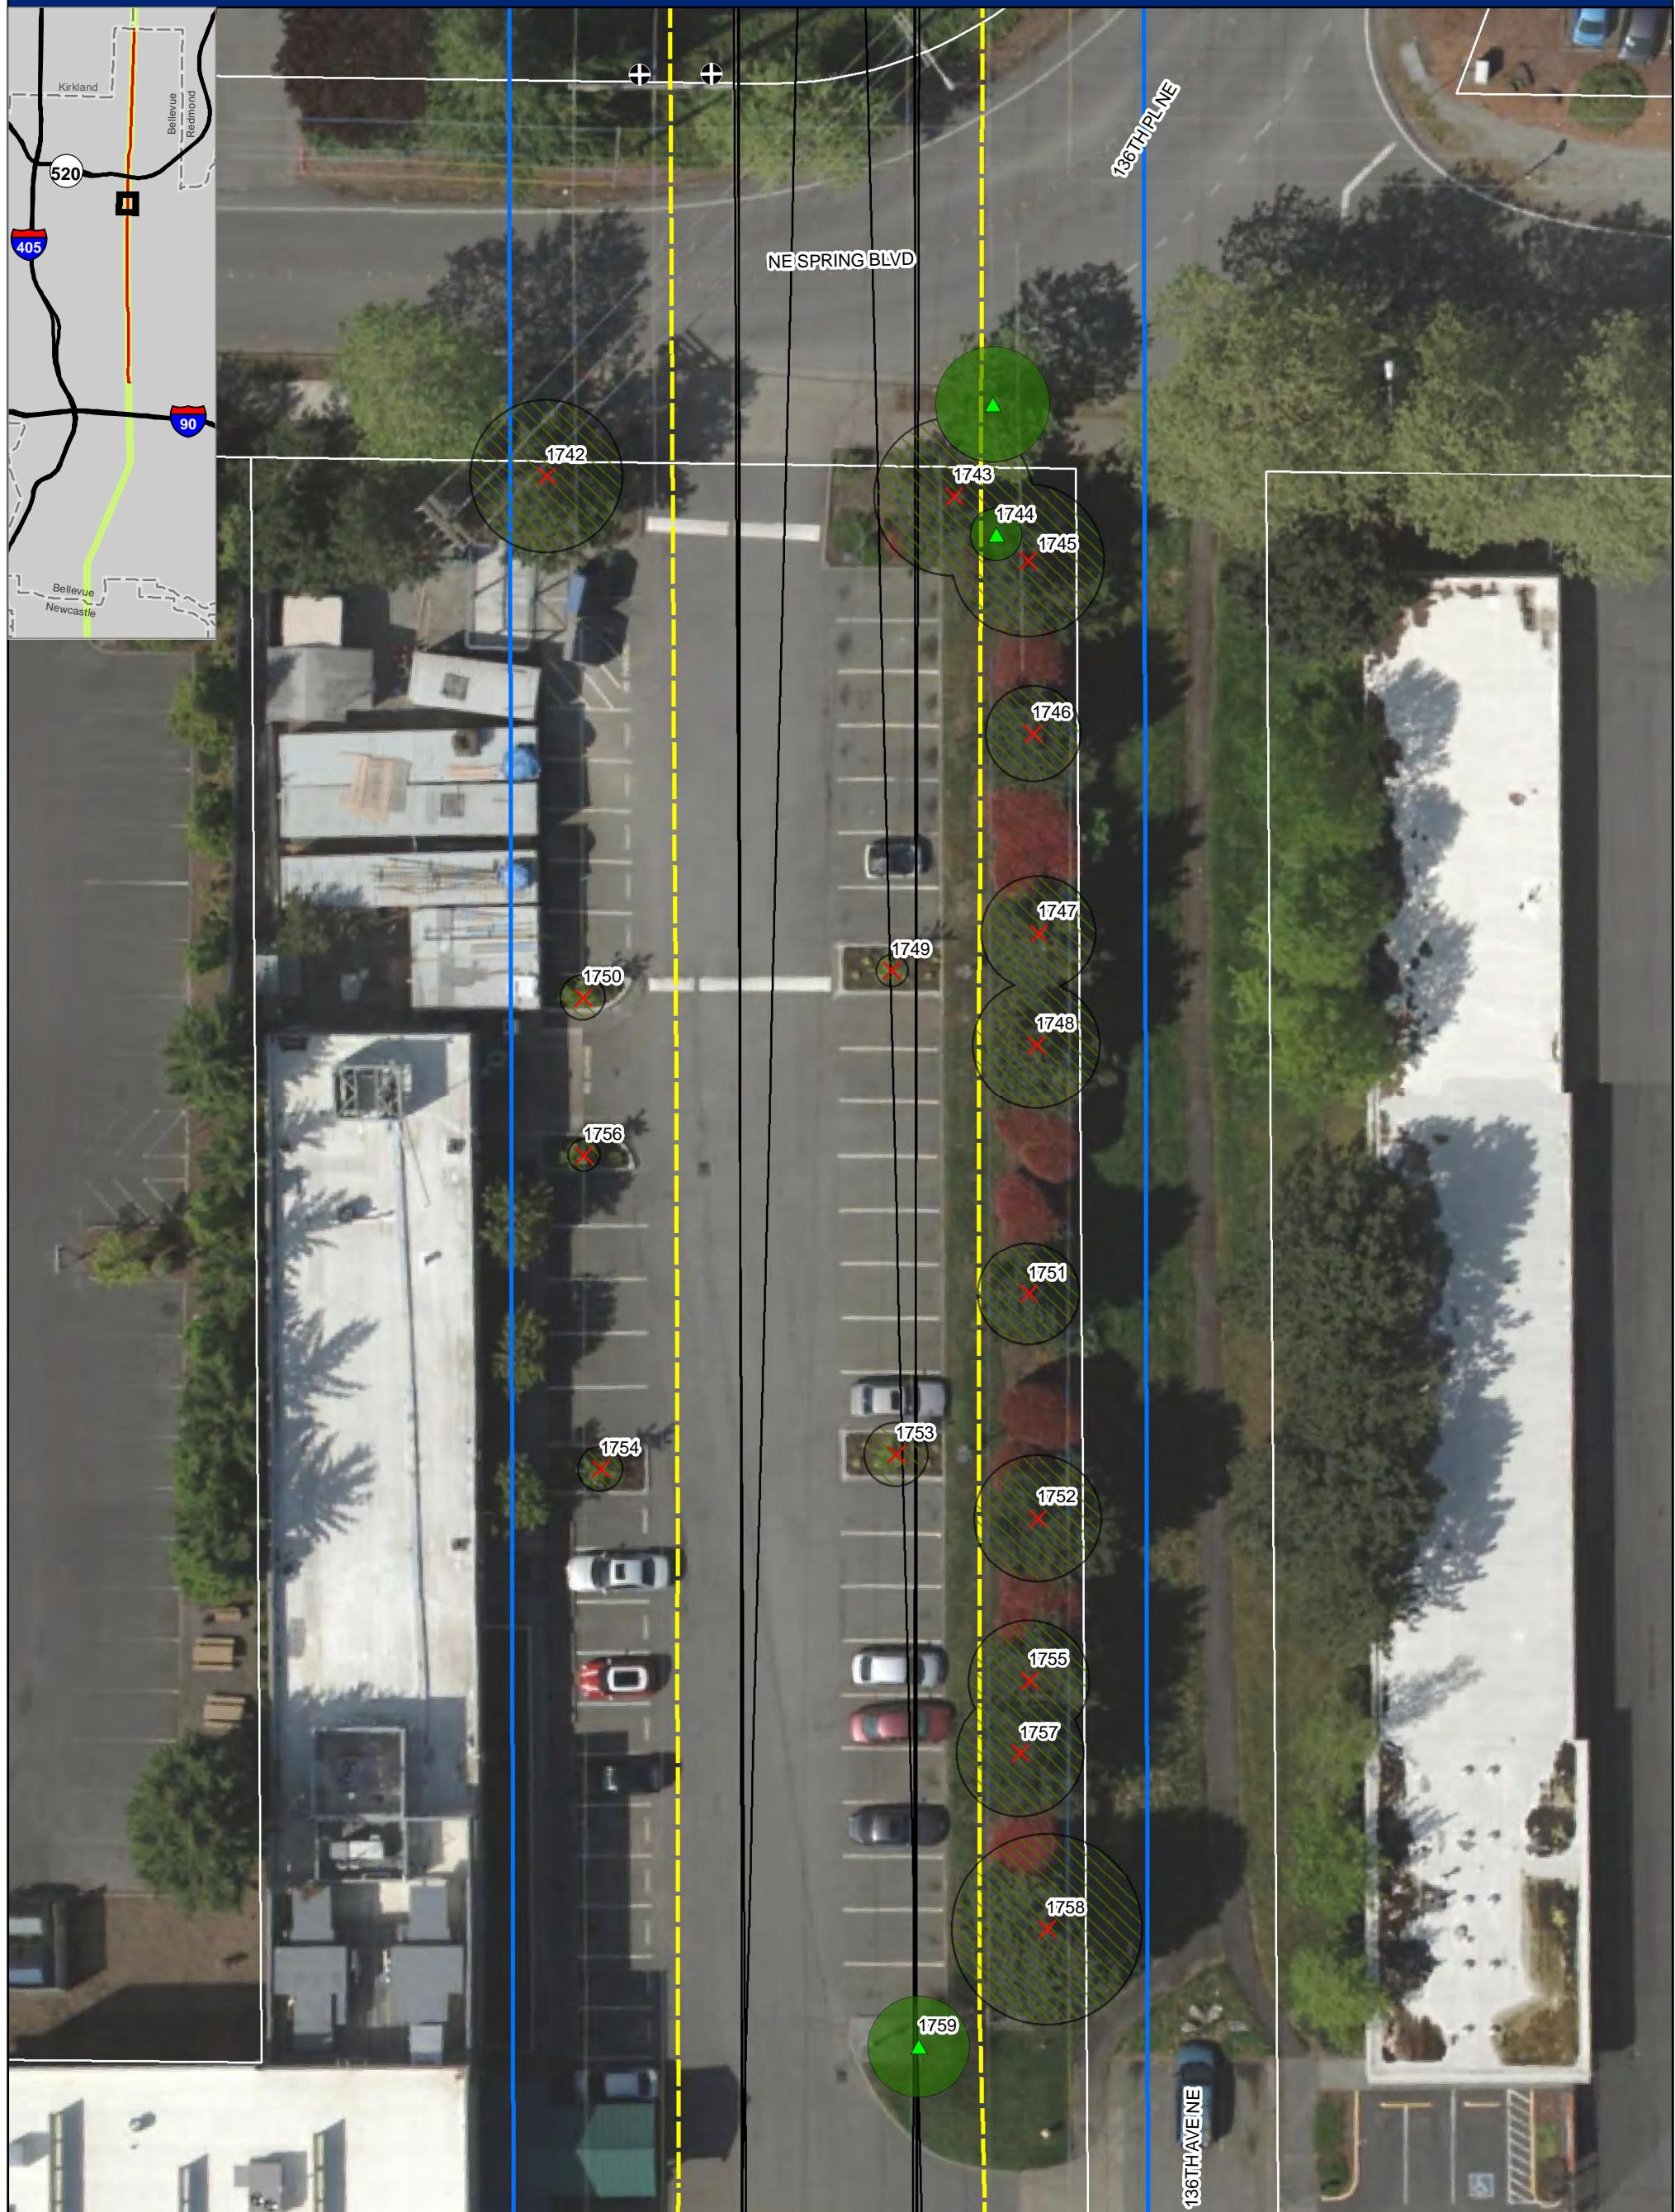
PSE EE230 - NORTH BELLEVUE OUTREACH MAP: TREE REMOVAL AND RETENTION

City Limit  
Parcel Boundary<sup>COB - white</sup>  
Existing Easement

Wire Zone  
Proposed Wires  
Existing Pole Locations  
Proposed Pole Locations

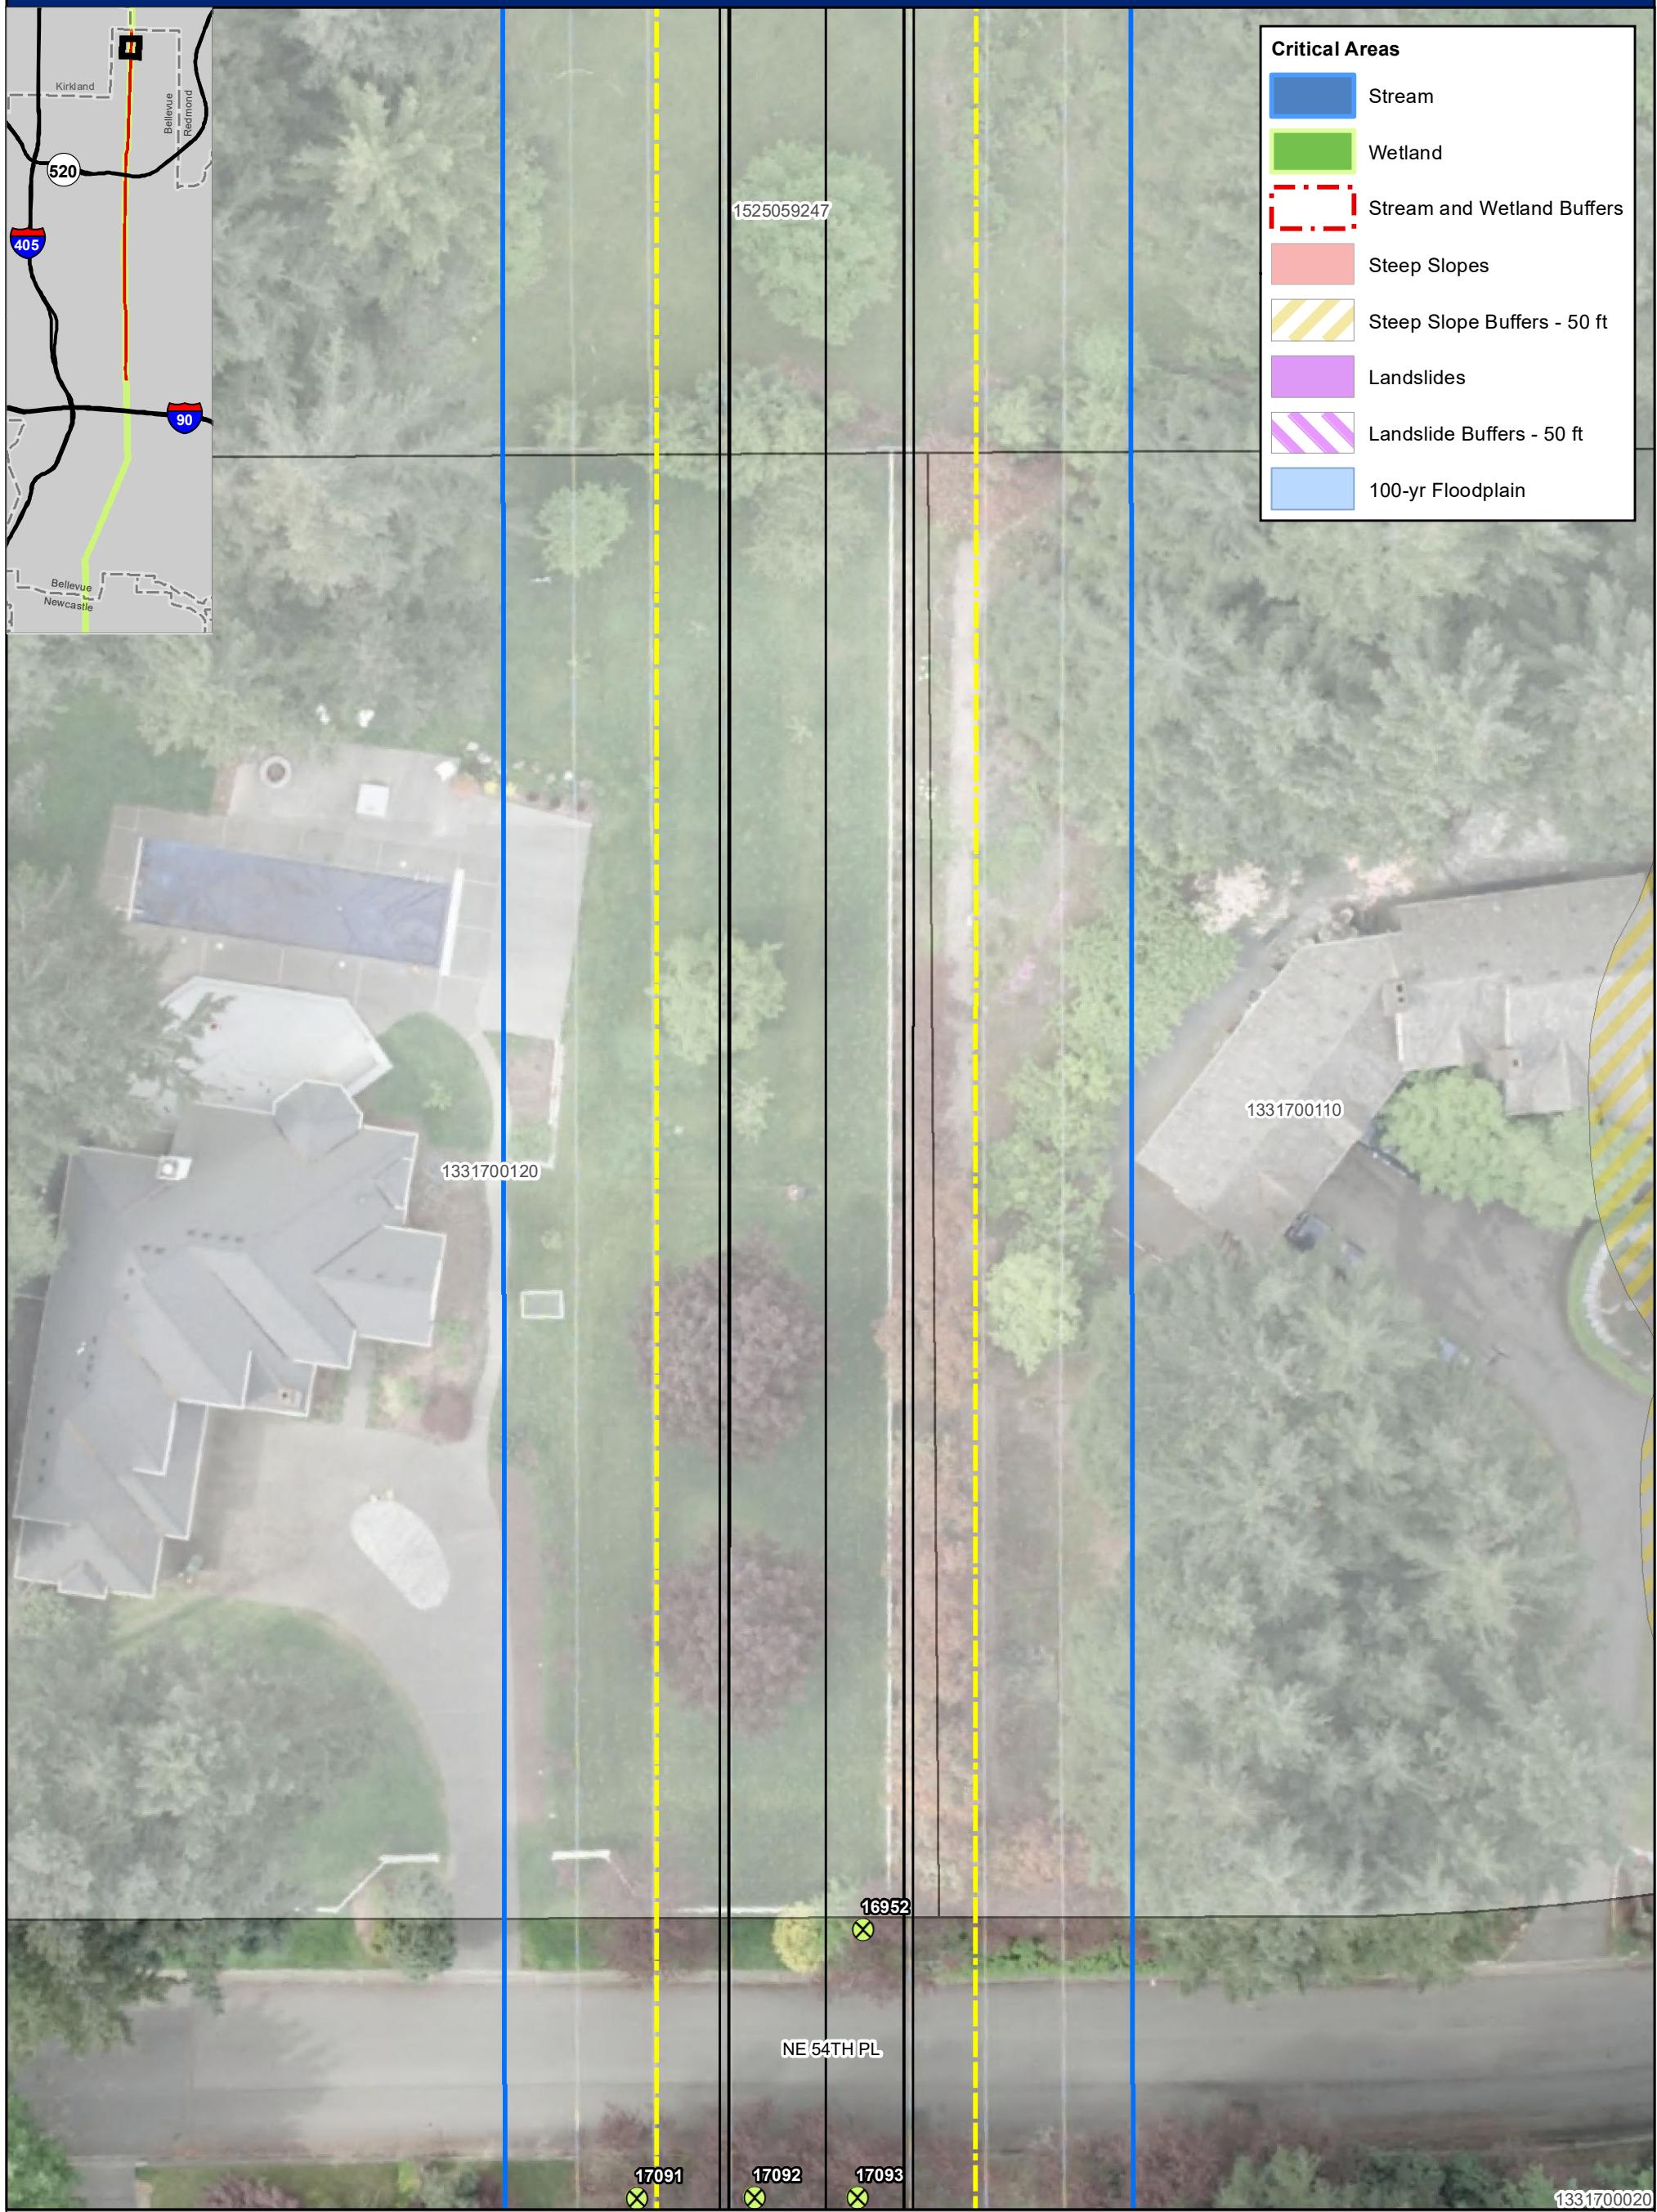
# PSE EE230 - NORTH BELLEVUE: PUBLIC TREE REMOVAL MAPS

Significant Trees to be Removed<sup>TWC</sup>

- City Owned
- Public ROW

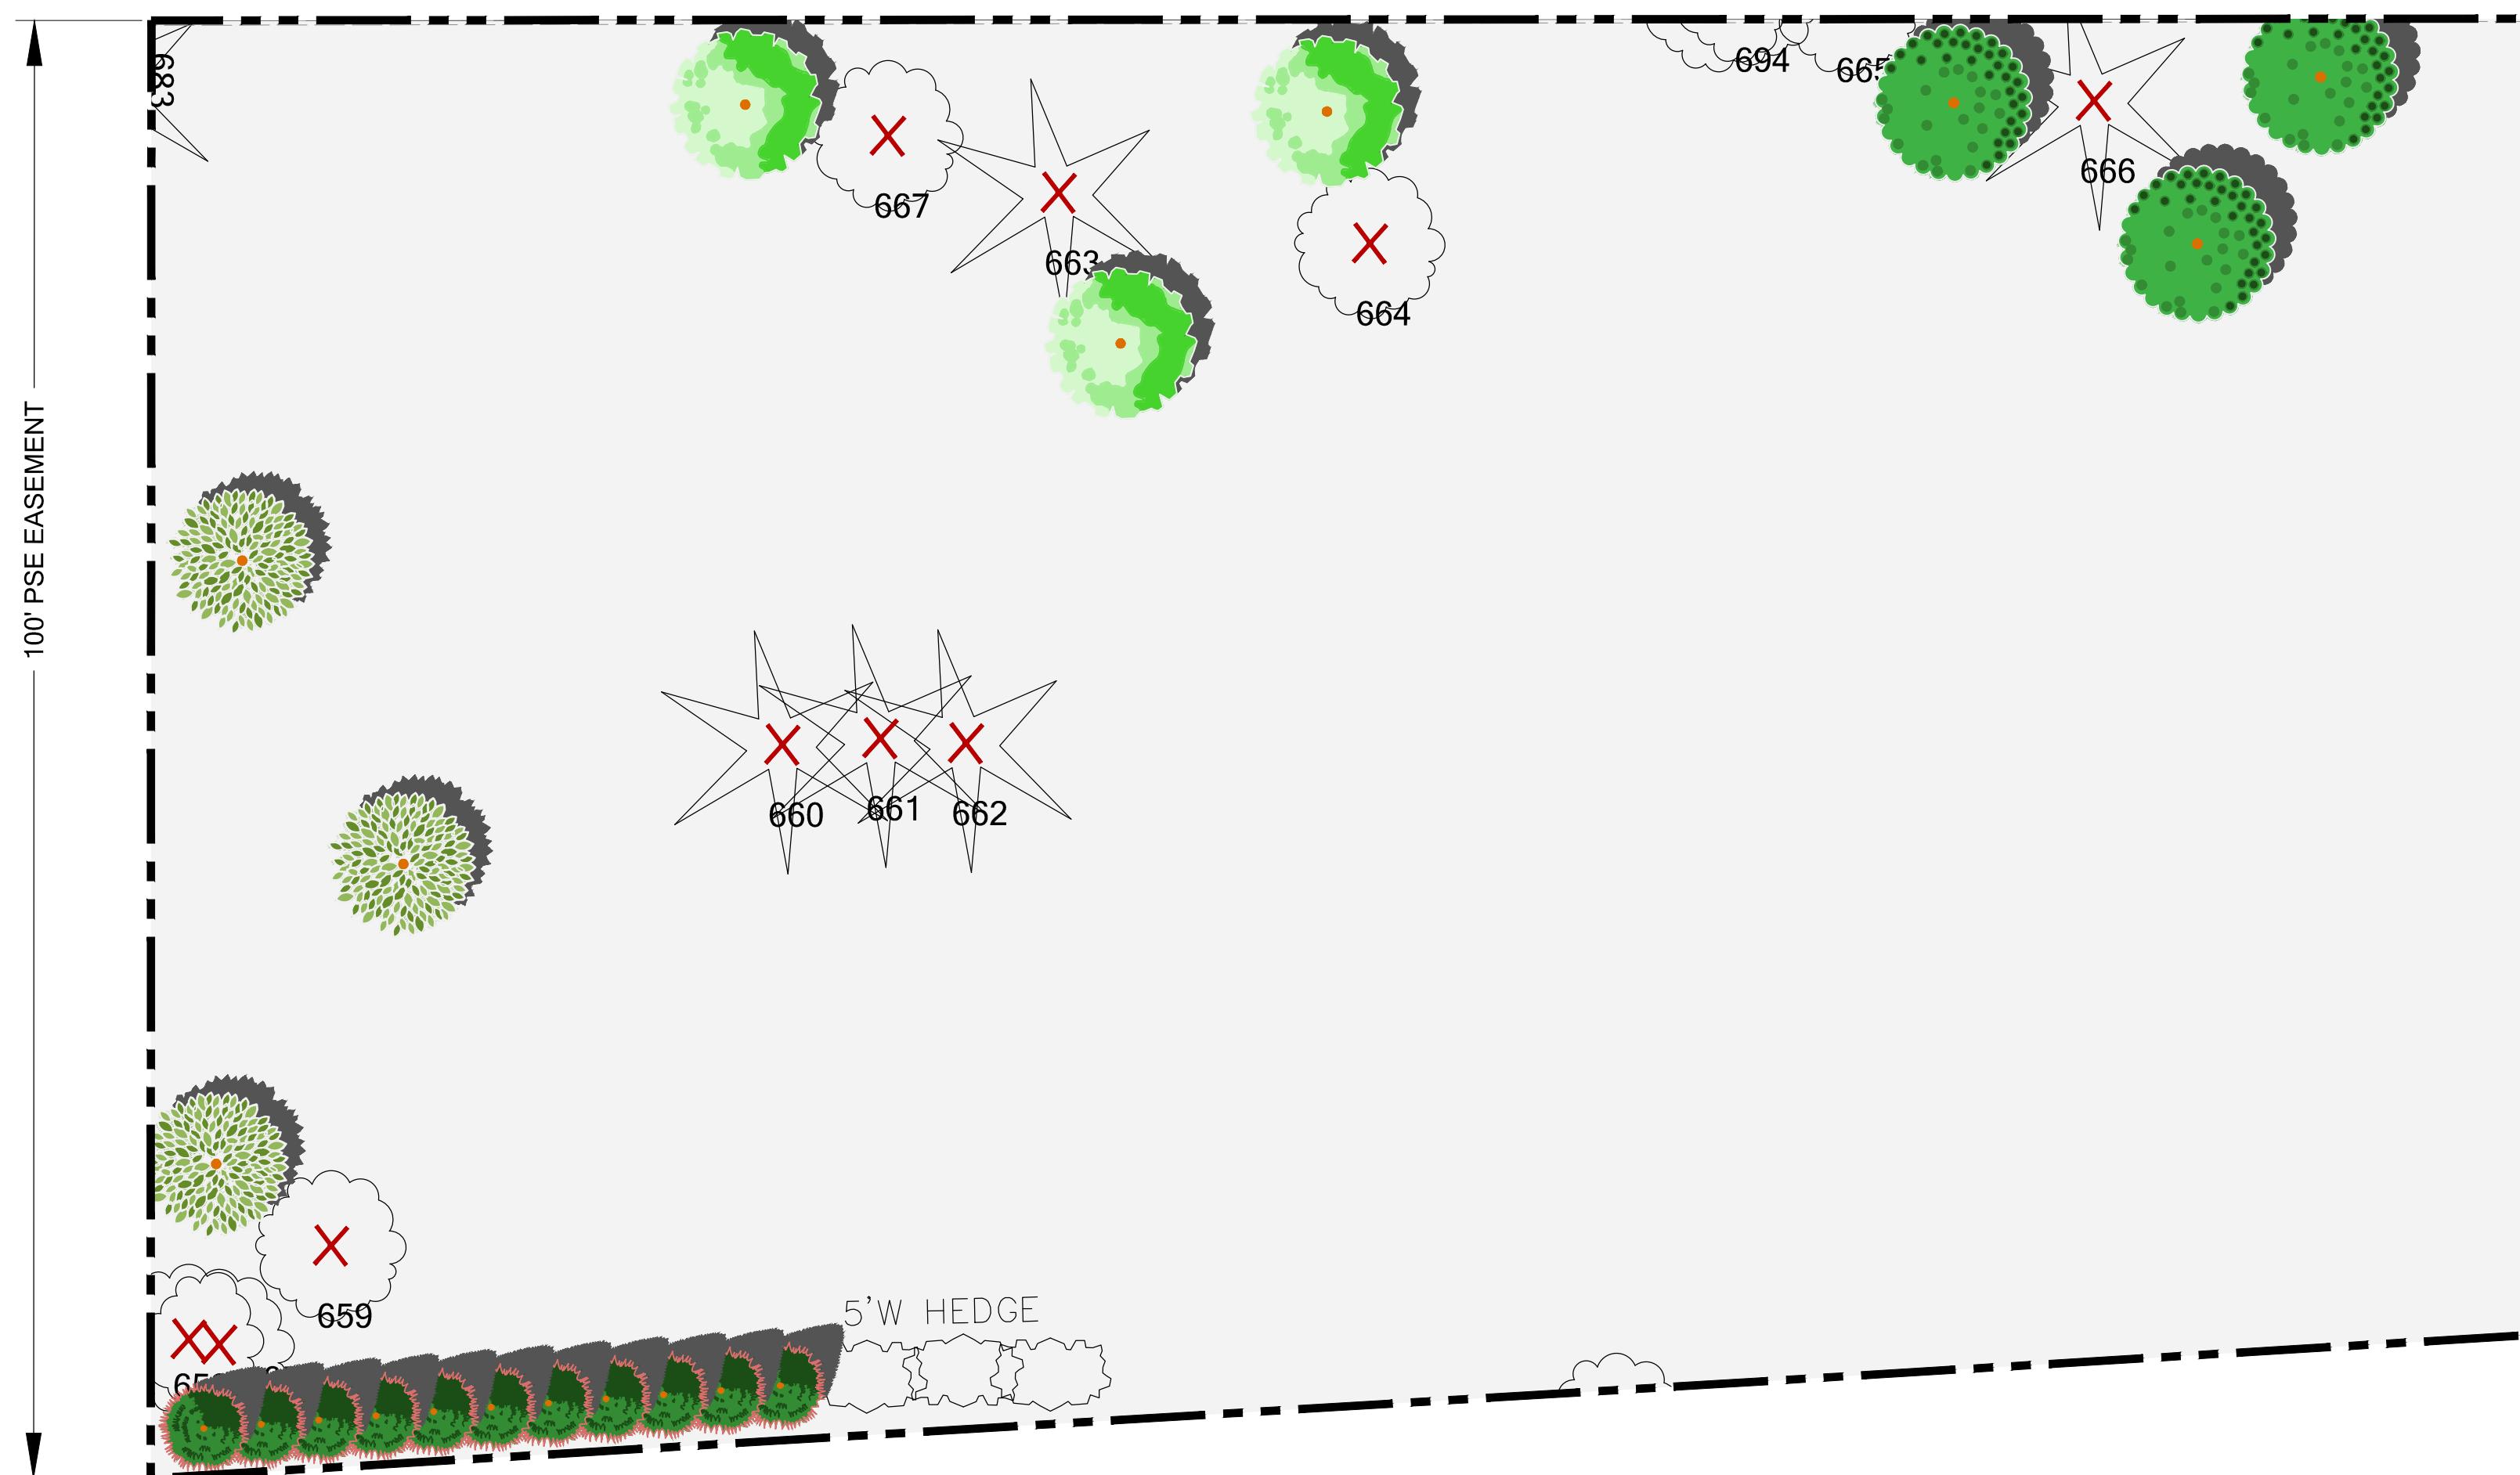
SHEET  
NUMBER:  
1 OF 1  
CONCEPTUAL\_PROPERTY\_OWNER.DWG

American arborvitae

Japanese snowbell Serviceberry

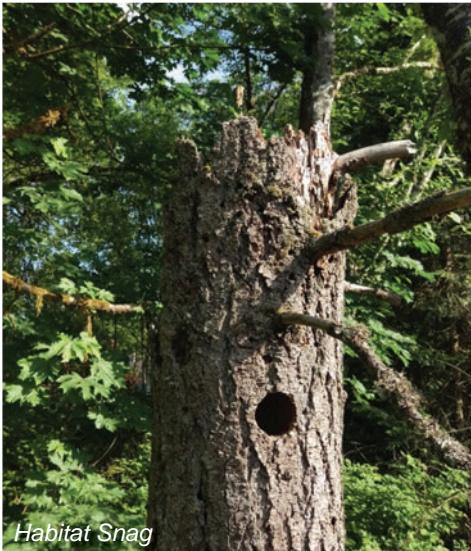
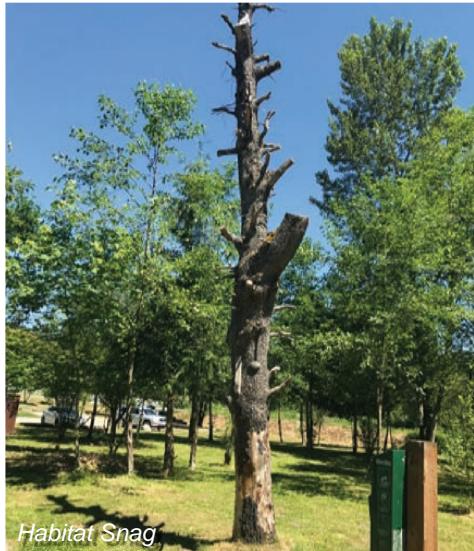
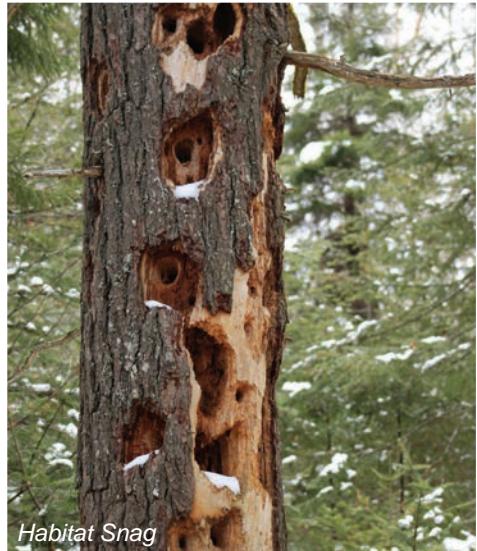
# Sample habitat snag features

A habitat snag is an alternative where the lower portion of the tree remains. The upper portion of the tree is removed and the tree is then 5 feet to 15 feet above the ground. The coronet cut (see below) at the top of the tree can then provide habitat for birds, amphibians, bees, bats and small mammals as it decomposes in place.

A coronet cut is a technique for producing a natural fracture effect in cut stub ends:

1. Cut at an angle to height as individually confirmed in the field by restoration consultant;
2. After slicing, cut down into the tree to create crevices at the top; and
3. Cut further by “bouncing” the chain saw on the top to create multiple incisions to encourage decay and colonization by insects and fungi.
