Factoria Blvd SE, Bellevue, King County, Washington

STEP Pedestrian Road Safety Assessment Report

July 12-13, 2021

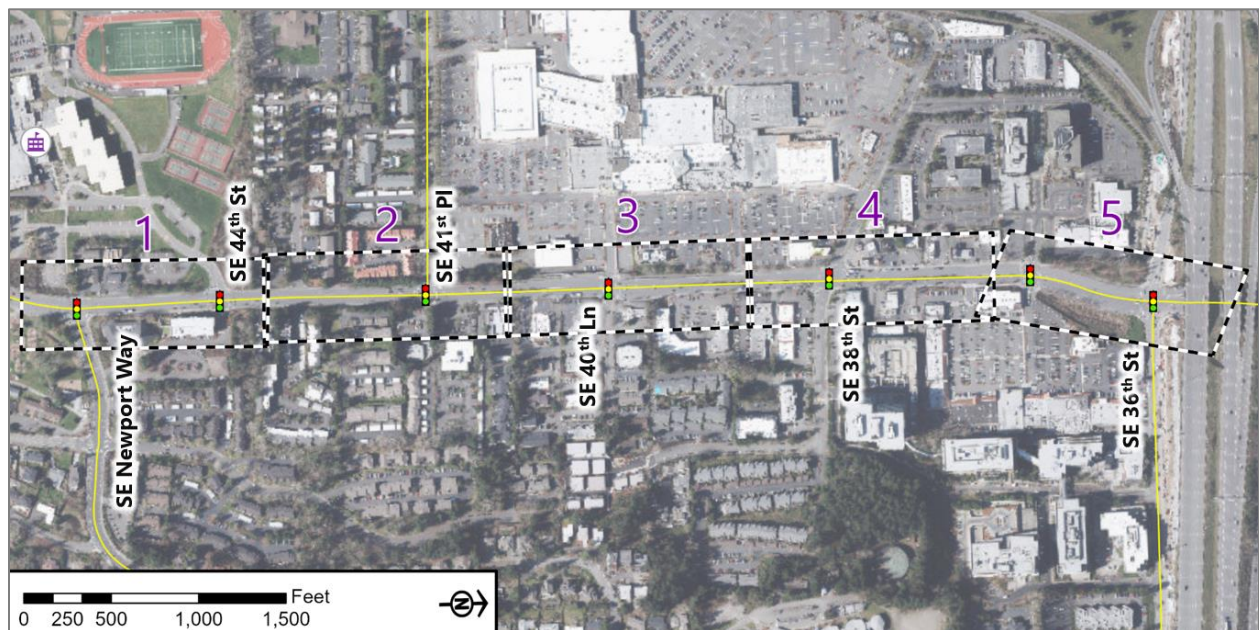
Figure 2 - Study Area Map Segments

The RSA reviewed the following five segments of Factoria Blvd SE (Figure 2). Each segment is approximately 1,000 ft long.

- Segment 1: SE Newport Way to south of SE 42nd St
- Segment 2: SE 42nd St to North of SE 41st Pl
- Segment 3: North of SE 41st Pl to SE 39th St
- Segment 4: SE 39th St to SE 3600 Block (Theater Entrance)
- Segment 5: SE 3600 Block (Theater Entrance) to SE 36th St

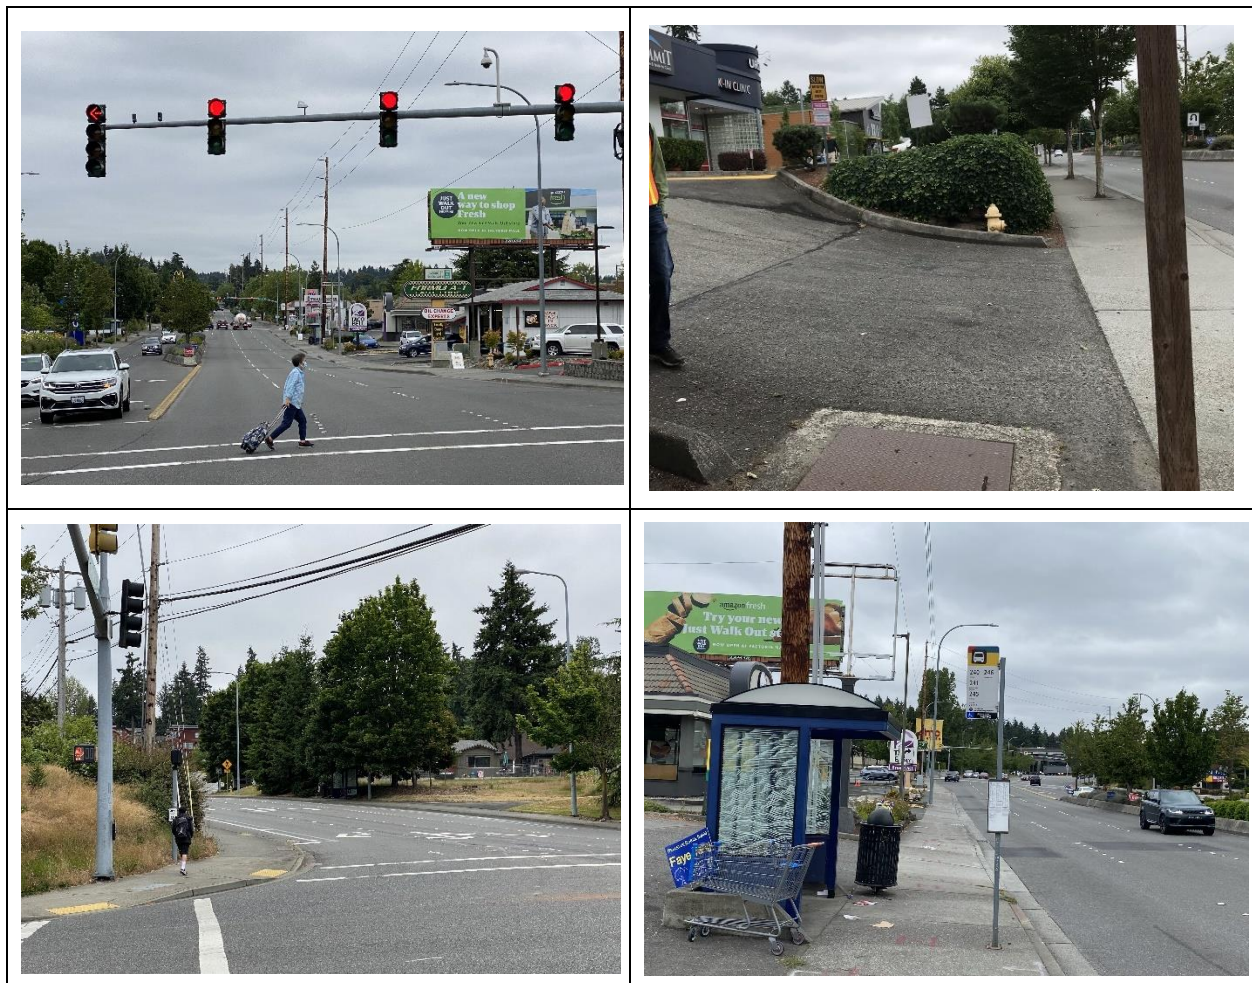
- *Access Management and Driveway Locations* – The corridor has many businesses with separate driveways, some of which are close to the signalized intersections. Driveways are often steeply angled and disrupt the level path for pedestrians along the sidewalk. Vegetation and retaining walls adjacent driveways also reduce the visibility of pedestrians and bicyclists along the sidewalk.
- *Transit Access* – The corridor has high levels of transit ridership, however numerous transit boarding and alighting areas are constrained by features like tree wells and driveways.

Figure 6 – **Upper Left:** Picture of Factoria Blvd, looking south at the 3700 Block, showing the median divided cross section at a signalized intersection. Credit: Complete Streets Bellevue. **Upper Right:** Picture of Factoria Blvd, looking south near SE 38th St, showing driveway access to the street and limited visibility of the sidewalk due to vegetation. Credit: City of Bellevue. **Lower Left:** Picture of Factoria Blvd at SE Newport Way, looking east, showing the intersection, wide curb radii, and crossing distance. Credit: City of Bellevue. **Lower Right:** Picture of Factoria Blvd, looking south near 3711 Factoria Blvd, showing a transit stop constrained by two driveways. Credit: City of Bellevue.

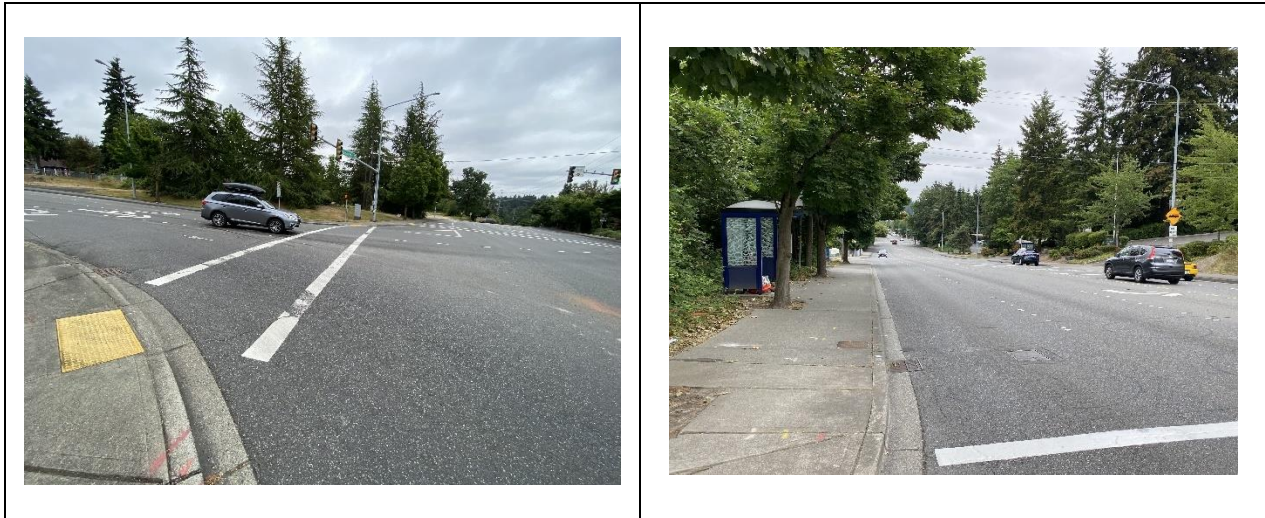
- Students have been observed crossing outside of the crosswalks.
 - The crossing time at SE Newport Way was reported short by RSA participants.
 - Sidewalks are present on both sides of the road.

- There is a steep slope next to the sidewalk between SE Newport Way and the high school driveway on the west side of the roadway.
 - The curb radii at SE Newport Way were observed to be large.

- Transit
 - The northbound bus stop close to SE Newport Way does not meet accessibility requirements (8 ft min depth). The southbound bus stop had reported poor lighting.

Figure 7 – **Left:** of SE Newport Way at Factoria Blvd, looking south, showing the wide crossing distance and standard transverse crosswalk markings. Credit: City of Bellevue. **Right:** Picture of Factoria Blvd, looking north on the west side of the street, showing the transit stop near the high school that was noted as frequently experiencing overflow of waiting riders. Credit: City of Bellevue.

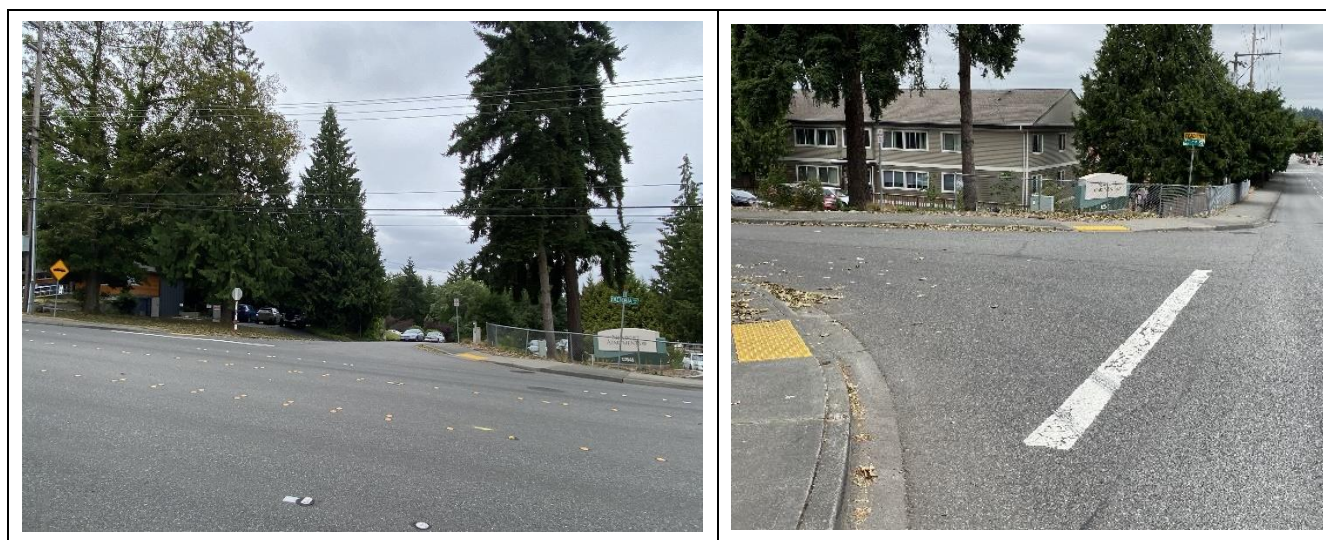
- Land Use
 - This segment contains multifamily housing on both sides of the roadway.
 - There is no landscape planter on the east side of roadway.
- Pedestrian Facilities and Behavior
 - The intersection at SE 42nd is missing crosswalk marking and the stop bar was ahead of the curb ramps.
 - High volume of high school students was reported crossing SE 41st on the west side of Factoria Blvd.
 - RSA participant discussion focused on a potential midblock crossing between SE 44th St and SE 41st Ln as the northbound bus stop was ~200 ft from a marked crossing.
- Vegetation
 - Overgrown vegetation and limbs were hanging down on east side just south of 41st Pl.
- Lighting
 - No lighting was observed on west side of road, and the sidewalk was fairly dark north of SE 42nd St.

*Figure 8 – **Left:** Picture of Factoria Blvd, looking west towards SE 42nd St, showing a potential location for an uncontrolled marked crossing. Credit: City of Bellevue. **Right:** Picture Factoria Blvd at SE 42nd, showing the placement of the stop bar in front of the curb ramps and no marked crosswalk. Credit: City of Bellevue.*

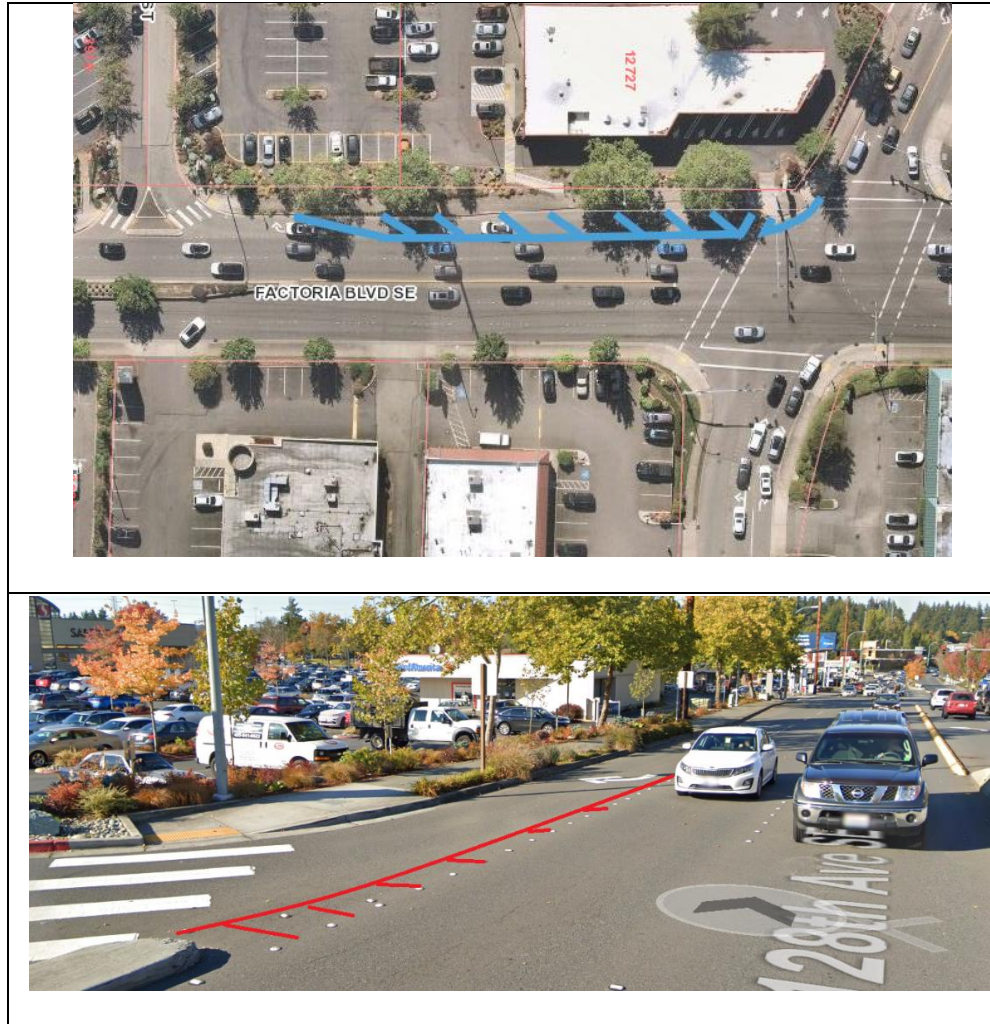
Figure 10 – **Top:** Concept sketch of dropped southbound right turn lane south of SE 38th St. Credit: City of Bellevue. **Bottom:** Concept sketch of updated turn lane channelization markings. Credit: City of Bellevue.

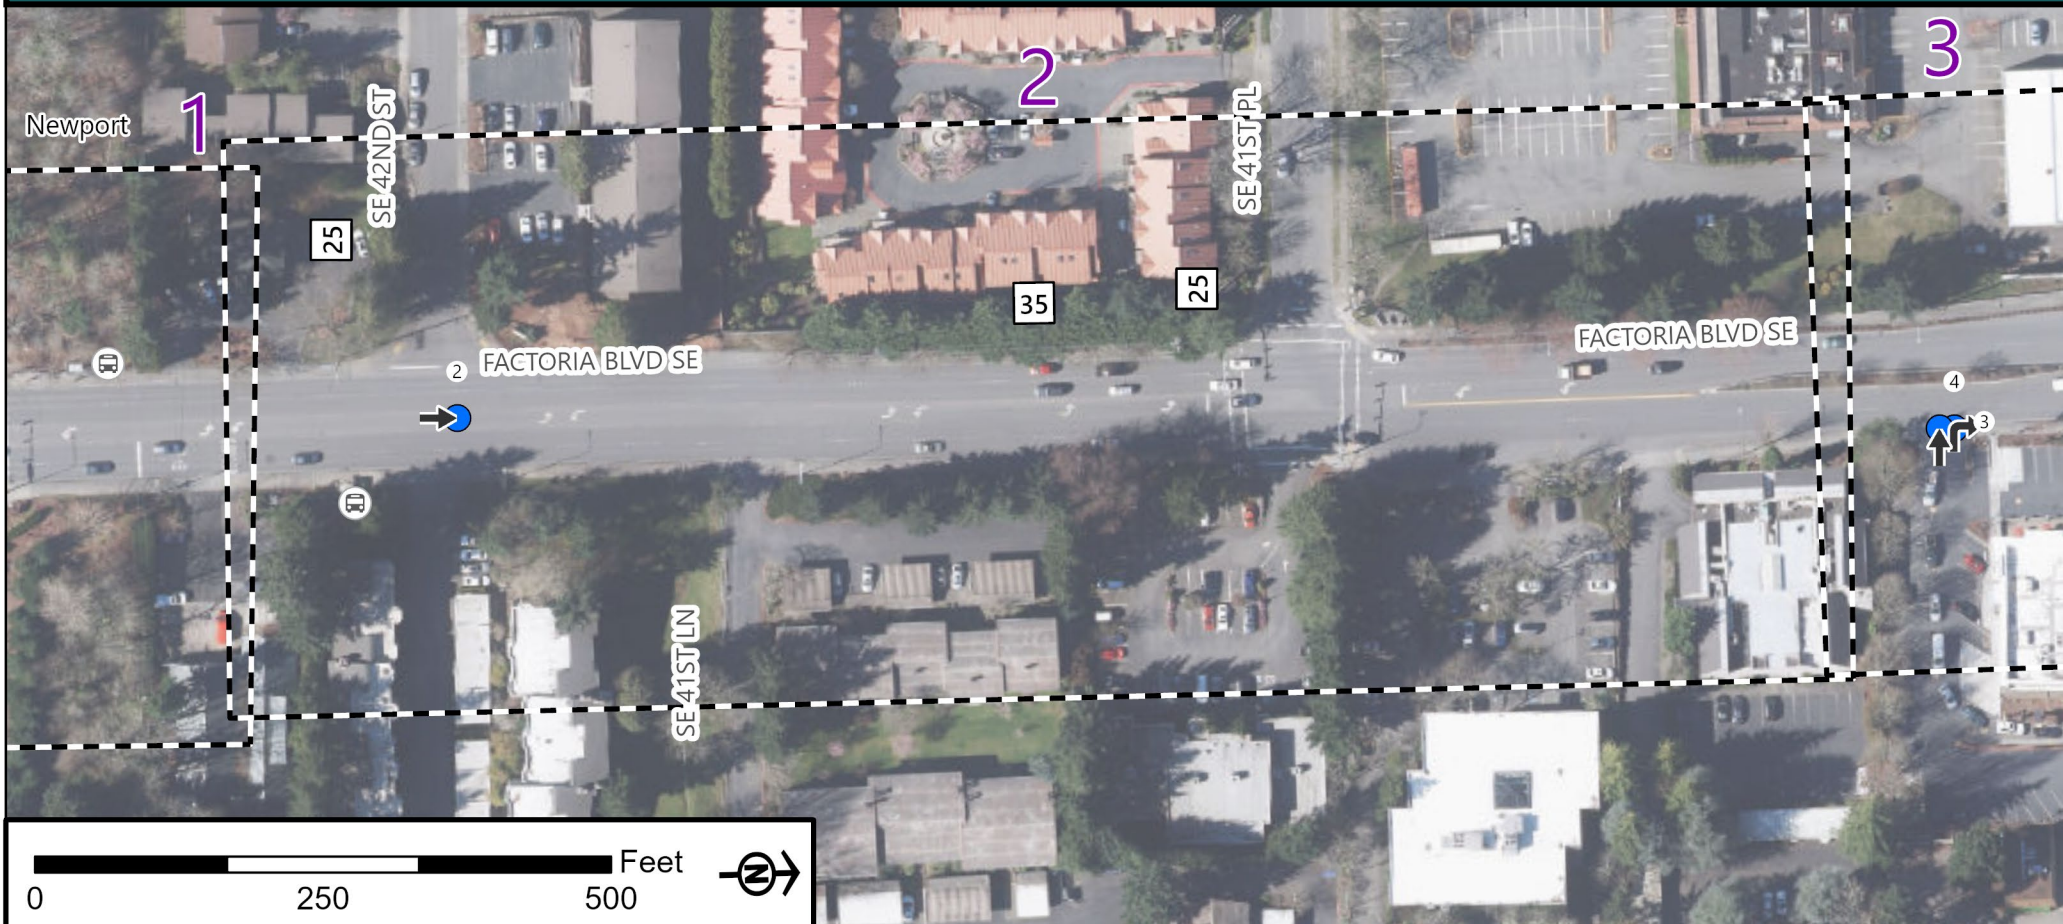
Segment 2 – SE 42nd ST to North of SE 41st PL

Injury Severity (2016-2020)

- Fatal
- Suspected Serious Injury
- Suspected Minor Injury
- Possible Injury
- No Apparent Injury

There was one reported pedestrian crash within Segment 2 (Table 3). The crash was a possible injury crash and occurred during daylight. The crash occurred at the minor road stop-controlled SE 42nd St intersection and involved a vehicle going straight. The contributing circumstance was listed as the pedestrian failing to

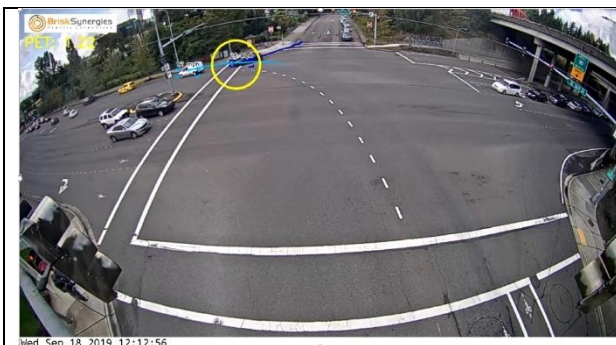
An Eastbound right-turning vehicle turning into a farther lane and crossing the conflict 1.22 seconds after the Westbound left turning vehicle

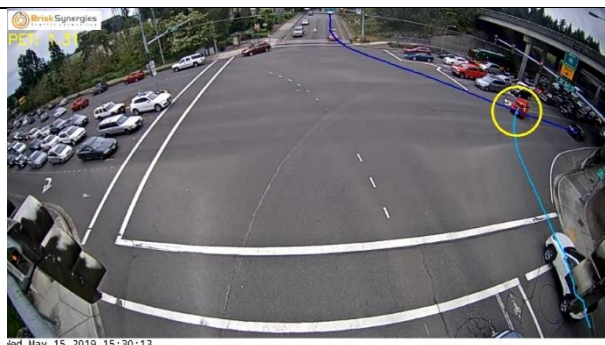
A Westbound right-turning vehicle turning 2 lanes away and crossing the conflict 1.31 seconds after the Westbound left-turning vehicle turning into a farther lane

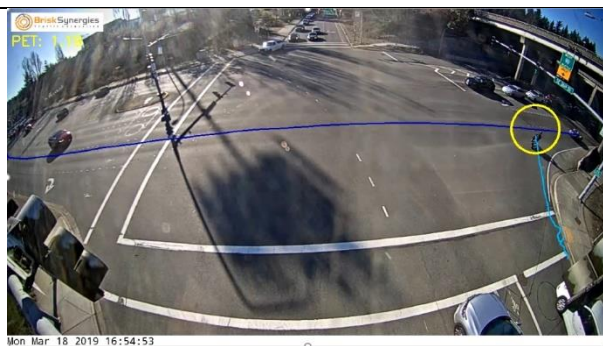
A Westbound right-turning motorcyclist turned a lane farther away and crossed the conflict about 1.19 seconds after the Northbound through vehicle.

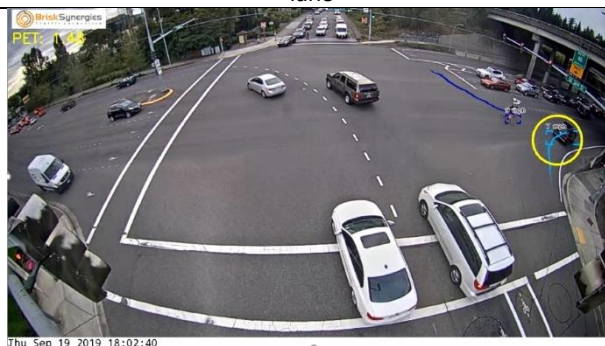
An Eastbound left-turning cyclist turned 2 lanes away and crossed the conflict about 1.48 seconds after the Westbound right-tuning vehicle.

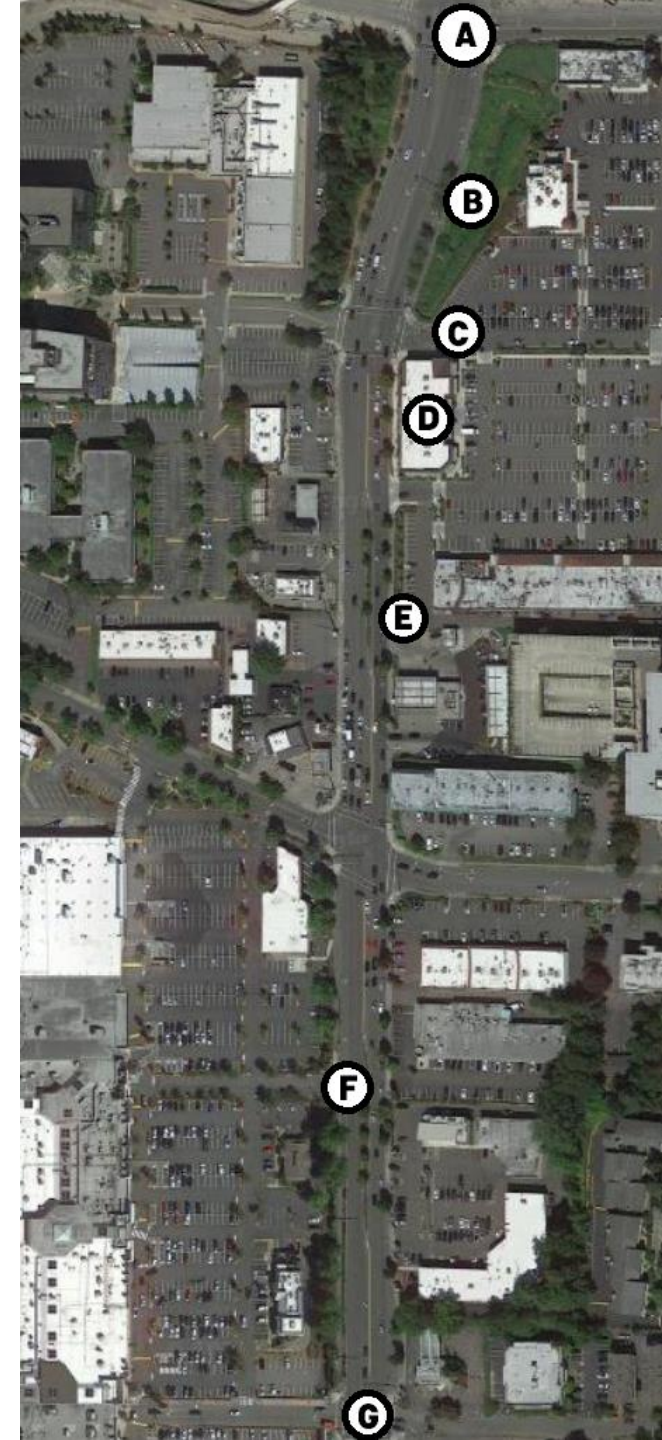
Day 1 - SE 36th St to SE 40th Ln

F: Scuffed up road markings imply dangerous area for pedestrians.

G: Crossing N/S is easy, but E/W requires a long wait. Hostile architecture.

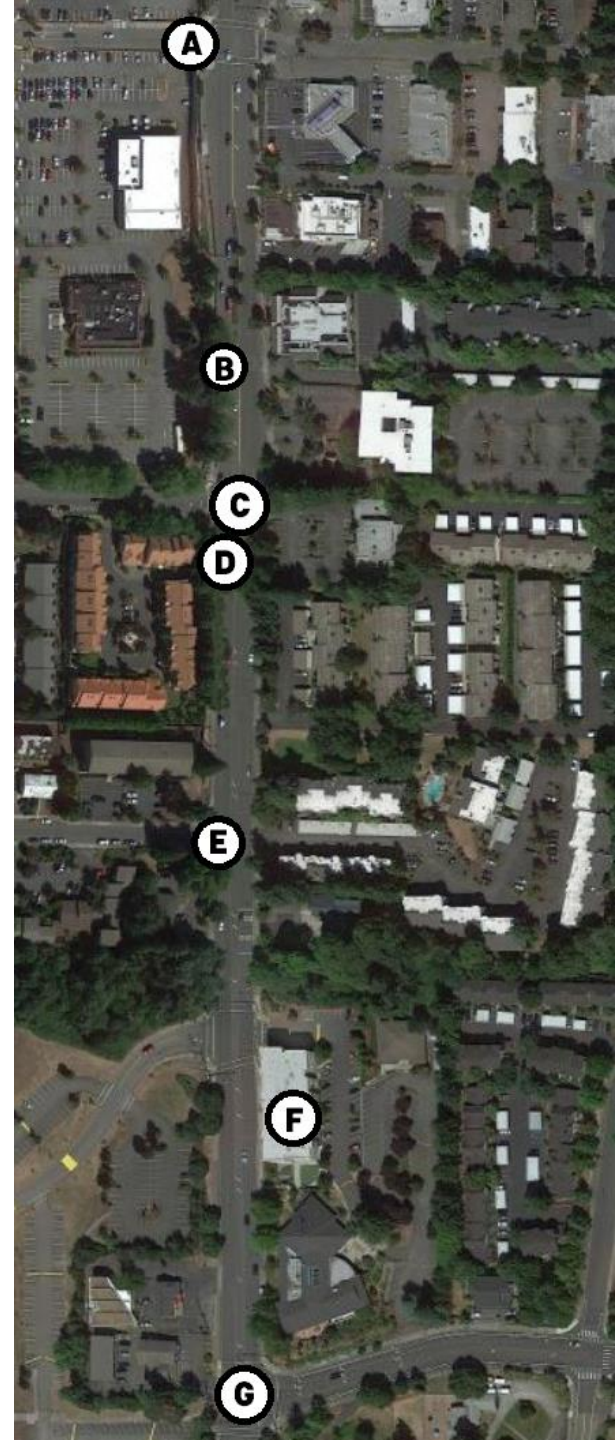
Day 2 - SE 40th Ln to Newport Way

F: Another example of patchwork sidewalk design that comes with redevelopment.

G: Newport Way crosswalk particularly terrible.
