**OPTIONAL DETERMINATION OF NON-SIGNIFICANCE (DNS) NOTICE MATERIALS**

File No. 22-118213-LO

Project Name/Address: COBU Cedar Terrace Pump Station Rehabilitation Project  
3205 115th Avenue NE, 11000 NE 33rd Place, and the King County  
Eastrail

# Critical Areas Study

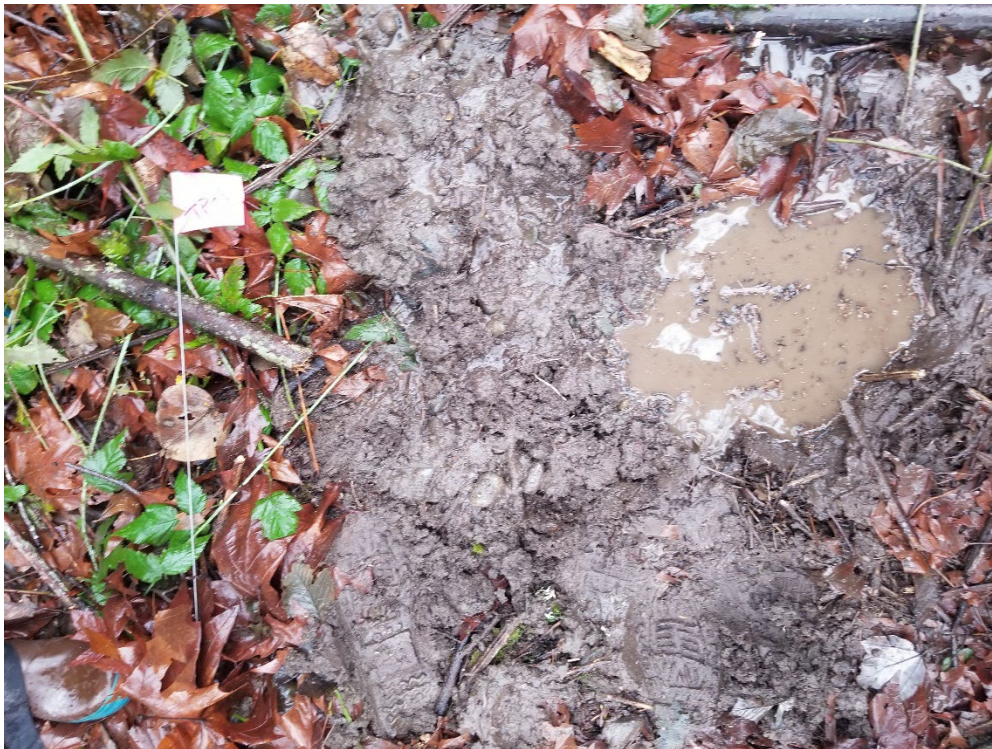
Test Plot 1 (TP-1) was in the northwestern portion of parcel 2025059160 in a relatively undisturbed depression at the base of the Eastrail multi-use corridor in an area with obvious surface water. The vegetation at TP-1 met the wetland vegetation criterion, although it can be described as marginal. The soils did not meet any hydric soil indicator; therefore, the hydric soil criterion was not met. Three primary wetland hydrology indicators were observed: Surface Water (A1), High Water Table (A2), and Saturation (A3); therefore, the wetland hydrology criterion was met. However, as explained above, it is likely that the recent snowmelt and heavy rain in the week preceding the site visit were the cause of the wetland hydrology indicators and that, based on the lack of hydric soils and marginal vegetation, these were not true wetland hydrology indicators. Since TP-1 did not meet all three criteria, the area represented by TP-1 is not a wetland.

**Photo 4—View of soils and hydrology at Test Plot (TP)-1.**

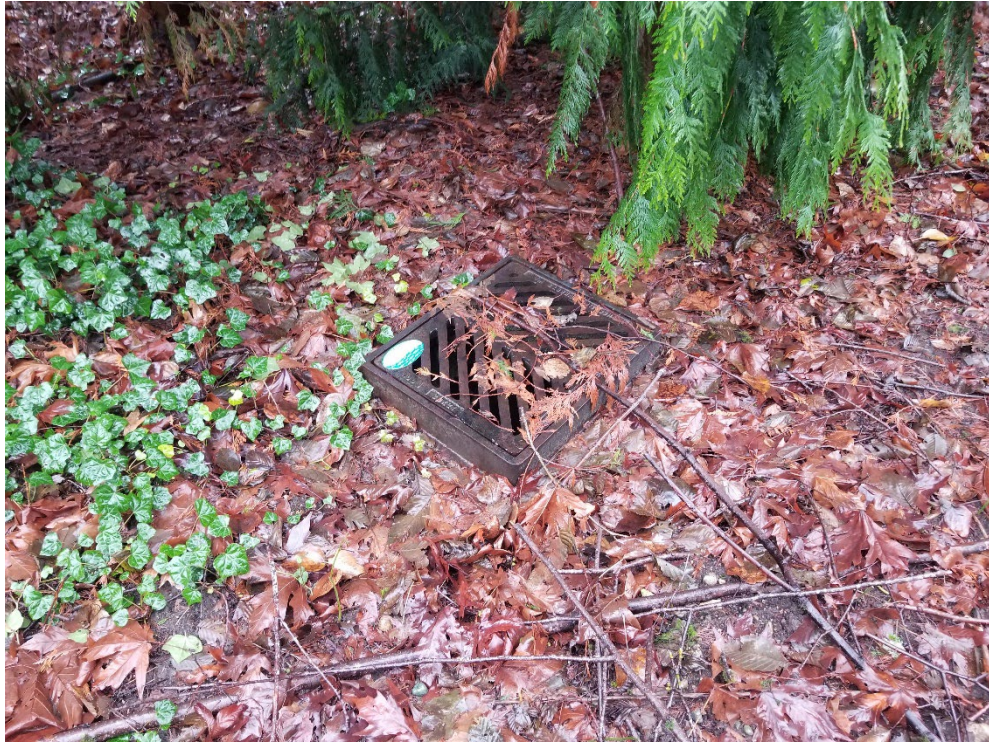
No open water channels were observed on the Project site parcels within 300 feet of the Project site. The unnamed tributary to Yarrow Creek is culverted through the Project site, and quickly flowing water was observed at catch basin inlets throughout parcels 2025059160 and 2025059102. An approximate alignment of the culverted tributary is shown in Figure 3. This tributary's flow is briefly exposed at the eastern edge of parcel 2025059102 where the culvert comes out from the Eastrail multi-use corridor berm and directs the tributary water into a detached standpipe (see Photos 27 and 28 in Appendix C). From this point, the tributary flows in an uninterrupted culvert to the southwestern edge of parcel 2025059102 along NE 33<sup>rd</sup> Place where it is daylighted into an open channel along the roadside.

**Photo 9—Catch basin inlet to the culvert that conveys the unnamed tributary near TP-1.**

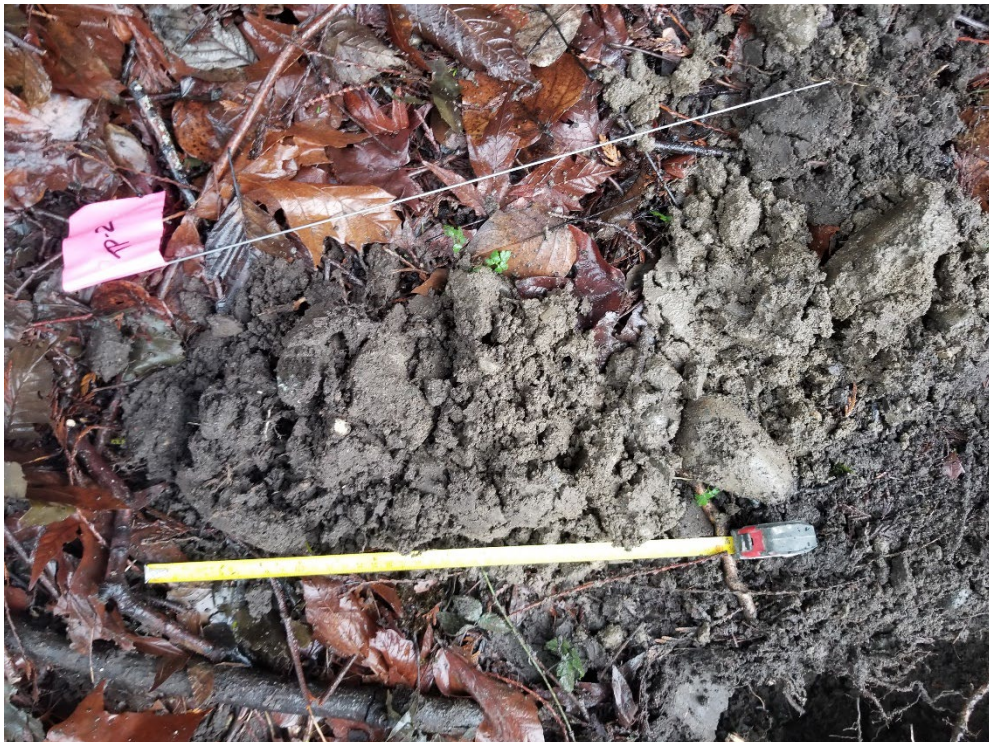
TP-2 was in the northwestern portion of parcel 2025059160 to the north of TP-1. Vegetation within TP-2 met the Dominance Test; therefore, the vegetation at TP-2 met the wetland vegetation criterion. The soils did not meet any hydric soil indicator; therefore, the hydric soil criterion was not met. Two primary wetland hydrology indicators were observed: High Water Table (A2) and Saturation (A3); therefore, the wetland hydrology criterion was met. Note that the soil was saturated to the surface, but the water table was only at 12-inches below the surface. As explained above, it is likely that the recent snowmelt and heavy rain in the week preceding the site visit were the cause of the wetland hydrology indicators and that, based on the lack of hydric soils, these were not true wetland hydrology indicators. Since TP-2 did not meet all three criteria, the area represented by TP-2 is not a wetland.

**Photo 10—Soil profile at TP-2.**

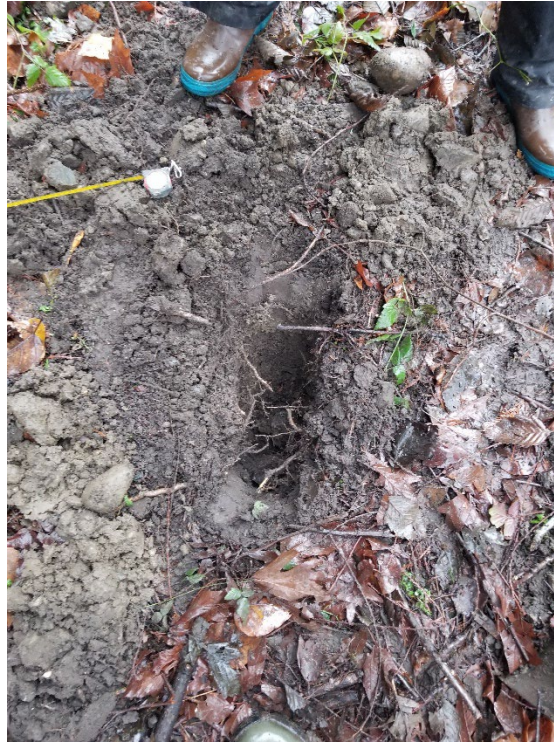
**Photo 15—Hydrology at TP-2.**

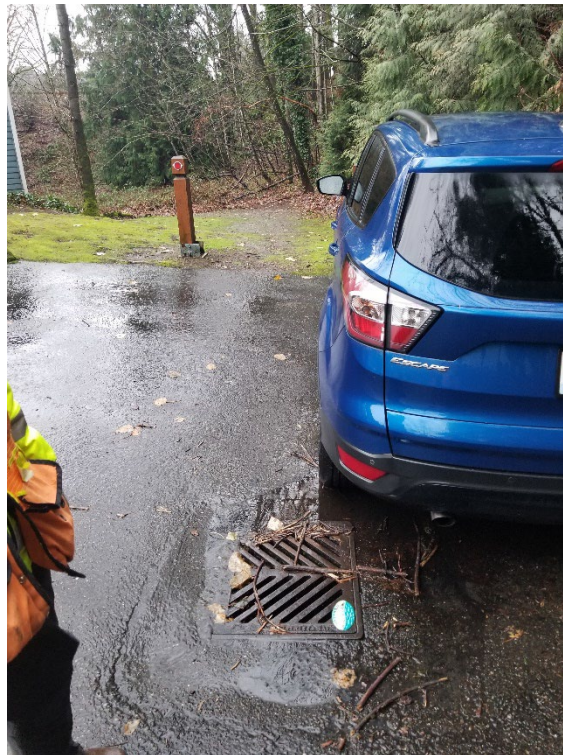
**Photo 16—Second catch basin inlet to the culvert that conveys the unnamed tributary, east of TP-1 and TP-2.**

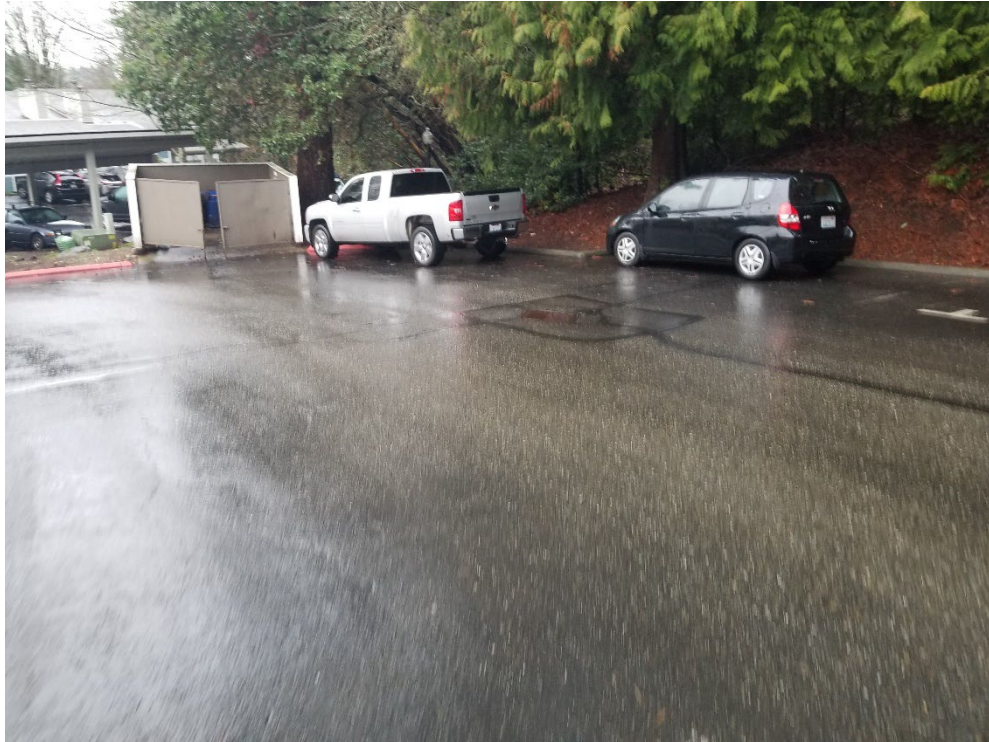
**Photo 17—Third catch basin inlet to the culvert that conveys the unnamed tributary.**

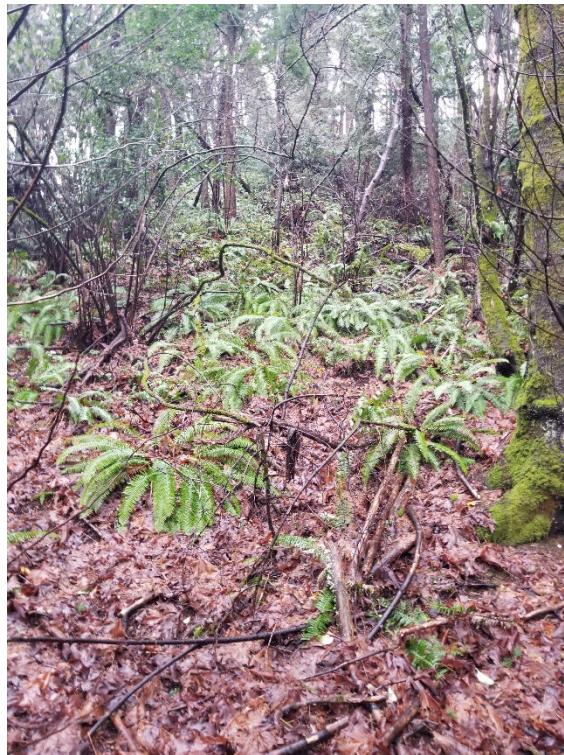
Steep slopes are the only geologic hazard areas identified in the Project site (Shannon & Wilson 2022). Steep slopes are defined as those areas with a slope of 40% or greater with a rise of at least 10 feet and that exceed 1,000 square feet in area (LUC 20.25H.120(A)(2)). The Project site parcels, and the surrounding areas, are significantly encumbered by steep slope critical areas (Bellevue 2022). The aspect of the slope on parcel 2025059160 is generally west-facing and comprises the undeveloped, vegetated areas of this parcel and the steep edges of the created stormwater (or detention) pond near the northwestern portion of the parcel. On all other Project parcels, steep slope areas are primarily associated with the Eastrail multi-use corridor, which is an elevated trail constructed of a relic railway with steep slopes along either edge. For additional information

**Photo 18—Steeply sloped area to north of the Cedar Terrace property.**

The geologic hazard area on the Project site—steep slopes along the east and west edges of the Eastrail multi-use corridor and along the detention pond—will not be impacted by the proposed Project. The Project proposes to use HDD to drill under the Eastrail multi-use corridor steep slopes without impacting the slope surface. This avoidance of the steep slopes will allow for the retention of vegetation on the slope and the stability of the slope feature. As required by LUC 20.25H.140(B), slope stability will be maintained during the open cut-and-cover portion of the work within the steep slope buffer using shoring methods. There is also a small area of fill along the open cut-and-cover area due to the low elevation of the ground surface in this area. The Project proposes to fill around the pipeline and increase the grade of the access road, which Bellevue has stated is an allowed use in a steep slope buffer (Folsom, pers. comm., 2022).

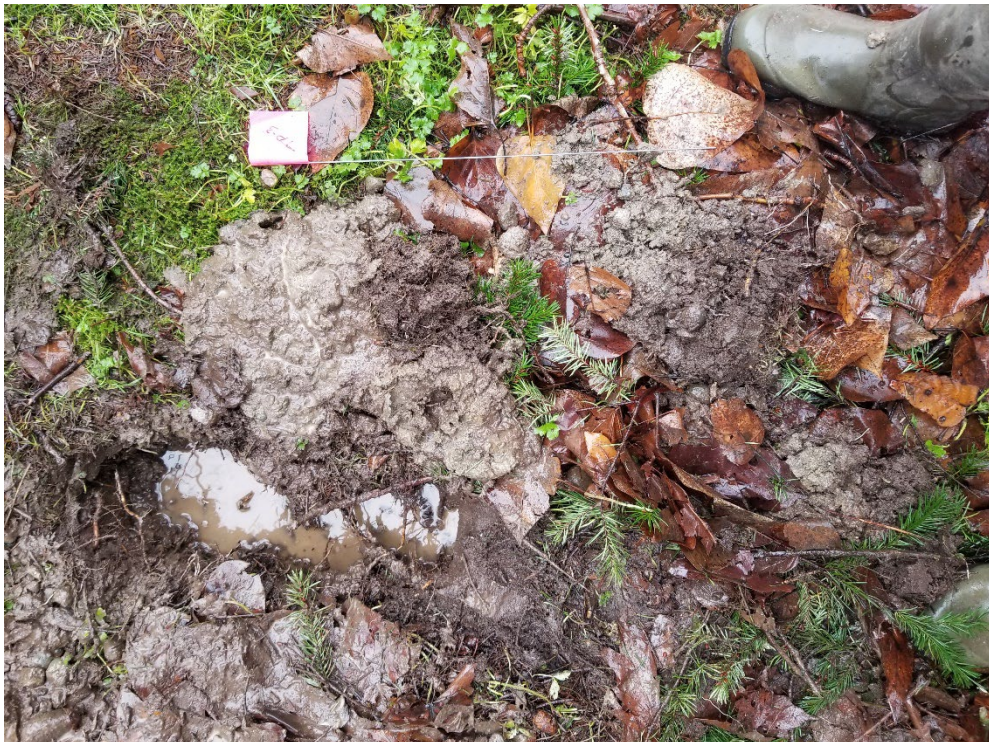
TP-3 was in the northwestern portion of parcel 2025059160 to the south of TP-1 and TP-2. Vegetation within TP-3 met the Dominance Test; therefore, the vegetation at TP-3 met the wetland vegetation criterion. The soils did not meet any hydric soil indicator; therefore, the hydric soil criterion was not met. Two primary wetland hydrology indicators were observed: High Water Table (A2) and Saturation (A3); therefore, the wetland hydrology criterion was met. As explained above, it is likely that the recent snowmelt and heavy rain in the week preceding the site visit were the cause of the wetland hydrology indicators and that, based on the lack of hydric soils, these were not true wetland hydrology indicators. Since TP-3 did not meet all 3 criteria, the area represented by TP-3 is not a wetland.

**Photo 20—Soils at TP-3.**

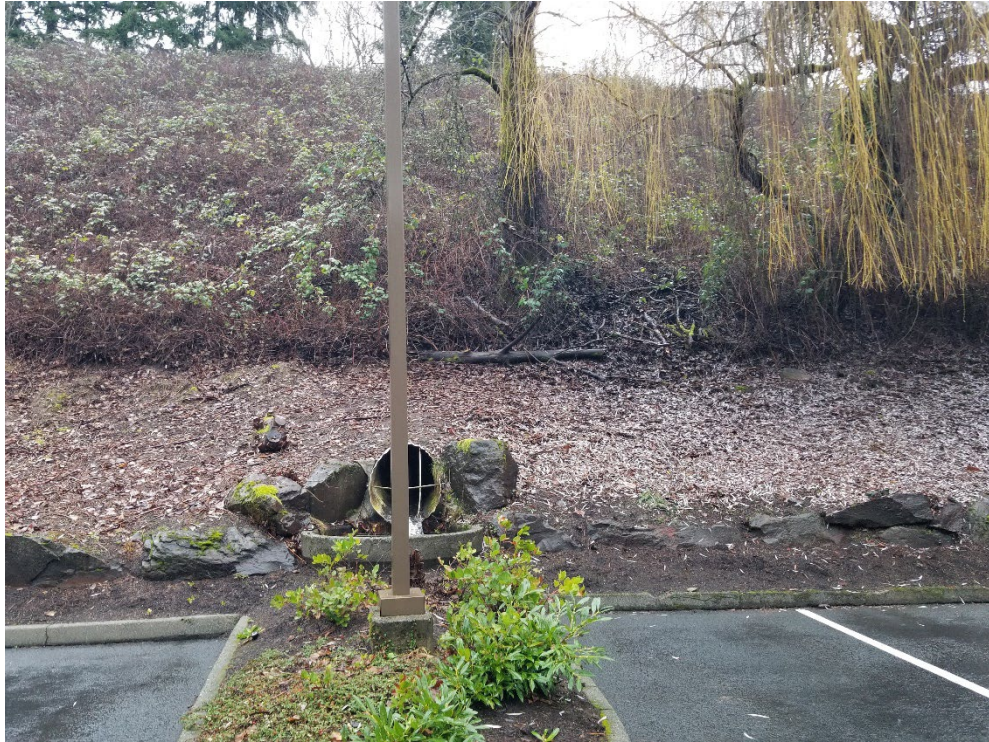
Although a portion of the unnamed tributary is identified by Bellevue as a Type F stream on parcel 2025059102 (Bellevue 2017), fish use on this parcel is unlikely because the tributary is entirely culverted through the parcel and there are fish barriers in the system. The culvert was surveyed by WDFW on February 24, 2022 (site ID 922607) and was identified as a fish barrier with no identified use by anadromous salmonids (WDFW 2022). As noted during the desktop analysis, no SalmonScape or PHS species are mapped as occurring within the tributary (WDFW 2021a, b).

**Photo 27—Unnamed tributary culvert outlet and stand pipe inlet on the SW Bel-Kirk LLC (parcel 2025059102).**

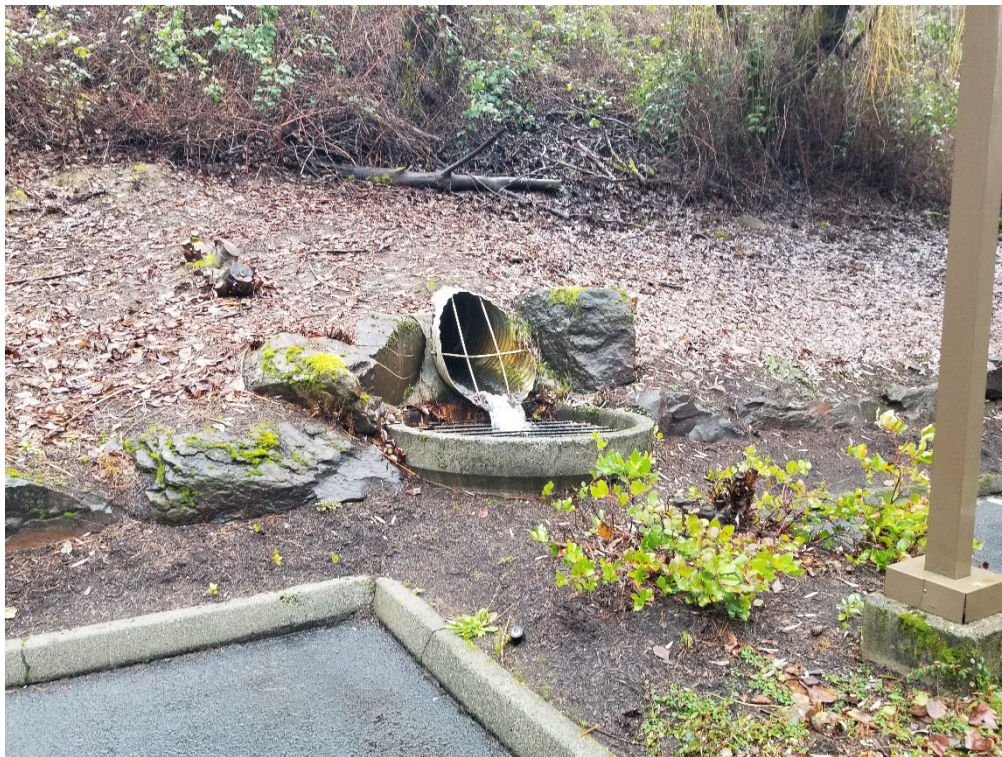
**Photo 28—View of the flowing unnamed tributary at the culvert outlet/standpipe inlet.**

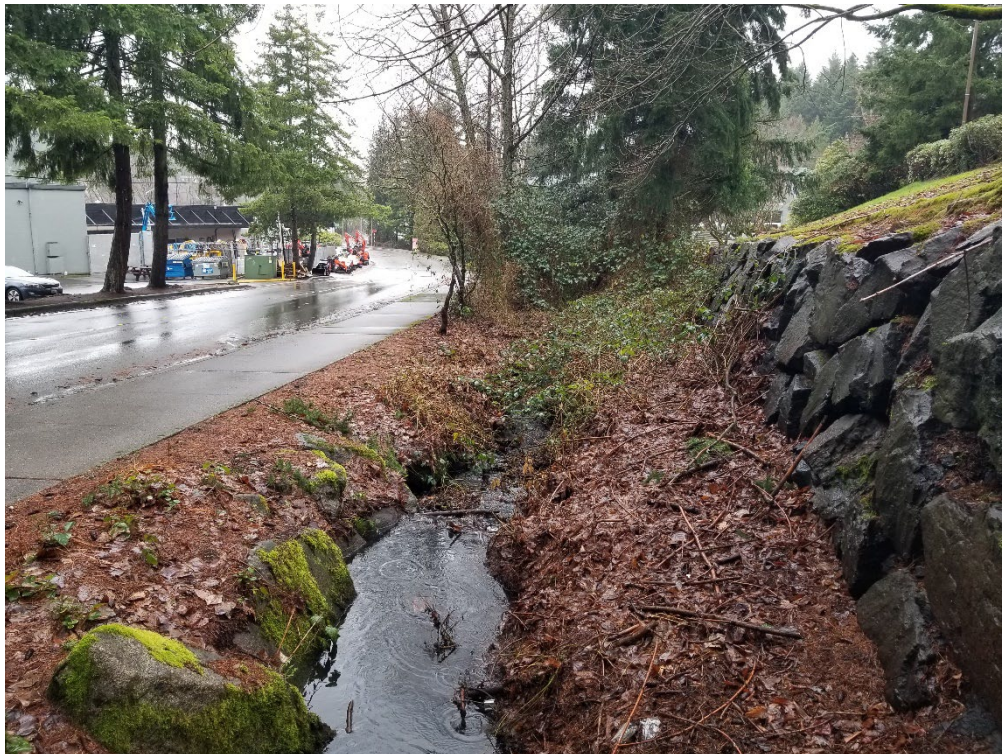
**Photo 30—Unnamed tributary outlet and open channel along NE 33<sup>rd</sup> Place, looking northwest.**

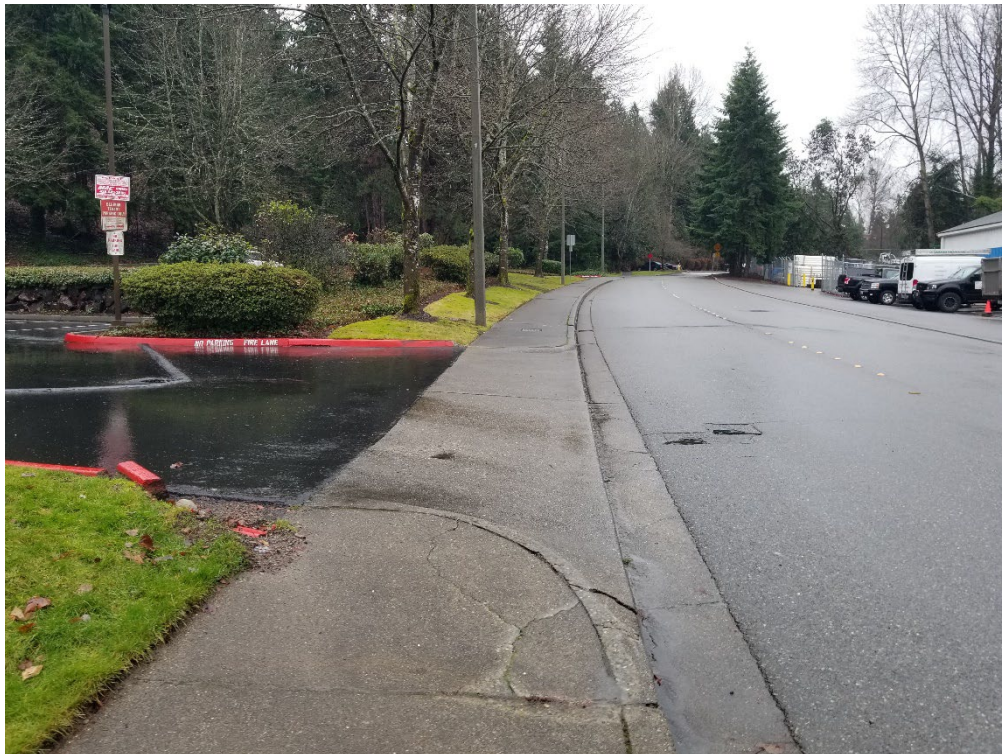
**Photo 32—NE 33<sup>rd</sup> Place at the driveway access to the Evergreen Office Park (parcel 2025059101), looking southeast. Unnamed tributary is culverted under the driveway.**

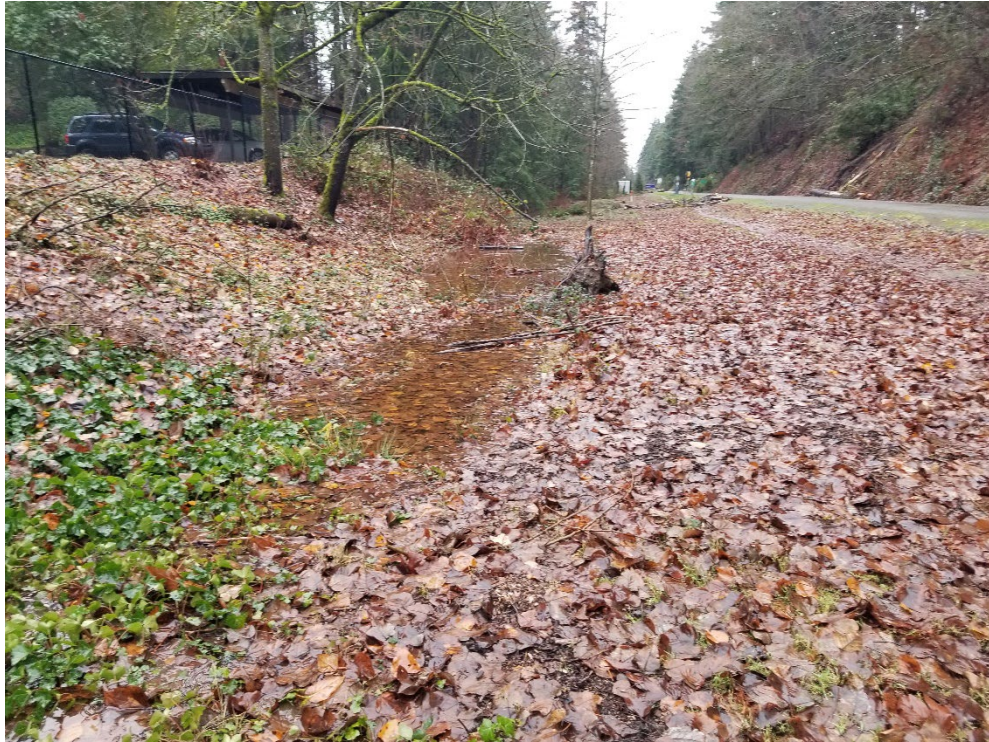
The area surrounding the Project site, including the public Eastrail multi-use corridor, was assessed for wetland indicators. Some visual wetland indicators were observed to the southwest of the trail near 108<sup>th</sup> Ave NE. No test plots were evaluated in this area. The estimated edges of this feature were mapped during the site visit, and the feature is well over 300 feet from the Project site at the closest point, as shown in Figure 3. Because the Project is far enough away to have no impact on this feature or its possible buffer, no further investigation is needed. No other off-site wetlands or wetland indicators were identified during the site investigation.

**Photo 37—Potential wetlands along the Eastrail Multi-Use Corridor trail to the north of the Project site.**
