Greater Kelsey Creek Watershed Assessment Report
prepared in support of the City of Bellevue Watershed Management Plan

Revision 3 (Final)
November 13, 2021

Bellevue Utilities Department

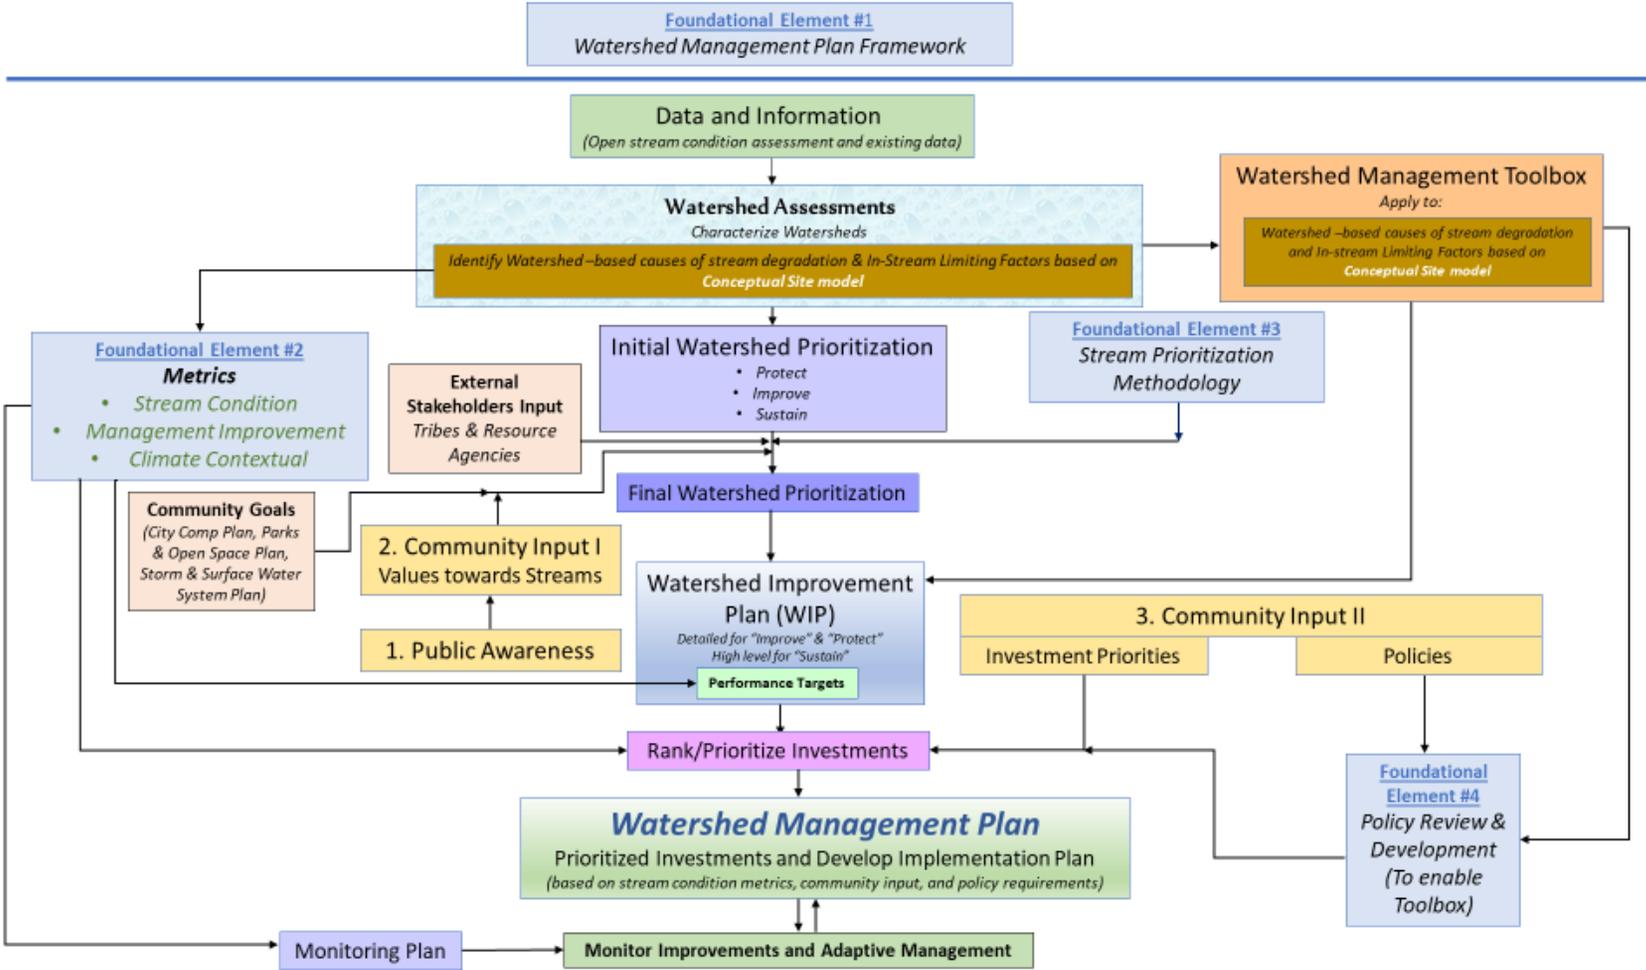
Figure 1. Watershed Management Plan Development Process.

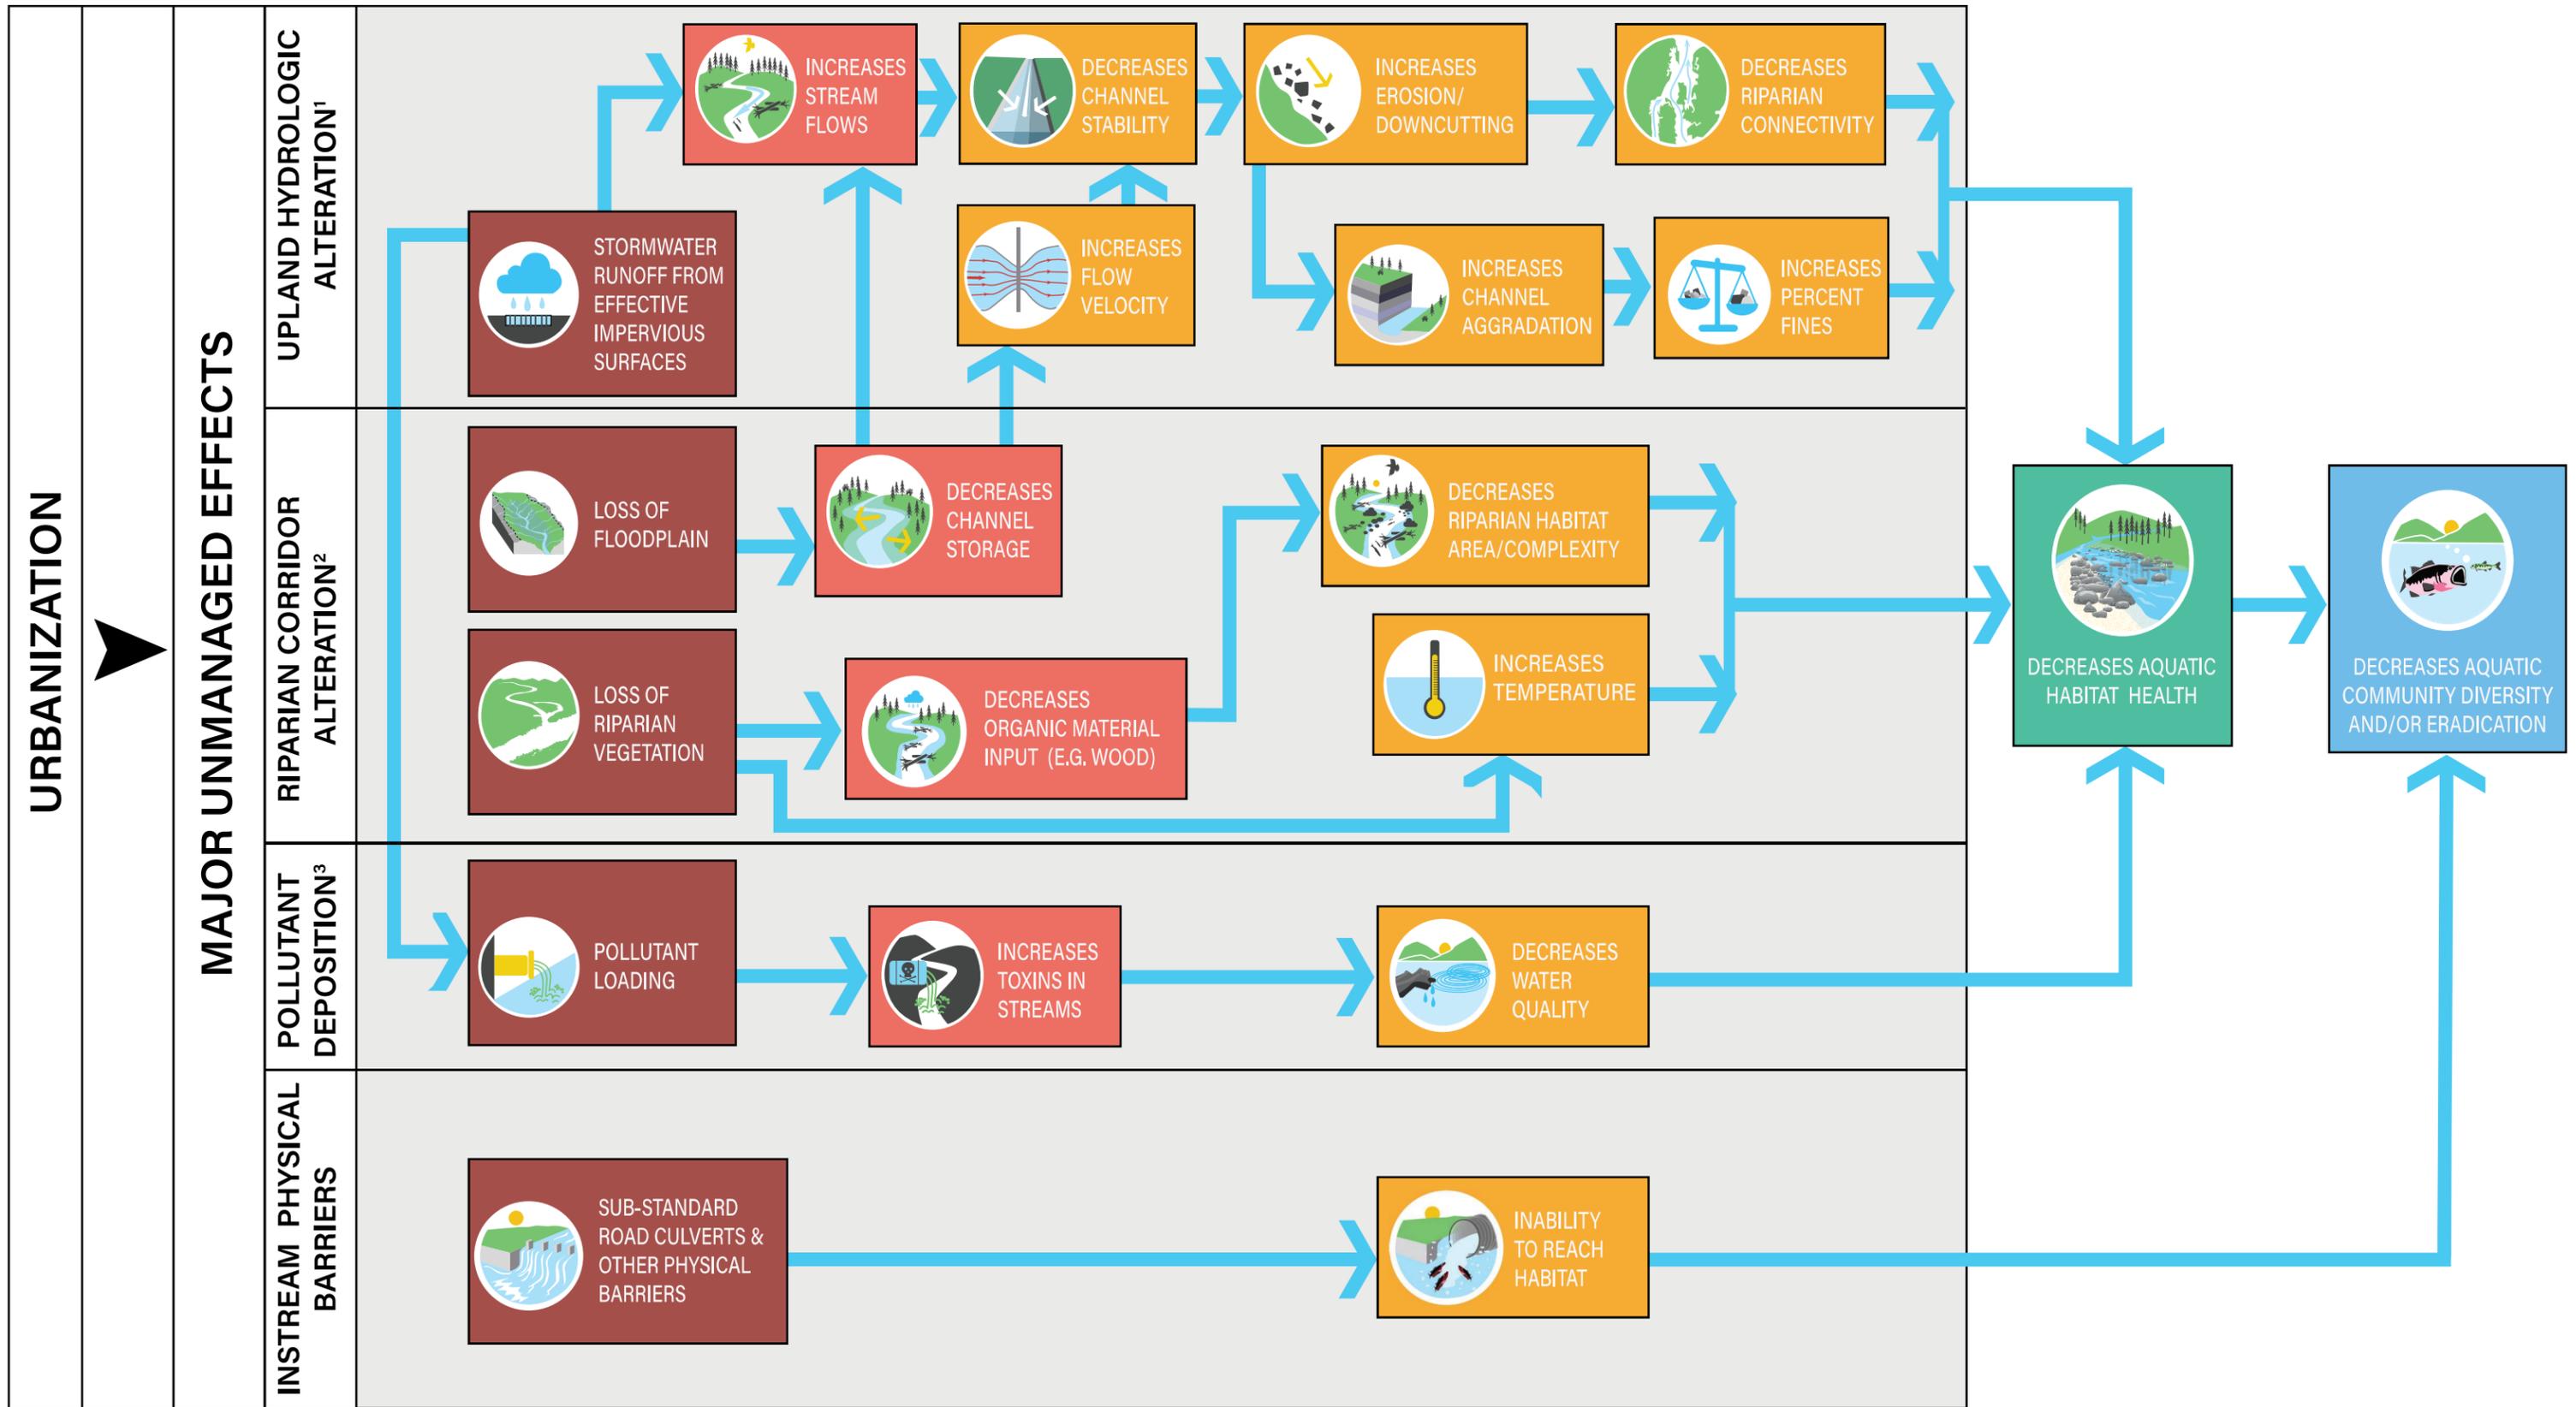
CONCEPTUAL MODEL OF THE IMPACTS OF URBANIZATION ON STREAM HEALTH

1 = Conversion of upland forest/ other vegetated areas to: Impervious areas (roads, roofs, sidewalks, driveways, parking lots, sport courts) that drain to streams
 2 = Removal of vegetation, paving, and armoring of riparian corridor
 3 = Vehicle deposits on roads and other impervious surfaces (petroleum products, antifreeze, brake and tire residue, etc.)
 - Releases from septic tanks/drain fields regulated by King County Public Health
 - Releases categorized as "Illicit Discharges" (illegal dumping, misuse of herbicides/ pesticides/ other chemicals, accidental spills, etc.) regulated by COB Phase II NPDES program

All the work performed to develop these components of the WMP will be informed by a conceptual model (Figure 2) that was created by the City to describe the primary effects of urbanization on stream health. This model shows the linkages between specific sources of stress on stream health (e.g., stormwater runoff) and the consequences, impacts, and outcomes that collectively contribute to degraded stream health. This model will be particularly important for identifying the specific limiting factors that are responsible for impaired stream health during preparation of the ARs and the appropriate solutions for improving conditions during preparation of the WIPs.

As shown in the conceptual model (Figure 2), precipitation falling on impervious surfaces causes stormwater runoff. This alteration of the natural hydrology is associated with erosive peak flows and pollutant transport. These stressors degrade both aquatic habitat and water quality.

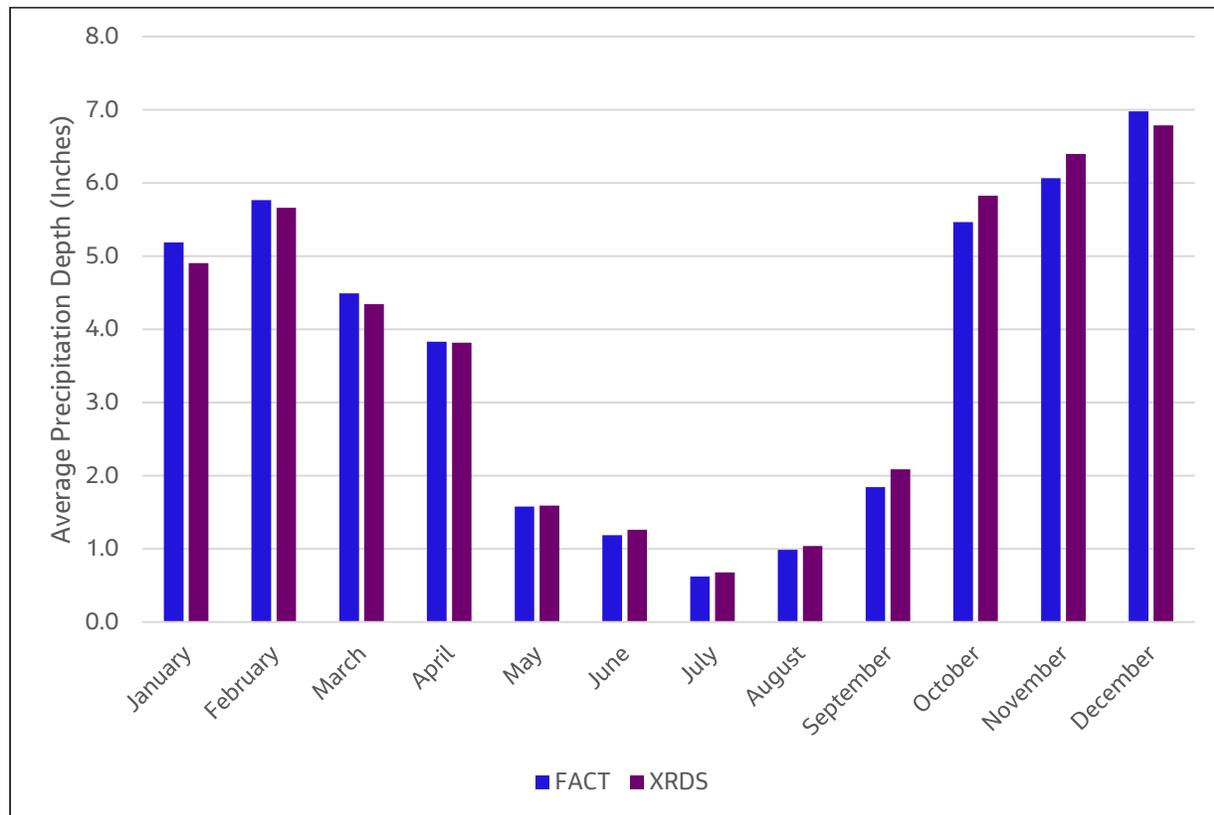
Figure 9. Precipitation Depth by Month in the Greater Kelsey Creek Watershed

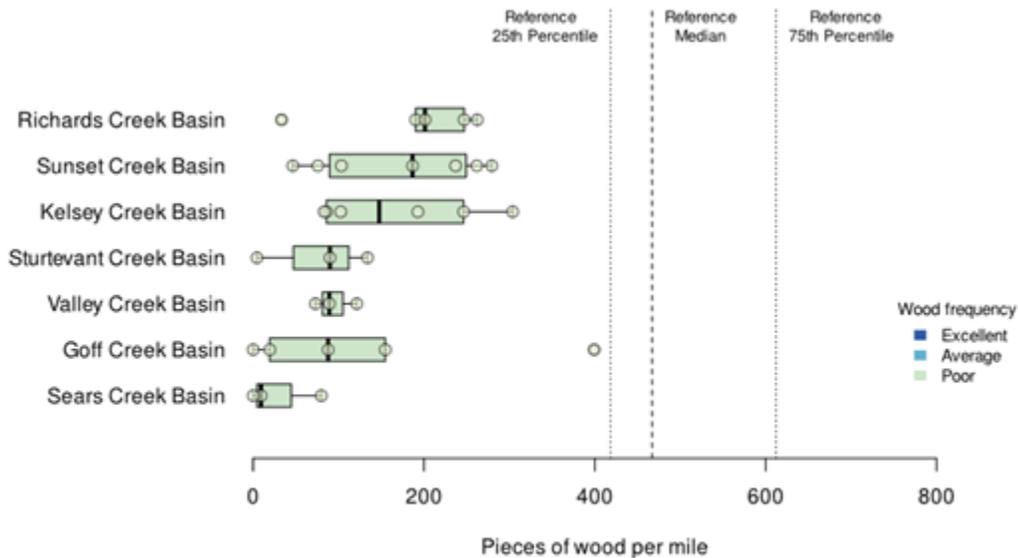
Figure 41. Large Woody Material Frequency in Greater Kelsey Creek Subbasins compared to reference levels (Fox and Bolton 2007)

Figure 41 shows the frequency of large woody material in the Greater Kelsey Creek Watershed subbasins as compared to reference levels.

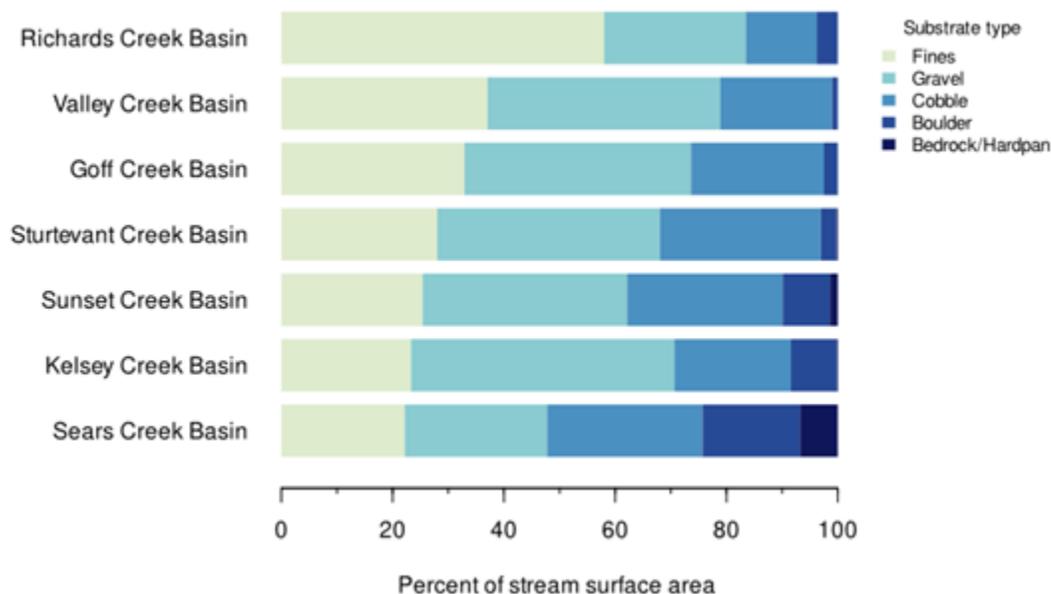
Figure 42. Substrate Composition of Riffle Habitat in the Subbasins of the Greater Kelsey Creek Watershed

Figure 42 shows the substrate composition of riffle habitat for the different Greater Kelsey Creek subbasins, determined by visual observation.

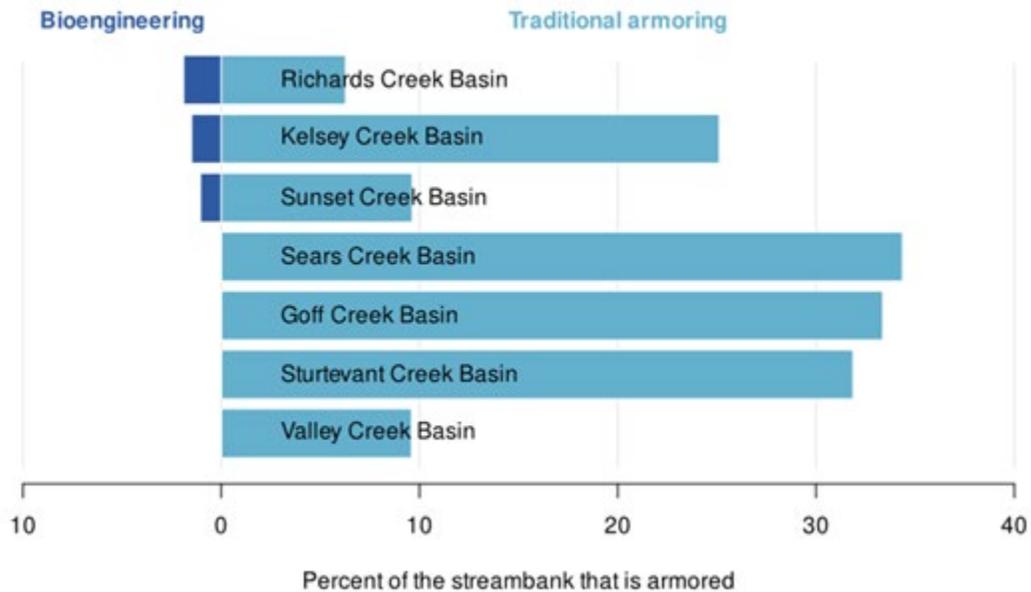
Figure 43. Diverging Bar Chart Showing the Proportion of Armored Streambank Using Traditional Materials (right) and Bioengineering (left) for the streams in the Greater Kelsey Creek Watershed

Figure 43 shows the proportion of armored streambank for the streams in the Greater Kelsey Creek Watershed. Figure 44 shows the percent of each stream within the Greater Kelsey Creek Watershed that is experiencing erosion.

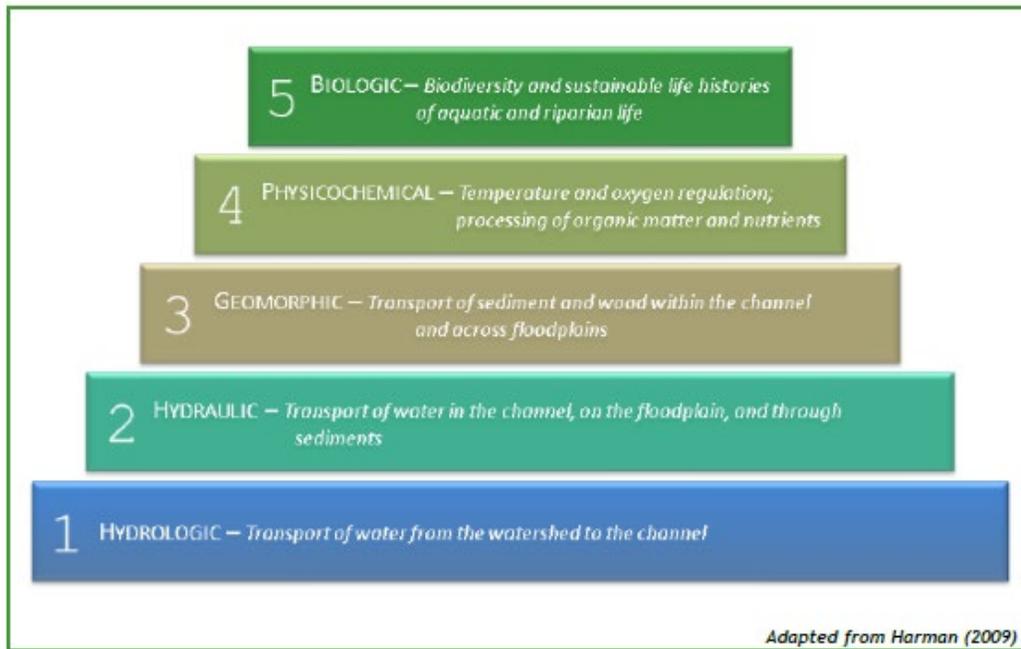
Figure 51. Stream Functions Pyramid.

Figure 51 presents a Stream Functions Pyramid model prepared by Harman (2009) which, along with the hierarchical model of stream functions, suggests improved stream health (located at the top of the pyramid) is most effectively attained by first addressing stressors at the lower levels of the pyramid. The intention of the pyramid is to show the dominant cause and effect relationships. In general, biodiversity is dependent on habitat structure and quality, which are dictated by the lower levels of the pyramid beginning with hydrologic conditions.

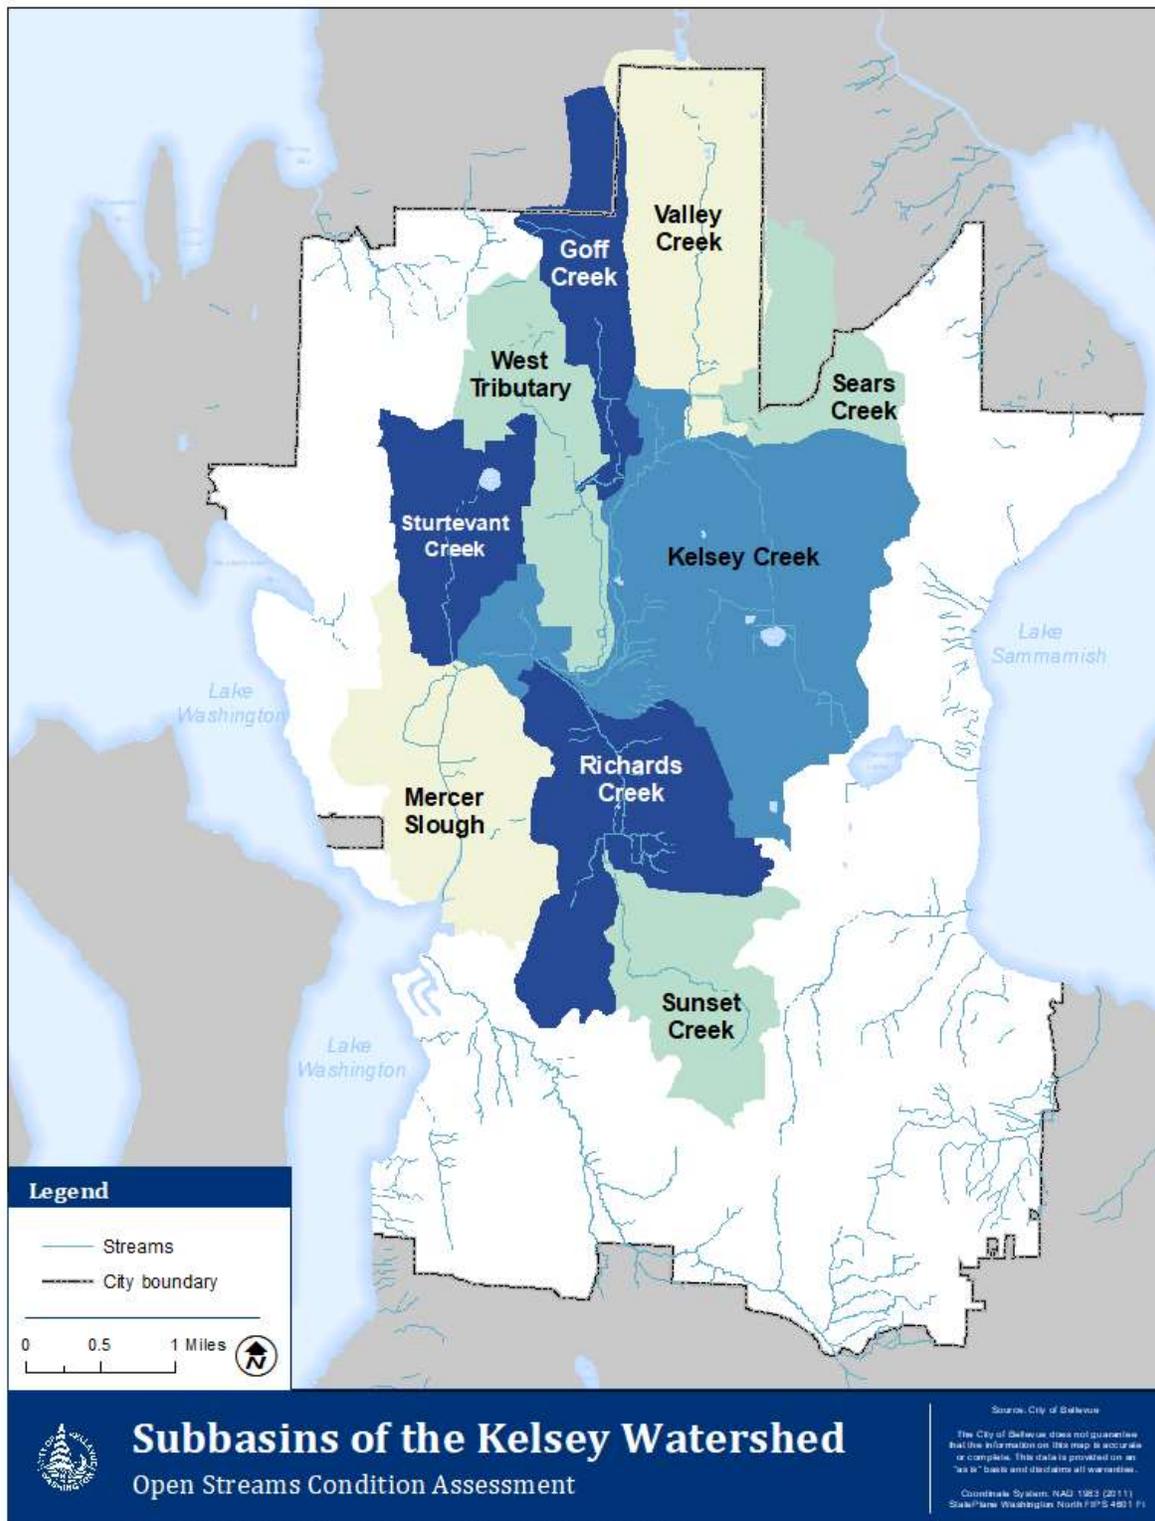
Map B-1. The nine subbasins of the Greater Kelsey Creek Watershed.

The Greater Kelsey Creek Watershed includes more than one-third of the open streams present in the City of Bellevue (**Map B-1**). As part of the Open Streams Condition Assessment (OSCA), Sturtevant, Richards, Sunset, Goff, Valley, and Sears Creek subbasins were surveyed in the spring to fall of 2019, and the mainstem of Kelsey Creek was primarily surveyed in the summer of 2020, although Reach 2 was surveyed the preceding fall. Mercer Slough was not surveyed during the OSCA project as it is not wadeable. The West Tributary of Kelsey Creek (West Tributary) was surveyed in 2016 under a different protocol (Tetra Tech 2016). **Map B-2** and **Table B-3** present the surveyed streams within the Greater Kelsey Creek Watershed and the survey level used for each. Stream reaches surveyed under a Level 3 assessment level are included in the table for completeness, but the data for those reaches are not presented in this report. Hereafter, the phrase “surveyed reaches” will apply to stream reaches assessed under a Level 1 or Level 2 protocol.

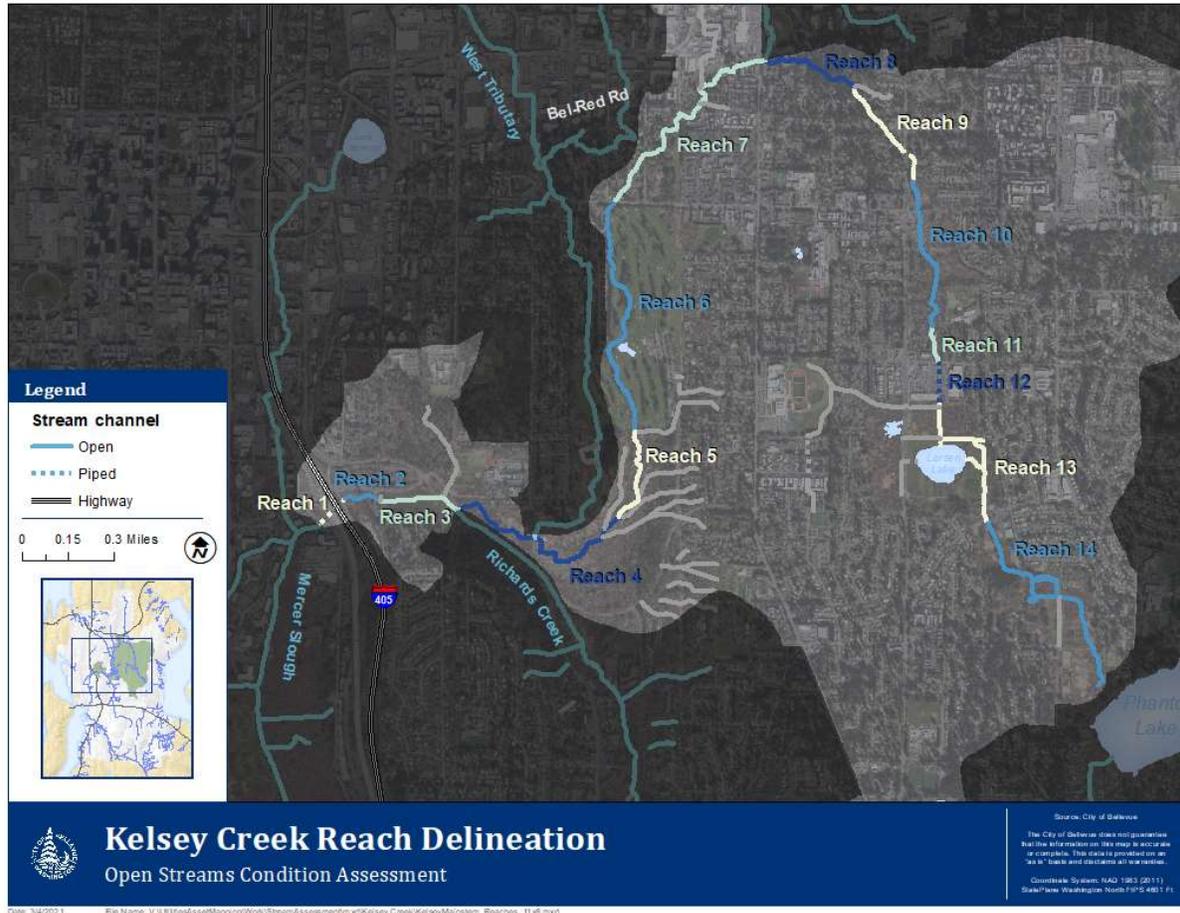
Map B-3. Mainstem reaches of Kelsey Creek.

Historically the headwaters of Kelsey Creek were found in the Phantom Lake area, flowing north through a broad wetland complex to Larsen Lake (**Map B-3**). As development occurred in Bellevue, the outlet of Phantom Lake was redirected towards Lake Sammamish, and much of the upper reaches of Kelsey Creek and its associated wetlands were ditched and modified to accommodate homesteads, farming, and roads. Today, the modified wetlands and ditches south of Larsen Lake act as the present-day headwaters. Kelsey Creek meanders north to a piped conveyance (Reach 12) and wetlands (Reaches 10 and 11) until the road crossing near 148th Avenue NE. The mainstem of Kelsey then flows through mixed commercial and residential properties (Reaches 7-9) until it reaches the Glendale Country Club and Kelsey Creek Park and Open Space (Reaches 5-6) and Kelsey Creek Wetlands (Reach 4). The stream becomes more slough-like (Reaches 2 and 3) before passing under I-405 (Reach 1) and becoming Mercer Slough at a concrete fish ladder that was rebuilt in 2003 to improve fish passage.

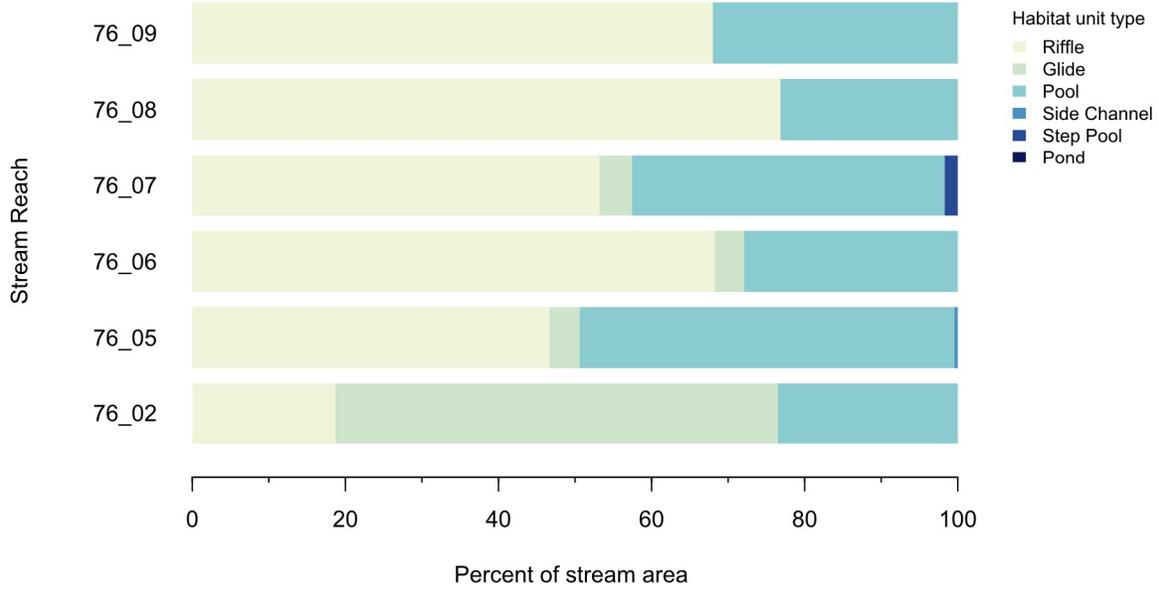
Figure B-3. Habitat unit composition (by percent area) of the Kelsey Creek mainstem reaches.

Figure B-4. Habitat unit composition (by percent length) of the Kelsey Creek mainstem reaches.

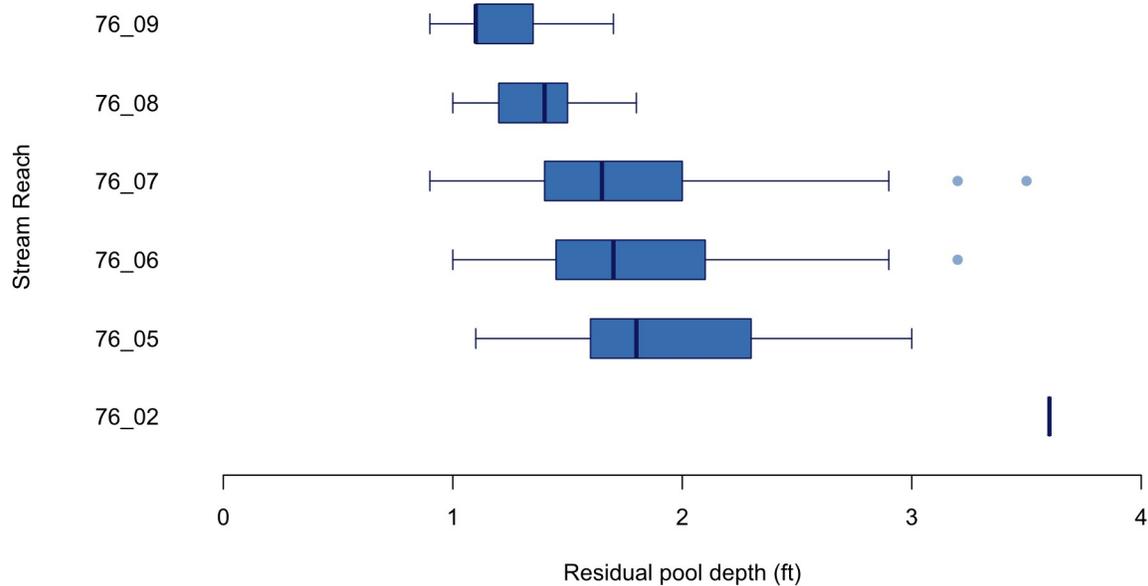
Figure B-5. Boxplot of residual pool depths observed in the mainstem reaches of Kelsey Creek.

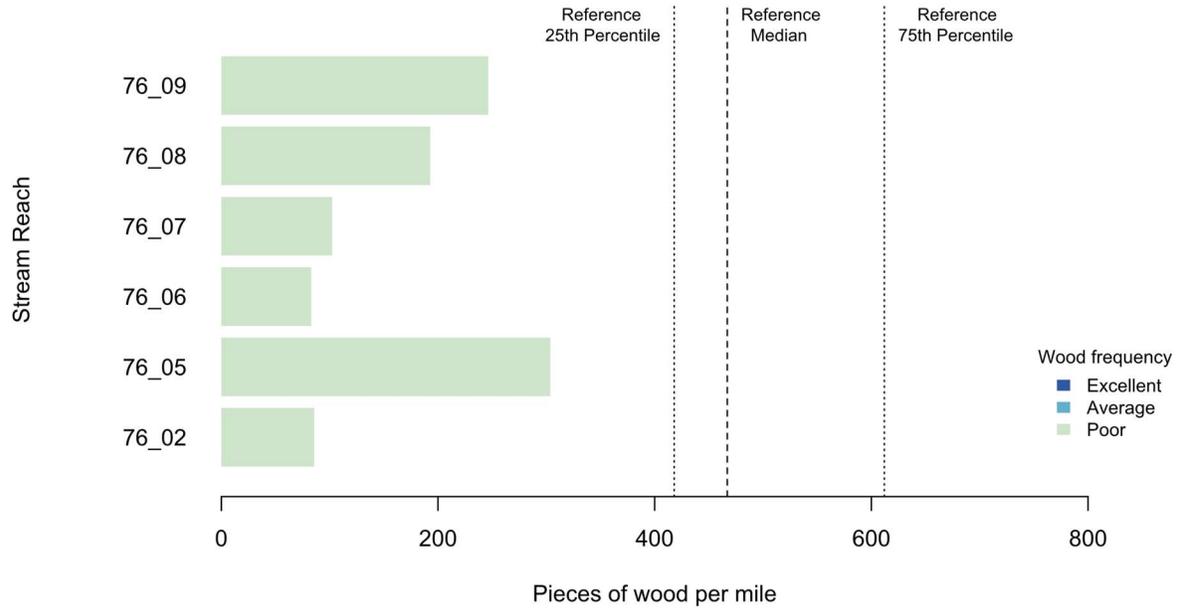
Figure B-6. Large woody material frequency in the mainstem of Kelsey Creek compared to reference levels (Fox and Bolton 2007).

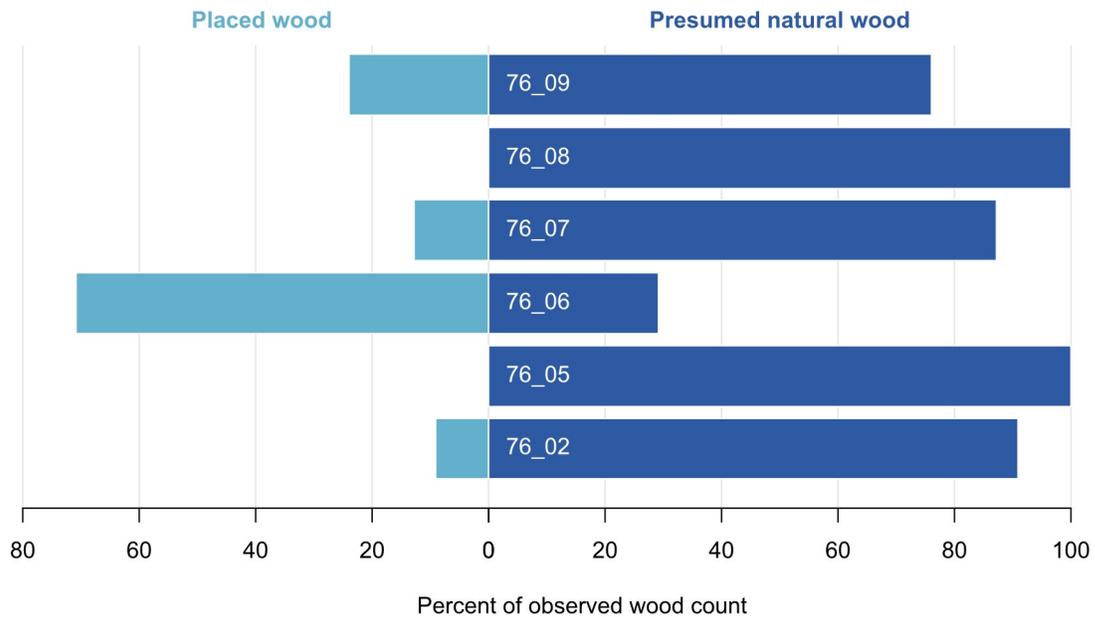
Figure B-7. Diverging bar graph showing the proportion of wood observed in each stream reach of the mainstem of Kelsey Creek that is of natural origin or was placed.

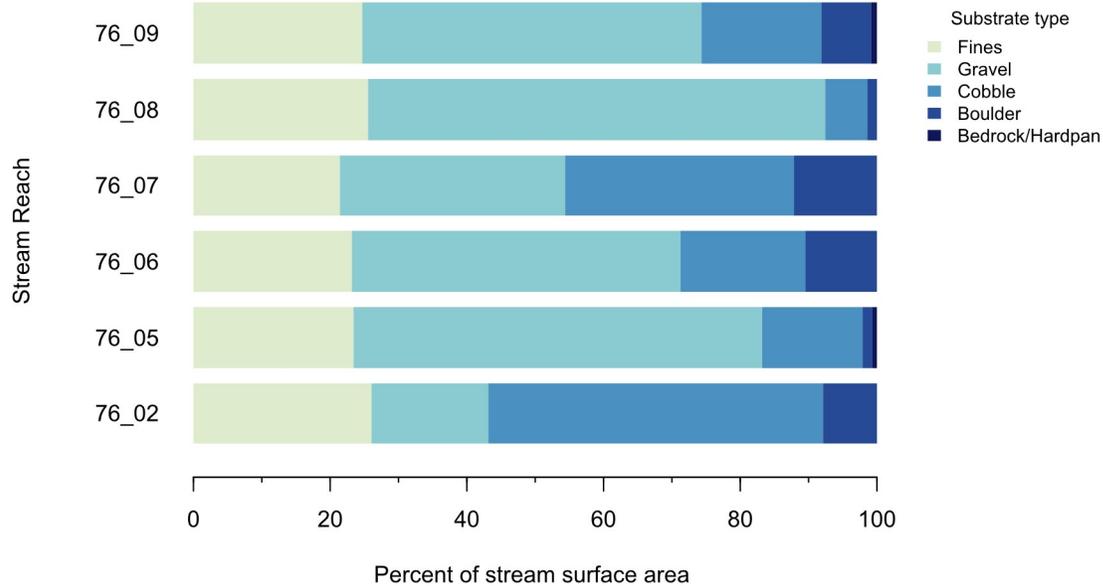
Figure B-8. Substrate composition of riffle habitat in the Kelsey Creek mainstem reaches, determined by visual estimation.

Substrate composition for riffle habitats in the mainstem of Kelsey Creek (**Figure B-8**) is predominantly gravels and cobbles throughout the stream corridor, consistent with sizes suitable for fish spawning and rearing habitat. Fines consistently account for just under a quarter of the substrate composition in riffle habitat, which is higher than ideal for salmonid spawning but is lower than that found in all other subbasins in the Greater Kelsey Creek Watershed. Exposed hardpan glacial till accounts for 10% of the substrate in fast water (riffle and glide) habitat in Reach 2 and is sporadically observed in Reaches 5 and 9. Qualitative habitat observations from the late 2000s document significant streambed scour and exposed hardpan throughout Reach 5, yet these appear to have filled in and become less significant by the time of the OSCA survey in 2020. Gravels are continuing to migrate downstream through Reach 5 and into the upper portion of the wetland Reach 4, potentially increasing spawning habitat.

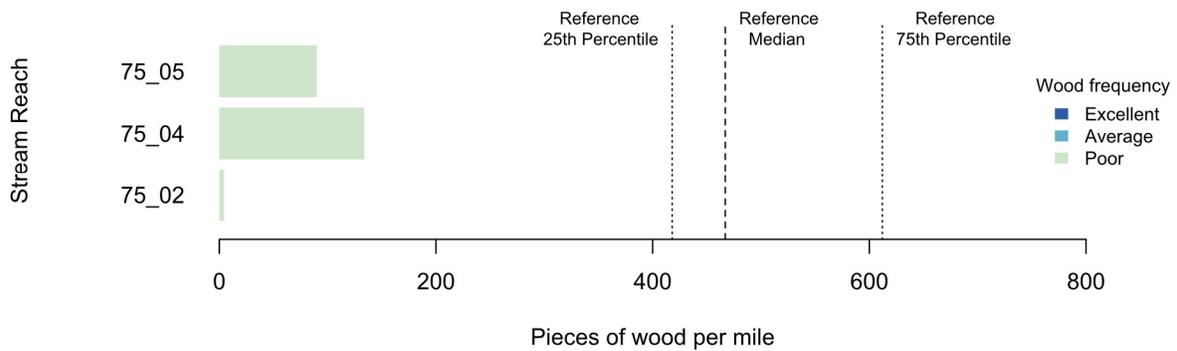
Figure B-17. Large woody material frequency in Sturtevant Creek compared to reference levels (Fox and Bolton 2007).

Large woody material (LWM) is largely absent from Sturtevant Creek. The average wood density across all surveyed reaches is 63 pieces per mile (4 pieces per 100 m), which is the second lowest LWM level observed in the Greater Kelsey Creek Watershed and is far below reference levels (**Figure B-17**). Only one piece of wood was observed in all of Reach 2. Stream restoration activities in Reach 5 have enhanced the rather meager LWM levels by contributing a high proportion of placed wood (**Figure B-18**). Opportunities for natural recruitment of LWM are minimal in Sturtevant Creek.

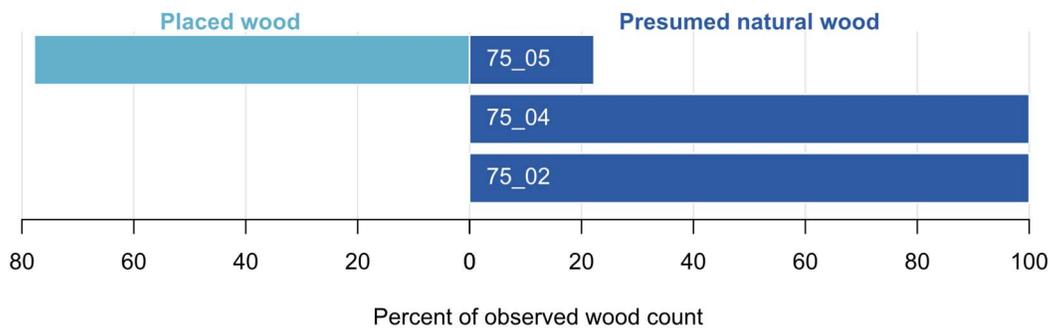
Figure B-18. Diverging bar graph showing the proportion of wood observed in each stream reach of Sturtevant Creek that is of natural origin or was placed.

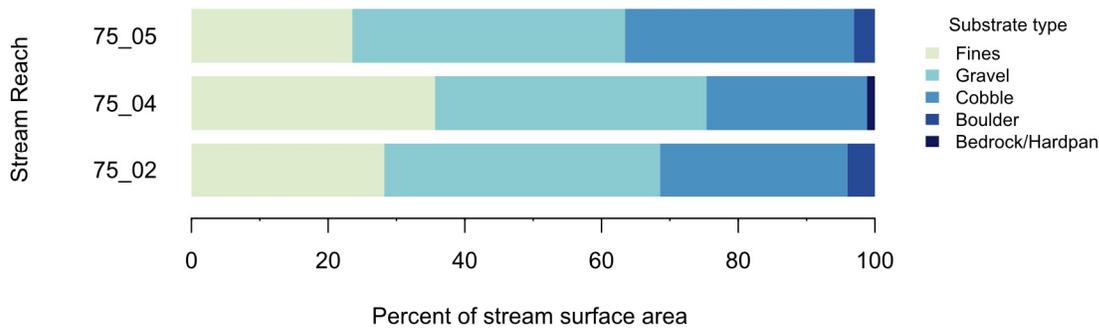
Figure B-19. Substrate composition of riffle habitat in Sturtevant Creek, determined by visual estimation.

Streambed substrate composition in Sturtevant Creek riffle habitat is predominantly (40%) gravel. Fines and cobbles are approximately equivalent and make most of the remaining substrate composition (Figure B-19). Although the percent fines in riffle habitat is slightly higher than ideal (28%), the substrate composition is still adequate for spawning salmonids. Substrate in glide habitats is generally less coarse, with fines comprising 49% of the substrate. Some of the “cobbles” present in Reach 4 are actually chunks of hardpan clay that have mobilized into the channel and are functioning as coarse substrate.

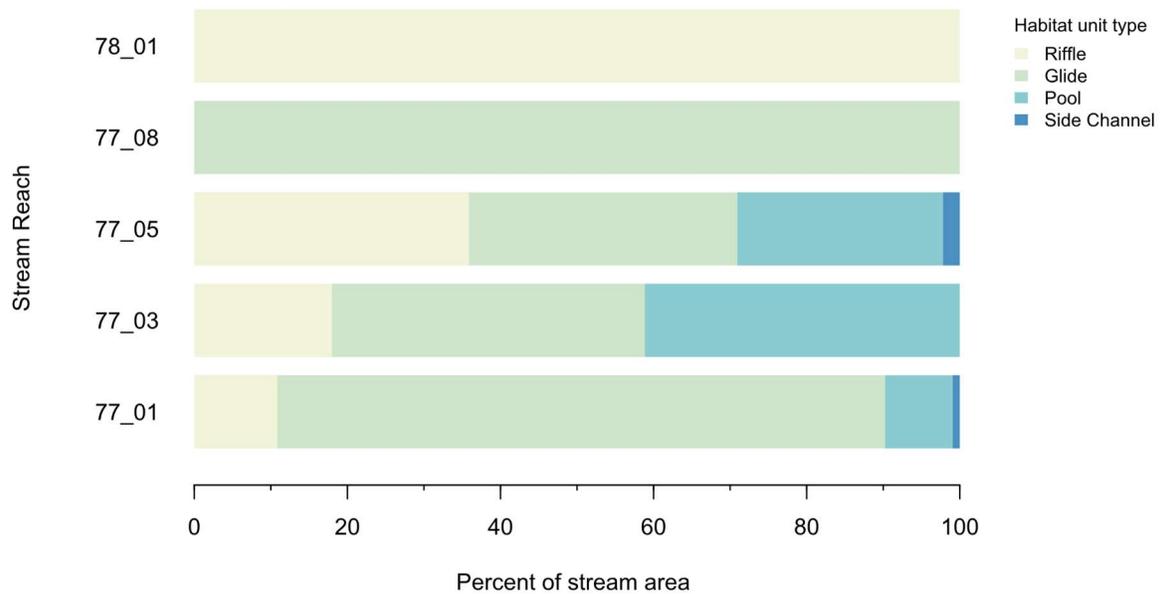
Figure B-25. Habitat unit composition (by percent area) of the Richards Creek Subbasin stream reaches. Richards Creek stream reaches have the prefix 77 and East Creek stream reaches have the prefix 78.

Figure B-26. Habitat unit composition (by percent length) of the Richards Creek Subbasin stream reaches. Richards Creek stream reaches have the prefix 77 and East Creek stream reaches have the prefix 78.

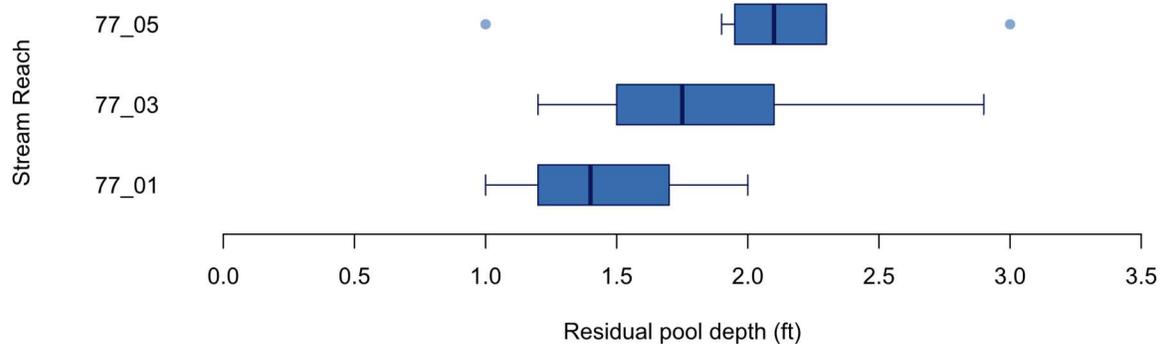
Figure B-27. Boxplot of residual pool depths observed in the Richards Creek Subbasin.

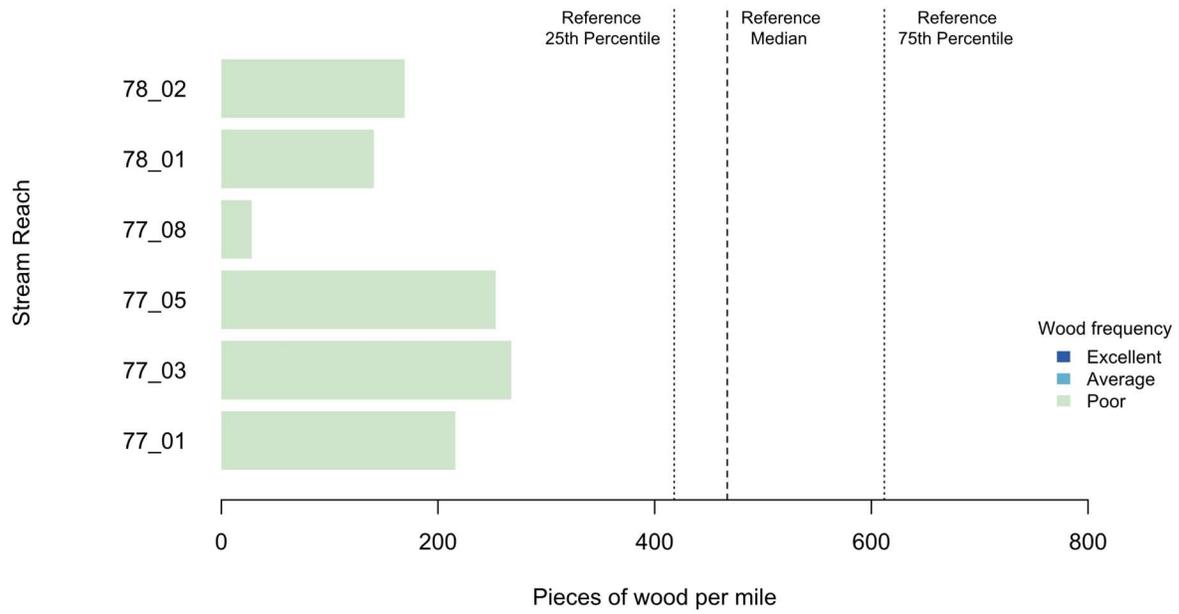
Figure B-28. Large woody material frequency in stream reaches of the Richards Creek Subbasin compared to reference levels (Fox and Bolton 2007). Richards Creek stream reaches have the prefix 77 and East Creek stream reaches have the prefix 78.

Reaches 5 and 8, there is very little natural LWM recruitment potential. In Reaches 1 through 5, beavers have facilitated the natural recruitment of LWM by felling trees and incorporating trees and large branches into dams, which trap and sort debris and sediment.

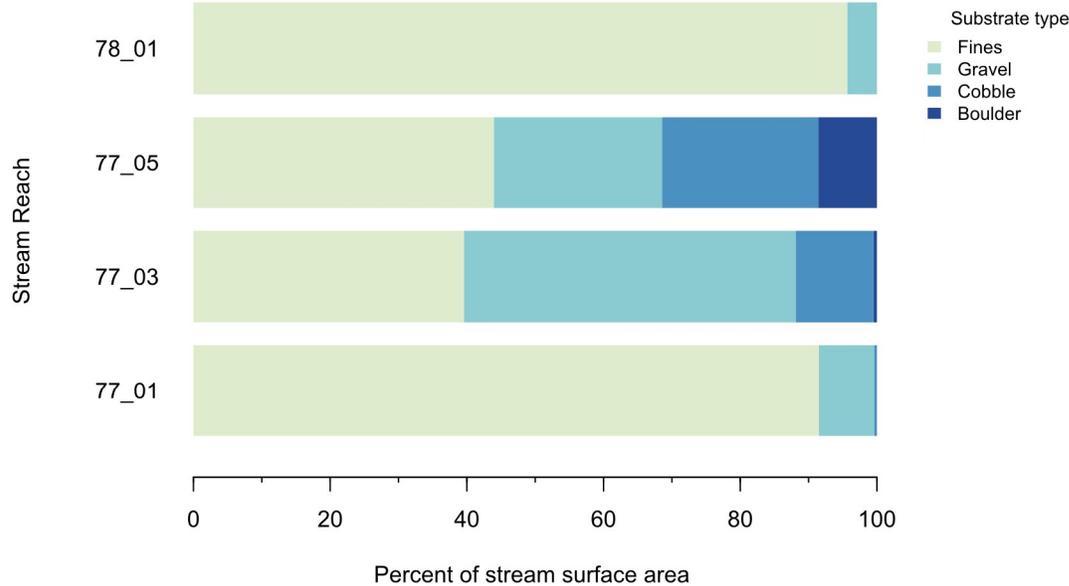
Figure B-29. Substrate composition of riffle habitat in the Richards Creek Subbasin, determined by visual estimation. Richards Creek stream reaches have the prefix 77 and East Creek stream reaches have the prefix 78.

The Richards Creek Subbasin has the highest proportion of fines found in the Greater Kelsey Creek Watershed. Fines account for 78% of the streambed substrate in all fast water habitat units and 58% in riffle habitat. Although substrate composition in riffle habitat varies among stream reaches (**Figure B-29**), no reach has less than 40% fines. This proportion of fines is generally too high for the successful spawning and incubation of Pacific salmon (NOAA 1996).
