Greater Kelsey Creek Watershed Assessment Report
prepared in support of the City of Bellevue Watershed Management Plan

Revision 3 (Final)
November 13, 2021

Bellevue Utilities Department

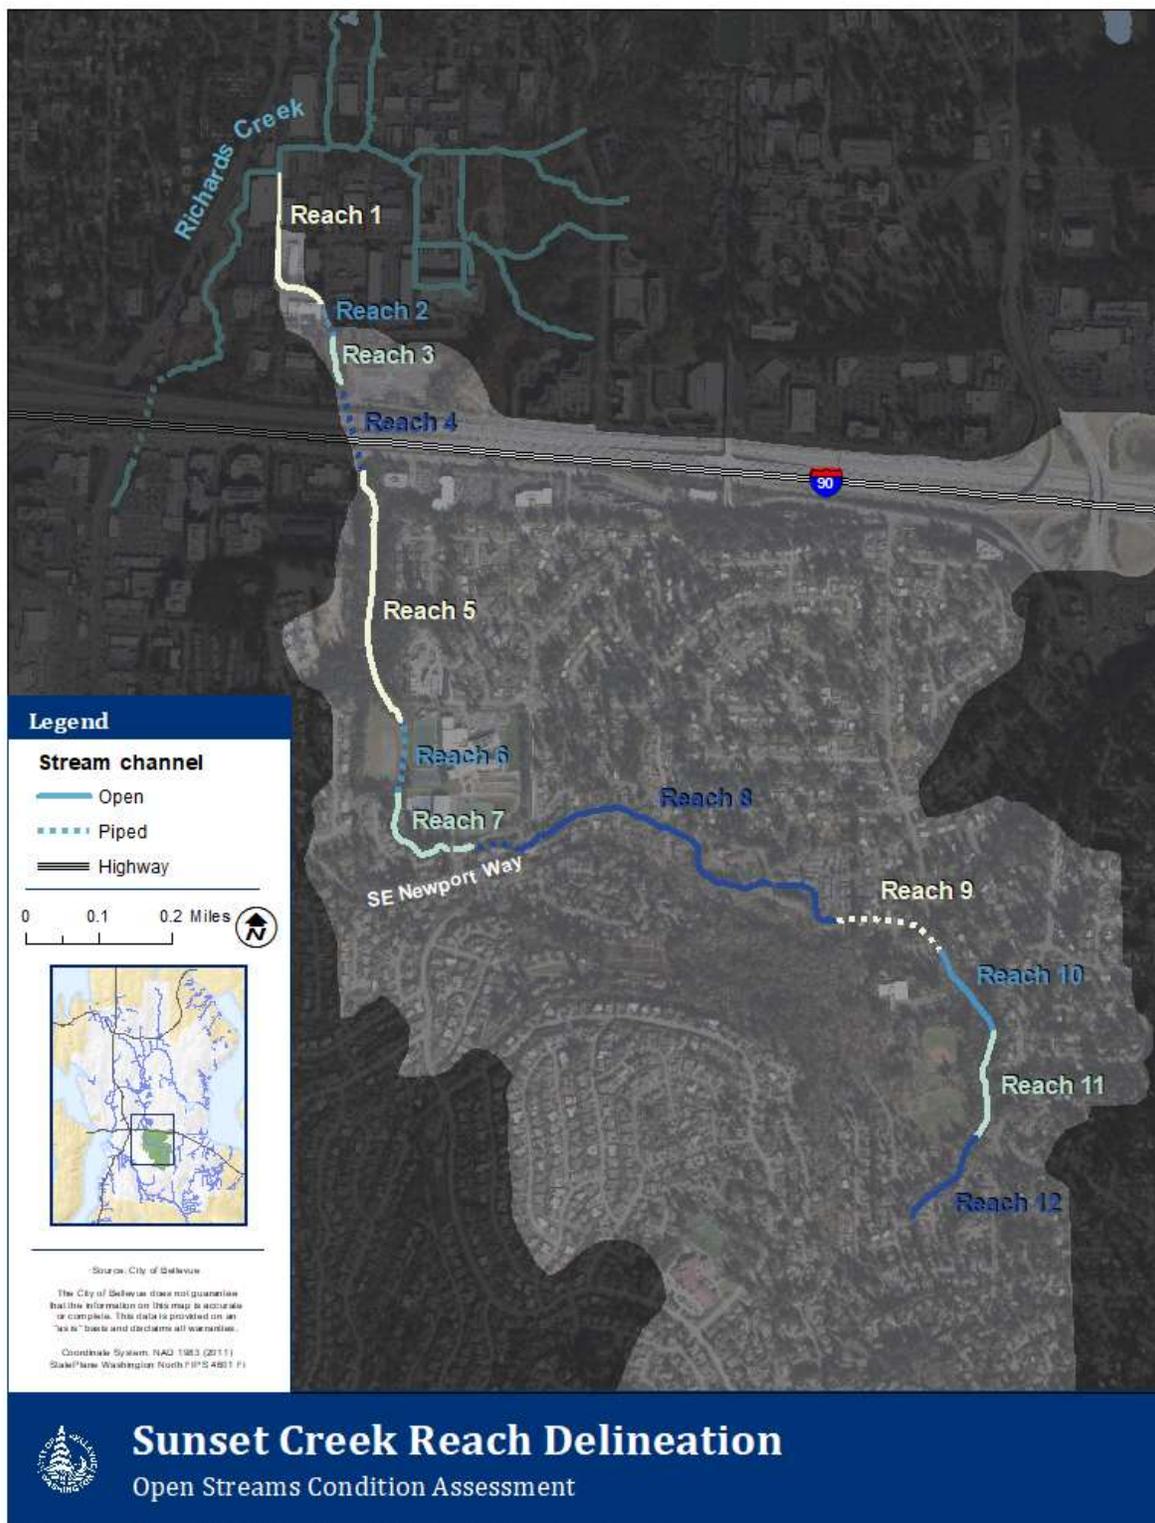
Map B-6. Sunset Creek stream reaches.

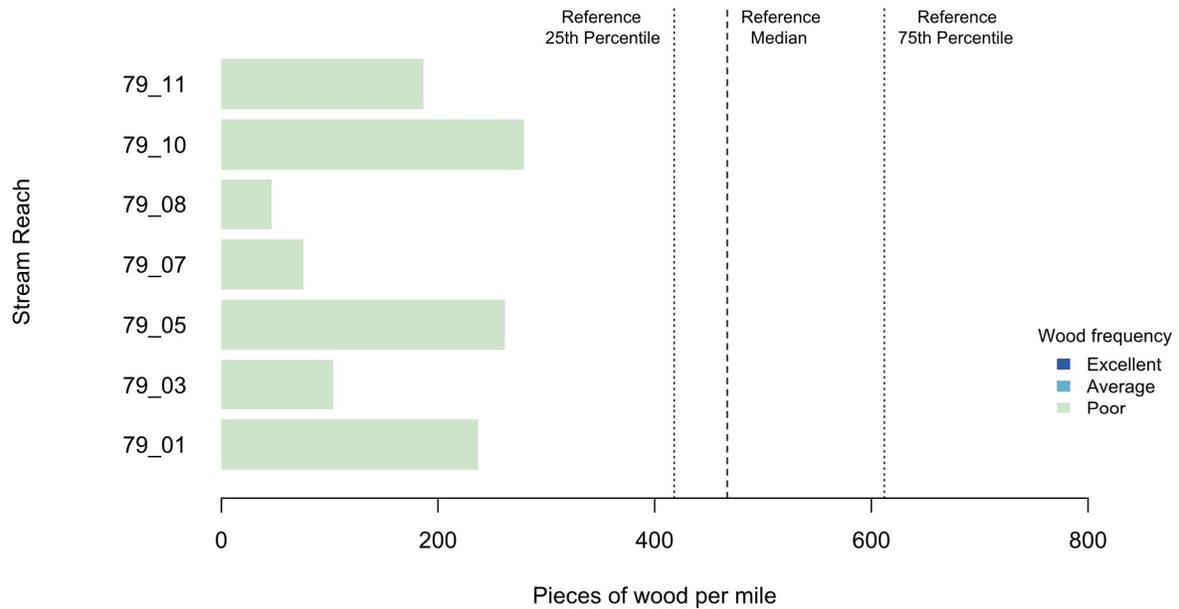
Figure B-38. Large woody material frequency in Sunset Creek compared to reference levels (Fox and Bolton 2007).

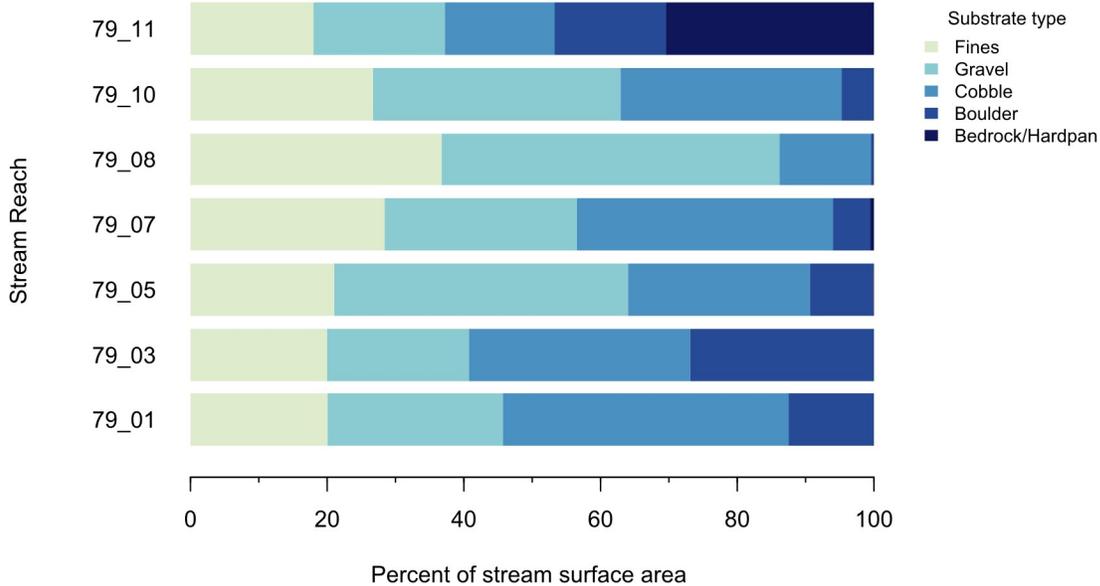
Figure B-39. Substrate composition of riffle habitat in Sunset Creek, determined by visual estimation.

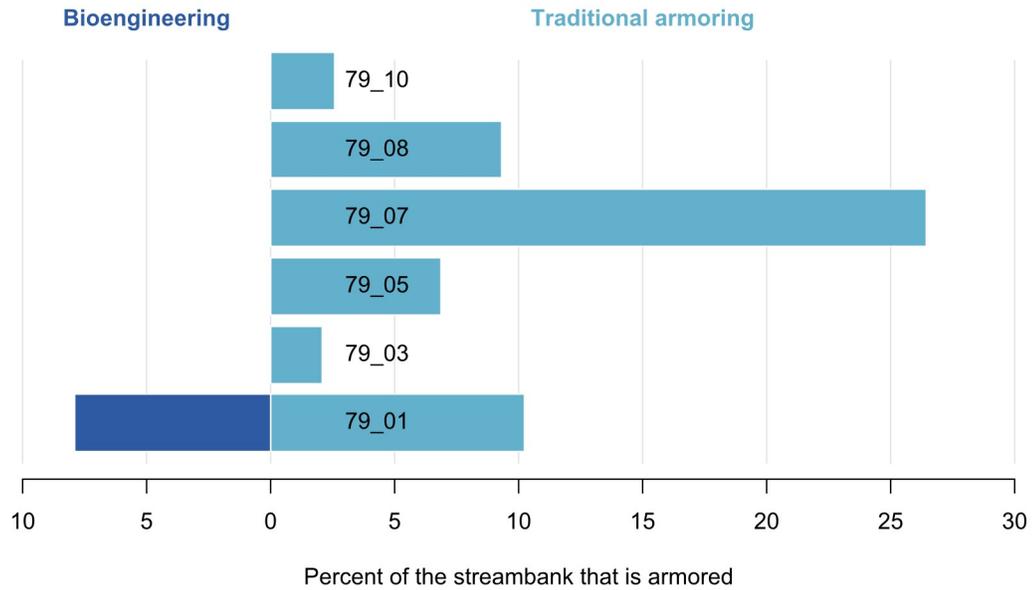
Figure B-40. Diverging bar graph showing the proportion of the streambank in Sunset Creek that is armored using traditional materials (right) and bioengineering (left).

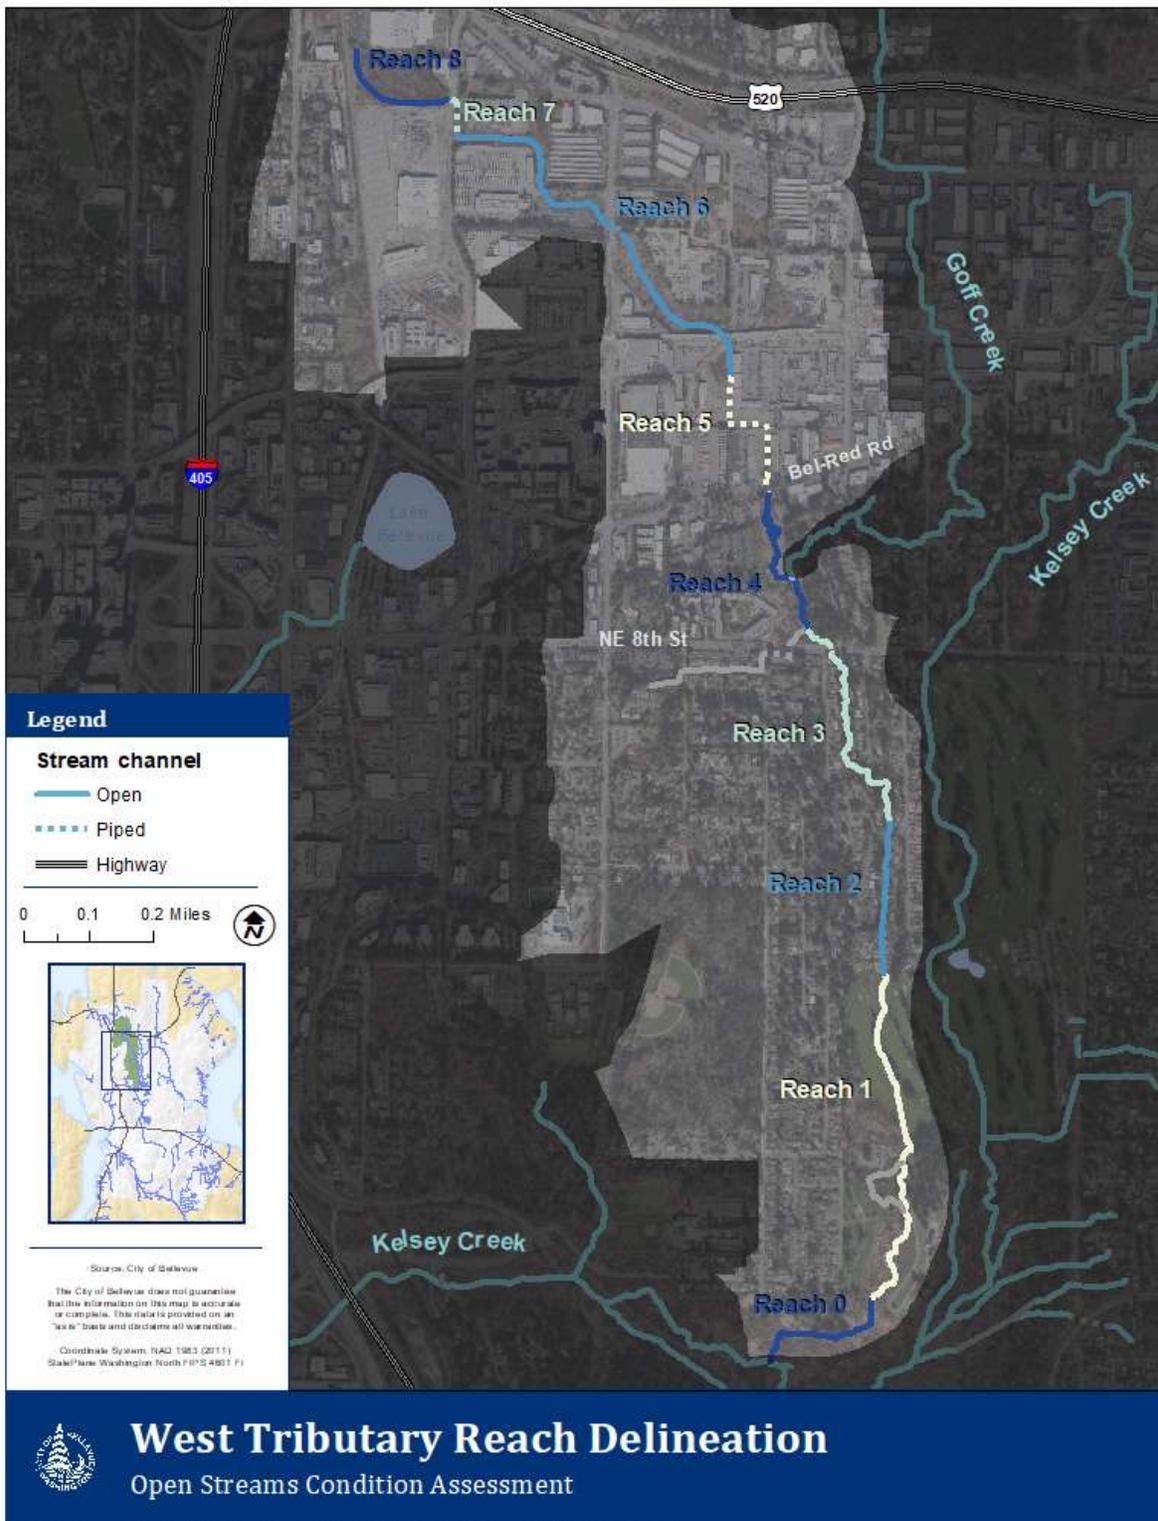
Map B-7. West Tributary stream reaches.

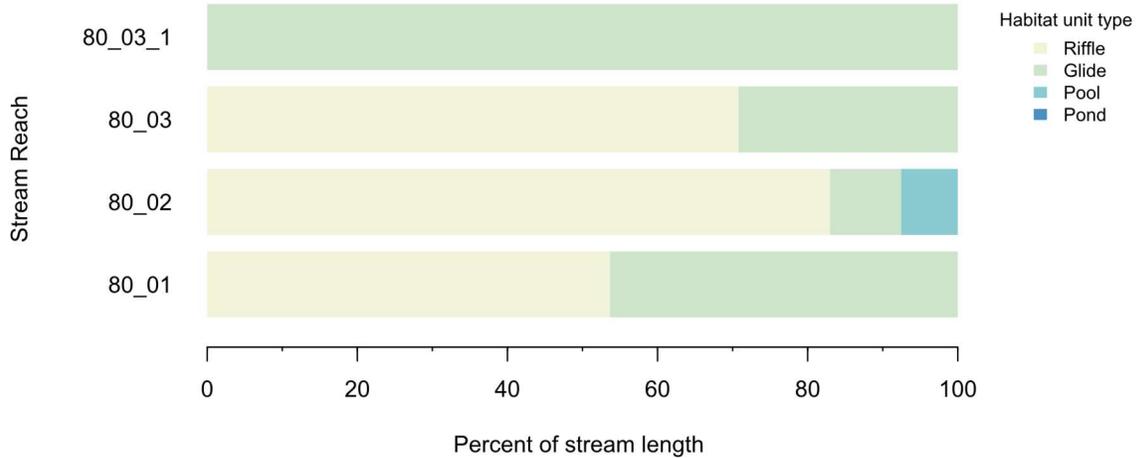
Figure B-43. Habitat unit composition (by percent area) of West Tributary stream reaches and the unnamed tributary (80_03_1).

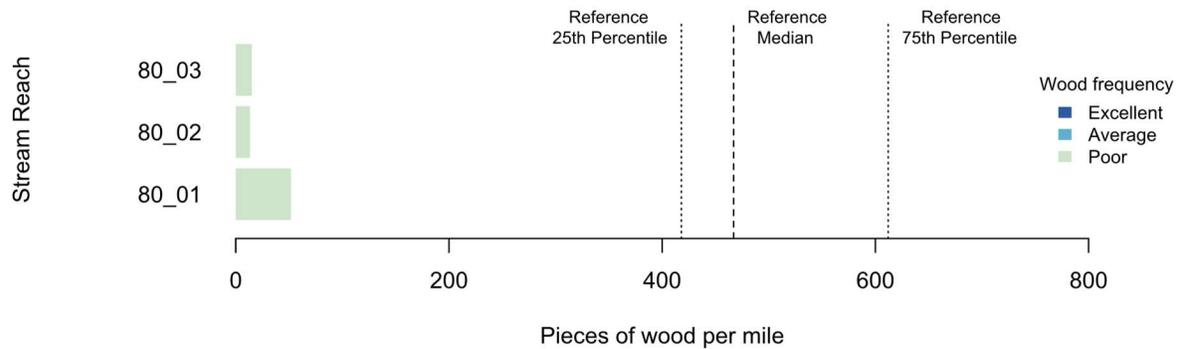
Figure B-45. Large woody material frequency in the mainstem reaches of West Tributary compared to reference levels (Fox and Bolton 2007).

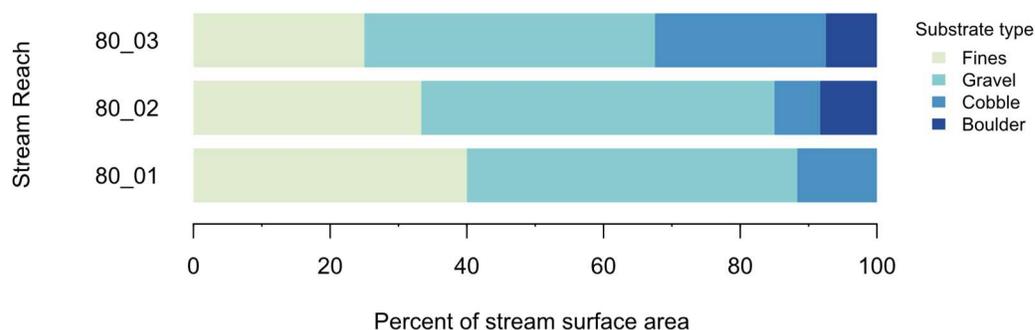
Figure B-46. Substrate composition of riffle habitat in West Tributary stream reaches, determined by visual estimation. Reaches not presented here did not have riffle habitat or were not surveyed.

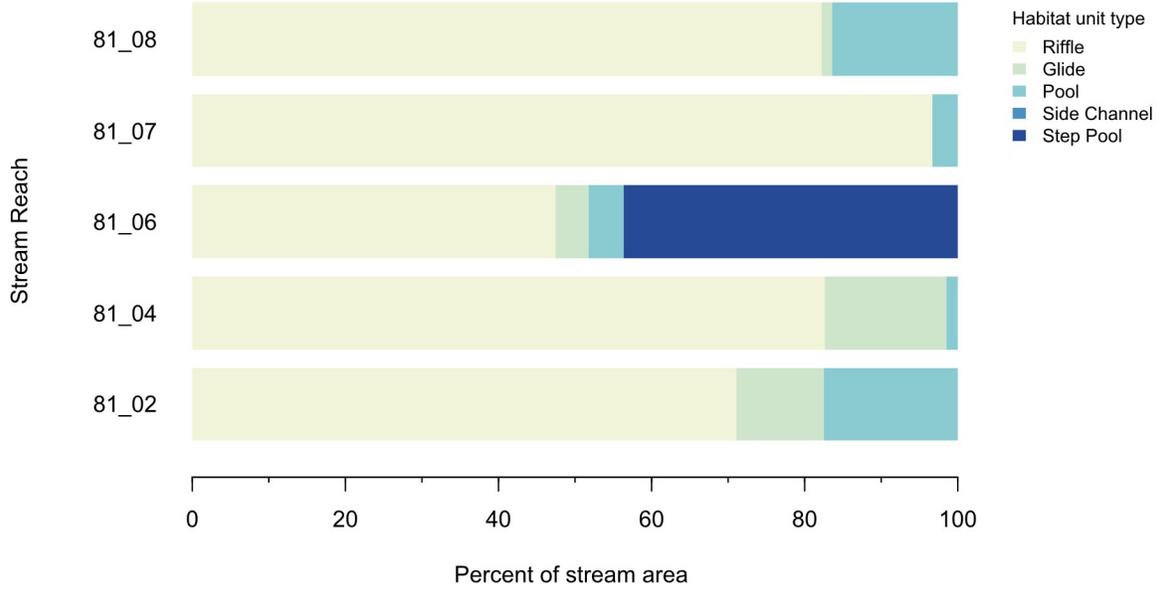
Figure B-49. Habitat unit composition (by percent area) of Goff Creek stream reaches.

Figure B-50. Habitat unit composition (by percent length) of Goff Creek stream reaches.

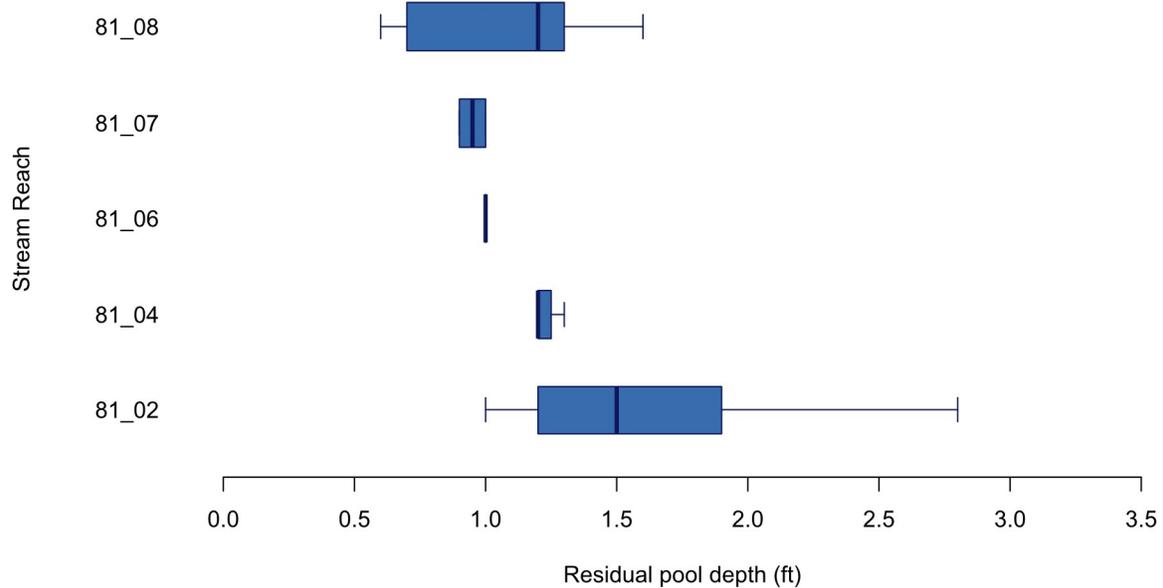
Figure B-51. Boxplot of residual pool depths observed in Goff Creek.

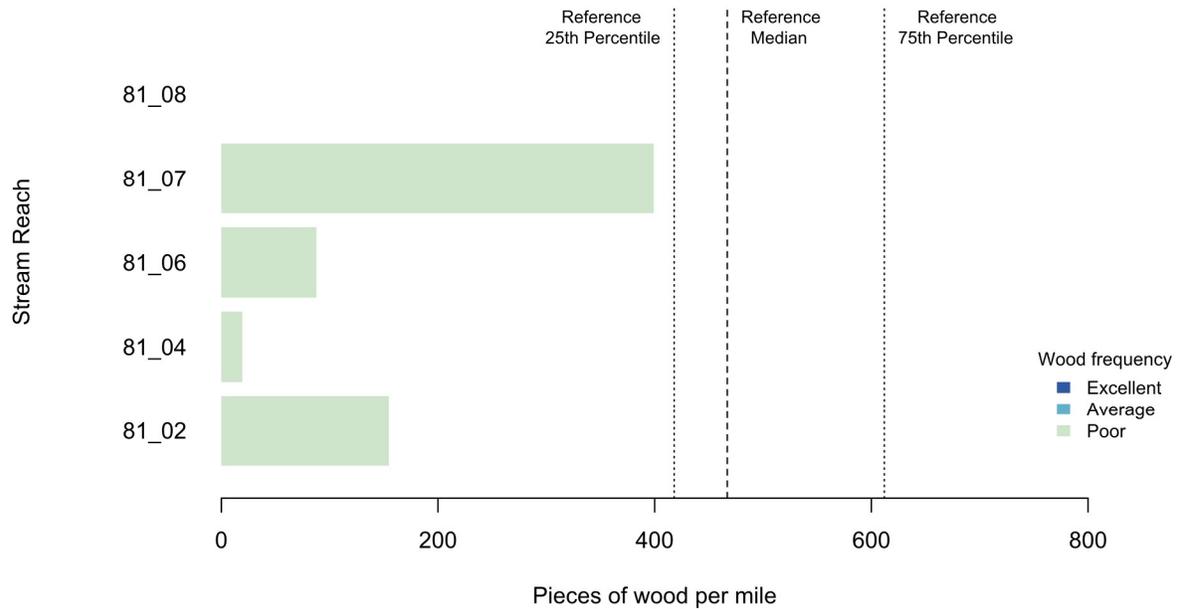
Figure B-52. Large woody material frequency in the mainstem reaches of Goff Creek compared to reference levels (Fox and Bolton 2007).

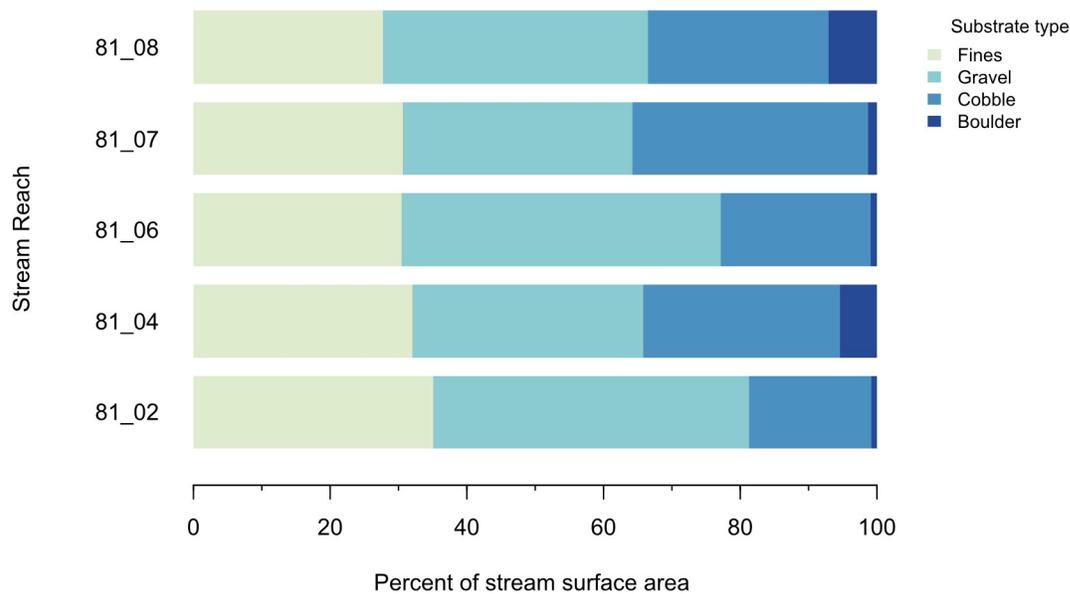
Figure B-53. Substrate composition of riffle habitat in Goff Creek stream reaches, determined by visual estimation.

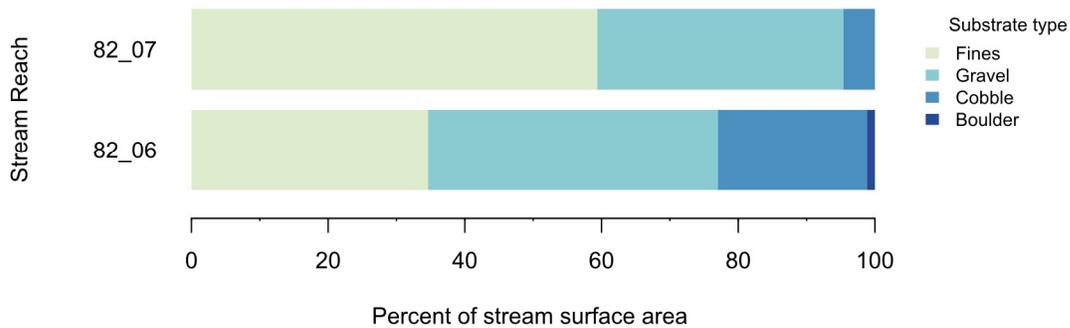
Figure 62. Substrate composition of riffle habitat in Valley Creek, determined by visual estimation. Reach 9 is excluded because it contained no riffle habitat.

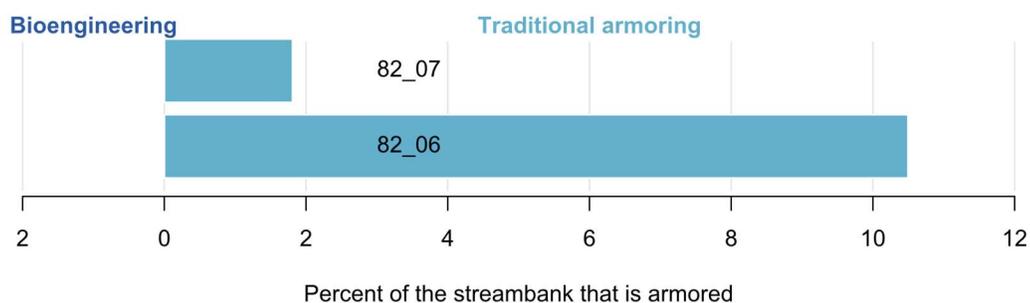
Figure B-63. Diverging bar graph showing the proportion of the streambank in Valley Creek that is armored using traditional materials (right) and bioengineering (left).

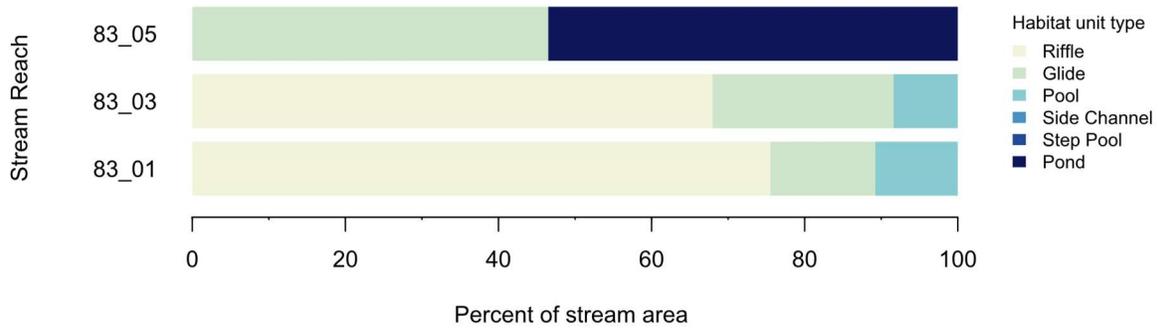
Figure B-68. Habitat unit composition (by percent area) in Sears Creek.

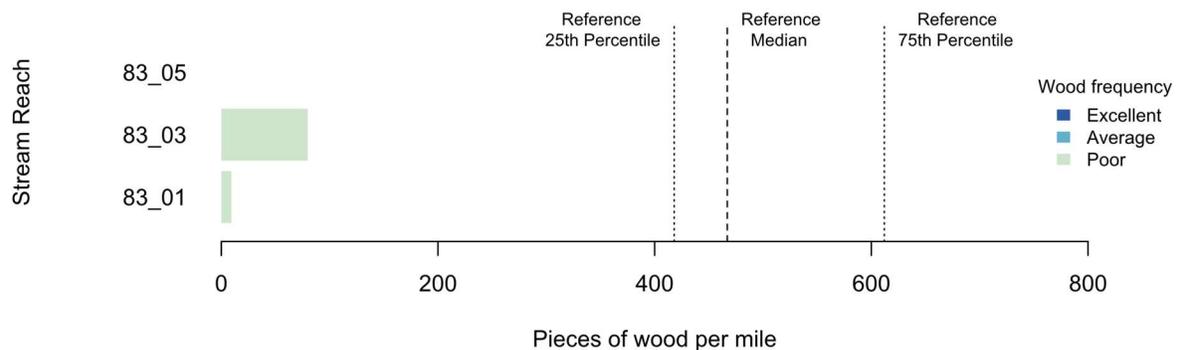
Figure B-71. Large woody material frequency in Sears Creek compared to reference levels (Fox and Bolton 2007).

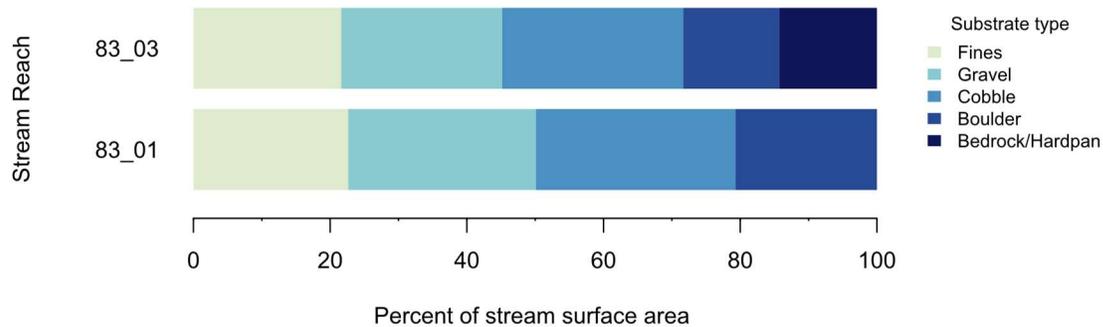
Figure B-72. Substrate composition of riffle habitat in Sears Creek, determined by visual estimation. Reach 5 is omitted because it does not contain riffle habitat.

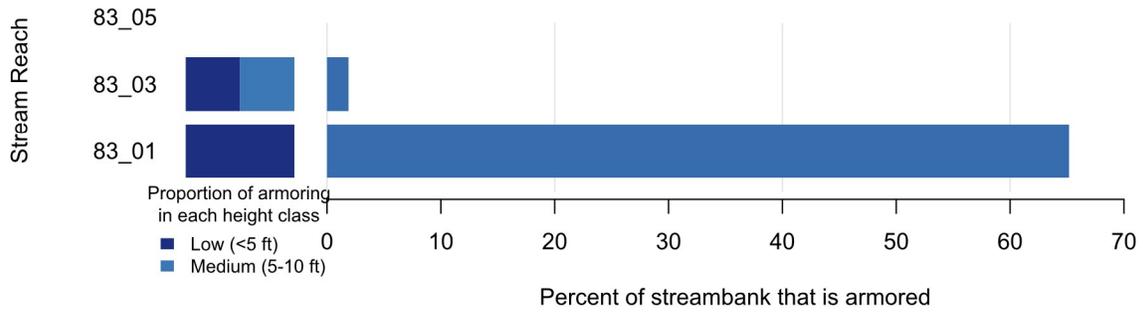
Figure B-73. Bar graphs showing the percent of each Sears Creek reach that is armored as well as the proportion of armoring in each armoring height class.
