Lake Sammamish Watershed Assessment Report

prepared in support of the City of Bellevue Watershed Management Plan for areas and tributaries that drain to Lake Sammamish within the City of Bellevue

Revision 3 (final)

March 16, 2022

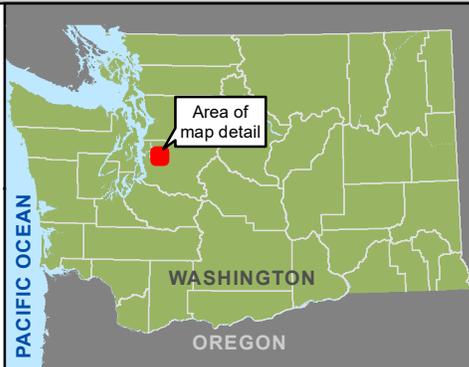
Figure 17. Lake Sammamish Watershed Topography and Geomorphology.

The topography within the City of Bellevue's portion of the Lake Sammamish Watershed is shown in Figure 17. Topography slopes generally east and northeast towards Lake Sammamish, with many high gradient streams confined by ravines and steep slopes (greater than 40 percent). The City's Open Streams Condition Assessment showed that of the subbasins surveyed, the six with the highest stream gradients in the City are within the Lake Sammamish Watershed (See Appendix B for further detail). The steep and urbanized nature of the Lake Sammamish Watershed contributes to a lack of wetland complexes and wide floodplains relative to other City watersheds. In many cases streams are incised and enter Lake Sammamish via piped conveyance.
