**City of Bellevue  
Development Services Department  
Land Use Staff Report**

**Proposal Name:** Long Short Plat

**Proposal Description:** Application for Preliminary Short Plat approval to subdivide a 34,781 square foot (SF) lot (approx. 0.8 acre) into 4 single-family building lots located in the R-5 land use district.

**File Number:** 23-100107-LN

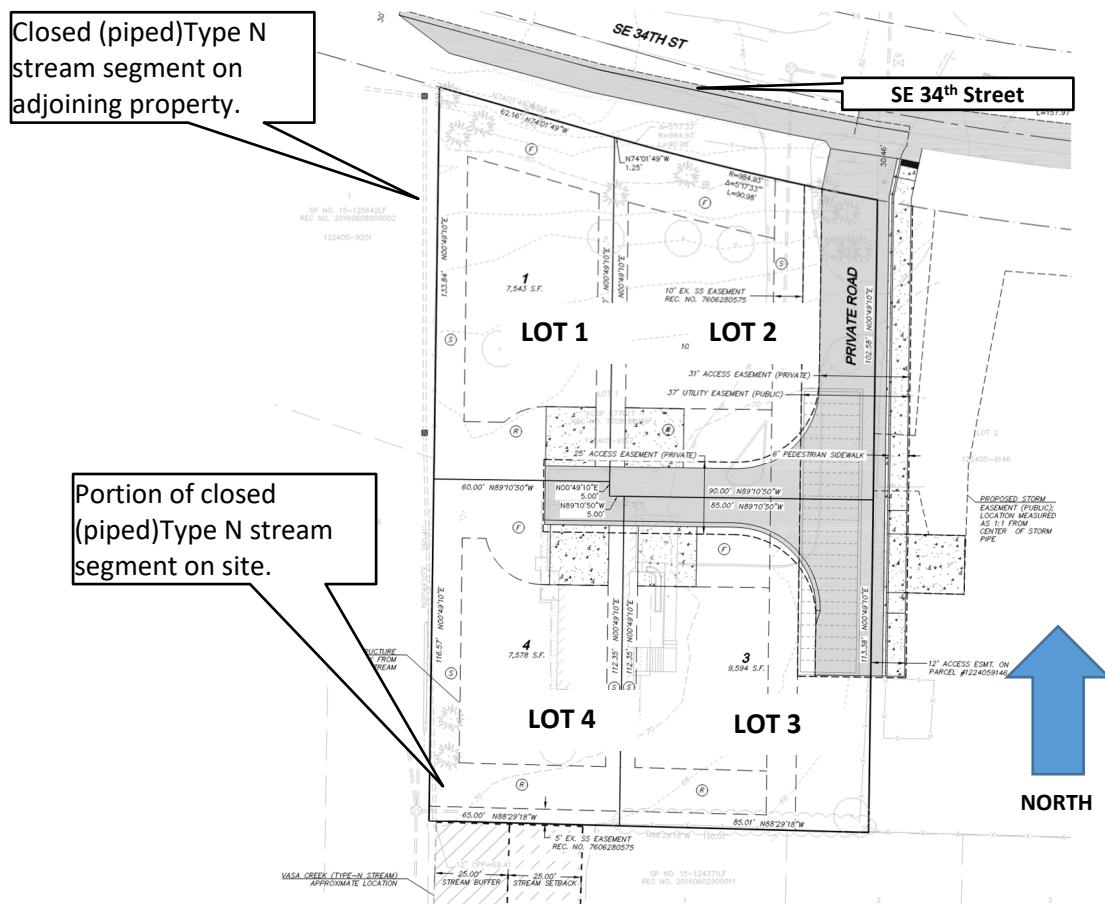
**Figure 1: Long Preliminary Short Plat Map**

The applicant is proposing a preliminary short plat to subdivide an existing 34,781 SF lot (approx. 0.8 acre) parcel (site) into four (4) new single-family lots as follows and as depicted on Figure 1 below:

- **Lot 1:** 7,543 SF
- **Lot 2:** 10,067 SF
- **Lot 3:** 9,594 SF
- **Lot 4:** 7,578 SF

The site contains an existing single-family dwelling which will be demolished as a result of this short plat proposal. Access to the four new lots will be provided via one shared private road from SE 34<sup>th</sup> Street. The subject site is located in the R-5 land use district and is within the Newcastle Subarea. The site contains 32 existing significant trees with a combined total of 502 diameter inches. A minimum of 30% (150.6) of existing diameter inches must be retained. The applicant proposes to retain 5 trees with a combined total of 158 diameter inches, or 31% of the existing significant trees on the site.

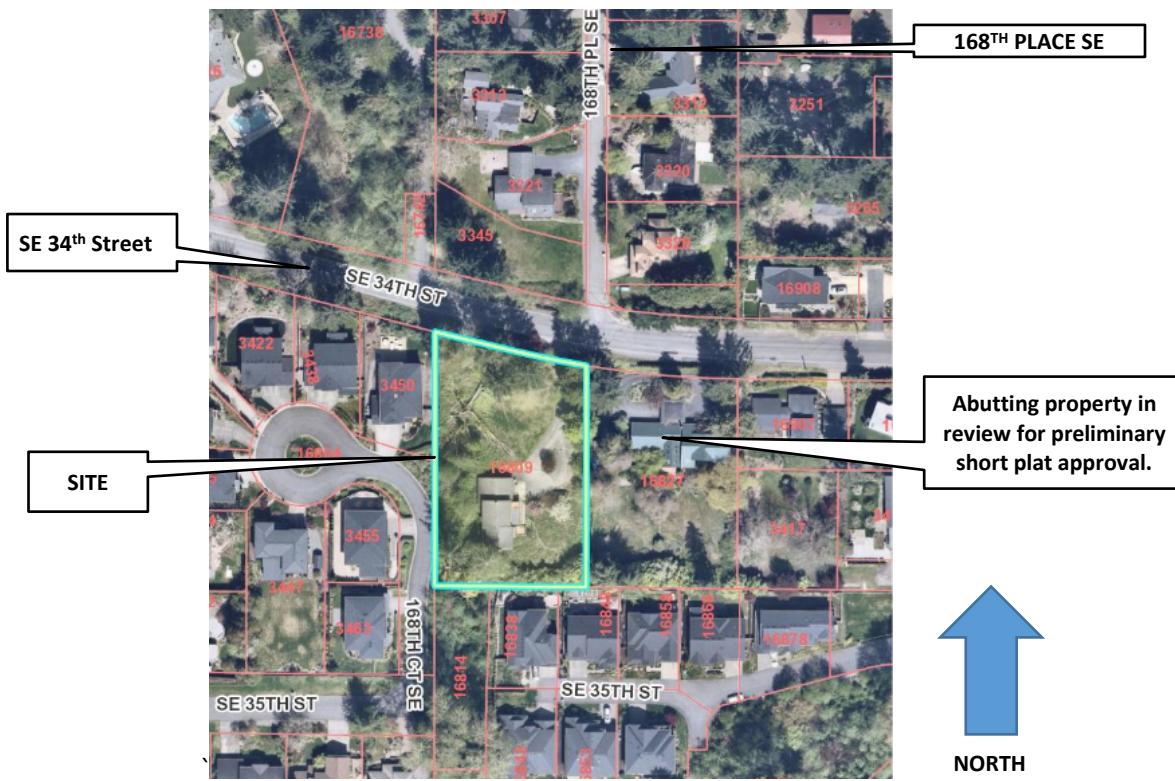
**Figure 2: Site Context**

The site is located in an existing single-family neighborhood. Single-family residences abut the site to the west, south and east. The subject property is currently developed with one single-family lot accessed via a shared driveway curb cut from SE 34<sup>th</sup> Street to the north. The driveway is shared with the adjoining single-family lot to the east, which is also in review for a proposed two (2) lot preliminary short plat.

The site's topography slopes downhill from north to south, with its highest elevation of approximately 84 ft at the northwest corner along SE 34<sup>th</sup> Street to an elevation of approximately 65 ft at the southeast corner, roughly 290 ft. away, resulting in a 7% slope. As described above, a portion of a closed (piped) Type N stream generally located on the parcel to the immediate west of the site intrudes onto the site at the southwest corner of proposed Lot 4. Refer to Condition of Approval regarding Critical Area Structure Setback from Closed Type-N Stream Segment in Section IX.C of this report.

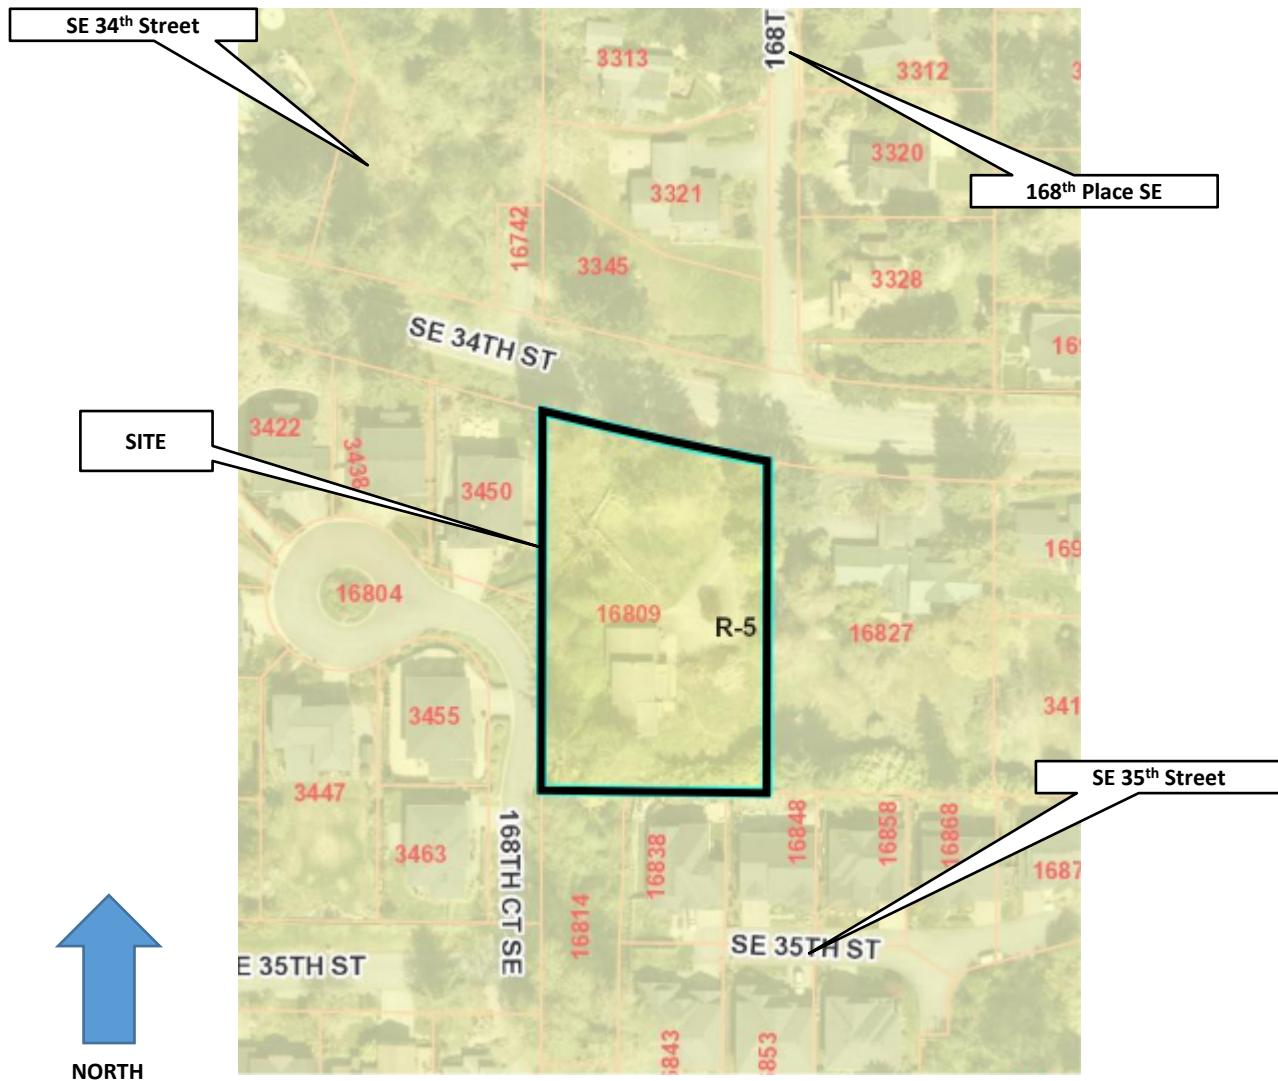
**Figure 3: Site Zoning Map**

The four lots proposed with this short plat application are permitted within the R-5 land use district. Refer to the table in Section III.B below for the proposal's conformance to dimensional requirements.

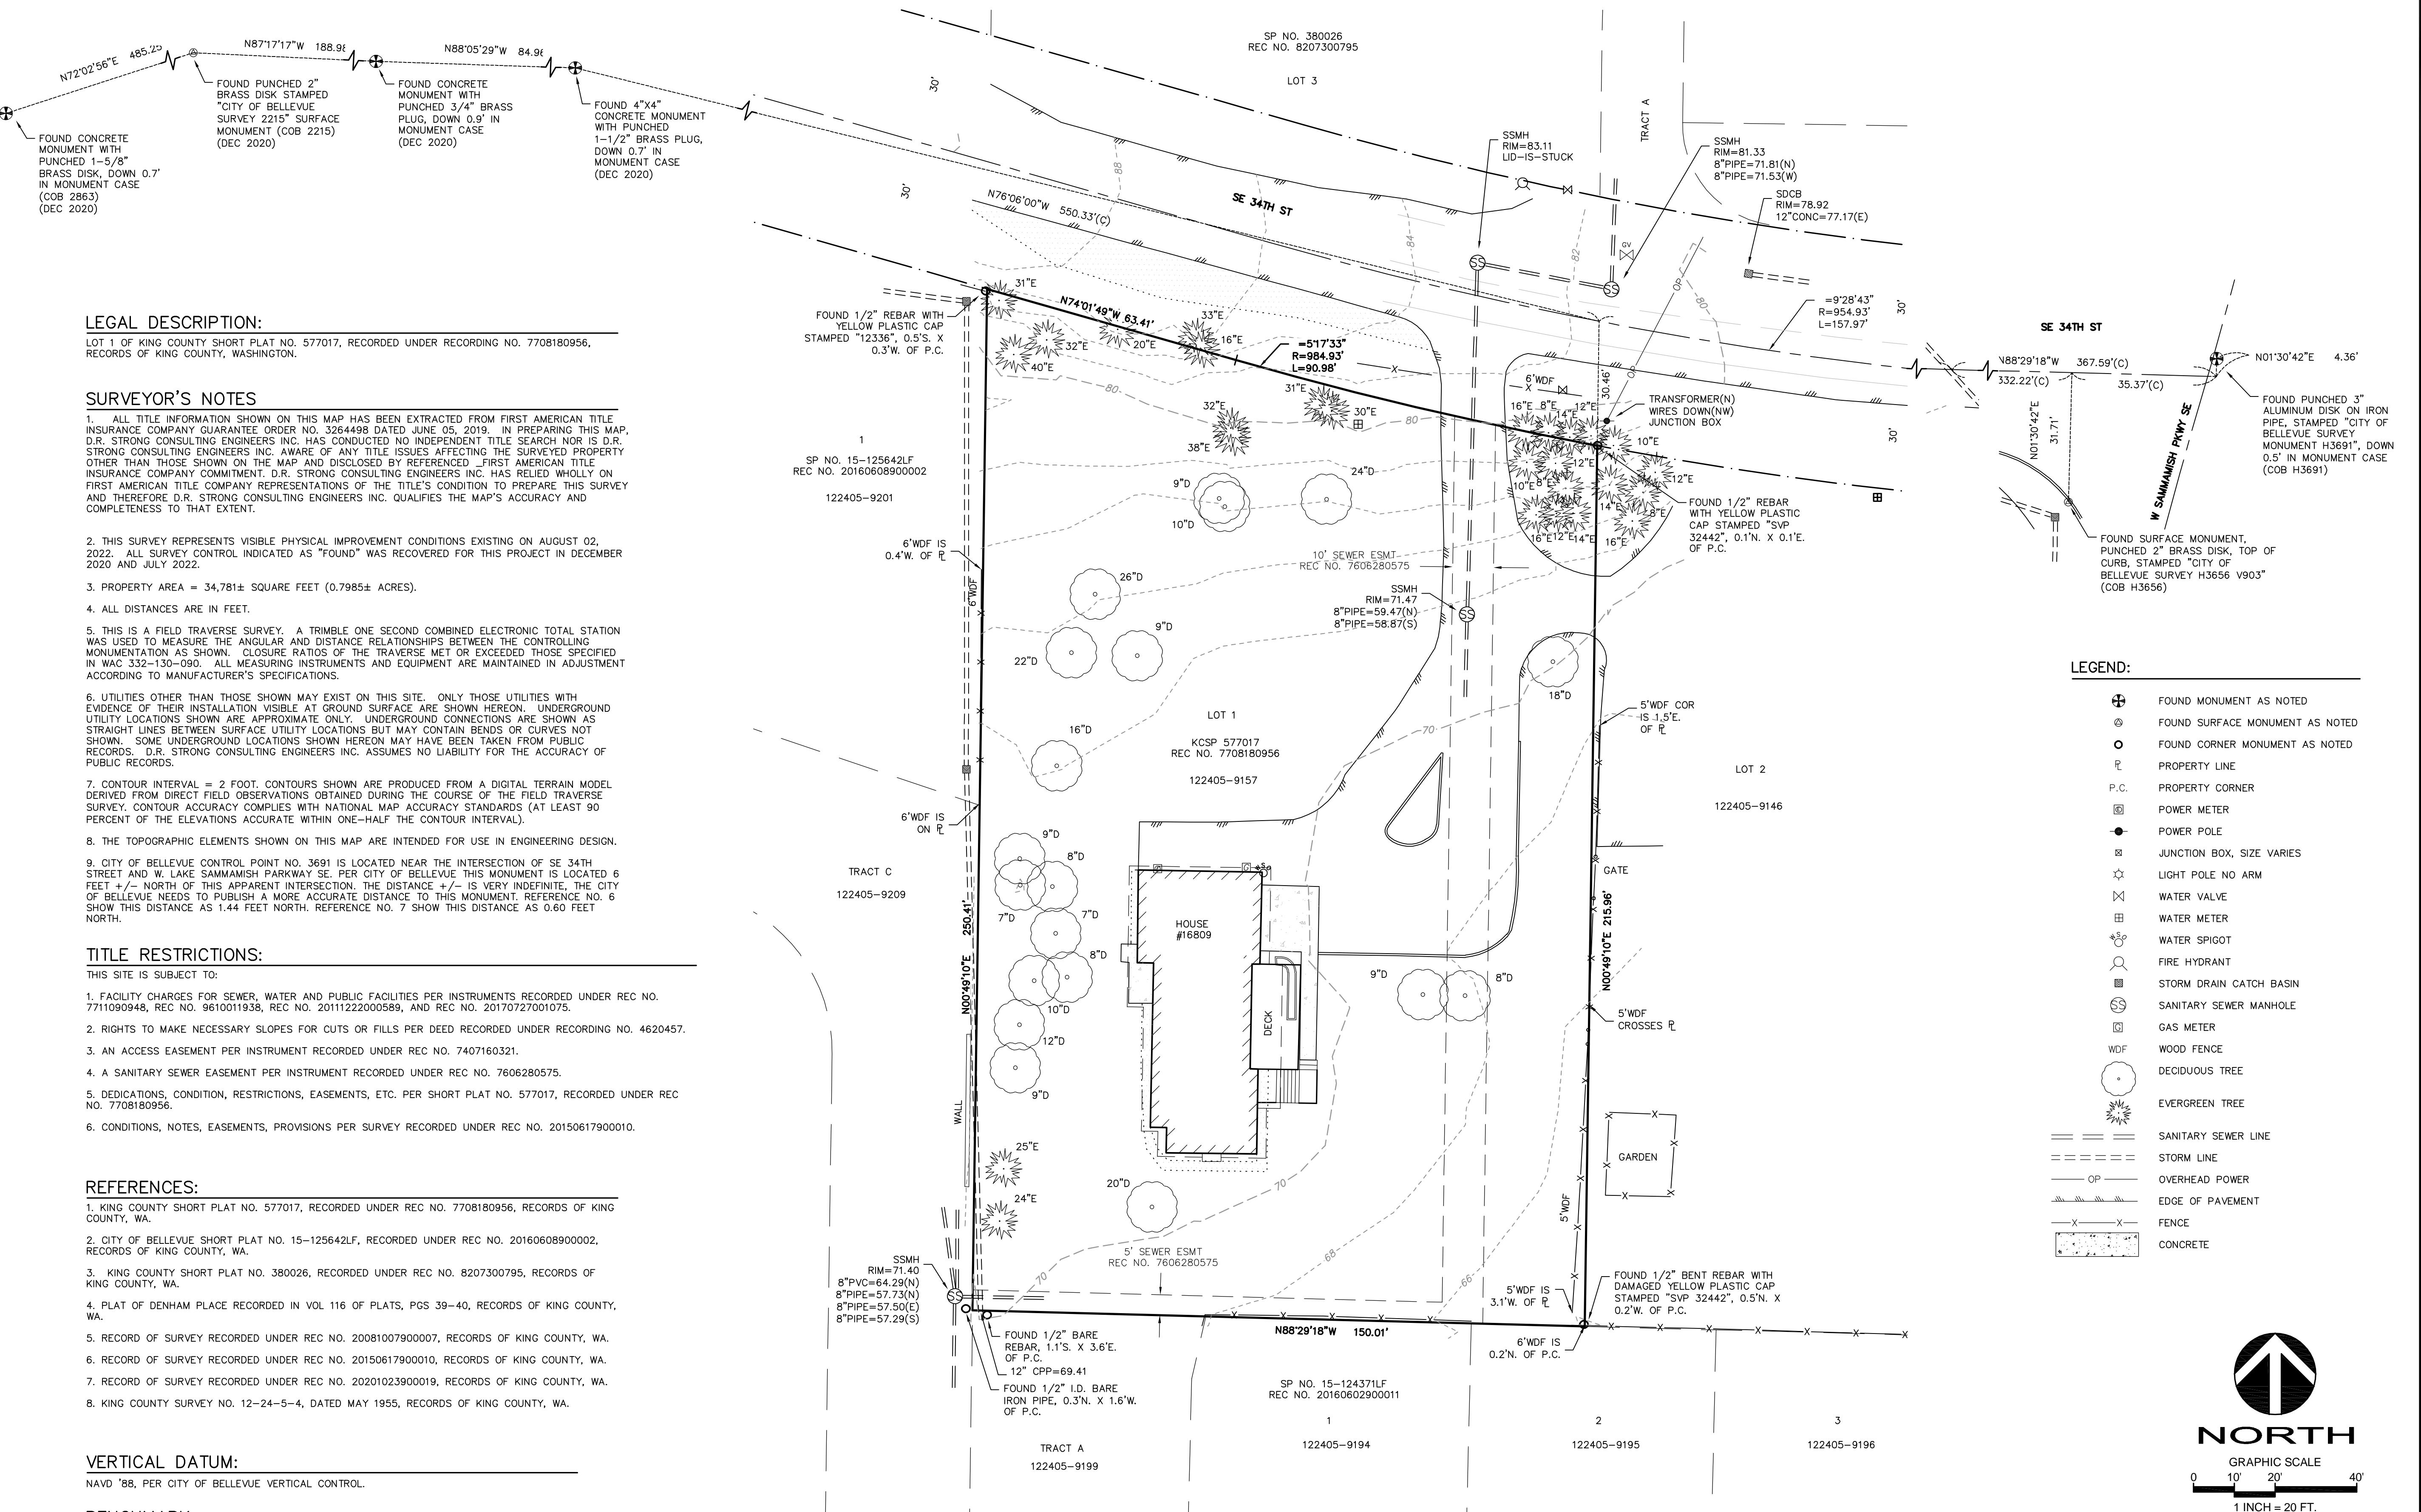
# BOUNDARY AND TOPOGRAPHIC SURVEY

A PORTION OF THE NORTHEAST QUARTER OF THE SOUTHWEST QUARTER  
SECTION 12, TOWNSHIP 24 NORTH, RANGE 5 EAST, W.M.,  
CITY OF BELLEVUE, KING COUNTY, WASHINGTON

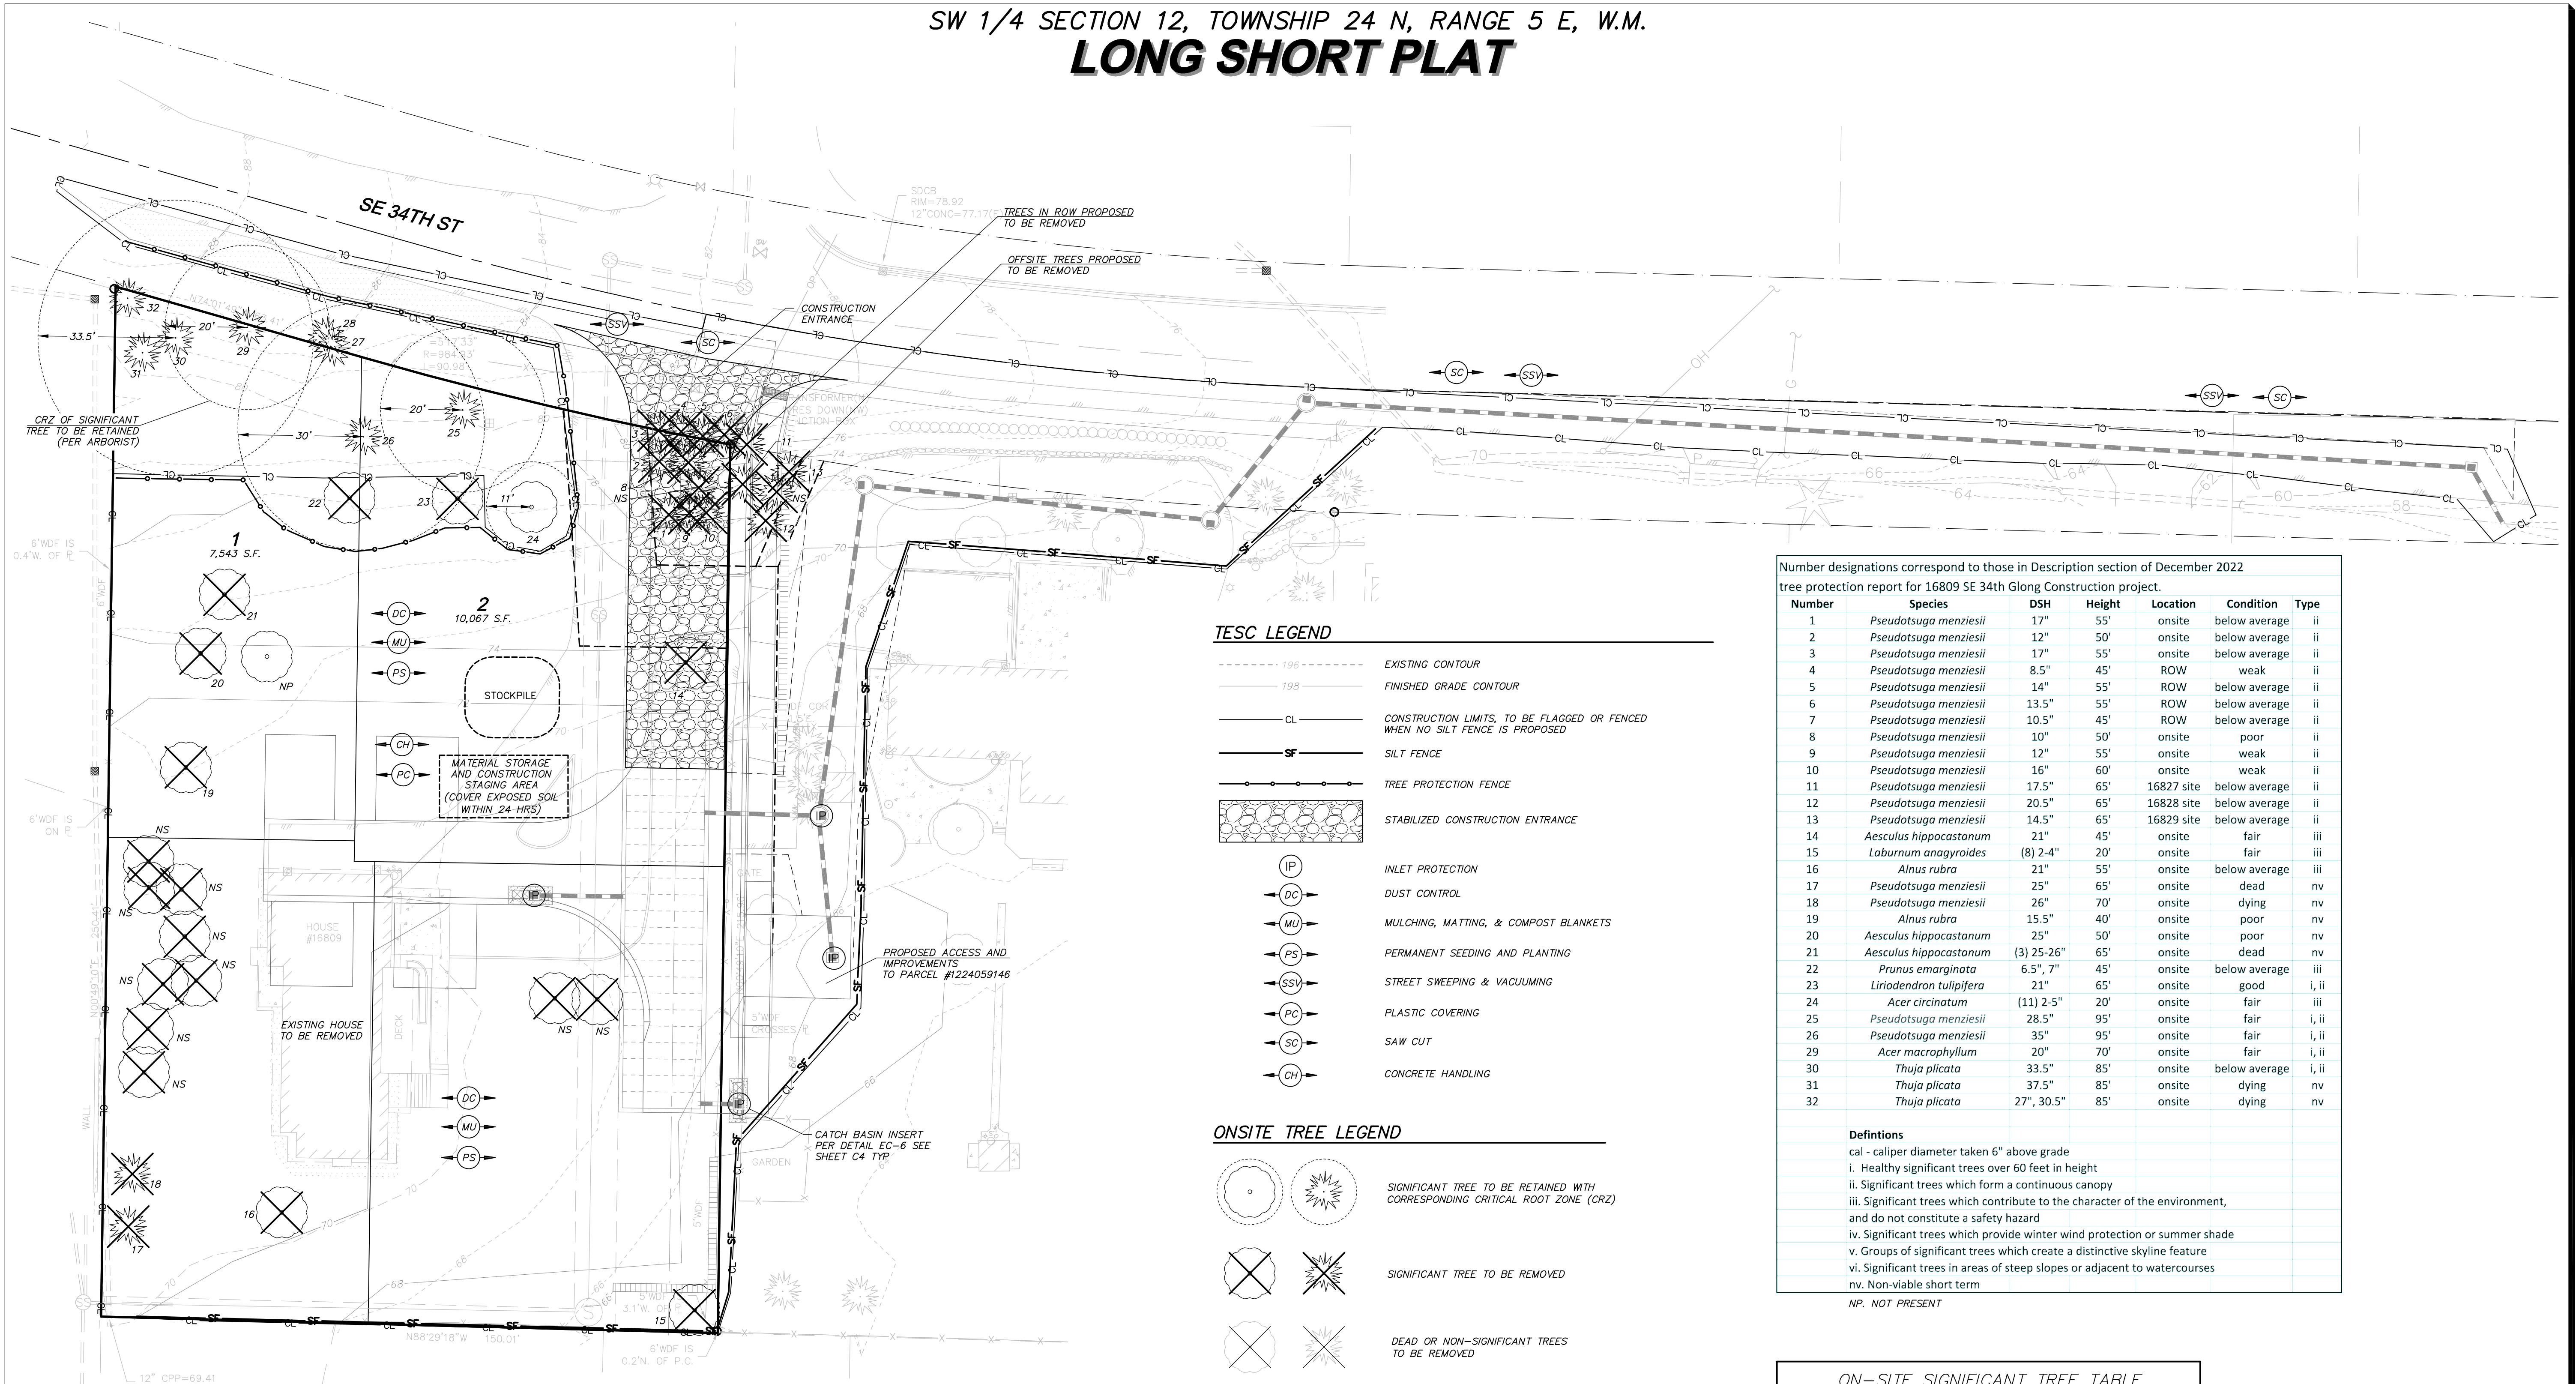
LONG SHORT PLAT  
PRELIMINARY T.E. S.C. PLAN AND  
TREE PRESERVATION PLAN  
16809 SE 34TH STREET  
BELLEVUE, WA 98008  
PARCEL NO. 1224059157

Number designations correspond to those in Description section of December 2022 tree protection report for 16809 SE 34th Glong Construction project.

Number	Species	DSH	Height	Location	Condition	Type
1	Pseudotsuga menziesii	17"	55'	onsite	below average	ii
2	Pseudotsuga menziesii	12"	50'	onsite	below average	ii
3	Pseudotsuga menziesii	17"	55'	onsite	below average	ii
4	Pseudotsuga menziesii	8.5"	45'	ROW	weak	ii
5	Pseudotsuga menziesii	14"	55'	ROW	below average	ii
6	Pseudotsuga menziesii	13.5"	55'	ROW	below average	ii
7	Pseudotsuga menziesii	10.5"	45'	ROW	below average	ii
8	Pseudotsuga menziesii	10"	50'	onsite	poor	ii
9	Pseudotsuga menziesii	12"	55'	onsite	weak	ii
10	Pseudotsuga menziesii	16"	60'	onsite	weak	ii
11	Pseudotsuga menziesii	17.5"	65'	16827 site	below average	ii
12	Pseudotsuga menziesii	20.5"	65'	16828 site	below average	ii
13	Pseudotsuga menziesii	14.5"	65'	16829 site	below average	ii
14	Aesculus hippocastanum	21"	45'	onsite	fair	iii
15	Laburnum anagyroides	(8) 2.4"	20'	onsite	fair	iii
16	Alnus rubra	21"	55'	onsite	below average	iii
17	Pseudotsuga menziesii	25"	65'	onsite	dead	nv

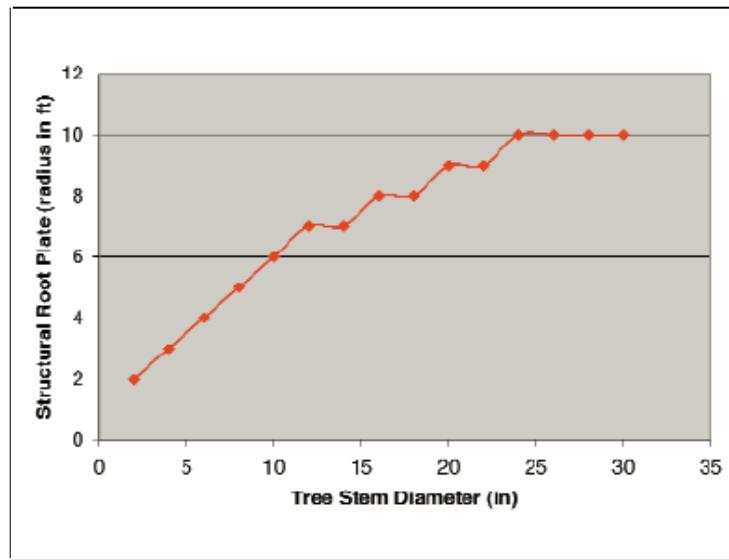
Figure 17. Size of the Structural Root Plate in relation to tree stem diameter. Note that the SRP levels off at 10' for any tree over 24" in diameter. (Coder 1996)

Typically intrusion within the Critical Root Zone is strongly discouraged by the tree care industry. However trenching type incursion, that is excavation that will occur along only one sector of a tree's CRZ, can reach significantly into the root growth area without having a detrimental long term effect. What does have to be absolutely protected is a tree's Structural Root Plate (SRP). This radial area is again related to the diameter inches of the tree in question but not quite in a direct proportion as in the CRZ. Figure 17 below illustrates the relationship.

As currently laid out the project will not cause impact on the Structural Root Plate of any tree that is slated for retention. The #17 and #18 fir trees would have had close to 10' SRPs when the 2015 development started. That work impacted both significantly and has resulted in the atrophy of the west side of their structural roots.

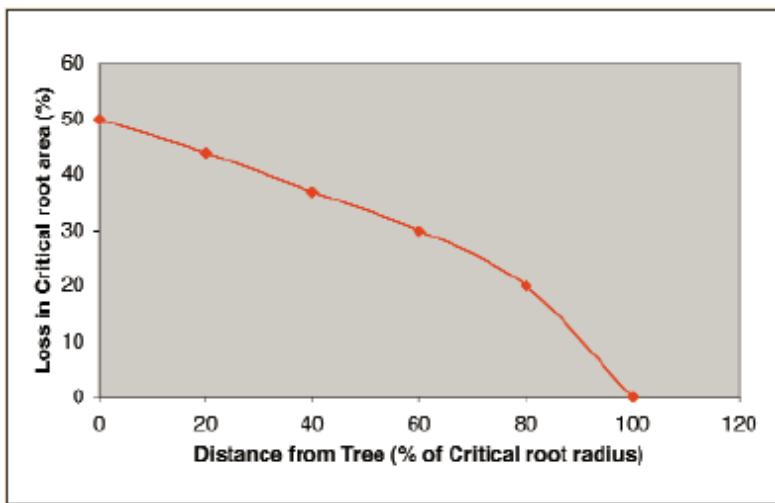
Figure 18. Chart giving the loss in critical root area as a function of the radial distance to the CRZ disturbance. (Coder 1996)

The chart shown in Figure 24 below is used to determine what percentage of a tree's Critical Root Area will be affected by trenching type incursion. In general trees can sustain losses of up to 30% of their CRA without having long term detrimental results.

Using the #31 cedar again as the example, with the building pad grading cut being 35' from the tree's base (according to the plot plan drawn by the author in the Figure 16) and it having a 37.5" DSH, there will be impact at a linear distance equal to 93% of the cedar's CRZ (35'/37.5'). The chart in Figure 18 shows that this would roughly equate to a 5% loss of the cedar's Critical Root Area (CRA) if the cut continued all the way across the theoretical root spread of the tree.

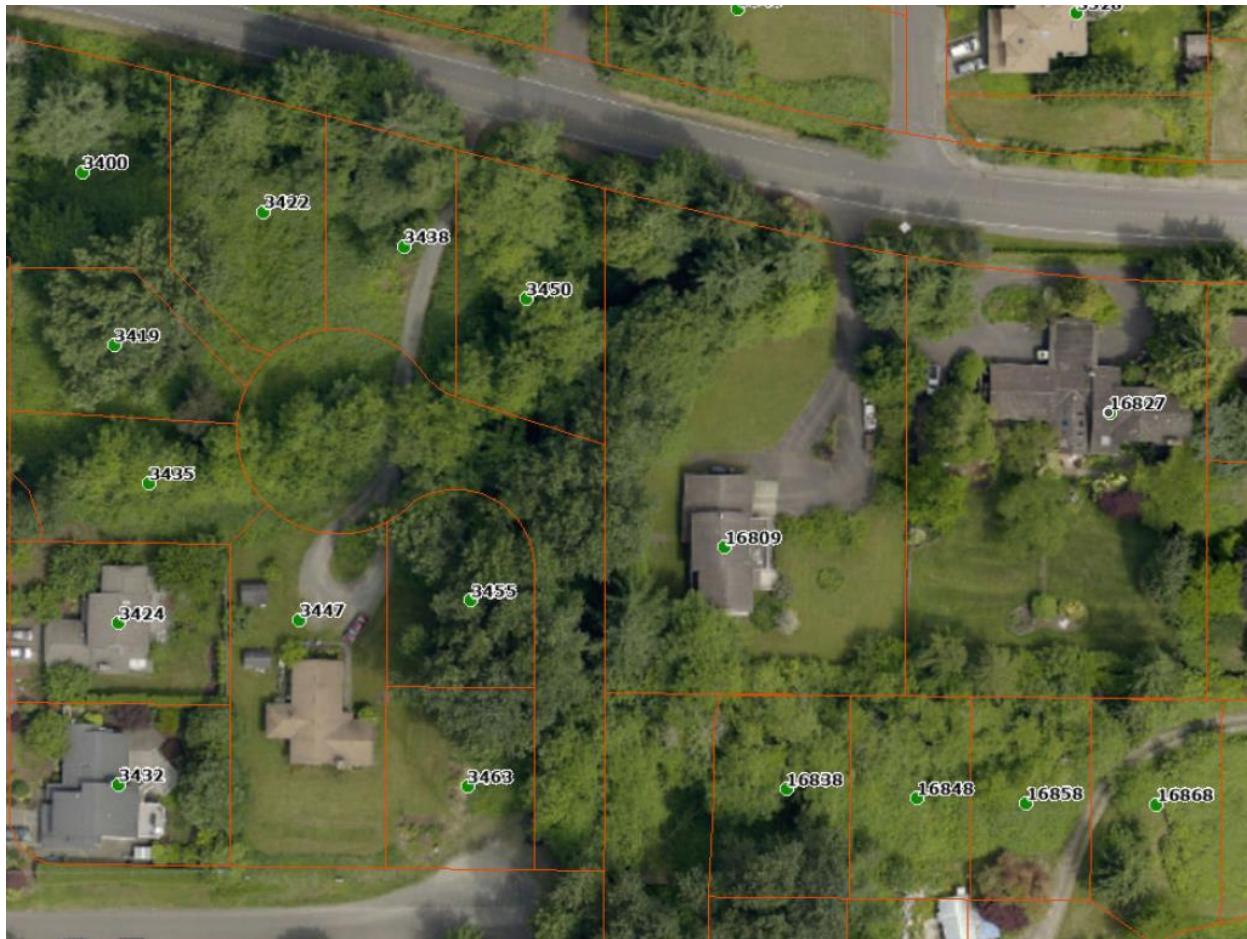
Figure 1. Aerial from 2013 showing the layout of the subject property and the surrounding area.

**Description:** The main layout of the 16809 parcel has been mostly undisturbed since the existing house was built in 1977. The lot shares its east side and main entry drive with the 16827 property next door (Figure 1). The areas to its west and south were sub-developed starting in 2015 with the last houses being finished in 2018 (Figures 2 and 3). The clearing and grading work came right to edge of the shared property lines over the entire south side and most of the west side.

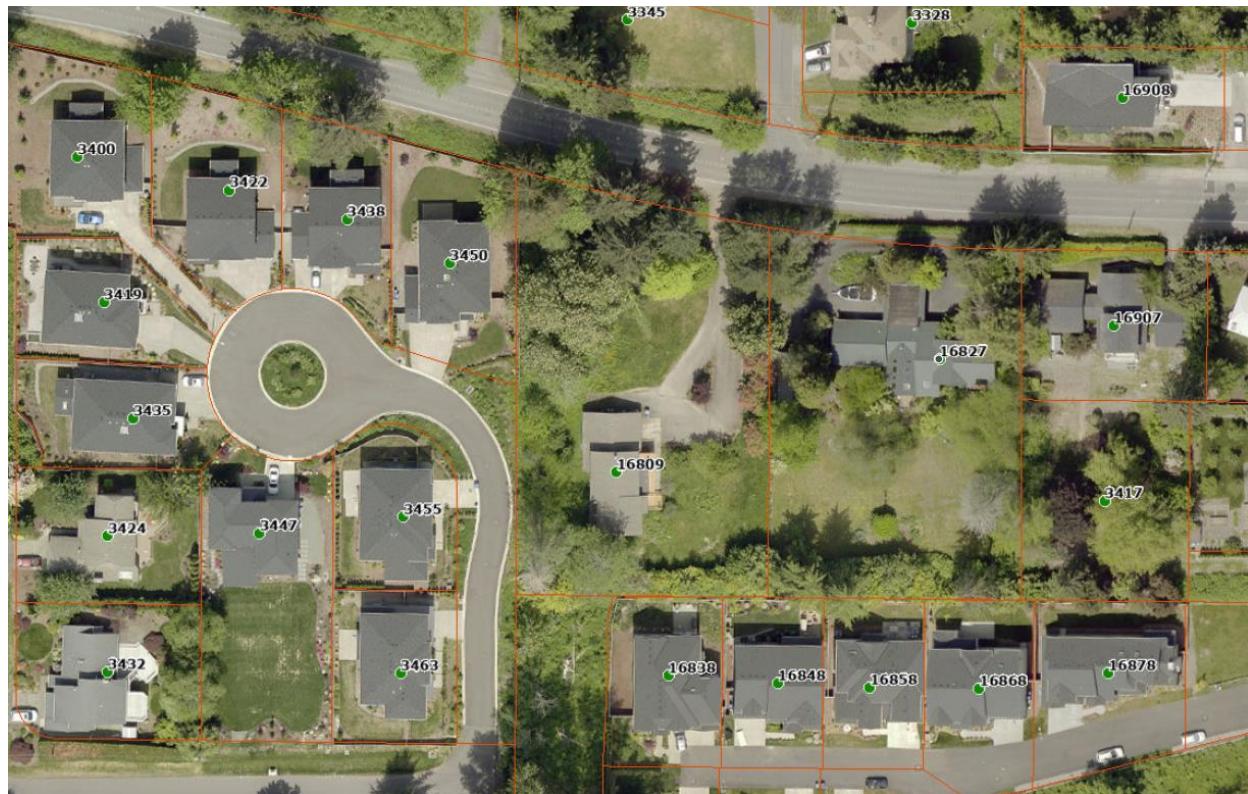
Figure 3. Aerial from 2019 showing the finished developments on the west and south side of the subject property.

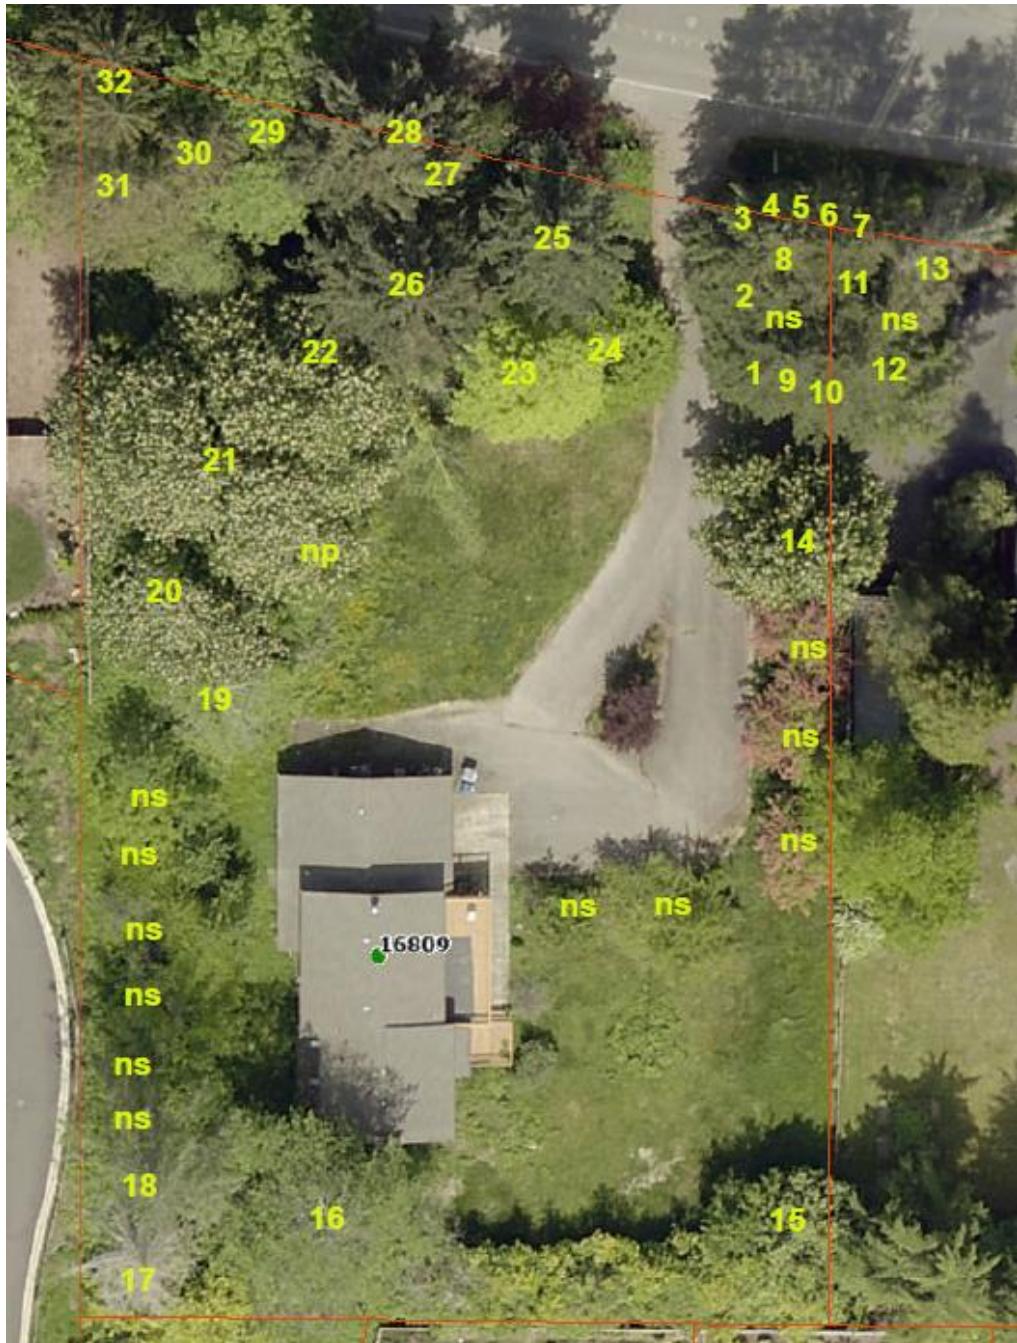
Figure 4. Aerial view showing the approximate location of the trees listed in the description section (yellow numerals). The red lines indicate the position of the property lines but may not match surveyed lines exactly. The two letter terms stand for non-significant (ns) and not present (np). The 'np' tree was flattened by the second section of the #21 tree that failed.

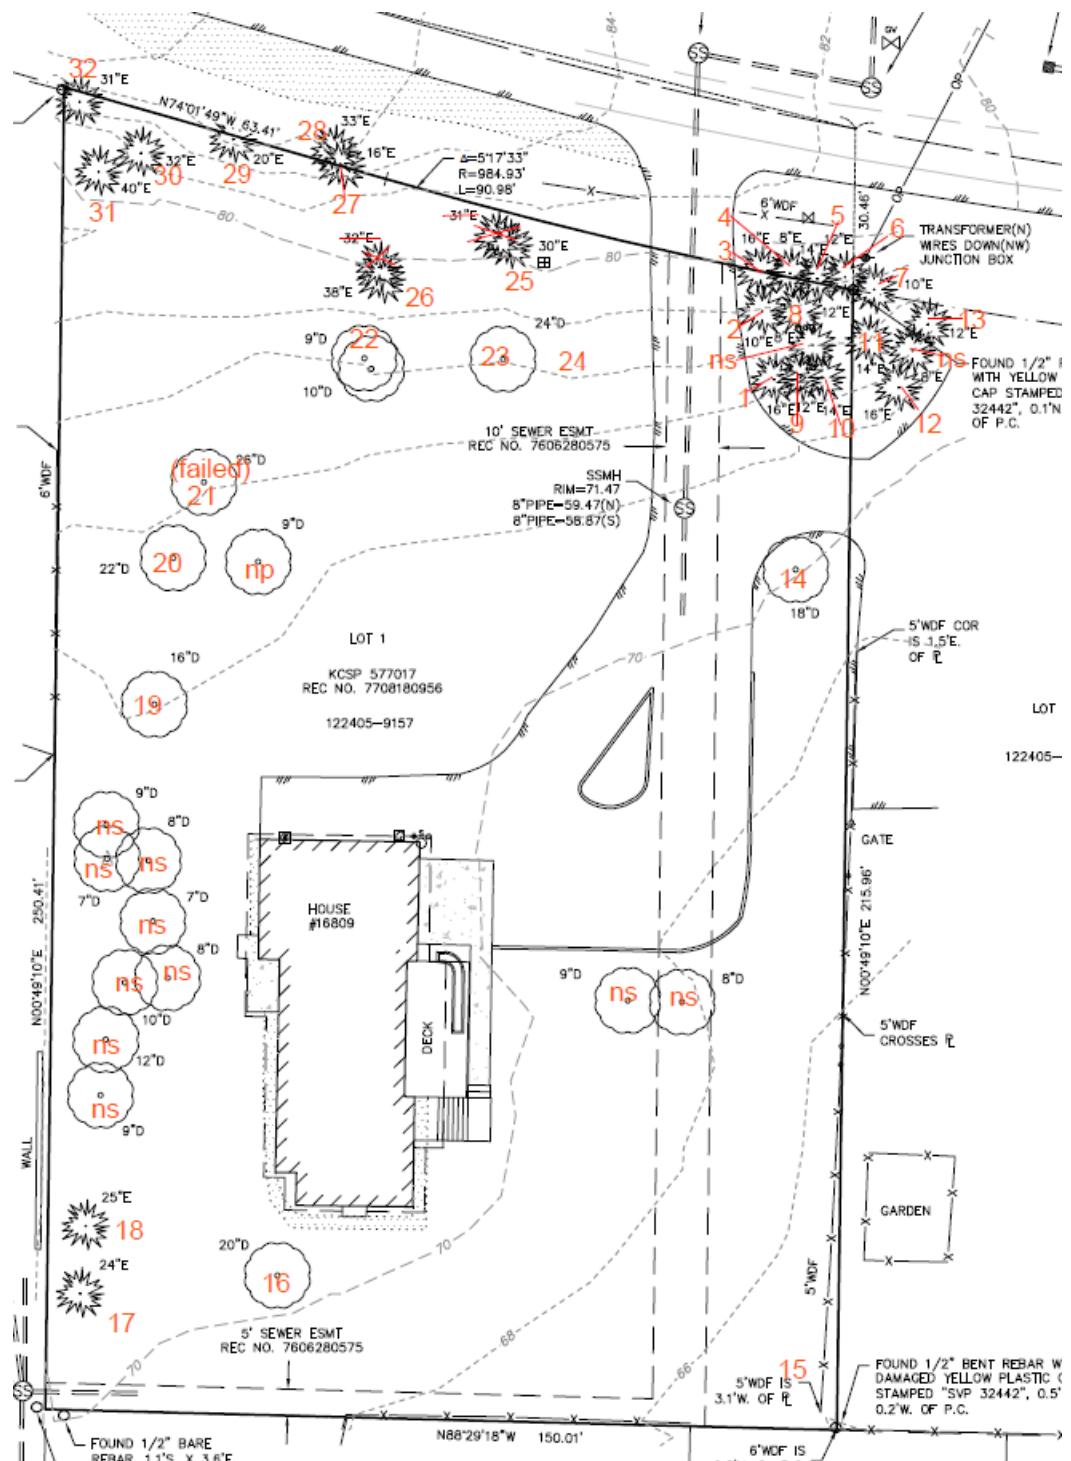
Figure 5. Excerpt from survey with the trees labeled. Note the #15 and #24 trees are only indicated by their numerals and may not be exactly placed.

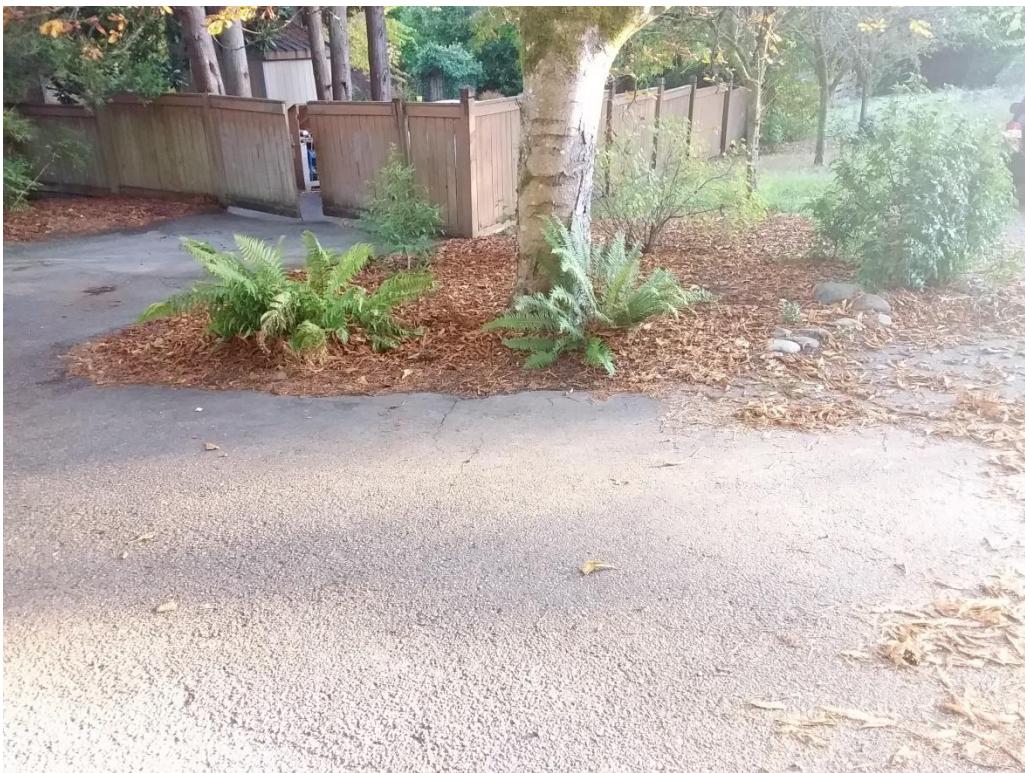
Figure 7. Looking SSE at the placement of the #14 chestnut from the entry to the 16827 driveway.

14. European Horse chestnut (*Aesculus hippocastanum*) 21" DSH, 45' tall, 16' radial spread in fair condition. Tree appears to be fighting off anthracnose. The tree stands at the end of a peninsula like landscape island where the entry drive splits between the subject and the 16827 properties (Figure 7). The subject side is 4.5' W of the tree and the end of the peninsula widens to 5' away and then as it turns the corner into the 16827 property it is 11' out from the base of the tree.

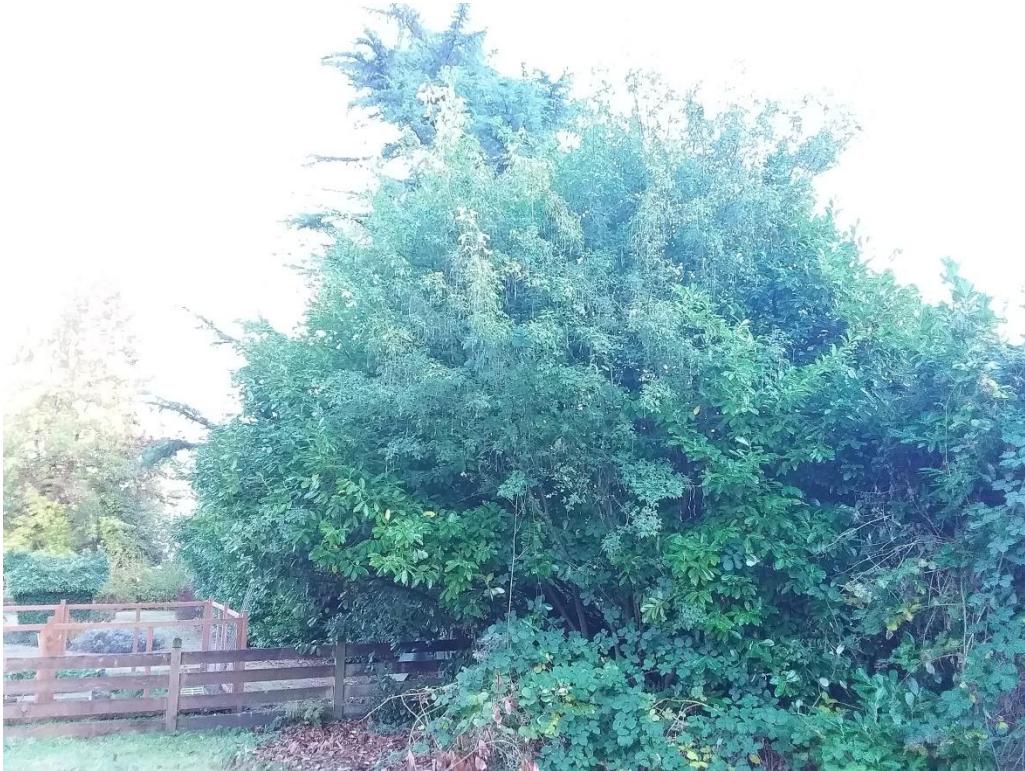
Figure 8. Looking SE at the #15 Golden Chain standing in the NE corner of the lot. It is getting overrun by the laurel and blackberries.

15. Golden Chain (*Laburnum anagyroides*) standing 15' N of the south fence and 12' W of the east fence (Figure 8). The tree tipped over at some point, re-rooted, and is now growing up into the 20' range. Eight 2-4" DSH stems are present and the canopy spreads amorphously because of the pressure of the large English Laurel behind it. Fair health.

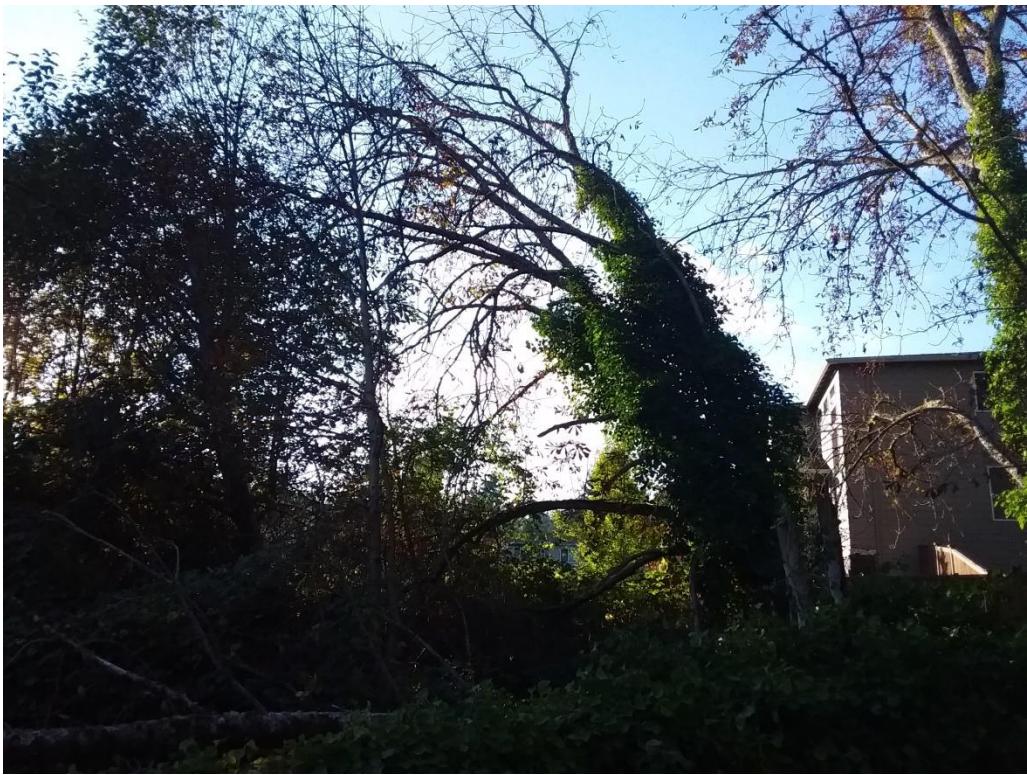
Figure 10. Looking west at the #20 chestnut showing its marked lean.

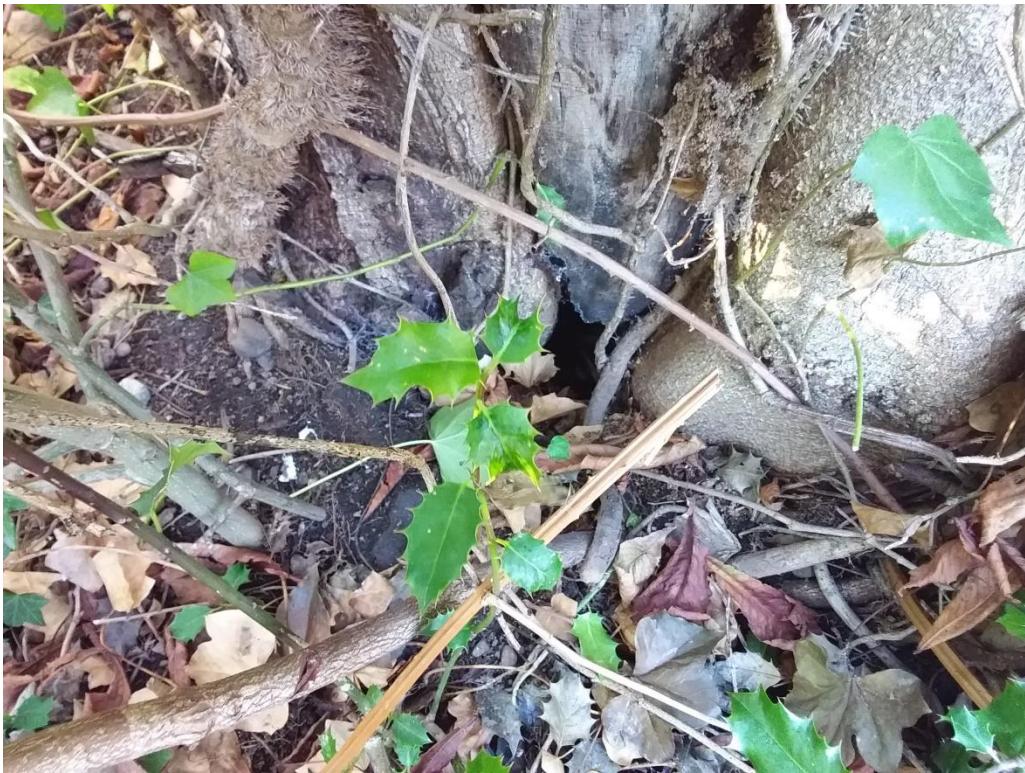
Figure 11. Hollow with decay at the base of the #20 tree.

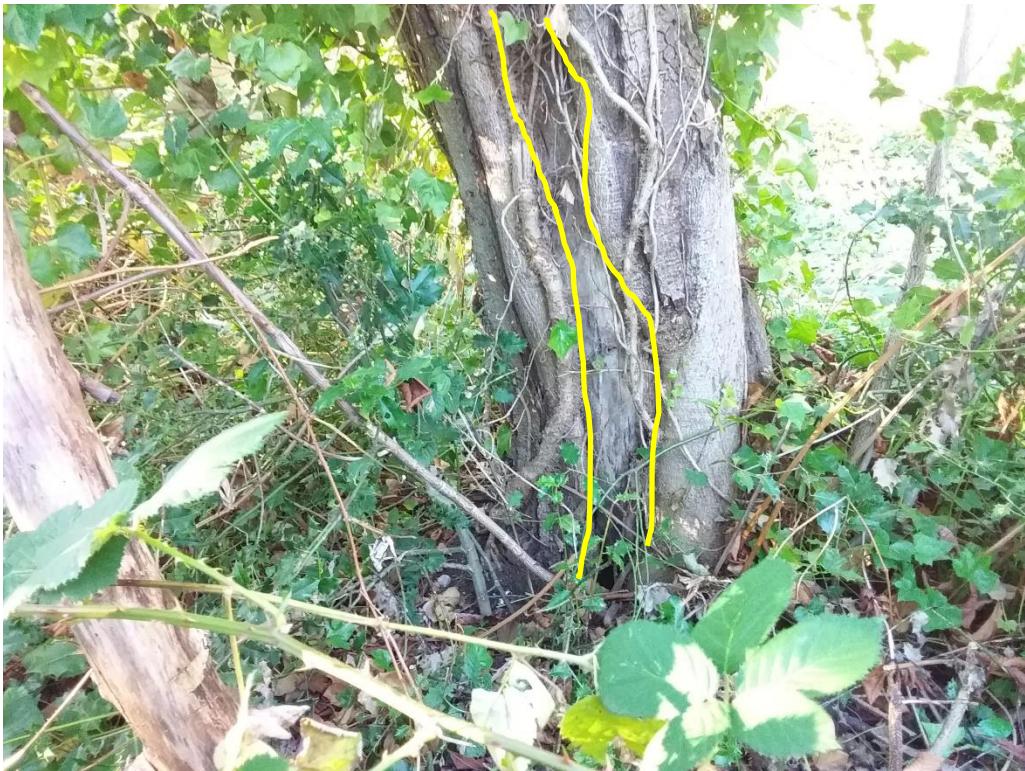
Figure 12. Base of the #20 stem showing the atrophy starting from the hollow at the base. Large ivy vines are running up the area.
