**City of Bellevue  
Development Services Department  
Land Use Staff Report**

**Proposal Name:** Long Short Plat

**Proposal Description:** Application for Preliminary Short Plat approval to subdivide a 34,781 square foot (SF) lot (approx. 0.8 acre) into 4 single-family building lots located in the R-5 land use district.

**File Number:** 23-100107-LN

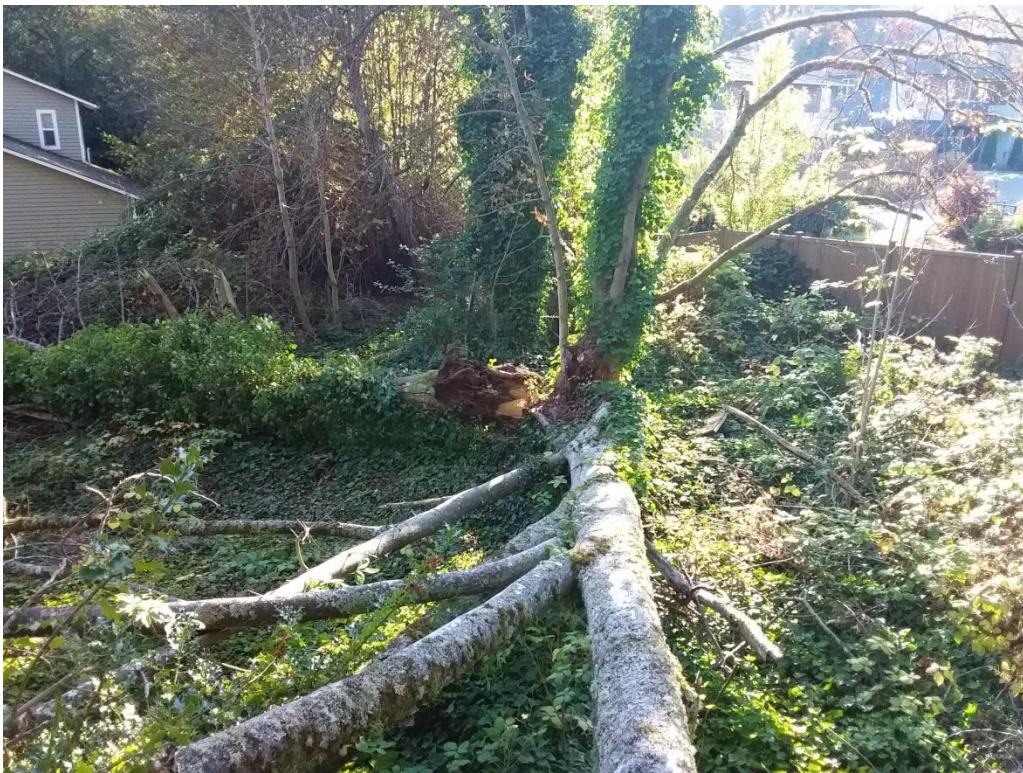
Figure 13. Looking SSW at the base of the #21 chestnut standing near the center of the first failed stem. The base of the second is in the center of the photo with its trunk reaching to the left.

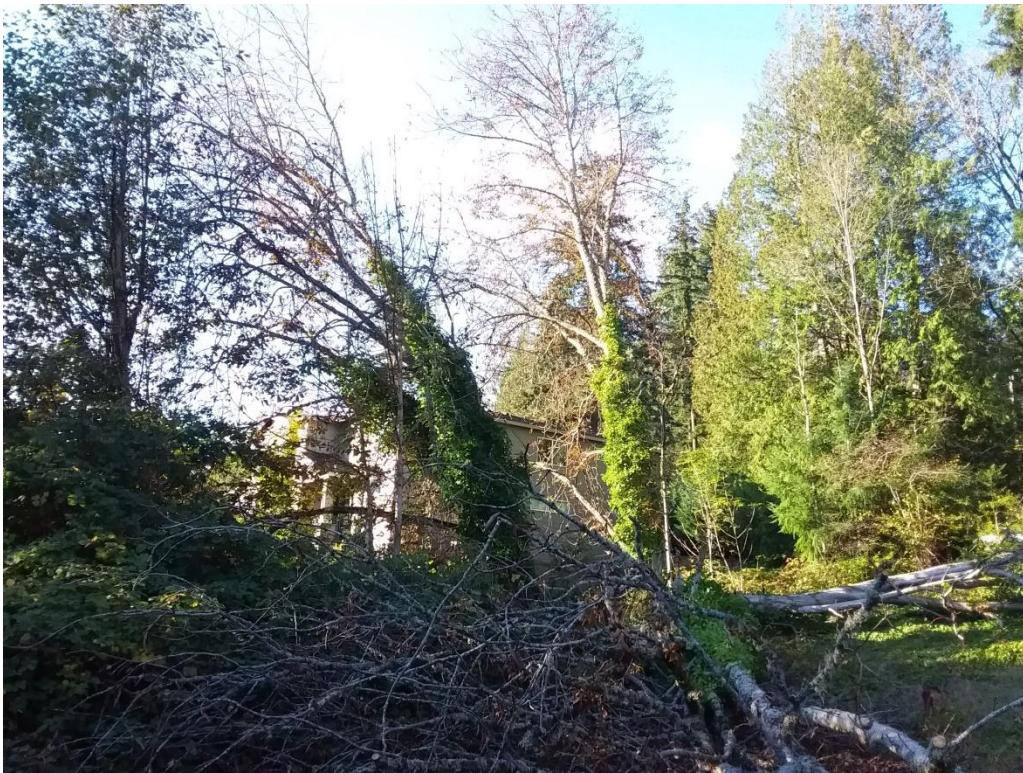
Figure 14. The last section of the #21 tree at background center shown leaning toward the west side neighbor's house. The first failed section is stretching out to the right of the photo. The end (top) of the second failed section is in the foreground. The #20 tree is at the center left side.

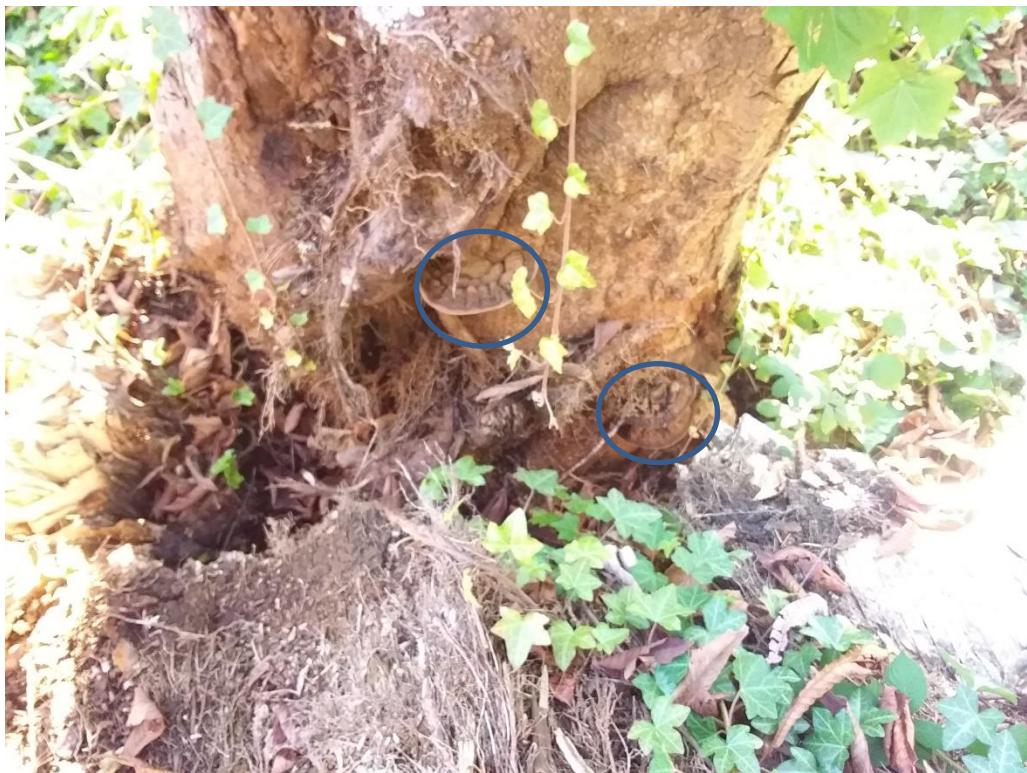
Figure 15. Looking down into the center of the base of the #21 tree. Note the Ganoderma fruiting bodies.

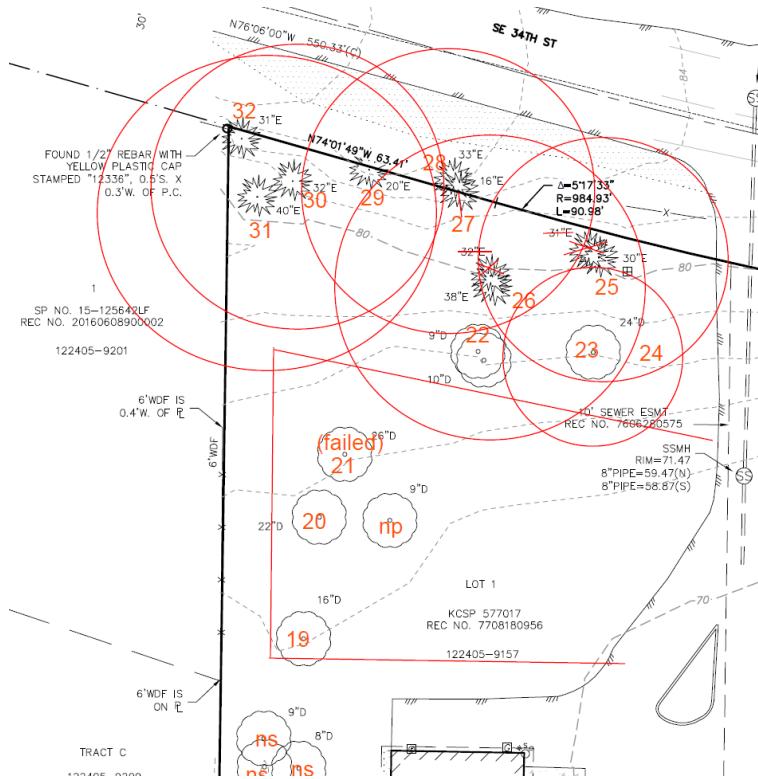
Figure 16. Excerpt from the survey showing CRZ circles for the north end trees and an outline of a building pad concept drawn by the author that creates an acceptable impact limit for them.

Using the #31 cedar again as the example, with the building pad grading cut being 35' from the tree's base (according to the plot plan drawn by the author in the Figure 16) and it having a 37.5" DSH, there will be impact at a linear distance equal to 93% of the cedar's CRZ (35'/37.5'). The chart in Figure 18 shows that this would roughly equate to a 5% loss of the cedar's Critical Root Area (CRA) if the cut continued all the way across the theoretical root spread of the tree.

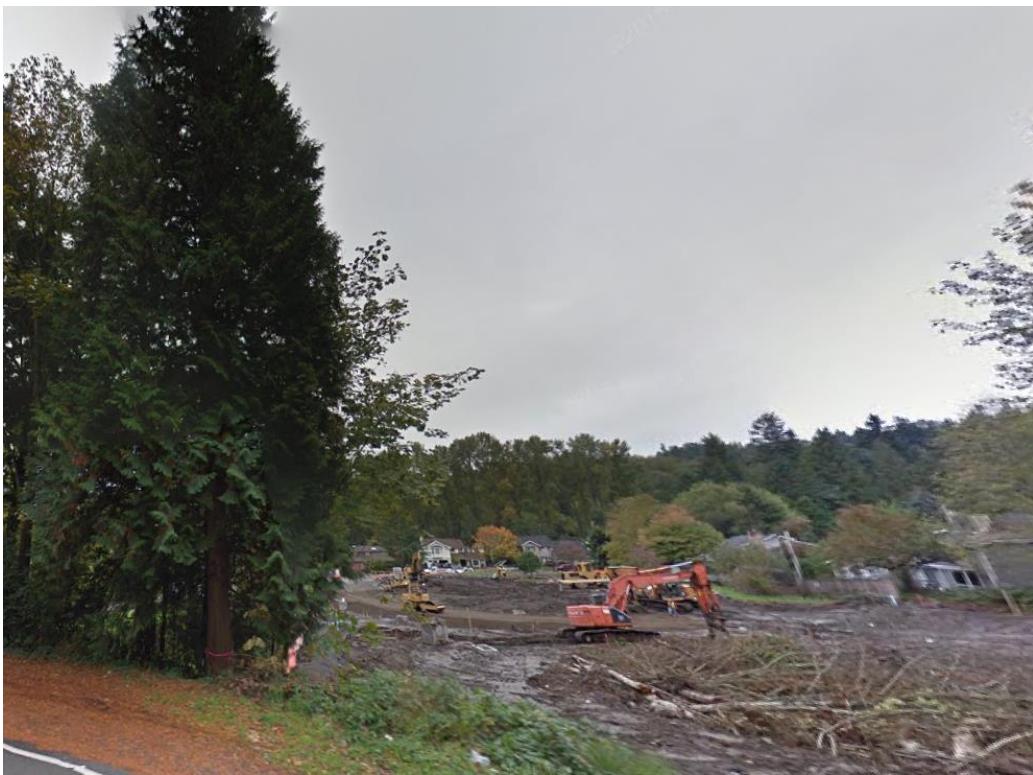
Figure 19. Google Street View image from 2015 showing clearing and grading on west side of the #31 and #32 cedars (left side of photo). Note dense, dark green canopies on the trees. There is no evidence of any tree protections present.

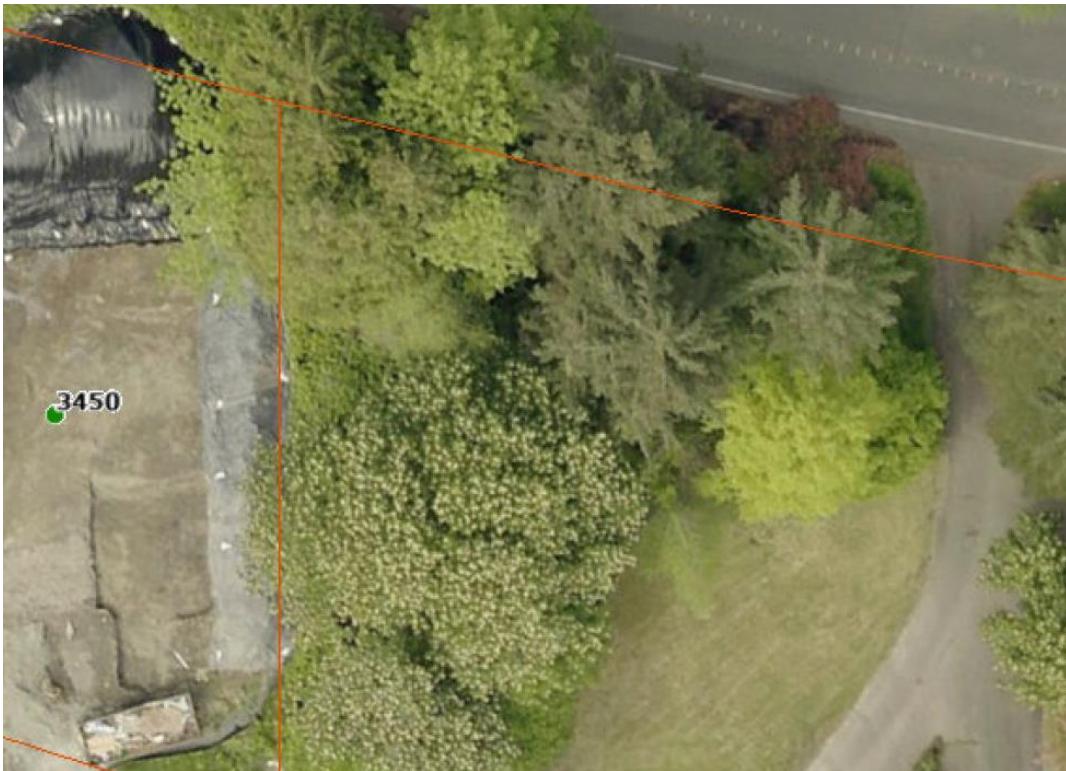
Figure 20. Aerial imagery from 2017 showing clearing and grading encroachment from the west side construction.

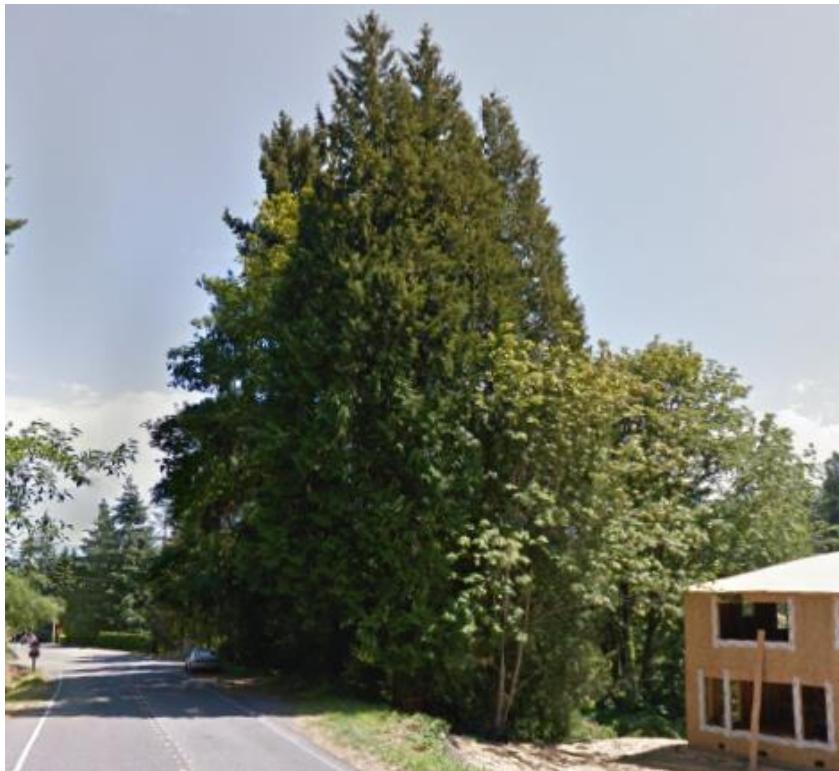
Figure 21. Street View image from 2017 showing conditions of cedars.

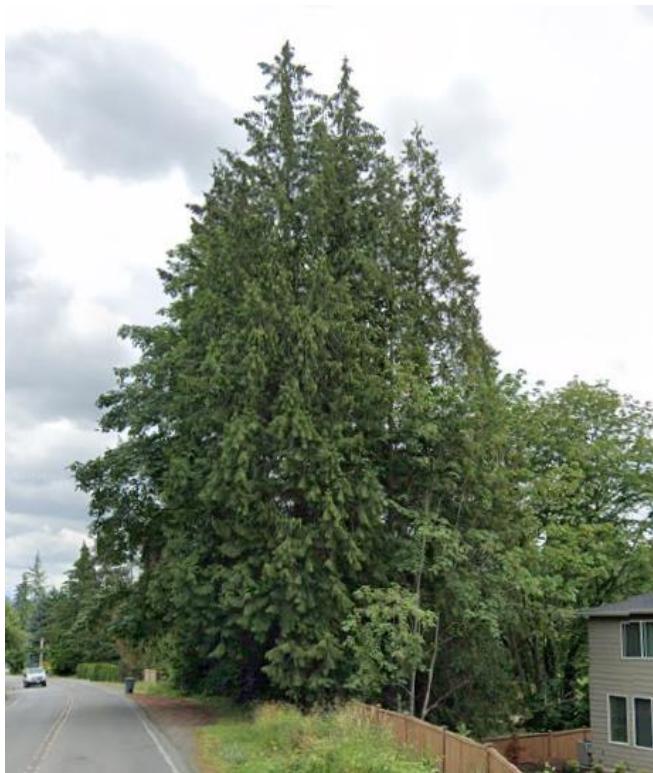
Figure 22. Street View from 2018 clearing showing the canopies thinning especially on the #31 cedar at the right edge of the stand.

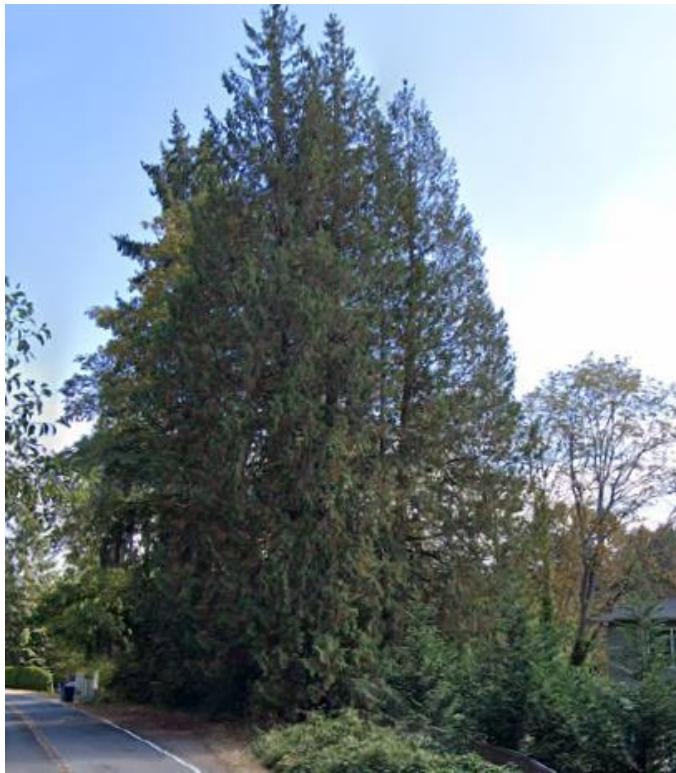
Figure 23. Street View image from 2021 showing discoloration in the canopies of the #31 and #32 cedars and extreme thinning.

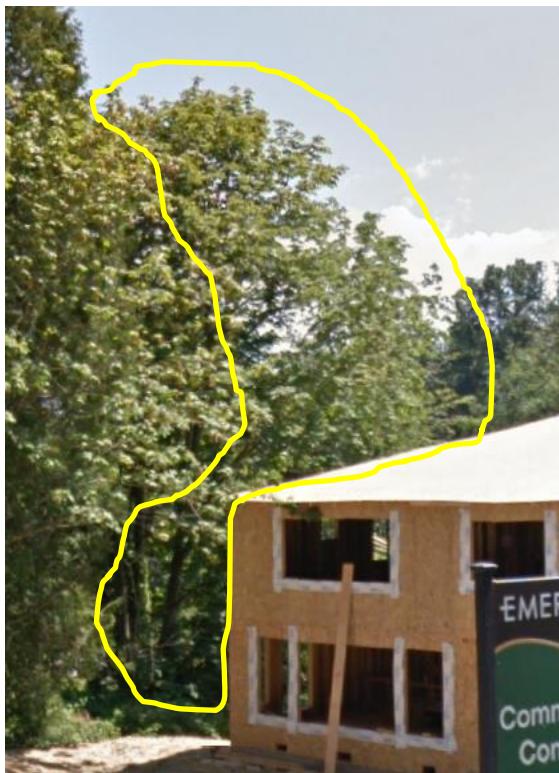
Figure 24. Street View imagery from 2017 showing the #21 chestnut. A young maple hides part of its canopy at the left side of the photo.

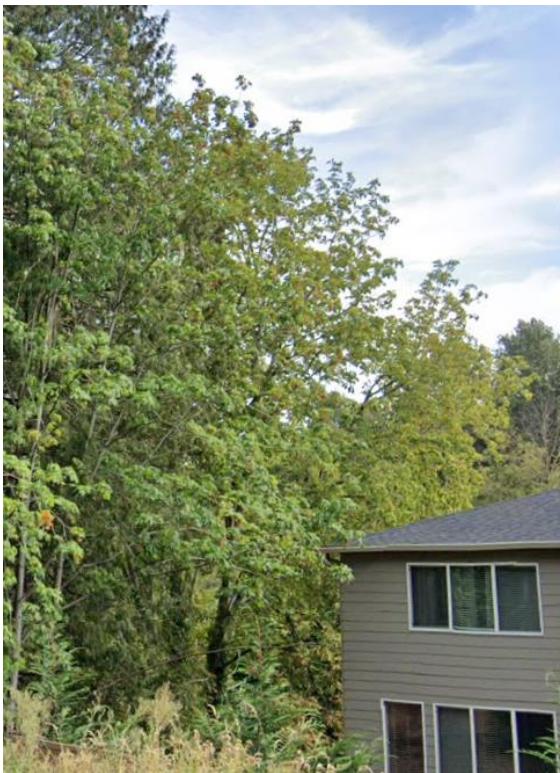
Figure 25. Street View imagery from August 2019 showing discoloration and thinning canopy on the #21 chestnut.

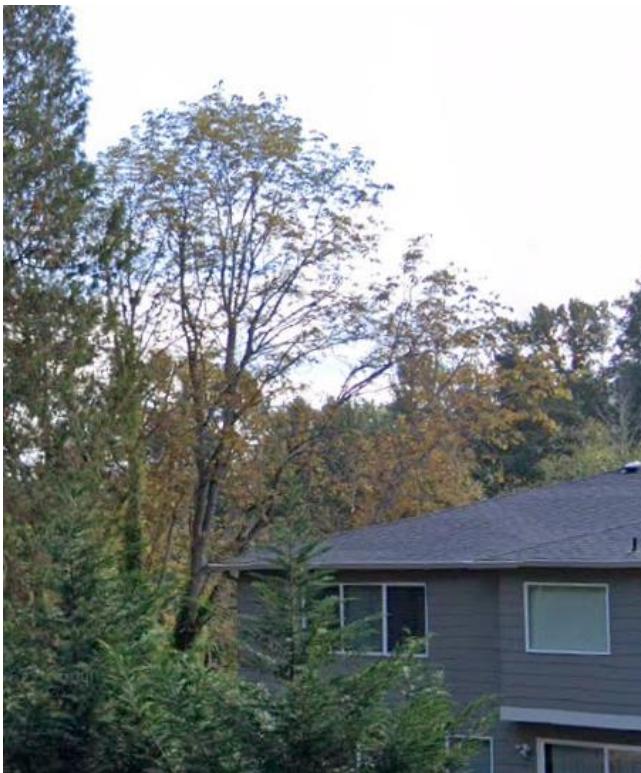
Figure 26. Street View image from September 2021 showing the #21 tree in obvious distress.
