**City of Bellevue
Development Services Department
Land Use Staff Report**

Proposal Name: Luo Residence

Proposal Description: Critical Areas Land Use Permit to restore unpermitted vegetation clearing and retaining wall construction within a Type-F stream buffer, category III wetland buffer, and 100-year floodplain.

File Number: 22-116548-LO

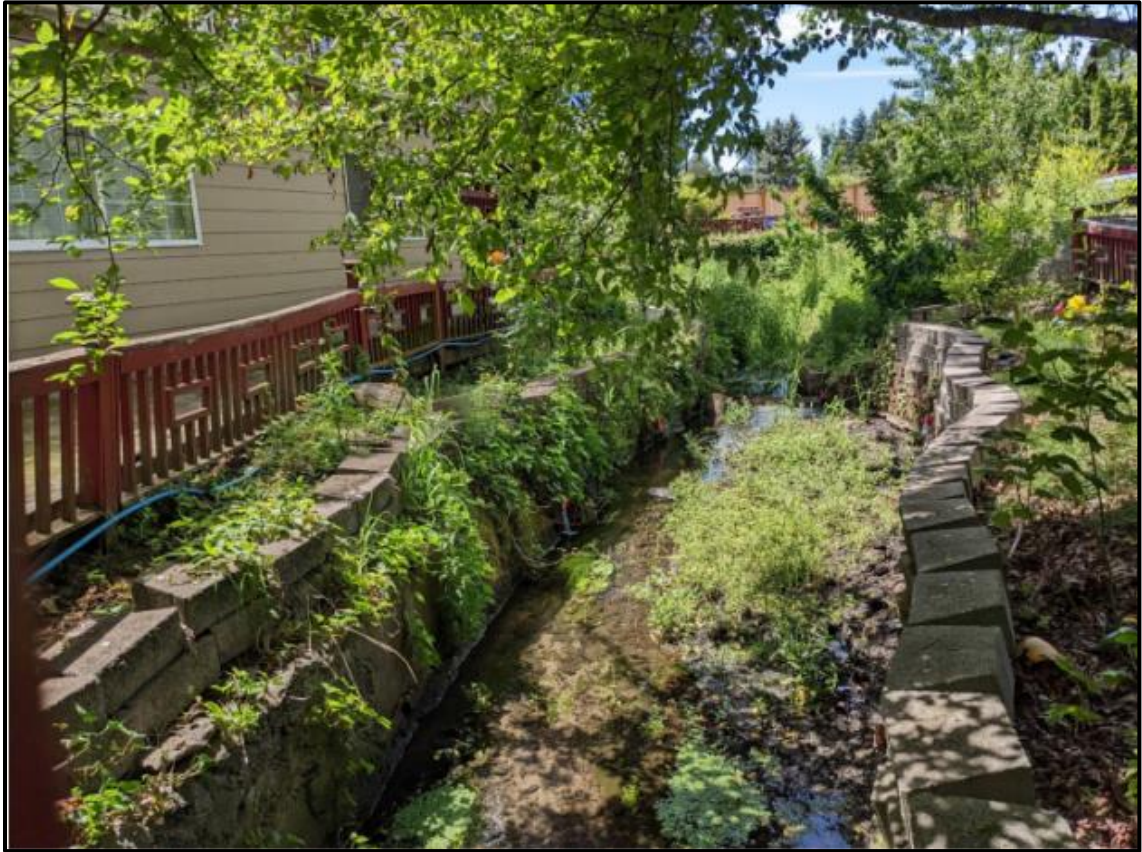
constructed in 1961 but has since undergone a series of remodels. The site contains Sunset Creek (Type-F stream), a category III wetland, 100-year floodplain, and their respective buffers. The existing single-family home and improvements are located within the stream and wetland buffers. Vegetation on the site contains a mixture of cottonwood (*Populus trichocarpa*), Douglas-fir (*Pseudotsuga menziesii*), western redcedar (*Thuja plicata*) and other ornamental trees and shrubs. Unpermitted pruning of a large cottonwood, retaining wall expansion, and new retaining wall installation within the on-site critical areas and buffers were identified in an enforcement action (COB 19-112949-EA). Areas of the 100-year floodplain, stream buffer, and wetland buffer are degraded with existing improvements associated with the house, non-native vegetation, ornamental shrubs, and invasive species. The site soils have been identified as Alderwood gravelly sandy loam (AgC) and Arents, Alderwood material (AmC) according to the USDA NRCS (2021) Web Soil Survey. See Figure 2 and Figure 3 below for the current site conditions and improvements.

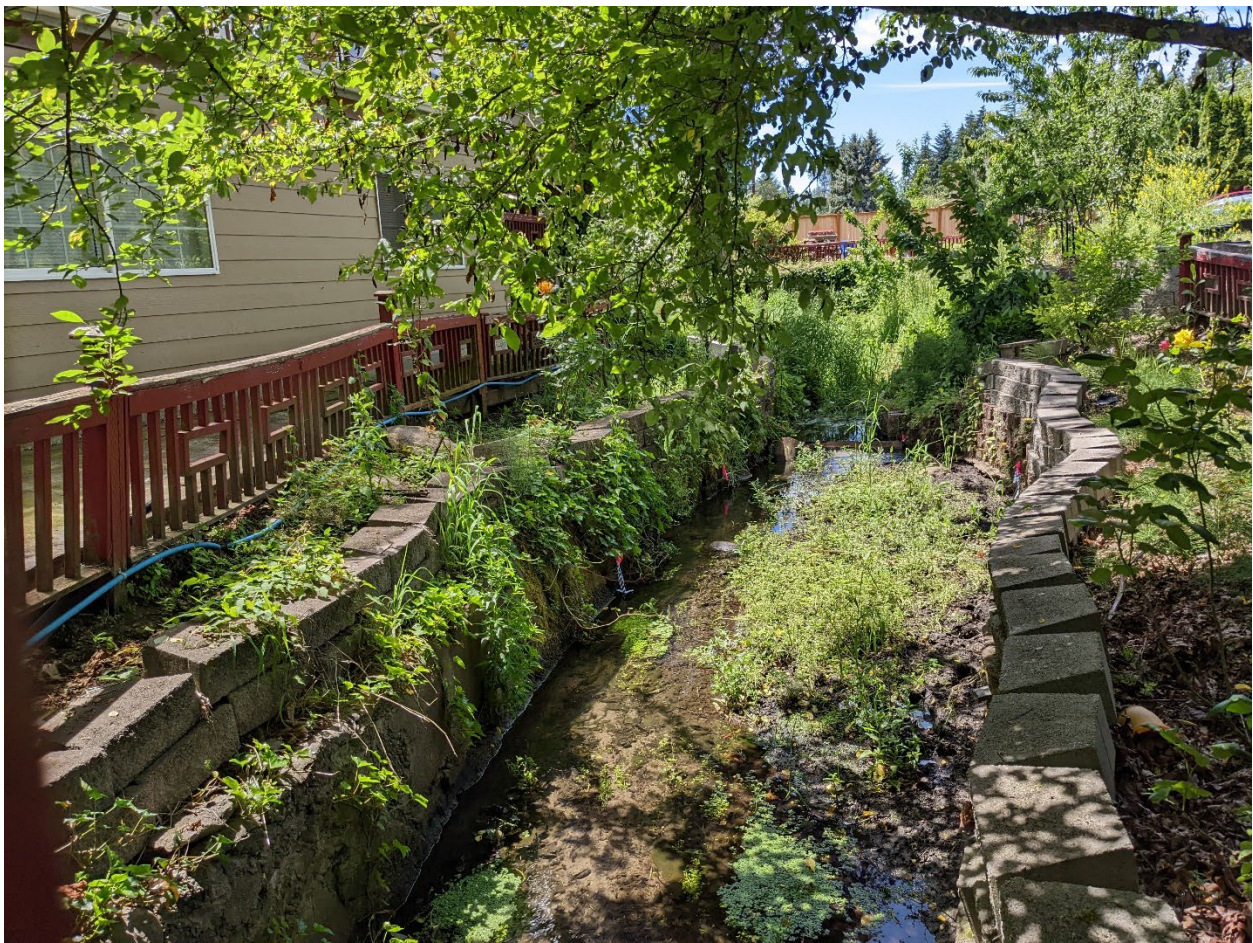
One stream, Sunset Creek, is present on the subject property. Sunset Creek has documented fish presence, including Coho salmon, which qualifies it as a Type F water. No ESA-listed salmonids are documented as currently inhabiting the stream. Within the property, Sunset Creek is approximately 10 feet in width and is armored and channelized by a concrete modular block

wall. There is minimal channel complexity and stream conditions are generally consistent throughout the site. Streambed substrate is primarily unconsolidated fine sediments and high amounts of silts. Sunset Creek is believed to be permanently flowing and contains riverine wetlands within the OHWM that have accumulated organic matter in soils on low terraces that appear to flood frequently. Sunset Creek enters the site through a culvert from the east and exits the site through a culvert to the west. The western culvert spans approximately 340 feet before resurfacing and soon angles to a northerly direction where it crosses I-90 and eventually flows into the Mercer Slough and Lake Washington. The OHWM was delineated and marked on both sides of the Sunset Creek blue and white striped flags labeled WMA-1L through WMA-18L (left bank) and WMA-1R through WMA-18R (right bank).

Figure 2. Sunset Creek.

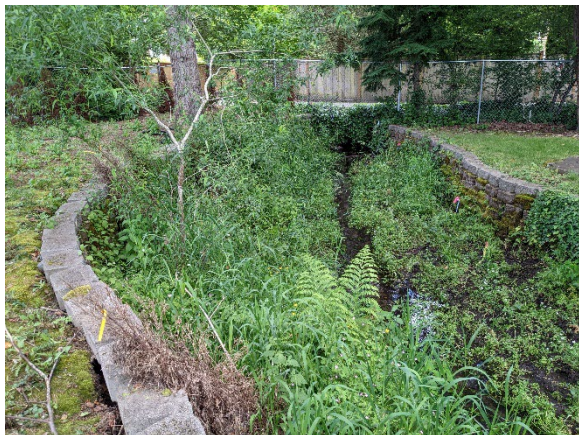
THE WATERSHED COMPANY		WETLAND A – Assessment Summary								
Location:		Within the channel of Sunset Creek								
WRIA / Sub-basin:		WRIA 8 / Mercer Slough sub-basin

2014 Western WA Ecology Rating:			Category III					
		Buffer Width and Structure Setback:			Buffer: 110 Feet Structure setback: 15 Feet					
		Wetland Size:			1,866 feet					
		Cowardin Classification(s):			Emergent					
		HGM Classification(s):			Riverine					
		Wetland Data Sheet(s):			DP-1					
		Upland Data Sheet (s):			DP-2					
		Flag Color:			Pink and black stripe					
		Flag Numbers:			A1 through A4					
Vegetation	Tree stratum:	n/a								
	Shrub stratum:	n/a								
	Herb stratum:	Water parsley, watercress, American veronica, reed canarygrass								
Soils	Soil survey:	Alderwood gravelly sandy loam and Arents and Alderwood material								
	Field data:	Redox dark surface								
Hydrology	Source:	Sunset Creek

Field data:	Surface water, high water table, saturation								
Wetland Functions										
	Improving Water Quality			Hydrologic		Habitat				
Site Potential	H	M	<u>L</u>	H	<u>M</u>	L	H	M	<u>L</u>	
Landscape Potential	<u>H</u>	M	L	<u>H</u>	M	L	H	M	<u>L</u>	
Value	H	M	<u>L</u>	<u>H</u>	M	L	<u>H</u>	M	L	TOTAL
Score Based on Ratings	5			8			5			18
Description and Comments										
The Wetland A boundary is coincident with the Sunset Creek boundary except as designated by Flags A1, A2, A3, and A4 which connect to the nearest exteriorly located OHWM flags.

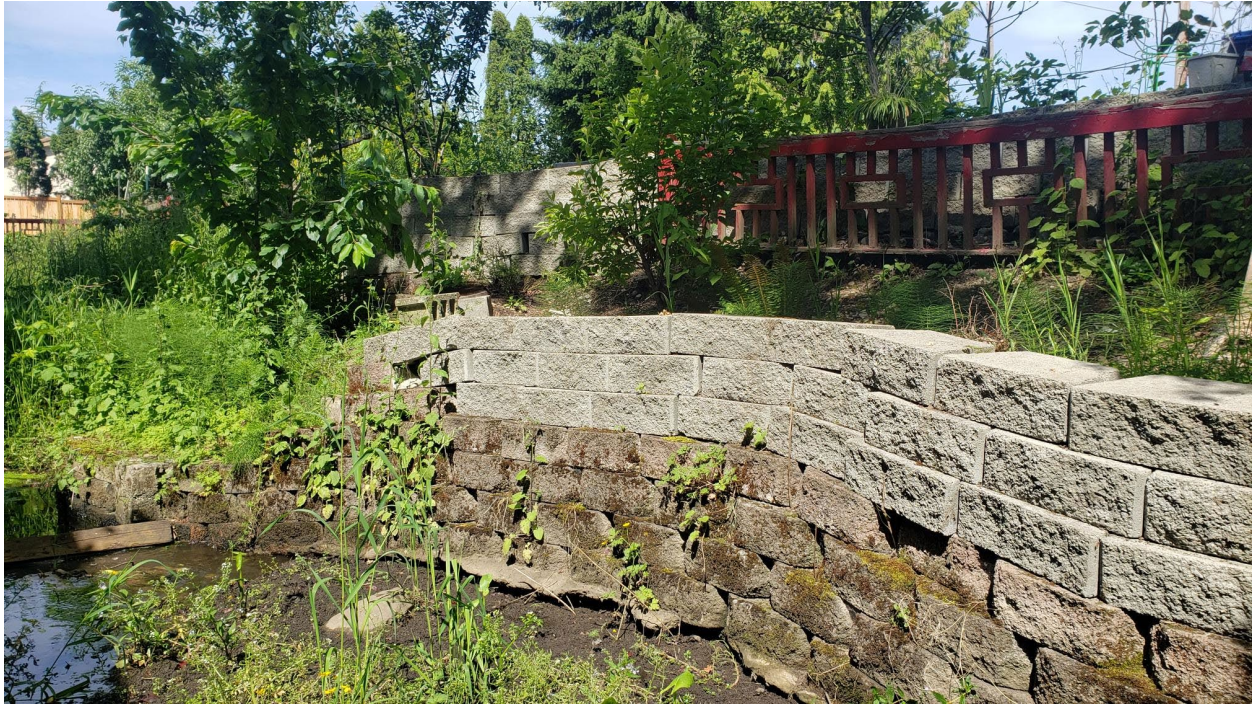
The concrete block walls which line the stream channel vertically expand existing stream channel armoring. New and old blocks can be distinguished by clearly evident discoloration and moss accumulation (Figure 3). The height of new concrete blocks added is variable throughout the property, generally ranging from one to six new blocks tall. Fine grading appears to have been completed behind walls to backfill and smooth the transition. We were unable to obtain records or photos of what the grade was prior to disturbance.

Figure 3. Concrete block wall along stream channel with three new layers and clearly distinguished by discoloration and moss accumulation.

All newly installed concrete blocks are to be removed, disposed or repurposed off-site or outside of critical areas and critical area buffers. Following removal of new concrete blocks, the area will be cleared of vegetation and regraded to pre-existing conditions. Existing vegetation consists nearly entirely of non-native weedy species. Backfilled soils behind retaining walls are to be graded to create a natural slope or to pre-existing grade. No soils will be imported or exported from the site. If heavy machinery is used, then all areas will be decompacted prior to plant installation and tree protection measures will be implemented. All retaining wall restoration and grading will occur in the dry season to reduce erosion. Following final grading soils will be stabilized and revegetated with a native grass seed mix. No grading or other soil disturbing activities will occur in the wetland, or otherwise below the lowest retaining walls.

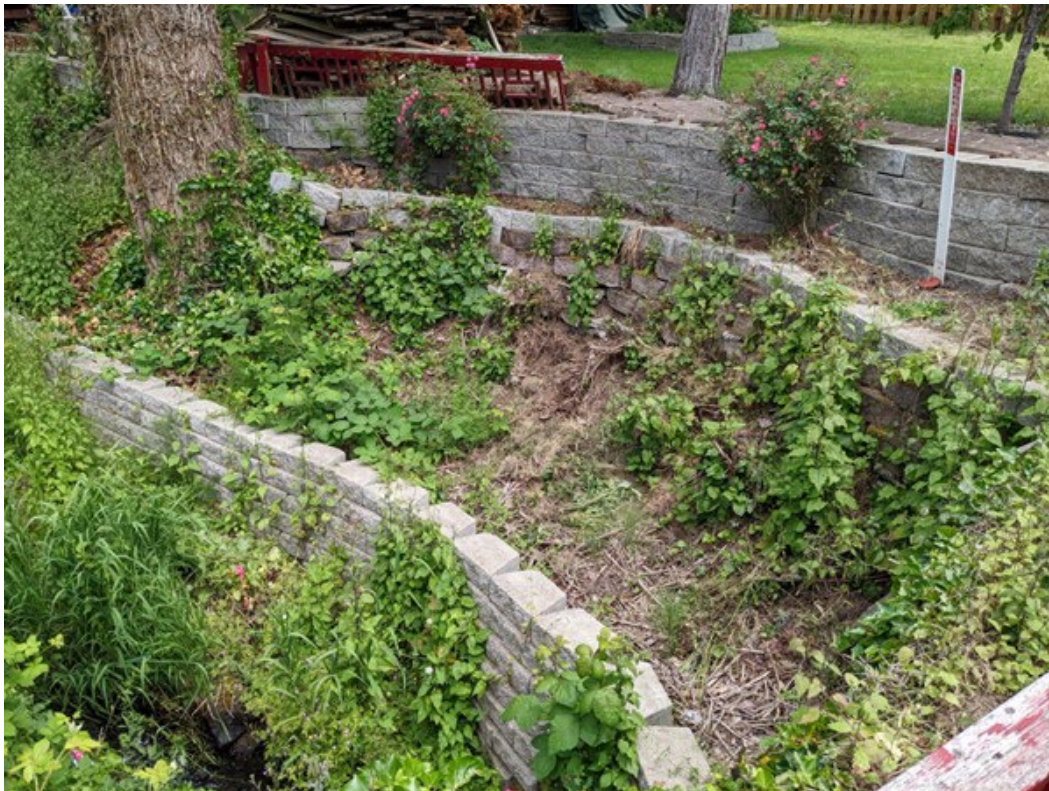
There are three retaining walls upslope from the stream, one to the north and two to the south. Together with the concrete block walls along the stream channel these create small terraces that are roughly flat between walls (Figure 3). Much of the uppermost walls on both the north and south side appear to be largely of new construction, but connect to areas with some pre-existing concrete blocks. The middle wall south of Sunset Creek was pre-existing with one new layer of blocks added.

Figure 4. Three levels of concrete block walls including the stream channel, middle level, and upper level. The upper level appears to be of entirely new construction.

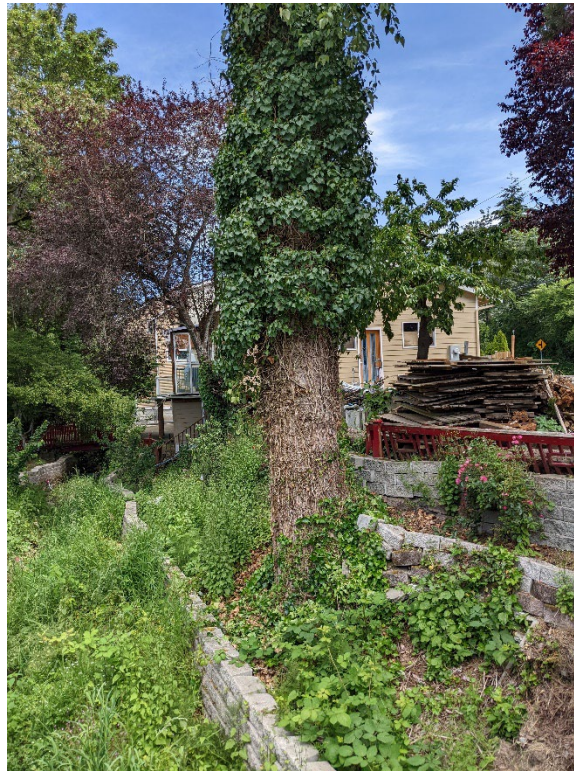
The pruned tree is a very large black cottonwood that measures 52 inches diameter at breast height (DBH) and the height is visibly estimated at 90 feet (Figure 5 & 6). The tree has experienced severe canopy dieback and is functionally dead except for one small live branch. Large pruning cuts are visible which have removed most of, but not all of, the pre-existing canopy. Black cottonwood tree wood decays rapidly and many of the upper branches are in advanced stages of decay. The single remaining scaffold branch and other stubs from cut branches have visible rot and fruiting fungal bodies. Northern flickers have excavated a nesting cavity near a pruning cut. Heavy growth of English ivy extends along the trunk to the lower extremities of canopy scaffold branches. English ivy along the trunk has been mostly cut, but not entirely removed. Although whole-tree failure does not appear to be likely or imminent, failure of large canopy branches poses a risk to human health and infrastructure. Hazard mitigation is discussed in the mitigation plan.

Figure 5. Trunk of the pruned black cottonwood. There is heavy growth of English ivy which has been cut at the base but not removed.

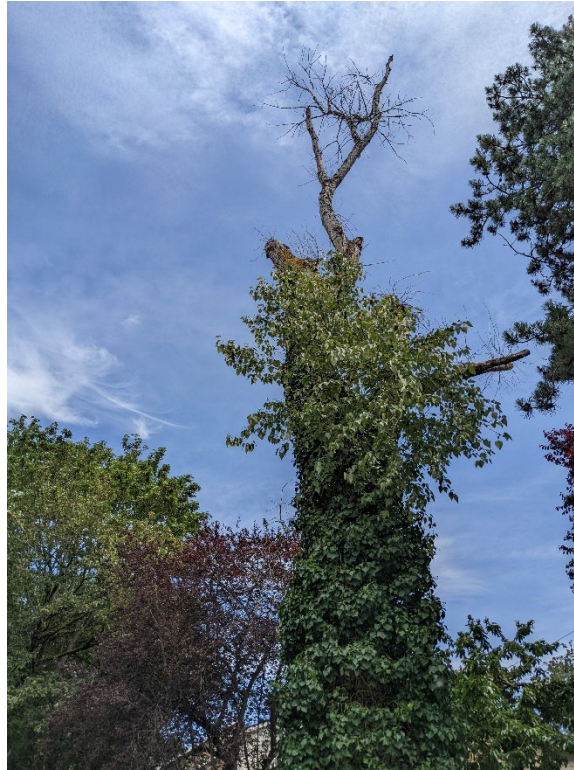
Figure 6. Trunk of the pruned black cottonwood. There is heavy growth of English ivy which has been cut at the base but not removed.

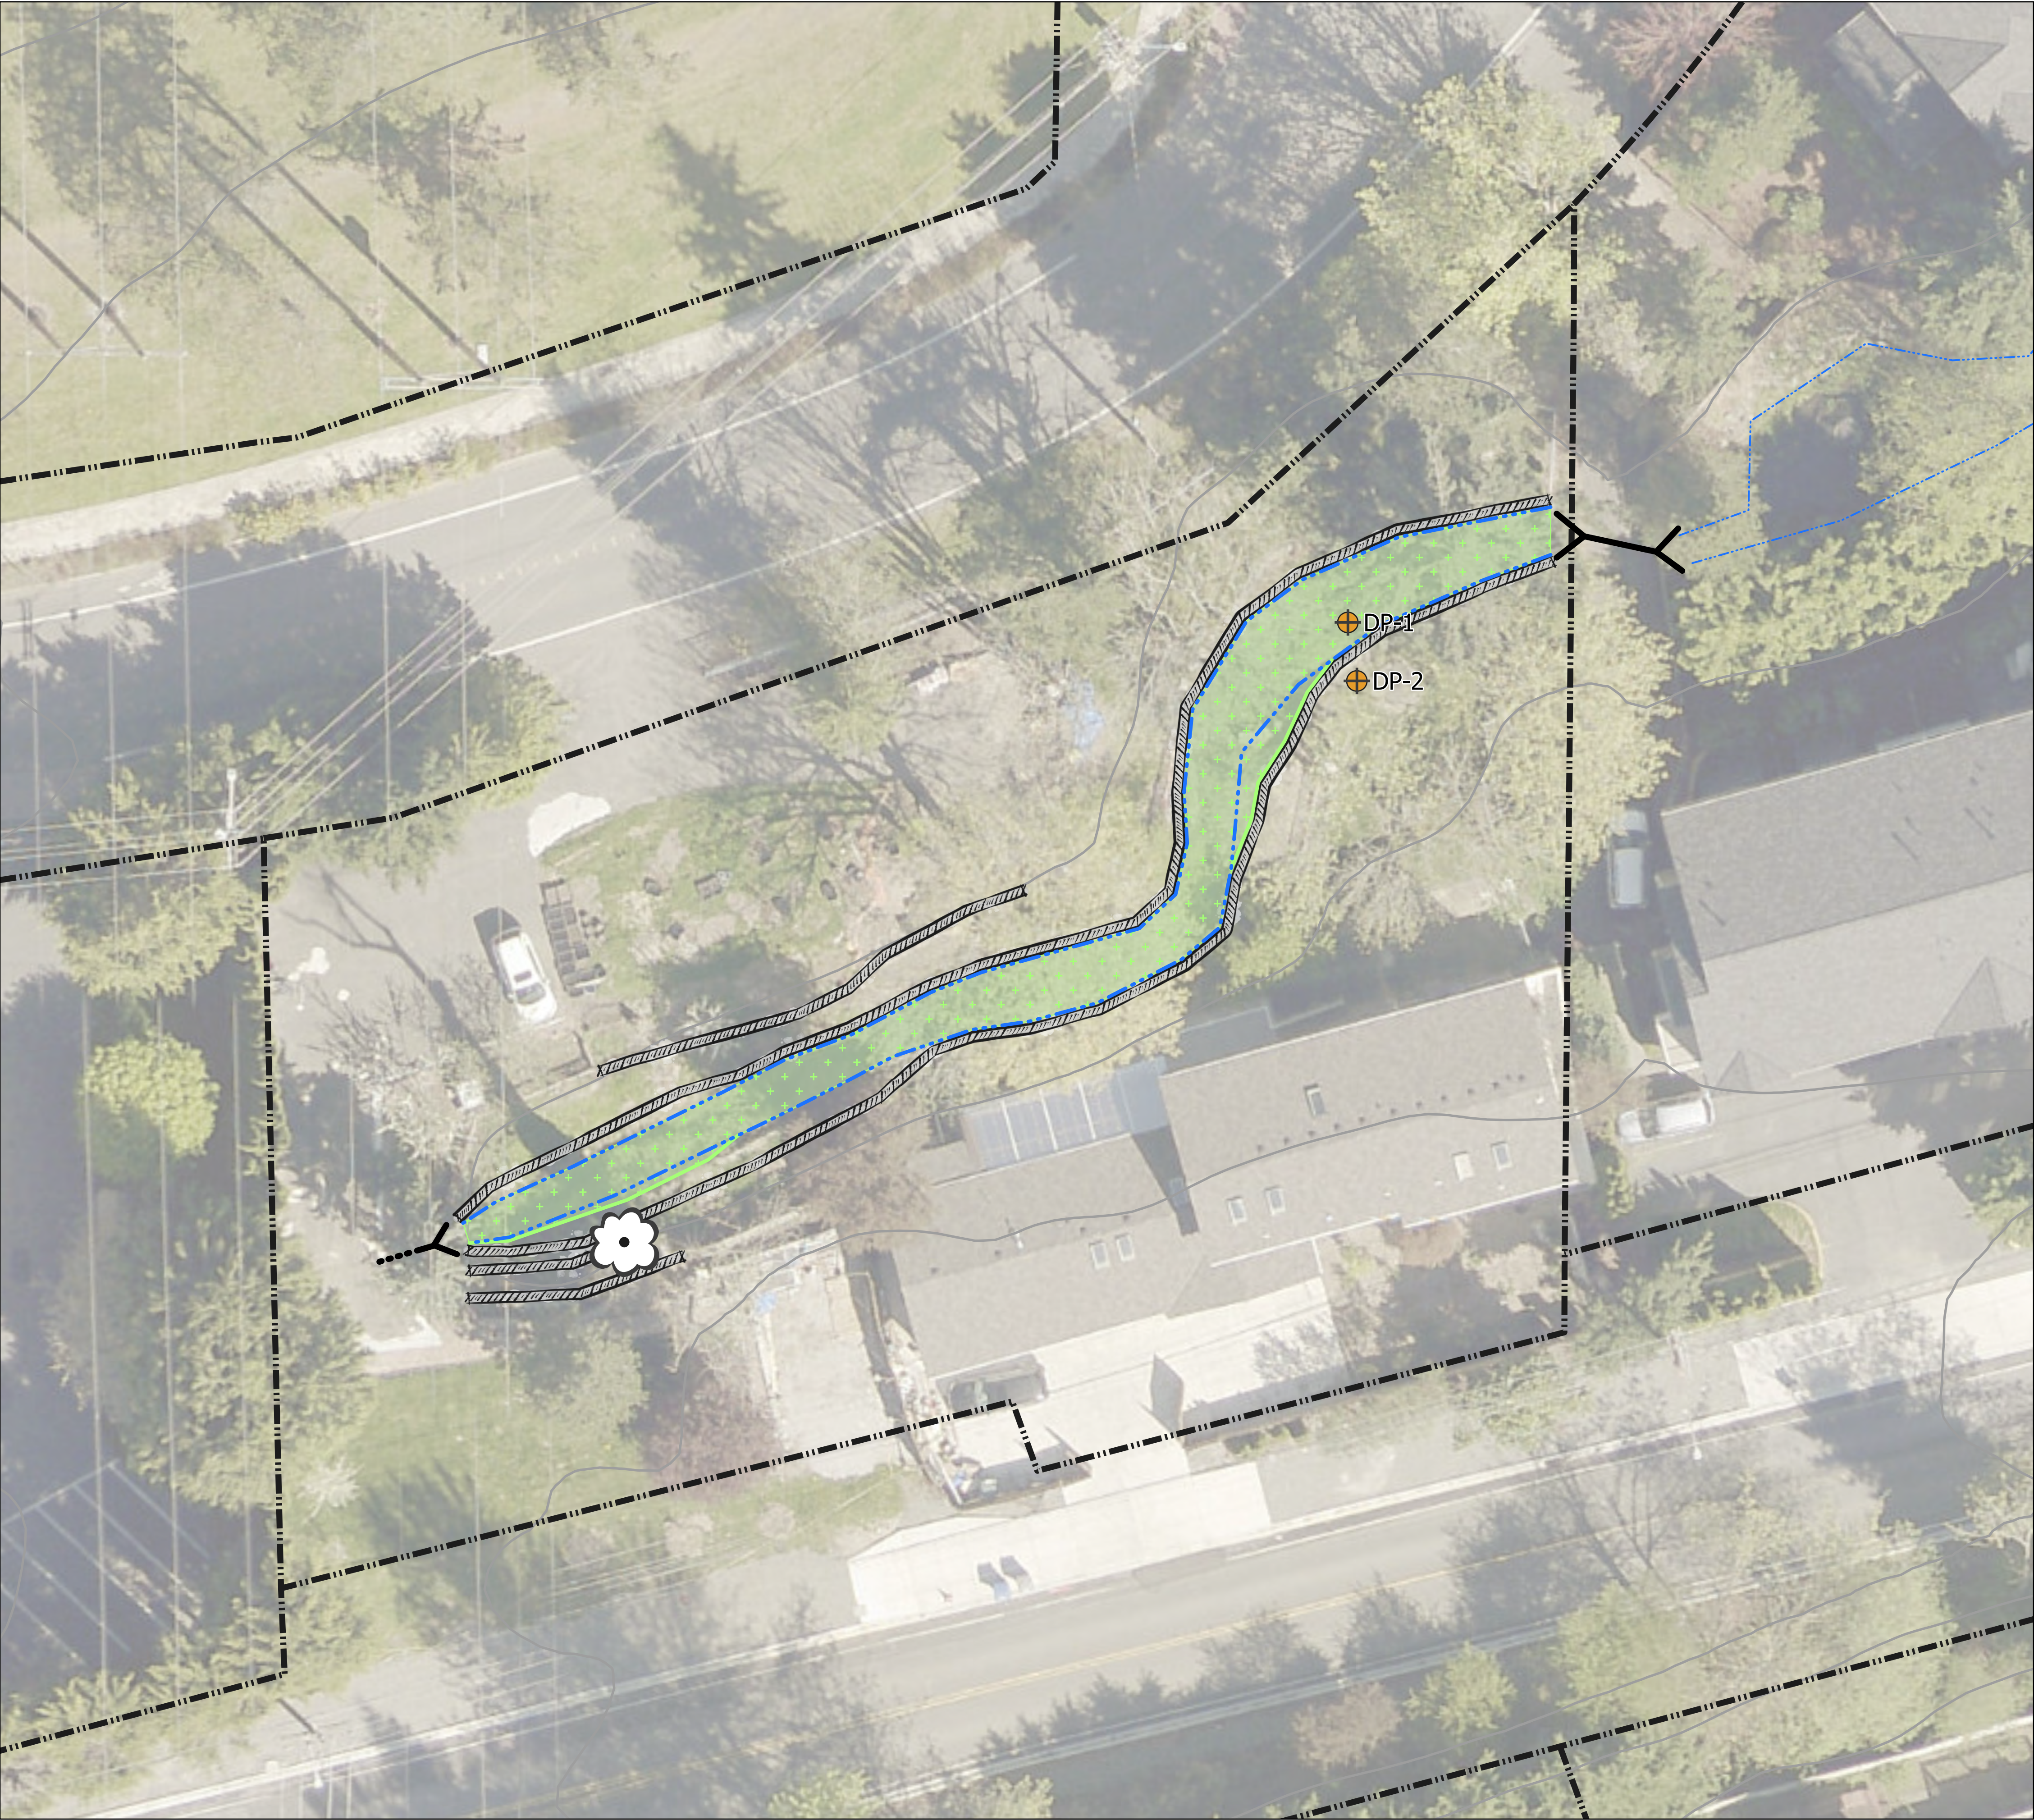
MITIGATION PLAN

A mitigation plan has been developed to compensate for impacts from the Project to the stream and stream/wetland buffers. The property will be restored to pre-disturbance conditions by removing the newly installed concrete blocks and enhancing an area of the stream/wetland buffer. The 1,849 square-foot mitigation area is larger than needed for compensation for a single tree but is proposed to compensate for temporal loss, and as a practical measure to stabilize soils which will be regraded. A small portion of the mitigation area is wetland enhancement. A mitigation plan set is provided in Appendix A which includes additional information on goals and performance standards, monitoring methods, maintenance, work sequence, material specifications, and contingency.

A total of 70 native container plants will be installed in the stream/wetland buffer enhancement area. Of these, there are nine replacement trees of species which are large in stature and comparable to the pruned black cottonwood; Sitka spruce, western redcedar, and bigleaf maple. In addition, five small cascara trees will be installed. There will be 56 installed shrubs spaced six feet on-center which include black hawthorn, red-osier dogwood, Pacific ninebark, red elderberry, Nootka rose, and snowberry. Plants are to be installed by cutting a hole through the mesh fabric and placing in a hole 2-3 times the width of the container.

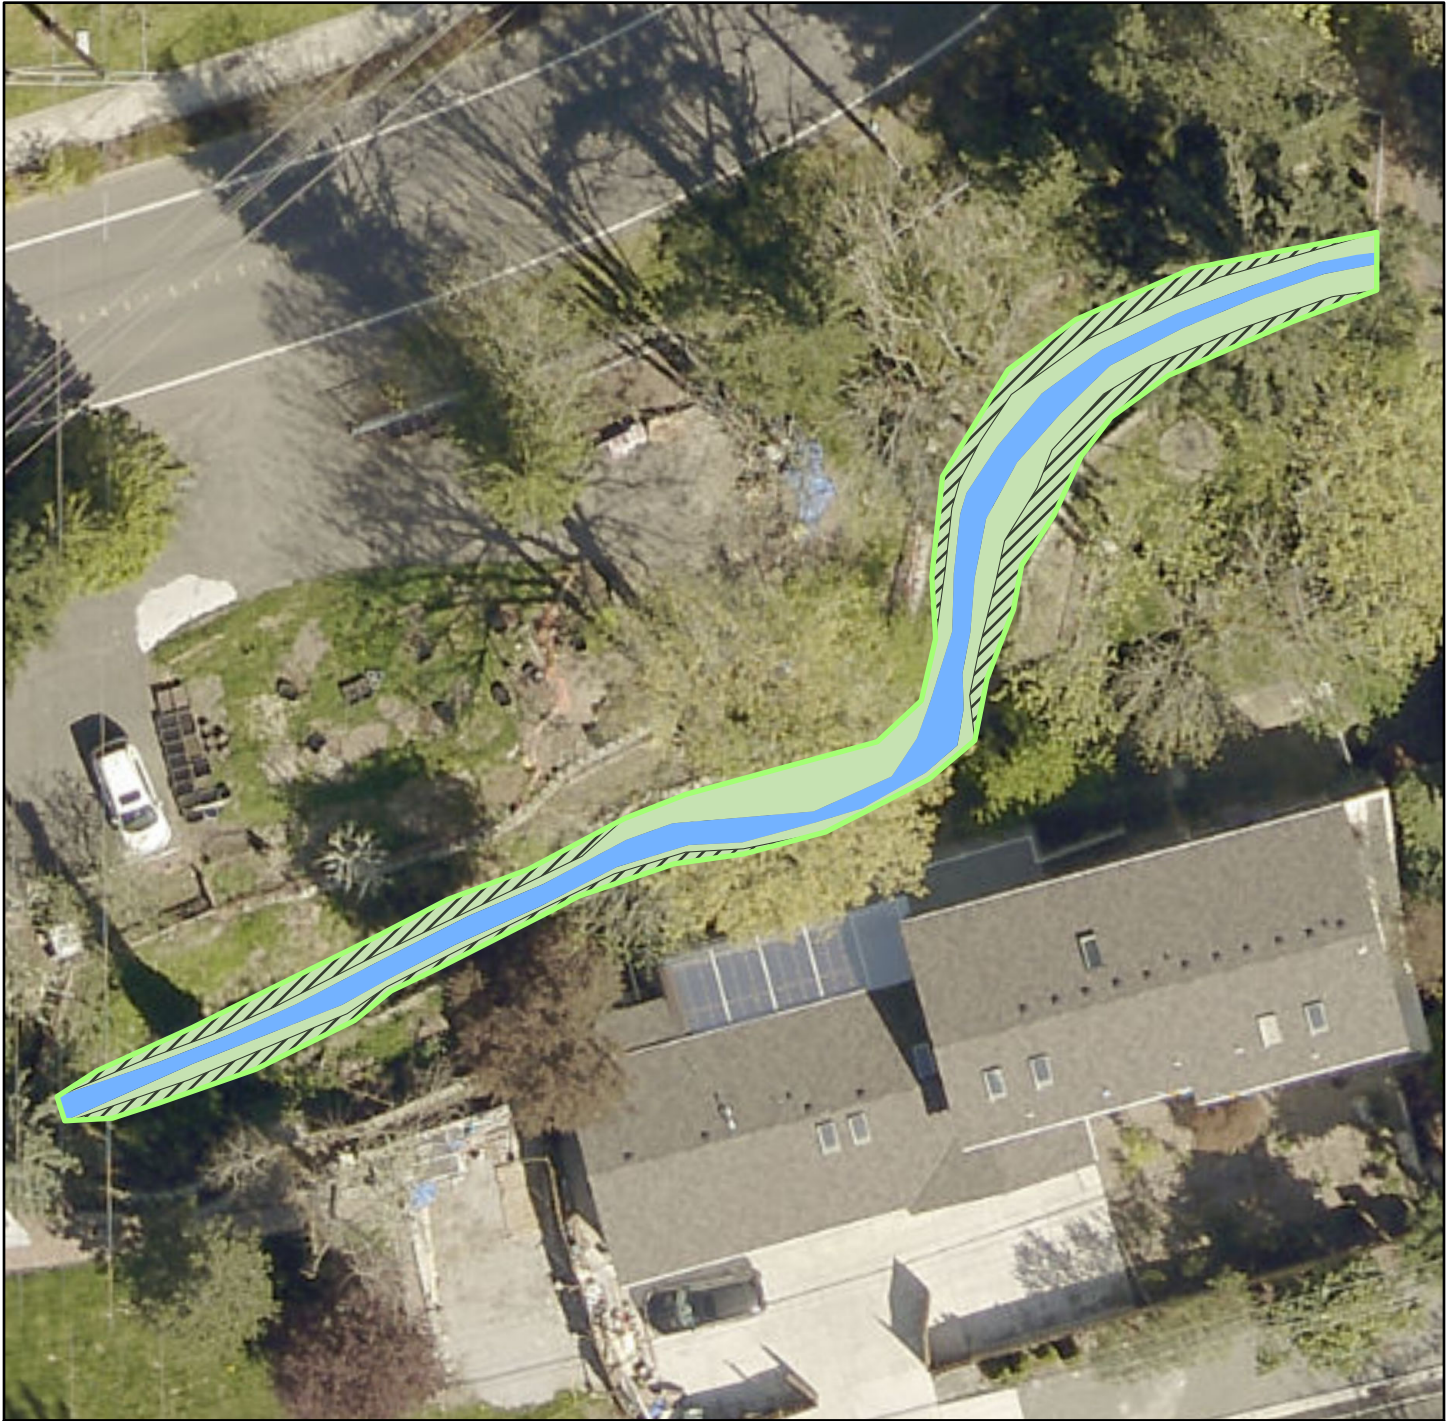
Wetland Rating Figure 1. Vegetation

Cowardin plant classes – R1.2, R4.2, H1.1, H1.4. Rating boundaries are estimated and not to scale. APH refers to "at person height." Dense vegetation layer is the same composition as the Cowardin
