MITIGATED DETERMINATION OF NON-SIGNIFICANCE

PROPOSAL NAME:	Airfield Park Master Plan
LOCATION:	2997 160th Ave SE
FILE NUMBERS:	23-117223-LM
PROPONENT:	Pam Fehrman, Project Manager, City of Bellevue, Parks Department
DESCRIPTION OF PROPOSAL:	
<p>Non-project SEPA Review in connection with a proposed update to the Bellevue Airfield Park Master Plan, which was previously adopted by the City Council in 2012. The proposed update includes the revised or new facilities, trails, a new aquatic center of up to 160,000 square feet, parking, sport courts, and associated improvements. If the updated Airfield Park Master Plan is adopted by the City Council, then the Plan will guide long-term phased development of the park.</p>

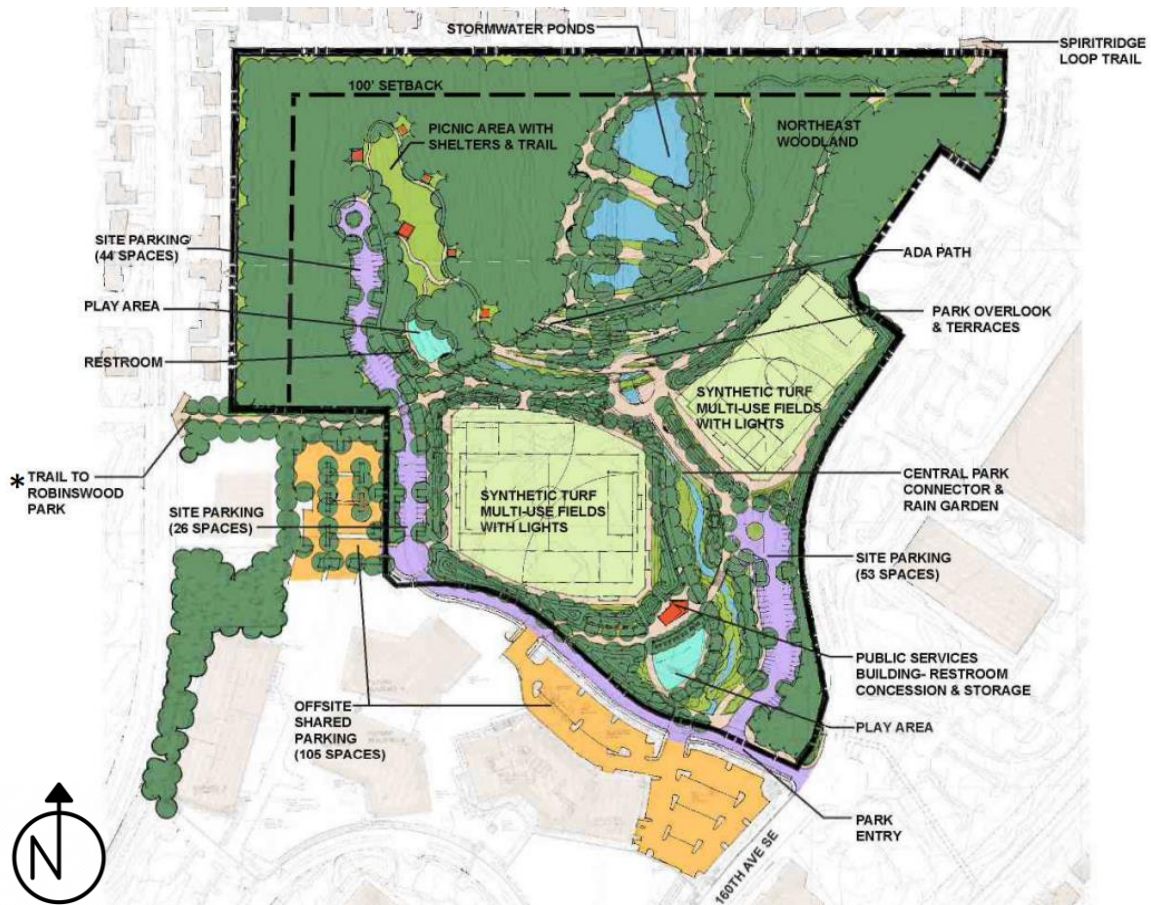
Figure 1. Existing Park Master Plan

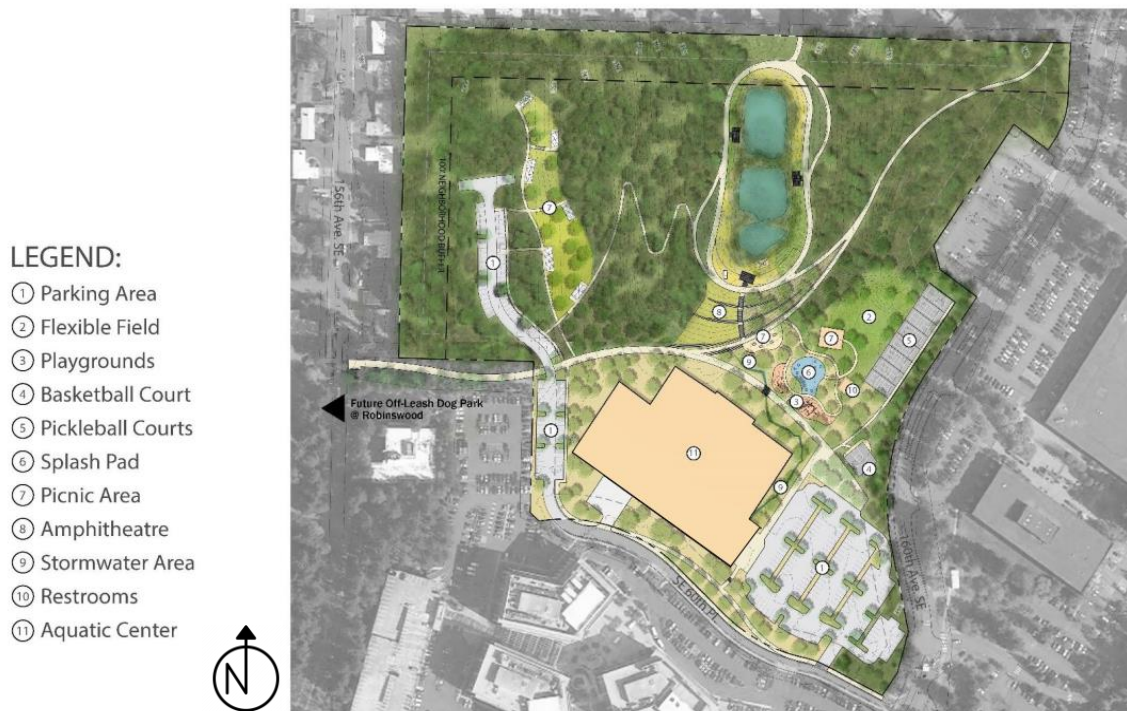
Figure 2. Proposed Park Master Plan Update

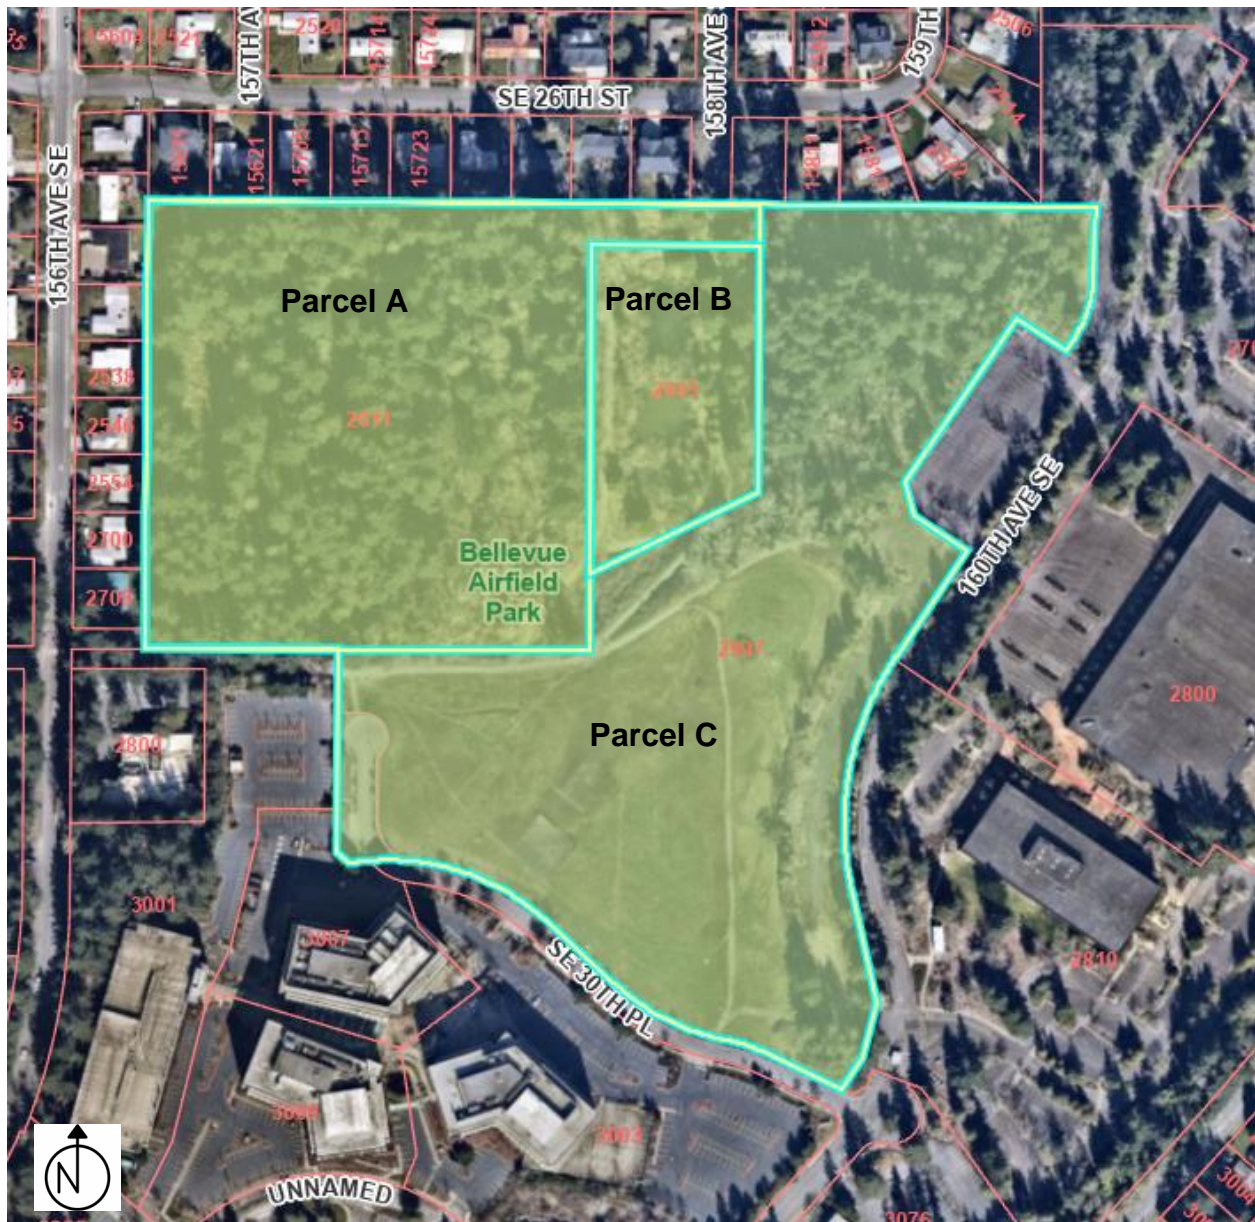
Figure 3. Project site parcels

- Mature Coniferous Forest: The largest habitat patch on-site consists of upland second-growth coniferous forest (see parcel A of **Figure 3**) located in the upper northwest portion of the site and totaling approximately 12 acres. This part of the park property is characterized by forested conditions containing mature trees and low to medium understory. There is little access to these areas and thus they are relatively undisturbed which is beneficial to the area as habitat; existing conifer forest stands will be largely retained (see pg. 12 of *Habitat and Wildlife Assessment*, Prepared by The Watershed Company, attachment #6). These areas provide ecological value with important nesting and breeding habitat for birds, small mammals, and amphibians. This area is proposed to maintain the same level of disturbance as the existing adopted plan which places the parking and picnic facilities in the same area, even without the plan update. Retention of trees is mitigated by LUC 20.20.900 and 20.25C, where applicable. Habitats associated with Species of Local Importance are mitigated by LUC 20.25H.

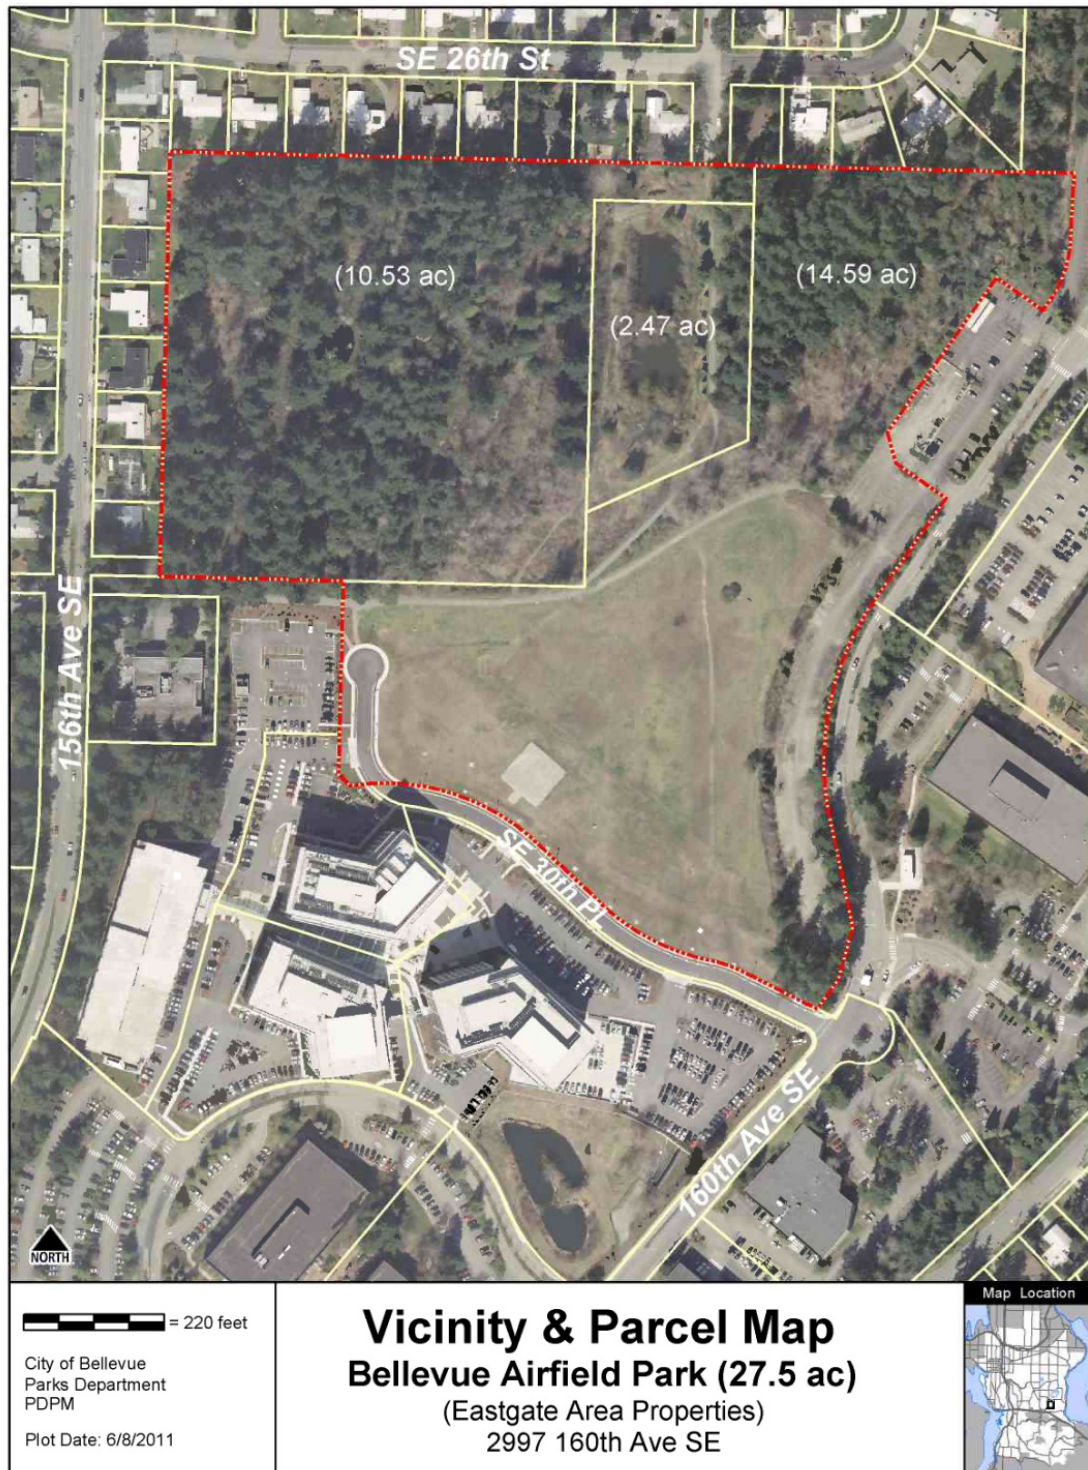
Figure 1: Existing conditions and area of tree assessment.
