TRANSPORTATION

Northup Way to Crossroads Trail

Project Overview

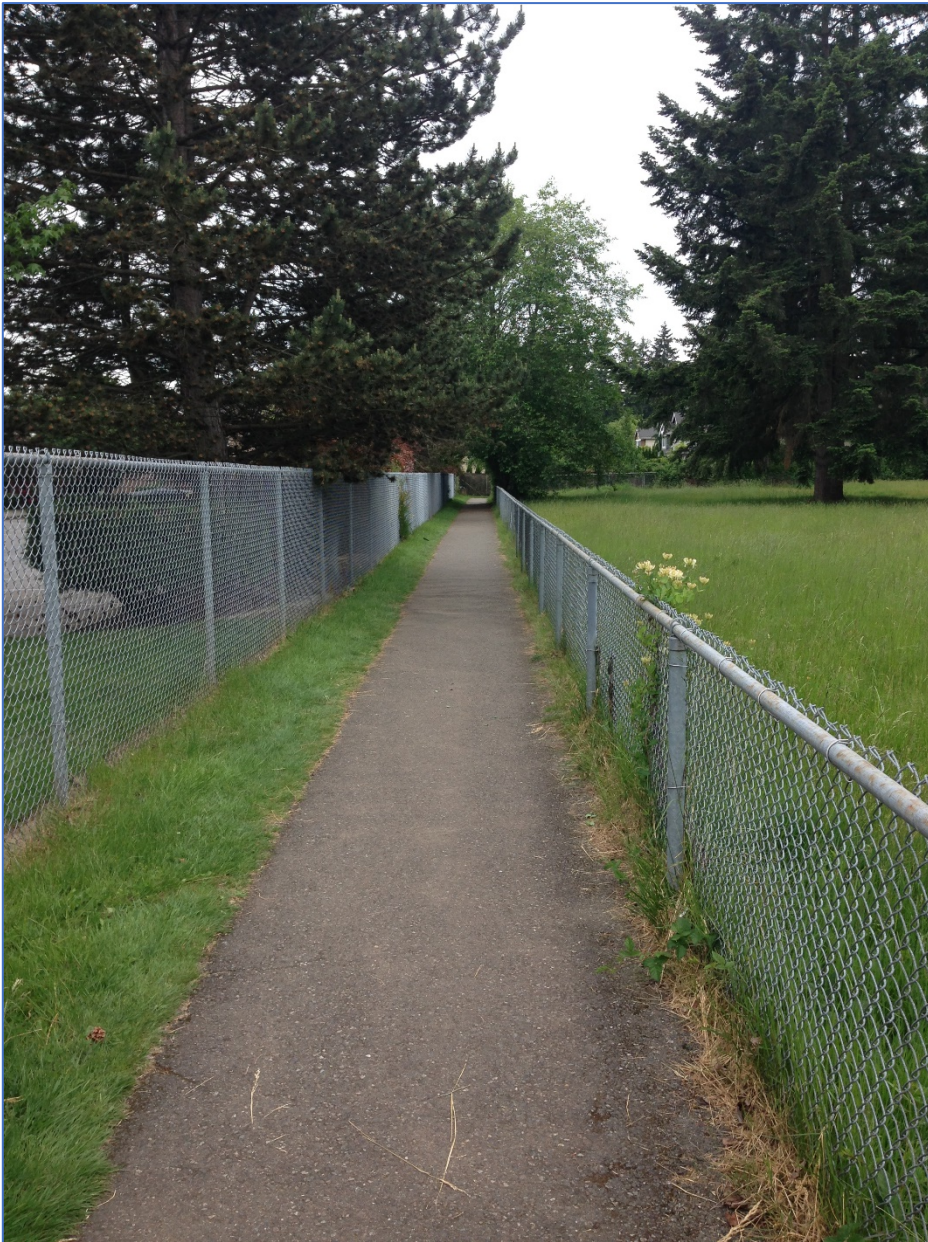
Segment 1: LDS

View looking south (from Northup Way)

- Trees along west fence line cause recurring damage (root heaving) to path

- Remove trees that abut west side fence
- Repair pavement where damaged by tree roots
- Reconfigure entry at Northup Way to facilitate access for wheelchairs, strollers, maintenance activities

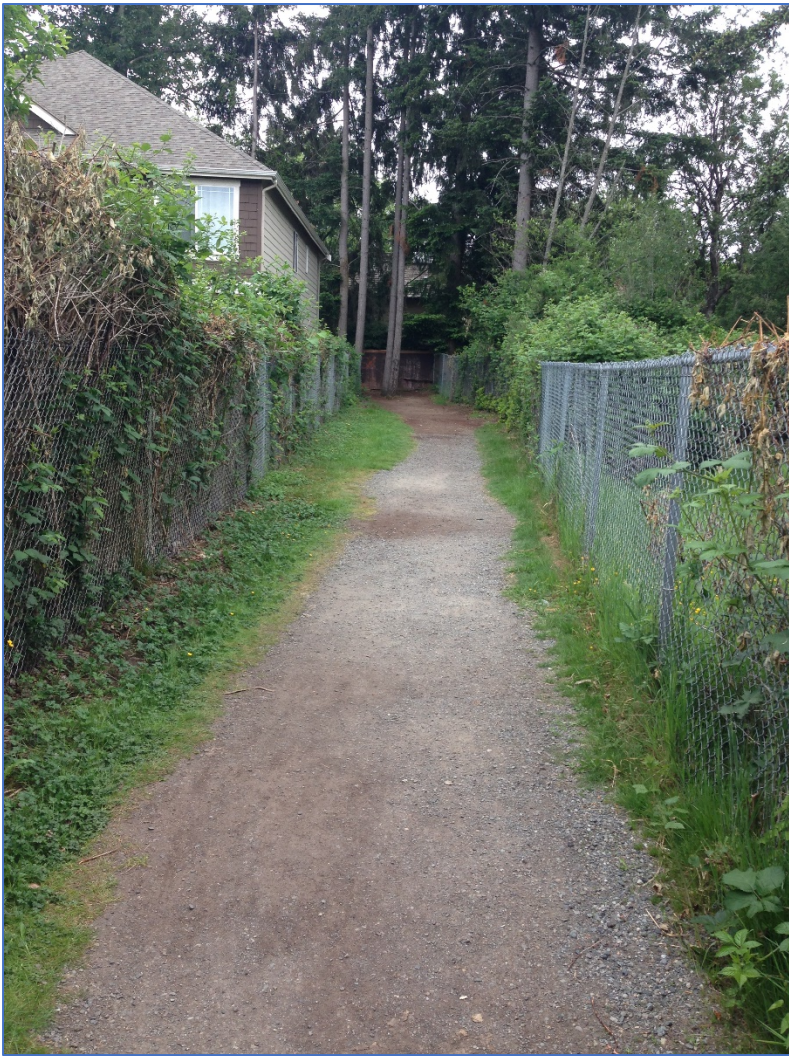
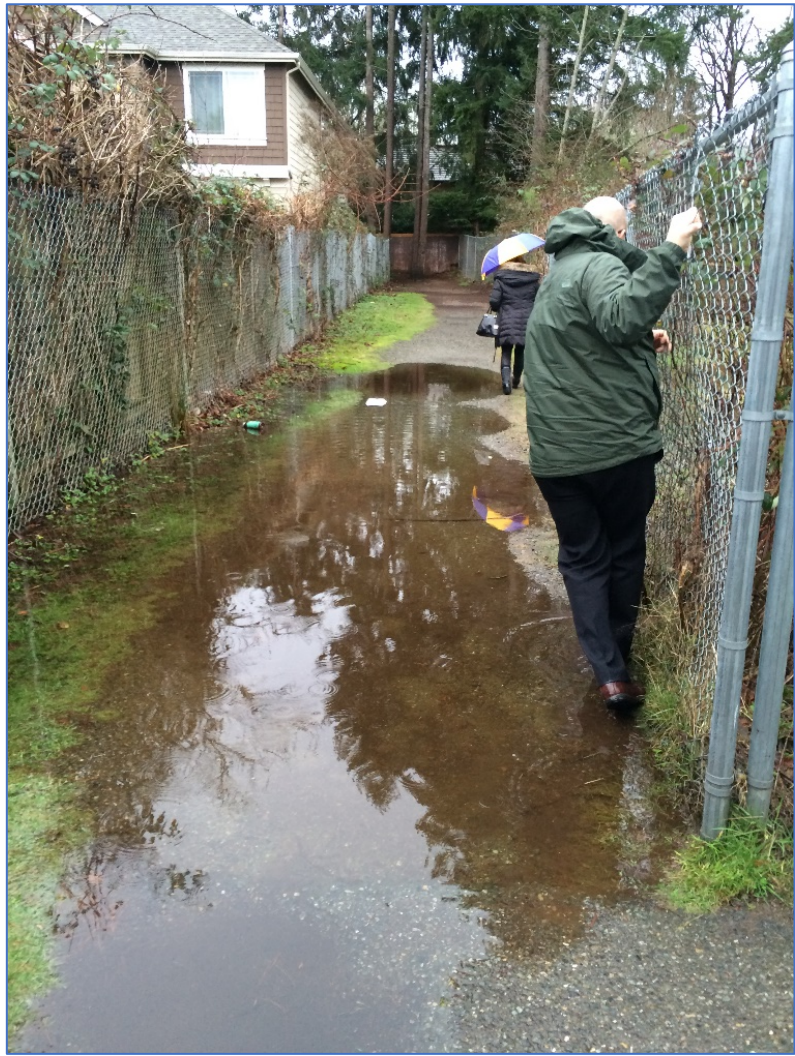
View looking west

- Surface is uneven
- Fence along north side veers outside of city easement

- Install asphalt paved surface
- Rebuild north side fence along edge of 10' wide easement

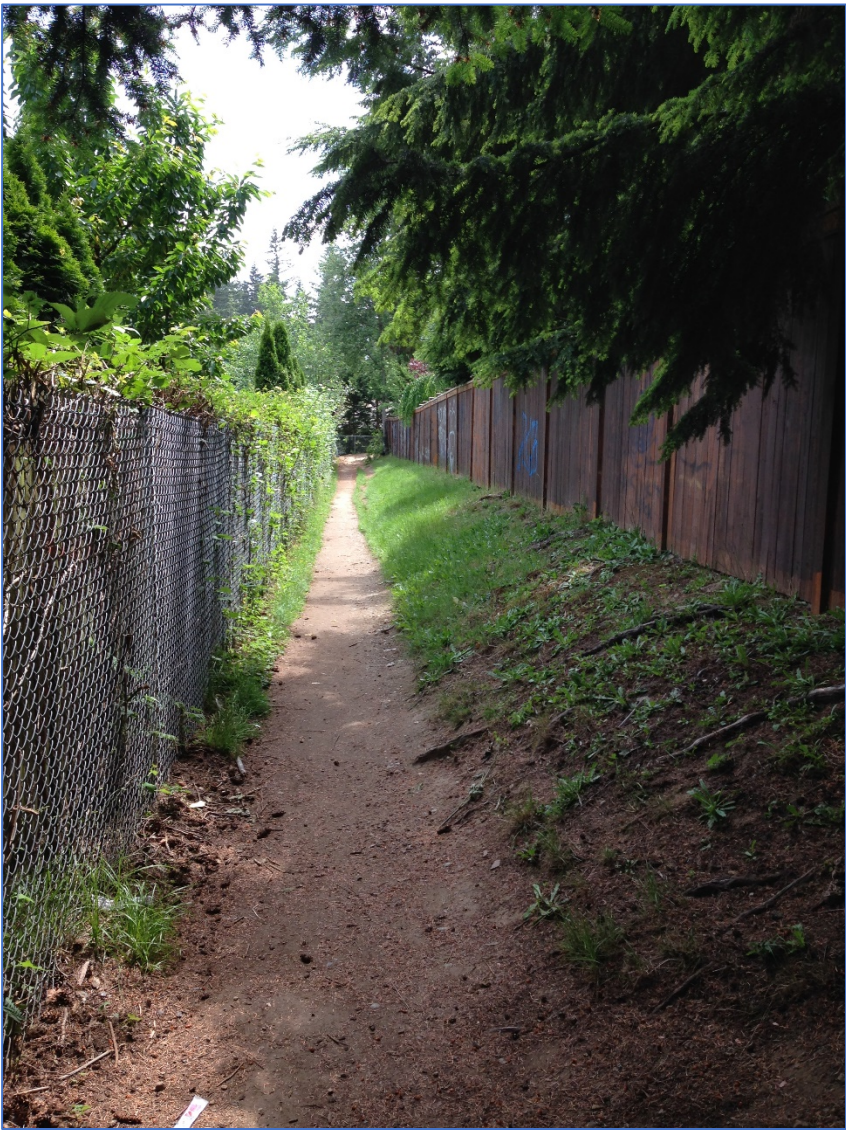
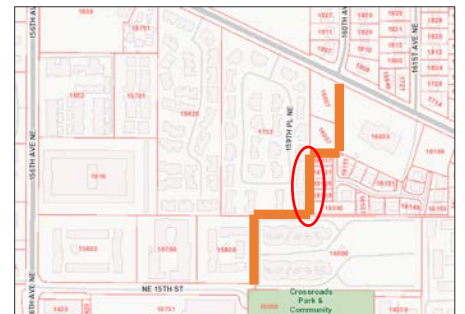
View looking south (Sonora on left, Inglebrook on right)

- Walkway is narrow, uneven
- Adjacent fences attract graffiti

- Raise trail, install asphalt paved surface
- Rebuild, raise east (Sonora) side fence
- Remove trees at north end (details on separate display board)
- *Potential improvement:* Plant climbing vines at base of fences on east and/or west sides of trail

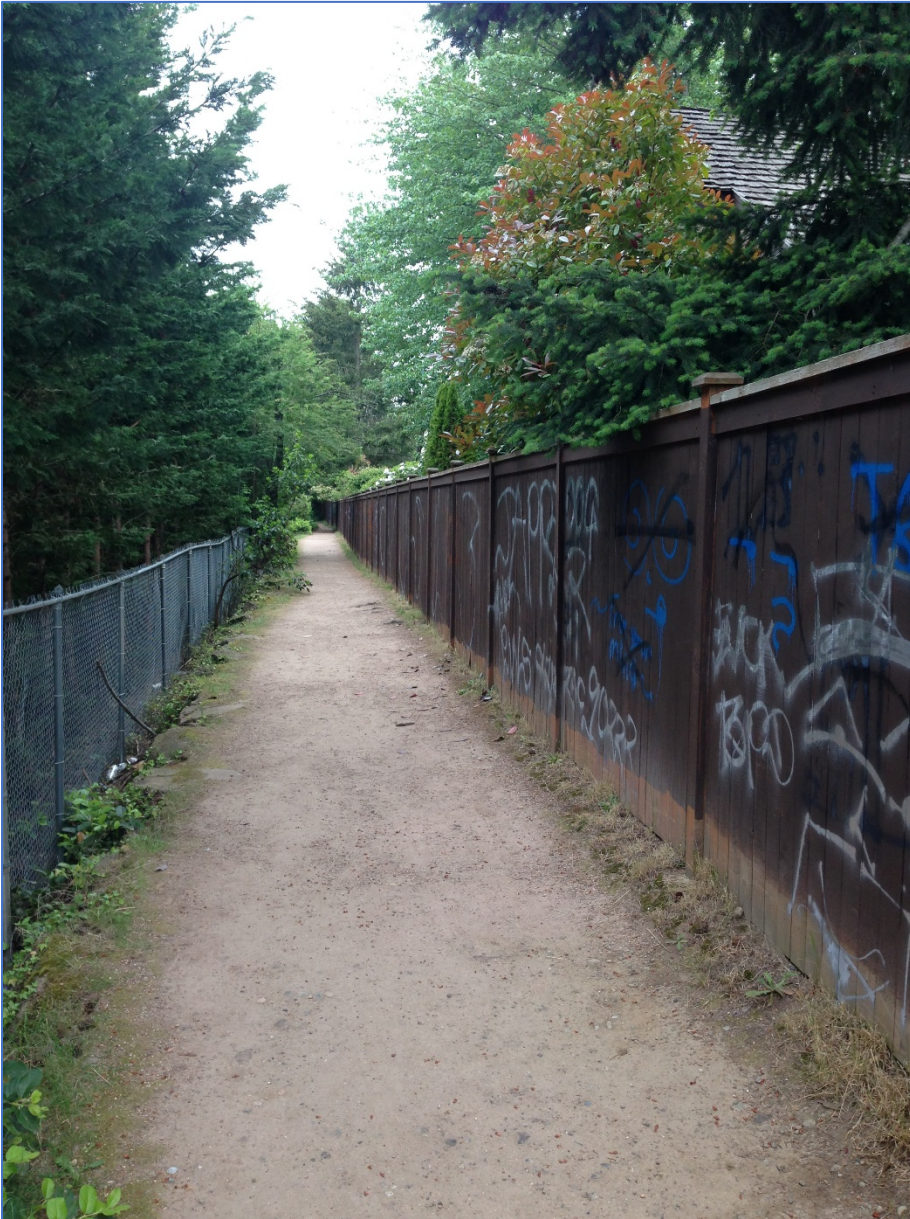
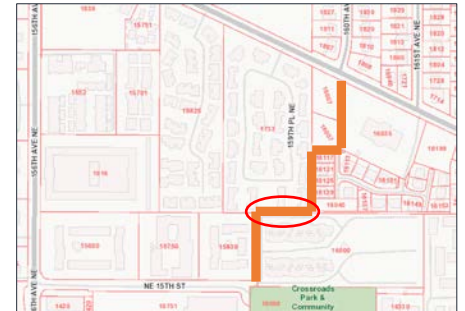
View looking west (Inglebrook on right; Crossroads Condos on left)

- Walkway narrows in certain locations
- Surface is uneven
- Adjacent fence attracts graffiti

- Widen path area where needed to accommodate a consistent trail width
- Install asphalt paved surface

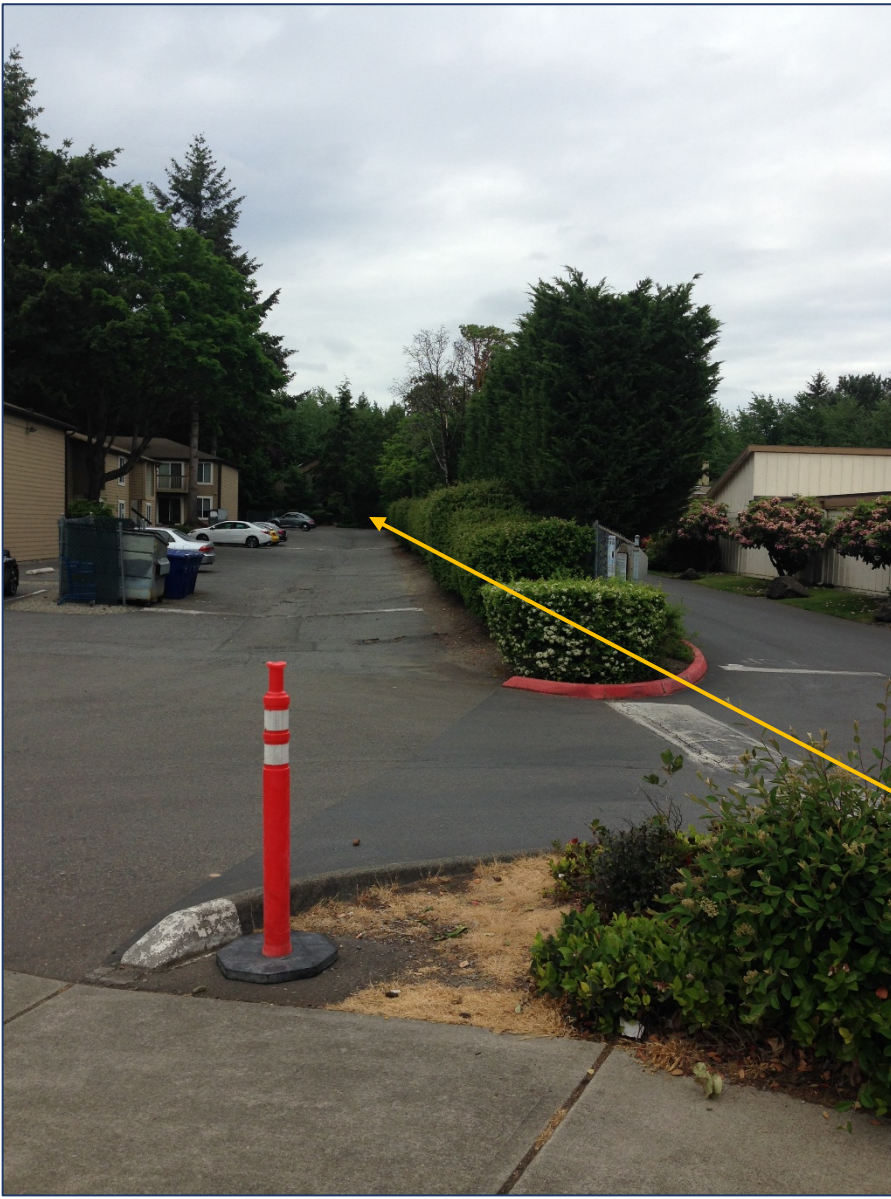
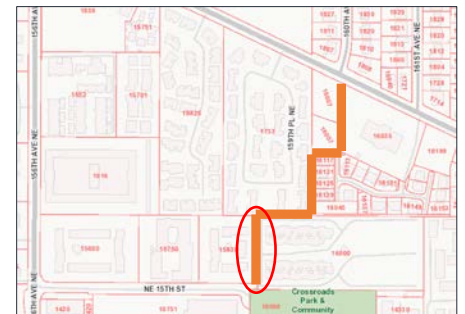
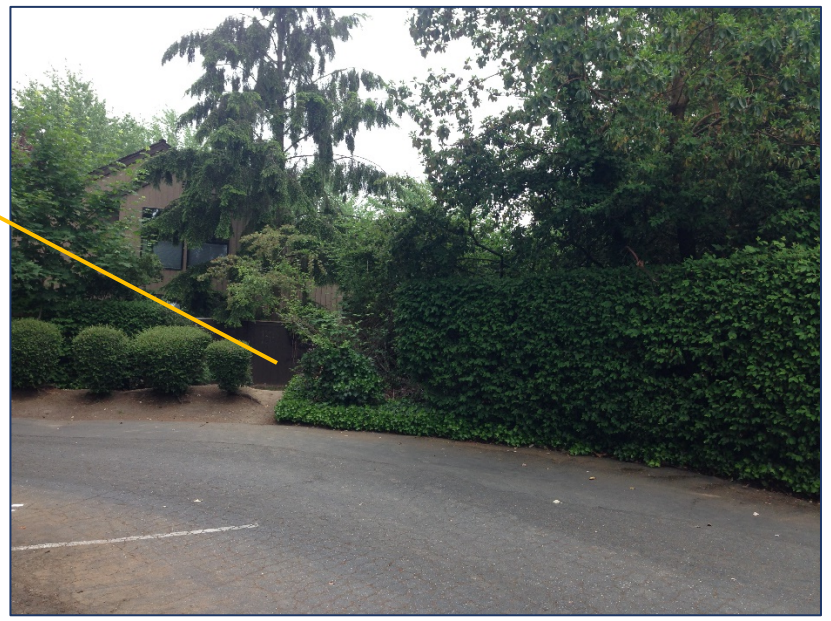
View looking north (from NE 15th Street)

- No designated walkway area
- Pavement is uneven, cross-slope exceeds ADA standards
- Berm and vegetation at north end impede movement
- No indication of public access

- Replace asphalt on middle and east side of drive area to reduce cross-slope and improve surface
- Stripe and stencil a 6' wide walk area along east edge of parking lot
- At north end, extend walkway through landscaping and berm, connect to East-West (Inglebrook) segment
- At NE 15th Street trailhead, install a directional bollard (post with sign) indicating public access, connection to Northup Way.

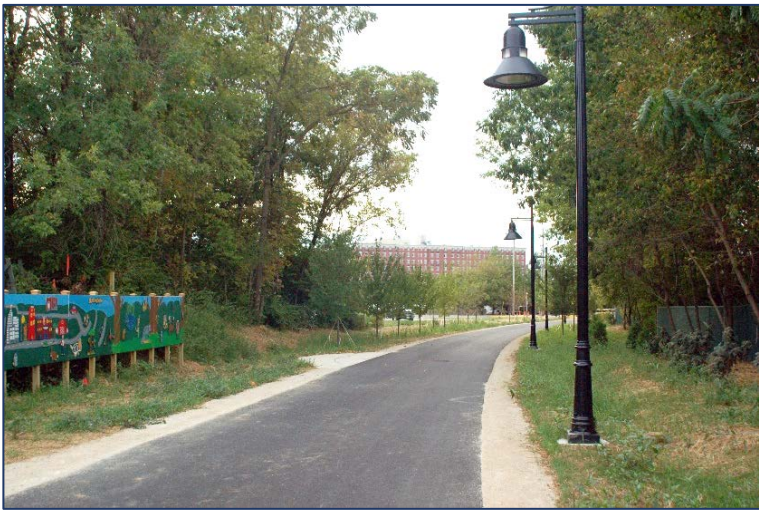
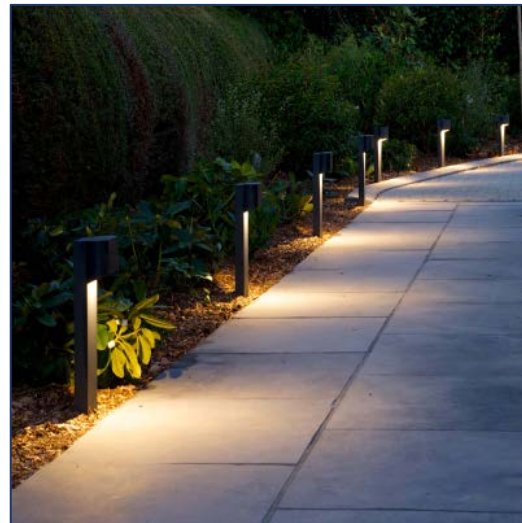
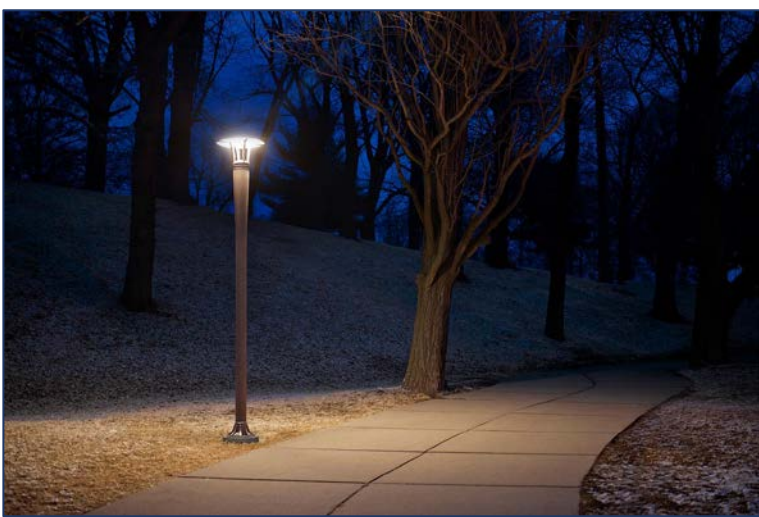
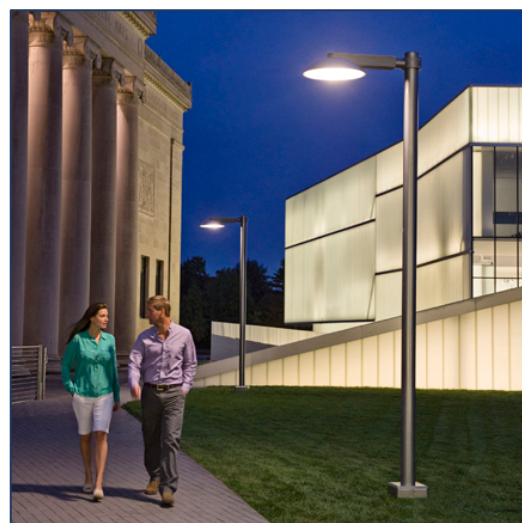
Examples of Pedestrian Scale Trail Lighting

- Install trash cans at corners (3 or 4 total, up from one can currently)
- Enhance maintenance
- Install pedestrian scale lighting to improve visibility and safety
 - Lights will be placed at strategic locations along trail
 - Further input and evaluation necessary for type of pole and light fixture
 - Pedestrian scale lights are typically 12-14ft tall. Bollard light fixtures (example shown in upper right image) will be considered.
 - Light will be directed onto the trail and will have minimal spill over from trail onto private property

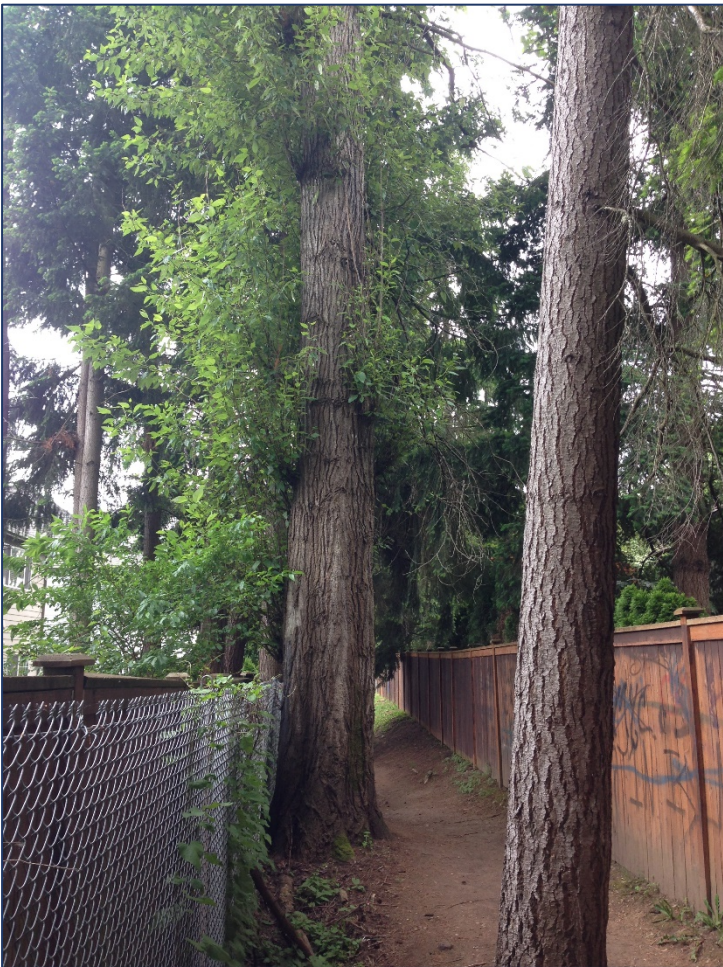
Trees in walkway area

- Large trees present fall hazard and occupy area needed for walkway
- Blank fence surfaces attract graffiti

- Remove trees (City is exploring options to plant replacement trees off-site)
- Install plantings where appropriate, potentially along fences (to discourage graffiti) and at trail heads

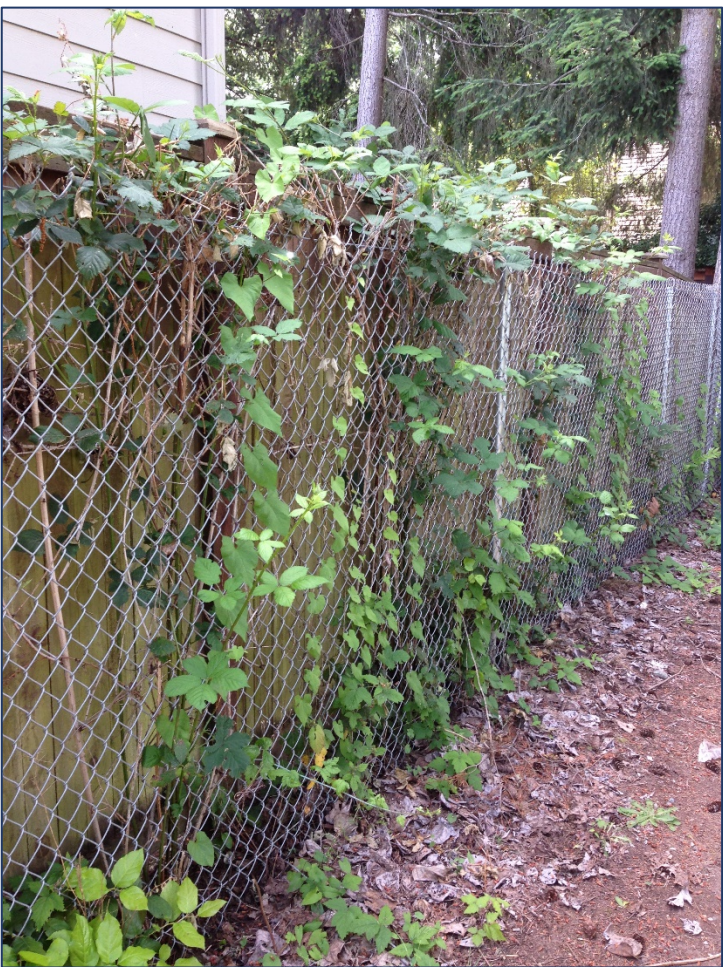
Vegetation along fence line
