**Toward Universal Access: Americans with Disabilities Act  
Sidewalk and Curb Ramp Self-Evaluation Report  
for the City of Bellevue**

*September 2009*

# ADA Self-Evaluation Report

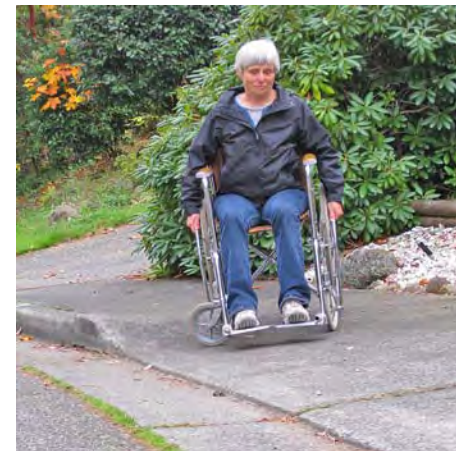
*Steep driveway cross slope.*

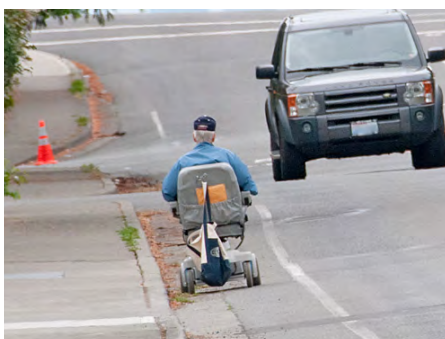
*Barrier forces street use.*

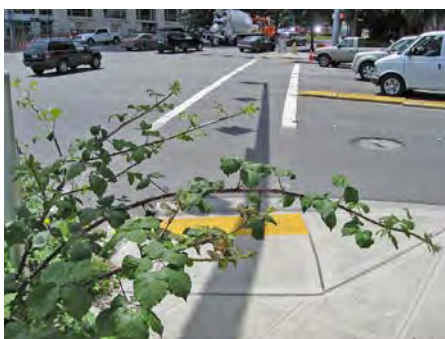
*Encroaching vegetation on ramp.*

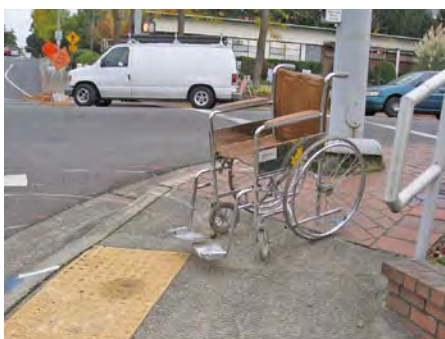
*Steep ramp flare slope.*

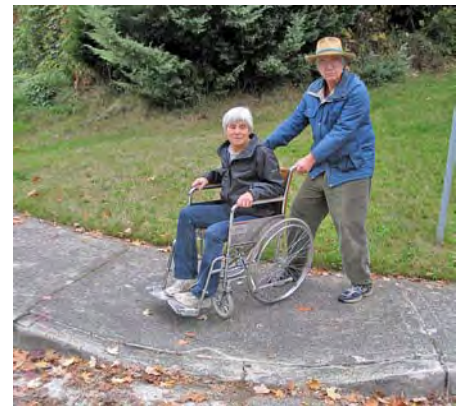
*No ramp landing panel.*

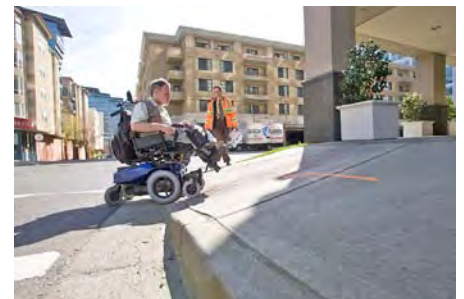
*Steep ramp running slope.*

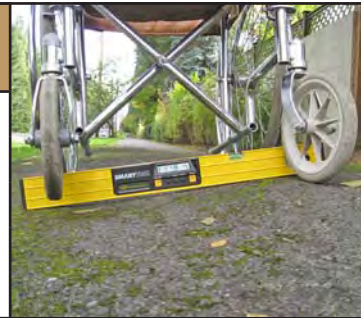
(iii) **Cross Slope.** Cross slope is defined as the slope measured perpendicular to the direction of travel. Changes in cross slope are commonly found at driveway crossings without level landings. Steep cross slopes can make it difficult for wheelchair or crutch users to maintain lateral balance and can cause walkers and wheelchairs to veer downhill or into the street. ADAAG 4.3.7 does not permit cross slopes to exceed 2%.

*Example of 18 percent cross slope at NE 24th Street & 167th Avenue NE.*

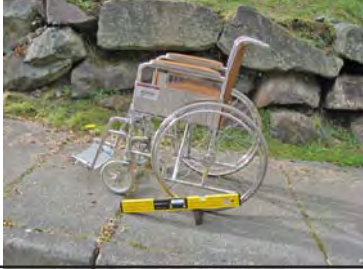
- (iv) **Running Slope (Grade).** Grade is defined as the slope parallel to the direction of travel. Both powered and manual wheelchairs can become unstable and/or difficult to control on sloped surfaces. ADAAG 4.8 specifies that any sidewalk that is greater than 5 percent is considered a ramp. Allowances are made to permit the grade of the sidewalk to be consistent with the grade of adjacent roadways.

| Example of 22 percent grade at 166th Avenue SE between Phillips Road & SE 39th Place. | | Impedance Category | Value | Weight (%) | Calculation |

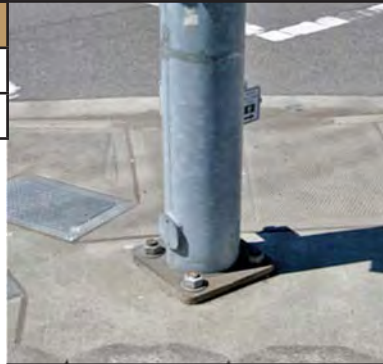
*Obstruction in ramp landing panel at SE 36th Street & Factoria Boulevard SE.*

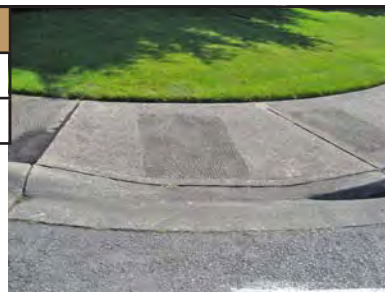
*Non-standard detectable warning surface at SE 34th Street & 111th Avenue SE.*

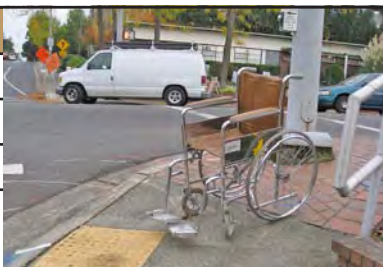
*Steep ramp flare slope at Main Street & 100th Ave SE.*

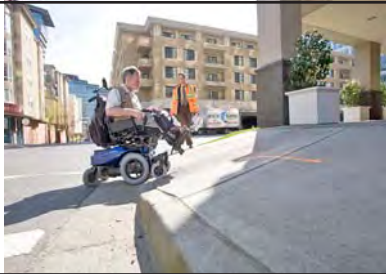
- (ix) **Ramp Panel Running Slope (Grade).** The ramp panel running slope is the sloped transition between the street and the sidewalk. Steep grades are difficult for people who use walking aids and manual wheelchairs to negotiate because more energy is needed to begin and to travel on sloped surfaces. ADAAG 4.8.2 specifies that the ramp panel running slope should not exceed 8.33%.

| <p><i>Steep ramp panel running slope at 109th Avenue NE &amp; NE 9th Street.</i></p> | Weight | Indicator | Rating Value |

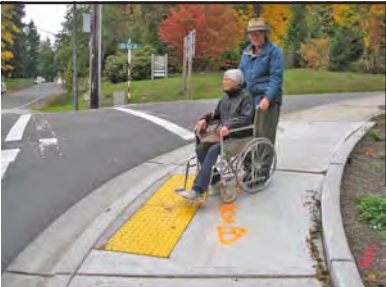
- (x) **Ramp Panel Cross Slope.** A curb ramp allows people who use wheelchairs and other wheeled devices to negotiate the elevation change between the roadway and the sidewalk without having to negotiate the curb. People with mobility impairments often have difficulty negotiating a grade and cross slope simultaneously. Since the grade of the ramp will be significant, the cross slope should be minimized. ADAAG 4.8.6 specifies that ramp panel cross slopes should not exceed 2%.

| <p><i>Steep ramp panel cross-slope at 128th Avenue SE &amp; SE 32nd Street.</i></p> | Weight | Indicator | Rating Value |

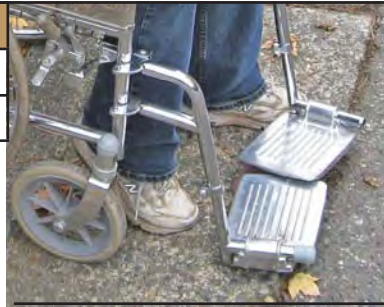
*Steep gutter running slope at SE 26th Street & 130th Avenue SE.*

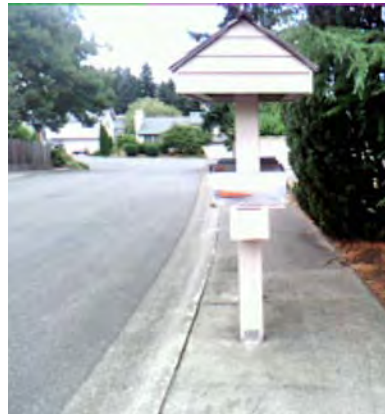
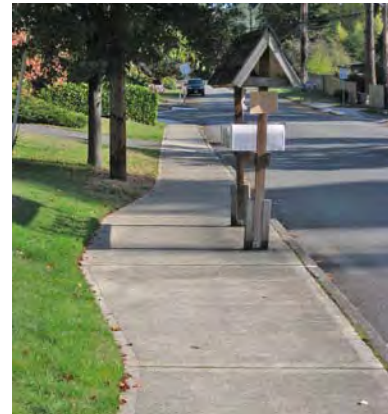
*SE Cascade Key & SE Skagit Key (left); and 163rd Avenue & Lake Hills Blvd SE (right).*

The City of Bellevue has implemented a number of work-around solutions to address fixed obstructions. Work-around solutions usually either relocate an obstruction or widen a small portion of the sidewalk to restore an accessible route. The examples below show work-around solutions. The top row shows an obstructing mailbox at left and a sidewalk widened to accommodate both a mailbox and an accessible route at right. The second row shows a hydrant obstructing a curb ramp at left, and a hydrant at right, located out of the pedestrian route, camouflaged by landscaping. The bottom row shows a pedestrian pole obstructing the top landing of a curb ramp at left and a pedestrian pole built into a concrete bulb out at right to accommodate both pedestrian pole access and sidewalk and landing access.

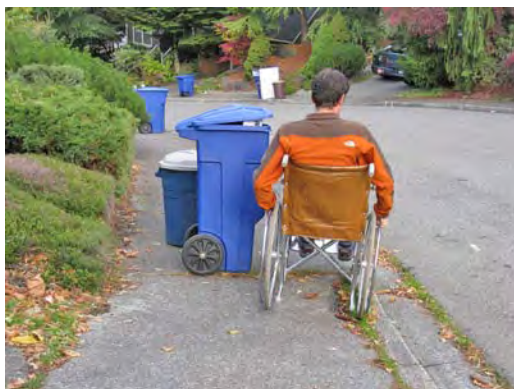
*Person in wheelchair navigating on trash day at 166th Avenue SE between Phillips Rd and SE 39th Place.*

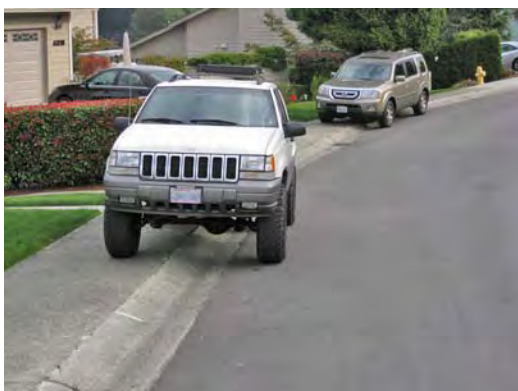
*Vehicles obstructing sidewalk at SE 36th Place & Somerset Place SE.*

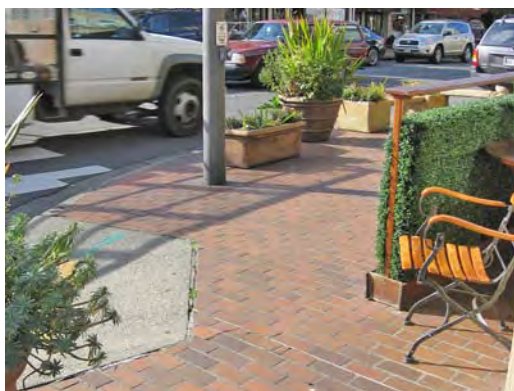
*Furniture and planters at sidewalk café obstruct ramp landing and narrow the pedestrian pathway at 102nd Avenue SE & Main Street.*

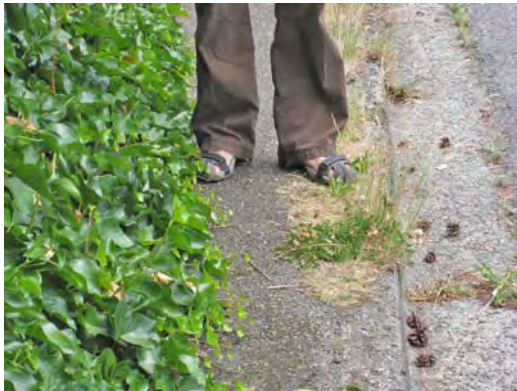
*150th Place & 45th Street SE.*

Vegetation is a subcategory of movable obstruction and is by far the most common obstruction on Bellevue's pedestrian network. When bushes or tree branches force pedestrians to turn back or move into the path of automobile traffic, they present serious obstacles to accessibility. The Bellevue City Code requires property owners to trim back vegetation on their property so that it does not "obstruct or impair the free and full use of the sidewalk or street" (BCC 14.06.010). The photos below show a variety of vegetation obstructions in Bellevue.

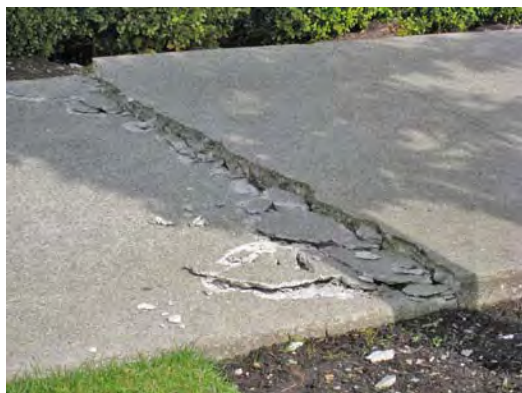
*Two inch change in level in a concrete sidewalk at 58th Place & SE 58th Street.*

(i) up to 0.25" - no modification required; (ii) 0.25 to 0.5 inches - bevel the surface with a maximum slope of 50 percent; and, (iii) greater than 0.5" - install a ramp with a maximum grade of 8.3 percent. Bellevue relied on its Ultra-Light Inertial Profiler (ULIP) to identify sidewalk locations with changes in level that exceed ADAAG standards using laser, accelerometer, and distance measurements. Before the final output is produced, the laser height data is first filtered to remove signals resulting from cracks/joints/gaps/grating and surface debris. Then the software searches for non-standard sidewalk faults (heaving) and transitions (bevels). Finally the software produces a file compatible with the city's computerized mapping system.

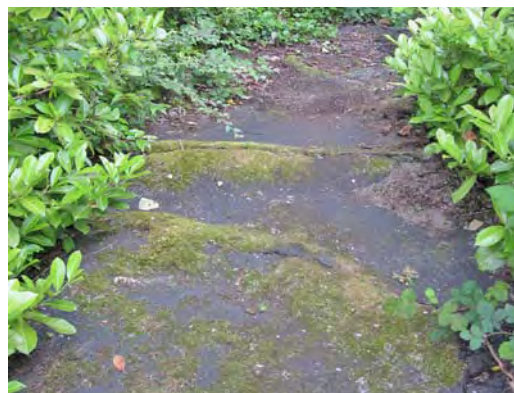
Heaving can affect all kinds of sidewalk surfaces. Concrete sidewalks are harder and whole panels (or panel pieces) tend to move as separate units, creating problems at the panel transitions where changes in level occur. Asphalt is more malleable and deforms in response to pressure. Thus, when trees roots push up under a sidewalk, asphalt tends to conform to the shape of the roots creating a situation where several rounded protrusions can disrupt ease of pedestrian movement.

*Change in level in an asphalt sidewalk at SE 27th Street & 124th Avenue SE.*

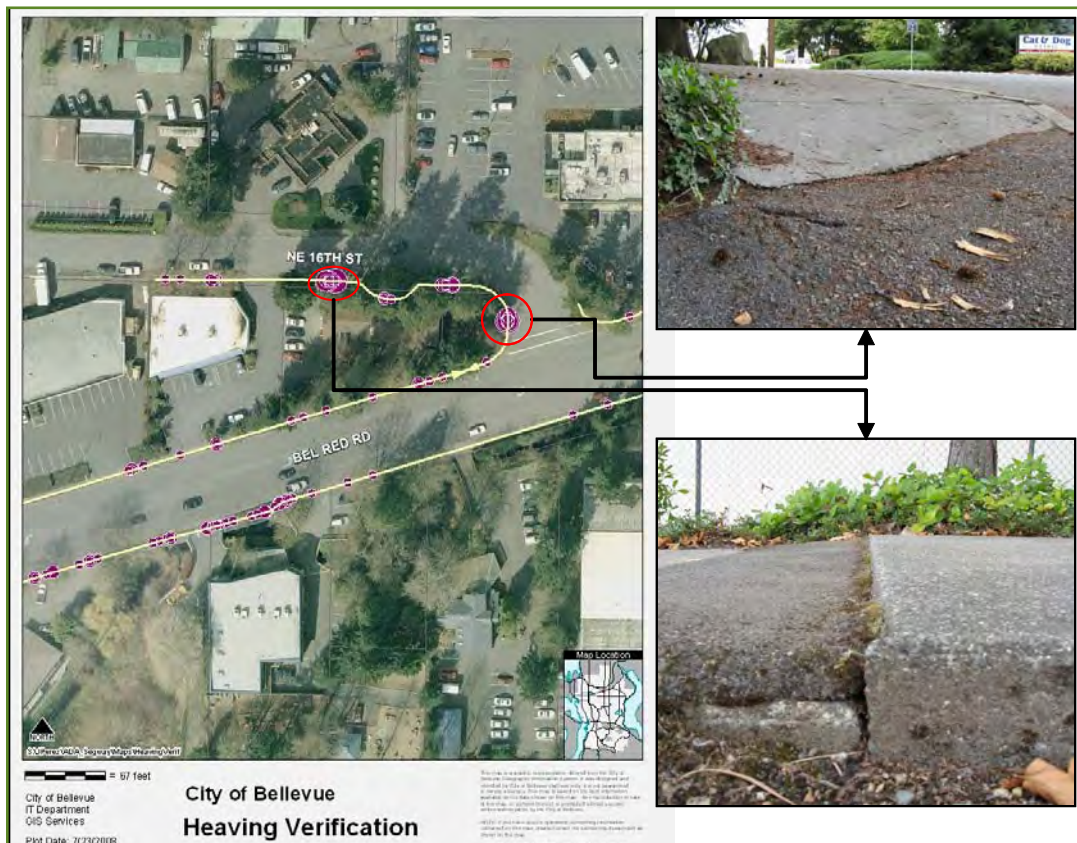
Field verifying ULIP results supported the city's QA/QC protocol and assisted in confirming that data acquired from the ULIP platform was repeatable, reproducible, and accurate. As reflected in the representative photo below, staff determined that the geospatial data for change in level locations was accurate and that individual heaves could be readily identified on the field.

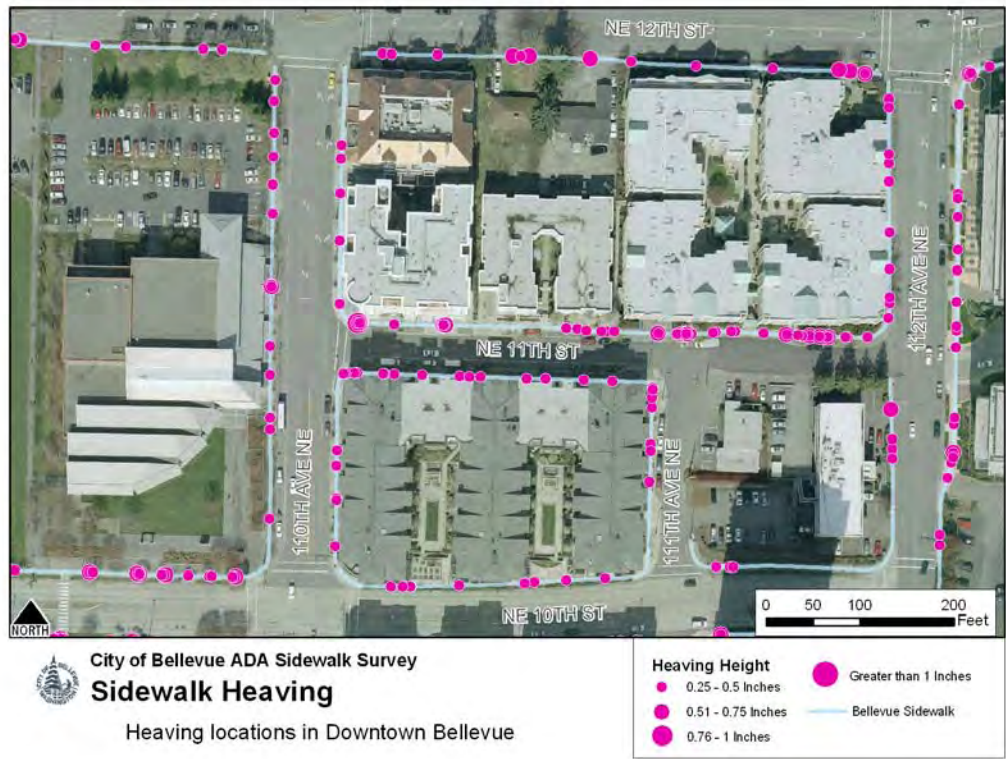
The map below shows heaving in an area in downtown Bellevue. The data collected for this project allows detailed maps such as this to be created for any neighborhood in Bellevue.

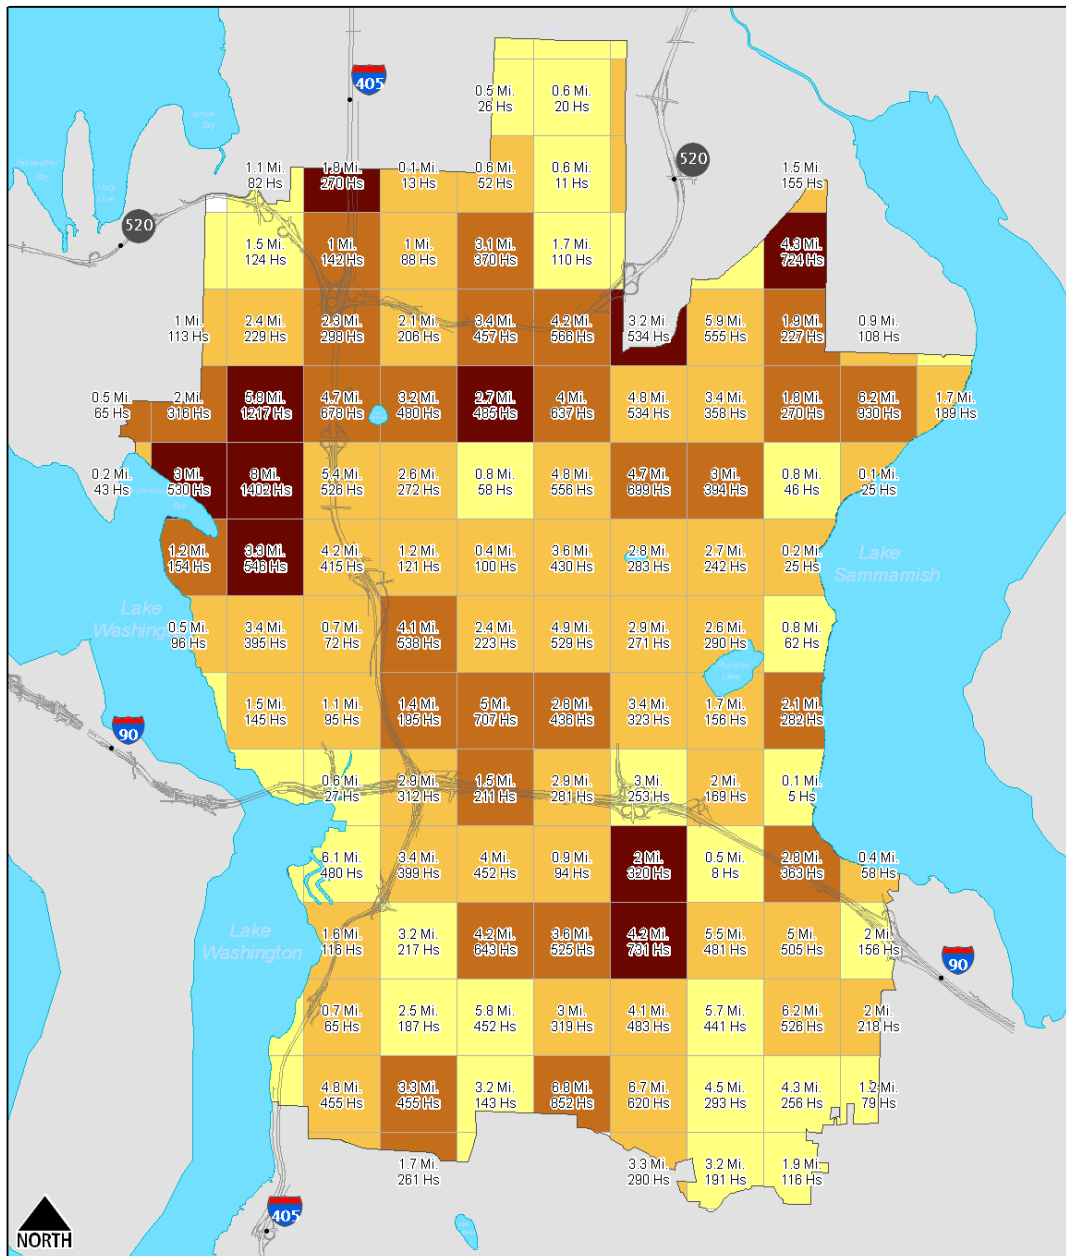
## City of Bellevue ADA Sidewalk Survey Sidewalk Heaving

The heaving index below aggregates the four heaving categories, giving a higher weight to the larger heaves. It is clear from the map that Downtown Bellevue, the Richards Road and Bel-Red corridors, the Newport Hills neighborhood, and the northeast corner of Bellevue have high heaving index scores.

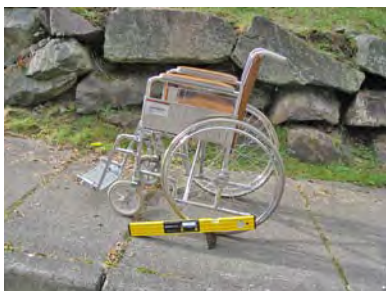
Sidewalk grade of 22% on 166th Avenue SE between Phillips Road and SE 39th Place.

Steep sidewalk grades are a barrier for many pedestrians. Powered and manual wheelchairs can become unstable and/or difficult to control on sloped surfaces. These areas are even more difficult for sidewalk users who are disabled to access when wet.

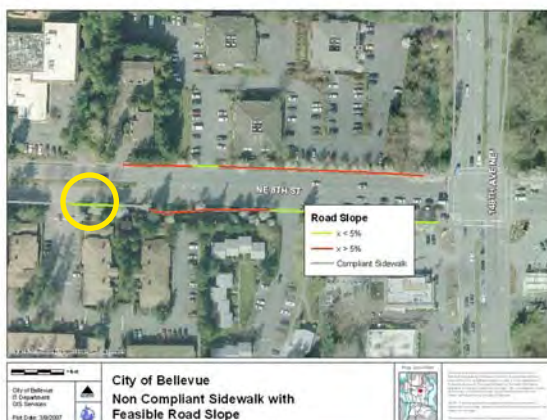
*The sidewalk segments (depicted in both red and green) along NE 8th Street and 148th Avenue NE were initially classified as having non-standard ADAAG grade values. After running its GIS script, Bellevue reclassified those sidewalk segments where the adjacent road grade is greater than 5% (red) as technically infeasible. Sidewalk segments with non-standard grades and adjacent to road grades that are less than 5% (green) are identified as a barrier in the ADA Self-Evaluation Report.*

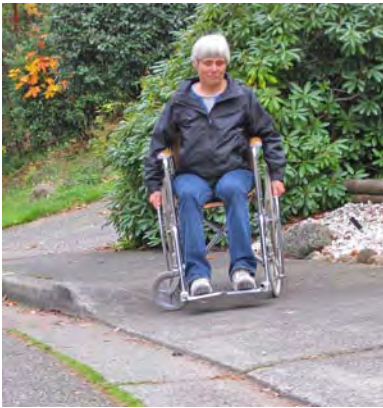
A series of driveway apron flares with 11% cross slope measurements at 130th Avenue SE & SE 26th Street.

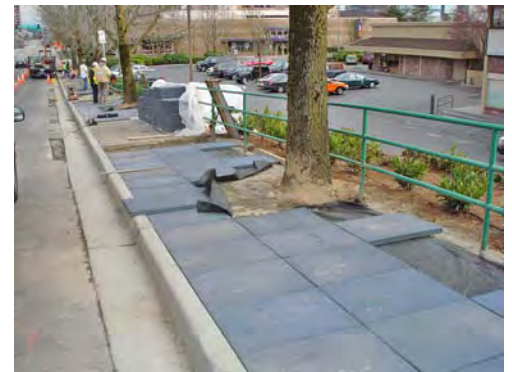
Rubber sidewalk panels at NE 10th Street west of 102nd Avenue NE allow tree roots to grow under the sidewalk without creating a change in level barrier for people with disabilities.

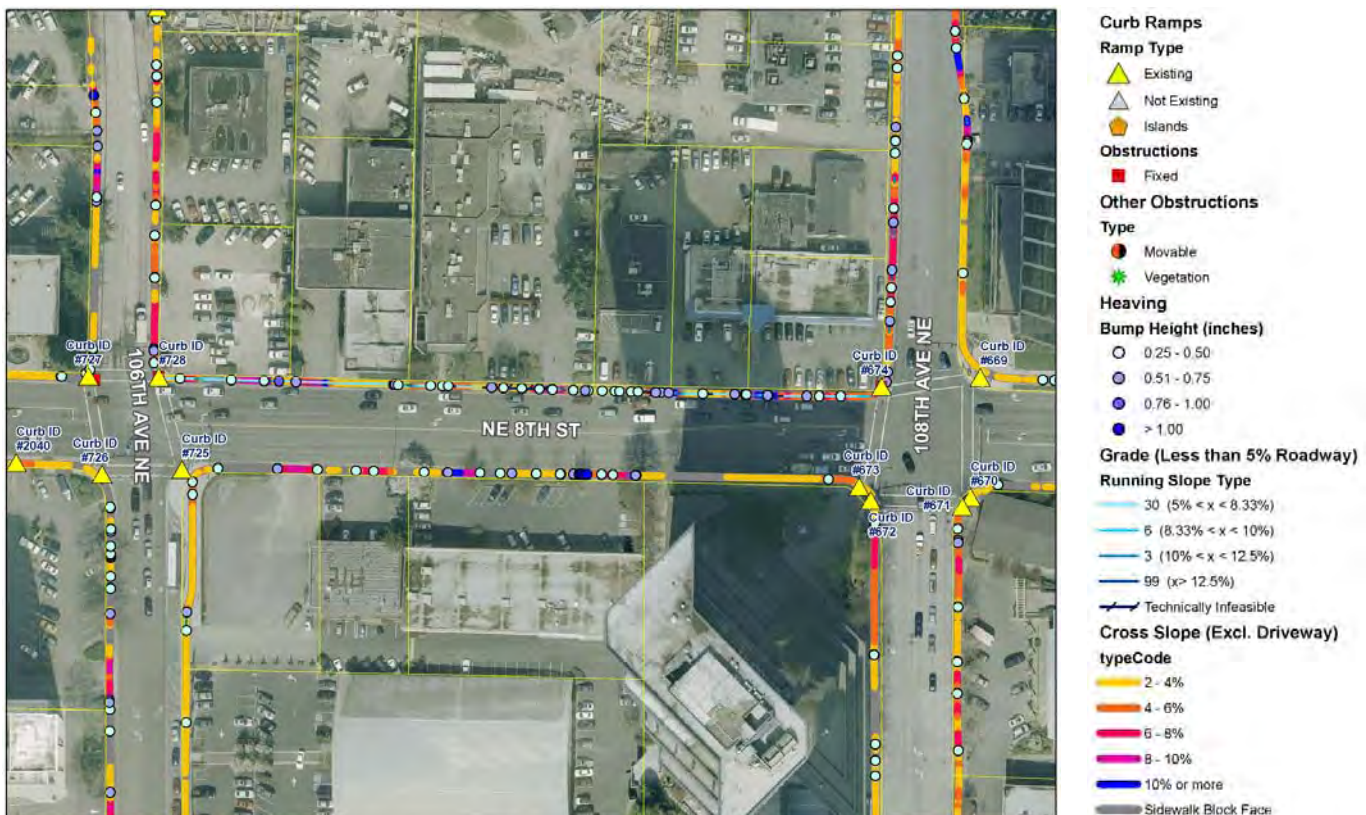
The following is an example of how the barrier scoring process makes use of activity and impedance score categories. Block ID: 1035 (NE 8th Street between 106th and 108th Ave NE) received a high impedance score (100 points) and a high activity score (70 points). With a combined barrier ranking score of 170, this block face is among the top 10 highest ranked sidewalk segments in the ADA Self-Evaluation Report.

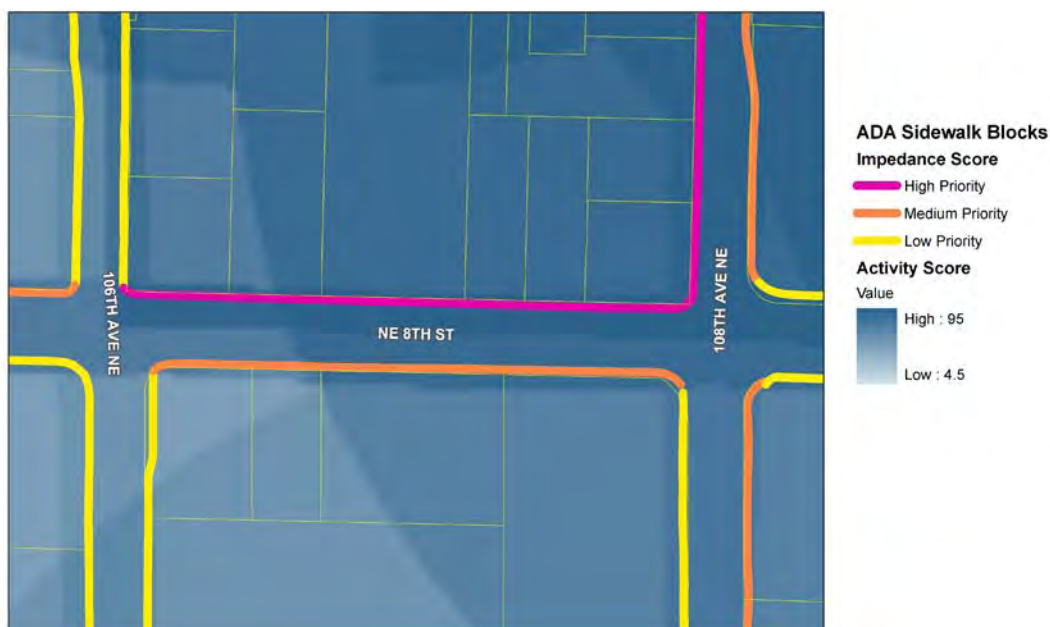
In the technical appendix report are maps that help the reader to visualize and analyze the sidewalk activity and impedance data. In these maps, we see the spatial relationships between activity and impedance scores and are able to prioritize improvements where they are most needed. Reflected in the image below is a snapshot of this merger of data-sets for Block ID: 1035.

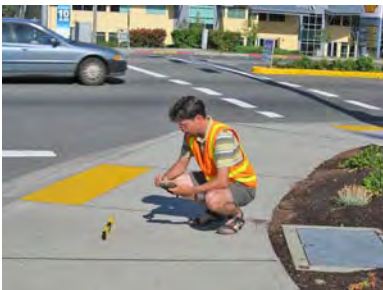
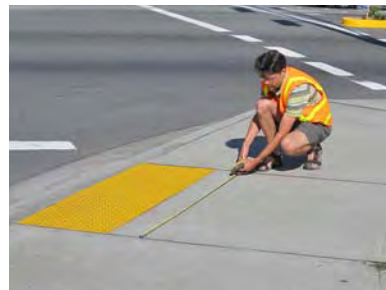
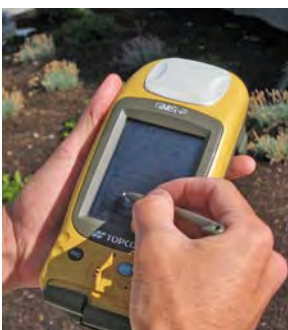
Field technicians documented each curb ramp barrier including geospatial coordinates, type of barrier, notes, and a digital image.

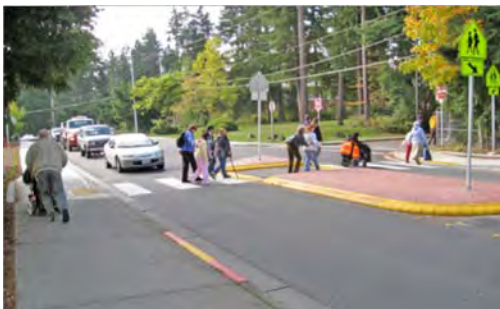
*Pedestrian median with a cut-through design provides people with disabilities a point of refuge when crossing at 164th Avenue NE south of NE 24th Street.*

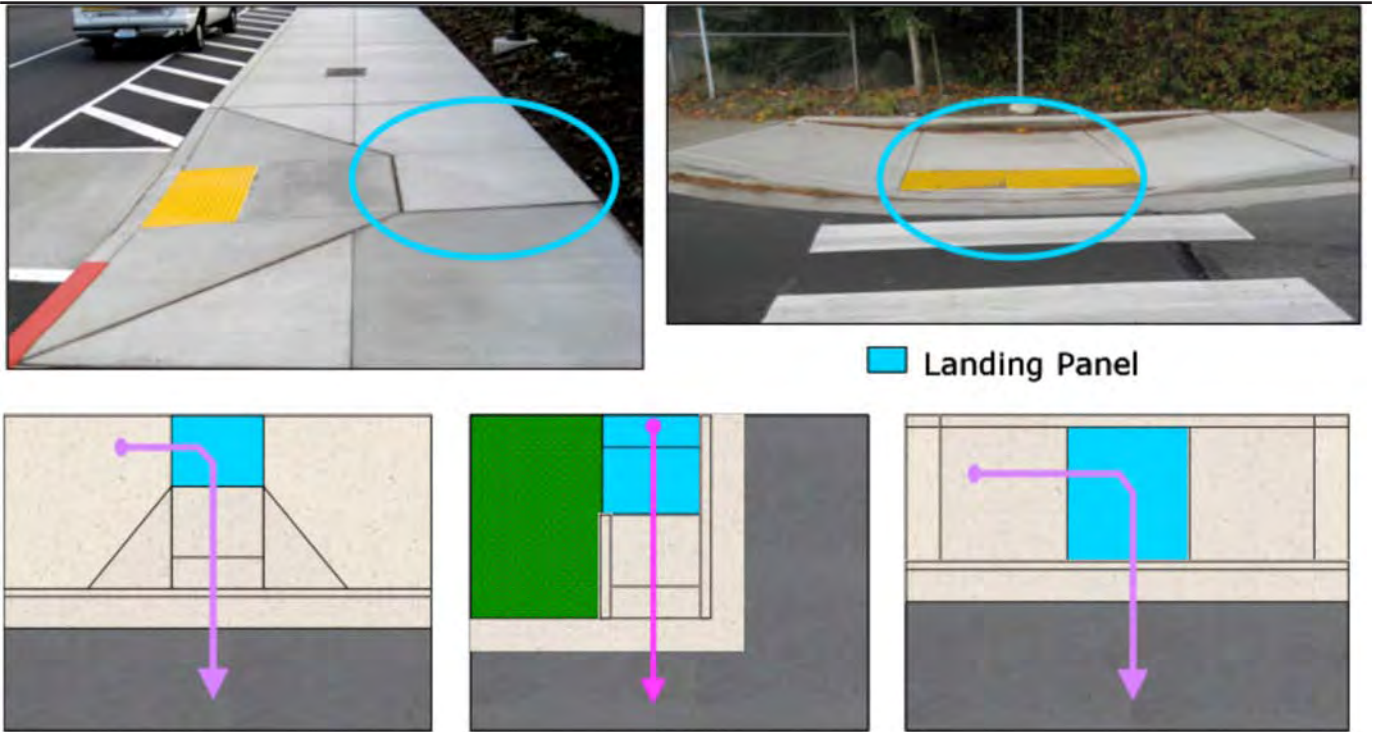
Locations: NE 24th and NE 167th

panels are a place where pedestrians will pause and reorient themselves either toward the sidewalk (in the case of a perpendicular ramp) or toward the street, these spaces should be flat. The field team found that 2,791 (79%) of the 3,511 existing ramps had non-standard ramp panel slopes of greater than 2%.

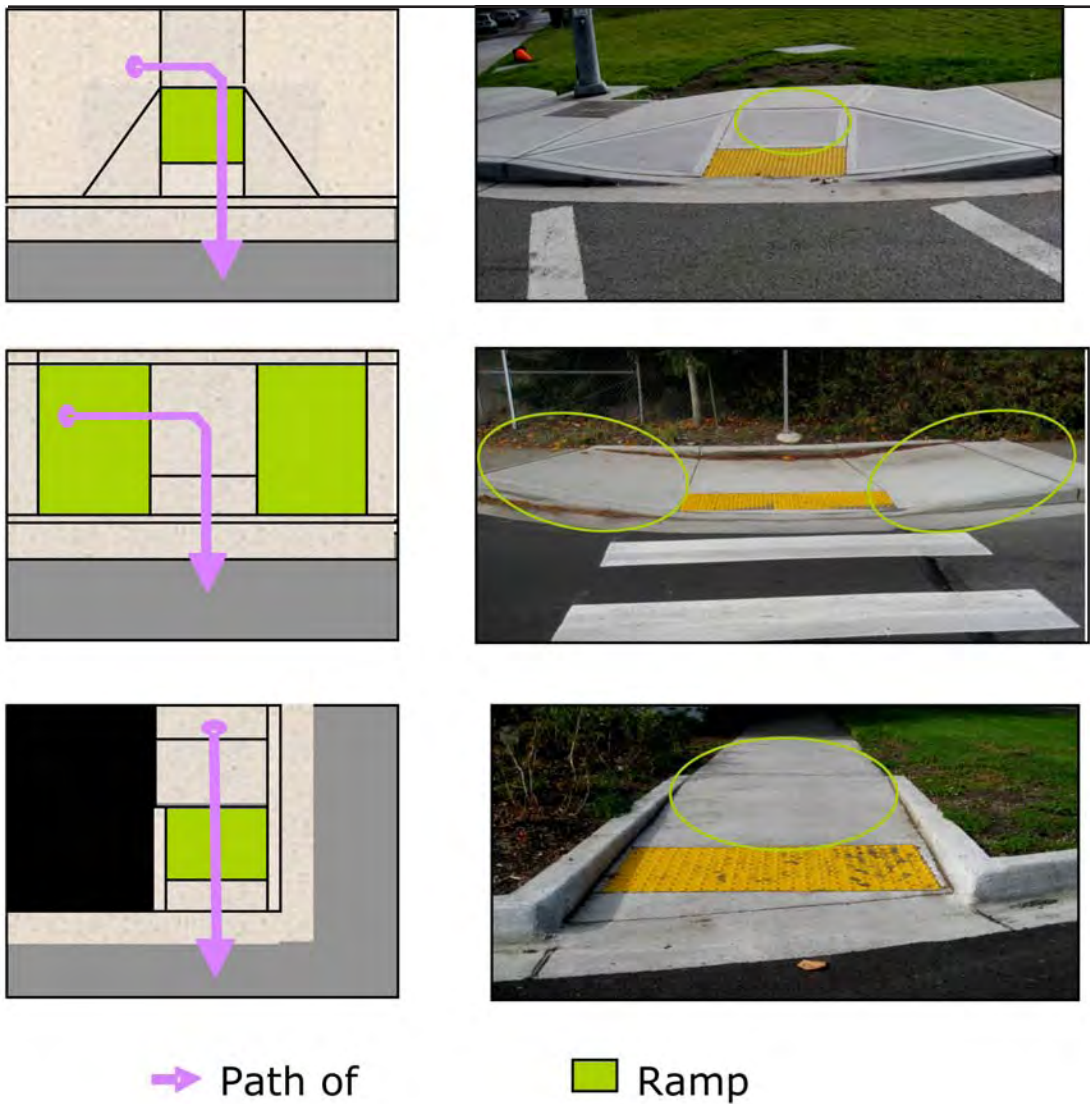
Locations: (from top) NE 24th and 164th NE; NE 24th and 167th NE; NE 24th and 167th NE

panel running slope, the survey team found: 1,525 (43%) had standard running slopes of less than 8.3%; 686 (20%) had non-standard running slopes of 8.3-10%; and, 1,300 (37%) had highly non-standard running slopes greater than 10%.

Ramp panel cross slope is measured perpendicular to the direction of travel. Like running slope, excessive cross slope poses a challenge for pedestrians with limited mobility by impairing stability. Regardless of ramp type, ADAAG requires cross slopes of less than 2%. Of the 3,511 ramps measured for ramp panel cross slope, the survey team found: 1,095 (31%) met ADAAG standards with cross slopes of less than 2%; 1,006 (29%) were non-standard with cross slopes of 2-4%; and, 1,410 (40%) were highly non-standard with cross slopes in excess of 4%.

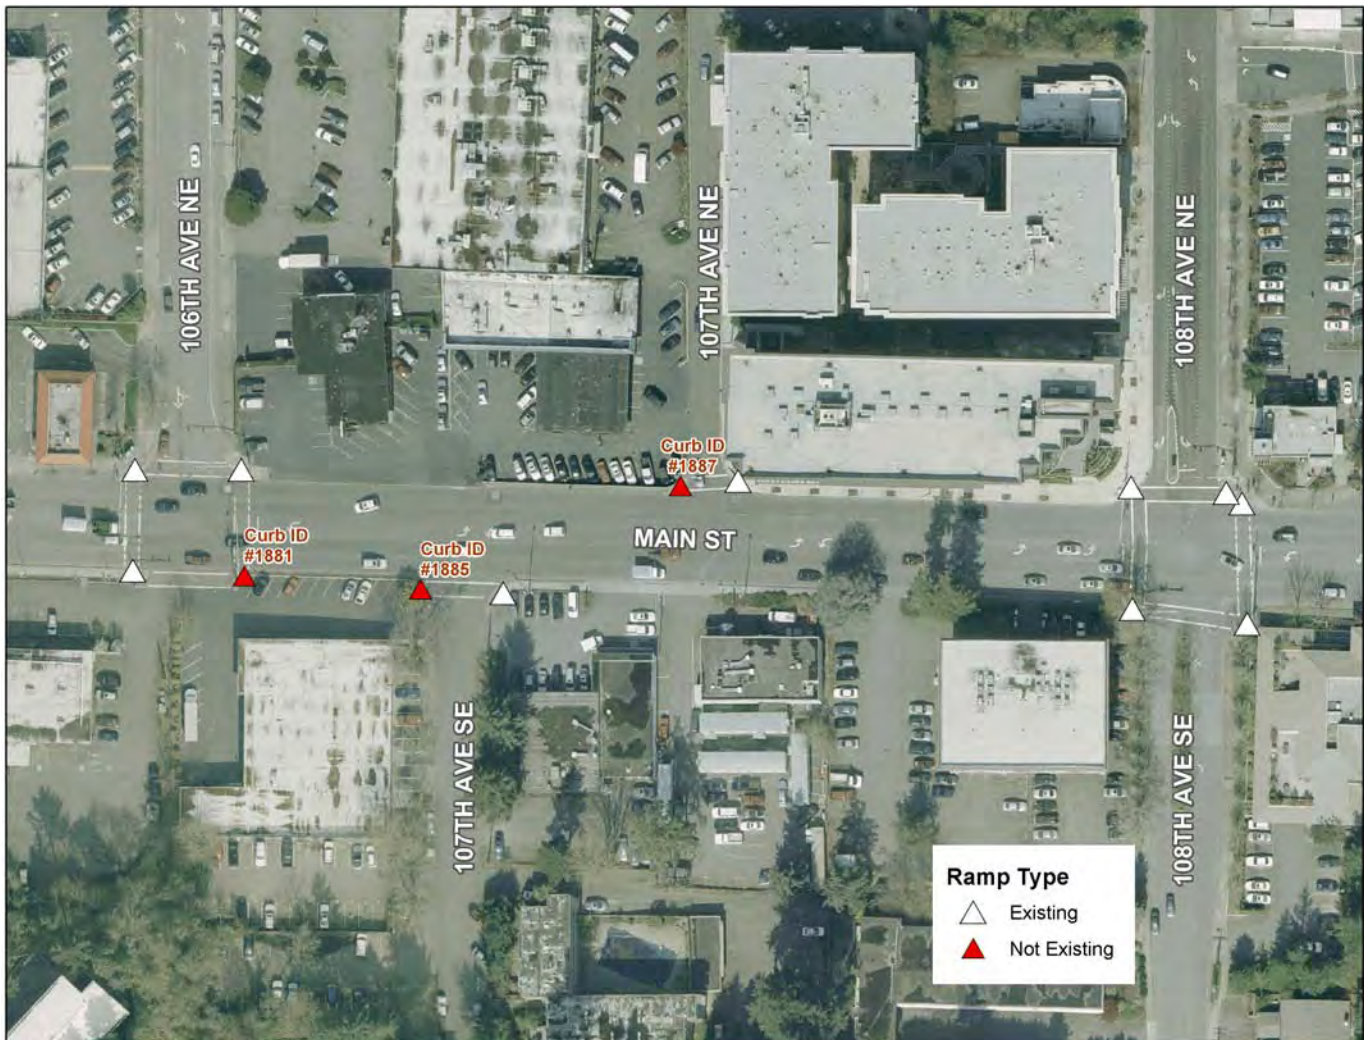
The following Main Street locations in the curb ramp inventory received the three highest barrier ranking scores: Curb ID: 1881 at 106th Avenue NE; Curb ID: 1885 at 107th Avenue SE; and, Curb ID: 1887 at 107th Avenue NE. Each of these locations received a high impedance score (100 points) because ramps are missing and they have a high activity score (81 points) because this location serves as a major connection to many destinations in downtown Bellevue.

In 2008, the City of Bellevue initiated a conceptual design project for Main Street from Bellevue Way to 116th Avenue NE. Work includes lane configuration options, enhanced pedestrian-bicycle facilities, potential open space opportunities and a framework for downtown gateways. The early-stage designs of proposed projects along this corridor all include accessibility enhancements, including the ramp locations identified in the ADA Self-Evaluation Report.
