MEYDENBAUER RESIDENCE

707 94TH AVE SE
BELLEVUE, WA 98004

PROJECT DESCRIPTION:
REMODEL TO AN EXISTING SINGLE-FAMILY RESIDENCE, NEW ACCESSORY STRUCTURES, AND ASSOCIATED SITE WORK AND DRIVEWAY UPGRADES.

As requested, PanGEO has completed a geotechnical engineering evaluation for the utilities that have been installed in the mapped Geologic Hazard Areas (i.e. Steep Slope and High Erosion Areas) in the western portion of the property. The purpose of our study is to evaluate the potential impacts of the installed utilities on the slope stability and the residence located to the east of the slope. Our service scope included reviewing readily-available geologic and geotechnical data, conducting a site reconnaissance, drilling one test boring, and developing the conclusions and recommendations presented in this report.

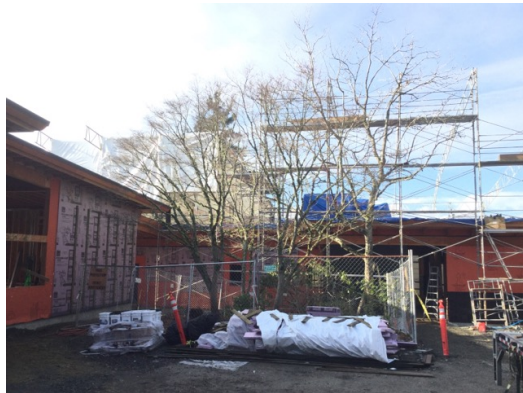
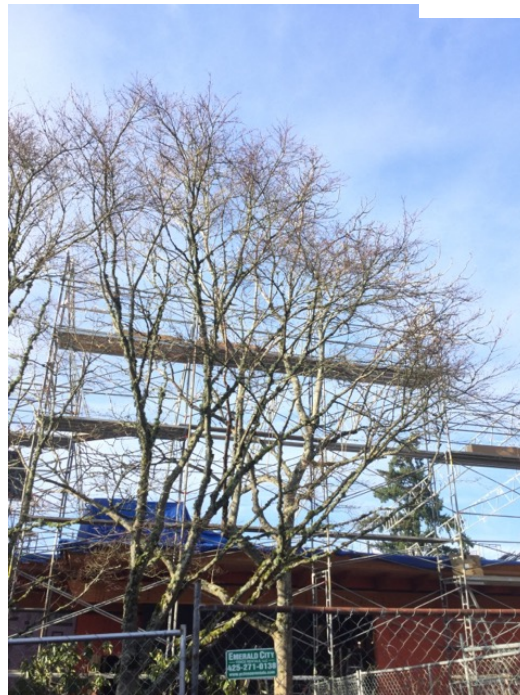
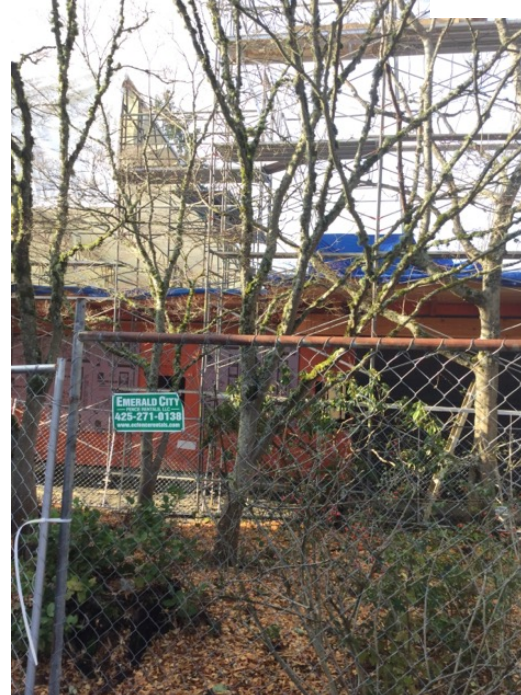
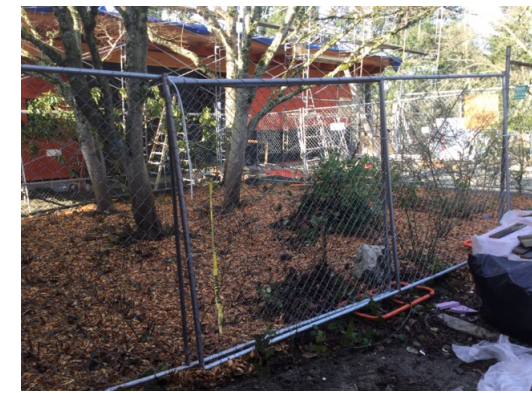
Tree	Species	DBH (in)	Drip Avg (ft)	CRZ (ft)	Vigor	Structure	Risk	Pres. Cat/Value	Recommendations
1	Japanese maple <i>Acer palmatum</i>	9.7, (9.7)	9.6	9.7	Fair	Fair to Good	Low	Government Medium	
Notes / Defects	<p>Observations: Tree protection has been in place during this project. The Critical Root Zone has not been impacted and this tree appears to be in fair to good condition based on growth extension. Wood chip mulch has been applied within the tree protection area. This tree has been pruned for construction clearance, and clearance from the finished structure. The shrub and ground cover layer within the Critical Root Zone has been cut. This tree has been watered.</p> <p>Recommendations: Continue watering from May through to the end of October. Maintain wood chip mulch cover over as much of the Critical Root Zone as is practicable.</p>								<p>Dripline (ft)</p> <p>N 9.6 S 9.6 E 9.6 W 9.6</p>

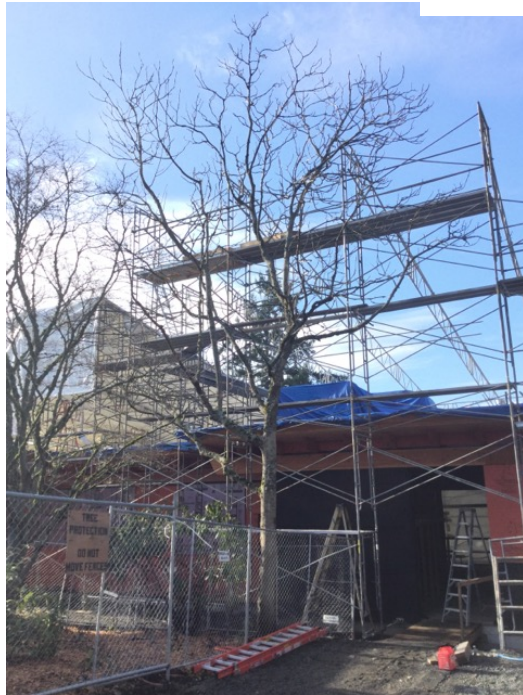
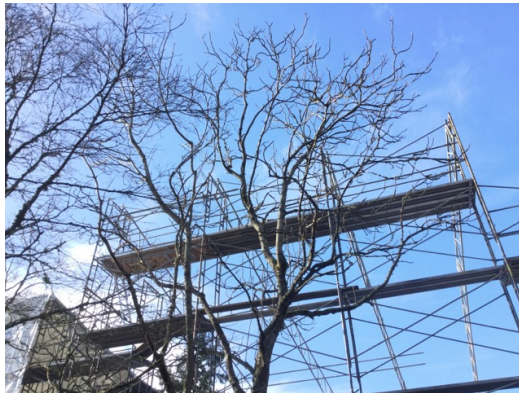
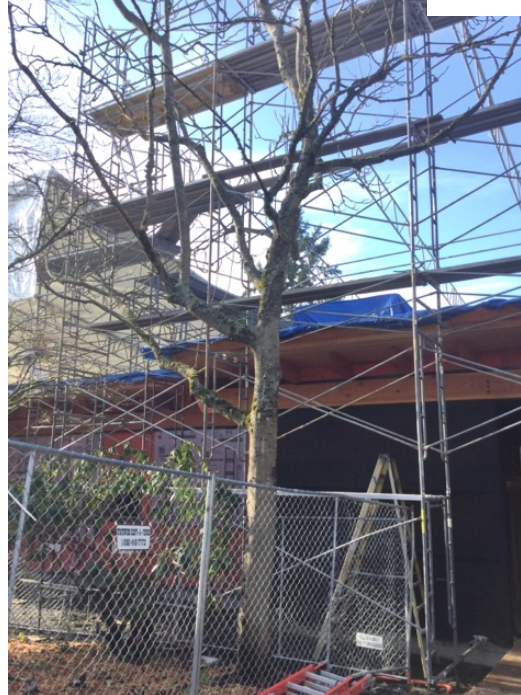
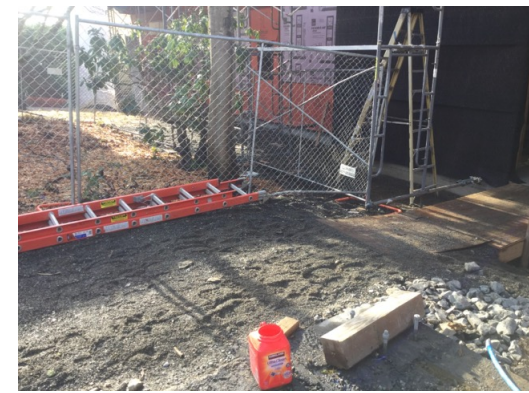
Scaffolding through the crown does expose those portions of the crown that are affected to damage. Please have contractors exercise care. Avoid heat close to the branches and trunk.								
	Continue watering from May through to the end of October.								
	Maintain wood chip mulch cover over as much of the Critical Root Zone as is practicable.

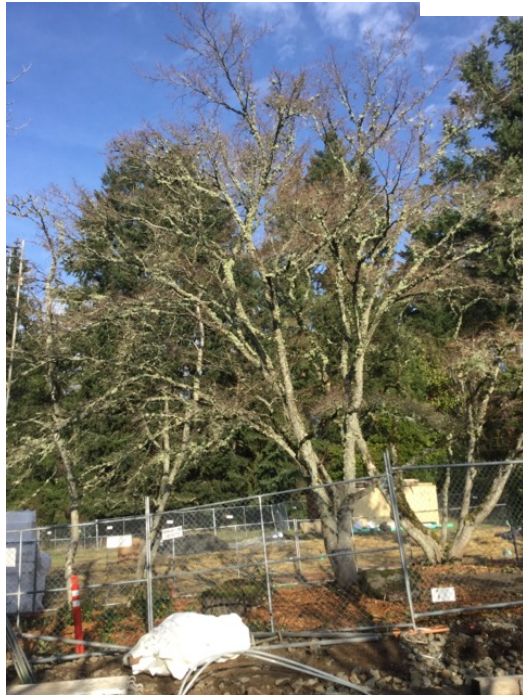
Photo 1

Tree	Species	DBH (in)	Drip Avg (ft)	CRZ (ft)	Vigor	Structure	Risk	Pres. Cat/Value	Recommendations
9	Japanese maple <i>Acer palmatum</i>	9.8, 9.4 (13.58)	18.4	13.6	Fair	Fair	Low	Government Medium	
Notes / Defects	Observations: Landscape shrubs and ground cover have been cut within the Critical Root Zone. The tree protection area that is not currently covered in a concrete or asphalt surface has been covered with wood chips. Some pruning for clearance has been completed. This tree has also been watered during the summer.								Dripline (ft)
	Recommendation: Continue watering from May through to the end of October.								N 18.4
	Maintain wood chip mulch cover.								S 18.4
	Retain hardscape (concrete or asphalt) that is over the Critical Root Zone for as long as possible during construction. Contact Urban Forestry Services, Inc., prior to removing this surface.								E 18.4
									W 18.4

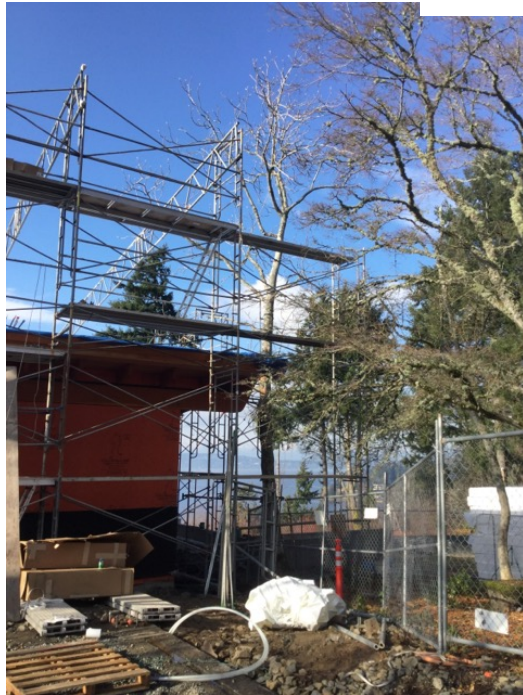
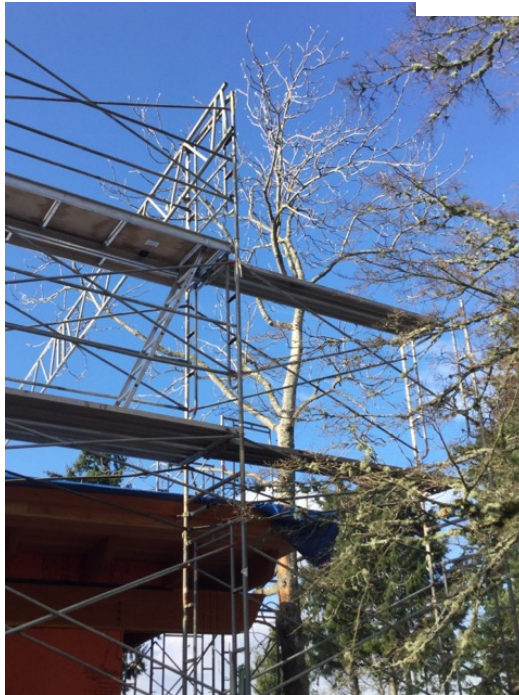
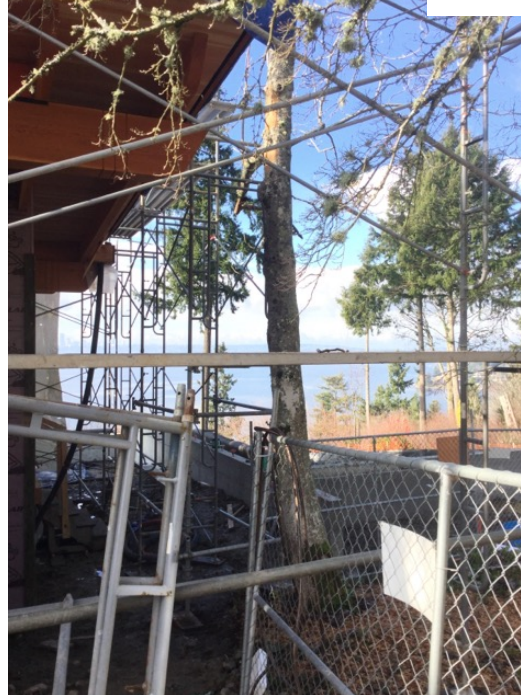
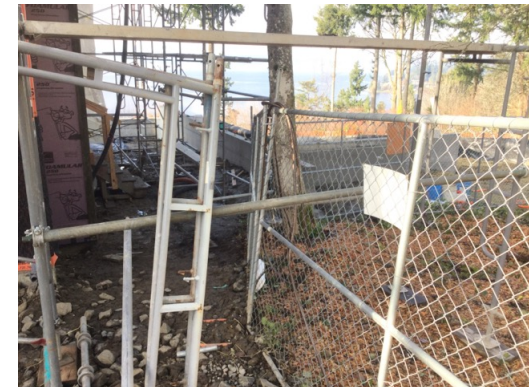
Tree	Species	DBH (in)	Drip Avg (ft)	CRZ (ft)	Vigor	Structure	Risk	Pres. Cat/Value	Recommendations
5	Magnolia <i>Magnolia species</i>	13.7, (13.7)	14.1	13.7	Fair to Good	Fair	Low	Government Medium	
Notes / Defects	<p>Observations: Despite its location close to construction this tree is currently showing no indications of strain relating to construction impact. Between approximately 15 to 25-feet height is an area of dead bark covering approximately 20 to 30% of the circumference, and measuring an estimated 30x8-inches. This dead area may have been caused by impact or some other construction impact. The dead area of bark and vascular tissue did not exist prior to construction. An explanation for this trees fair to good condition is the lack of root loss.</p> <p>Recommendations: Stress the importance to all persons working on the project of not directly impacting (hitting) the tree with material or machinery, and to keep all sources of heat from the branches and trunk. Continue watering from May through to the end of October. Maintain wood chip mulch cover over as much of the Critical Root Zone as is practicable.</p>								<p>Dripline (ft) N 14.1 S 14.1 E 14.1 W 14.1</p>

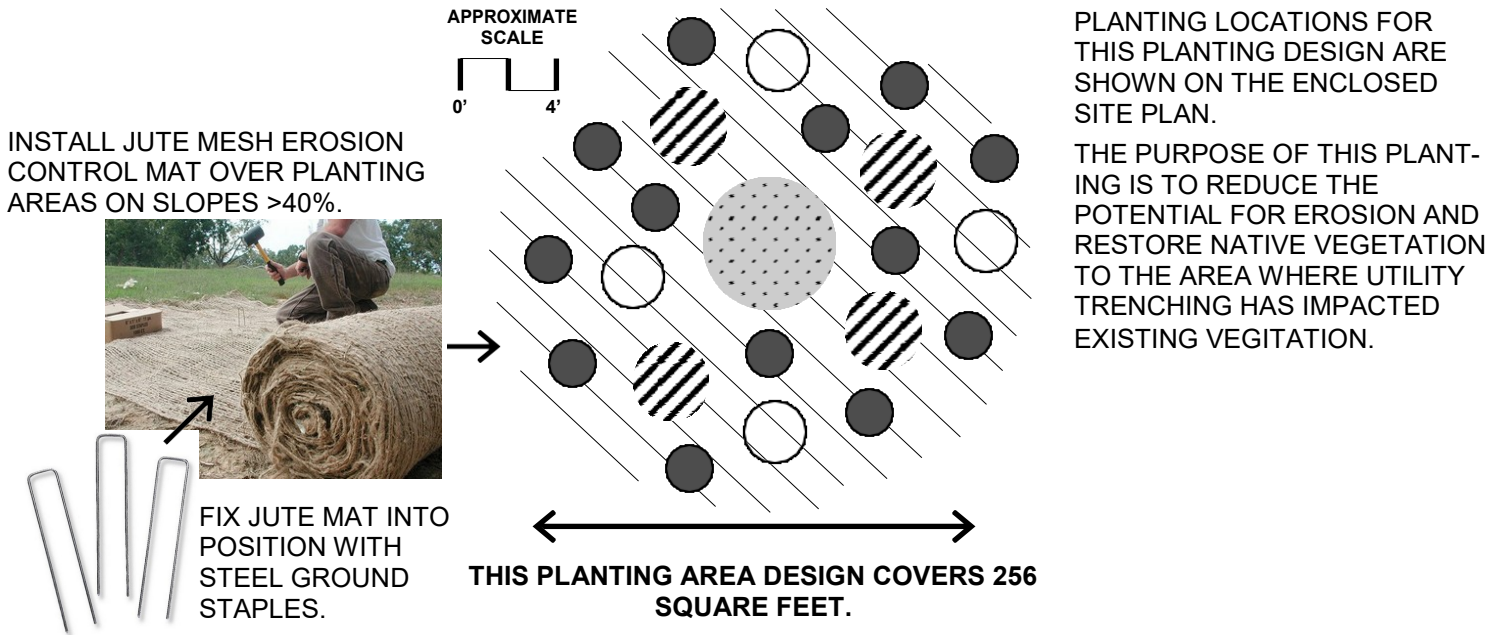
THIS DETAIL SHOWS THE RECOMMENDED PLANTING DESIGN FOR THE ENVIRONMENTALLY CRITICAL AREA (ECA).

1. CLEAR THE PLANTING AREA OF NOXIOUS AND INVASIVE PLANTS AND DISPOSE OFF-SITE.
2. INSTALL JUTE MESH EROSION CONTROL MAT AND FIX INTO POSITION ON SLOPES >40% WITH STAPLES.
3. INSTALLED PLANT SPACING SHALL BE A MAXIMUM OF 3 FEET ON CENTER.
4. INSTALL PLANTS AS PER THE CITY OF BELLEVUE STANDARD AND MAINTAIN AS PER THE CITY OF BELLEVUE ECA STANDARD MITIGATION PLAN INSTRUCTIONS.
5. THE DISTURBED TRENCHING AREA MUST BE RESTORED USING THE PLANTING LAYOUT SHOWN ON THE ENCLOSED SITE PLAN. THE DESIGN ABOVE WILL NEED TO BE REPLICATED MULTIPLE TIMES TO ACHIEVE APPROPRIATE COVERAGE (EACH DESIGN COVERS ROUGHLY 256 SQFT)
