3938 179TH LN SE

**CRITICAL AREAS REPORT
AND
MITIGATION PLAN
FOR**

3938 179TH LANE SE - SINGLE FAMILY RESIDENCE

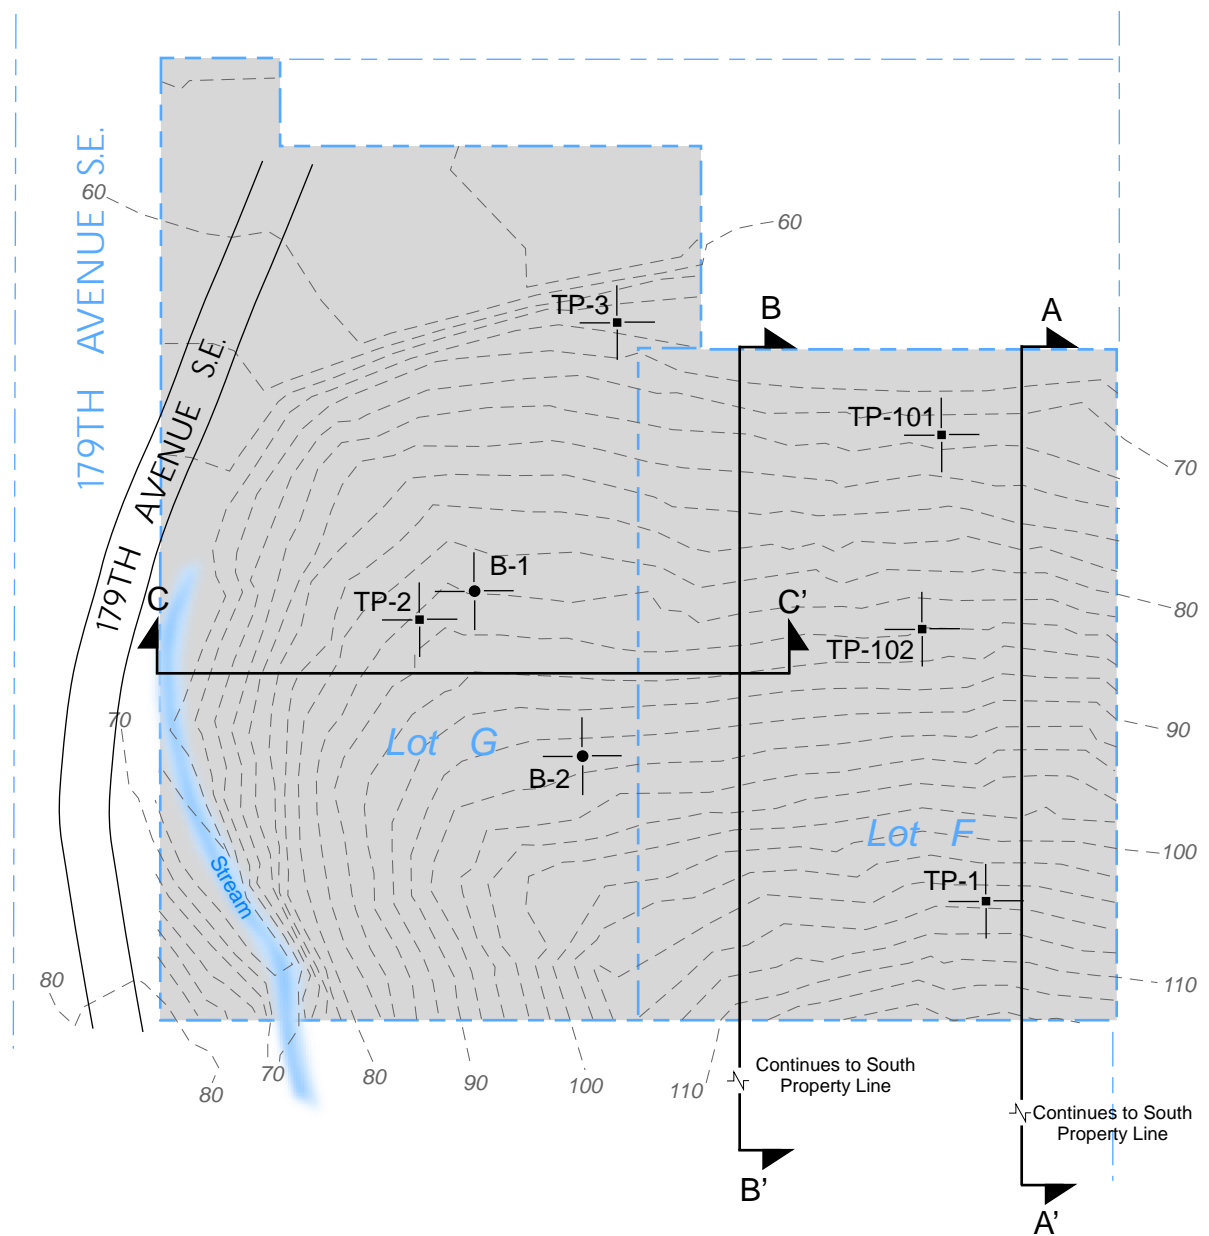
Drwn. By MRS
Checked By HTW
Date 09/26/2022
Proj. No. 2861.05
Plate 2

- TP-101 | Approximate Location of ESNW Test Pit, Proj. No. ES-2861.02, Nov. 2015
- B-1 | Approximate Location of ESNW Boring, Proj. No. ES-2861.03, Jan. 2015
- TP-1 | Approximate Location of ESNW Test Pit, Proj. No. ES-2861.01, June 2013
-

The topography of the site consists of a moderate to steep north descending slope with an average gradient of approximately 34 percent across a vertical relief of 46 feet, as well as a steep west descending slope through the southwesterly portions of the site with an average gradient of up to 50 percent across a vertical relief of 25 feet. The western steep slope descends to the stream. The Subsurface Exploration Plan (Plate 2) illustrates the approximate limits and local topography of the property.

As part of our study, we completed slope stability analyses through three representative cross-sections; cross-section locations are illustrated on the Subsurface Exploration Plan (Plate 2). The slope stability analyses were completed for static and seismic for both the existing and proposed conditions. The results of the slope stability analyses indicate adequate safety factors of greater than 1.5 and 1.15 for static and seismic, respectively, and also indicate negligible effects on the safety factors for the proposed conditions. A summary of the slope stability analyses is provided below; the results of the slope stability analyses are provided with this report.

Slope stability analyses have been completed within representative site cross-sections for both the existing and proposed site conditions; the cross-section locations are illustrated on the Subsurface Exploration Plan (Plate 2) and the slope stability results are provided as part of this report. Based on the results of the slope stability analyses, the site slopes exhibit adequate safety factors for both static and seismic conditions and the proposed conditions will have a negligible impact on the slope stability.

The subsurface conditions at the site were explored by excavating five test pits and advancing two borings at the approximate locations illustrated on Plate 2 of this report. The test pit and boring logs are provided in this Appendix.
