**CRITICAL AREAS REPORT
AND
MITIGATION PLAN**

3958 179TH LANE SE - SINGLE FAMILY RESIDENCE

PORTION OF SECTION 13, TOWNSHIP 24N, RANGE 5E, W.M.

Vicinity Map
179th Short Plat
Bellevue, Washington

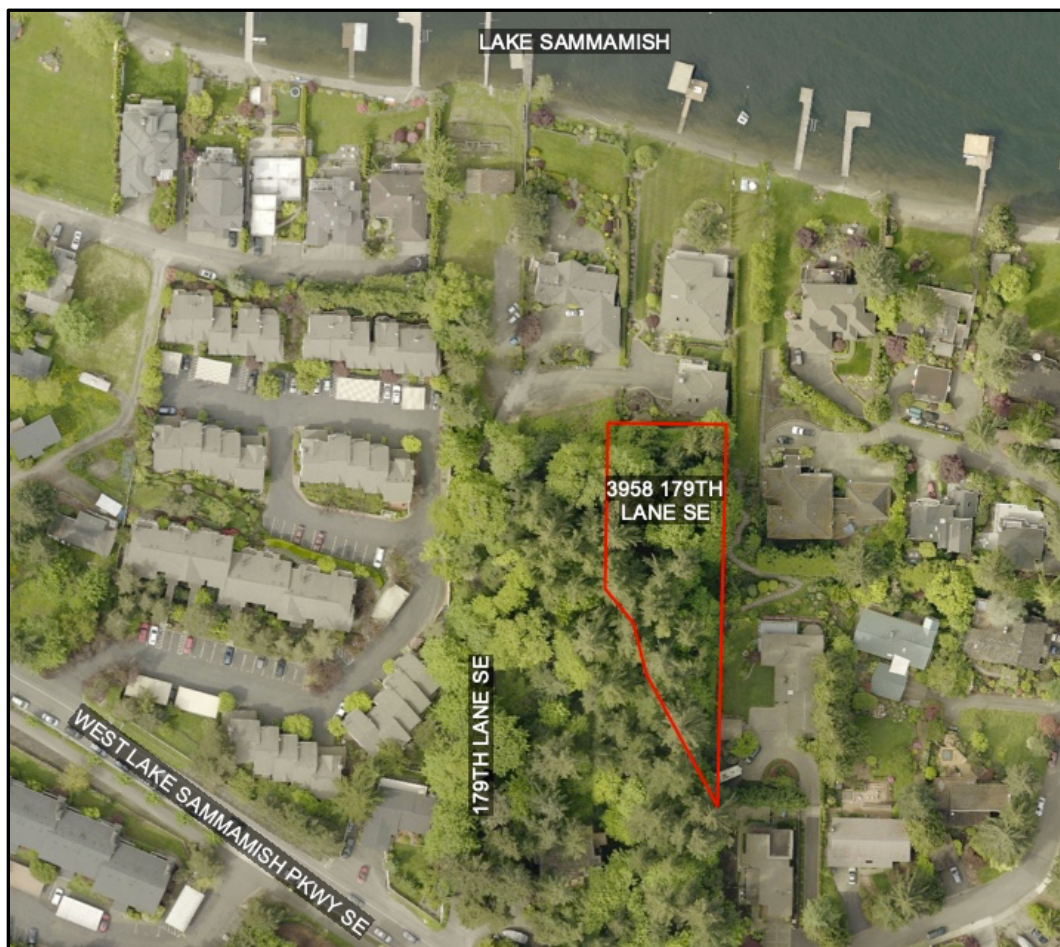
Figure 1 - Aerial photo of the subject property (not to scale)

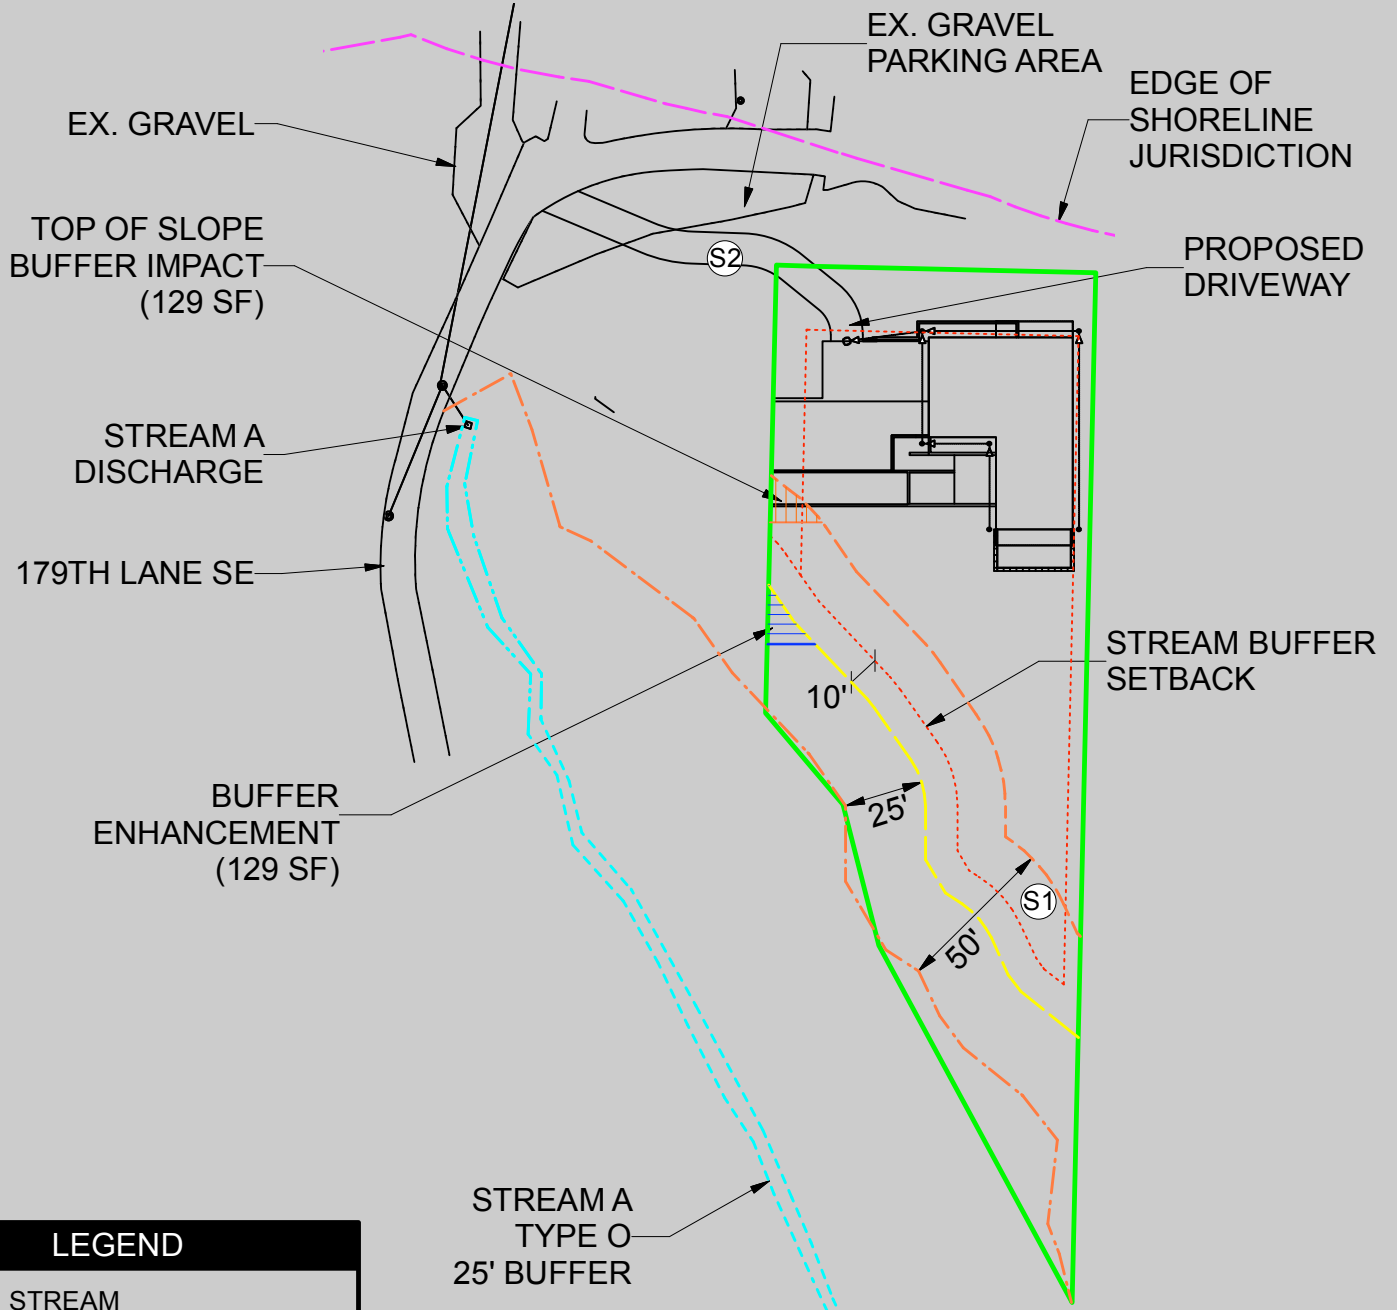
- STREAM
- STREAM (ESTIMATED)
- TOP OF BANK/SLOPE
- FINAL BUFFER
- STREAM BSBL
- STANDARD TOP OF SLOPE BUFFER
- BUFFER ENHANCEMENT
- TOP OF SLOPE BUFFER IMPACTS
- S1 DATA SITES (S1 - S2)

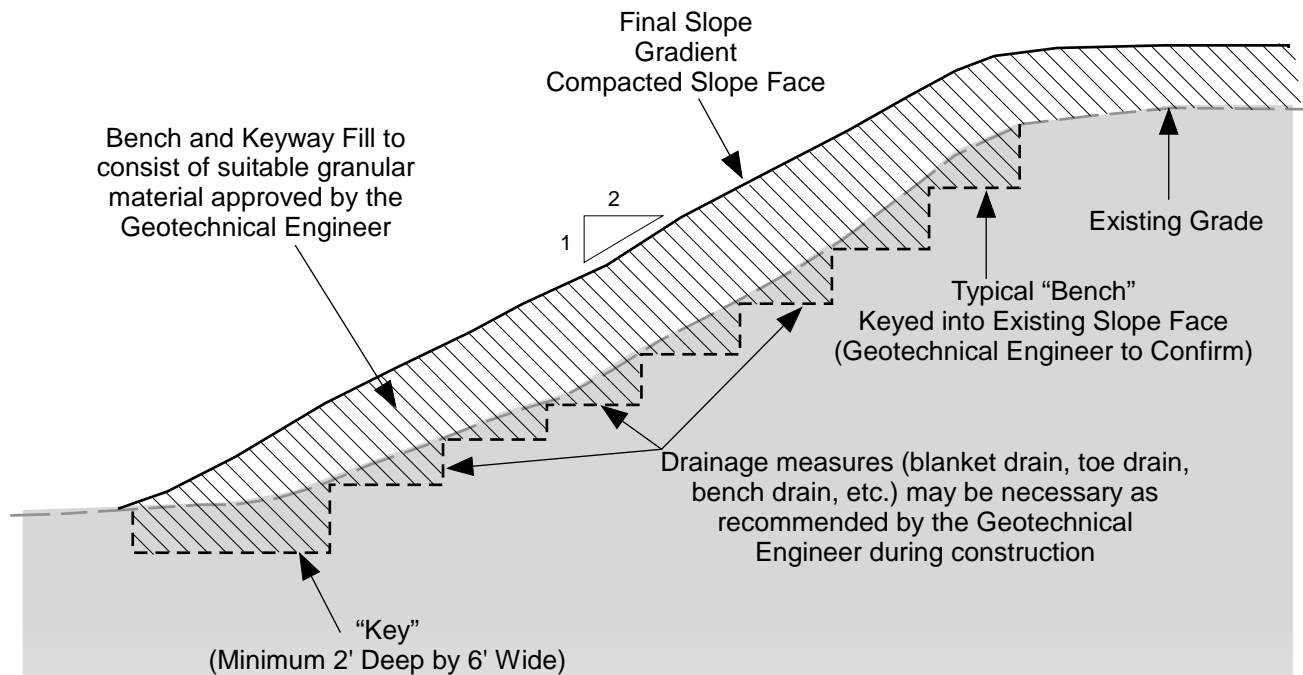
Drwn. CAM	Date 09/26/2022	Proj. No. 2861.05
Checked HTW	Date Sept. 2022	Plate 3

- Slope should be stripped of topsoil and unsuitable materials prior to excavating Keyway or benches.
- Benches will typically be equal to a bulldozer blade width of approximately 8 feet but shall be at least 4 feet.

Slope Fill Detail
179th Short Plat
Bellevue, Washington

Some minor fill may be placed on existing sloped topography to establish the site access along the northwestern portion of the site. Structural fill within sloping areas should be placed on a level bench as depicted on Plate 3 (Slope Fill Detail). Benches must be "keyed" into the slope and subsequently filled and compacted with suitable structural fill before continuing to the next bench. Sloping finish grades should be "overbuilt" using a bench-style fill and cut to the design gradient to ensure a compacted slope face is maintained. ESNW should observe structural fill placement to confirm subgrade conditions and provide additional drainage recommendations, as necessary.

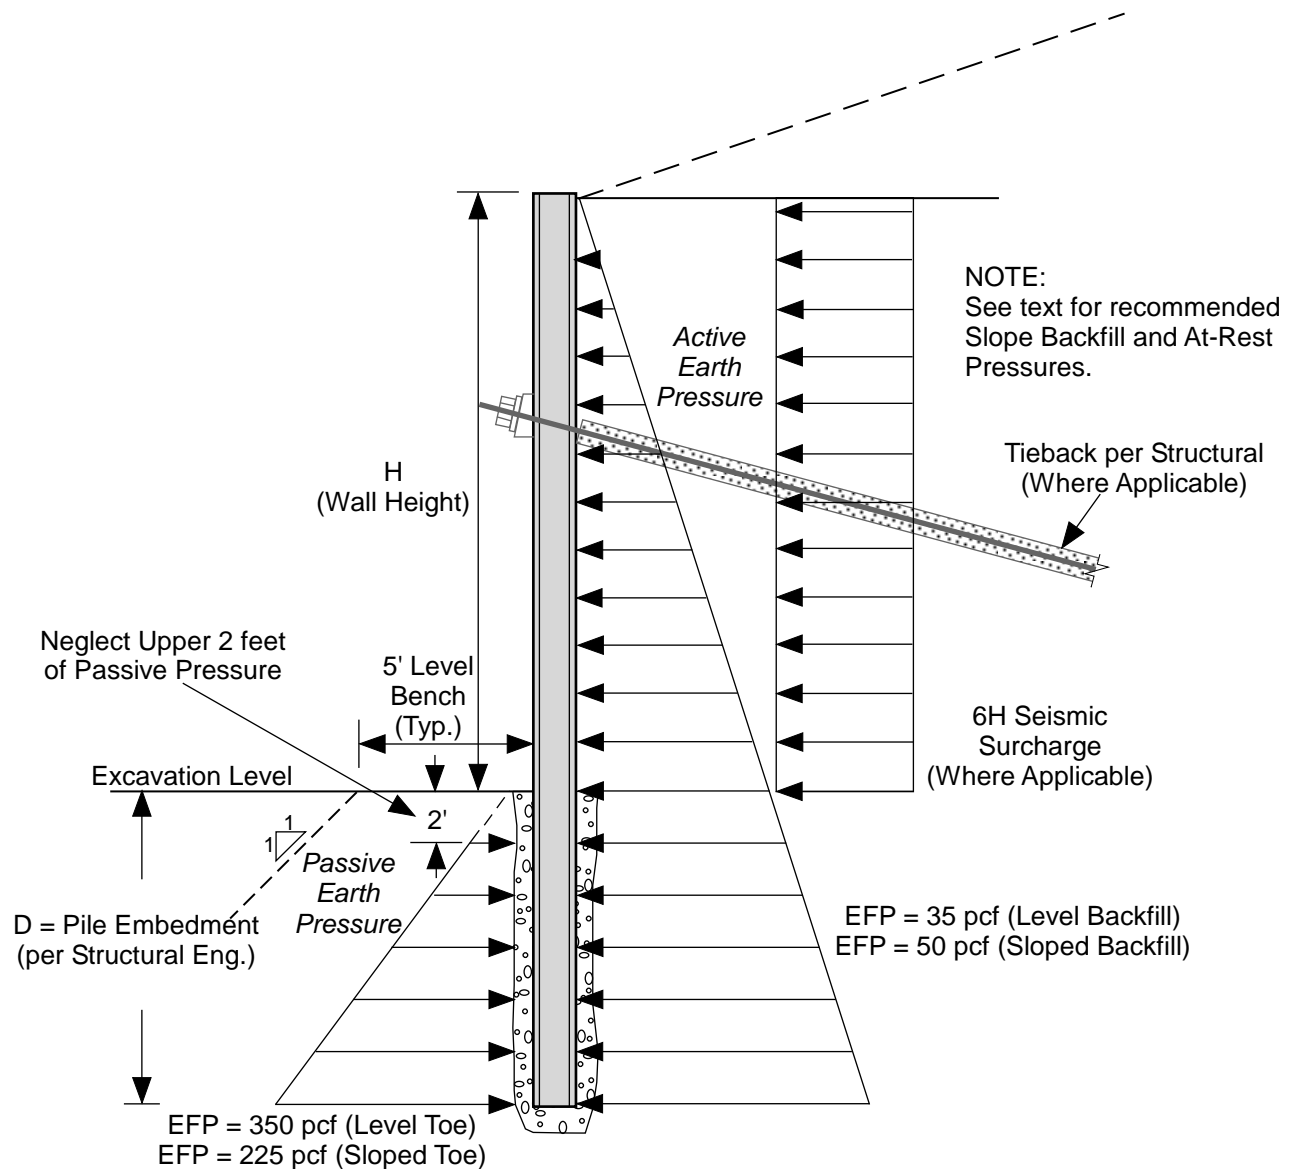
Passive Pressure includes a factor of safety of 1.5.

Earth Solutions NW_{LLC} Geotechnical Engineering, Construction Observation/Testing and Environmental Services	
Cantilever & Single Tieback Wall 179th Short Plat Bellevue, Washington			
Drwn. CAM	Date 09/27/2022	Proj. No.	2861.05
Checked HTW	Date Sept. 2022	Plate	4

A typical earth pressure distribution for cantilever and single tieback shoring is provided on Plate 4 of this study. Allowable soldier pile deflections for walls subjected to active earth pressures should be limited to one inch.

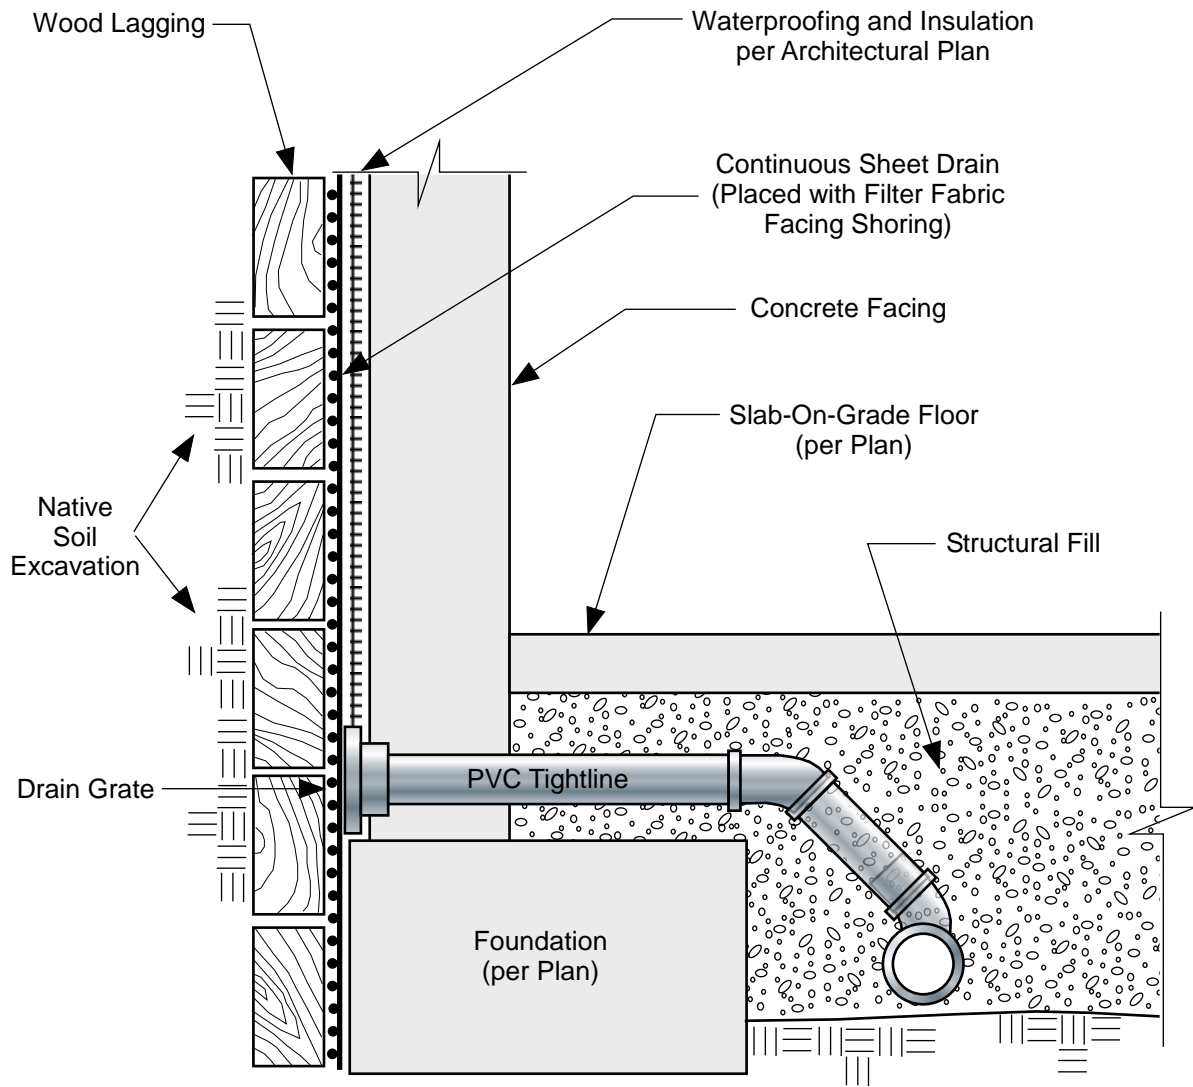
NOTE: Drain through wall should be installed at middle of lagging.

Earth Solutions NW_{LLC} Geotechnical Engineering, Construction Observation/Testing and Environmental Services	
Shoring Wall Drainage Detail 179th Short Plat Bellevue, Washington			
Drwn. CAM	Date 09/26/2022	Proj. No.	2861.05
Checked HTW	Date Sept. 2022	Plate	6

Temporary shoring walls should be provided with adequate drainage to reduce the potential for excess hydrostatic pressure build-up. During construction, drainage occurring between the timber lagging is usually sufficient to prevent the development of excessive hydrostatic pressures. Where permanent building walls will be constructed along the temporary shoring walls, a sheet drain material should be installed along the face of the shoring wall. A typical detail illustrating a sheet drain and permanent wall drainage system is provided on Plate 6 of this study.

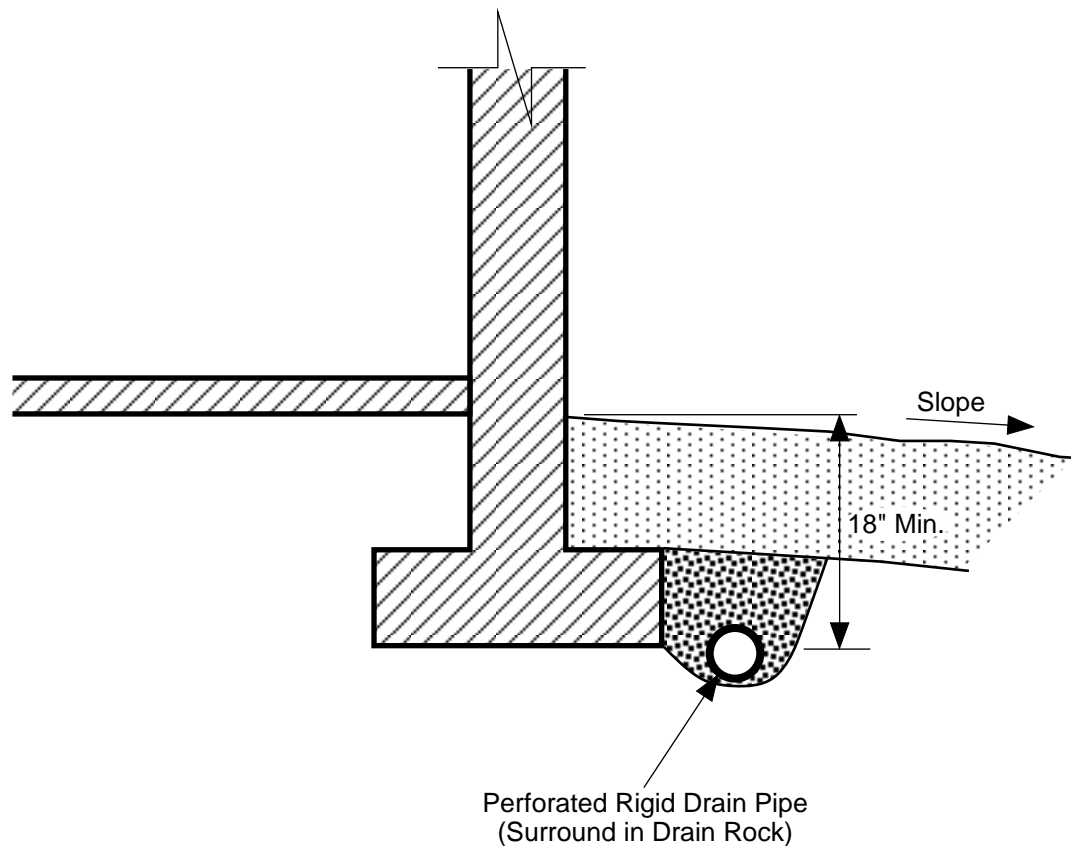
- Do NOT tie roof downspouts to Footing Drain.
- Surface Seal to consist of 12" of less permeable, suitable soil. Slope away from building.

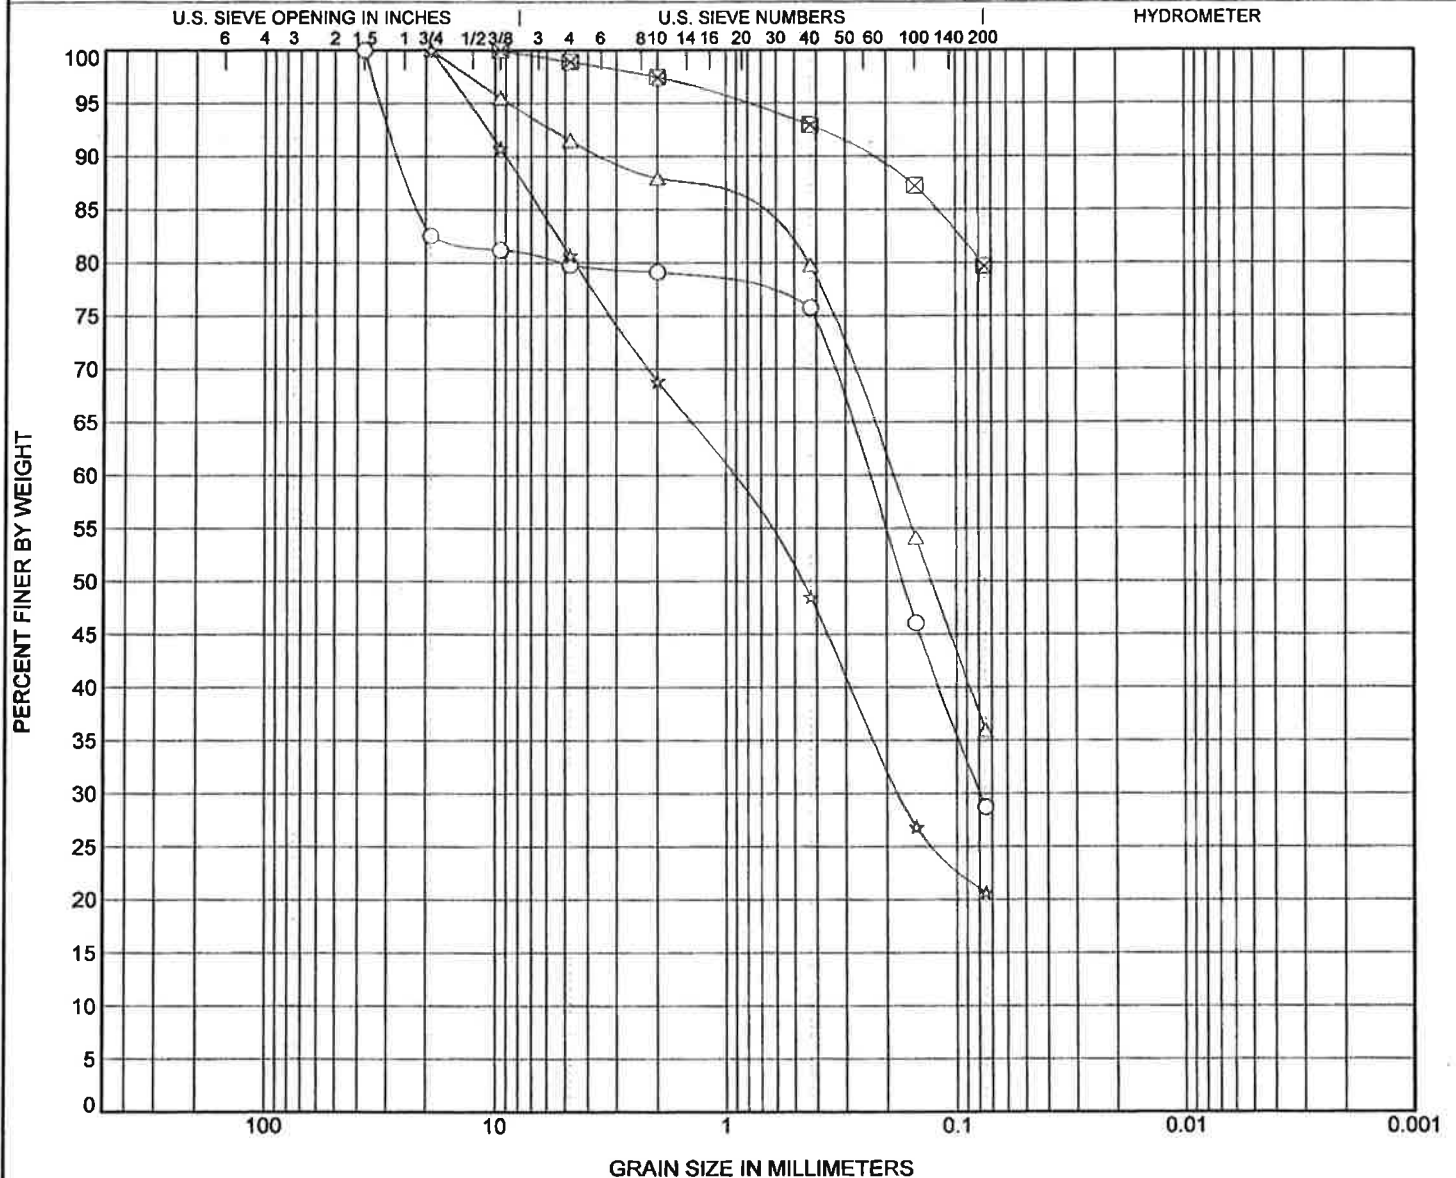
Specimen Identification			Classification			LL	PL	PI	Cc	Cu
○	B-1	5.0ft.	Tan Silty SAND with Gravel, SM							
⊗	B-1	20.0ft.	Gray SILT with Sand, ML							
△	B-2	10.0ft.	Tan Silty SAND, SM							
☆	B-2	40.0ft.	Gray Silty SAND with Gravel, SM							
Specimen Identification			D100	D60	D30	D10	%Gravel	%Sand	%Silt	%Clay
○	B-1	5.0ft.	37.5	0.244	0.079		20.2	51.1	28.7	
⊗	B-1	20.0ft.	9.5				1.1	19.2	79.7	
△	B-2	10.0ft.	19	0.191			8.5	55.5	36.0	
☆	B-2	40.0ft.	19	1.022	0.175		19.4	60.0	20.7

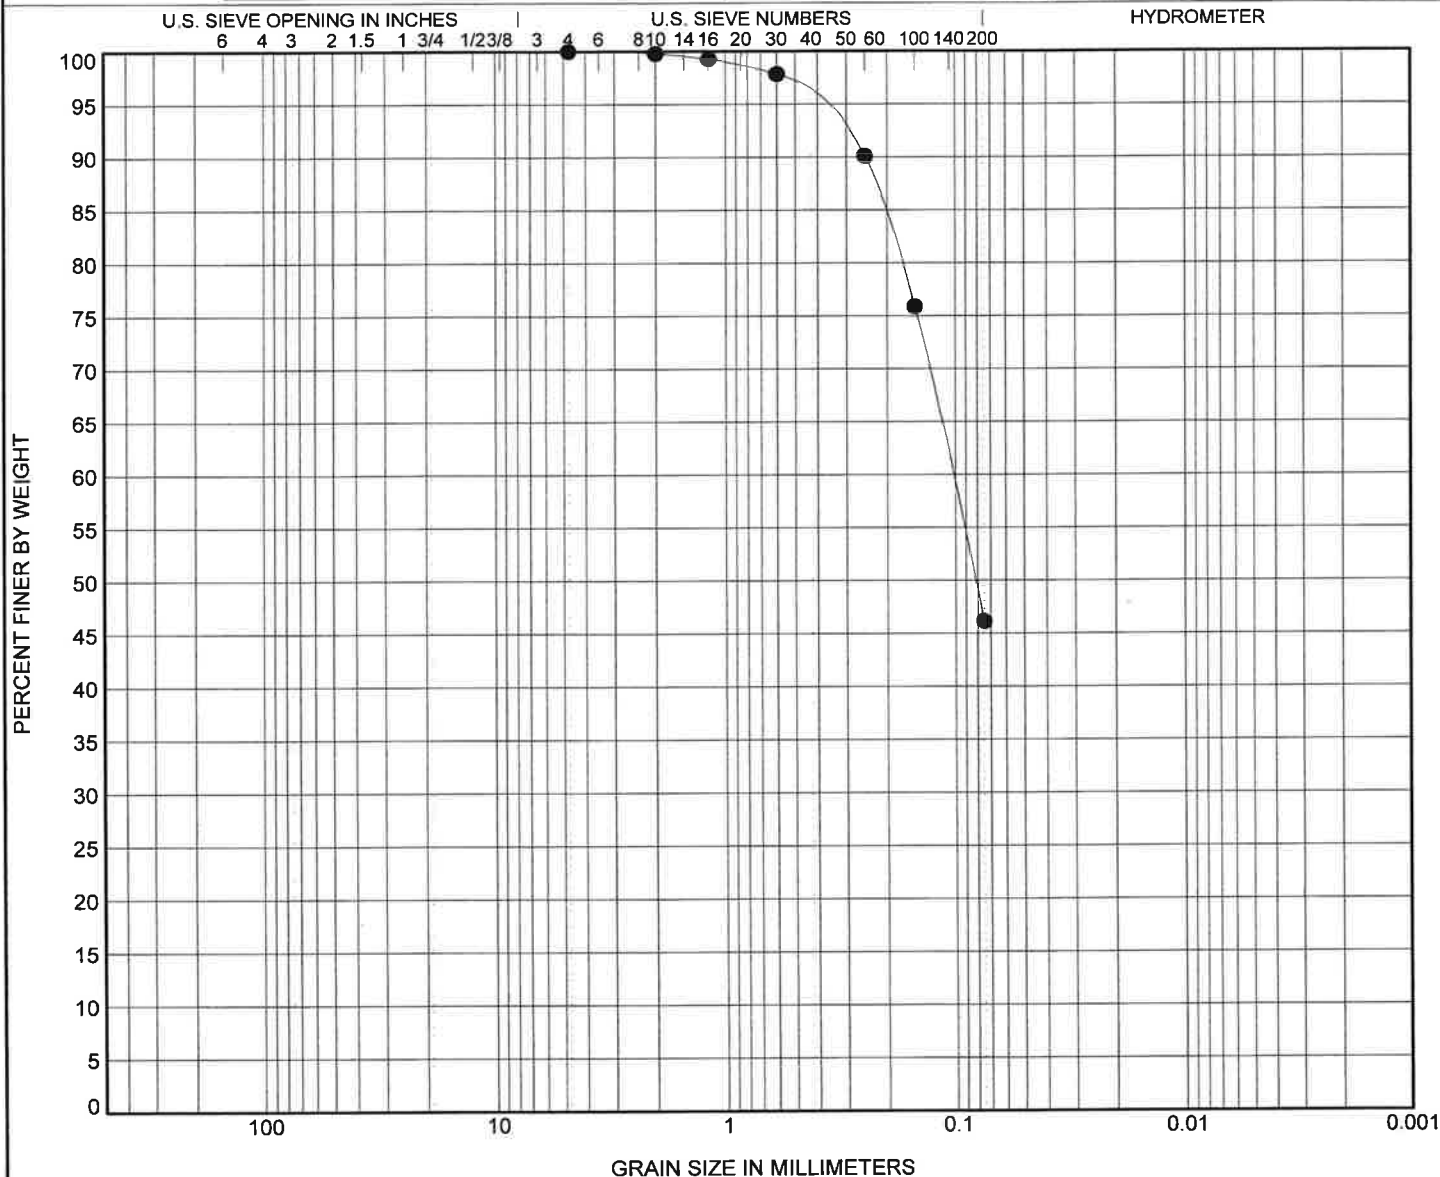
Specimen Identification		Classification								Cc	Cu
● TP-102	7.5ft.	USDA: Tan-Gray Slightly Gravelly Very Fine Sandy Loam. USCS: SM.									
Specimen Identification		D100	D60	D30	D10	LL	PL	PI	%Silt	%Clay	
● TP-102	7.5ft.	4.75	0.104						46.1

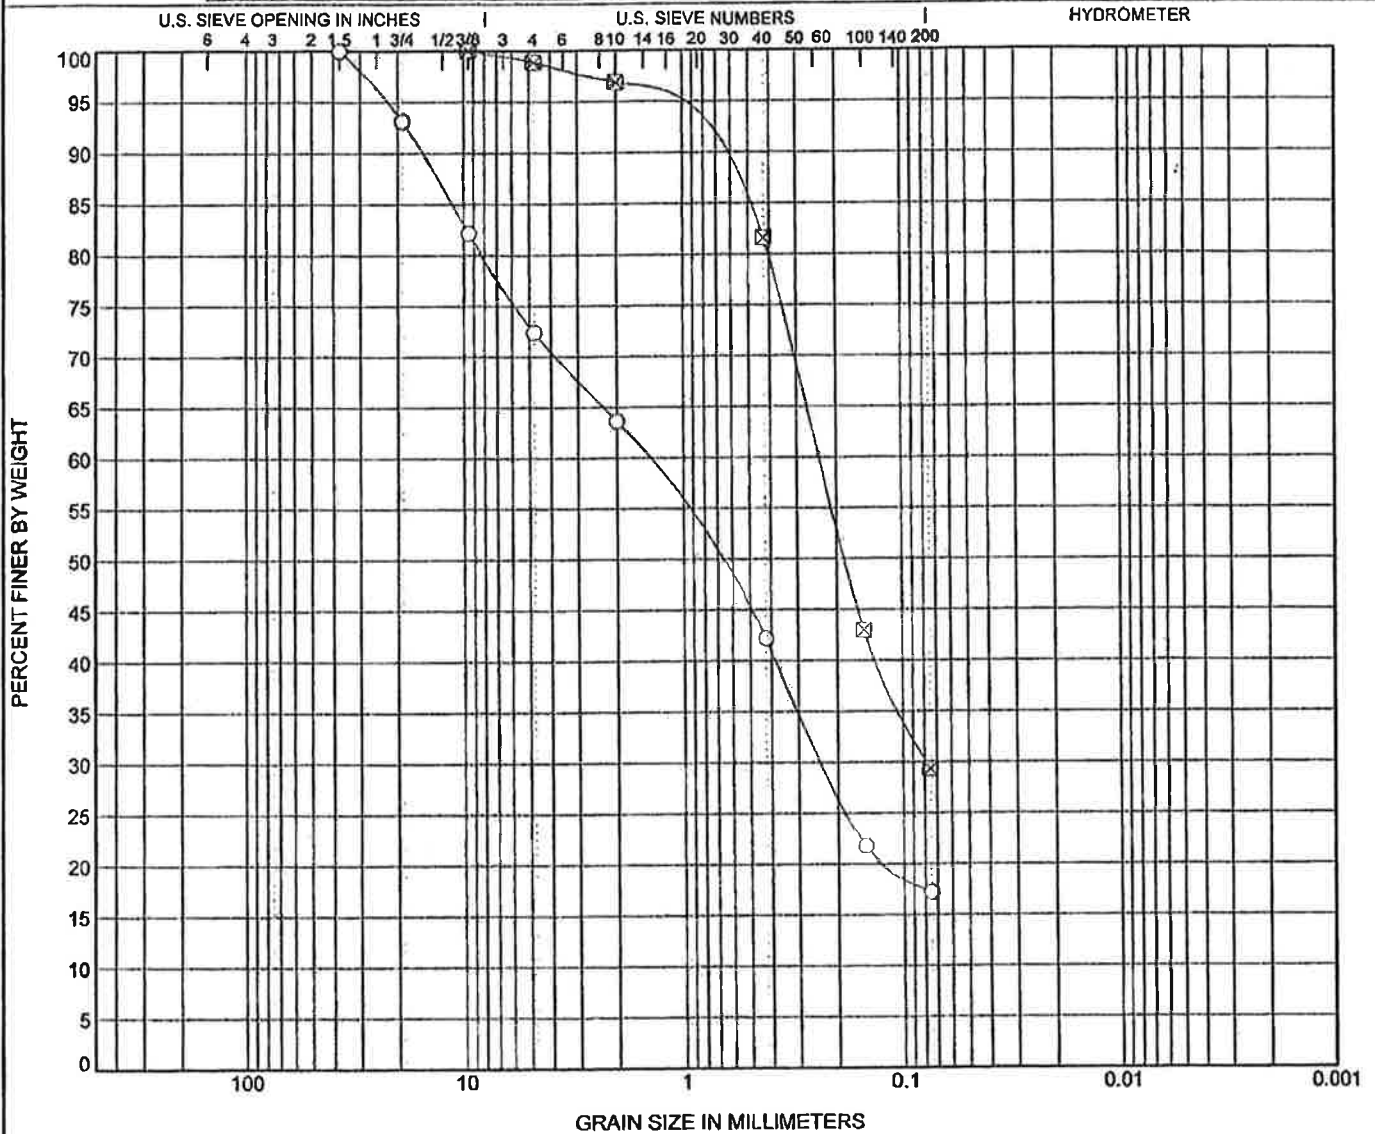
Specimen Identification			Classification					LL	PL	PI	Cc	Cu
○	TP-1	13.0ft.	Brown Silty SAND with Gravel, SM									
☒	TP-2	8.0ft.	Brown Silty SAND, SM									
Specimen Identification			D100	D60	D30	D10	%Gravel	%Sand	%Silt	%Clay		
○	TP-1	13.0ft.	37.5	1.538	0.229		27.6	55.1	17.3			
☒	TP-2	8.0ft.	9.5	0.237	0.078		1.2	69.5	29.3
