Lake Washington Wastewater Lake Line Management Plan

FINAL / July 2024

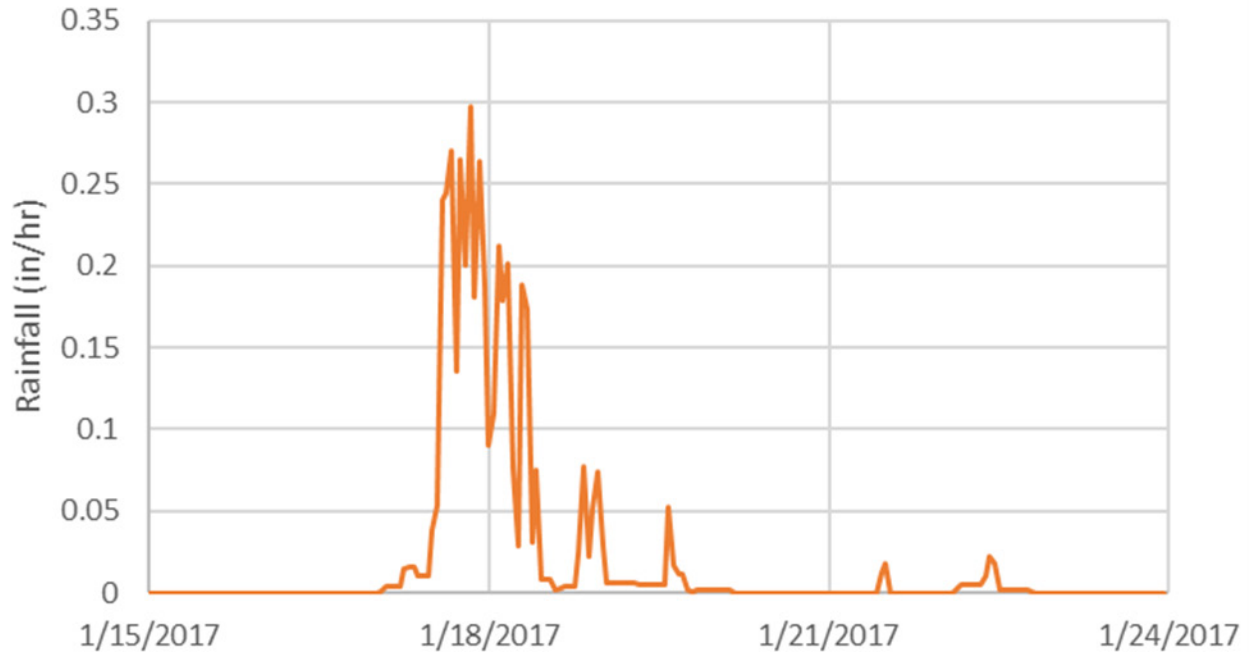
Figure 2.6 Lake Line System 25 Year Design Storm

antecedent conditions is to base analysis on a historical precedent. The City has selected a wet weather event from 2017 to represent the design event hydrograph. This hydrograph's volume was scaled up to represent a 24-hour storm recurrence interval of 25 years based on the NOAA design events¹.

Figure 2.7 shows the scaled historical design storm rainfall intensity and duration used for the capacity analysis. A period of rain events occurred over three days. The storm peak lasts 24 hours, with a peak rainfall intensity of 0.30 inches per hour and a 24-hour volume of 3.75 inches.

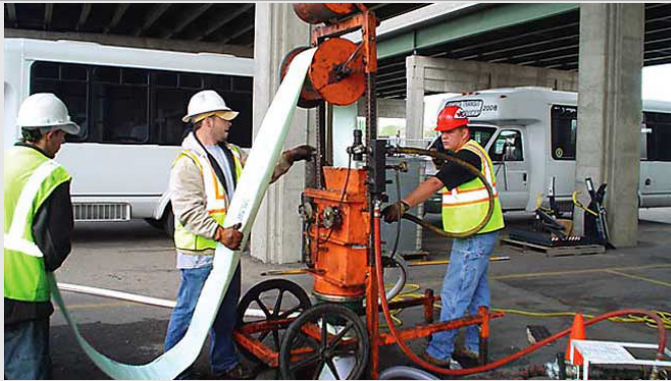
Cured-in-Place Pipe (CIPP)

This approach rehabilitates the existing lake line sewer pipeline using a CIPP liner. This would require maintaining the alignment and elevation of the existing pipe. The reduction in capacity due to the liner thickness is typically offset by the improvement in the smoothness of the installed pipe liner.

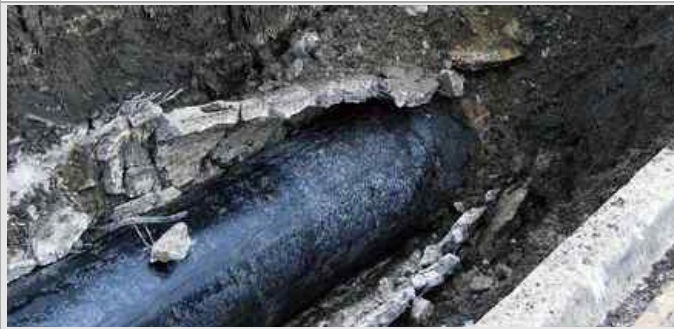
Pipe Bursting

This approach is a trenchless method of replacing the existing pipe by pulling a new pipe through the existing pipe while bursting the host pipe so that existing diameters can be maintained or increased in the new pipeline.

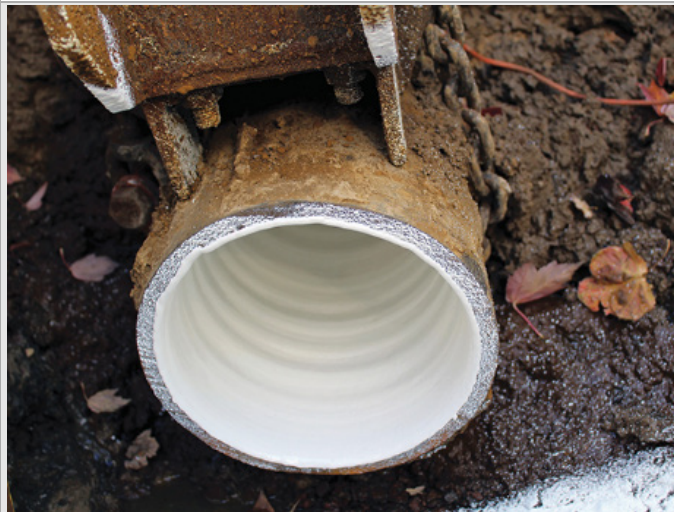
Emerging Technologies

Fiber-reinforced flexible hose: This involves insertion of a semi structural collapsible hose through the host pipe.

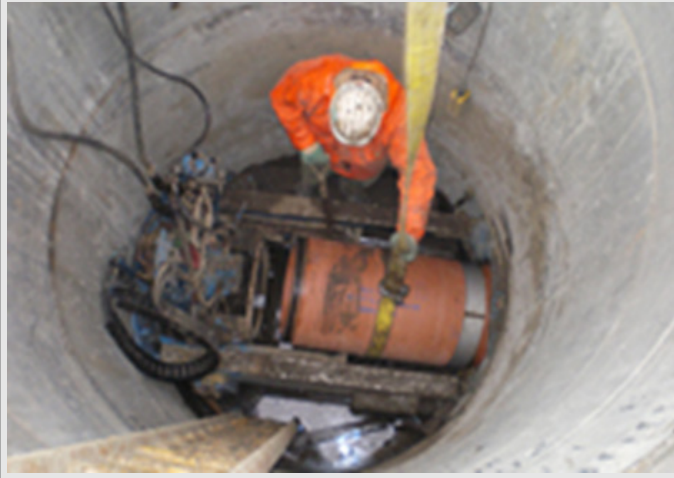
Gravity Sewer Line via Trenchless Technology

This approach constructs a new pipeline along the shore using trenchless construction, likely to be an auger bore given site constraints.

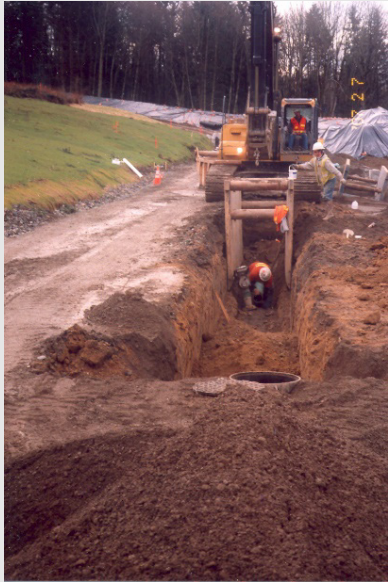
Upland Alternatives	
<p>Gravity Sewer Line</p>

<p>This approach constructs a new pipeline upland from the lake lines either within private property or along the roadway in City ROW using either open cut or trenchless constructions. Construction of new side sewers could use open cut or trenchless technology to redirect flows away from the lake and toward the road.</p>
<p>Grinder Pumps</p>

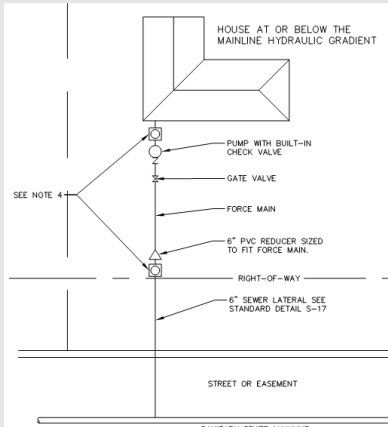
<p>City of Bellevue 2019 Sewer Engineering Standard Details - S-34 Single Home Sewer Pump System</p>	<p>This approach constructs new grinder pumps to convey sewage up to the street and connect to either the existing sewer mainlines or new sewer lines in City ROW. Similar to the vacuum sewers, these would require additional infrastructure on private property, but multiple side sewers could be connected to a single grinder pump to reduce the amount of new infrastructure.</p>
<p>Vacuum Sewers</p>

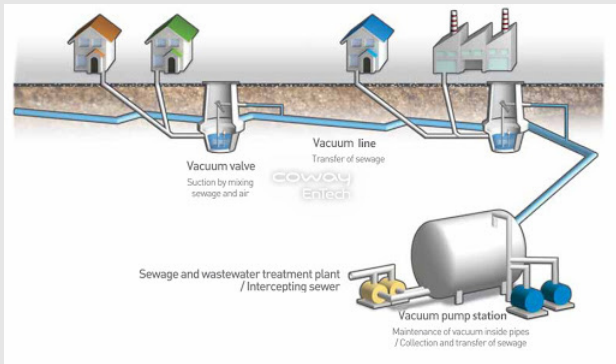
<p>Coway Entech – Vacuum Sewer System</p>	<p>This approach constructs a new pipeline which diverges away from the lake and requires a partial vacuum to convey sewage at flat or reverse grades. Generally, these systems are more maintenance intensive than traditional gravity systems and may require the acquisition of additional property to locate the vacuum pump station.</p>

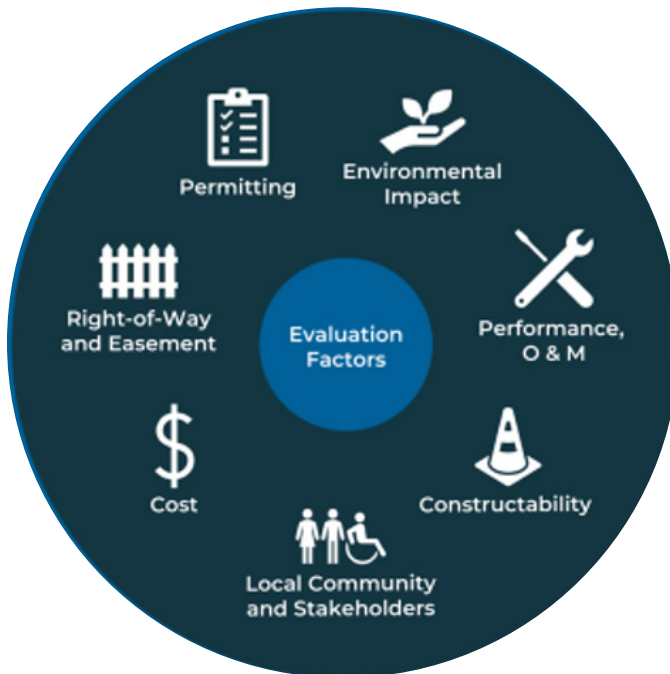
Figure 5.4 System Alternatives Analysis Evaluation Factors

An alternatives analysis was completed for each service area to determine a preferred system alternative using the following seven evaluation factors that were weighted for scoring and selection: permitting, environmental impact, right-of-way and easement, performance/operations and maintenance, constructability, cost, and local community, as represented in Figure 5.4.

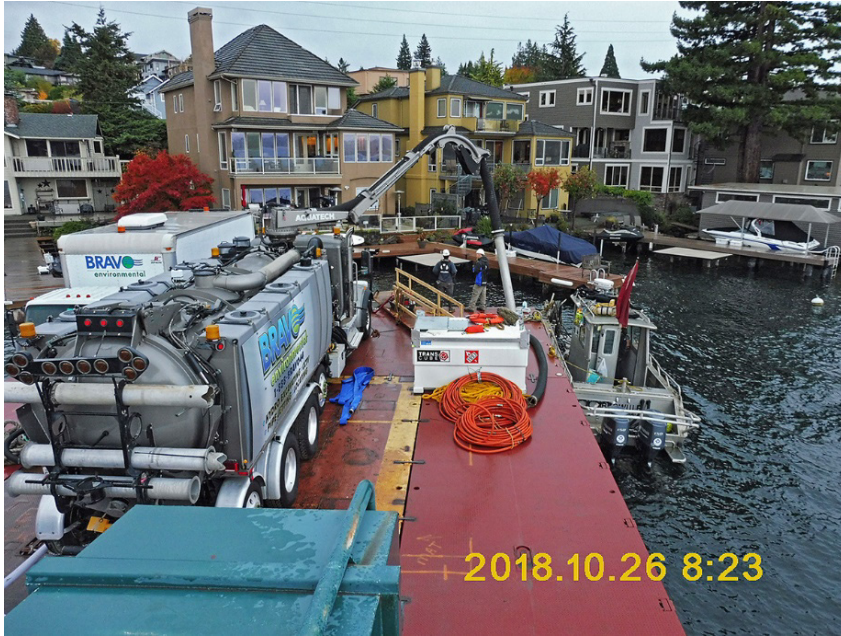
Figure 5.6 City of Renton Emergency Lake Line Cleaning - Vector Barge (2018)

Hydro-jetting and CCTV of the lake line is anticipated to require the installation of temporary access points where a portion of the existing line is removed and replaced with a tee, and a caisson is attached to provide a temporary manhole extension to the water surface (Figure 5.7). Cleaning and inspection can then be performed by vacuum trucks and other equipment brought to the access point by barge (Figure 5.6). Alternate access points from shore can be used in conjunction with the temporary access points, where they exist.

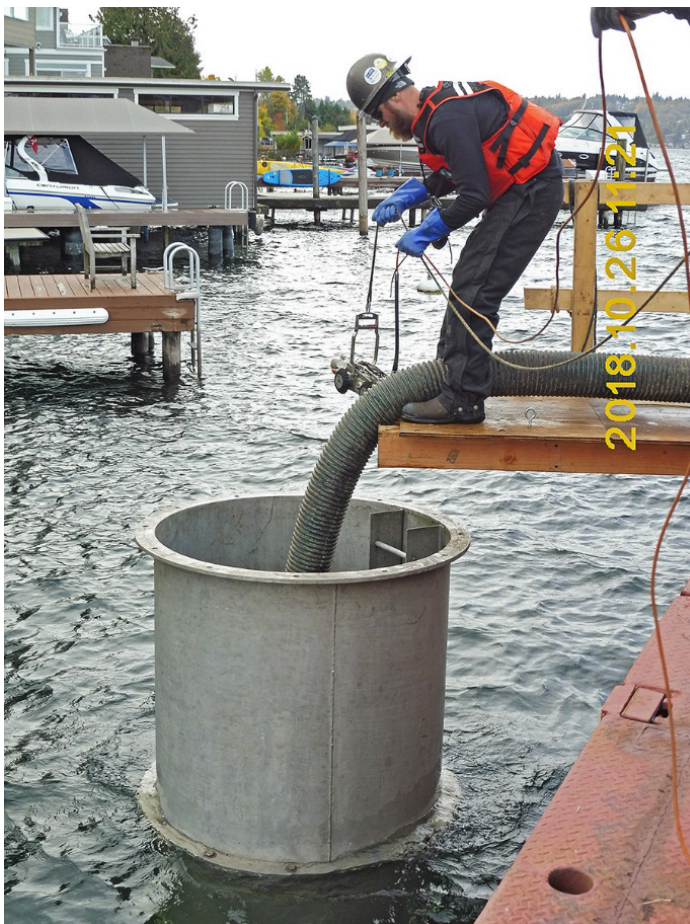
Figure 5.7 City of Renton Emergency Lake Line Cleaning - Temporary Caisson Access

The basis of cost for hydro-jetting and CCTV inspection is an emergency cleaning project completed by the City of Renton on the Kennydale lake line in 2018. The estimated cost includes field work to obtain coupons, laboratory testing and analysis, and engineering services to generate a study report. The costs were escalated from 2018 to 2023 dollars resulting in \$243/LF. Cleaning and inspection of the entire lake line system is recommended in the near-term; however, due to the scale of this effort the City may wish to complete it in phases. Refer to Chapter 7 for a possible phased implementation plan.

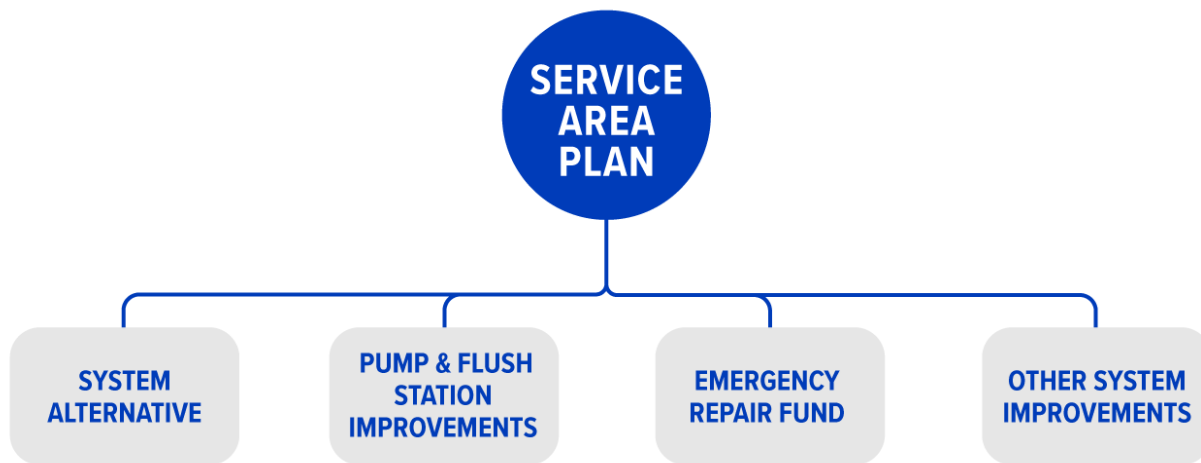
Figure 5.10 Service Area Plan Components

A **service area plan** summarizes the key characteristics of the area including land use, number of customers, lake line system components and area priority. A service area plan consists of four primary components: system alternative, pump and flush station improvements, emergency repair fund, and other system improvements as shown in Figure 5.10. Associated estimated costs and regulatory considerations are also included.

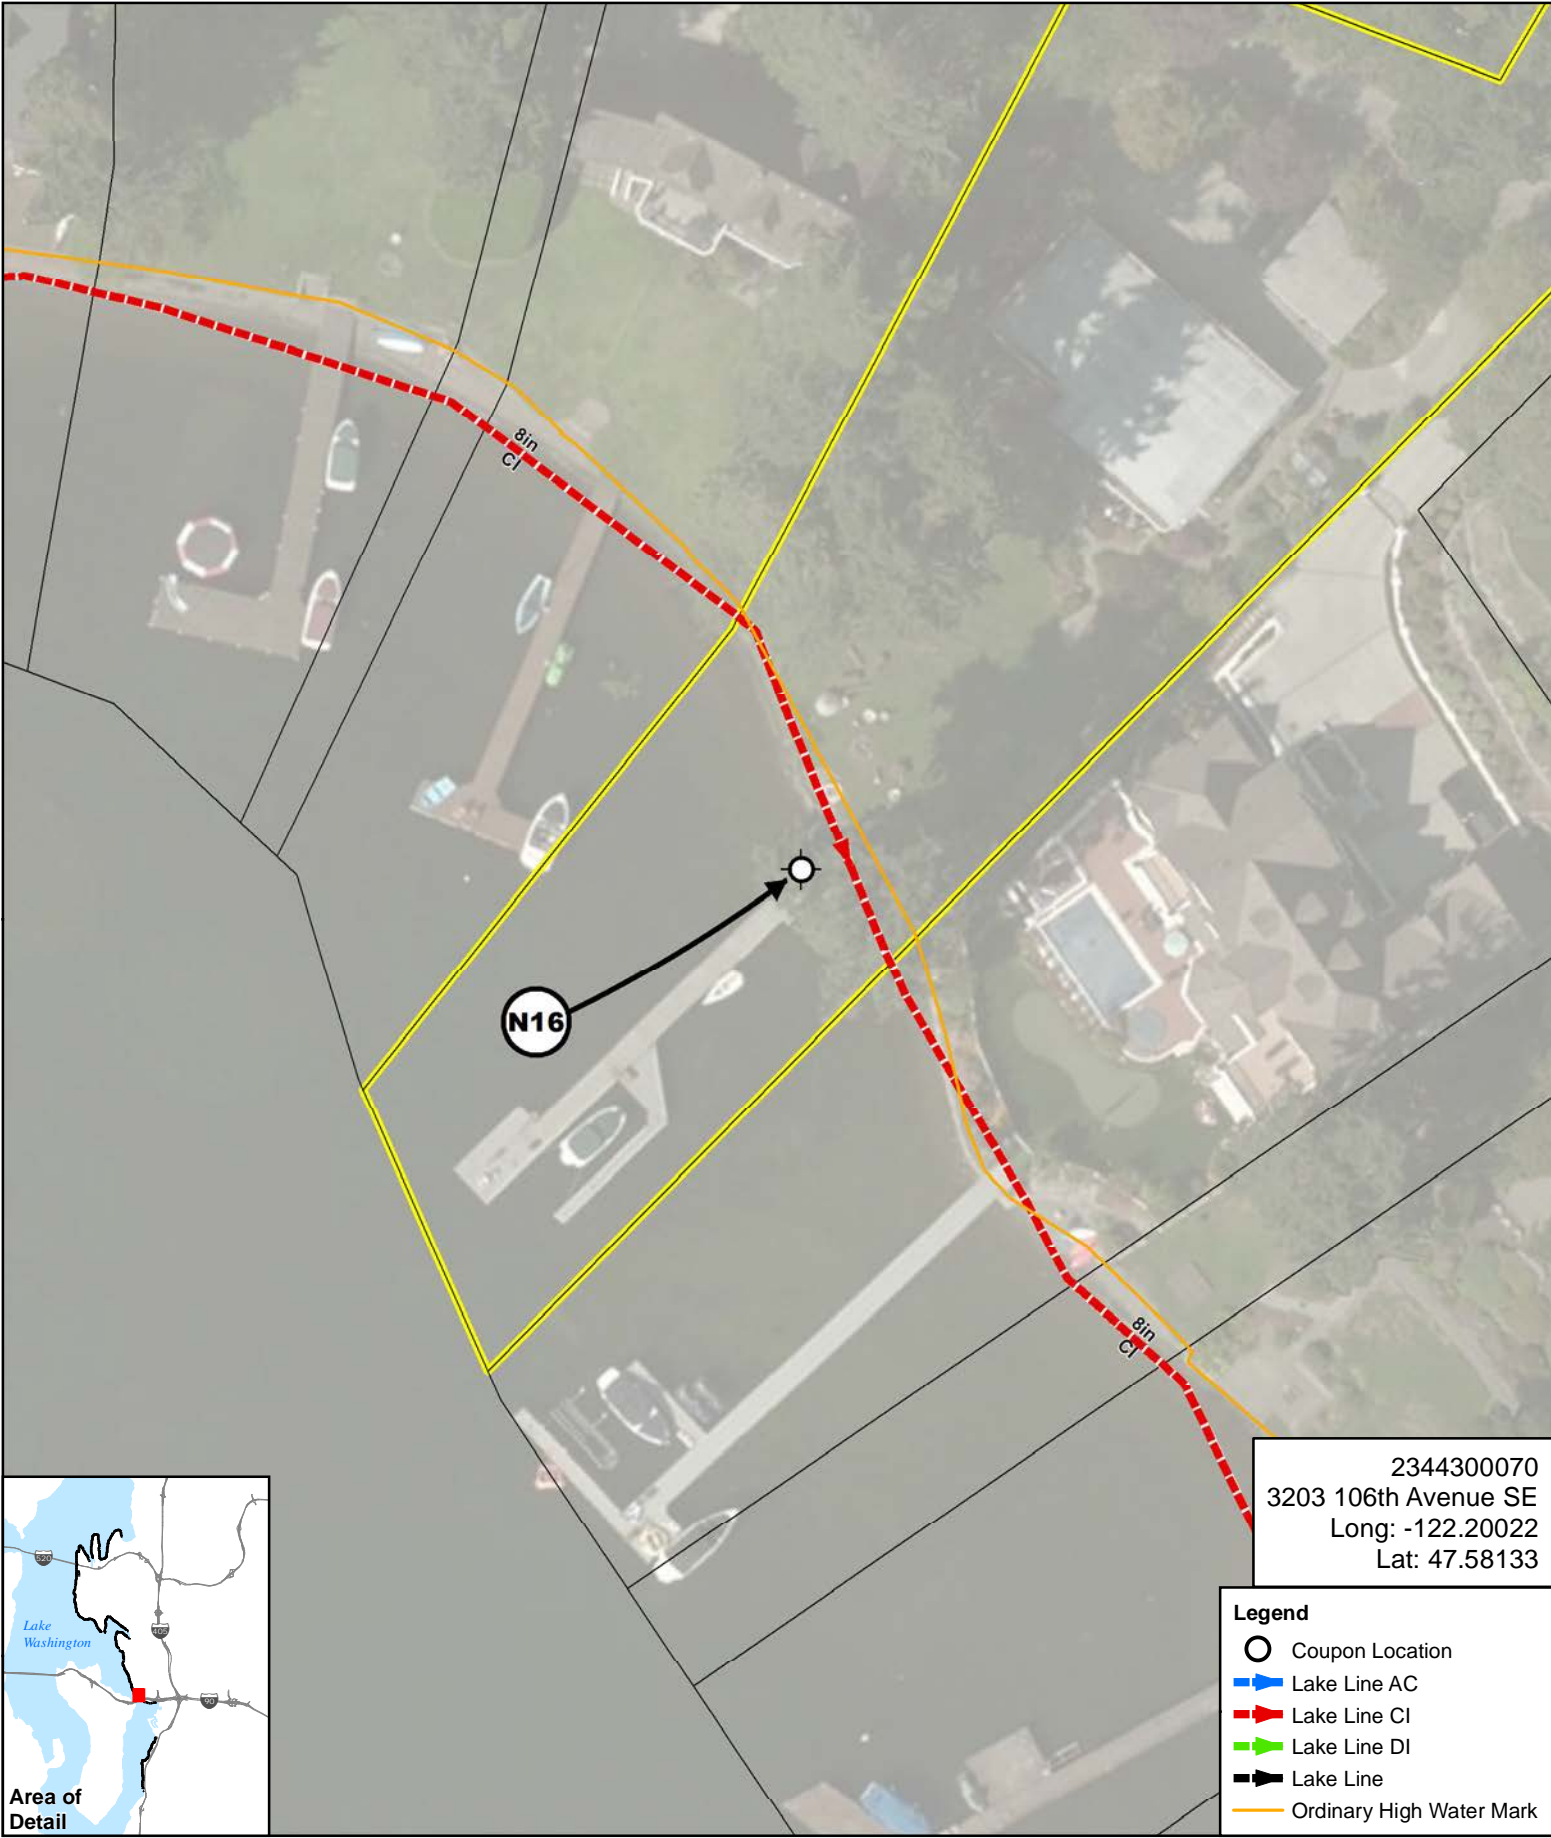
Figure N15
 September 2016

2344300070
 3203 106th Avenue SE
 Long: -122.20022
 Lat: 47.58133

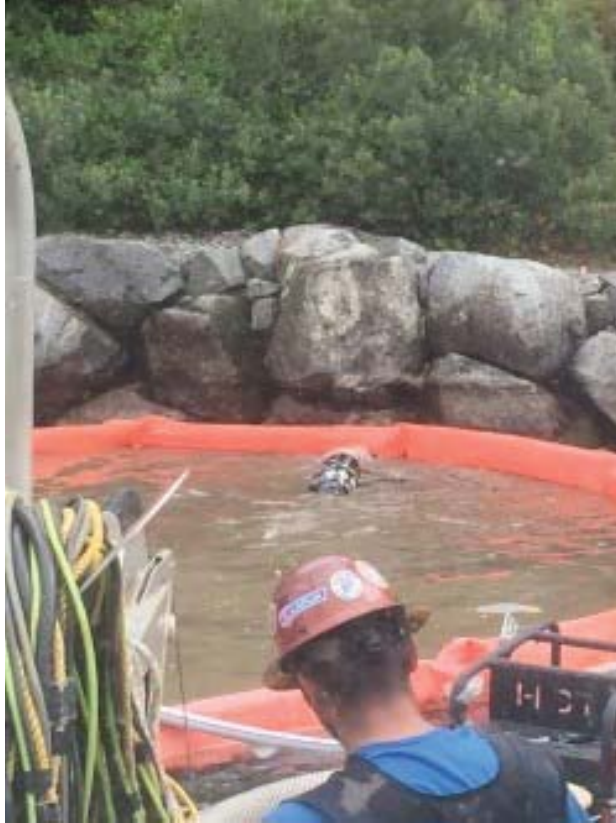
REPORT CONTINUATION PAGE:

1000- found pipe, pipe closer to beach than marker. (see picture at bottom)

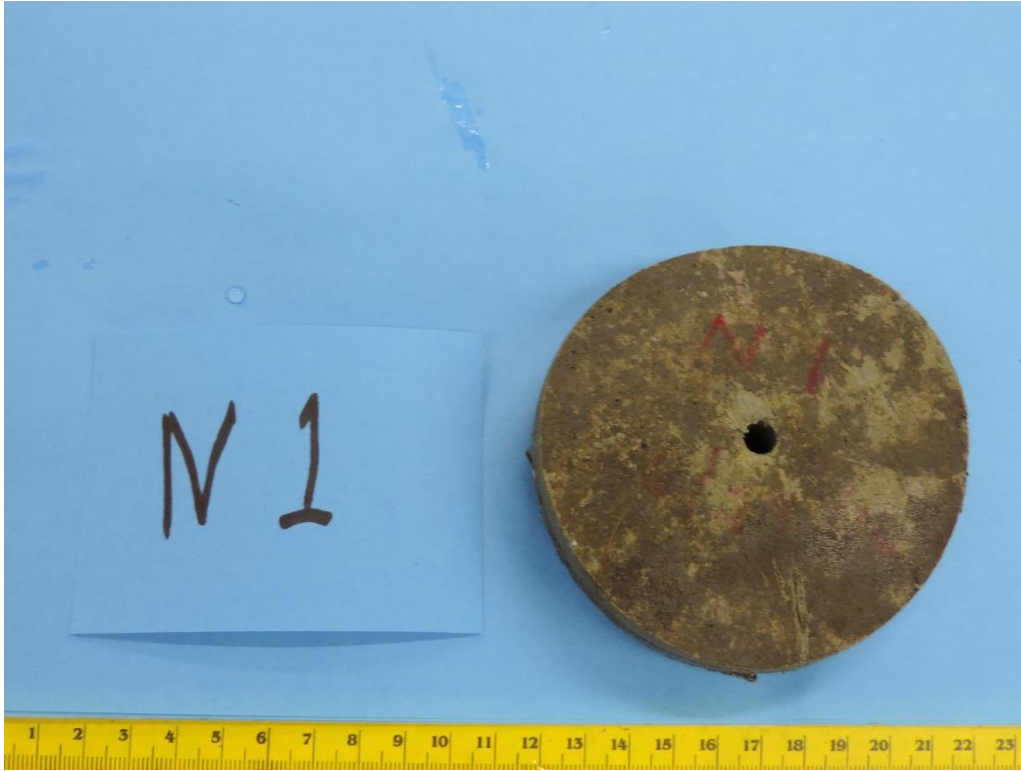
Overall view of sample N-1.

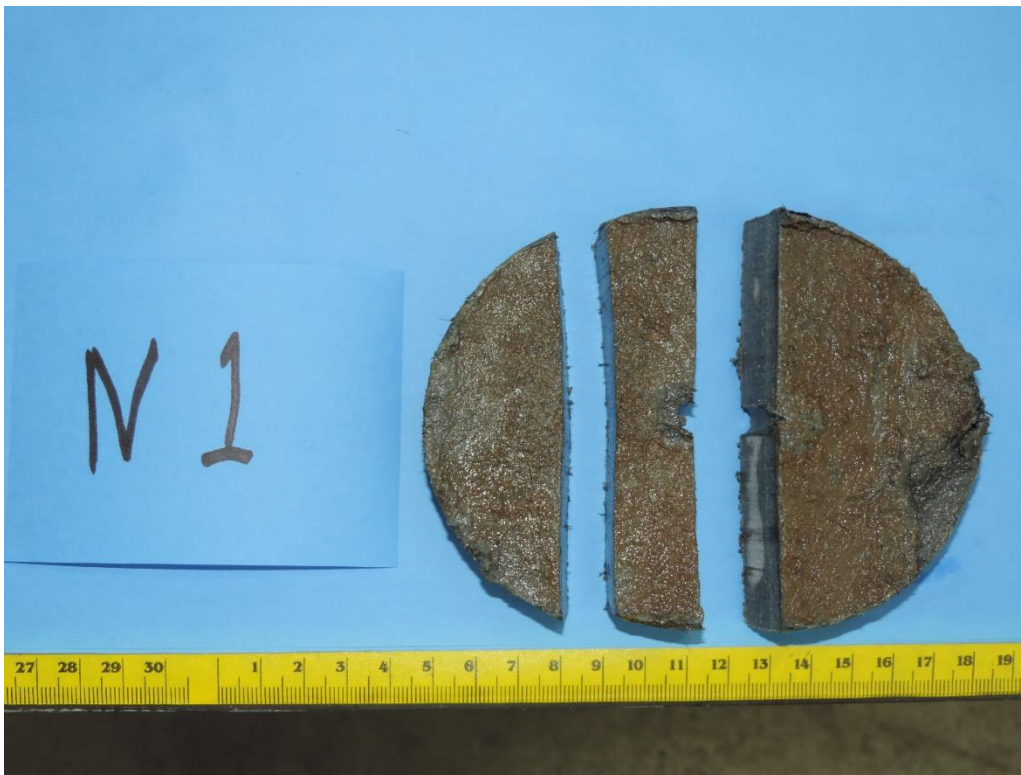
Overall view of sample N-1 after sectioning.

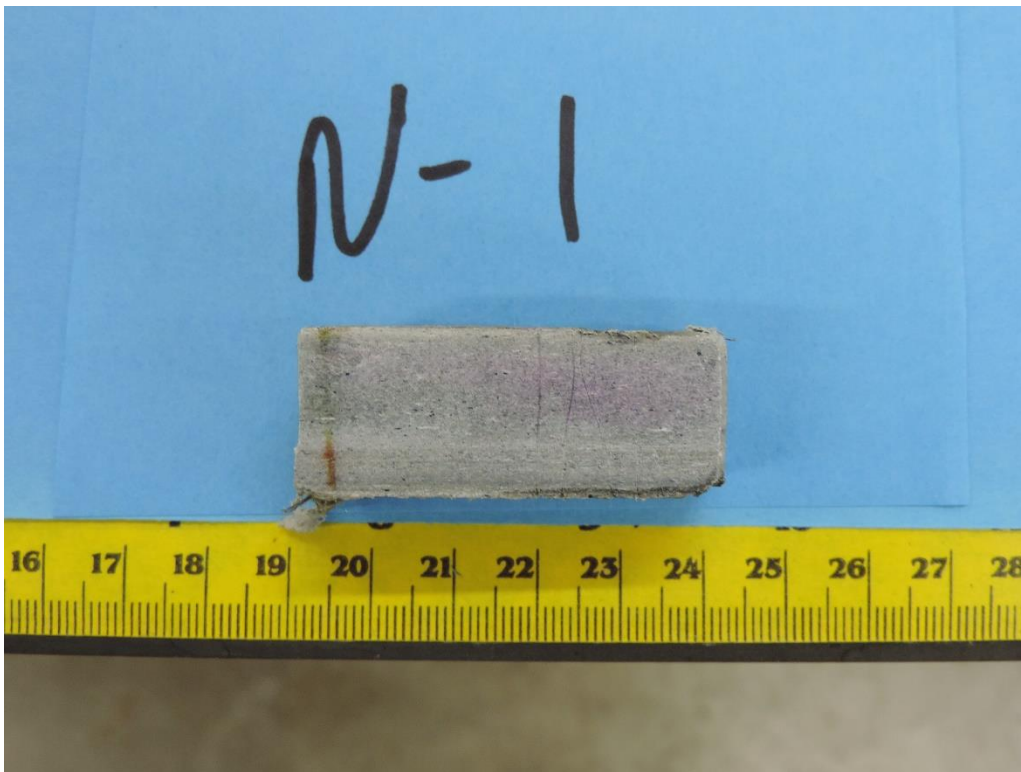
Close up of the cross section of N-1 after phenolphthalein, hardness and pH testing. This indicates that the inner layer (bottom) has a reduced pH as well as the top layer.

The test results obtained using the pH pen, phenolphthalein and SEM-EDS data indicate the reduction of calcium content of both the internal and external surfaces has occurred due to acid leaching. This results in a substantially weaker pipe wall. The middle section of the pipe wall had a calcium content ranging from 19.5 % to 24.4%, which likely represents the original calcium content of new pipe. The pH of the middle sections ranged between 7 and 11; the original pH was likely 10.0 or above. As calcium is removed, the pH falls to 7 or below based on environmental conditions. The external surface layer had a pH between 3 and 7 correlating with low Mohs hardness data.

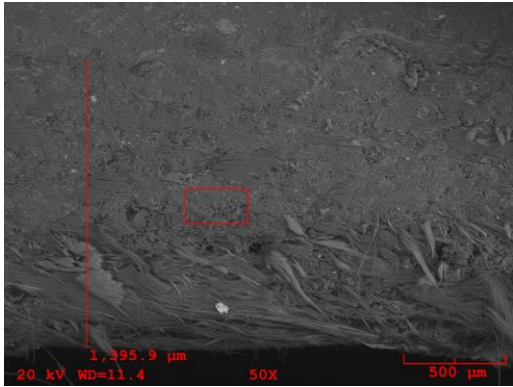
Analysis Report: N-1 cross section-1-1

kV 20.0
 Takeoff Angle 35.0°
 Elapsed Livetime 30.0

EDS of the inner layer of sample N-1 showing a reduced calcium content.

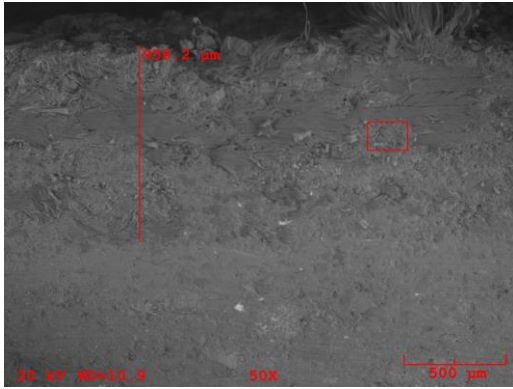
Analysis Report: N-1 cross section-15-1

kV 20.0
 Takeoff Angle 35.0°
 Elapsed Livetime 20.0

EDS of the outside layer of sample N-1. Note the reduced calcium content compared to the previous spectra.

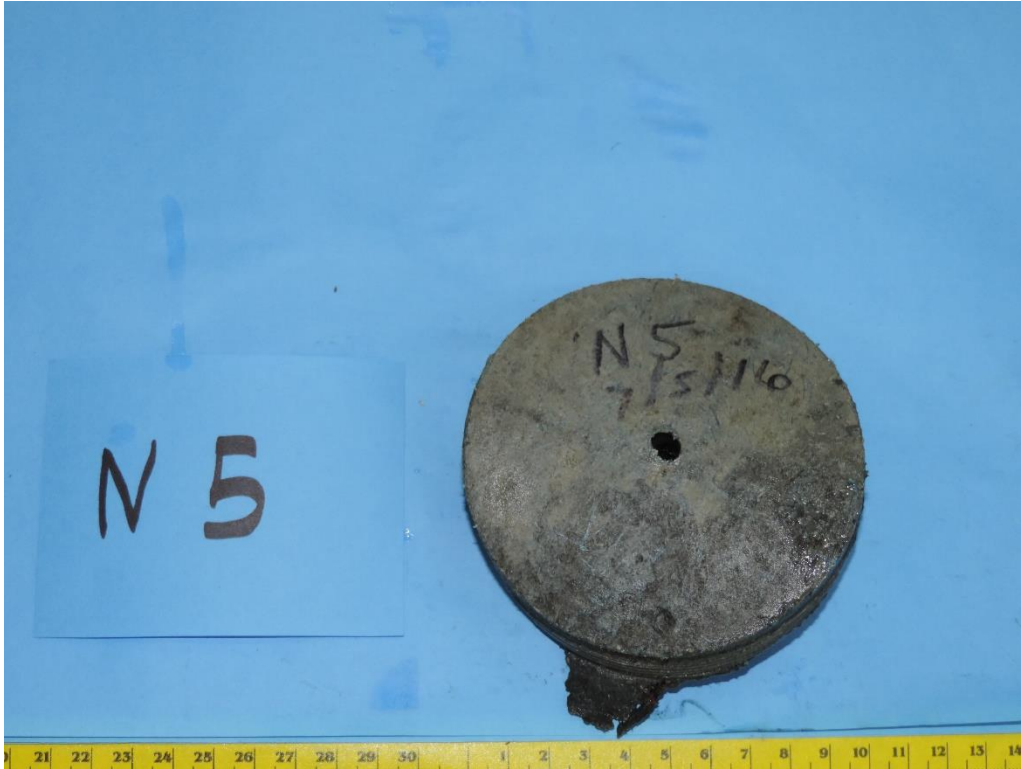
Overall view of sample N-5.

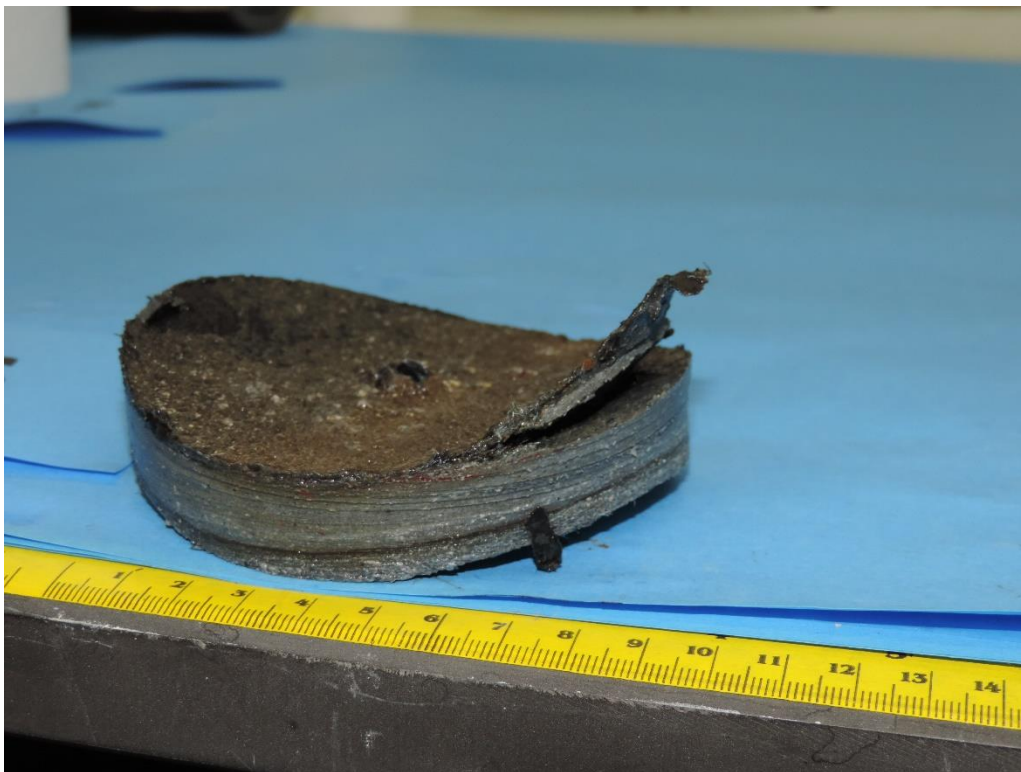
Close up of an area of delamination at the inside layer of N-5.

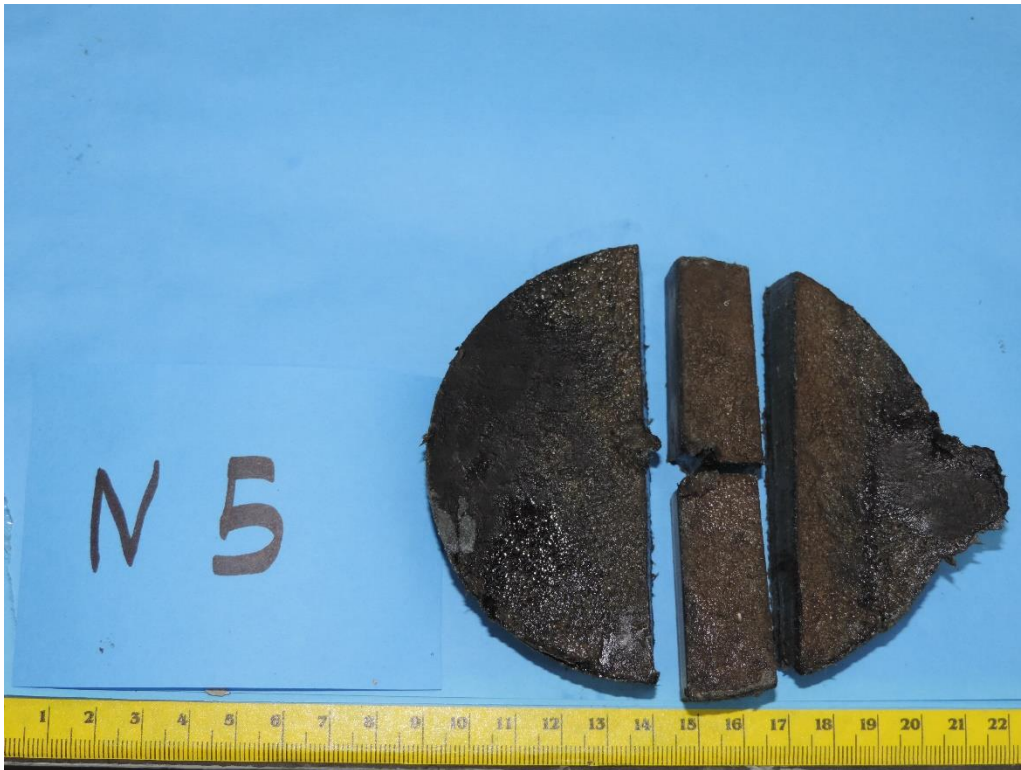
Overall view of sample N-5 after sectioning.

- **N-5** was found to have an overall thickness of 0.66". The phenolphthalein test indicated that chemical attack was occurring from both the inside and outside. The inside and outside regions were about 0.18" with a pH of approximately 7, the center region had a pH of 8.

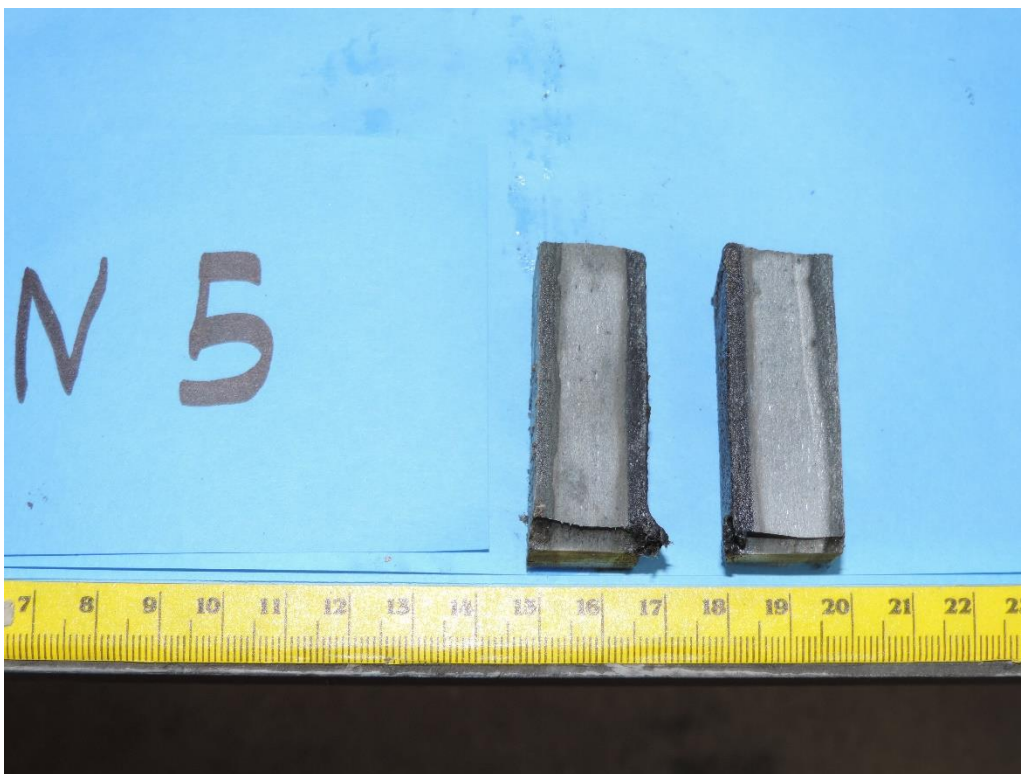
Close up view of the cross sections of sample N-5. Note the layers of attack are clearly visible at the inside and outside of the sample.

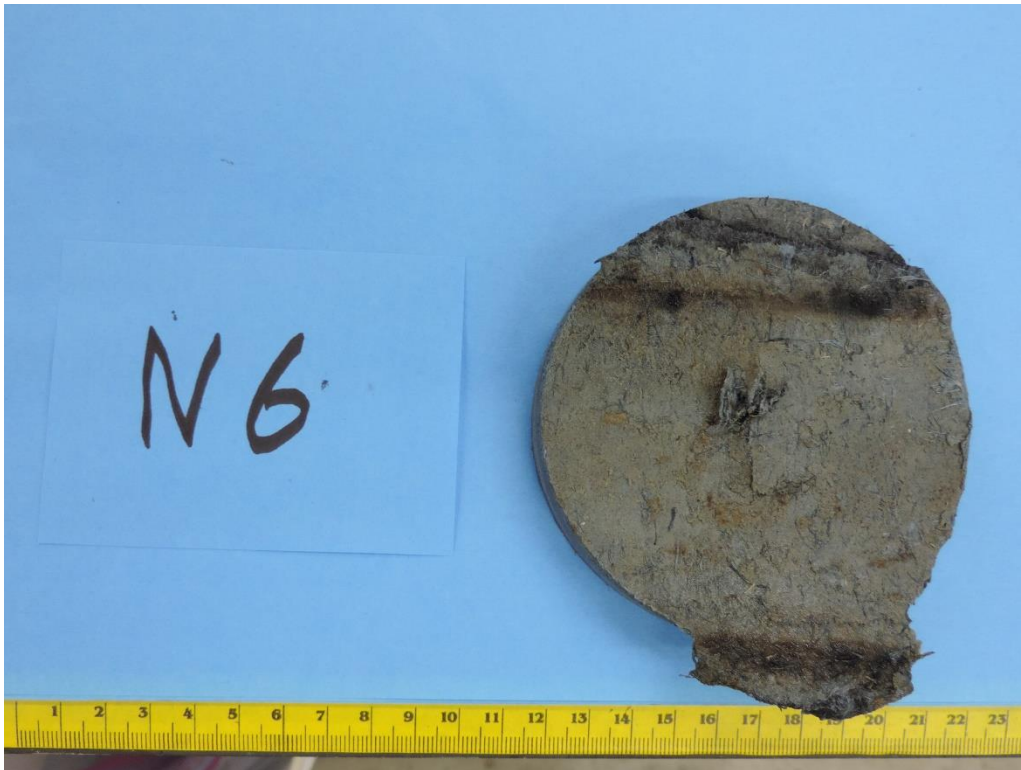
Overall view of sample N-6.

- **N-6** was found to have an overall thickness of 0.65". The phenolphthalein test again indicated that there was chemical attack occurring from both the inside and outside.

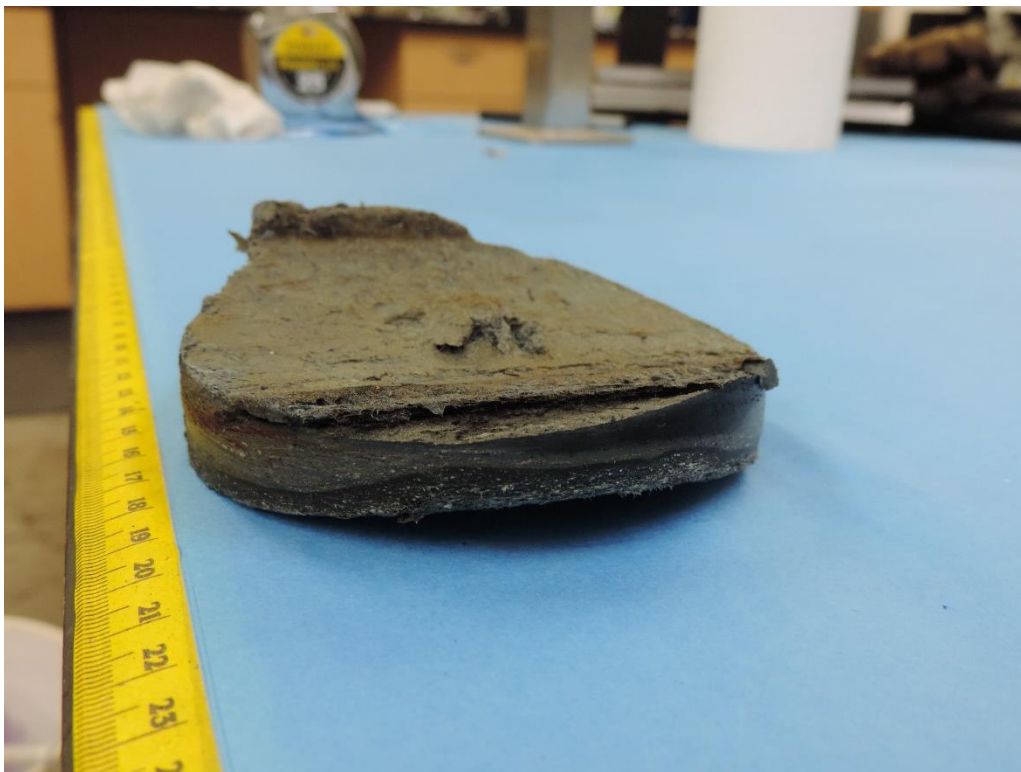
Close up of an area of delamination and thinned wall thickness on sample N-6.

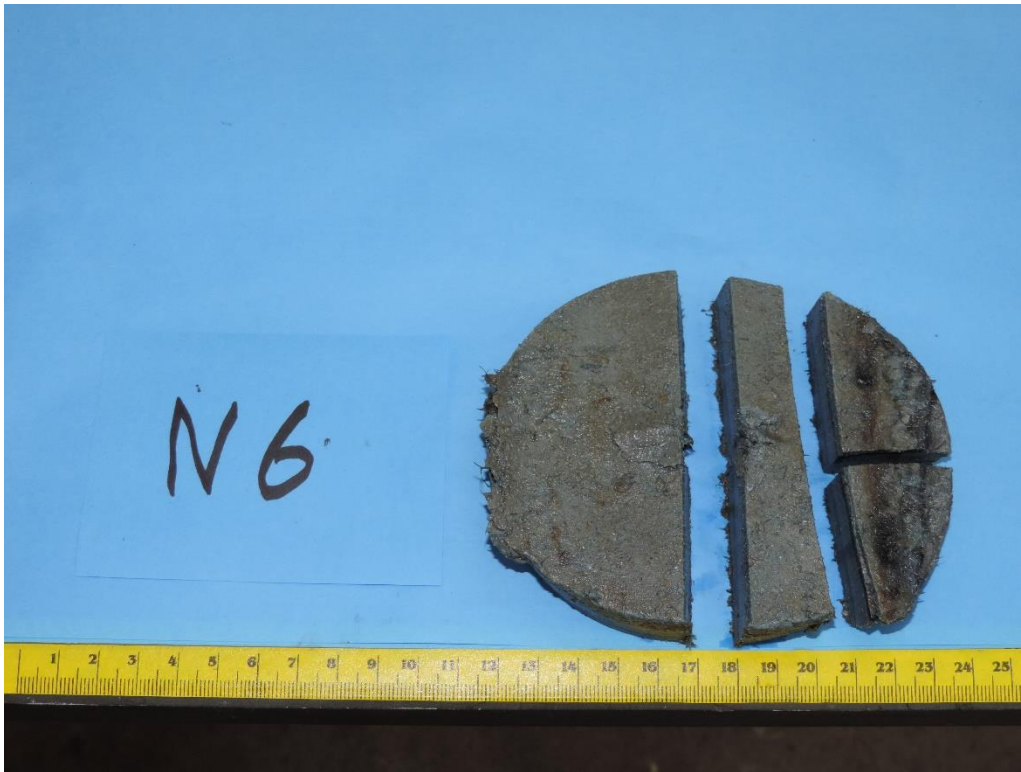
Overall view of N-6 after sectioning.

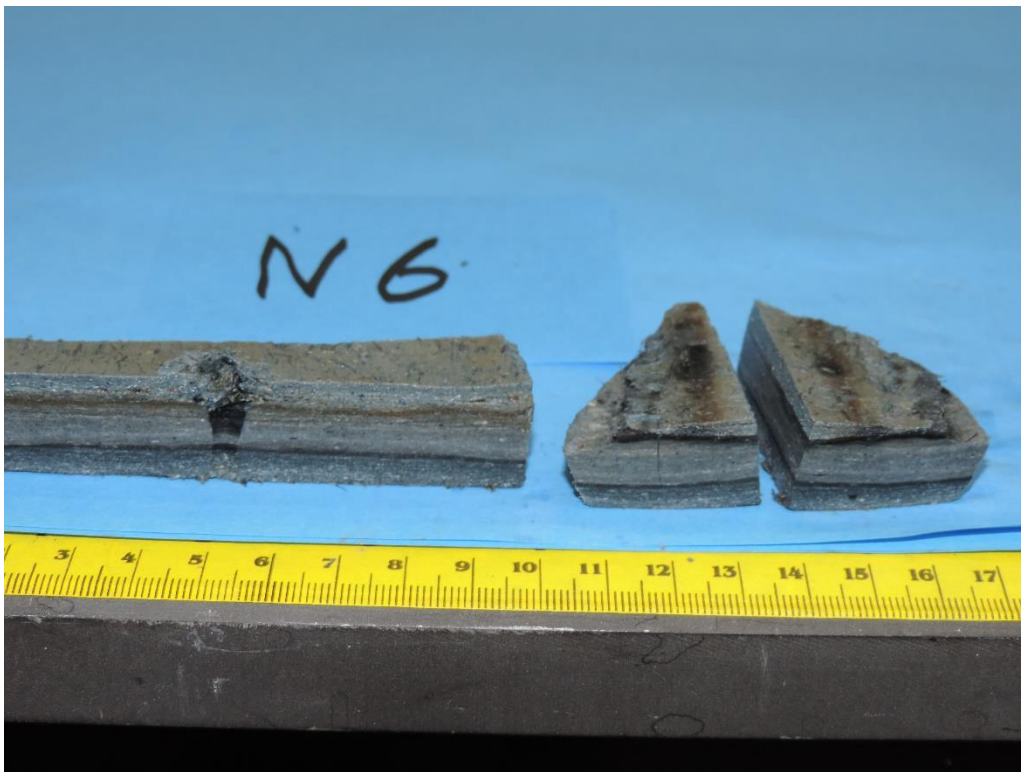
Close up of the cross sections of N-6.

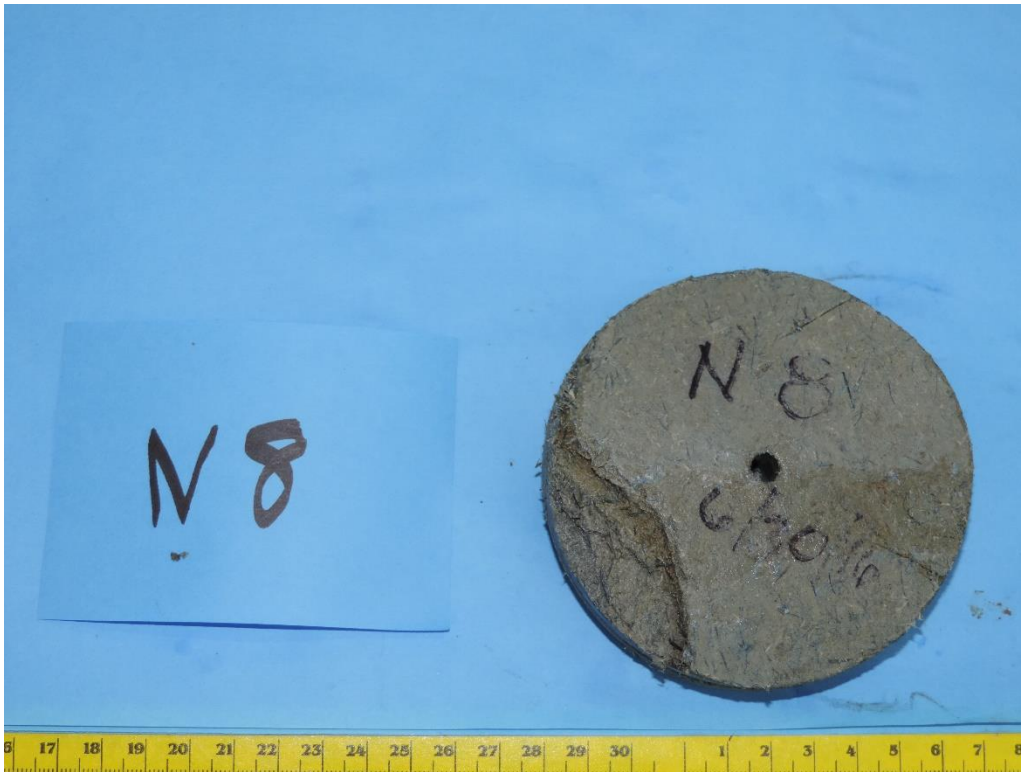
Overall view of sample N-8. Note the area that has chipped off on the OD.

- **N-8** was found to have an overall thickness of 0.68". The phenolphthalein test indicates that there was a thin layer (0.03") of reduced pH at the inside with an outer layer about 0.29" with a pH of 7 and a Mohs hardness of 3.0. This potentially looked like two layers of different material or just more severe attack from the outside. This reduced pH region also had reduced calcium content.

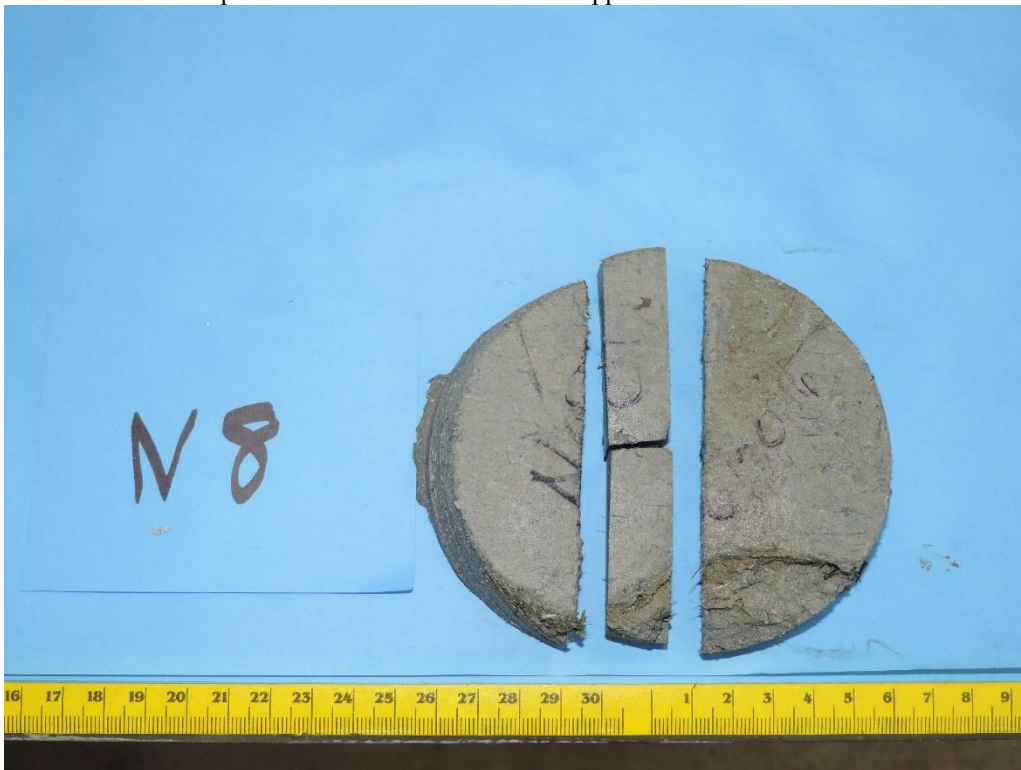
Overall view of N-8 after sectioning.

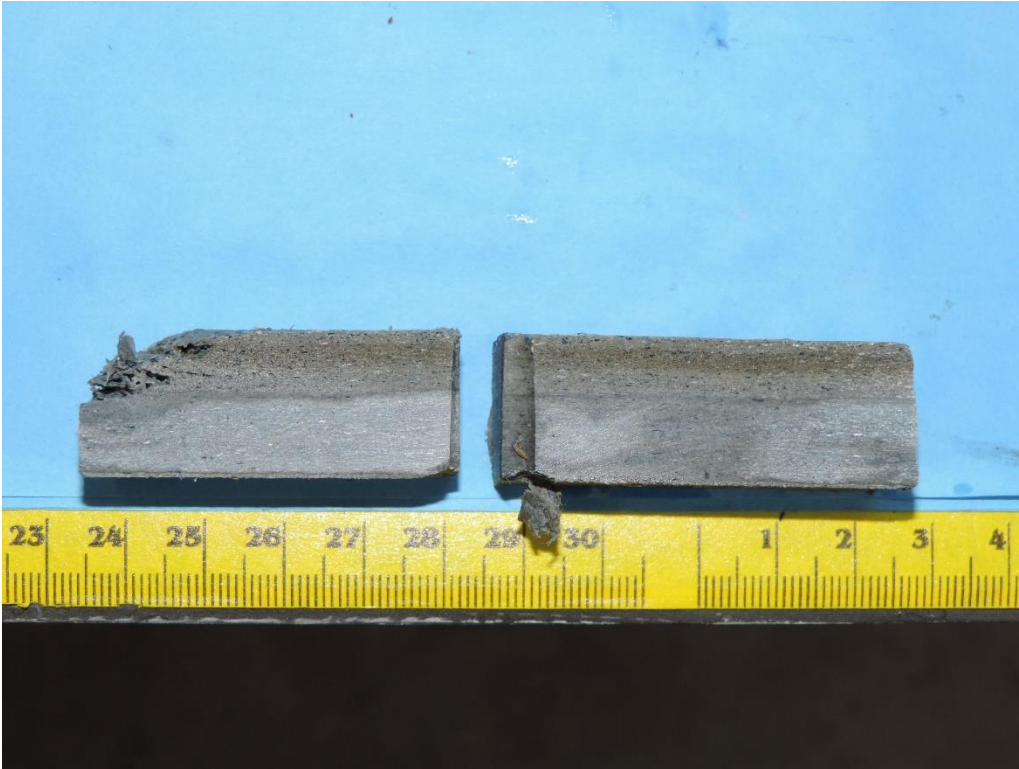
Overall view of the cross section of sample N-8. The inside is at the bottom.

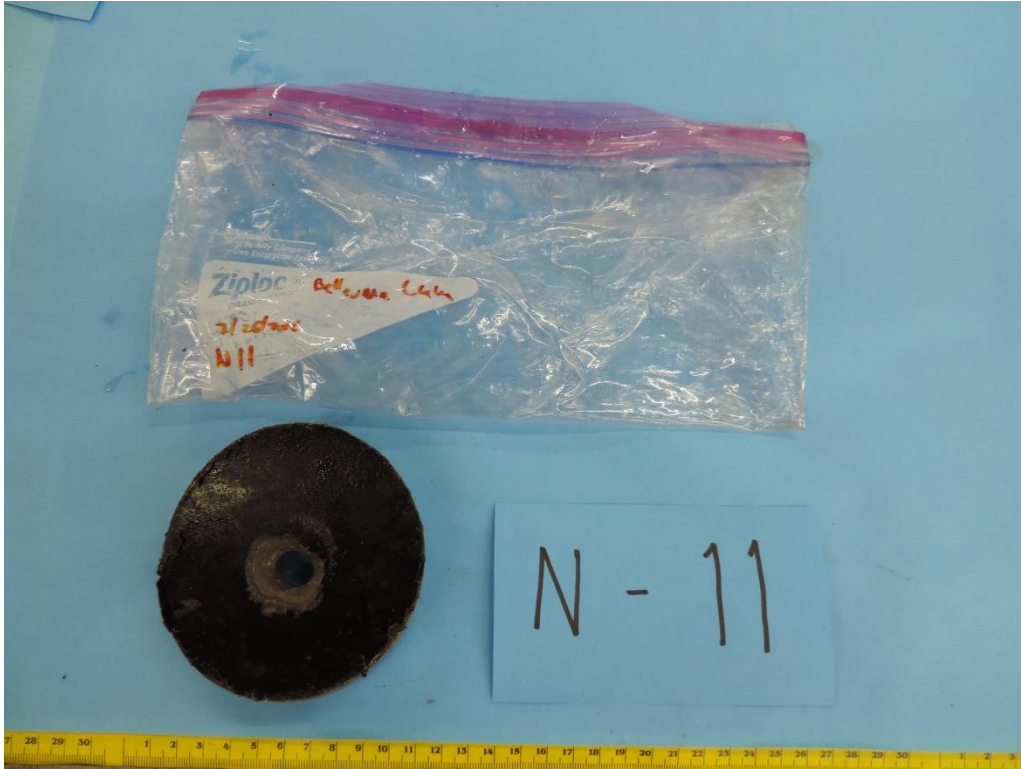
Overall view of sample N-11.

- **N-11** was found to have an overall thickness of 1.07". The phenolphthalein test indicates that there is a reduced pH at both the inside and outside of the pipe sample.
