Lake Washington Wastewater Lake Line Management Plan

FINAL / July 2024

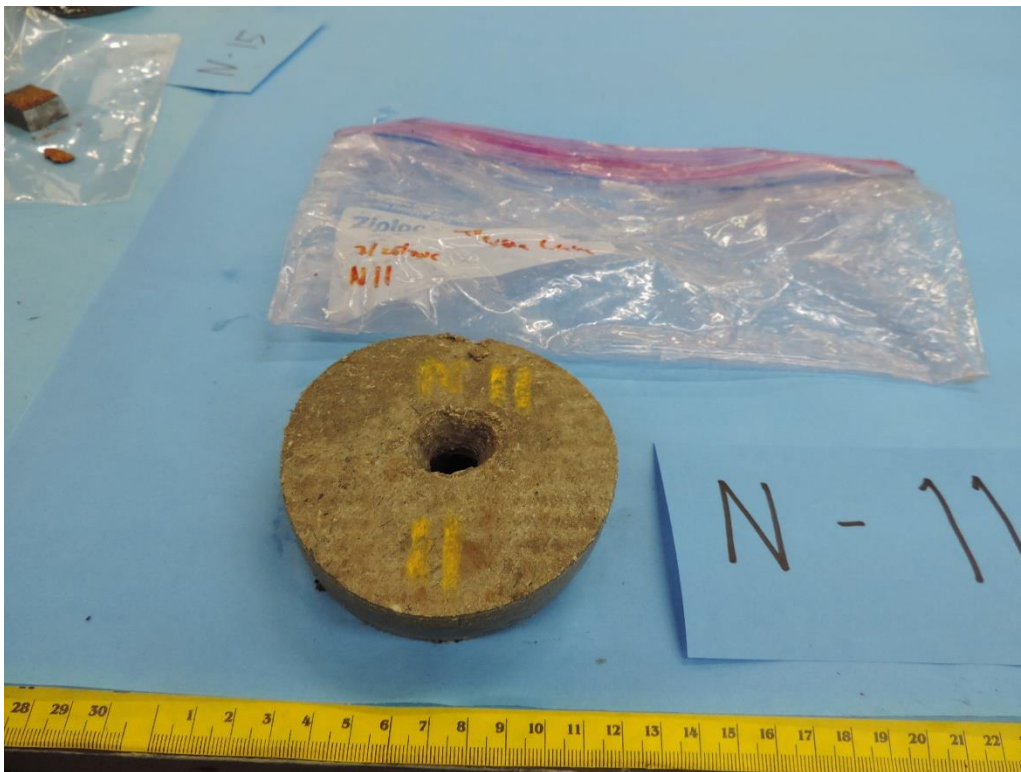
Same as above, except the outside surface is viewed.

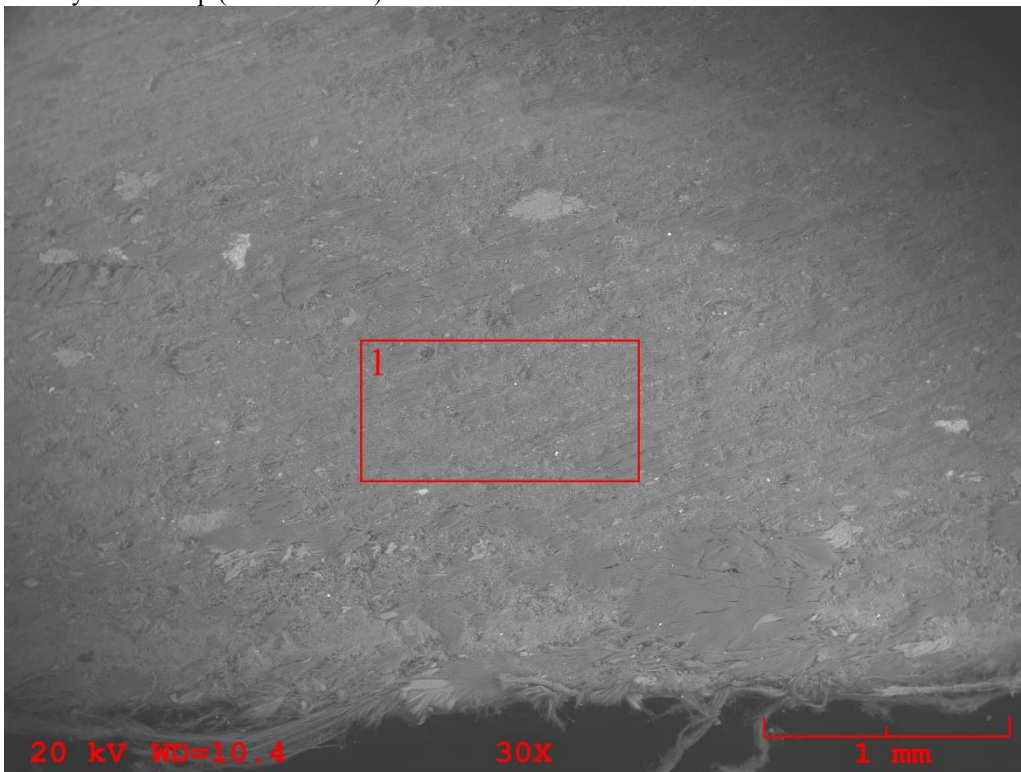
30x SEM image of the inside layer of N-11.

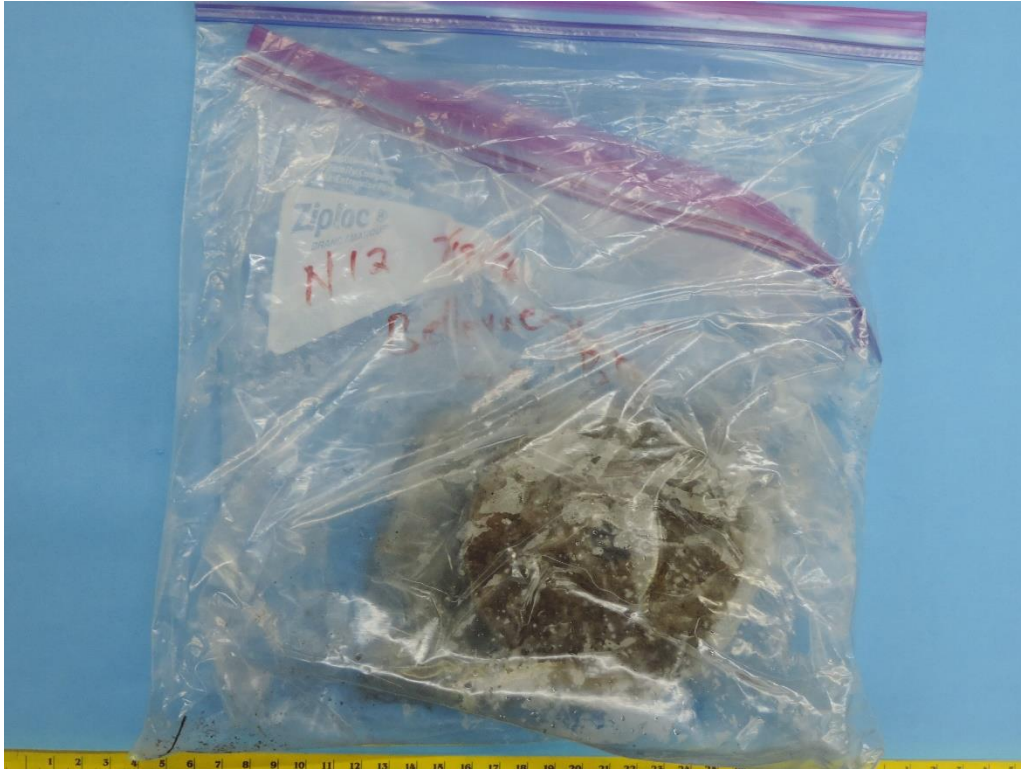
Overall view of sample N-12. Note this sample initially was misidentified as N-17.

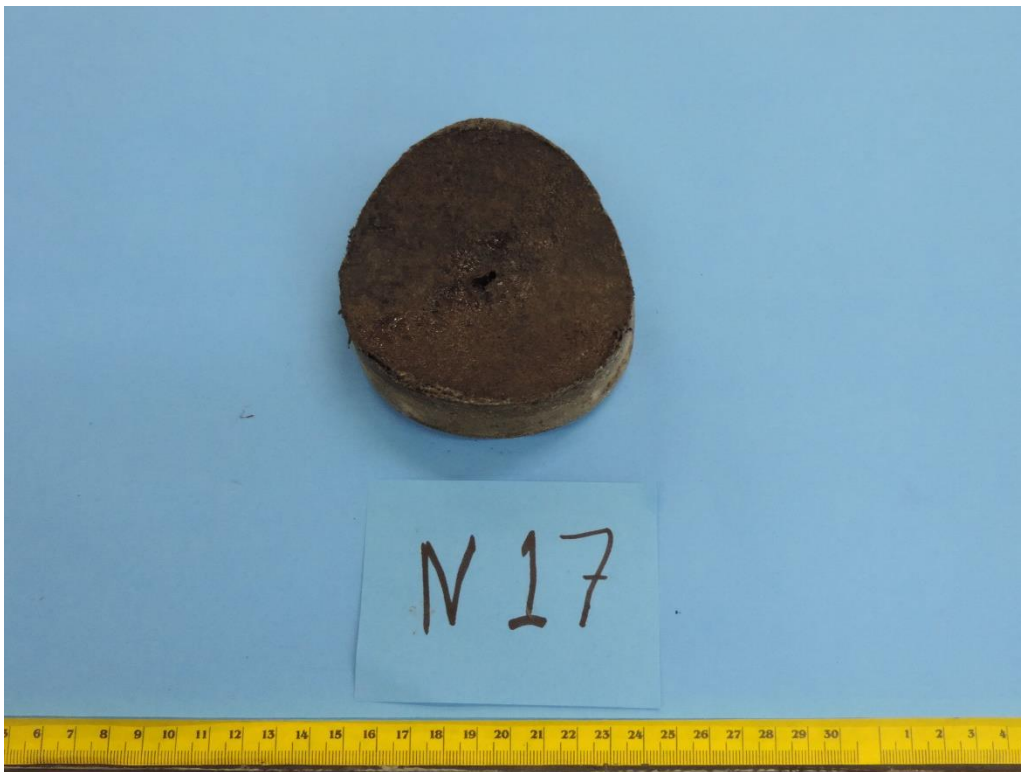
Close up of sample N-12 (not N-17).

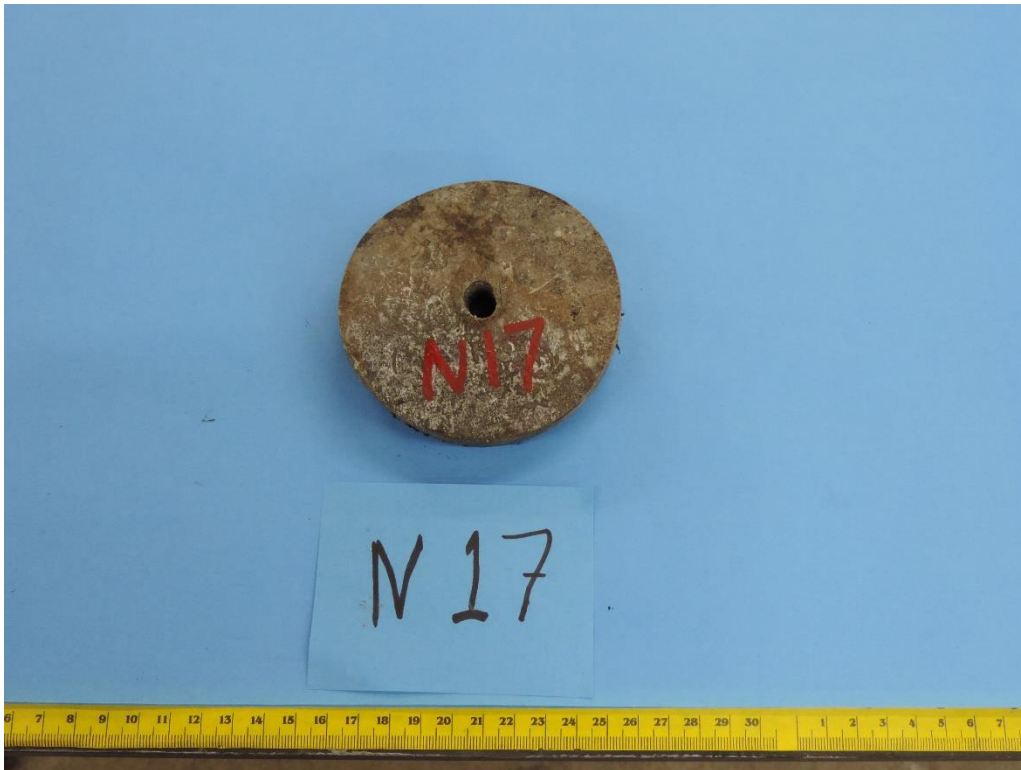
Overall view of the outside of N-12 (not N-17).

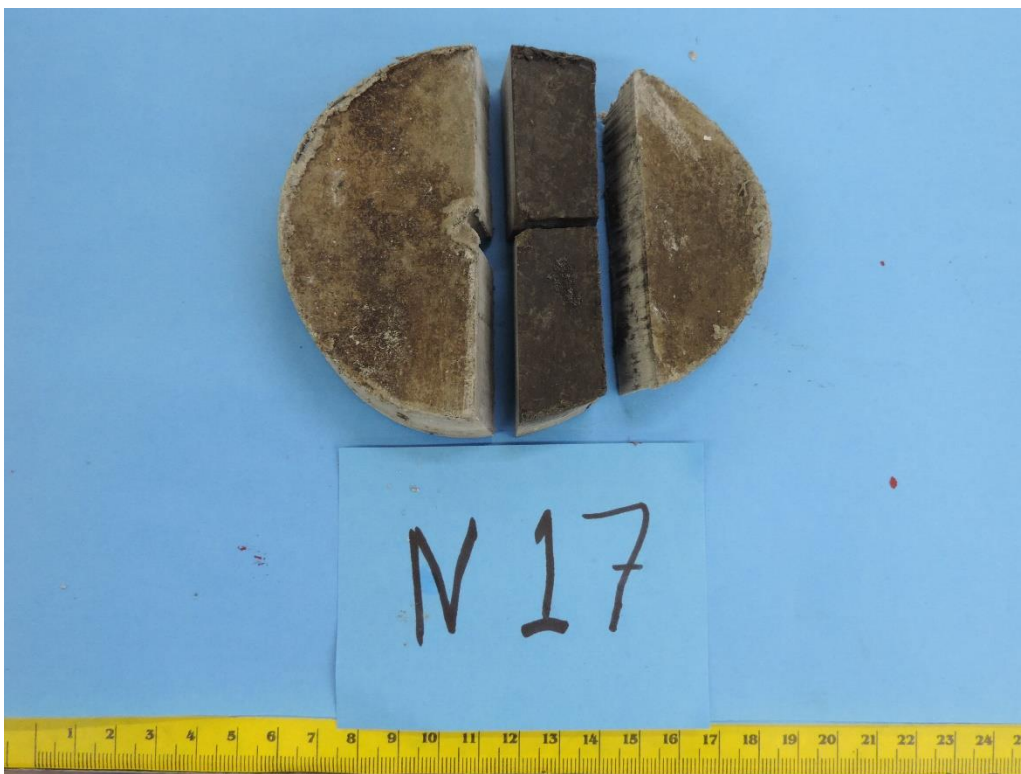
Overall view of sample N-12 (not N-17) after sectioning.

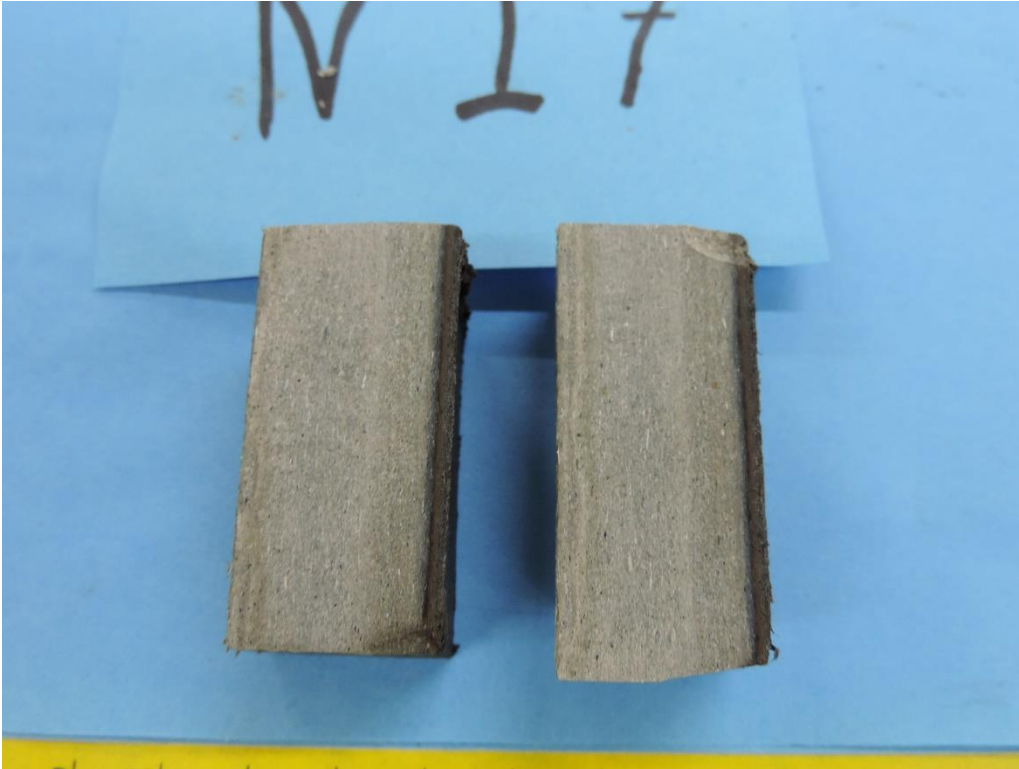
Close up view of the cross section of N-12. Note the inside is the dark layer.

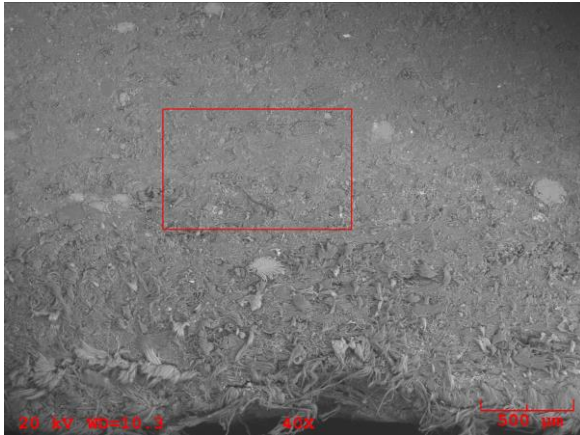
Analysis Report: Sample 12 cross section-1-1

EDS of the inside layer of N-12.

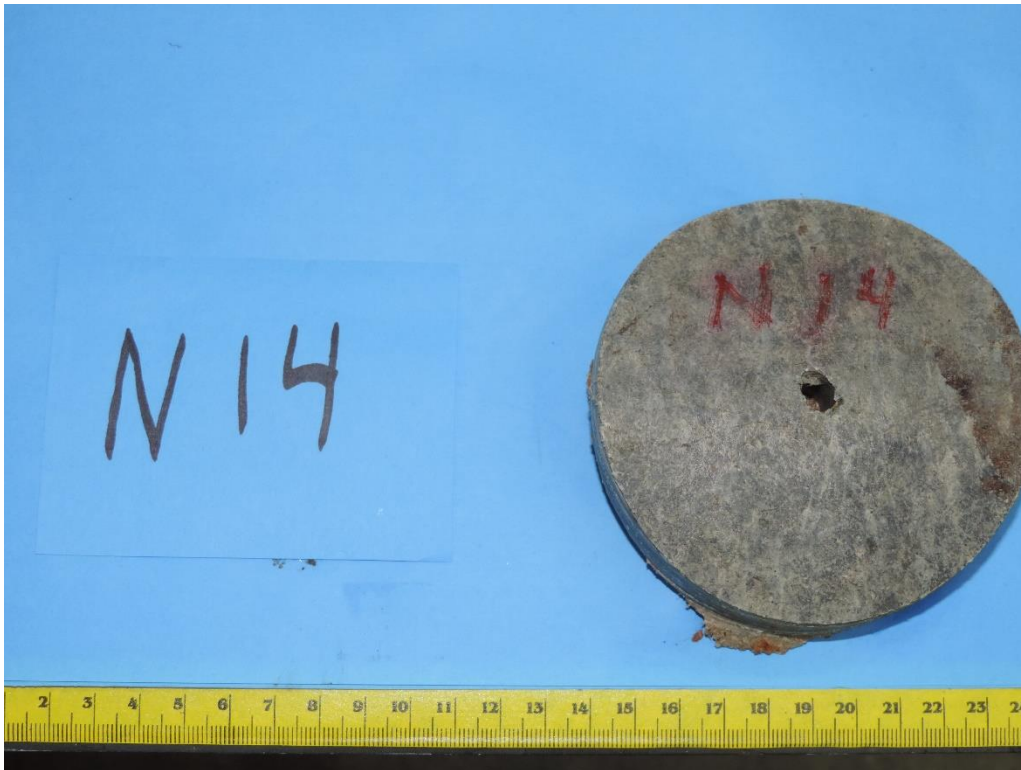
Overall view of the outside of sample N-14.

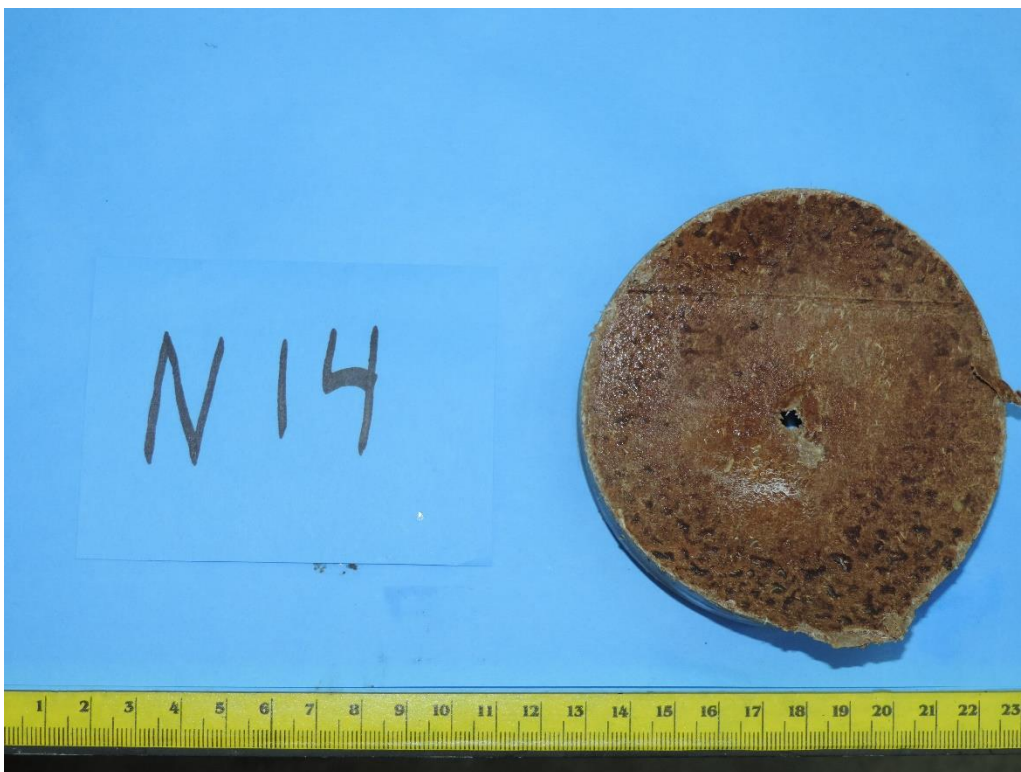
Same as above, except the inside surface is viewed.

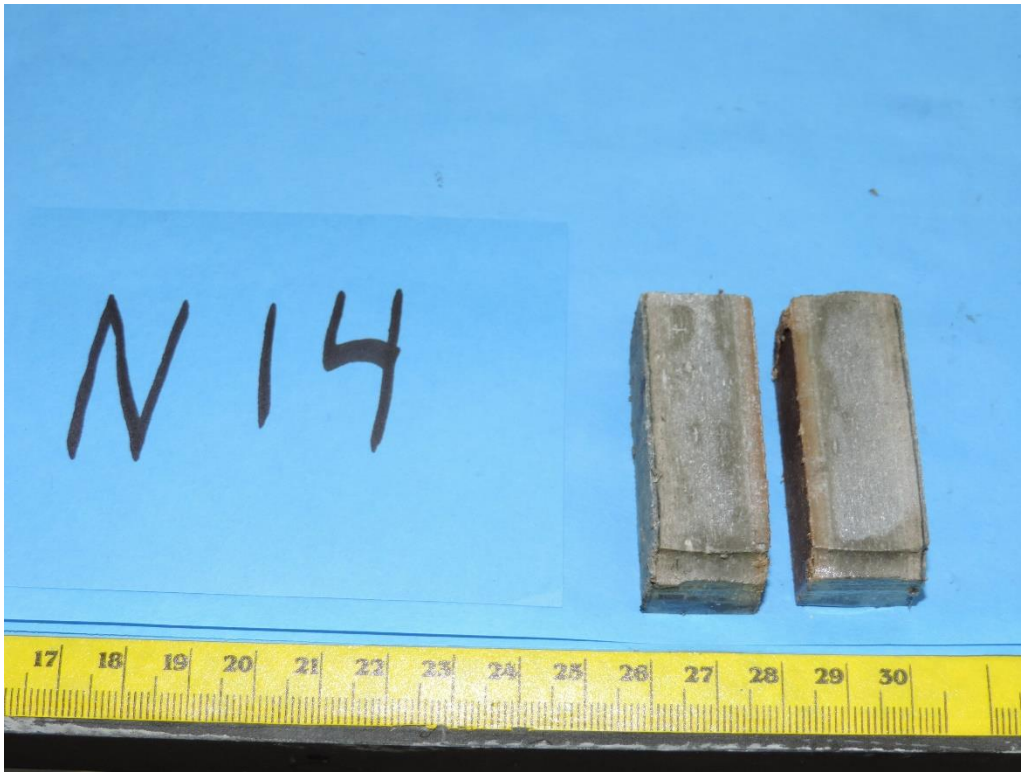
Close up of the cross sections of sample N-14. Note the inside surfaces are adjacent to each other.

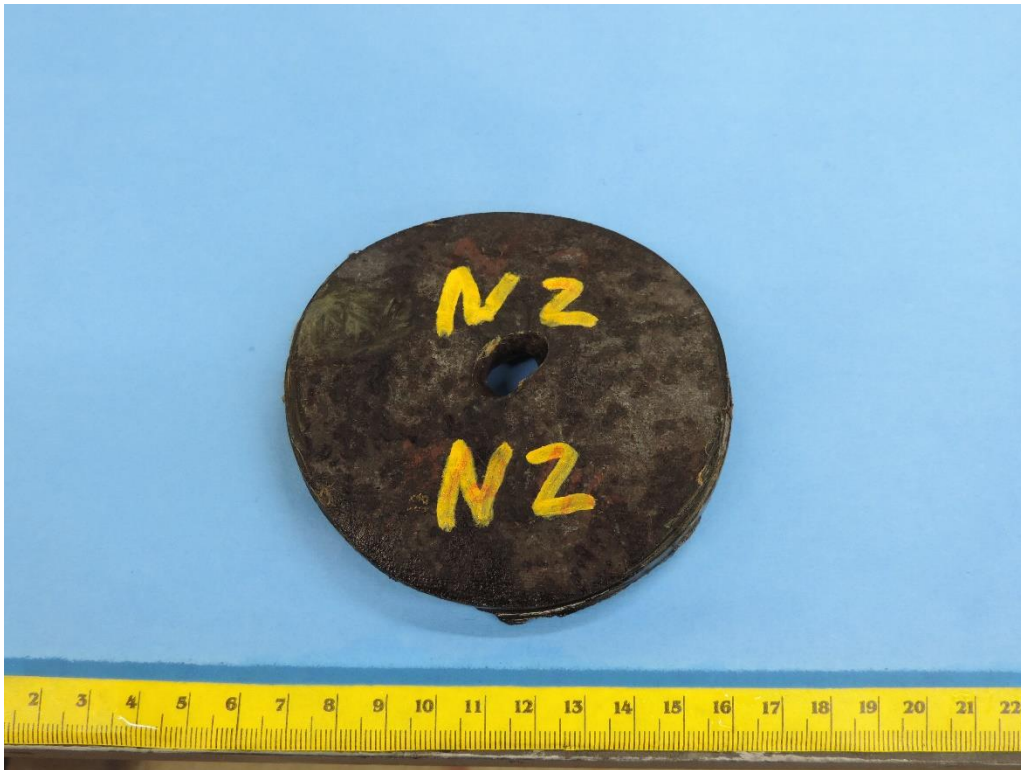
Overall view of the outside of N-2.

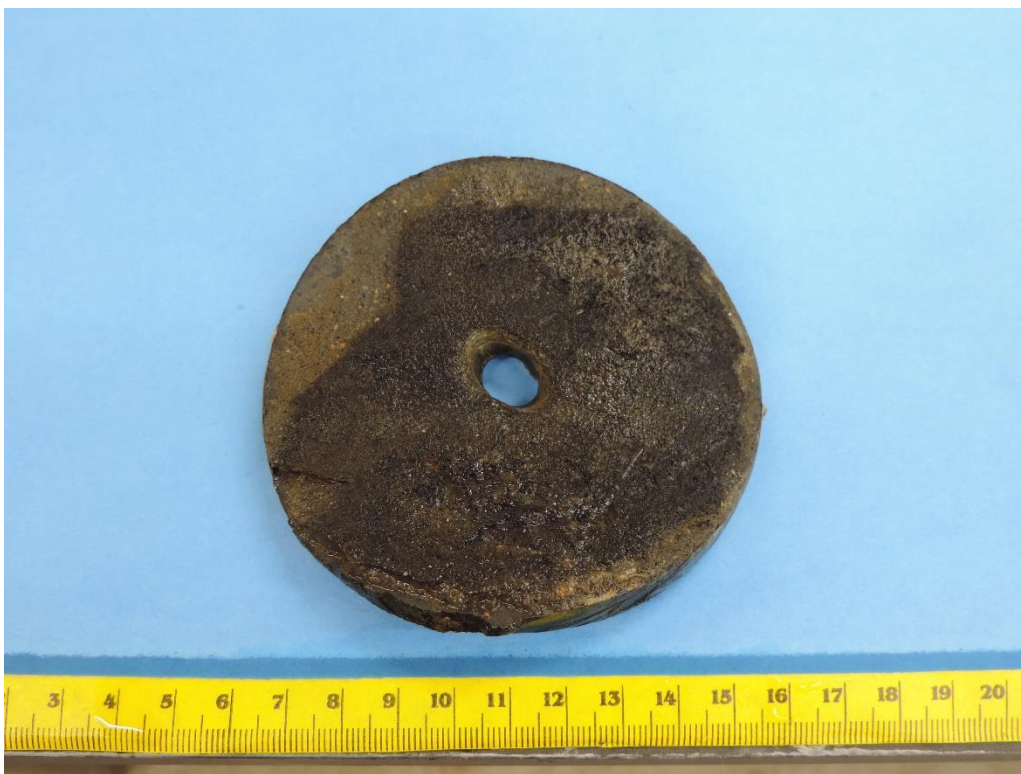
Close up of the inside surface of sample N-2. Note a layer of cement is present.

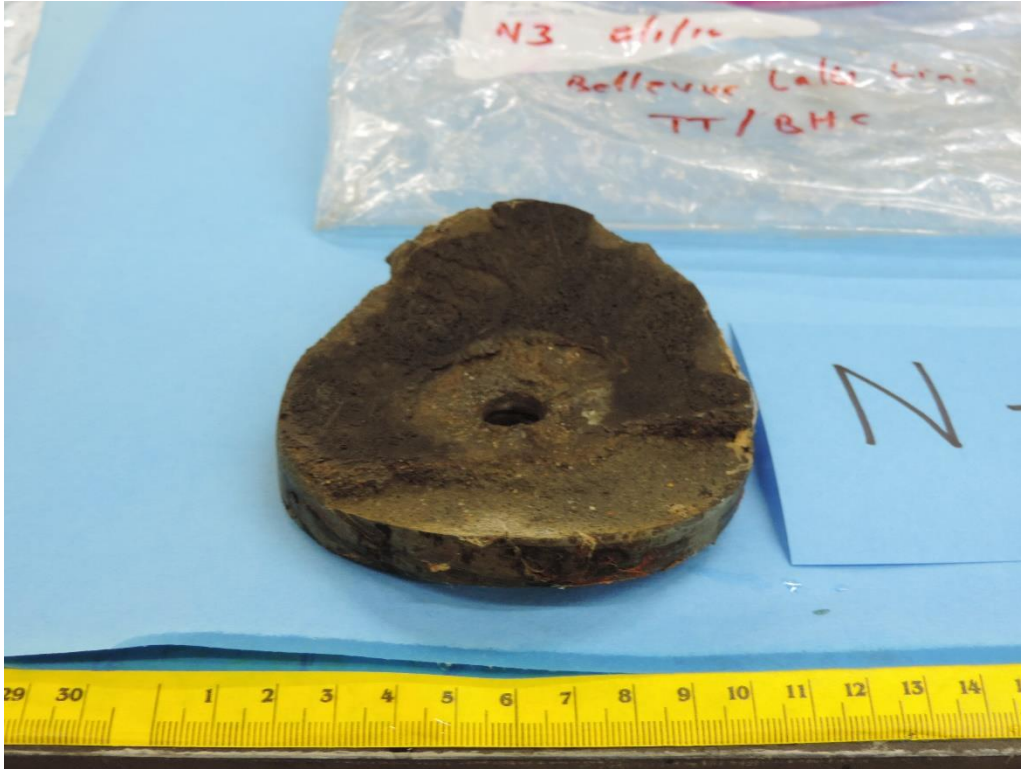
Close up of the inside of sample N-3 with a chipped cement layer.

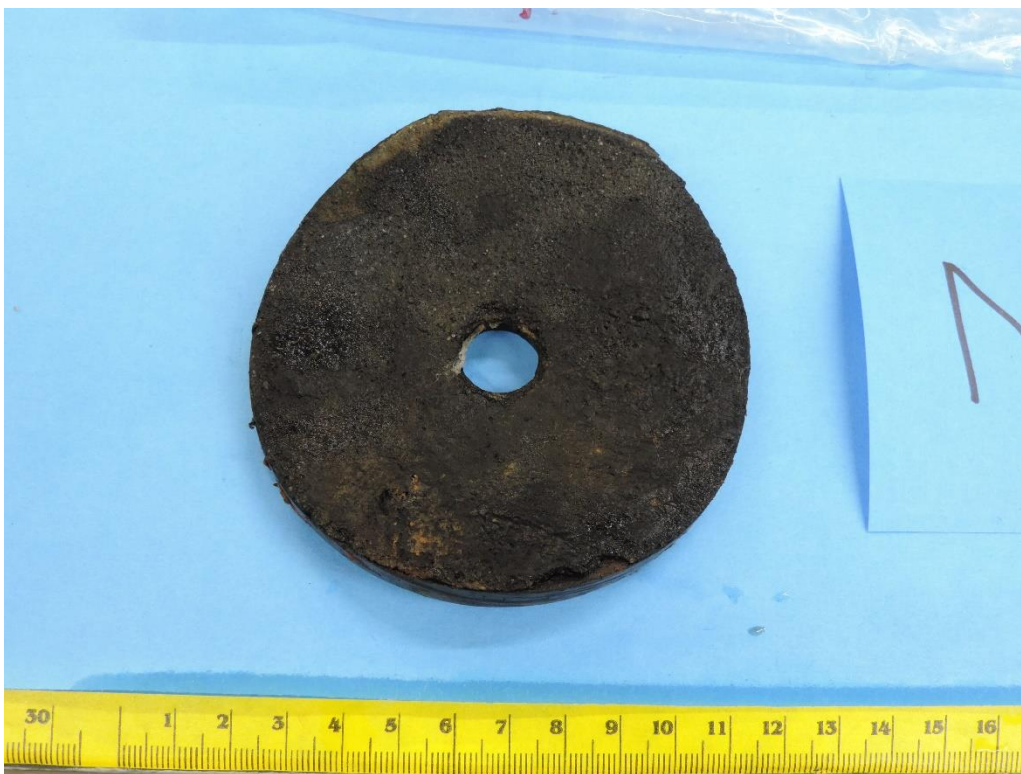
Close up of the inside of sample N-4.

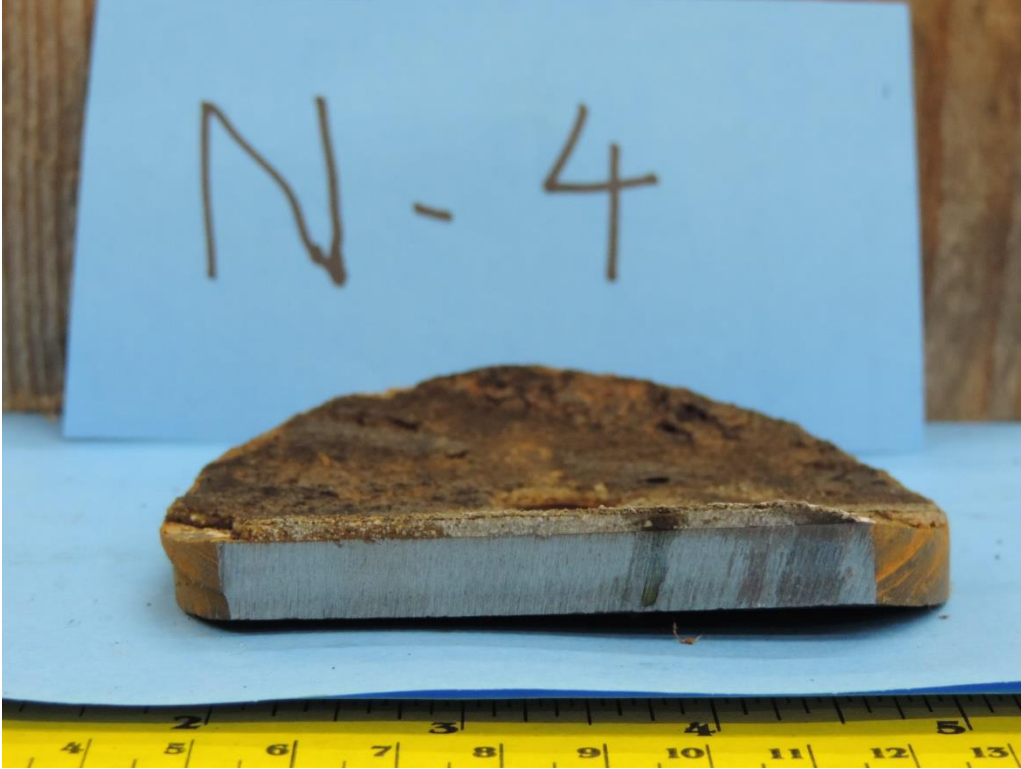
Close up of the Ph and phenolphthalein tested cross section from N-4. An acidic pH was detected, except directly above the cast iron pH was neutral.

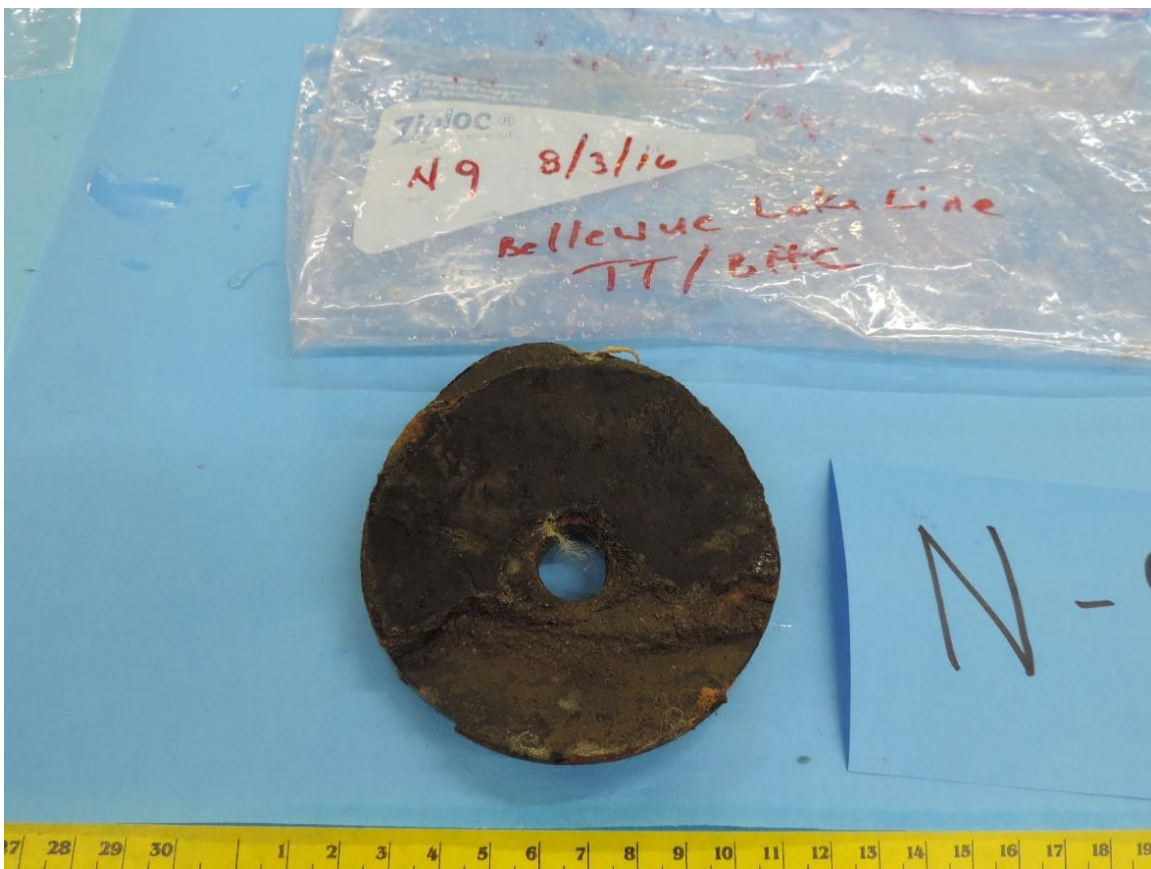
Close up of the inside of sample N-9.

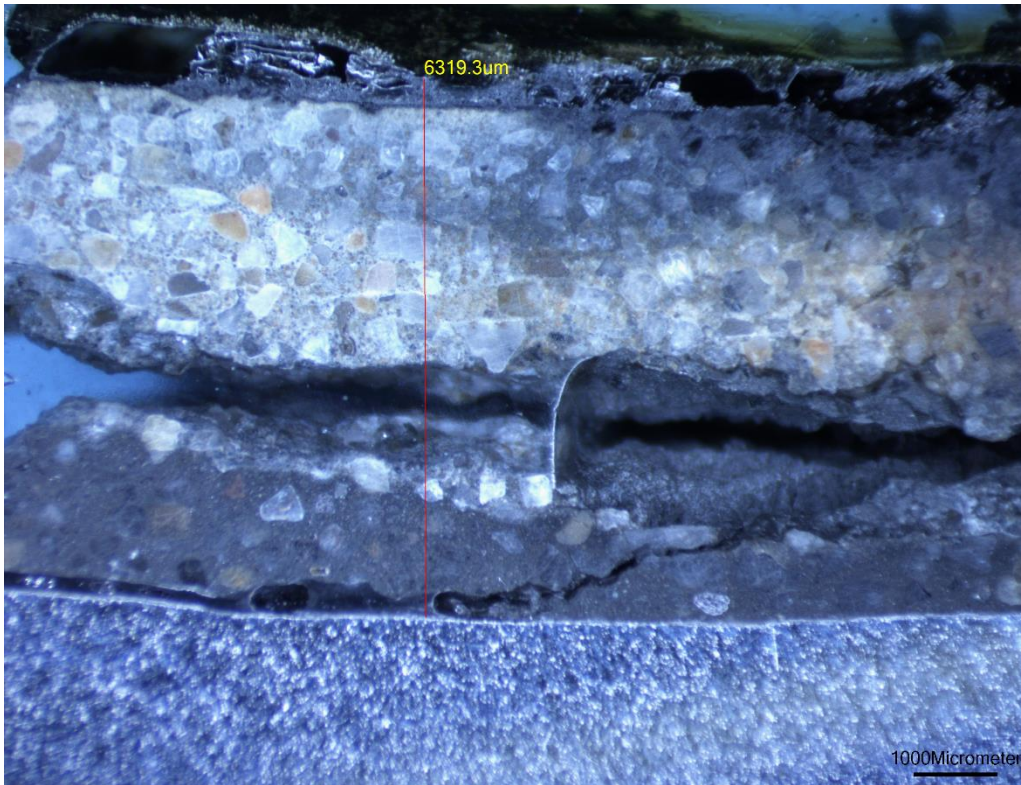
10x view of the cement layer on sample N-9 measured. There was no corrosion attack in the base metal.

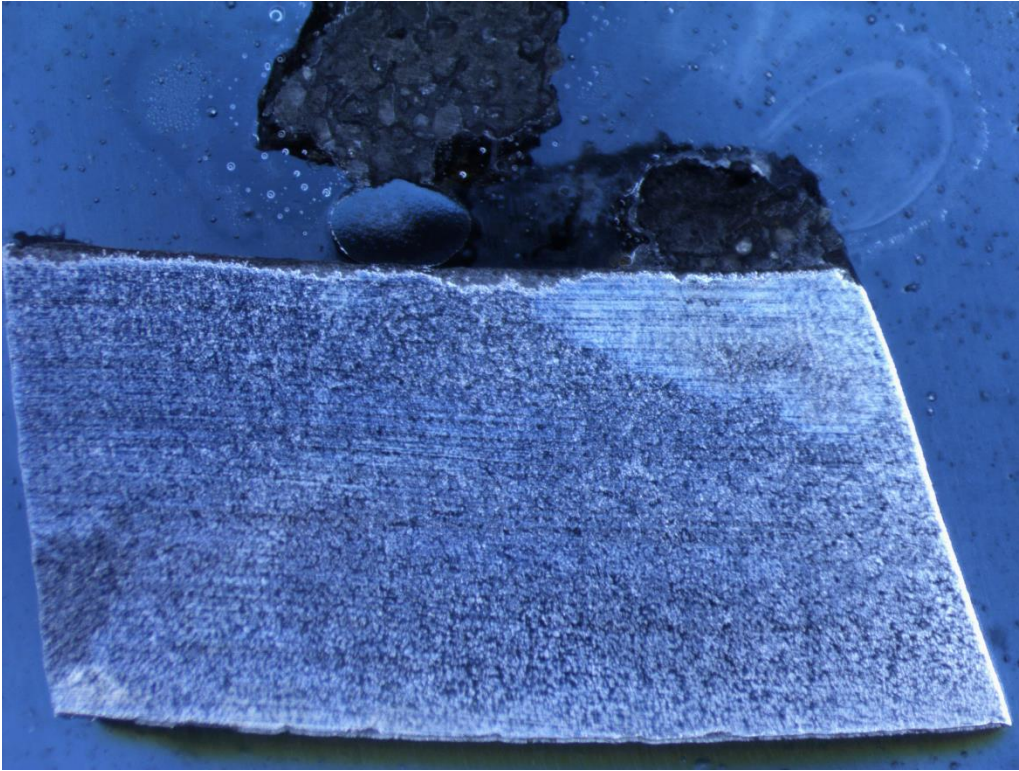
7x view of the cross section from sample N-10. Note there is a small amount of corrosion attack on the inside surface indicating the cement layer is no longer providing protection.

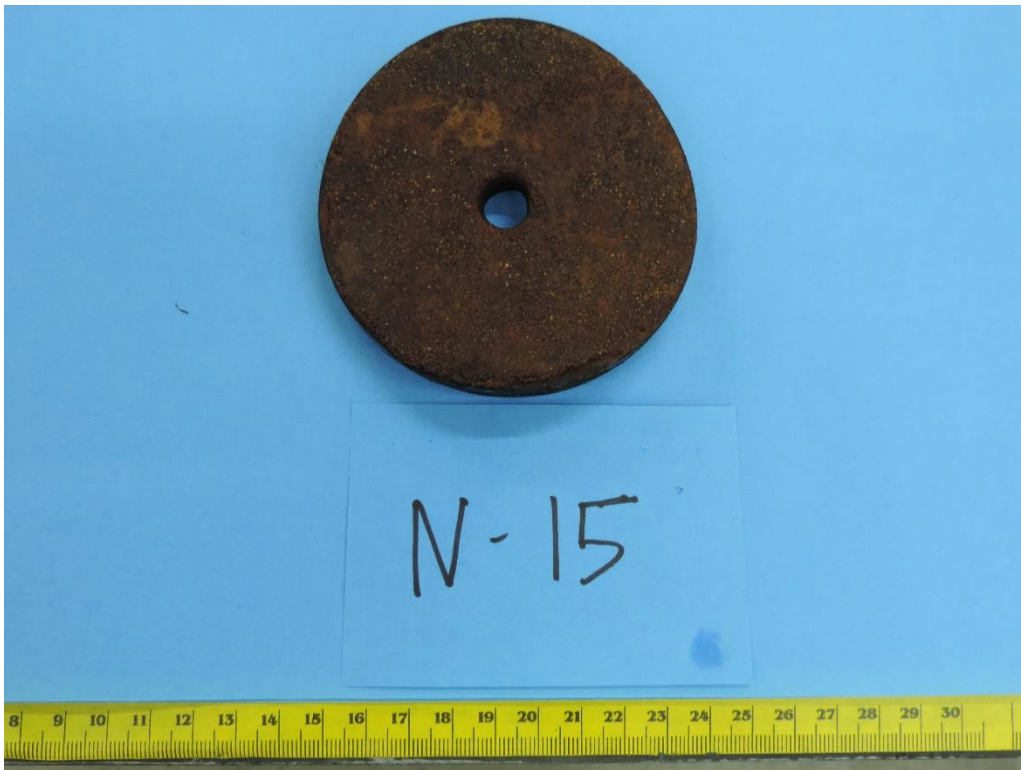
Overall view of the inside of sample N-15.

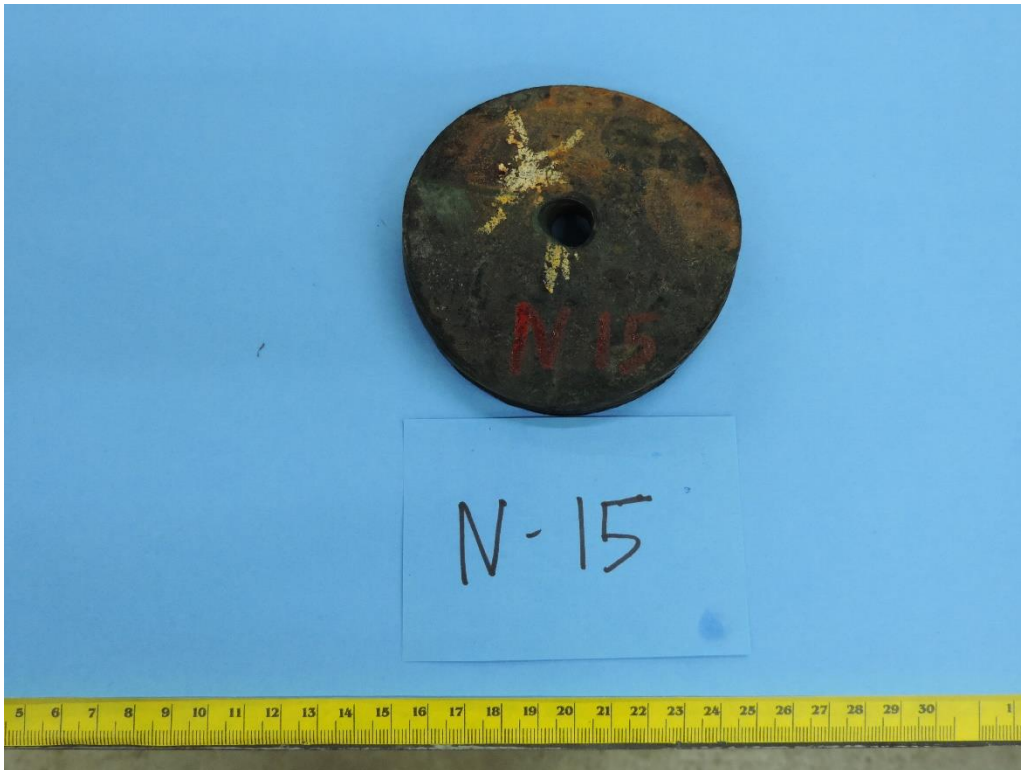
Overall view of the outside of sample N-15.

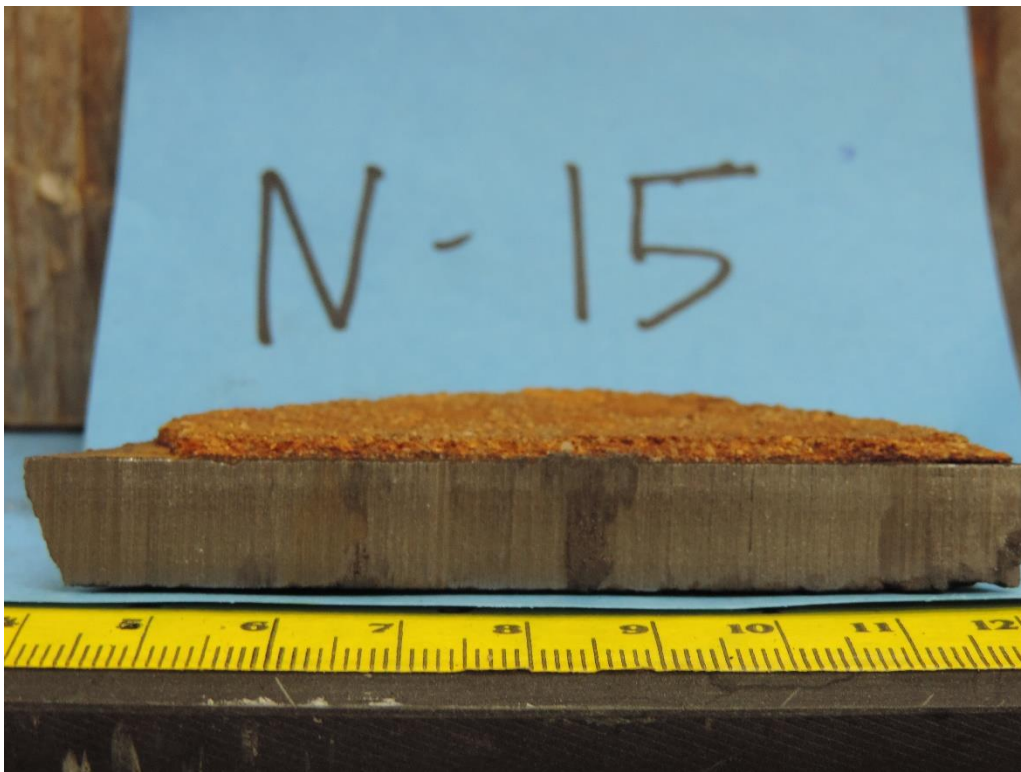
Close up of the cross section of sample N-15. The pH testing indicated the cement layer was acidic, but due to the heavy iron staining an accurate reading could not be obtained.

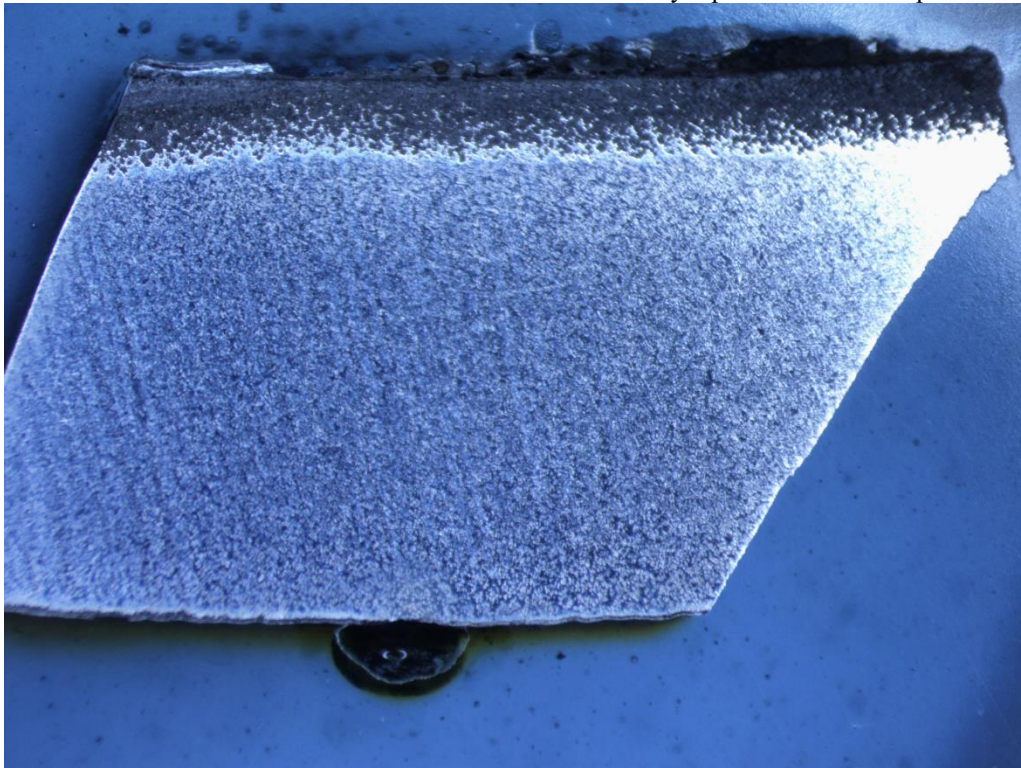
7x view of the cross section from sample N-16. Note corrosion has initiated at the inside surface in the absence of cement.

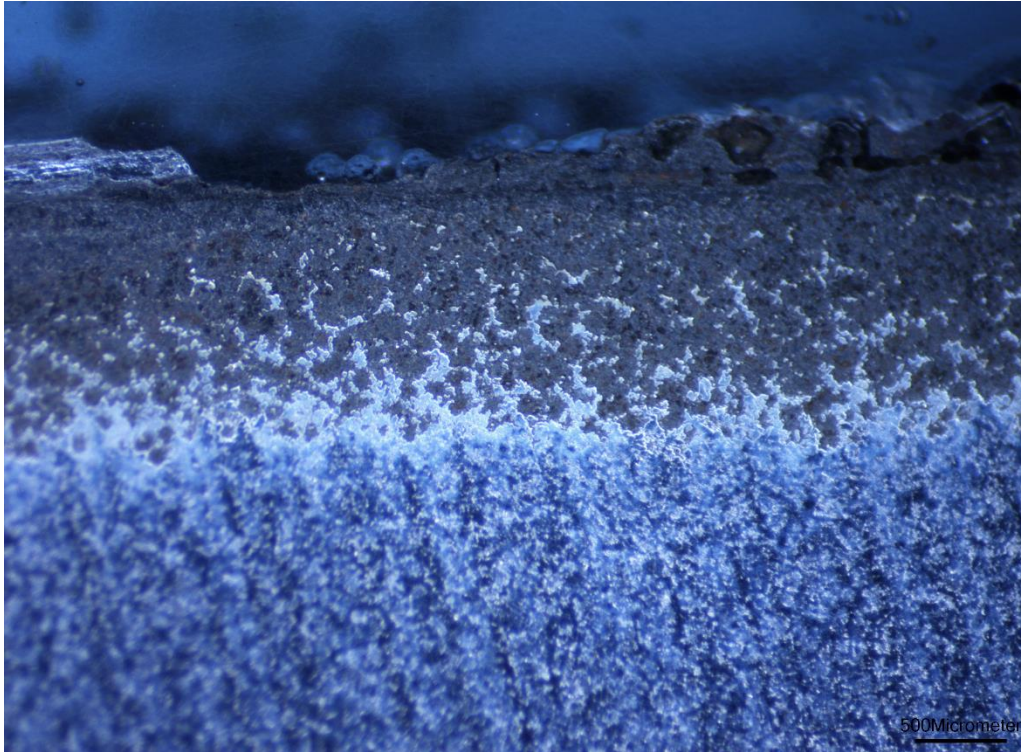
20x view of the corrosion on sample N-16.

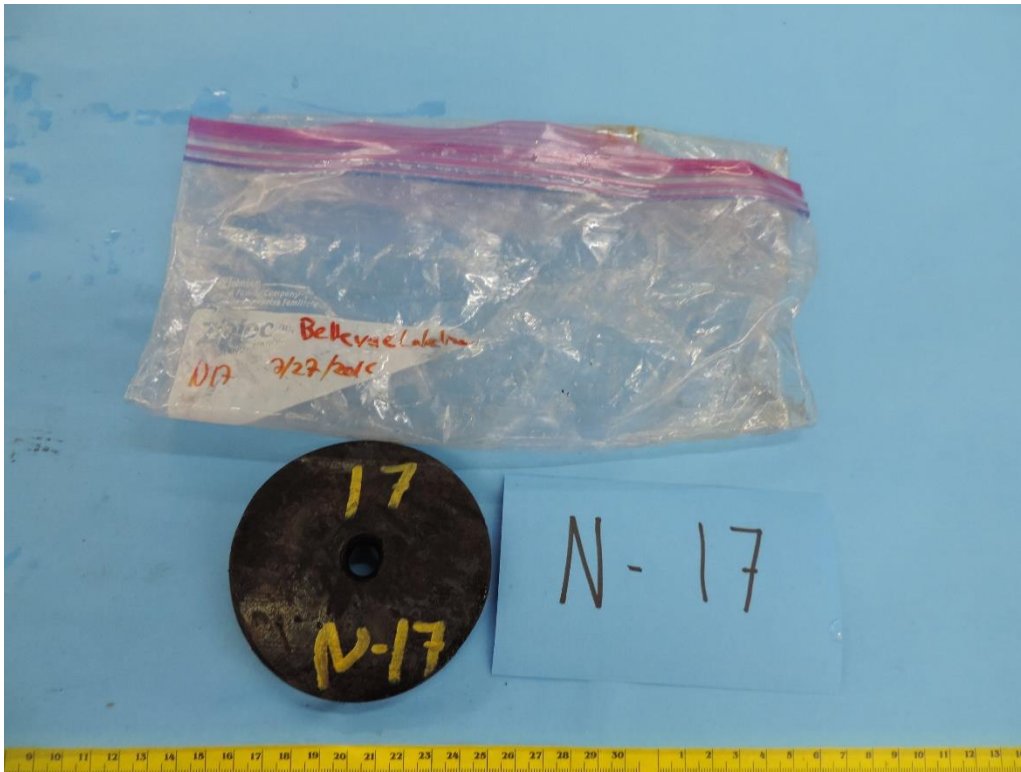
Overall view of the outside of sample N-17 (the real #17).

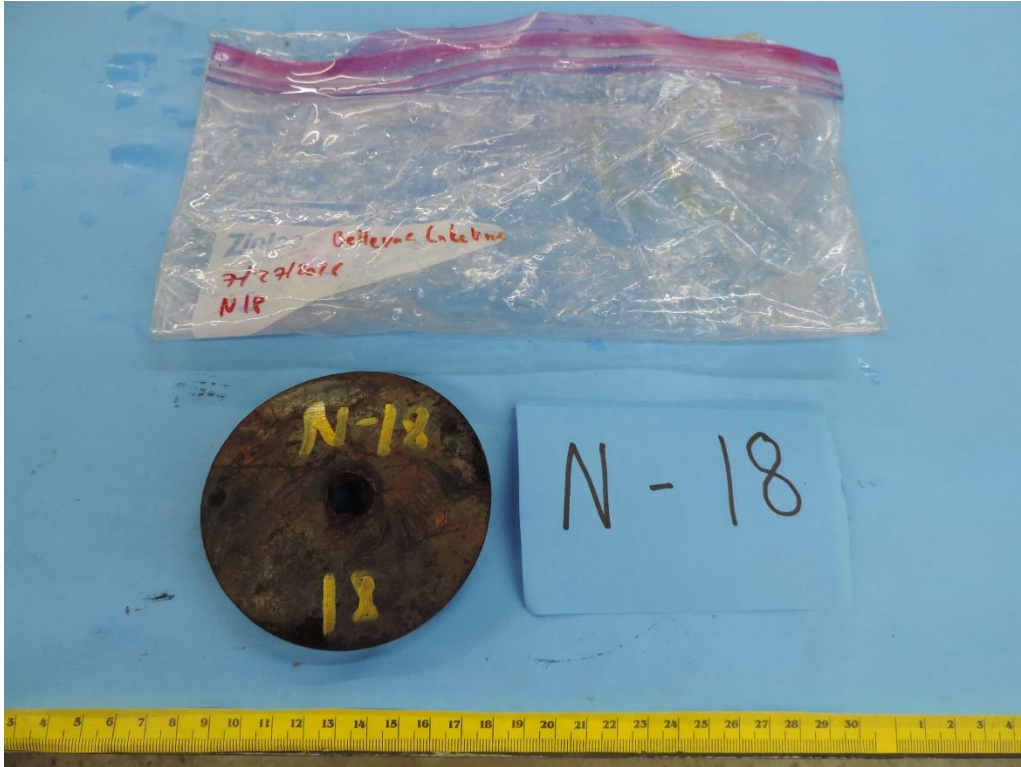
Overall view of sample of the outside of N-18

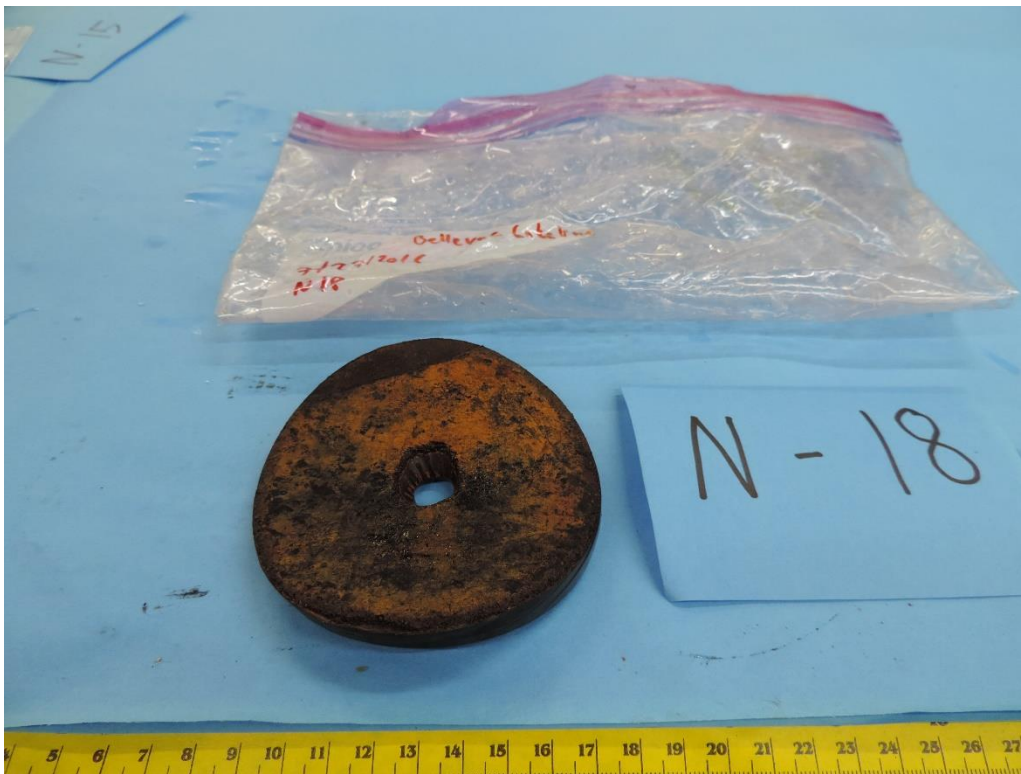
Overall view of the inside of sample N-18.

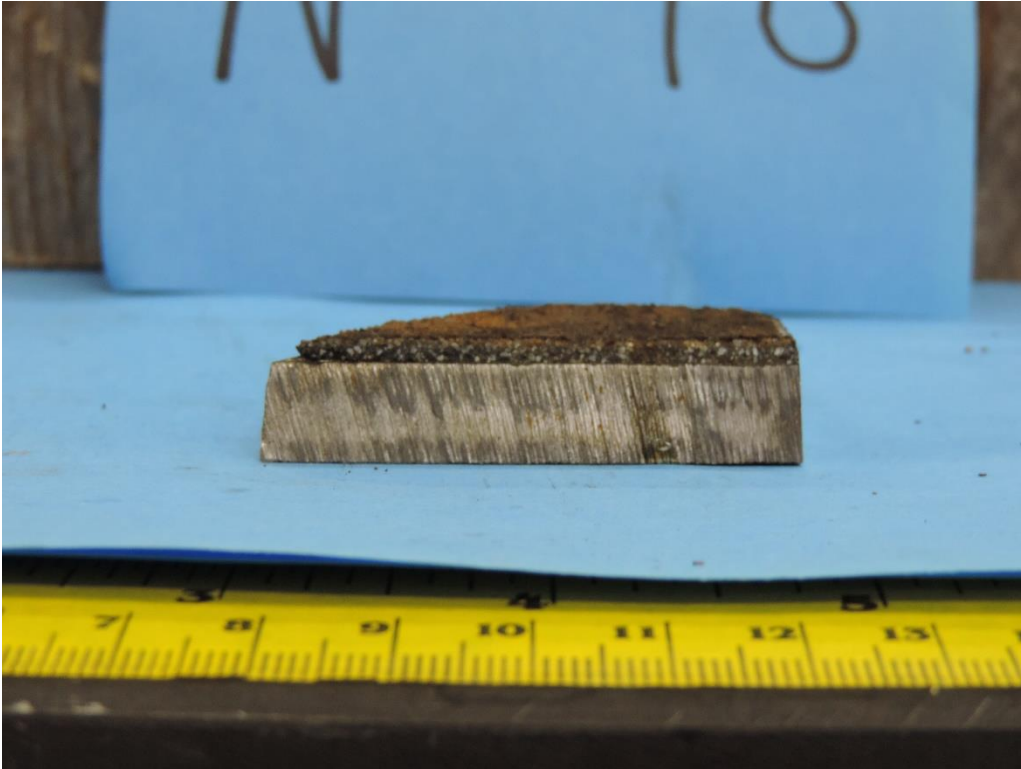
Cross section of sample N-18. The cement layer had darkened sufficiently so an accurate pH could not be measured.

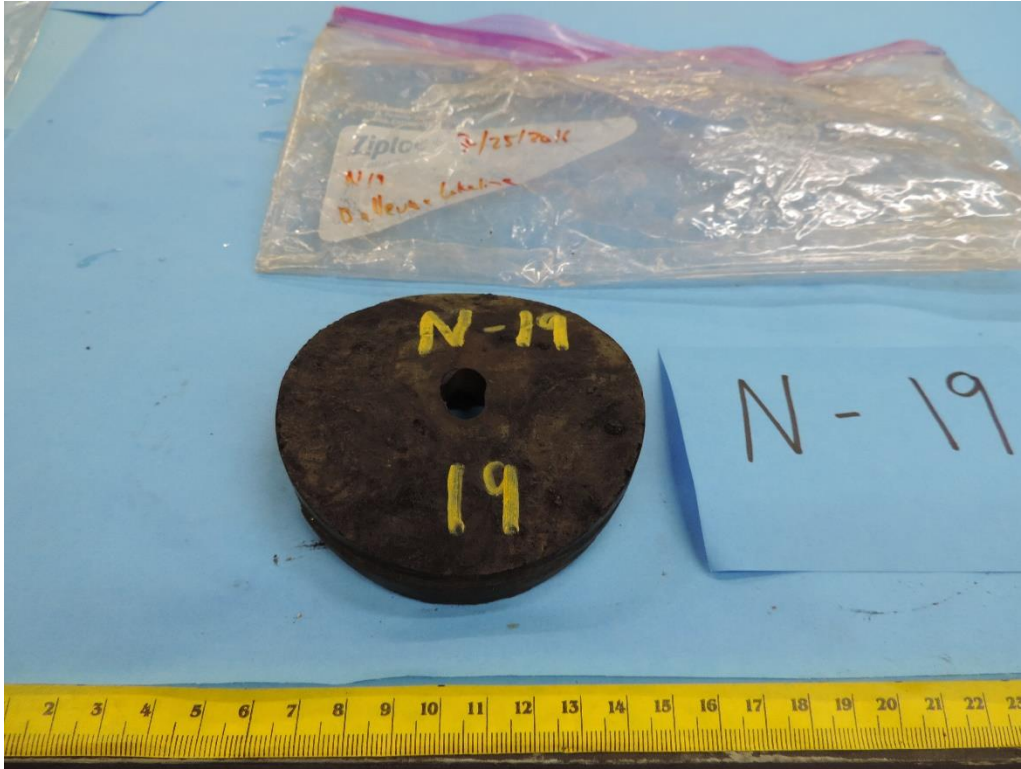
Overall view of the outside of sample N-19.
