Lake Washington Wastewater Lake Line Management Plan

FINAL / July 2024

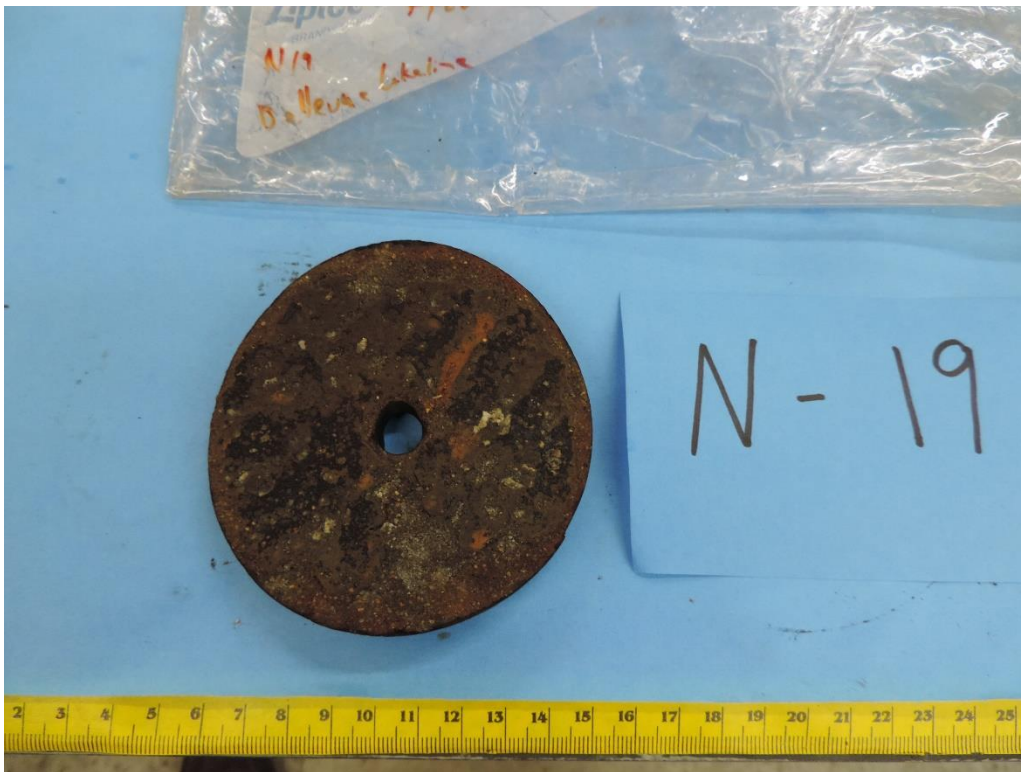
Overall view of the inside of sample N-19.

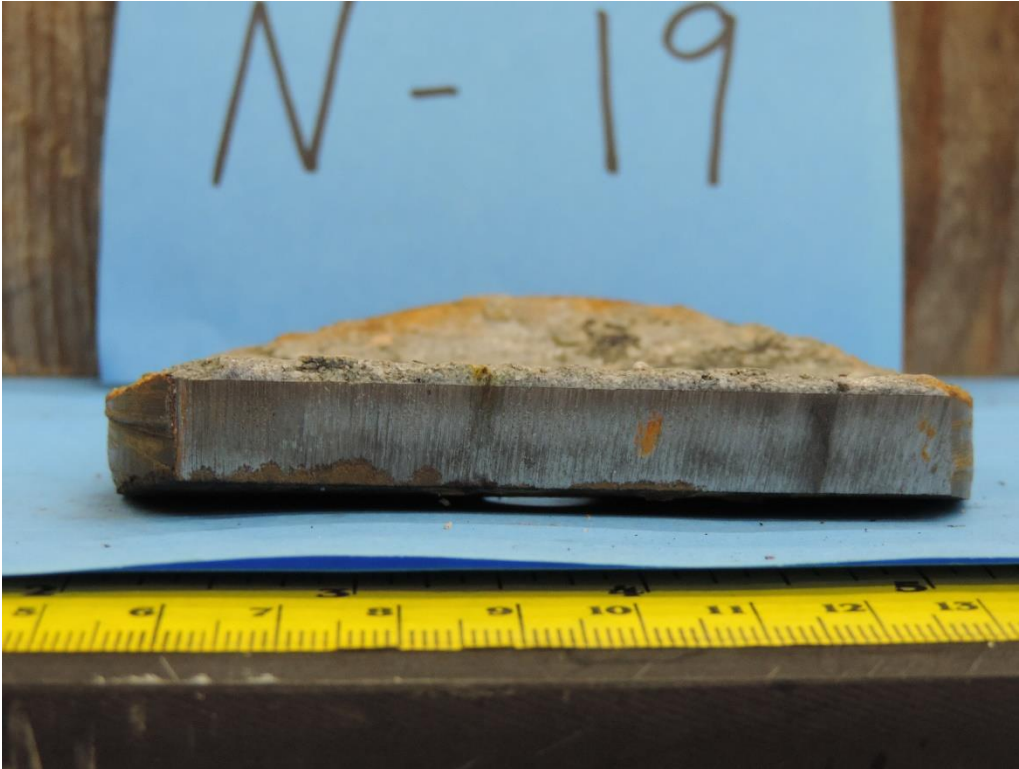
Cross section of sample N-19 after pH and phenolphthalein testing. This indicates that the upper layer of cement is slightly acidic trending toward neutral close to the cast iron.

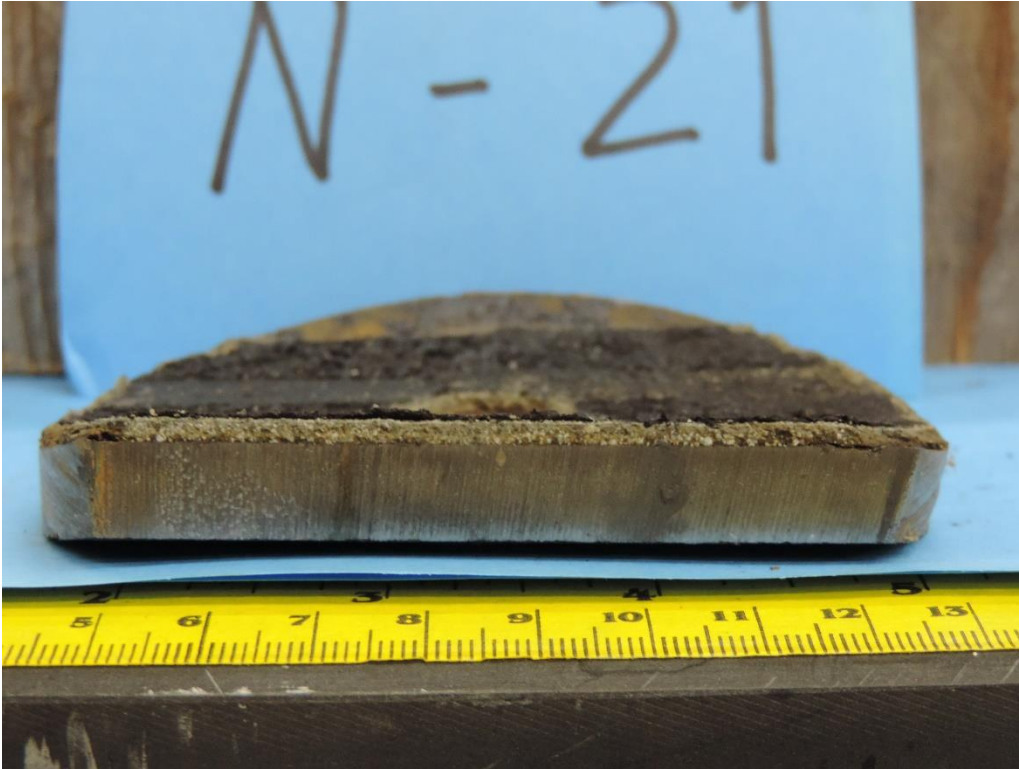
Cross section of sample N-21 after pH and phenolphthalein sampling. That indicated that the cement was slightly acidic.

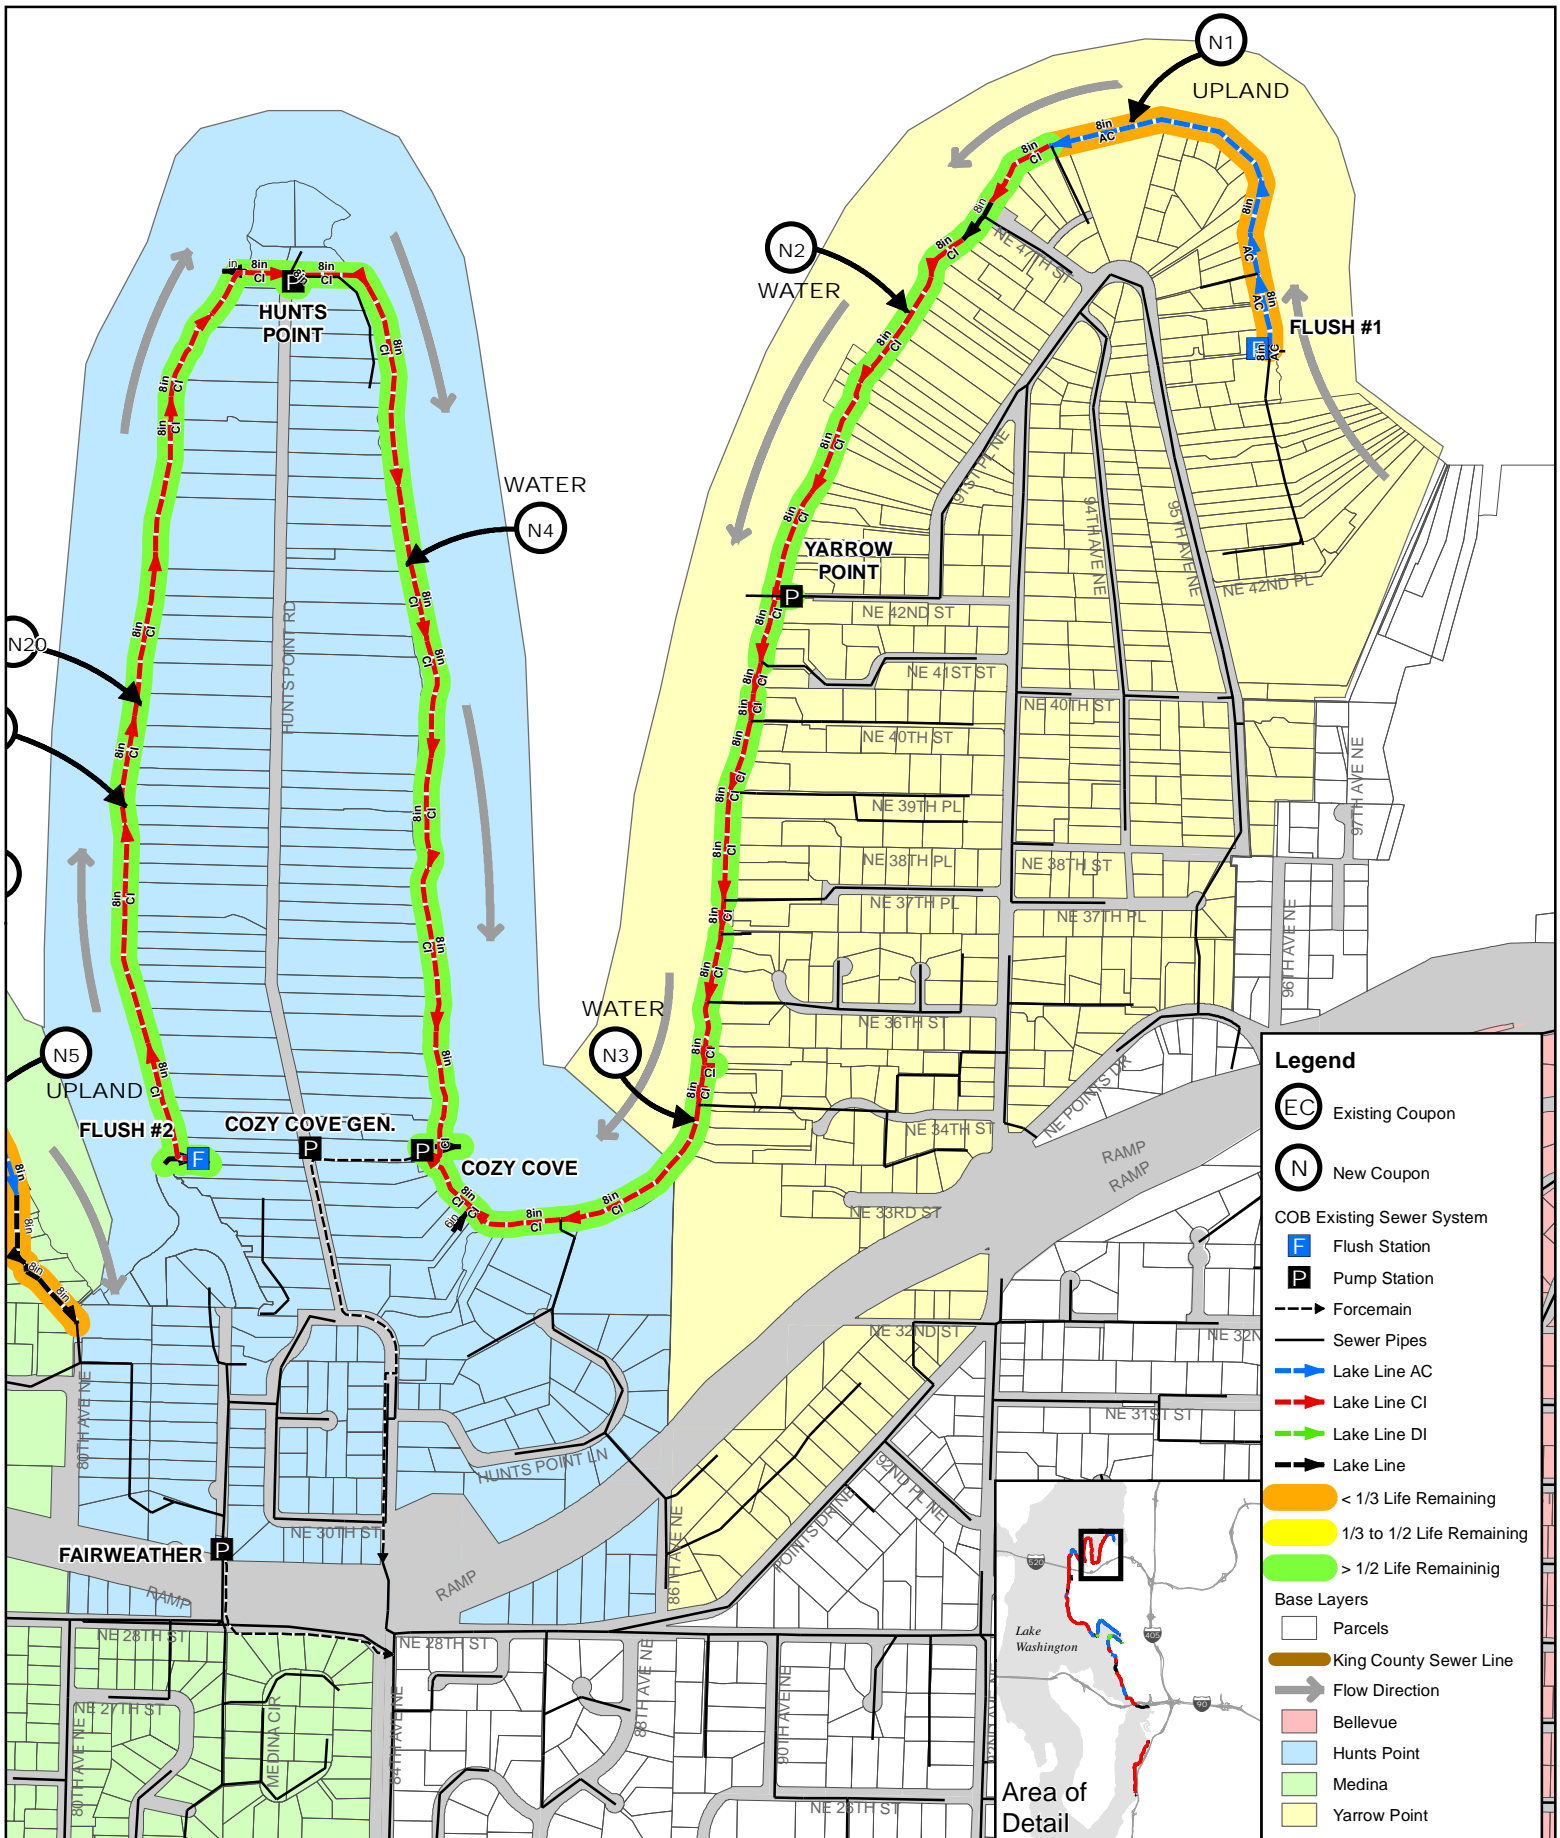
Figure 1
 December 2016

Appendix F. Remaining Life Estimates

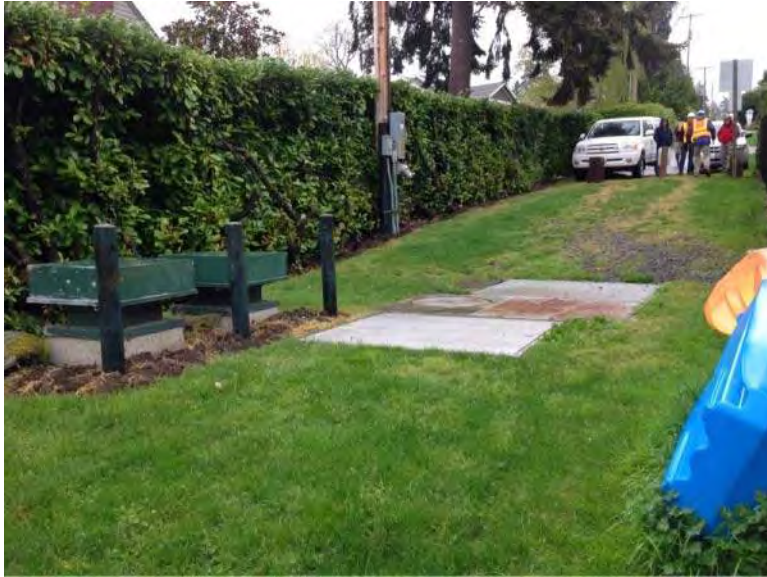
General site view toward vehicle access

- Located at the end of 42nd street, removable bollards preventing public vehicle access to edge of lake
- Two spaces for vehicle parking in front, full vehicle access to site when bollards removed

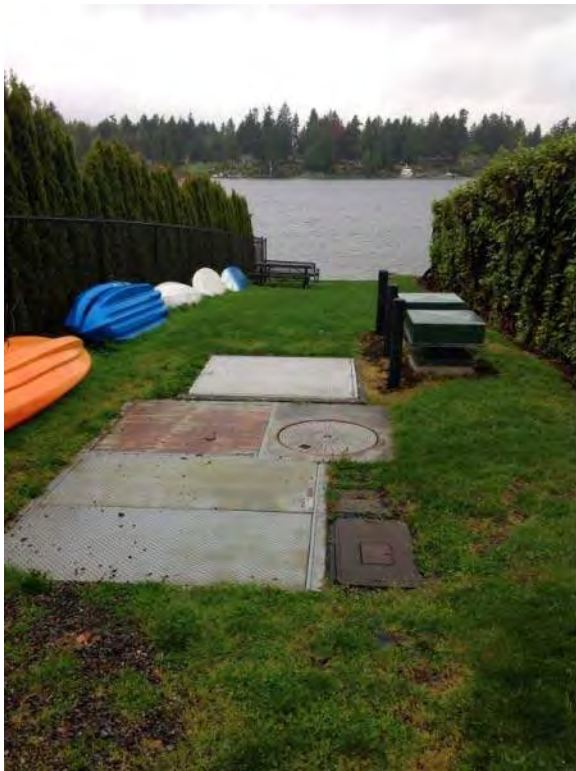
General site view toward lake

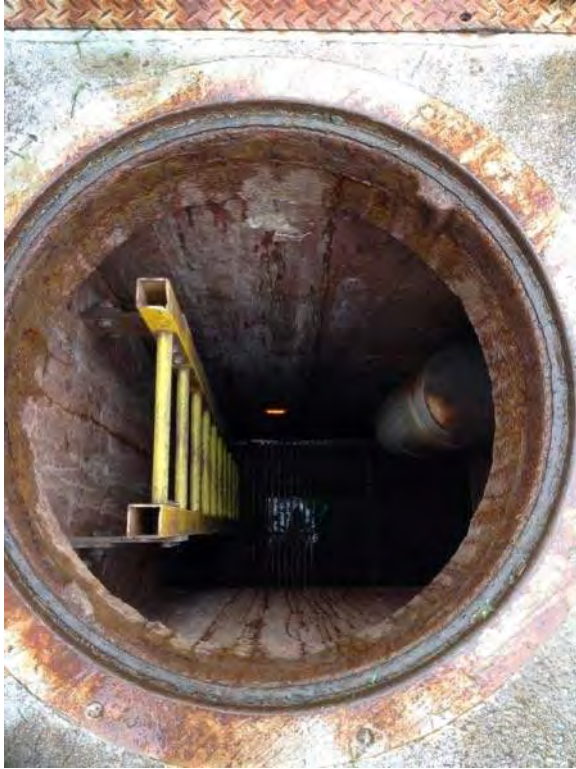
Wet well interior shows signs of corrosion and partial coating failure

Condition Rating 3 – Ground surface inspection identified interior coating is delaminating.

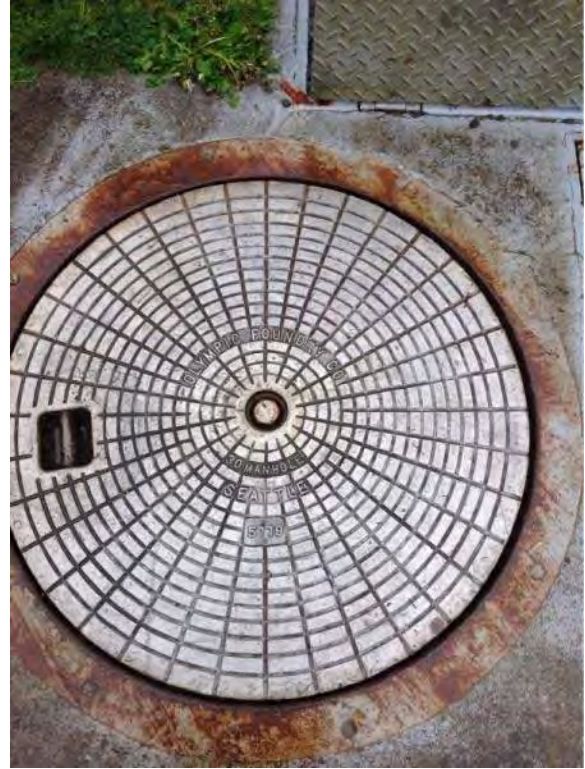
Wet well lid locks to secure access

- Upon failure of locking access lid, alternate lid will need to be purchased/fabricated or entire top of wet well will need to be replaced with new concrete top and hatch

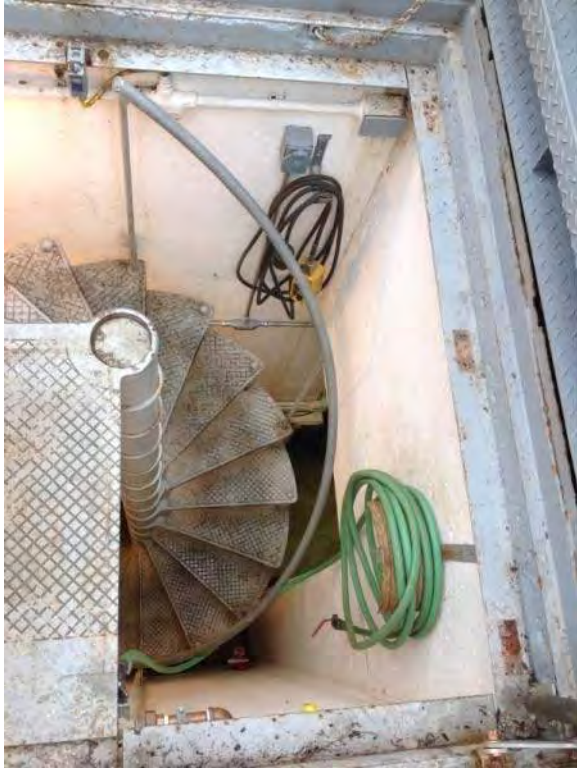
Spiral staircase appears to be in good condition

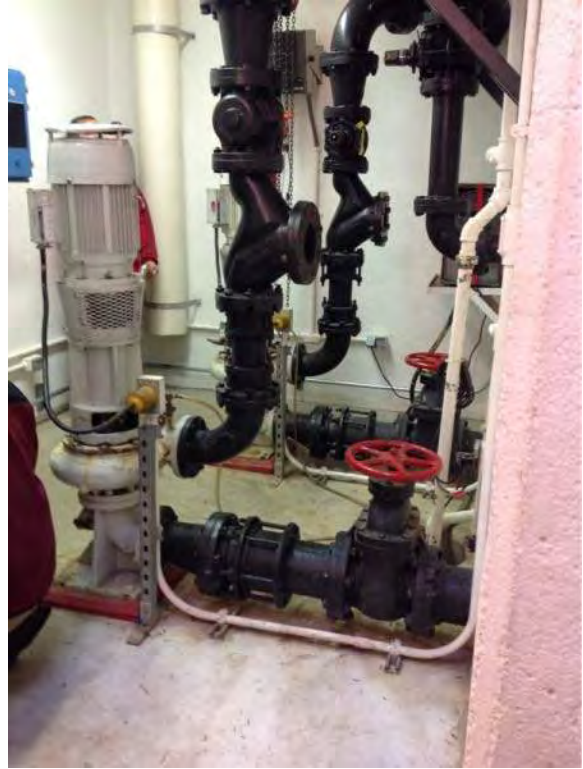
Pump and piping configuration

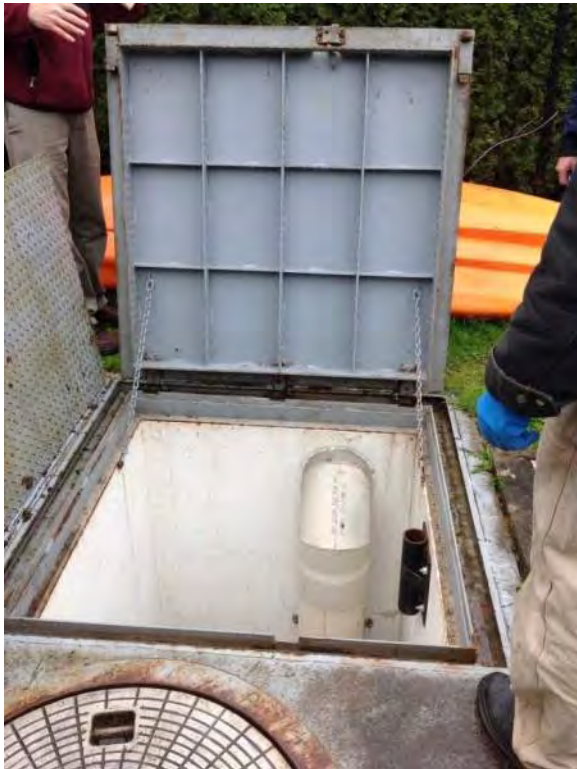
Equipment access hatch

- No vent out of structure – passive through open hatch
- Heavy hatch on equipment access – not routinely opened
- No exhaust fan – required in addition to supply fan to unclassify space per NFPA 820 code

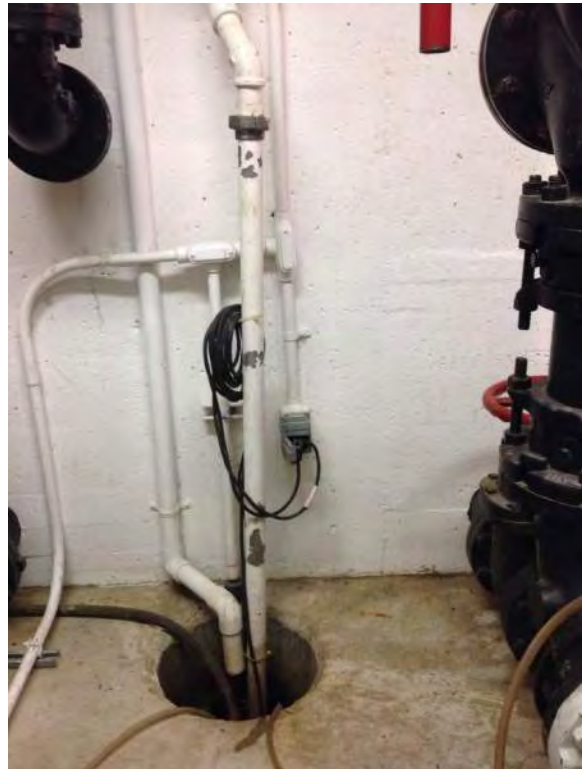
Sump pump in dry pit

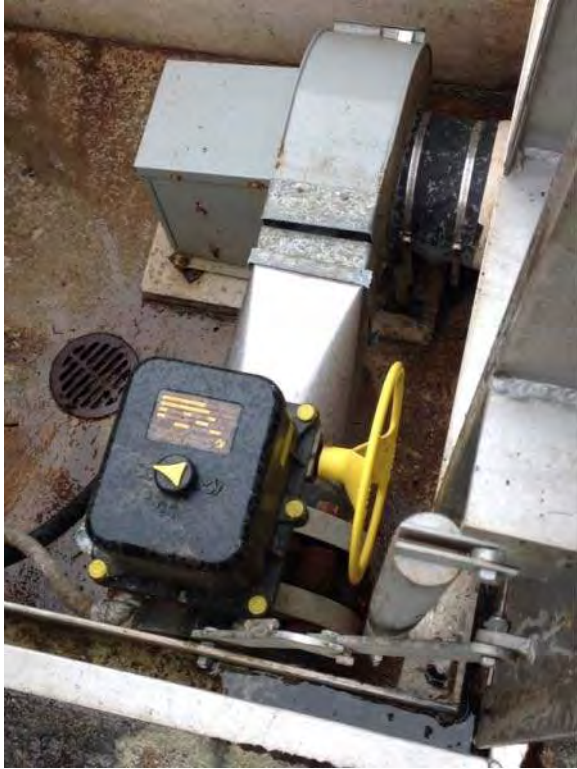
Interior of wet well blower vault appears to be in good condition

- Wet well blower vault houses supply ventilation fan for wet well
- Duct isolation valve opens and fan starts when switch is activated in the dry pit
Equipment does not appear to be rated for Class 1, Division 2 space (NFPA 820).
Equipment was grandfathered-in so replacement is needed upon the next major rehabilitation project. See section 2 for grandfathered term reference.

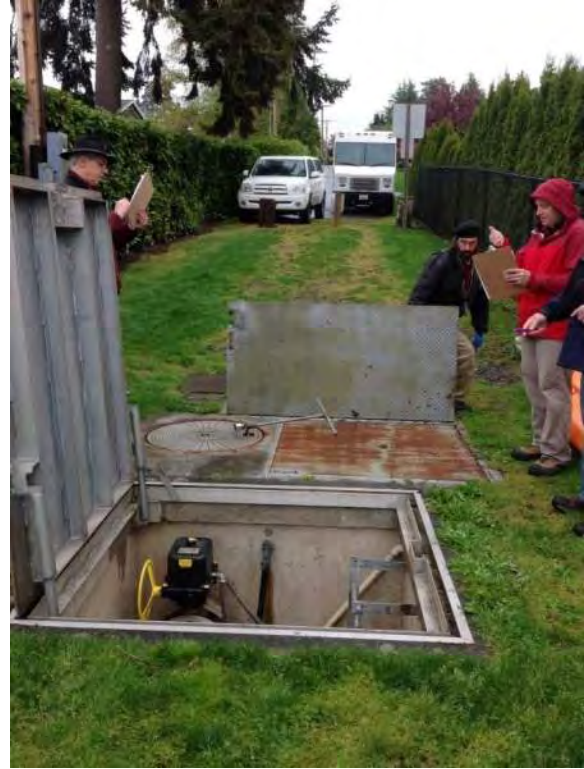
Wet well blower vault hatch opening

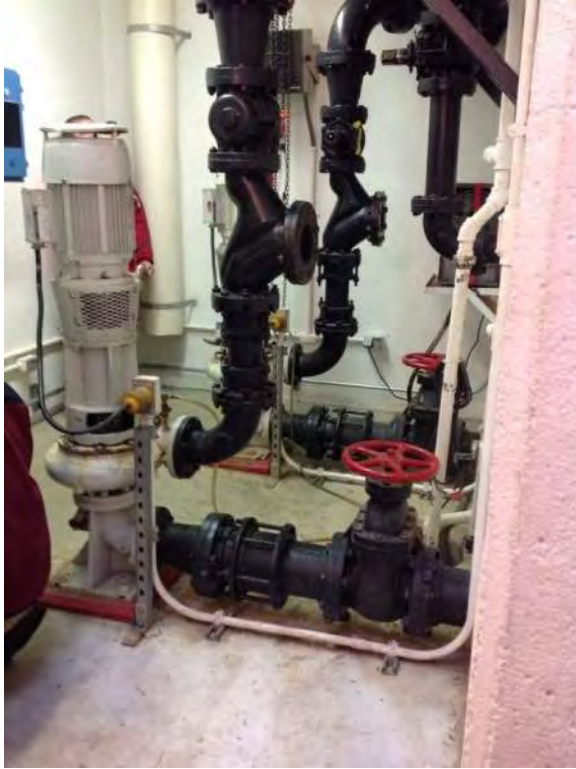
Duplex configuration (Pump 1 in foreground)

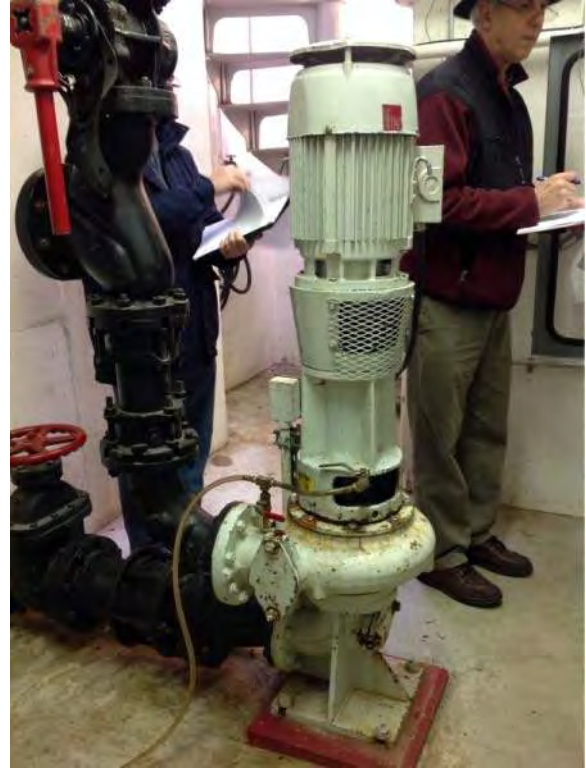
Pump and motor #1

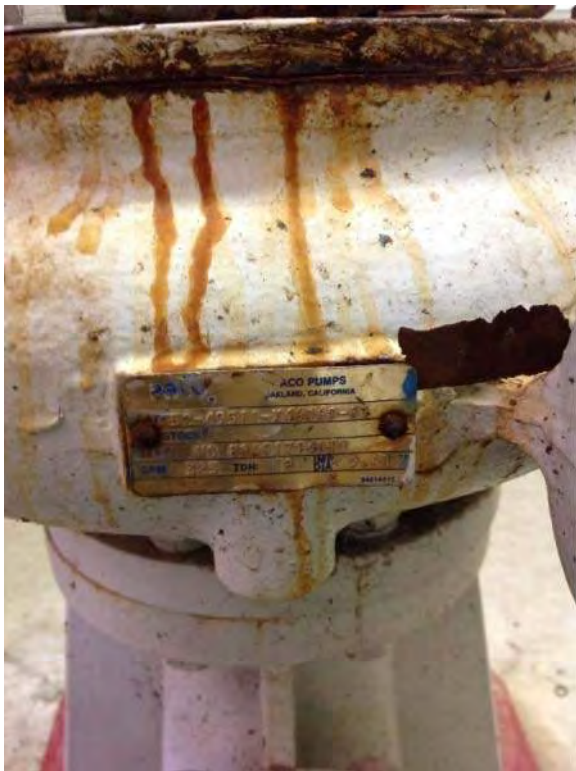
Pump 1 showing signs of aging on exterior

- Pump operating below the pump curve and at a lower head condition, most likely the result of wet end wear and differing head conditions from the original design. With limited remaining life, the pump should be considered for replacement.

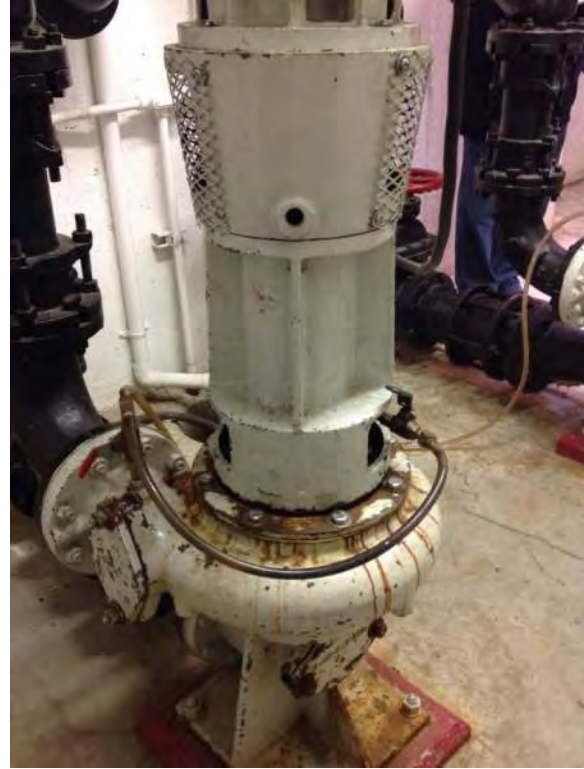
Pump and motor #2

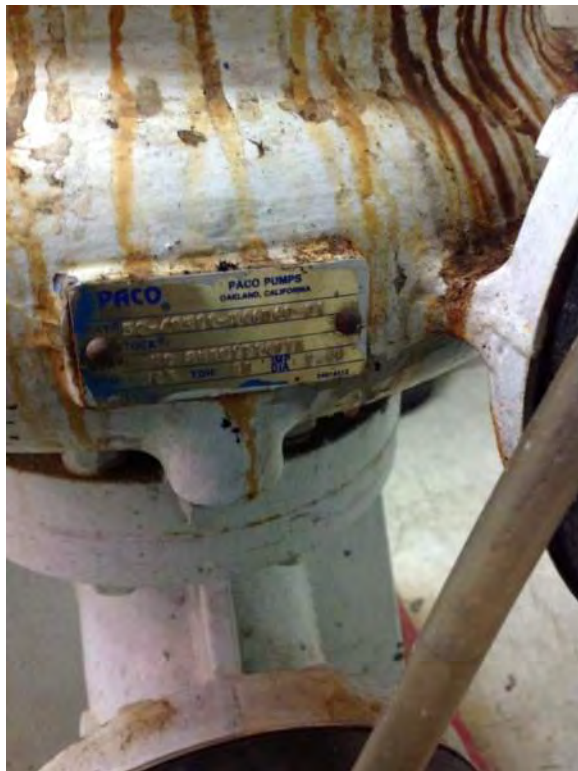
Pump 2 showing signs of aging on exterior

- Pump operating below the pump curve and at a lower head condition, most likely the result of wet end wear and differing head conditions from the original design. With limited remaining life, the pump should be considered for replacement.

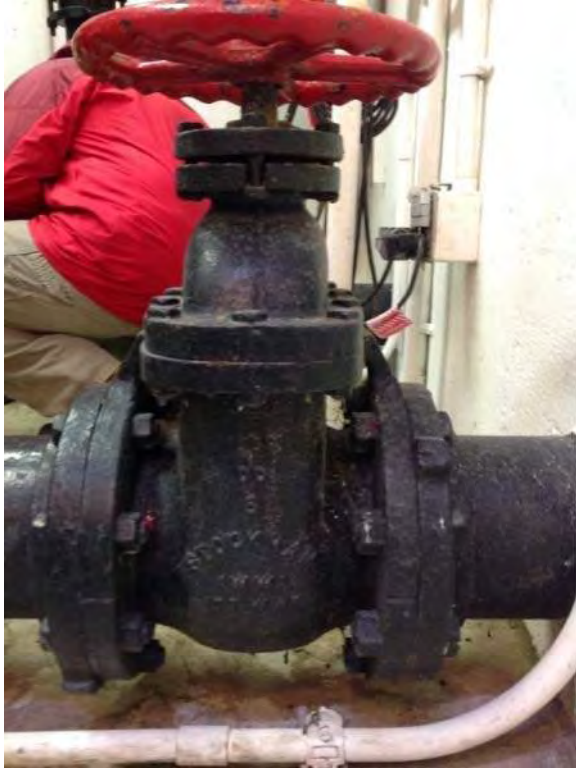
Gate valve isolation for suction piping

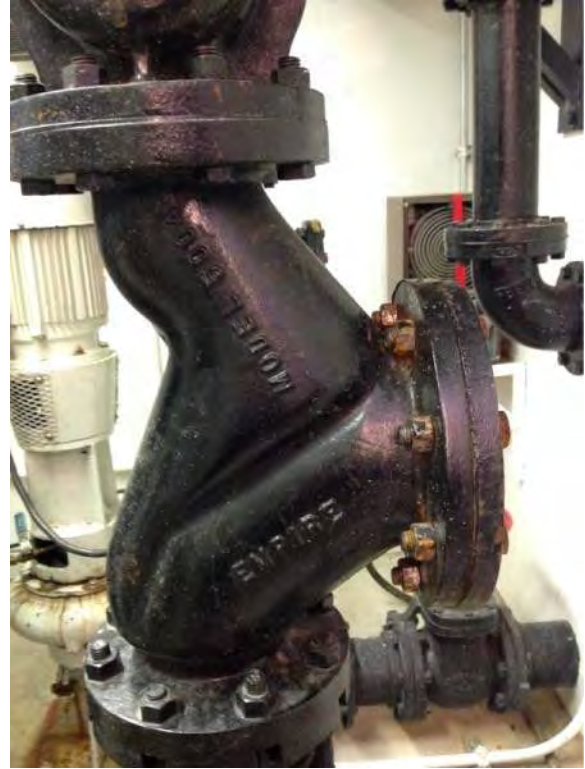
Ball check valve vertical installation on discharge piping

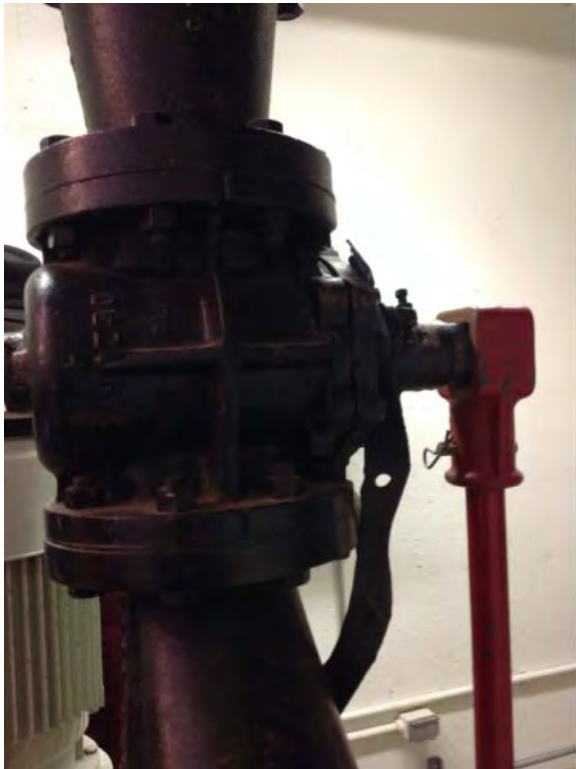
Plug valve on discharge piping

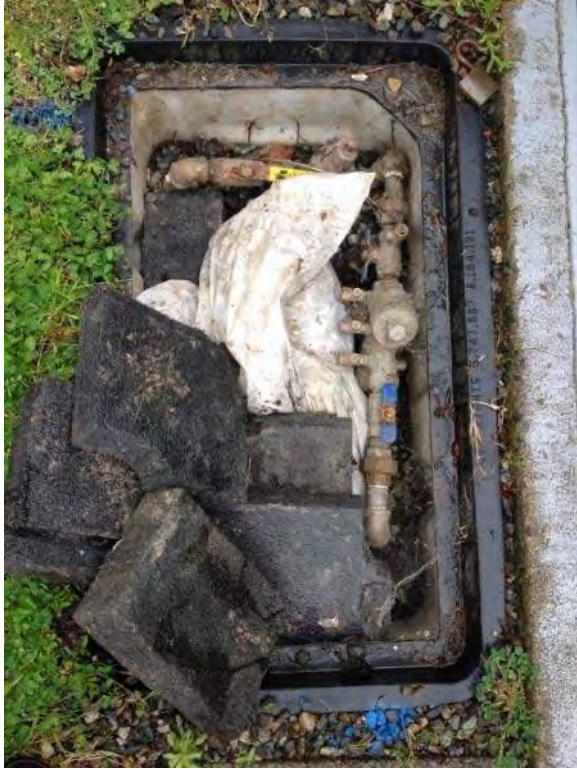
Backflow preventer assembly, below grade

- Backflow assembly adjacent to dry well below grade, no drain to daylight – does not meet code for installation

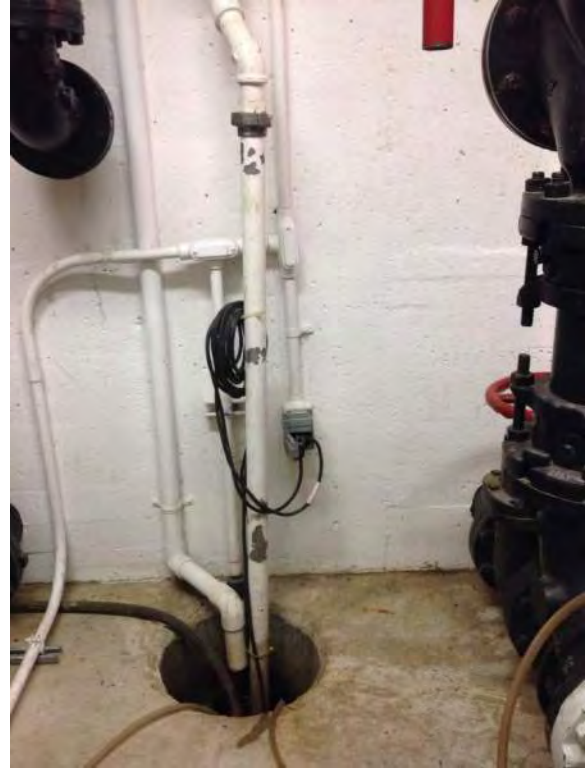
4" drain off header to wet well, near sump

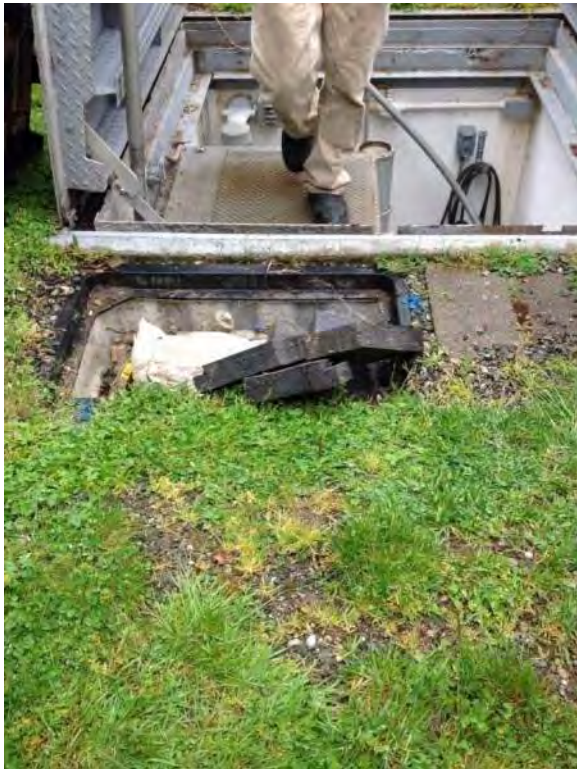
Backflow preventer assembly adjacent to dry pit

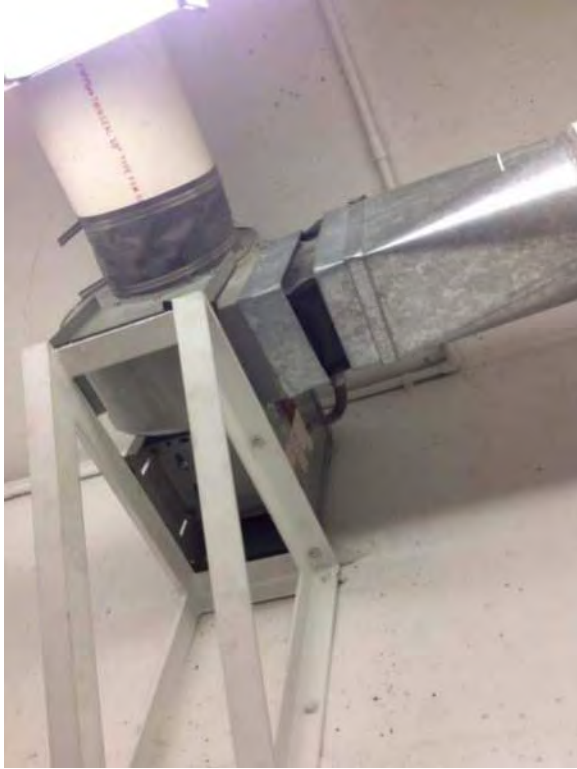
Supply fan located near ceiling of dry pit

Location	Ceiling of dry pit
Fan type	Centrifugal
Airflow rate	820 CFM @ 1" SP*

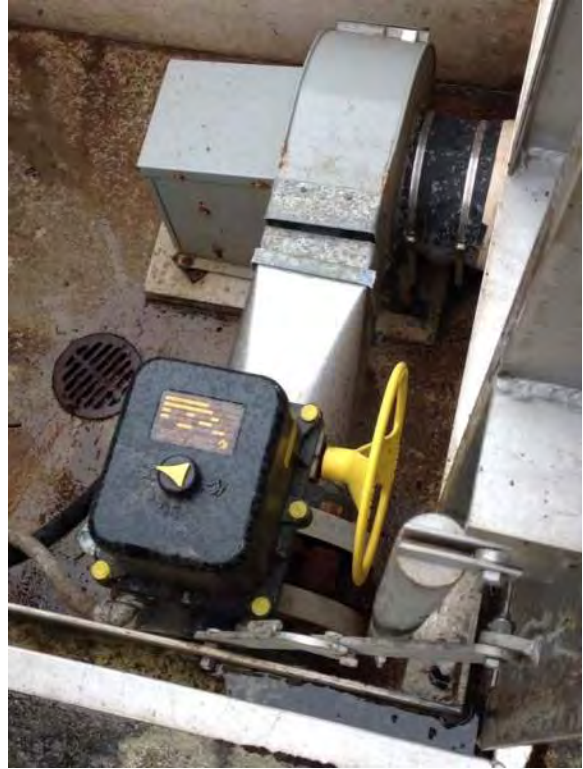
Wet well supply fan located in wet well blower vault

Location	Located in adjacent wet well blower vault
Fan type	Centrifugal
Airflow rate	560 CFM @ 0.5" SP*

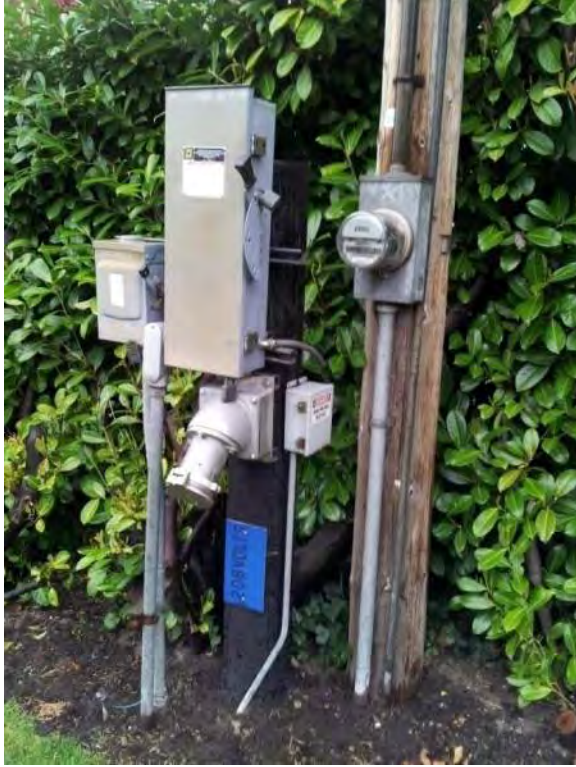
Utility service and generator receptacle

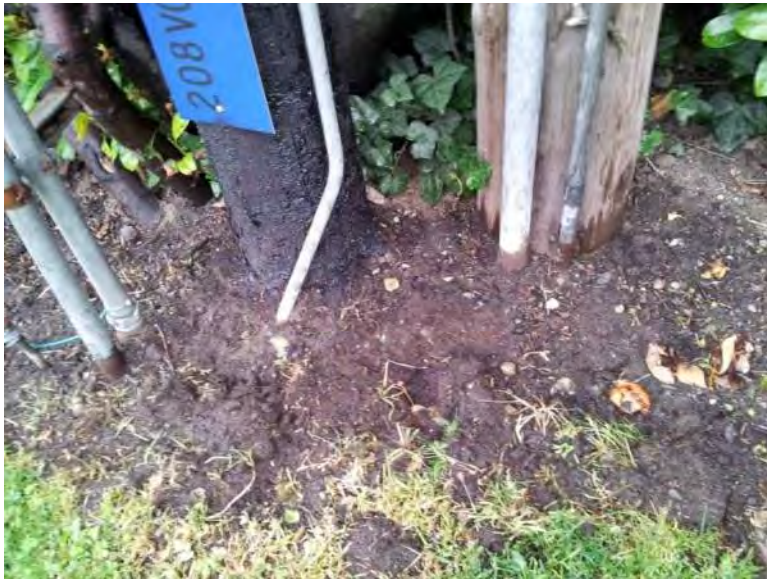
GRC conduit corroded at grade

Condition Rating 3 – Galvanized rigid conduit for the meter base is corroded at grade

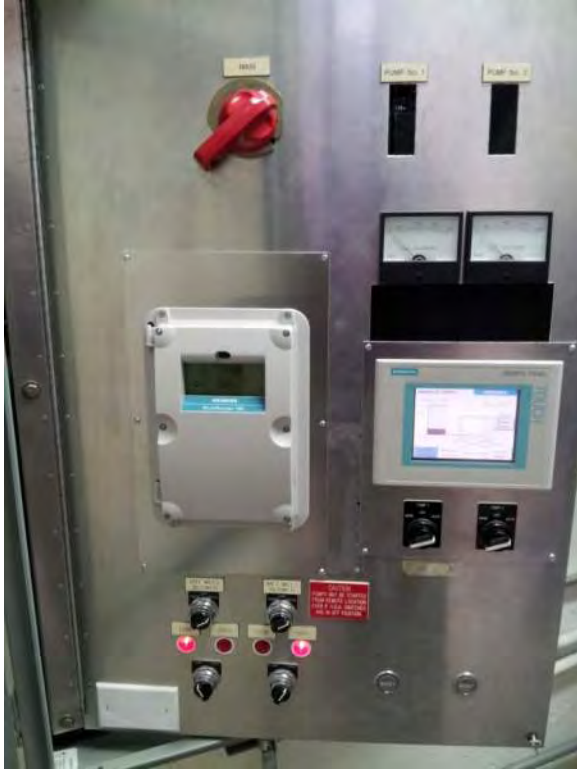
Starters located in dry pit, appears to be in good condition

Condition Rating 1 – Both GE and Cutler Hammer starters are in good condition

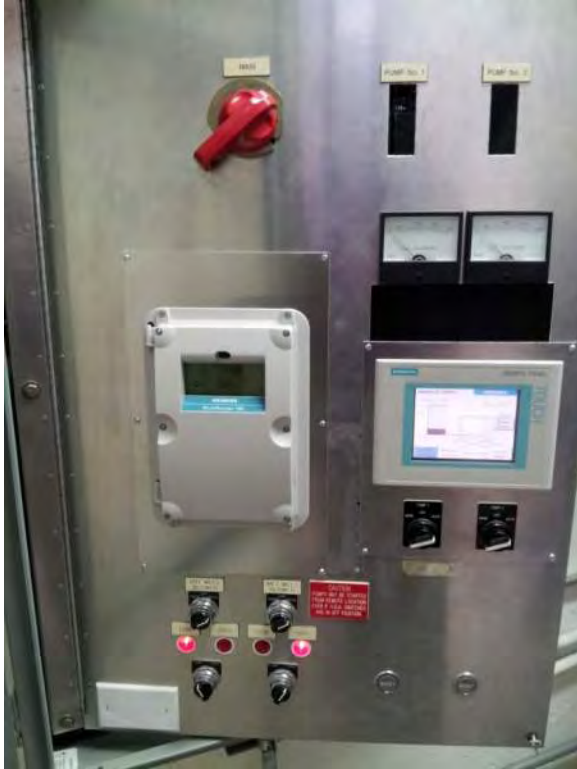
Telemetry control panel with operator interface, appears to be in good condition

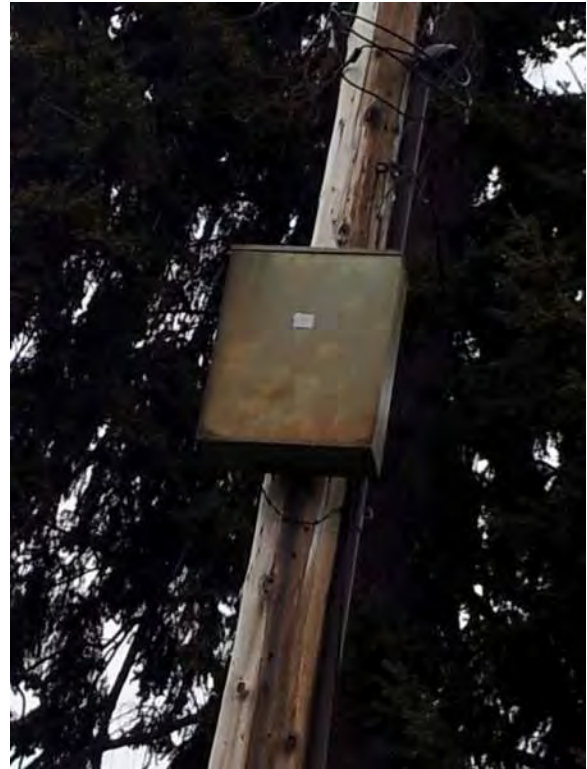
Rusted telephone network interface termination box, located overhead at top Qwest pole

- Control panel located in dry pit, power panel was not opened upon site visit
- Rust along all seams of telephone network interface termination box, wires poorly configured, not accessible

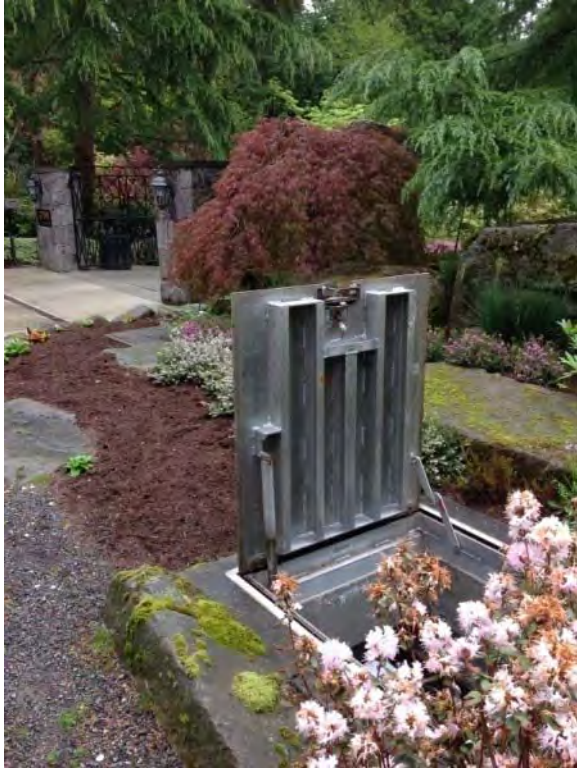
Generator vault on side of road

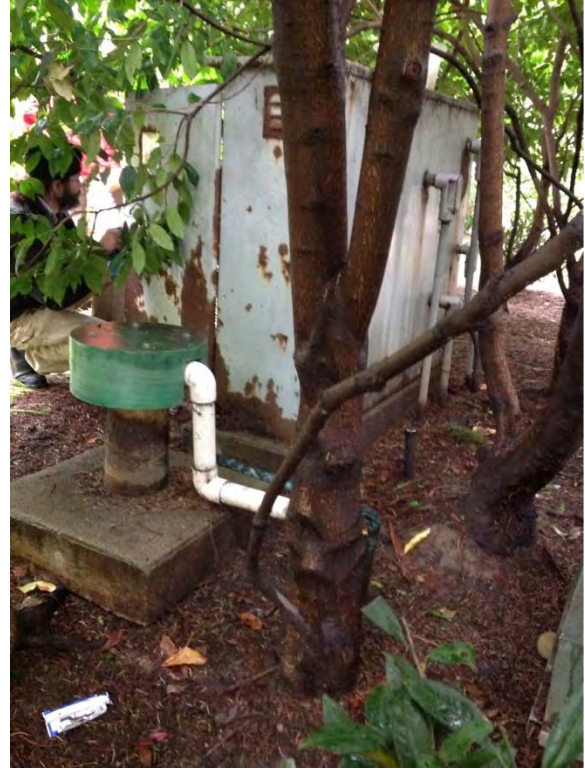
Service cabinet overgrown with bushes

- Located in the backyard of a private lot, adjacent to the lakefront
- Overall hatch over wet well and dry pit constructed when backyard elevation raised approximately 2 feet
- Service cabinet overgrown with bushes near front of road
- Difficult access to blower vault due to bushes around hatch

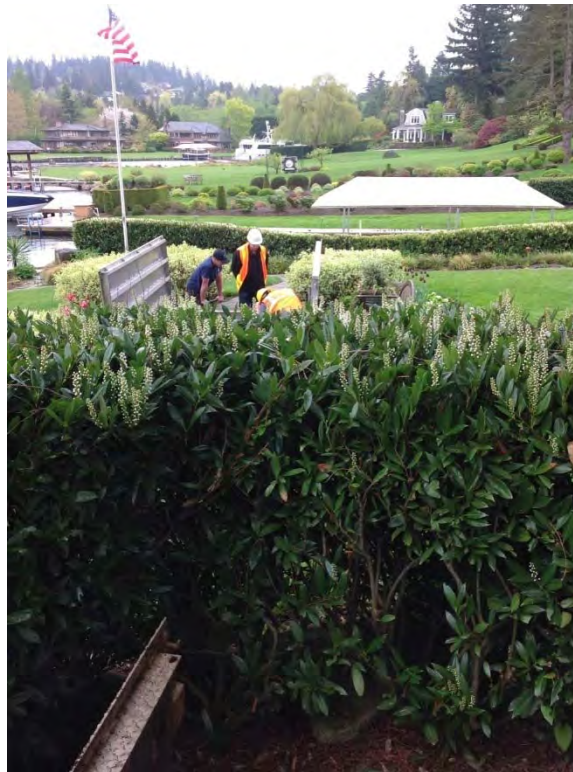
Overall hatch to wet well and dry pit located in yard

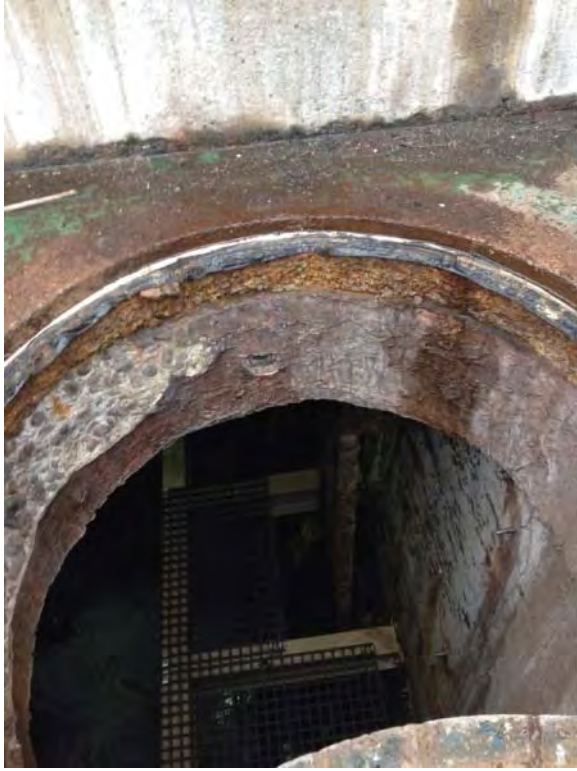
Interior of wet well, some exposed aggregate

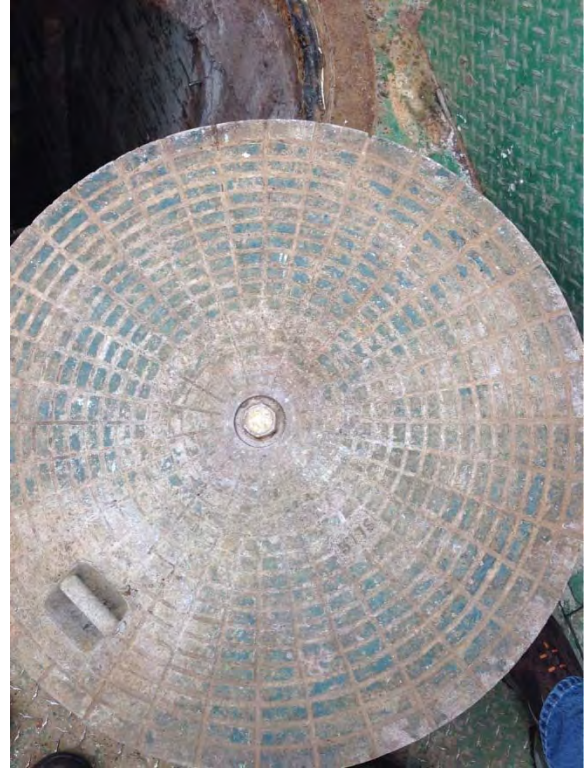
Wet well manhole lid

- Upon failure of locking access lid, alternate lid will need to be purchased/fabricated or entire top of wet well will need to be replaced with new concrete top and hatch

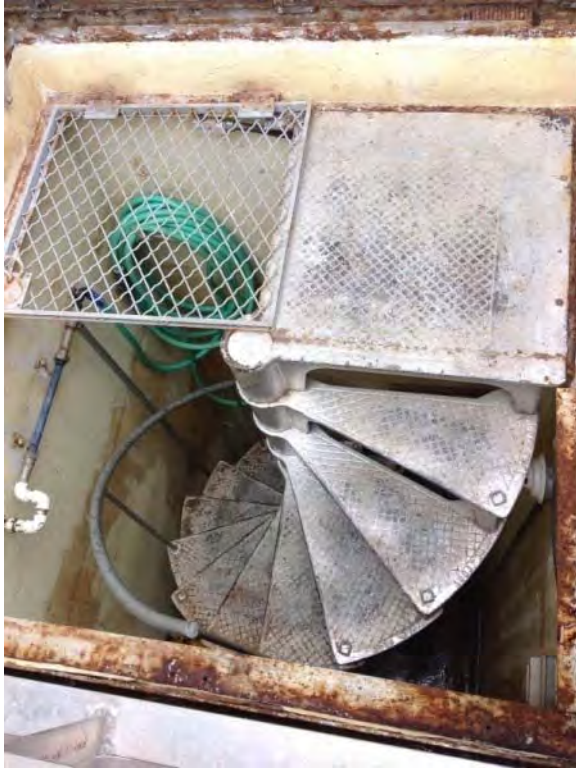
Spiral staircase to dry pit, metal grating used to step onto main platform

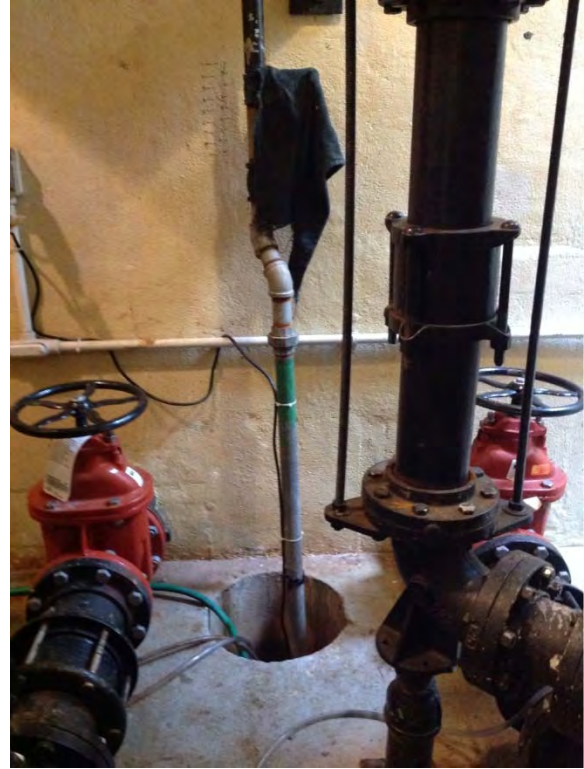
Sump pump in dry pit

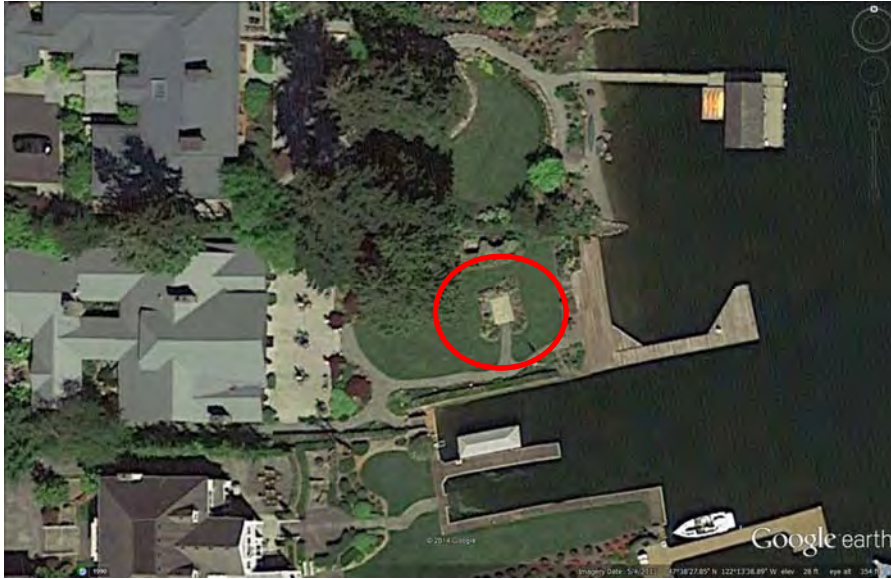
Overall aesthetic top cover vault located in yard

- Added a few years ago when property elevation was raised approximately 2 feet – no stairs/steps down to original lift station top elevation from ground surface

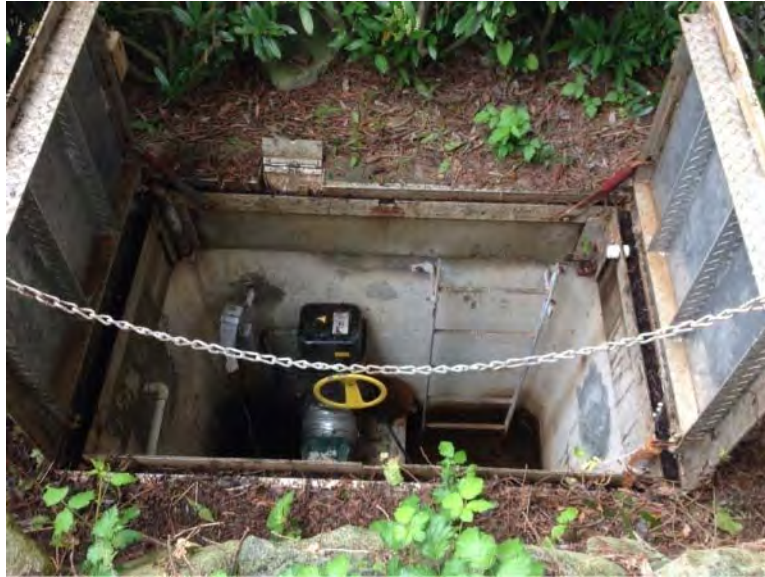
Fall protection on one side of wet well blower vault
