Lake Washington Wastewater Lake Line Management Plan

FINAL / July 2024

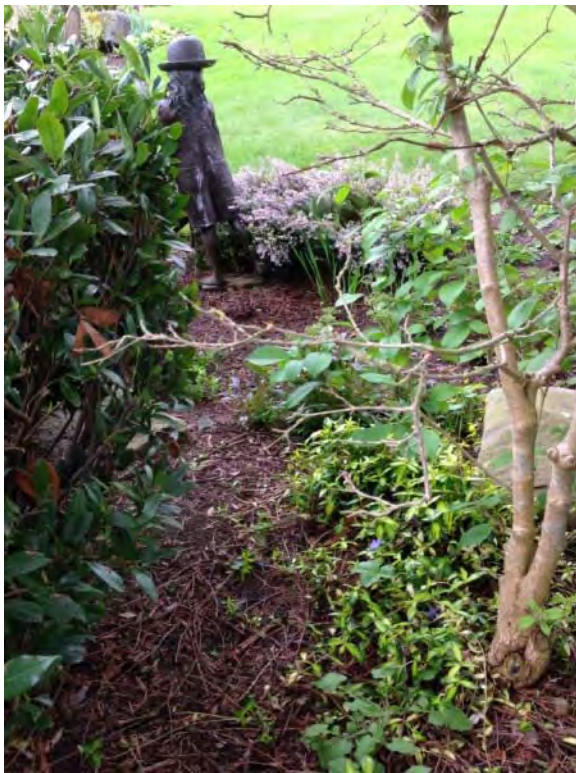
Path used to access wet well blower vault

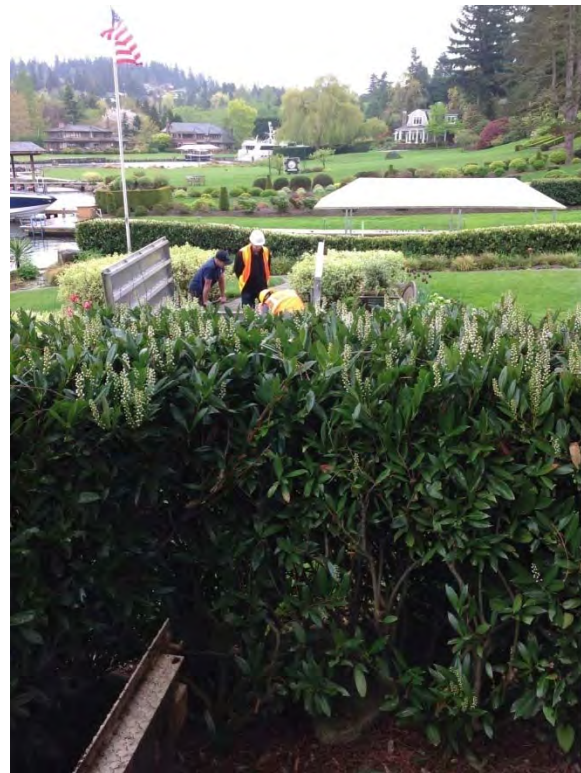
Overall aesthetic top cover vault located in yard

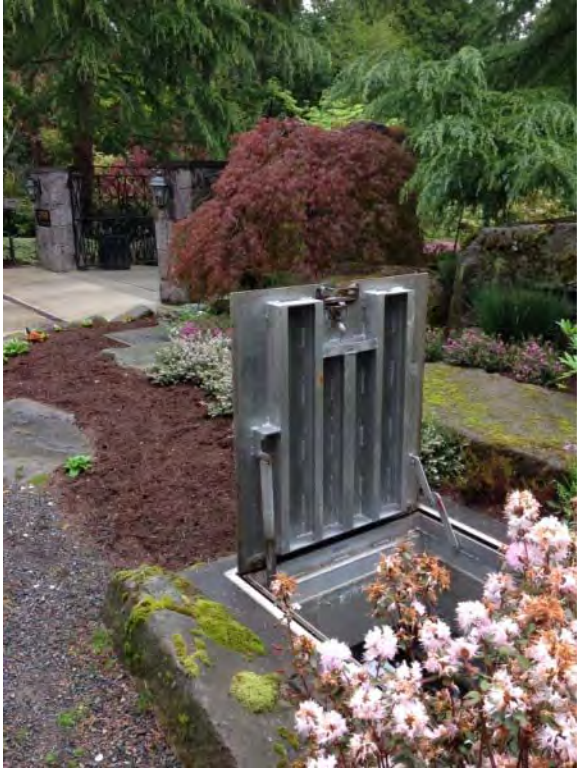
Generator vault located adjacent to street

- Located adjacent to roadway near service cabinet
- Vault drain and cooling water return are piped directly to drain line – no atmospheric connection to wet well

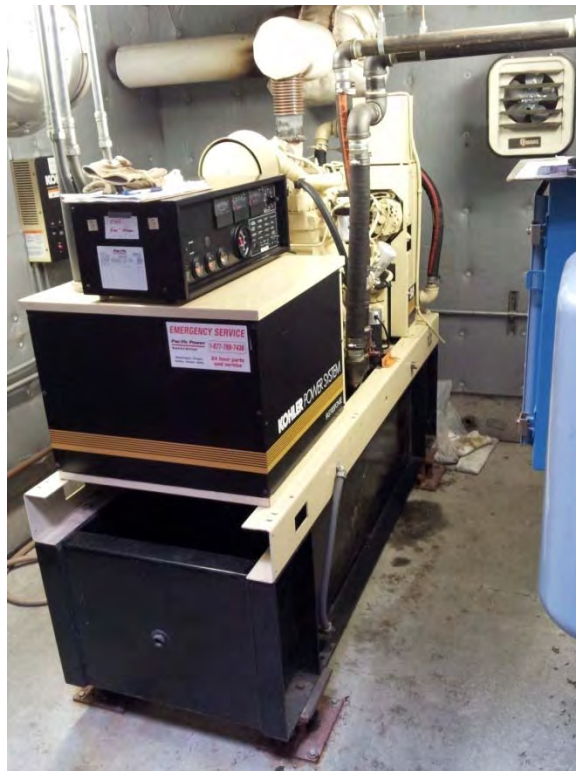
Interior of generator vault

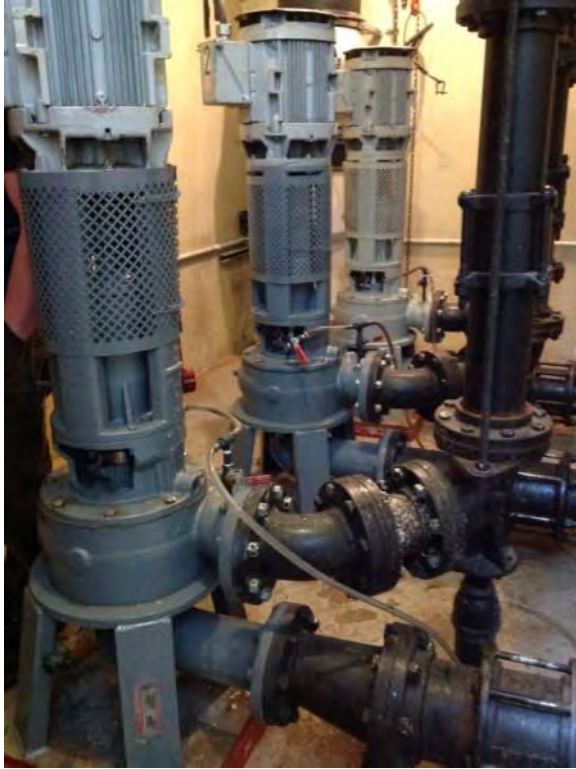
Triplex configuration

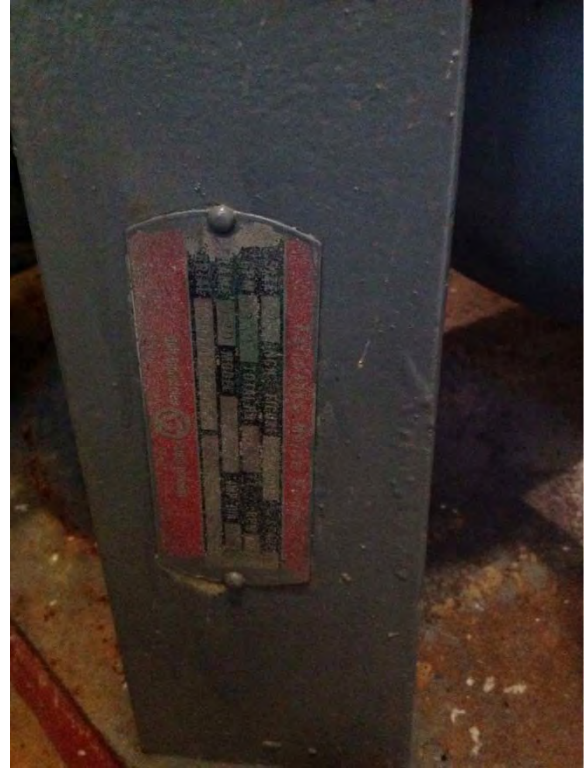
Pump name plate, painted over, difficult to read information, typical of all three pumps

- Painting over pump name plate made it difficult/impossible to read information for all three pumps
- Hoisting rail is not marked with load capacity, as required by code
- Replaced impeller and volute in 2013
- Reported loss of pump redundancy

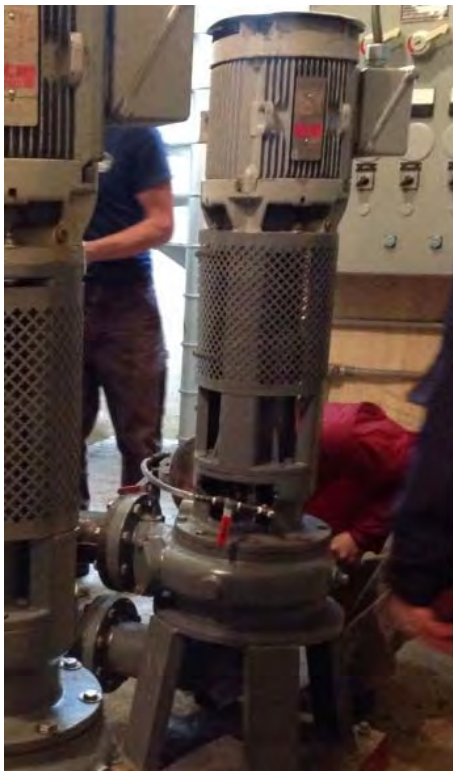
Pump and motor #1

Pump style	Vertical, centrifugal, non-clog
Make	Fairbanks Morse
Model	B5442CLV-T20*
Serial No.	K3P10567650-5*
Horsepower	10
Voltage/phase	230/460/3
Date of installation	1988
Design Conditions	320 gpm @ 52.5 feet TDH
Able to isolate pump?	Yes
Ability to access/remove pump from station	Yes, trolley chain hoist and rail

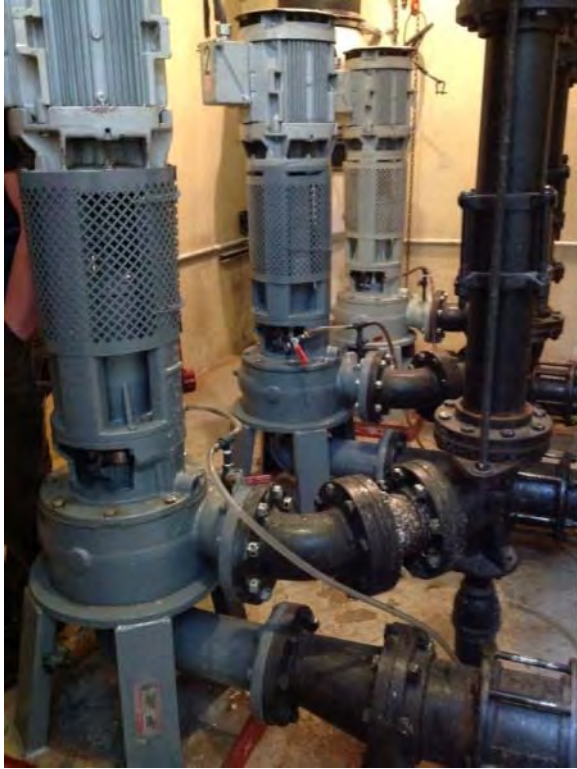
Triplex configuration

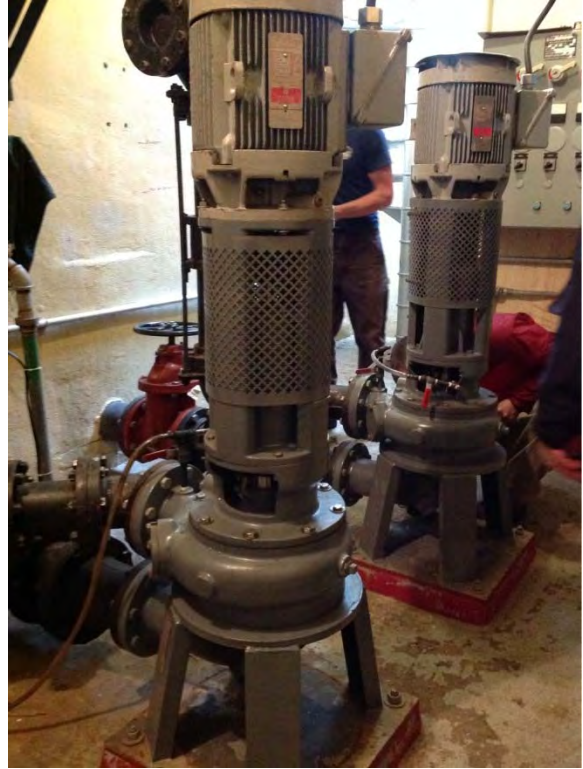
Pump and motor #2

Pump style	Vertical, centrifugal, non-clog
Make	Fairbanks Morse
Model	B5442CLV-T20*
Serial No.	K3P10567650-5*
Horsepower	10
Voltage/phase	230/460/3
Date of installation	1988
Design Conditions	320 gpm @ 52.5 feet TDH
Able to isolate pump?	Yes
Ability to access/remove pump from station	Yes, trolley chain hoist and rail

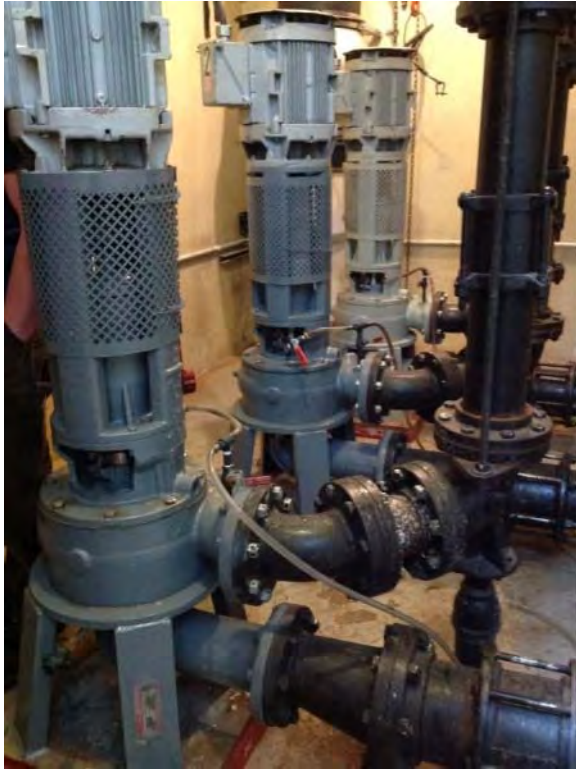
Triplex configuration

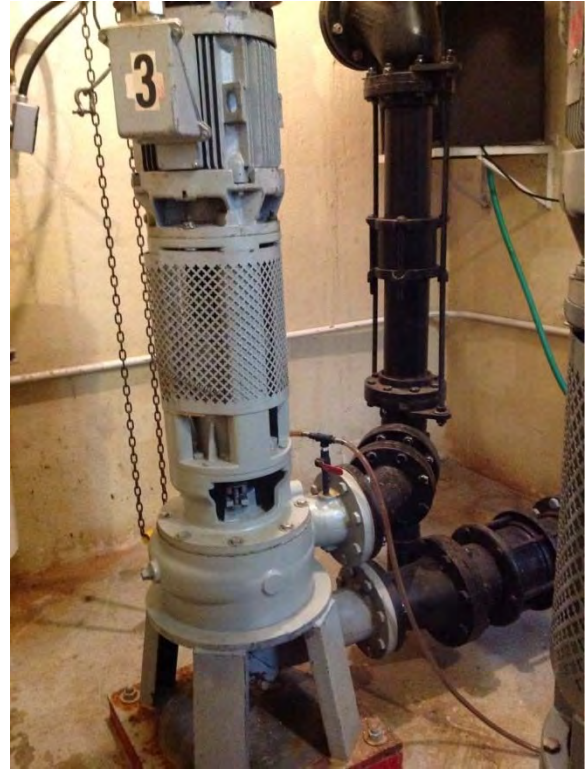
Pump and motor #3

Pump style	Vertical, centrifugal, non-clog
Make	Fairbanks Morse
Model	B5442CLV-T20*
Serial No.	K3P10567650-5*
Horsepower	10
Voltage/phase	230/460/3
Date of installation	1988
Design Conditions	320 gpm @ 52.5 feet TDH
Able to isolate pump?	Yes
Ability to access/remove pump from station	Yes, trolley chain hoist and rail

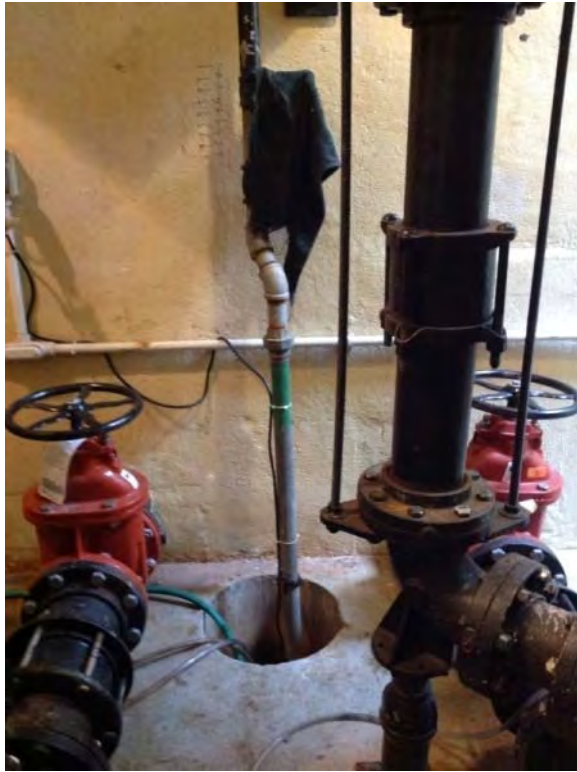
Gate valve with hand wheel on suction piping

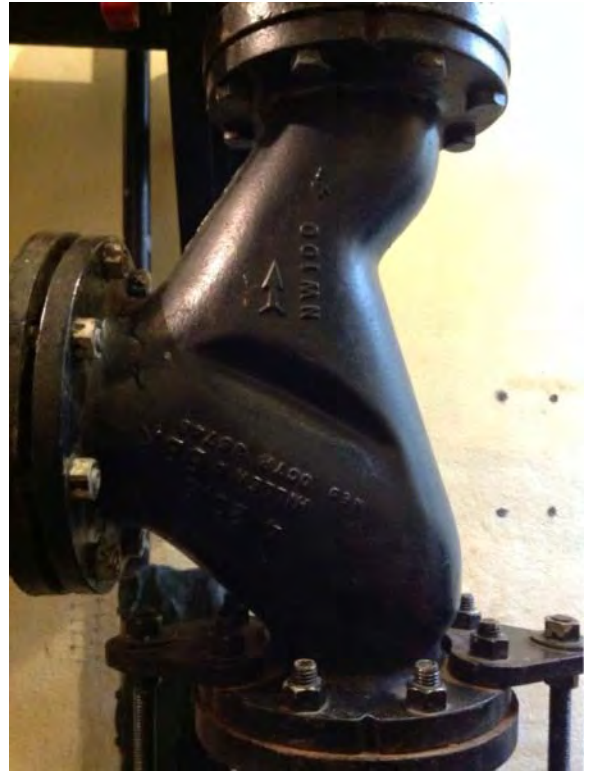
Discharge ball check valve, installed vertically

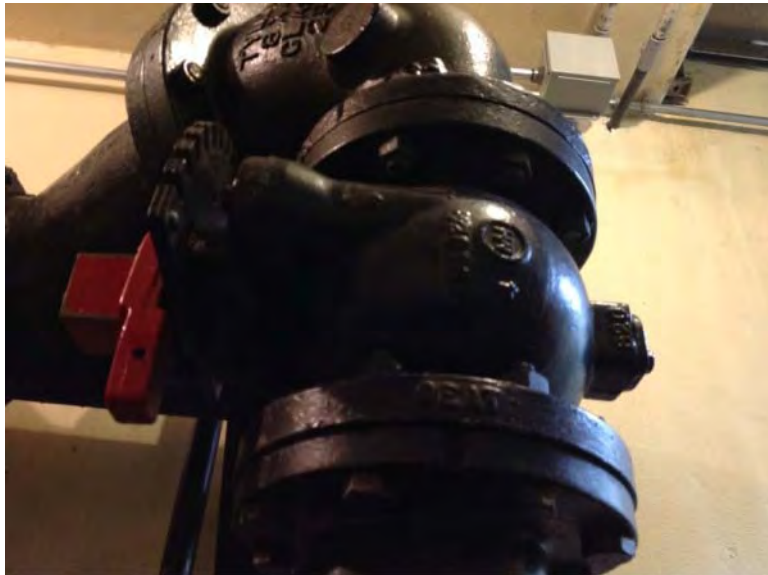
Discharge plug valve

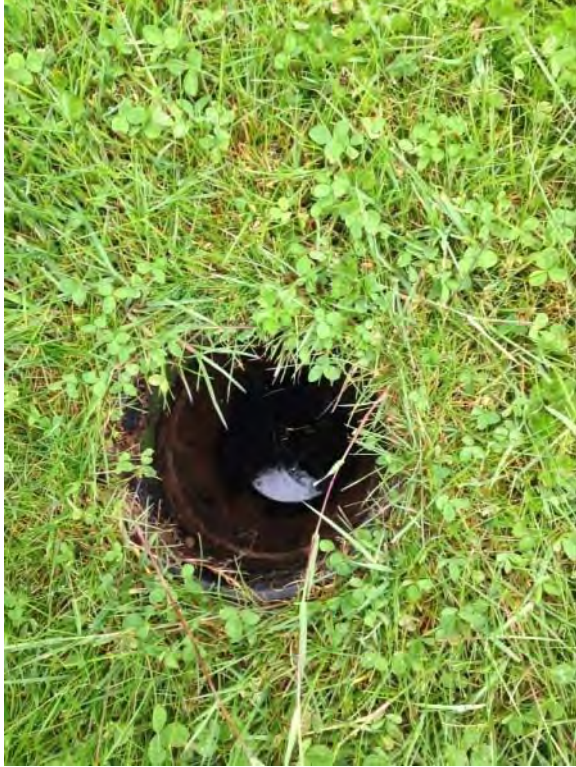
Force main isolation valve not accessible

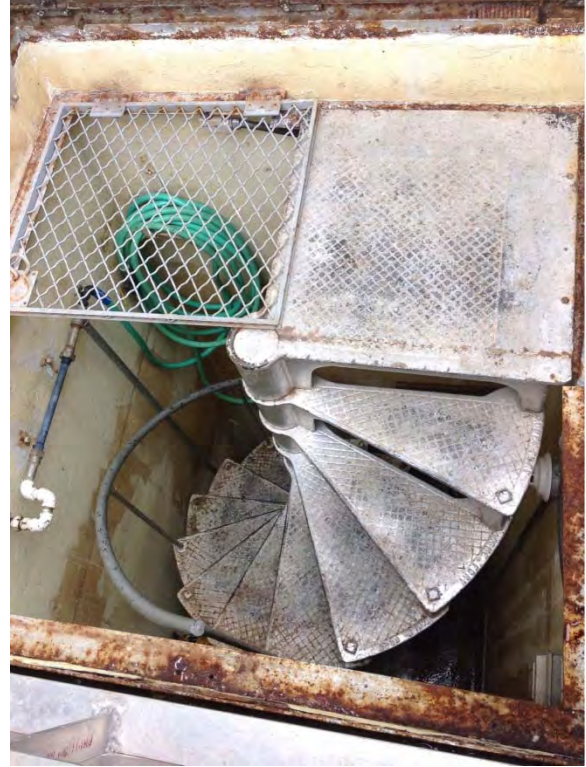
Washdown water supply located in dry pit

Supply	Domestic/Metered
Accessed	Hose bib in dry pit
Backflow prevention assembly	¾" reduce pressure backflow device
Enclosure/Freeze protection	In generator vault/Heat tape

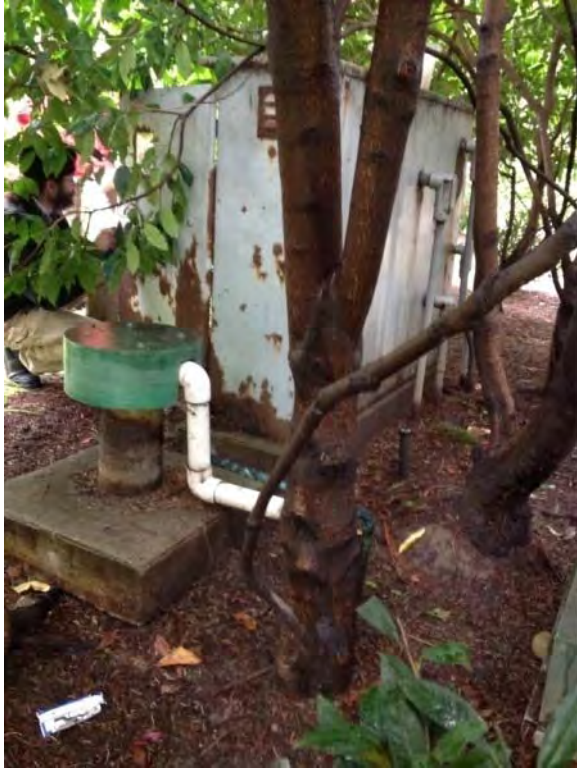
Wet well vent approximately 18" from service cabinet

- Service cabinet is in poor condition and rusting, rehabilitation is recommended. Corrosion is likely due to close proximity with wet well vent, relocation of wet well vent recommended.

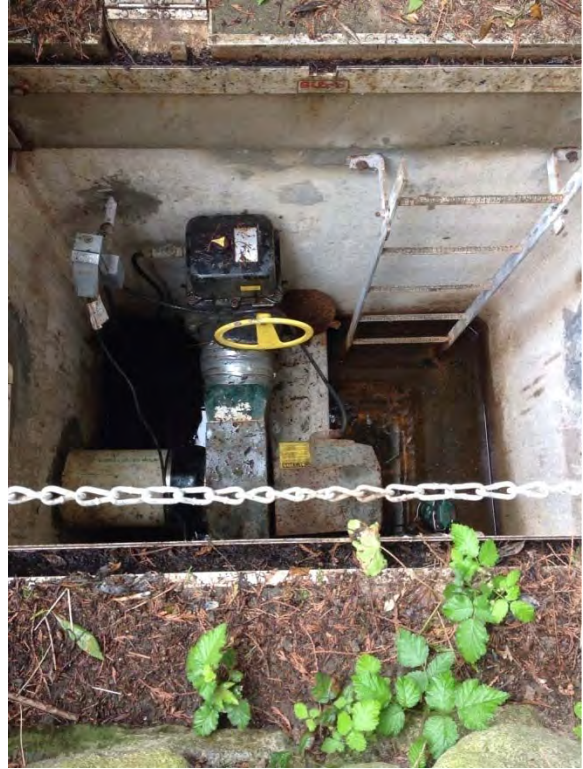
Wet well supply fan located in wet well blower vault

Location	Located in adjacent wet well blower vault
Fan type	Centrifugal
Airflow rate	975 CFM @ 0.5" SP*

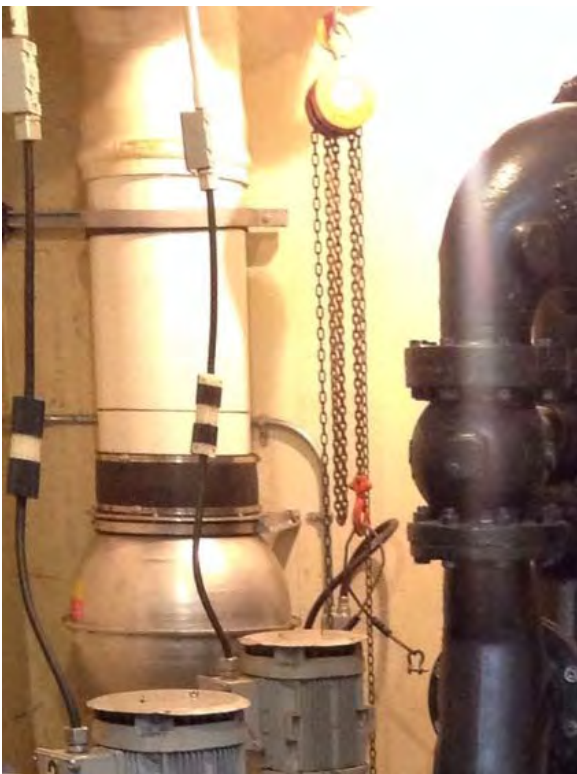
Supply fan located in corner of dry pit

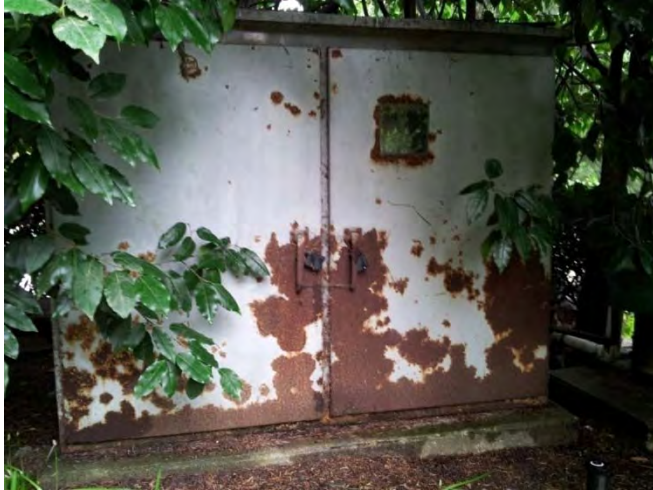
Rusted service cabinet near vent

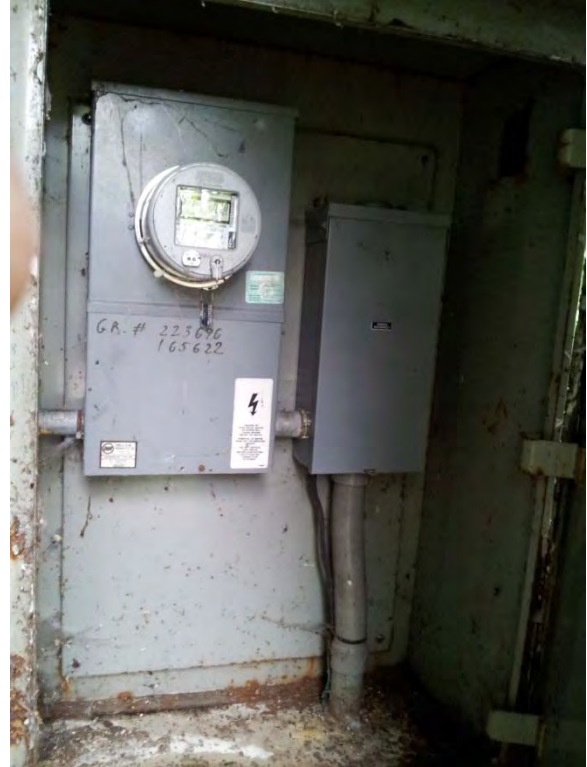
Service meter located in rusty service cabinet

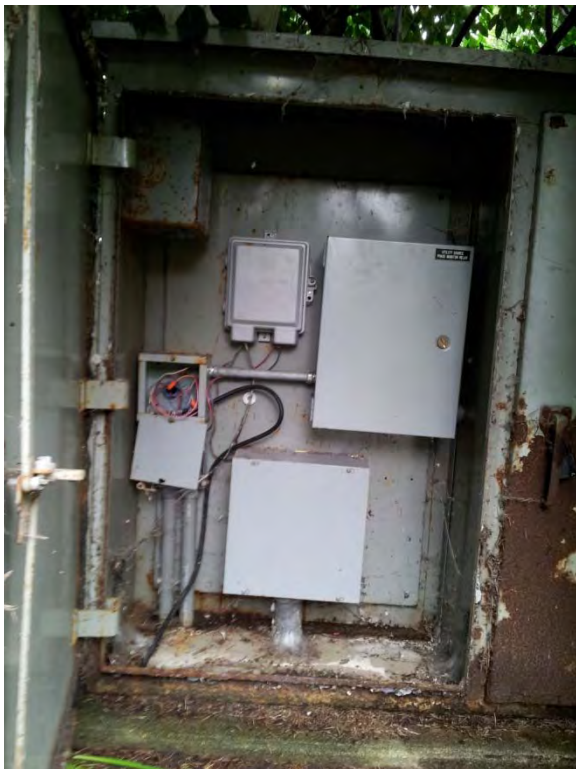
Interior of service cabinet

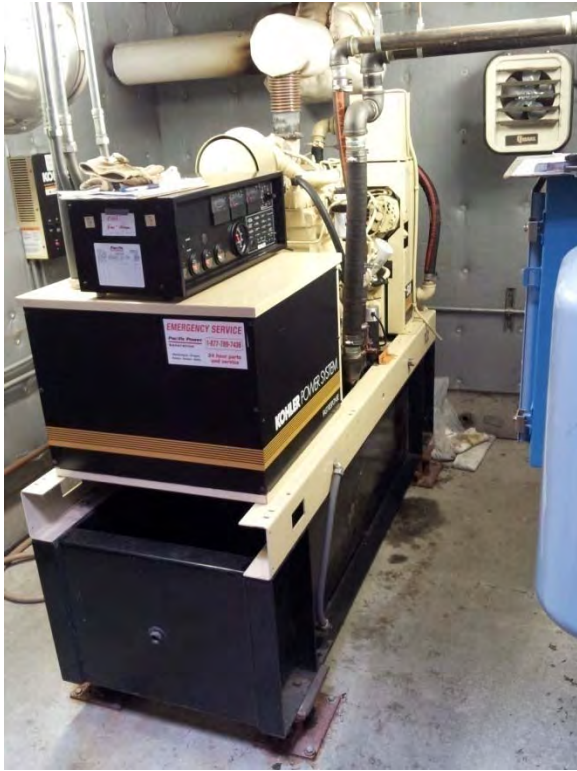
Emergency generator located in underground vault, appears to be in good condition but with decreasing useful life

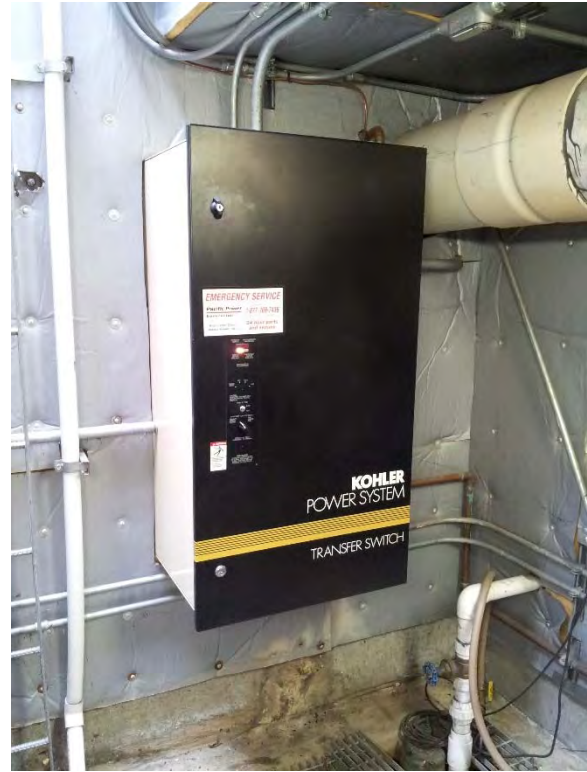
Transfer switch located in generator vault, appears to be in good condition

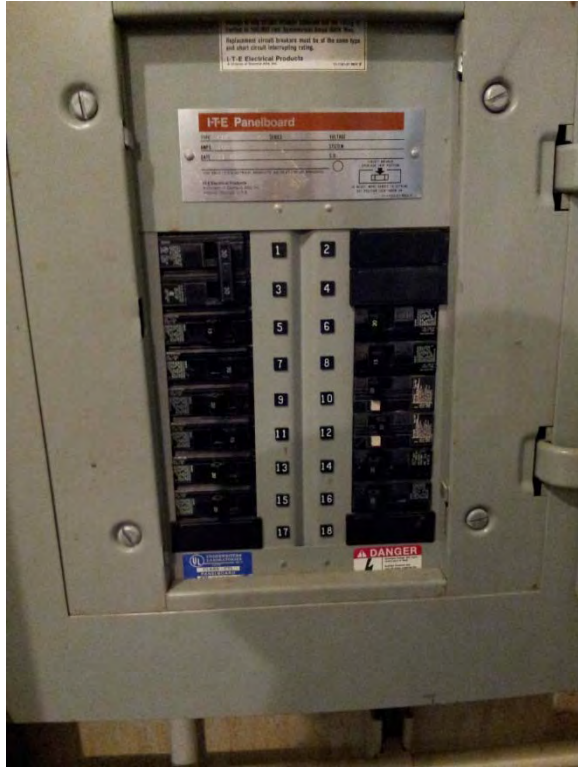
Power panel for dry pit

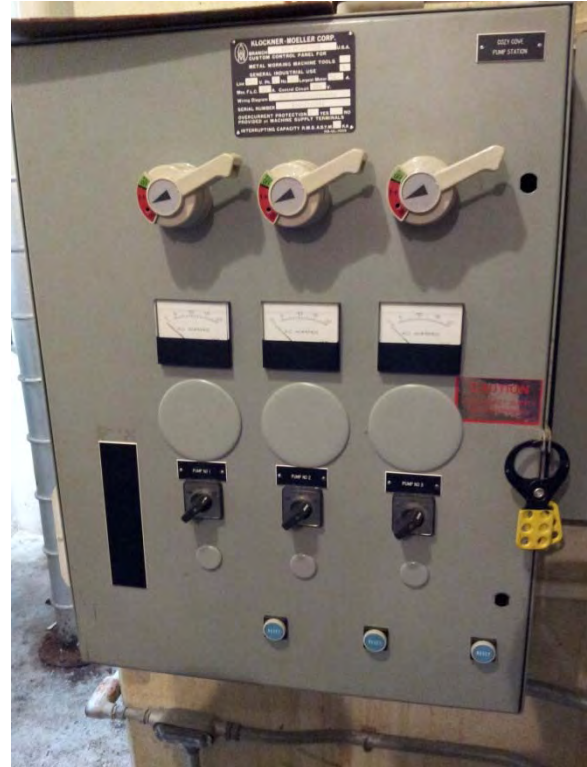
Klockner-Moeller starter and circuit breakers appear to be in good condition, but with decreasing useful life and parts are no longer made

- Klockner Moeller starters are obsolete

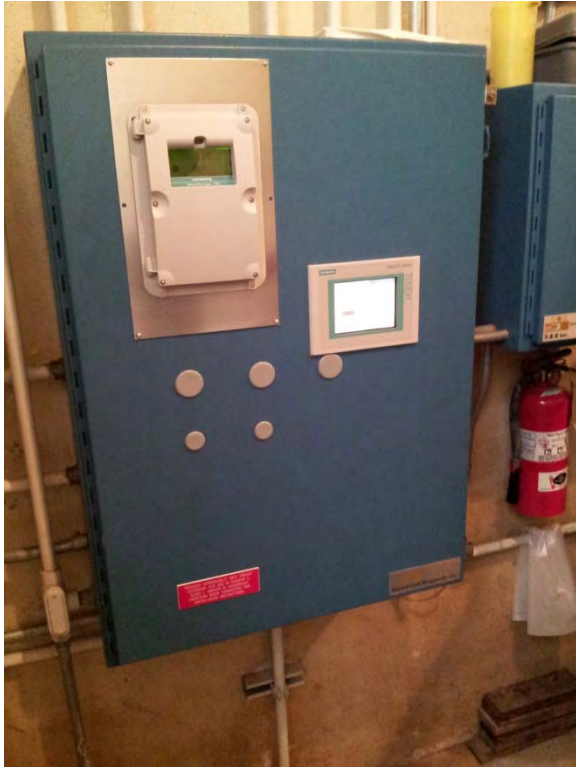
Telemetry control panel located in dry pit, appears to be in good condition

- 23” to 480 VAC pump in dry pit, clearance issue
- 20” to 480 VAC pump communication box, clearance issue
- 3’-3” to 480 VAC pump communication box

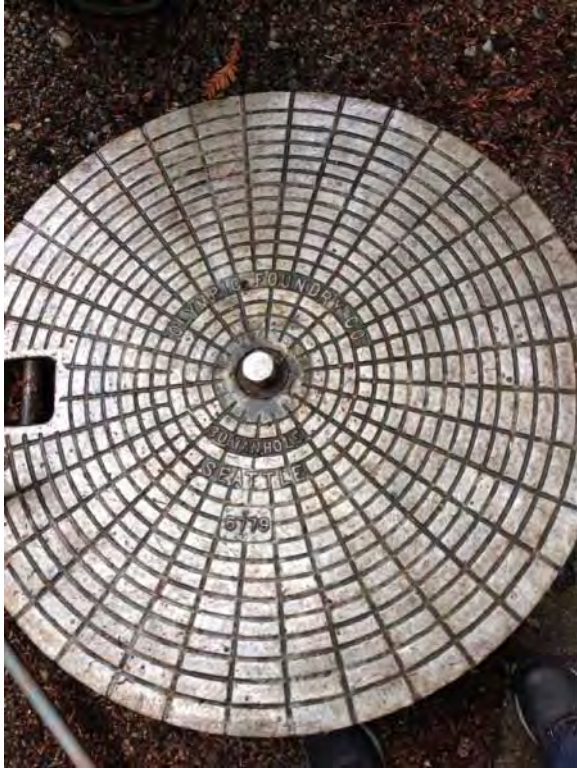
Wet well manhole lid (locking)

- Upon failure of locking access lid, alternate lid will need to be purchased/fabricated or entire top of wet well will need to be replaced with new concrete top and hatch

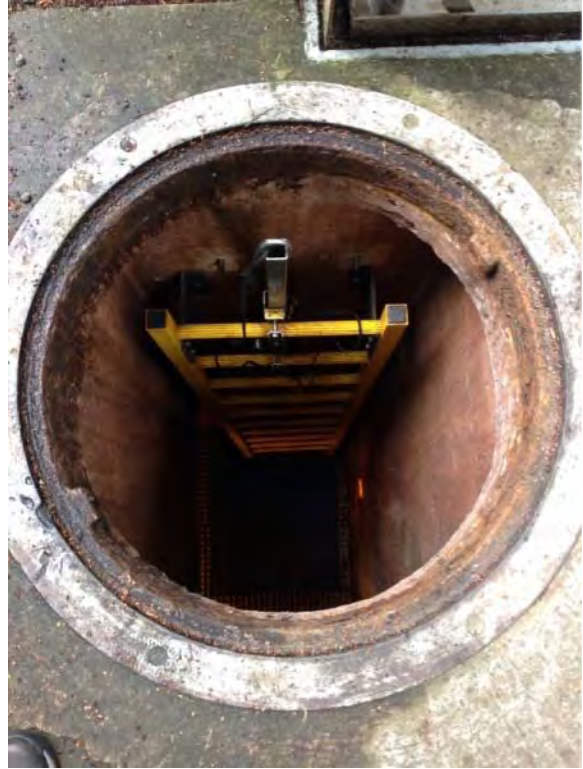
Interior of wet well

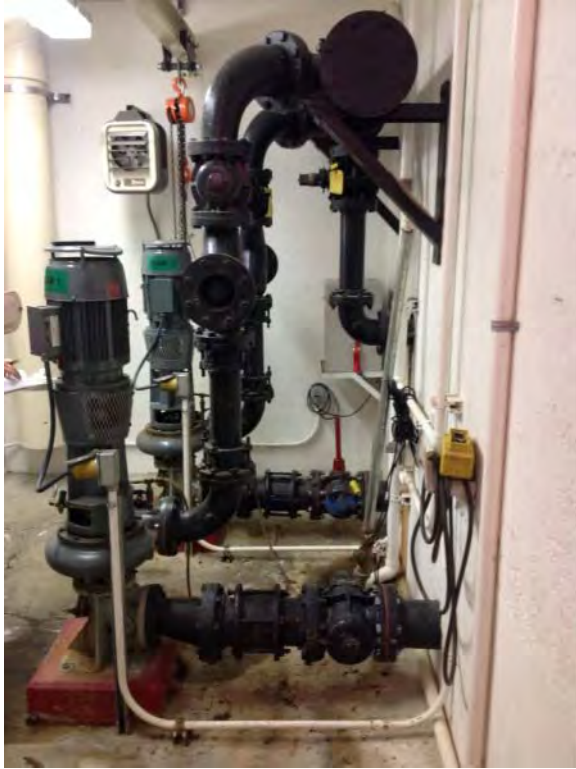
Pumps and piping in dry pit

- Wall leaking behind panel, also leaking at header drain penetration to wet well
- Some odor in dry pit – possibly attributed to inadequate washdown of facility following removal of rags from pump, or similar activity.
- No exhaust fan – required in addition to supply fan to un-classify space per NFPA 820 code

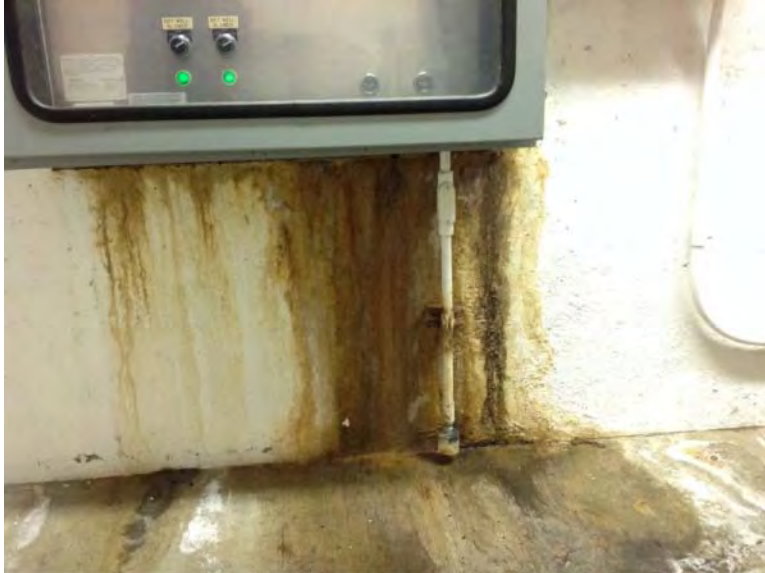
Evidence of water damage behind panel –
no new leakage observed

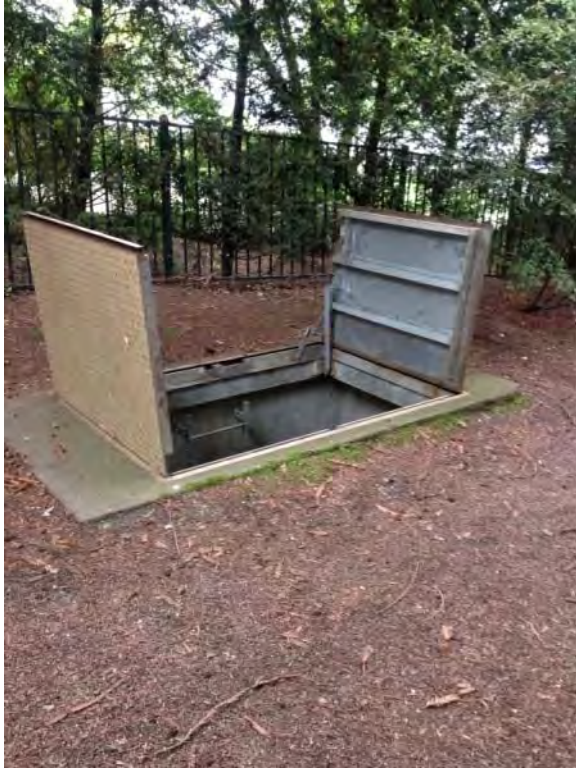
No fall protection for blower vault

In addition to addressing these deficiencies, access hatch fall protection should be installed for the dry pit and wet well blower vault to provide safety for the public and staff when the vault hatches are in the open position. Installing fall protection on the wet well access is not recommended due to its infrequent use, but when it is open for an extended period of time, temporary handrail should be used.

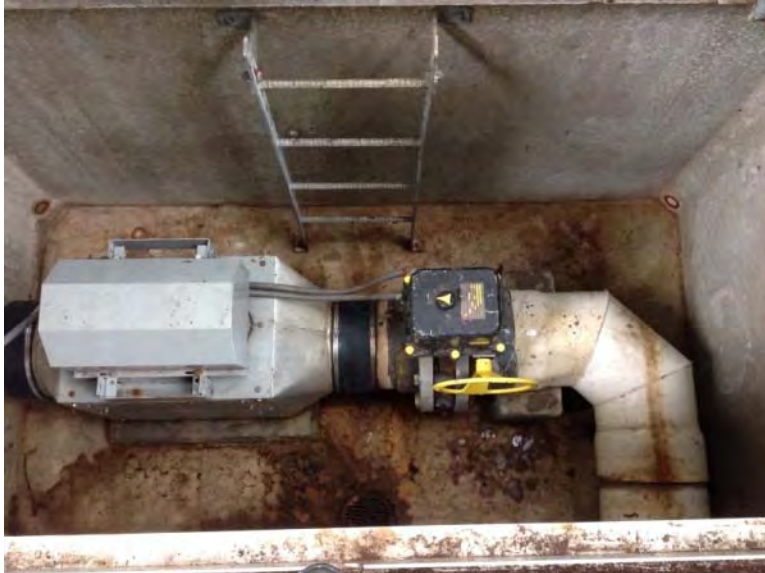
Interior of blower vault shows concrete in good shape, but ladder location presents a slightly challenging access

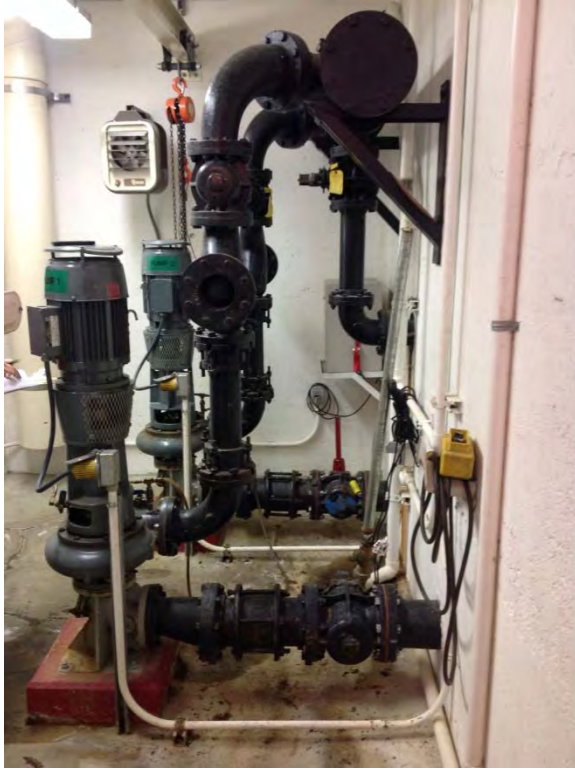
Duplex configuration (Pump 1 in foreground)

Pump style	Vertical, non-clog
Make	Paco Pumps
Model	52-49511-SX46D60-01
Serial No.	88A0224301-B
Horsepower	3
Voltage/phase	208/3
Date of installation	1989
Design Conditions	250 gpm @ 14 feet TDH
Able to isolate pump	Yes
Ability to access/remove pump from station	Trolley/hoist and rail

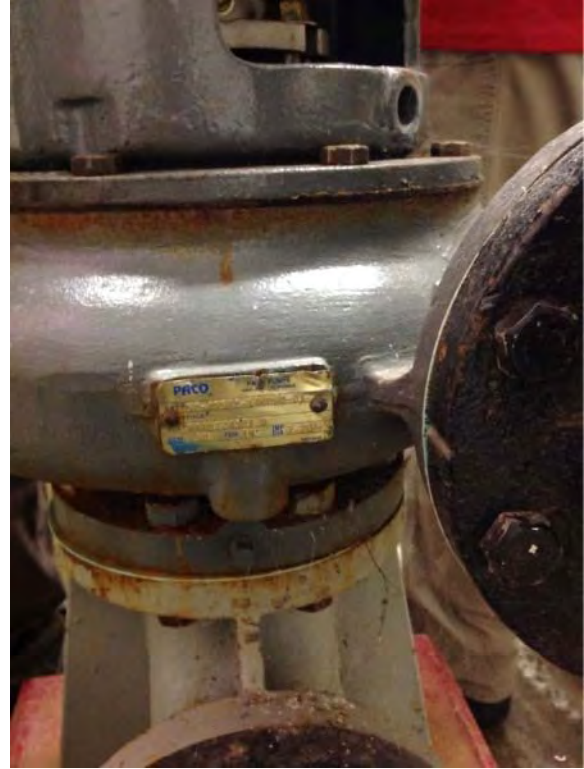
Pump 1

- Likely that the pump is operating near the end of its curve, potentially problematic from a cavitation perspective.

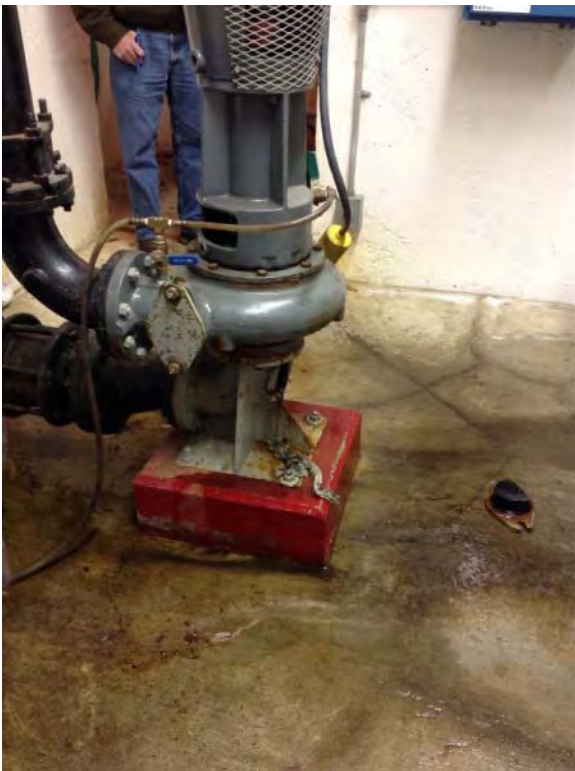
Minor rag removal from Pump 1 was performed during evaluation visit

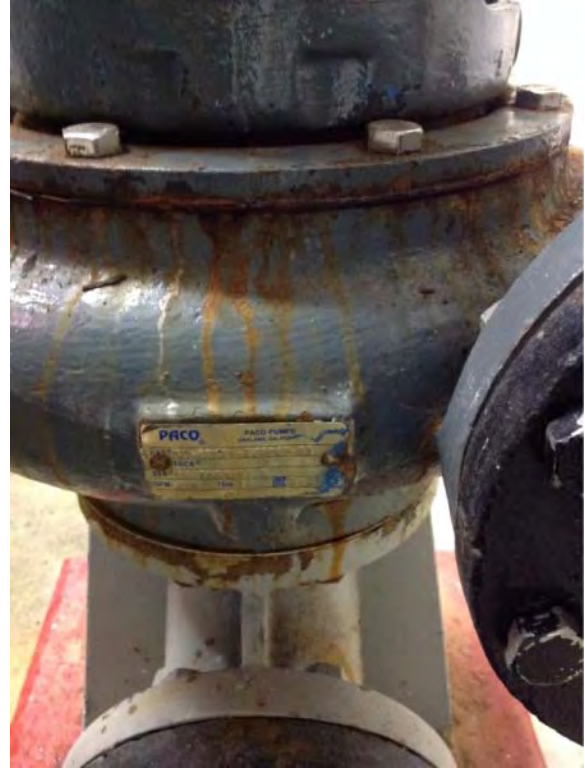
Pump 2

Pump style	Vertical, non-clog
Make	Paco Pumps
Model	52-49511-SX46D60-01
Serial No.	88A0224301-A
Date of installation	1989
Design Conditions	250 gpm @ 14 feet TDH
Able to isolate pump?	Yes
Ability to access/remove pump from station	Trolley/hoist and rail

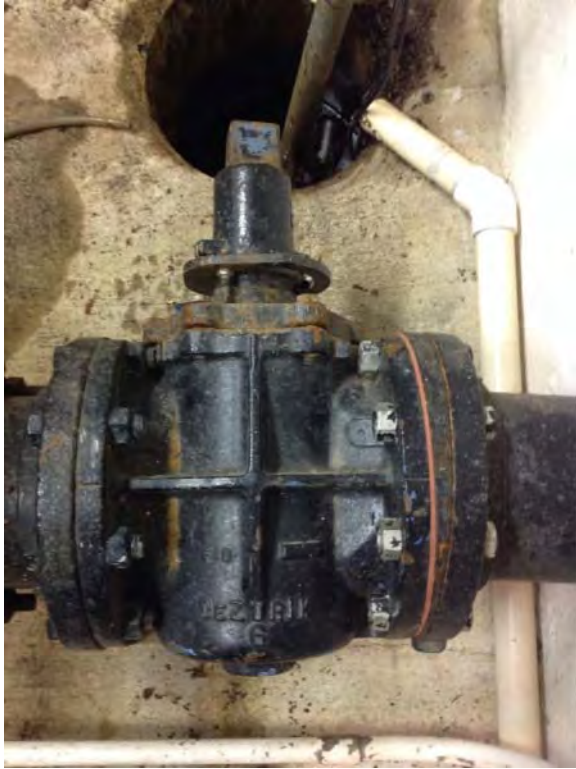
Suction plug valve – horizontal axis of rotation with seat to pump

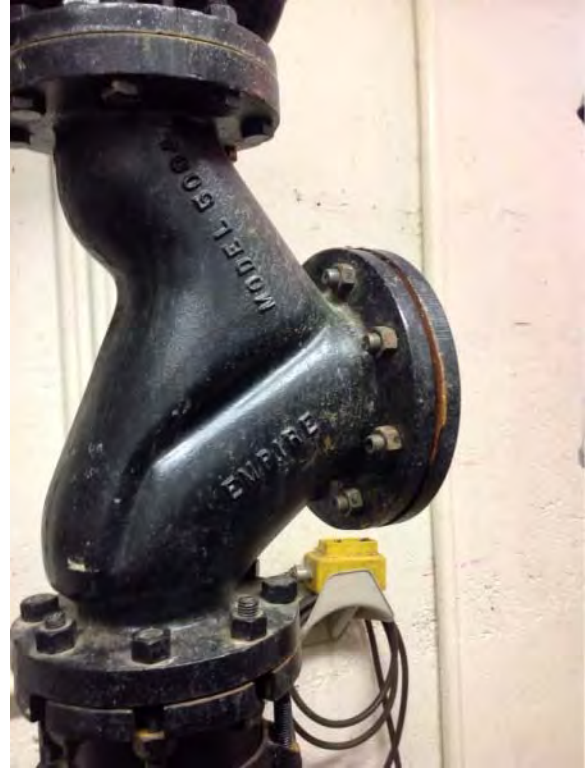
Discharge ball check valve, installed vertically

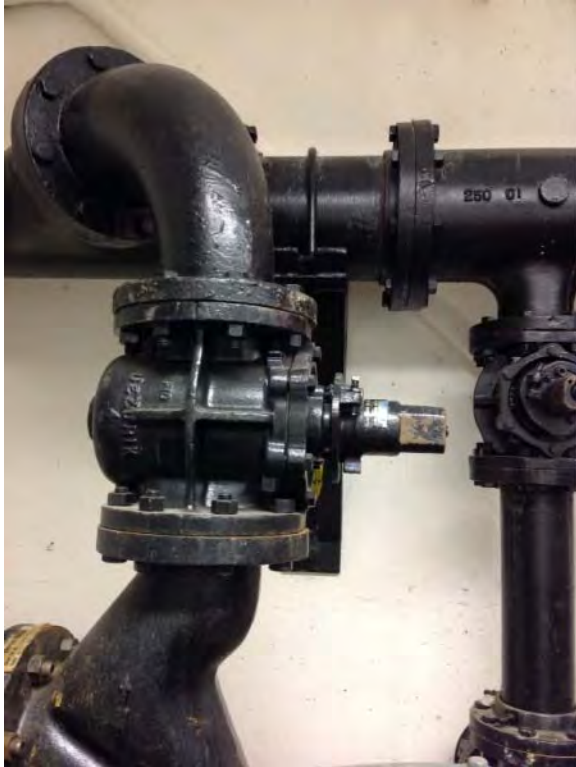
Discharge plug valve – set up to prevent debris collection in valve

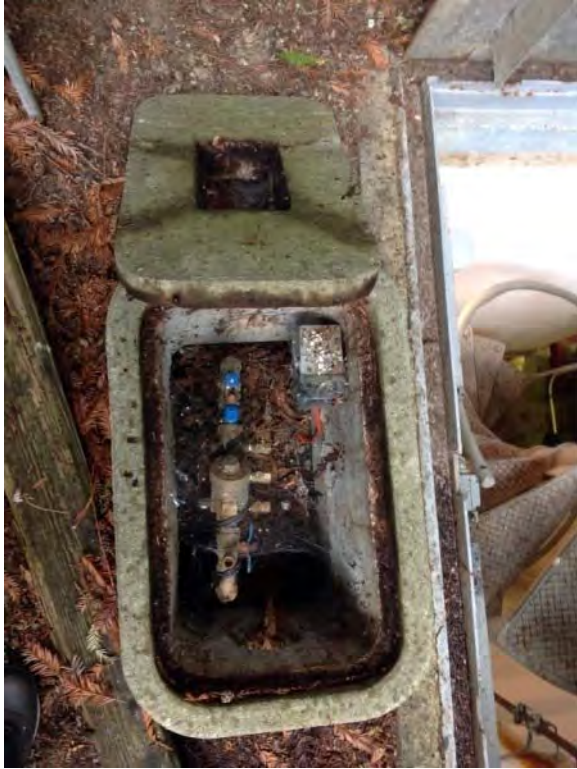
Backflow assembly adjacent to dry pit in above ground concrete meter box

- Backflow assembly adjacent to dry pit above ground in concrete meter box, drains to daylight

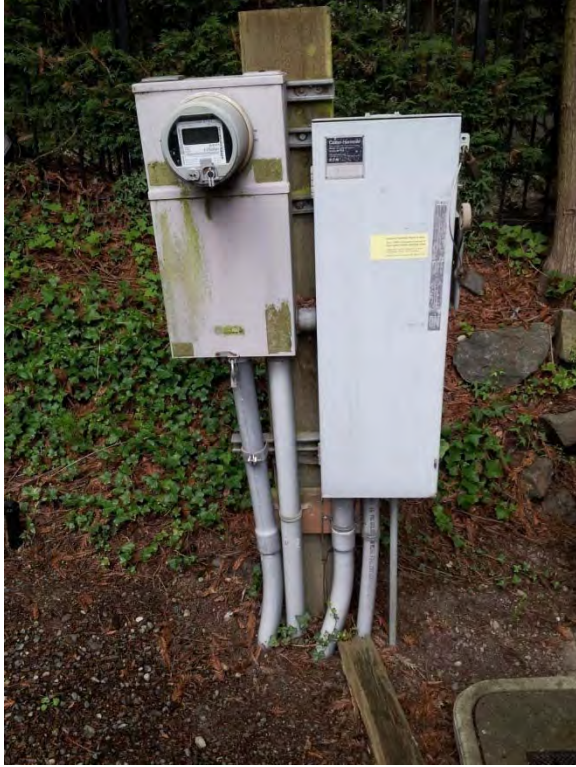
Power meter base and service entrance disconnect equipment, appears to be in good condition

- Power meter base on outdoor pedestal, no rust, PVC conduit

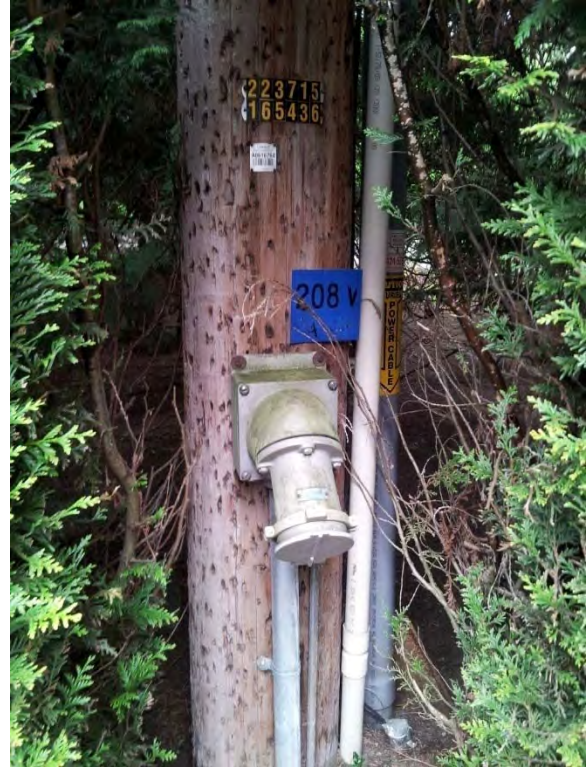
Generator receptacle located on Qwest pole near roadway, appears to be in good condition

- Generator receptacle along roadway before one lane road to station

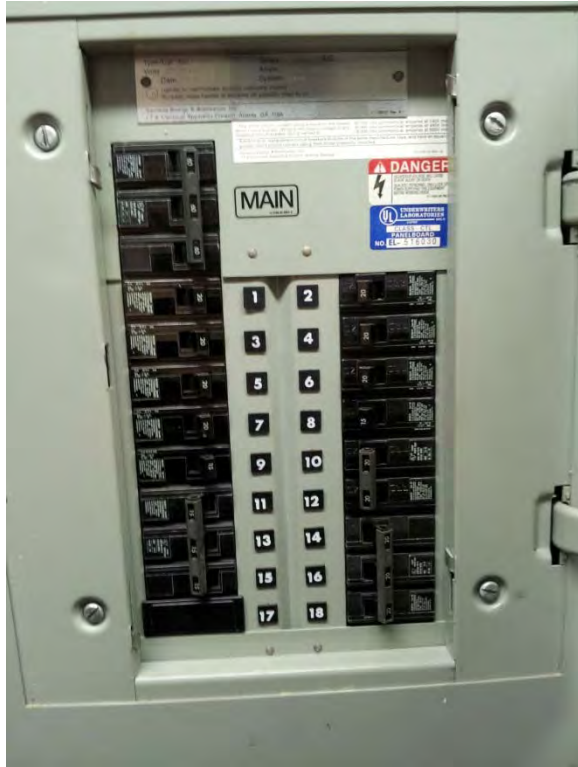
Panelboard located in dry pit, appears to be in good condition

Condition Rating 1 – Cutler Hammer panel appears to be in good condition

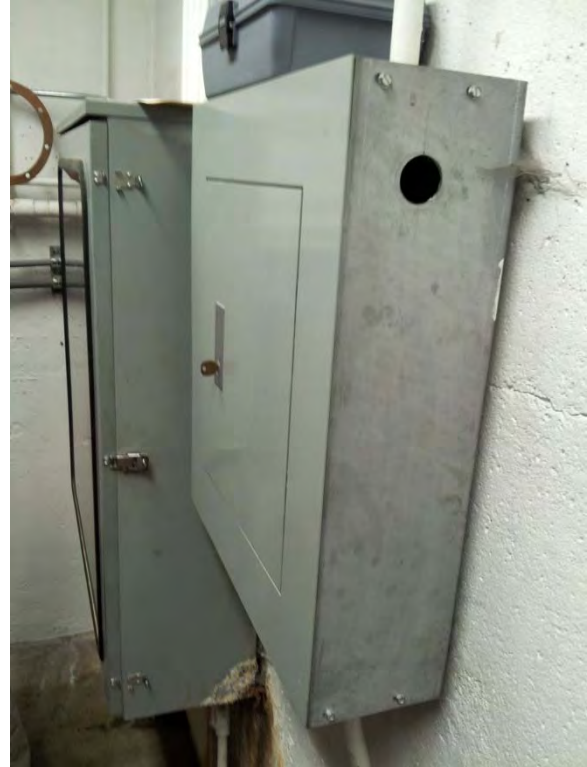
Hole in panelboard

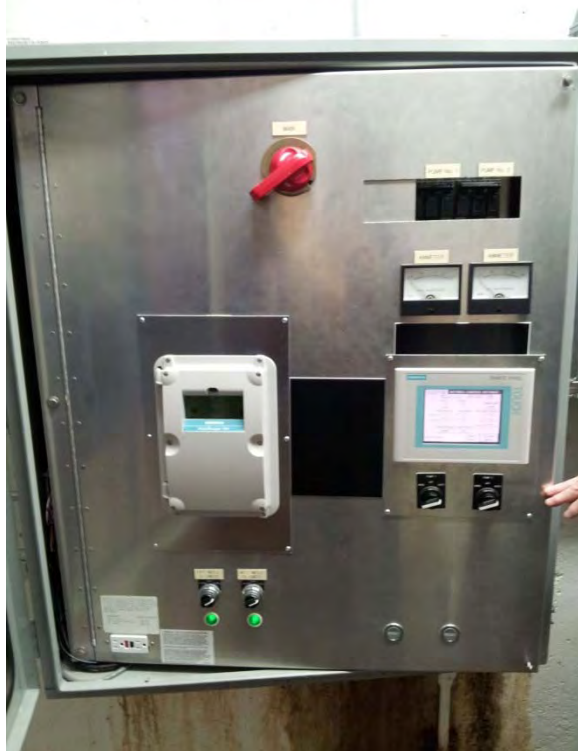
Starters located in dry pit appears to be in good condition

Condition Rating 1 – Both the Furnas starter and replacement Siemens starter appear to be in good condition

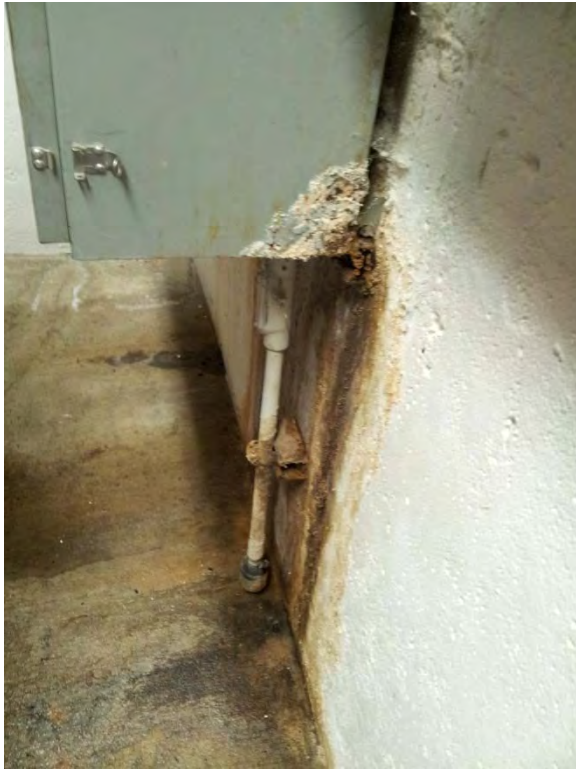
Some corrosion on telemetry control panel but other than that appears to be in good condition

- Some corrosion near bottom of power and control panel

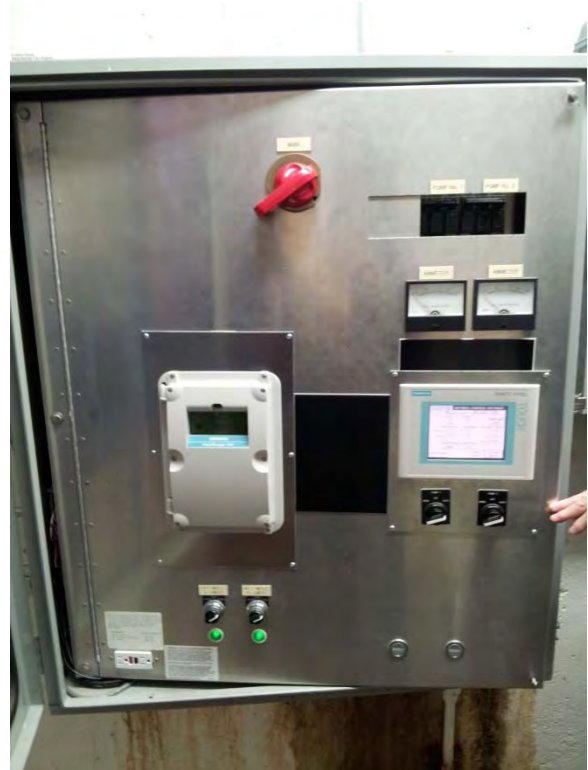
Telemetry control panel with operator interface
