Lake Washington Wastewater Lake Line Management Plan

FINAL / July 2024

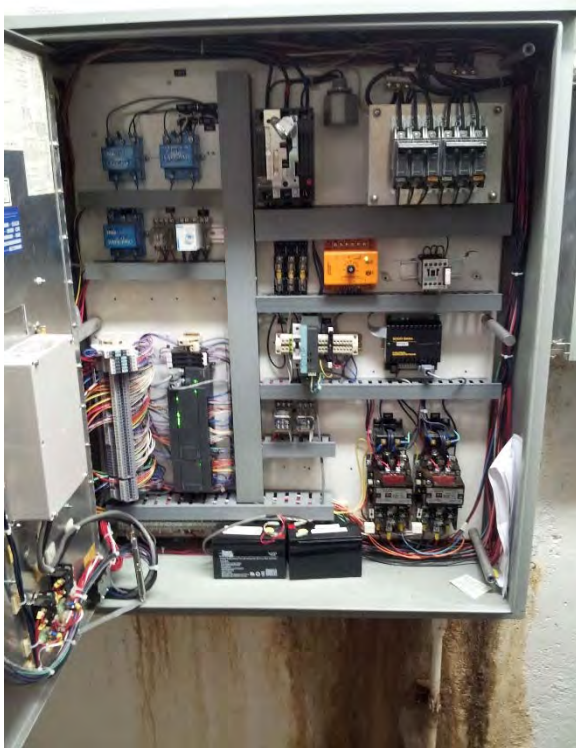
Interior of telemetry control panel

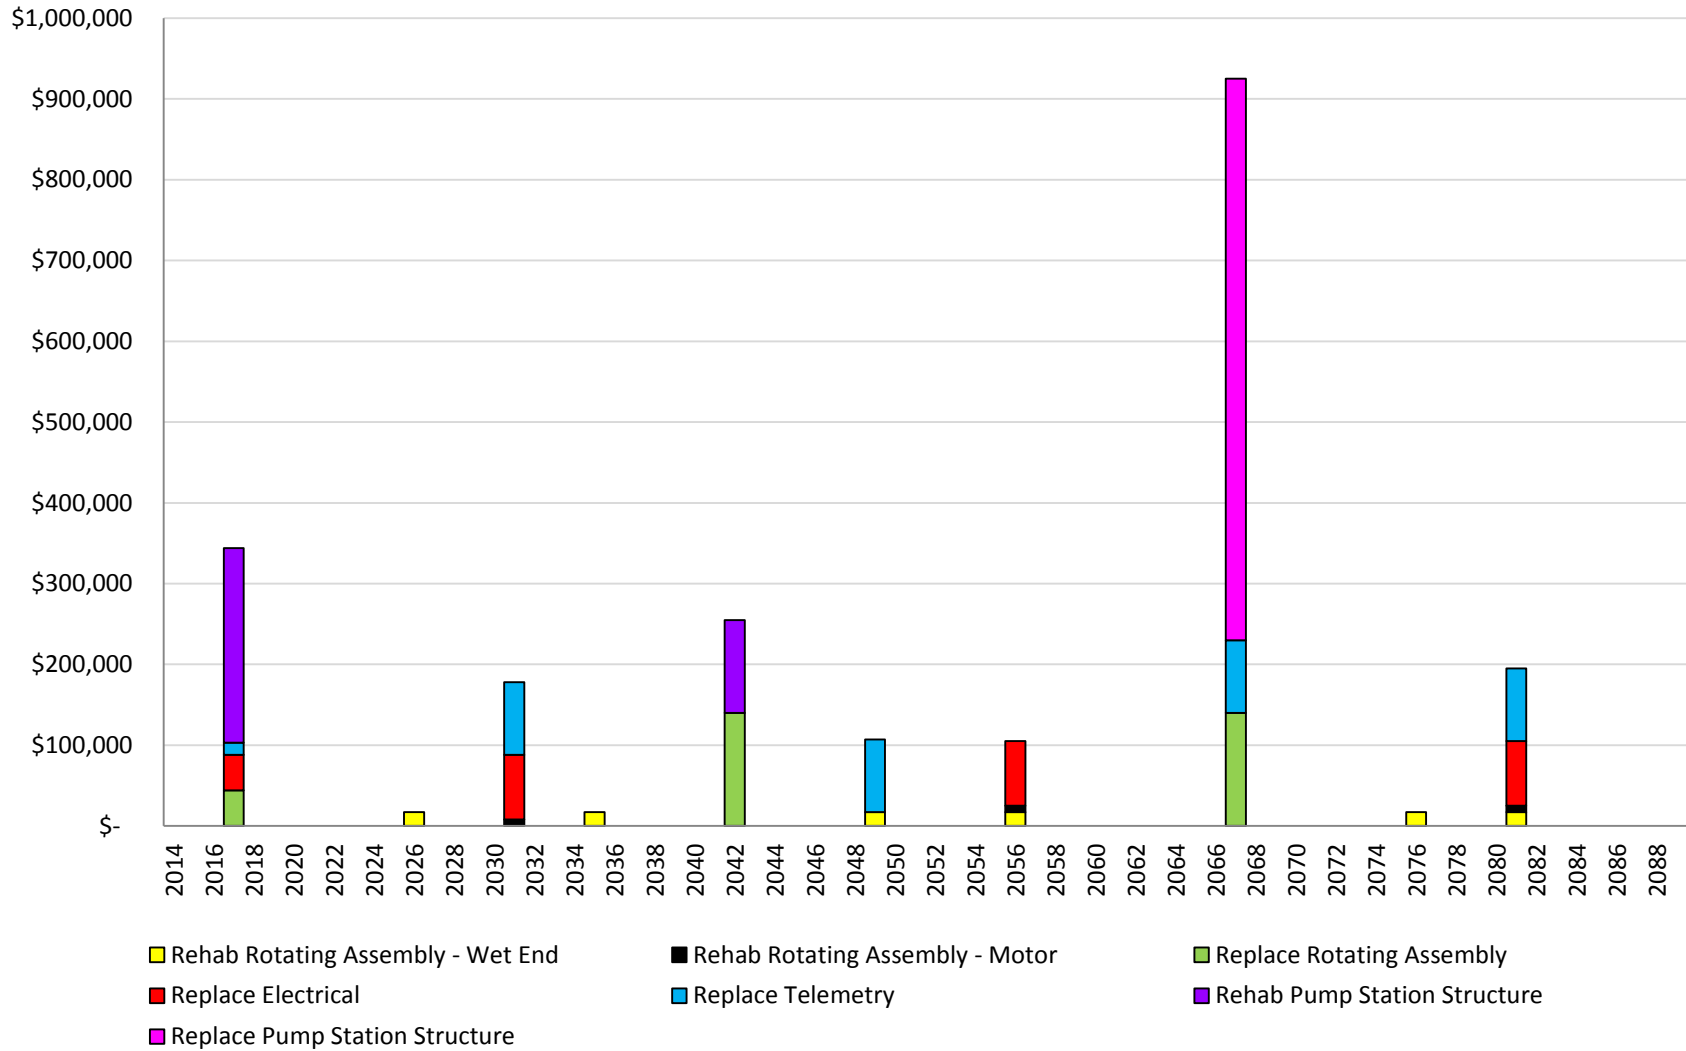
Figure 7-2: 75-year cost planning

Evergreen East PS Rehabilitation/Replacement Schedule Cost Planning

The 75-year replacement cycle is based on the anticipated condition of the pump stations at the end of the 10-year capital project plan and assumes improvements defined in Table 7-4 have been implemented in the timeline identified.

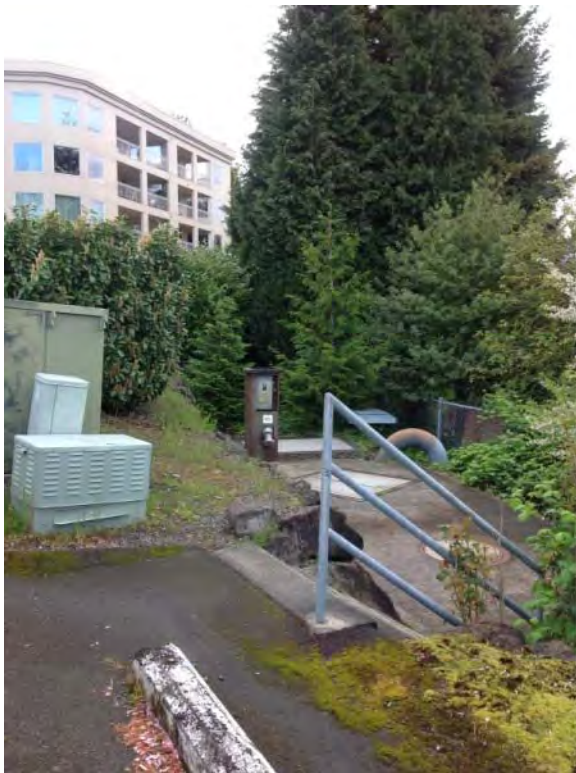
General site, stairs leading down to station
– station is lower than adjacent parking

- Steps down to station
- Future City park area

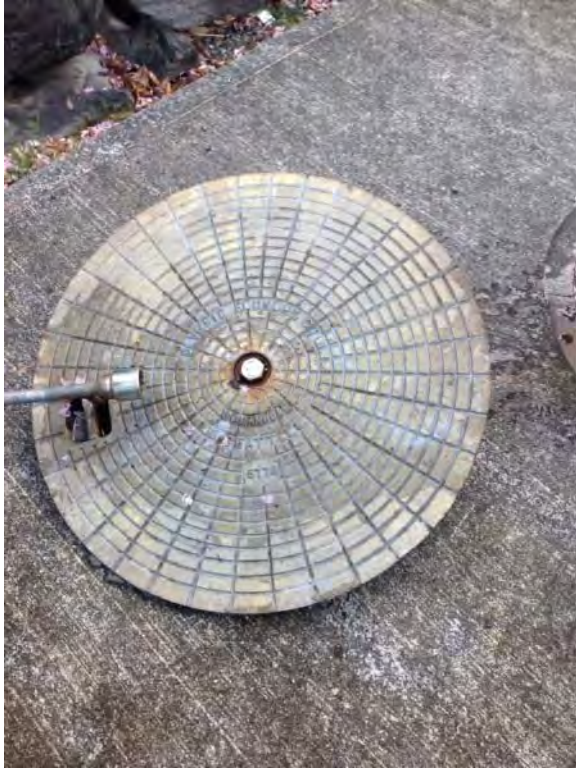
Wet well manhole lid

- Upon failure of locking access lid, alternate lid will need to be purchased/fabricated or entire top of wet well will need to be replaced with new concrete top and hatch

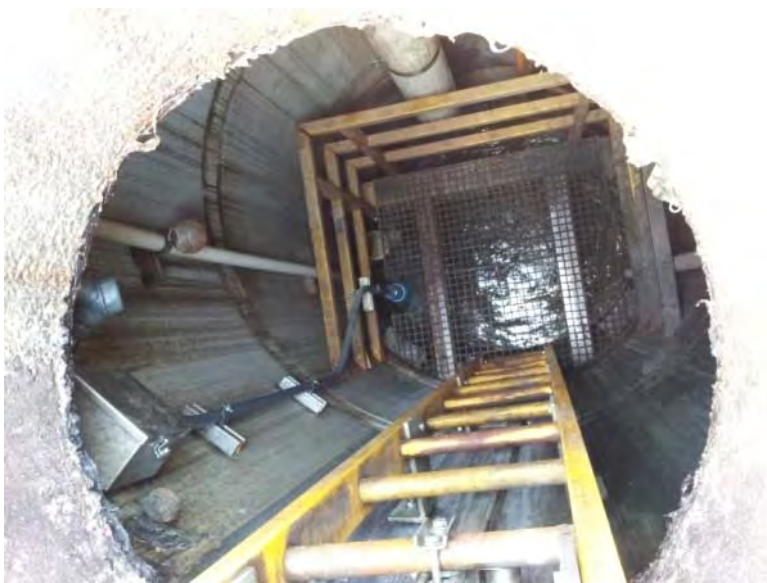
Interior of wet well

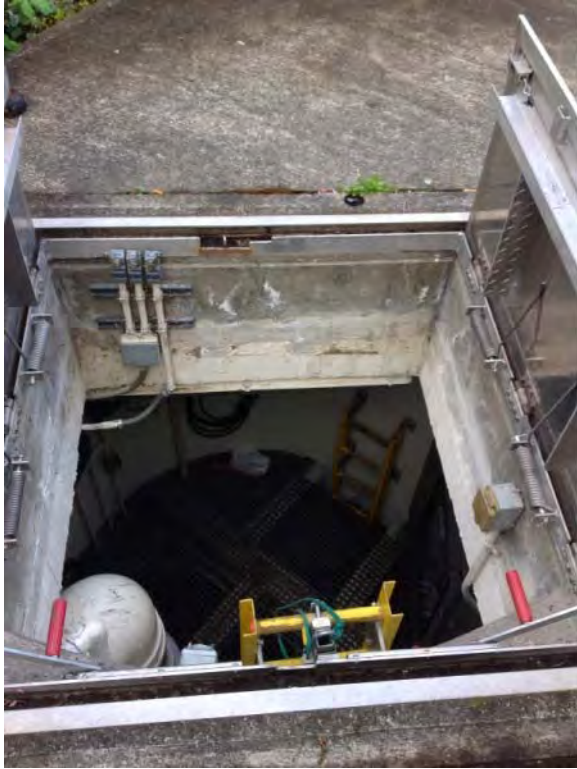
Entry to dry pit, no fall protection

- Tight space, two levels for panels and pumps, only a couple of feet between pumps
- A lot of rust and epoxy injections on wall indicate previous leakage – no current leakage identified
- Pulling pumps challenging, needs boom truck to pull fully out of dry pit
- Hatch on one side difficult to access. Staff had to open one side then reach under to open other side
- No exhaust fan – required in addition to supply fan to un-classify space per NFPA 820 code

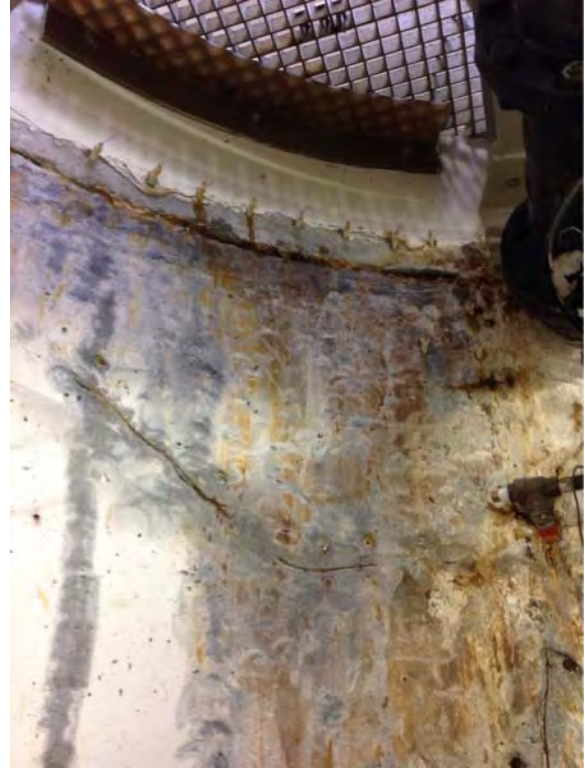
Rusting and epoxy injections on interior wall

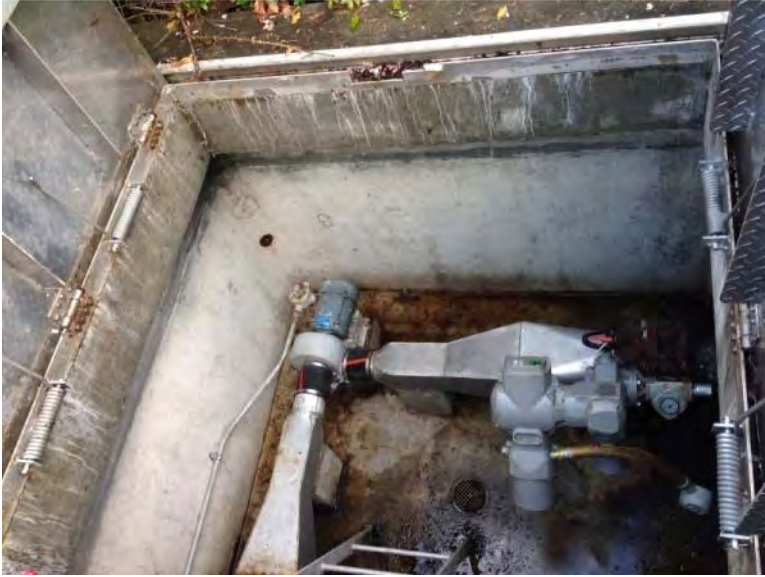
Interior of wet well blower vault appears to be in good condition

- Supply intake needs to be cleared
- Drain in vault goes to wet well. P-trap but no automatic primer

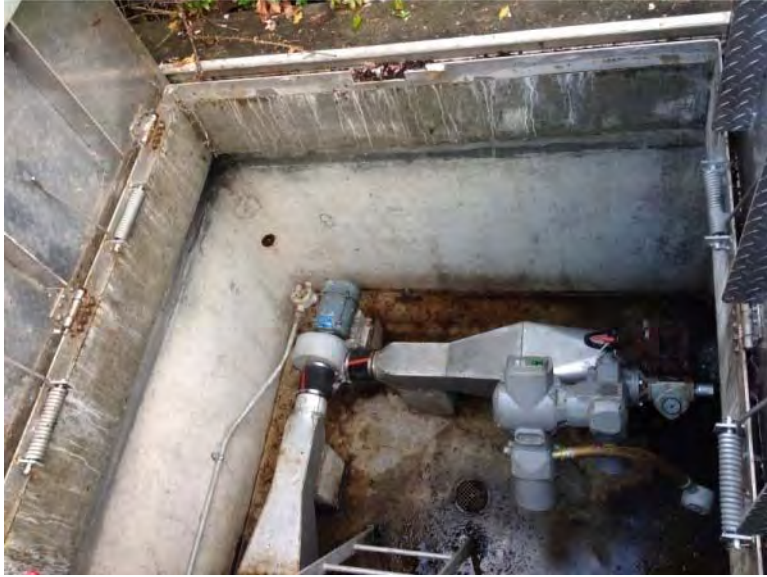
Interior of wet well blower vault appears to be in good condition

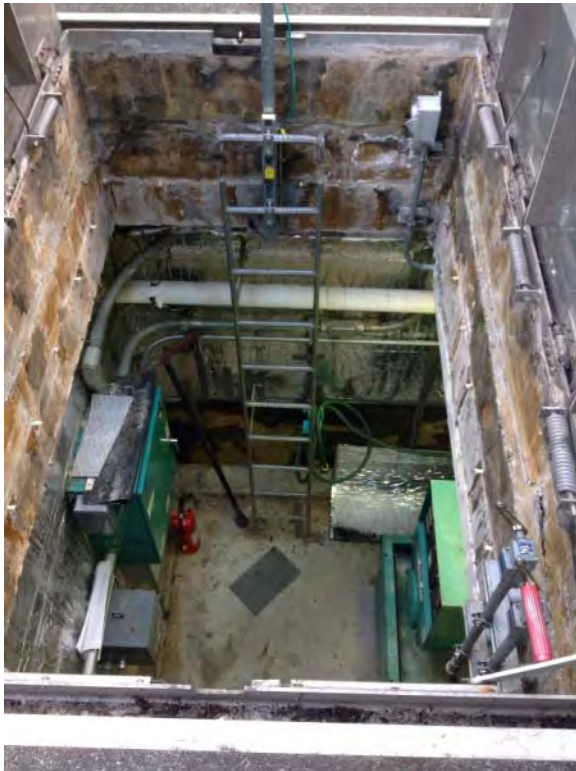
Interior of generator vault, no fall protection

- Insulation in vault falling off
- Drain in generator vault goes to wet well, no automatic primer
- Sewage has been found in generator vault, hydraulic limitation on outfall reportedly backs up into wet well and subsequently into generator vault

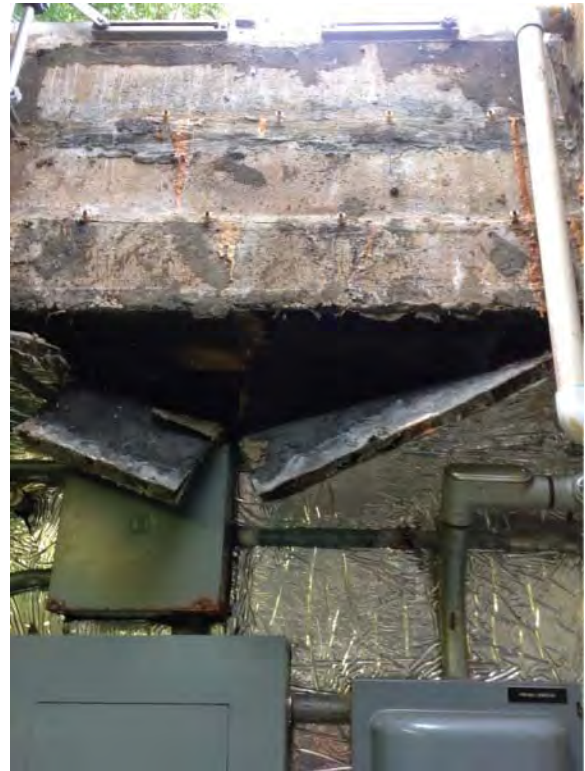
Insulation in generator vault falling off

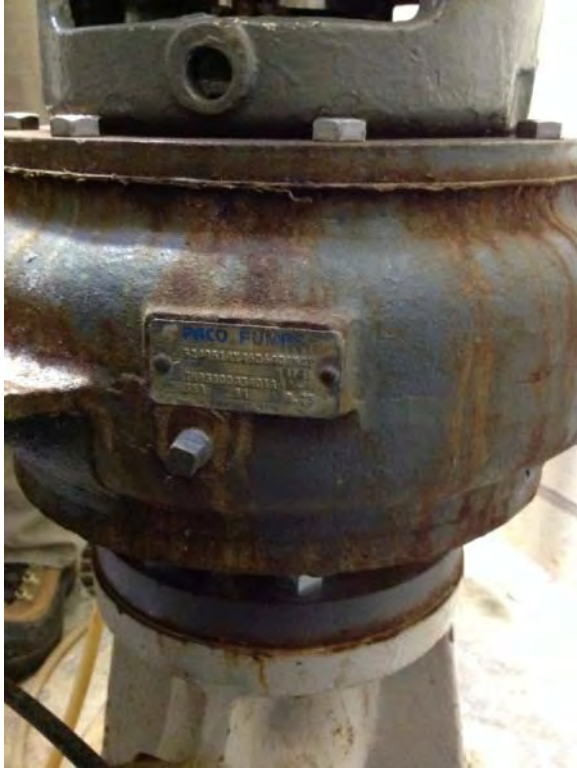
Pump 1 showing signs of aging on exterior

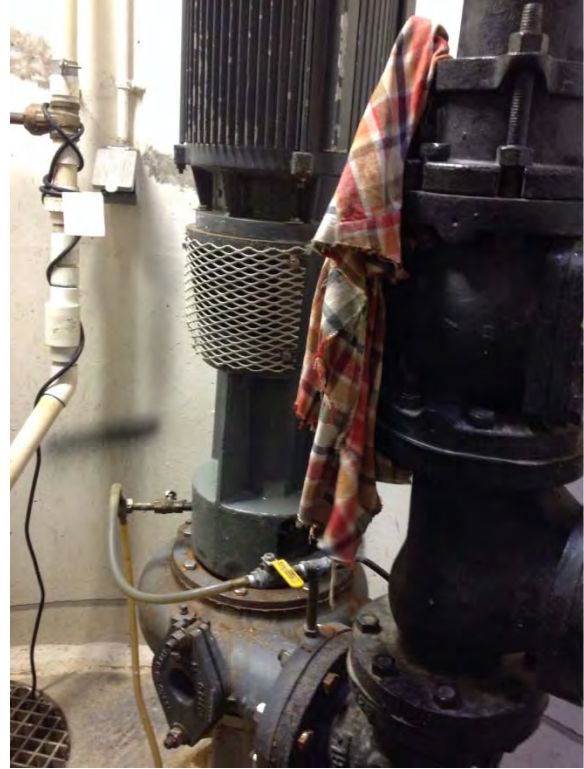
Pump and motor #1

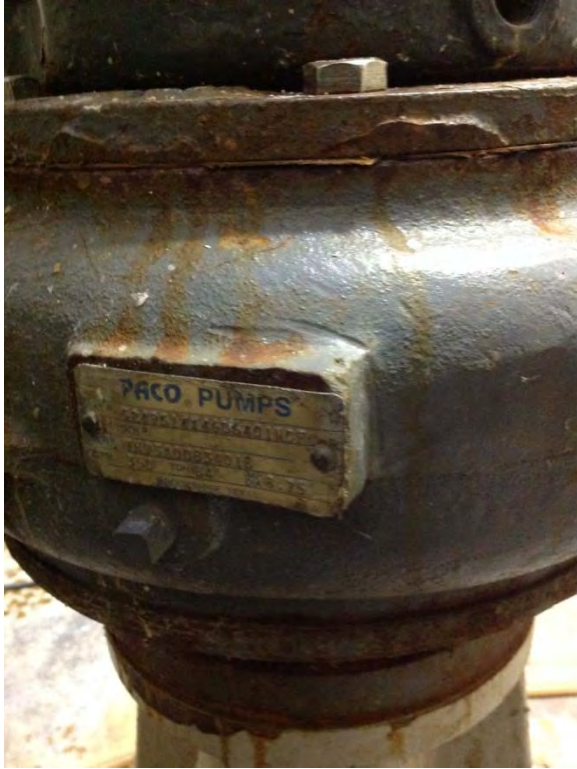
Pump 2 showing signs of aging on exterior

- Pump appears to be operating at far left of curve, potential to experience a number of hydraulic problems, largely surrounding low velocities through the pump that may contribute to ragging and recirculation.

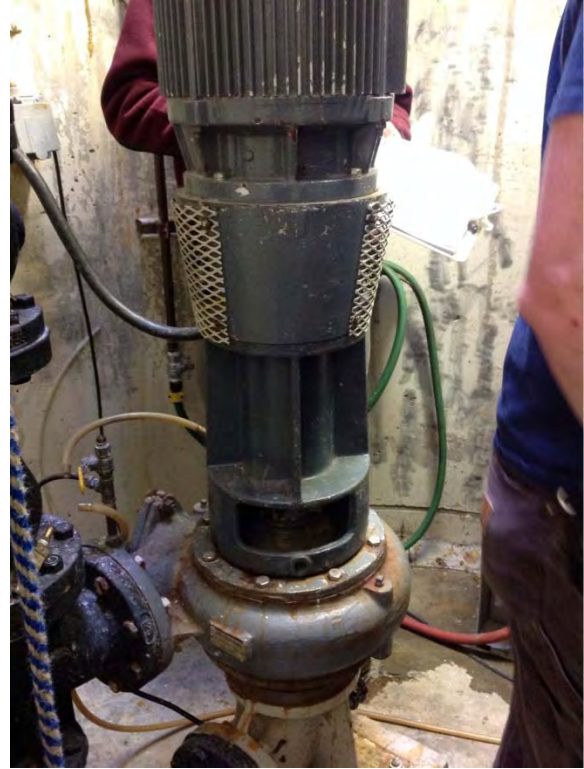
Pump and motor #2

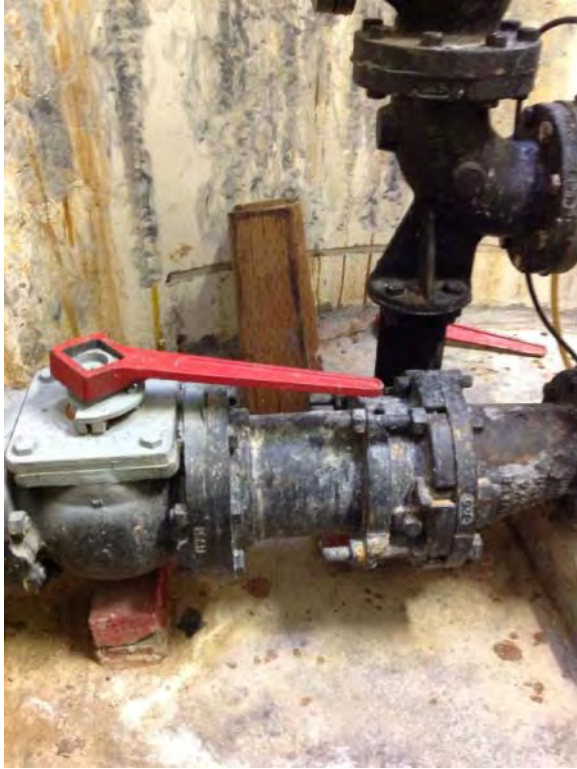
Suction plug valve, vertical shaft orientation
– not desirable

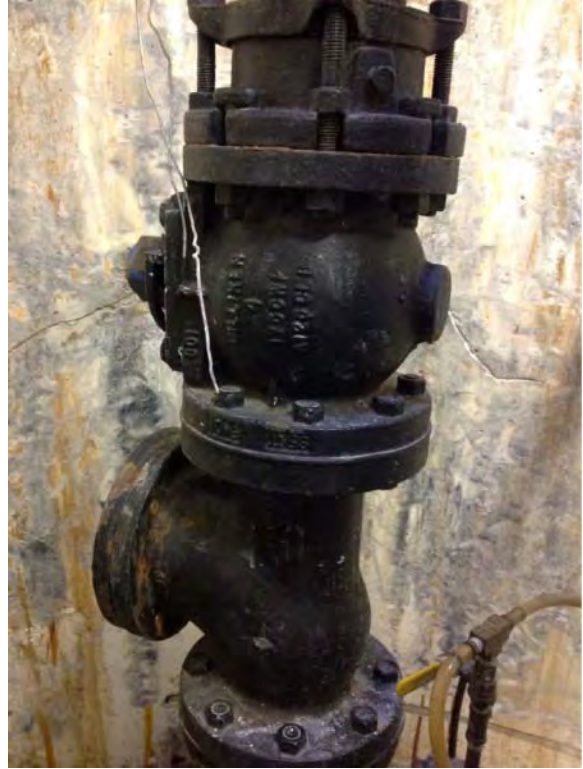
Discharge ball check valve and plug valve

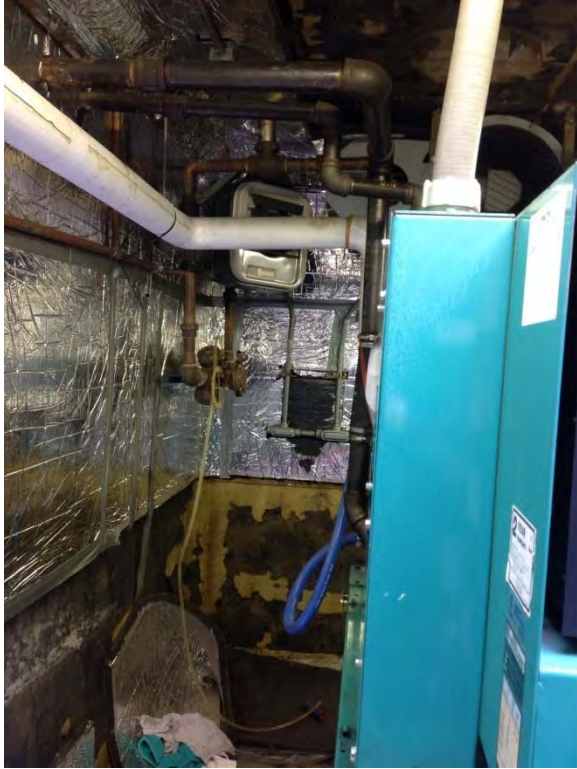
- Backflow prevention assembly in generator vault, not to code, does not drain to daylight
- Provides water to both vault and dry pit
- Serves generator cooling (flow through) and water supply
- Vault drain does not include automatic primer – recommend adding to avoid potential gas venting from wet well

Backflow prevention assembly in generator vault

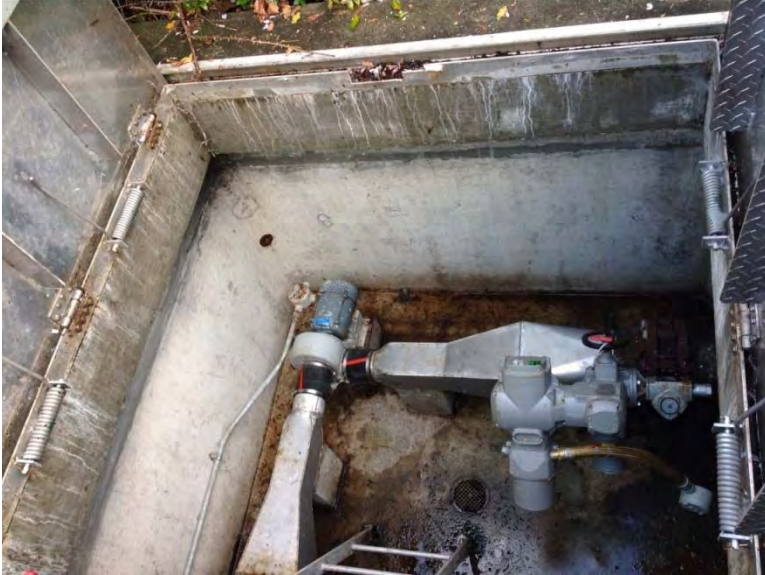
- Noisy, potential bearing issue – may reduce fan life
- Intake vent needs to be cleared of brush outside

Wet well supply fan located in wet well blower vault

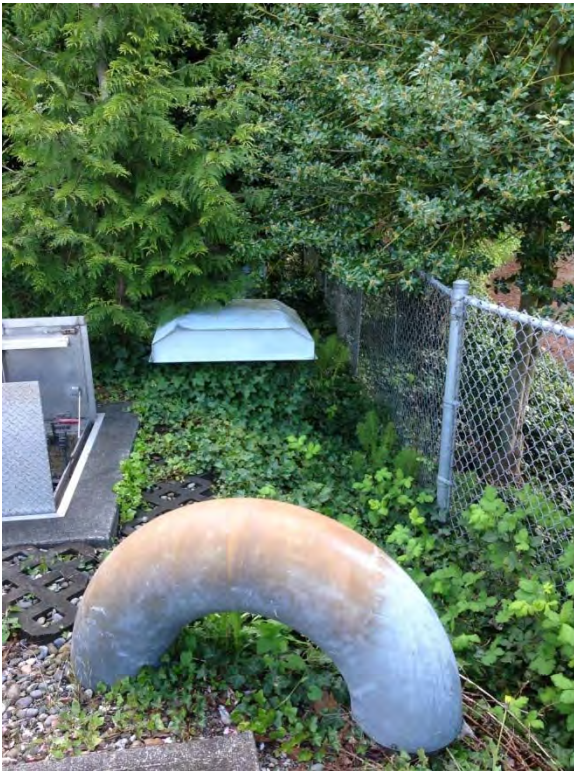
Intake needs to be cleared of brush

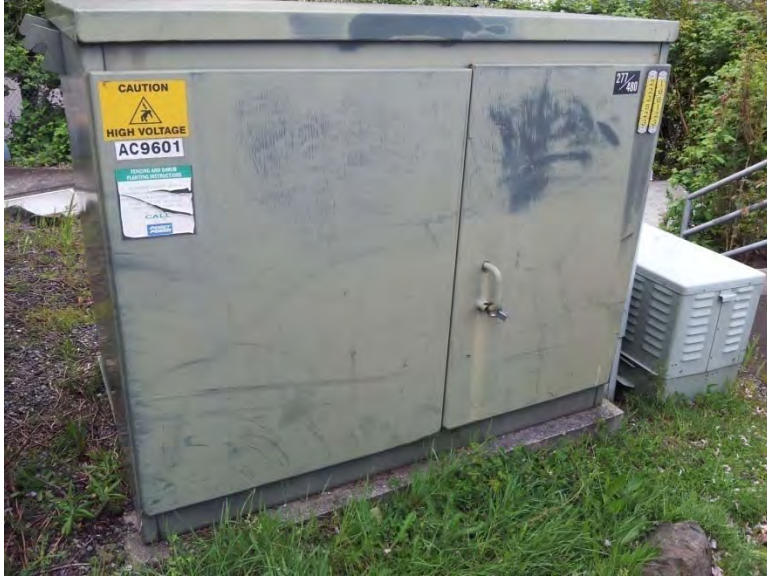
Utility service cabinet

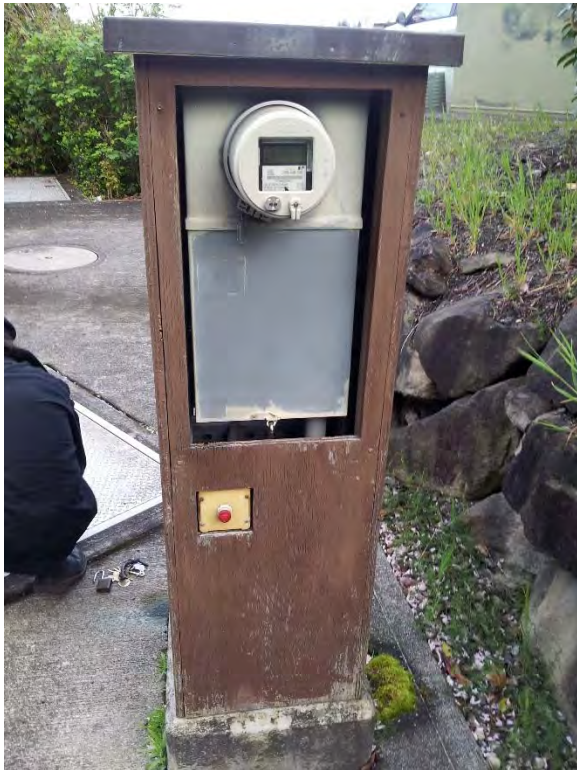
Service meter located on outdoor pedestal, appears to be in good condition

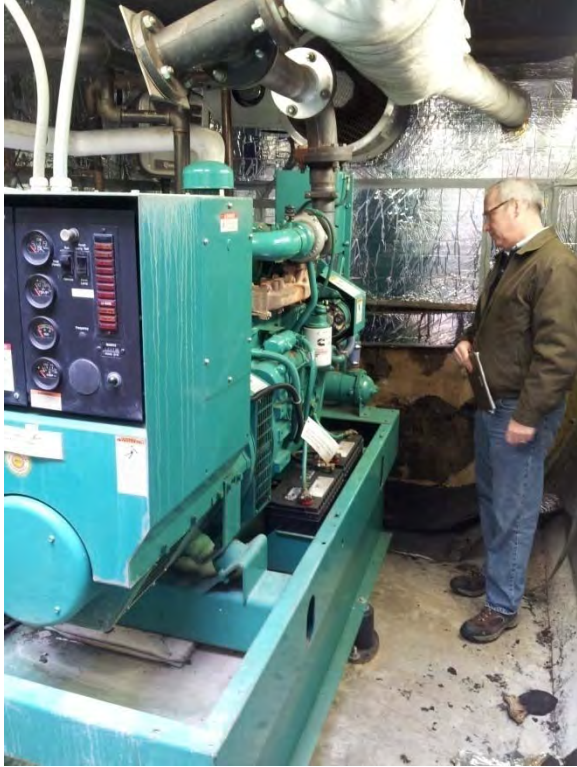
- City water cooled generator, supplied using 2 solenoid valves,
- Utility power phase monitor located in power and control panel, non-standard

Emergency generator located in underground vault, appears to be in good condition but with decreasing useful life

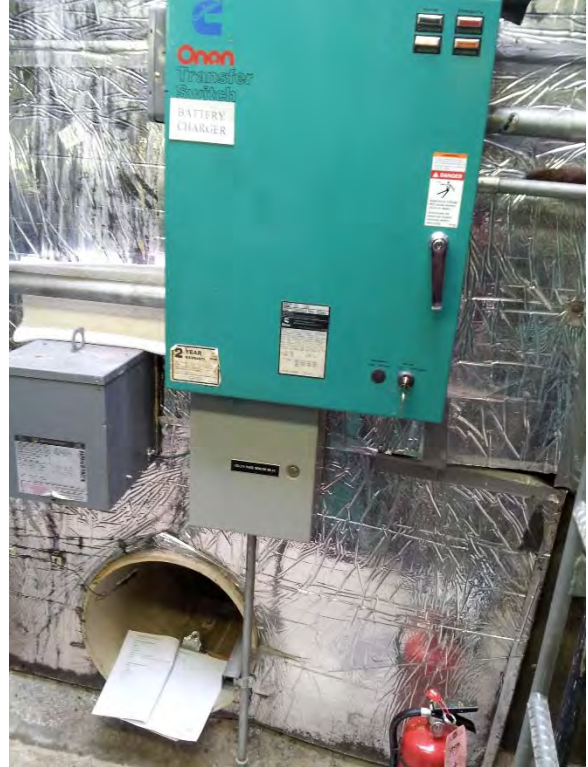
Transfer switch located in generator vault

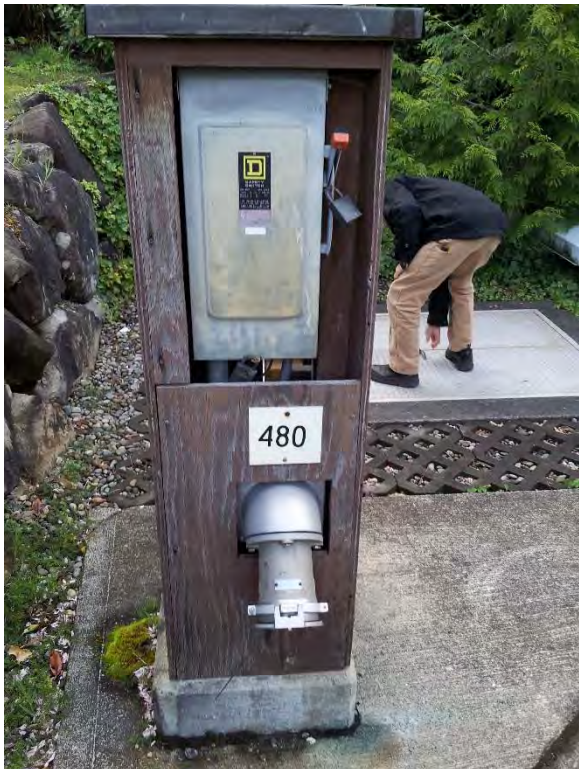
Generator receptacle and transfer switch appear to be in good condition but aging

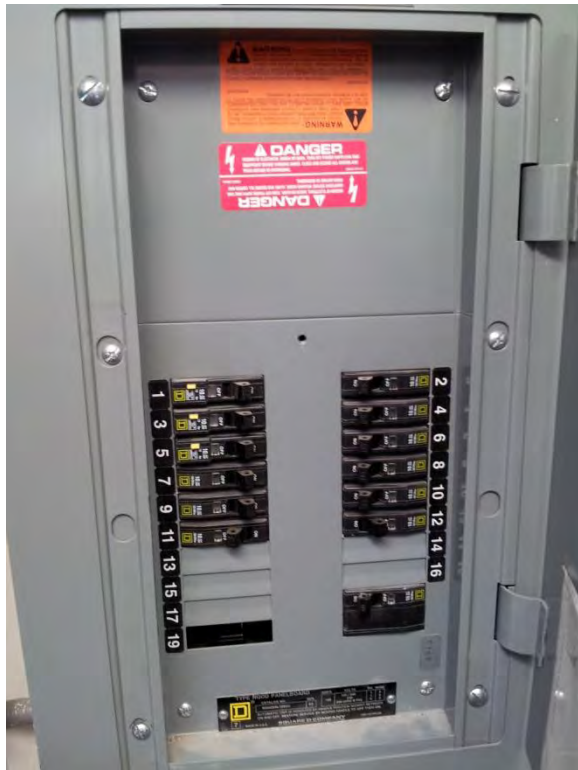
Panelboard located in dry pit, appears to be in good condition, but have decreasing useful life

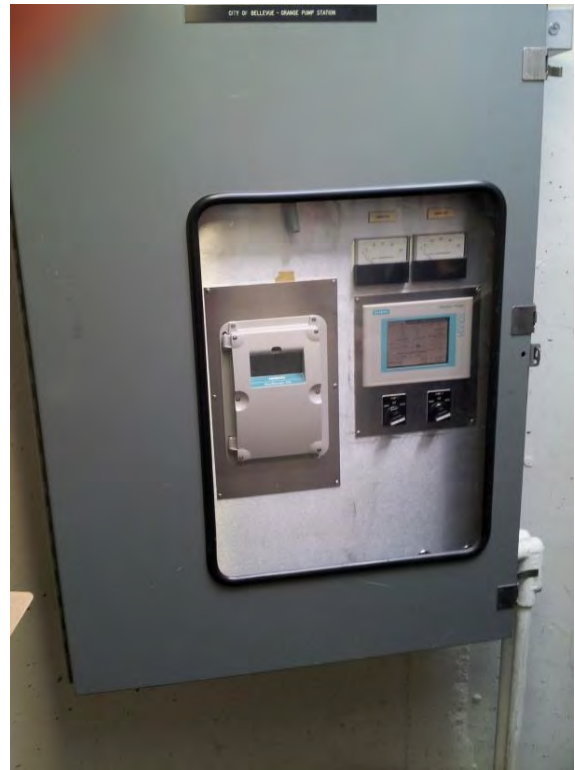
Starters located in dry pit, appears to be in good condition but have decreasing useful life

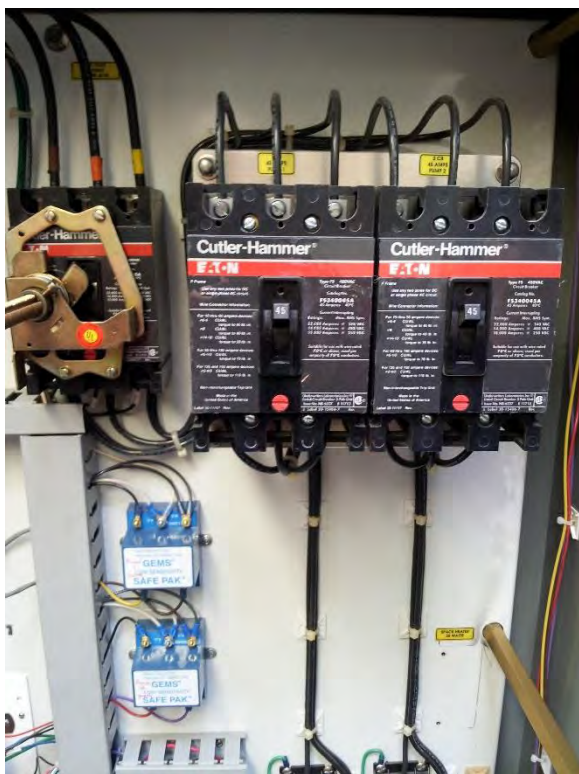
Cutler Hammer starters located in telemetry control panel

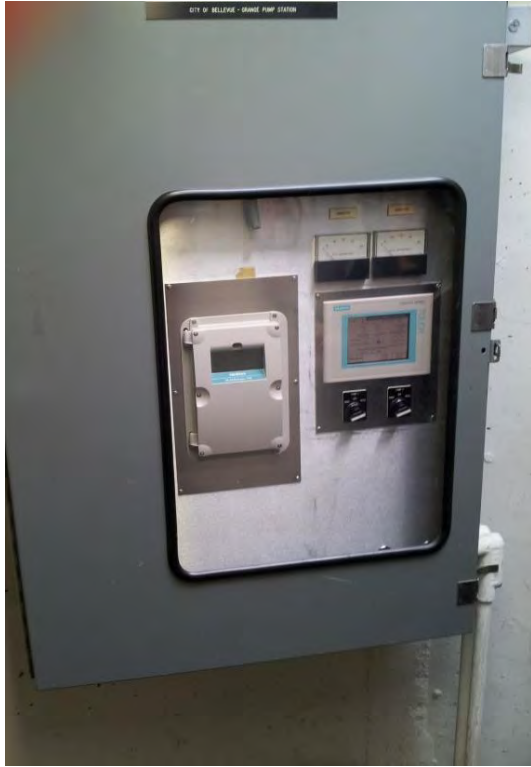
Telemetry control panel located in dry pit with operator interface

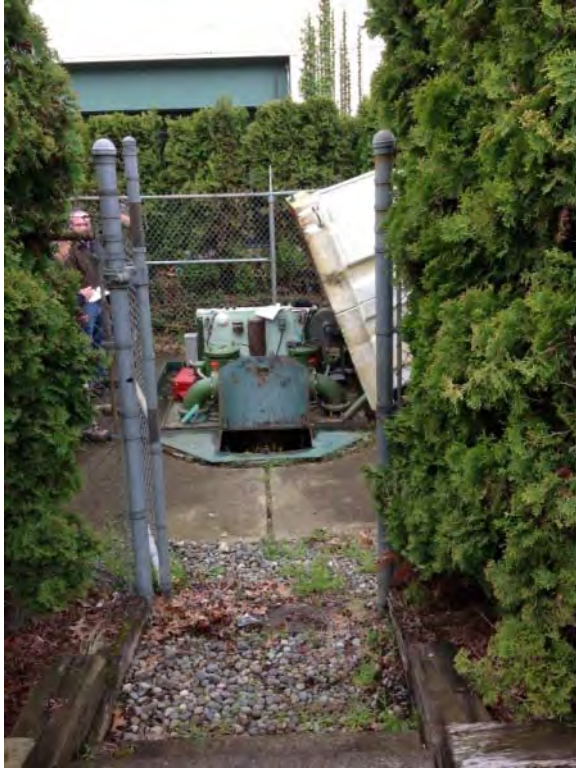
Access to station through locking personnel gate. No vehicle gate access to station

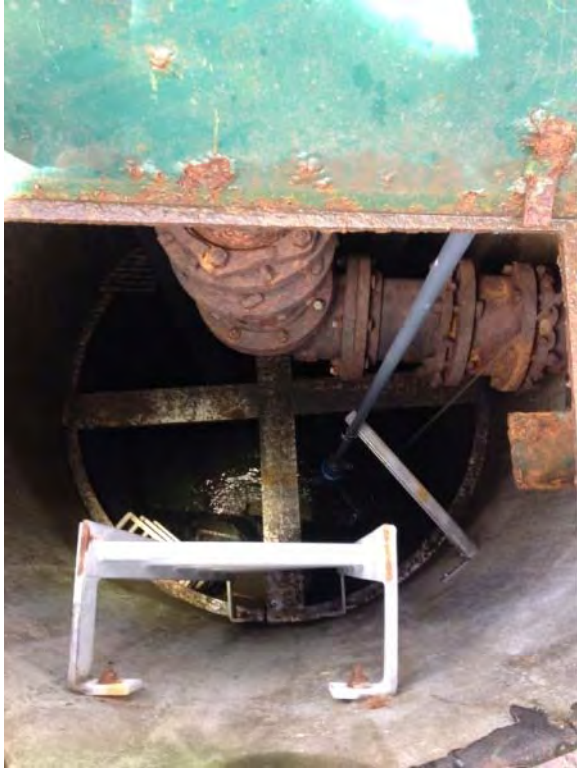
- Sections of grating platform have been removed from the wet well and stacked in corner of site
- Some corrosion on metal cover and access hatch
- Access hatch is a metal plate not connected to cover

Interior of wet well, small opening for access
– underside of hatch showing corrosion

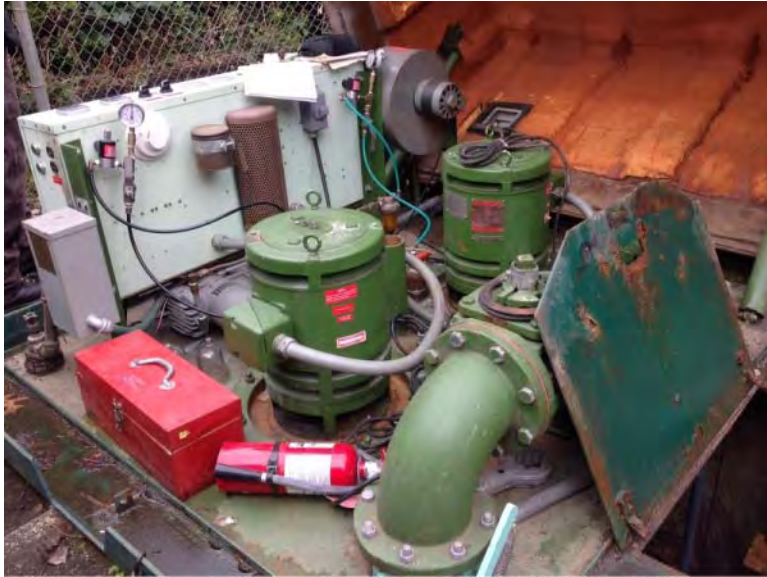
Pumping system sits on top of wet well

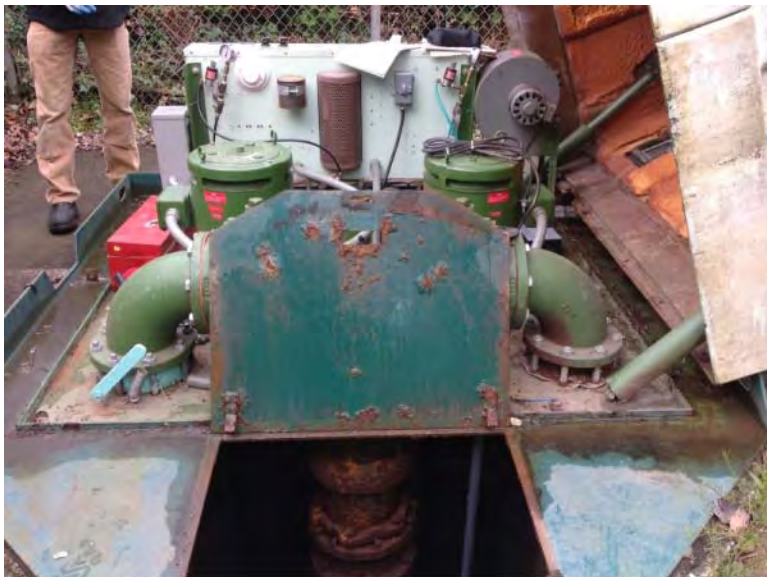
Some rusting on interior of steel plate – likely indicates corrosion on underside of metal floor. Wet well hatch is not sized to prevent dropping into wet well.

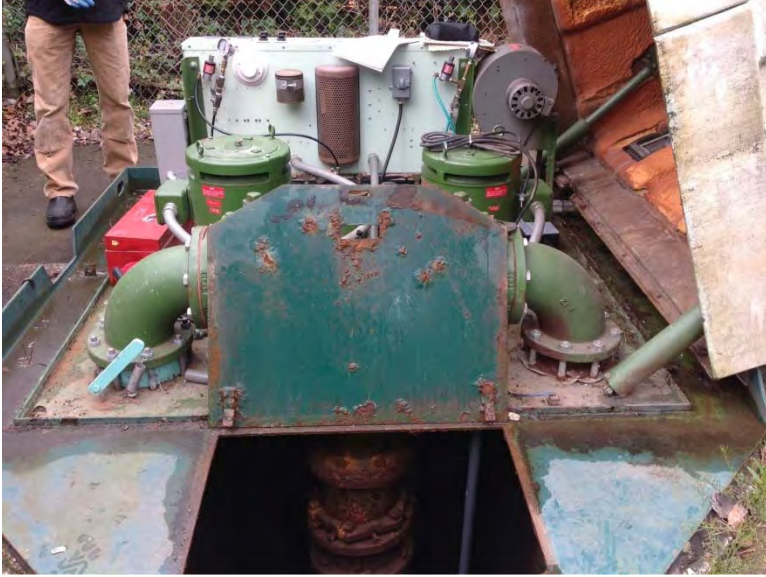
Pumps below steel plate, could not observe

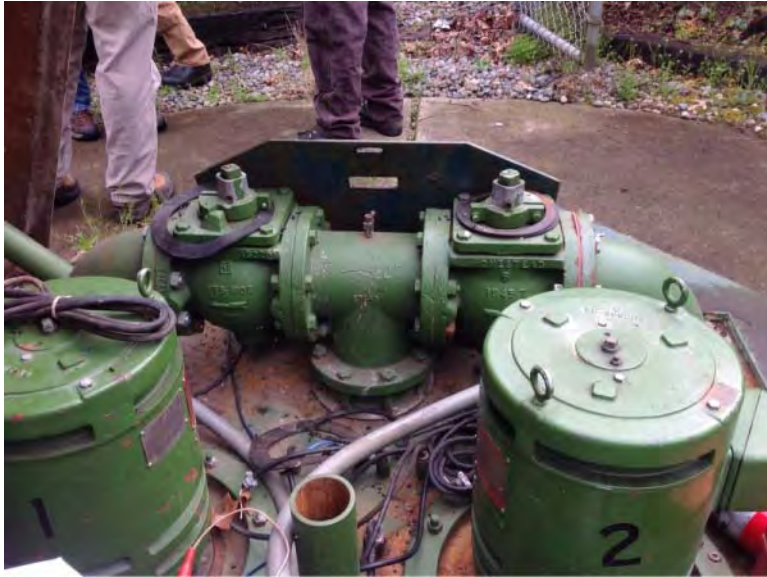
Plug valves, vertical shaft orientation is not desirable due to sediment settling in bottom bearing

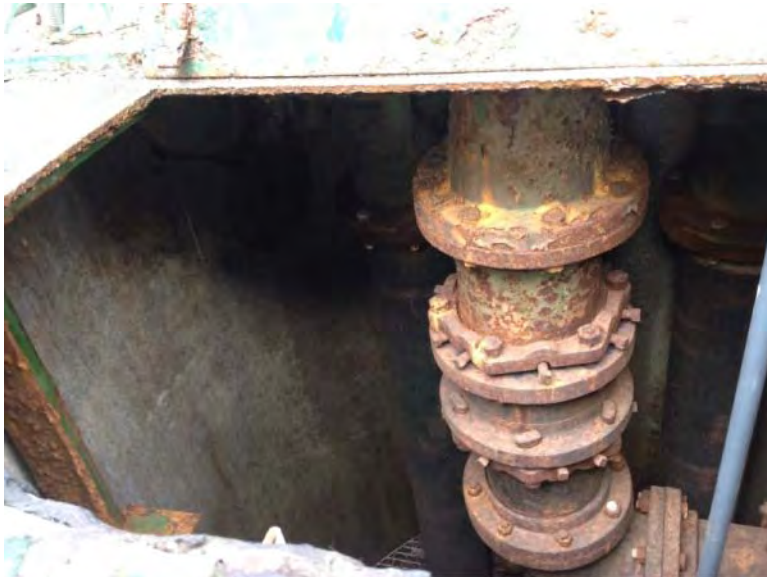
- Paint chipping, significant rust, likely unable to disassemble without damaging piping
- Check valves installed partially in metal cover, access for service or replacement challenging

Significant rust on discharge piping

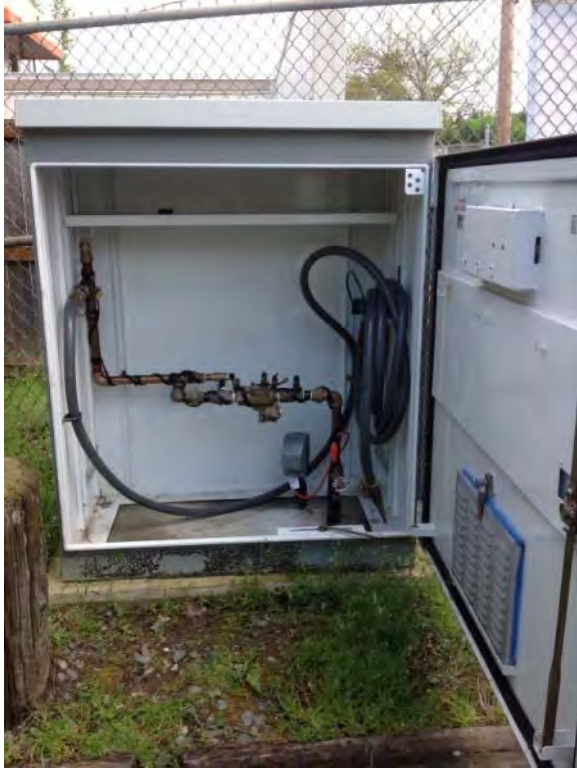
Backflow preventer in above ground enclosure

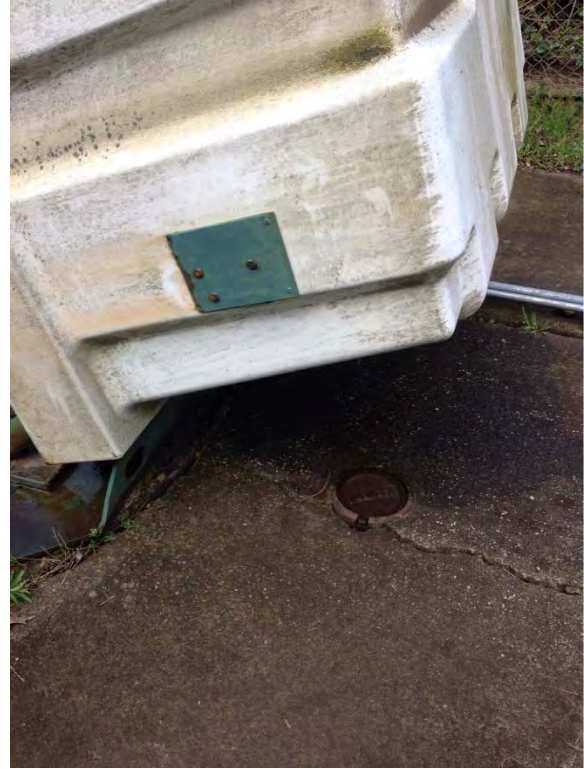
Isolation valve adjacent to site, unknown if operable

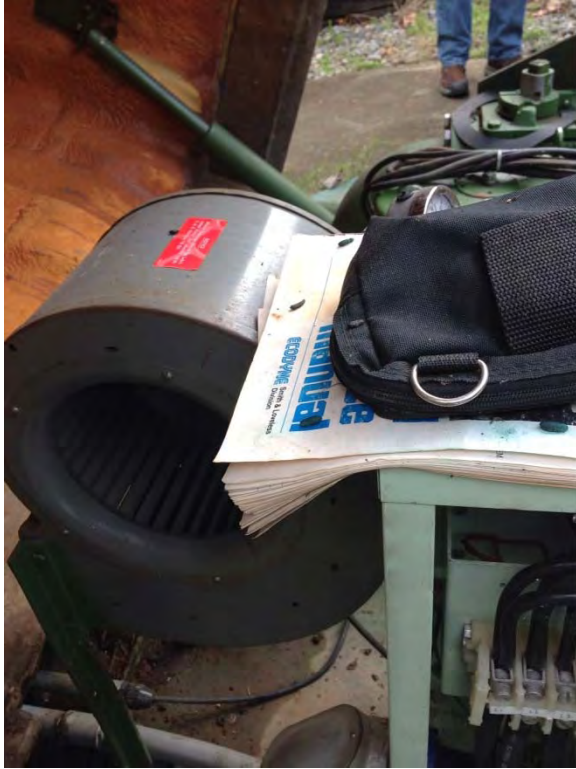
Supply fan on steel plate

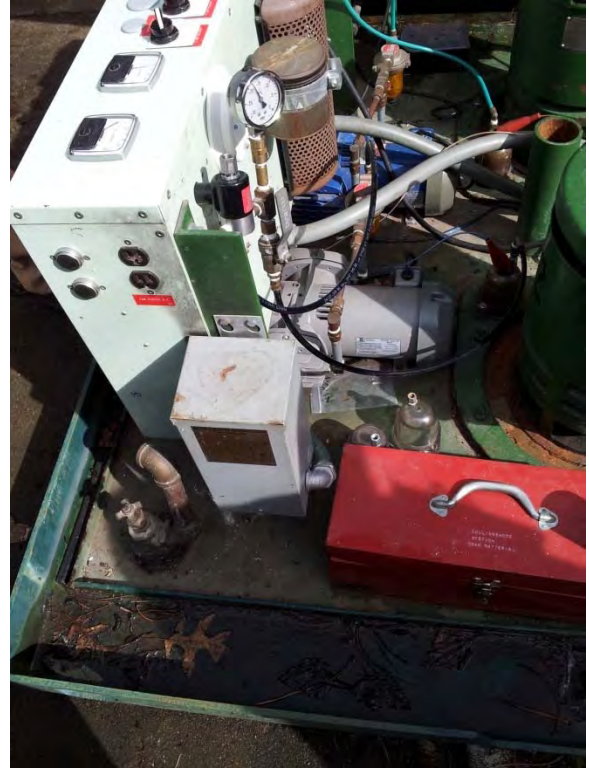
- Ventilation for cooling, thermostat controlled, attempt to activate heat sensor did not succeed

Heat sensors for ventilation cooling on power and control panel

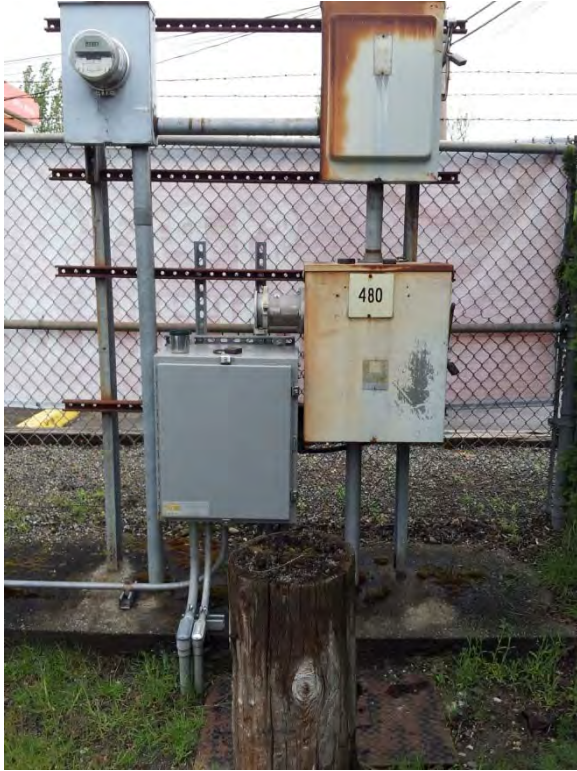
- Clearance issues with wooden pole in front of panels

Utility service and generator receptacle,
clearance issue with wood pole

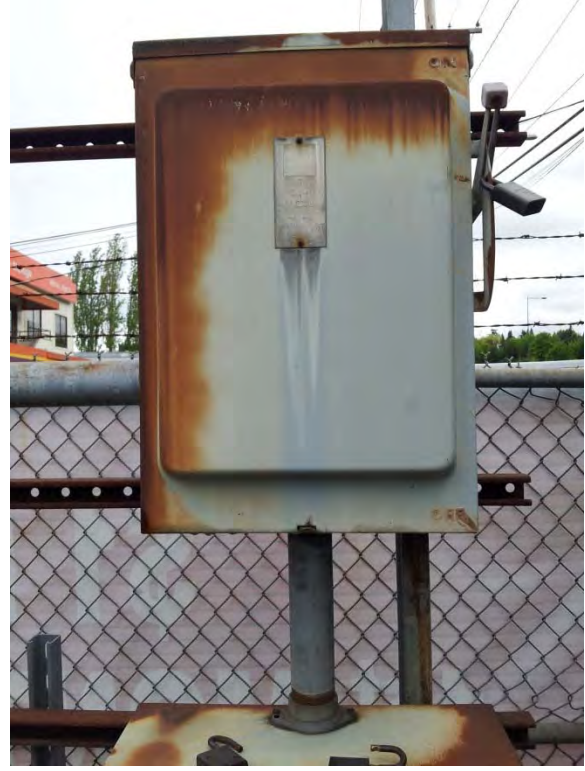
Rust on main disconnect

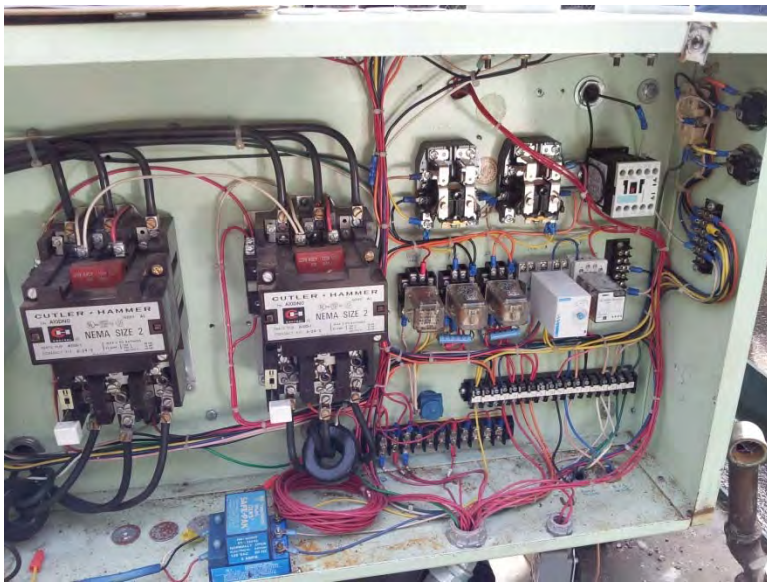
Interior of power and control panel with Cutler Hammer starters

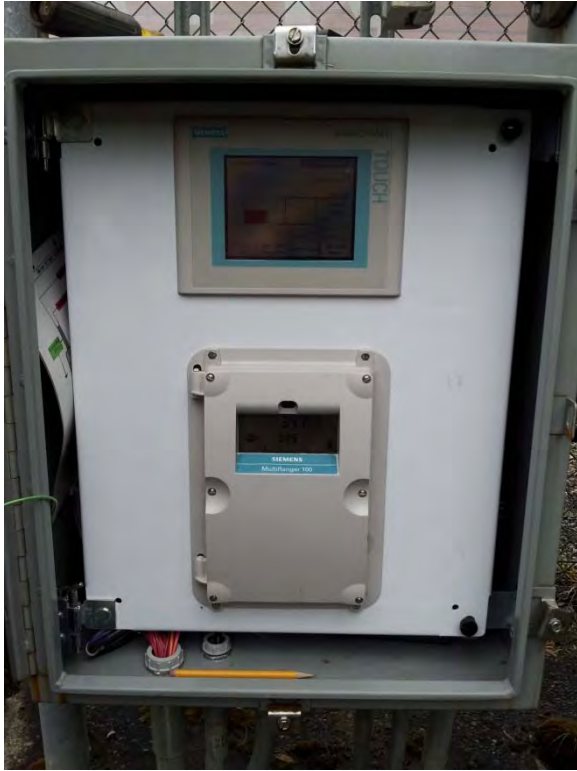
Operator interface located on steel rack

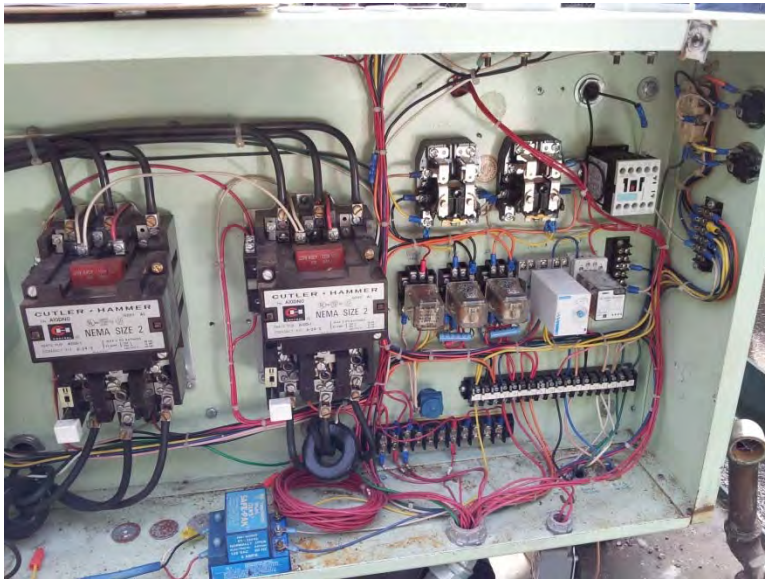
Interior of telemetry control panel, appears to be in good condition

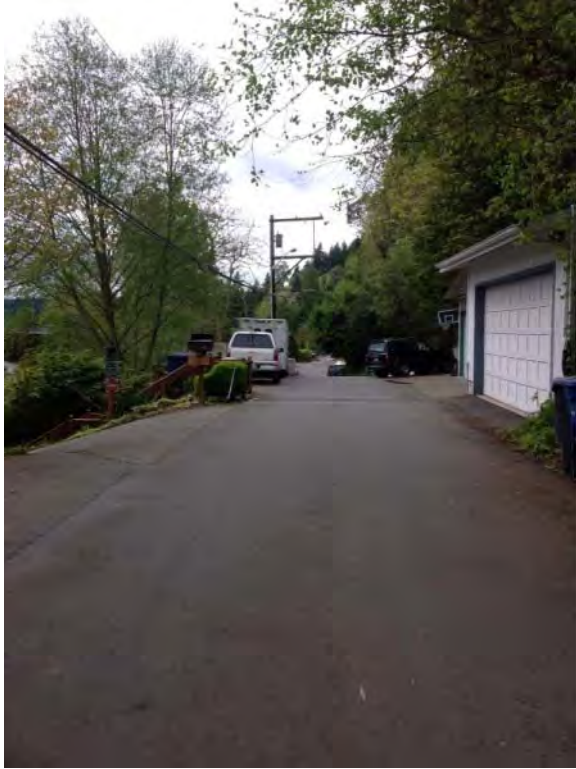
Unreserved parallel parking approximately 300' from station is all that is available
