Lake Washington Wastewater Lake Line Management Plan

FINAL / July 2024

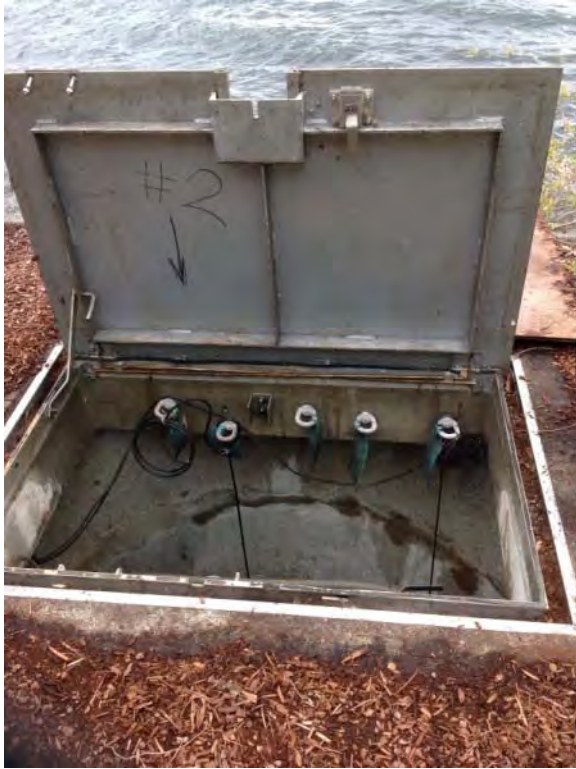
Wet well is located directly adjacent to lake

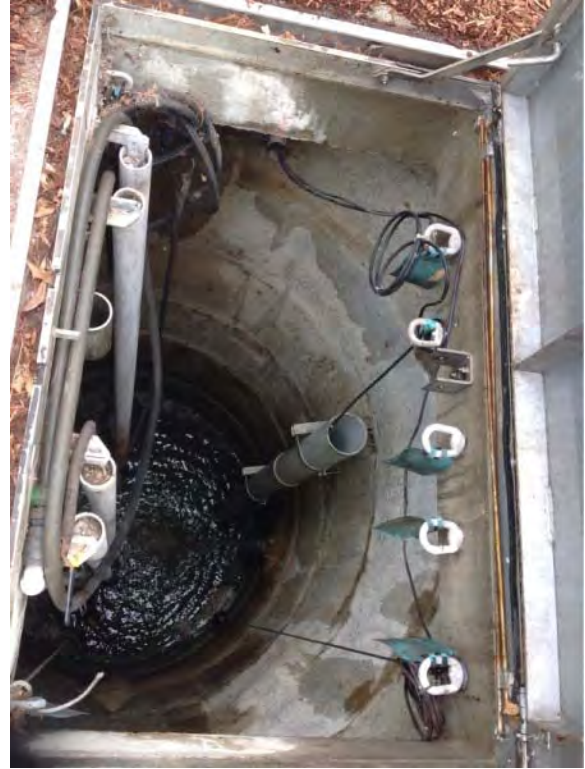
Interior of wet well appears to be in good condition

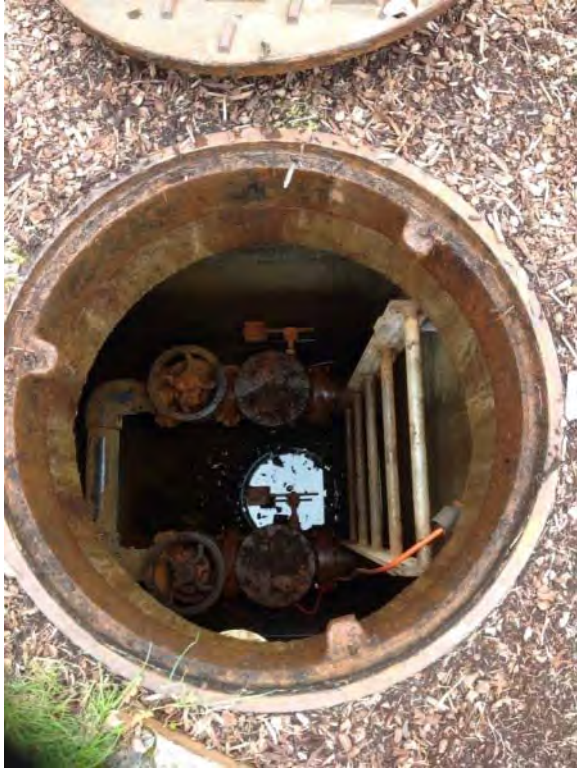
Underground vault accessed through manhole lid. Standing water present.

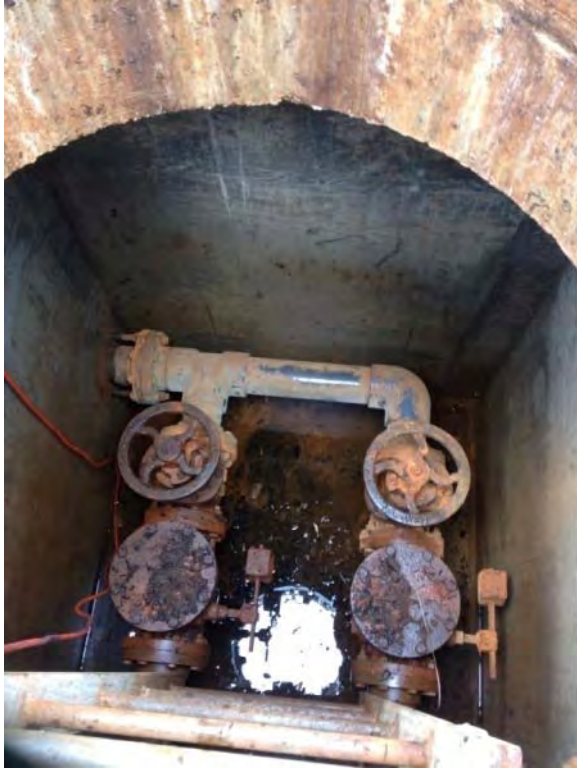
Swing check valves and gate valves with hand wheel

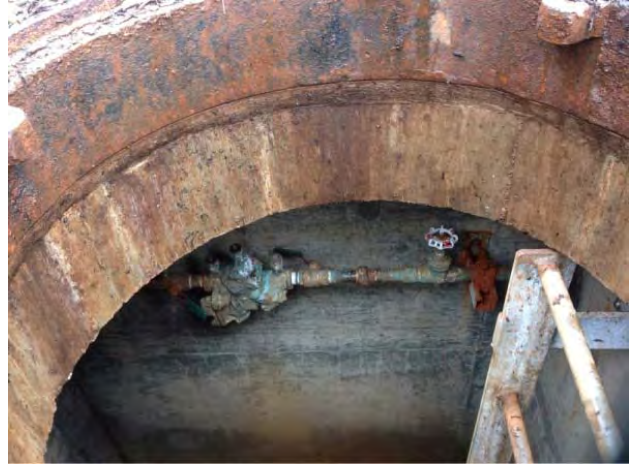
Backflow preventer in check valve and isolation vault

- Backflow assembly located in valve vault, no drain to daylight, water service meter up on street 300 feet away – does not meet code for installation

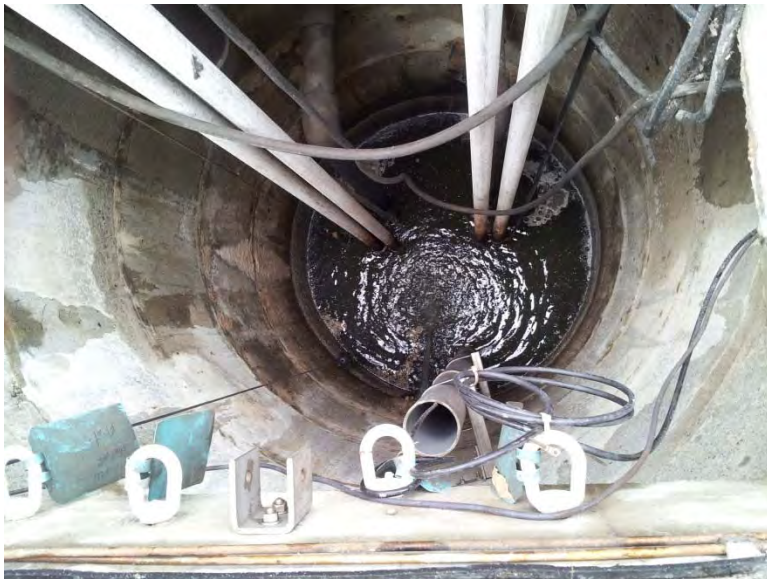
Discharge piping in wet well, piping is grey

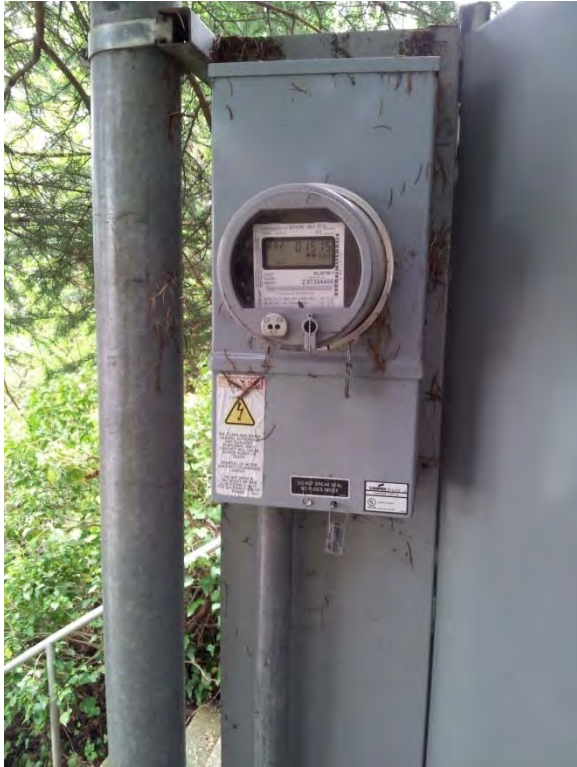
Utility meter base

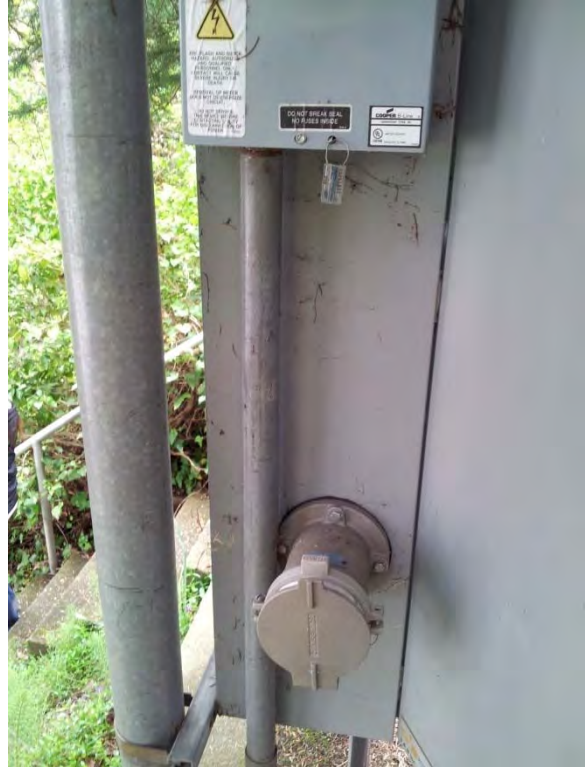
Generator receptacle

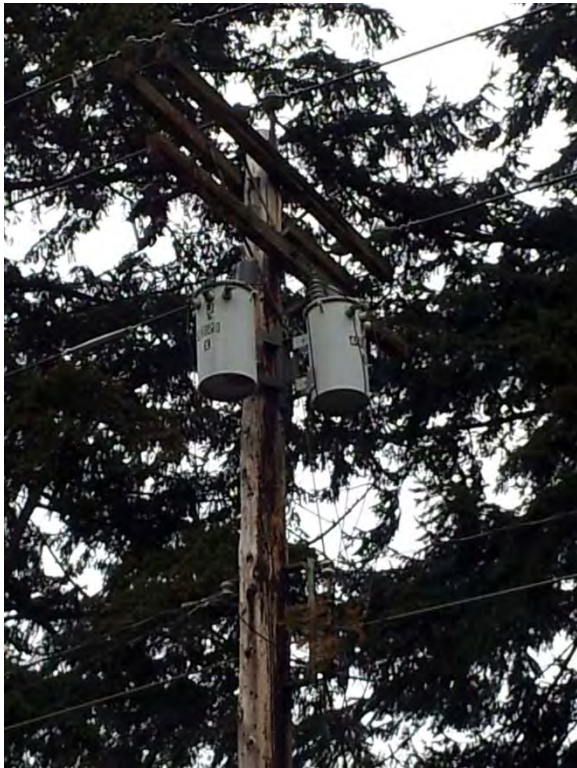
Overhead utility transformer

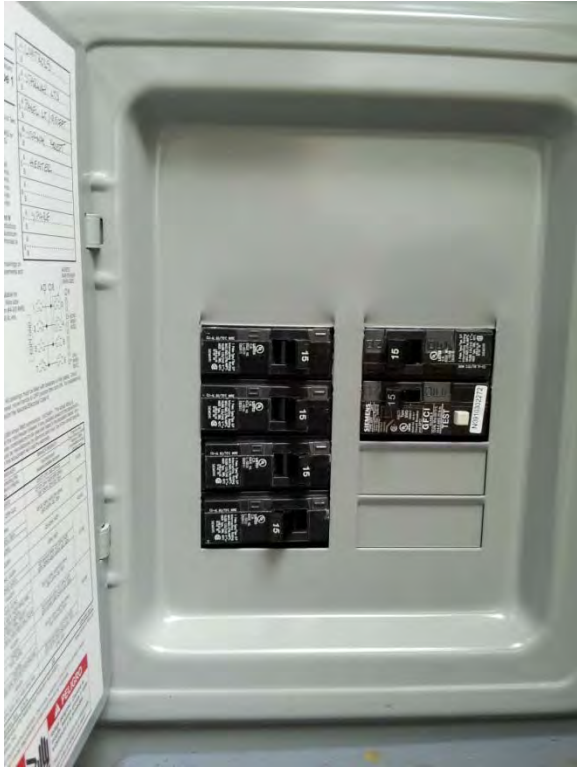
Panelboard located adjacent to street

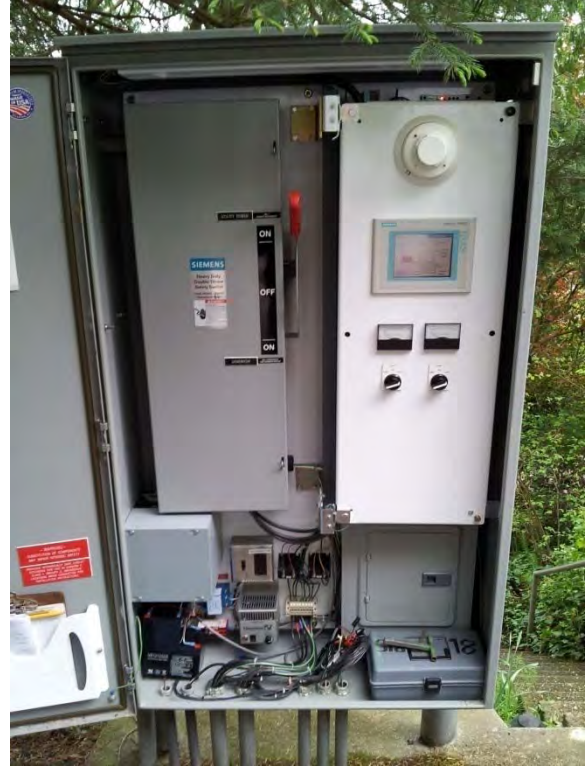
Starters located in cabinet, appears to be in good condition

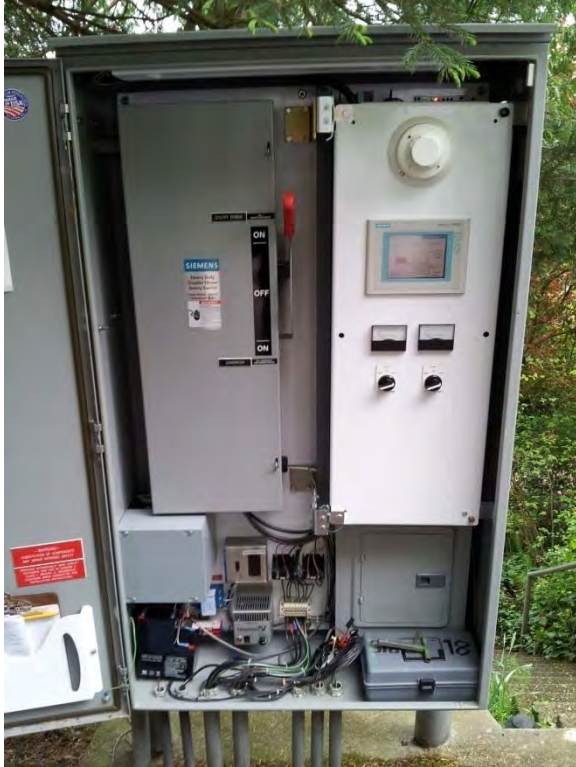
Telemetry control panel with operator interface

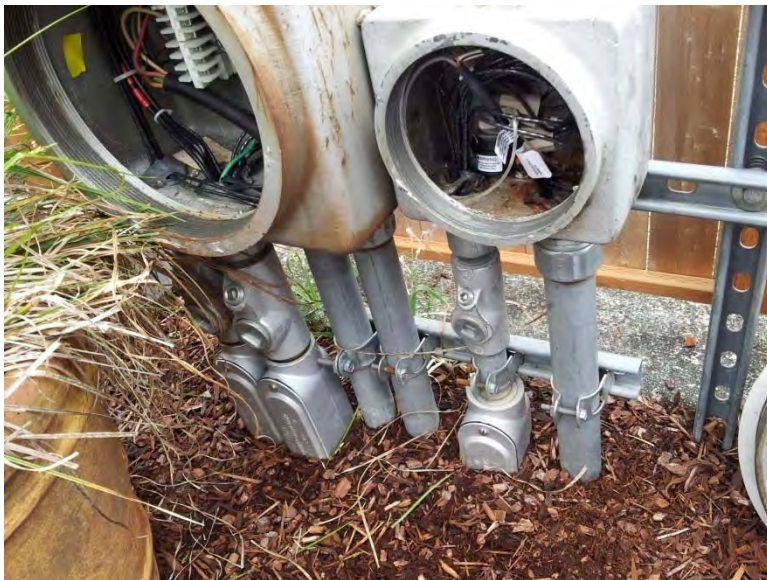
Submersible cable termination enclosure above grade at waterfront

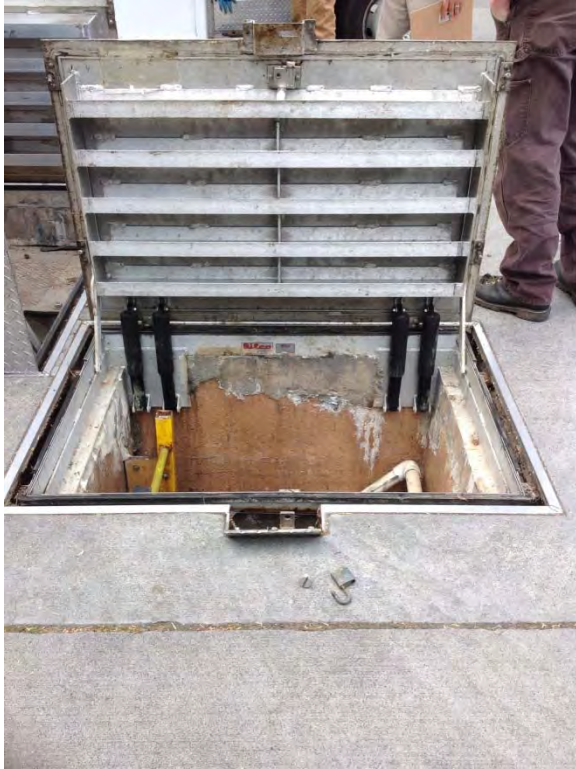
Wet well lift assist hatch, fatiguing evident

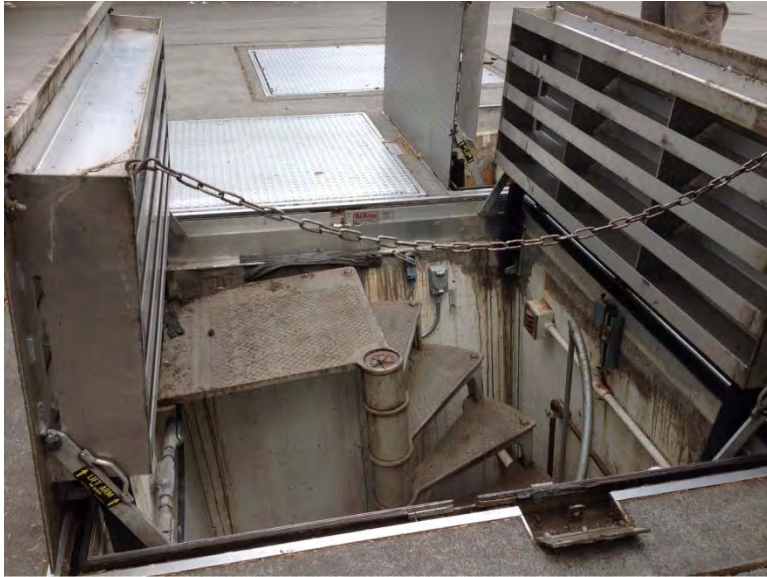
Access fall protection on one side of hatch opening

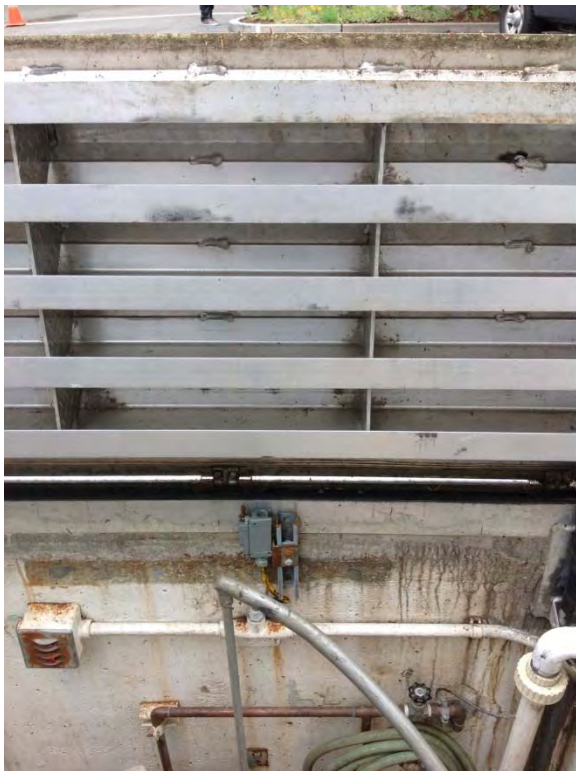
Dry pit hatch, fatiguing evident

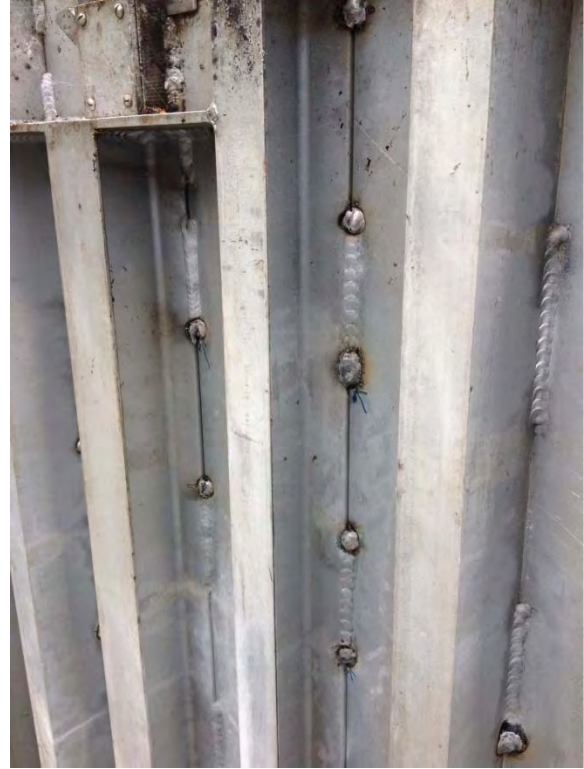
Wet well blower vault hatch, tacked up/re-hinged

- Drains to wet well
- Tacked up re-hinged hatch, fatiguing – due to trucks (garbage and others)
- Equipment does not appear to be rated for Class 1, Division 2 space (NFPA 820). Equipment was grandfathered-in so replacement is needed upon the next major rehabilitation project. See section 2 for grandfathered term reference.

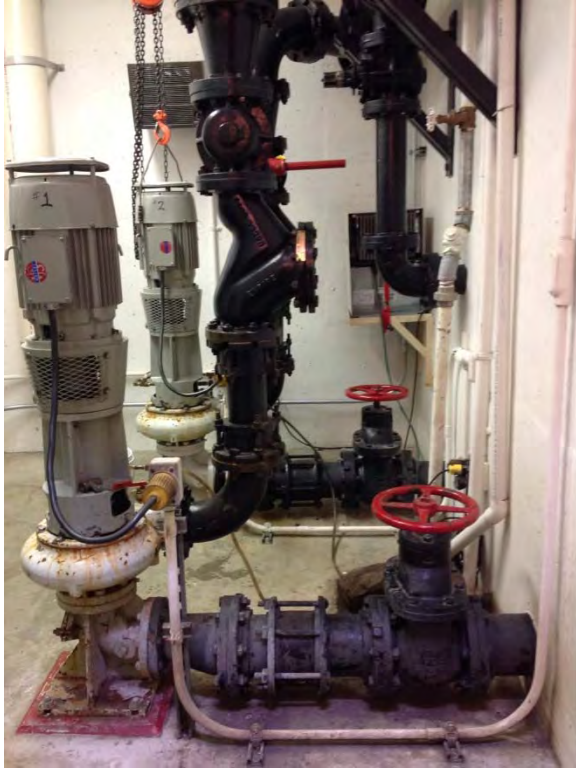
Duplex configuration, Pump 1 in foreground

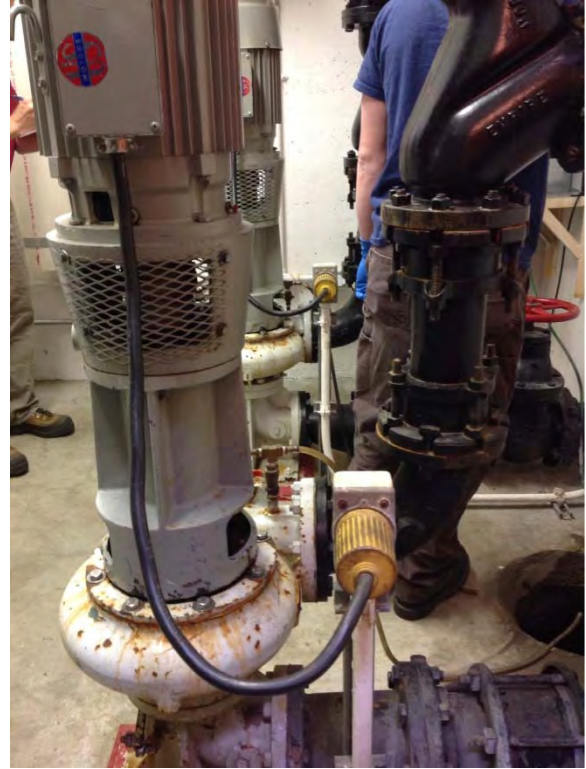
Pump and motor #1

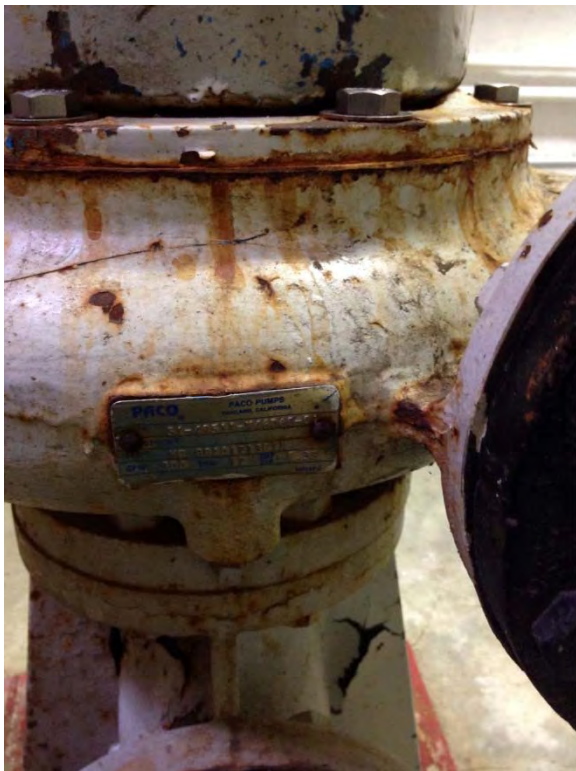
Pump 1 showing signs of aging on exterior

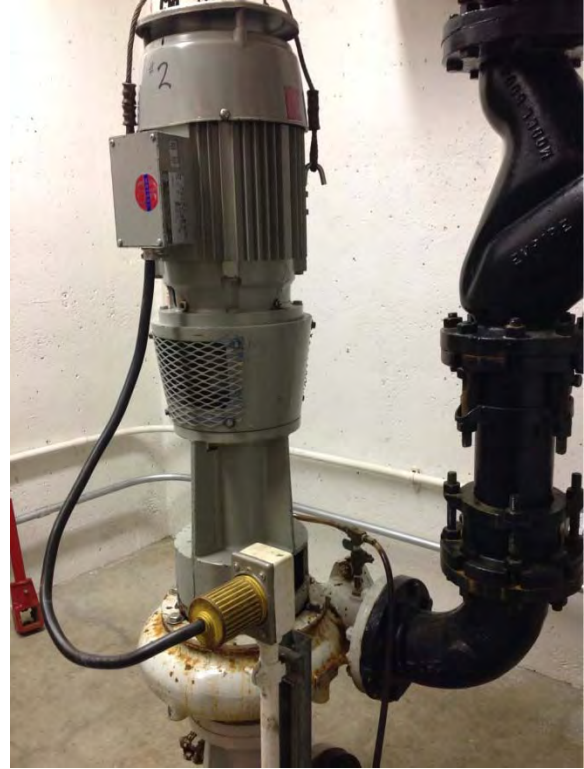
Pump and motor #2

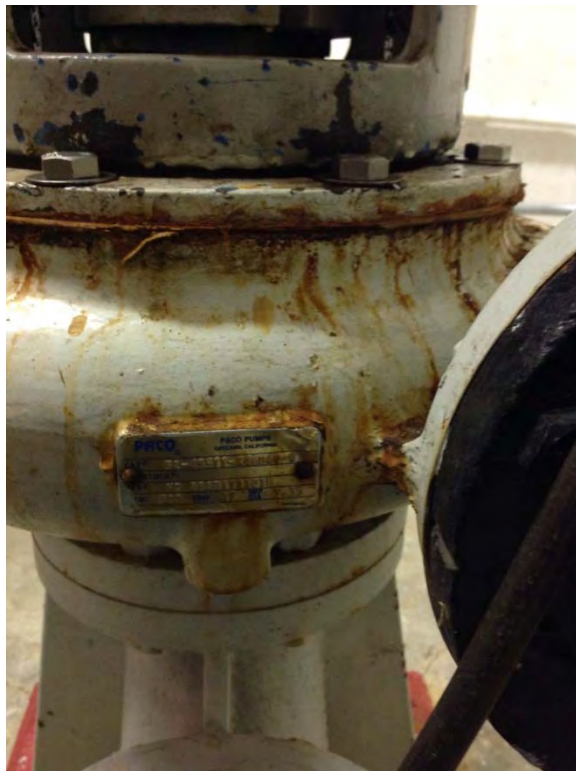
Pump 2 showing signs of aging on exterior

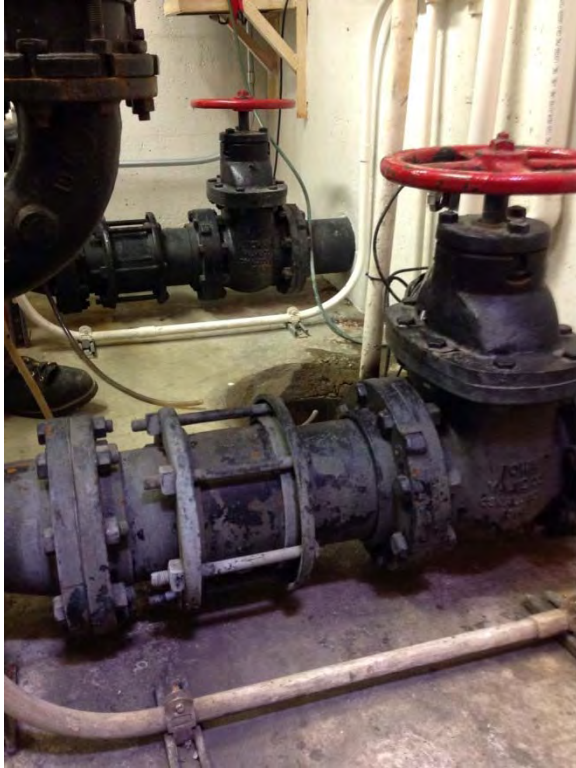
Gate valve isolation for suction piping

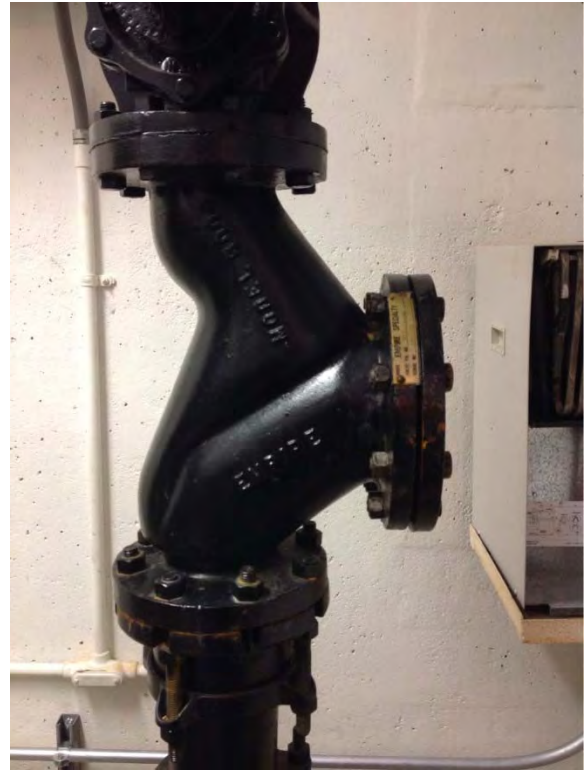
Ball check valve vertical installation on discharge piping

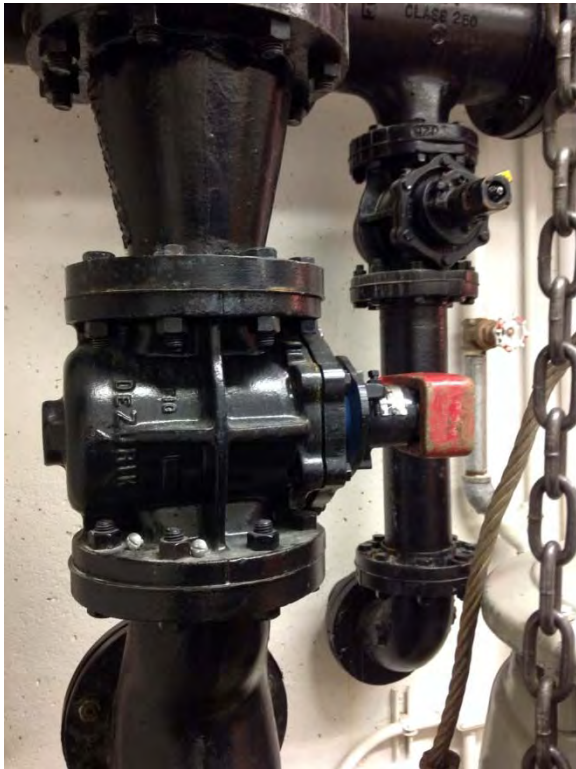
Plug valve on discharge piping

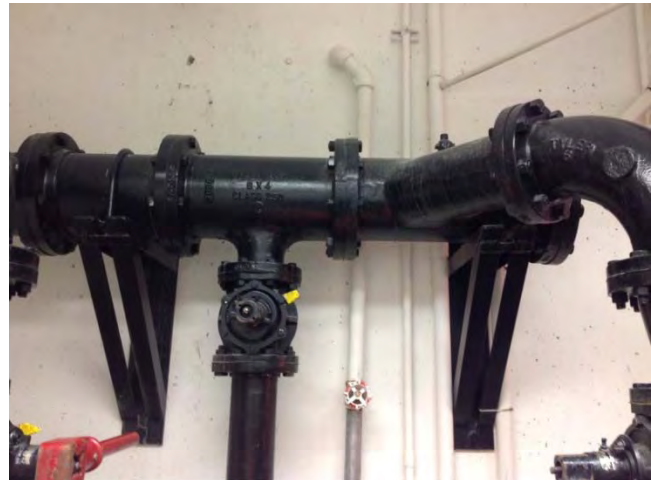
Common discharge piping

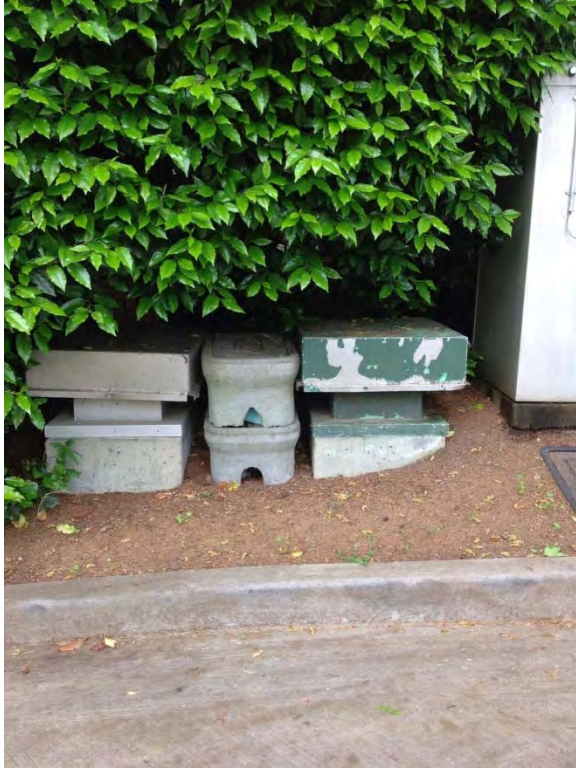
- Back flow assembly located between supply vents, adjacent to street

Backflow prevention assembly in two stacked water meter boxes between supply vents

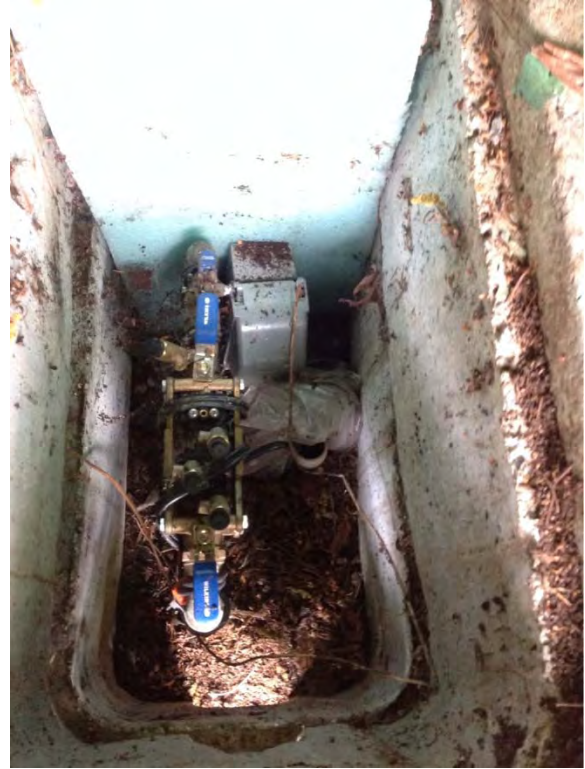
Backflow prevention assembly above grade

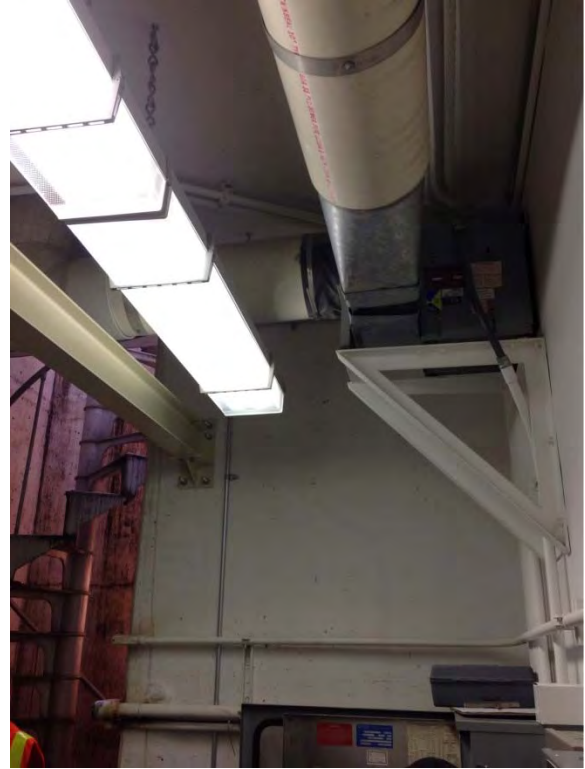
Location	10' AFF in dry pit
Fan type	Centrifugal
Airflow rate	820 CFM @ 1" SP*

Supply fan located near ceiling of dry pit

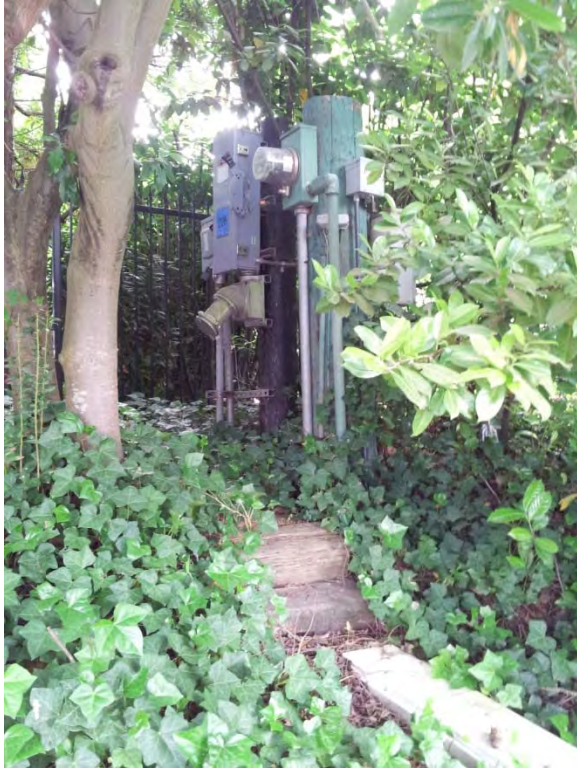
Utility service and generator receptacle located in raised landscaping area

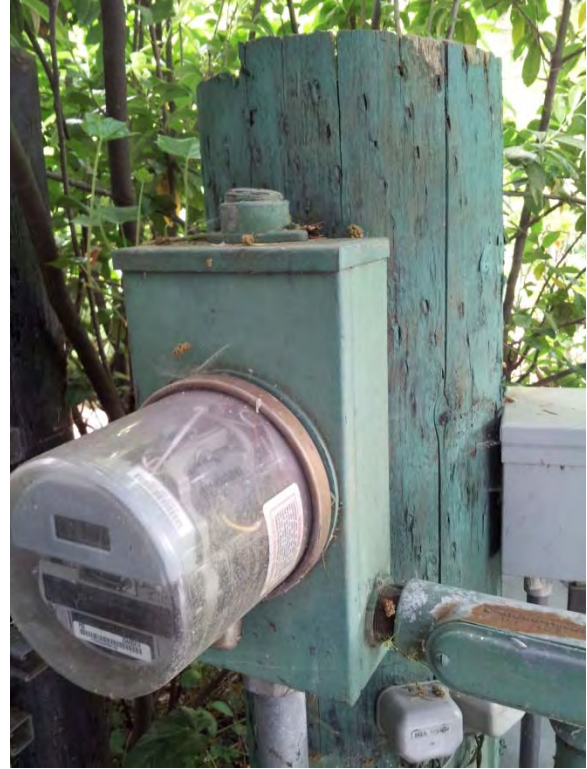
Service meter located on wood pole

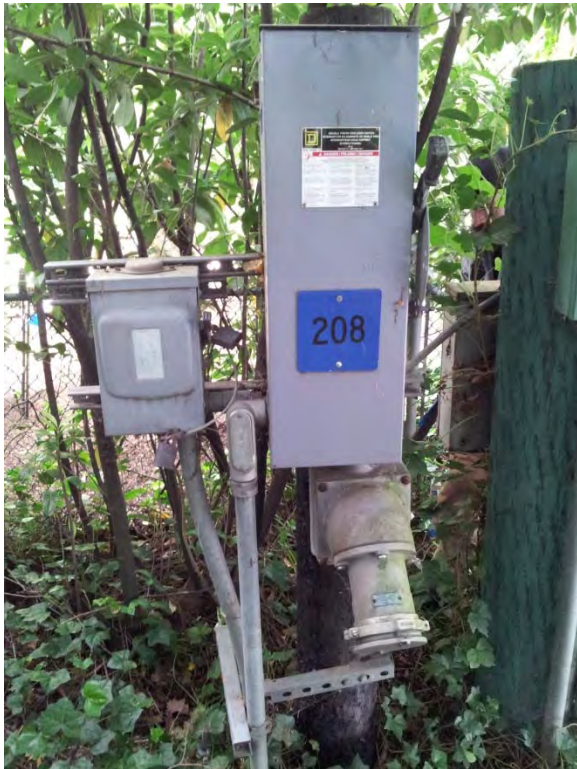
Generator receptacle located below manual transfer switch

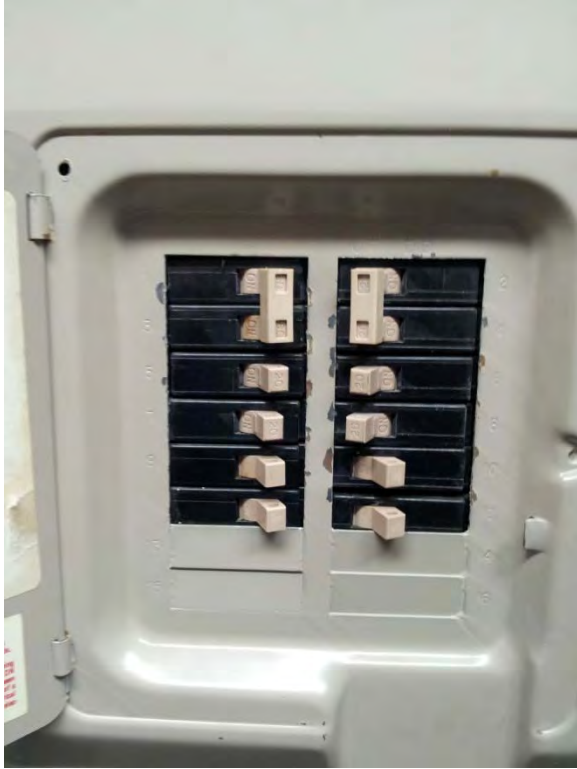
Condition Rating 3 – Old circuit breaker panel nearing end of its useful life

Panelboard located in dry pit, nearing end of its useful life

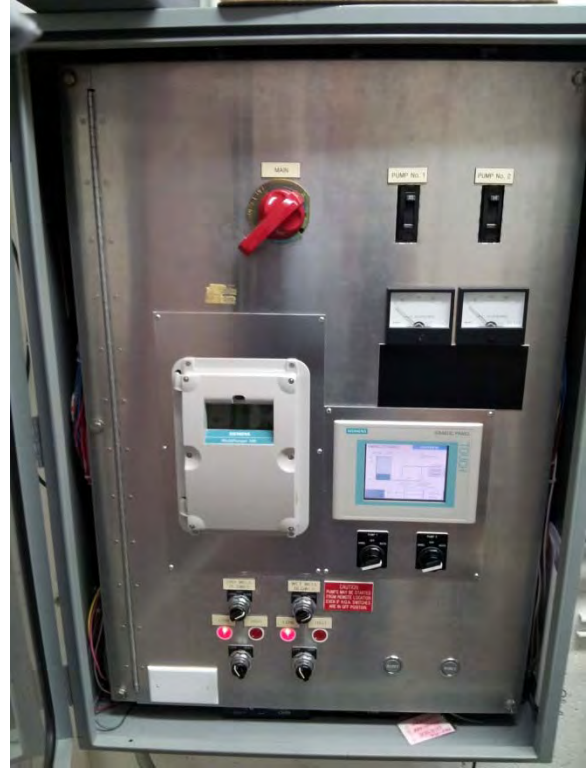
Condition Rating 3 – Original starters are nearing end of useful life

Original starters located in dry pit, nearing end of useful life

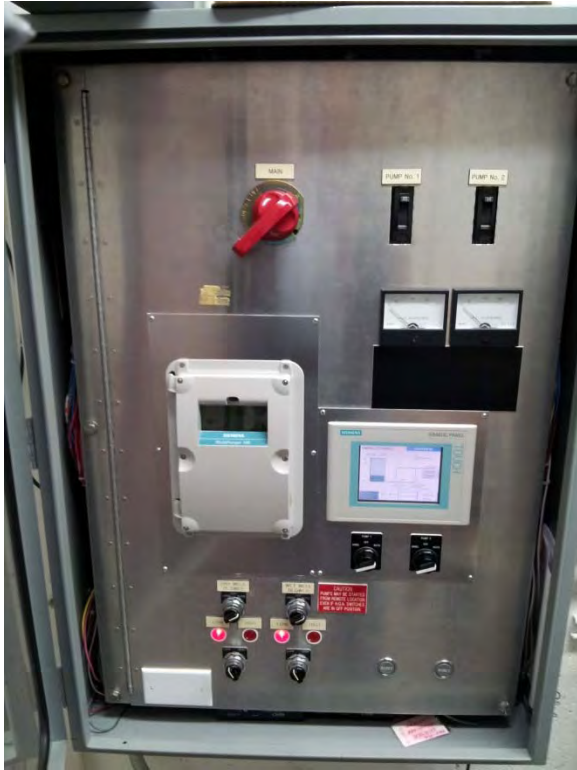
Starter/control panel with operator interface

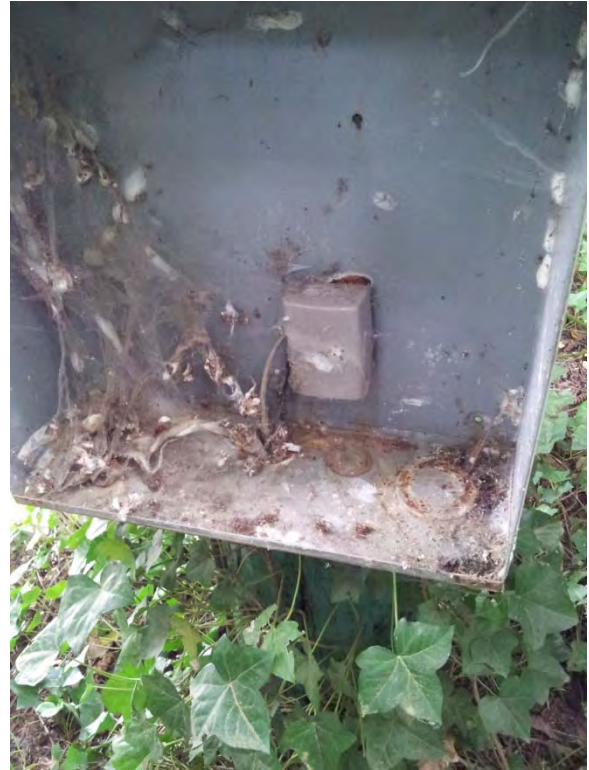
Telephone network interface located in oversized outdoor panel

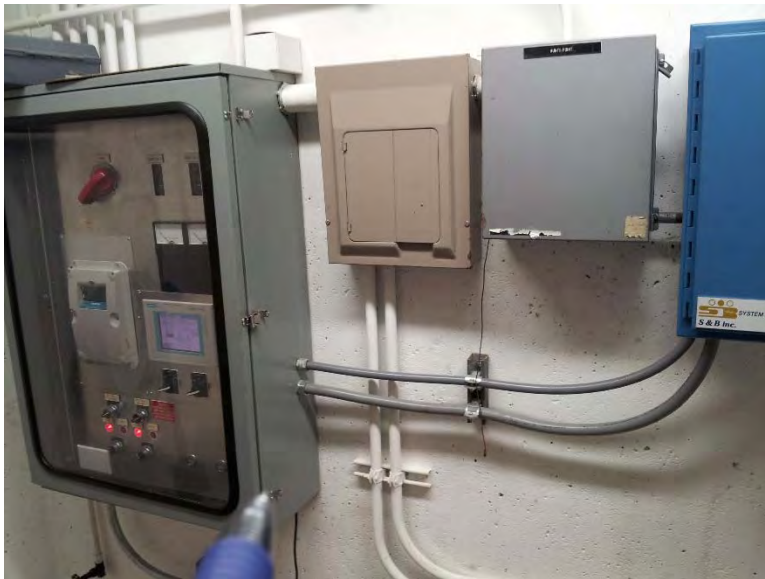
Starter/control panel located in dry pit

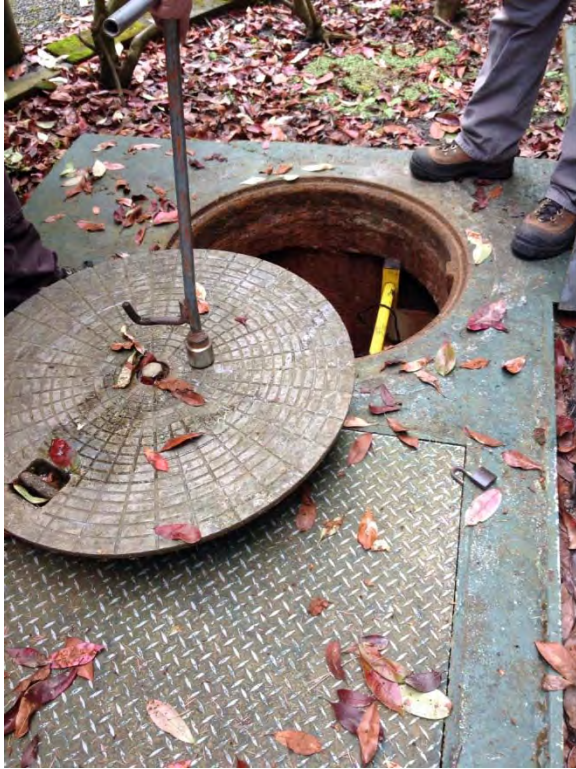
- 30" back from ladder to 12" diameter PVC vent pipe – possible clearance requirement issue
- Upon failure of locking access lid, alternate lid will need to be purchased/fabricated or entire top of wet well will need to be replaced with new concrete top and hatch

Wet well manhole lid

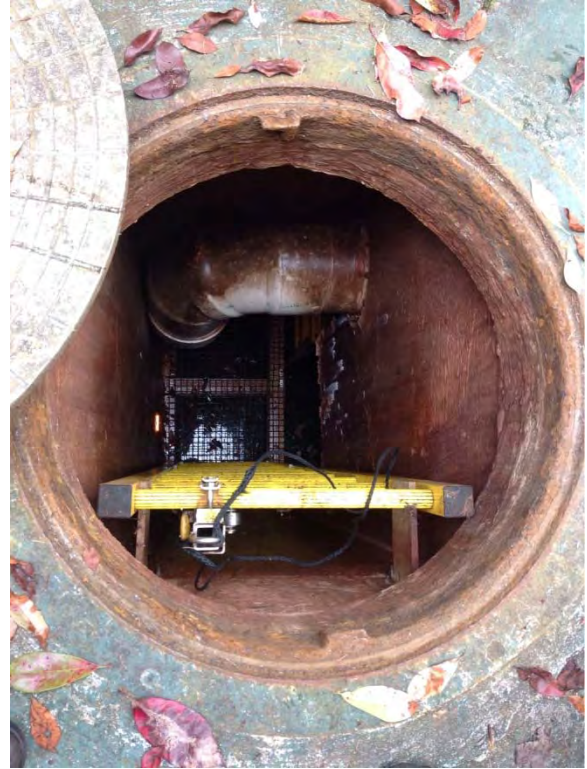
Interior of wet well, 30" back from ladder to 12" diameter PVC vent pipe

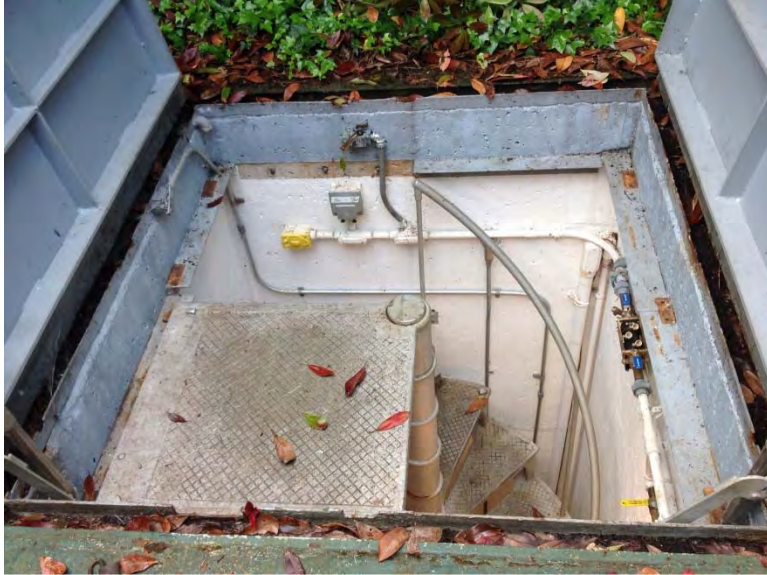
Some new paint interior near hatch and opening

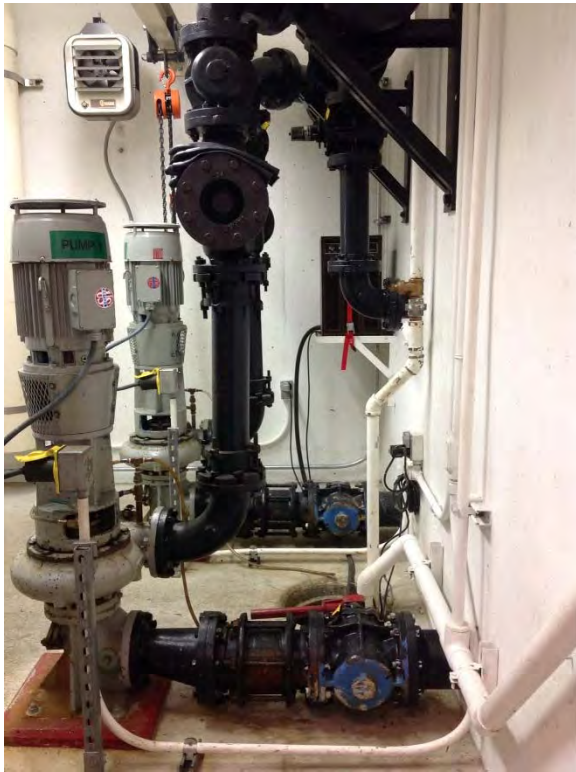
Interior of dry pit appears to be in good condition with good lighting

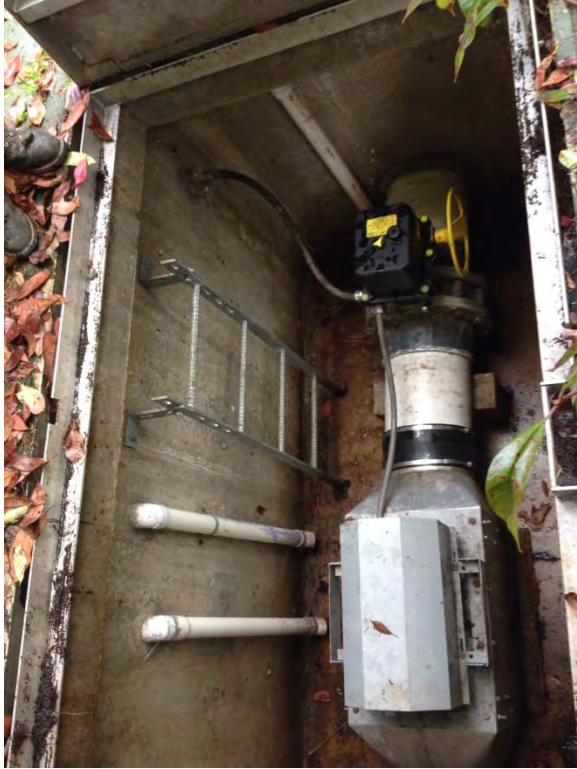
- Drains to dry pit
- Equipment does not appear to be rated for Class 1, Division 2 space (NFPA 820). Equipment was grandfathered-in so replacement is needed upon the next major rehabilitation project. See section 2 for grandfathered term reference.

Interior of wet well blower vault appears to be in good condition

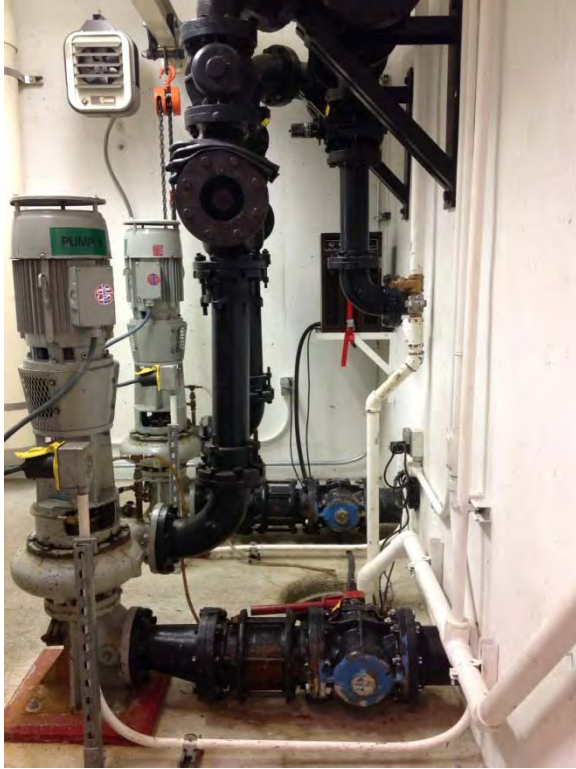
Duplex configuration, Pump 1 in foreground

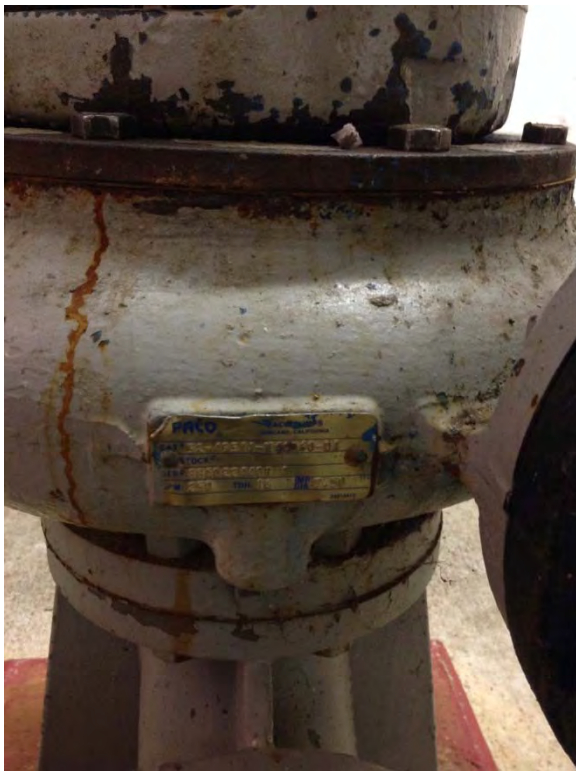
Pump 1 showing signs of aging on exterior

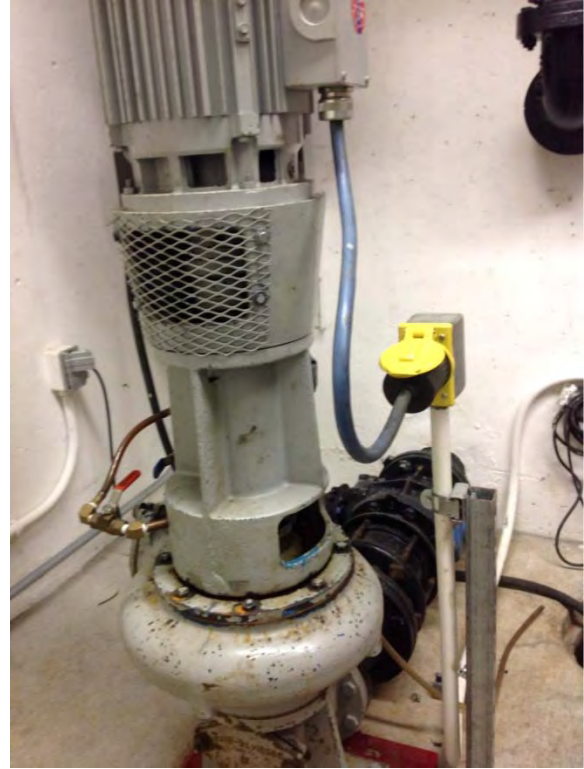
Pump and motor #2

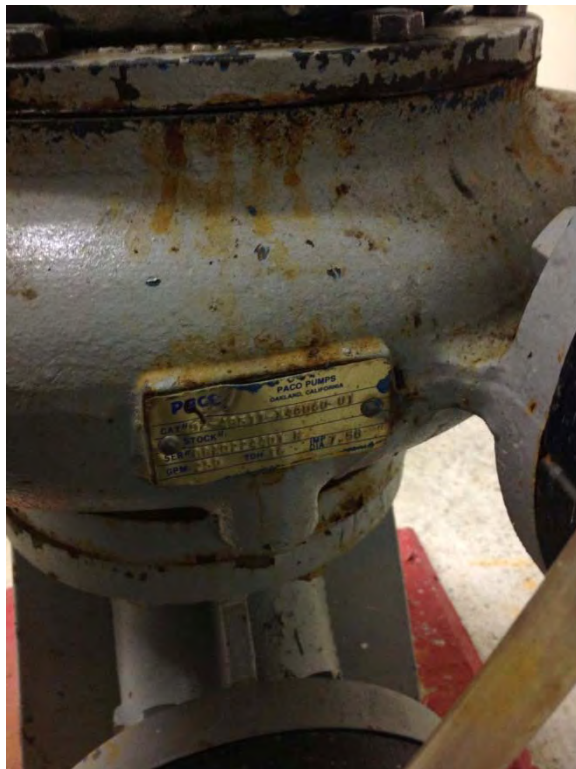
Pump 2 showing signs of aging on exterior

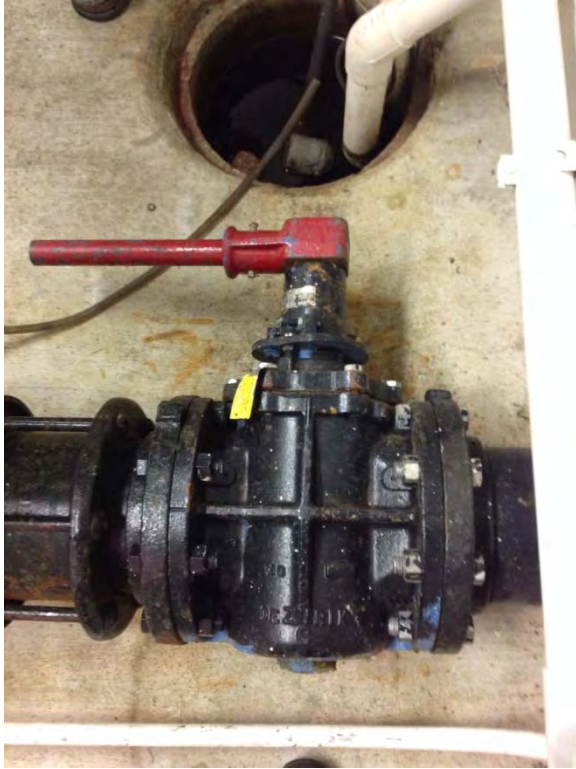
- Plug valve seats away from pump in vertical position – should seat up to avoid debris build up on backside of plug

Plug valve isolation for suction piping, horizontal axis of rotation

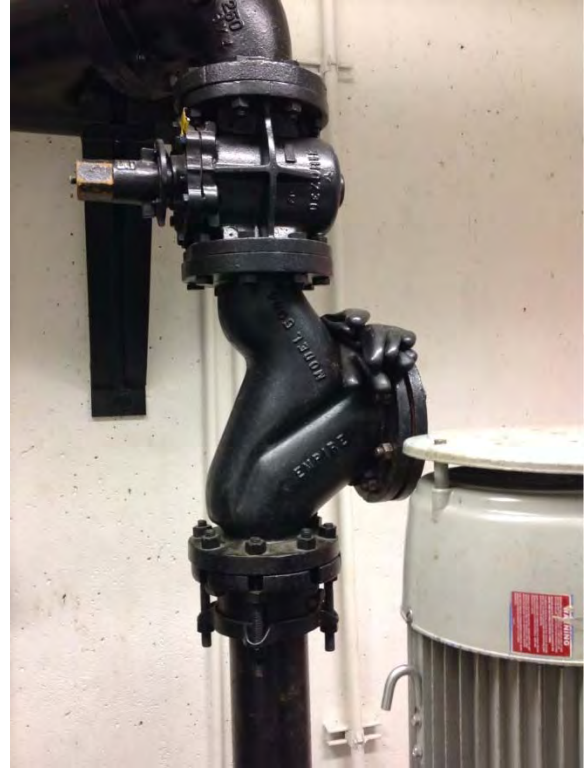
Ball check valve vertical installation and plug valve isolation on discharge piping

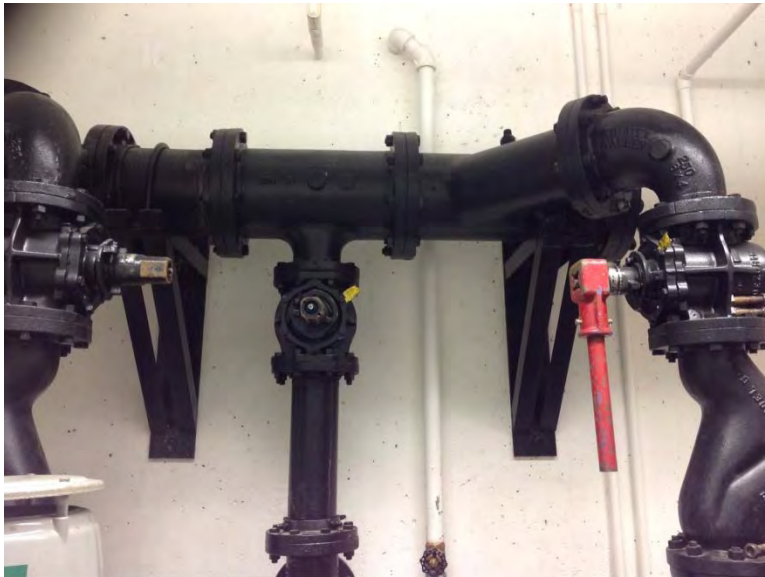
Common discharge piping

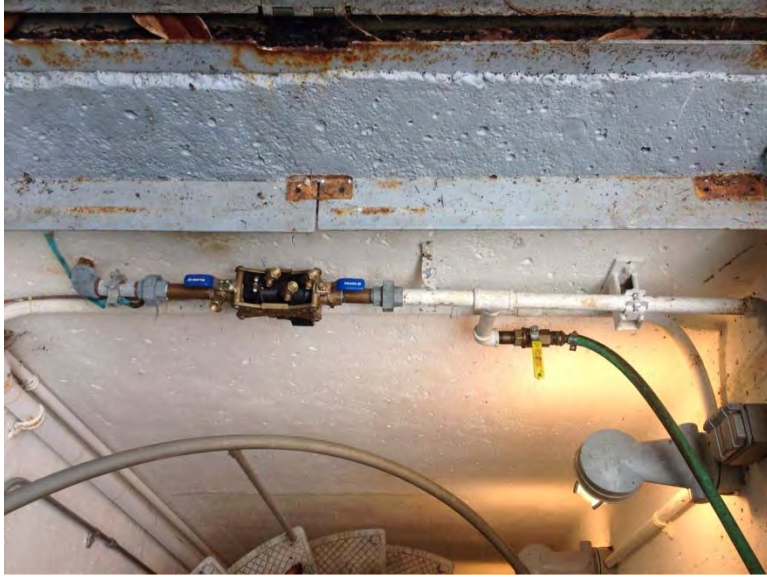
Supply	Domestic, metered. Shared service with the home adjacent to station.
Access	Hose bibb in dry pit in two locations
Backflow prevention assembly	Reduced pressure backflow device
Enclosure/Freeze protection	In dry pit near opening/dry pit insulation

Backflow prevention assembly located near dry pit opening
