Lake Washington Wastewater Lake Line Management Plan

FINAL / July 2024

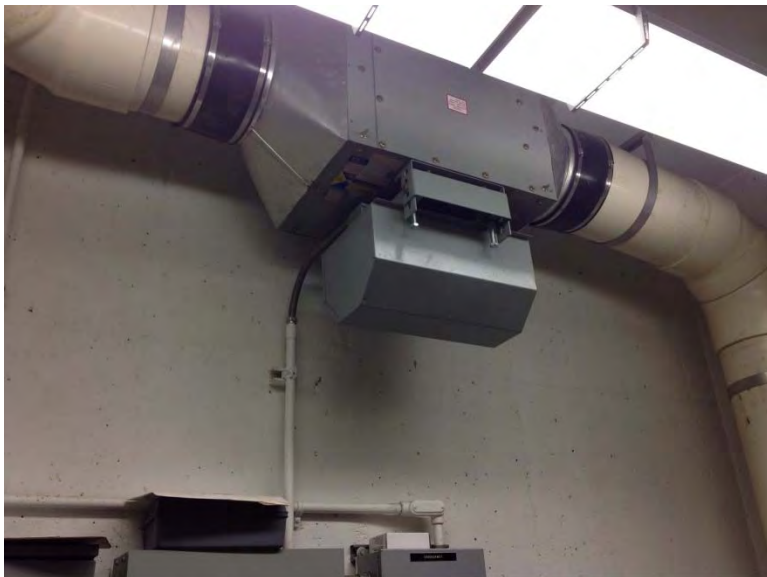
Supply fan located near ceiling of dry pit

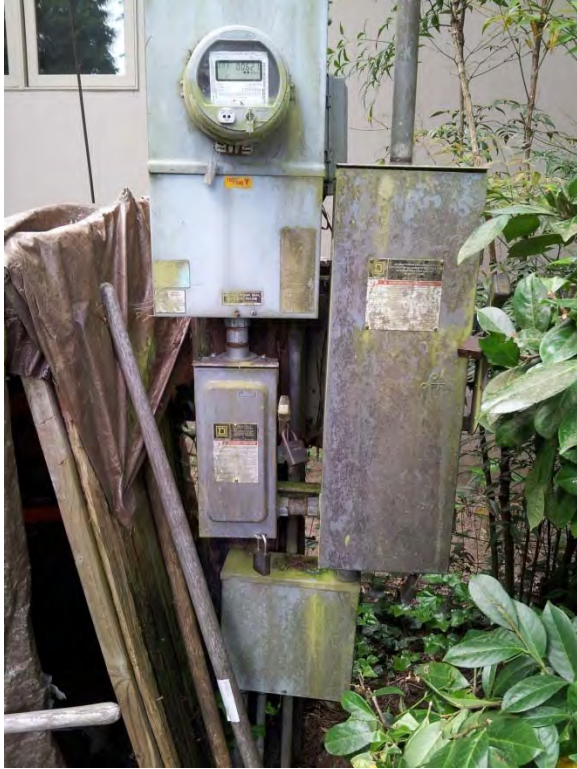
Utility service, service meter and manual transfer switch located on pole adjacent to site

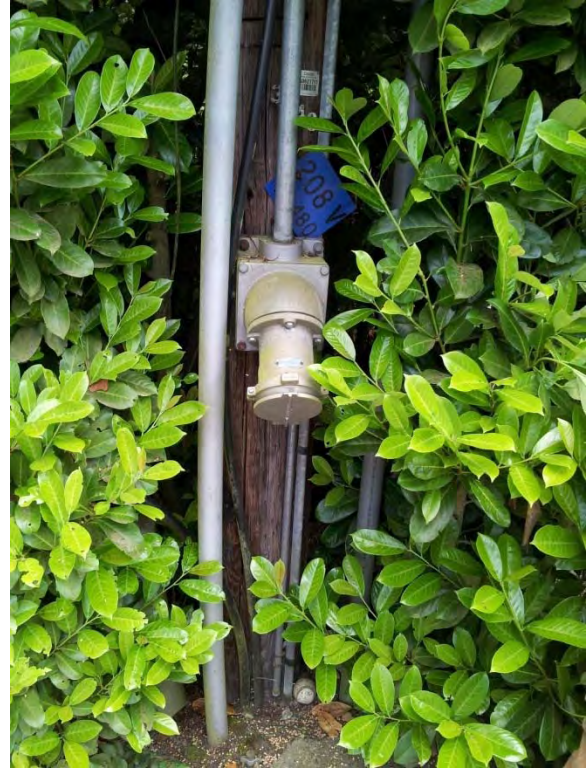
Generator receptacle located on pole near Evergreen Point Road

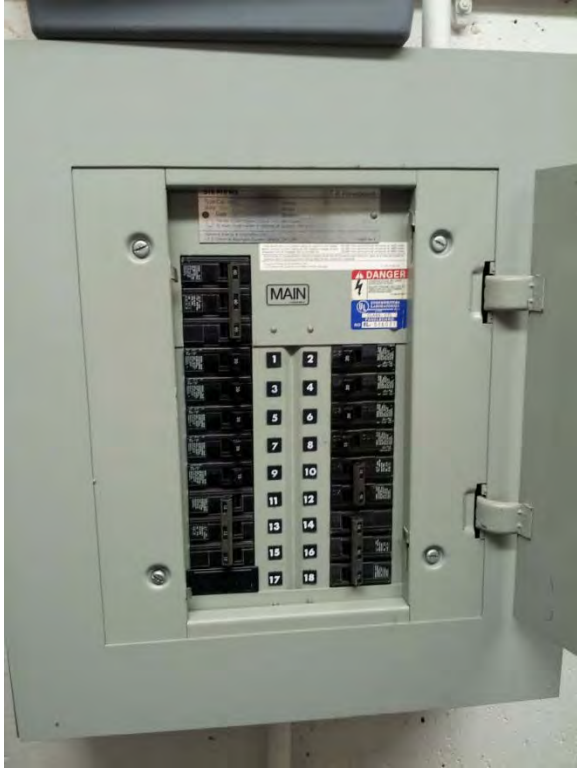
Panelboard located in dry pit, appears to be in good condition

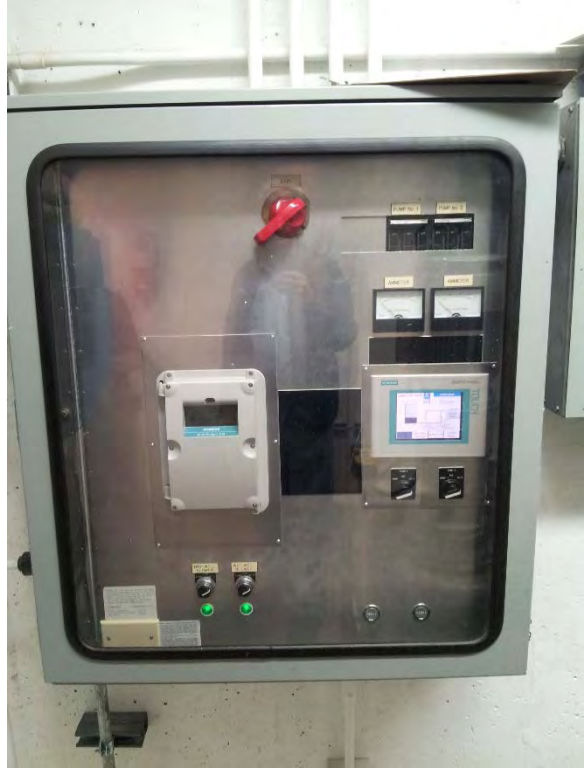
Starters located in dry pit, one original starter approaching end of useful life, the other has been replaced with a newer model

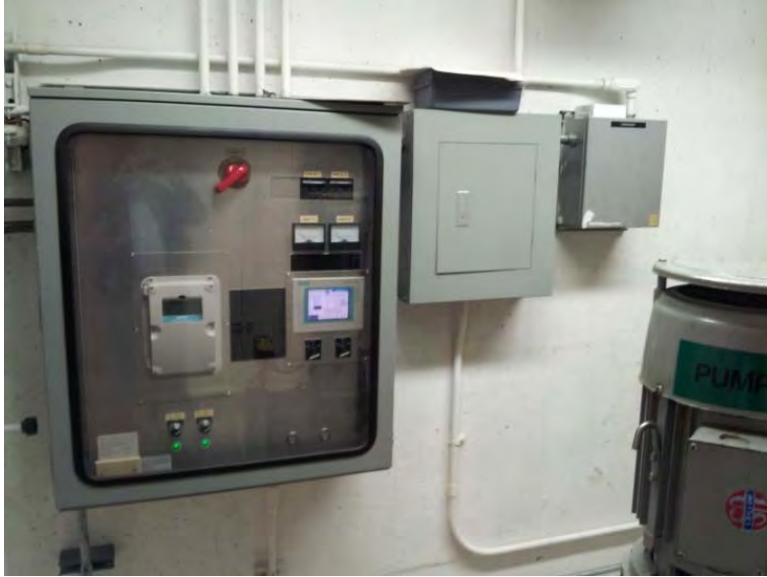
- Intrinsically safe relays do not have required clearance or barriers, code violation

Telemetry control panel located in dry pit, appears to be in good condition

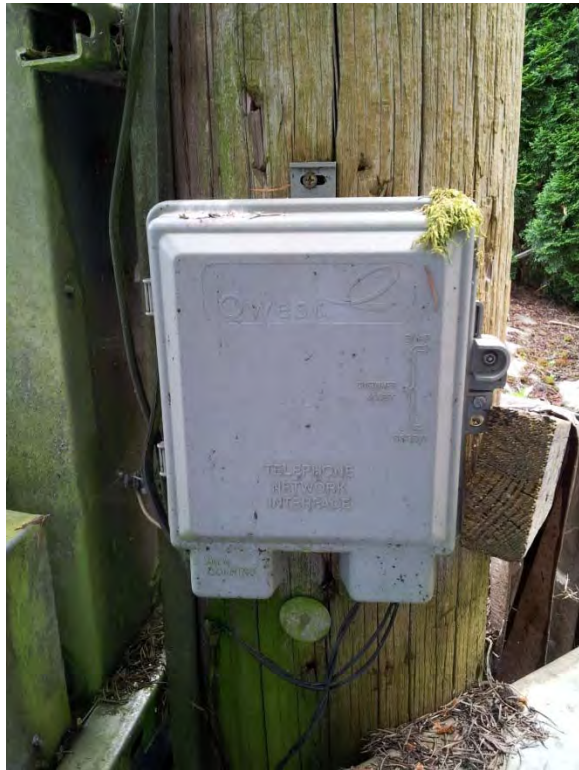
Telephone network interface located in outdoor junction box

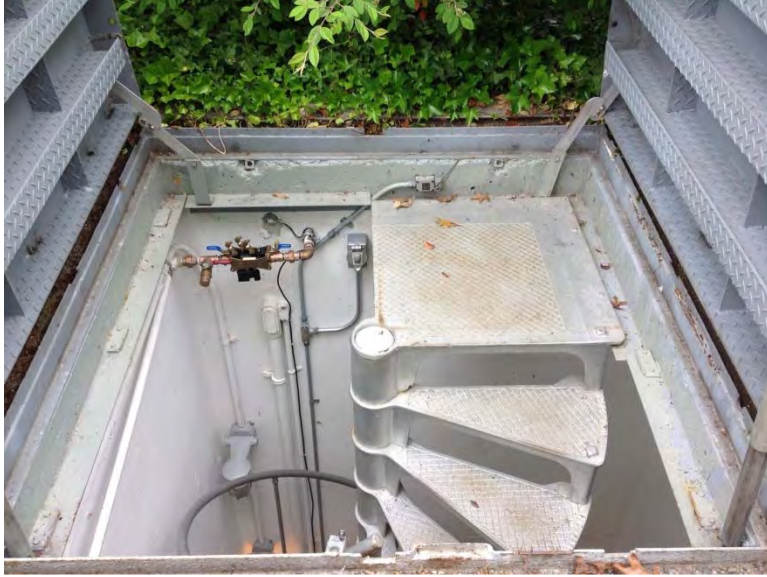
- Dry Pit access to top of spiral stair case on opposite side of accessibility – staff currently steps over open space to landing

Dry pit access to top of spiral stair case
on opposite side of accessibility

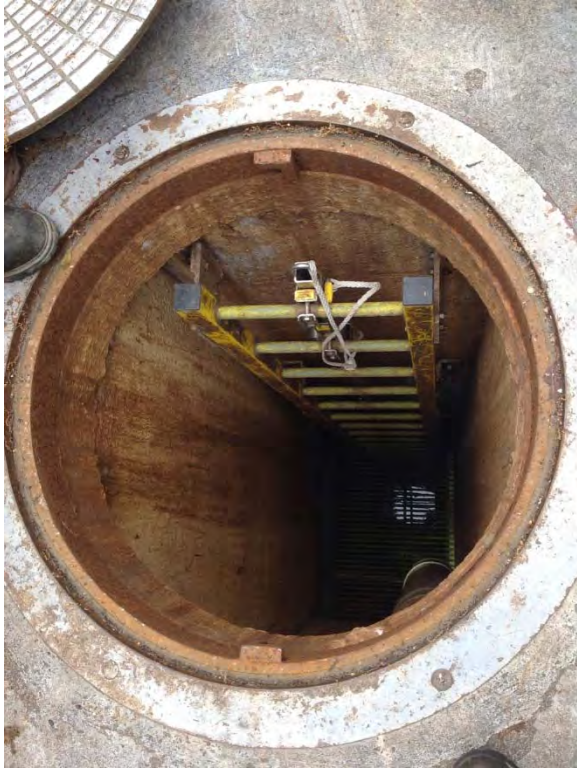
Interior of wet well appears to be in good condition with some degradation

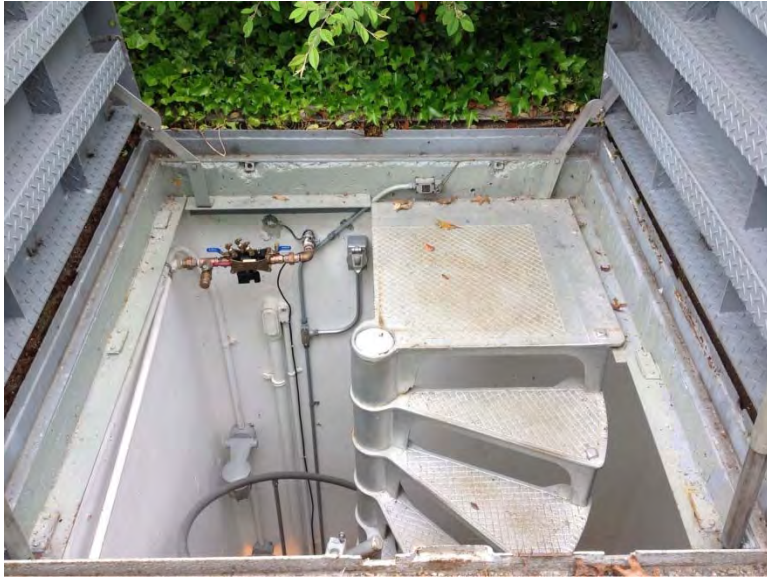
- Safety issue when stepping over to spiral staircase landing
- Sump pump has grating and wire mesh, removes hazard for stepping into sump

Potential safety issue, stepping over to spiral staircase landing

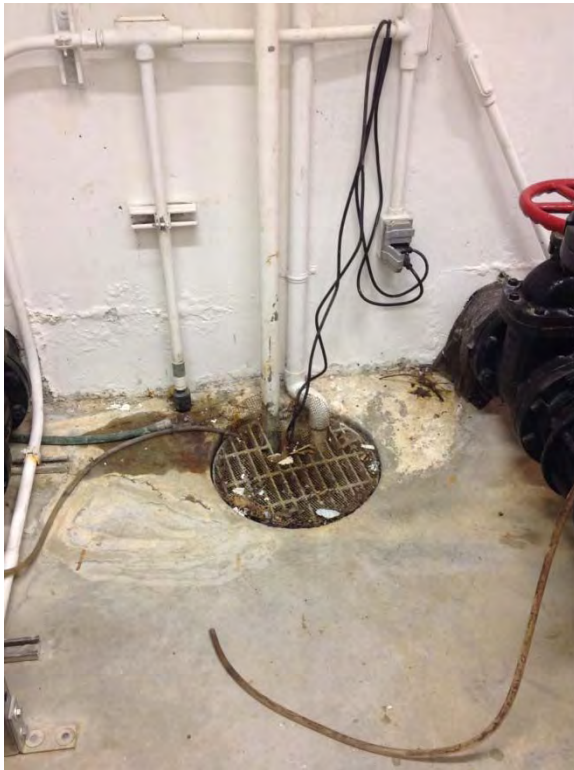
Metal grating and wire mesh on sump, no hazard for stepping into sump

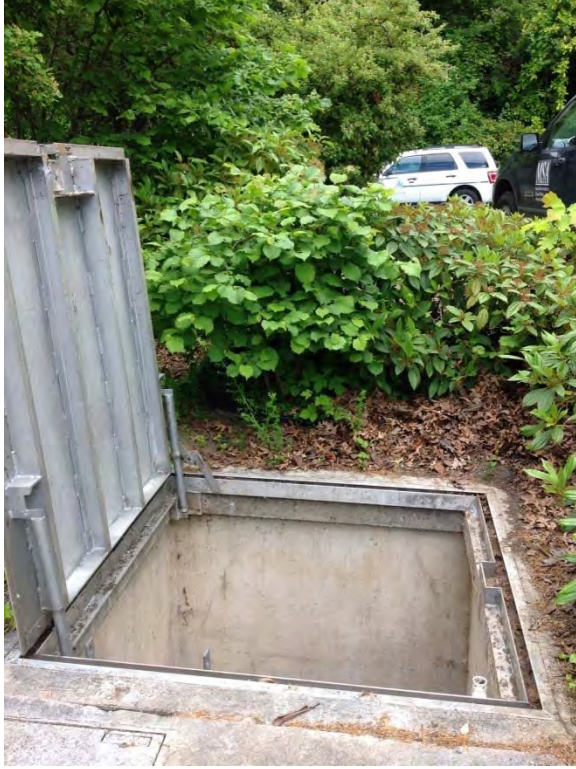
Wet well blower vault hatch

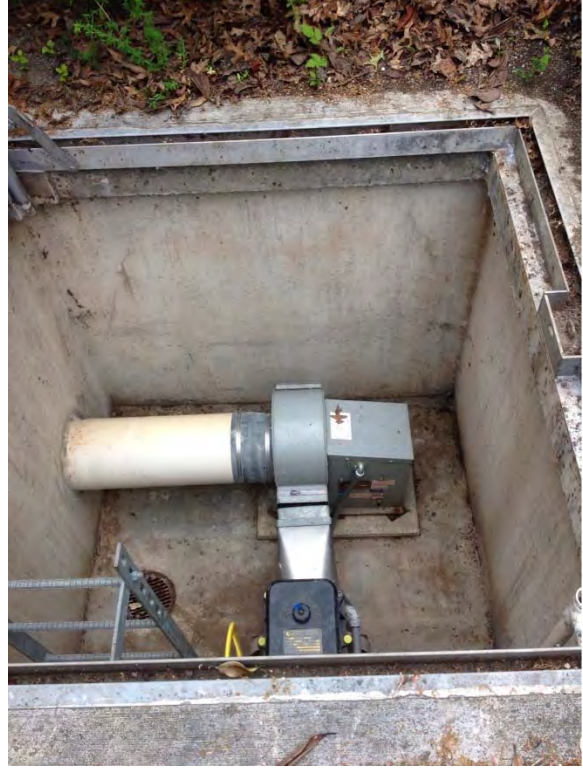
- Equipment does not appear to be rated for Class 1, Division 2 space (NFPA 820). Equipment was grandfathered-in so replacement is needed upon the next major rehabilitation project. See section 2 for grandfathered term reference.

Interior of wet well blower vault

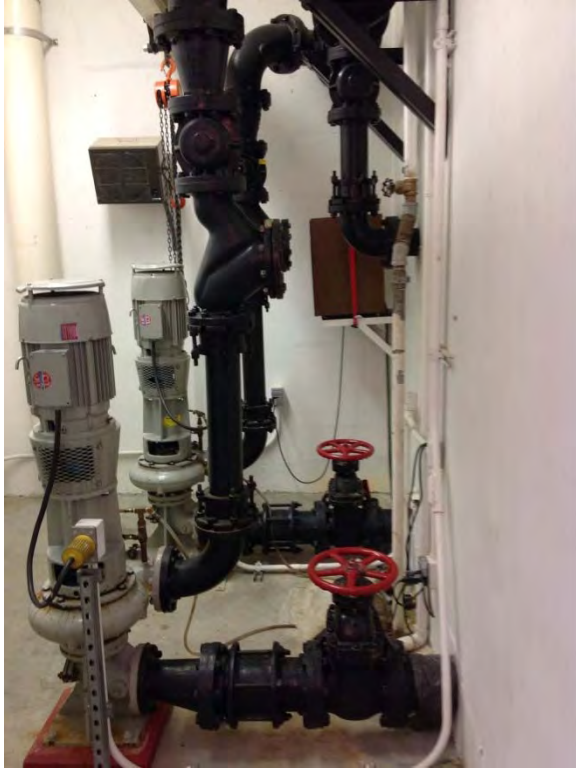
Duplex configuration, Pump 1 in foreground

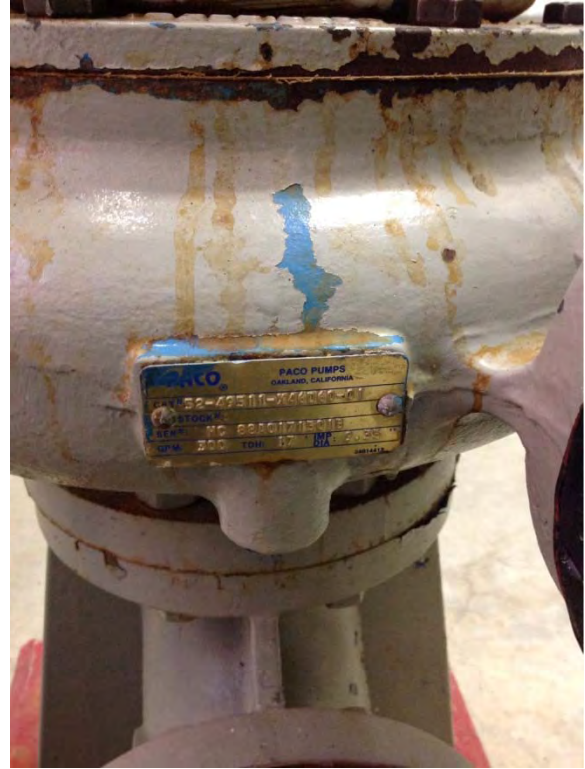
Pump 1 showing signs of aging on exterior

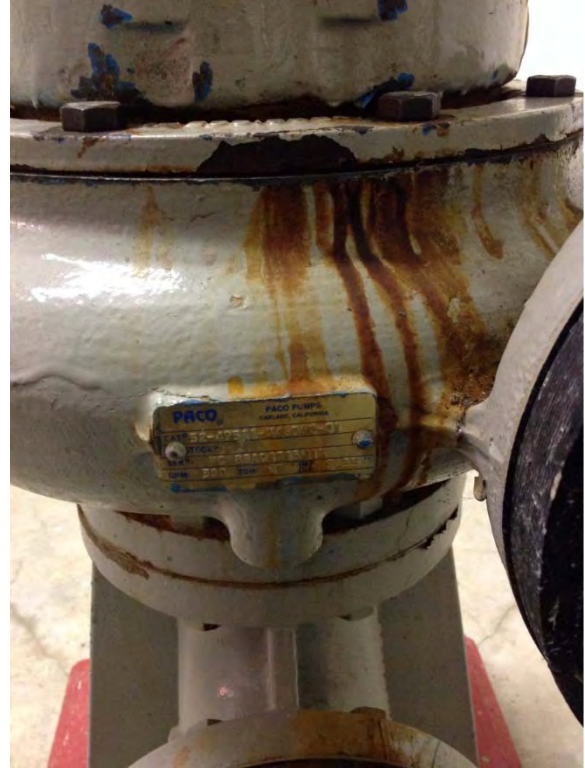
Pump 2 showing signs of aging on exterior

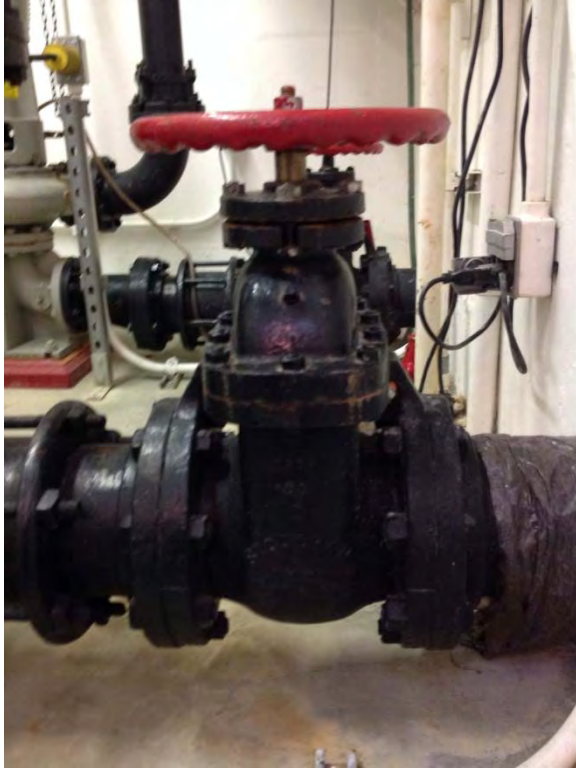
Gate valve isolation for suction piping

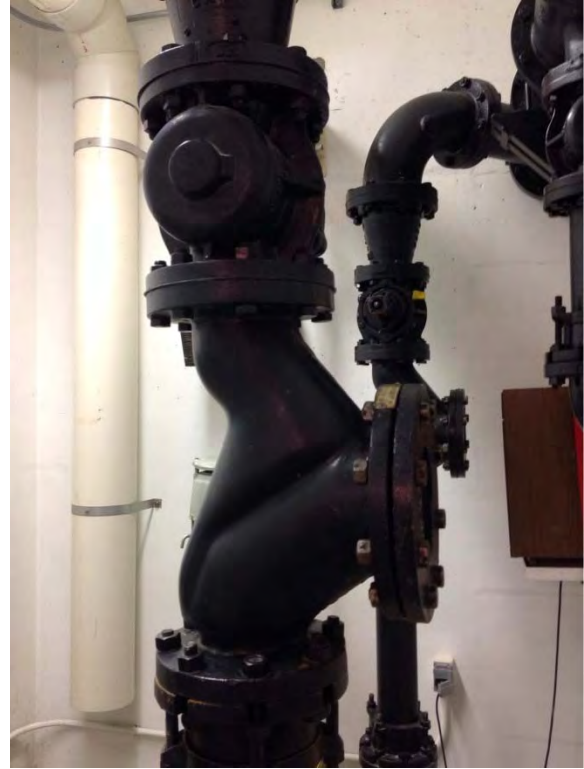
- Plug valve seats up – ideal installation

Ball check valve vertical installation and plug valve on discharge piping

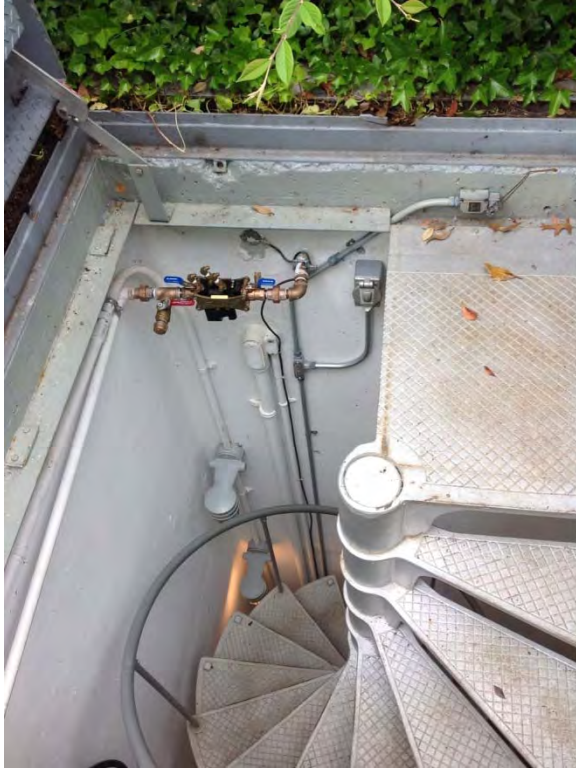
Backflow prevention assembly near top of dry pit

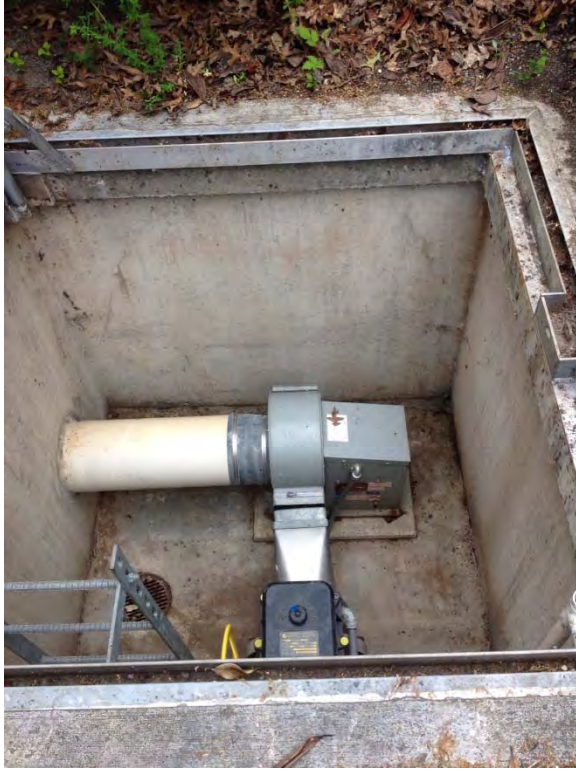
Wet well supply fan located in wet well blower vault

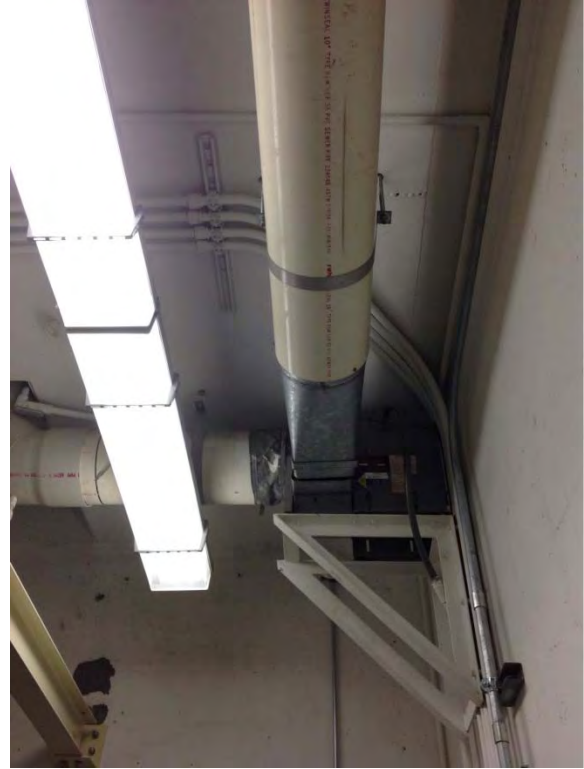
Supply fan located near ceiling of dry pit

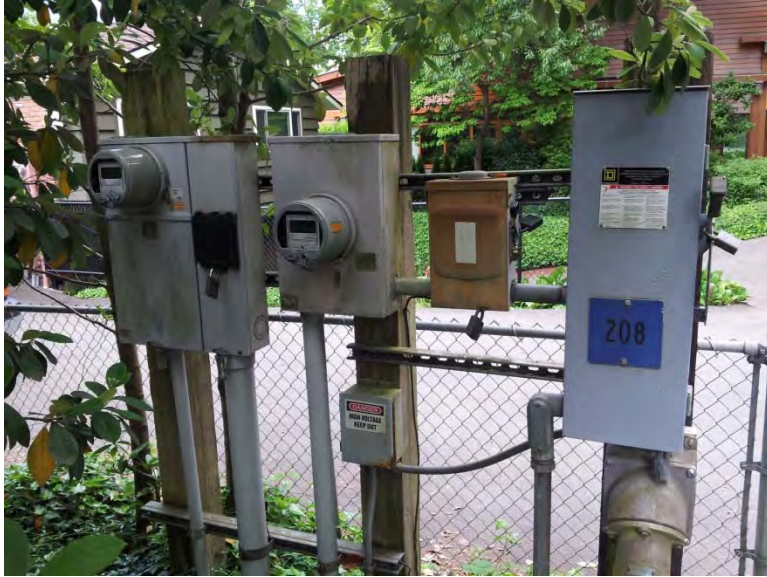
Utility service and generator receptacle located on steel rack near gate, disconnect equipment needs replacement

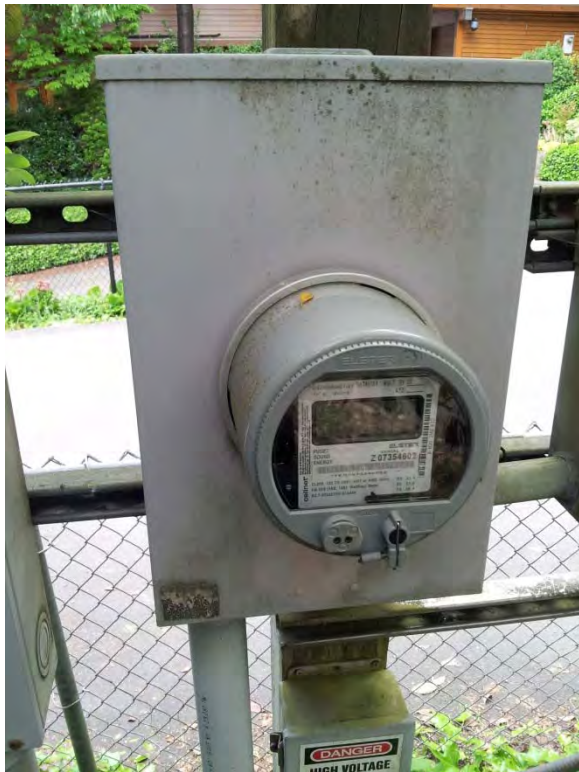
Utility service meter

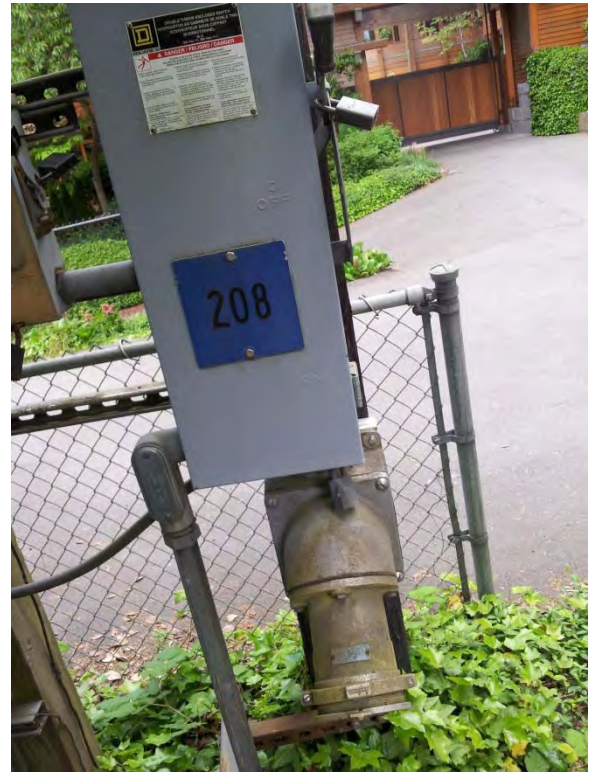
Generator receptacle located below manual transfer switch

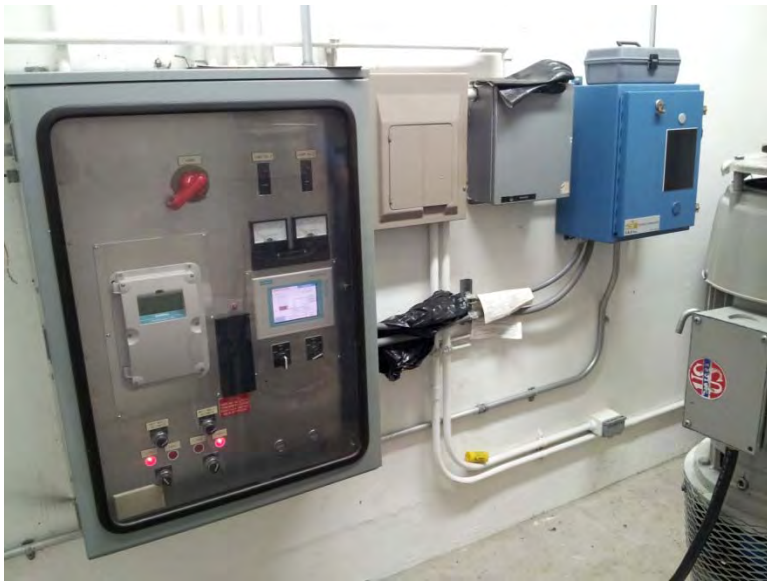
Panelboard and starters located in dry pit

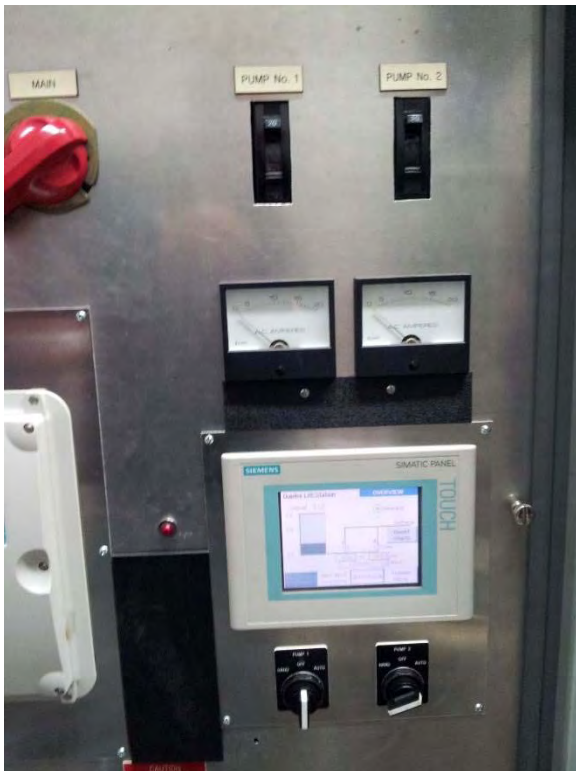
Original Cutler Hammer starters and GE circuit breakers appear to be in good condition but have limited remaining life

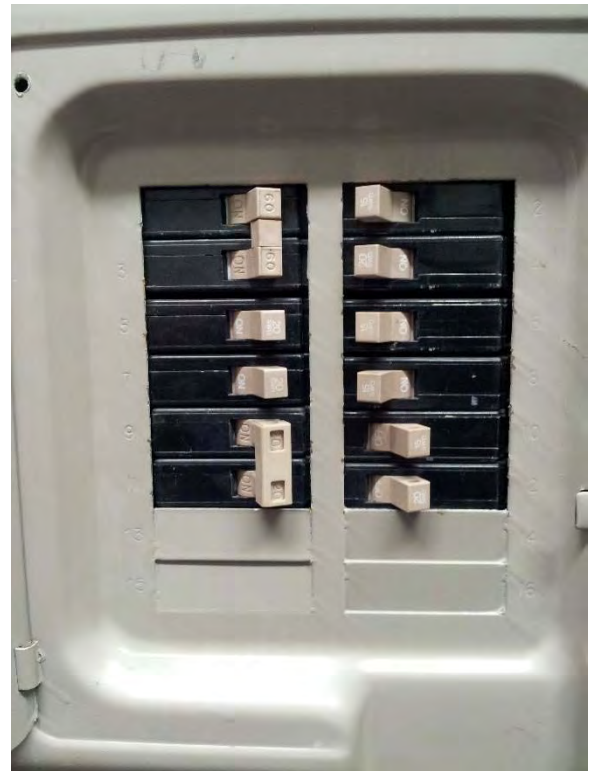
Cutler Hammer Load Center is nearing end of useful life

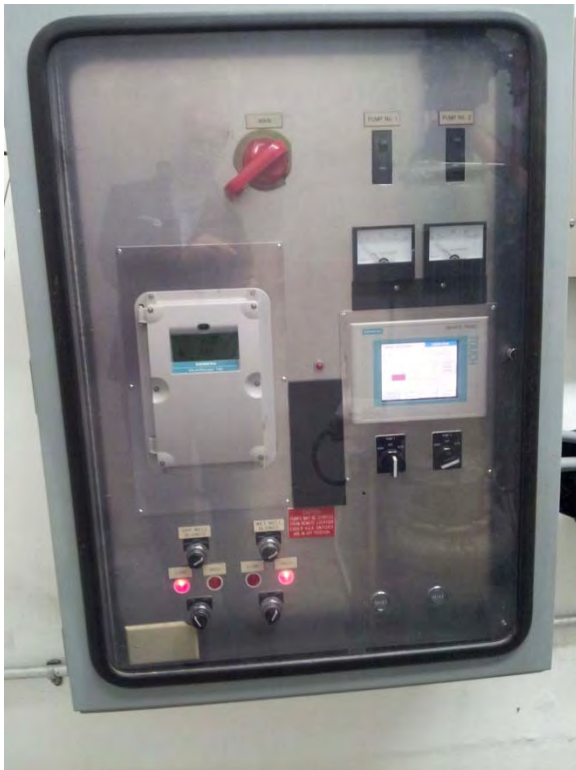
Telemetry control panel appears to be in good condition

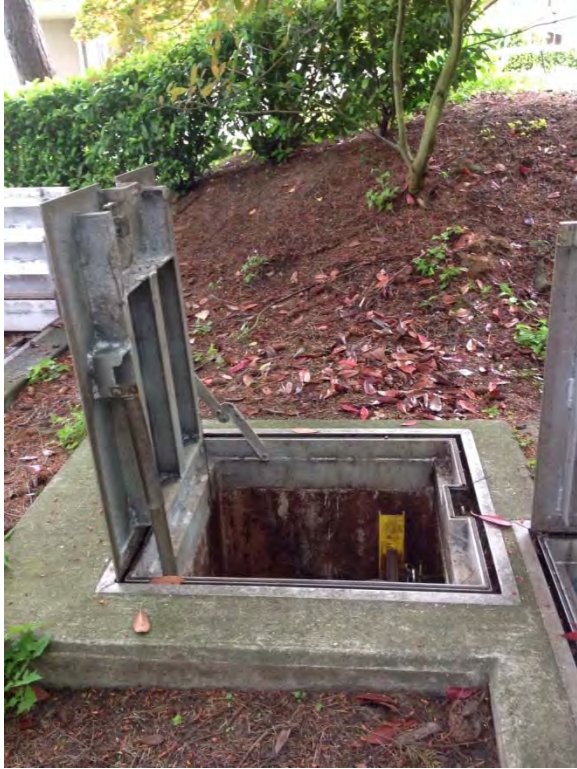
Wet well access hatch

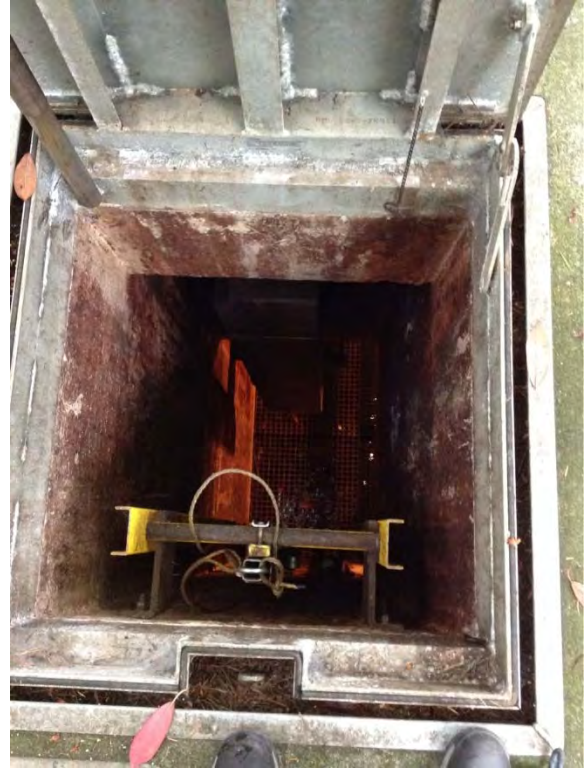
Interior of wet well

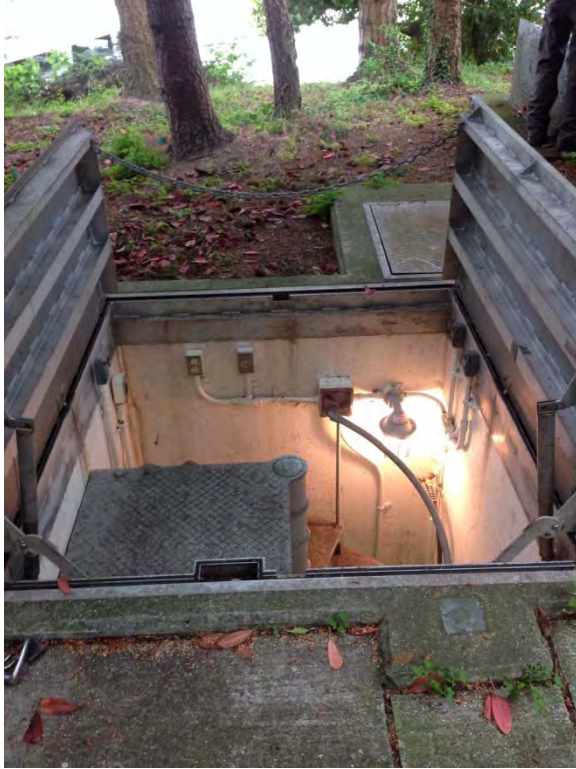
Lift assist access hatch and spiral staircase, chain fall protection on one side

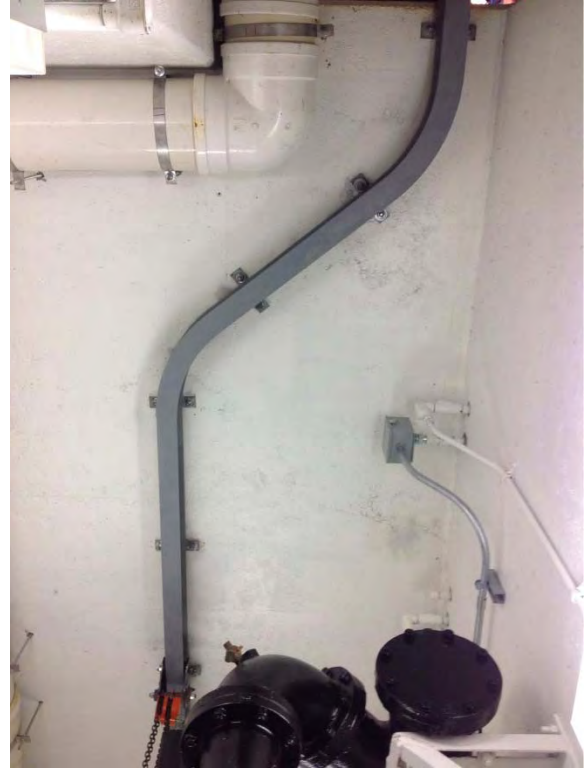
- No equipment access hatch

Ceiling of dry pit, rail with no equipment access hatch

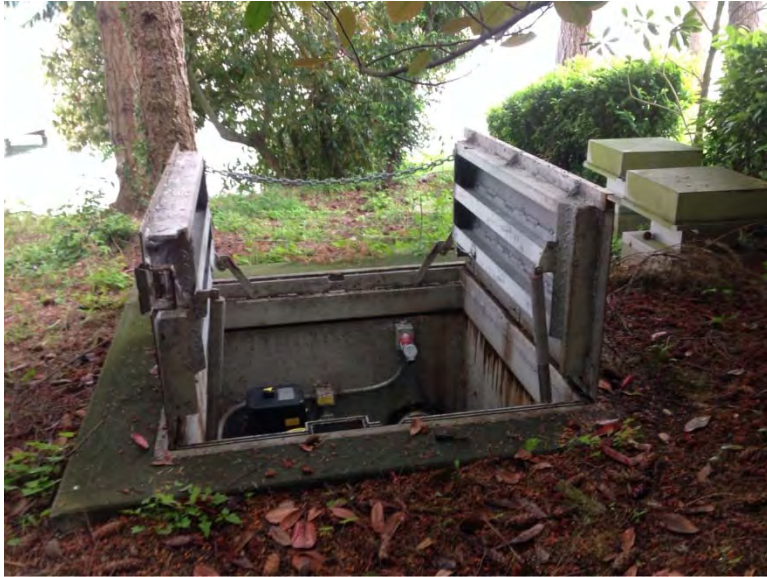
Wet well blower vault hatch, chain fall protection on one side

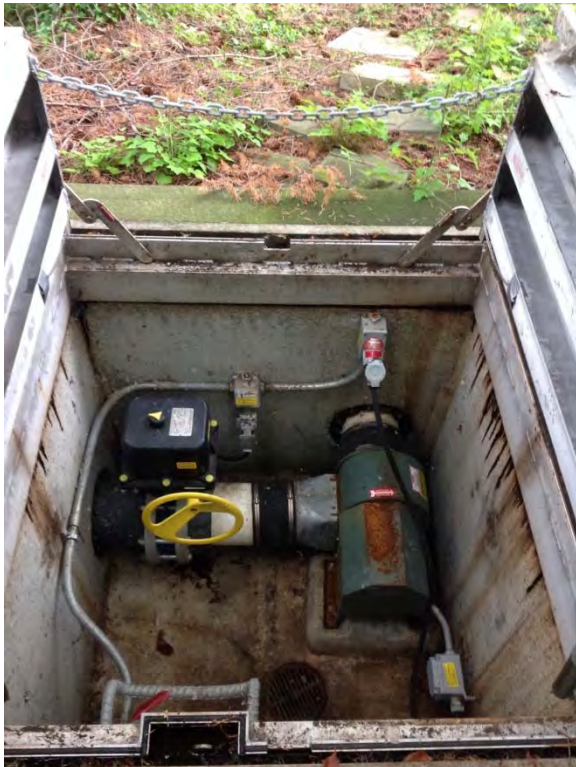
Interior of wet well blower vault

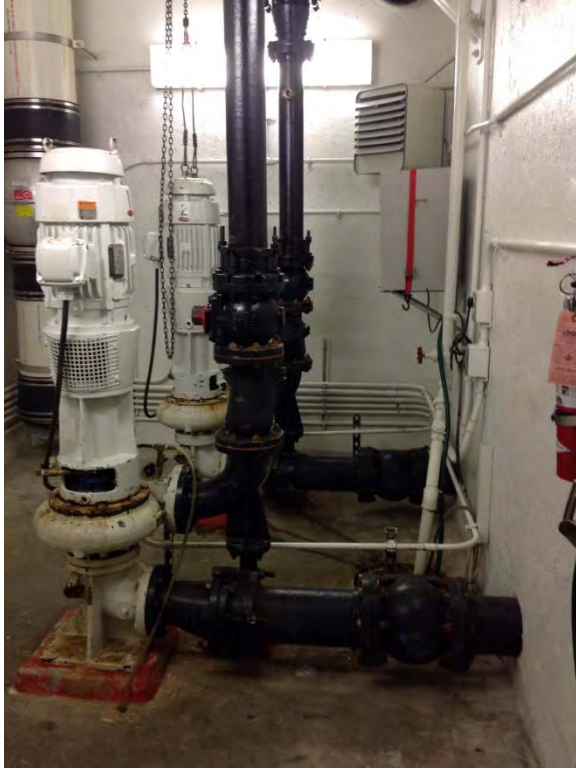
Duplex configuration, Pump 1 in foreground

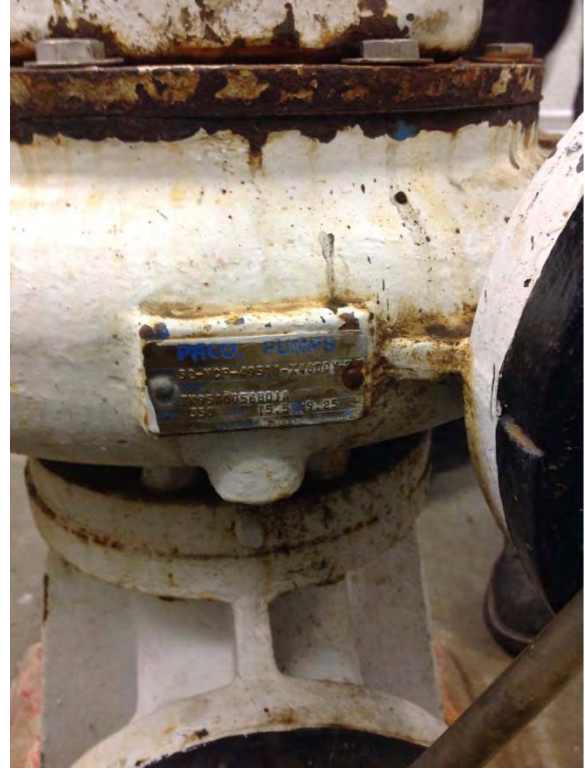
Pump 1 showing signs of aging on exterior

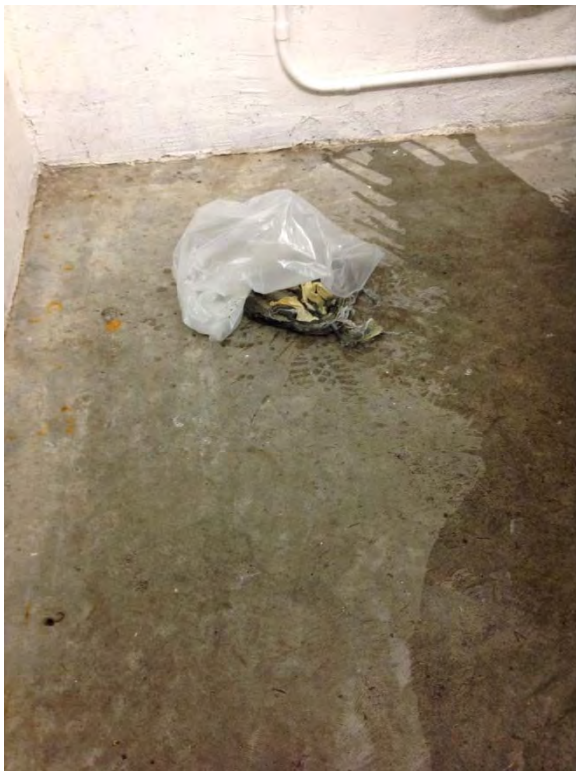
Rag removal from Pump 1 was performed during evaluation visit

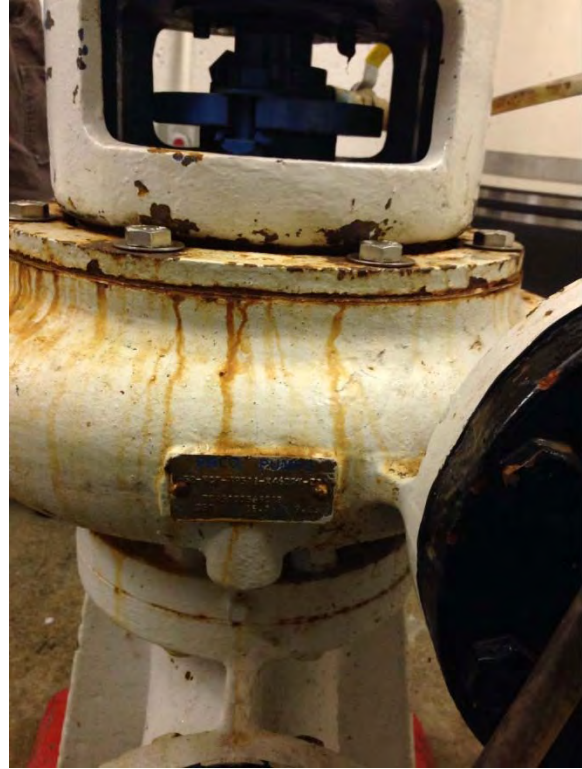
Duplex configuration, Pump 2 in background

Pump 2 showing signs of aging on exterior

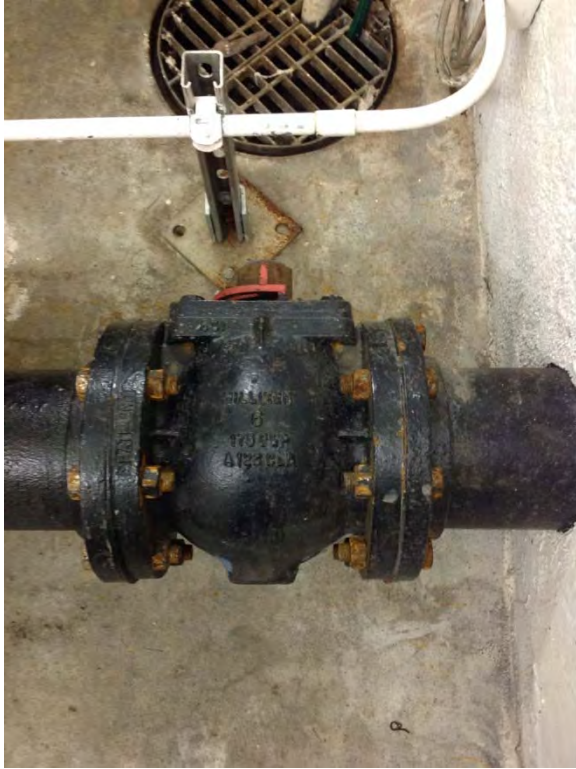
Plug valve isolation for suction piping

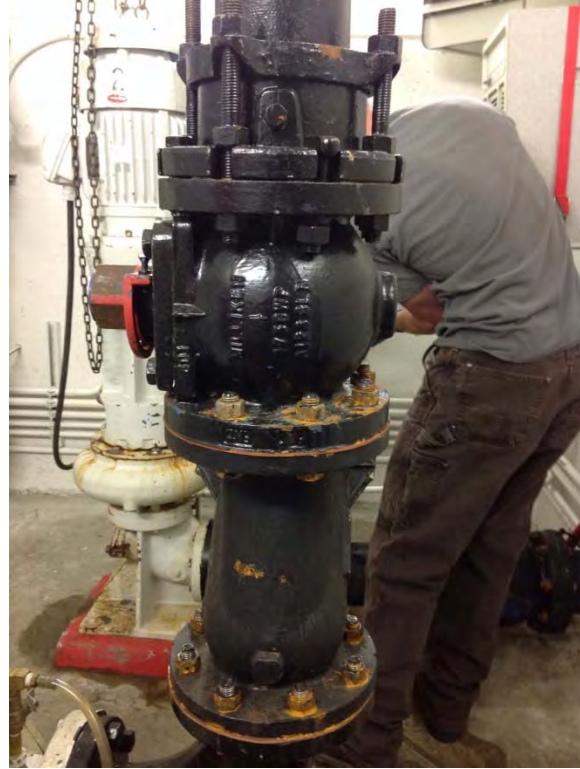
Ball check valve vertical installation and plug valve on discharge piping

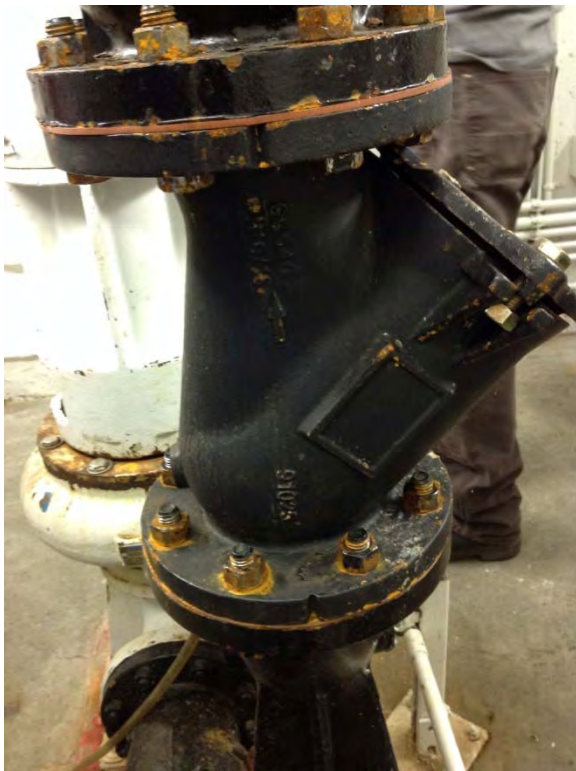
Ball check valve vertical installation on discharge piping

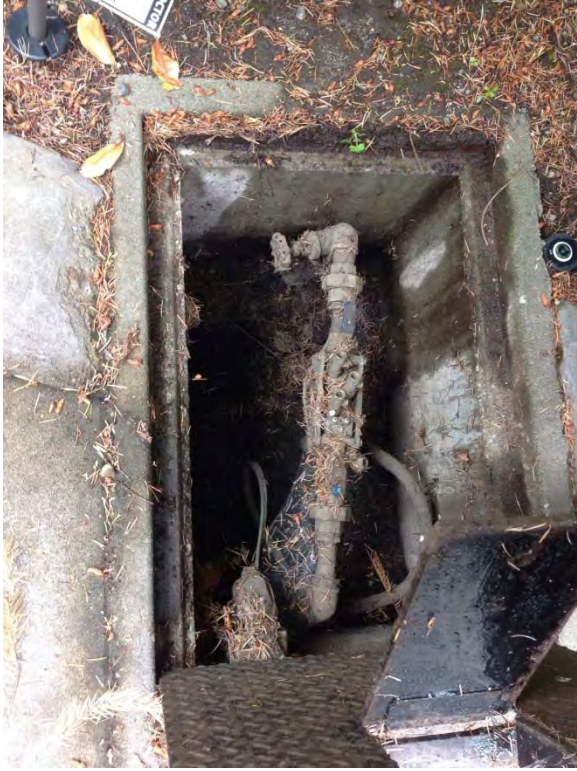
Backflow prevention assembly in below grade box

- Backflow assembly below grade in meter box, no drain to daylight – does not meet code for installation

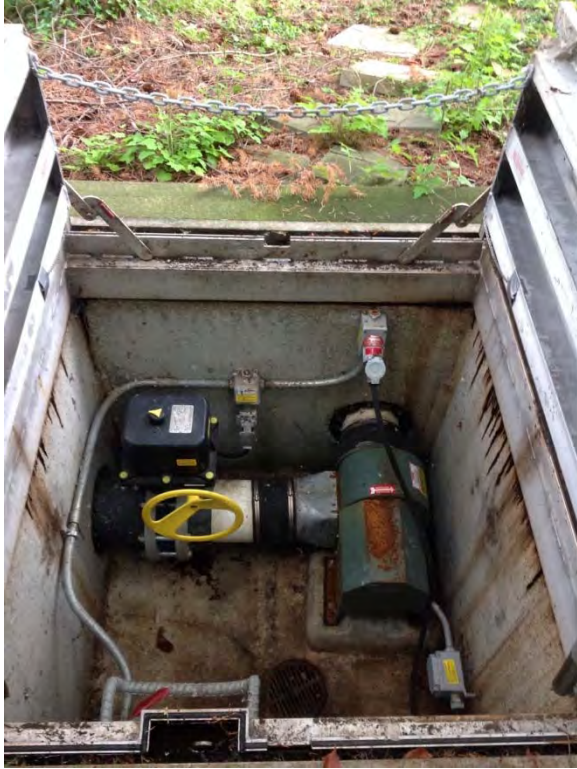
Wet well supply fan located in wet well blower vault

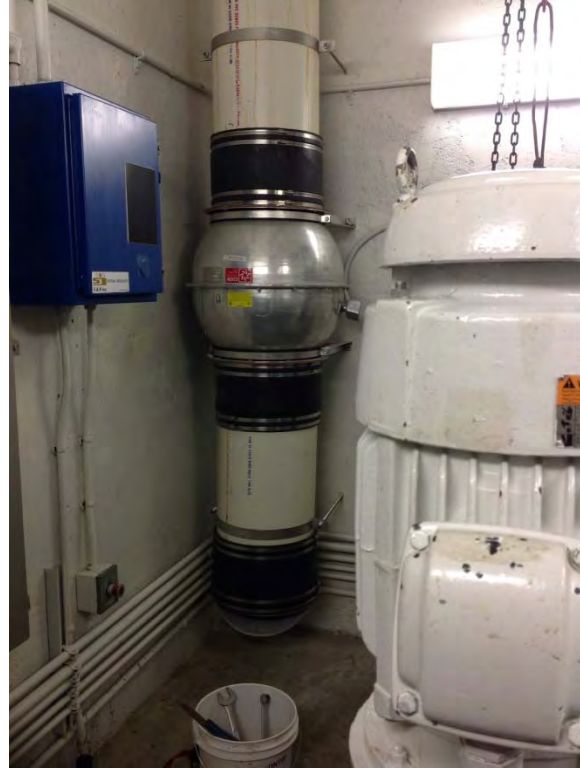
Supply fan located 5 feet AFF in dry pit

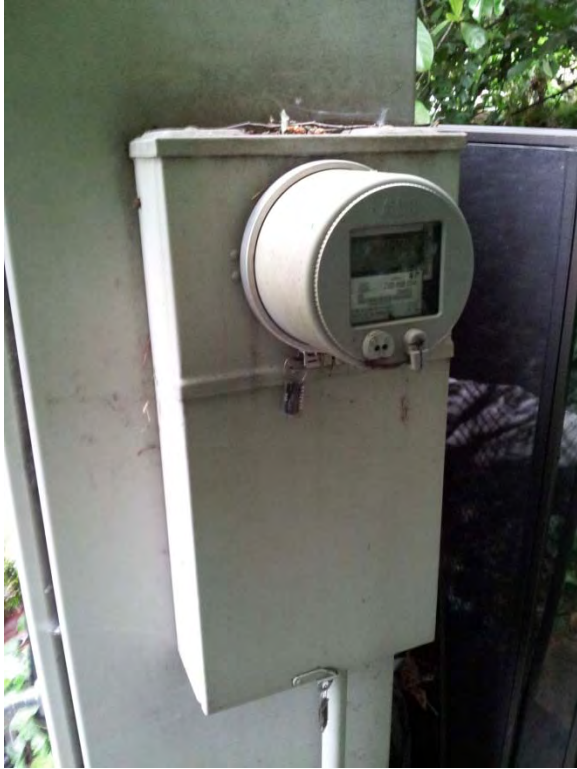
Utility service meter on outside of service equipment cabinet

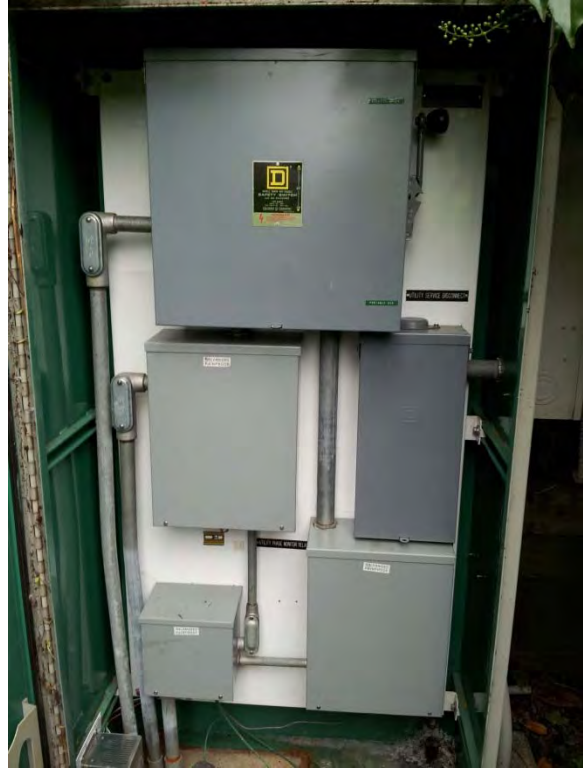
Interior of service equipment cabinet

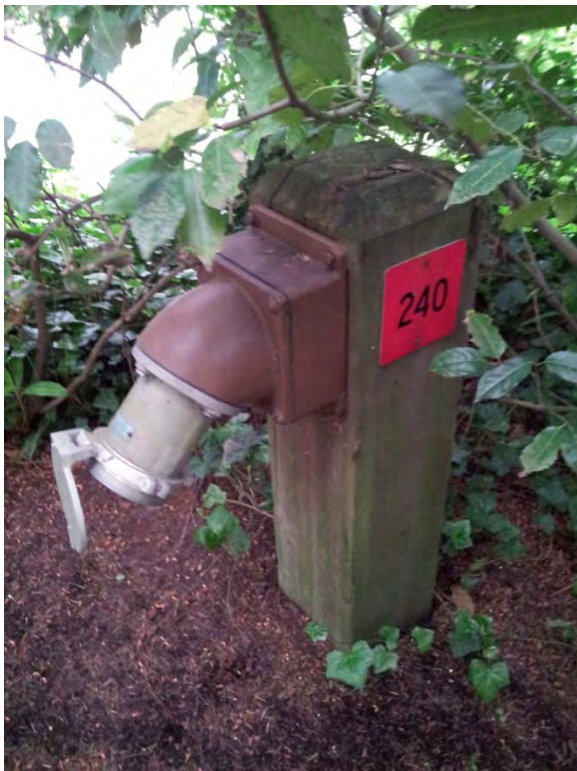
Generator receptacle on wood post

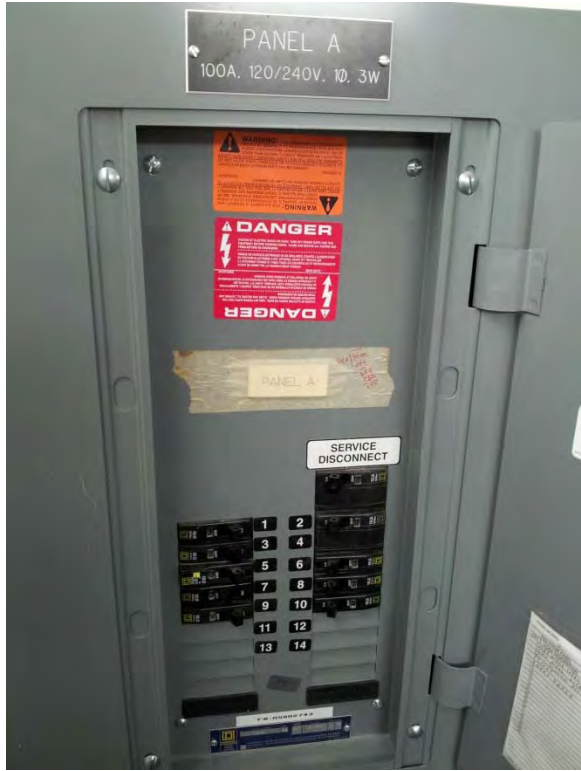
Panelboard located in dry pit, appears to be in good condition

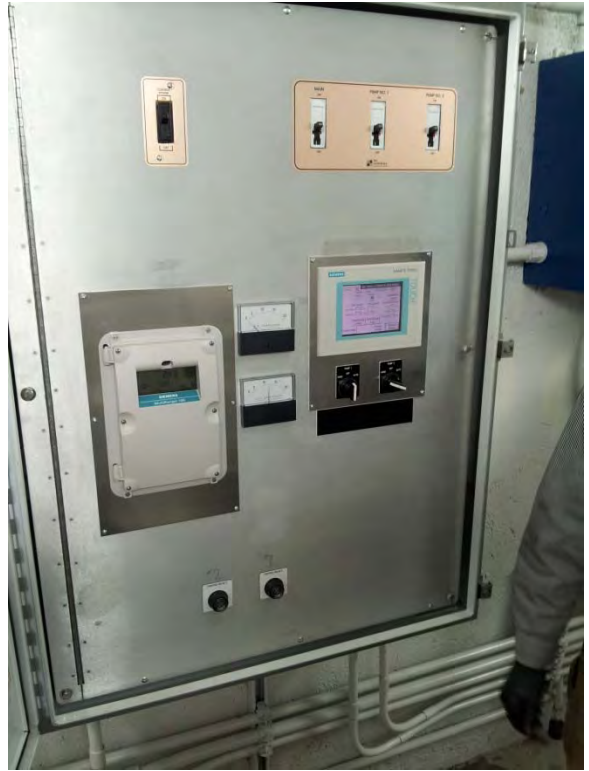
Starters located in dry pit, appears to be in good condition

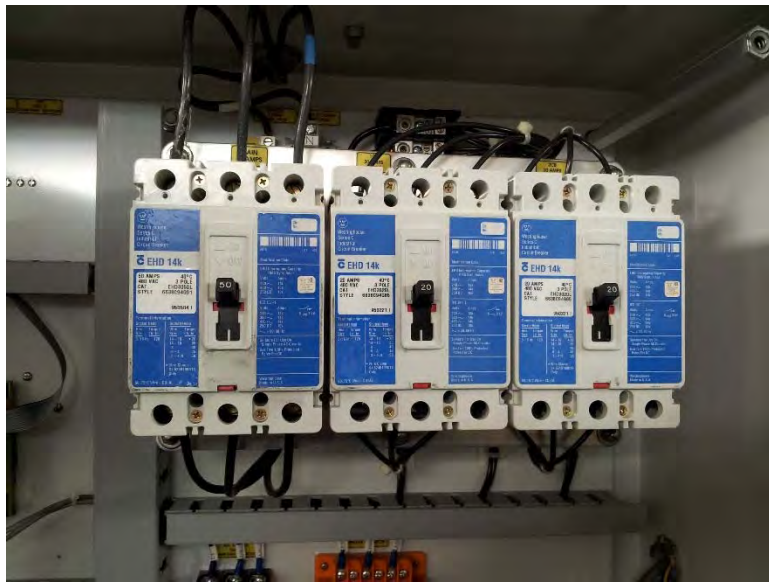
Westinghouse circuit breakers appear to be in good condition

Condition Rating 1 – Starters and circuit breakers are Westinghouse and appear to be in good condition
