Lake Washington Wastewater Lake Line Management Plan

FINAL / July 2024

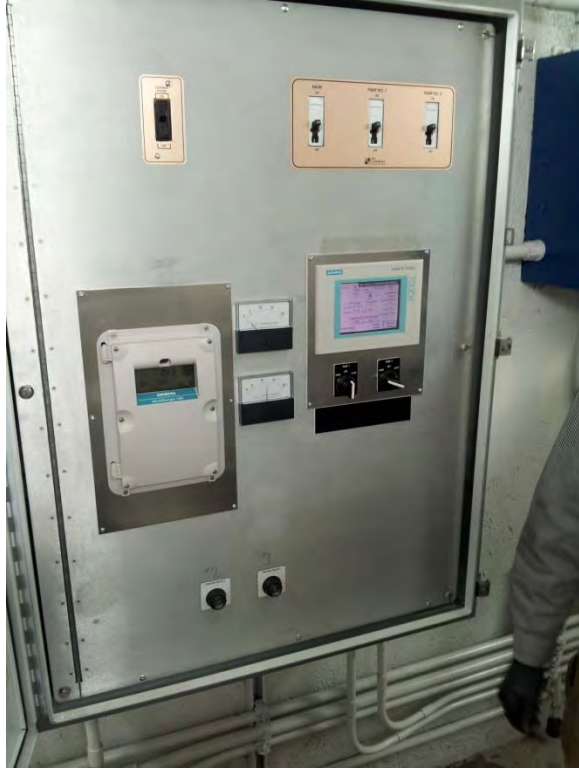
Telemetry control panel located in dry pit, appears to be in good condition

Criticality Rating 3 – Critical but redundant, PLC alternates and calls for pumping, backup operation is hardwired from the floats to the starter

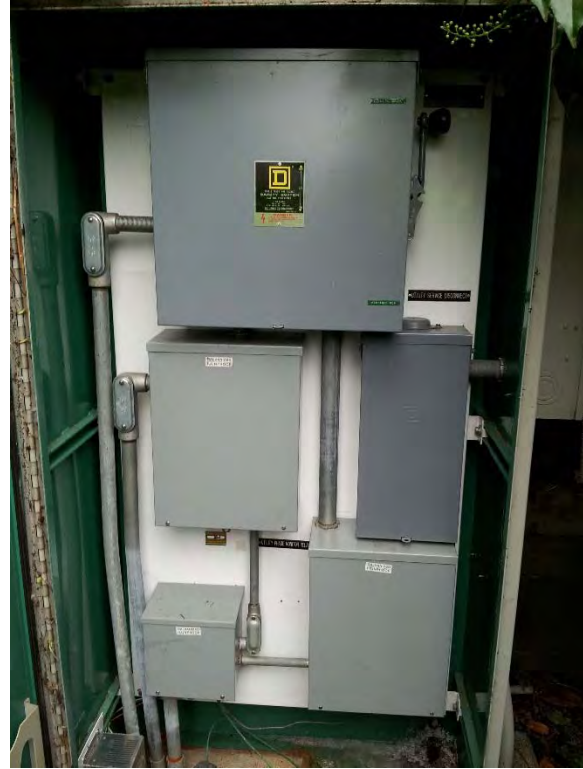
Telephone network interface located in service equipment cabinet

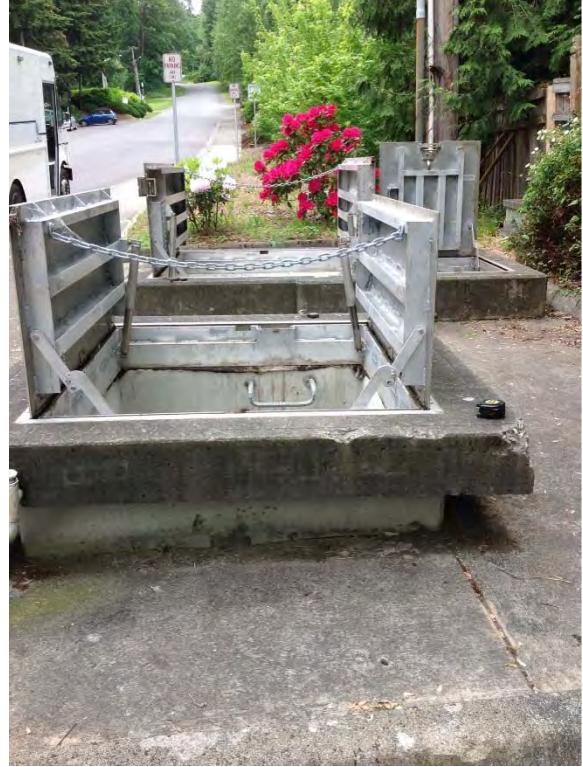
All vaults raised 12” – 18” above grade

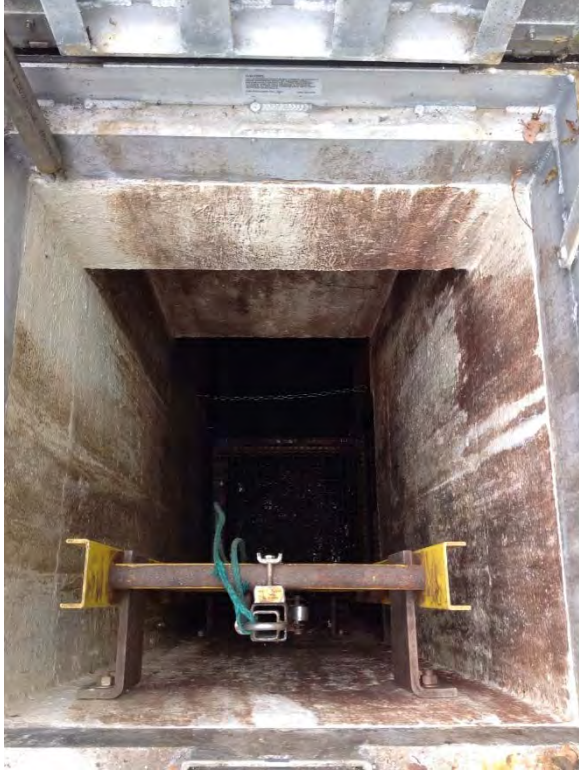
Interior of wet well

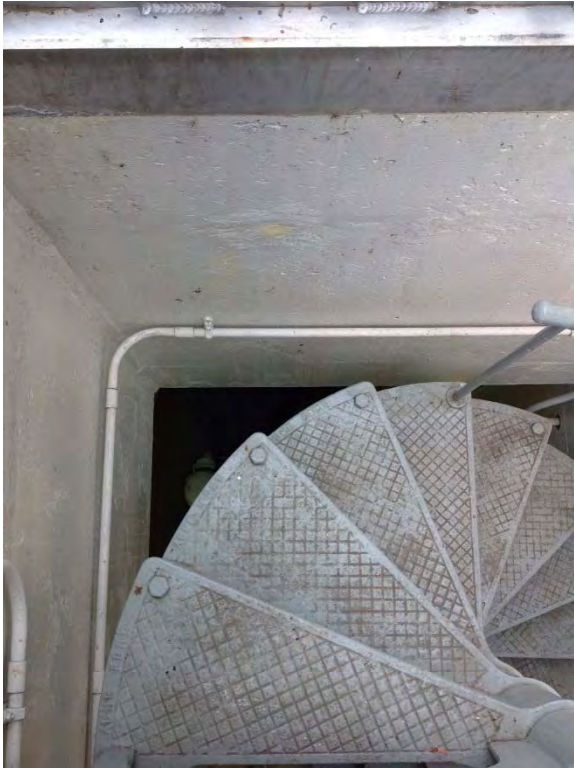
Gap between spiral staircase and wall, no rail on staircase by gap

- Gap between spiral staircase and wall, no rail on staircase by gap, potential fall/safety issue
- Grating on sump drain
- No equipment access hatch

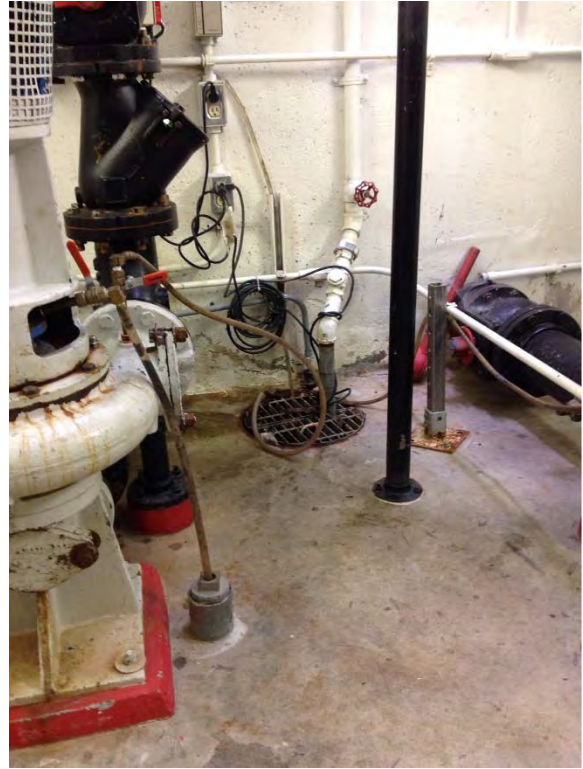
Grating on sump drain

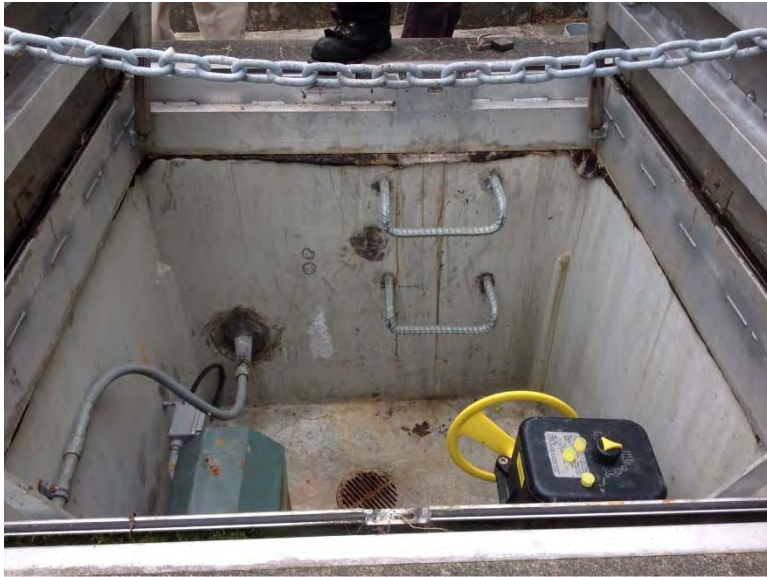
Wet well blower vault hatch, chain fall protection on one side

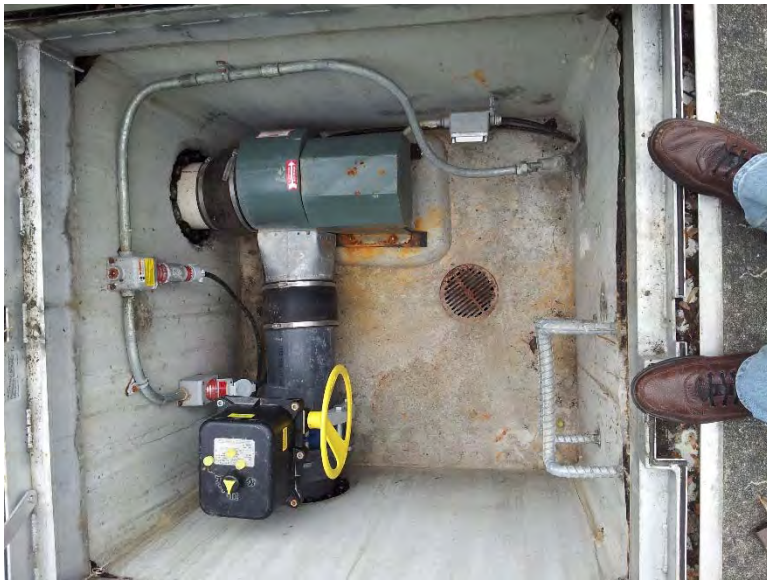
Interior of wet well blower vault

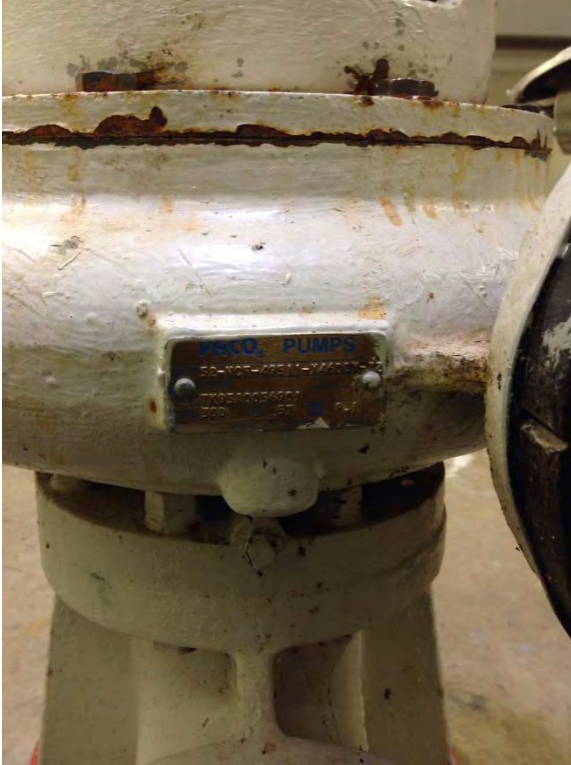
Pump 1 showing signs of aging on exterior

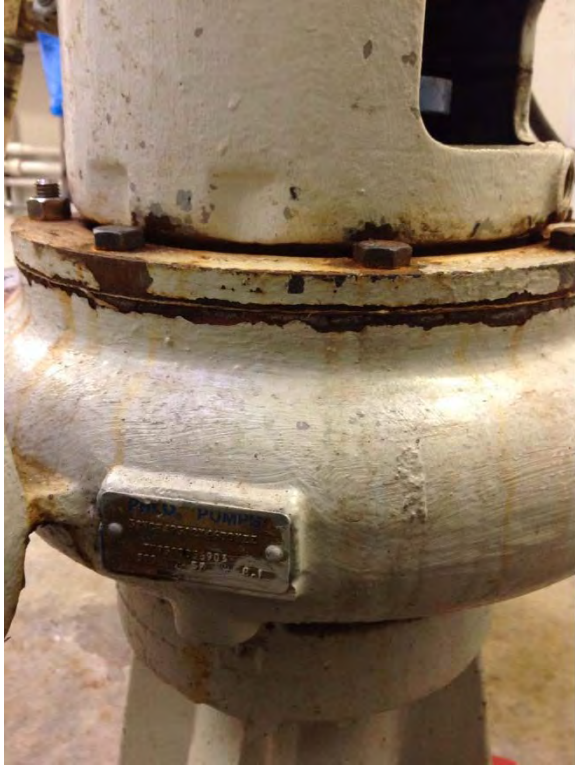
Pump 2 showing signs of aging on exterior

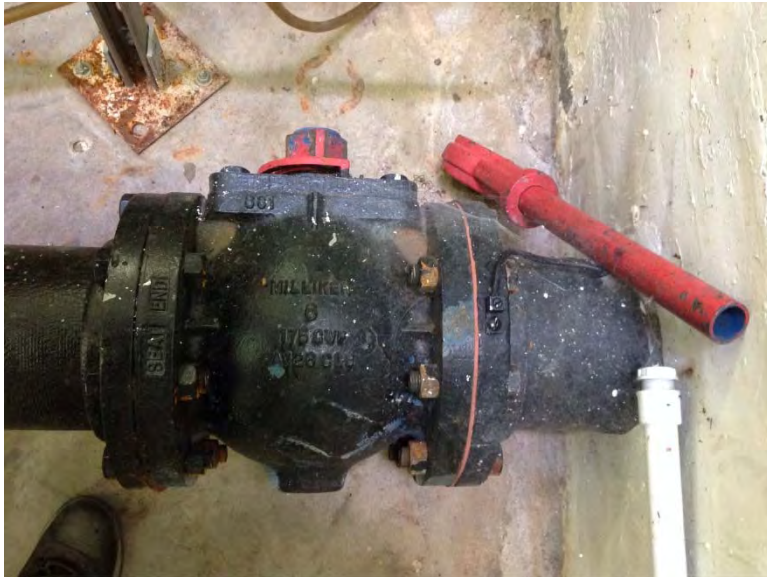
Plug valve isolation for suction piping, horizontal installation - ideal

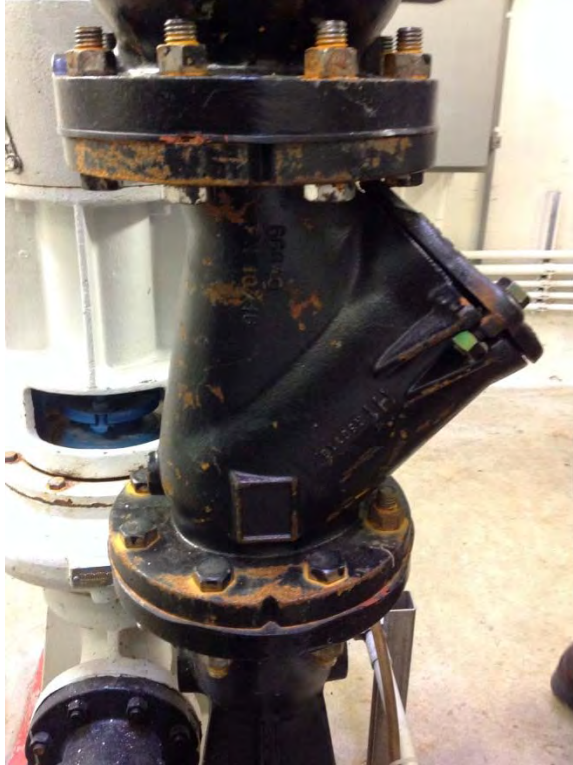
Ball check valve vertical installation on discharge piping

- Ball check valve, vertical installation

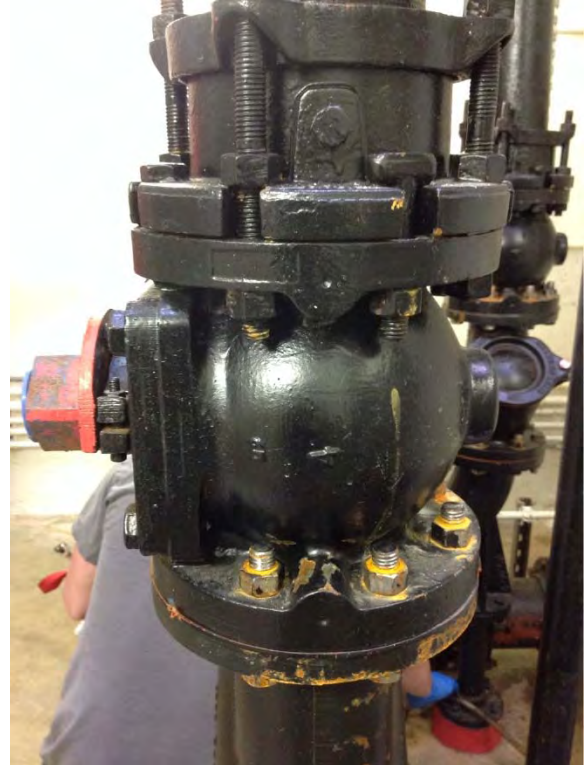
Plug valve vertical installation on discharge piping

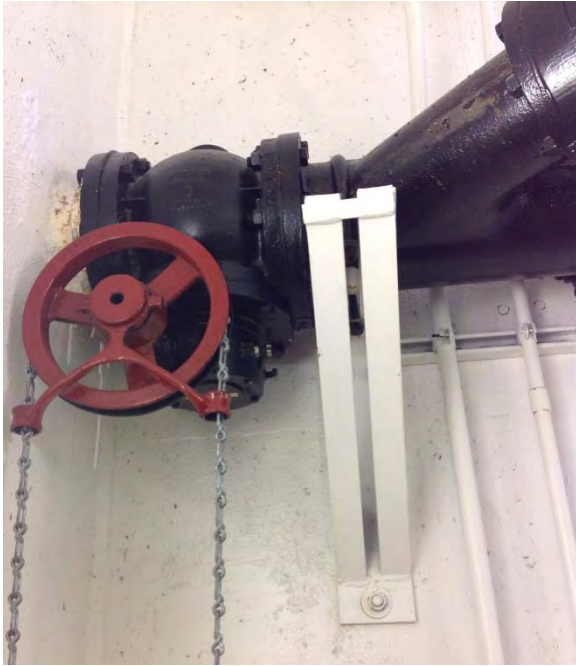
8" plug valve for force main isolation inside dry pit

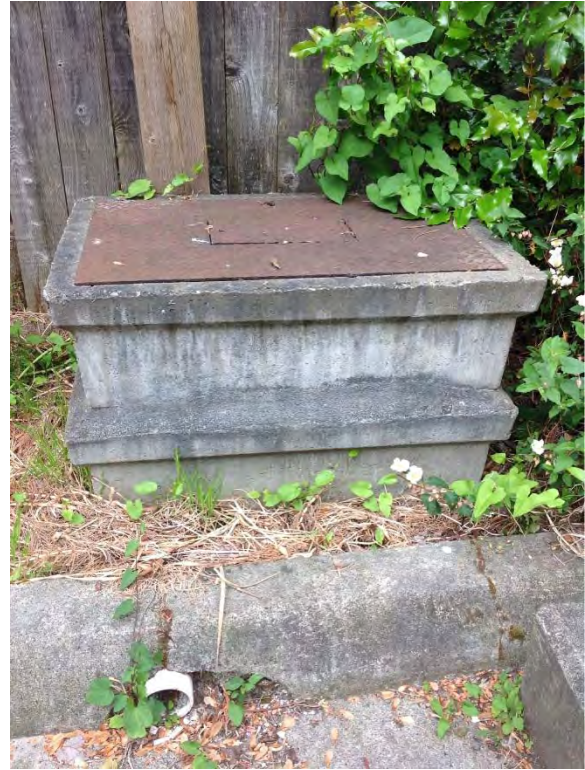
Backflow prevention assembly in two stacked water boxes, 12" above grade

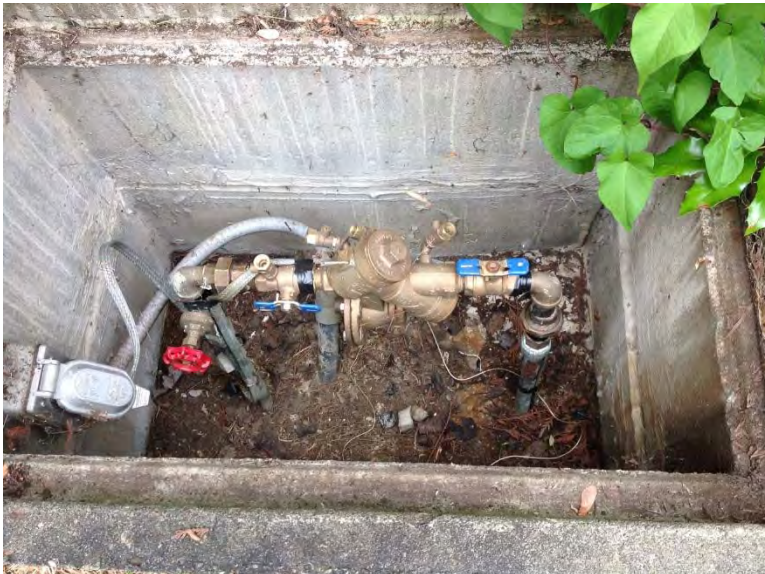
Backflow prevention assembly in water boxes

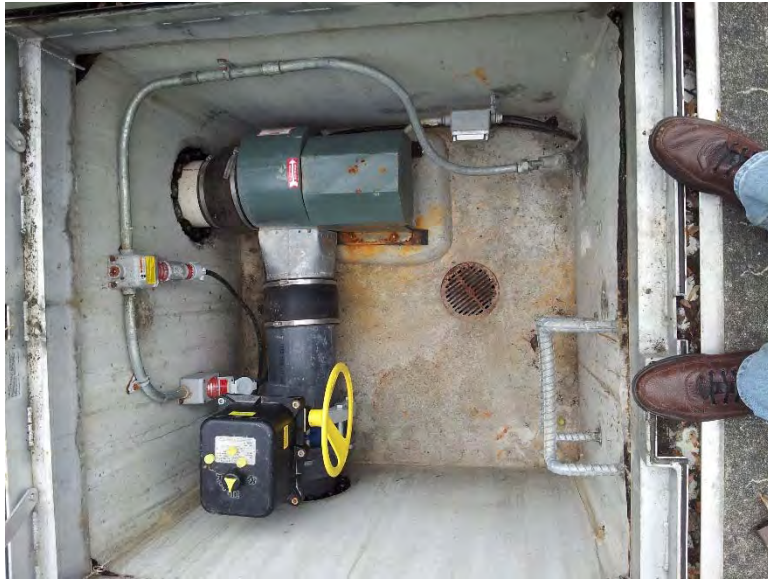
Wet well supply fan located in wet well blower vault

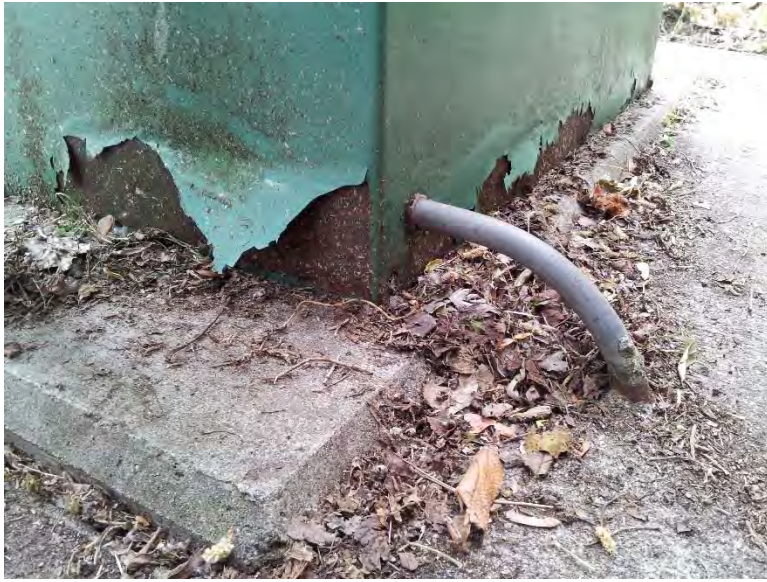
Service cabinet paint is chipping near bottom, conduit corroding near grade

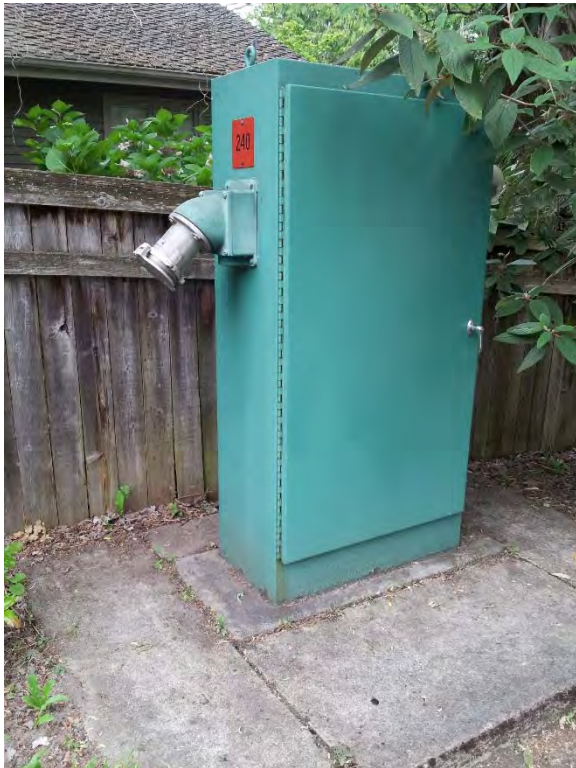
Generator receptacle located on outside service cabinet

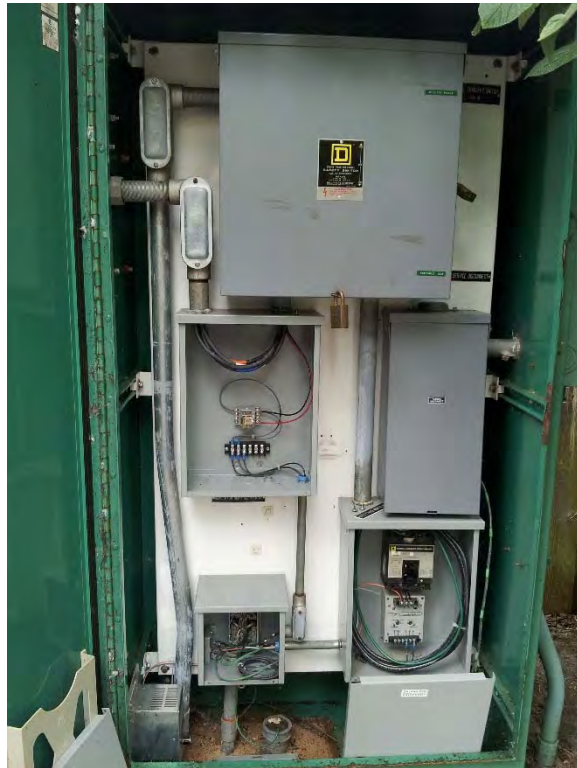
Transfer switch located in service cabinet

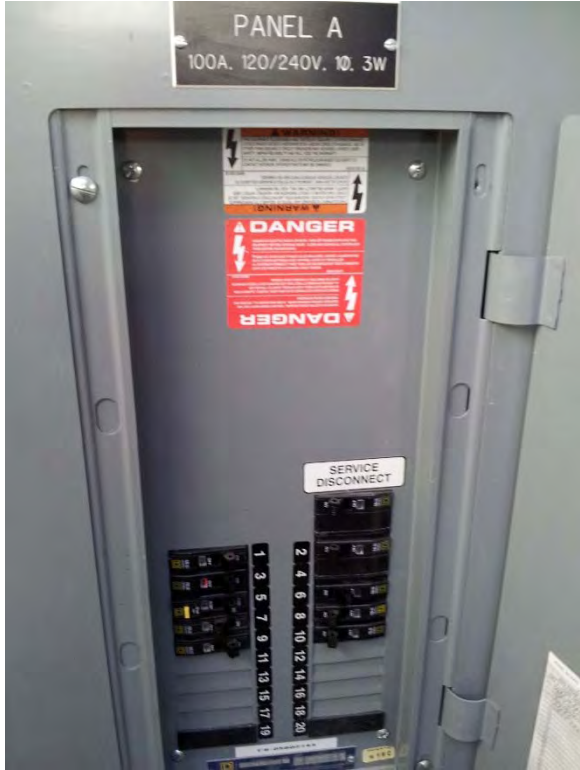
Panelboard located in dry pit

Condition Rating 1 – Square D panelboard appears to be in good condition

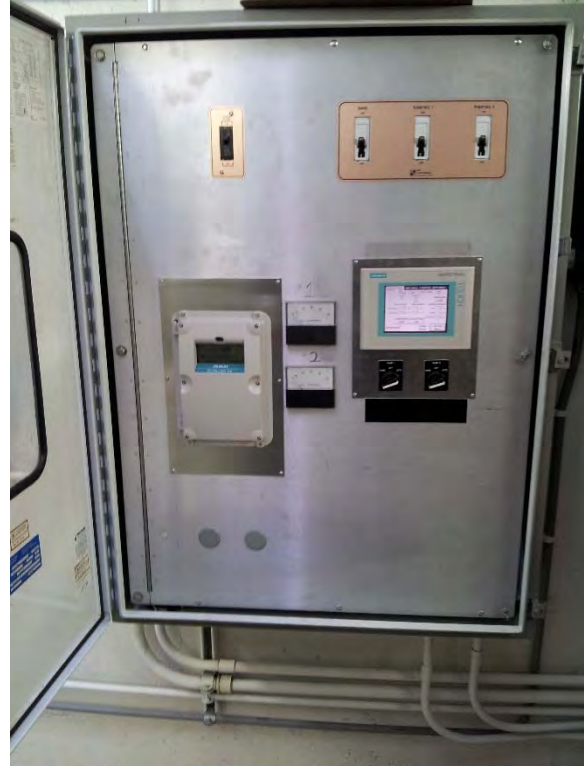
Starters located in dry pit, appears to be in good condition

Condition Rating 1 – Cutler Hammer starters and Westinghouse circuit breakers appear to be in good condition

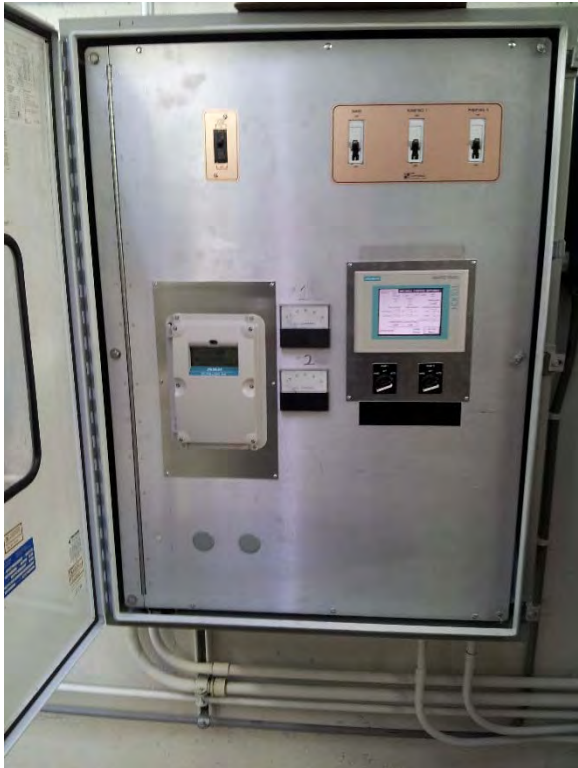
Telemetry control panel with operator interface located in dry pit, appears to be in good condition

Criticality Rating 3 – Critical but redundant, PLC alternates and calls for pumping, backup operation is hardwired from the floats to the starter

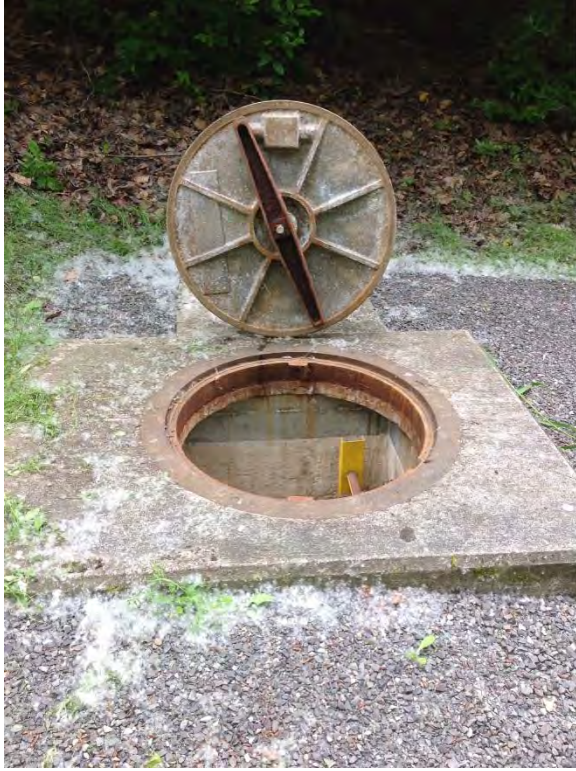
Manhole lid and top portion of wet well

- Upon failure of locking access lid, alternate lid will need to be purchased/fabricated or entire top of wet well will need to be replaced with new concrete top and hatch

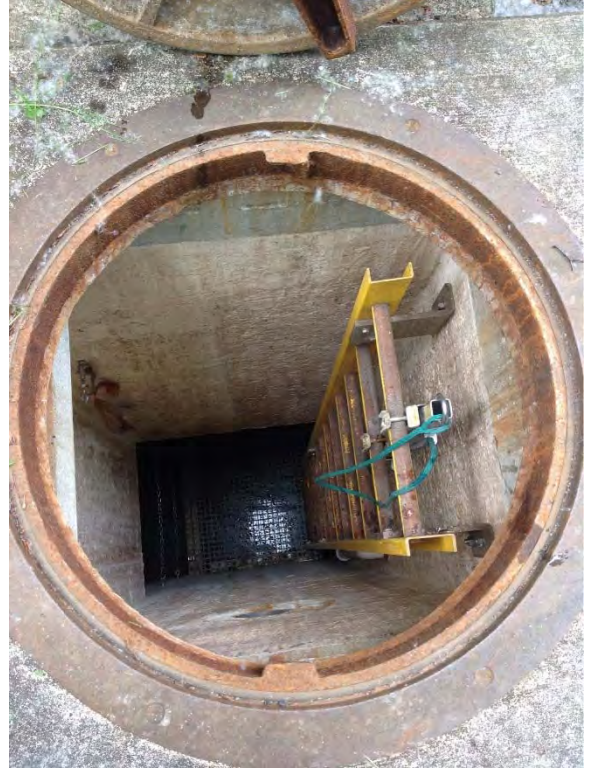
Interior of wet well

Condition Rating 2 – Ground surface inspection identified some delamination of interior coating.

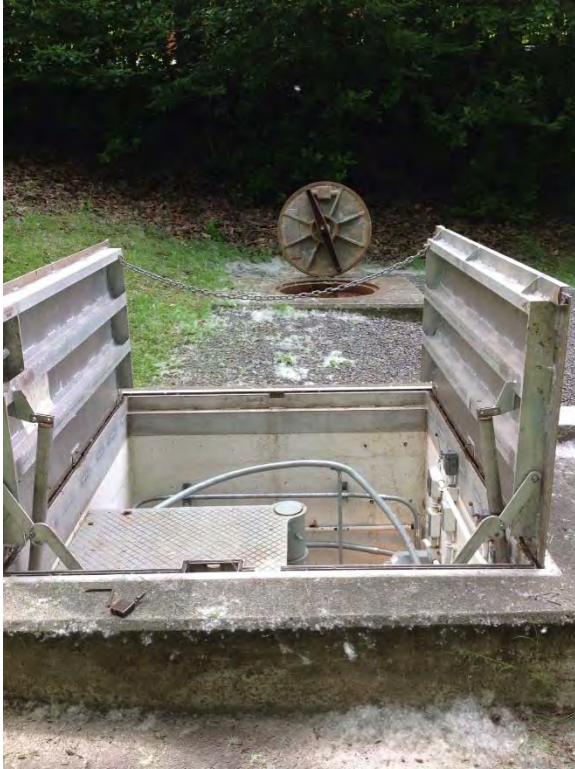
Lift assist hatch and chain fall protection on one side

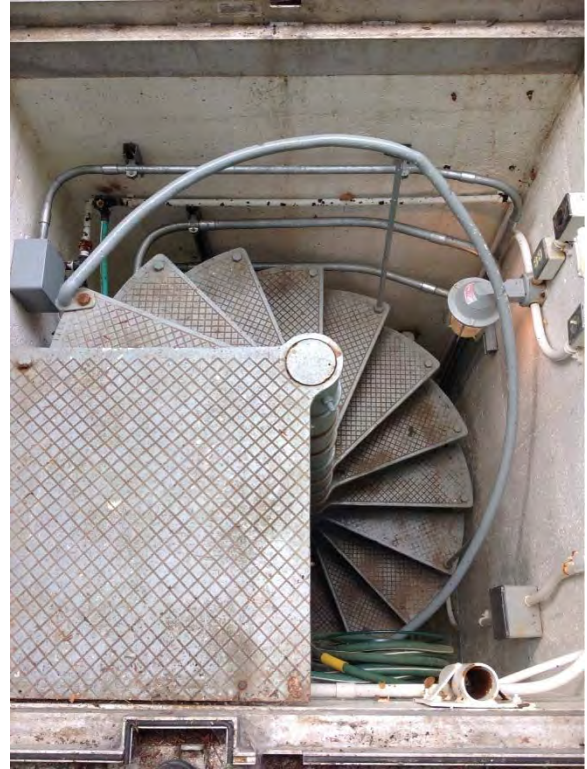
Spiral staircase rail begins at top of staircase

- No equipment access hatch
- Spiral stair case hand rail starts from beginning of treads down

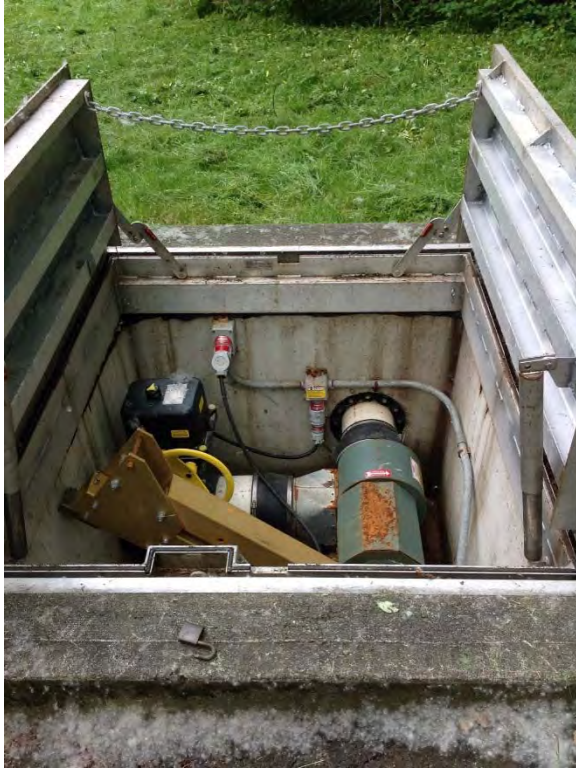
Wet well blower vault hatch, chain fall protection on one side

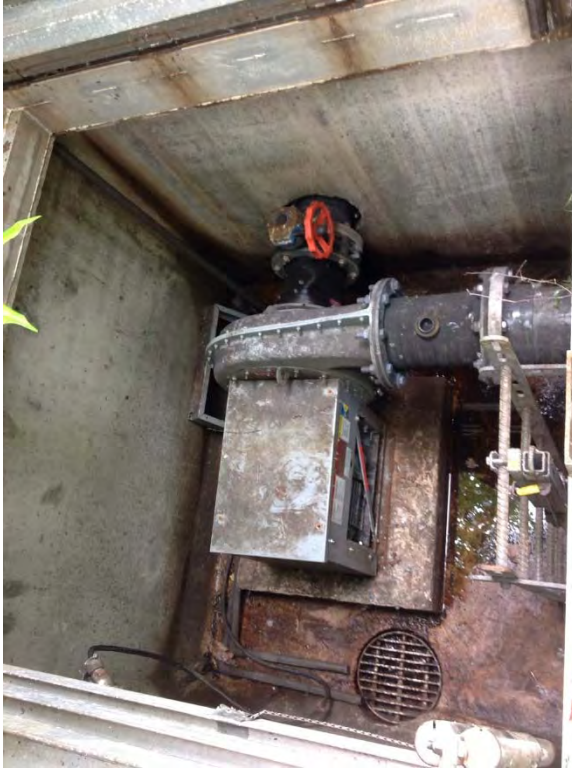
Interior of odor control fan vault, some rusting and water in vault

- Flexible piping “sucked in”, rigid and stuck in that position even when wet well lid opened
- Some rusting and water in vault

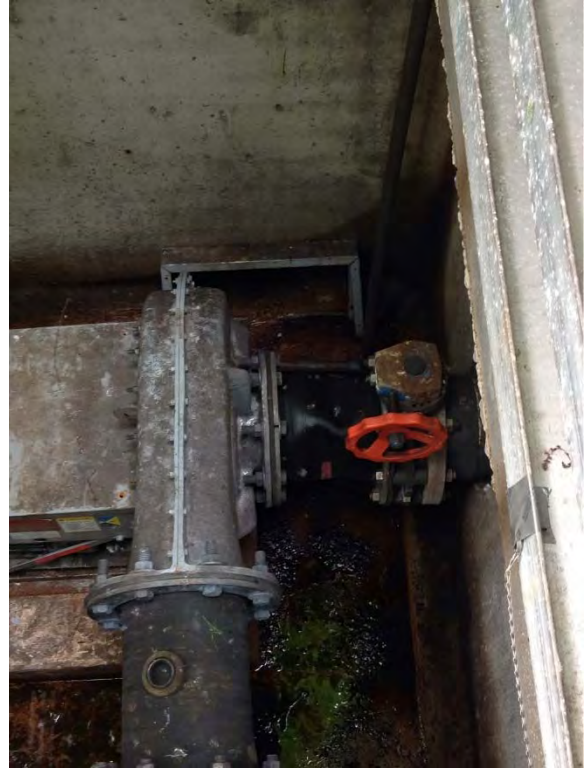
Piping imploded near red hand-wheel, stuck in rigid position even when wet well lid opened

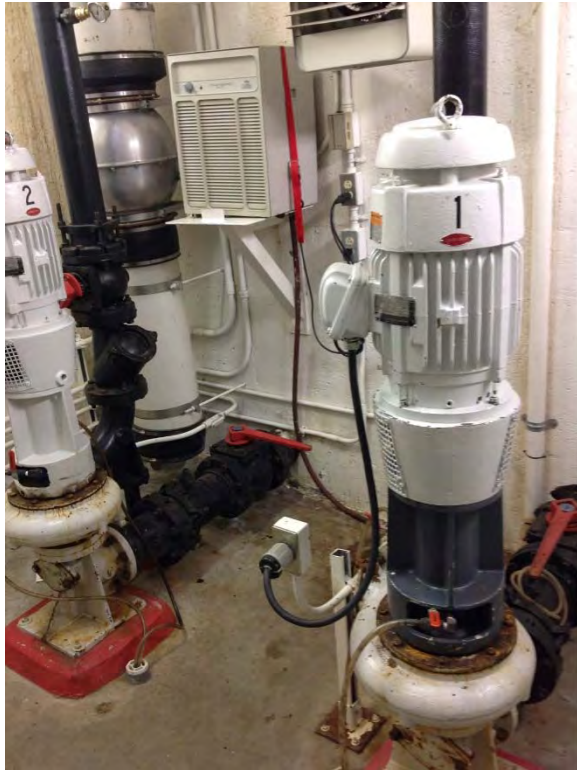
Duplex configuration, pump #1 in foreground

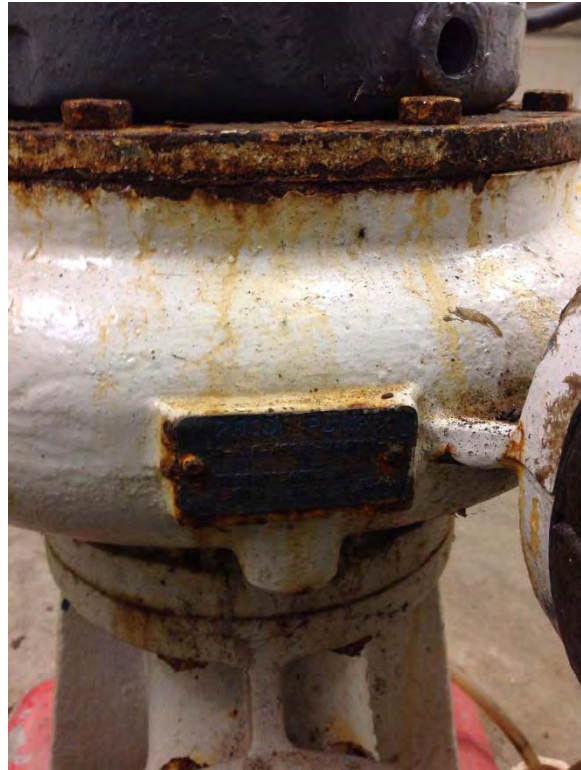
Pump #1 showing signs of aging on exterior

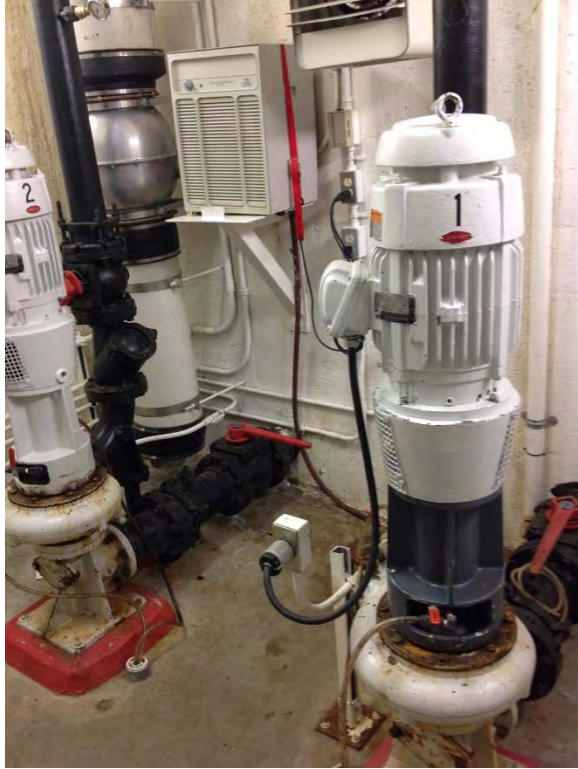
Duplex configuration, pump #1 on the right

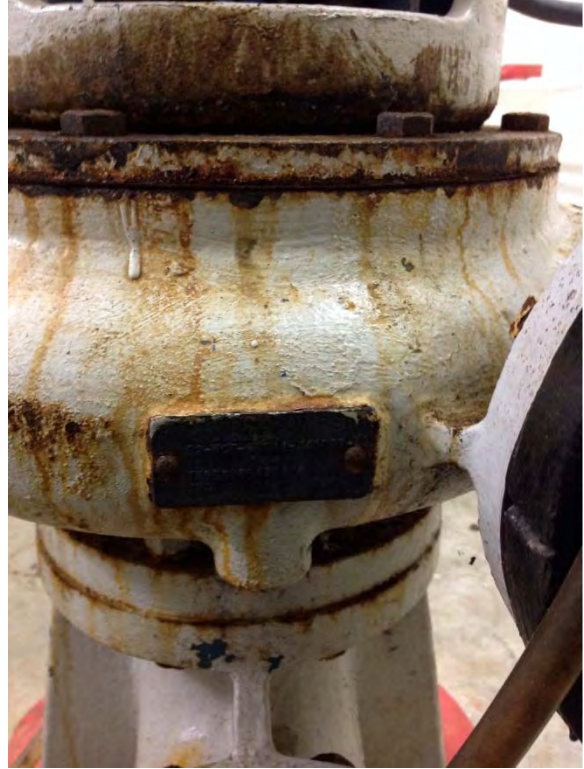
Pump #2 showing signs of aging on exterior

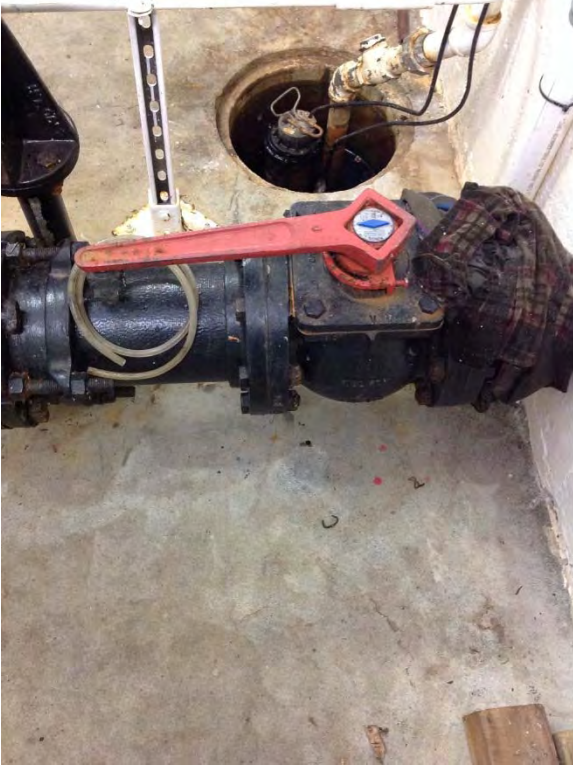
Plug valve isolation for suction piping,
vertical axis of orientation – not ideal

- Plug valve seats up – ideal
- Ball check valve vertical installation

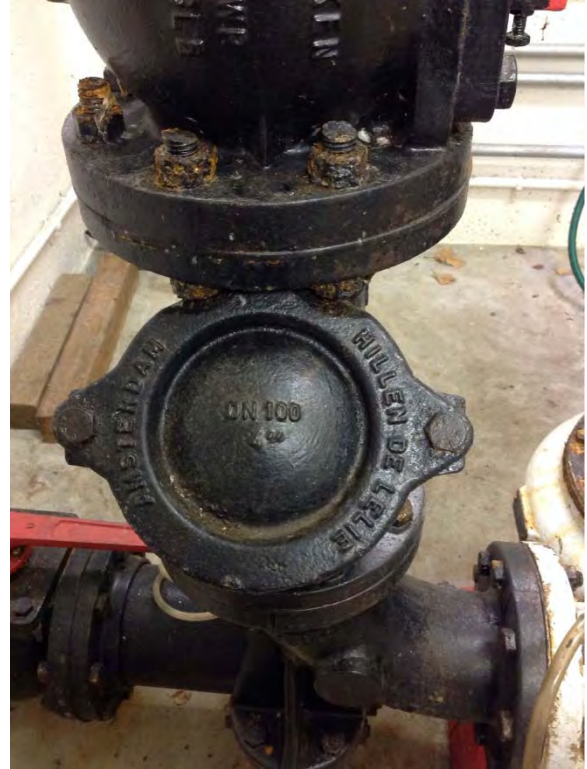
Ball check valve, vertical orientation

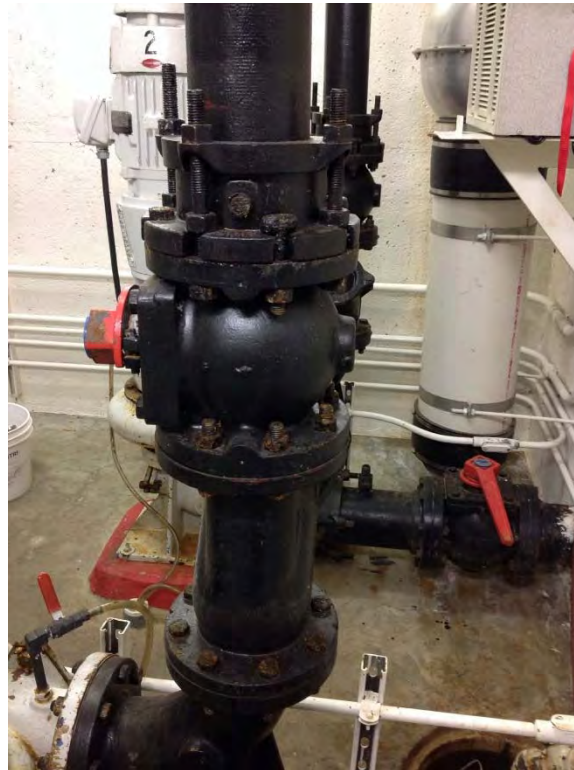
Ball check valve and plug valve on
discharge piping

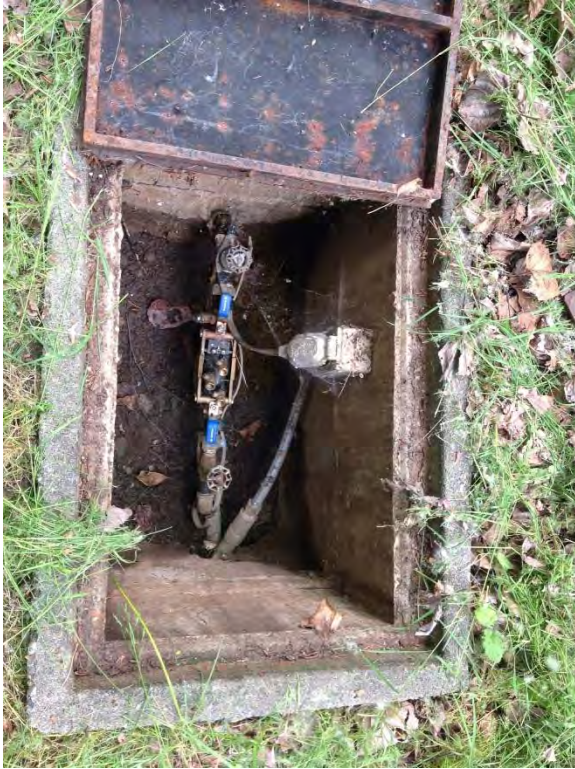
Backflow prevention assembly in below grade box

- Backflow assembly in below grade meter box, no drain to daylight – does not meet code for installation

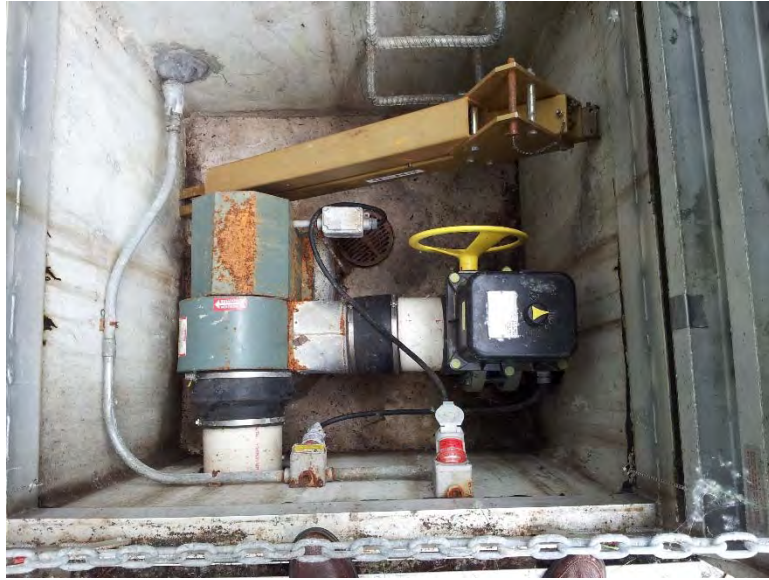
Wet well supply fan located in wet well blower vault

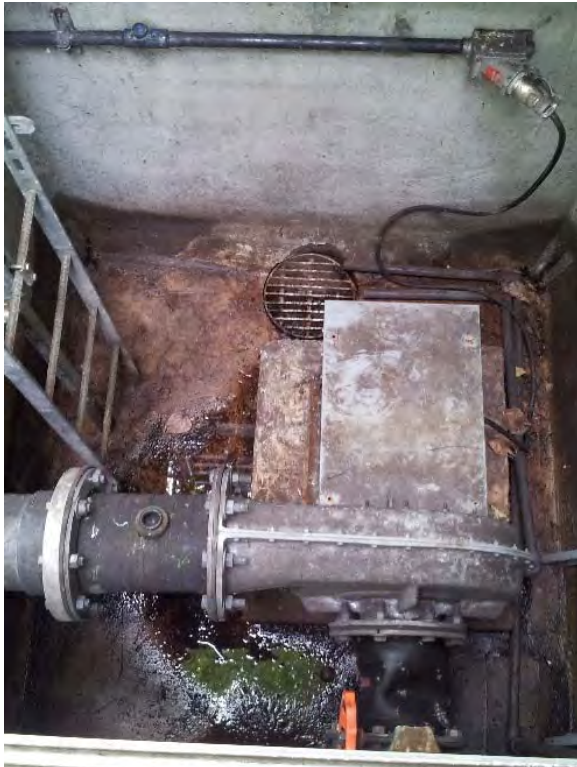
Wet well exhaust fan located in odor control fan vault

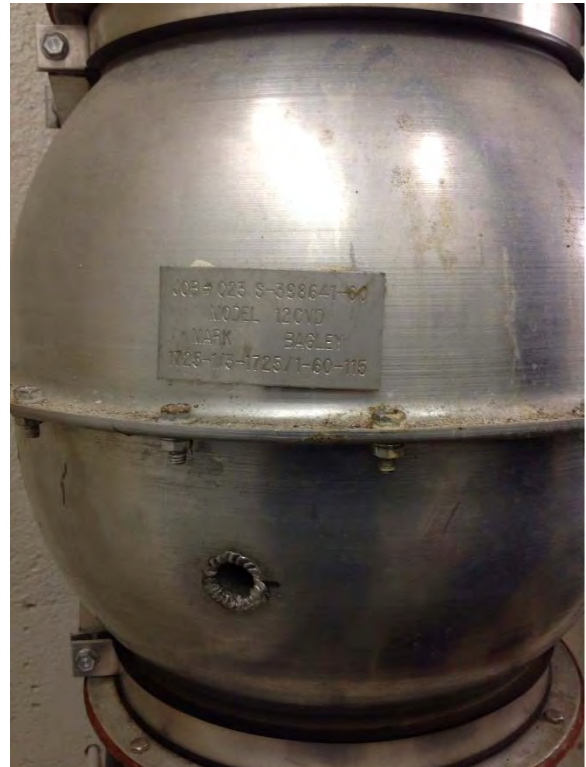
Supply fan located 5 feet AFF in dry pit

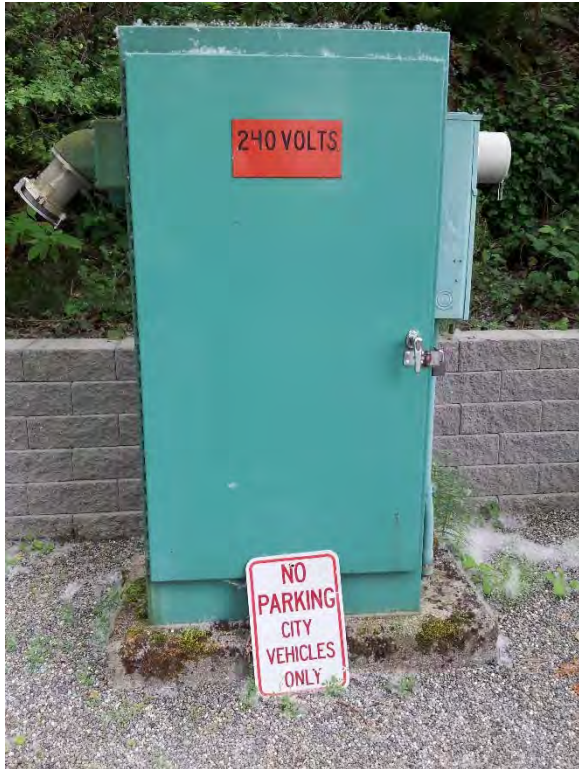
Generator receptacle and service meter located on service cabinet

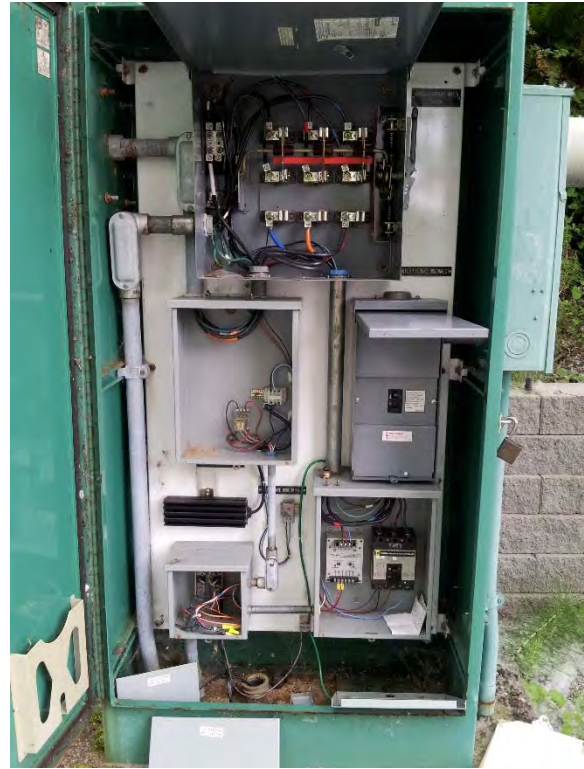
Interior of service cabinet including manual transfer switch

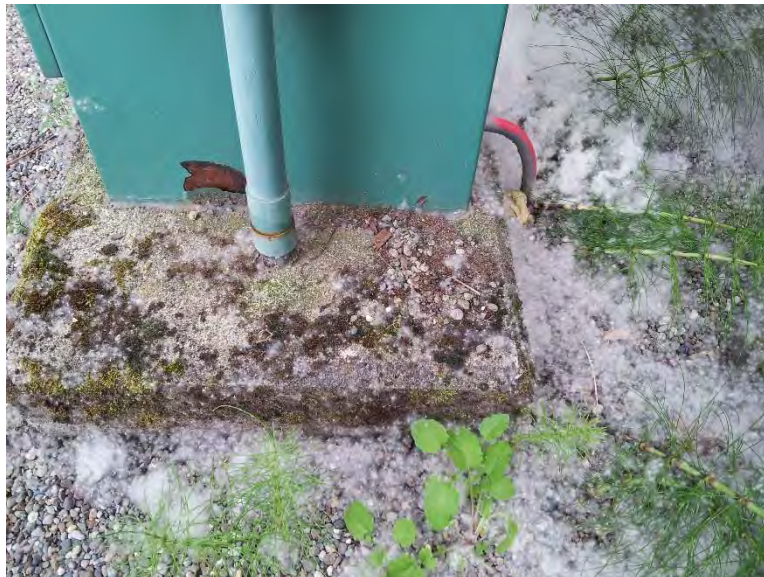
Some paint chipping/rusting near bottom of service cabinet

- Some paint chipping/rusting near bottom of service cabinet

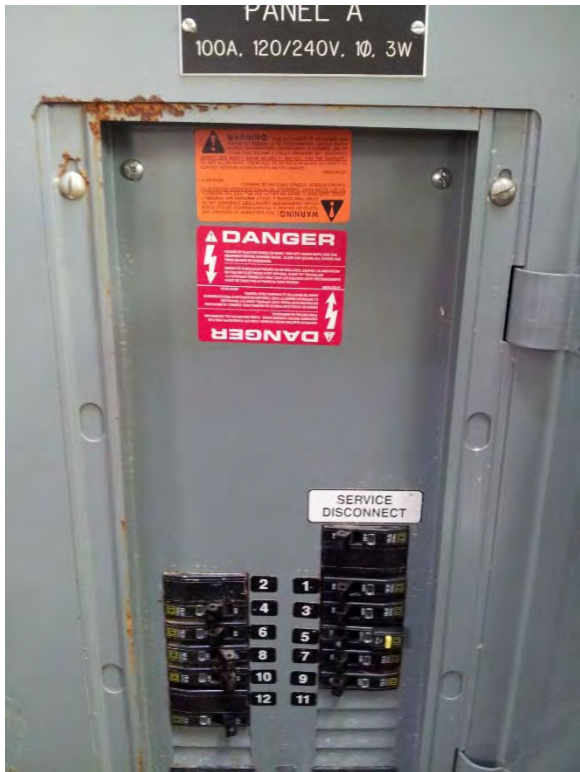
Panelboard located in dry pit, appears to be in good condition with some surface rust

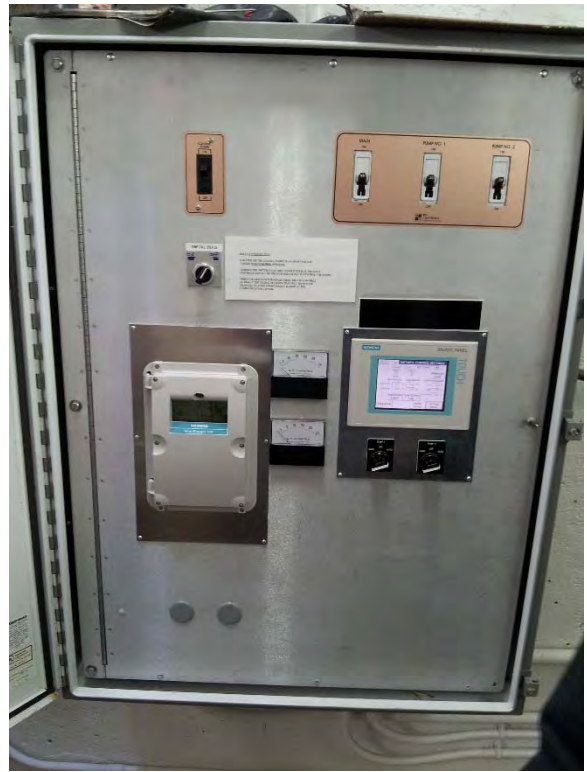
Starters located in dry pit, appears to be in good condition

Criticality Rating 3 – Critical but redundant, starters needed to run the pumps but if one starter fails the other will still operate

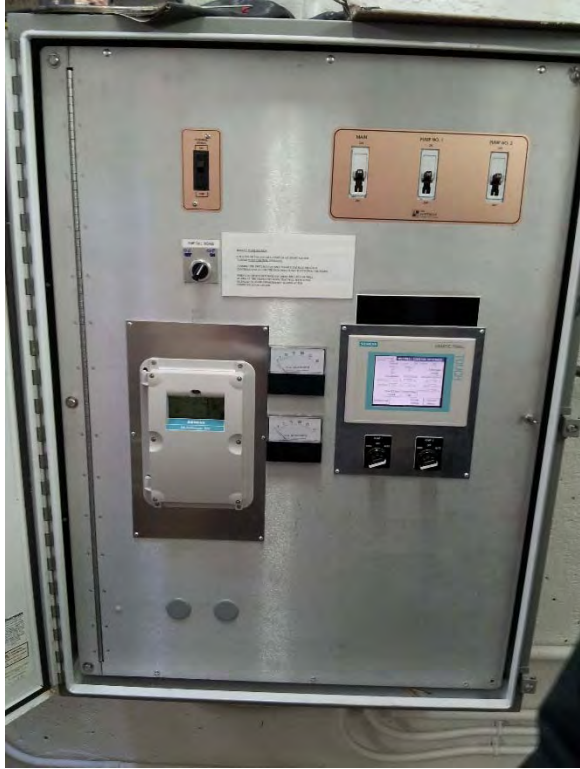
Telemetry control panel with operator interface located in dry pit, appears to be in good condition

Criticality Rating 3 – Critical but redundant, PLC alternates and calls for pumping, backup operation is hardwired from the floats to the starter

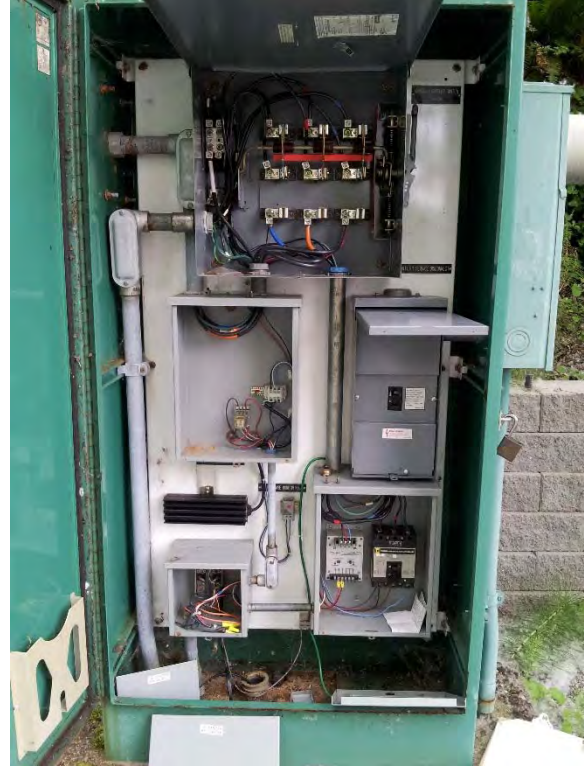
Telephone network interface in service cabinet

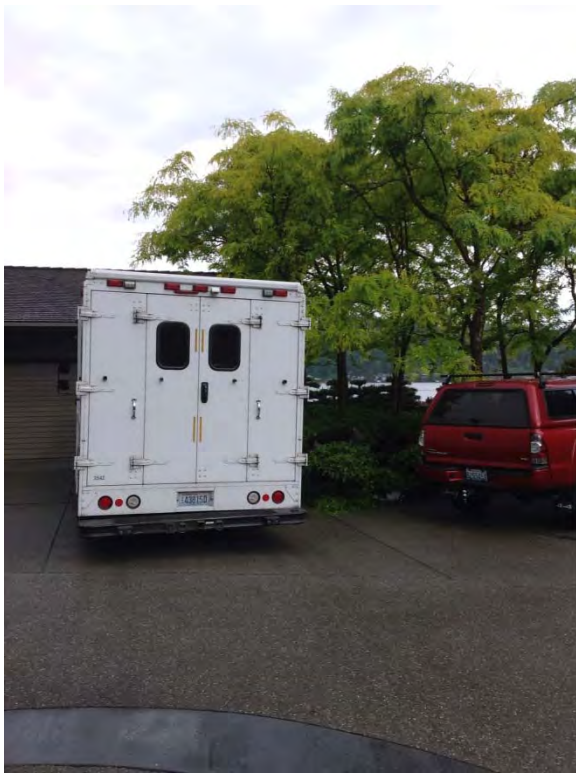
Parking adjacent to station at dead end

Vehicle access to site	Paved one lane path, dead end, parking adjacent to station
Landscaping	None, taken care of by others
Site lighting	None
Fencing/security	None
Public accessibility to site	Full access to site, adjacent to resident garages
