Lake Washington Wastewater Lake Line Management Plan

FINAL / July 2024

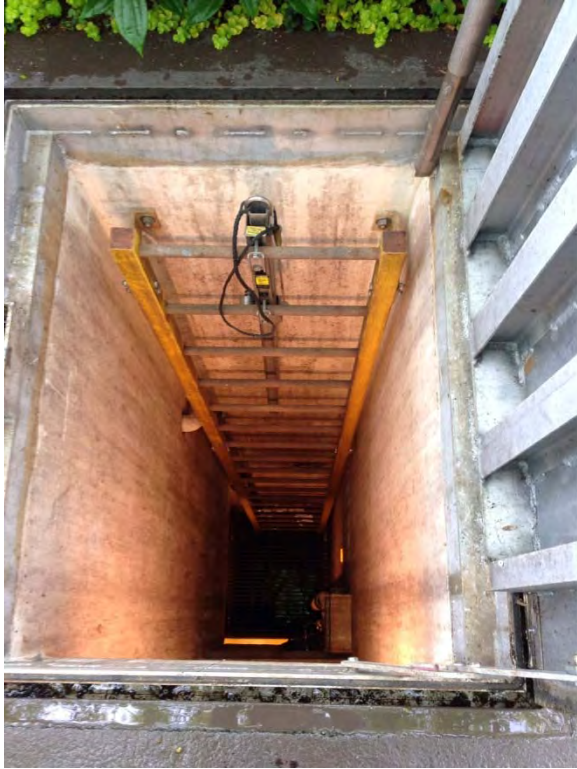
Interior of wet well, showing signs of degradation

Condition Rating 2 – Ground surface inspection identified interior coating showing signs of degradation.

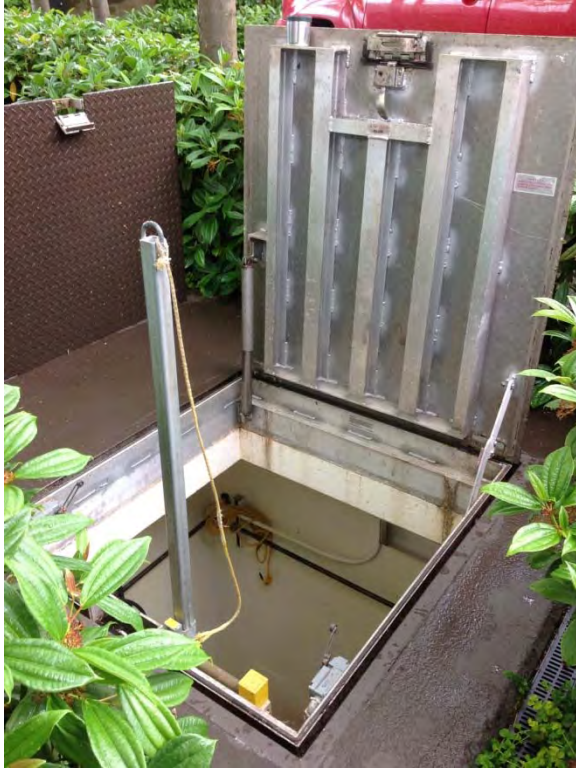
Lift assist hatch and post to access ladder to first level

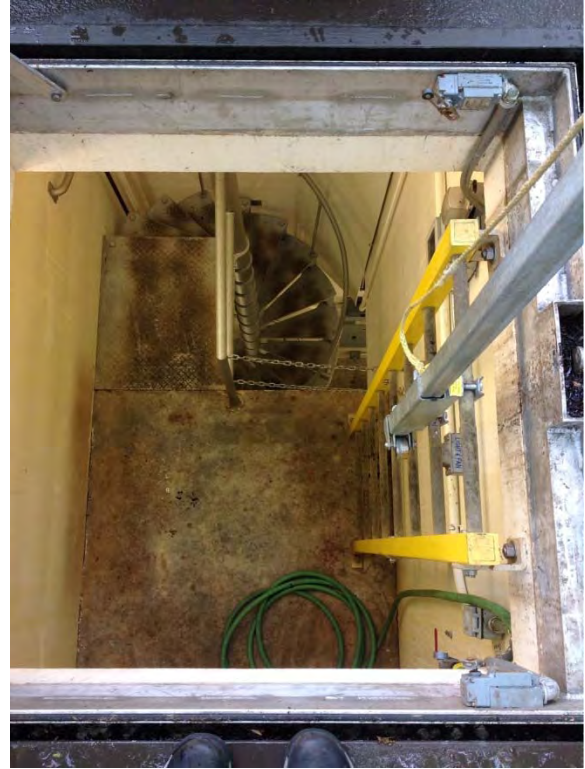
Ladder to first level landing, spiral stair case down to bottom level

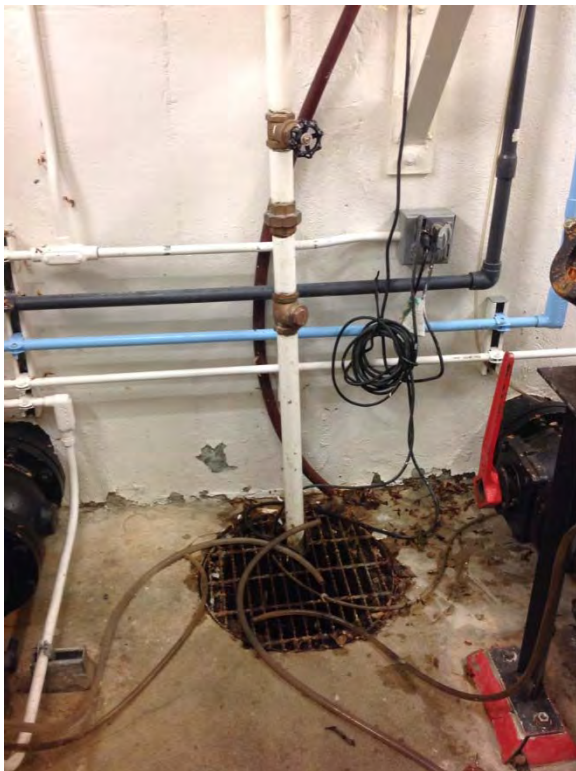
Grating on sump drain, note some coating failing near bottom of wall

- Some coating failing near bottom/floor of dry pit
- Top or first level added to station when grade was raised for surrounding development
- Narrow access around dry pit hatch
- Grating on sump drain
- No equipment access hatch

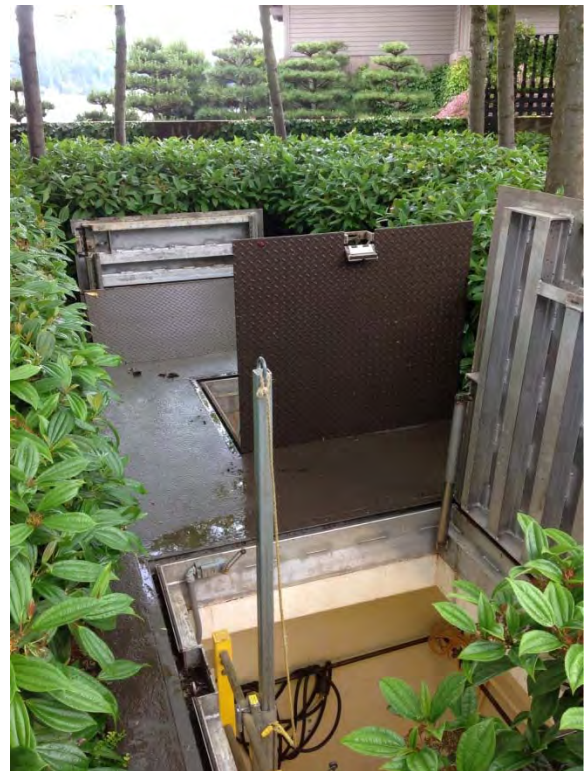
Narrow access around dry pit hatch

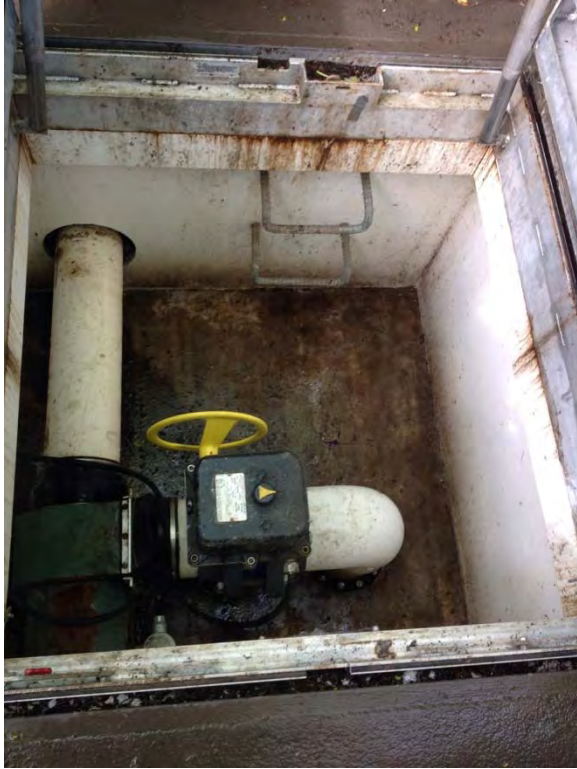
Interior of wet well blower vault

- Vault floor is damp

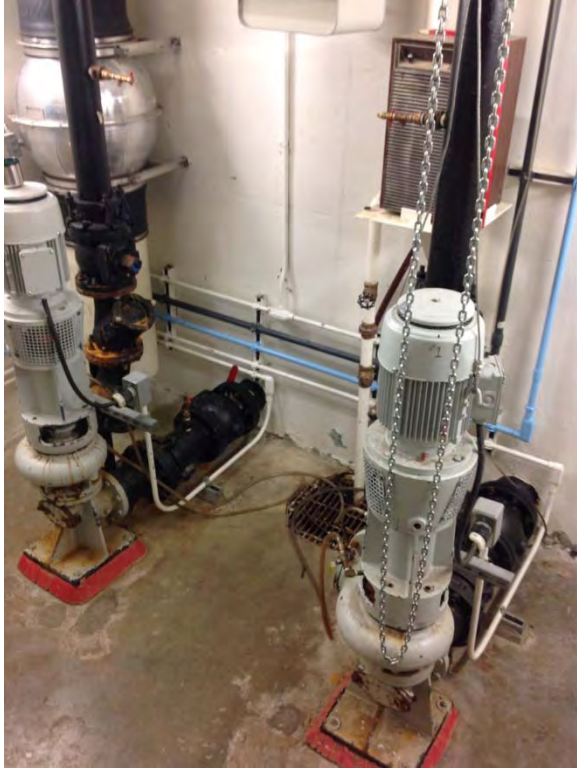
Duplex configuration, pump 1 on the right

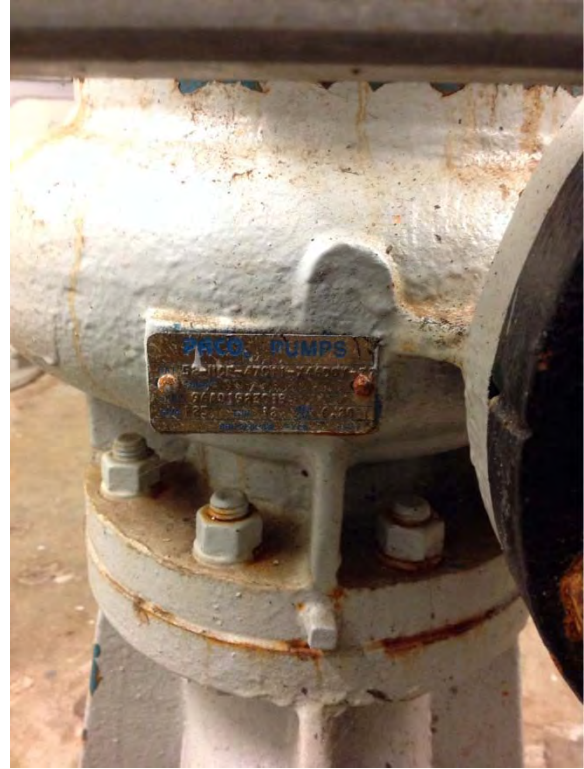
Pump 1 showing signs of aging on exterior

Condition Rating 3 – Based on visual observations and drawdown testing the pump is in fair condition and the reliability is still acceptable

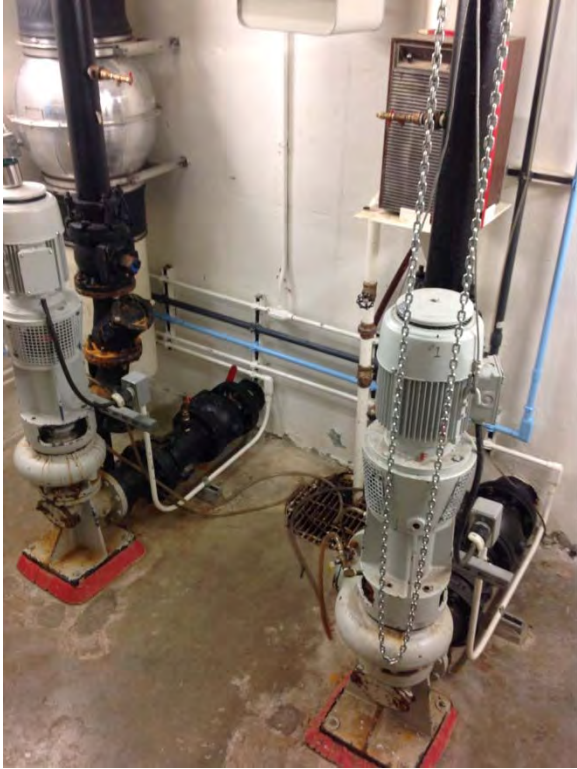
Duplex configuration, pump 2 on the left

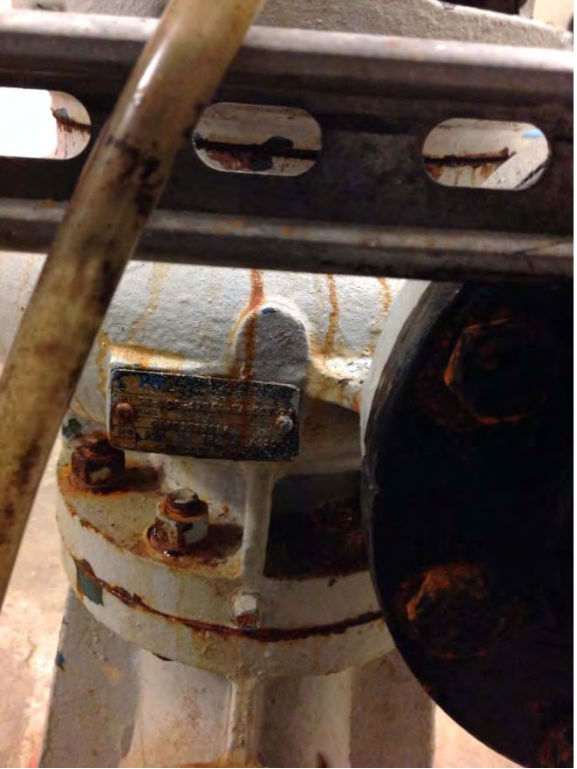
Pump 2 showing signs of aging on exterior

Condition Rating 3 – Based on visual observations and drawdown testing the pump is in fair condition and the reliability is still acceptable

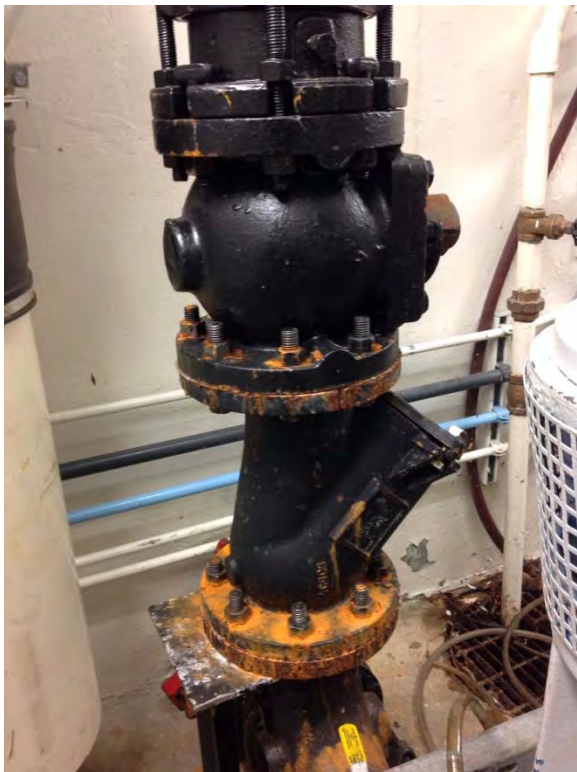
Ball check valve vertical installation and plug valve on discharge piping

- Ball check valve slams when pump shuts down, vertical installation

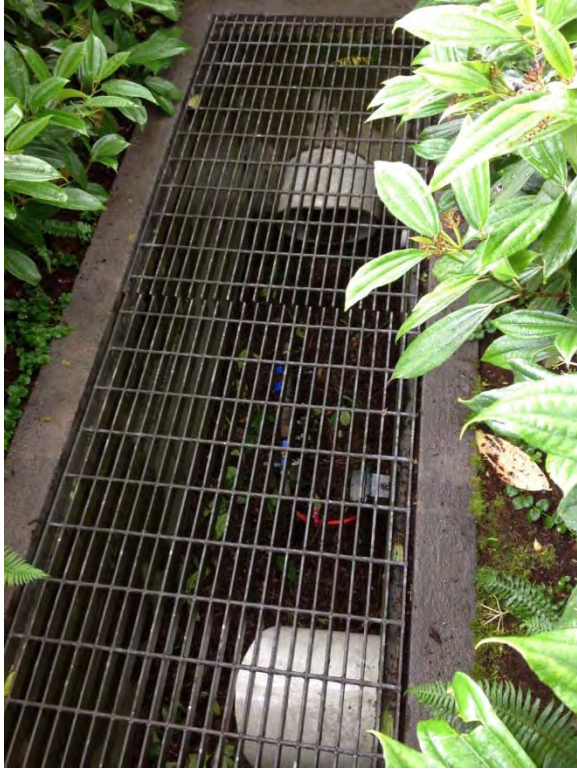
Backflow prevention assembly in underground air intake vault

- Backflow assembly located below grade, no drain to daylight – does not meet code for installation

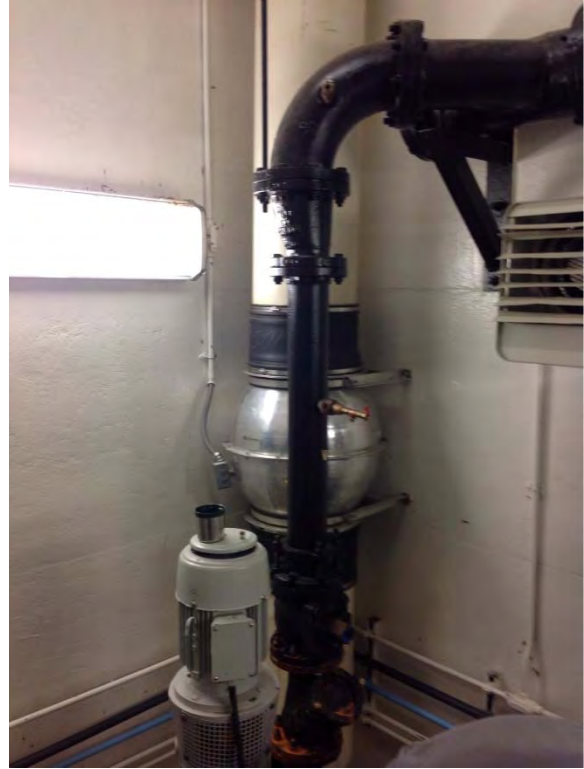
Supply fan located 5 feet AFF in dry pit

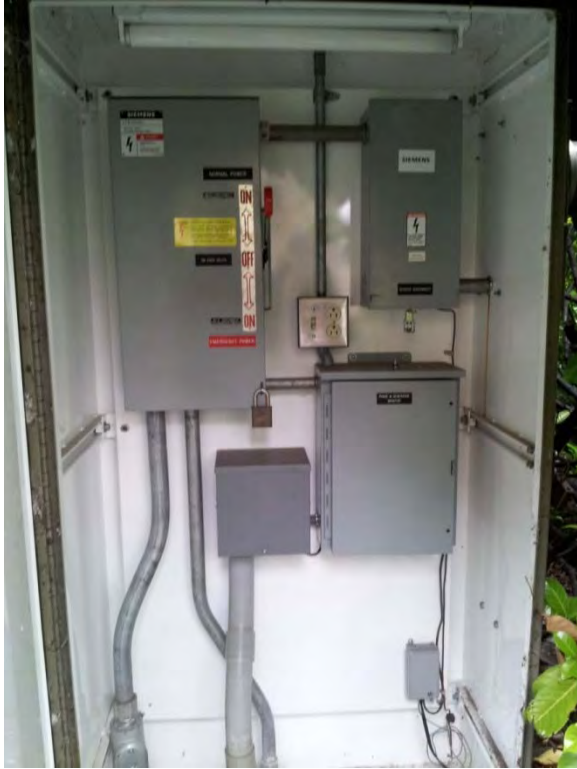
Manual transfer switch located in service cabinet

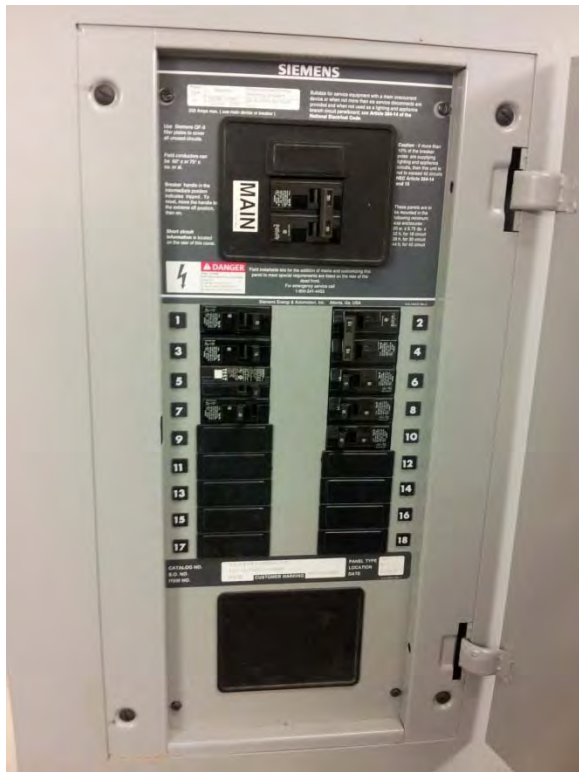
Panelboard located in dry pit, appears to be in good condition

Condition Rating 1 – Siemens panelboard appears to be in good condition

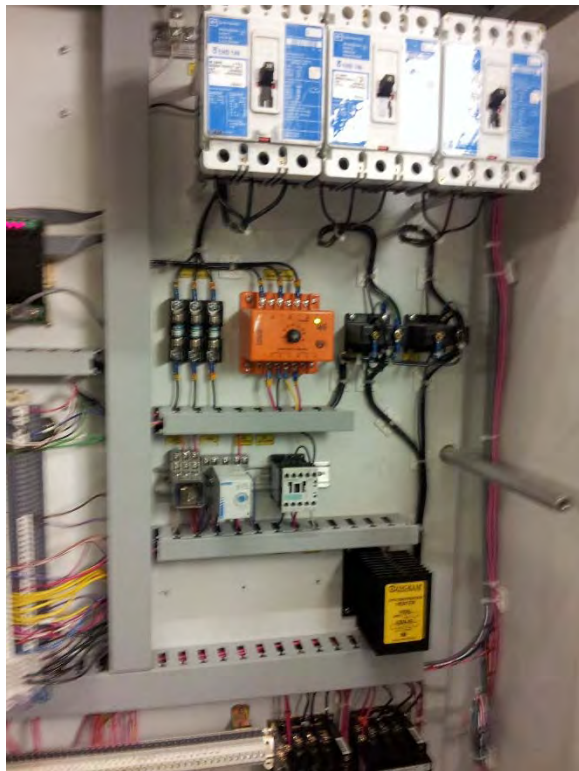
Westinghouse circuit breakers appear to be in good condition

Condition Rating 1 – Square D starters and Westinghouse circuit breakers appears to be in good condition

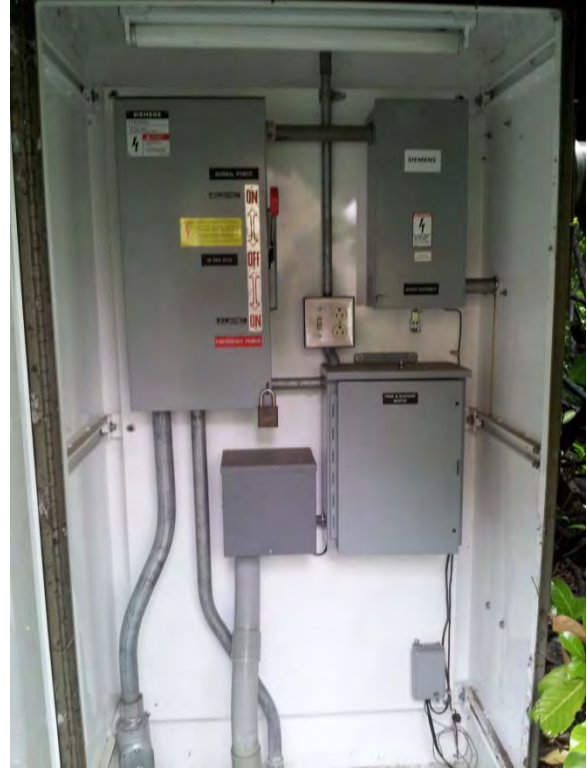
Telephone network interface located in service cabinet

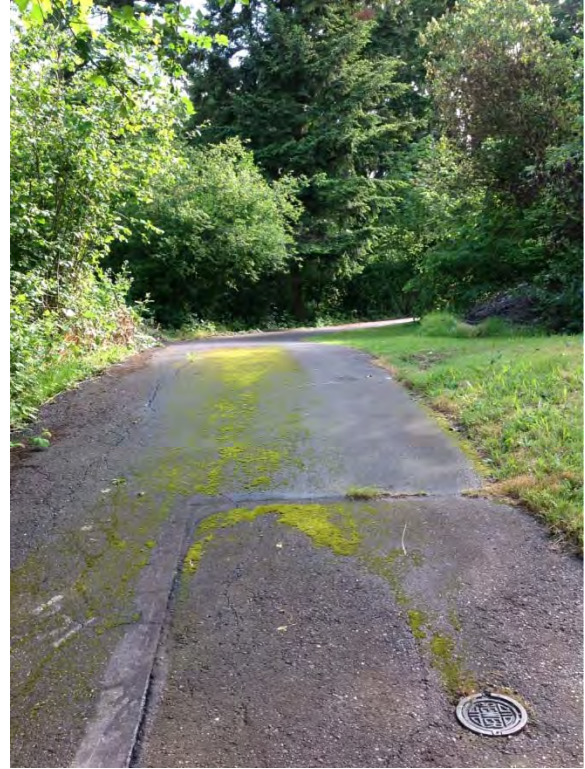
Moss growth on asphalt concrete

- Big grease problem reported – none identified in field
- Moss growth on asphalt concrete – slippery
- Gate to access road locked

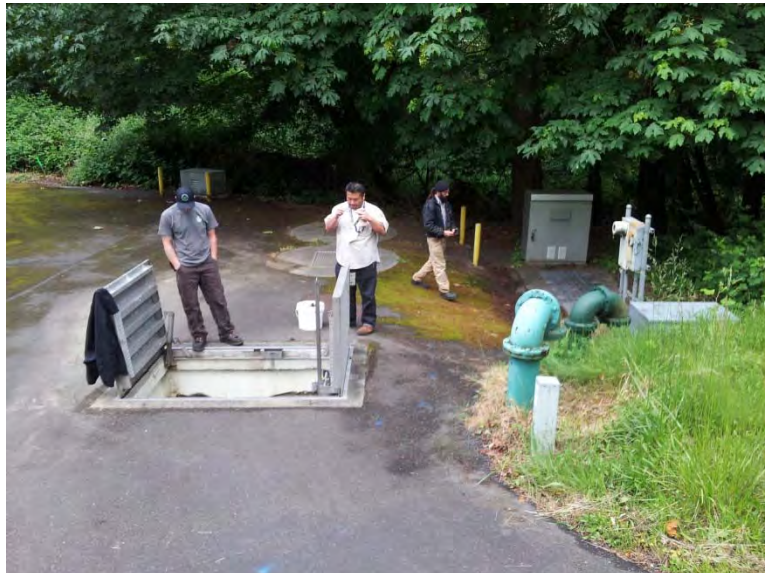
General site layout, more moss growth on asphalt concrete and a lot of vegetation maintained by others

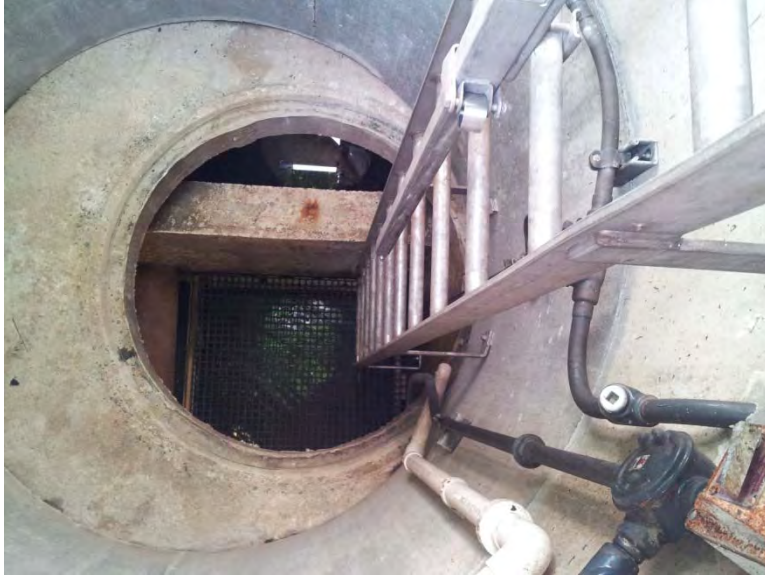
Interior of wet well including connected overflow wet well

- Back-up wet well baffled structure
- Overflow connected wet wells

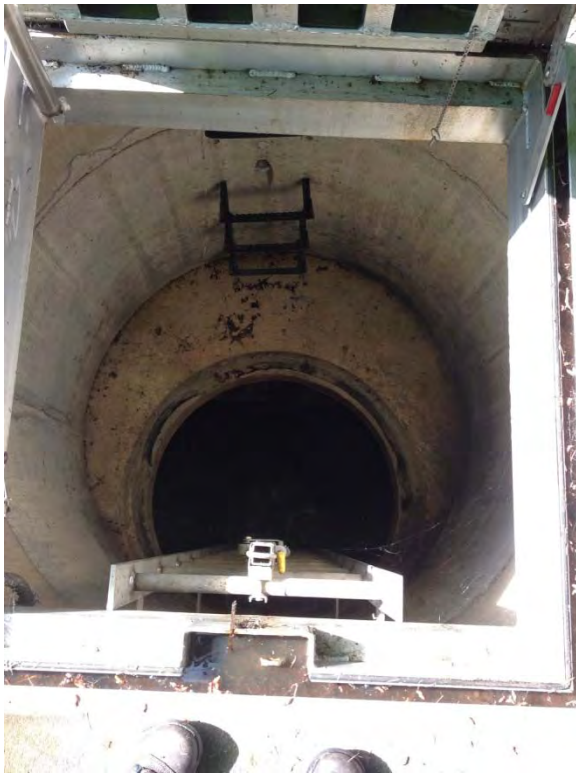
Interior of overflow wet well

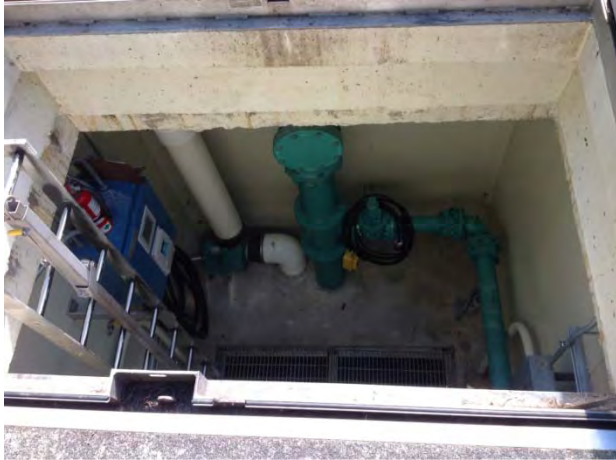
Interior of first floor of dry pit

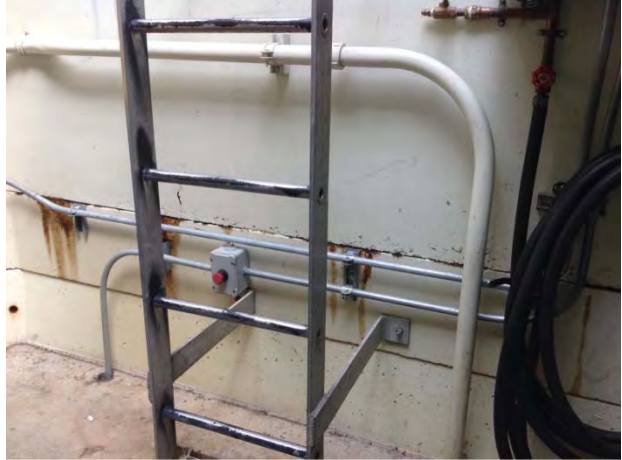
Some rusting near bottom of first floor seam

- Concrete spalled in top corner – reinforcing exposed and rusted. Should be patched to prevent further deterioration.
- Some rusting and delamination near access and at seam near bottom of the first floor
- Access to lower level via ladder – safety issue – recommend replacing grating w/ common 2-leaf grating hatch, relocated ladder to center

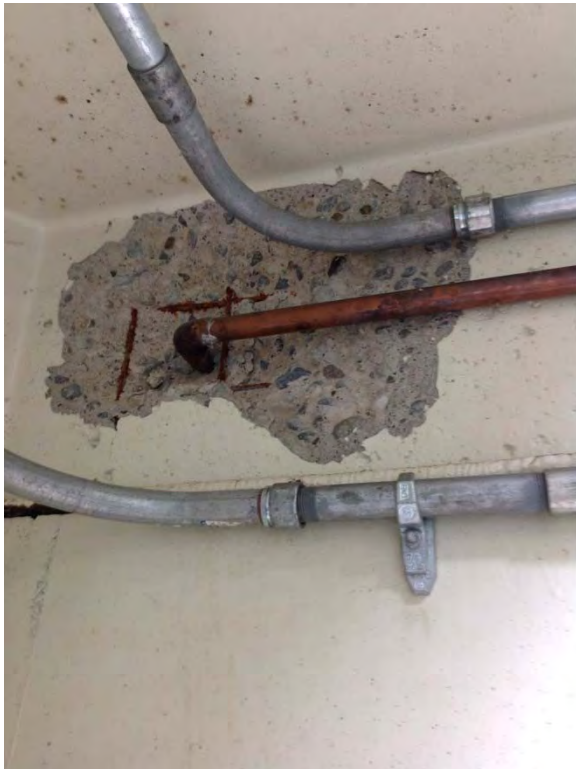
Concrete spalled in top corner – reinforcing exposed and rusted

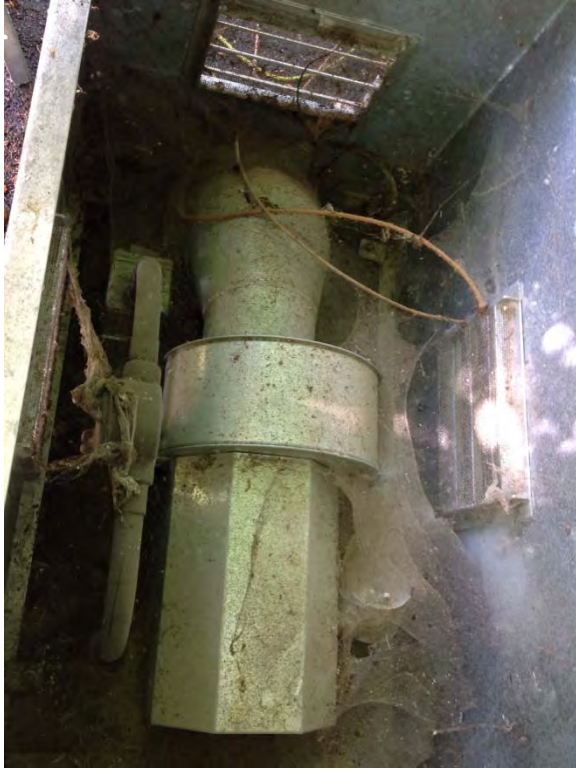
Interior of above grade exhaust fan vents, a lot of cobwebs, some branches inside

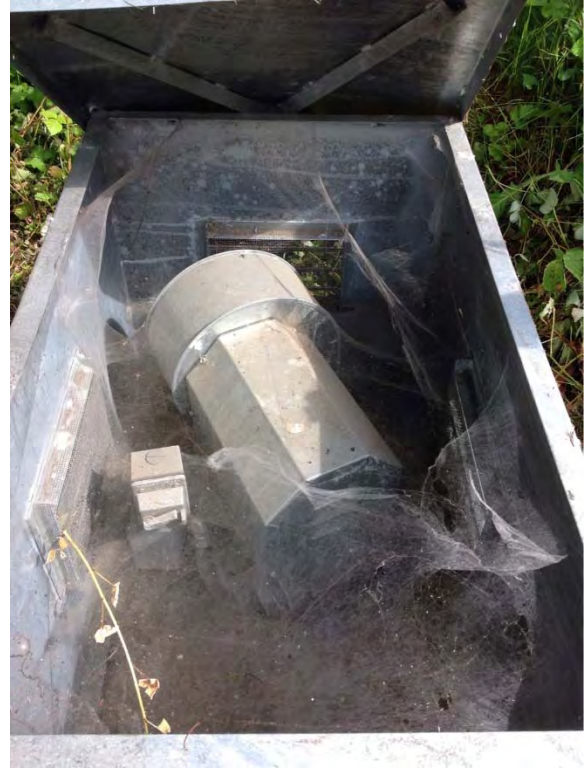
Interior of above grade supply fan vents, a lot of cobwebs, some branches inside

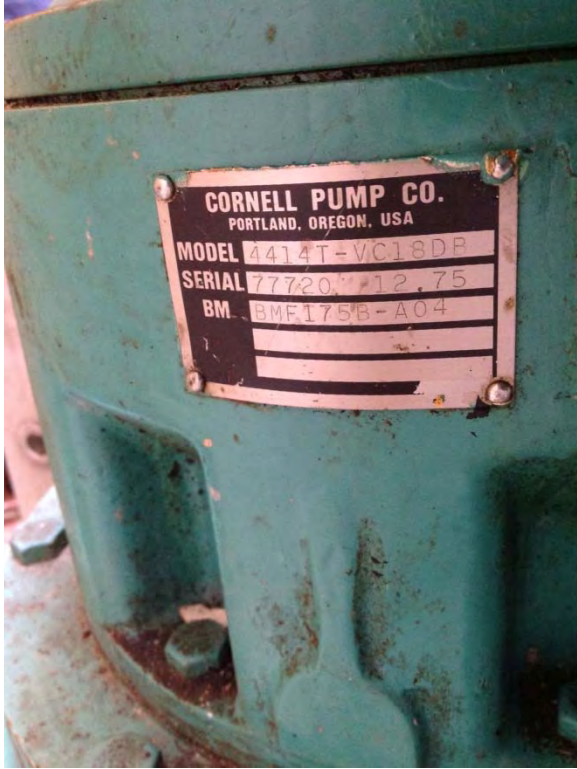
Pump 1 showing signs of aging on exterior

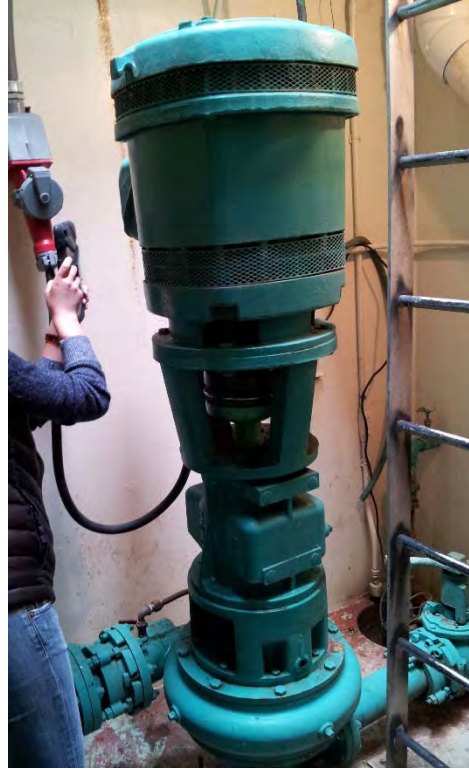
Pump and motor #1

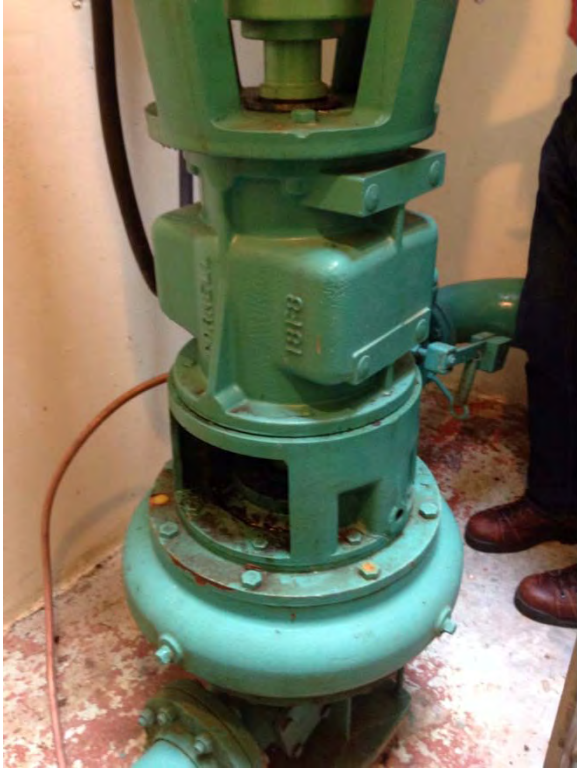
Pump 2 showing signs of aging on exterior

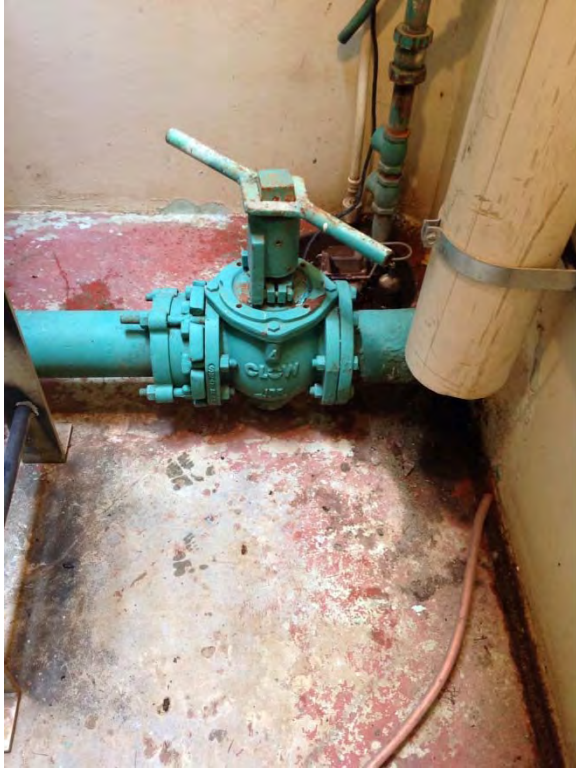
Plug valve isolation for suction piping, vertical axis of orientation – not ideal

- Plug valve seats to pump, vertical axis of rotation – not ideal. Should be addressed upon replacement of rotating assembly.
- Swing check valve slams upon shut down

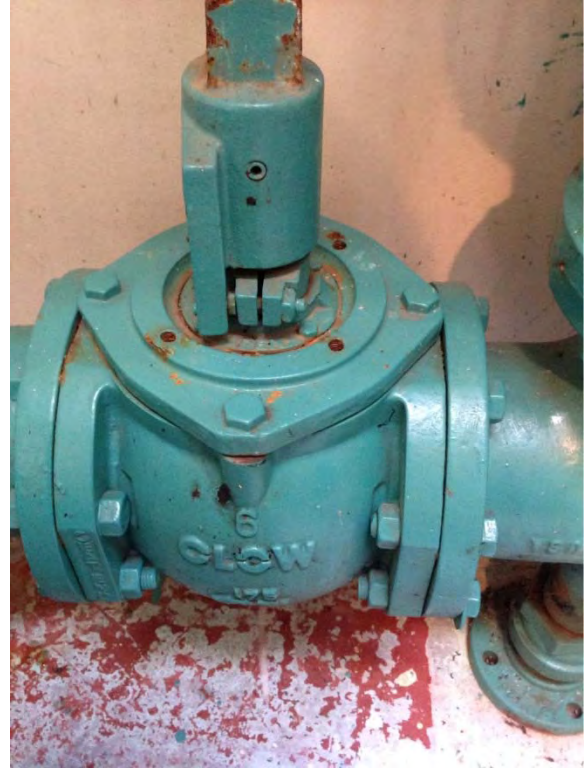
Plug valve isolation for discharge piping, vertical axis of orientation – not ideal

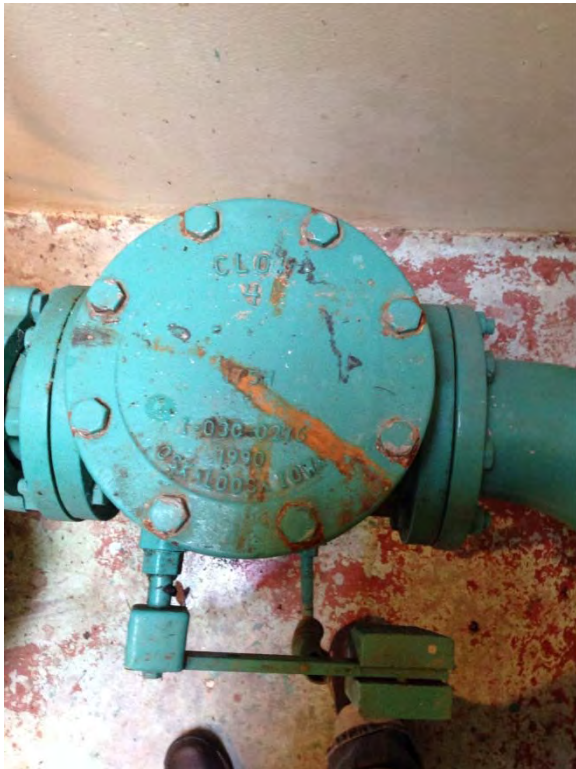
Swing check valve on discharge piping, with outside weight level and spring

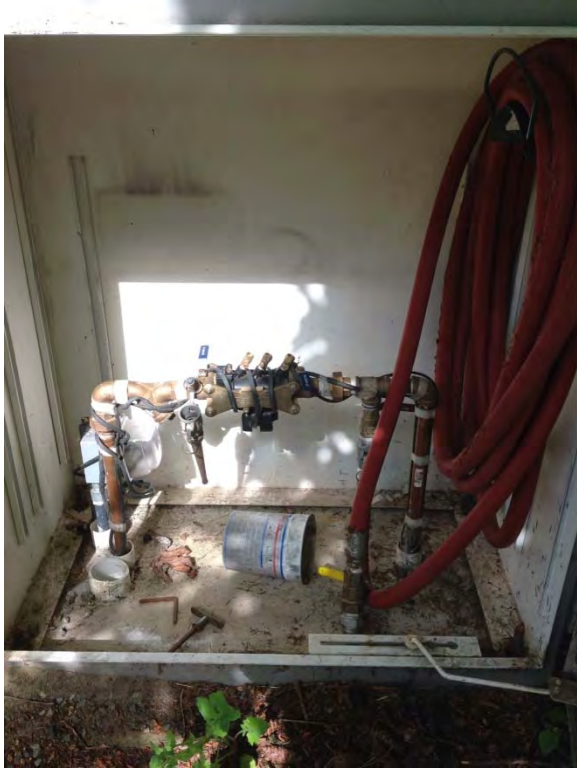
Backflow prevention assembly in above grade stainless steel insulated enclosure

Supply	Domestic/Metered
Access	Top floor of dry pit
Backflow prevention assembly	Wilkins reduced pressure backflow device
Enclosure/Freeze protection	Stainless steel above ground enclosure/Insulated

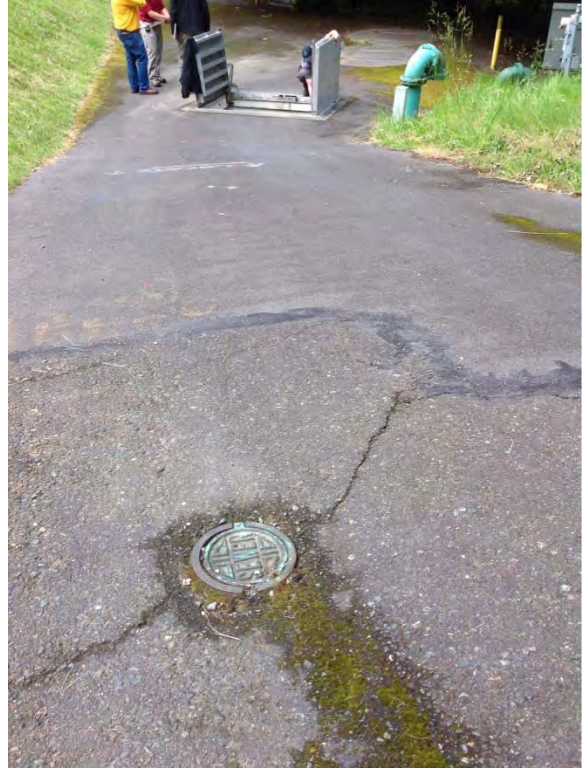
Isolation valve in access road approximately 20 feet from station

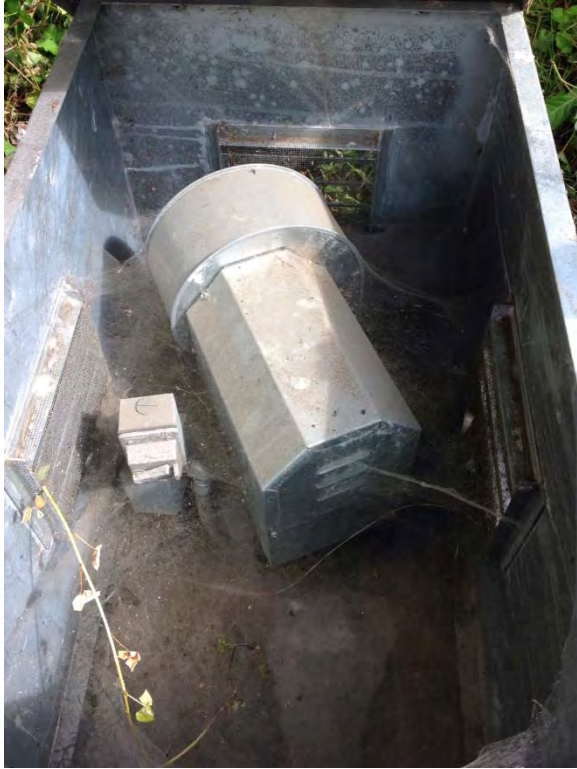
Wet well supply fan located in above grade enclosure

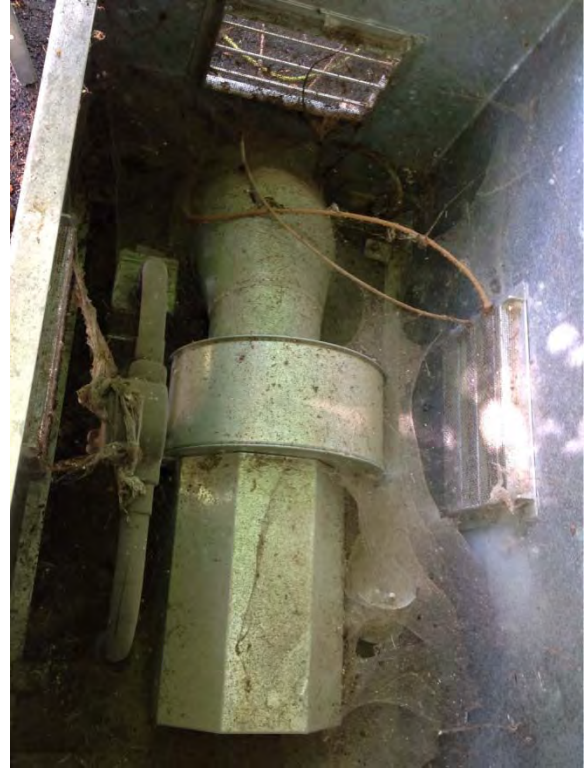
Wet well exhaust fan located in above grade enclosure

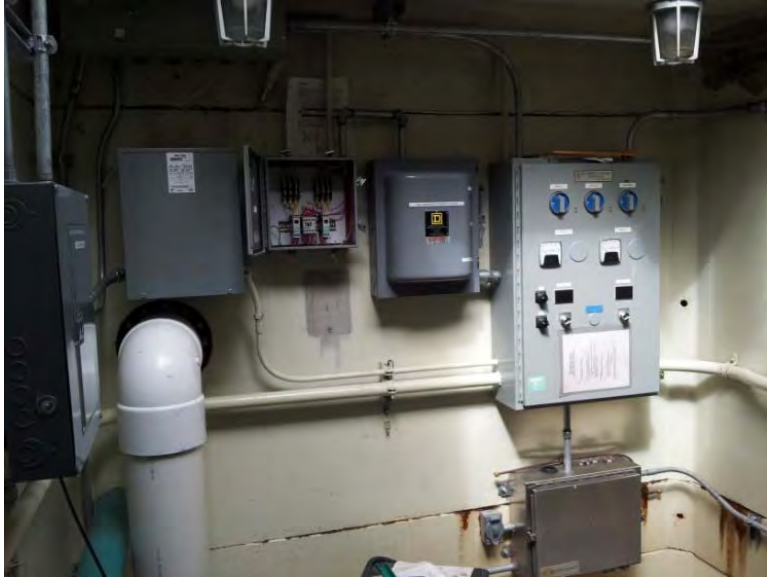
Square D Panelboard located in dry pit on left side

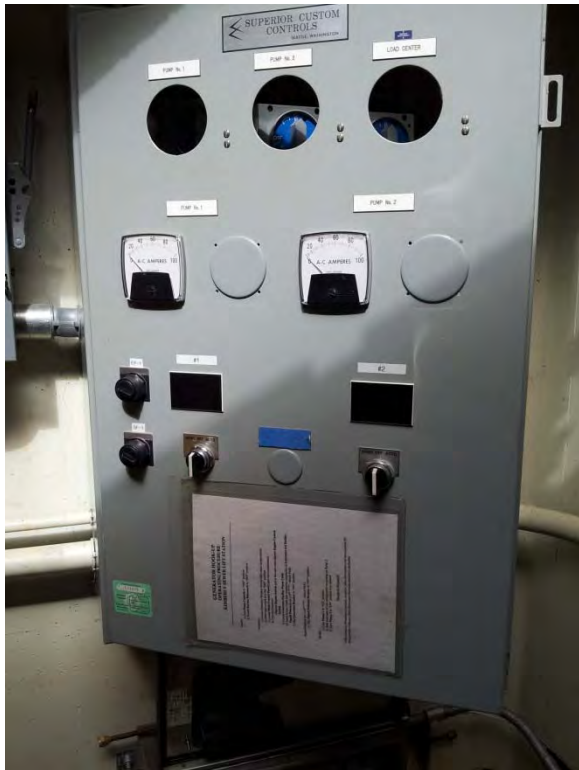
Starters located in dry pit, appears to be in good condition

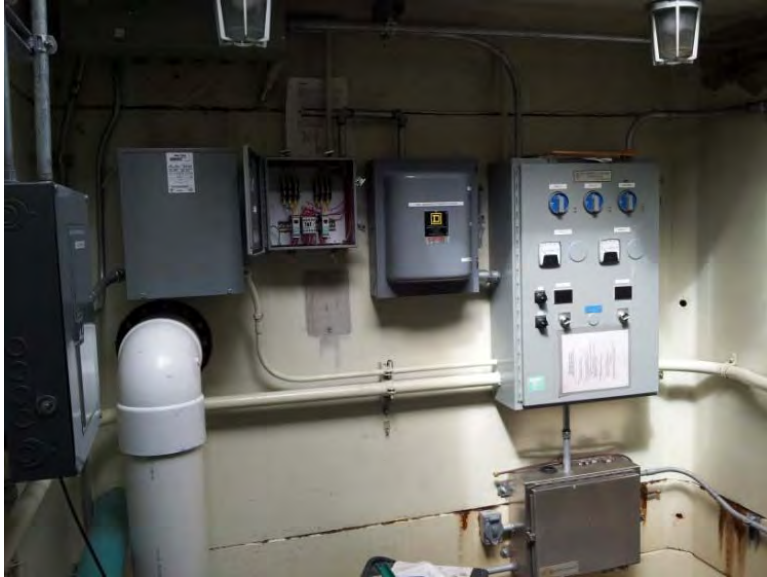
Power and control panel layout in dry pit

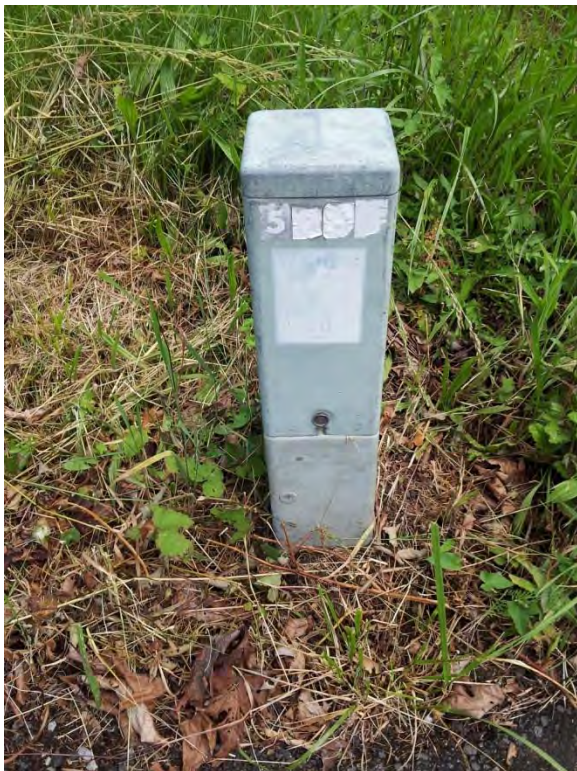
Telephone network interface located in outdoor telephone pedestal adjacent to station

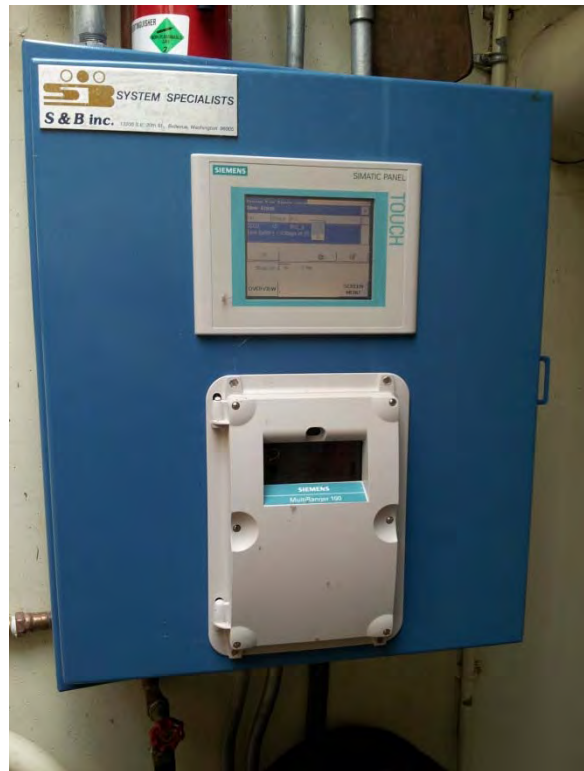
Telemetry control panel located in dry pit, appears to be in good condition

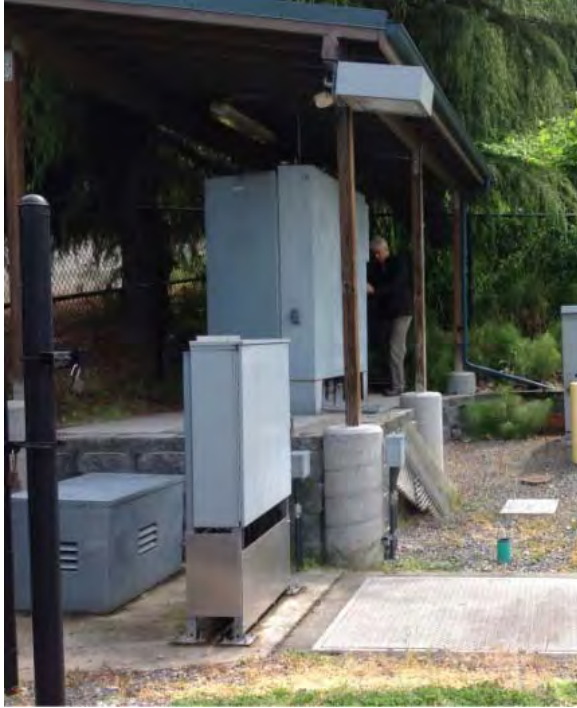
Main control cabinet up 2' – 3', no railing – potential safety issue

- Main control cabinet up 2'-3', no railing – potential safety issue
- Davit base for pump hoisting approximately 4" above grade, tripping hazard next to wet well
- Wet well hatch opening is too large to accommodate fall protection

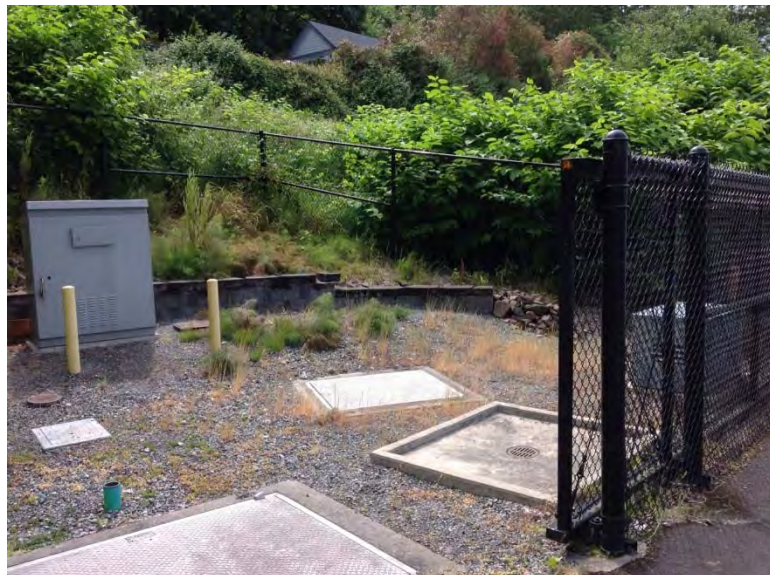
Station layout, green davit base for pump hoisting approximately 4" above grade, tripping hazard next to wet well

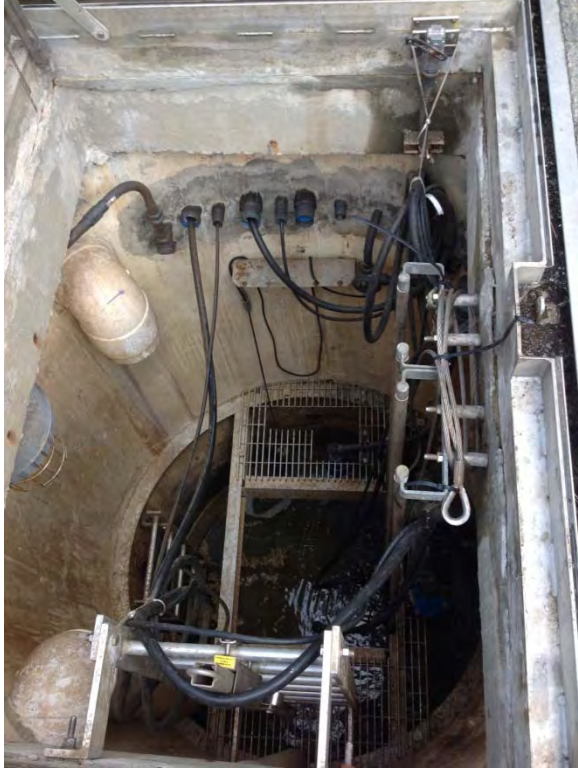
Interior of wet well

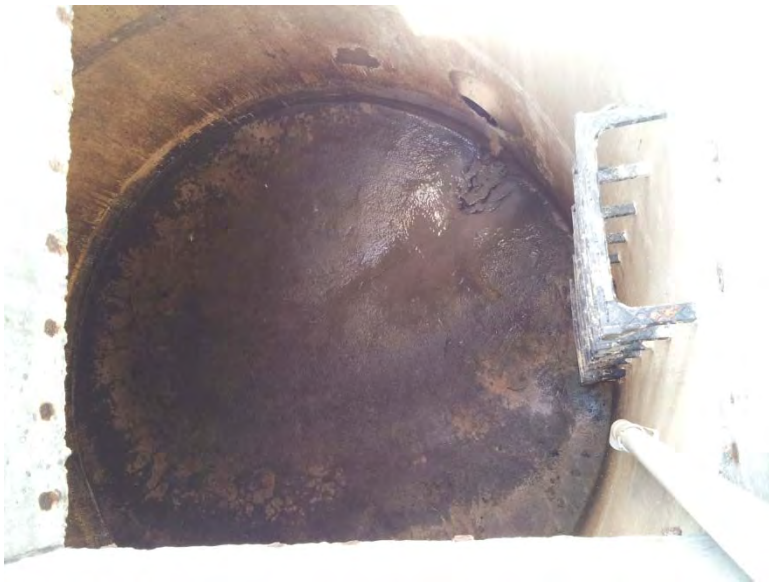
Interior of holding tank adjacent to wet well

- Some grating from the wet well stored outside
- Back up wet well/holding tank located adjacent to station within gated area, approximately 8' inside diameter

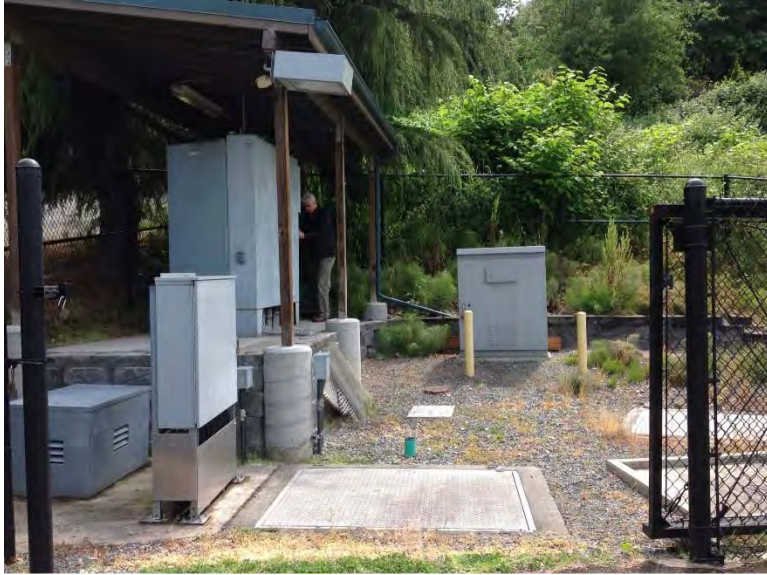
Timber shed with metal roof on platform providing cover for power and control equipment

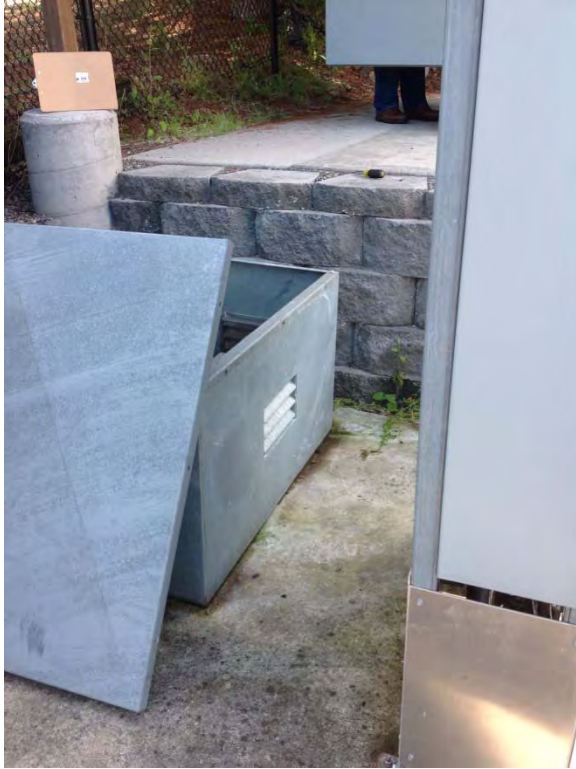
Above grade steel enclosure for exhaust fan

- Two blower vent enclosures one houses supply fan and the other houses the exhaust fan for the wet well

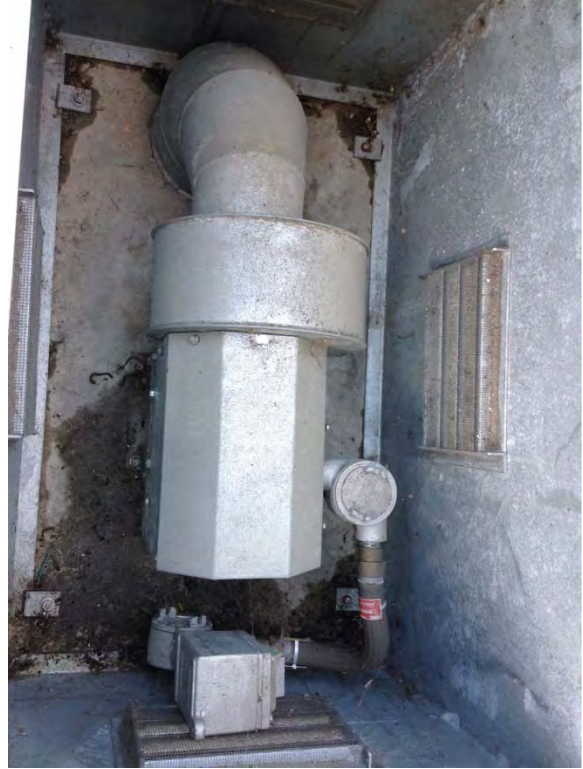
Interior of exhaust fan above grade steel enclosure

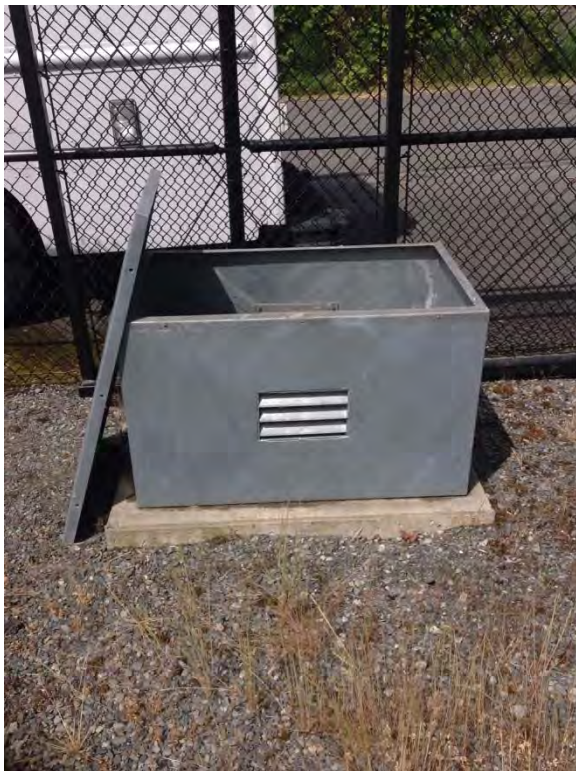
Above grade steel enclosure for supply fan

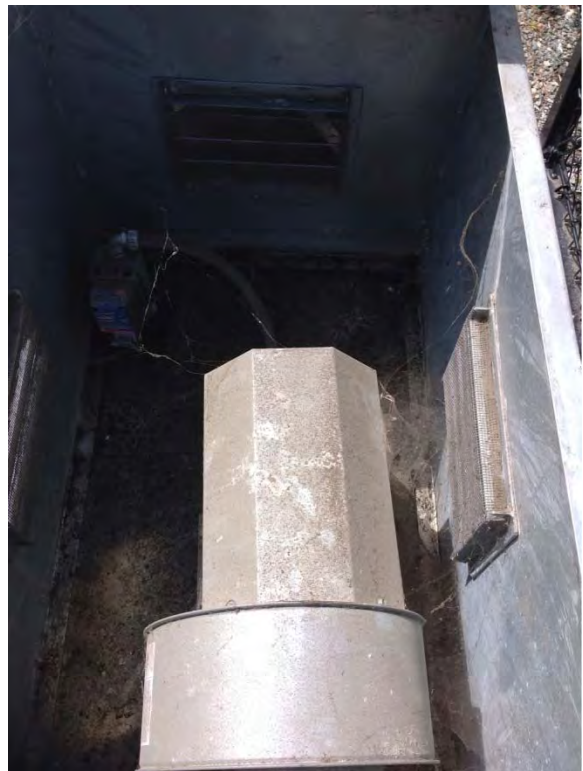
Interior of supply fan above grade steel enclosure
