Lake Washington Wastewater Lake Line Management Plan

FINAL / July 2024

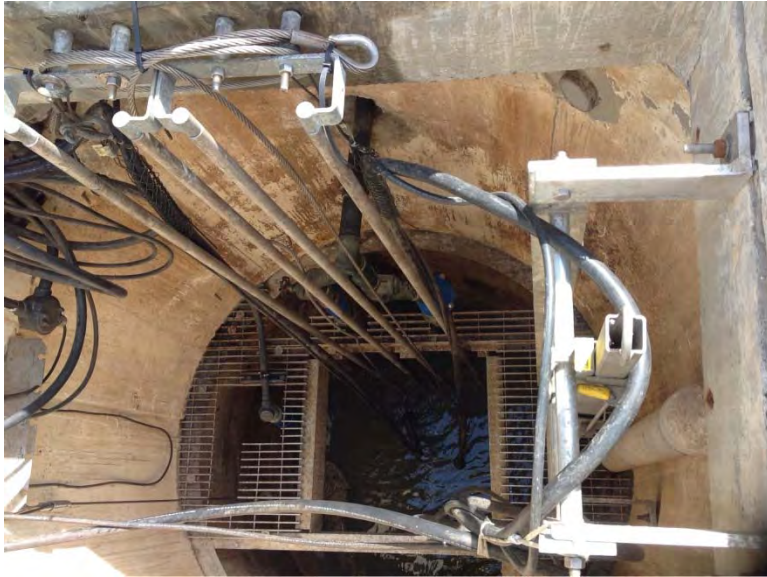
Submersible station, unable to observe pumps

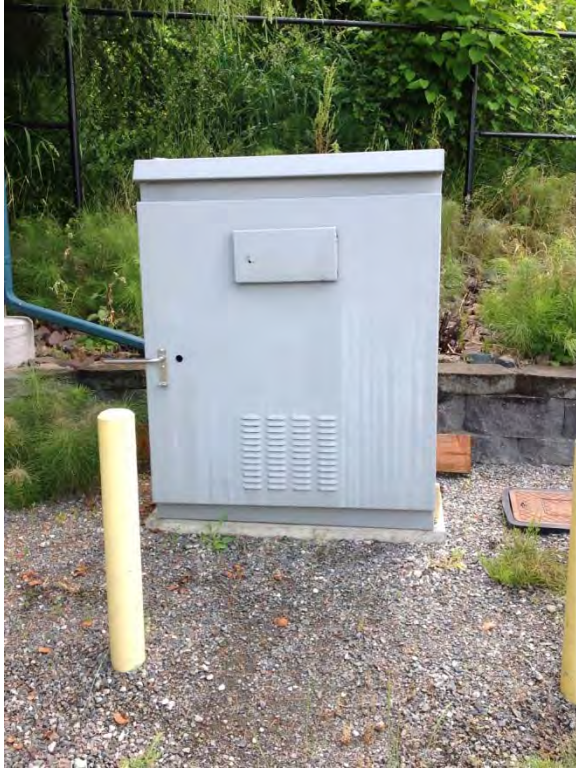
Backflow prevention assembly in above grade stainless steel enclosure

Supply	Domestic/Metered
Access	Hose bibb in backflow preventer enclosure
Backflow prevention assembly	Zurn reduced pressure backflow device
Enclosure/Freeze protection	Painted steel enclosure/Heat tape

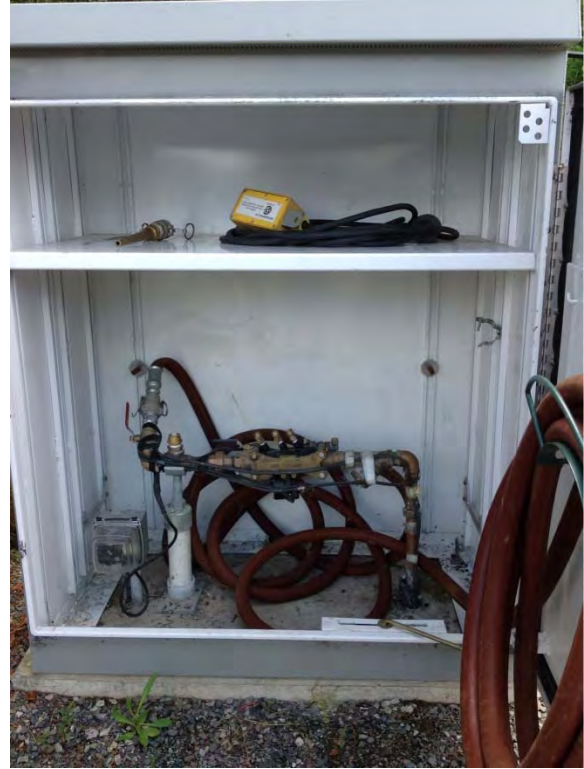
Backflow prevention assembly with heat tape and hose bibb for wash down located in enclosure

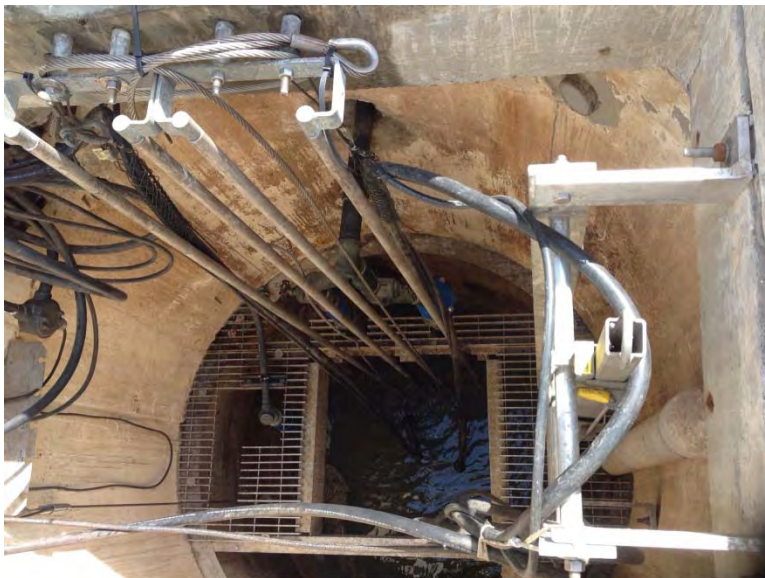
Gateway valve and ball check valve located in wet well, PVC and galvanized discharge piping

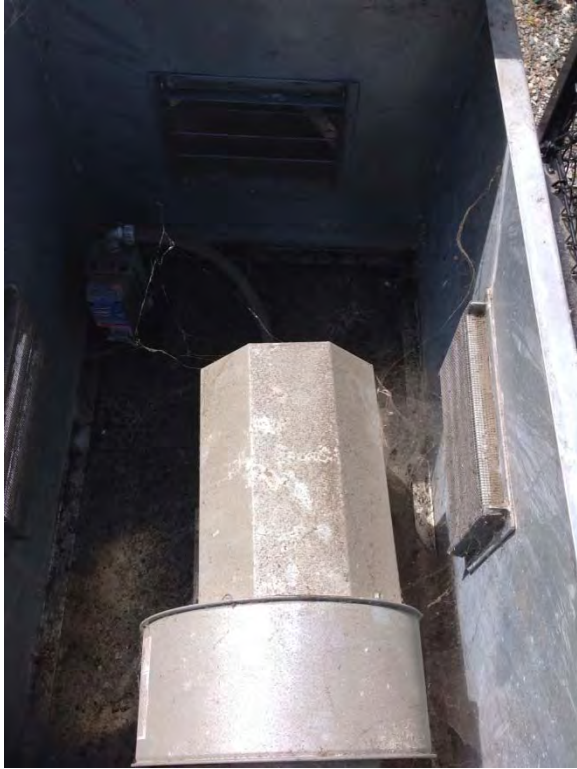
Wet well supply fan located in above grade steel enclosure

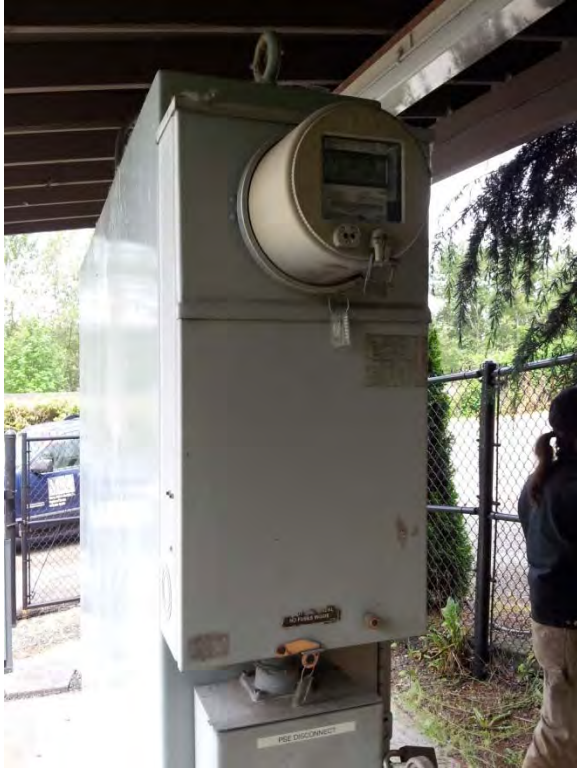
Service meter located on side of power and control panel

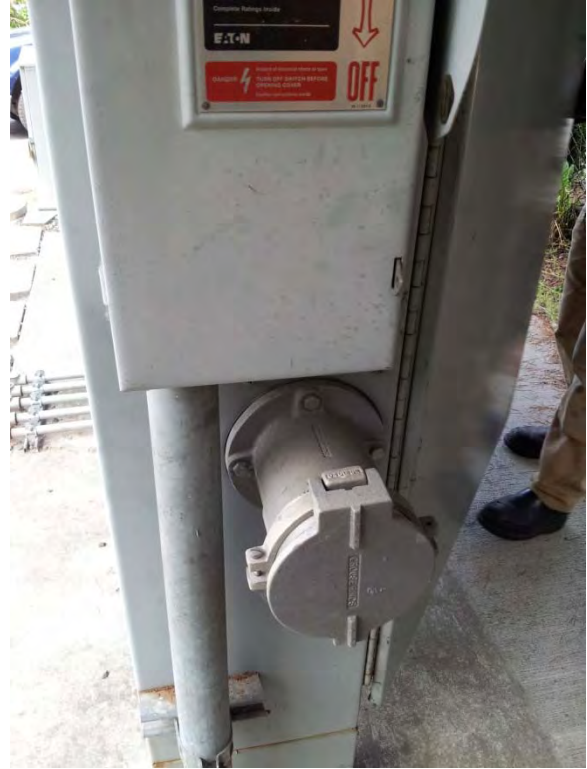
Generator receptacle mounted thru outside of power and control panel

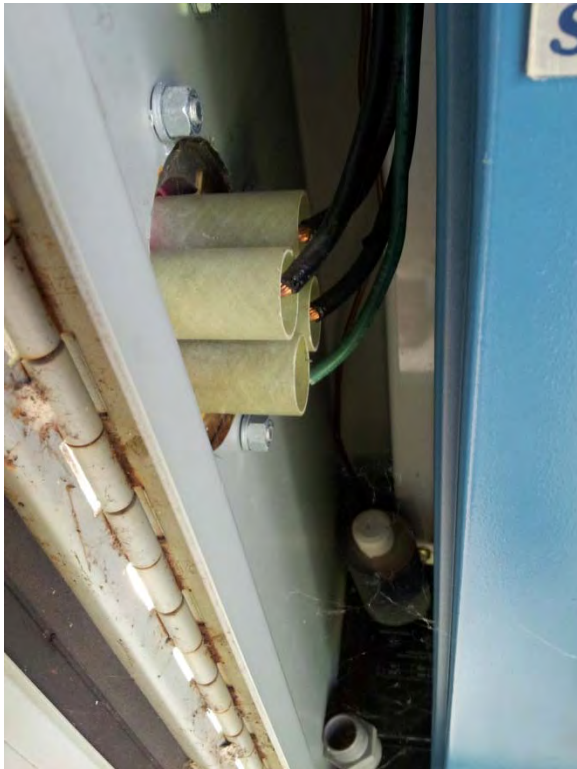
Generator receptacle needs to be mounted for clearance of conductors

- Generator receptacle needs to be mounted for clearance of conductors

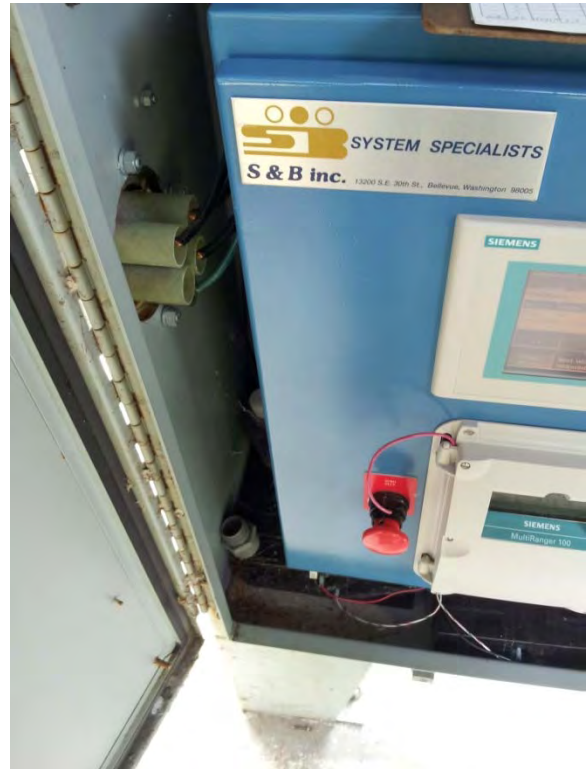
Generator receptacle needs to be mounted for clearance of conductors, alternate view

Due to the ease of access at this site and its low impact on the public and private residents, the deficiencies were lumped into one project. The timing of the recommended project is driven by the generator receptacle since it is a safety hazard.

If the generator receptacle wiring issue is not addressed, personnel working near the receptacle and panel could be exposed to a safety hazard. The submersible pump are nearing the end of their useful life based on perceived age. The consequence of failure of this component will reduce the level of service to the station below industry standards and regulatory requirements.

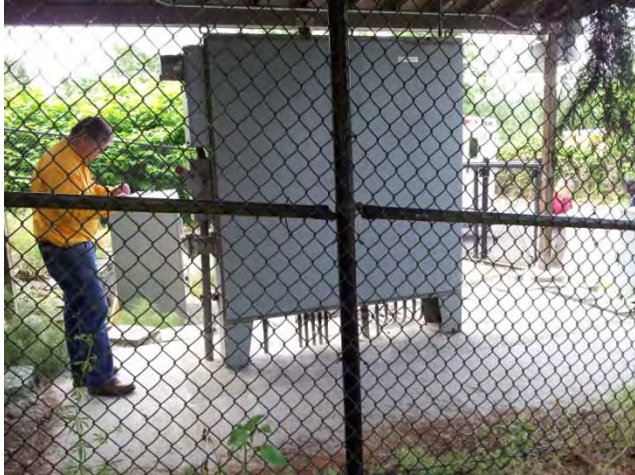
Power and control panel outdoor enclosure located on platform

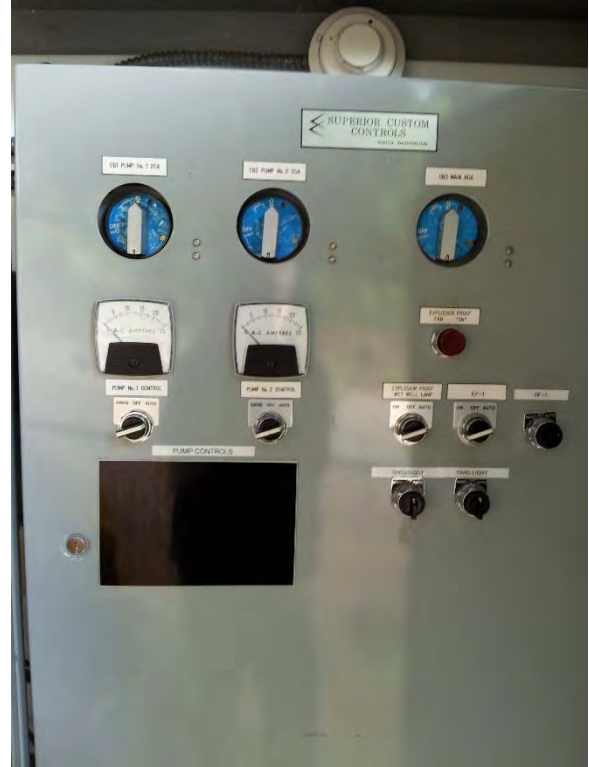
Starters located in power and control panel outdoor enclosure, appears to be in good condition

Condition Rating 1 – Both the Furnas starter and replacement Siemens starter appear to be in good condition

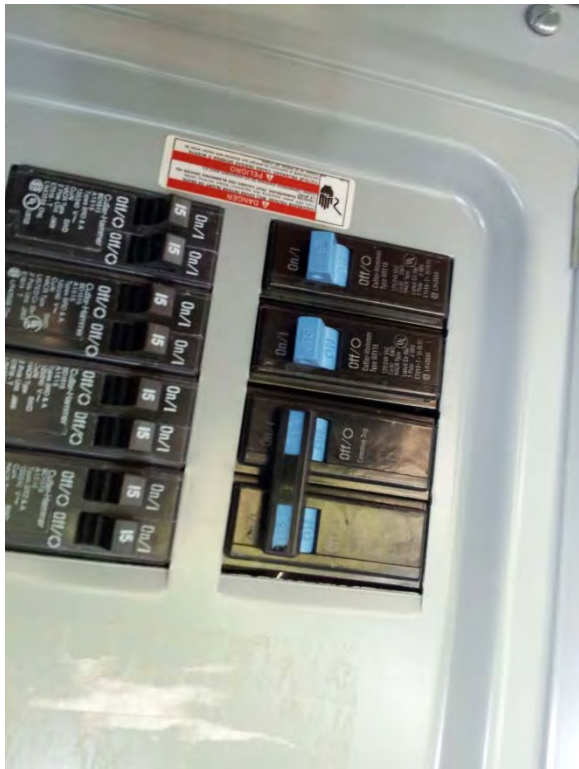
Panelboard located in power and control panel outdoor enclosure, appears to be in good condition

Condition Rating 1 – Cutler Hammer panel appears to be in good condition

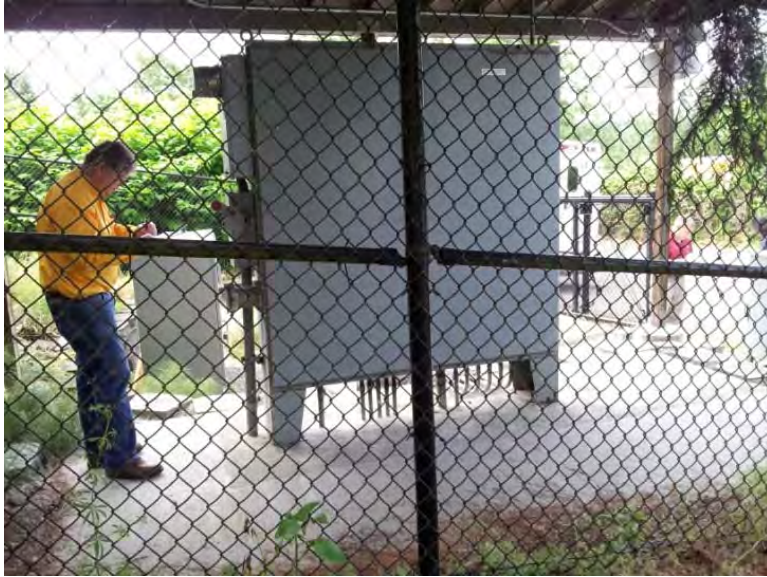
Power and control panel outdoor enclosure located on platform

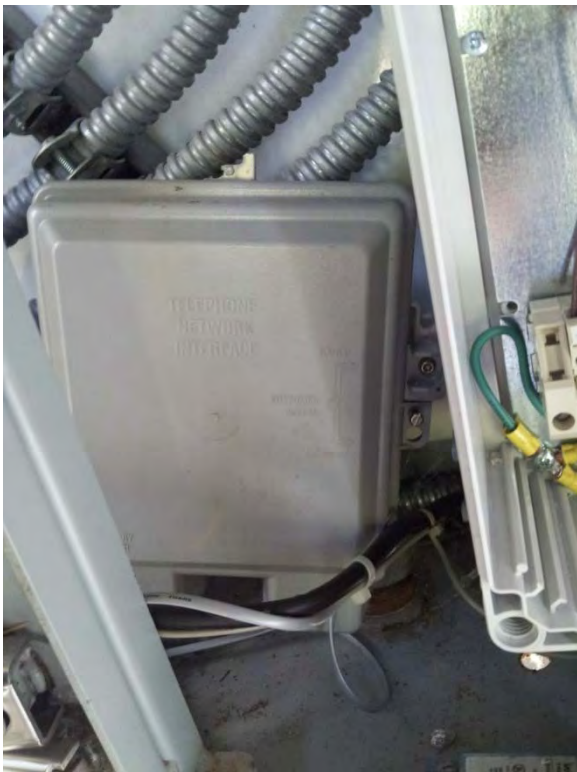
Telephone network interface located in power and control panel enclosure

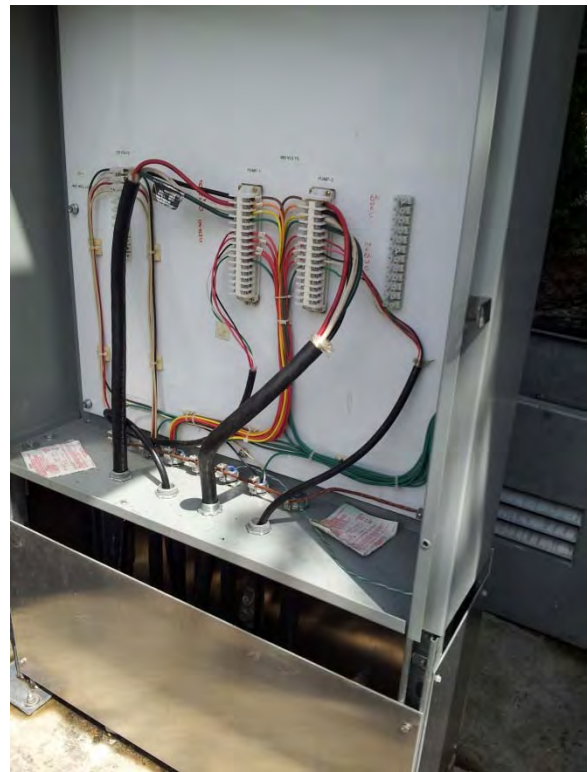
Submersible cable termination enclosure adjacent to wet well in above grade enclosure, fairly new appears to be in good condition

Condition Rating 1 – Large fairly new termination cabinet appears to be in good condition

Criticality Rating 3 – Critical but redundant, transmits power from the starters to the pump cords but if one cord or termination fails the other pair will still operate

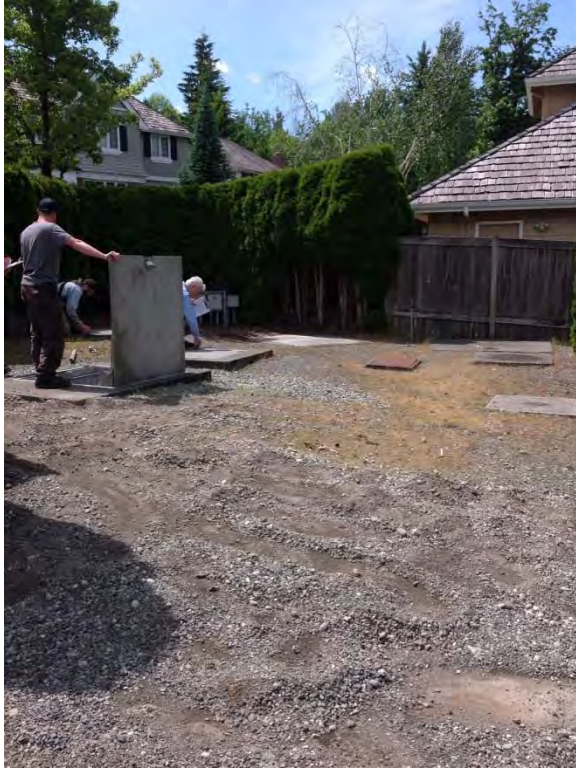
Hatches several inches above grade – potential tripping hazard

- Hatches several inches above grade – potential tripping hazard

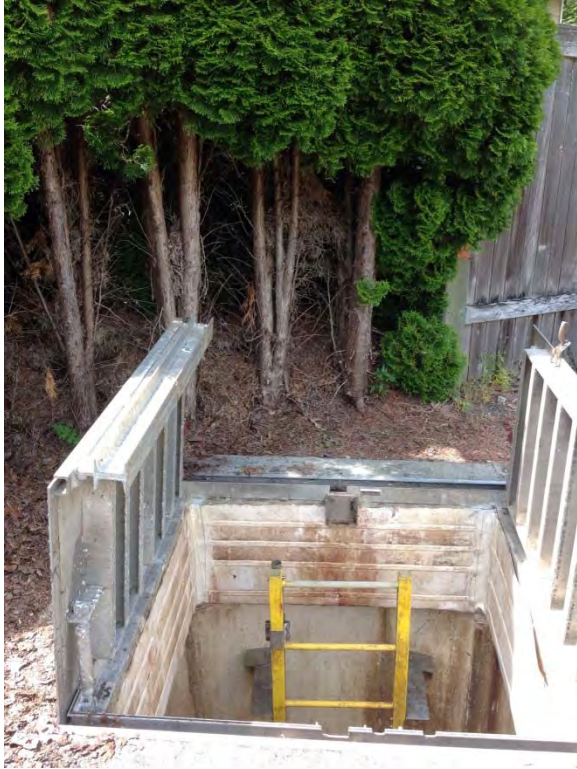
Wet well hatch and ladder

Condition Rating 2 – Ground surface inspection identified there is some delamination of the PVC liner.

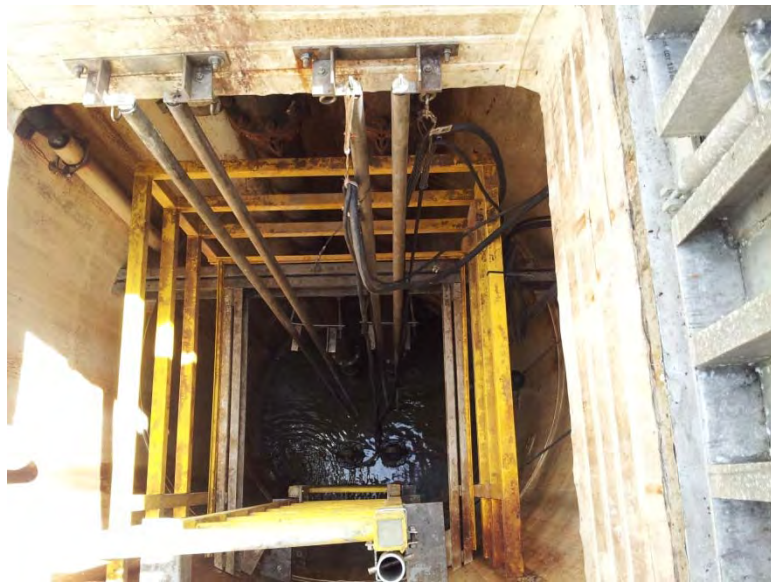
Interior of wet well

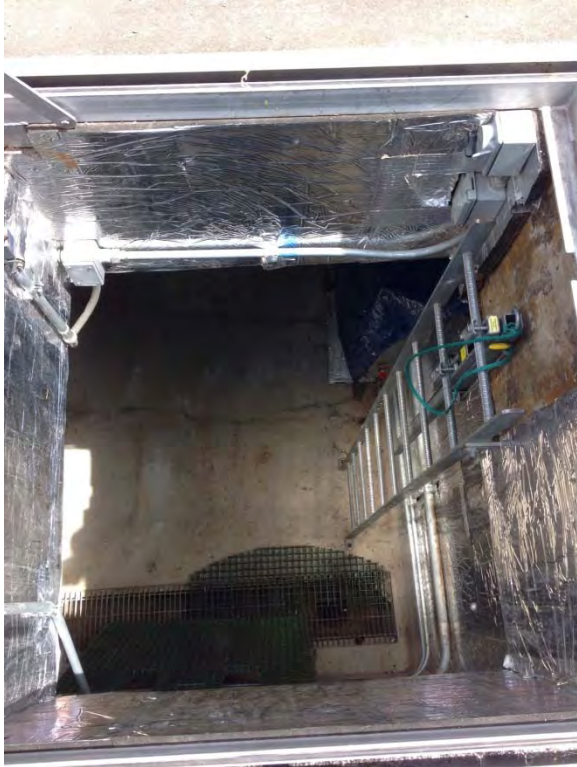
Interior of dry pit/generator vault with sound proof panels

Condition Rating 1 – Dry pit/generator vault appears to be in good condition.

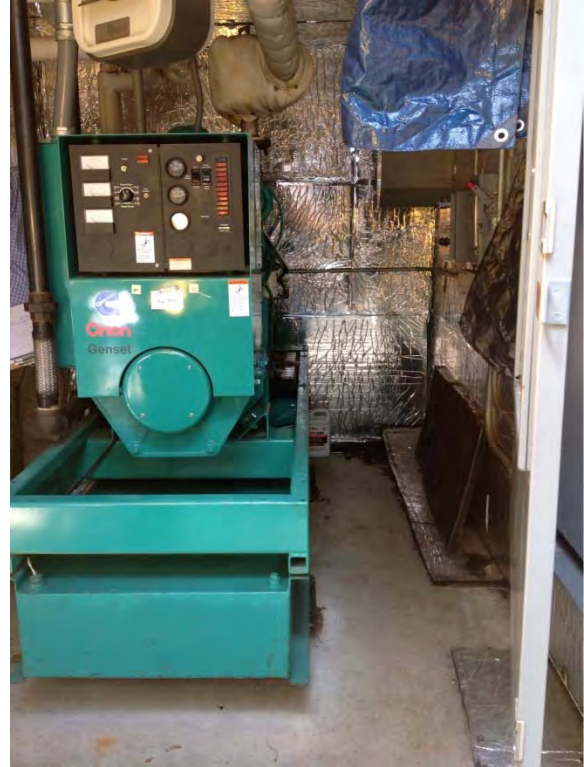
Generator located in vault

- Water cooled generator

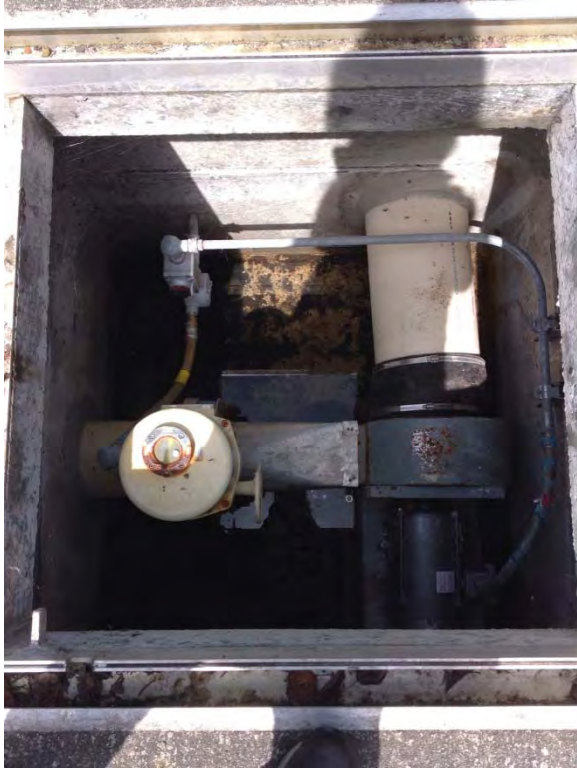
Interior of wet well blower vault,
flooding evident

- Flooding evident

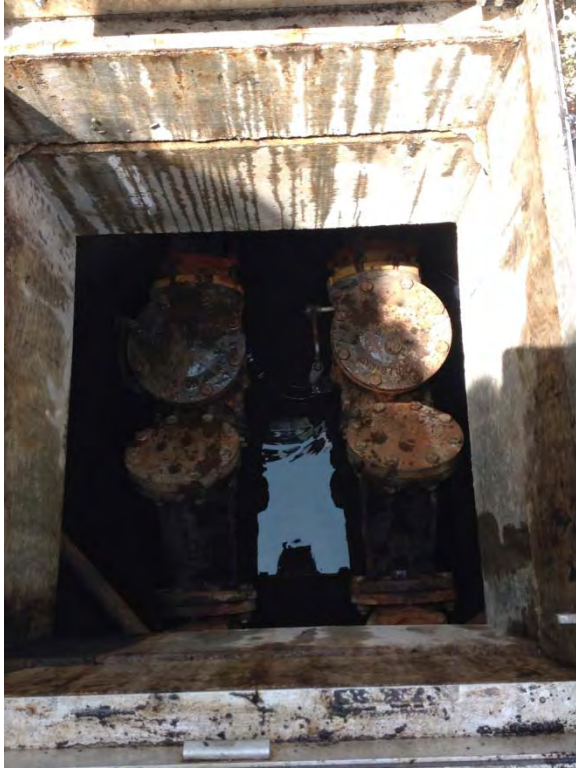
Isolation and check valve vault, flooding evident, check valve leaking upon site visit

Condition Rating 2 – Interior of vault appears to be in good condition, but flooding is evident and there is raw sewage in the vault due to the leaking check valve.

- Flooding evident
- Check valve leaking, raw sewage in vault

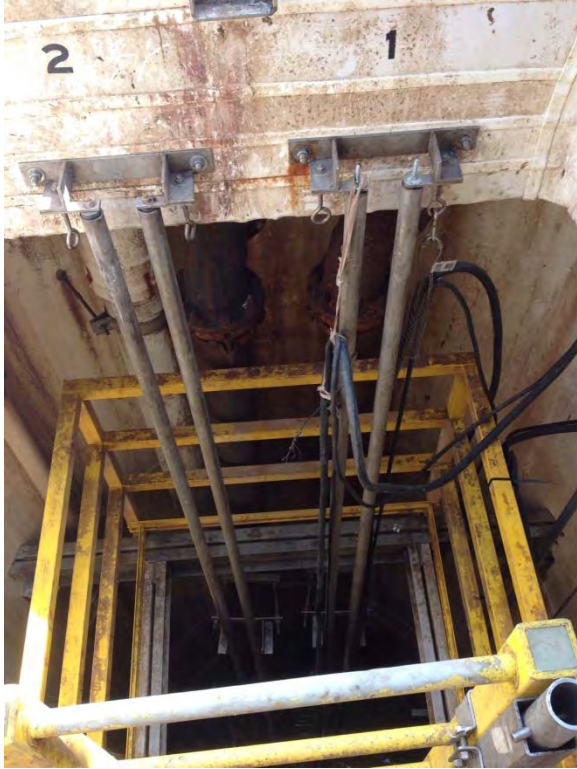
Submersible station, unable to observe pumps

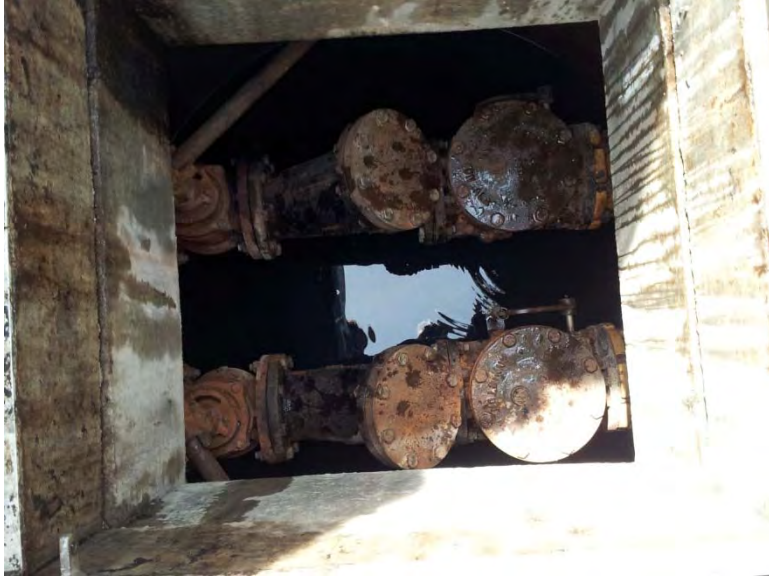
Plug valve and swing check valve with outside level and spring located in isolation and check valve vault, some rusting evident

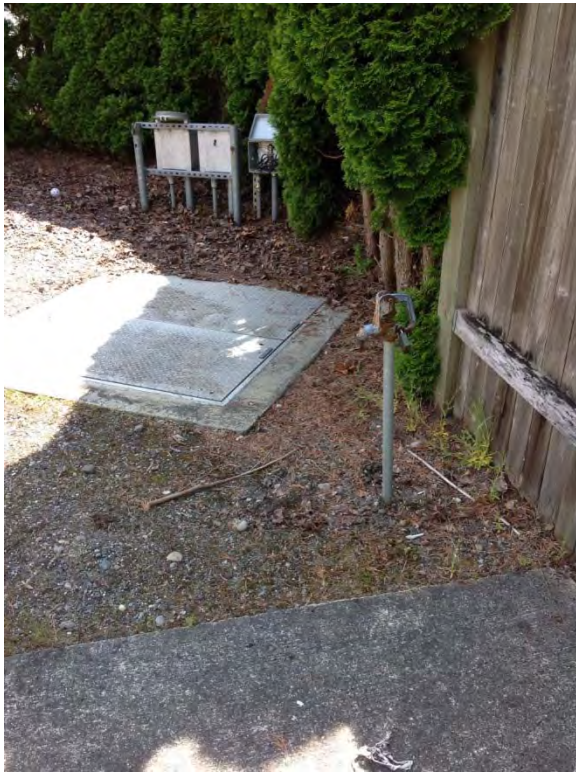
Freeze-less yard hydrant near wet well

Supply	Domestic/Metered
Access	Hose bibb in underground generator vault, freeze-less yard hydrant near wet well
Backflow prevention assembly	Reduced pressure backflow device
Enclosure/Freeze protection	Above grade enclosure/Heat tape

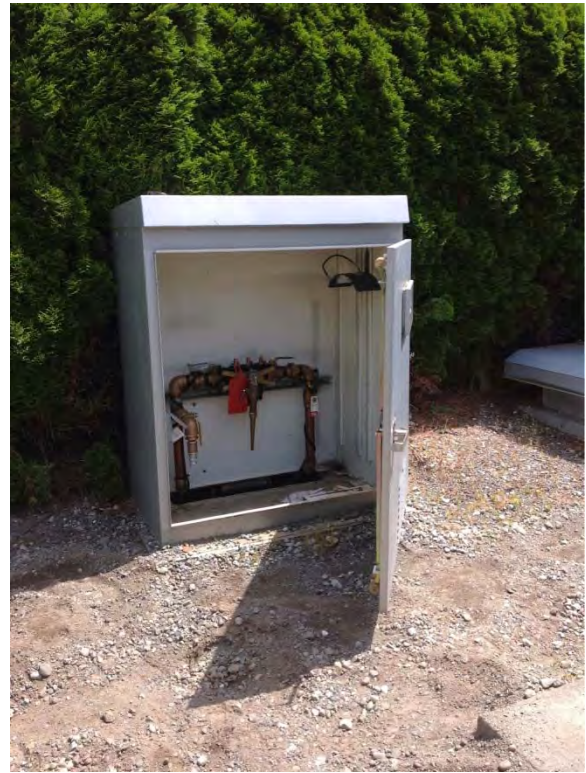
Backflow prevention assembly in above grade enclosure

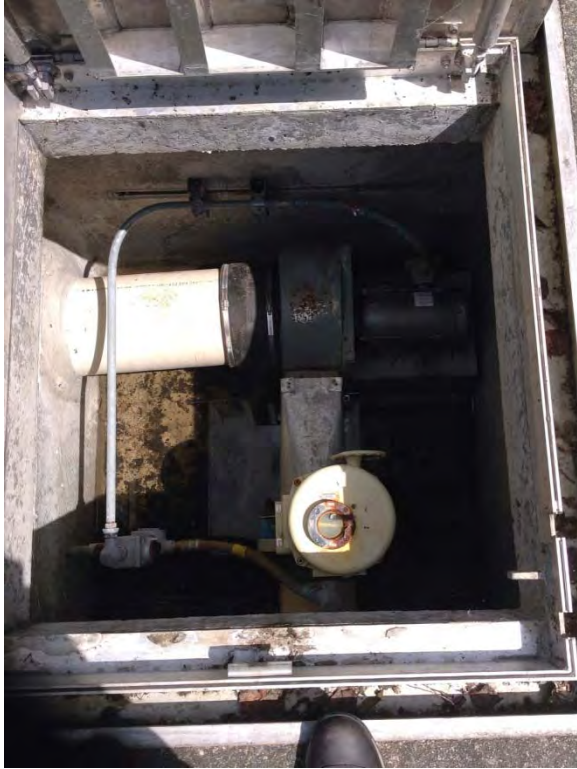
Wet well fan located in wet well blower vault

- Two speed exhaust fan

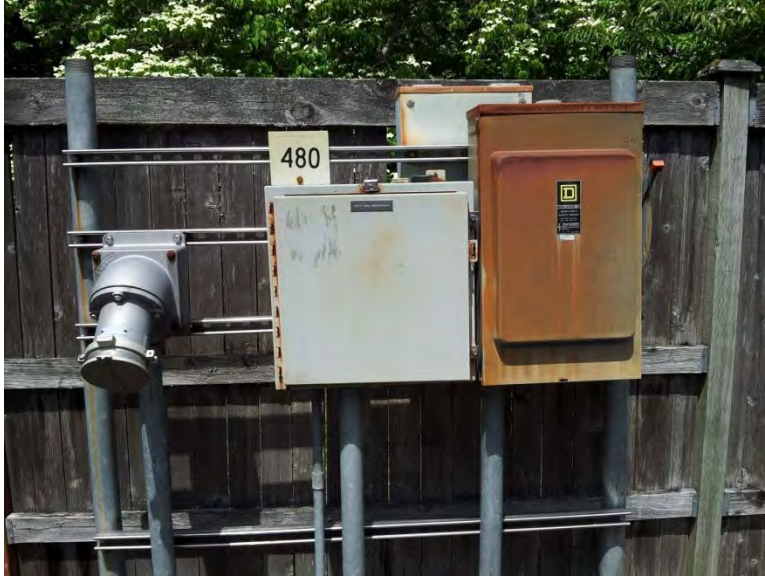
Service entrance equipment rack including generator receptacle located behind arborvitae adjacent to site

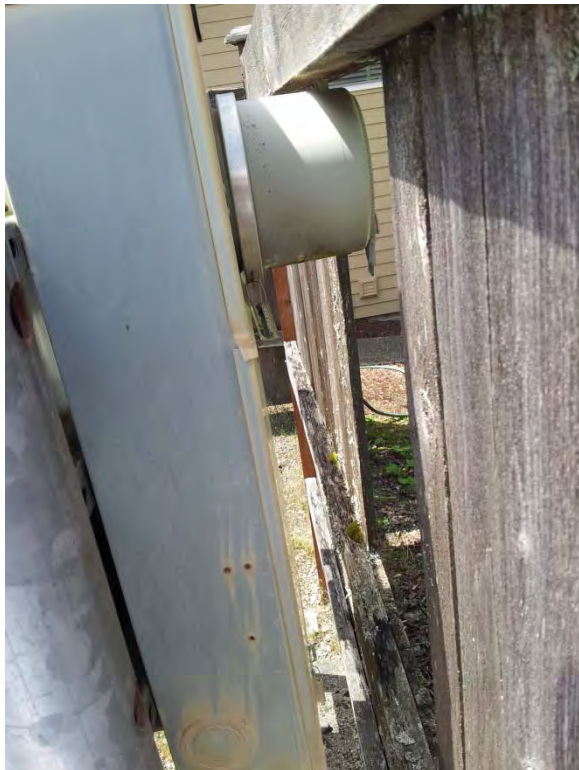
Service meter located on service entrance equipment rack

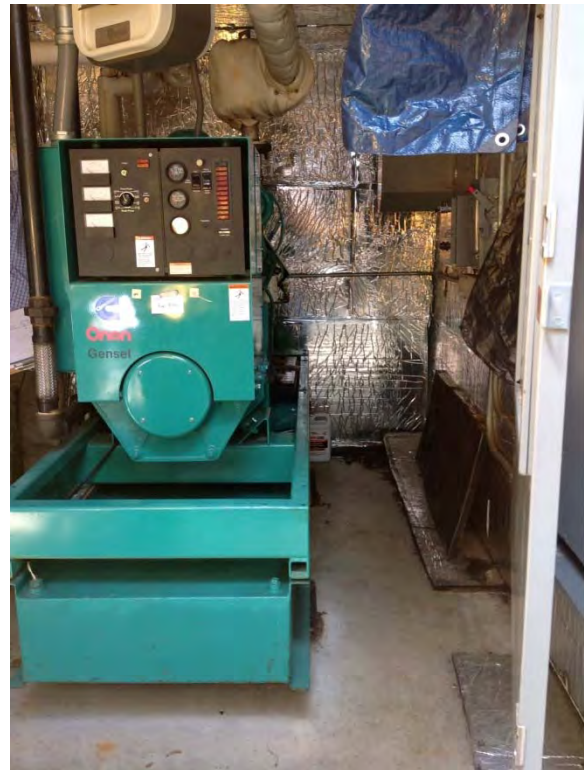
Standby generator located in dry pit/generator vault

Serviceability Rating 3 – Standard parts; generator located in vault; service is more difficult

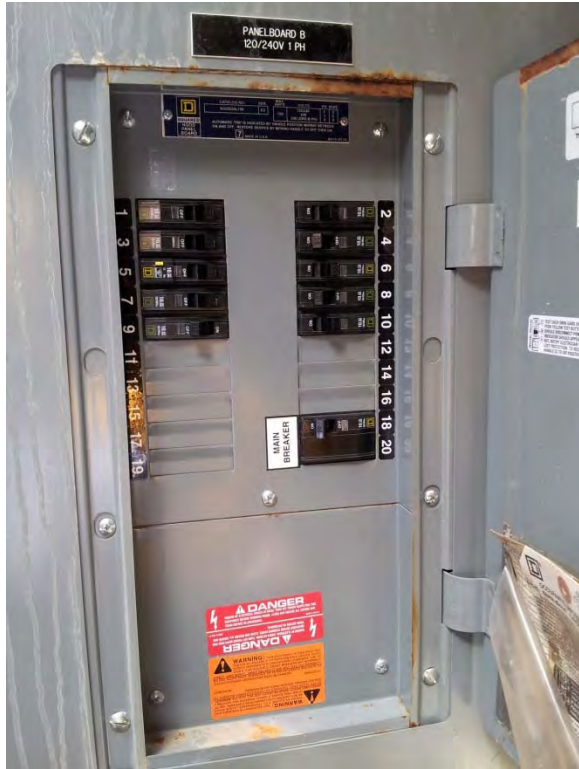
Panelboard located in dry pit/generator vault, some surface rust

Criticality Rating 3 – Critical, panelboard provides the 120 V power for the telemetry control panel, PLC and floats

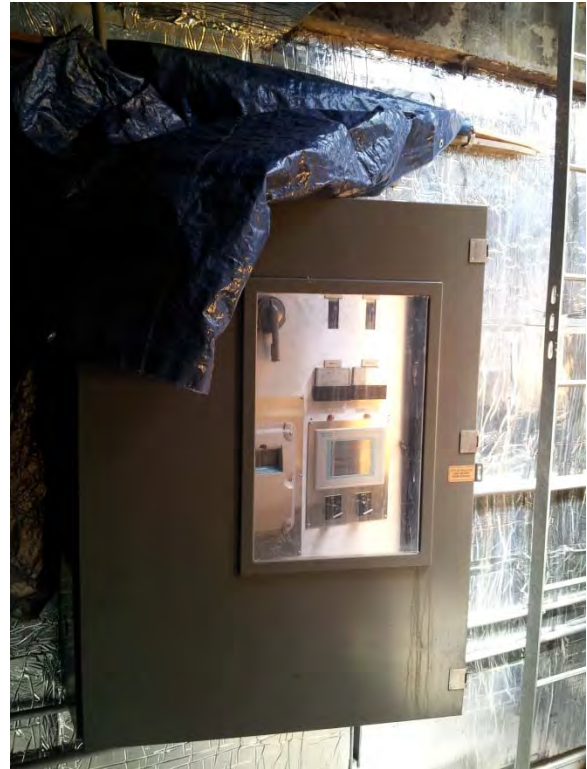
Starter/control panel with operator interface located under tarp in dry pit/generator vault

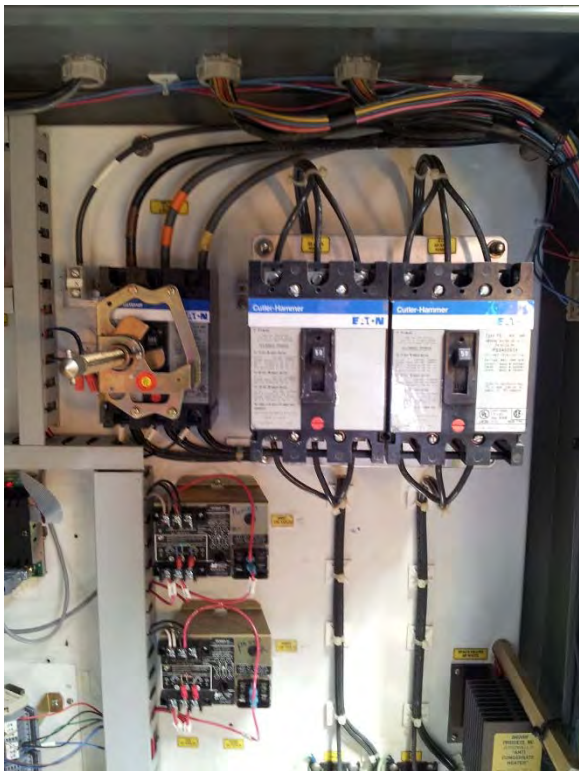
Original starters and circuit breakers are Eaton Cutler Hammer, appear to be in good shape but aging

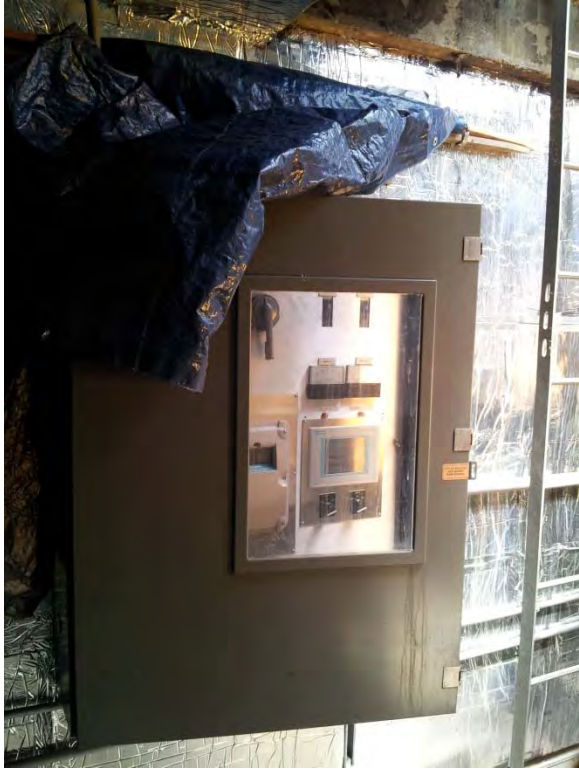
Starter/control panel with operator interface located under tarp in dry pit/generator vault

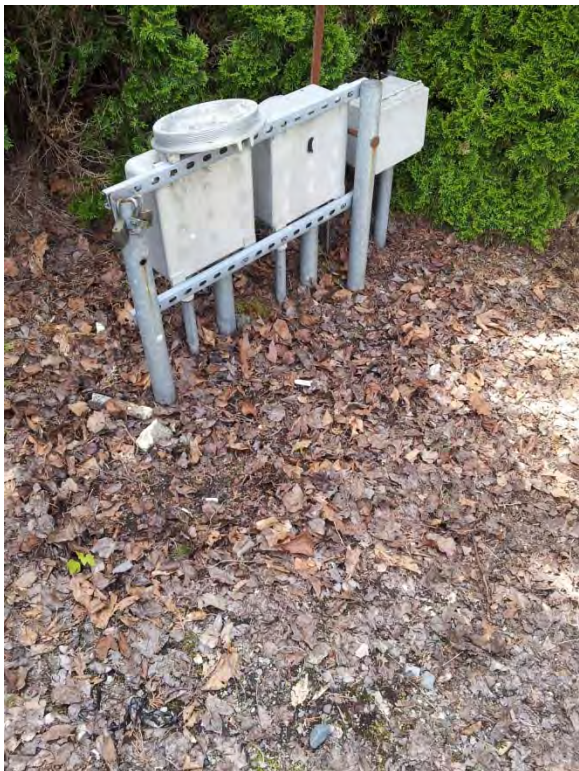
Submersible cable termination enclosure in above grade explosion proof box

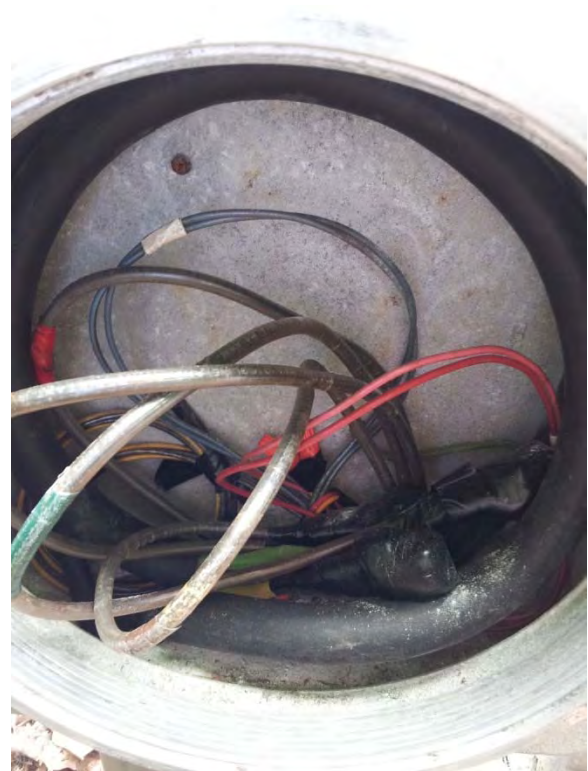
Terminal block spilled in – no terminals

- Terminal block spilled in – no terminals

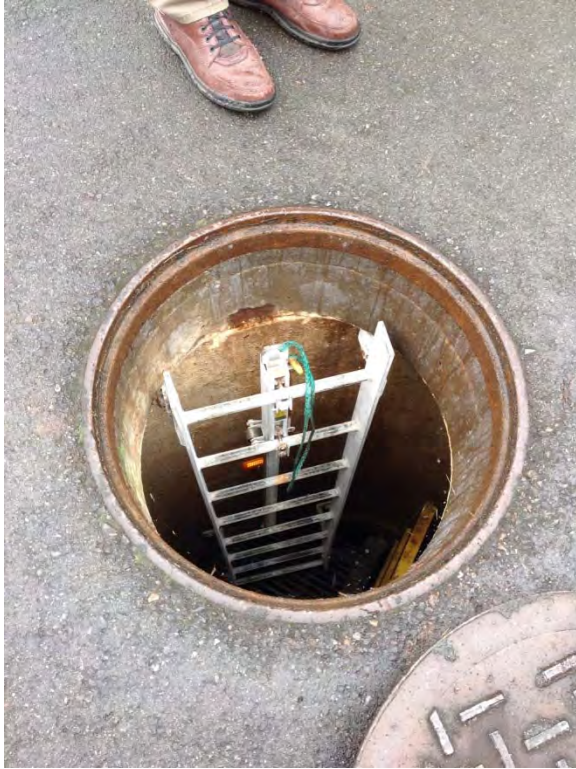
Wet well manhole lid and ladder, access adjacent to station in roadway

- Wet well manhole lid in street adjacent to station

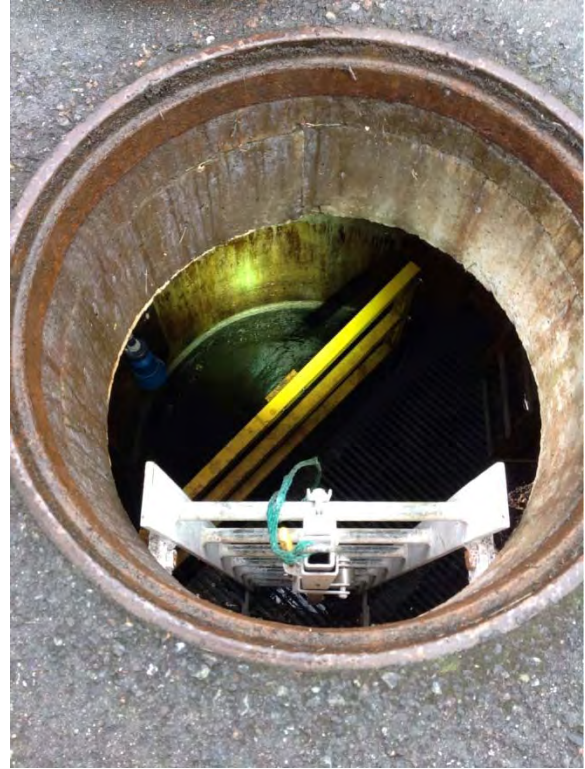
Interior of wet well

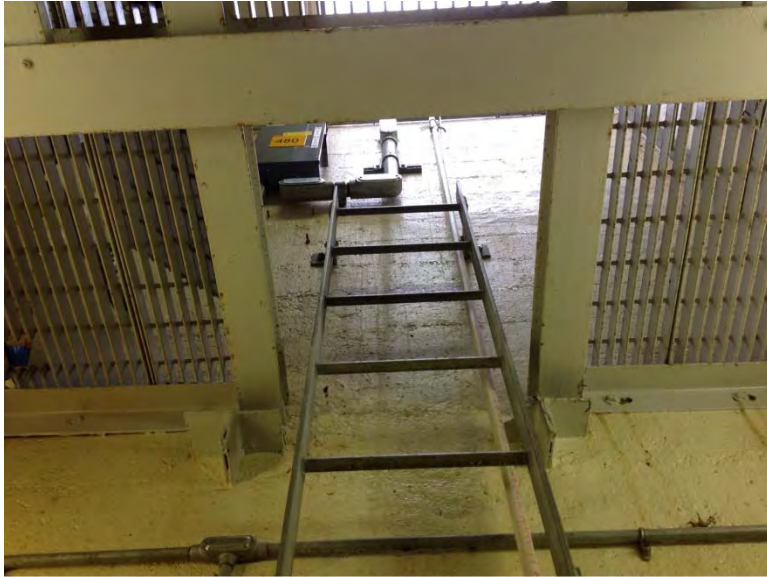
Ladder used to access pump level, somewhat challenging access for maintenance

- Tight space, somewhat challenging access for maintenance
- Discoloration on end wall – some from groundwater seepage, some from an old waterline leak
- Support bracket for mid-level grating platform appears to be significantly corroded, potential failure point. Further investigation of the structural integrity should be completed by the structural consultant.
- Supplemental evaluation done by CG Engineering, see Appendix B for summary of structural findings.

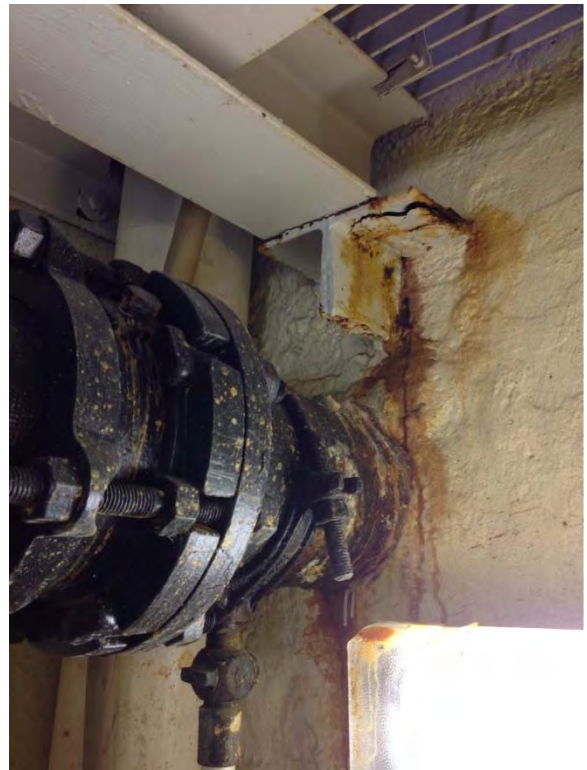
Support bracket for mid level grating platform appears to be significantly corroded, potential failure point

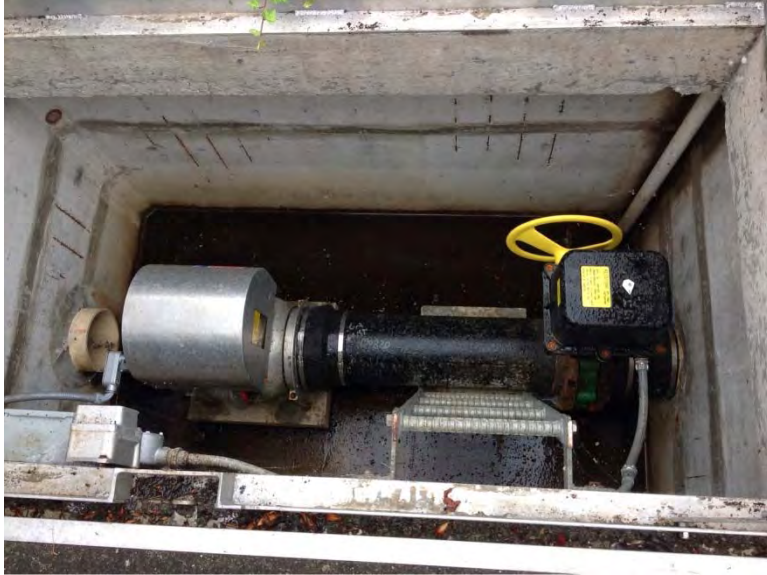
Interior of wet well blower vault, vault is damp but appears to be in good condition

Condition Rating 1 – Wet well blower vault appears to be in good condition.

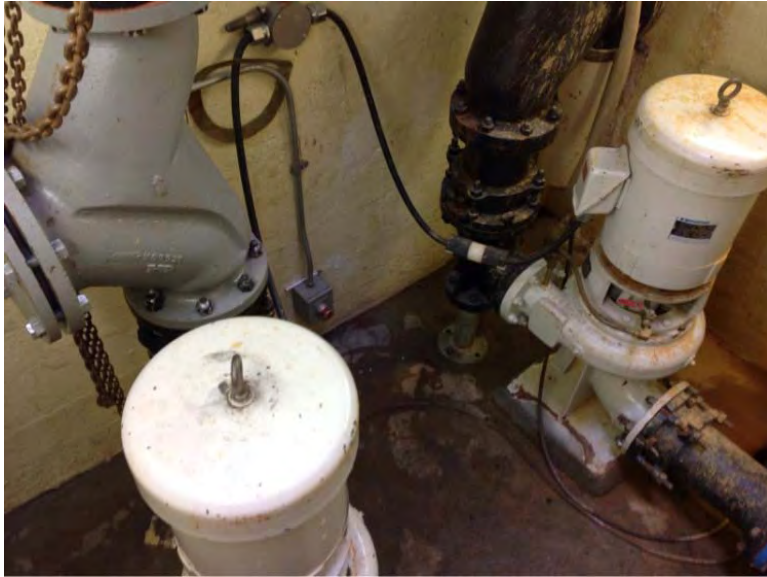
Duplex station configuration, pump 1 on left

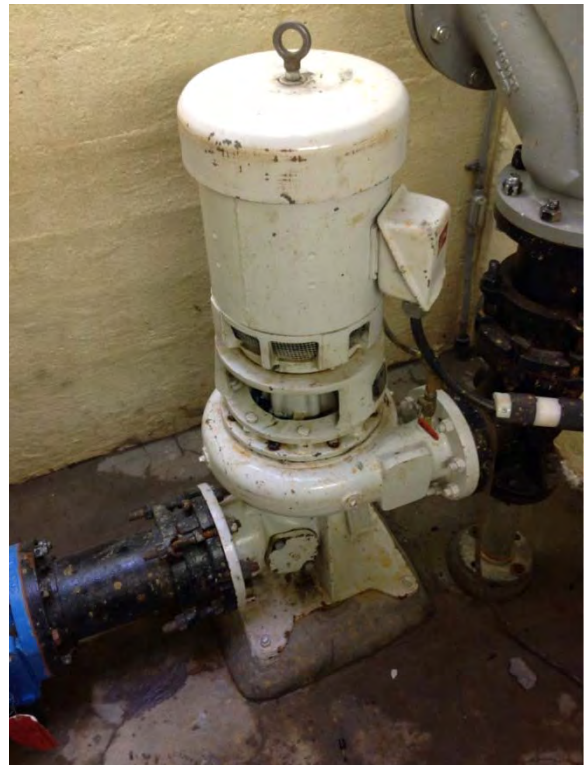
Pump and motor #1, showing signs of aging on exterior

Condition Rating 2 – Based on visual observations and drawdown testing the pump is in good condition with some degradation and the reliability is still acceptable

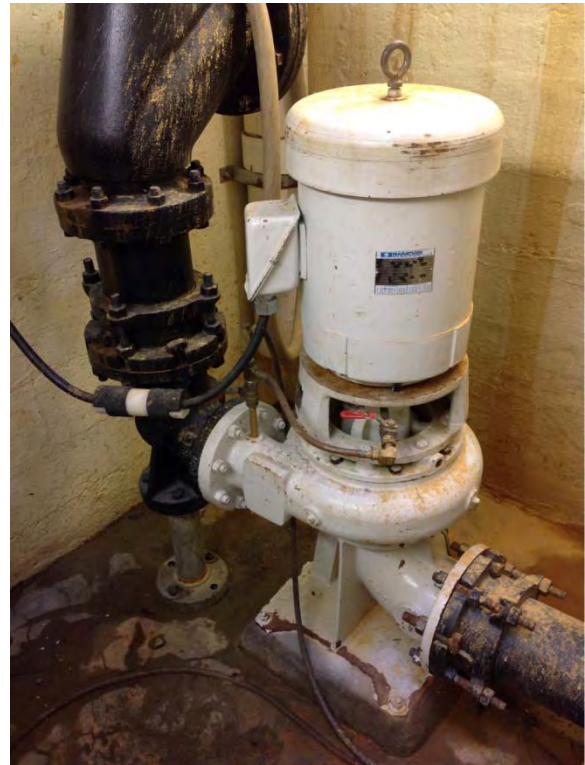
Pump and motor #2, showing signs of aging on exterior

Condition Rating 2 – Based on visual observations and drawdown testing the pump is in good condition with some degradation and the reliability is still acceptable

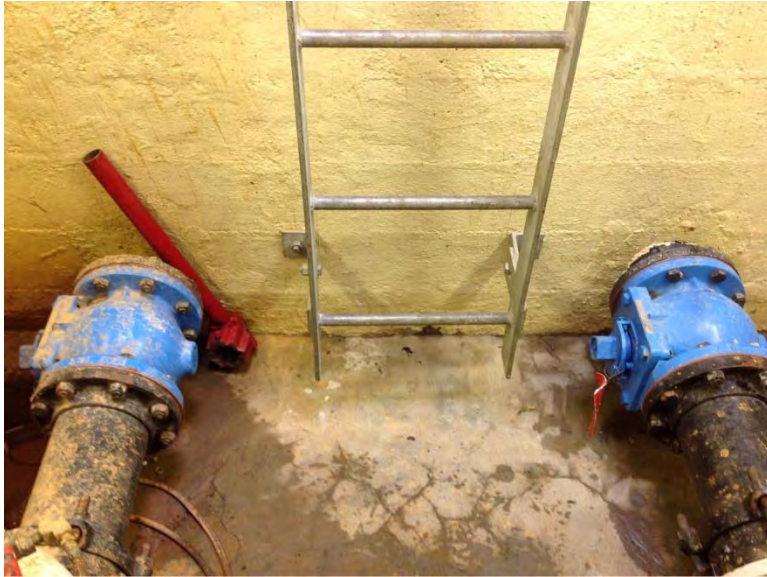
Plug valve on suction piping horizontal axis of rotation - ideal

- Plug valve seat end is down toward pump, better for sealing flow but can accumulate debris behind plug and stop valve from working. Should be addressed upon replacement of rotating assembly.
- Ball check valve vertical installation

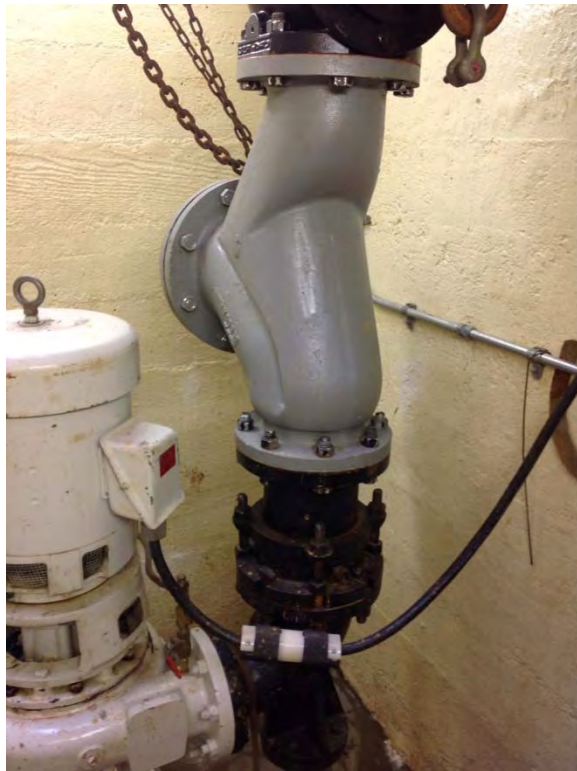
Ball check valve vertical installation on discharge piping

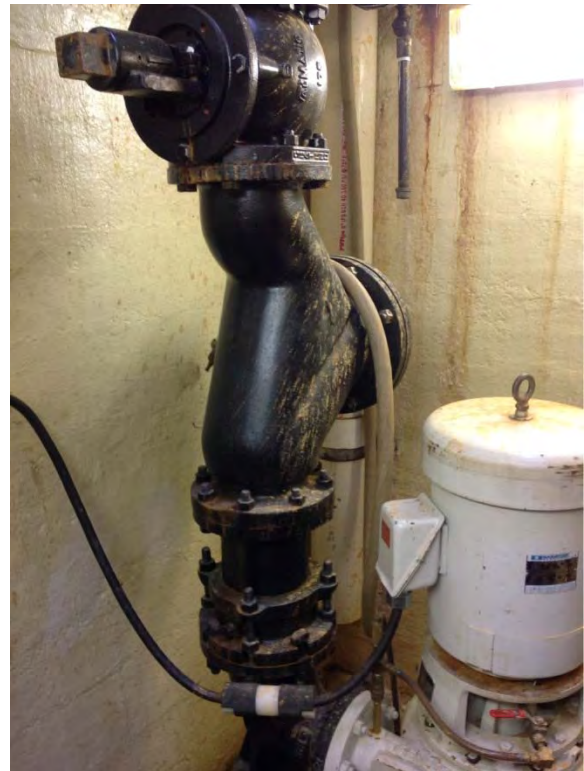
Plug valve on discharge piping, seat end is down toward pump, better for sealing flow but can accumulate debris behind plug and stop valve from working
