Lake Washington Wastewater Lake Line Management Plan

FINAL / July 2024

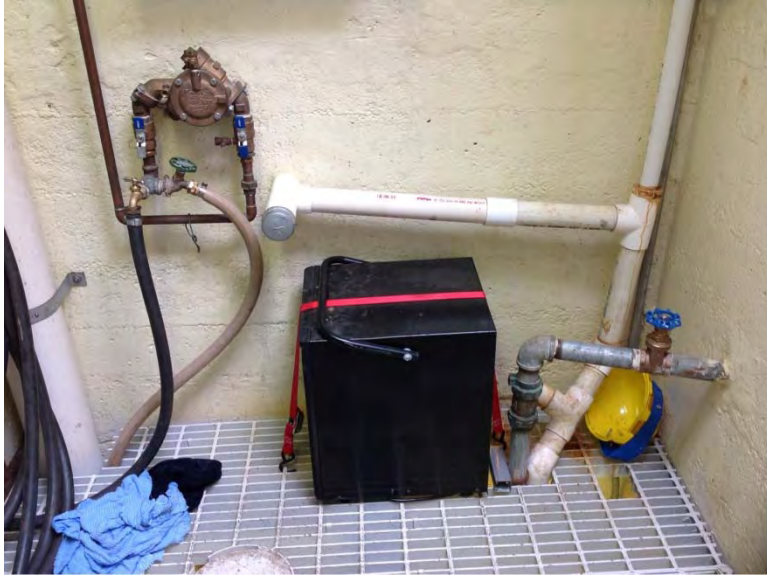
Service valve/connection on top level with hose to pump level

Supply	Domestic/Metered
Access	Service valve/connection on top level w/ hose to pump level
Backflow prevention assembly	Febco reduced pressure backflow device
Enclosure/Freeze protection	In upper level of dry pit/None

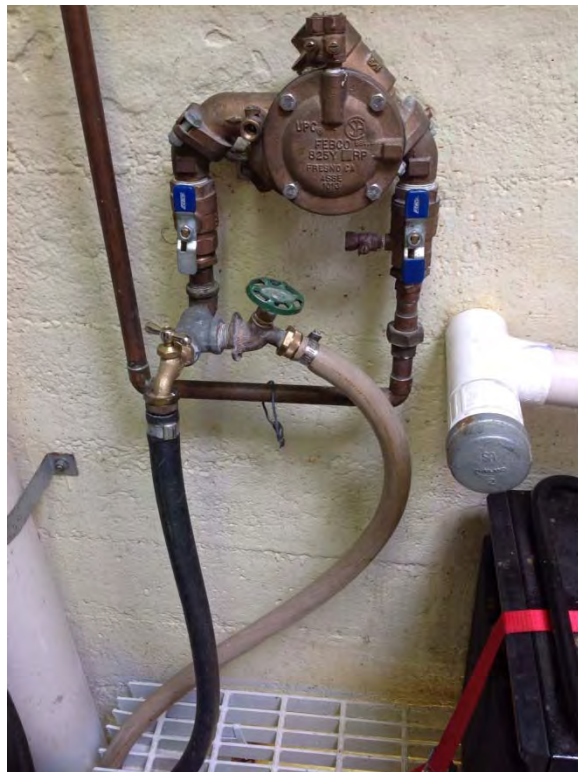
Backflow prevention assembly located in upper level of dry pit

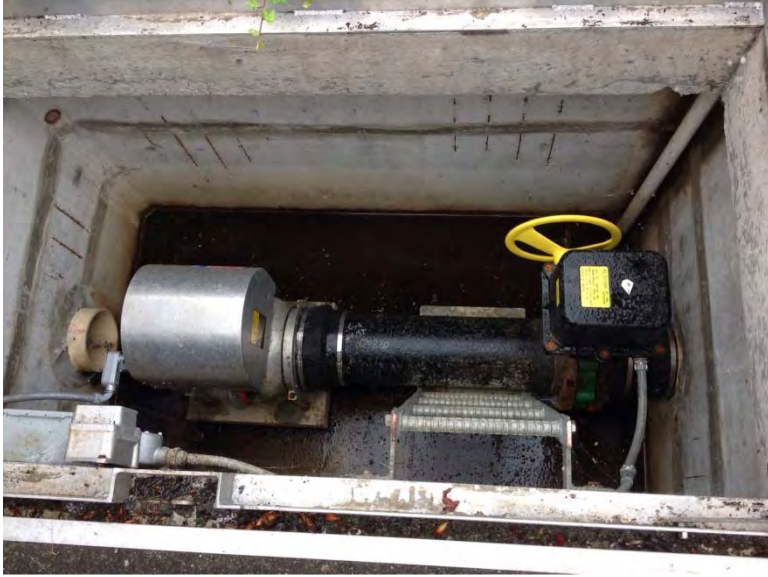
Wet well supply fan located in wet well blower vault

Condition Rating 1 – The supply fan is in good condition

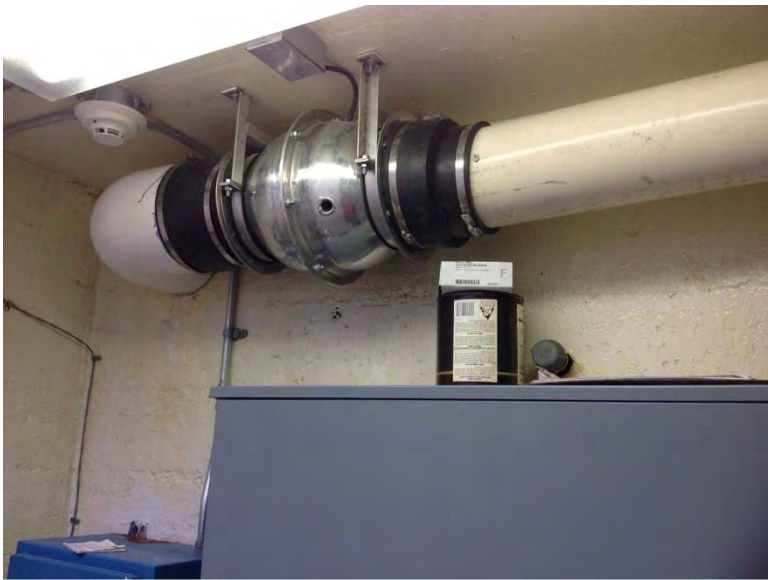
Dry pit supply fan located at ceiling at upper level

Serviceability Rating 2 – The supply fan can be difficult to access since it is located at the top of the dry pit

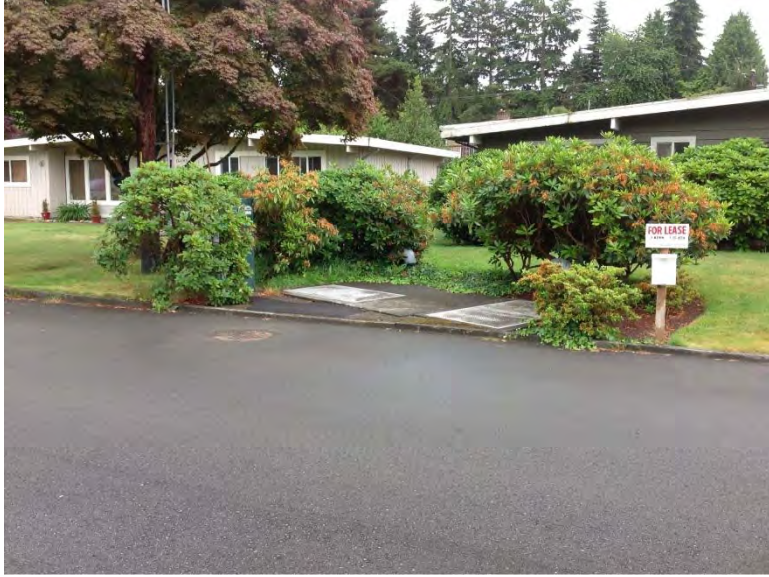
Electrical service meter and generator receptacle located between bushes

Condition Rating 1 – Manual transfer switch and generator receptacle appear to be in good condition

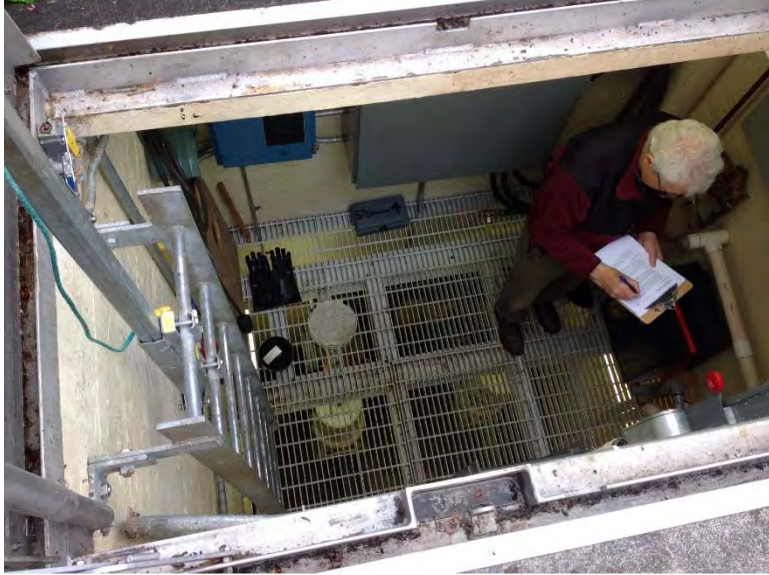
Panelboard and starters located on upper level of dry pit

Condition Rating 2 – The Cutler Hammer starters are in good condition, but aging

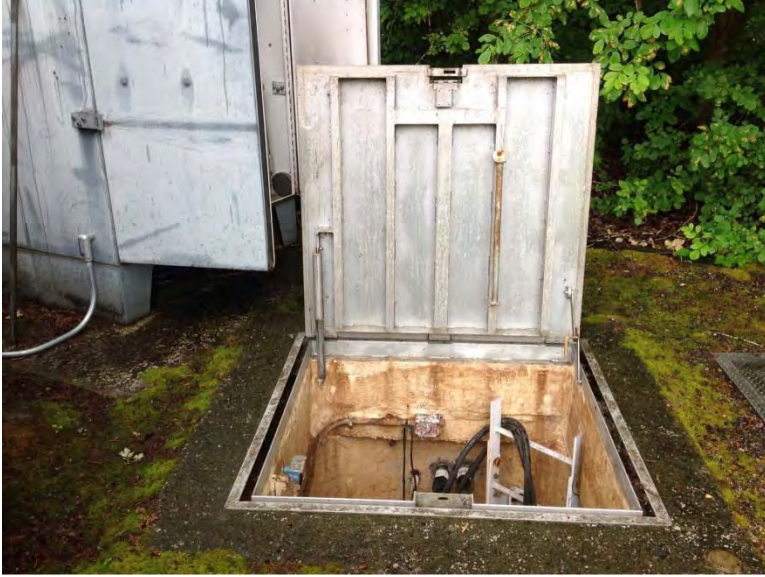
Wet well access hatch and ladder

- Corrosion of all materials in the wet well, including stainless steel rails
- Electrical components corroded
- Coating appears to be in good shape
- Water surface appears to be about 12 feet below ground surface

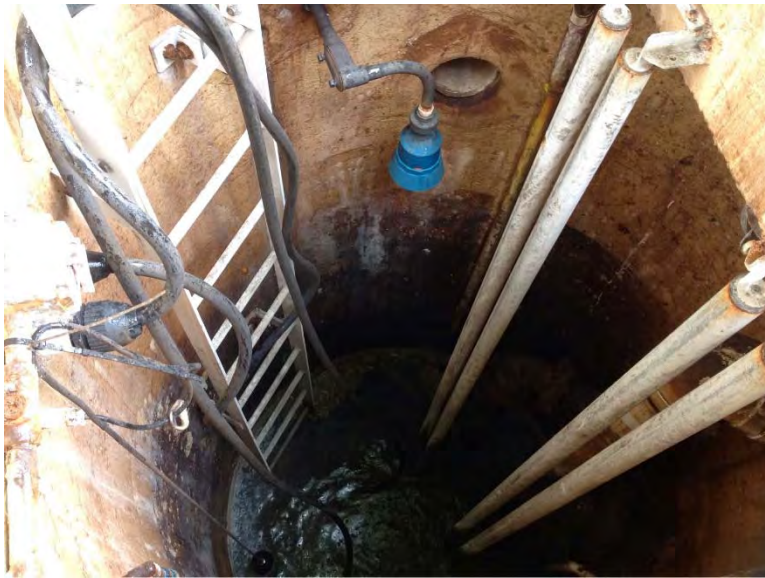
Interior of wet well appears to be in good condition

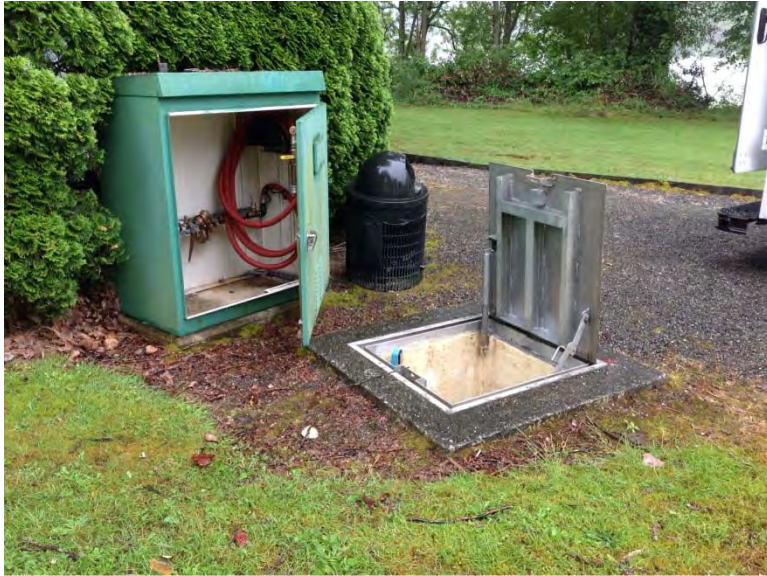
Wet well blower and check valve/isolation valve vault location

- No drain or sump, sump pump sitting on floor, some standing water at bottom
- Outside air intake through valve vault to fan, blows to wet well (direct connection) – continuous ventilation reduces potential for issues, but lack of mechanical supply to valve vault does not reduce classification rating

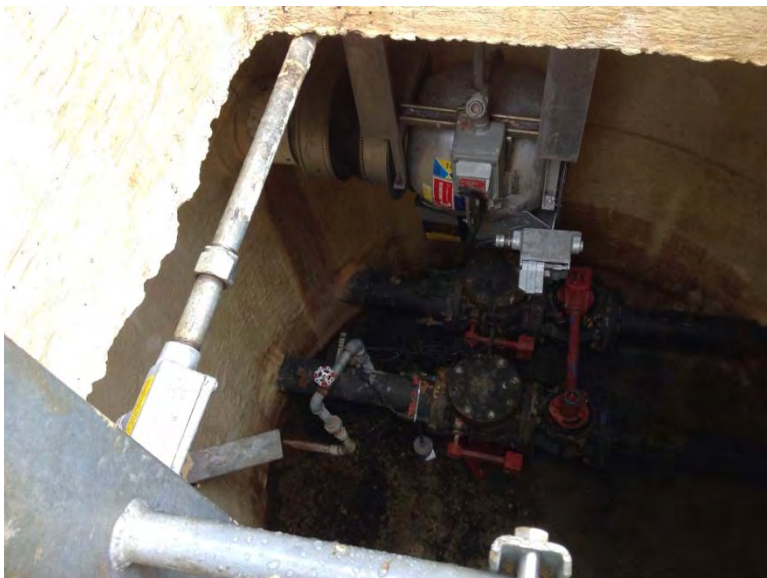
Interior of wet well blower and check valve/isolation valve vault

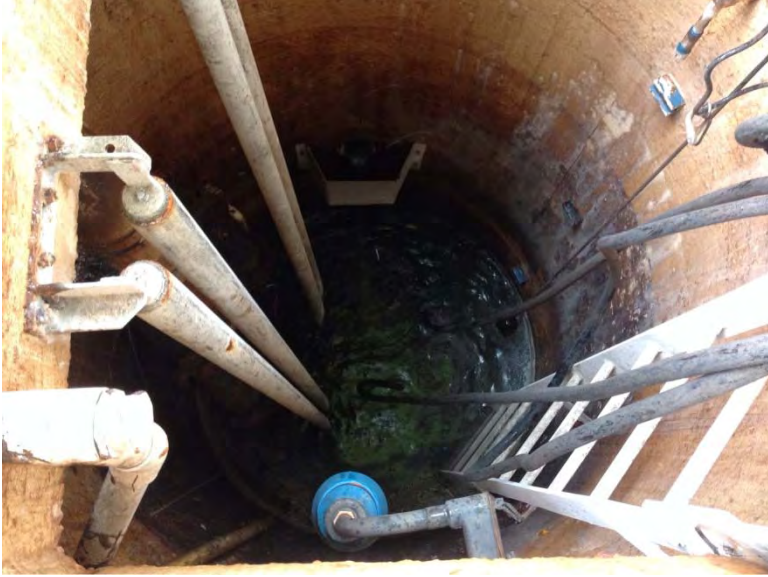
Submersible station, unable to observe pumps

- Could not confirm static pressure during testing
- Pump appears to be operating near the design point, however operating below the original pump curve indicating potential wear

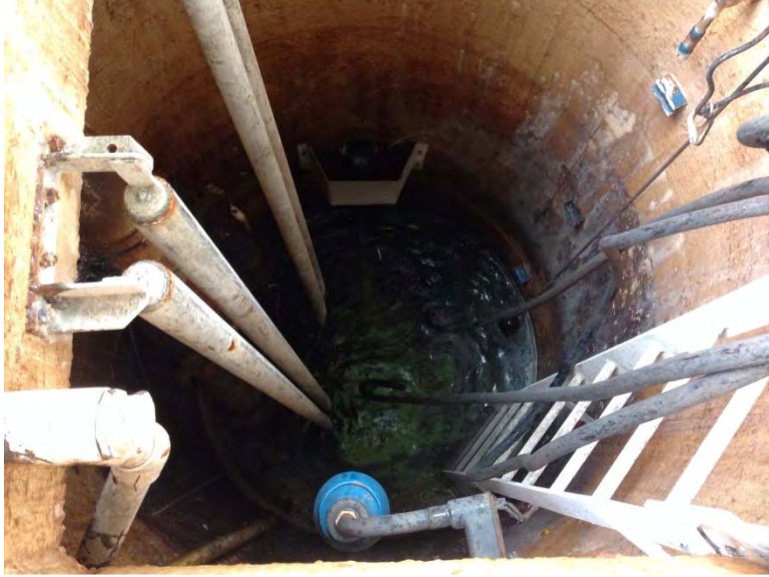
Submersible station, unable to observe pumps

- Could not confirm static pressure during testing
- Pump appears to be operating near the design point, however operating below the original pump curve indicating potential wear

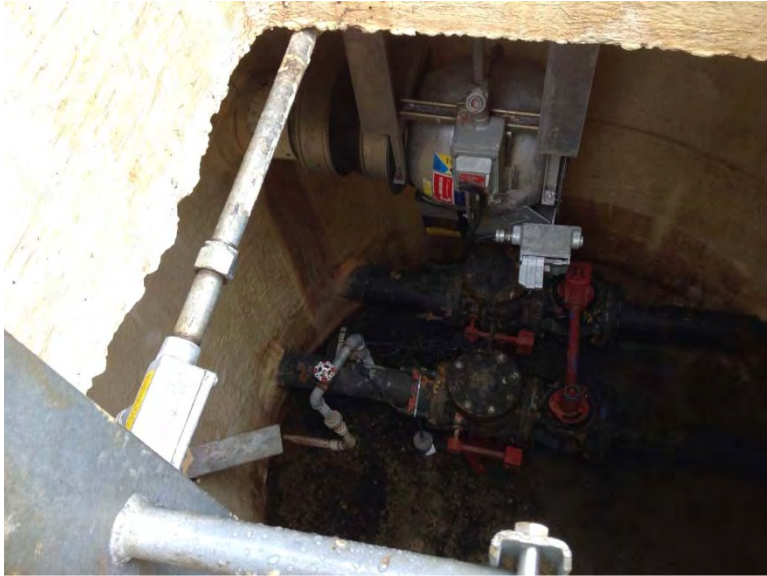
Plug valve and swing check valve located in adjacent underground vault

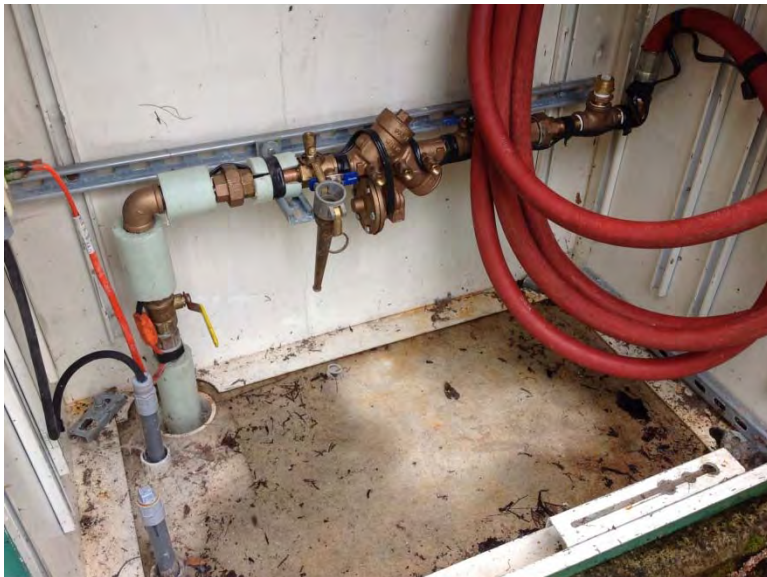
Wilkins reduced pressure backflow assembly located in enclosure with heat tape

Supply	Domestic/Metered
Access	Inside back flow preventer box
Backflow prevention assembly	Wilkins reduced pressure backflow device
Enclosure/Freeze protection	Metal painted enclosure/Heat tape

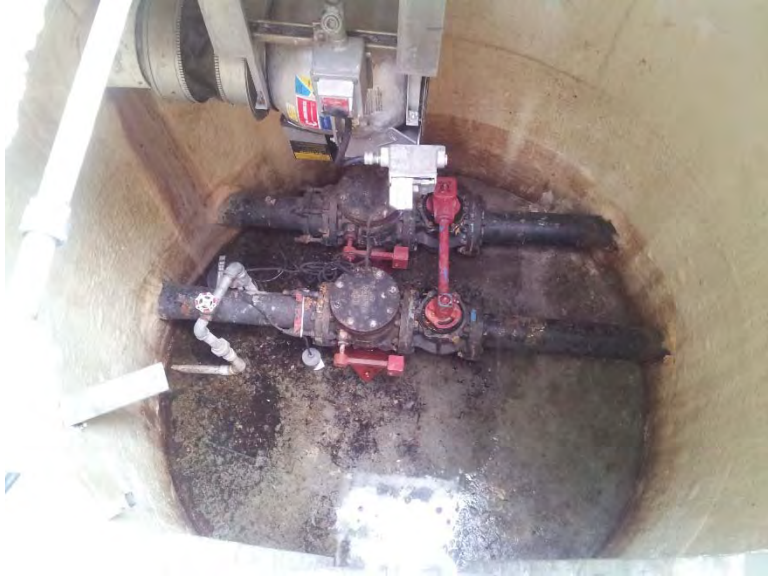
Wet well blower vault located in adjacent underground vault

- Fan draws air through gooseneck into valve vault and pushes it into wet well
- Wet well vents through open hatch (fan only turns on when hatch is open) and exhaust gooseneck

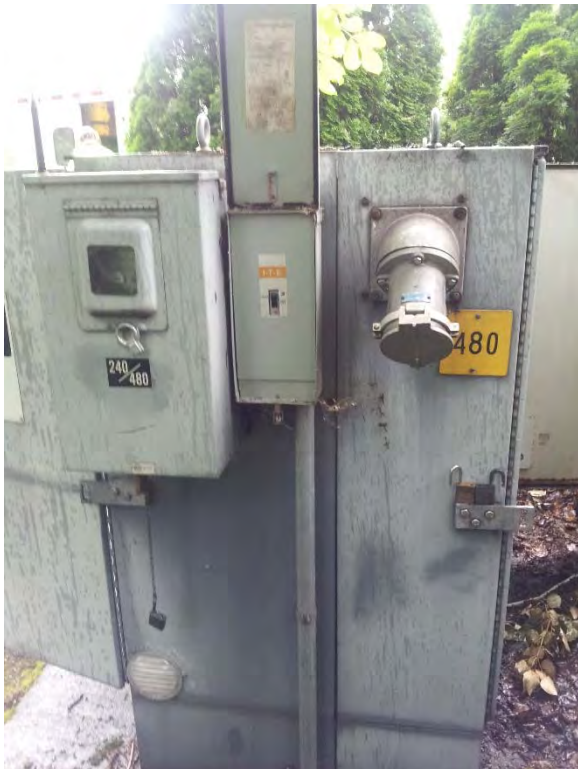
Electrical service meter and generator receptacle located outside of power enclosure

Criticality Rating 3 – Critical but redundant, power could be provided by utility power

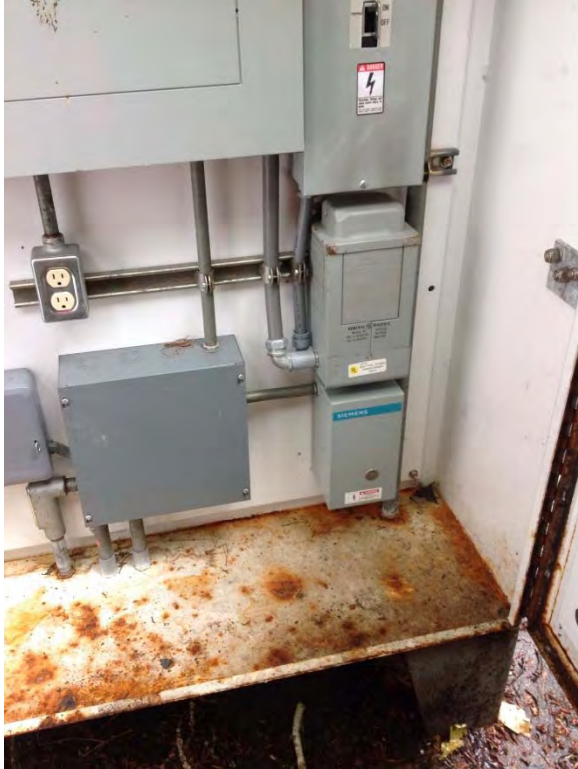
All power and control conductors come through 1-3/4" galvanized rigid conduit with seal rotting

- Conduits to wet well are not sealed – term part of explosion proof area but not built to explosion proof rating

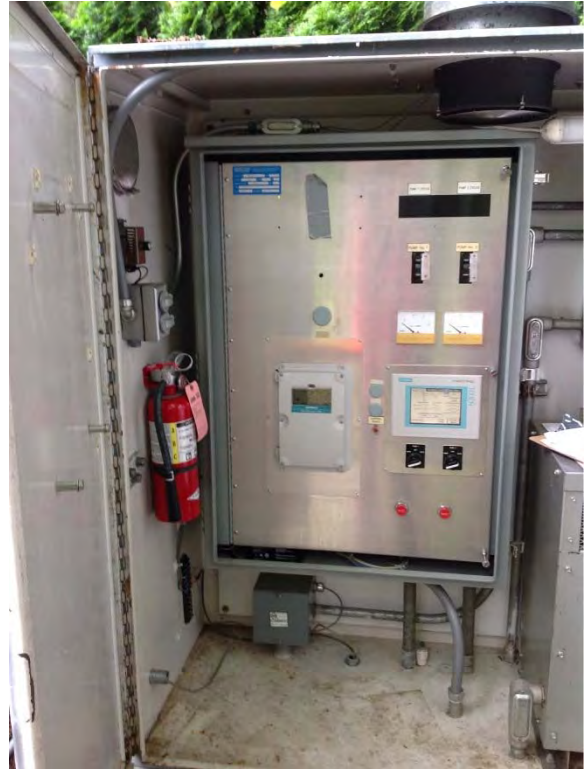
Telemetry control panel with operator interface located in control enclosure

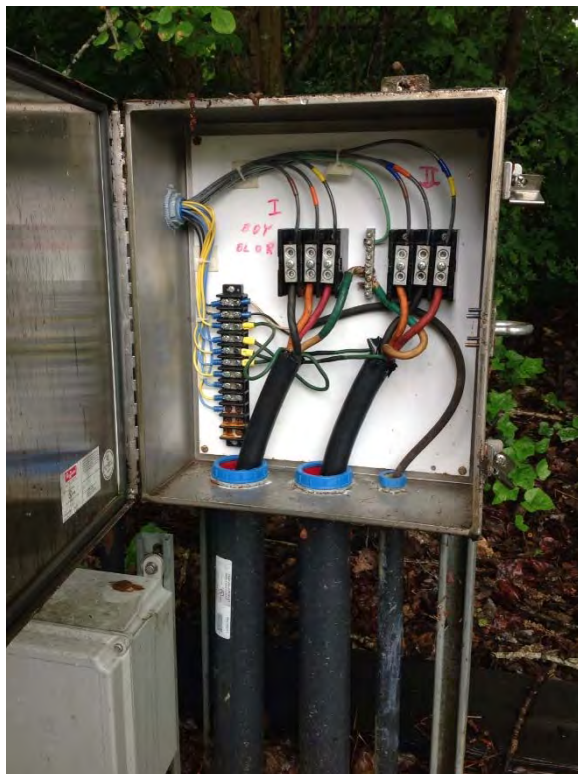
Submersible cable termination enclosure

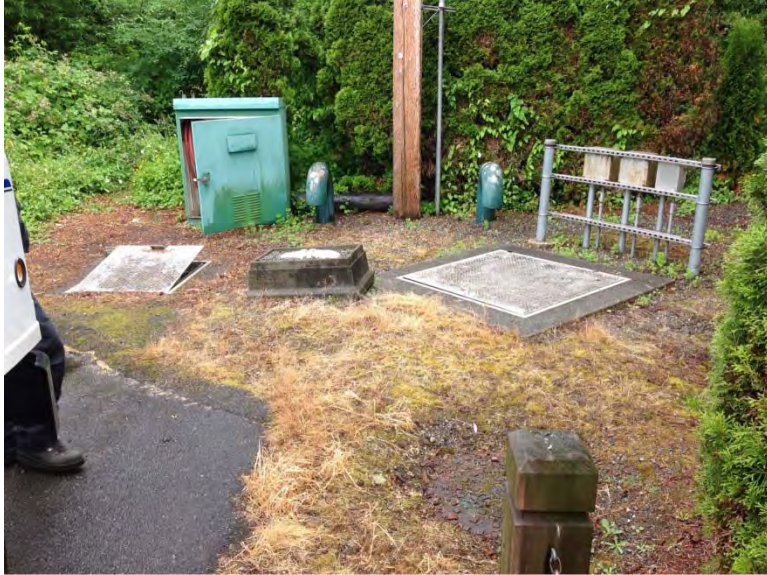
General site, overgrown gravel surfacing and concrete box around high point in vent line approximately 12” high – potential tripping hazard

- Concrete box around high point in vent line is 12” high – potential tripping hazard

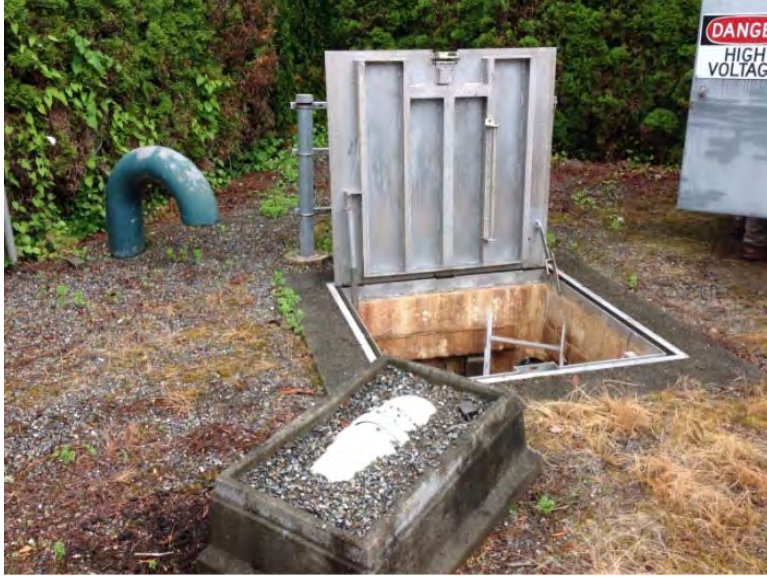
Wet well access hatch and ladder

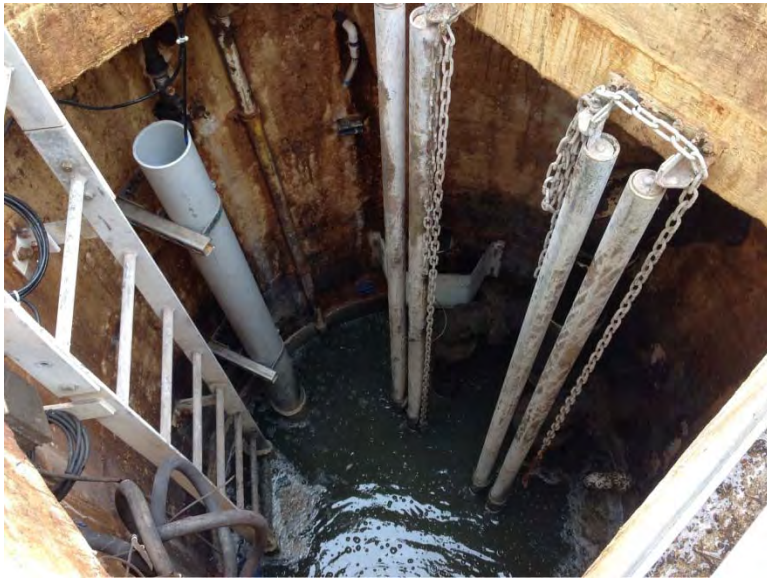
Alternate view of interior of wet well

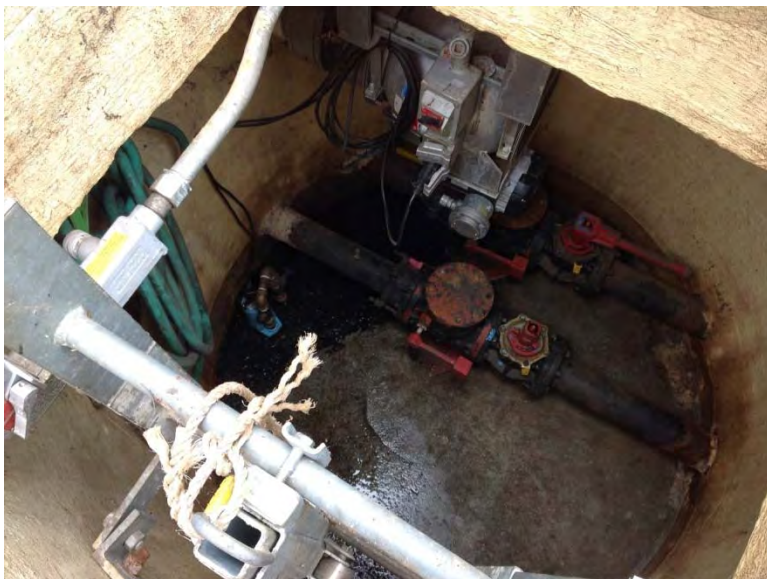
Interior of wet well blower and check valve/isolation valve vault

- Outside air intake through valve vault to fan, blows to wet well (direct connection) – continuous ventilation reduces potential for issues, but lack of mechanical supply to valve vault does not reduce classification rating.

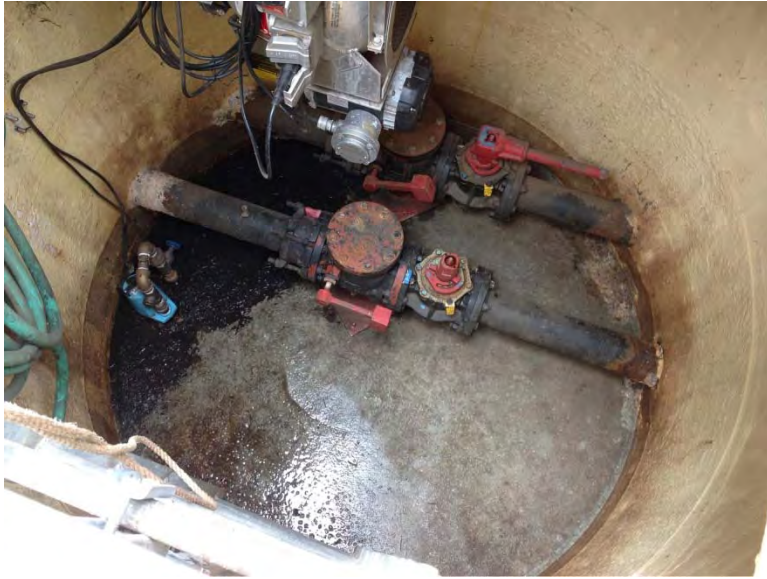
Plug valve and swing check valve located in adjacent underground vault

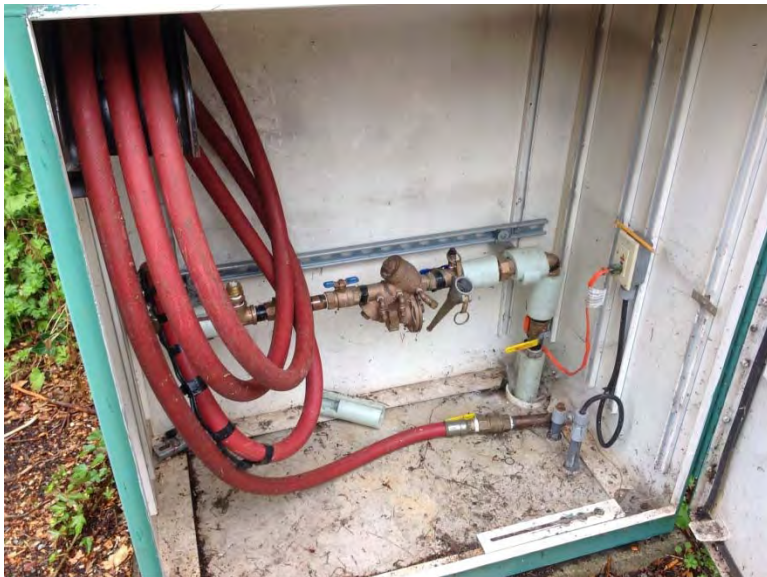
Wilkins reduced pressure backflow assembly and hose bibb located in enclosure with heat tape

Supply	Domestic/Metered
Access	Inside back flow preventer box
Backflow prevention assembly	Wilkins reduced pressure backflow device
Enclosure/Freeze protection	Painted metal enclosure/Heat tape

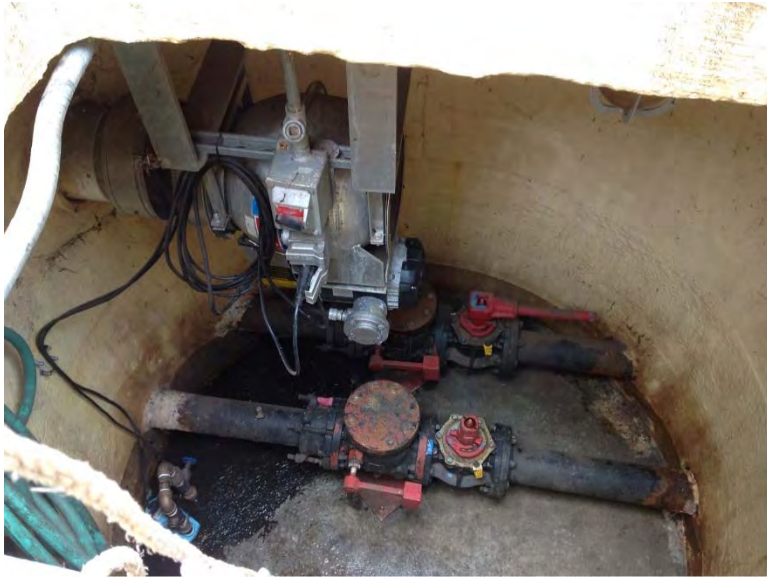
Wet well supply fan located in wet well blower and check valve/isolation valve vault

- Fan did not operate during evaluation visit, source of problem unknown
- Wet well switch is corroded however, and switch sticks in position – replacement/inspection is recommended

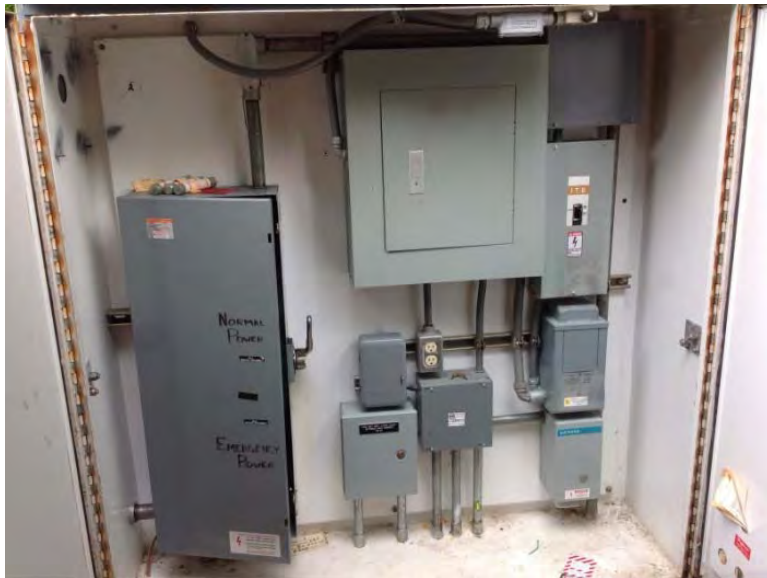
Manual transfer switch located in outdoor power enclosure

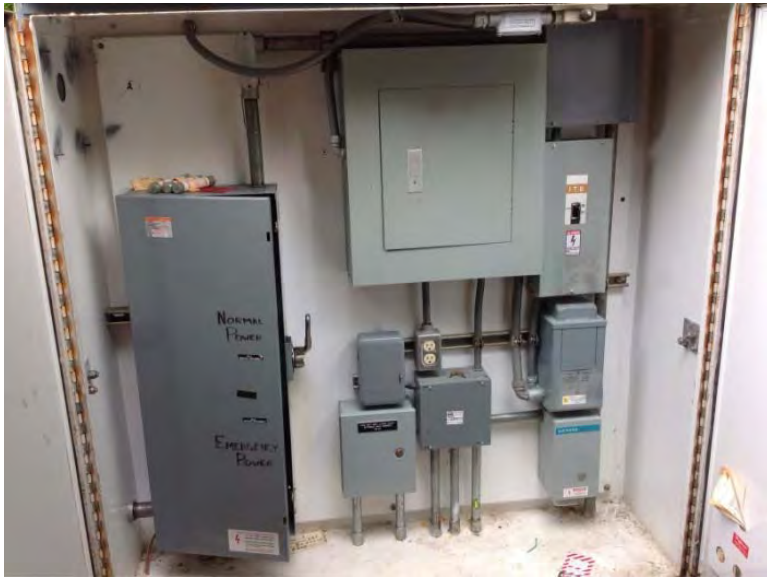
Panelboard located in outdoor power enclosure

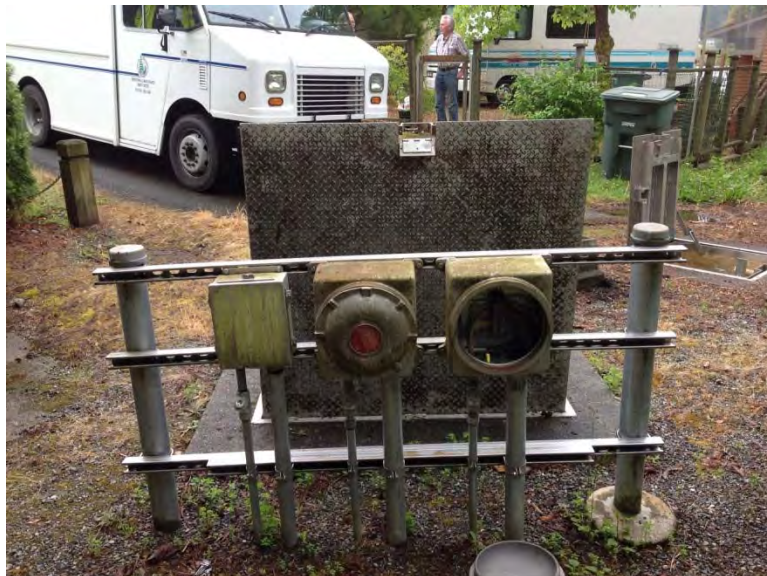
Submersible termination enclosure located in explosion proof junction box on pipe rack

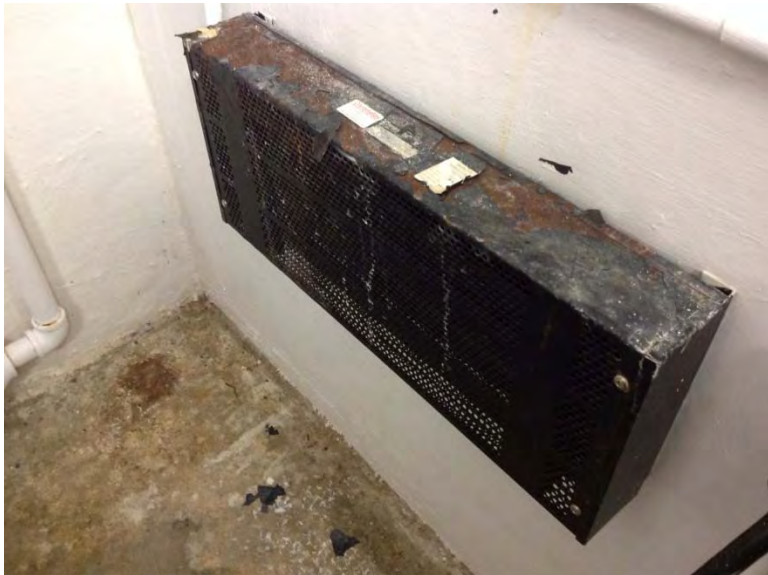
Heater in dry pit is significantly corroded

- Heater is corroded
- Coating near floor is flaking – possibly due to water intrusion through wall
- Less than the required 3' clearance from Flush 10 panel to pump motor and from pump motor connection to wall

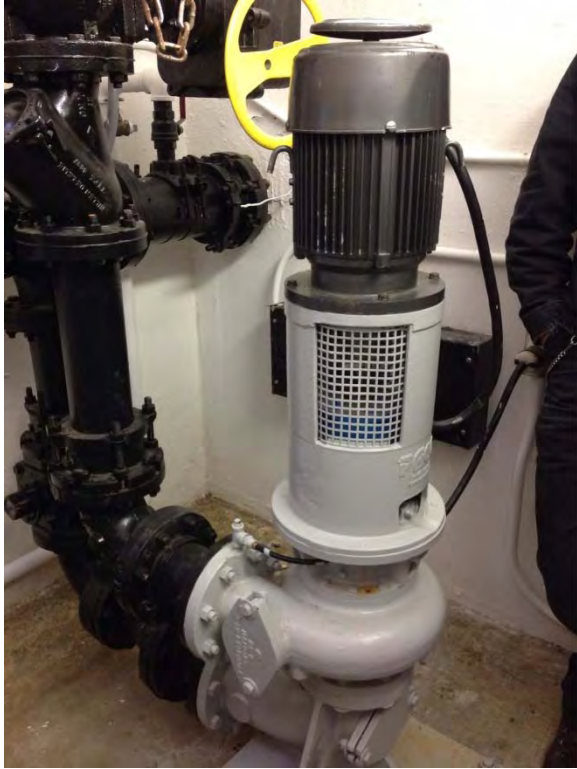
Pump and motor #1

- Hoisting rail is not marked with load capacity, as required by code

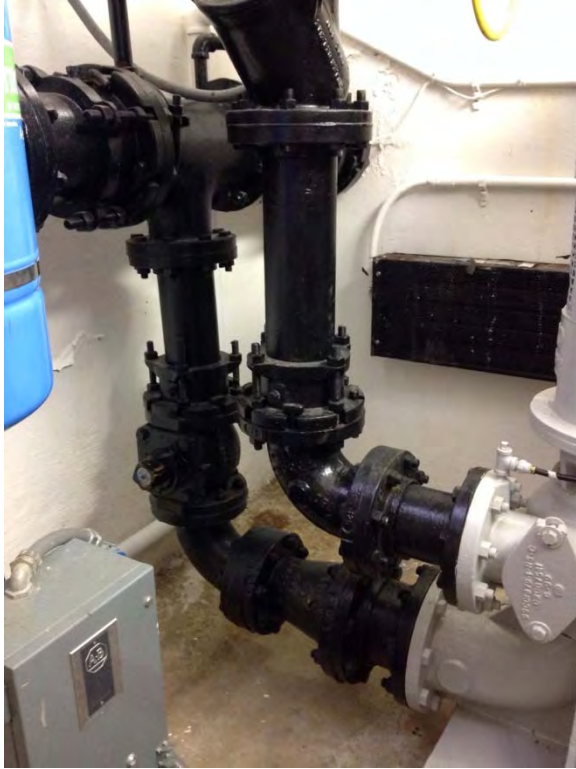
Discharge and piping configuration

- Ball check valve, vertical installation
- Automated discharge plug valve to prevent siphoning

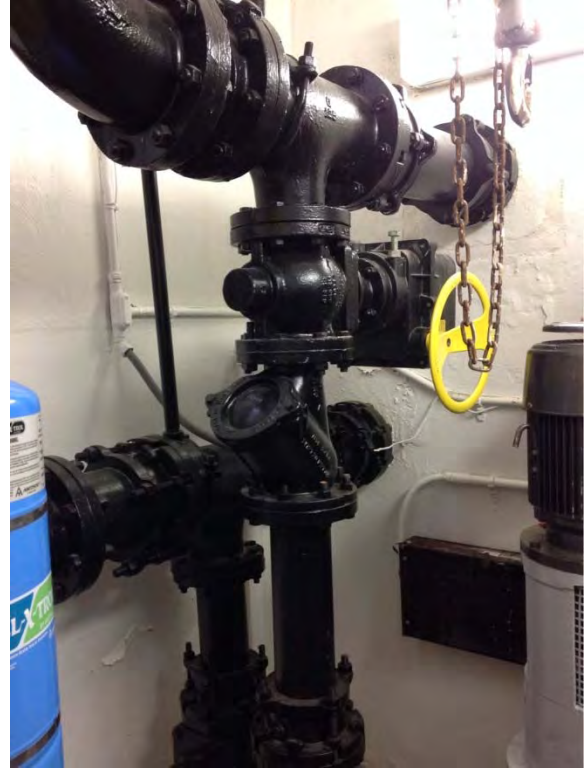
Automated discharge plug valve to prevent siphoning, ball check valve located below discharge plug valve

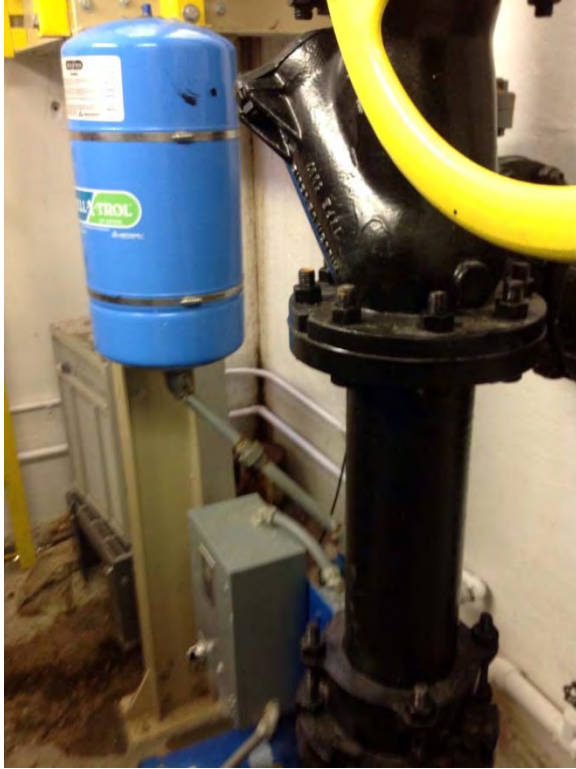
Booster package for water service

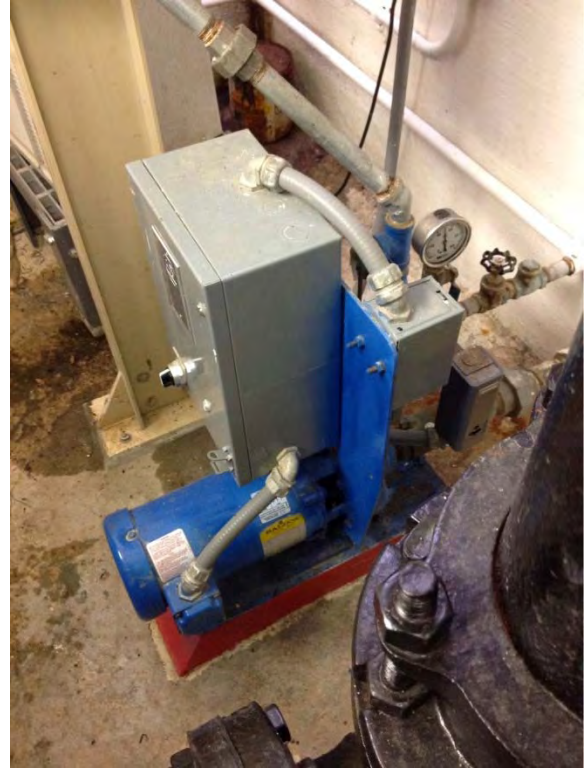
Booster package for water service, water supply from lake

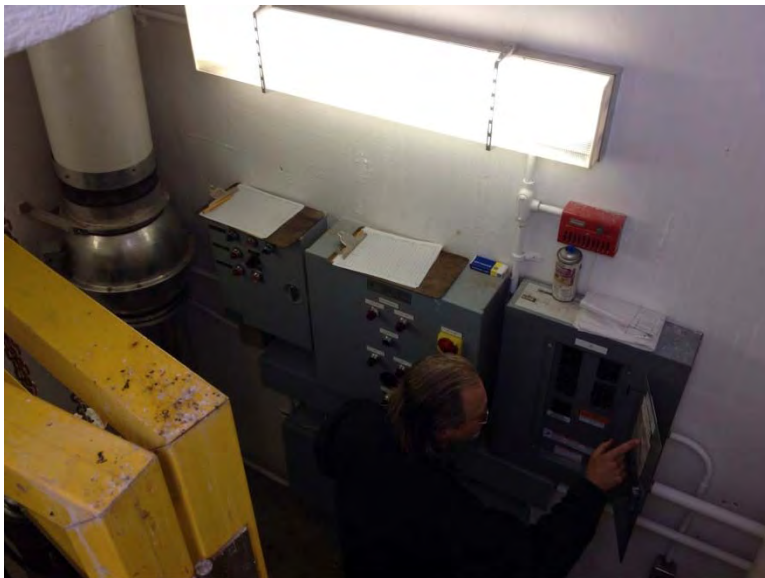
Supply fan located 5'-6" AFF in dry pit

Serviceability Rating 2 – The supply fan can be difficult to access since it is located 5'-6" AFF in the dry pit

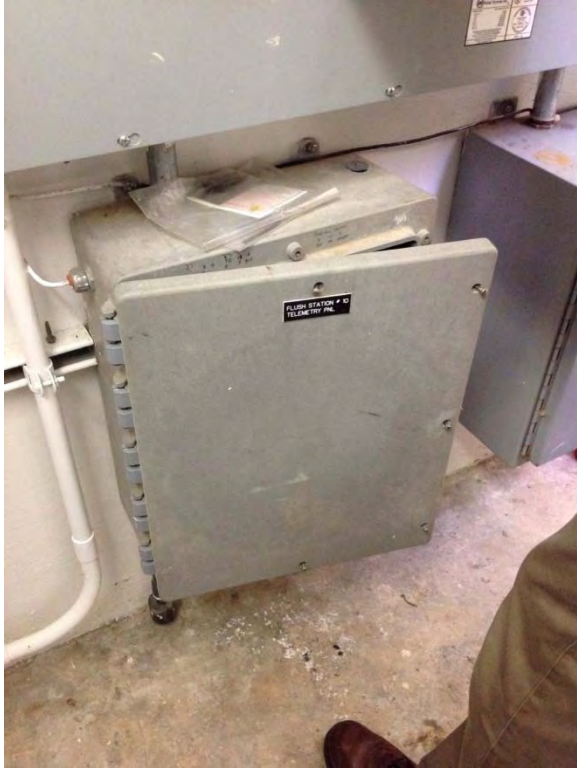
Flush 10 telemetry panel

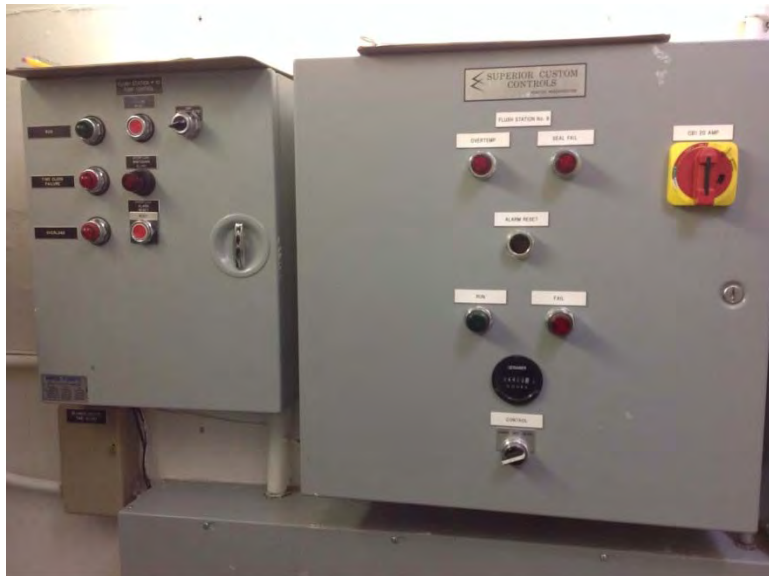
Flush 10 starter/control panel adjacent to Flush 9 starter/control panel in Flush 10 dry pit

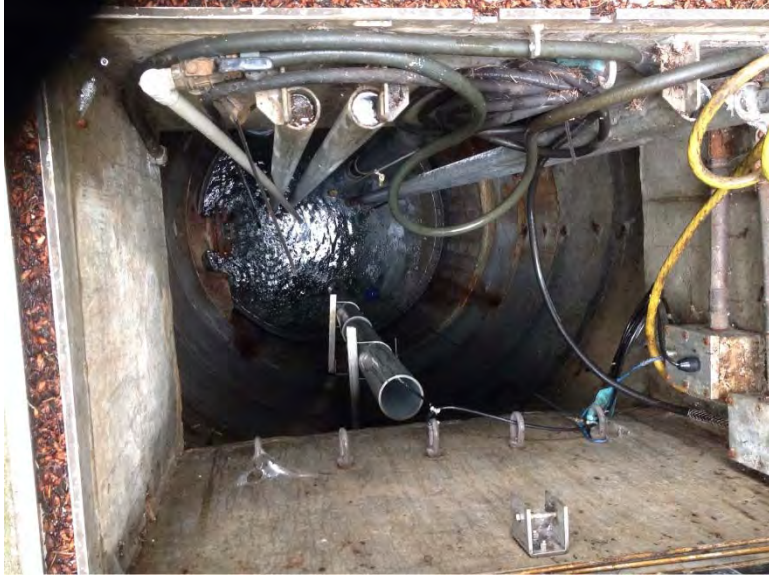
Interior of wet well, no access ladder

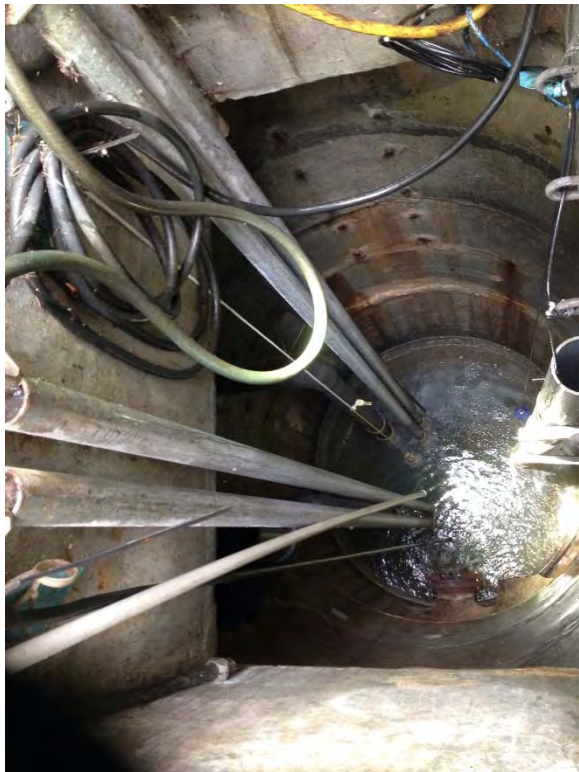
Some lower level corrosion and exposed aggregate on the lower 1'-2' of well

Condition Rating 2 – Ground surface inspection identified the lower 1'-2' of the wet well appears to have exposed aggregate – no other significant signs of corrosion.

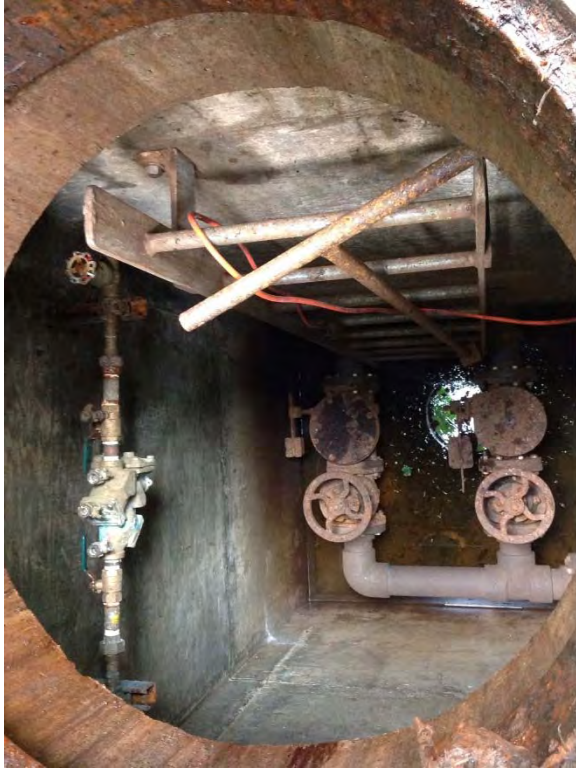
Check valve and isolation valve vault,
flooding evident

- Flooding evident
- Pumps stagnant water in vault to wet well

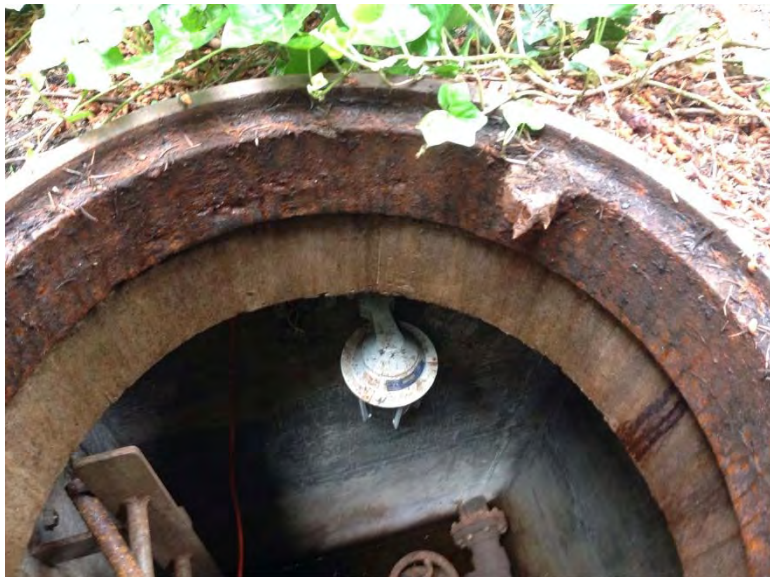
Valve vault light can be plugged in with extension cord,
extension cord located in vault upon site visit

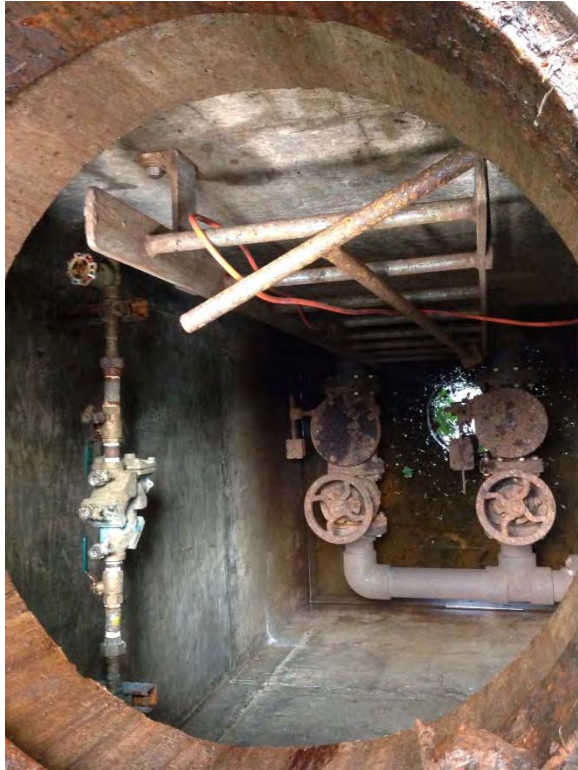
Gate valve with hand wheel for isolation and swing check valve with outside weight and lever

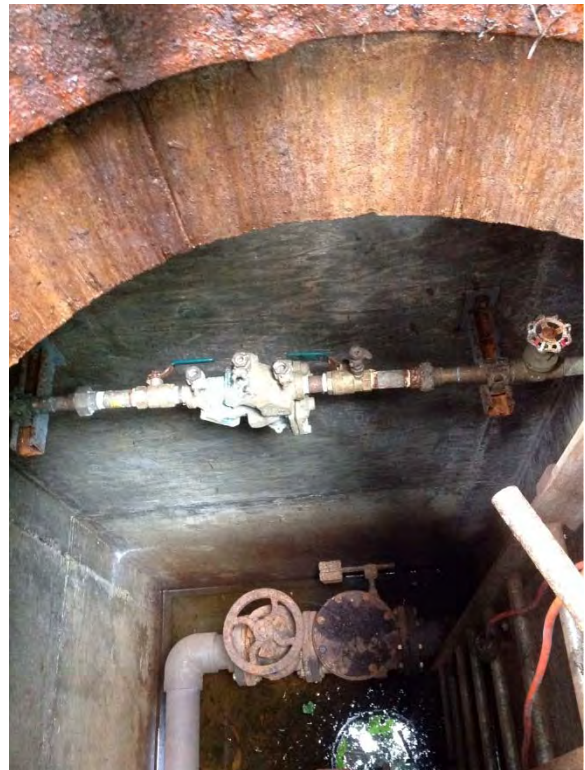
Backflow prevention assembly located in check valve/isolation valve vault

- Backflow assembly does not drain to daylight – does not meet code for installation

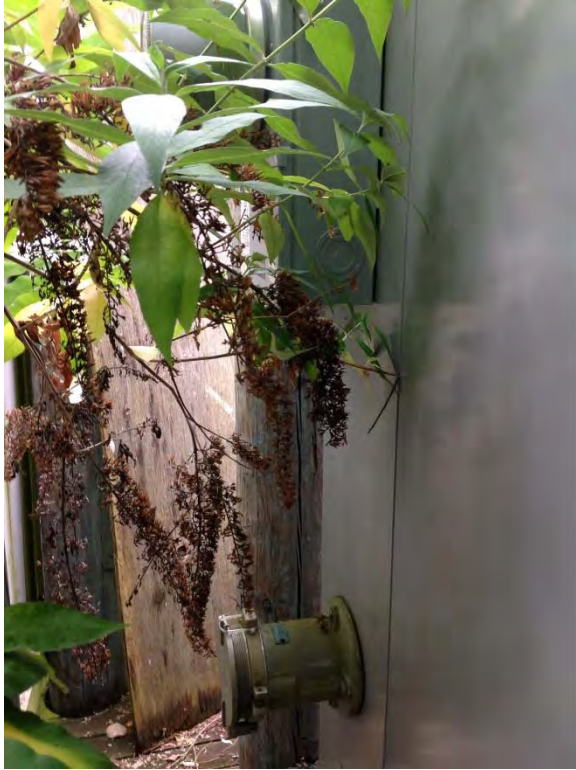
Service meter and generator receptacle located on side of power and control panel enclosure near paved road

- Generator receptacle on side of power and control panel adjacent to fence, would have to remove fencing to plug in power from standby generator

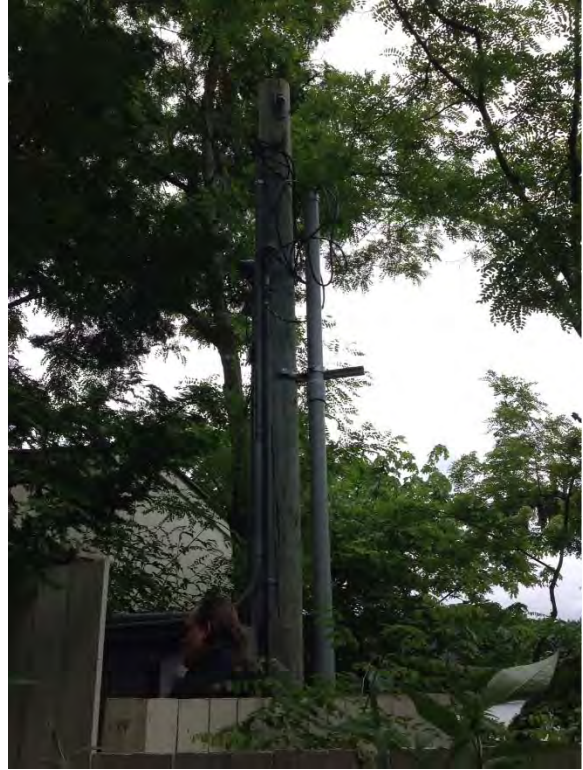
Overhead utility transformer, a lot of exposed cable

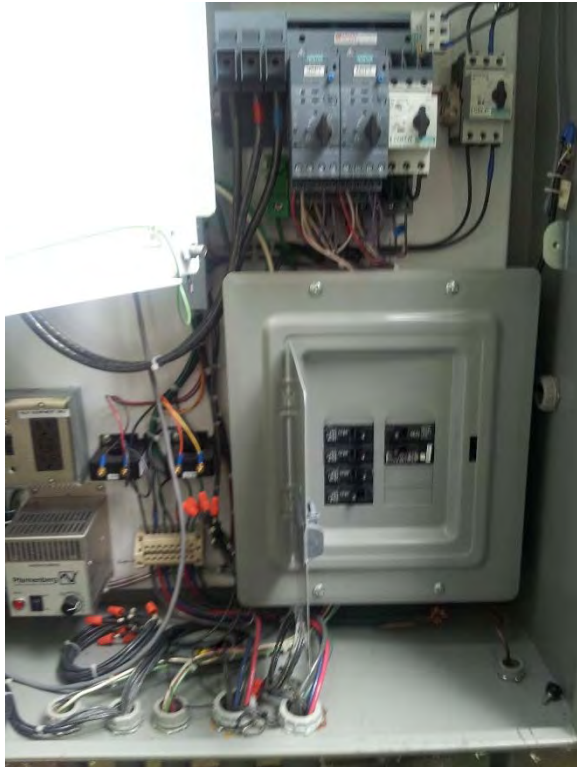
Panelboard located in outdoor power and control panel enclosure, appears to be in good condition

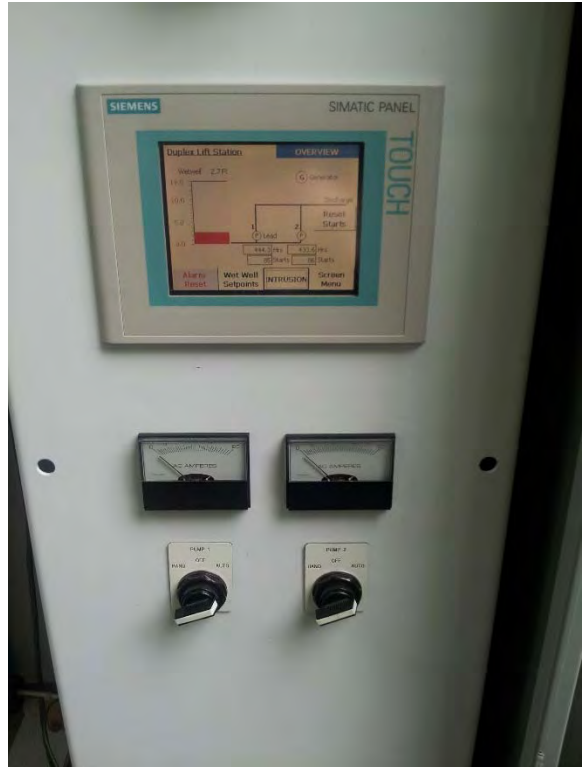
Starters located in outdoor power and control panel enclosure, appear to be in good condition
