Lake Washington Wastewater Lake Line Management Plan

FINAL / July 2024

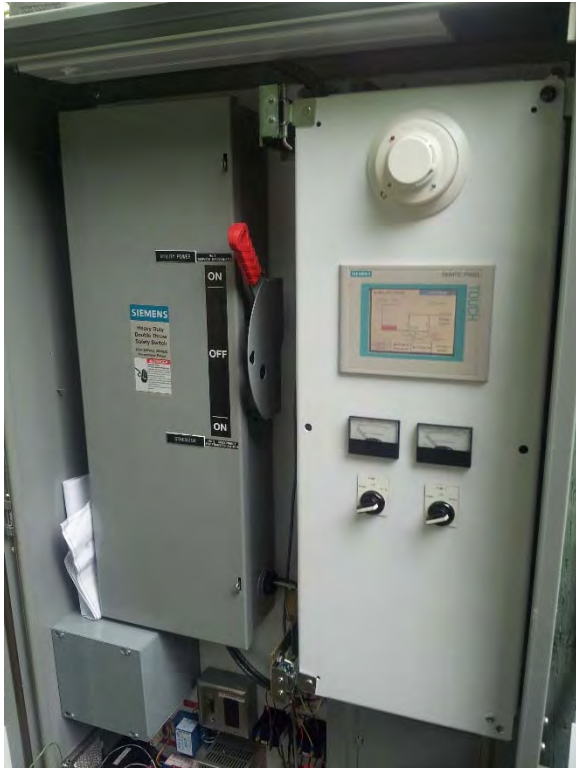
Telemetry control panel with operator interface located in outdoor power and control panel enclosure, appears to be in good condition

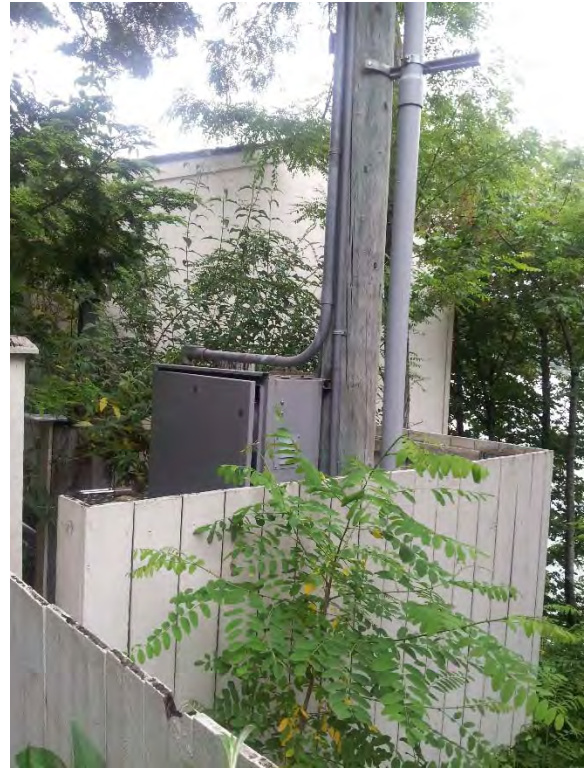
No vent fan in outdoor power and control panel enclosure, it is sheltered however, so it should stay cool

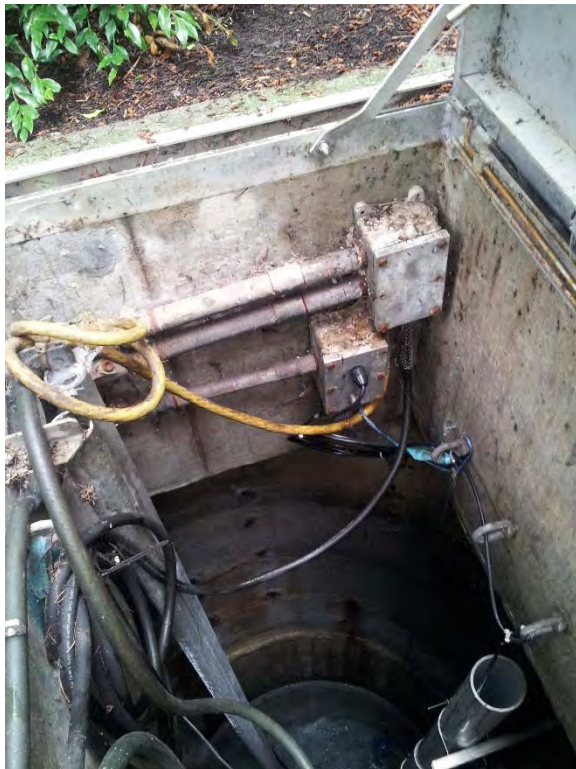
Submersible cable termination enclosure located in wet well, not fully secured and some corrosion evident

Serviceability Rating 4 – Standard parts; junction boxes in the mouth of the wet well safety hazard to access; hatch blocking easier access to junction boxes.

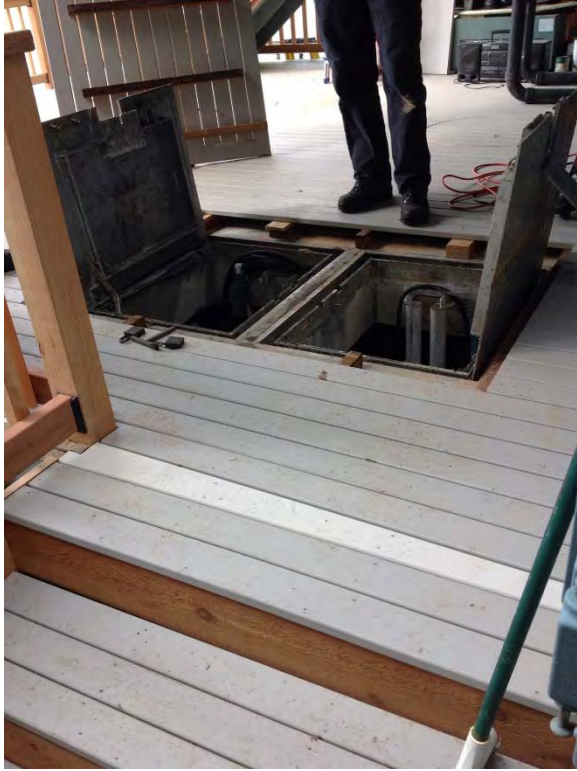
Wet well double hatch and ladder

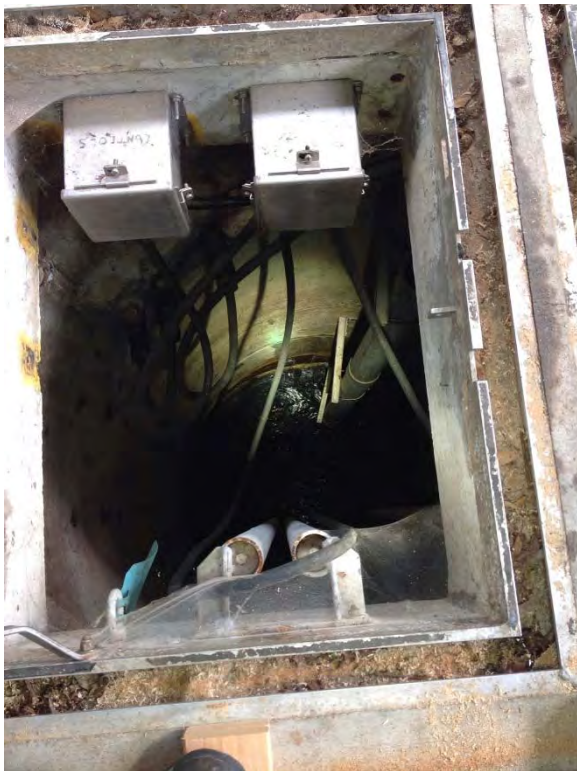
Some seepage in wet well, ground water intrusion in three locations, near bottom of wet well

- Some seepage in concrete wet well, ground water intrusion in three locations, estimated at < 0.5 gpm
- No significant issues noted – some mild grease in wet well
- Operation above hopper

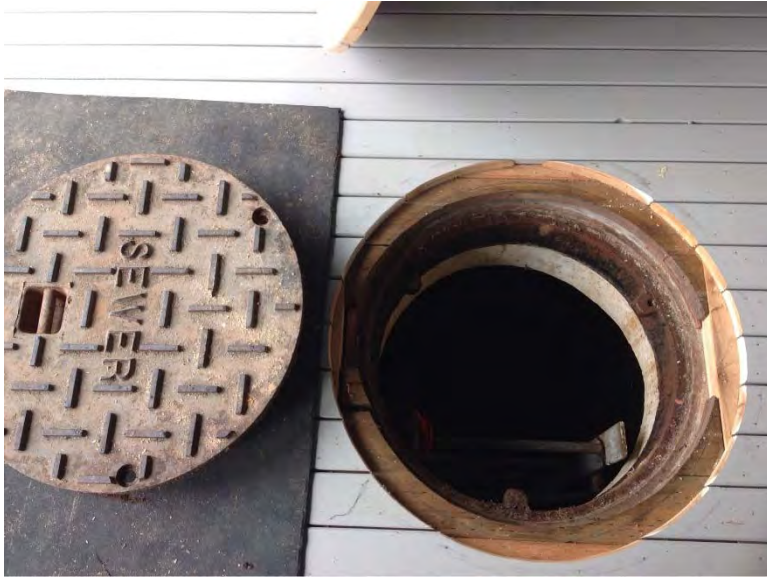
Check valve and isolation valve vault with manhole lid and ladder

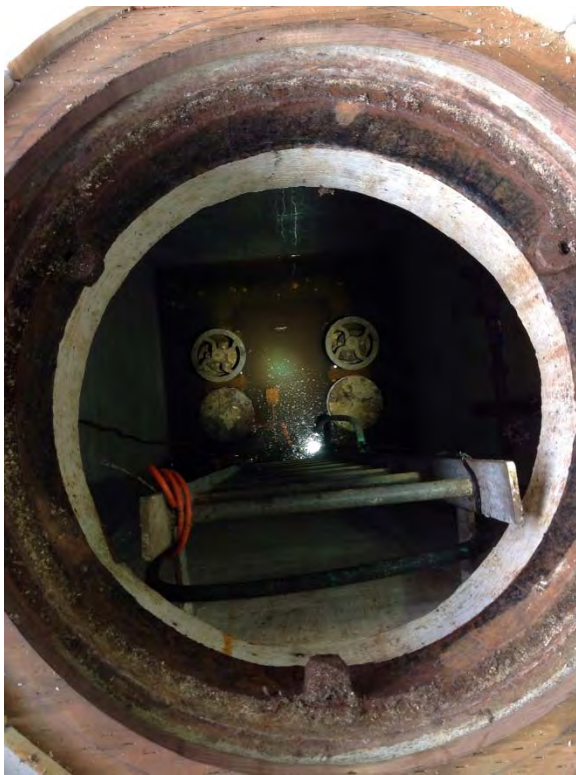
Valves look to be completely submerged in water with just the tops of the valves above water

- Flooding evident in valve vault
- Hole in false deck
- Valves look to be completely submerged in water with just the tops of the valves above water

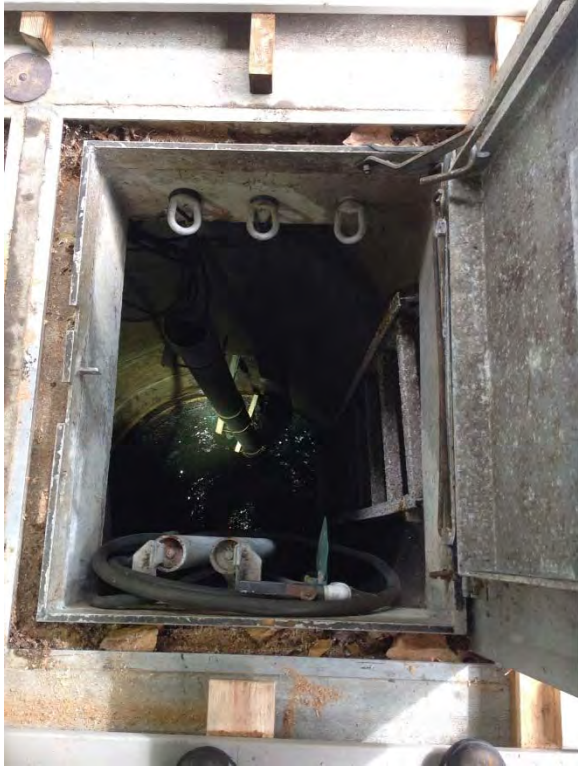
Submersible station, unable to observe pumps

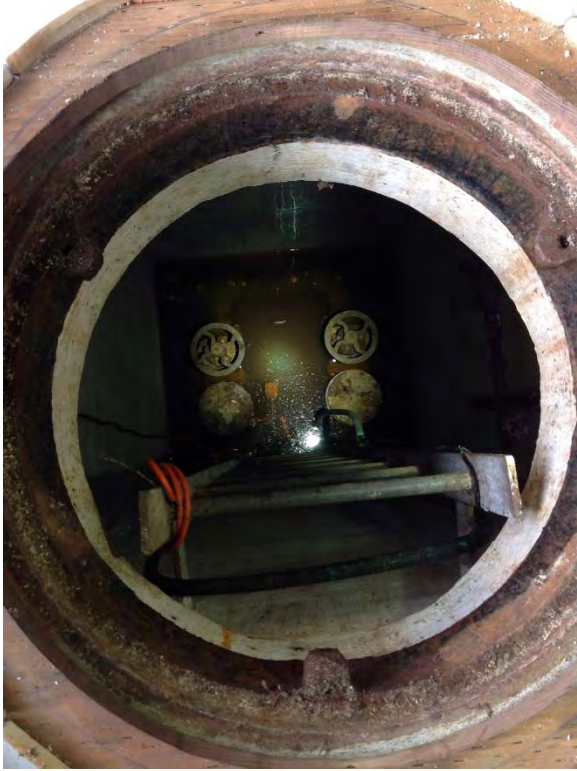
Gate Valve with hand wheel for isolation and swing check valve with outside weight and lever located in check valve and isolation valve vault, submerged in water upon site visit

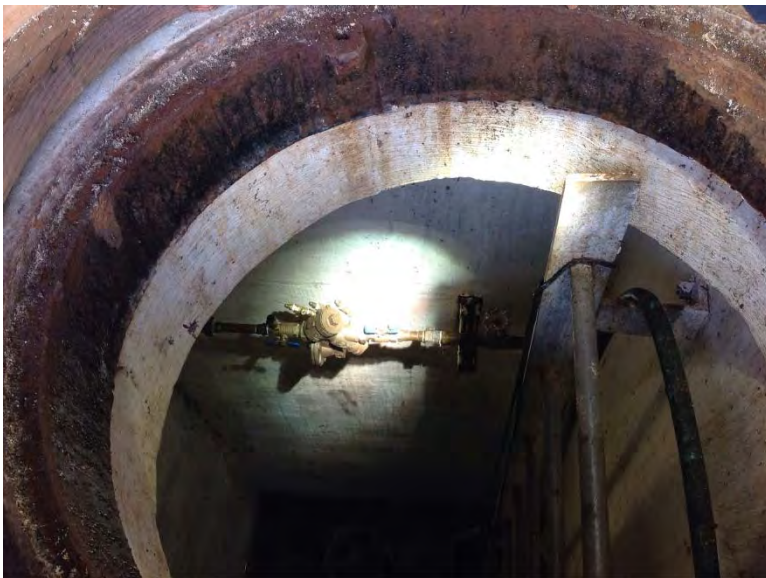
Reduced pressure backflow assembly located in check valve and isolation valve vault

- Reduced pressure backflow assembly does not drain to daylight – does not meet code for installation

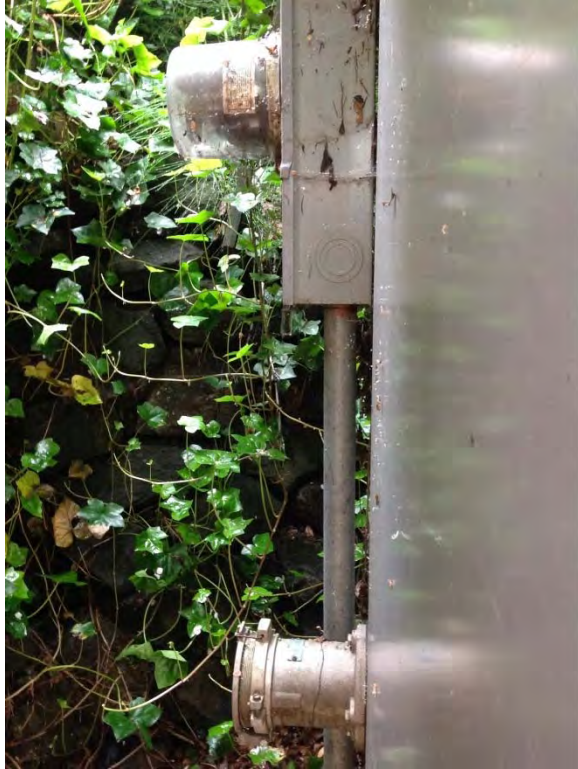
Service meter and generator receptacle located on side of power and control panel enclosure near paved road

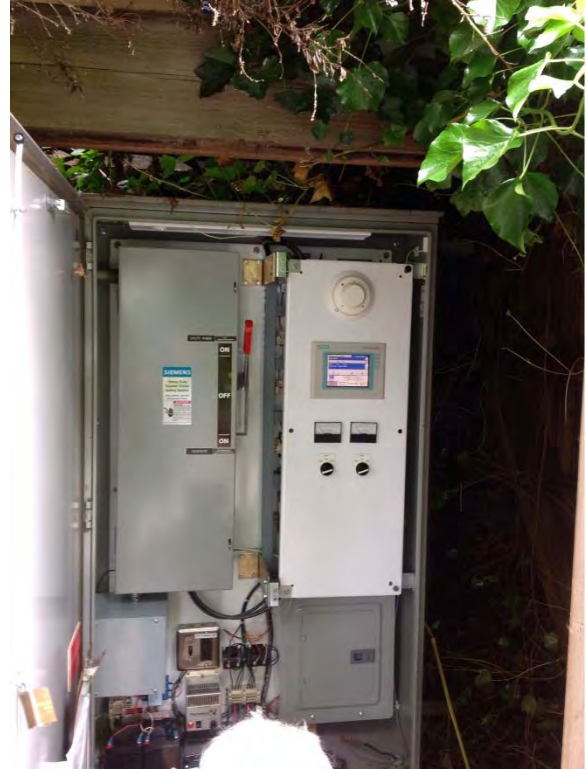
Power and control panel layout in outdoor enclosure

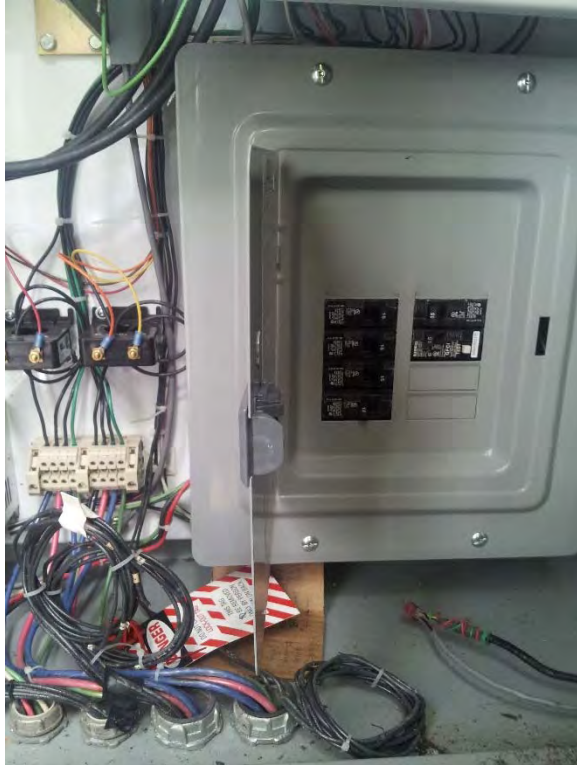
Panelboard located in outdoor power enclosure, appears to be in good condition

Condition Rating 1 – Panel appears to be in good condition, dry transformer running hot – no transformer required however, small load center

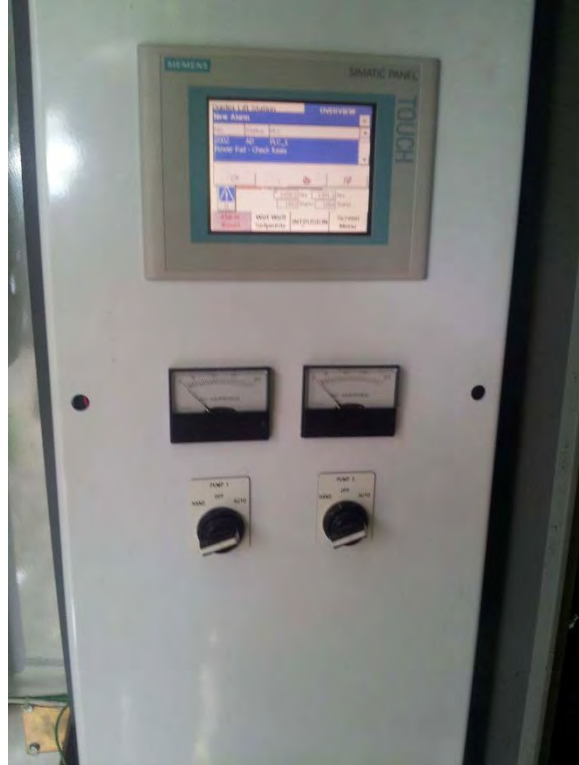
Starters located in outdoor power enclosure, appears to be in good condition

Condition Rating 1 – Siemens starters appear in good condition, newer equipment

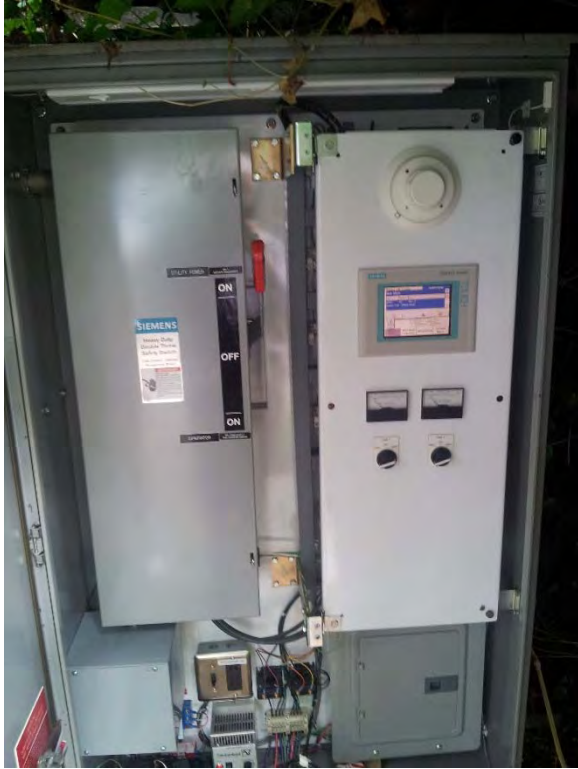
Telemetry control panel with operator interface located in outdoor power enclosure, appears to be in good condition

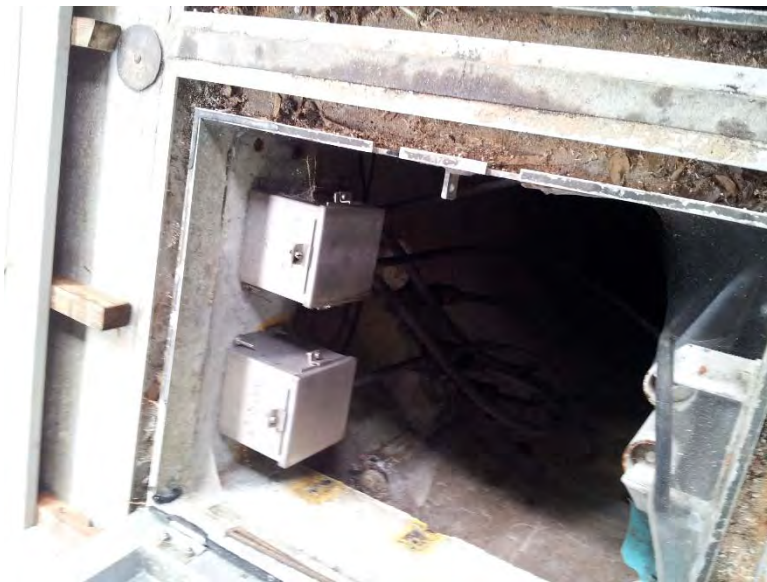
Junction boxes located in mouth of wet well, difficult to access

- No terminal block, bolted connections, cannot see (3 flights down), wet well to 12"x12"x12" HH in walkway

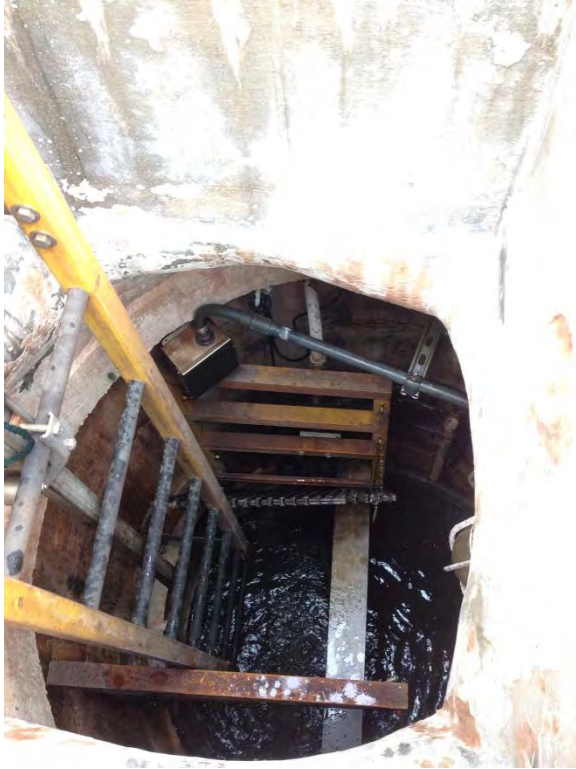
Interior of wetwell, some pitting in lower sections – still coated but should be inspected

- Some coating delaminating, but no signs of corrosion
- Pitting in lower sections – still coated but should be inspected

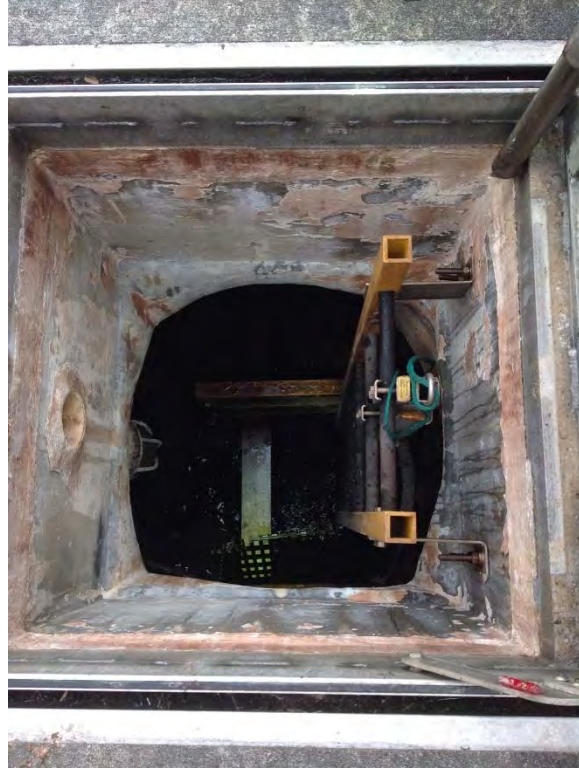
Some delaminating in interior, but no signs of corrosion

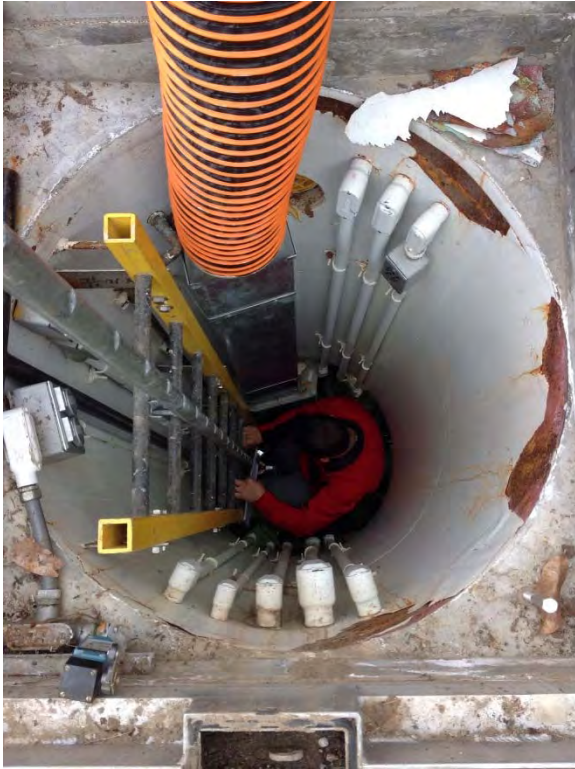
Interior of dry pit, tight space, only two people can fit at one time

- Fall protection available but you need to step over opening before latching on
- Cathodic protection, no anodes, assumes cathodic protection is successfully operating – paint coating on side needs to be replaced (delaminating)
- Tight space, only two people can fit at one time

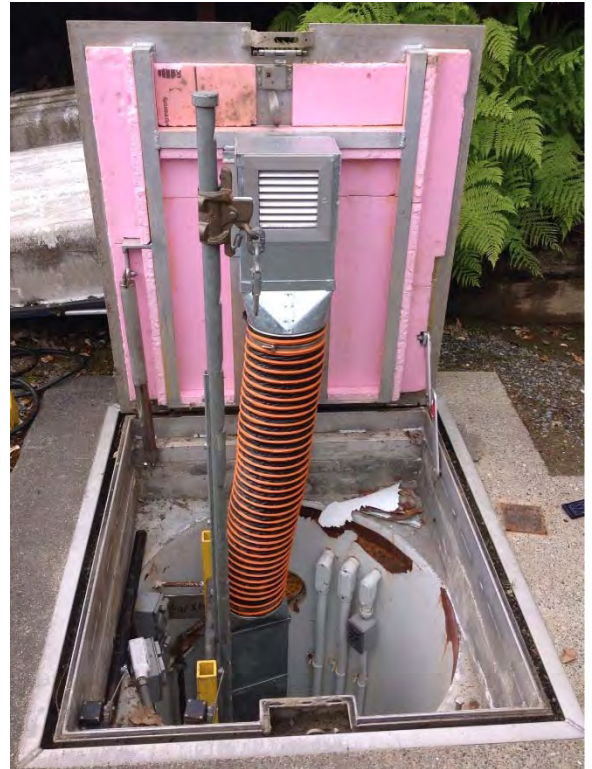
Fall protection available but you need to step over opening before latching on

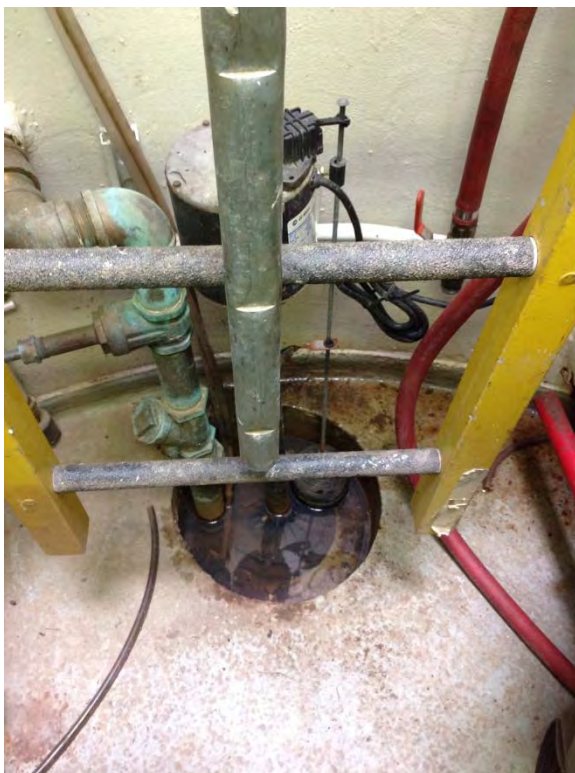
End of ladder, above/adjacent to sump pump and drain

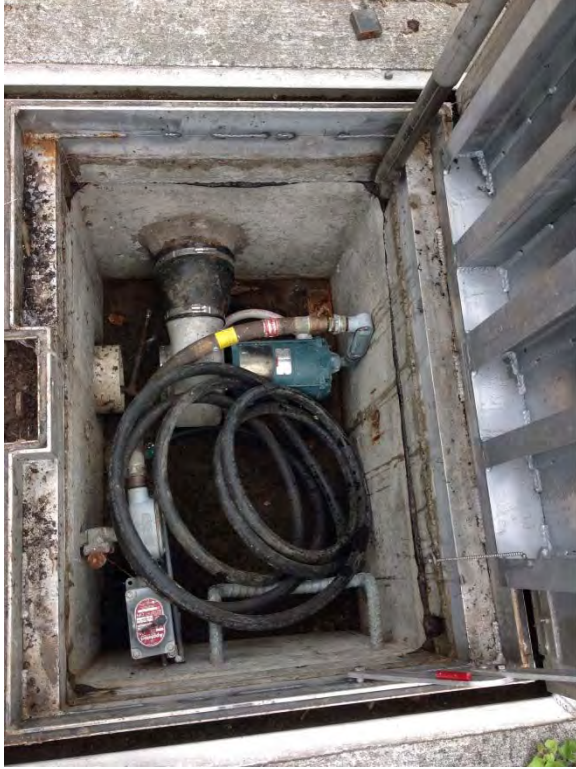
Interior of wet well blower vault, appears to be in good condition.

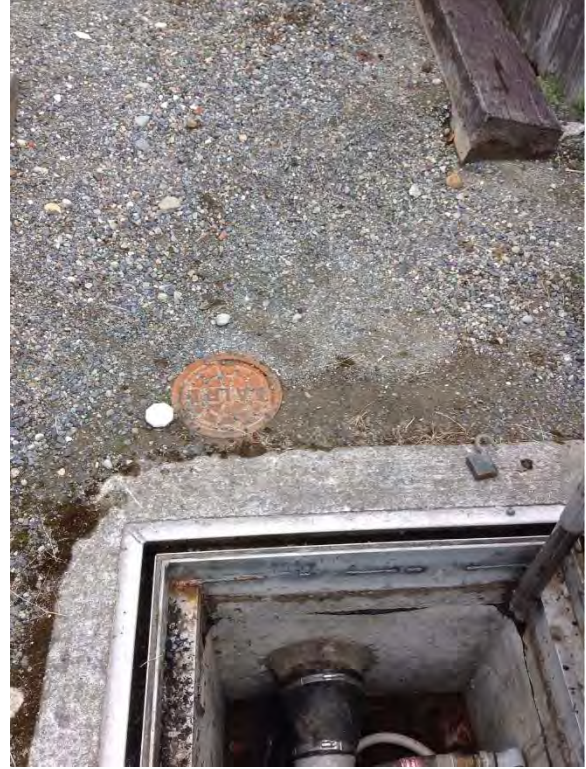
Air valve adjacent to vault

- Air valve adjacent to vault
- Directly connected to wet well – no automated valve – manual valve is always open
- No issues noted

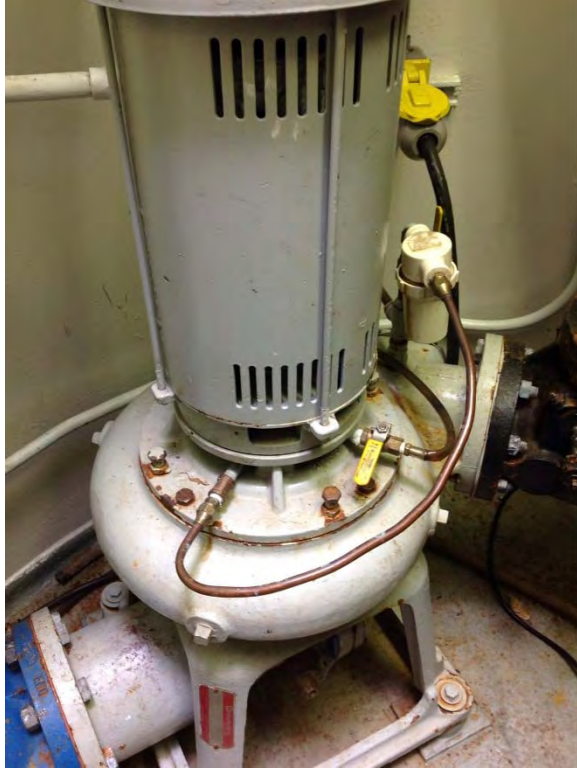
Pump and motor #1

- Flow measurement is much lower than design point while head conditions are relatively the same

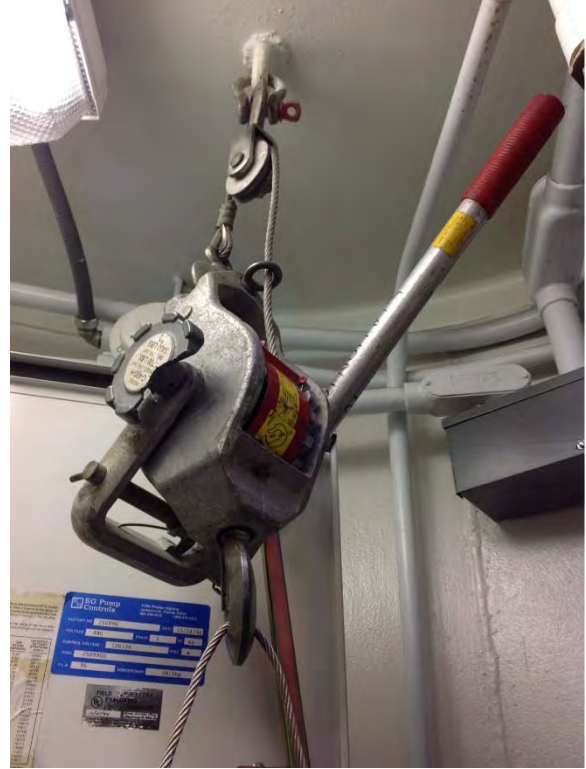
Lifting eye and chain fall attached to ceiling of metal can#1

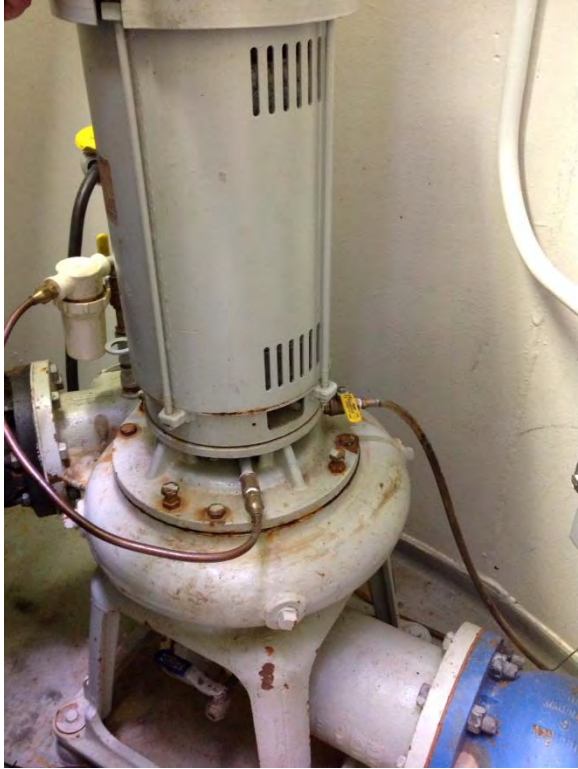
Pump and motor #2

- Flow measurement is much lower than design point while head conditions are relatively the same

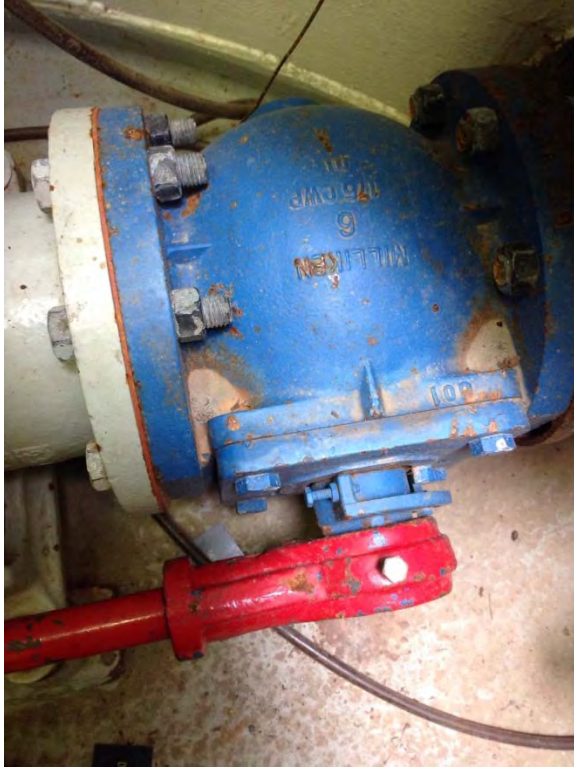
Plug valve horizontal axis of rotation - ideal

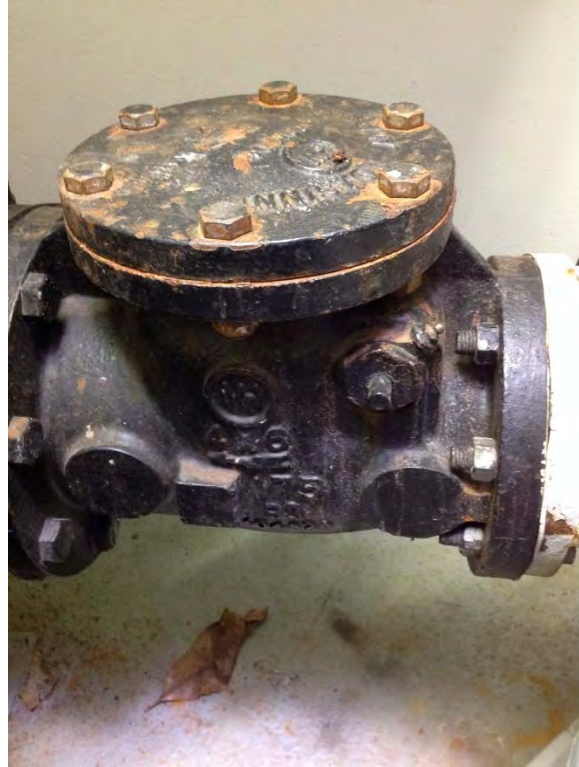
Swing check valve with outside weight and lever 4" x 6"

- Plug valve vertical axis of rotation – not ideal
- Swing check valve is 4"x6"

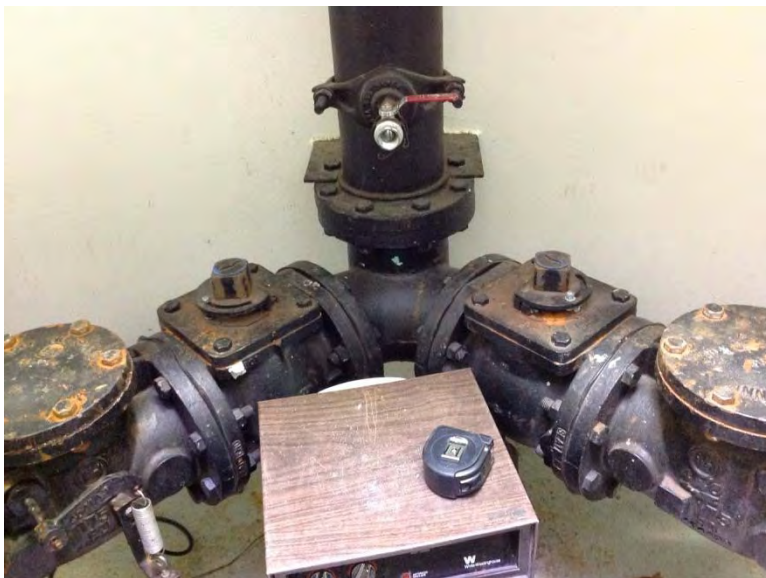
Plug valve and swing check valve with outside weight and lever located on discharge piping, plug valve vertical installation – not ideal

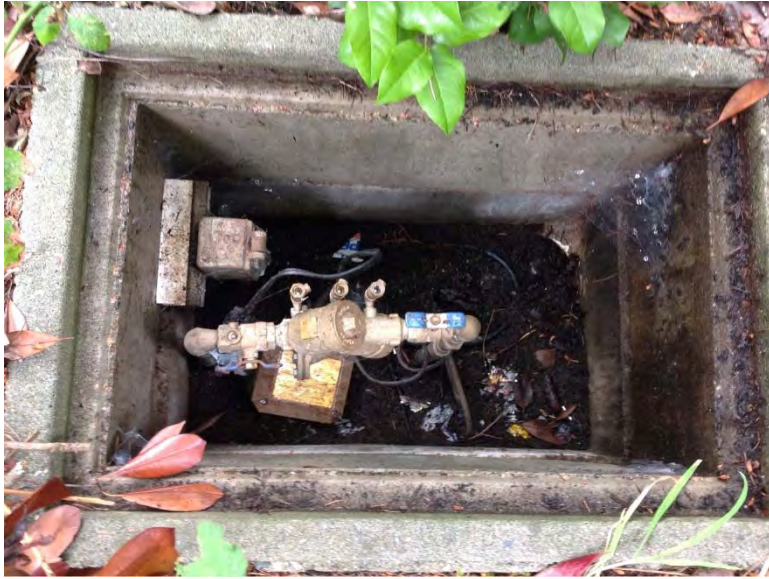
Reduced pressure backflow assembly located in below grade water meter vault adjacent to West Lake Sammamish Parkway

- Below grade and no free drain in backflow assembly – does not meet code for installation

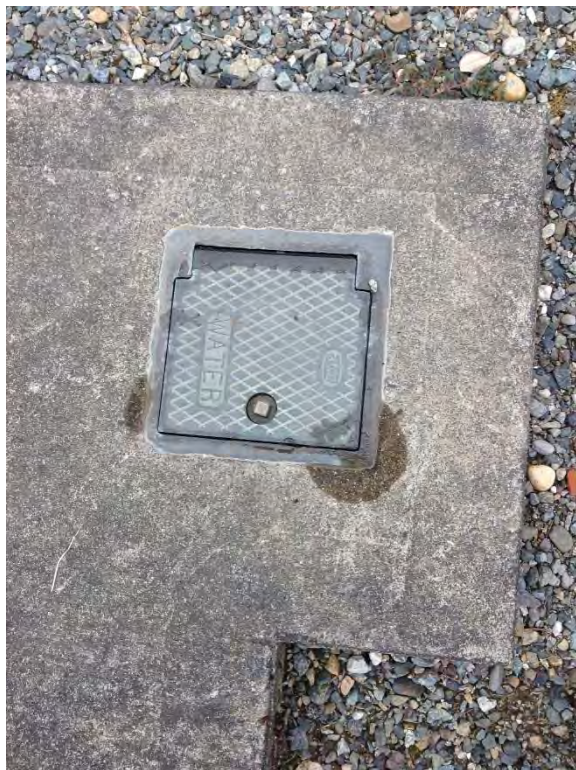
Wash down water supply adjacent to wet well

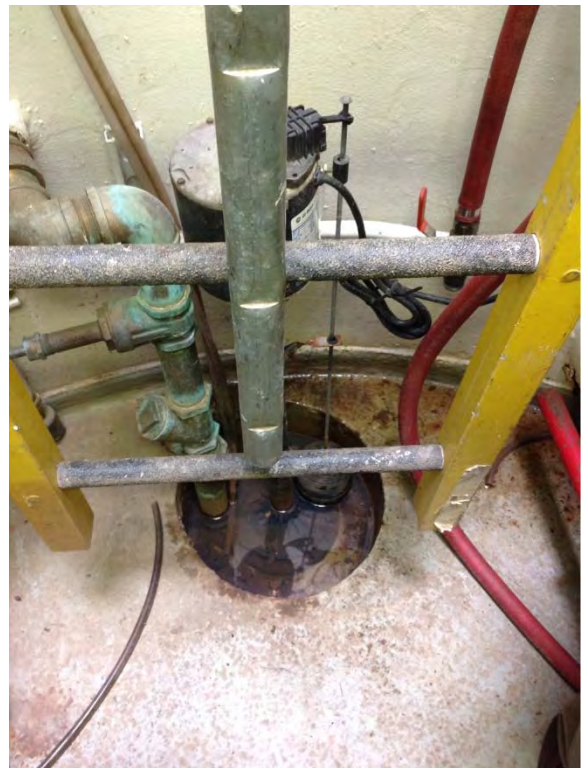
Wash down water hose in dry pit

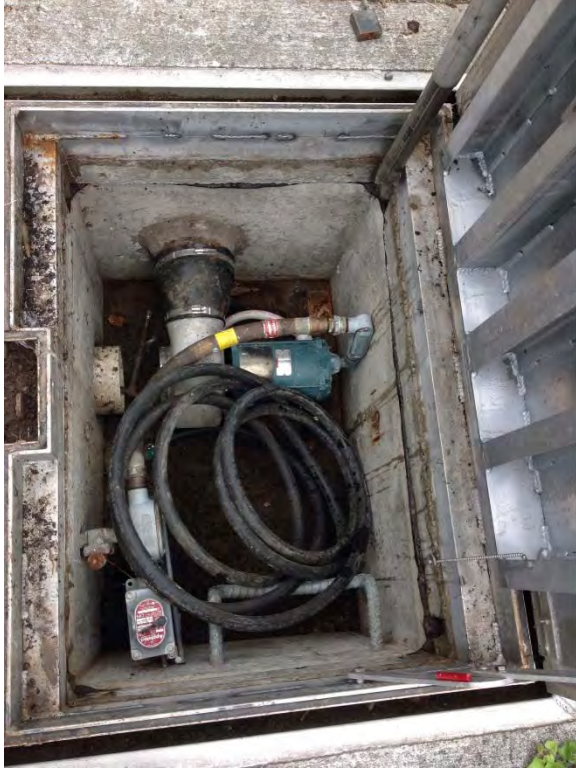
Wet well supply fan located in wet well blower vault

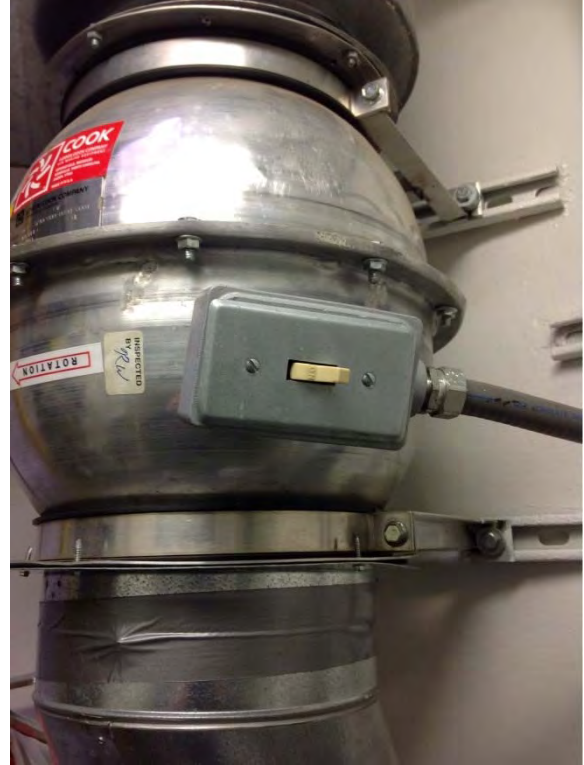
Dry pit supply fan located 6' AFF in dry pit

Serviceability Rating 2 – The supply fan can be difficult to access since it is 6' AFF in the dry pit

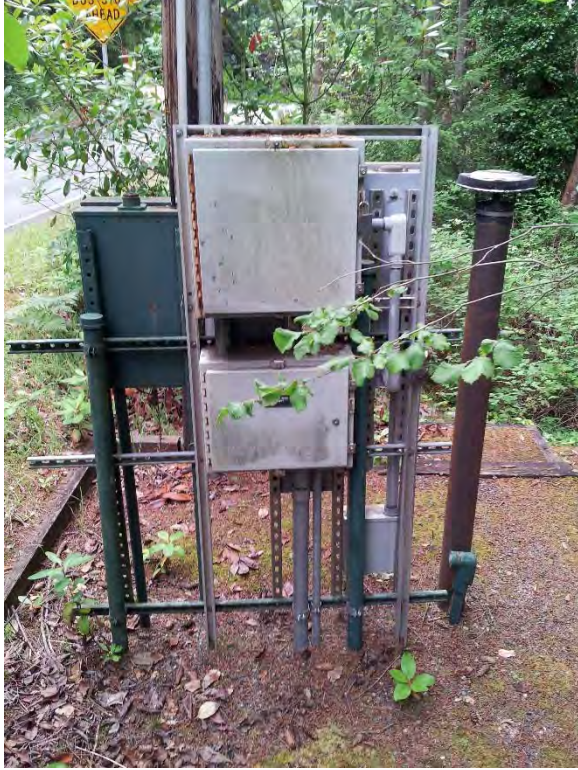
Utility service and back-up power located adjacent to West Lake Sammamish Parkway on steel rack

- Manual transfer switch is a double throw enclosed switch

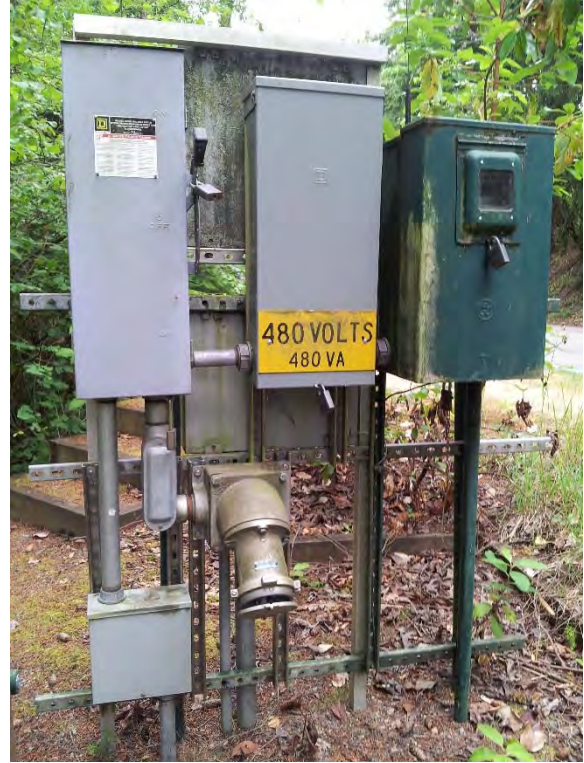
Generator receptacle located on rack

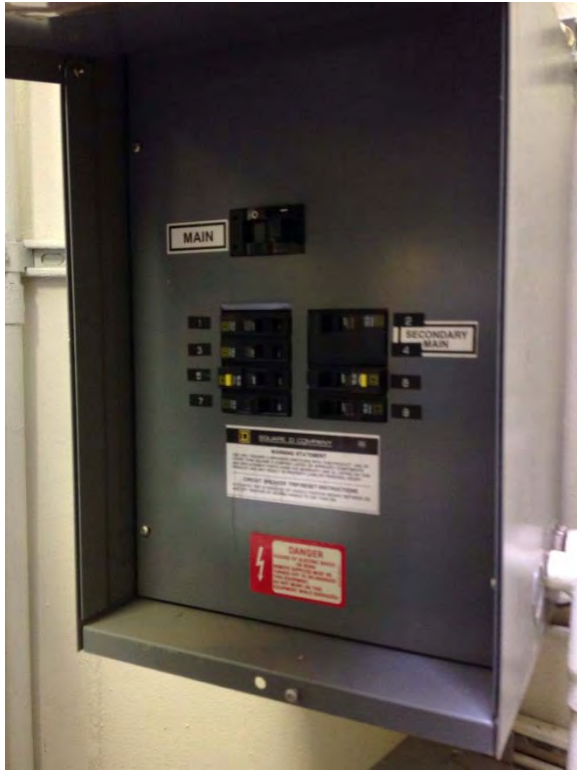
Panelboard located in dry pit, appears to be in good condition

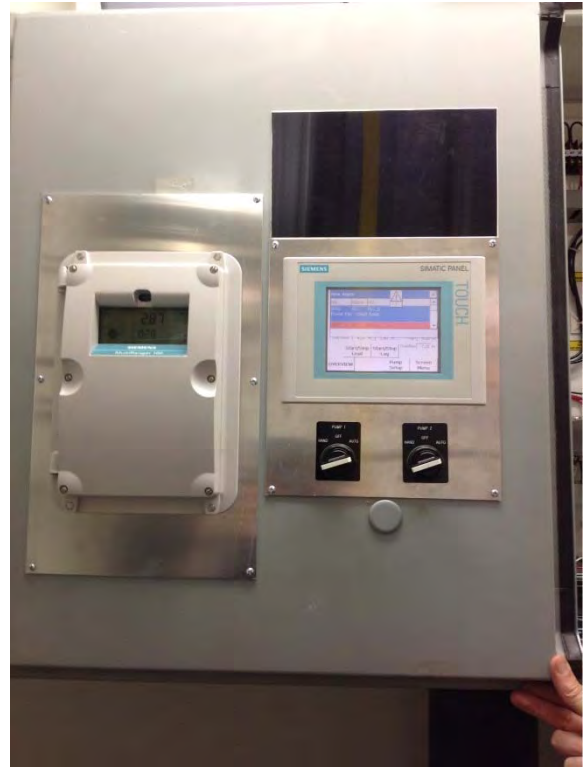
Starters located in dry pit, appears to be in good condition but aging

Criticality Rating 3 – Critical but redundant, starters needed to run the pumps but if one starter fails the other will still operate

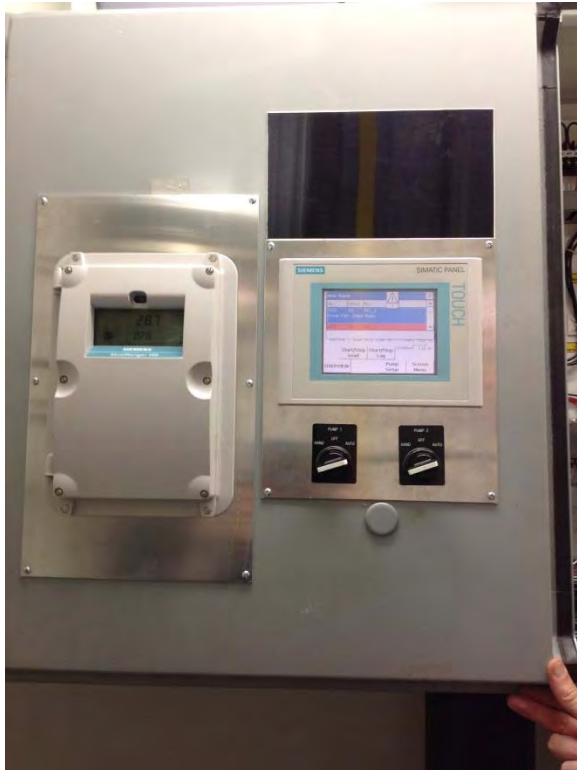
Telemetry control panel located in dry pit with operator interface, appears to be in good condition but with some clearance violations

- ISR clearance violations on the side: 24” to switch for fan, 28” to vent duct, 28” to transformer and LP, 40” to fall arrest, 42” to ladder

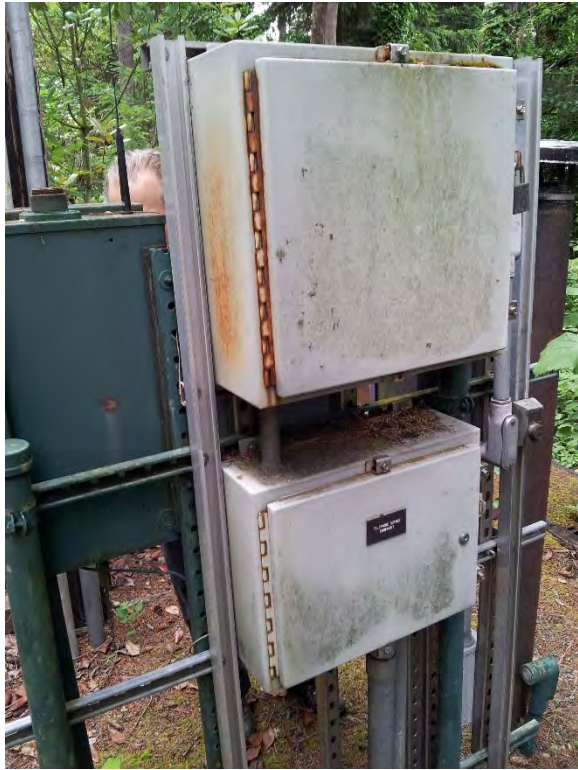
Telephone network interface located on rack along West Lake Sammamish Parkway in NEMA 4 box, showing signs of aging

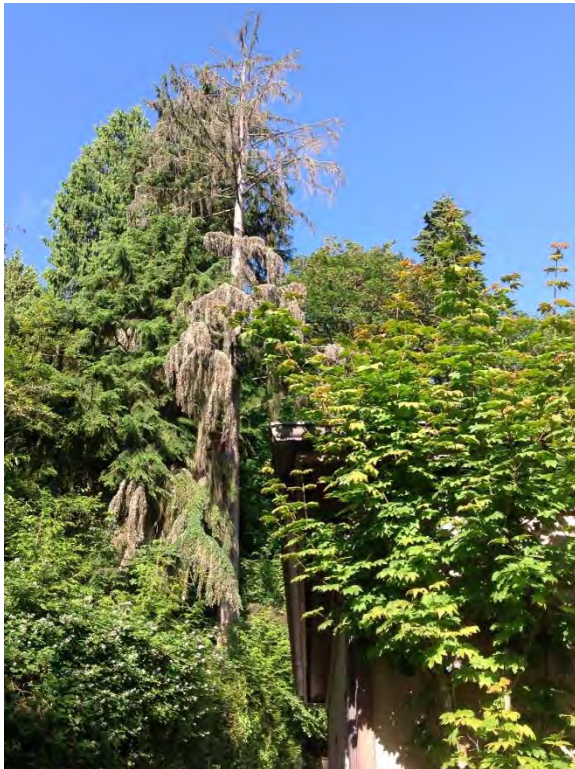
Approximately 80' tall Douglas Fir snag adjacent to/above station that could likely fall on station – should be removed

- There is a large Douglas Fir approximately 80' tall, that could potentially fall on the station – should consider removing
- Box for chain-fall is 5.5' AFF, potential safety hazard

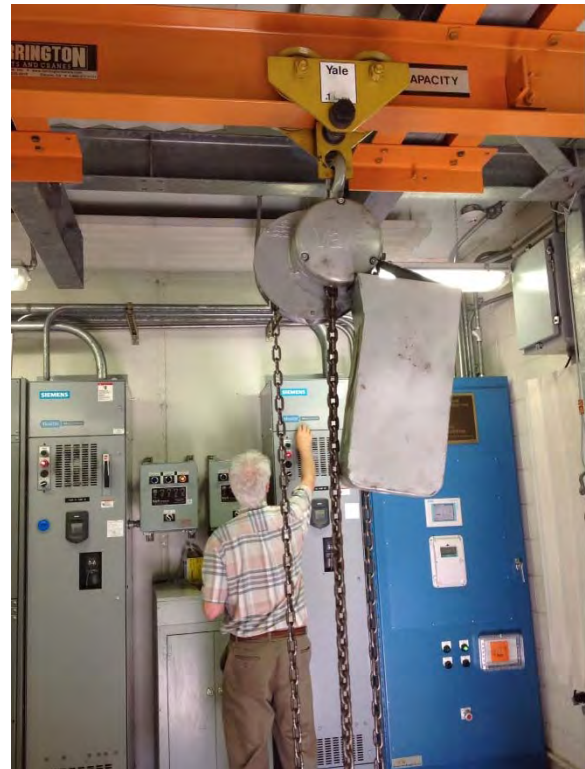
Box for chain fall is 5' -6" AFF, potential safety hazard

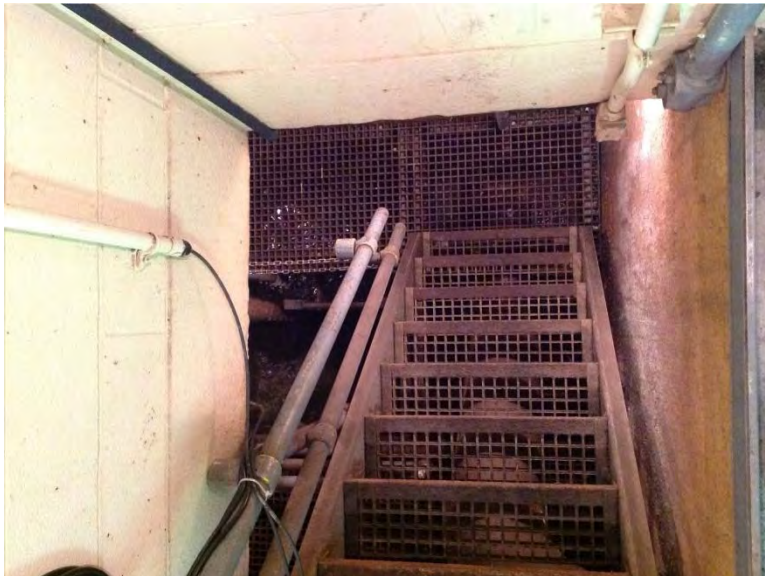
Stairs to access wet well

- Stairs and railing to wet well, lock on exterior door

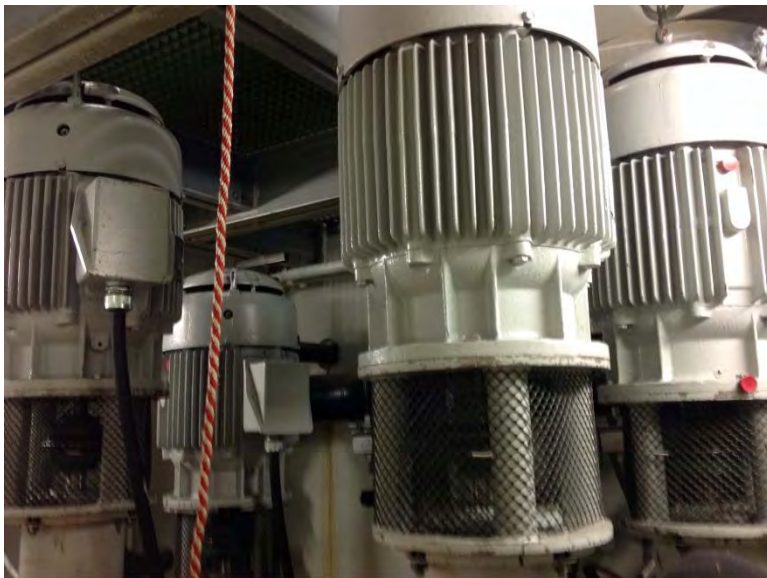
Interior of dry pit pump level

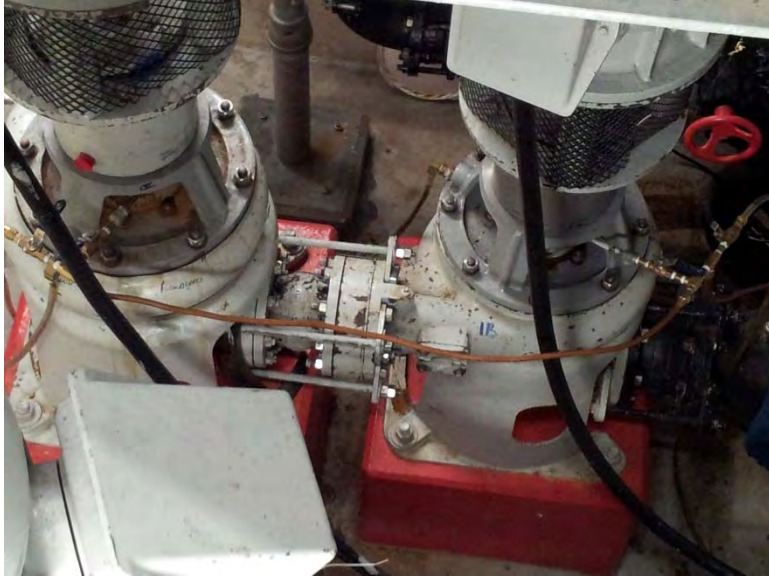
Pumps 1A and 1B

The configuration of this station is unique since there are four pumps total at this station with two sets of two pumps pumping in series, meaning that pump B discharges directly into the suction of pump A. The field tested performance of the pumps at Station 12 measured similar flow (~690 gpm vs. 750 gpm) and similar head conditions (137 ft vs. 138 ft). Given the significant pitting within the volute, it is possible that the pump degradation is at least partly responsible for the decrease in flow. Additional hydraulic evaluation efforts were completed at Station 12 to determine the source(s) of hydraulic issues, the findings of this testing can be found in Appendix C.

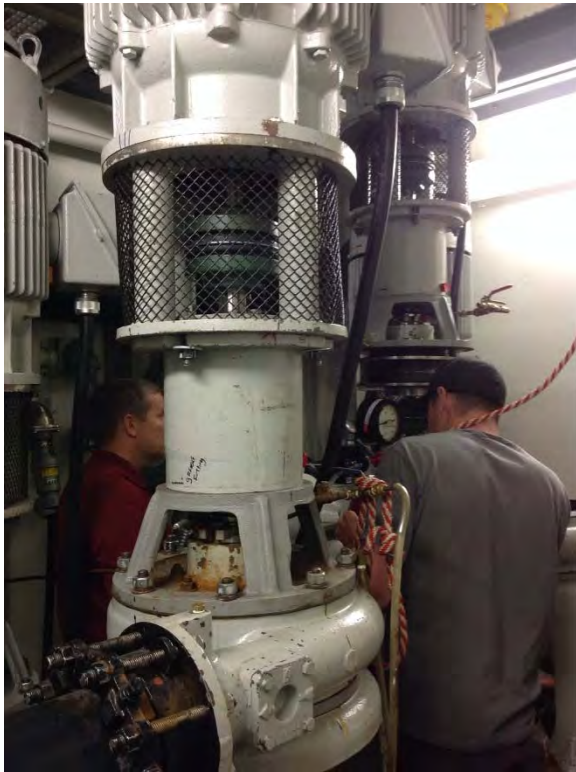
Pump and motor 1A

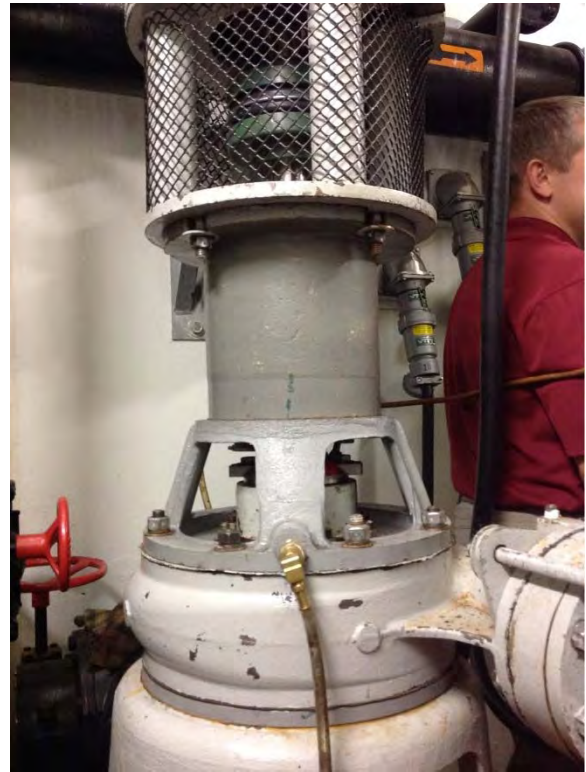
Pump and motor 1B

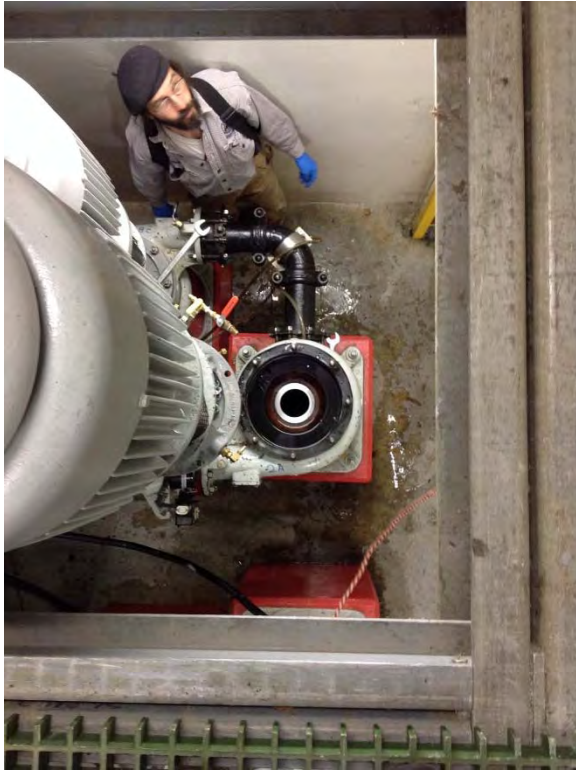
Pump 2A disassembled upon site visit to observe interior of volute

Condition Rating 2 – Based on visual observations of the wet end the pump appears to be in good condition with the exception of pitting/grooves on the volute observed on both pumps
