Lake Washington Wastewater Lake Line Management Plan

FINAL / July 2024

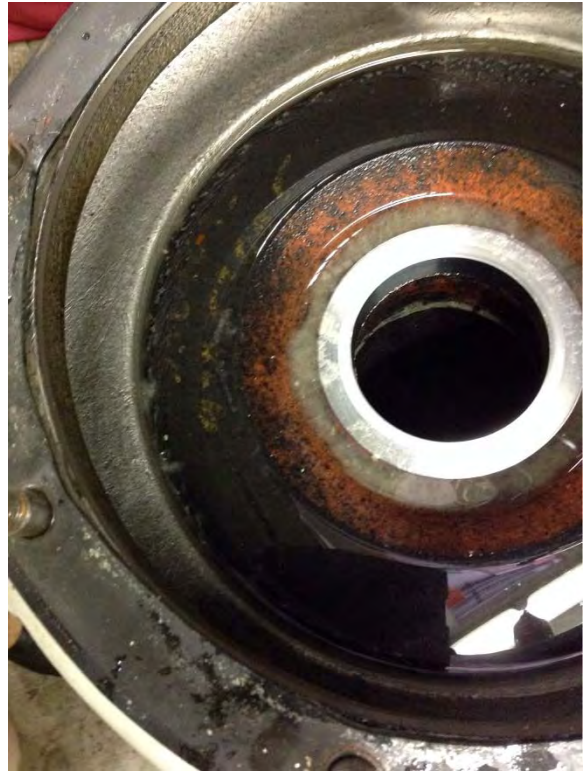
Interior of Pump 2A volute with pitting and grooves

The pump run hours and starts for this facility seem to be reasonable and no accelerated wear is anticipated due to these indicators. However, the observed pitting indicates a significant issue, which will continue to degrade and ruin these pumps. Further, specific testing and documentation is recommended to avoid pump failure.

Condition Rating 2 – Based on visual observations of the wet end the pump appears to be in good condition with the exception of pitting/grooves on the volute observed on both pumps

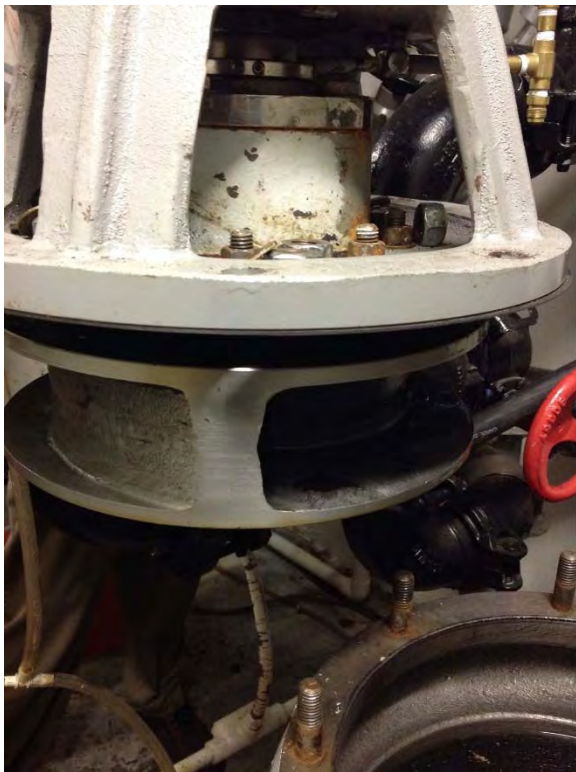
Pump 2B disassembled upon site visit to observe interior of volute

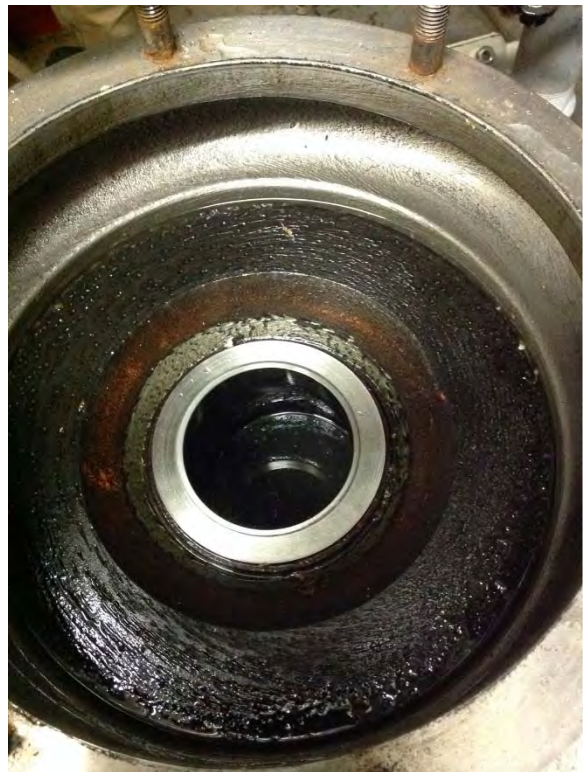
Interior of Pump 2B volute with pitting and grooves

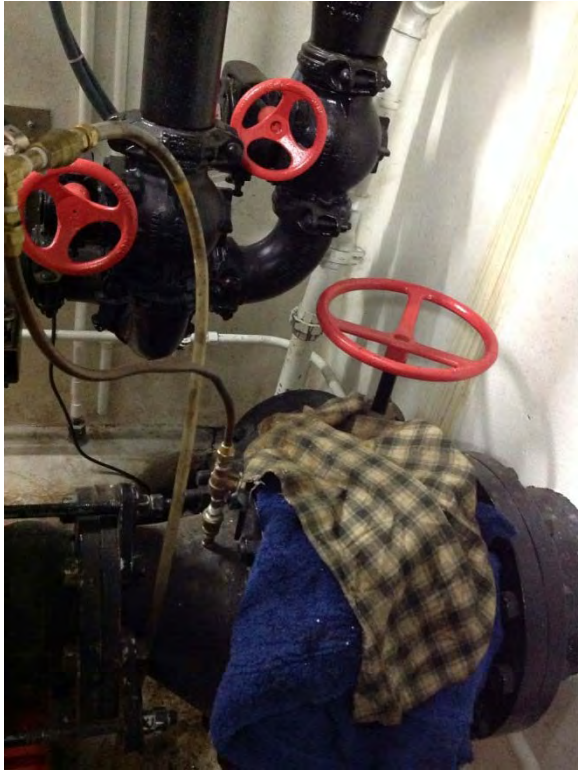
Suction piping

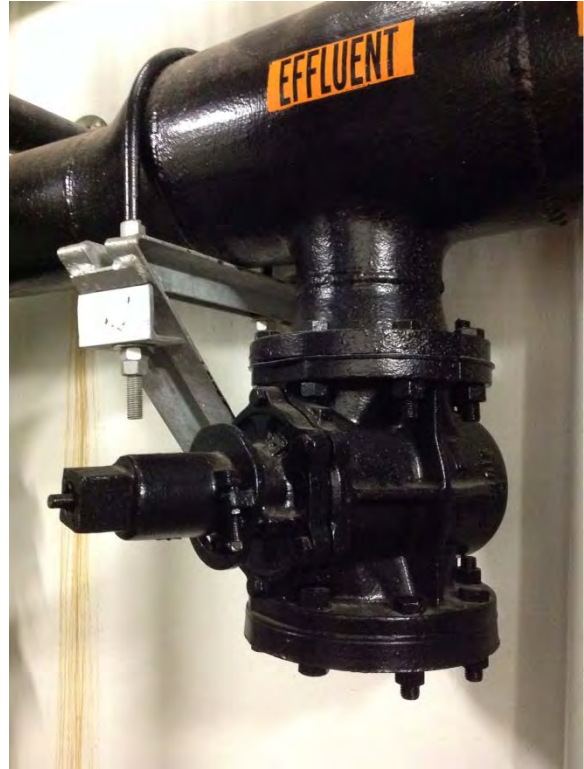
Common discharge piping

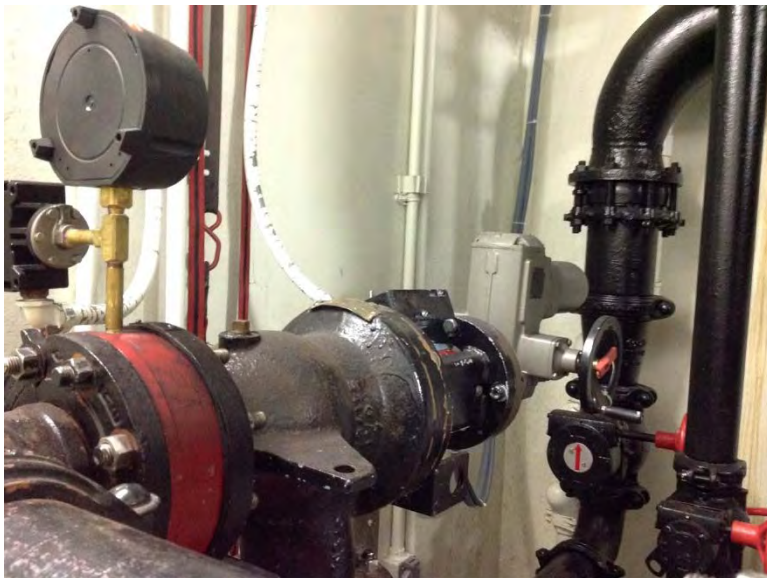
Discharge piping with automated check valve

- Automated check valve – high head station

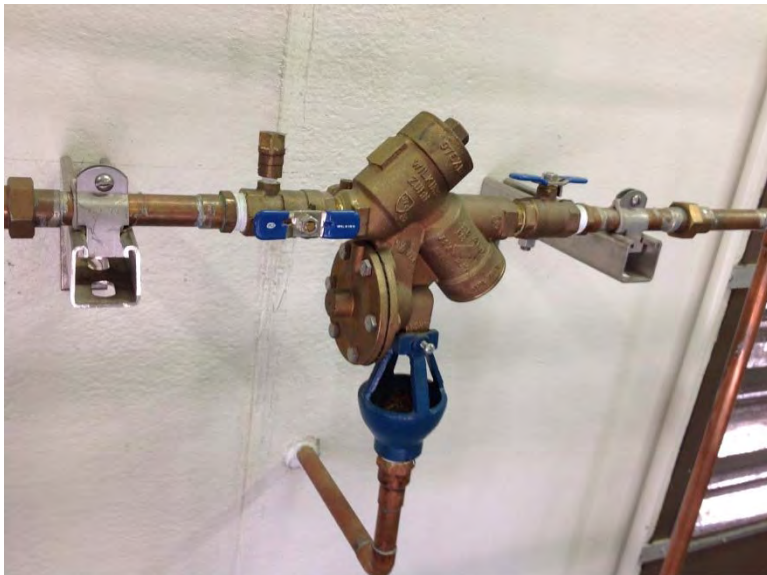
Backflow assembly located in building top floor, drains to daylight

- Reduced pressure backflow assembly located in building top floor, drains to daylight

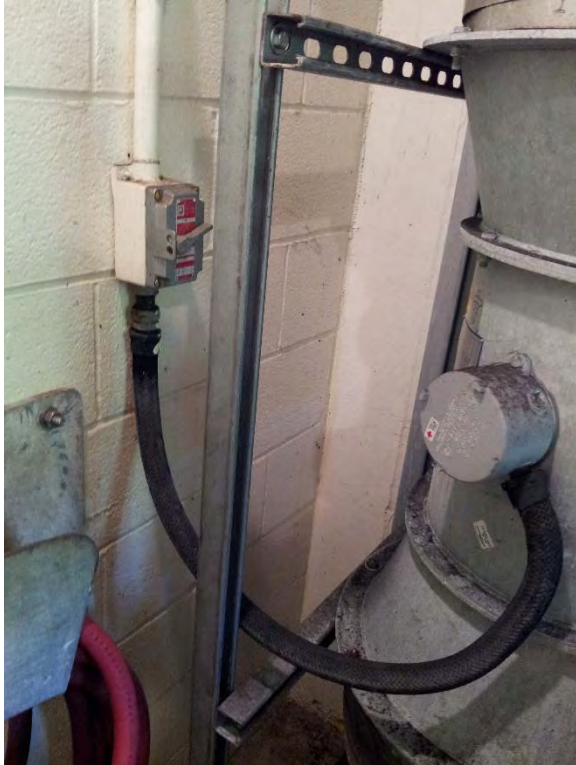
Wet well supply fan located behind exhaust fan in wet well access room

- Dual system – unoccupied – continuous exhaust through no passive supply (negative pressure)
- Carbon system – occupied – continuous supply to lower levels
- Wet well odor treatment fan, inlet screen plugged
- The wet well room that the ventilation fans are located has direct access to the wet well. There is no covering/hatch on the wet well and the stairs down lead directly into it. This space should be classified and treated as a confined space.

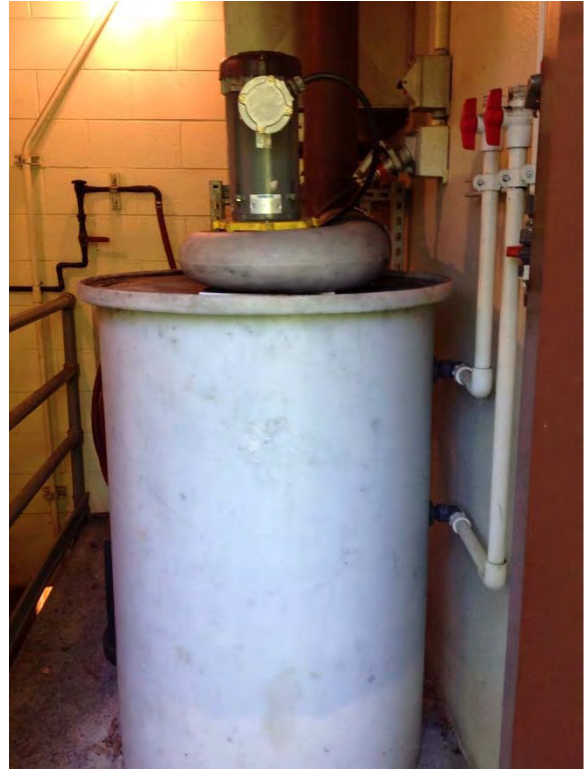
Wet well ventilation exhaust fan and carbon canister located in wet well access room

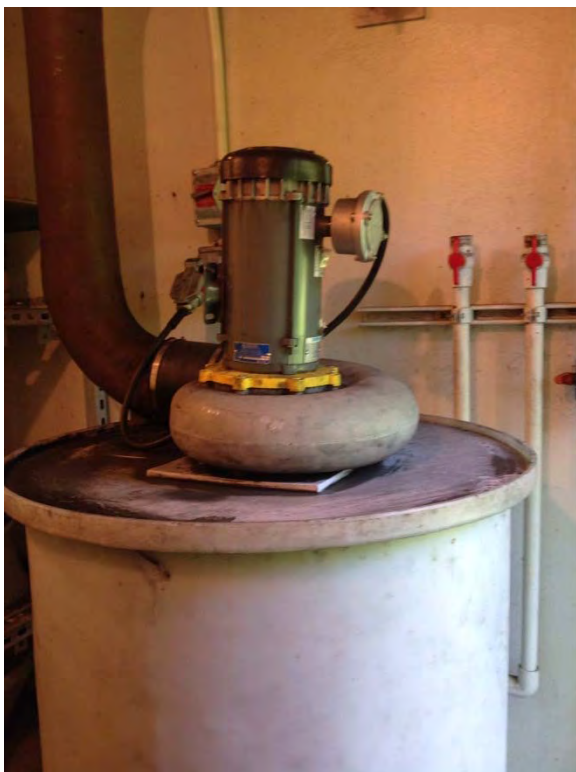
Centrifugal exhaust fan located on top of carbon canister

Location	Wet well room
Fan type	Centrifugal on top of carbon canister
Airflow rate	300 CFM*

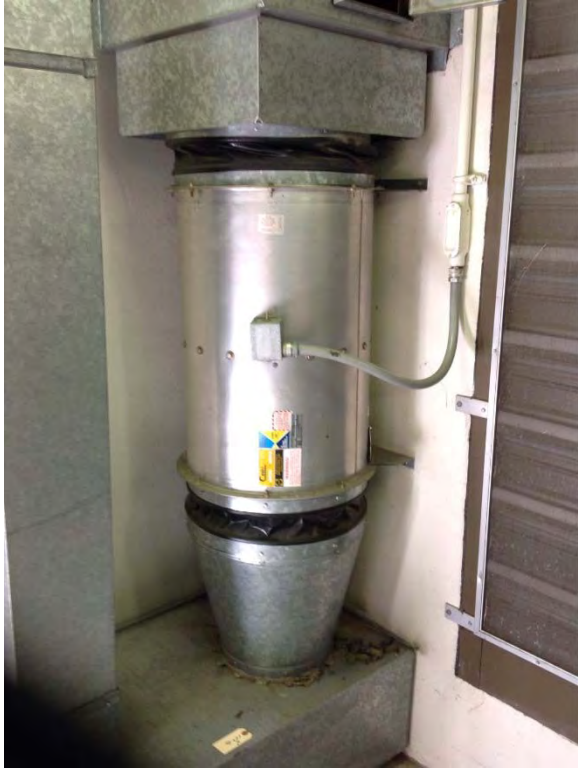
Dry pit supply fan located in corner of control building 4' AFF

- Screens were completely dusty could not see through

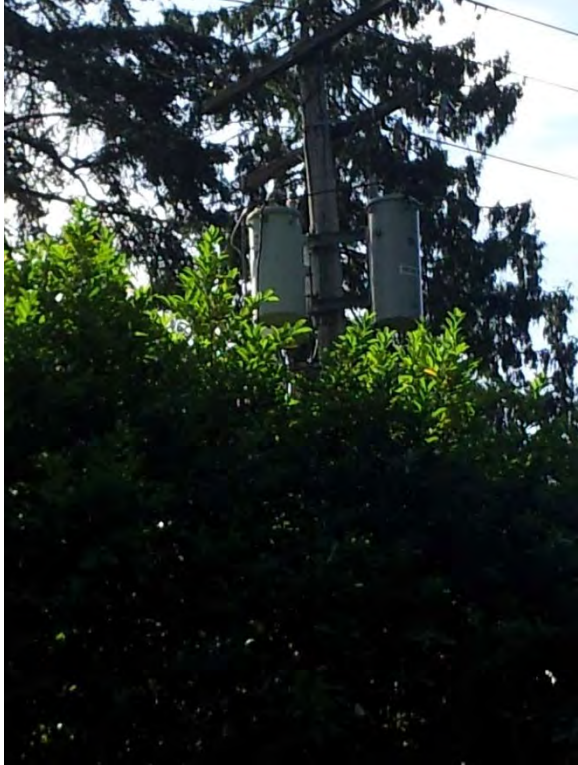
Utility transformer overhead adjacent to station

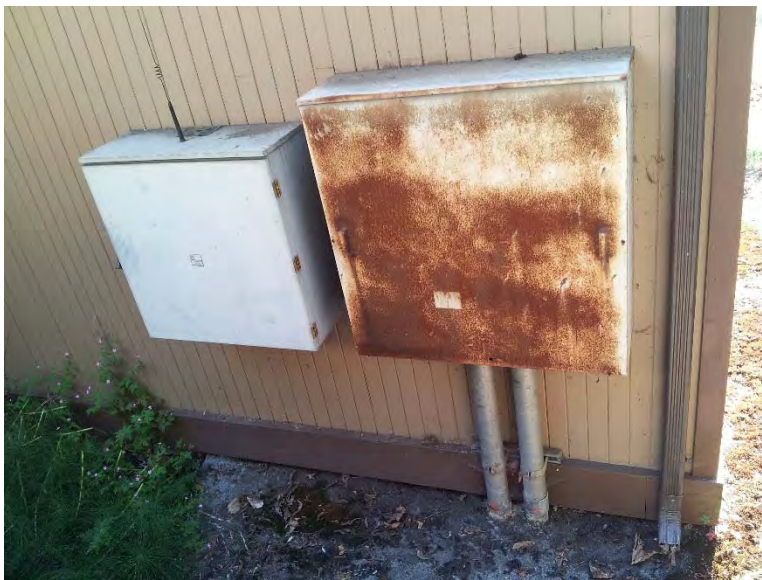
Utility service meter located in back of building, current transformer compartment very rusty

Condition Rating 2 – Meter base appears to be in good condition but current transformer compartment is rusty; needs repair or replacement. Main disconnect appears to be in good condition, but aging.

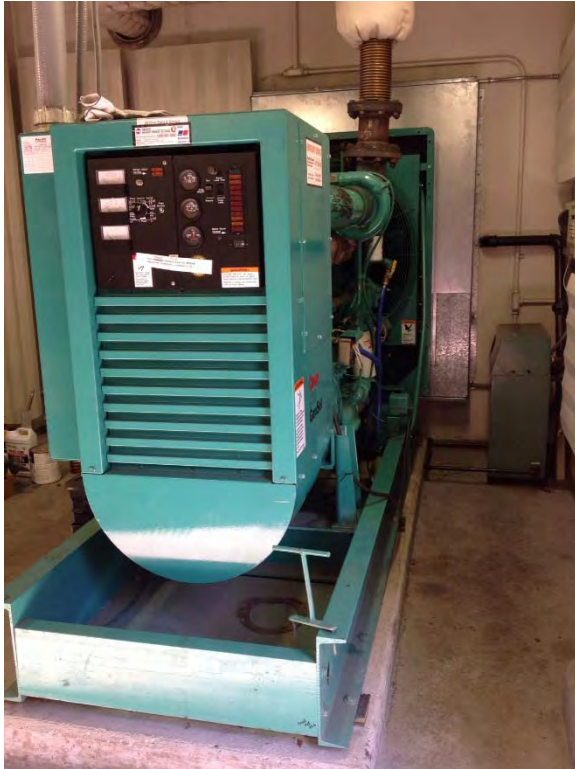
Standby generator located on top floor of control building, appears to be in good condition but aging

Condition Rating 2 – Auto transfer switch and diesel generator appear to be in good condition, but aging. Underground fuel storage tank is monitored

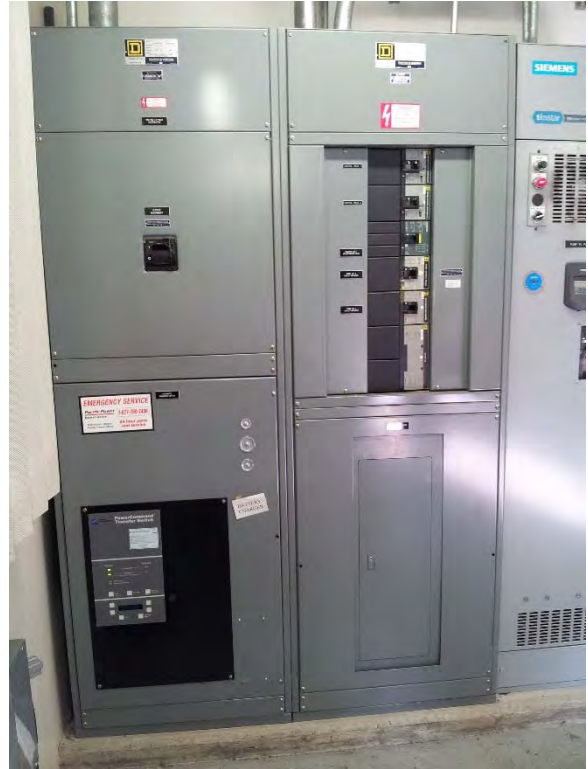
Transfer switch located in top floor of building, appears to be in good condition but aging

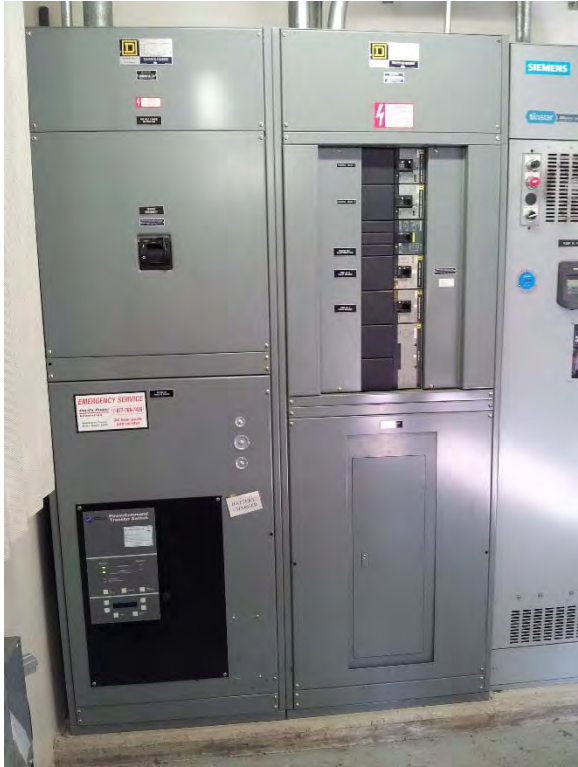
Panelboard located on top floor of control building

Condition Rating 2 – Panel and transformer appear to be in good condition, but aging

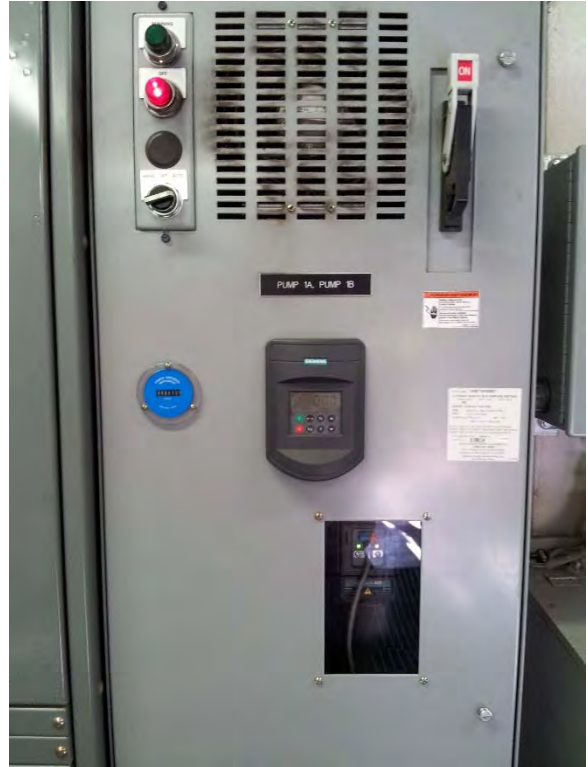
Starters for Pump 1A and 1B, appears to be in good condition but aging

Condition Rating 2 – The Siemens drives appear to be in good condition, but aging. Line reactors installed but likely don't keep harmonics to within IEEE 519 limits. Investigate operating harmonics

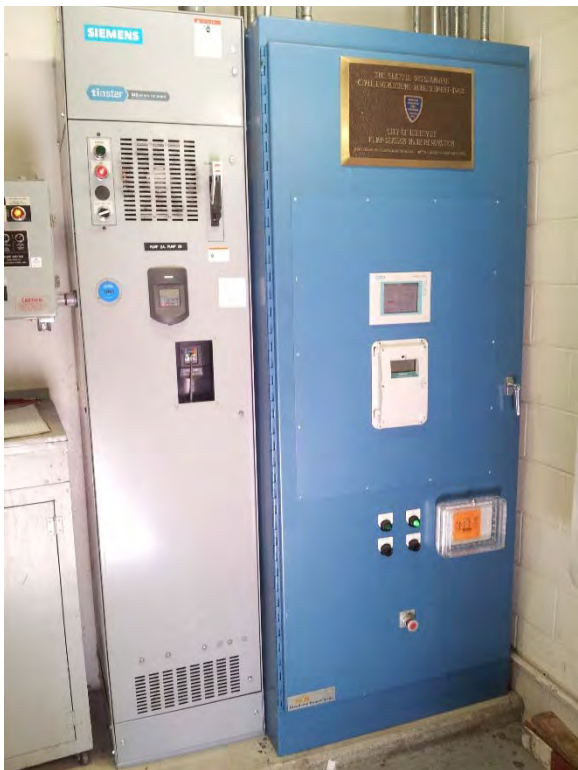
Starters for Pump 2A and 2B, appears to be in good condition but aging

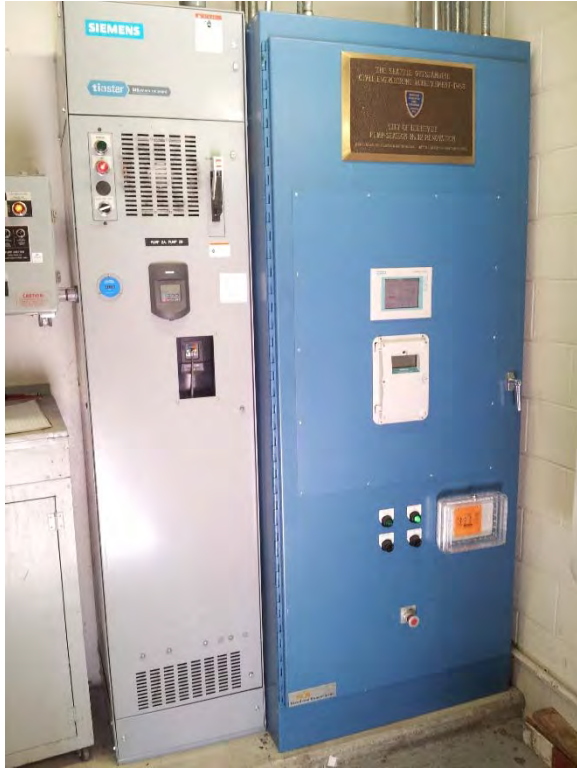
Telemetry control panel with operator interface located on top floor of control building, appears to be in good condition

Criticality Rating 3 – Critical but redundant, PLC alternates and calls for pumping, backup operation is hardwired from the floats to the starter

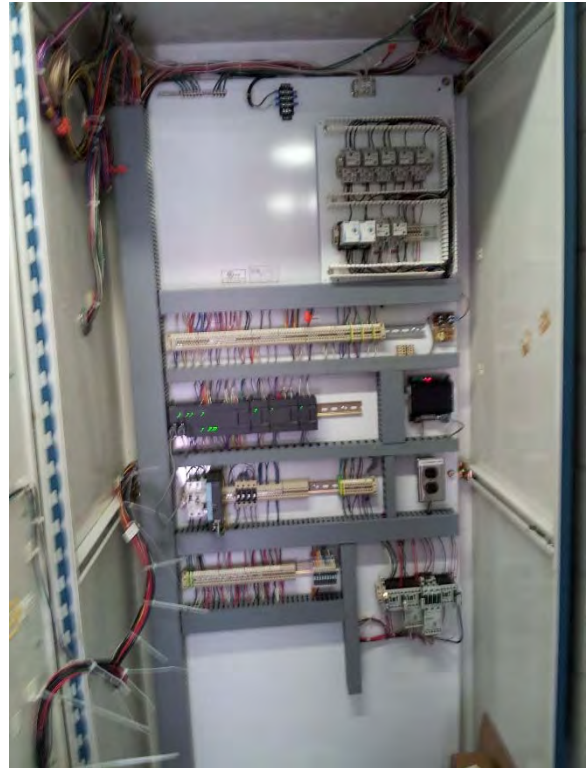
Interior of telemetry control panel

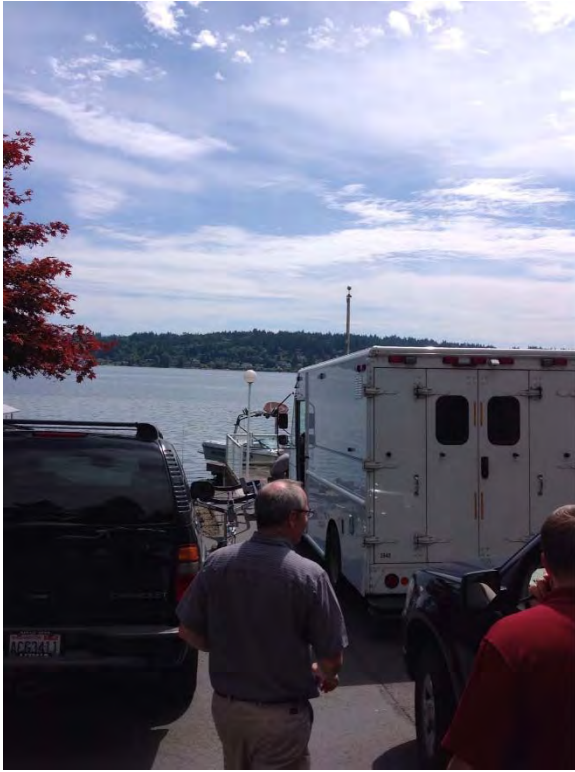
Vehicle parking adjacent to site

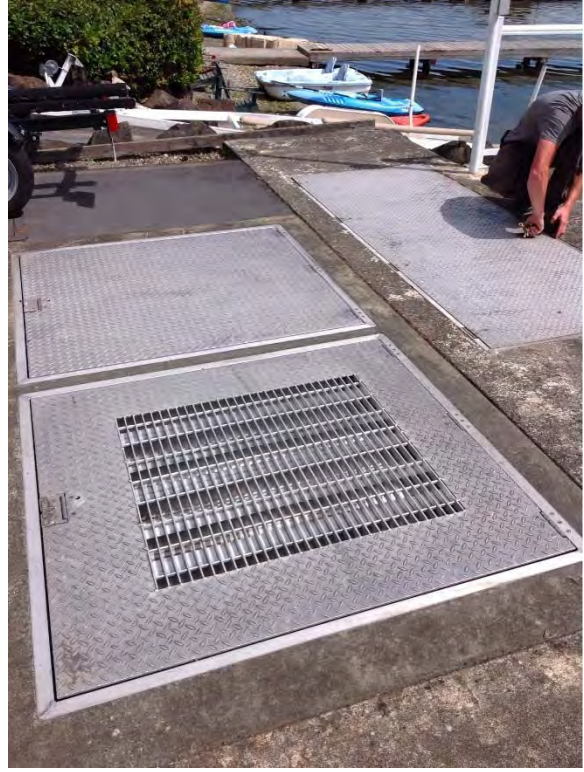
Station in paved deck area, site drops off to lake level with no railing around, potential safety issue

- Drop-off alongside of site where railing does not wrap around – potential safety issue

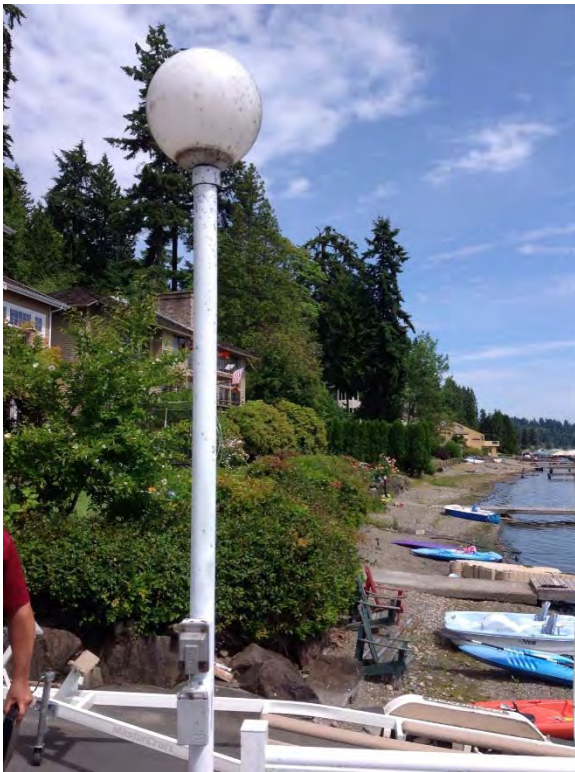
Site lighting between dry pit and wet well on deck area adjacent to station

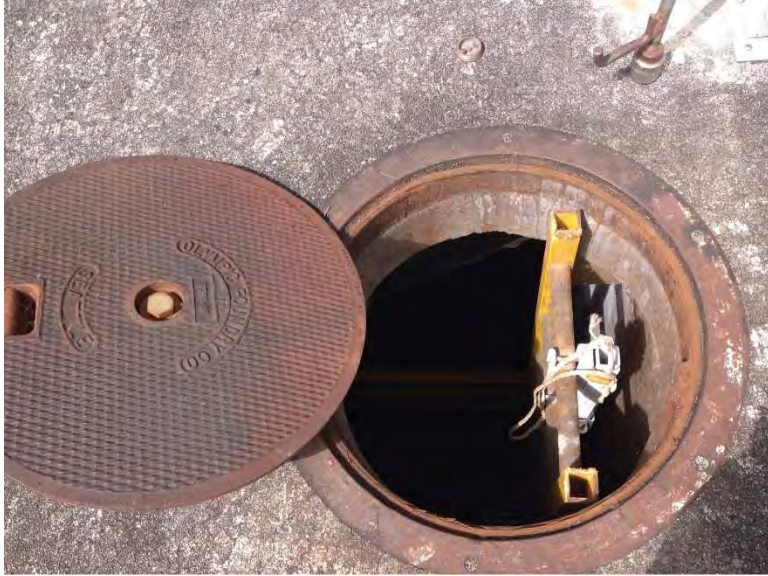
Wet well manhole lid and ladder, interior appears to be in good condition

- Upon failure of locking access lid, alternate lid will need to be purchased/fabricated or entire top of wet well will need to be replaced with new concrete top and hatch

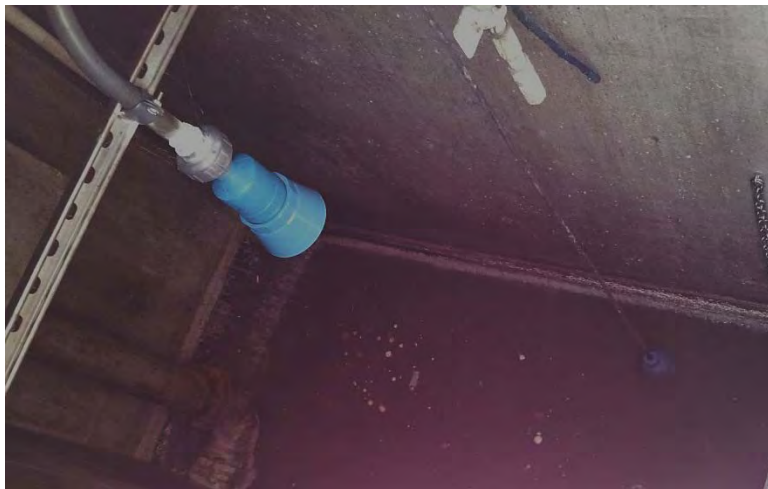
Interior of wet well appears to be in good condition

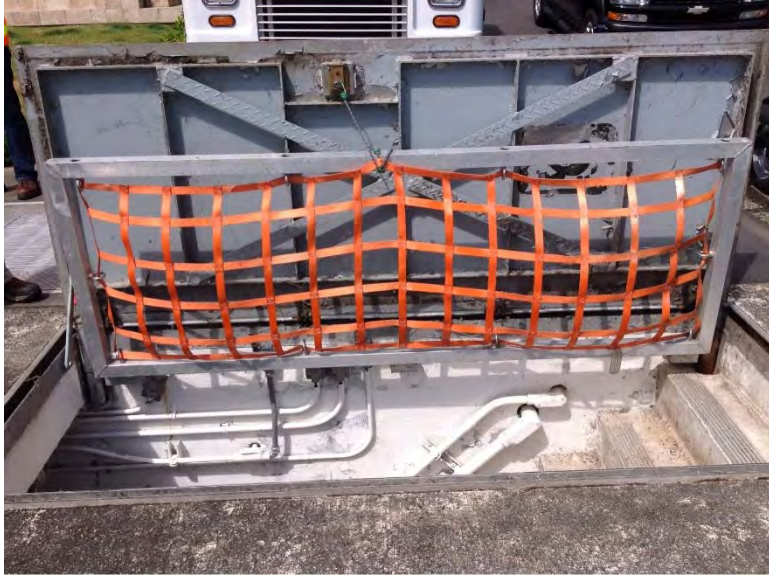
Dry pit fall protection net near stairway

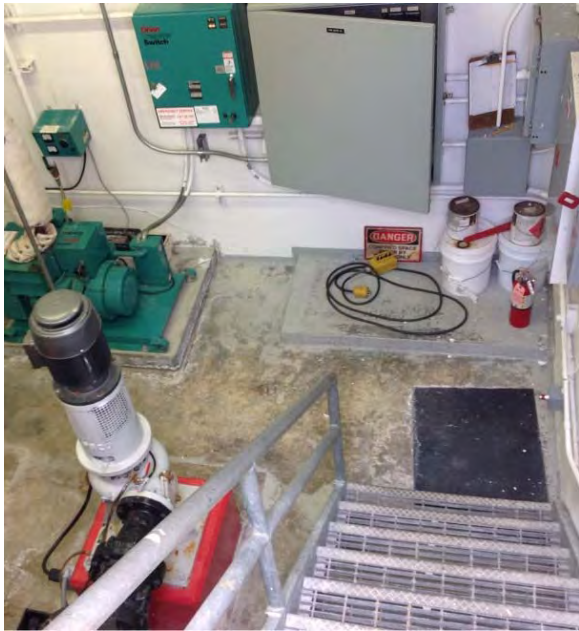
Interior of dry pit appears to be in good condition

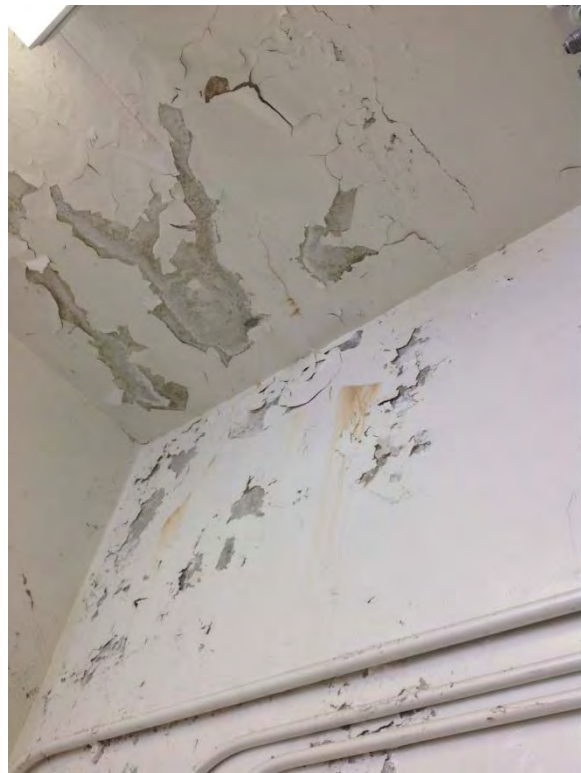
Some coating failure on ceiling – appears to be due to poor prep work

- Some coating failure on ceiling – appears to be due to poor prep work
- No equipment access hatch, will have to carry equipment up stairs

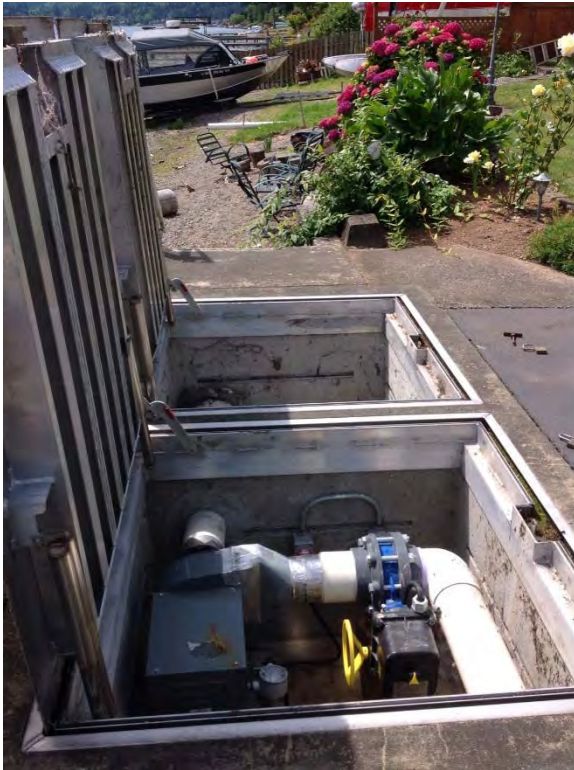
Wet well blower vault and air intake vault in deck area

- Grate covering for air intake vault adjacent to wet well blower vault, grate covering is locked

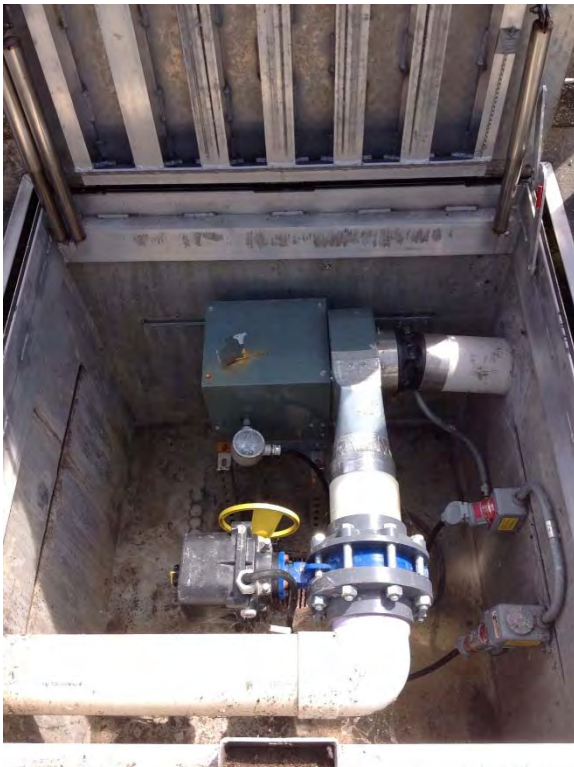
Interior of wet well blower vault appears to be in good condition

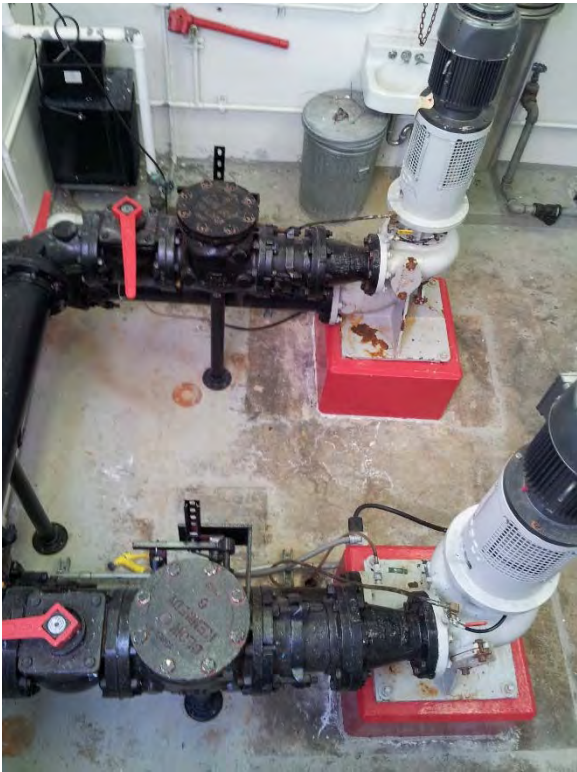
Duplex configuration, pump #1 in foreground

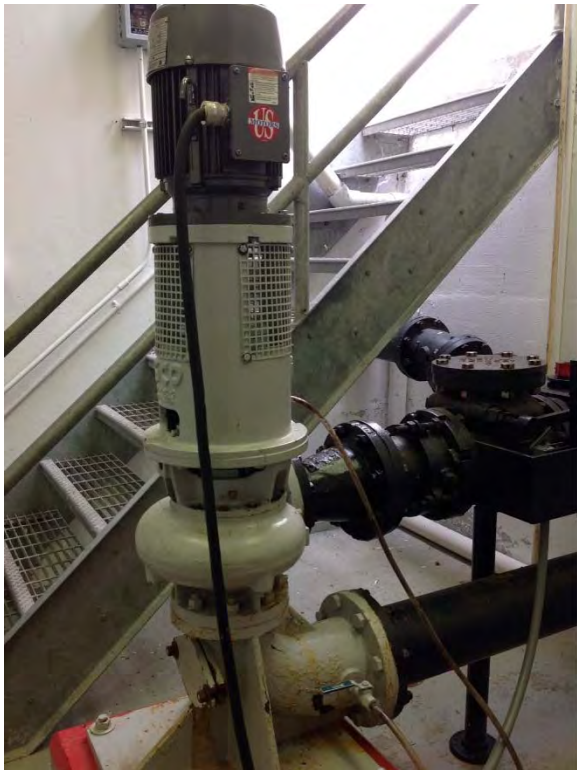
Pump and motor #1

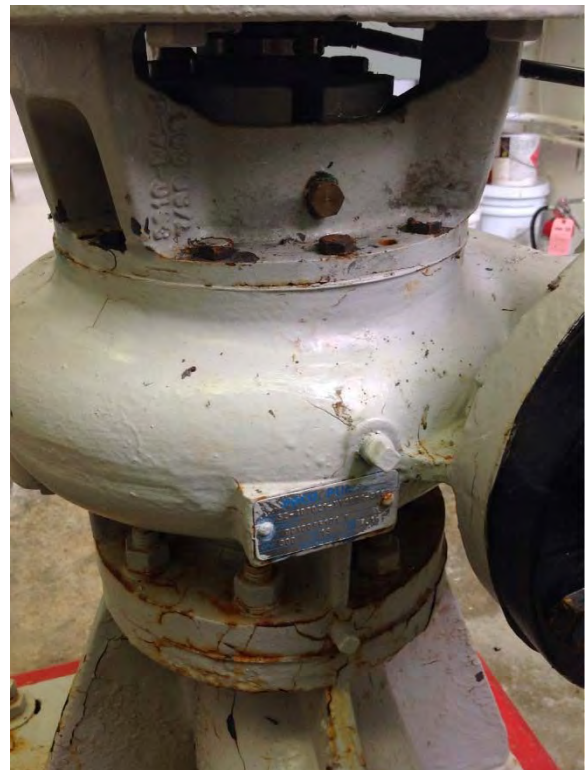
Exterior of pump #1 showing signs of aging

- Measured flow is below pump curve, may indicate possible wear

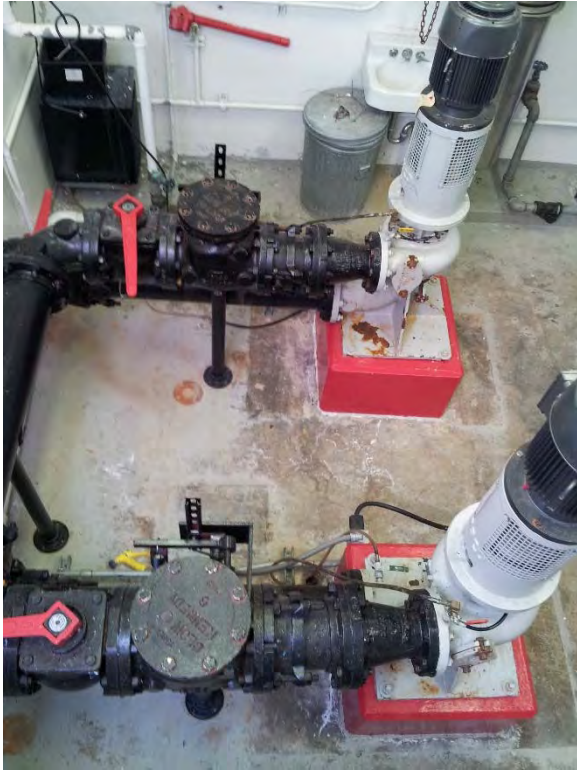
Duplex configuration, pump #2 in background

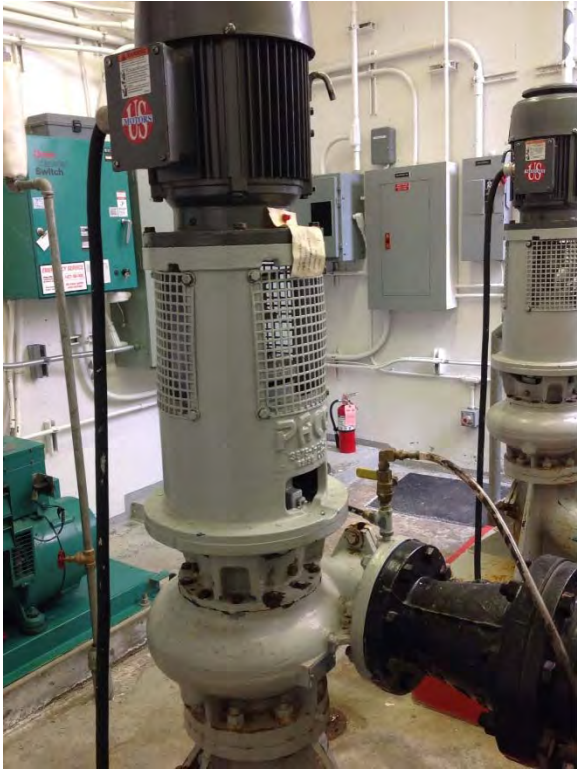
Pump and motor #2

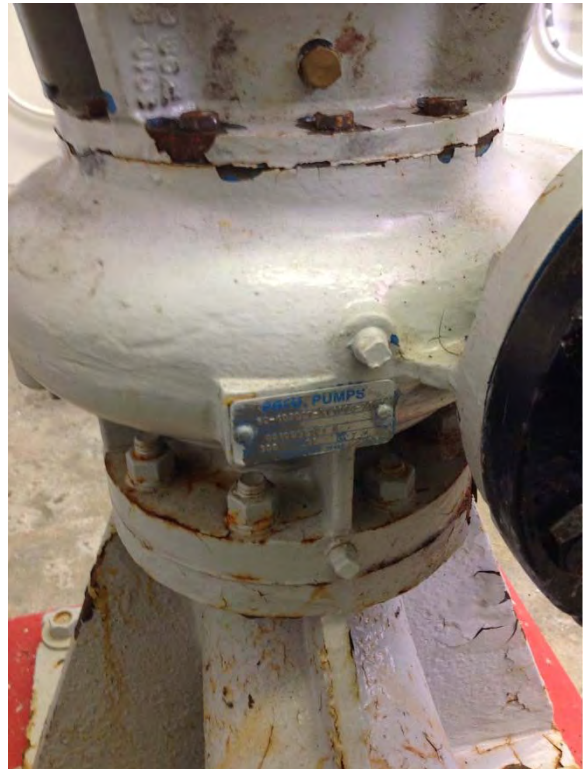
Exterior of pump #2 showing signs of aging

- Measured flow is below pump curve, may indicate possible wear

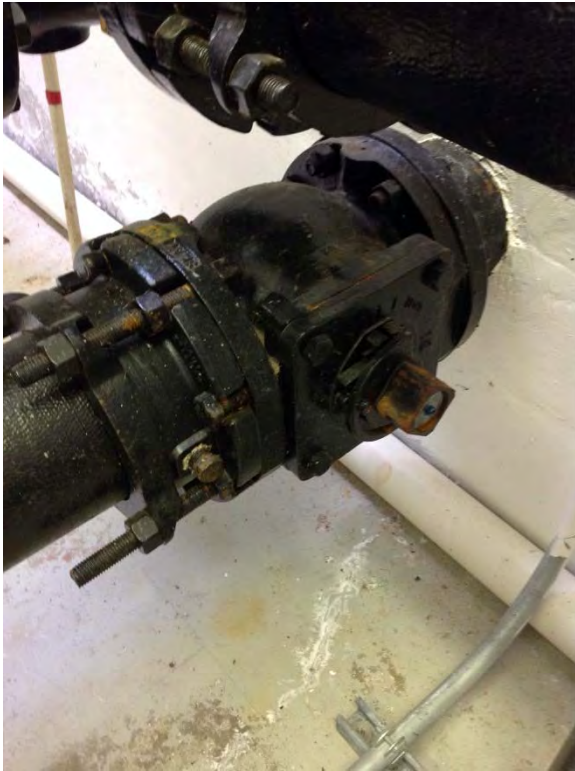
Plug valve installed with horizontal axis of rotation on suction piping for pump1 - ideal

- Plug valve installed with horizontal axis of rotation on suction piping for pump 1 – ideal
- Plug valve installed with vertical axis of rotation on suction piping for pump 2 – not ideal. Should be addressed upon replacement of rotating assembly.

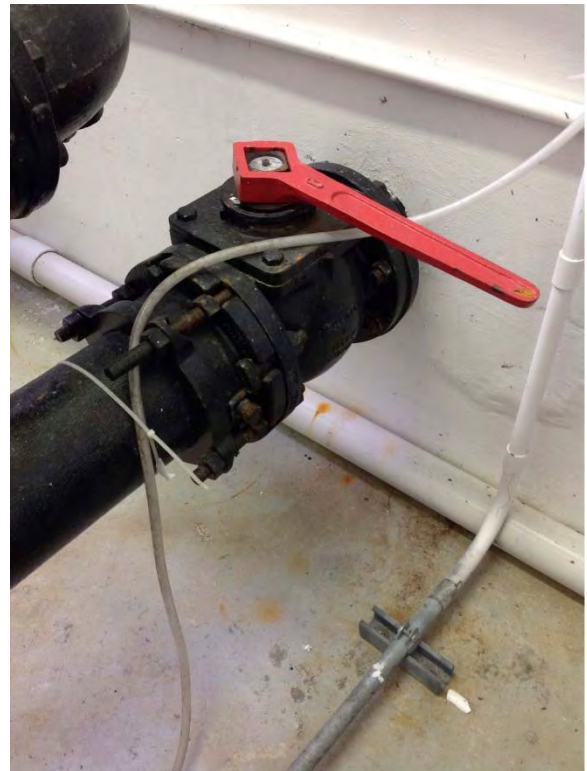
Plug valve installed with vertical axis of rotation on suction piping for pump 2 – not ideal

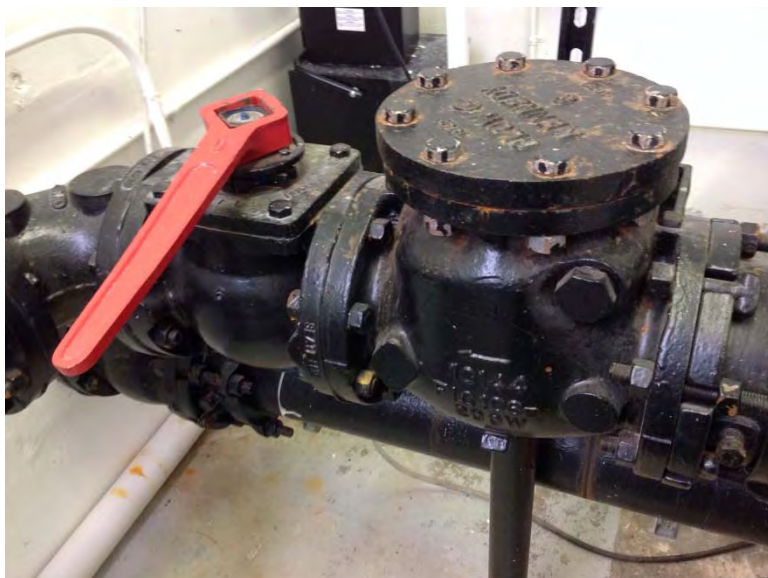
Discharge piping with plug valve and swing check valve with outside lever and spring, plug valve installed with vertical axis of rotation – not ideal

- Plug valve installed with vertical axis of rotation – not ideal. Should be addressed upon replacement of rotating assembly.

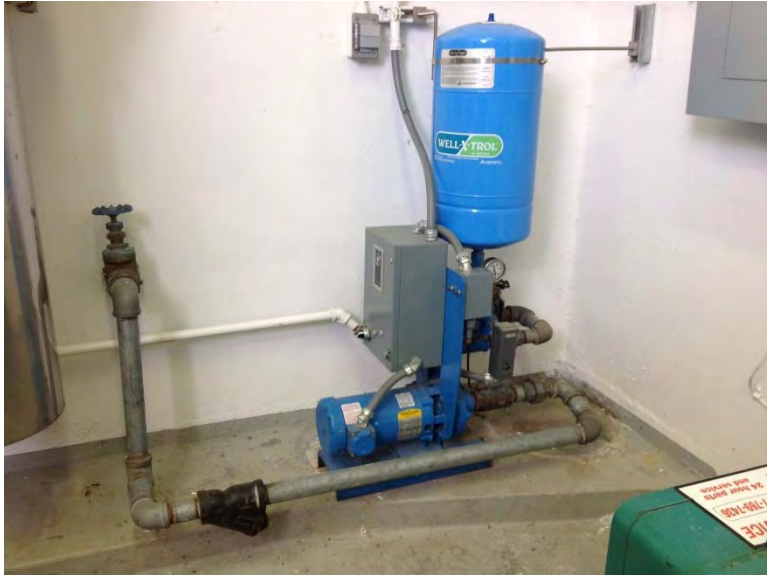
Washdown water supplied from lake using pressure tank system located in corner of dry pit

Supply	From lake – pressure tank system
Access	Corner of dry pit
Backflow prevention assembly	None
Enclosure/Freeze protection	N/A

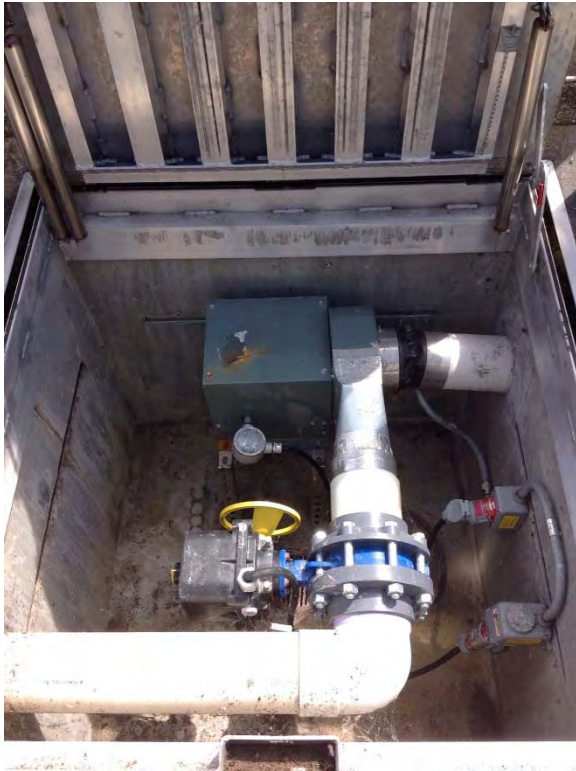
Wet well supply fan located in wet well blower vault

Location	Wet well blower vault
Fan type	Centrifugal
Airflow rate	260 CFM @ 0.38" SP*

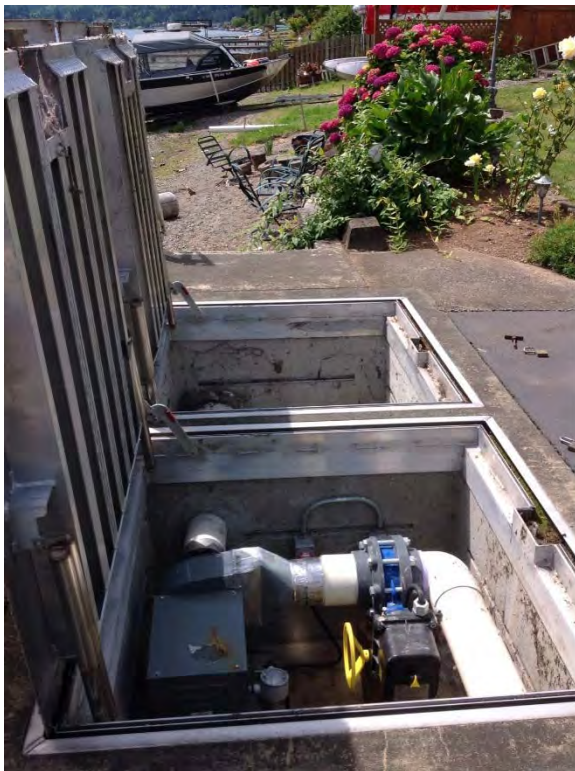
Air intake for wet well supply fan and dry pit exhaust fan located in vault

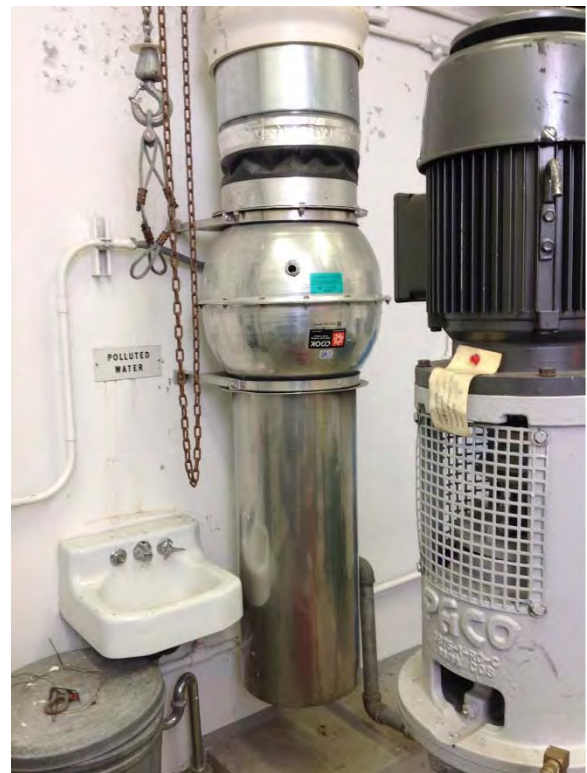
Dry Pit exhaust fan located 5' AFF in dry pit

- Exhausting dry pit does not meet NFPA 820 code, pressure differential, install supply fan and provide continuous ventilation

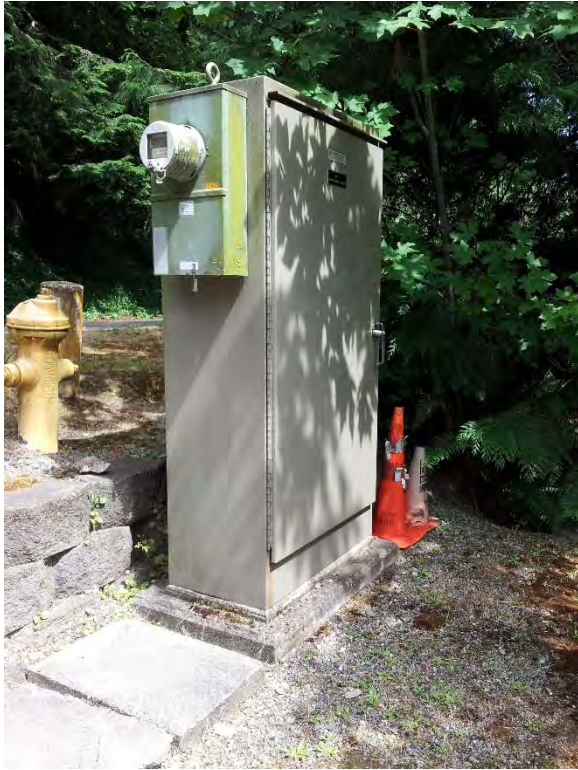
Service meter located on outdoor power cabinet

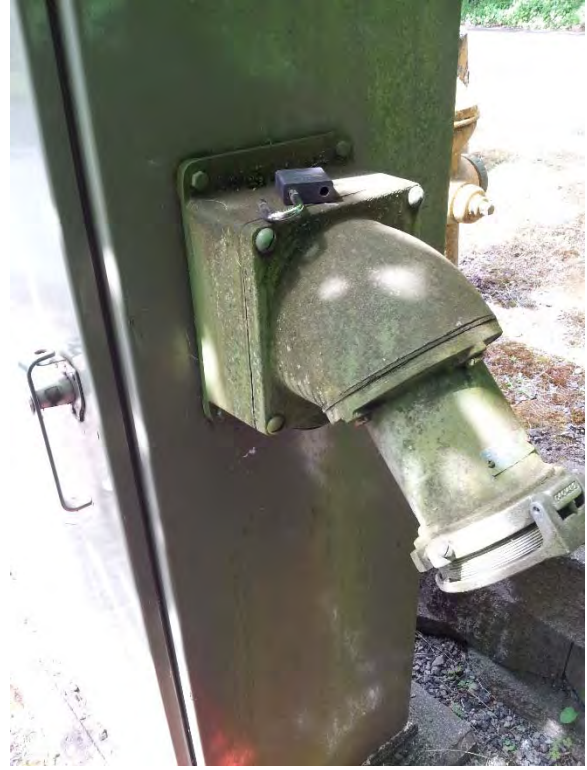
Generator receptacle located on outdoor power cabinet

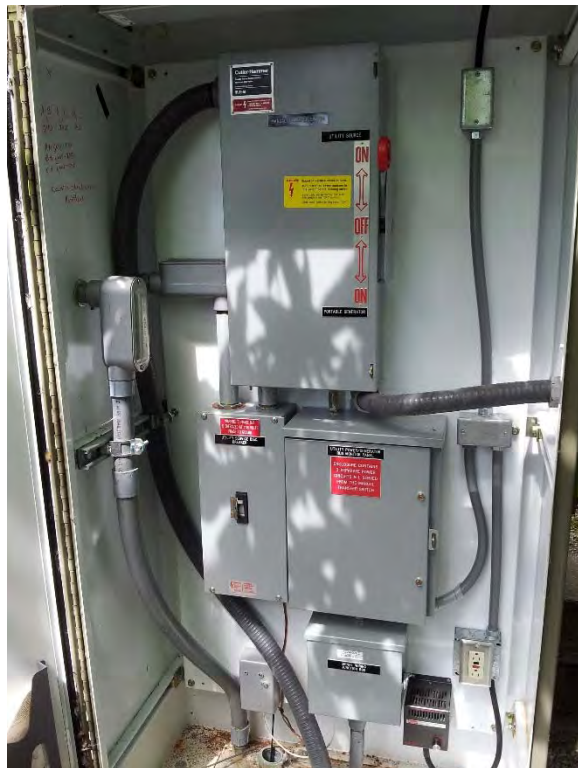
Interior of power cabinet

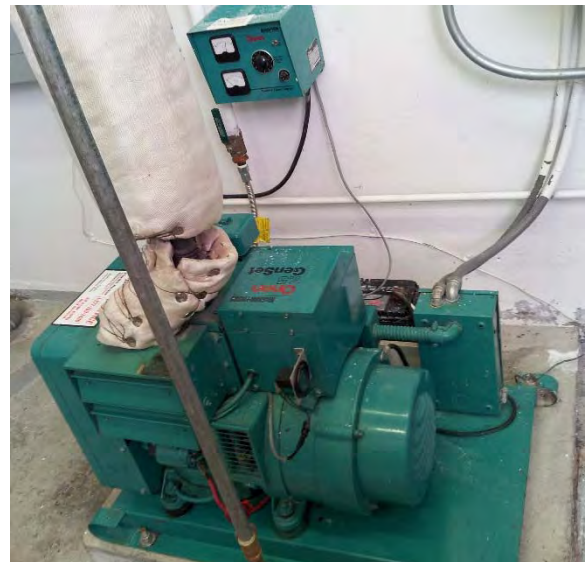
Standby generator located in dry pit

Condition Rating 2 – Transfer switch and propane generator appear to be in good condition, but aging

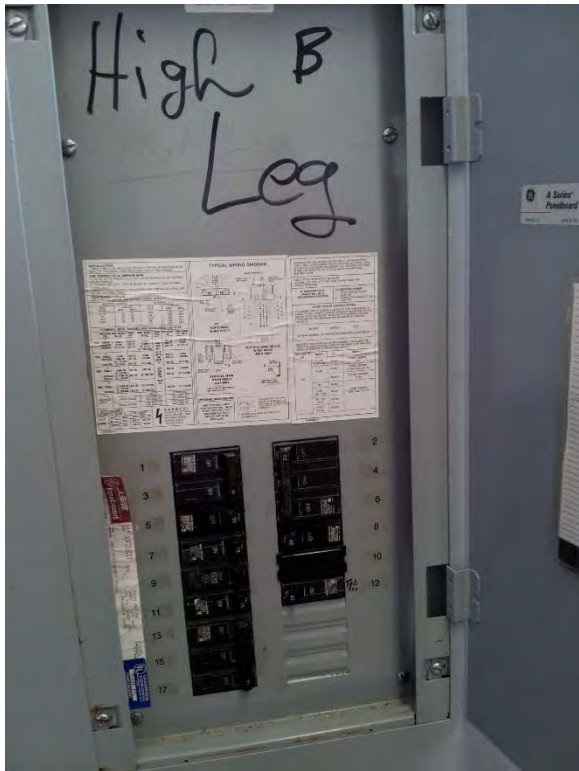
Panelboard located in dry pit

Condition Rating 2 – GE panel appears to be in good condition, but aging
