Lake Washington Wastewater Lake Line Management Plan

FINAL / July 2024

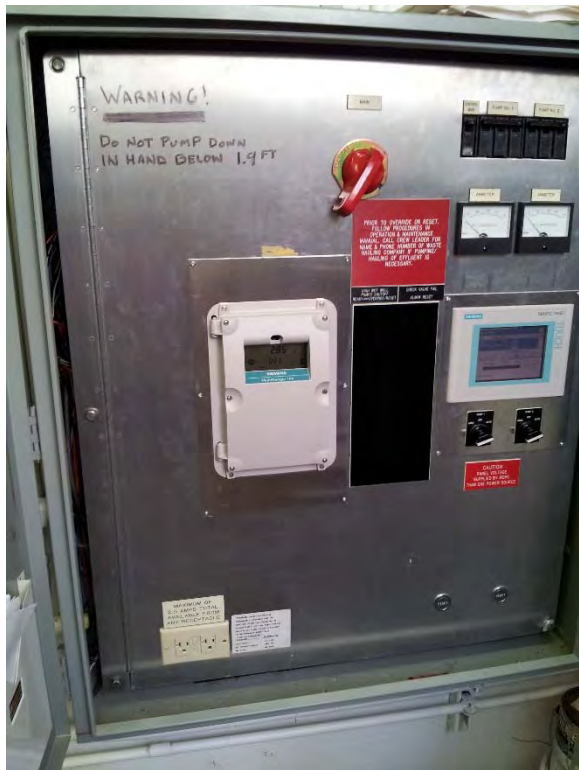
Starters located in dry pit

Condition Rating 2 – The Cutler Hammer starters appear to be in good condition but aging

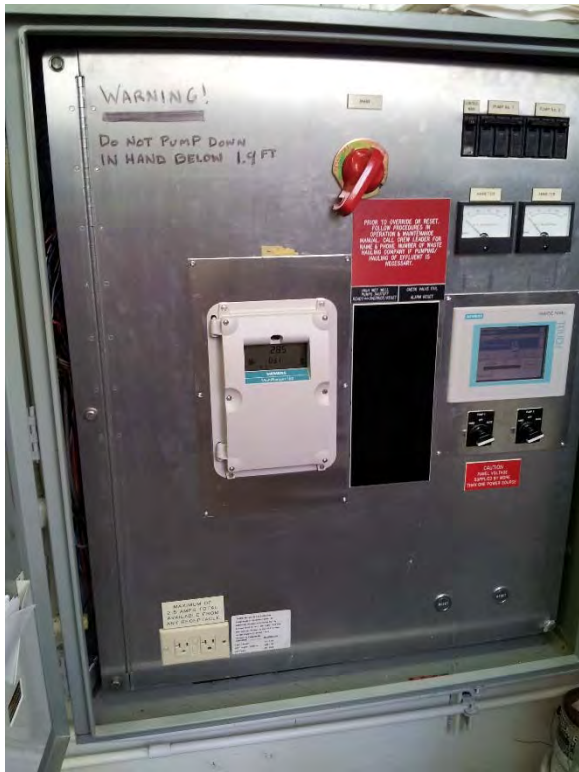
Telemetry control panel with operator interface

Criticality Rating 3 – Critical but redundant, PLC alternates and calls for pumping, backup operation is hardwired from the floats to the starter

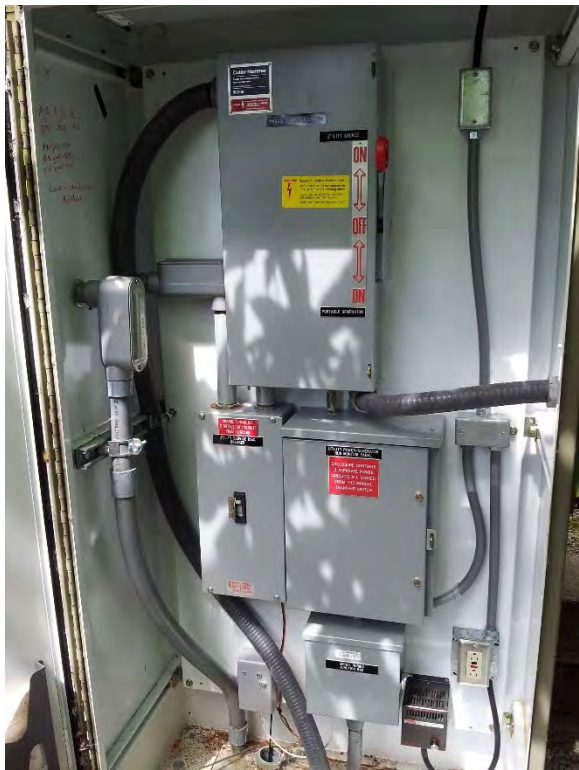
Telephone network interface located in outdoor power cabinet

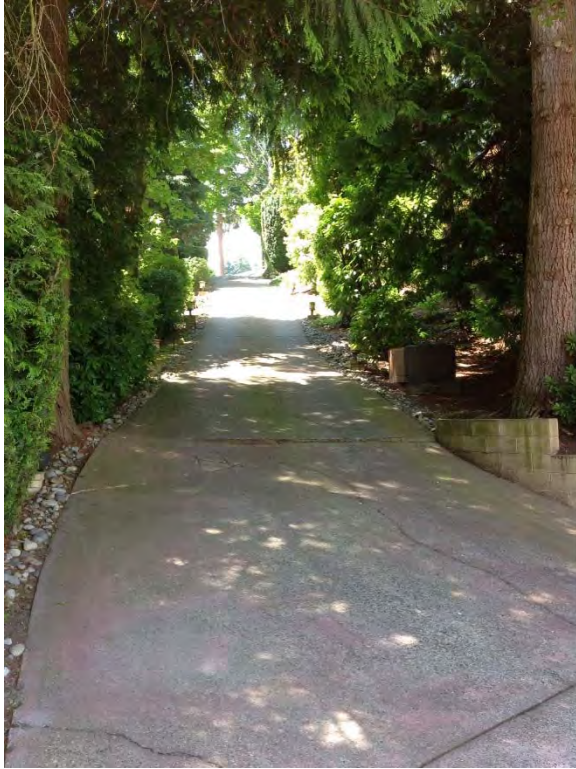
One lane steep driveway access to station

Vehicle access to site	Steep one lane driveway, private, parking is approximately 25' from the station
Landscaping	Lots of vegetation, maintained by homeowners beach club
Site lighting	None
Fencing/security	Chain link fence on two sides with barbed wire topping
Public accessibility to site	No access for public, but access security pad for homeowners beach club

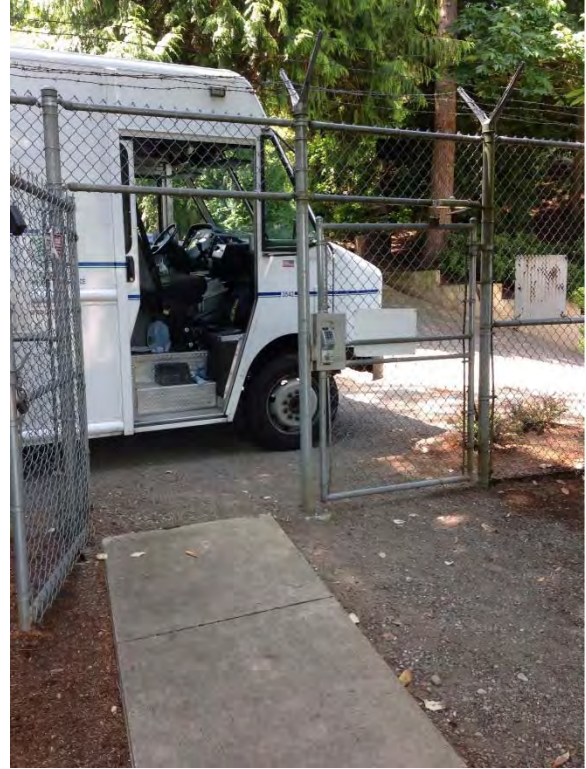
Parking adjacent to station

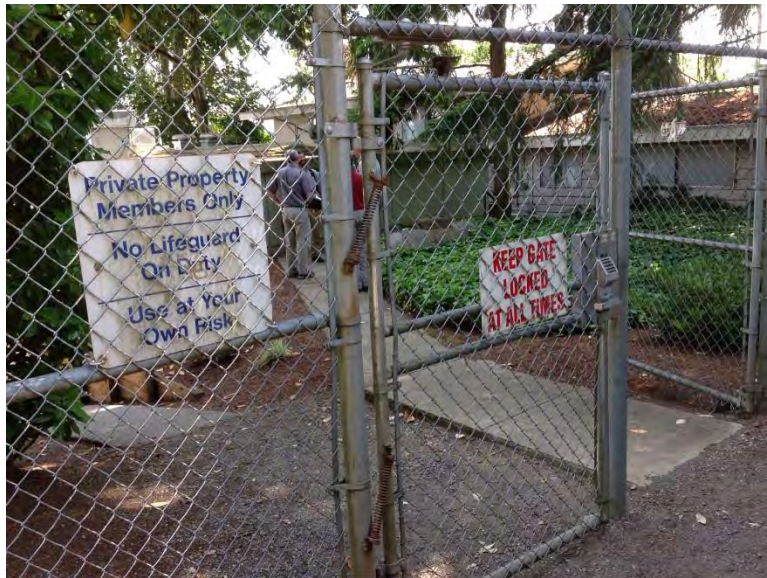
Chain link fence with barbed wire topping, no access for public, but there is an access security pad for home owners beach club

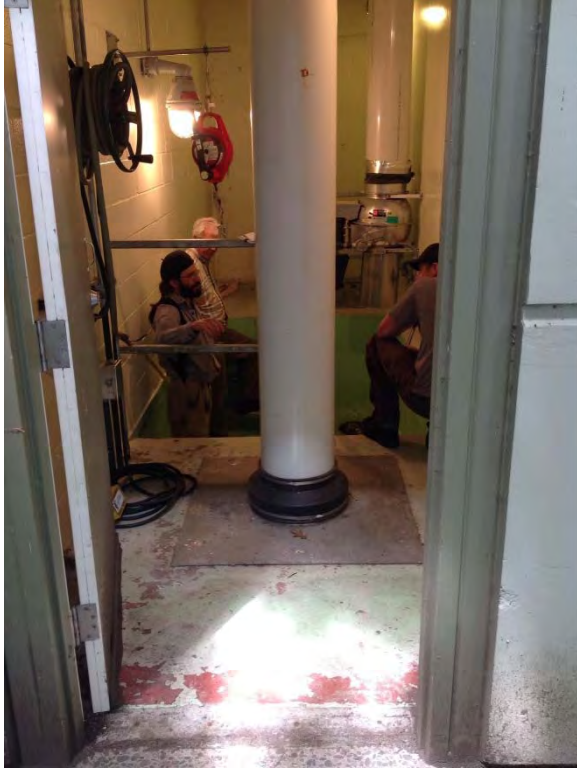
Wet well accessed through separate door adjacent to control building

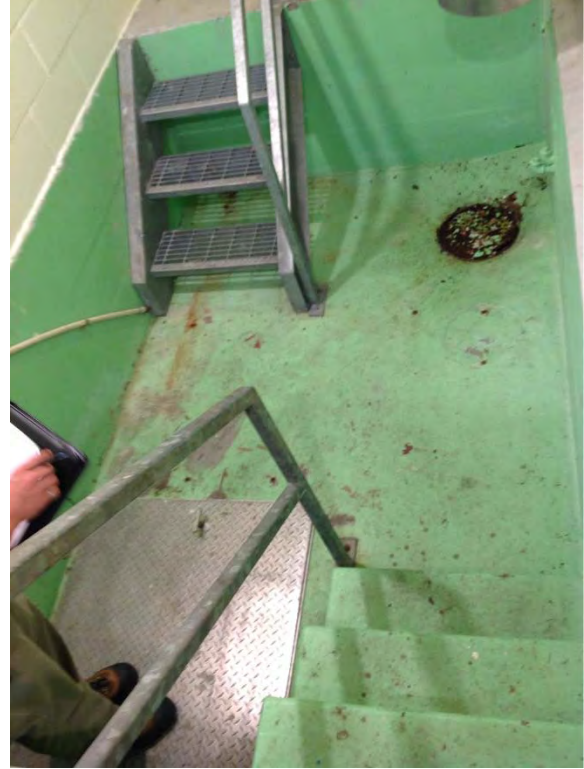
Wet well access hatch

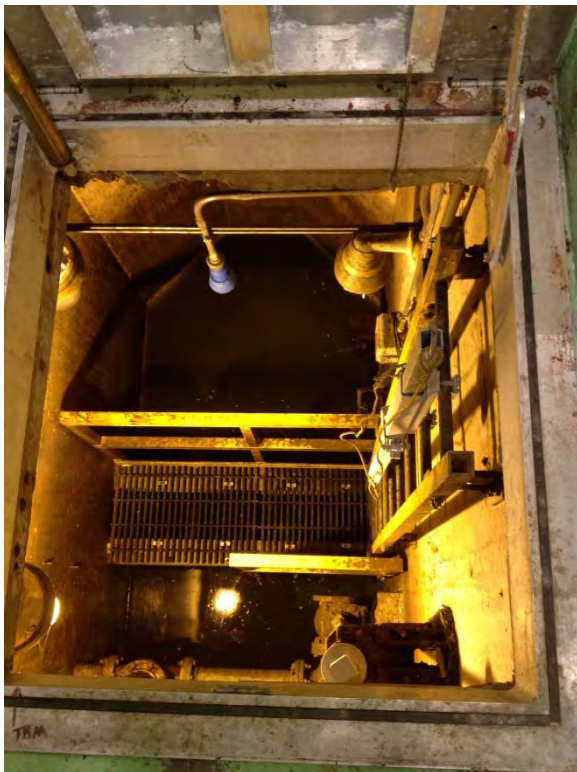
Interior of wet well appears to be in good condition

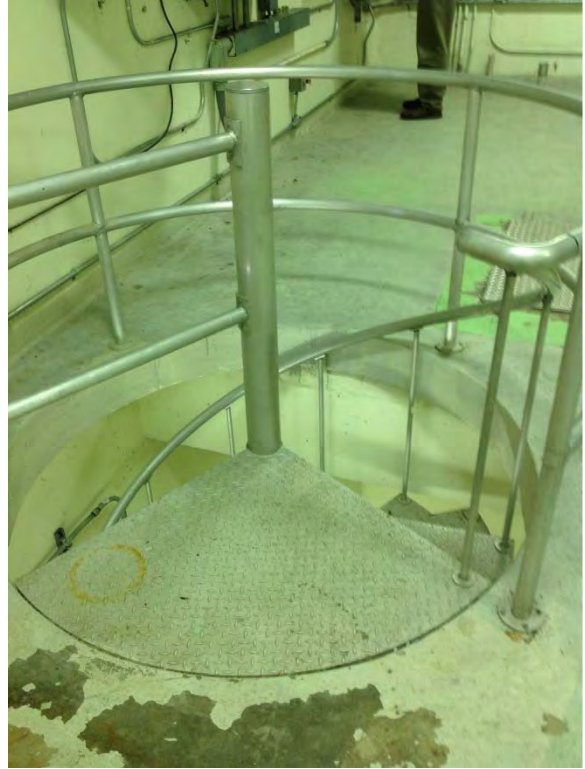
Dry pit/pump level accessed from spiral staircase in control building

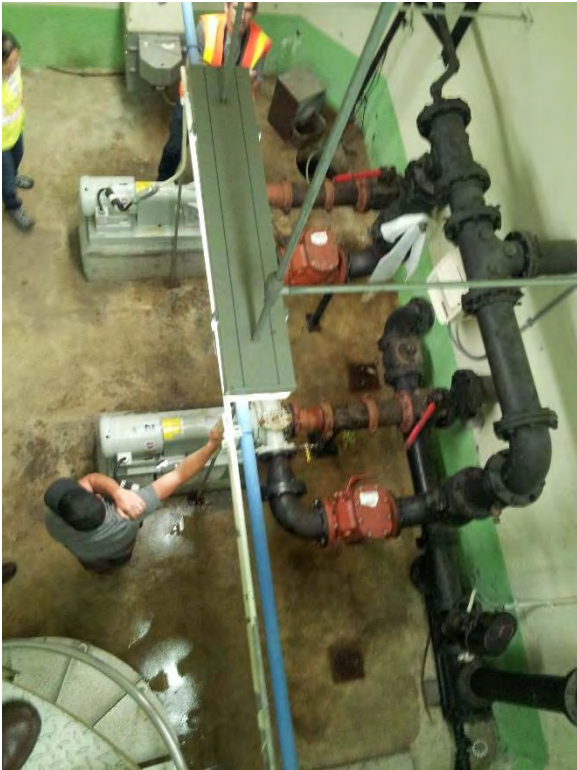
Interior of dry pit

- Control building sits on top of dry pit
- Lower level dimensions, 20 ½' x 22'
- Flush 6" pipe from lake
- Minor concrete spall in the ceiling, should be monitored

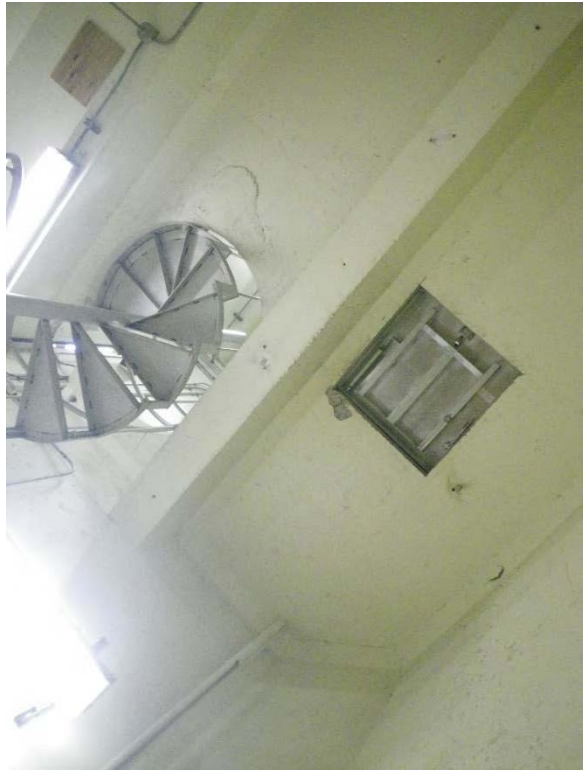
Minor concrete spall on ceiling of dry pit, should be monitored

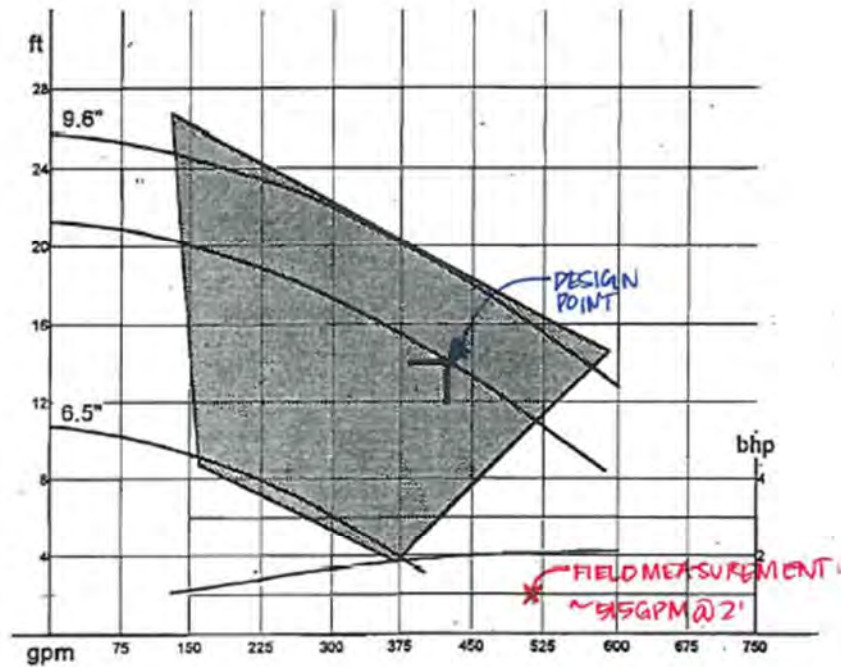
Performance Curve:

Manufacturer	PACO Pumps, Inc. P. O. Box 12924 845 – 92 nd Avenue Oakland, CA 94604-2924
Local Representative	PACO Pumps, Inc. 3215 S. 116 th St. Seattle, WA 98168 (206) 433-2600; Fax (206) 433-0263
Description	Model 52-NCH-49513-346COX Dry Pit Non-Clog 2/hp, 230V, 3Ø, 850 RPM Motor
Design Point:	424 GPM at 14 feet TDH
Serial No's.:	Pump 1: 94A0205901B (North) Pump 2: 94A0205901A (South)

The field tested performance of the pumps at Station 1 measured considerably higher flow (~515 gpm vs. 424 gpm) and a lower head (2 ft vs. 14 ft) than the design point. Assuming the accuracies of the measurements are reasonable and based on the pumping system head comparison in the following figure, it is possible that the design system head condition was overestimated relative to the current situation. Regardless, the pump appears to be operating near the end of the pump curve where cavitation could be a potential concern.

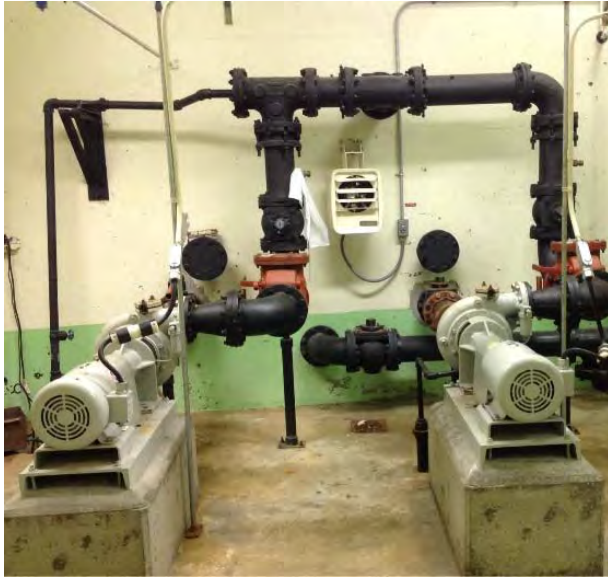
Duplex configuration pump #1 on left

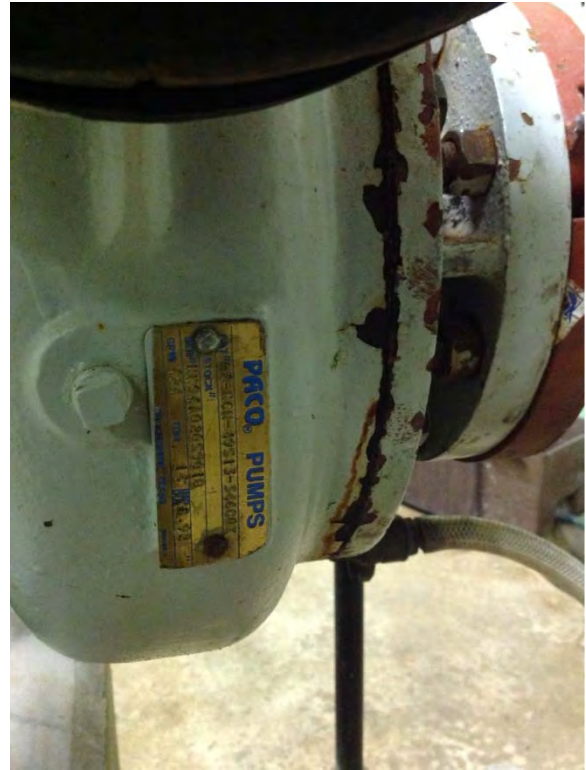
Pump 1 showing signs of aging on exterior

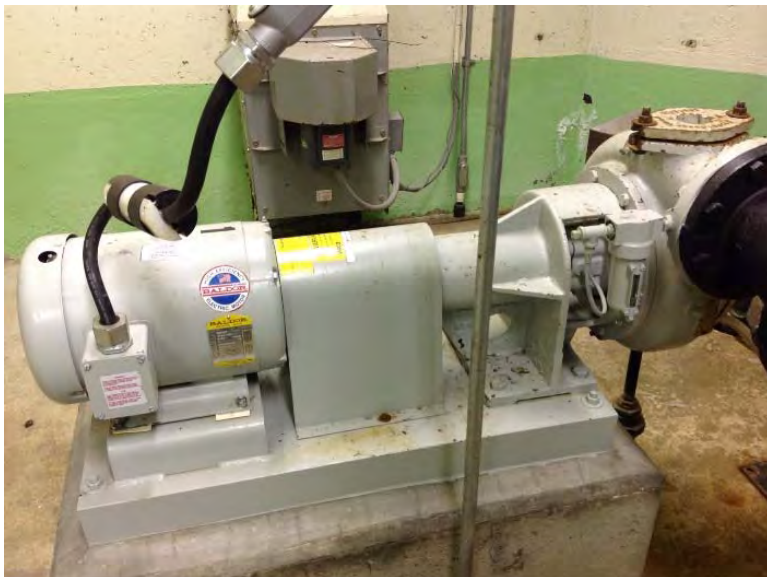
Pump and motor #1

- The pump appears to be operating near the end of the pump curve, cavitation could be a potential concern.

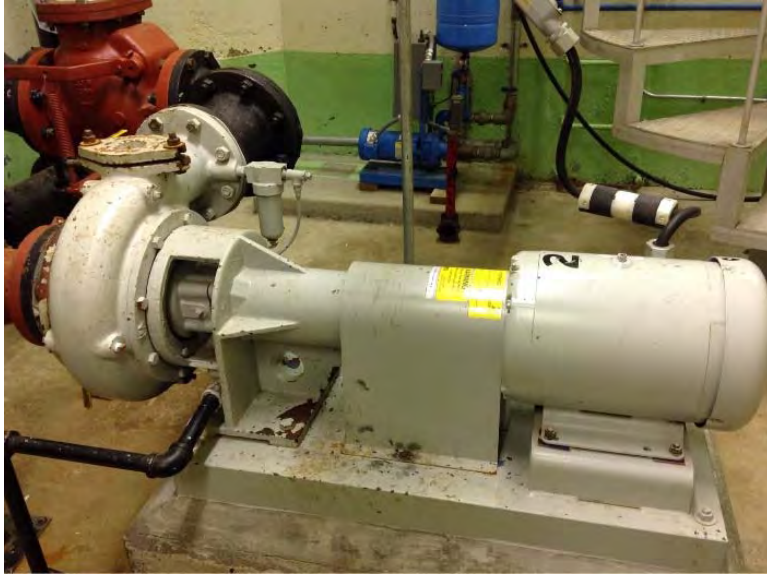
Pump and motor #2

- The pump appears to be operating near the end of the pump curve, cavitation could be a potential concern.

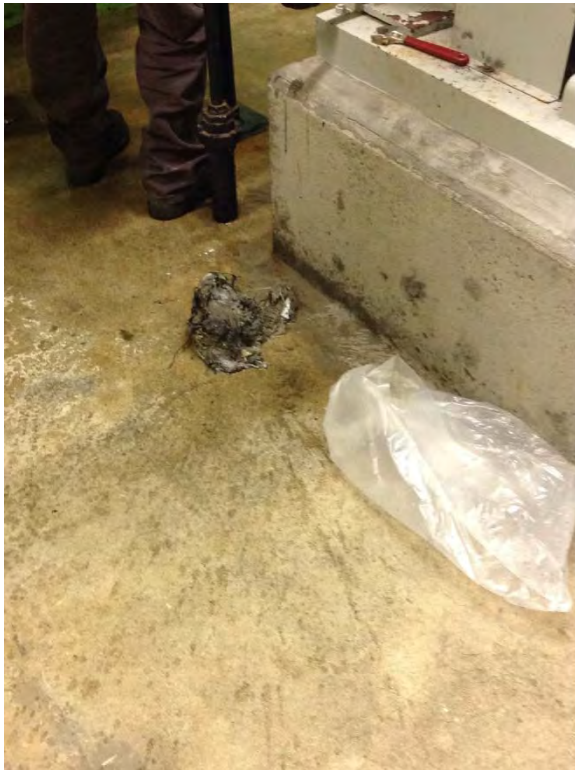
Removal of rags upon site visit

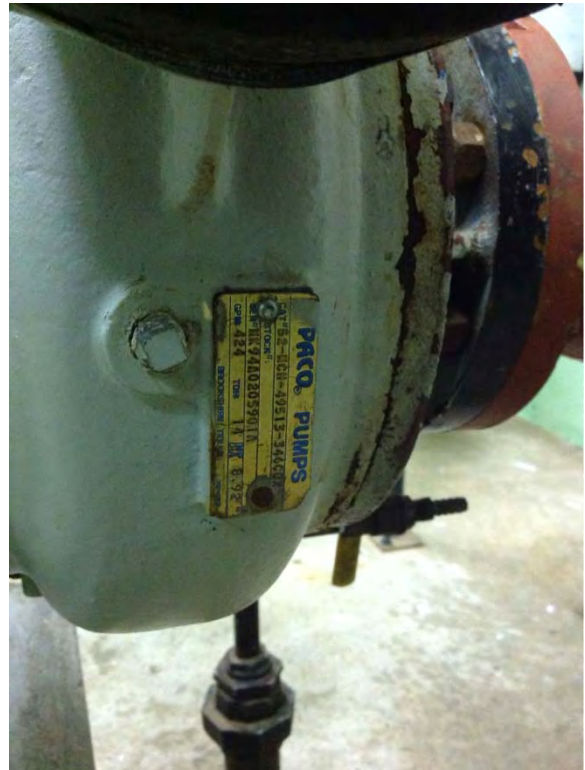
Pump 2 showing signs of aging on exterior

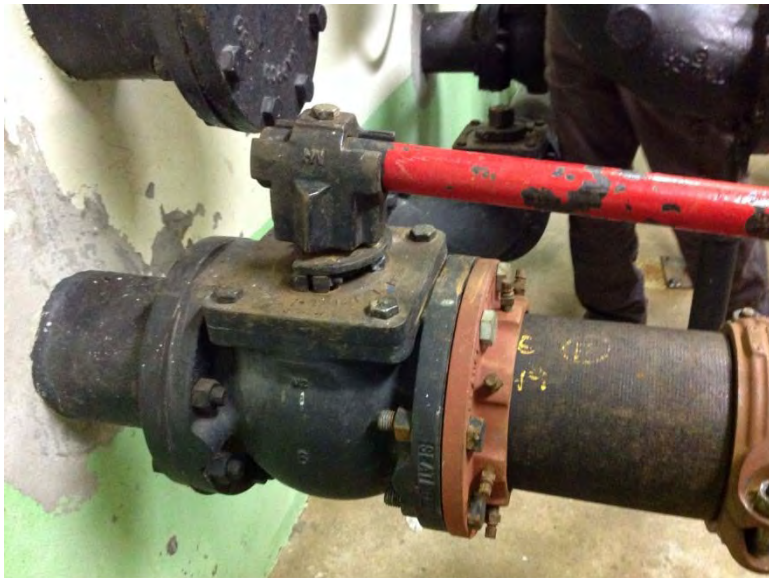
Plug valve on suction piping with vertical axis of rotation – not ideal

- Plug valve with vertical axis of rotation – not ideal. Should be addressed upon replacement of rotating assembly.

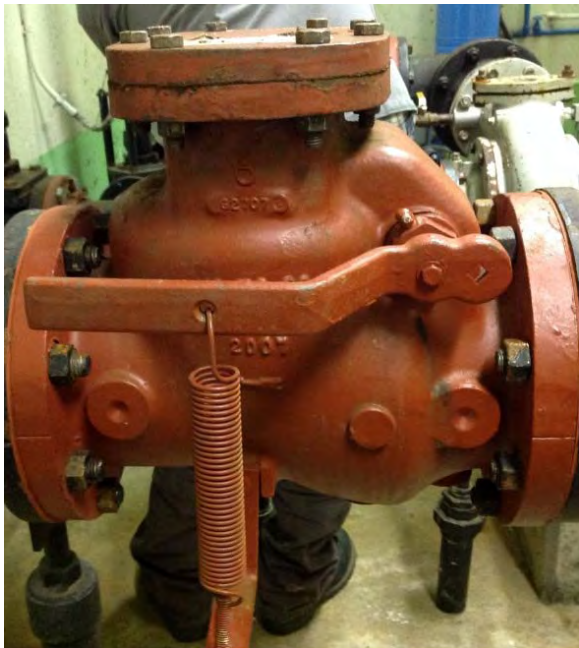
Swing check valve with outside lever and spring on discharge piping

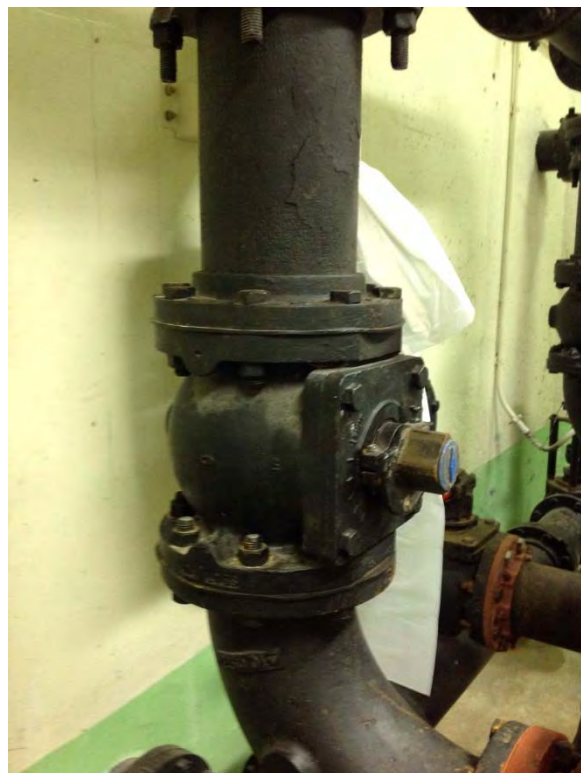
Plug valve on discharge piping seats down – potential gravel trap

- Plug valve seat is down (gravel trap) – not ideal. Should be addressed upon replacement of rotating assembly.

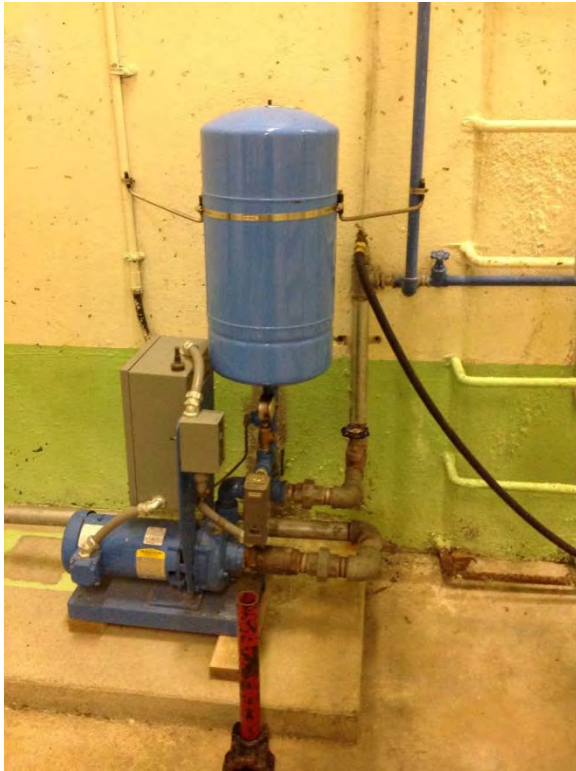
Washdown water supply from lake using pressure tank system

Supply	From lake – pressure tank installation
Access	Bottom of dry pit
Backflow prevention assembly	None
Enclosure/Freeze protection	N/A

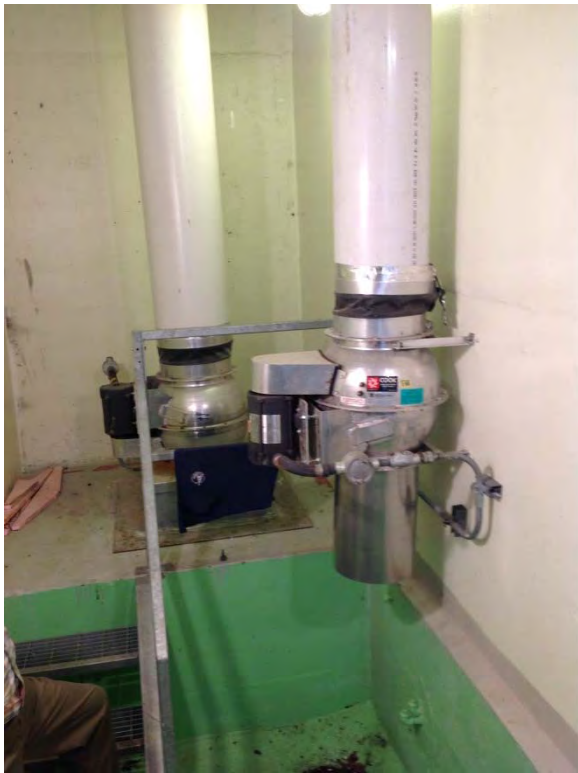
Wet well ventilation configuration in wet well access room, supply fan in foreground, exhaust fan in background

- Switch for both in wet well building
- Two blowers one to wet well one to building area

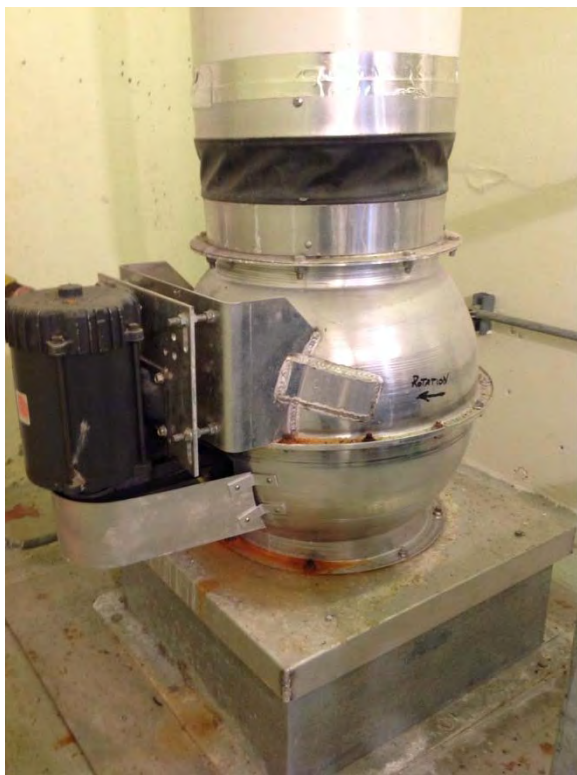
Wet well exhaust fan located in raised area in wet well access room

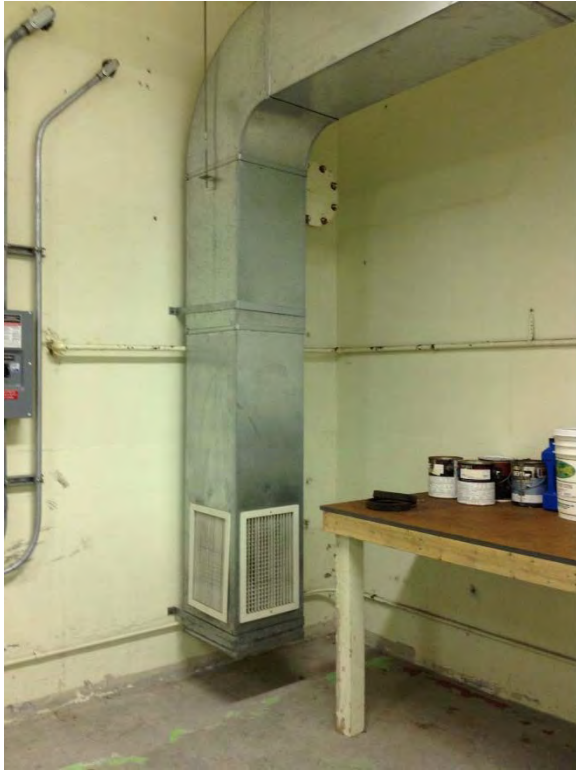
Supply fan duct work located in control building

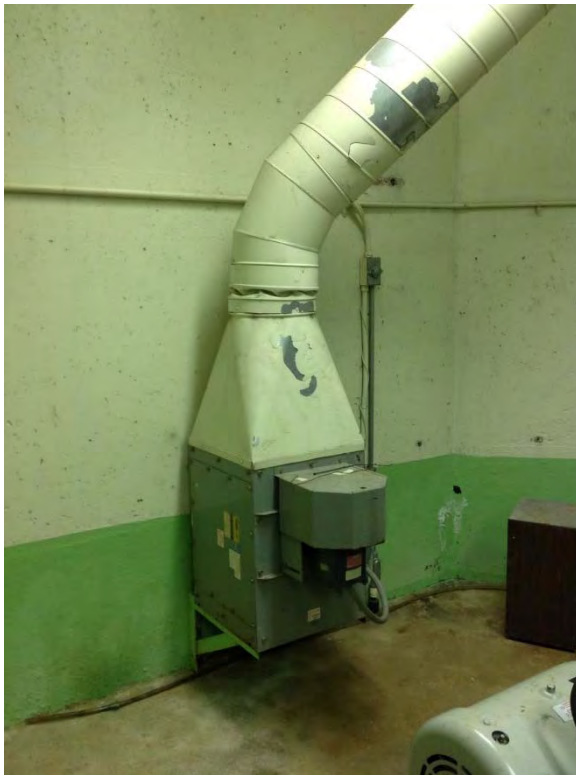
Exhaust fan located 2' AFF at pump level

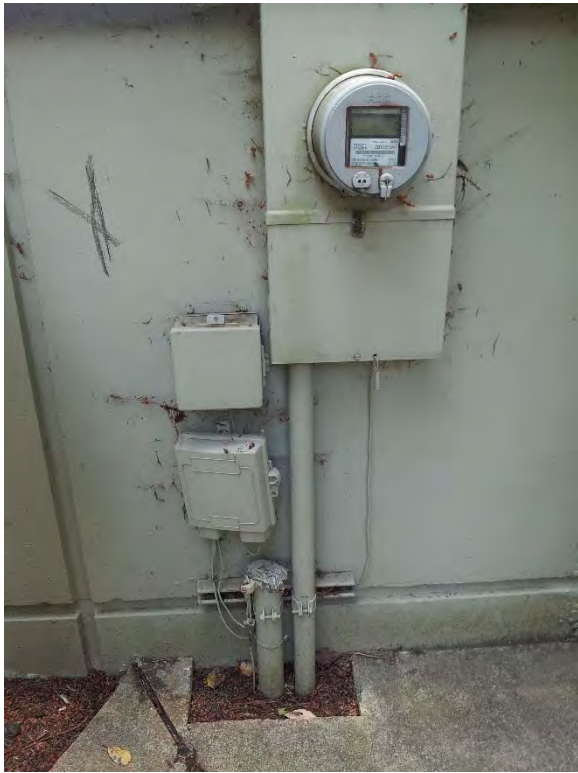
Service meter located outside west wall
of control building

Condition Rating 1 – Meter base and fused disconnect appear to be in good condition

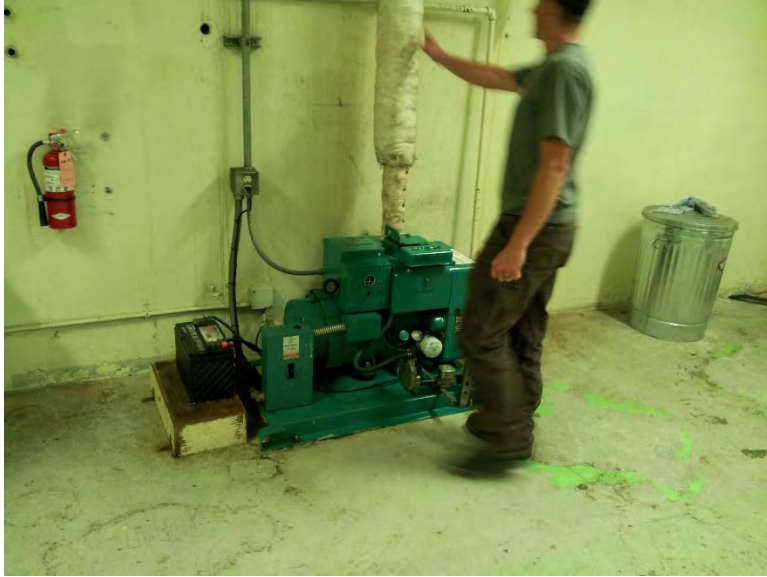
Standby generator located on top floor of control building

Condition Rating 3 – Transfer switch and propane generator appear to be in good condition but aging

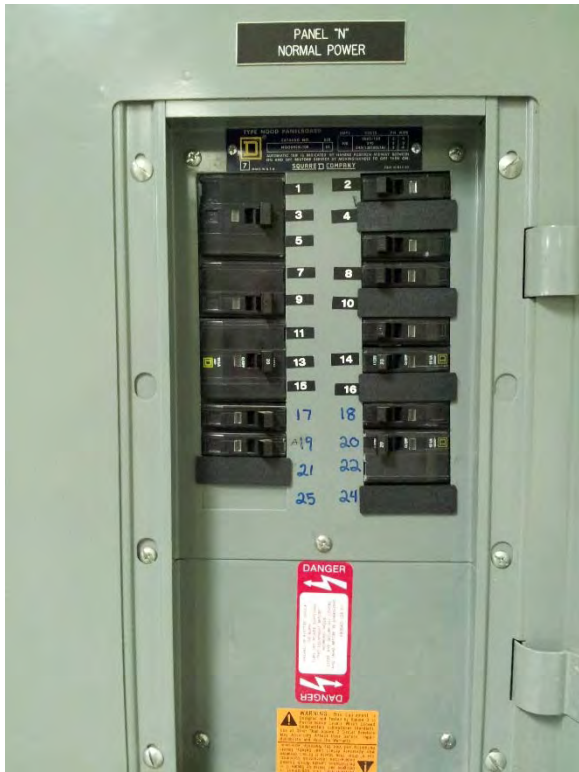
Panelboard located on south wall in the control building

Condition Rating 1 – Square D panels appear to be in good condition

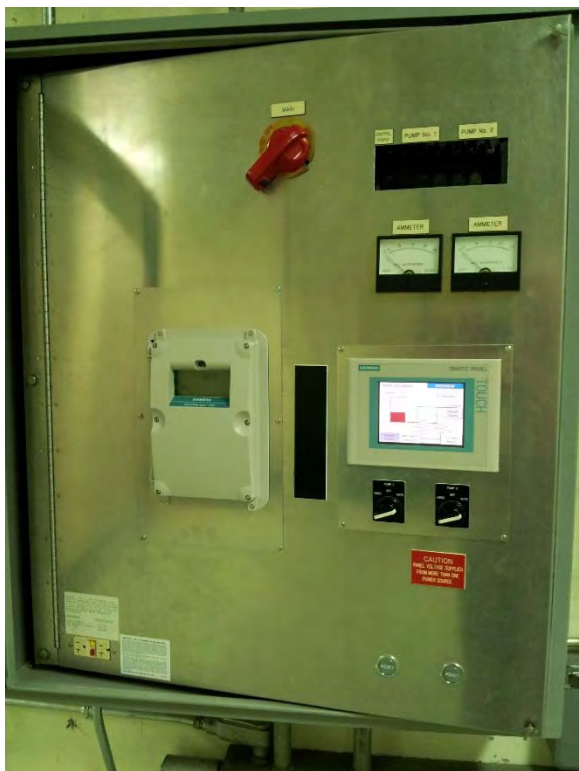
Starters located in control building

Condition Rating 2 – The Cutler Hammer starters appear to be in good condition but aging

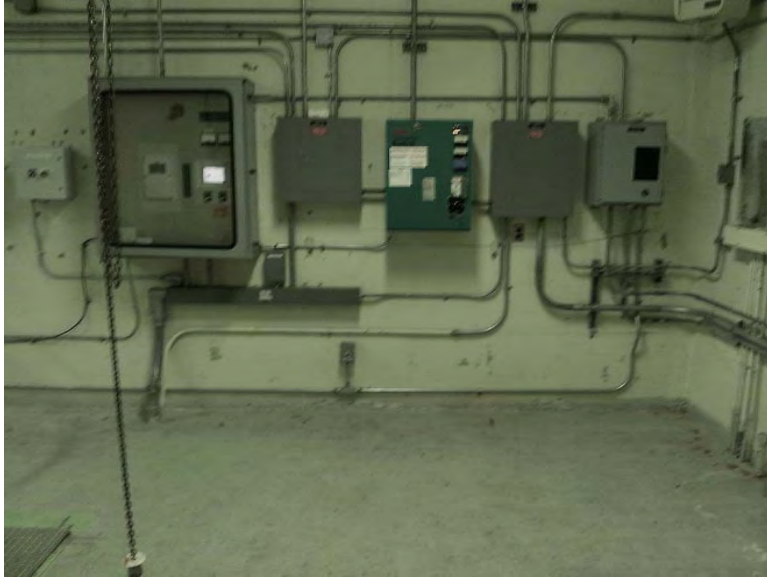
Layout of electrical/telemetry equipment on top floor of control building

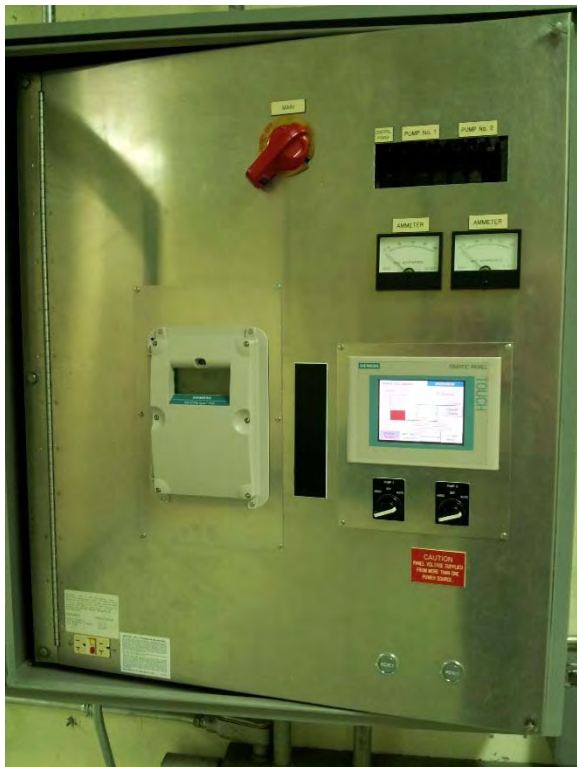
Telemetry control panel with operator interface located in control building

Condition Rating 1 – Appears to be in good condition

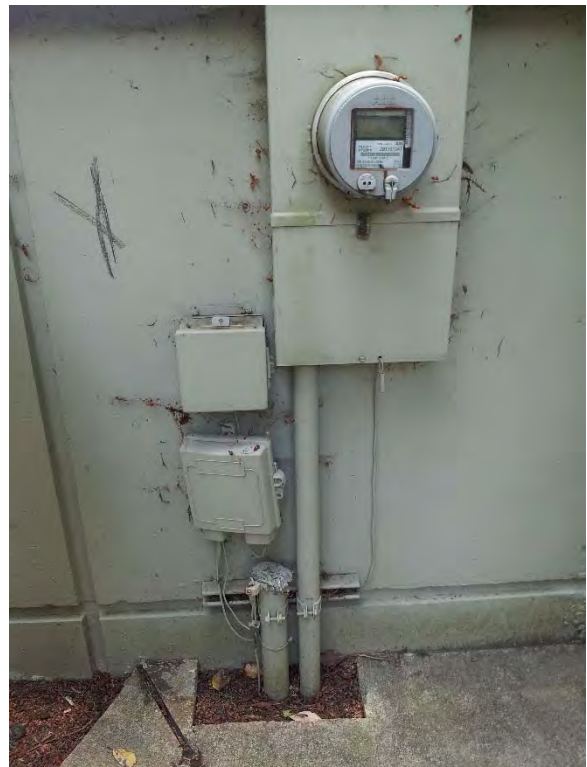
Telephone network interface located outdoor on west wall

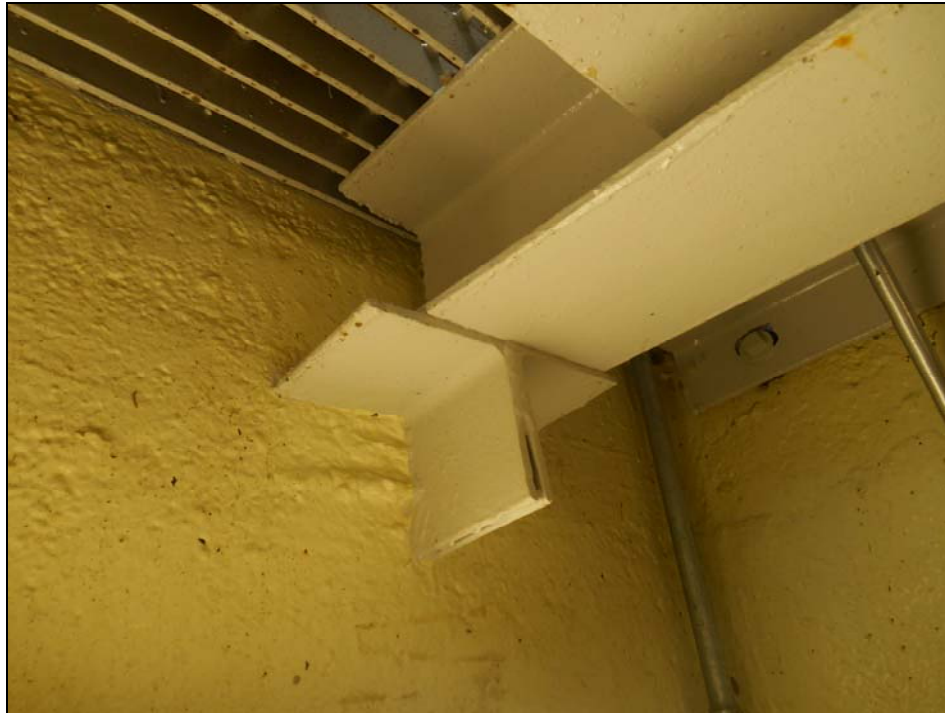
Photo 1: Beam Seat in Good Condition

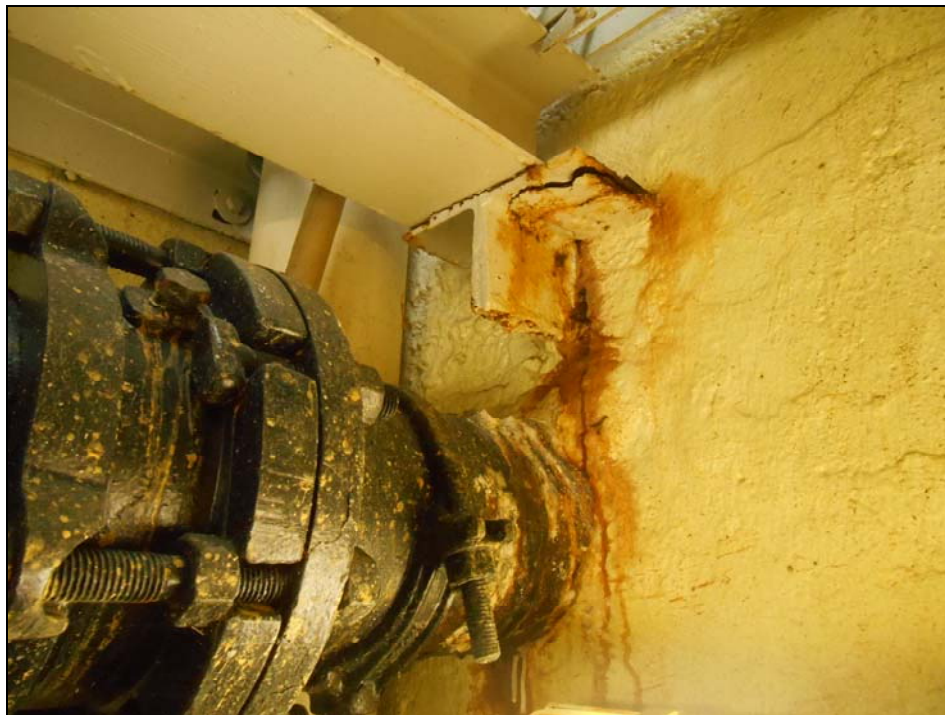
Photo 2: Beam Seat in Need of Replacement & 6" Cast Iron Pipe with Surface Rust

We recommend replacement of the rusted beam seat connection and re-coating of the 6" cast iron pipe within a year. The approximate construction cost associated with the recommended structural condition upgrades is approximately \$6,000. We do not anticipate that the operation of the lift station would need to be interrupted during the recommended repairs.

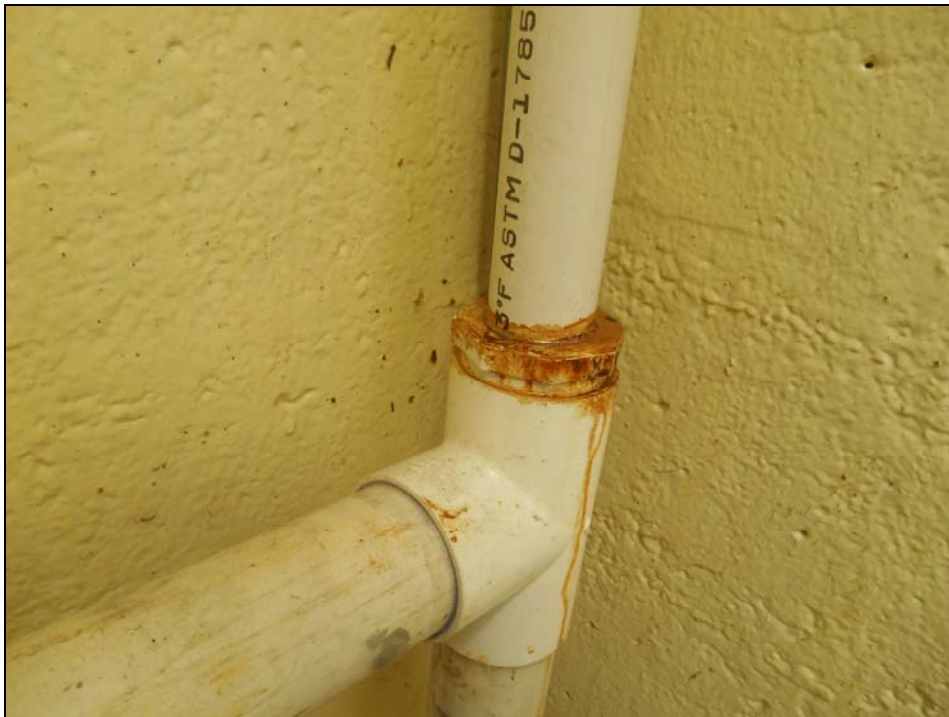
Photo 4: Water Leak at Tee Fitting

The water leak and humid / wet condition should be rectified as soon as possible by the city maintenance staff. We recommend periodic future monitoring of possible water intrusion, efflorescence, and rust.

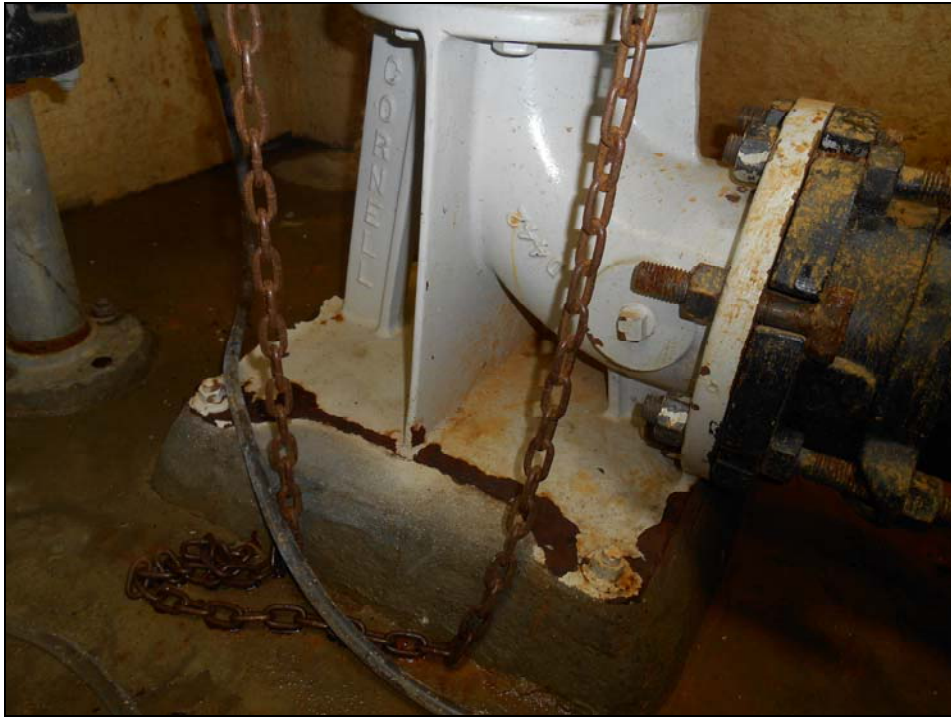
Photo 5: Rust at Pump Base Anchorage Plate

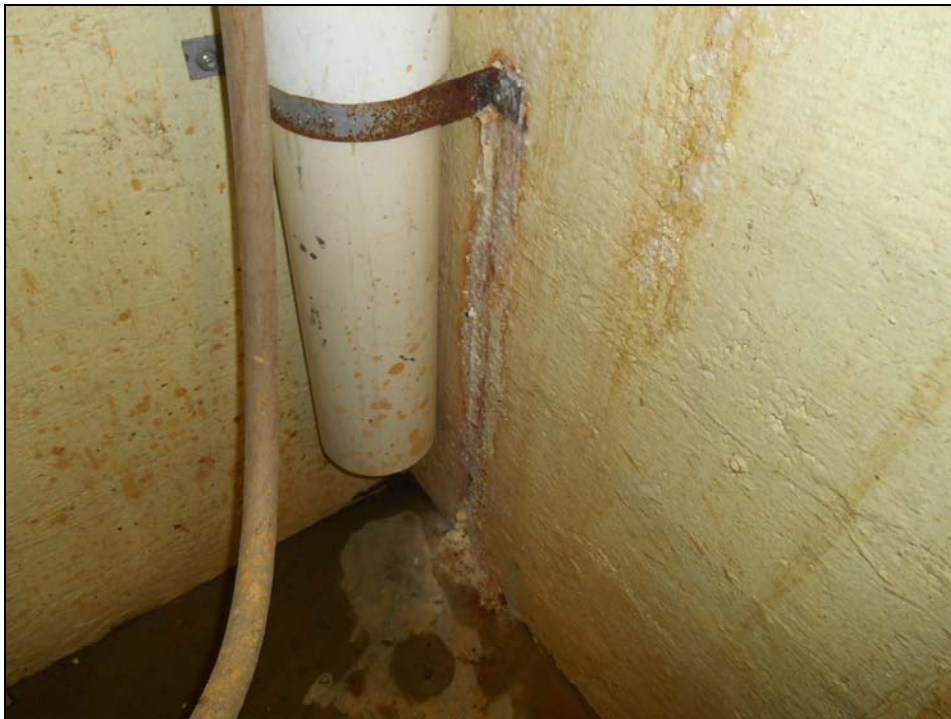
Photo 6: Efflorescence at Concrete Wall

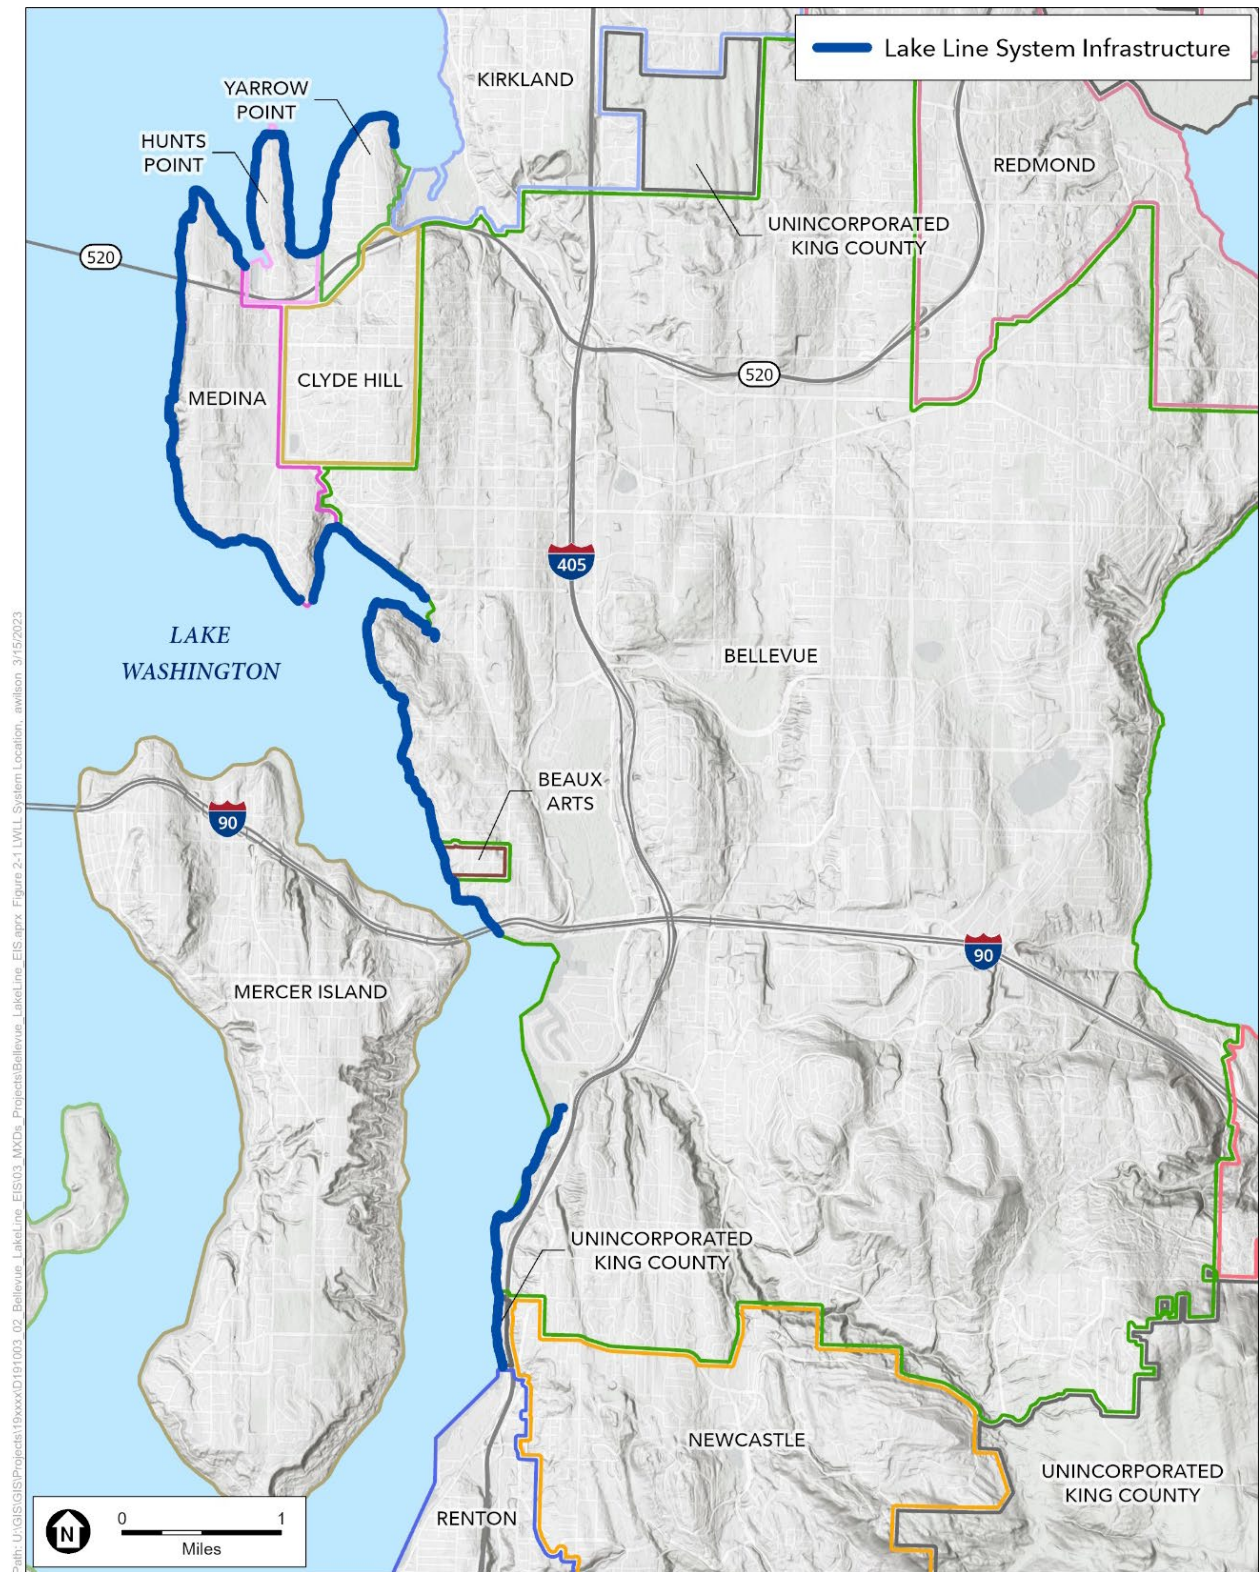
The lake line system includes approximately 14.6 miles of lake lines along the Lake Washington shoreline with 15 pump stations and eight flush stations. The lake lines are sewer pipes that follow the shoreline of Lake Washington underwater and in some cases on land adjacent to the lake. Approximately 9 miles of these pipelines are cast iron, 3 miles are asbestos cement, and 1 mile is unknown and miscellaneous material types. Most of the lake line system was constructed in the 1950s and 1960s. Wastewater enters the lake line through City-owned collectors, pump stations, and numerous private lateral side-sewers that discharge directly to the lake line.

The lake line system relies on pump and flush stations to convey wastewater to the gravity system or King County Wastewater Treatment Division (WTD) regional conveyance system. The City's lake line pump and flush stations are commonly located on the waterfront and on private properties, often resulting in difficult access. Pump and flush stations convey flows through the lake lines and then discharge flow in the upland sewer system.
