Lake Washington Wastewater Lake Line Management Plan

FINAL / July 2024

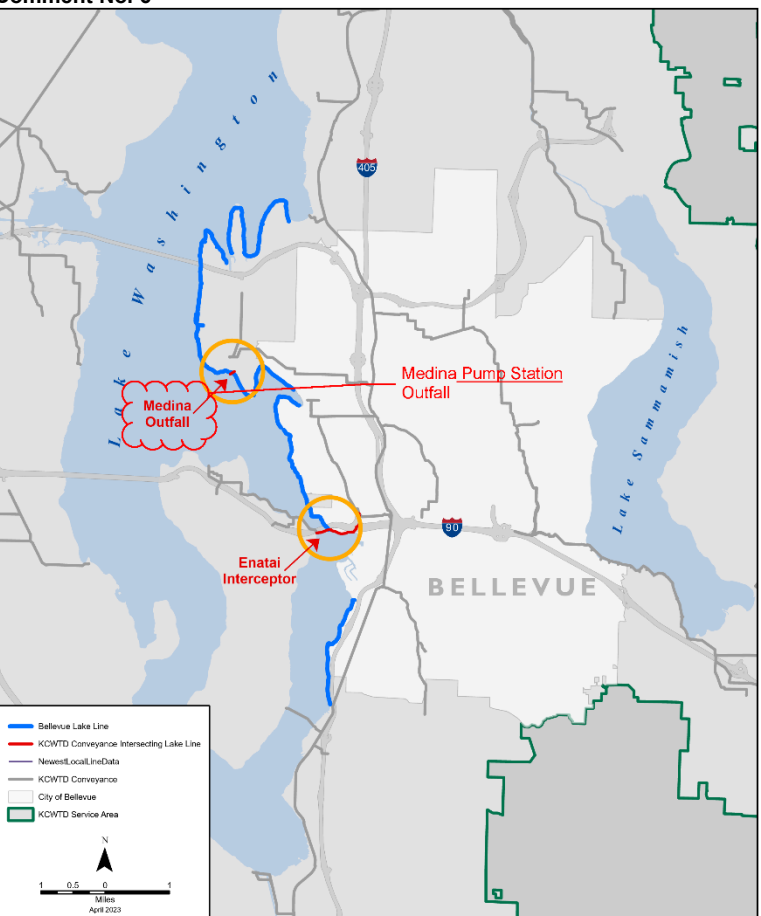
<p>King County Department of Natural Resources and Parks Wastewater Treatment Division</p> <p>WORKING DRAFT</p> <p>Bellevue Lake Line Intersections with KCWTD Conveyance</p> <p><small>The information included on this map has been compiled from a variety of sources and is subject to change without notice. King County makes no representations or warranties, express or implied, as to accuracy, completeness, timeliness, or rights to the use of such information. This document is not intended for use as a survey product. King County shall not be liable for any general, special, indirect, incidental, or consequential damages including, but not limited to, lost revenues or lost profits resulting from the use or misuse of the information contained on this map. Any sale of this map or information on this map is prohibited except by written permission of King County. File Name: C:\WTD\Projects\Environmental\Projects\Bellevue_SEPA_20210420\Bellevue_SEPA_20210420.aprx (local) Data Source: King County</small></p>	<p>6-2 See Response to Comment 6-2.</p>

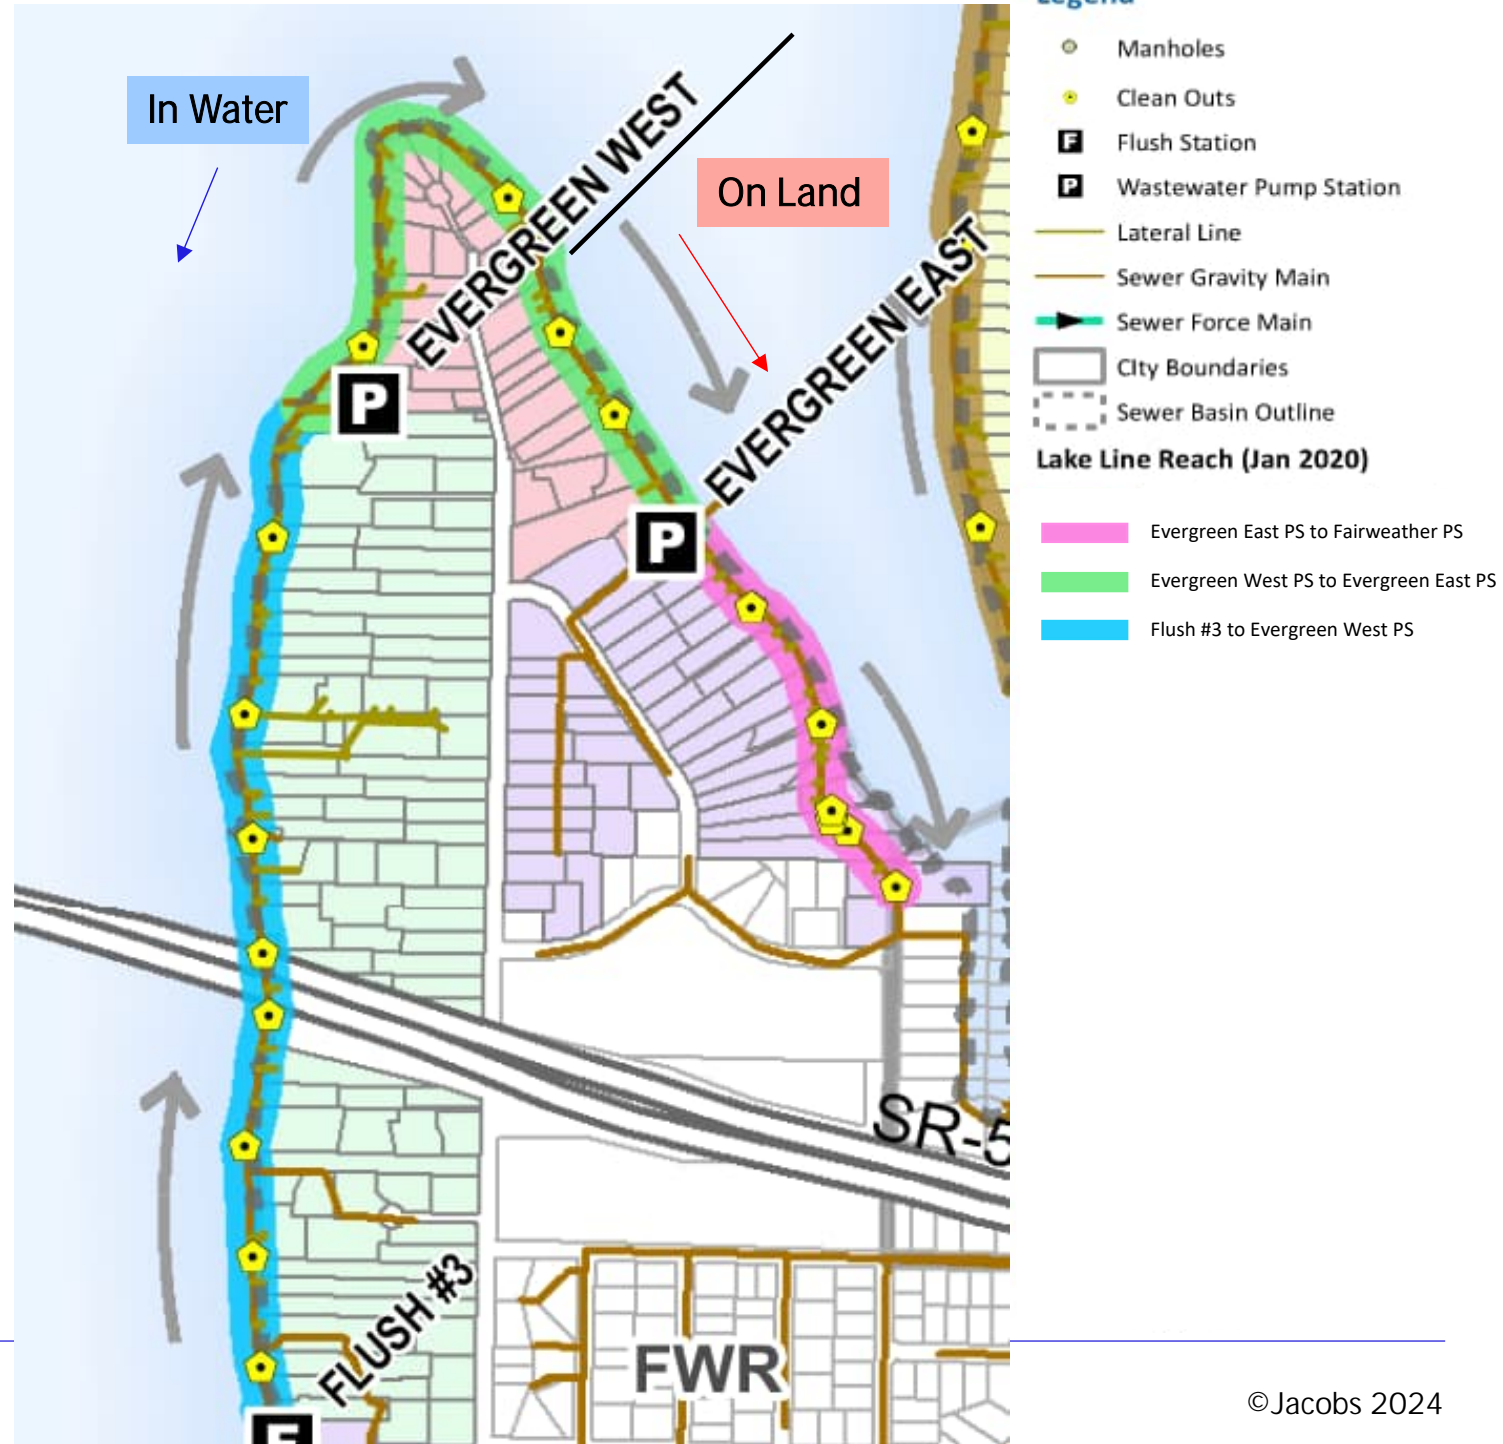
Evergreen Point

Alternative	Method
Within the Lake	- Gravity Sewer Line via Open Cut Construction
On-Shore	- Gravity Sewer Line via Open Cut Construction - Gravity Sewer Line via Trenchless Construction
Upland	- Grinder Pumps

Pipe Size (in.):	8
Pipe Material:	AC / Mixed / CI
Segment Length (ft.):	8,423 Total 2,900 On Land 5,523 In Water
# Parcels Served:	172
# Parcels Adjacent to LL:	86
Location:	In Water

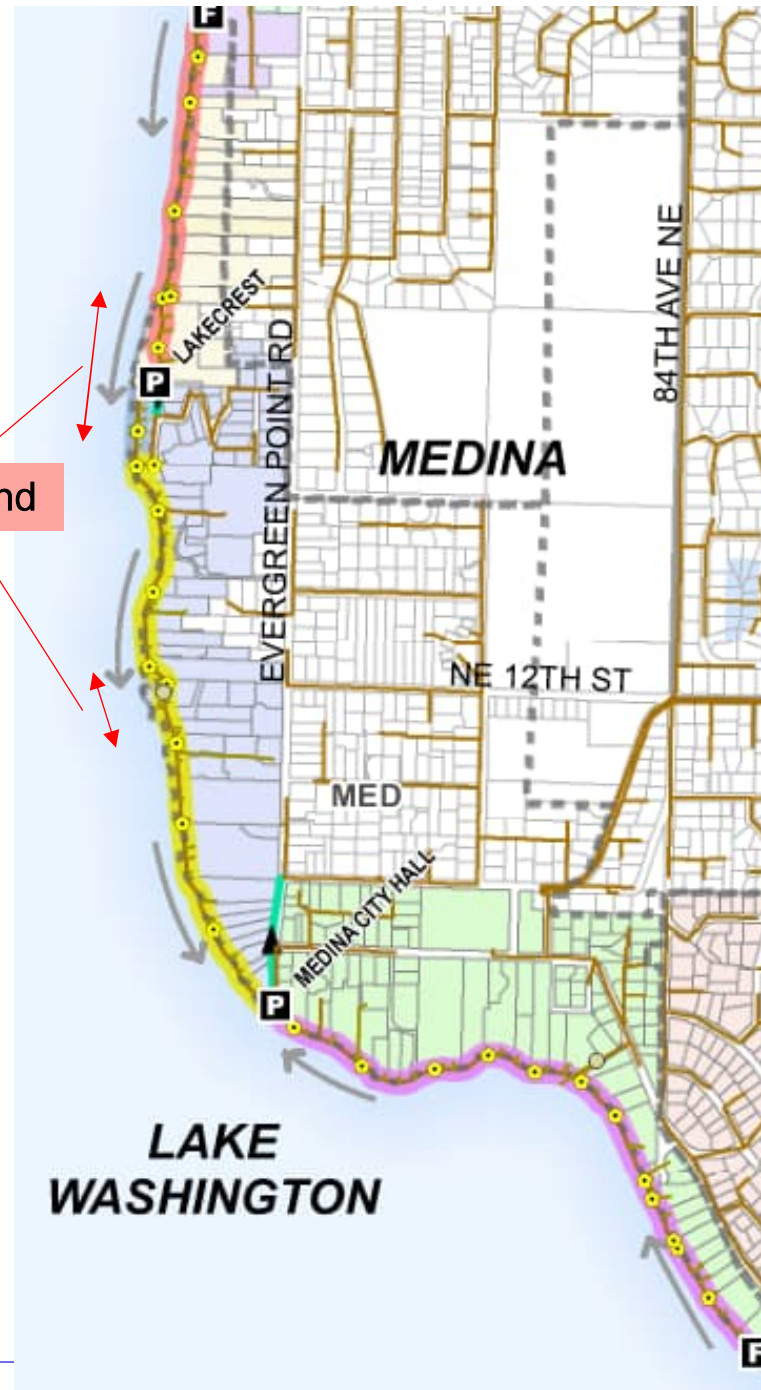
Medina South

Alternative	Method
Within the Lake	- Gravity Sewer Line via Open Cut Construction
On-Shore	- Gravity Sewer Line via Open Cut Construction - Gravity Sewer Line via Trenchless Construction
Upland	- Grinder Pumps

Pipe Size (in.):	8
Pipe Material:	AC / Mixed / CI
Segment Length (ft.):	12,320 Total 586 On Land 11,734 In Water
# Parcels Served:	213
# Parcels Adjacent to LL:	83
Location:	In Water

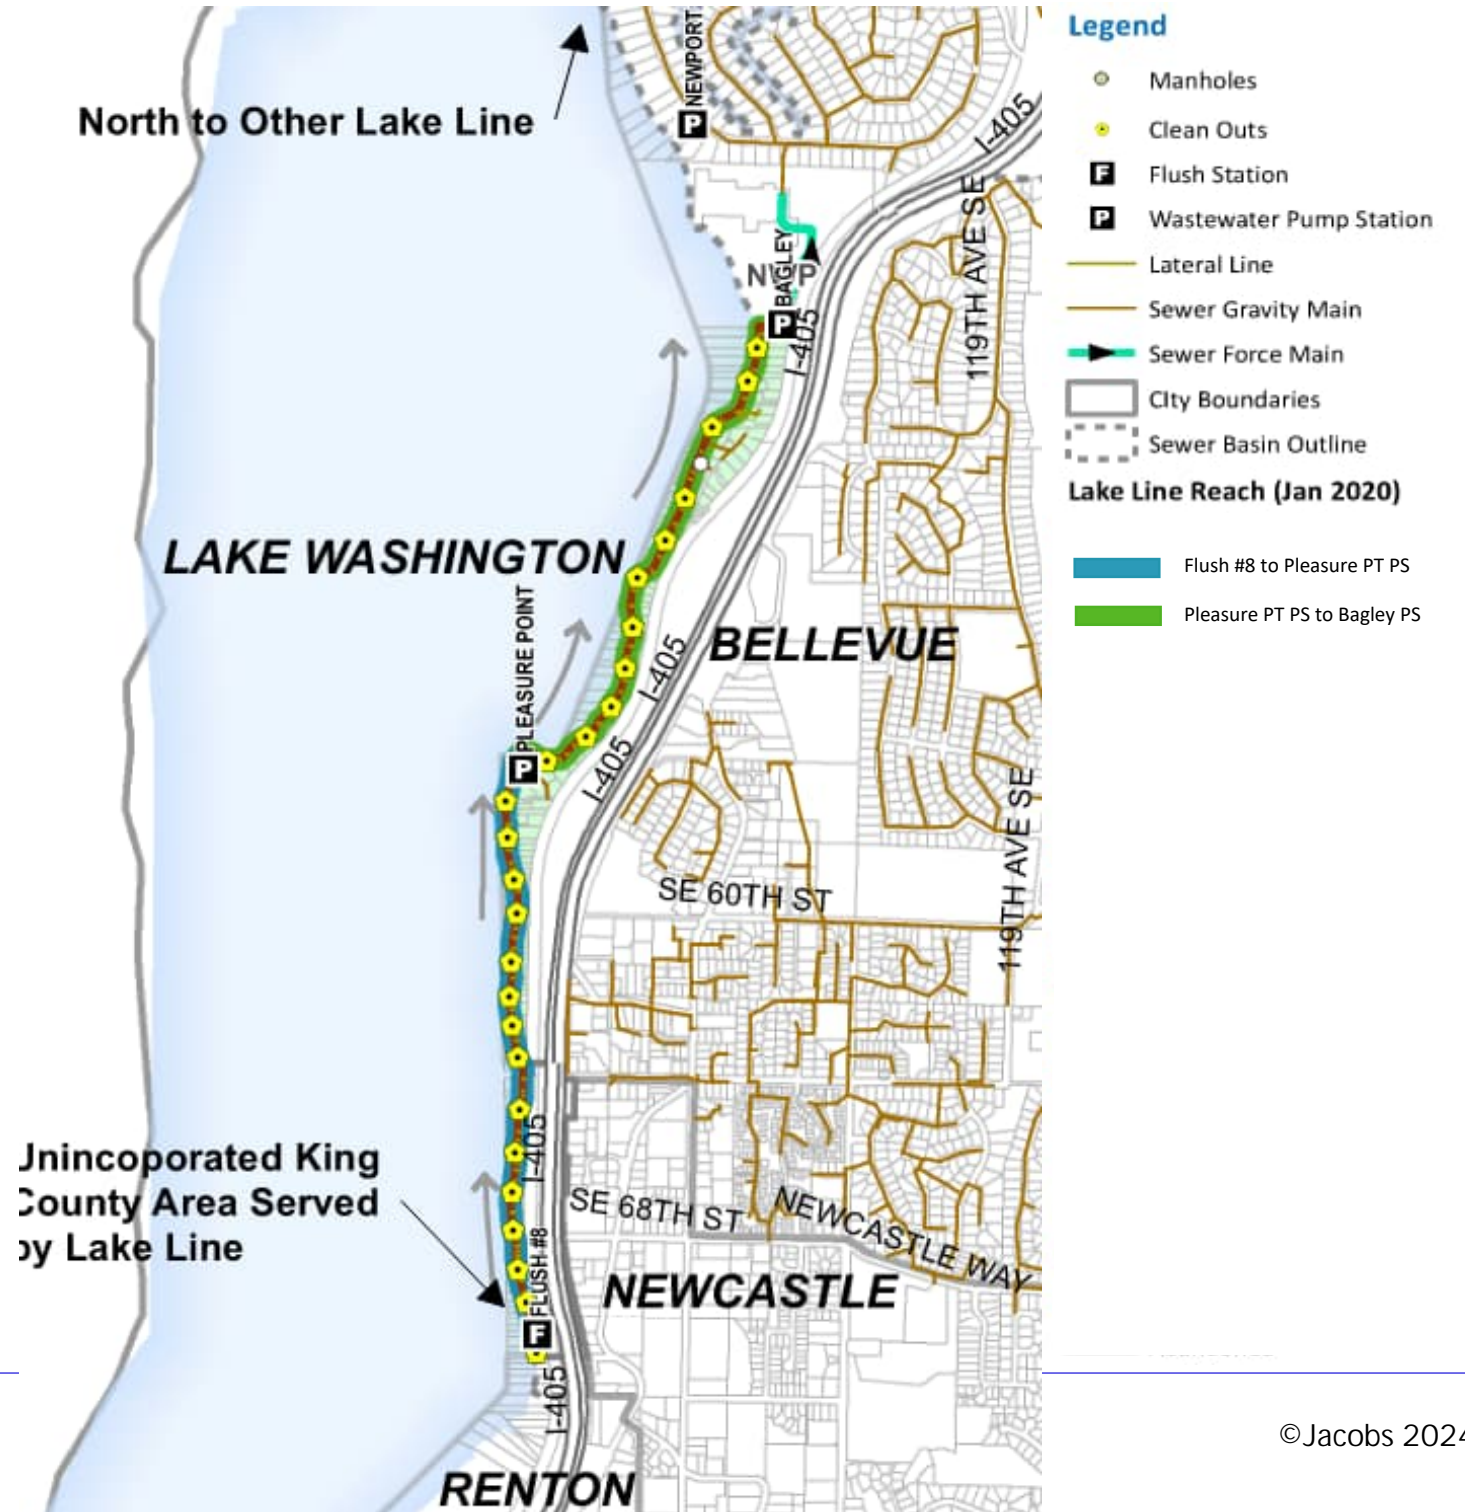
Alternative	Method
Within the Lake	- Gravity Sewer Line via Open Cut Construction
On-Shore	
Upland	- Grinder Pumps

Pipe Size (in.):	8
Pipe Material:	CI
Segment Length (ft.):	10,175
# Parcels Served:	149
# Parcels Adjacent to LL:	131
Location:	In Water
