OPTIONAL DETERMINATION OF NON-SIGNIFICANCE (DNS) NOTICE MATERIALS

SEPA Environmental Checklist

Vicinity Map for Bellevue Fire Station 10 File 20-110651-LO and 20-110652-LB

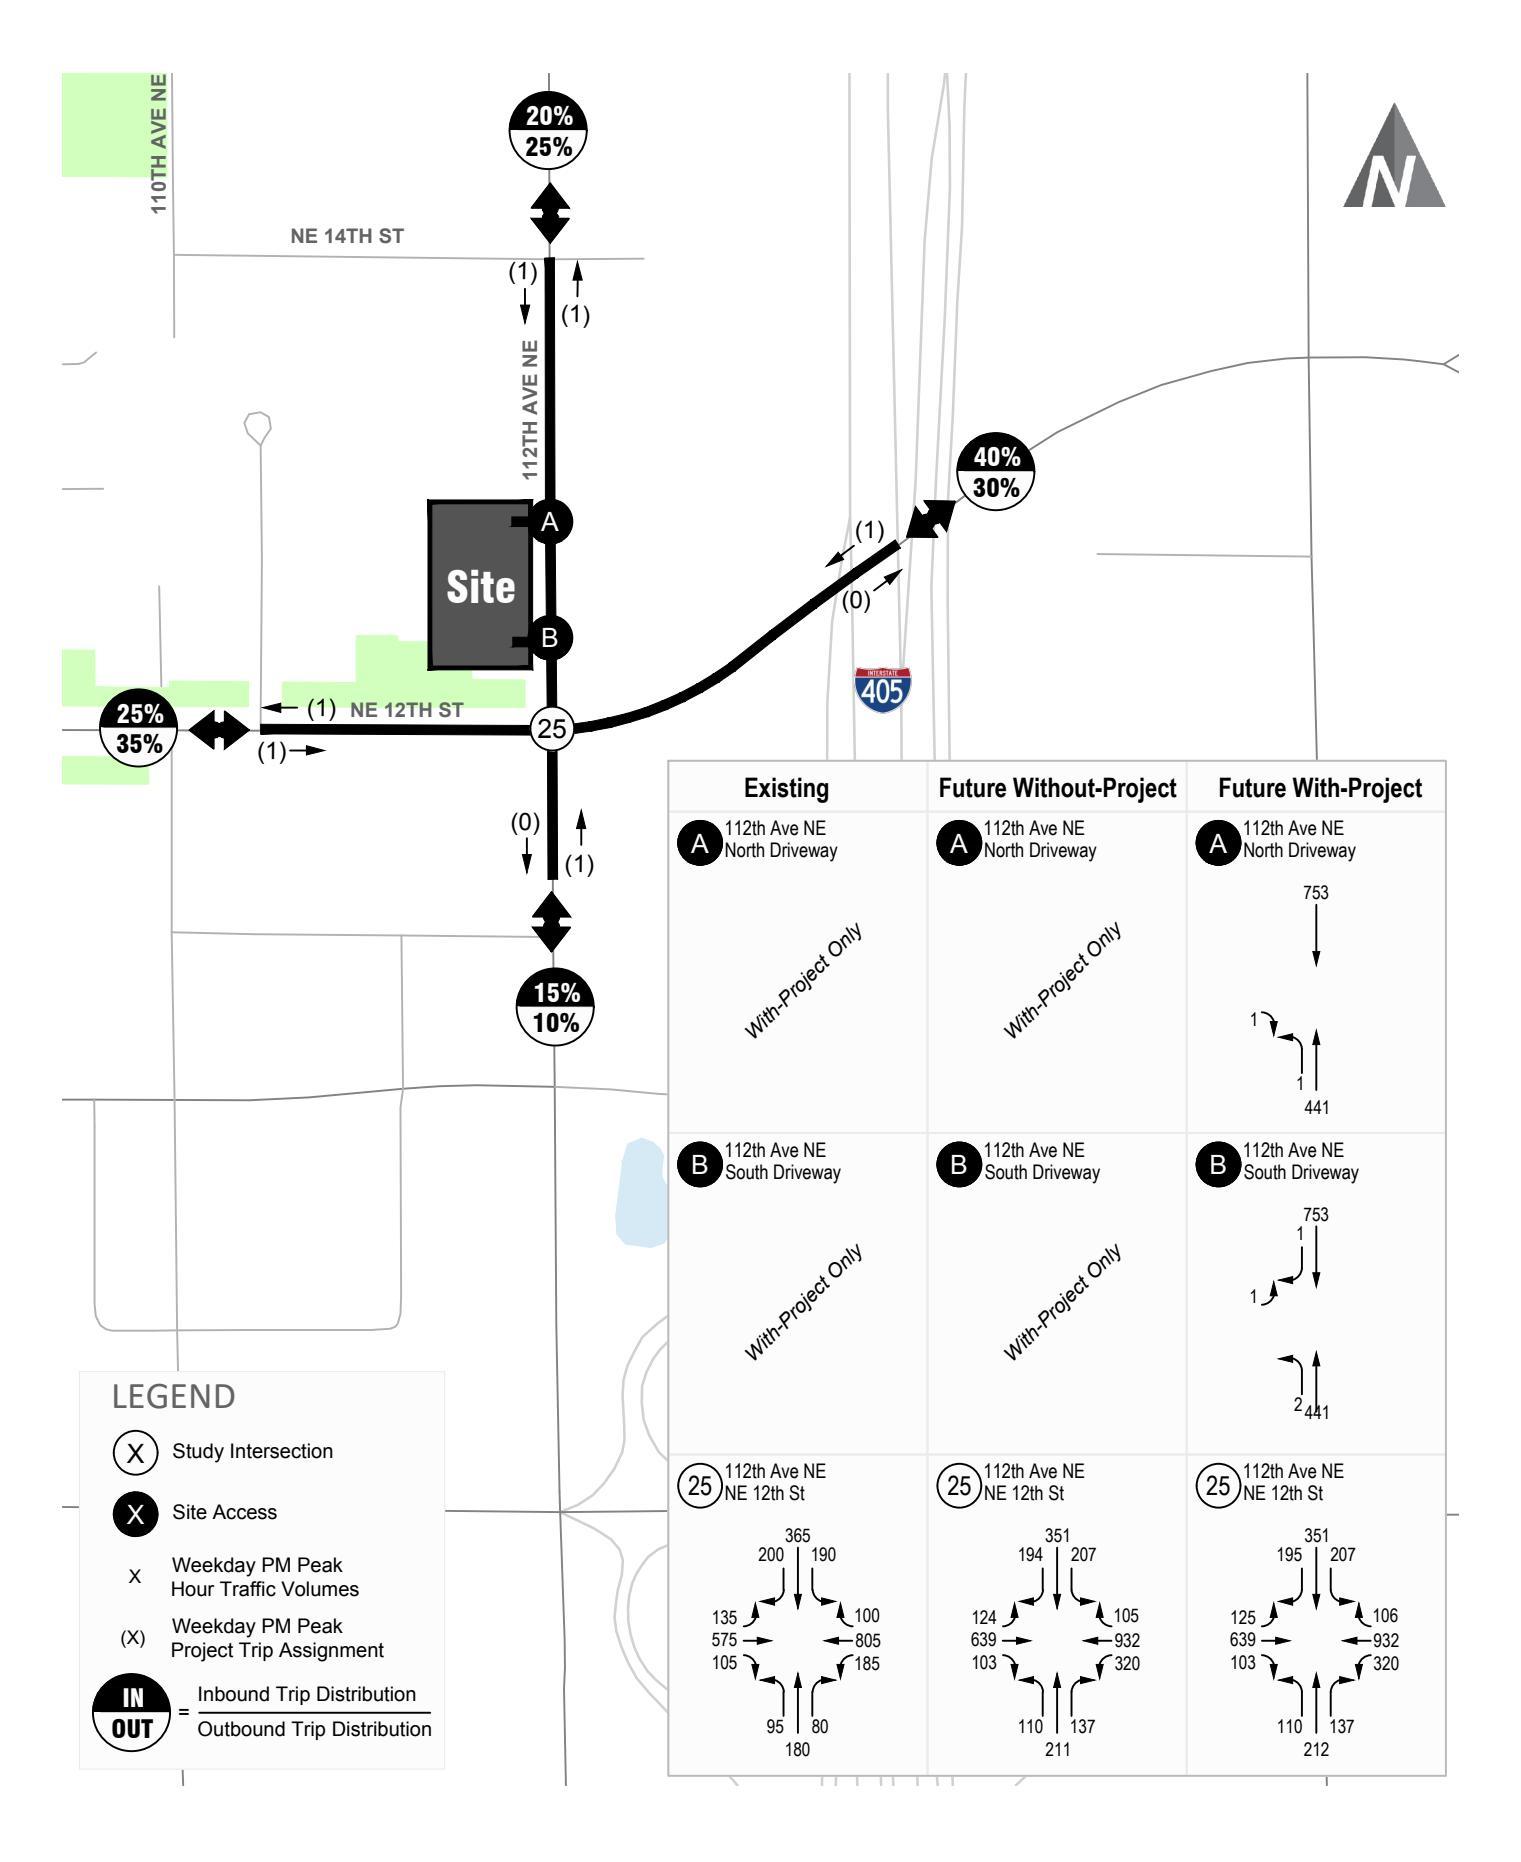
FIGURE

Existing, and future traffic volumes, along with trip distribution and trip assignment for projectgenerated trips, are shown in Figure 2.

Future with-project traffic volumes were determined by adding project-generated trips to the City of Bellevue 2024 traffic model. Project-generated PM peak hour trips (shown in Table 2) were distributed through the network based on traffic patterns observed in the City of Bellevue 2024 traffic model. It should be noted that only inbound emergency vehicle trips were included in this analysis. Outbound emergency vehicle trips will activate the emergency traffic signal and will be given right-of-way to travel through the study intersections. Based on data provided by the BFD, an average of one emergency call is expected during the weekday PM peak hour. During this time, emergency vehicles will have the right-of-way and all other vehicular traffic will be stopped. For the remainder of the time, traffic conditions will be typical and other project-generated trips will travel through the network normally and are analyzed as such.

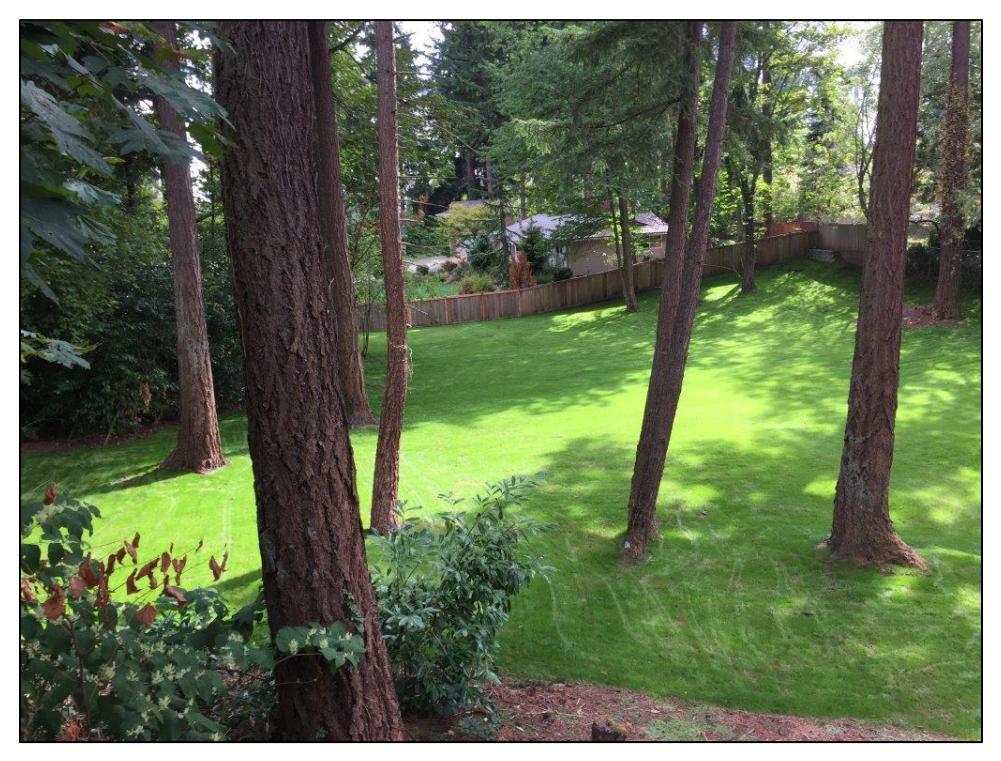
Figure 2. Looking southwest from the northern end of parcel number 126620-0330 (photograph provided by City of Bellevue, dated 08/27/2016). Site conditions after grading.

Wetland A has a history of disturbance. The northern end on parcels 126620-0330 and -0331 was altered with City-issued clearing and grading permits in 2002 and 2015. As the photographs from 2016 and 2017 (Figures 2 and 3 below) show, site alterations did not eliminate wetland presence. The southern portion of Wetland A, on parcel number 1266200341, contained a landscaped pond. The pond was filled sometime in 2017. Our wetland delineation study found high groundwater persists in this general location; it meets wetland criteria under the site disturbance methodology. Figures 4 and 5 below document the pond and subsequent fill placement. Fill placed in the former pond is mixed with debris and remnants of the old fence that cross the wetland.

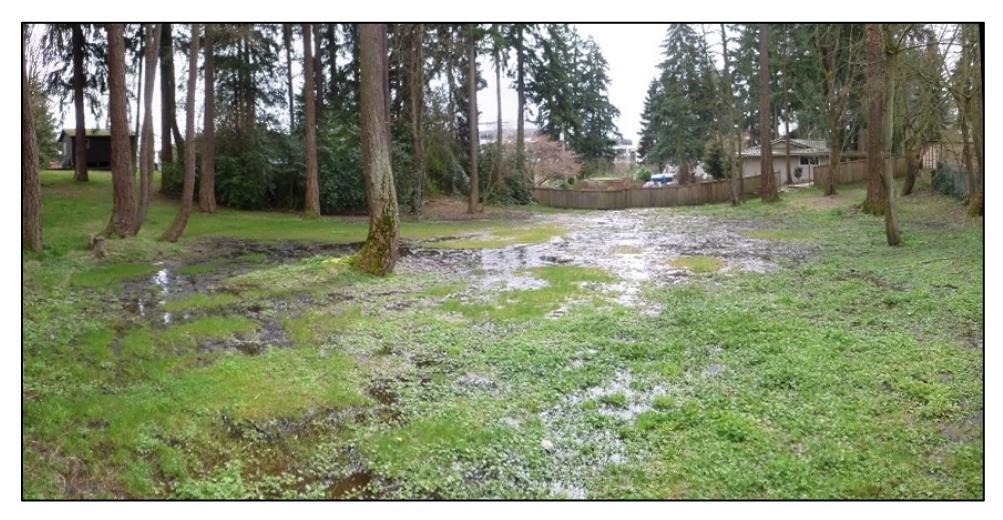
Figure 3. Looking south from the northwest end of parcel number 126620-0330 (photograph taken by The Watershed Co., dated 03/23/2017). Note persistence of wetland conditions.

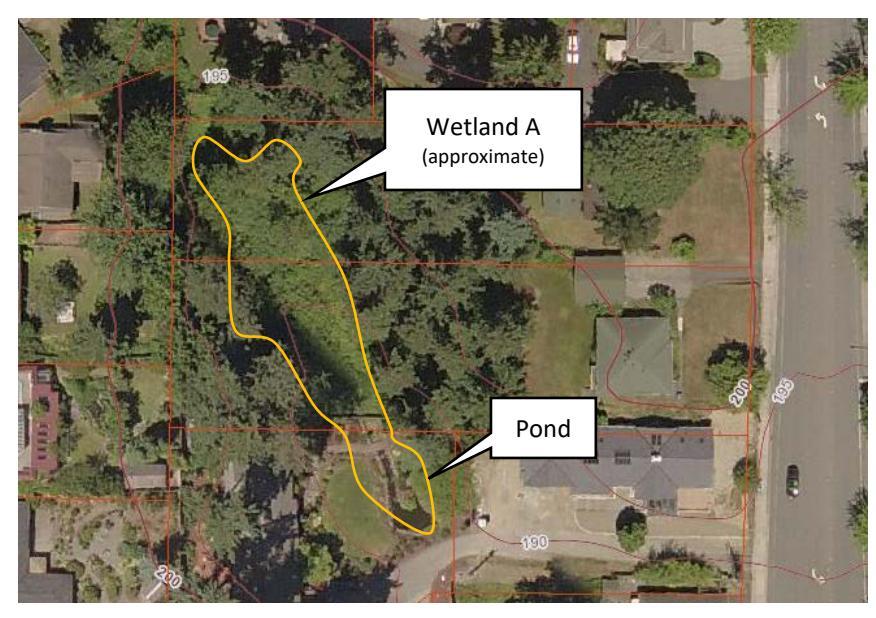
Figure 4. Aerial photograph showing pond presence (King County iMap, dated 2007).

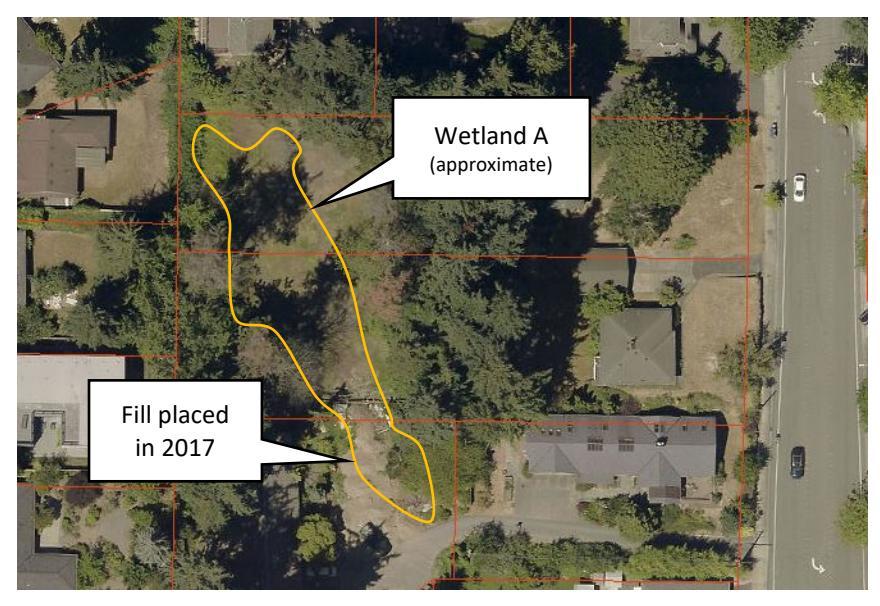
Figure 5. Aerial photograph showing fill placement (King County iMap, dated 2017).

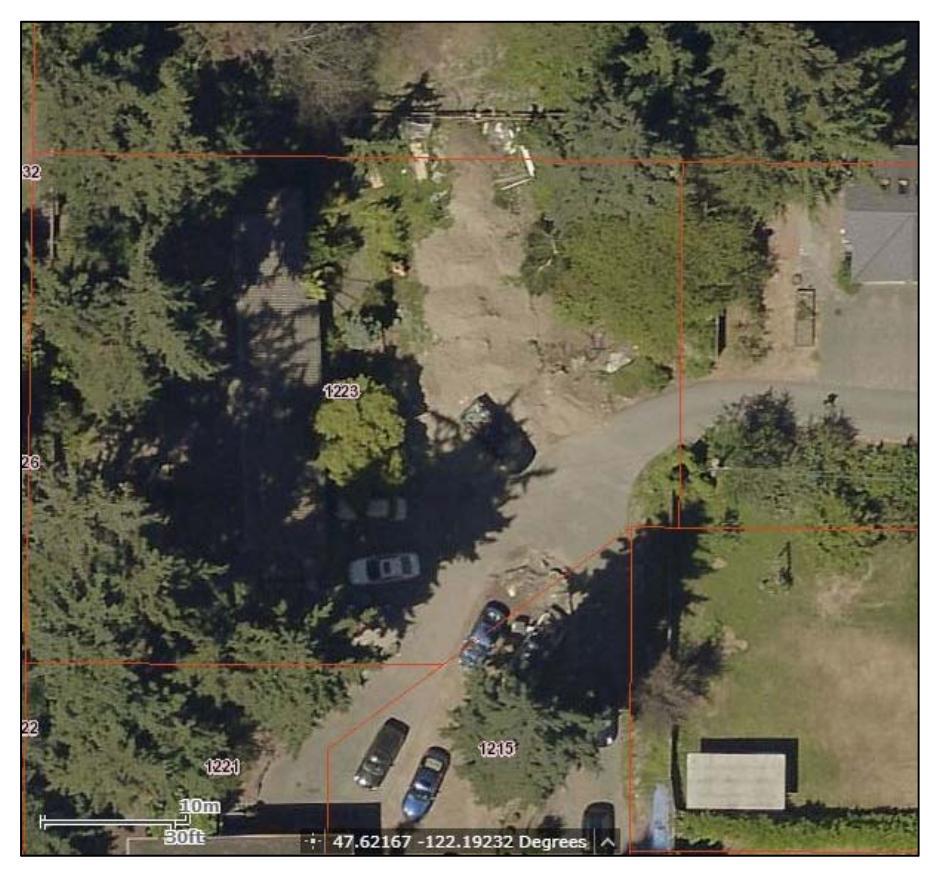
Figure 2. Fill placement evident in south end of Wetland A on 2017 aerial photograph (Source: King County iMAP).

The southeast portion of the wetland, located on parcel 1266200341 (house # 1223), was modified in 2017 (see Figure 2 below). This area was historically maintained as a pond feature, but has been filled in and diked with wood (see enclosed photos). A culvert was observed at the north property line; it is angled to the southeast. The general area of the former pond exhibited high ground water and saturation during the March 2019 site visit (see wetland data points).

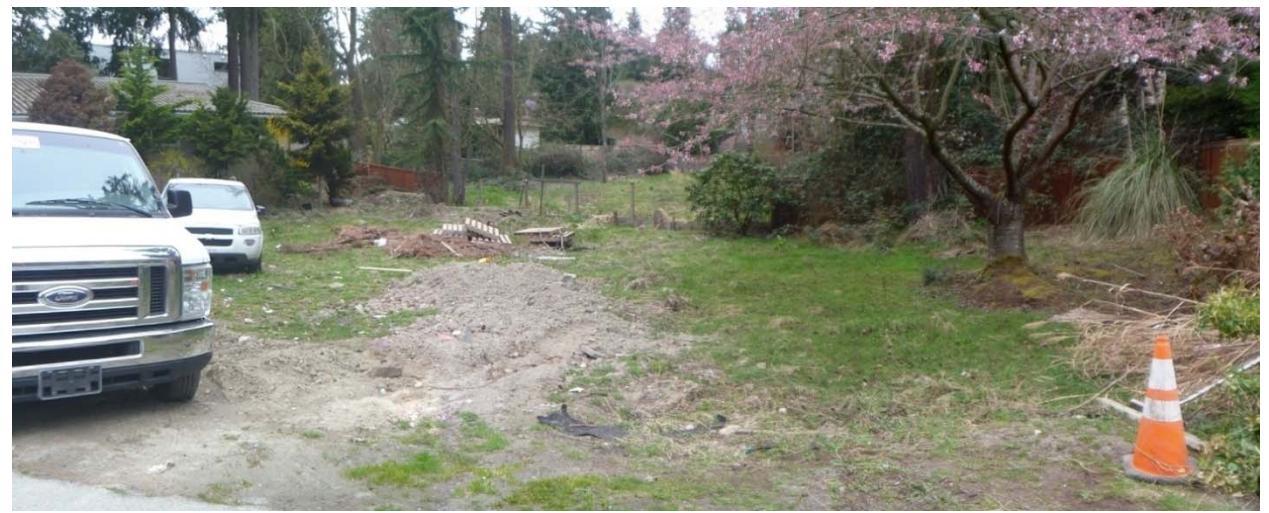
Photo 1. Former pond area, now filled (looking northwest from parcel 1266200341 driveway). Photo taken 3/25/19.

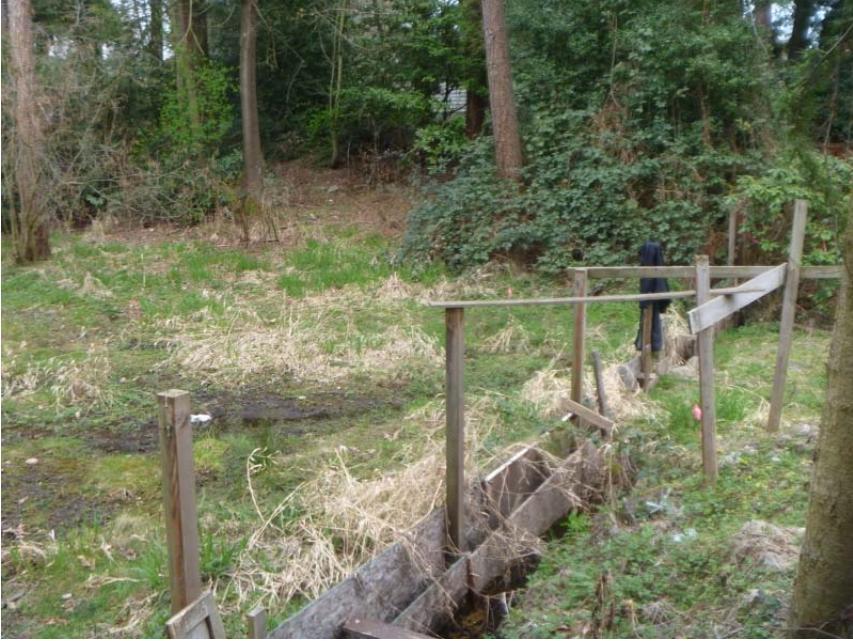
Photo 2. Wooden dike at northern property boundary of parcel 1266200341 (looking east). Taken 3/25/19.

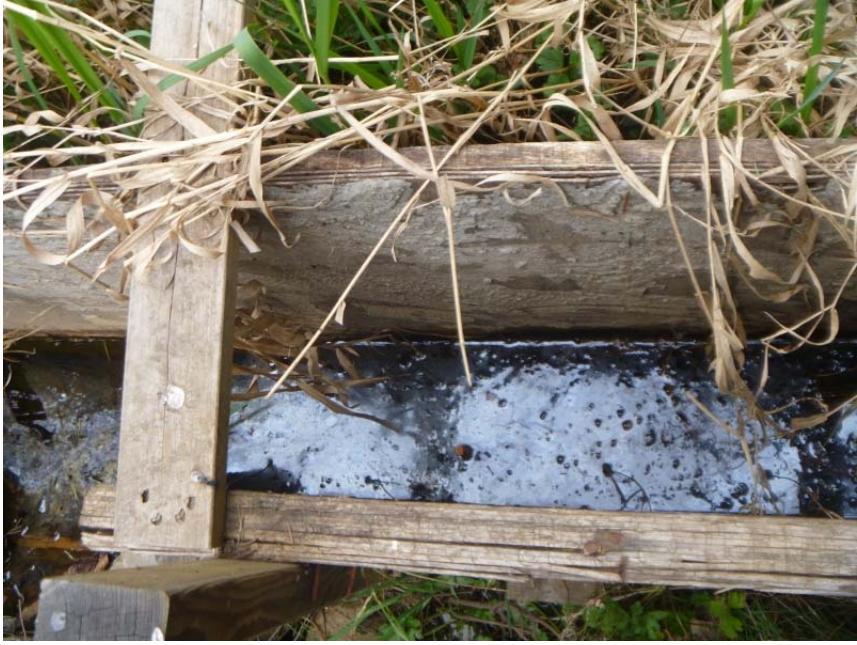
Photo 3. Inundation present within dike structure. Photo taken 3/25/19.

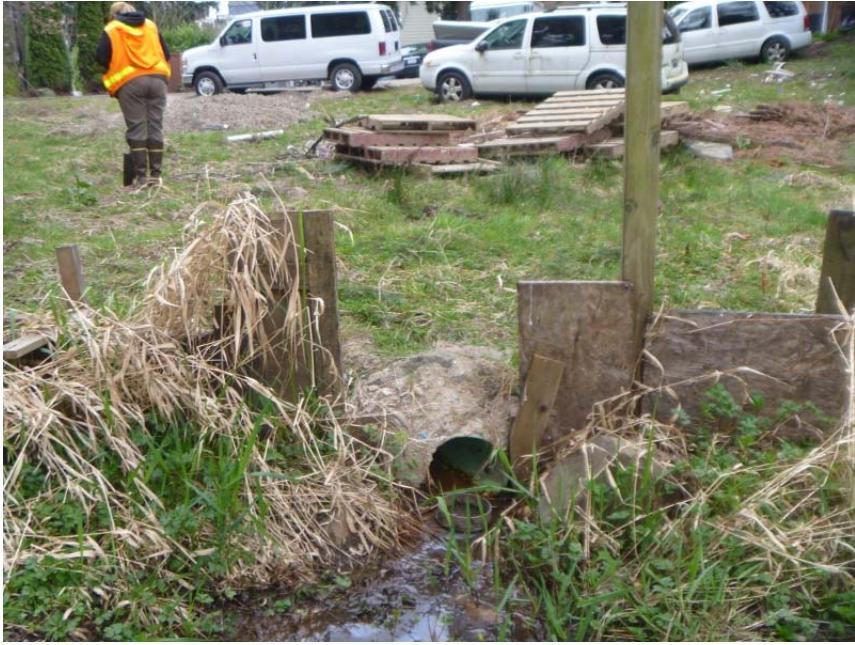
Figure 4. Culvert opening at dike structure. Photo taken 3/25/19.

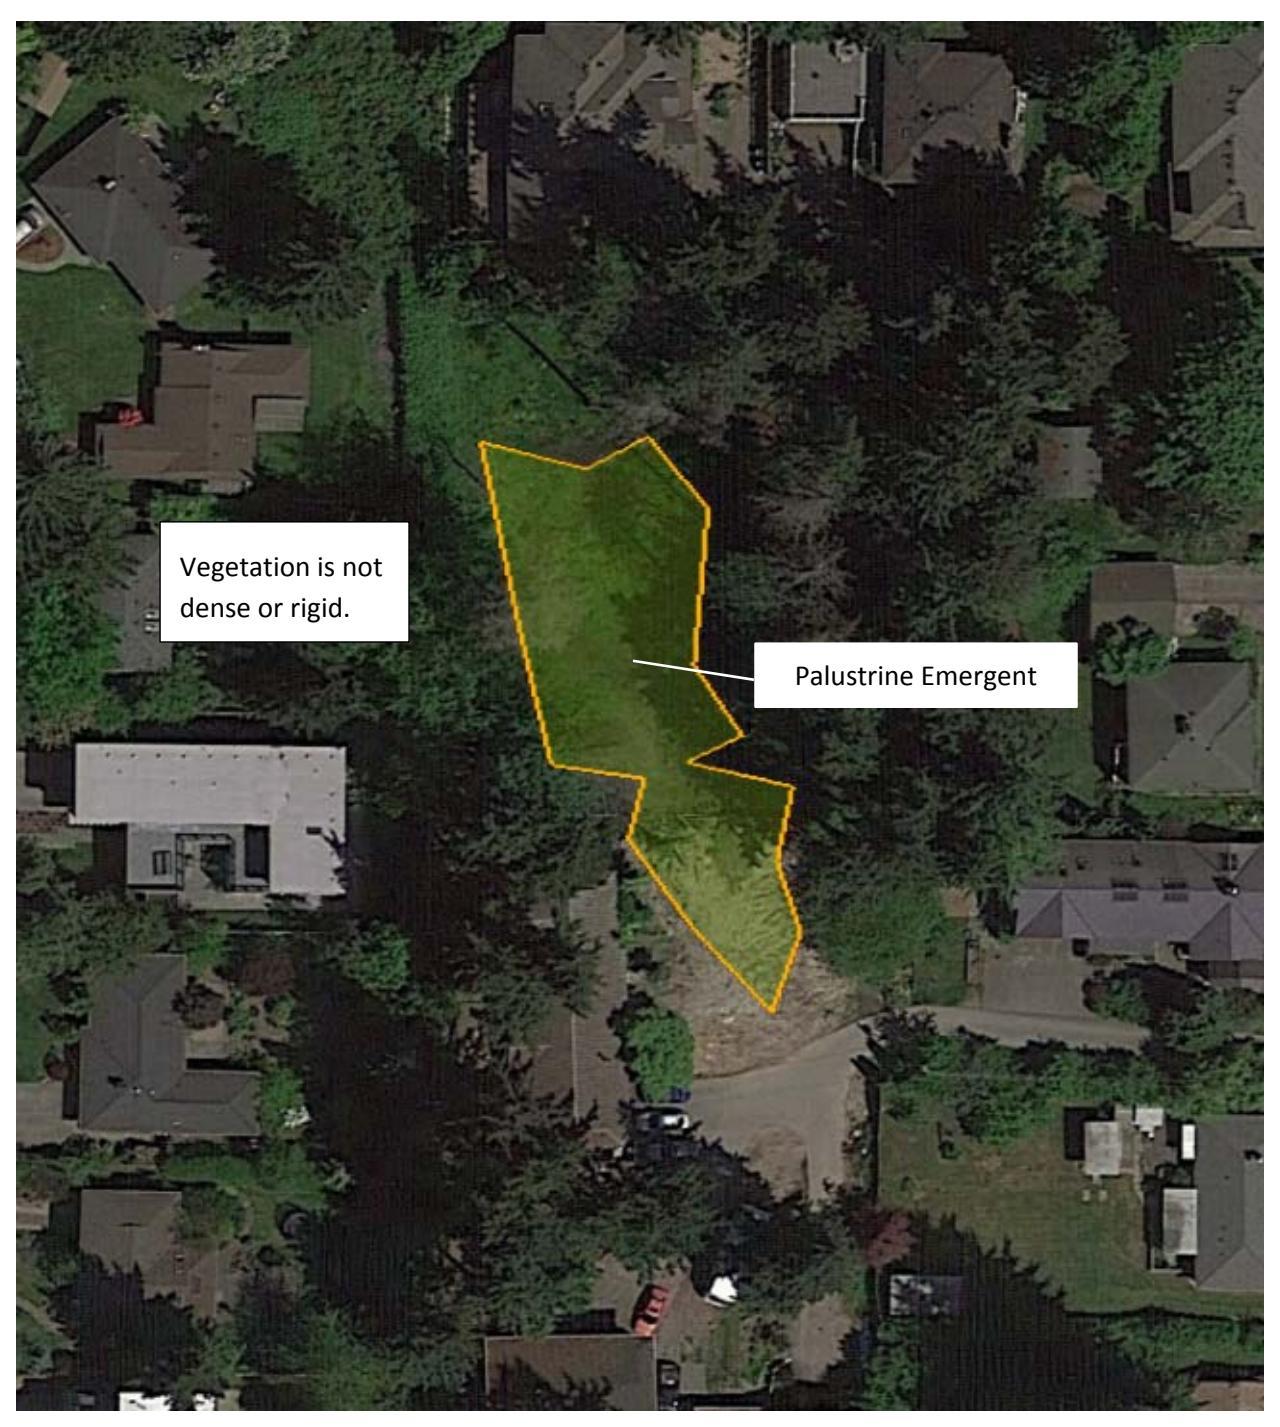
Figure 1. Cowardin plant classes – H1.1, H1.4; and Plant cover of dense and rigid trees, shrubs, and herbaceous plants – S1.3, S4.1

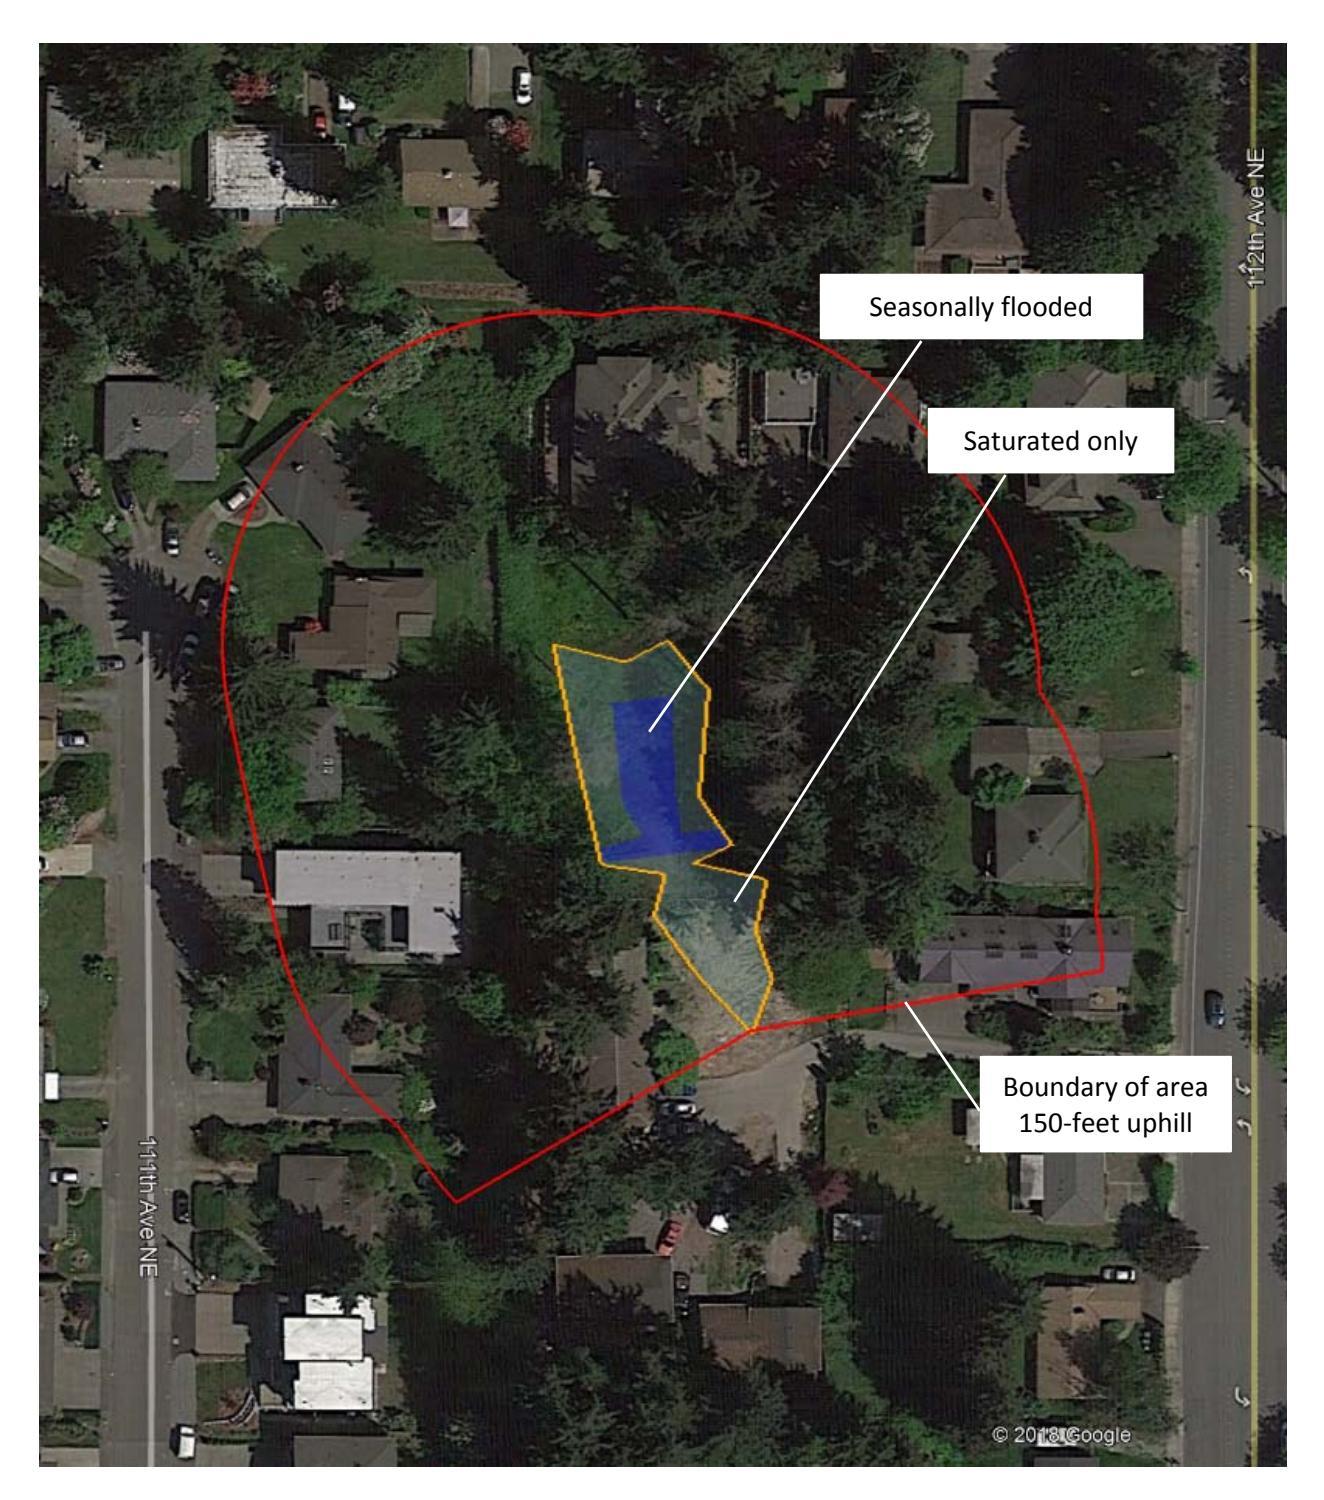
Figure 2. Hydroperiods and area 150-feet uphill– H1.2, S2.1, S5.1

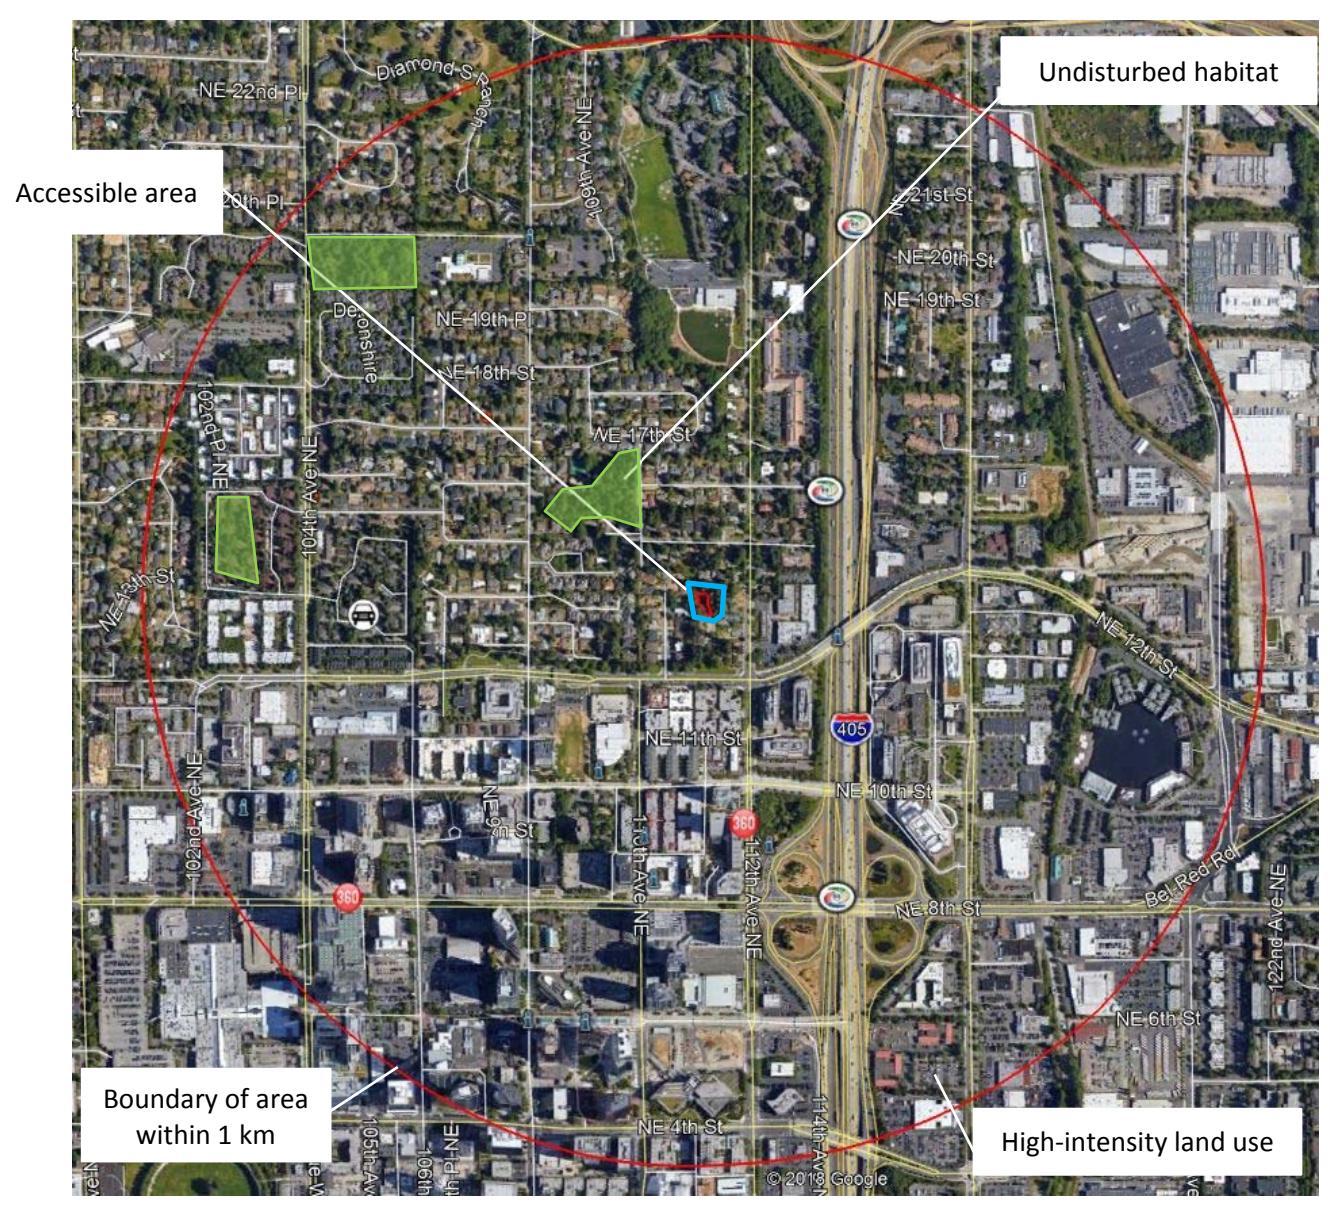
Figure 3. Undisturbed habitat and moderate-low intensity land uses within 1 km from wetland edge including polygon for accessible habitat – H2.1, H2.2, H2.3

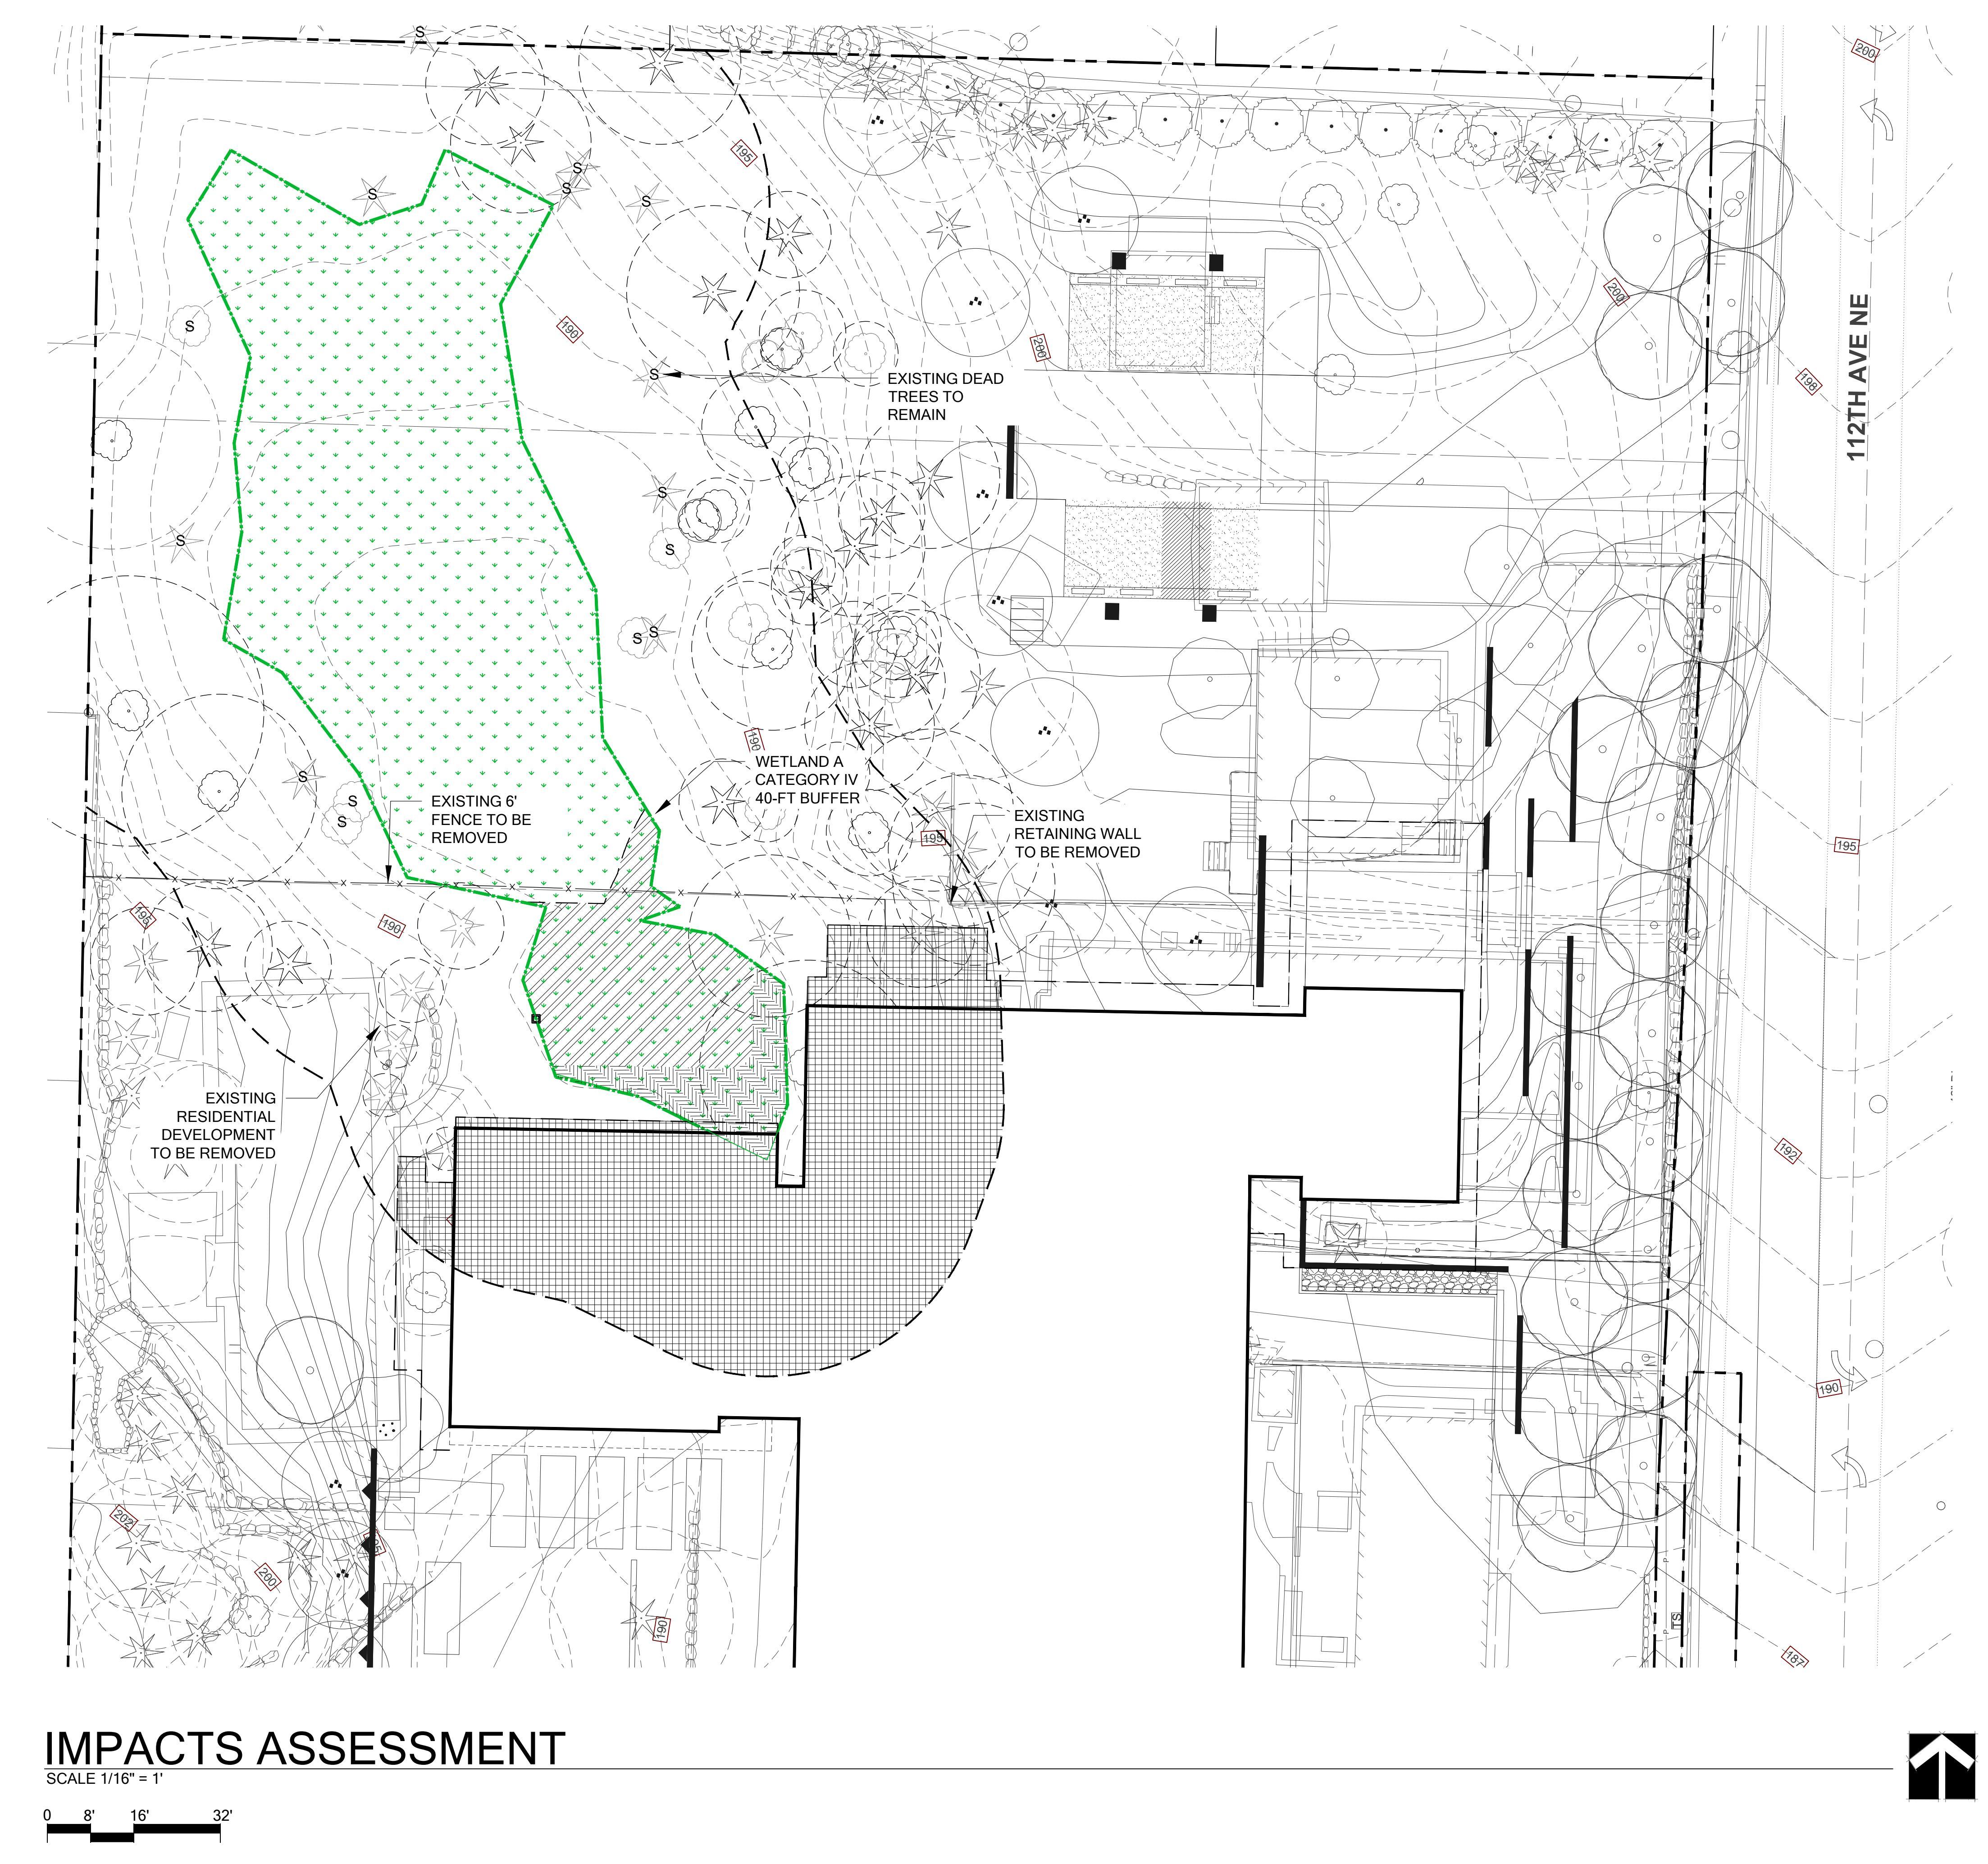
PRE-EXISTING DEVELOPMENT - 2,280 SF PROPOSED DEVELOPMENT - 2,465 SF PAPER FILL 1,209 SF

PERMANENT BUFFER IMPACTS 5,058 SF
