UW Student Reports on the Bellevue Bike Share Pilot Parking and Greenhouse Gas Emissions

# Lime Bike-share in Bellevue, WA

# CEE 416 / CET 580 / URBDP 598

Net Green House Gases Emissions Impact of Electric Bikeshare in the City of Bellevue CET 583: Transportation Energy and Sustainability

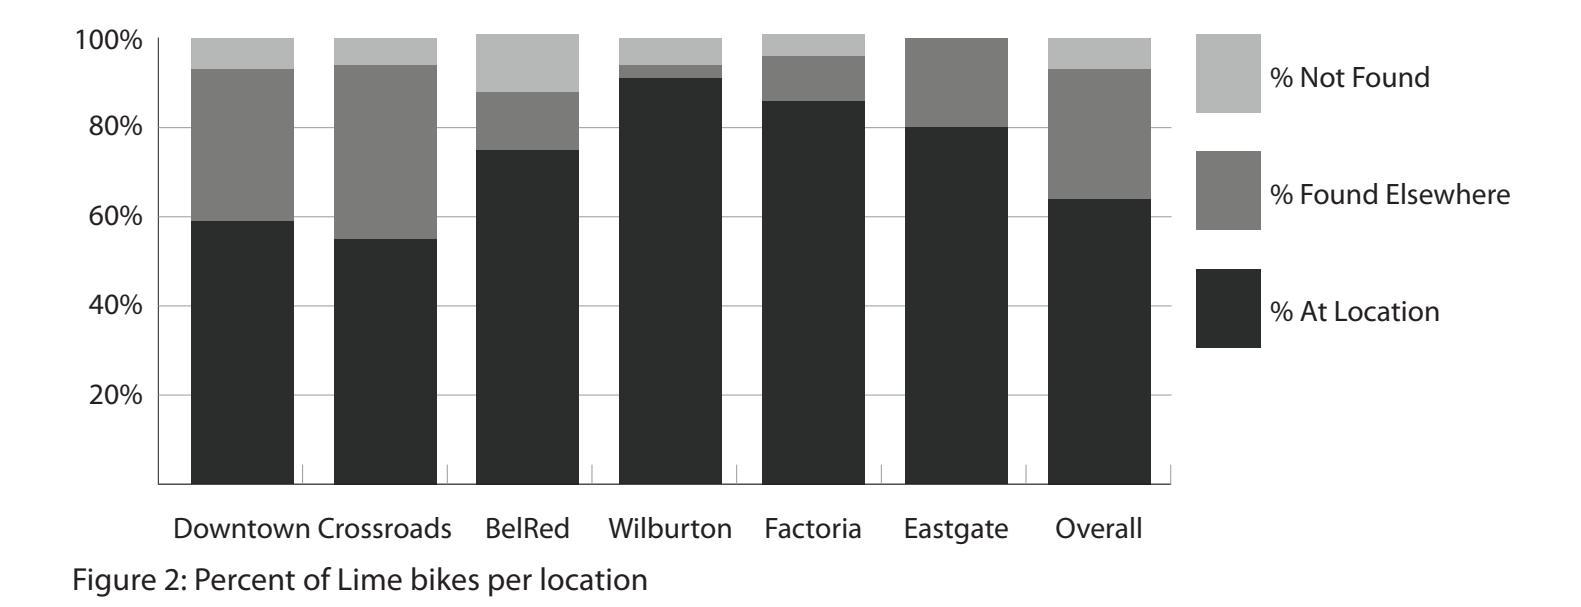
Figure 1: Number and percent of Lime bikes at the 6 locations within Bellevue, WA

Location	At Location	% at Location	Found Later	% Found Elsewhere	Not Found	% Not Found	Total	% of Total
Downtown	129	59%	75	34%	15	7%	219	69%
Crossroads	17	55%	12	39%	2	6%	31	10%
BelRed	6	75%	1	13%	1	13%	8	3%
Wilburton	31	91%	1	3%	2	6%	34	11%
Factoria	18	86%	2	10%	1	5%	21	7%
Eastgate	4	80%	1	20%	0	0%	5	2%
Total	205	64%	92	29%	21	7%	318	100%

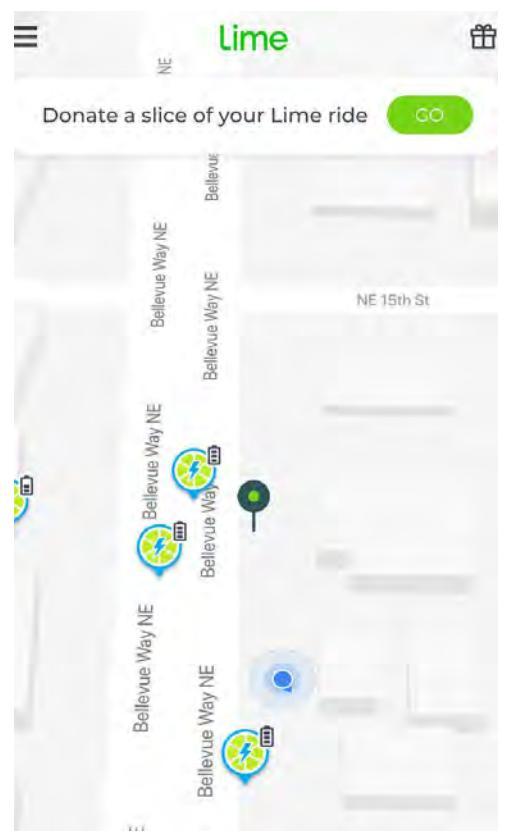
Figure 3: In-app screen capture of the actual conditions in image 2.

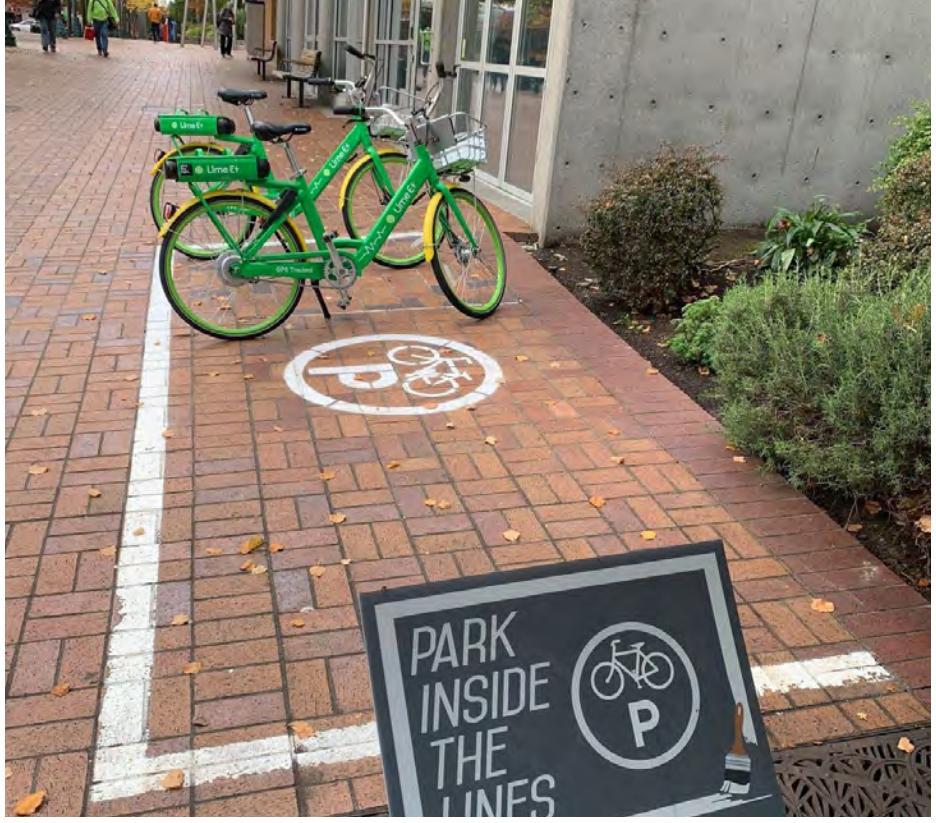
Figure 4: Bike Hub on the north side of the Bellevue Transit Center demonstrating actual locations of bikes, not reported correctly in the app.

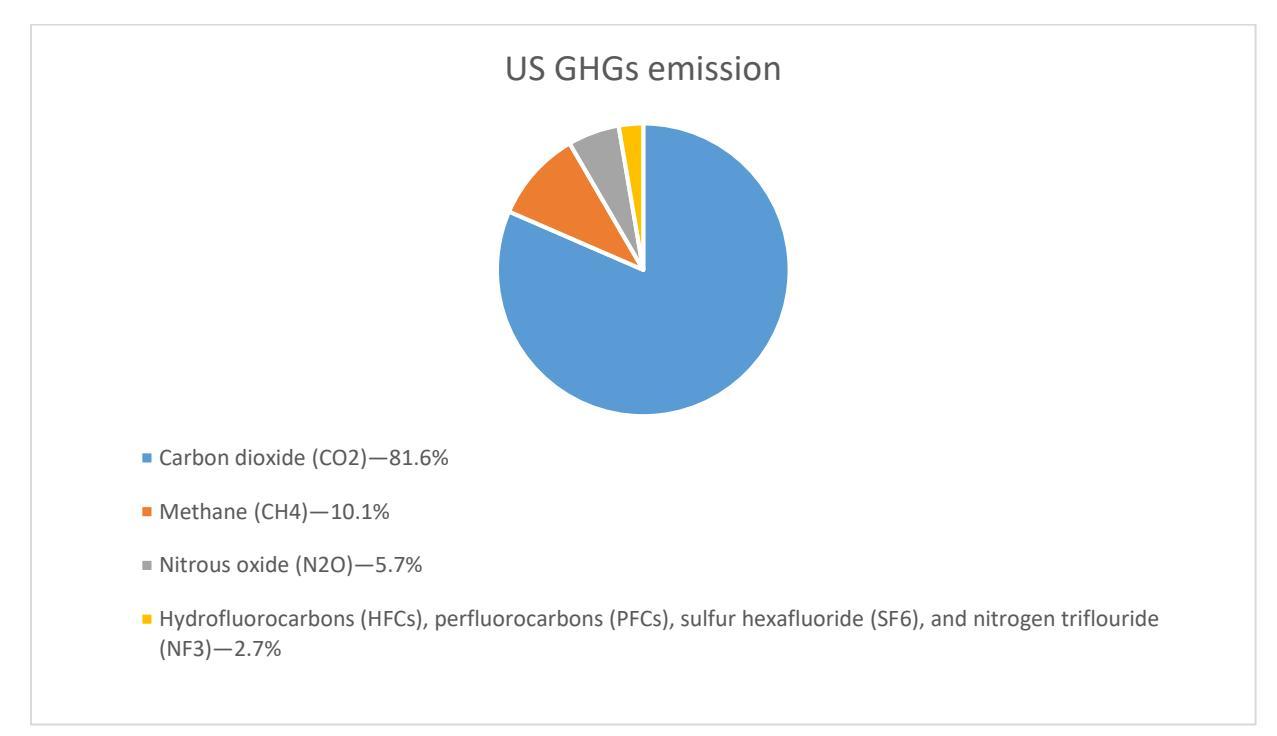
Figure 2 US GHGs emission (U.S Energy Information Administration, 2011)

U.S Energy Information Administration - EIA – Illustrates the major greenhouse gases emitted by the United States as a result of human activity, and their share of total U.S. greenhouse gas emissions of 6,511.3 million metric tons in 2016 (U.S Energy Information Administration, 2011):

CO2 is a large majority of greenhouse gases at 81.6% of total emissions. Emission is CO2 which is produced from coal, natural gas, biomass and other gasses burning in Puget Sound to deliver us convenient electricity. Also, we have CH4, N2O and SF6 amount in the table 2.

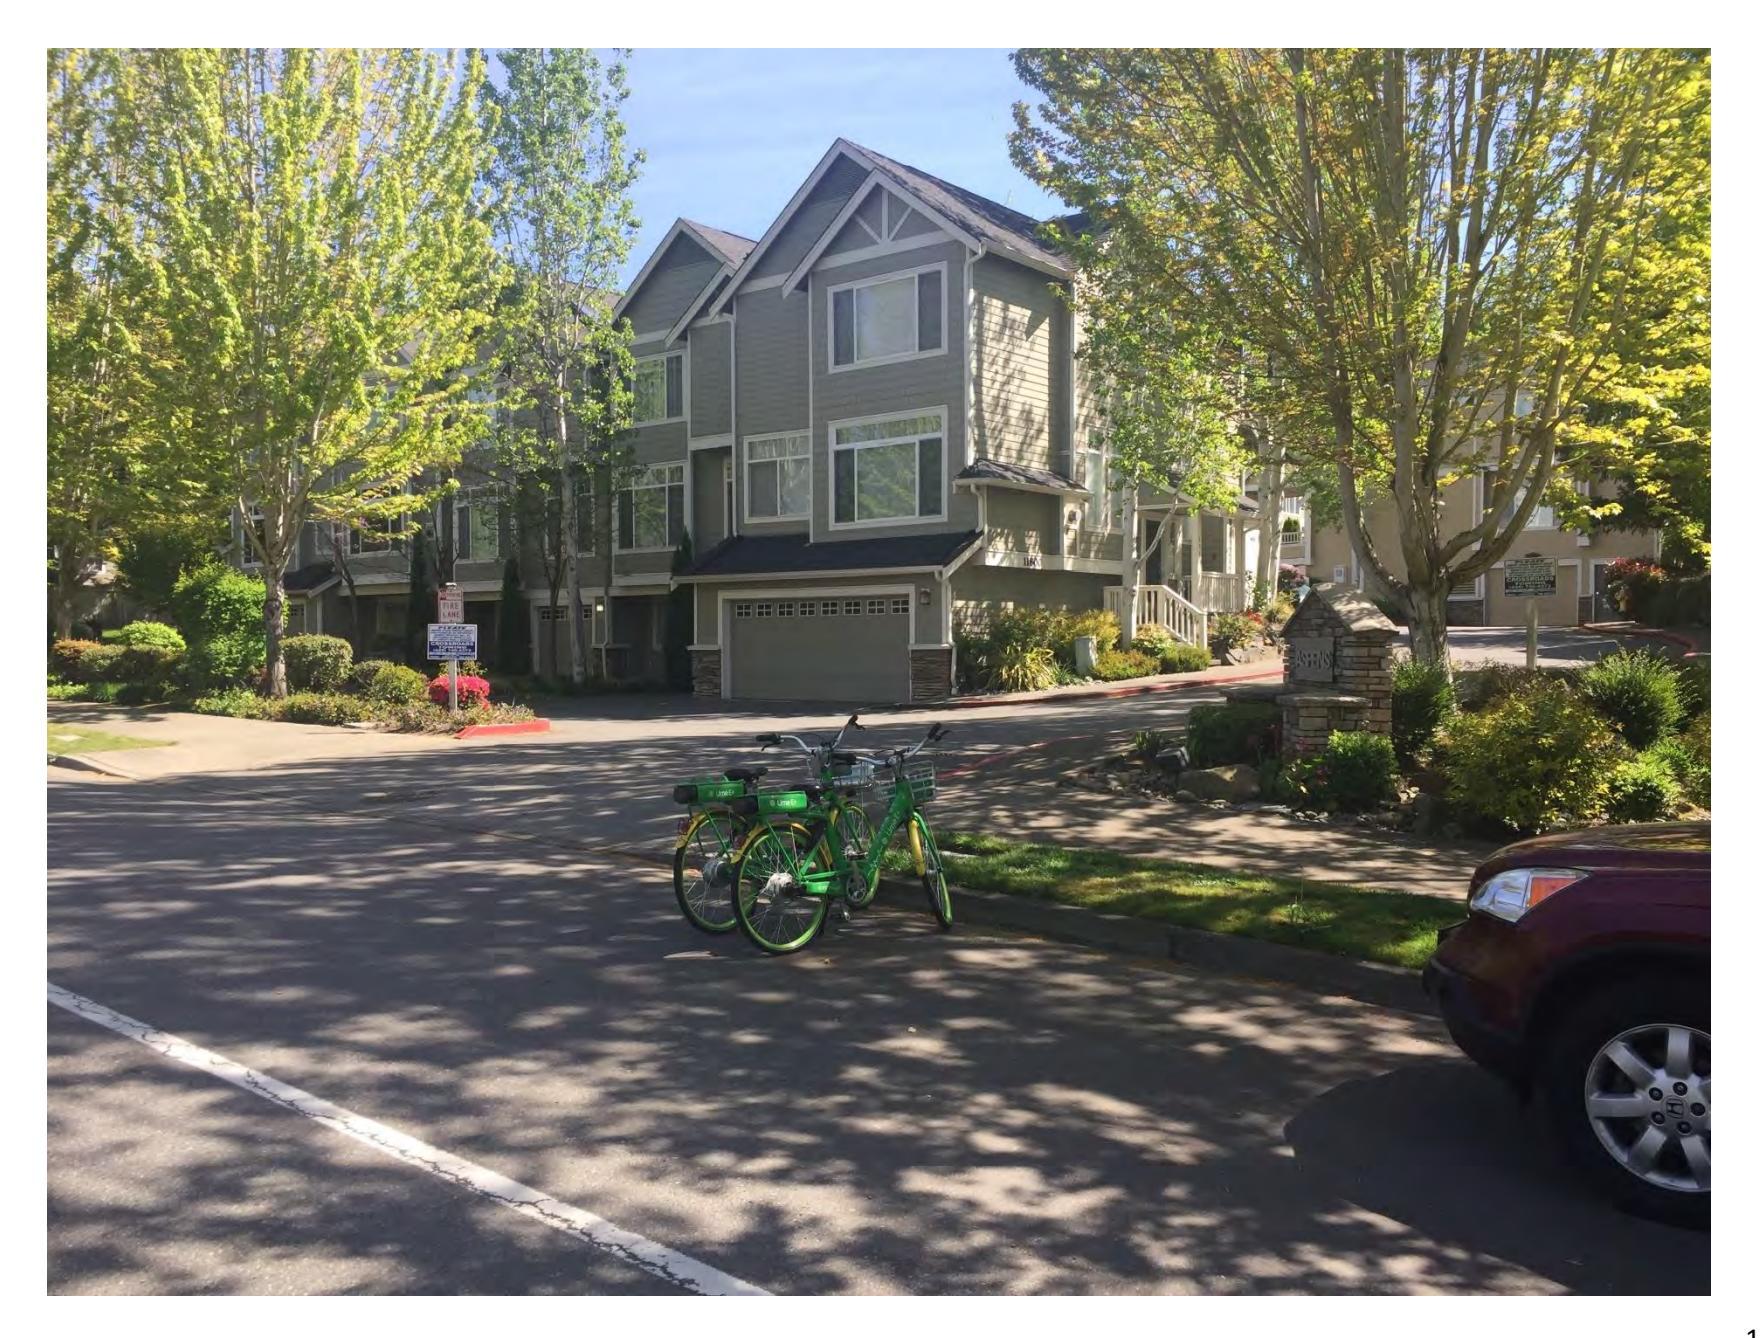
DIKE SHARE AUGUT OUIT	- Della Cana		
Contact: Audrey (206) 335-3436, Jeanne (703) 772 3376	5, Tianqi (607)-882-3	3787	
Name (First, Last)	Kellen Bowers		
Date (DD/MM/YYYY)	5/7/19		
Audit Area	Wilburton		
Individual Observations	DOLL STREET	DOTATION SHOP AND AND A REAL OF	
Time (HH:MM)	11:16	45	
Bike ID			
Vendor	lime		
E- bike or pedal bike?	F-bil	KL	
Location: Street	14014	AND NE SHIT	
Location: Cross-street(s)	120 th	THE NE	
Location: Block face (N, S, E, W)	North	100 100	
Is the bike in a designated bike hub?	Na		
Street Characteristics	Y/N	(If yes, please describe.)	
Sidewalk is less than six feet wide	X	4 Ft	
Residential	N		
Commercial or mixed-use (Retails, industry, etc)	¥	Mixed Use	
Recreation (Park, school, etc)	N		
Others?	N		
Parking	Y/N	(If yes, please describe.)	
Safety hazard	N		
Obstruction hazard	N		
ADA hazard	Y	corner of sidewalk entancedent

Bike is not upright	N	
Parked is not on hardscape	N	
The blke is parked within the following:	Y/N	(if yes, please describe.)
At the corner of sidewalks	Y	sidewalk and next to proking lat entines
A driveway	2	
A vehicle travel lane	N	
Paved shoulder along an arterial street	N	
Near hydrants or fire protection systems	N	n
Near Sidewalk Cafés or sidewalk seating areas	N	
Within six feet of a transit zone, except at existing bike racks	2	H
Privately owned property, such as sky-bridges, plazas	N	
is this Bike causing a problem? Please Provide Photo for every single bikel	N.

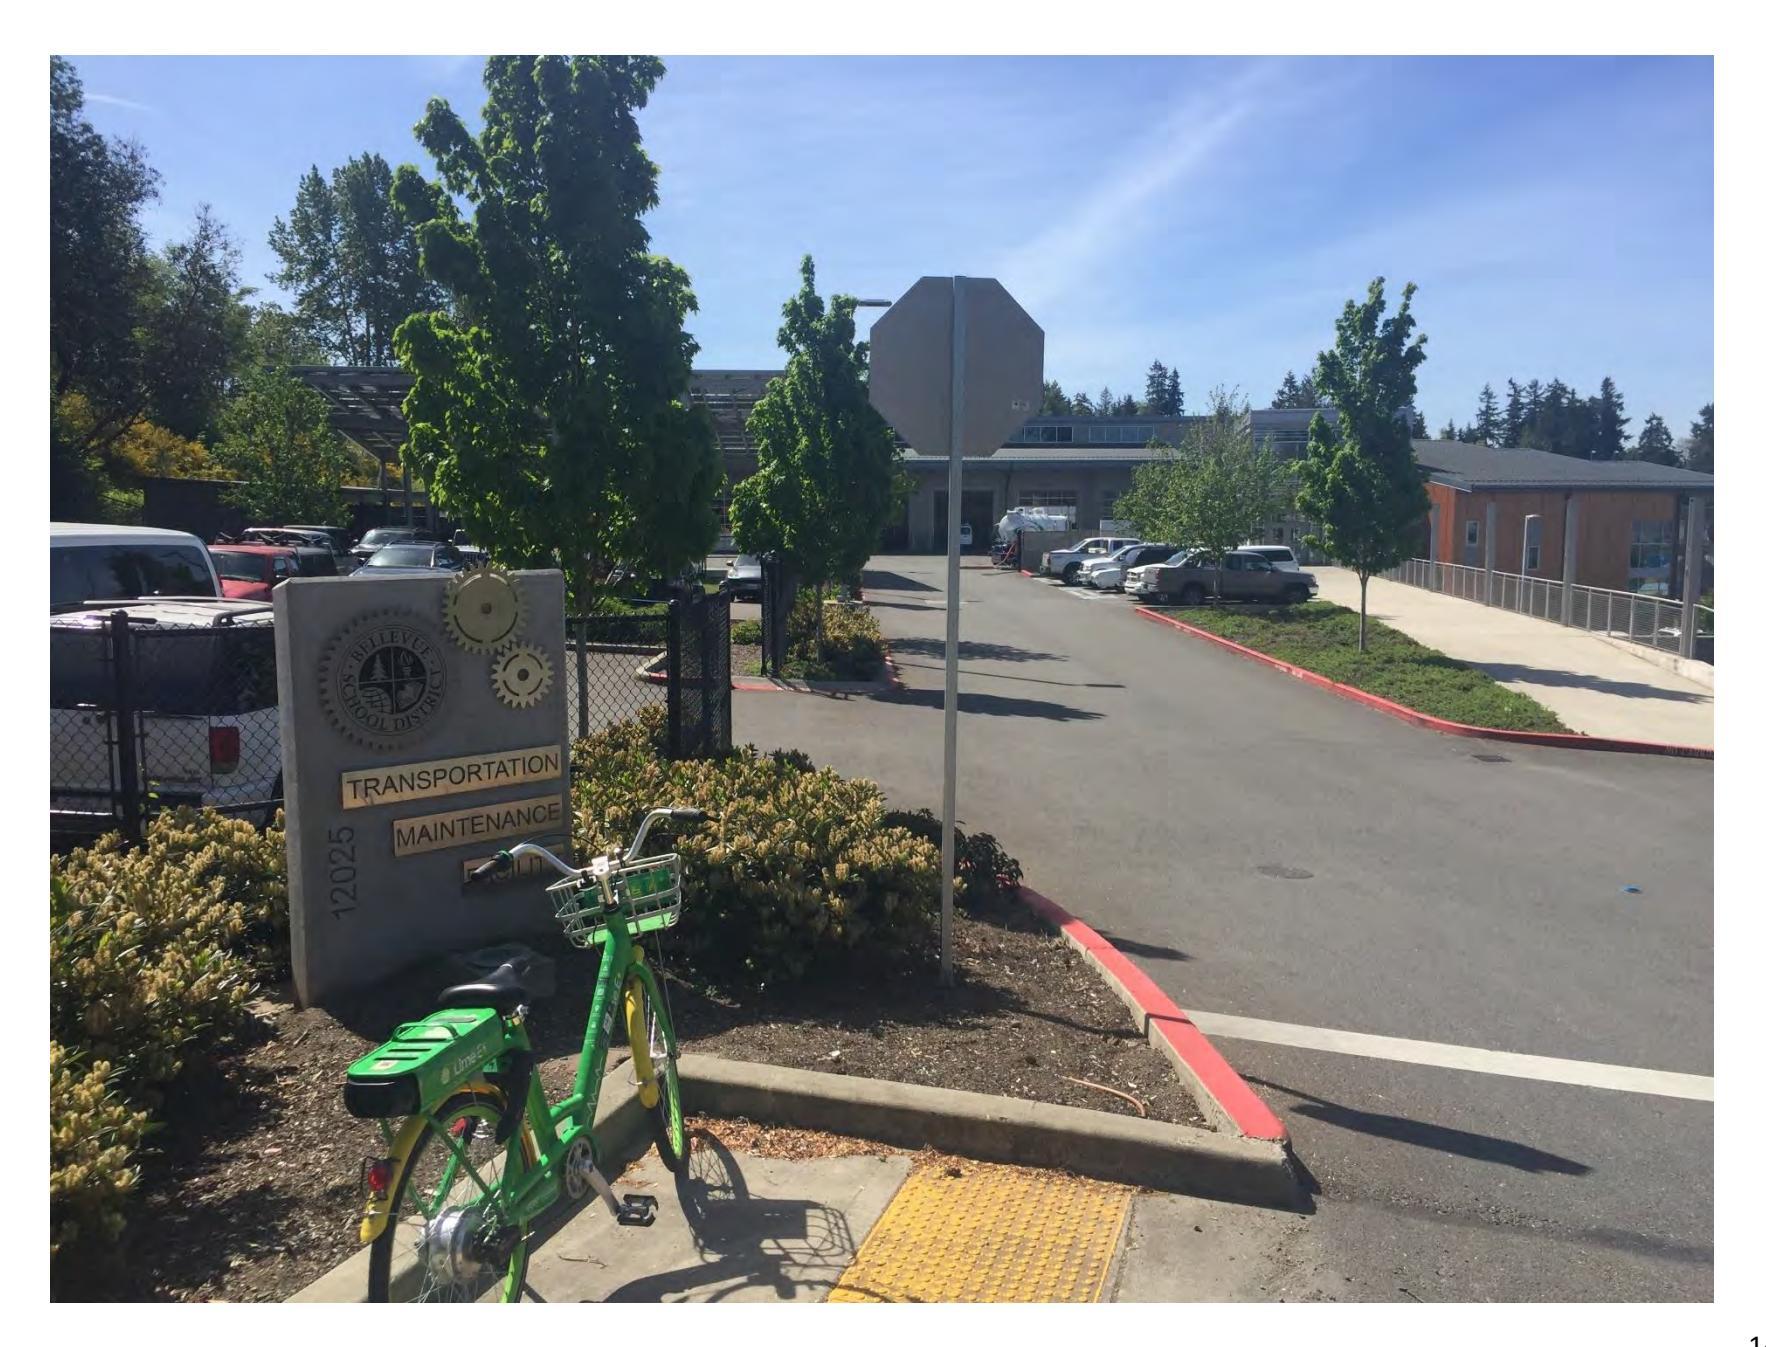
Name (Eirst Last)	Kellen Burers		
Date (DD/MM/YYYY)	5/7/19		
Audit Area	Willow	etas	
ndividual Observations	A A A A A	a contraction when the first second and	2
Time (HH:MM)	11:39	AM	
Bike ID	732	- 932	
Vendor	Line		
E- bike or pedal bike?	E-bih	<i>د</i>	
Location: Street	120 14	ALL NE	
Location: Cross-street(s)	8+2 2	+	
Location: Block face (N, S, E, W)	SE		
Is the bike in a designated bike hub?	No	The second	and the second se
Street Characteristics	YIN	(If yes, please describe.)	10000
Sidewalk is less than six feet wide	N		
Residential	N		
Commercial or mixed-use (Retails, industry, etc)	Y	COMMUTCIAL	
Recreation (Park, school, etc)	N		
Others?	N		
Parking	Y/N	(If yes, please describe.)	
Safety hazard	N		_
Obstruction hazard	Y		
ADA hazard	Y

Bike is not upright	N	
Parked is not on hardscape	N	
The bike is parked within the following:	YIN	(If yes, please describe.)
At the corner of sidewalks	Y	
A driveway	N	
A vehicle travel lane	N	
Paved shoulder along an arterial street	N	
Near hydrants or fire protection systems	N	
Near Sidewalk Cafés or sidewalk seating areas	M	
Within six feet of a transit zone, except at existing bike racks	N	-
Privately owned property, such as sky-bridges, plazas	N	
Is this Bike causing a problem? Please Provide Photo for every single bike!	N.

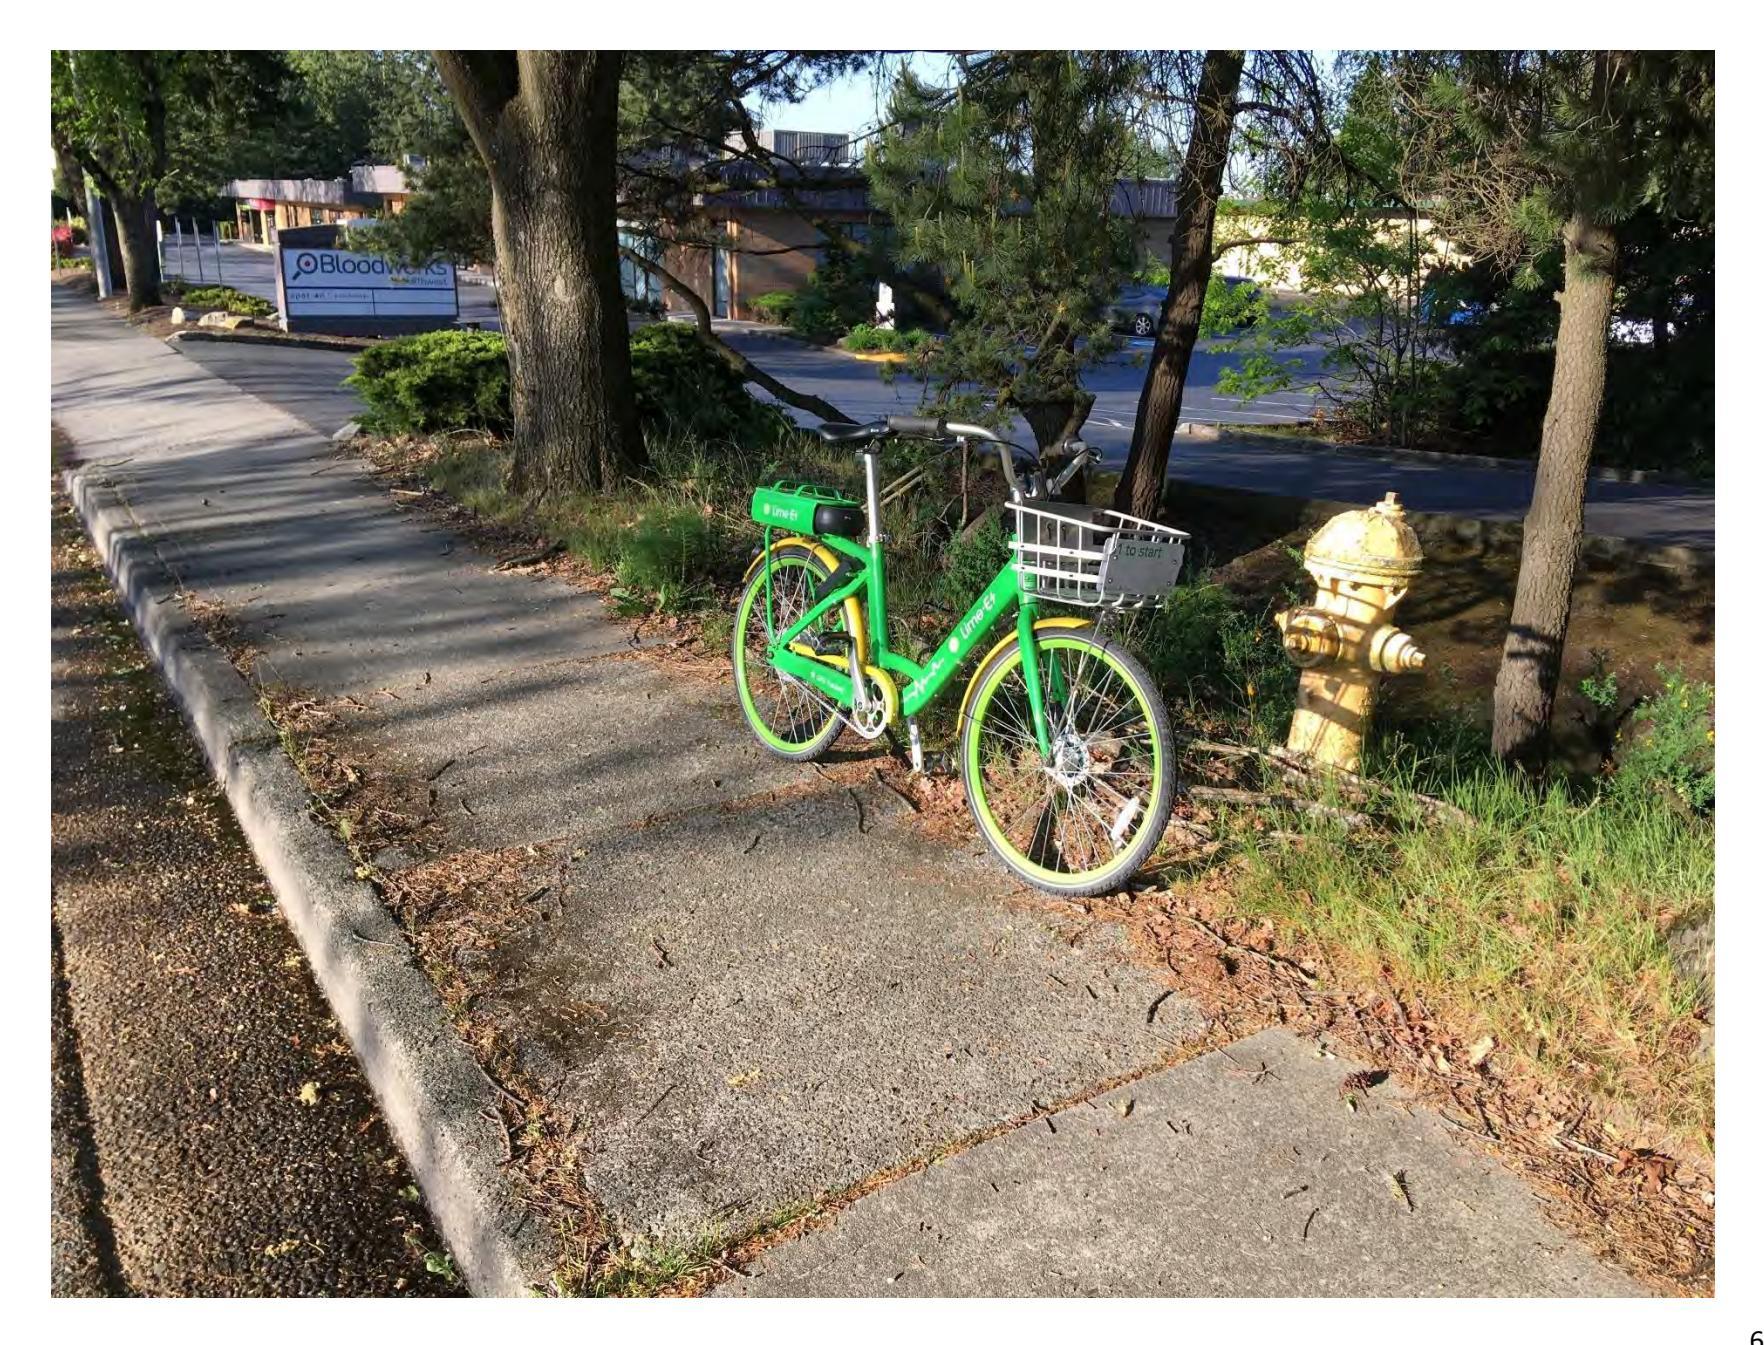
l It's blocking a fire hydron +

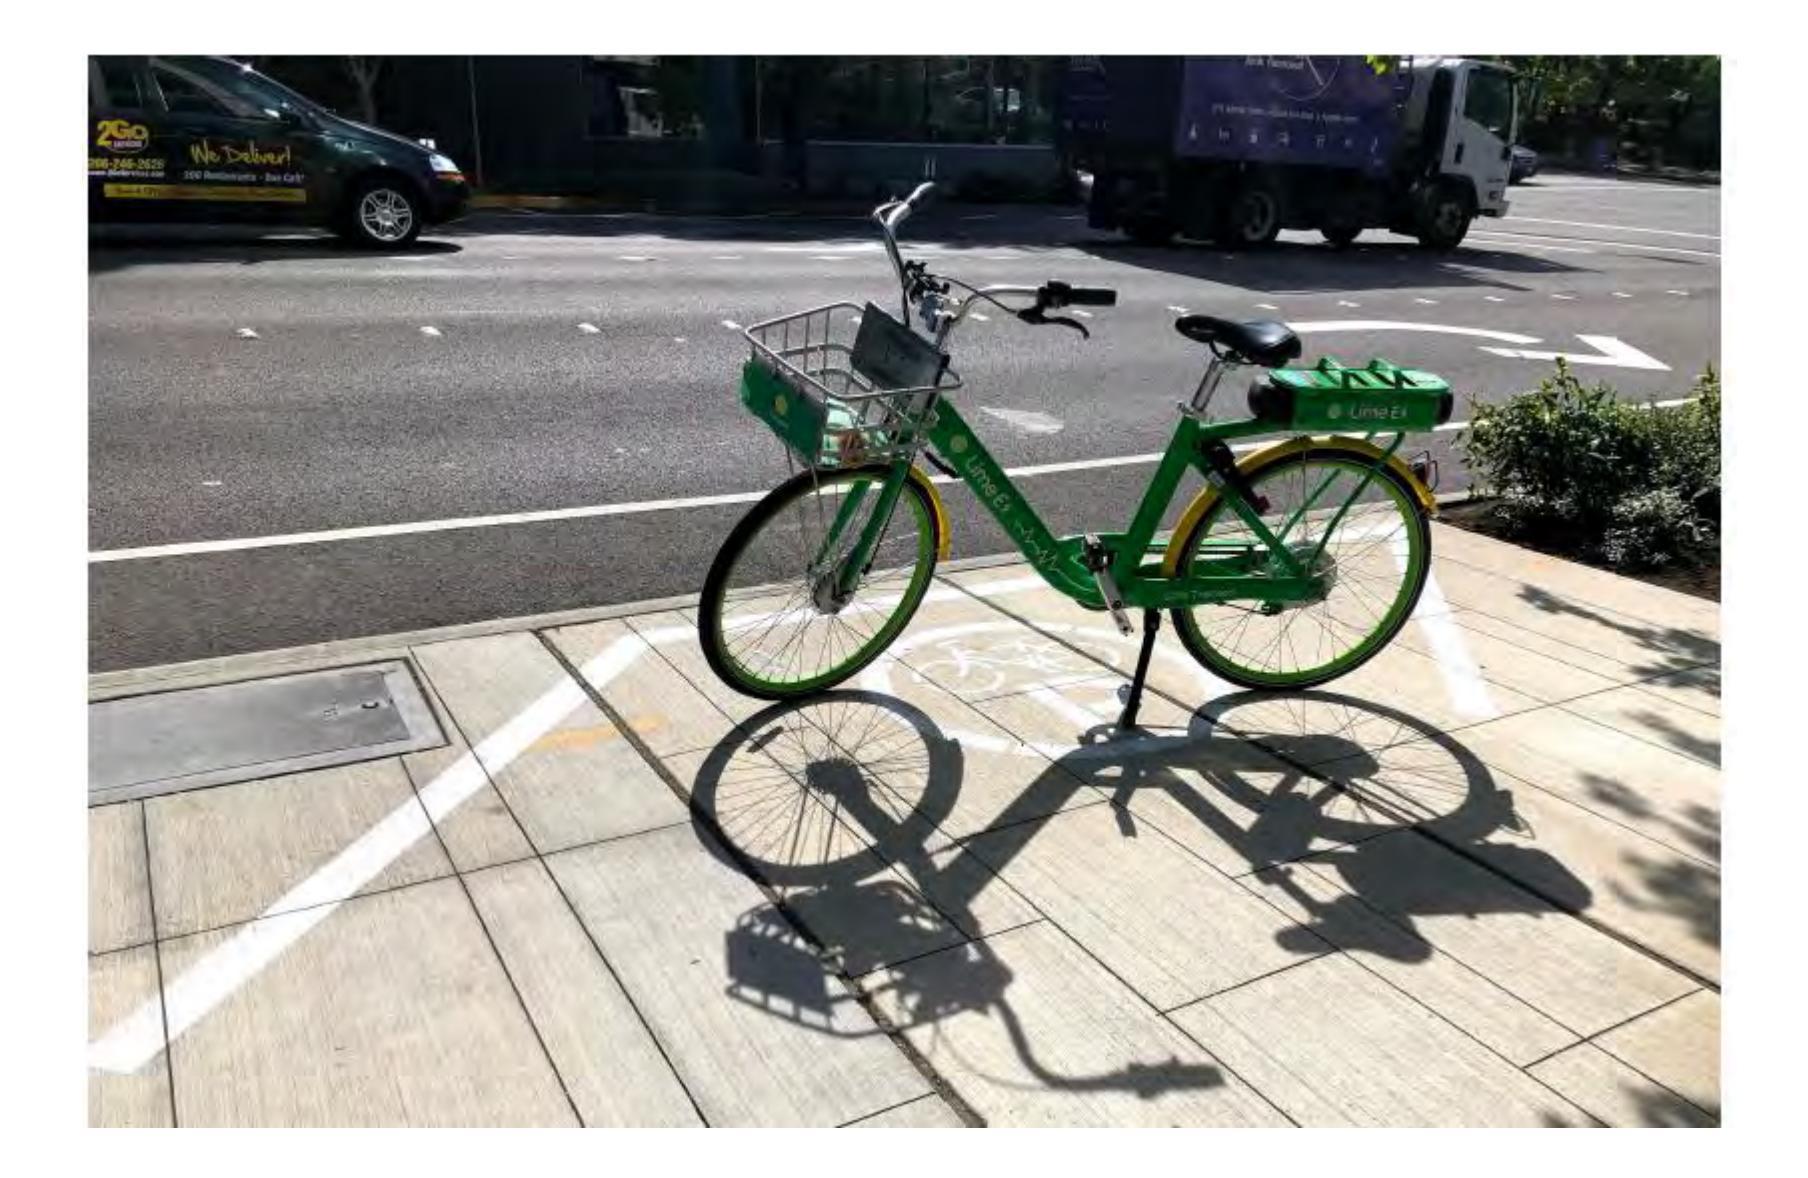
bike is partic hovizontally in the deligned bike hub ithis caused problem for other bike to partie in the future
