**City of Bellevue
Development Services Department
Land Use Staff Report**

Proposal Name: Ludwig Residence Remodel & Addition

Proposal Address: 9921 SE 16th Street, Bellevue, WA 98004

Proposal Description: Proposal to expand an existing single-family residence within a 50-foot top-of-slope buffer from a steep slope critical area. The proposal includes mitigation and restoration planting within the steep slope buffer and steep slope.

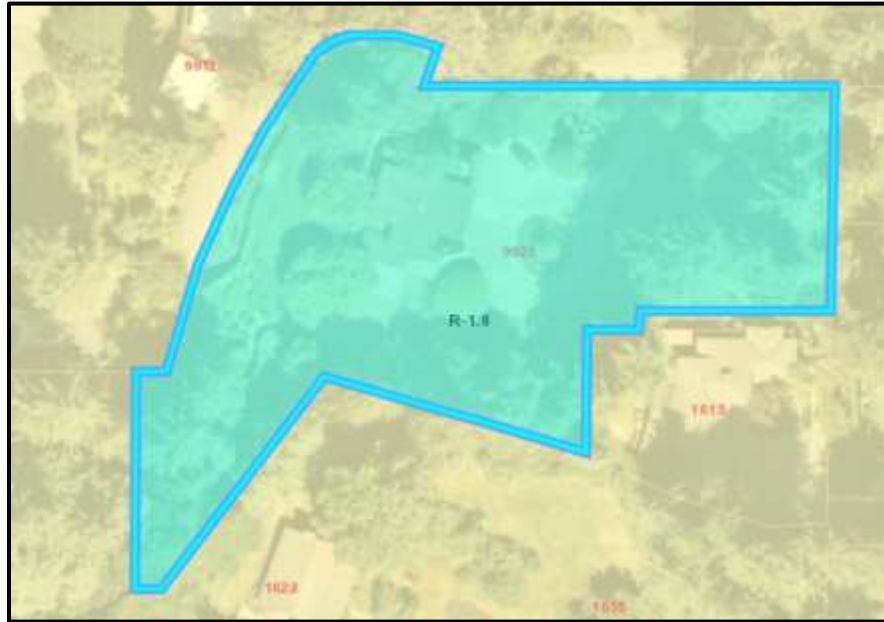
The property is zoned R-1.8, single-family residential. **See Figure 3 for a zoning map.**

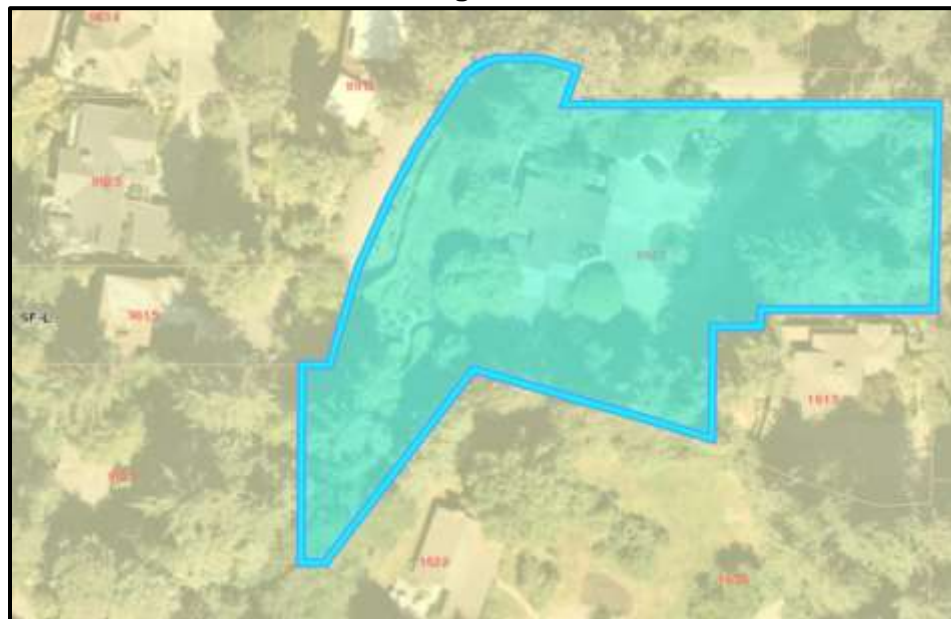
The site has a Comprehensive Plan Land Use Designation of SF-L (Single-Family Low Density) and is surrounded by sites within the same Comprehensive Plan Land Use Designation. **See Figure 4 for Comprehensive Plan Map.**

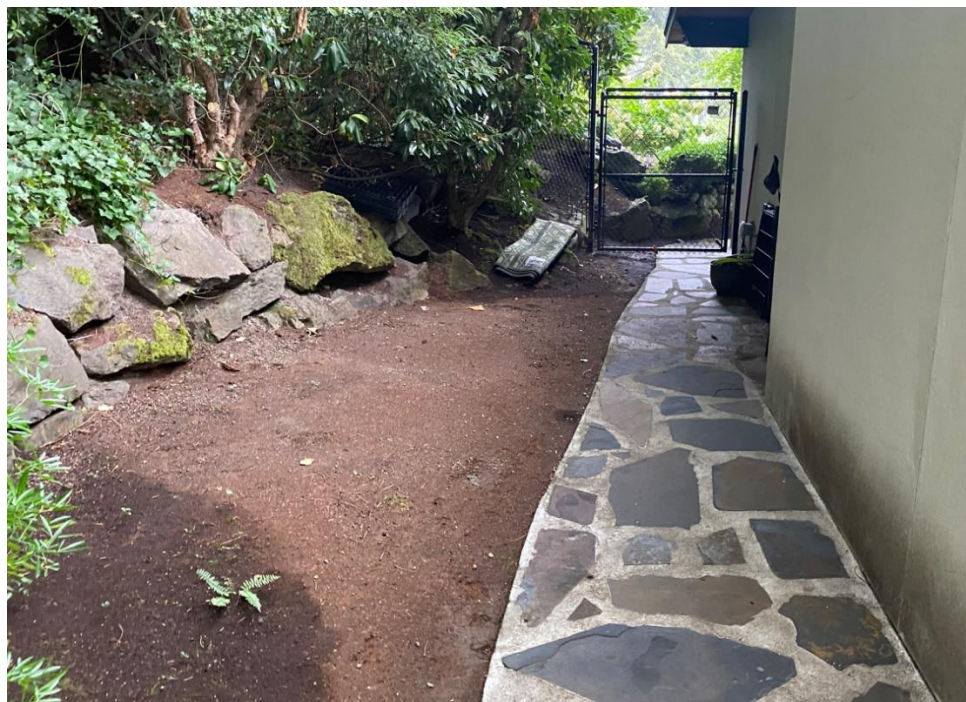
Plate 1. View of the existing conditions on the south side of the house where the proposed addition is planned, looking west.

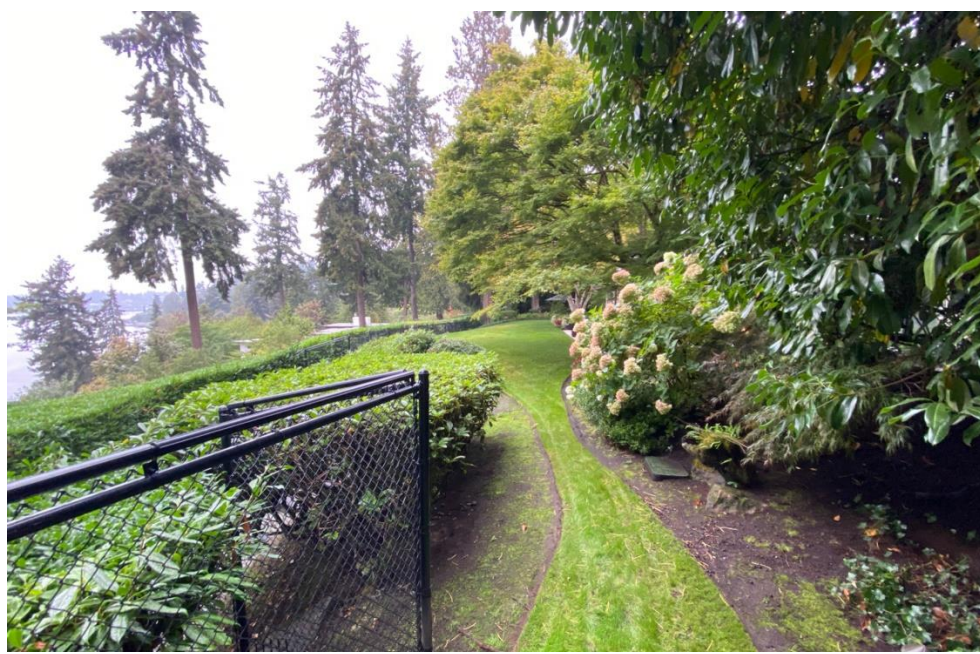
Plate 2. View of the west side of the property near the top of the west-facing slope mapped as steep slope critical area, looking north.

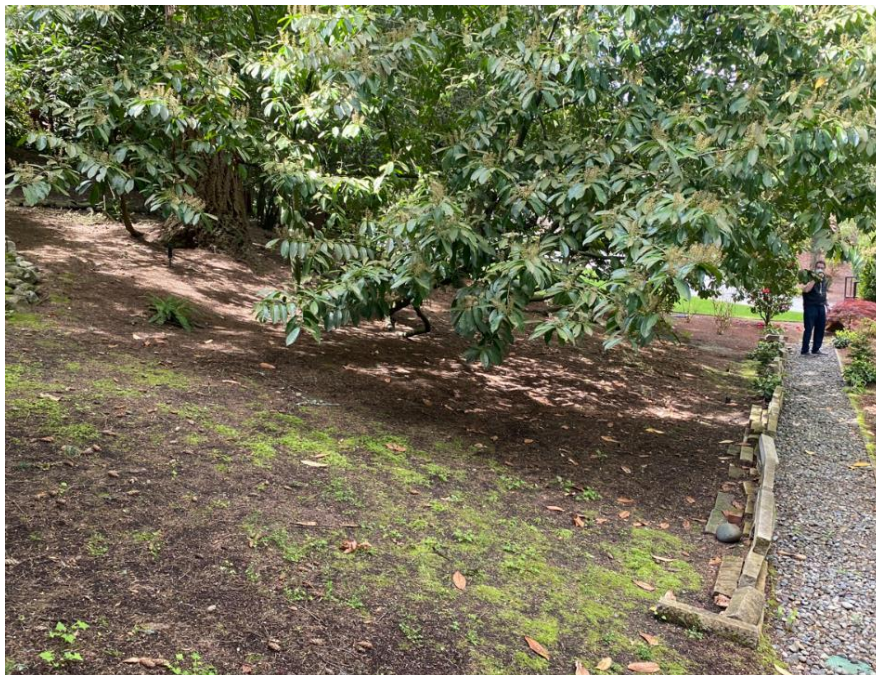
Plate 3. North-facing slope on the east side of the property at the location of the proposed detached carriage house, looking west.

The slope on the east side of the property where the detached carriage house is planned has a grade of about 20 to 25 percent and a vertical relief of about 18 feet. The slope on the south side of the property where the sport court is planned are about 10 to 14 percent with vertical relief of about 6 to 8 feet.

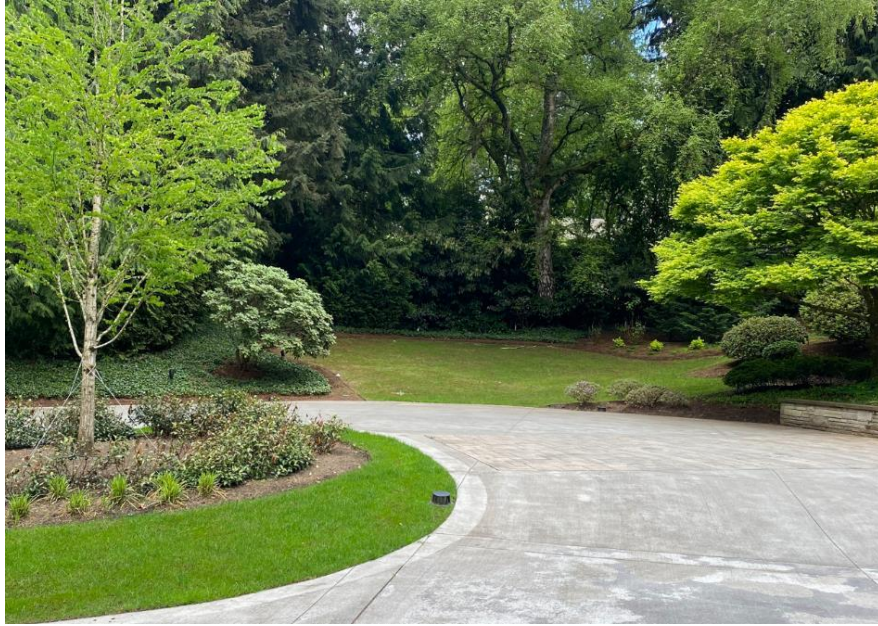
Plate 4. Existing lawn near the southeast corner of the existing house and south side of the roundabout driveway at the proposed sport court location, looking south.

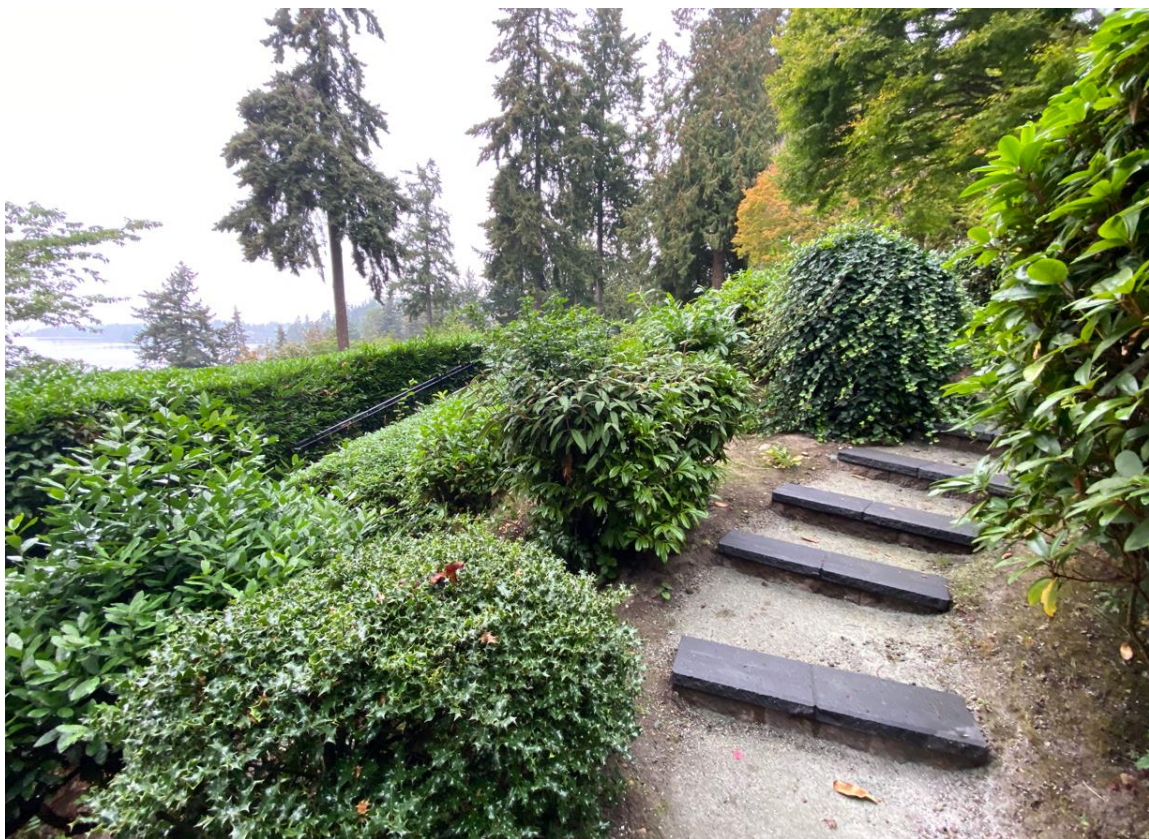
Plate 5. View of the existing conditions along the west slope, looking north.

appeared to be completely covered with mulch and topsoil. We also did not observe signs of erosion on the ground. We did not observe signs of leaning or creep in the vegetation or pathway. Existing trees on the site slopes also appear vertical with no obvious signs of creeping soil (see foreground of Plate 5).

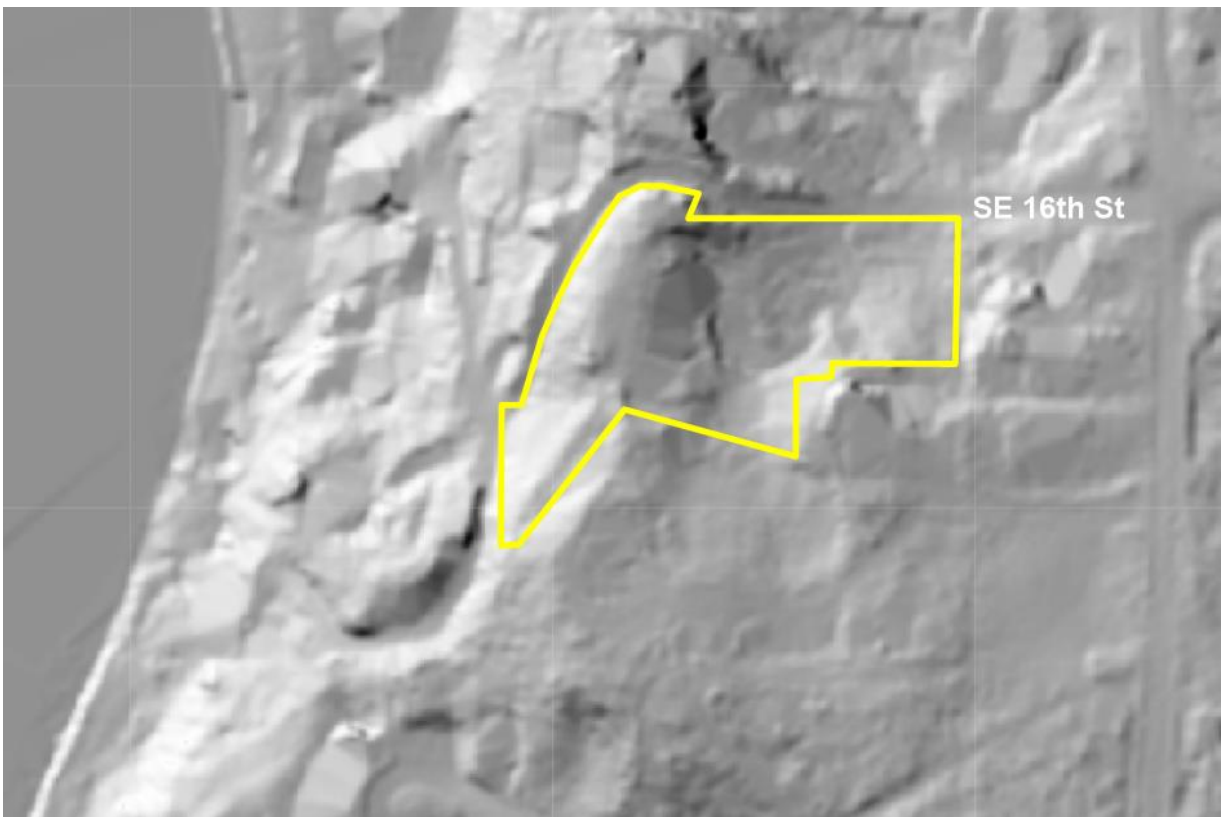
Plate 6. LiDAR image of the project site (Source: WSDNR LiDAR Portal, King County 2016).

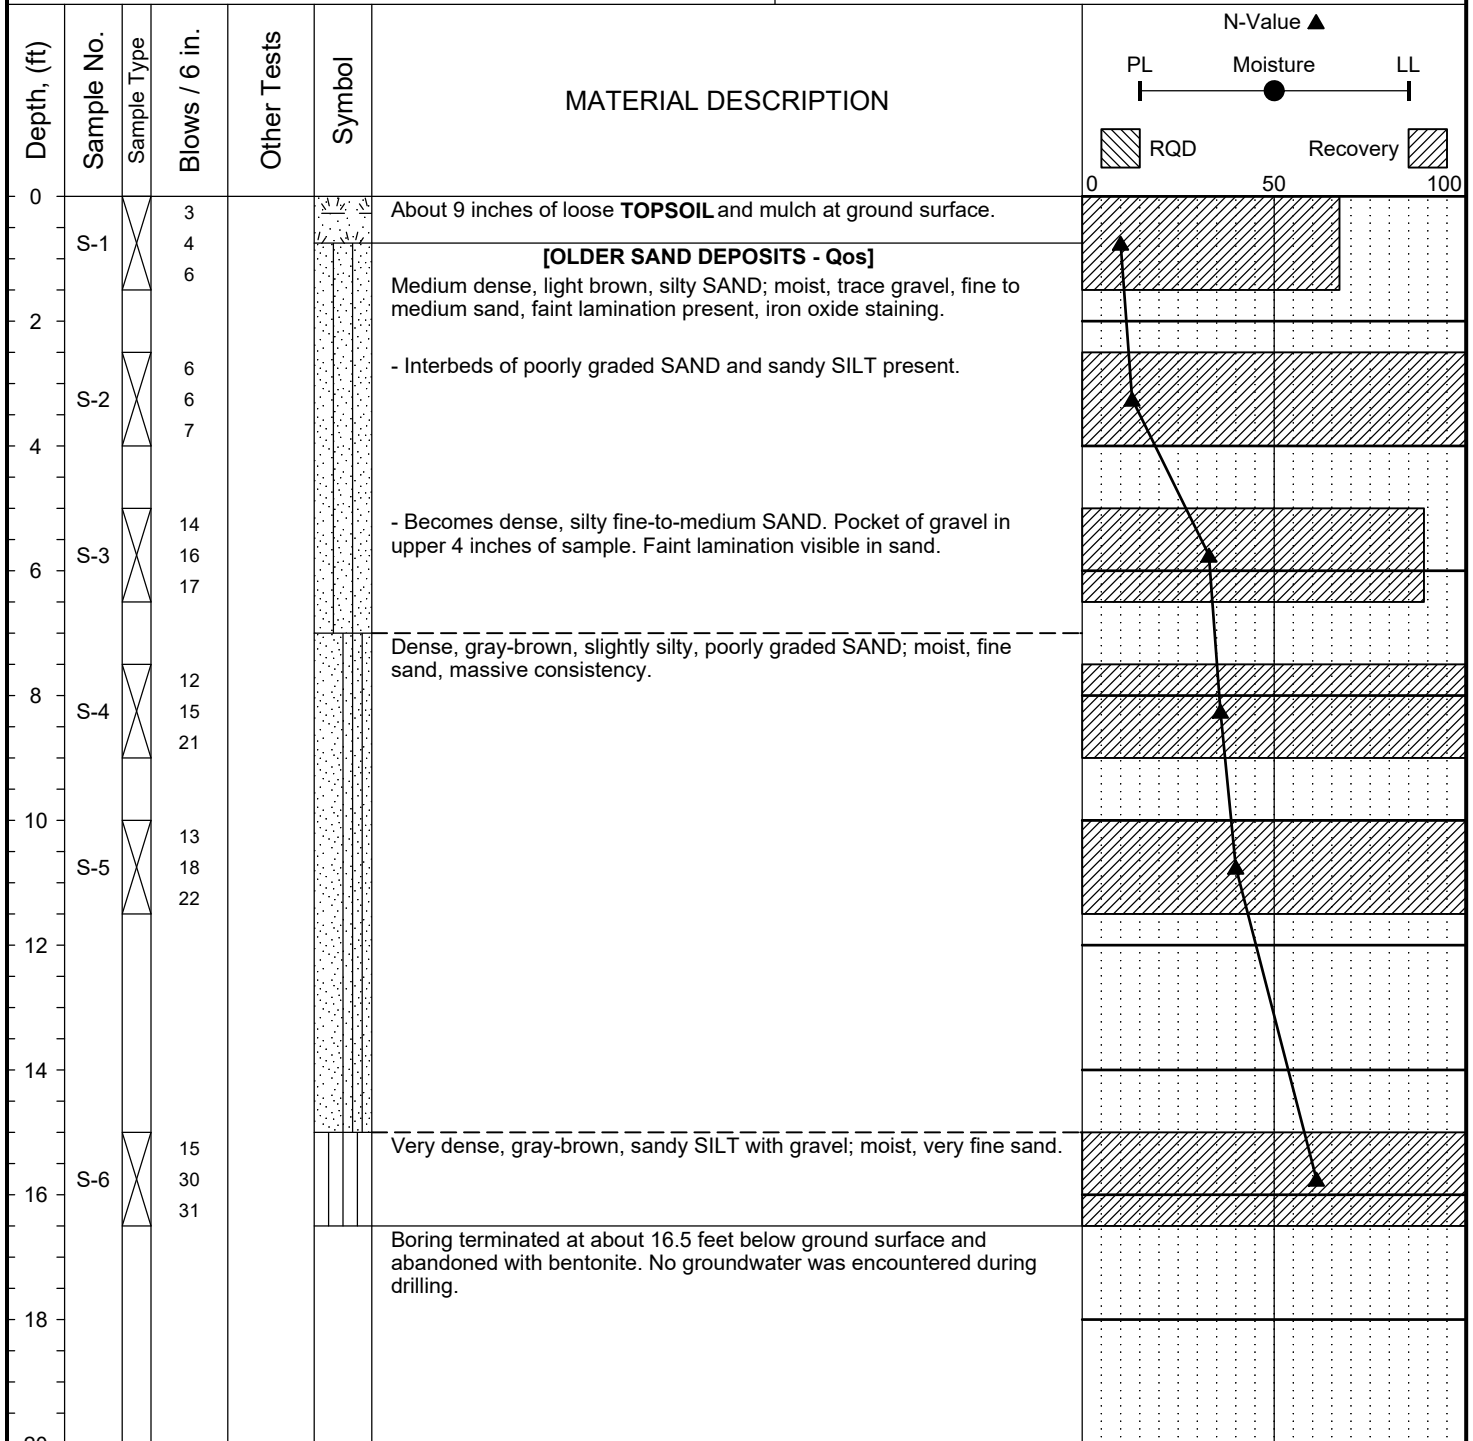
Project:	Ludwig Residence	Surface Elevation:	Approx. El. 118'
Job Number:	22-219	Top of Casing Elev.:	N/A
Location:	9921 SE 16th Street, Bellevue, Washington	Drilling Method:	HSA, Mini Bobcat Track Rig
Coordinates:	Northing: , Easting:	Sampling Method:	SPT, Rope & Cathead

Completion Depth: 16.5ft
 Date Borehole Started: 10/12/22
 Date Borehole Completed: 10/12/22
 Logged By: A. Ong
 Drilling Company: Geologic Drill Partners, Inc.

Remarks: Standard penetration test (SPT) sampler driven with a 140 lb. safety hammer. Hammer operated with a rope and cathead mechanism. The elevations are approximated from the project topographic survey by Terrane, dated 12/15/2021, and measuring from known site features. This information is provided for relative information only and is not a substitution for field survey. **Datum: NAVD88**

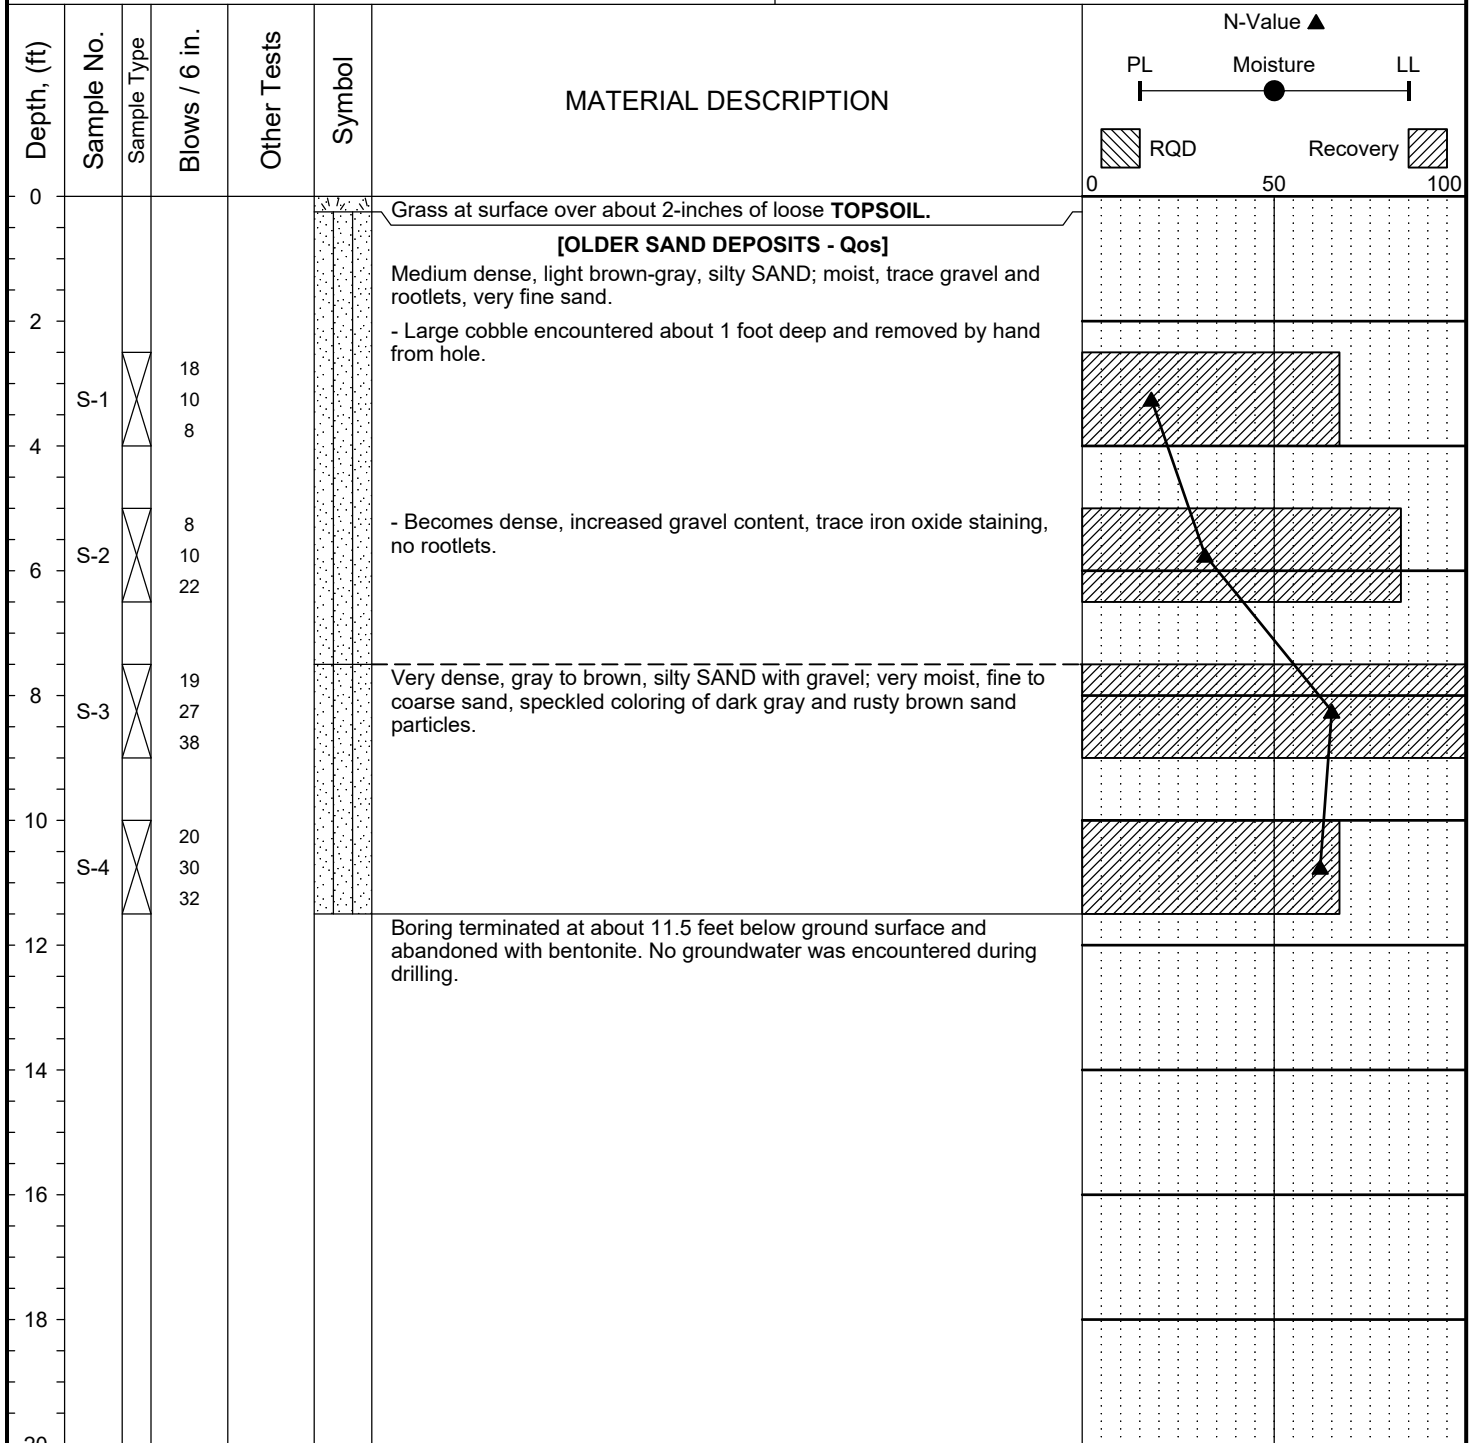
Project:	Ludwig Residence	Surface Elevation:	Approx. El. 109'
Job Number:	22-219	Top of Casing Elev.:	N/A
Location:	9921 SE 16th Street, Bellevue, Washington	Drilling Method:	HSA, Mini Bobcat Track Rig
Coordinates:	Northing: , Easting:	Sampling Method:	SPT, Rope & Cathead

Completion Depth:	11.5ft	Remarks:	Standard penetration test (SPT) sampler driven with a 140 lb. safety hammer. Hammer operated with a rope and cathead mechanism. The elevations are approximated from the project topographic survey by Terrane, dated 12/15/2021, and measuring from known site features. This information is provided for relative information only and is not a substitution for field survey. Datum: NAVD88
Date Borehole Started:	10/12/22		
Date Borehole Completed:	10/12/22		
Logged By:	A. Ong		
Drilling Company:	Geologic Drill Partners, Inc.

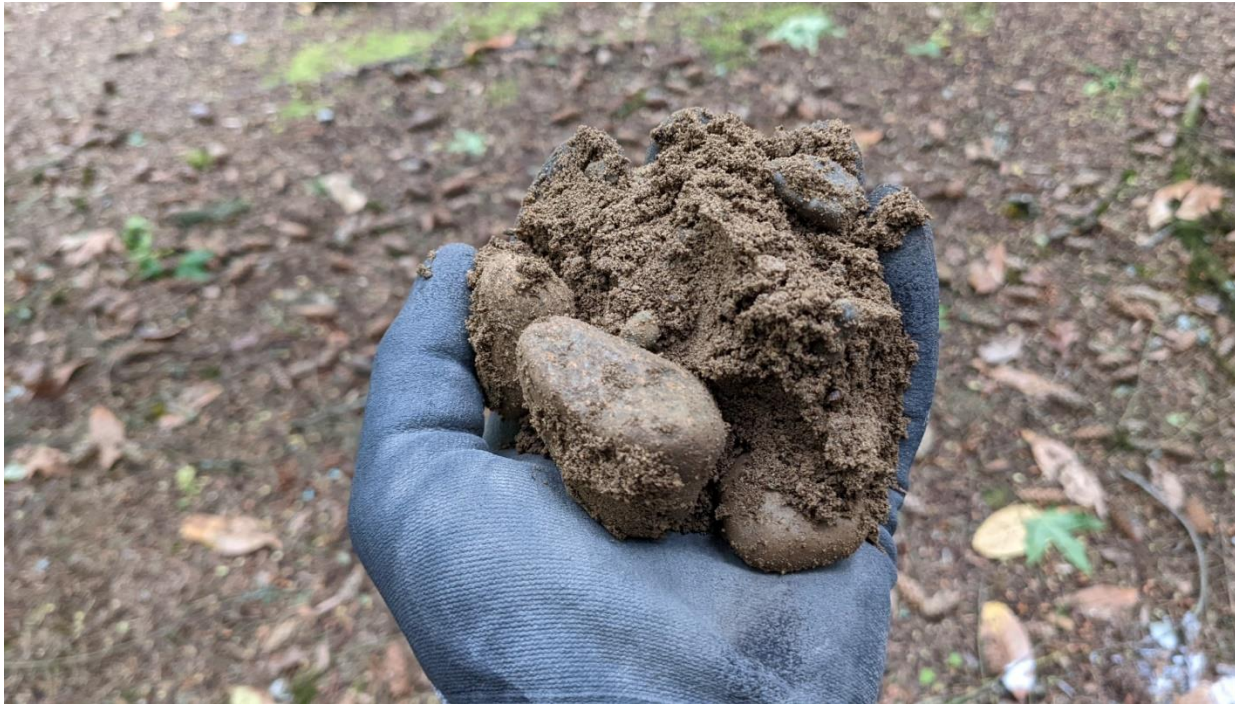
Hand Boring No. HB-1	
Location: 47.596508, -122.2-7992 (WGS84)	
Approximate ground surface elevation: 100 feet (NAVD88)	
<u>Depth (ft)</u>	<u>Material Description</u>
0 – 1/3	Topsoil and forest duff: 4 inches thick
1/3 – 2	Medium dense to dense, light brown, silty SAND with gravel, moist [Weathered Older Sand Deposits - Qos], occasional roots
2 – 2 1/2	Dense to very dense, light brown, slightly silty SAND with gravel, moist [Older Sand Deposits - Qos] - Refusal at approximately 2 1/2 feet

Image of soils encountered approximately 2 feet below the existing ground surface. Groundwater seepage was not observed during excavation.	
Logged by: J. Manke

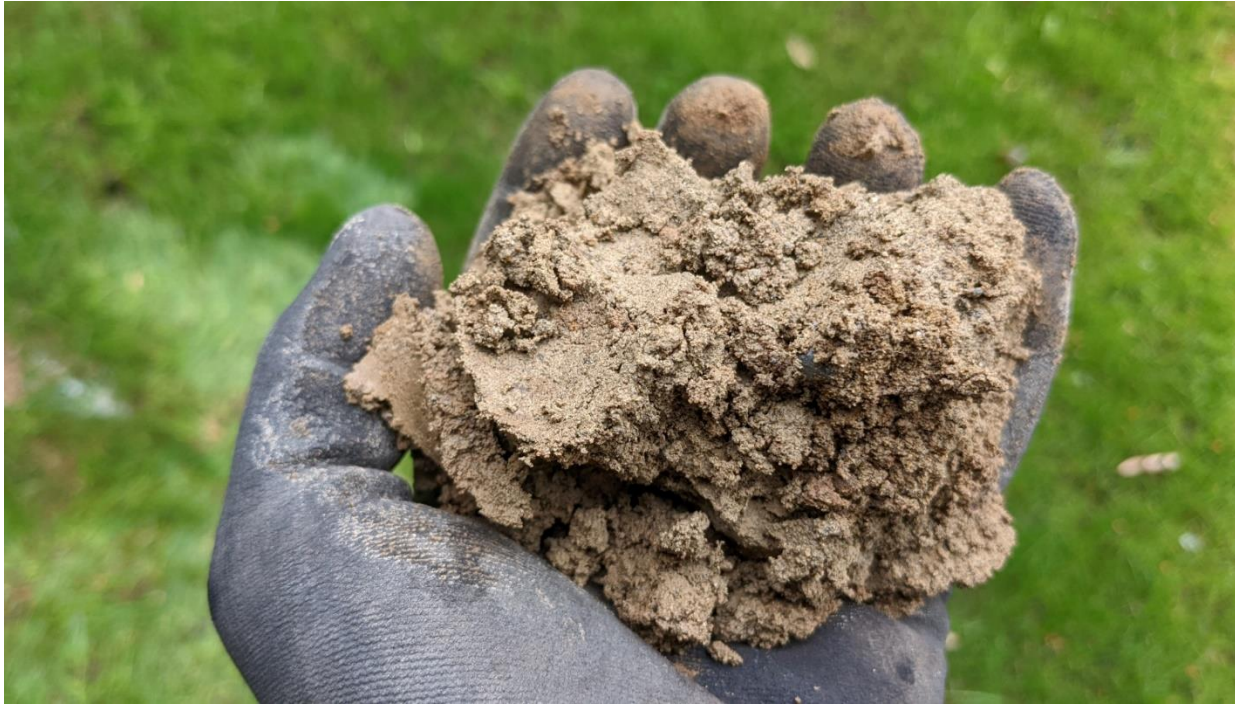
Hand Boring No. HB-2	
Location: 47.596258, -122.208422 (WGS84)	
Approximate ground surface elevation: 108 feet (NAVD88) 47.596483, -122.207925	
<u>Depth (ft)</u>	<u>Material Description</u>
0 – ¼	Grass and topsoil: 3 inches thick
¼ – 3½	Medium dense, light brown, silty SAND with trace gravel, moist [Weathered Older Sand Deposits - Qos] , occasional roots
3½ – 4	Dense to very dense, light brown, slightly silty SAND with gravel, moist [Older Sand Deposits - Qos] - Refusal at approximately 4 feet

Image of soils encountered approximately 2 feet below the existing ground surface. Groundwater was not encountered at the time of excavation.

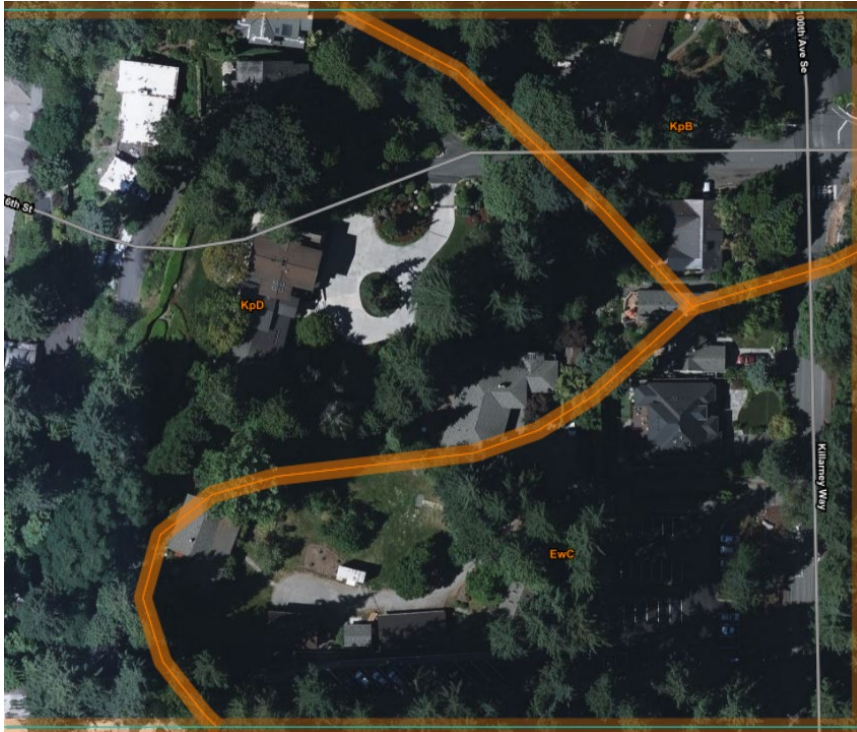
Figure 3. The soil profile on-site (Web Soil Survey).

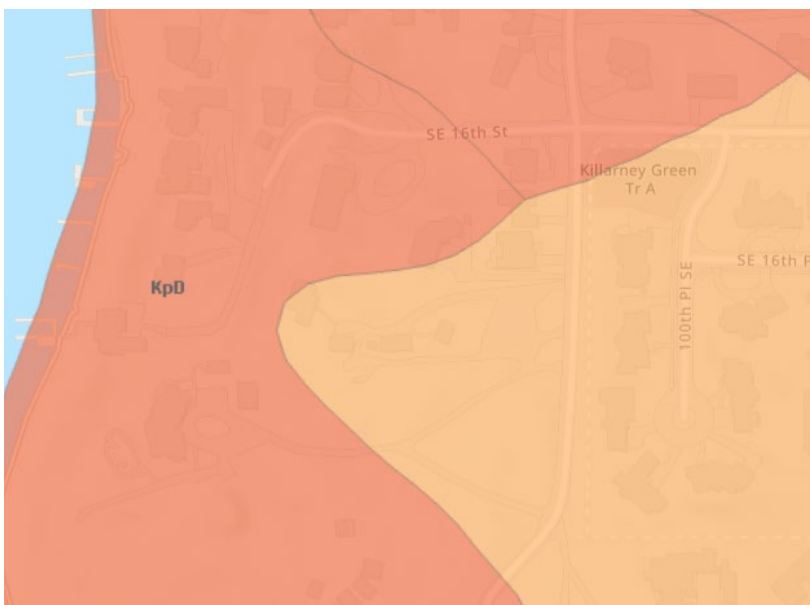
Figure 4. Soil types on site, from the City of Bellevue maps.

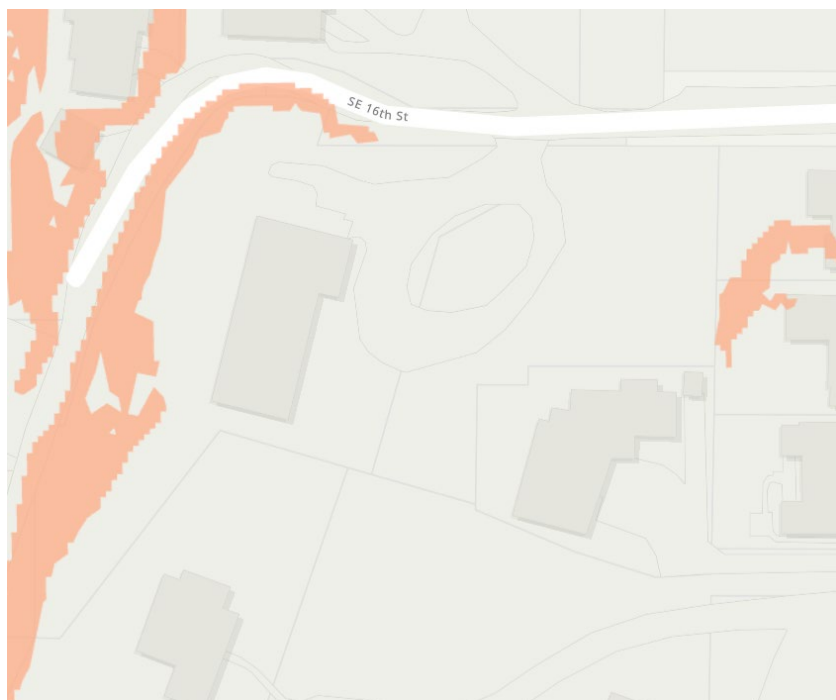
Figure 5. Steep slopes on-site from the City of Bellevue. Red indicates steep slope areas.

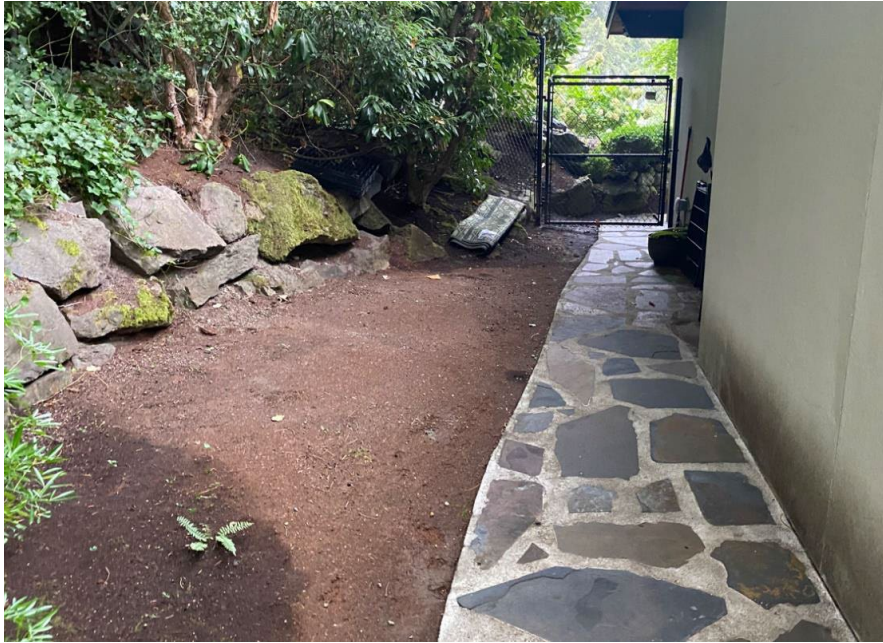
Figure 7. View of the existing conditions on the south side of the house where the proposed addition is planned, facing west.

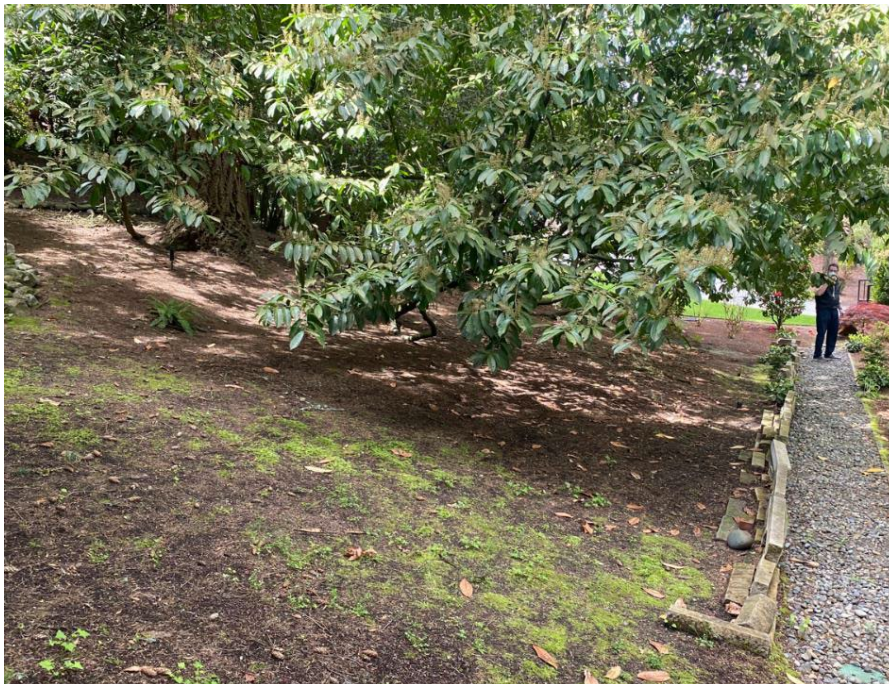
Figure 8. North-facing slope on the east side of the property at the location of the proposed Guest Cottage, facing west.

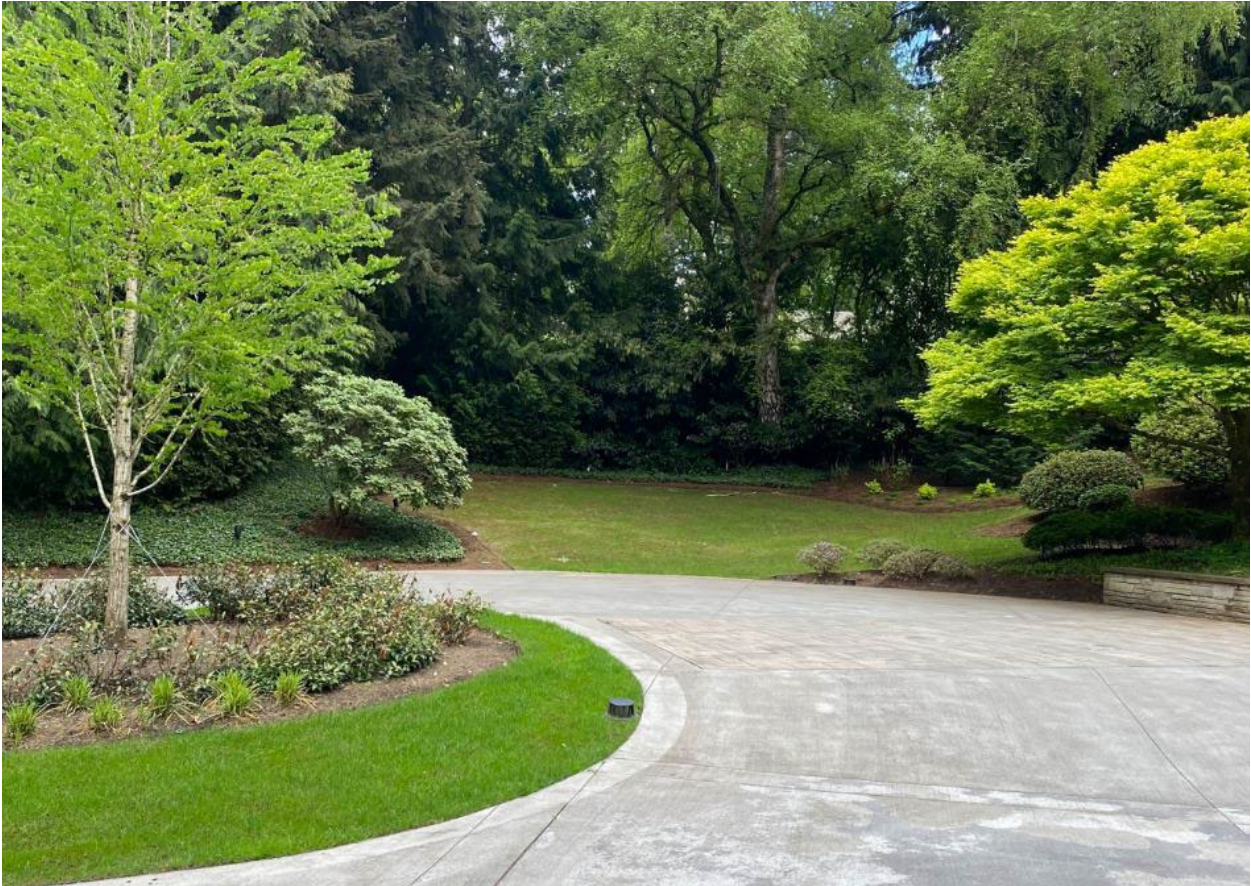
Figure 9. Existing lawn area near the southeast corner of the existing house and south side of the roundabout driveway at the proposed sport court location, facing south.
